Post-tensioned Multistrand Anchorage Capacity Deterioration Due To Corrosion: John Day Lock Project

by Robert Ebeling, Richard Haskins, David Scofield, John Hite, and Ralph Strom

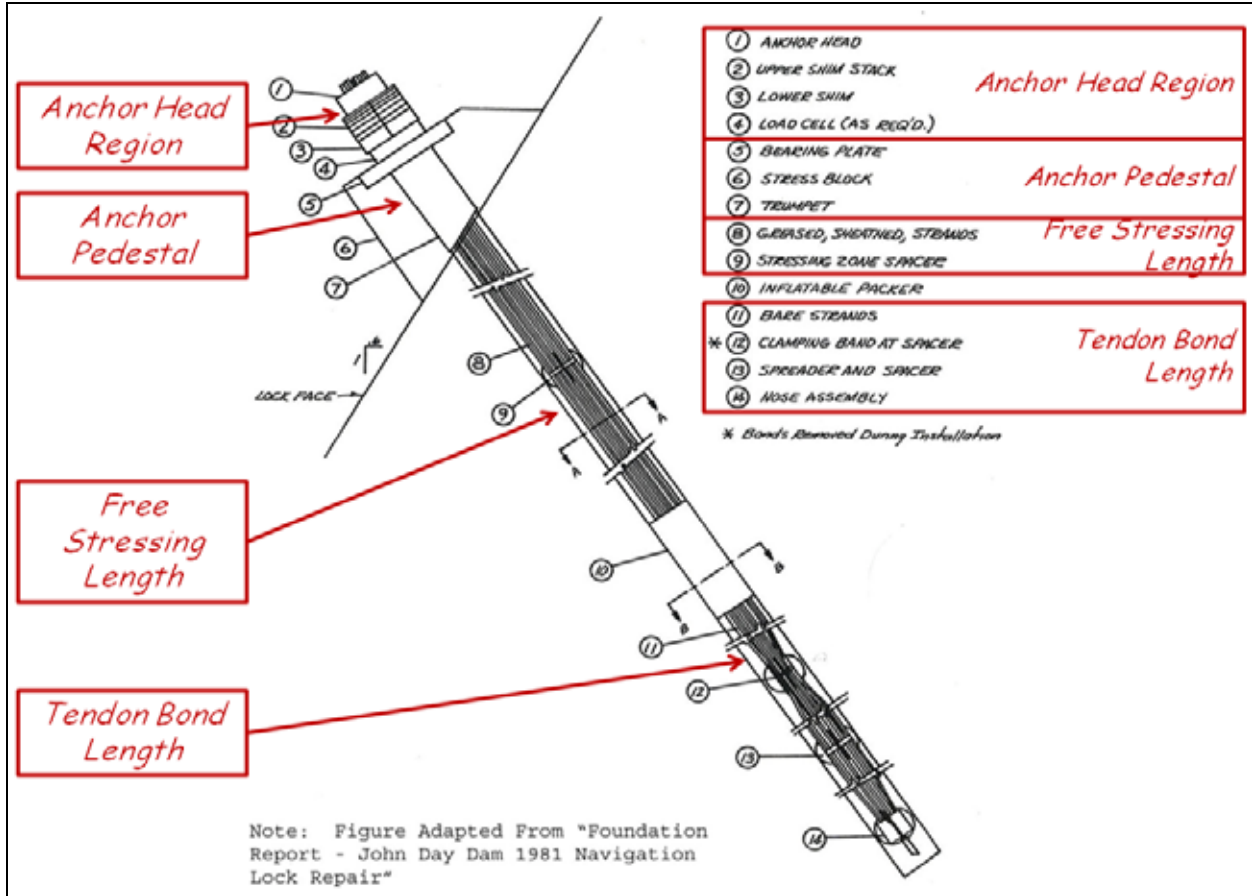
Figure 2. Three stage anchorage system used at John Day Lock.

The original lock-off load for the anchors at the time of installation (1981) was 1,518 kips per anchor. Three-stage grouting was used at the time of installation. Single-stage grouting is preferred today. Figure 2 shows some of the details of the anchors used at John Day Lock. There are individual sheaths around each strand in the free length (i.e., stretch zone of the anchor) in which load transfer does not take place. It is important to observe that the anchor wire was bare strand in the bonded zone contained within the basalt rock below the lock (detail 11 in Figure 2). At the time of initial anchor installation, seepage was observed coming out the top(s) of some anchors. The anchor heads were inspected from 1981 through 1995 and no broken strands were found. The inspections were halted in 1995.
