TECHNICAL REPORT S-74-8

COMPARATIVE PERFORMANCE OF STRUCTURAL LAYERS IN PAVEMENT SYSTEMS

DESIGN, CONSTRUCTION, AND BEHAVIOR UNDER TRAFFIC OF PAVEMENT TEST SECTIONS

U. S. Army Engineer Waterways Experiment Station

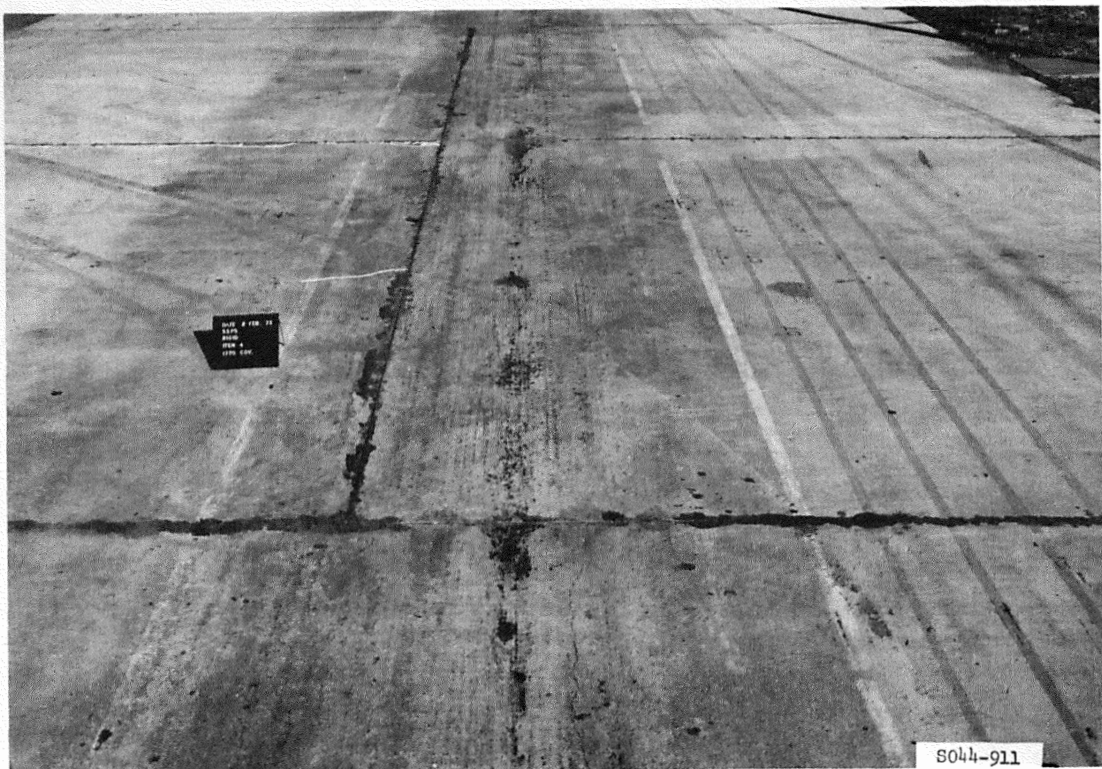
Figure A18. Item 4, lane 1, rigid pavement test section, after 1770 coverages by 200-kip twin-tandem assembly

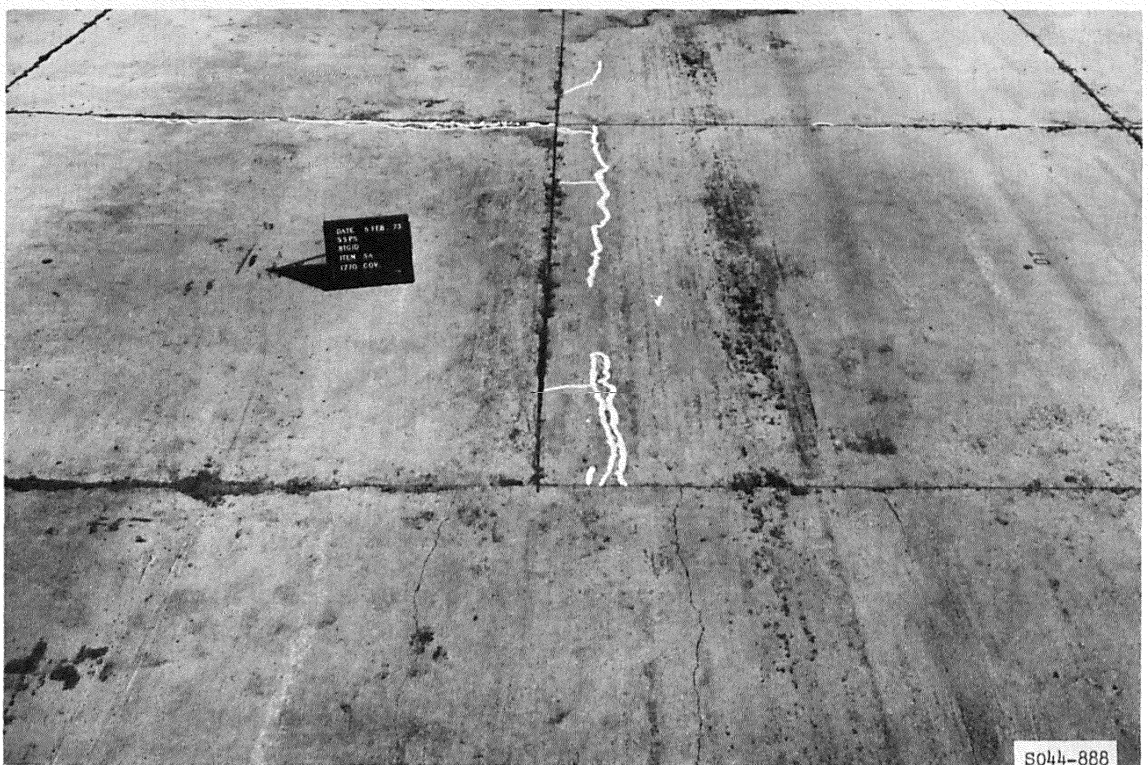
Figure A22. Subitem 5a, lane 1, rigid pavement test section, after 1770 coverages by 200-kip twin-tandem assembly

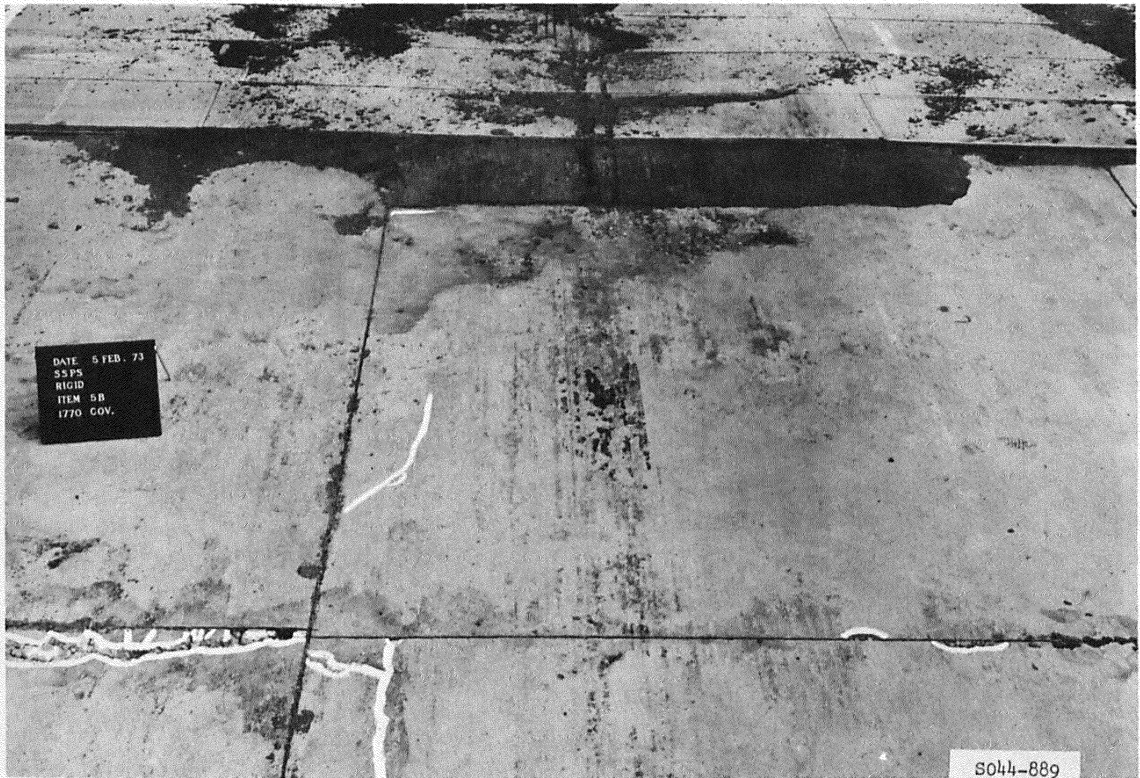
Figure A25. Subitem 5b, lane 1, rigid pavement test section, after 1770 coverages by 200-kip twin-tandem assembly

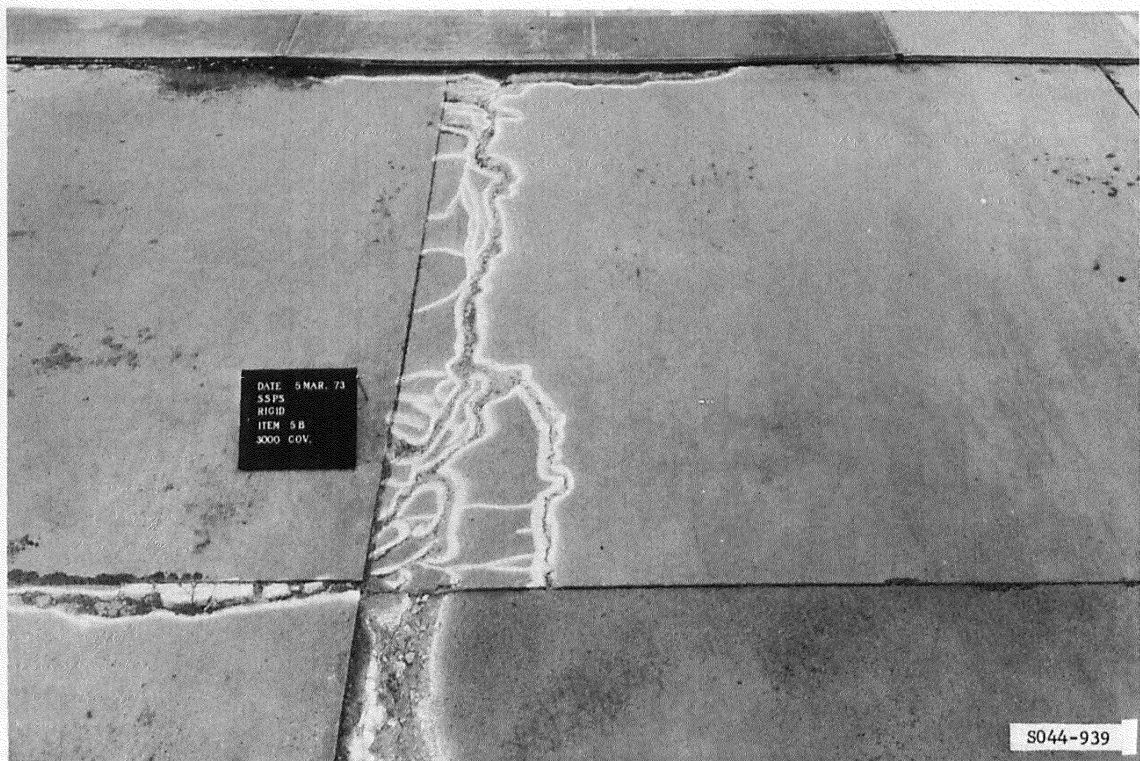
Figure A26. Subitem 5b, lane 1, rigid pavement test section, after 3000 coverages by 200-kip twin-tandem assembly

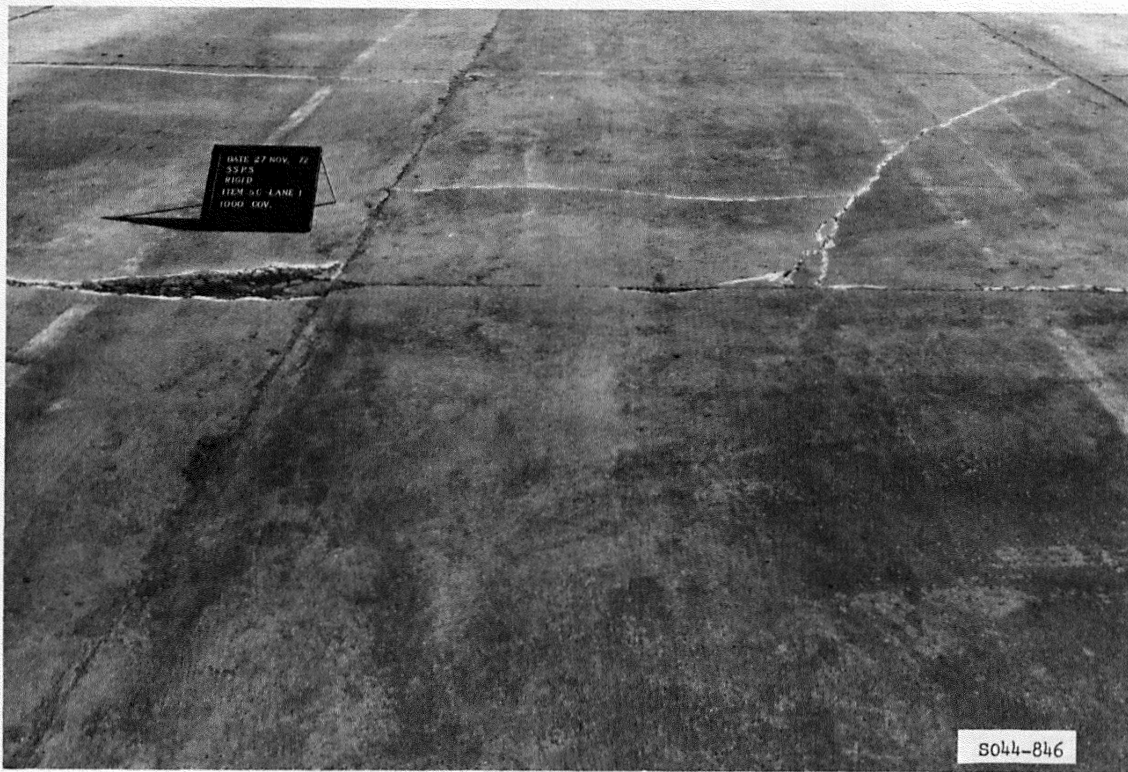
Figure A27. Subitem 5c, lane 1, rigid pavement test section, after 1000 coverages by 200-kip twin-tandem assembly

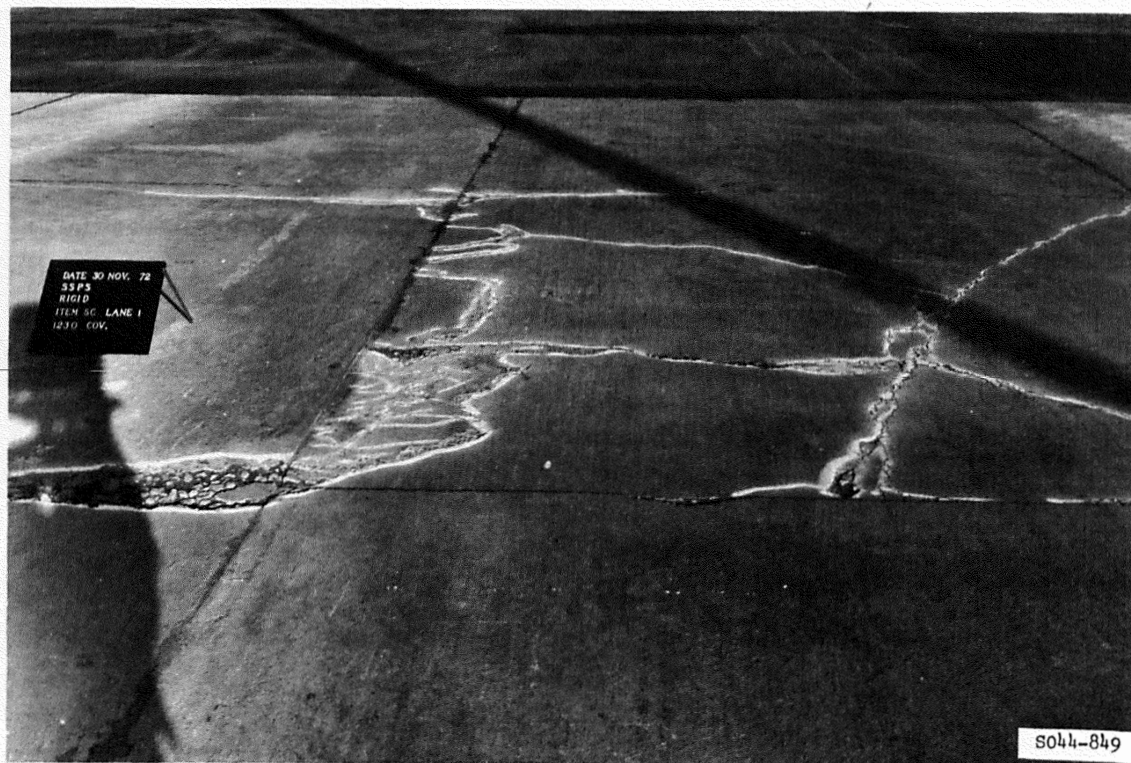
Figure A28. Subitem 5c, lane 1, rigid pavement test section, after 1230 coverages by 200-kip twin-tandem assembly

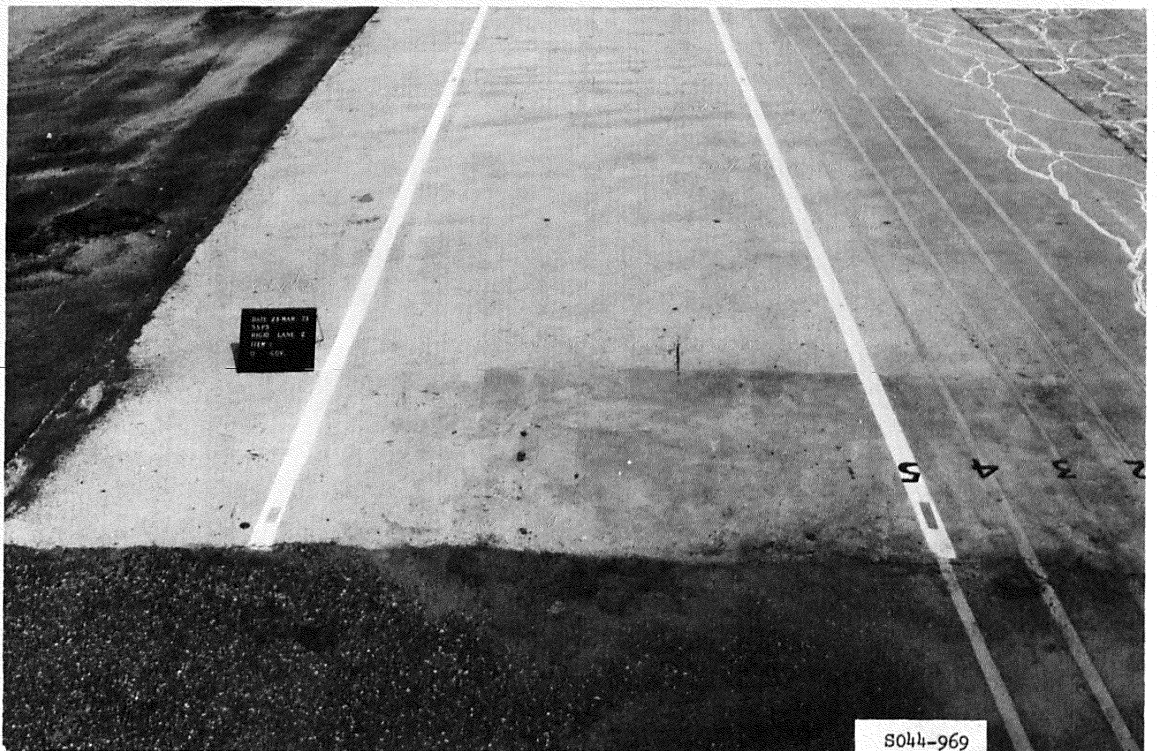
A general view of item 1 prior to traffic is shown in Figure A31. No cracks were observed in the pavement surface prior to static loading for instrumentation readings, but, during static loading, several cracks developed in the item (Figure A32). Cracks continued to develop with the application of traffic, and, at 200 coverages, cracking was heavy at the west end and moderate at the east end of the item (Figure A33). Traffic was continued, and, at 430 coverages, severe cracking had developed at the west end of the item. Landing mat was placed over the area, and traffic was continued to 1010 coverages. At 1010 coverages, cracking had become severe over the entire item (Figure A34), and the item was considered to have reached the complete failure condition. Permanent deformation of the pavement is shown in the cross sections in Figure A35. The west end of the item is not included in the profiles because the polypropylene used to encase the lean clay was torn, probably during

construction, and the lean clay became wet causing a premature failure in about 10 ft of the extreme west end. The large deformation at the east end of the item was probably due to a load transfer failure where the fibrous-reinforced concrete slab joined the transition slab. Permanent deformation in the traffic lane, not including the two ends, averaged 0.5 in. with a maximum deformation of 0.7 in. A slight upheaval (0.3 in.) of the pavement surface occurred outside the traffic lane at the north edge of the pavement.

Figure A31. Item 1, lane 2, rigid pavement test section, prior to traffic

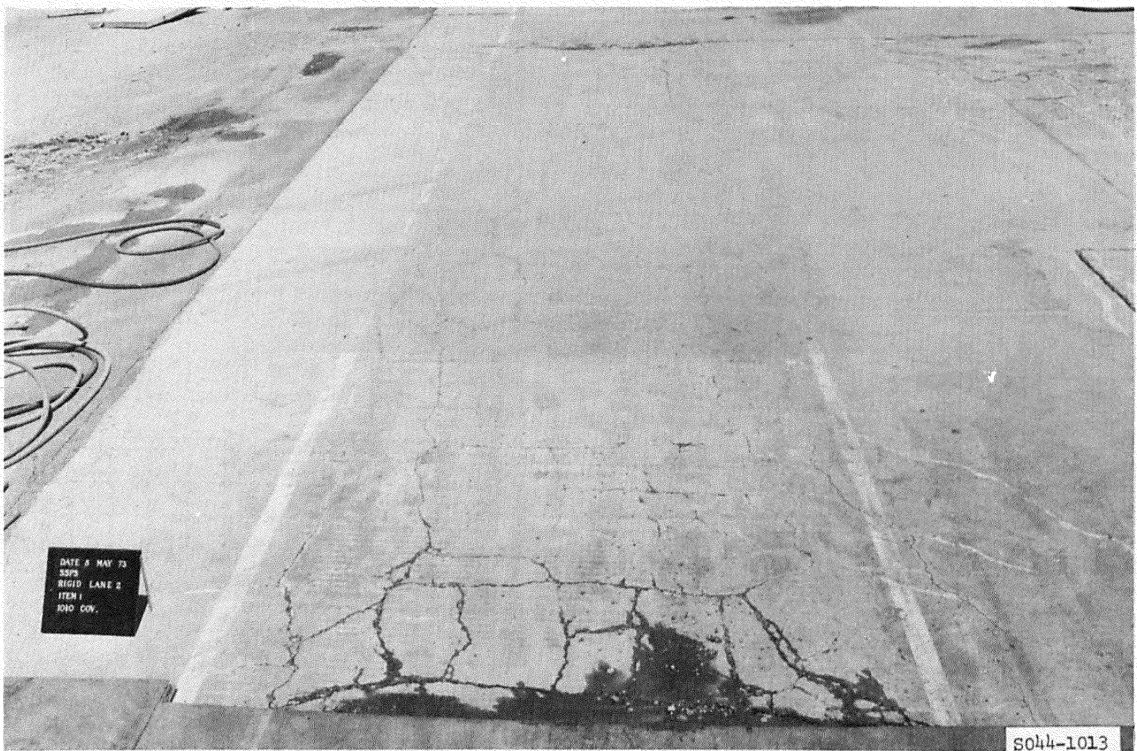
Figure A34. Item 1, lane 2, rigid pavement test section, after 1010 coverages by 240-kip twin-tandem assembly

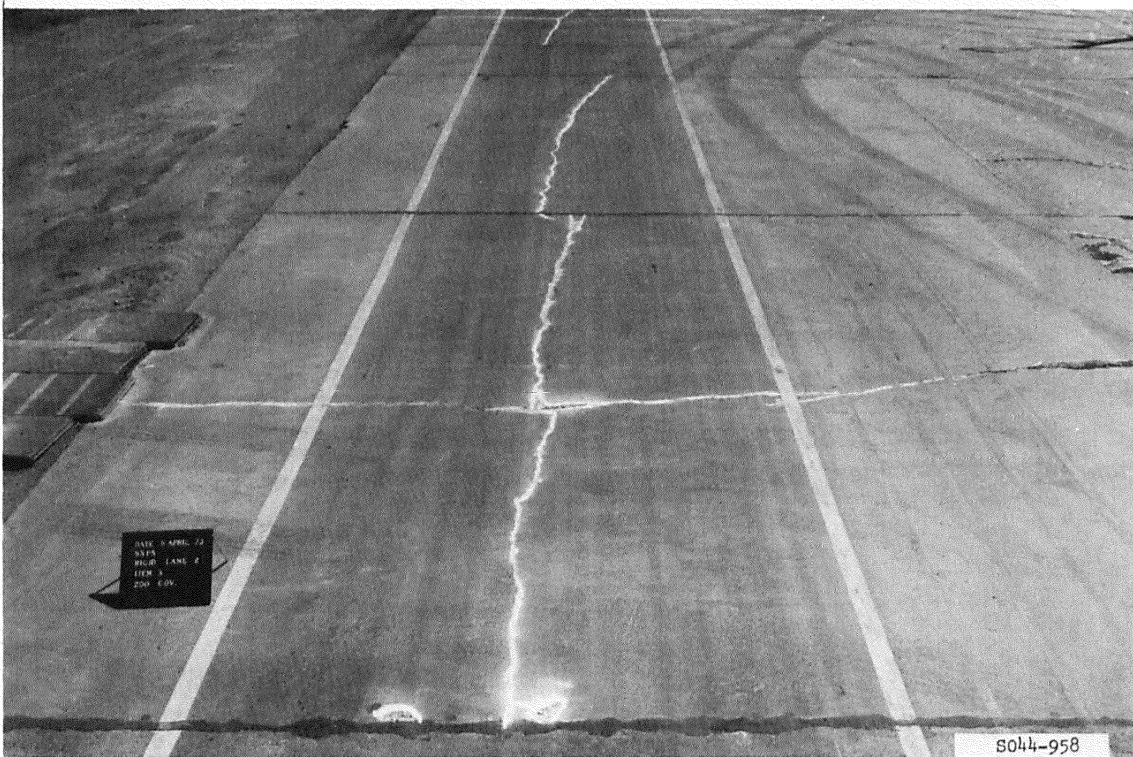
crack developed in the center of the traffic lane. After 200 coverages, these were the only cracks in the item except for minor spalling at the west transition slab (Figure A41). Traffic was continued to 1200 coverages on the west half of the item and to 1500 coverages on the east half of the item, with severe spalling occurring along the crack paths and at transverse joints (Figure A42). The progression of cracks with the application of traffic is shown in Figure A32. Cross sections of the pavement surface at selected intervals of traffic are shown in Figure A43. These profiles show that an average of 0.13 in. of permanent deformation occurred in the traffic lane during the application of traffic.

Figure A41. Item 3, lane 2, rigid pavement test section, after 200 coverages by 240-kip twin-tandem assembly

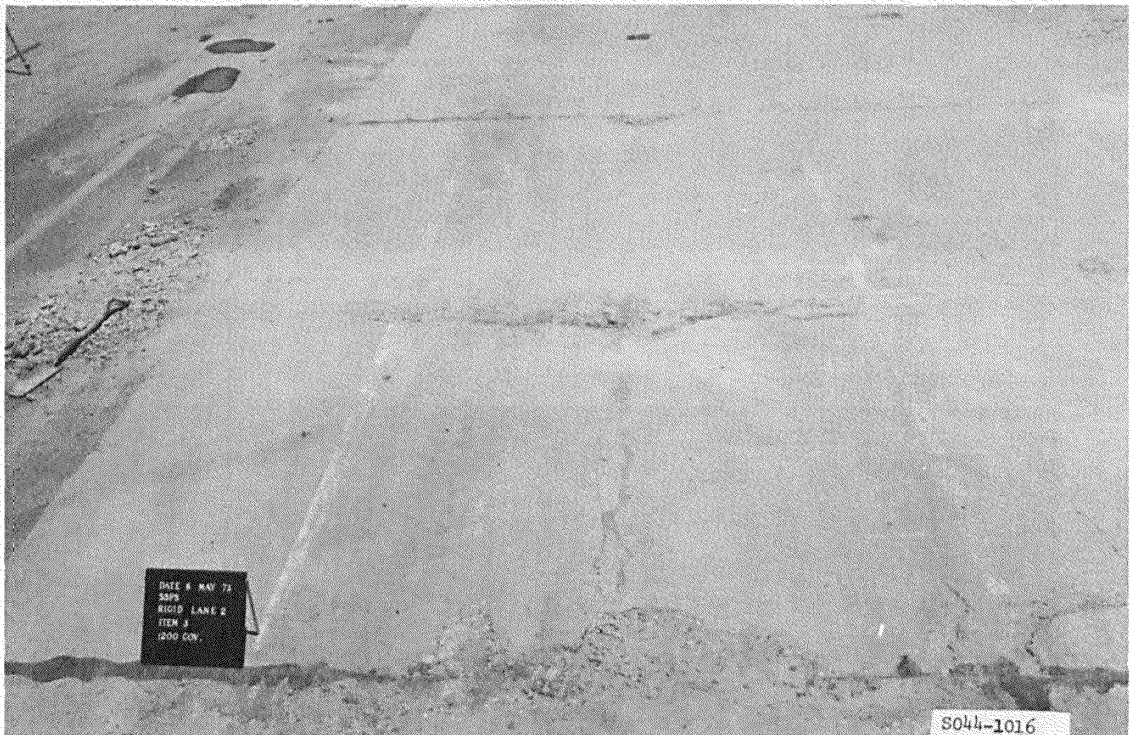
Figure A42. Item 3, lane 2, rigid pavement test section, after 1200 coverages by 240-kip twin-tandem assembly

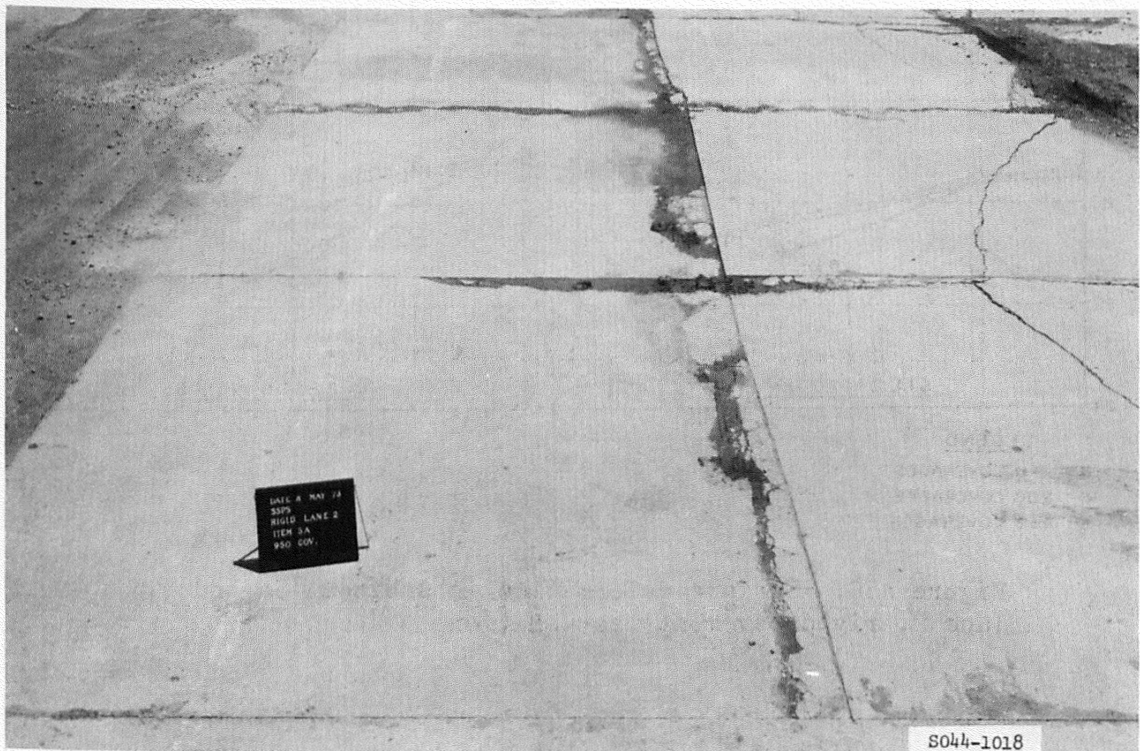
Figure A49. Subitem 5a, lane 2, rigid pavement test section, after 950 coverages by 240-kip twin-tandem assembly

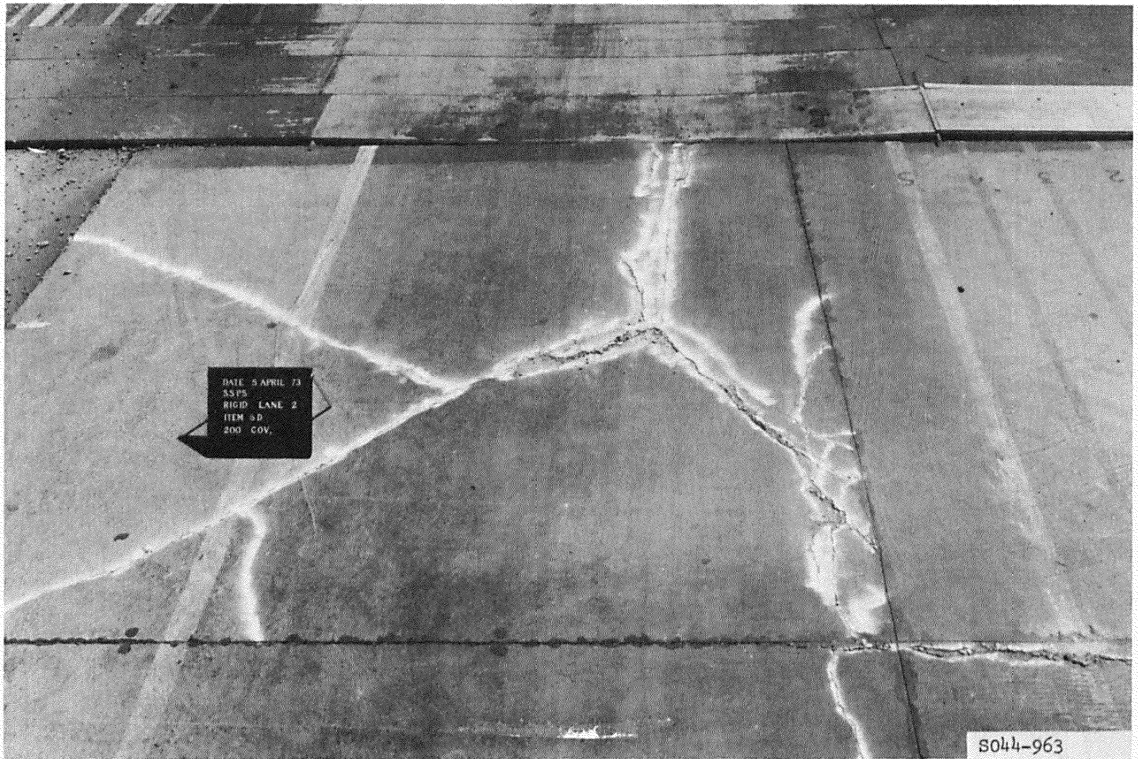
Figure A56. Subitem 5d, lane 2, rigid pavement test section, after 200 coverages by 240-kip twin-tandem assembly

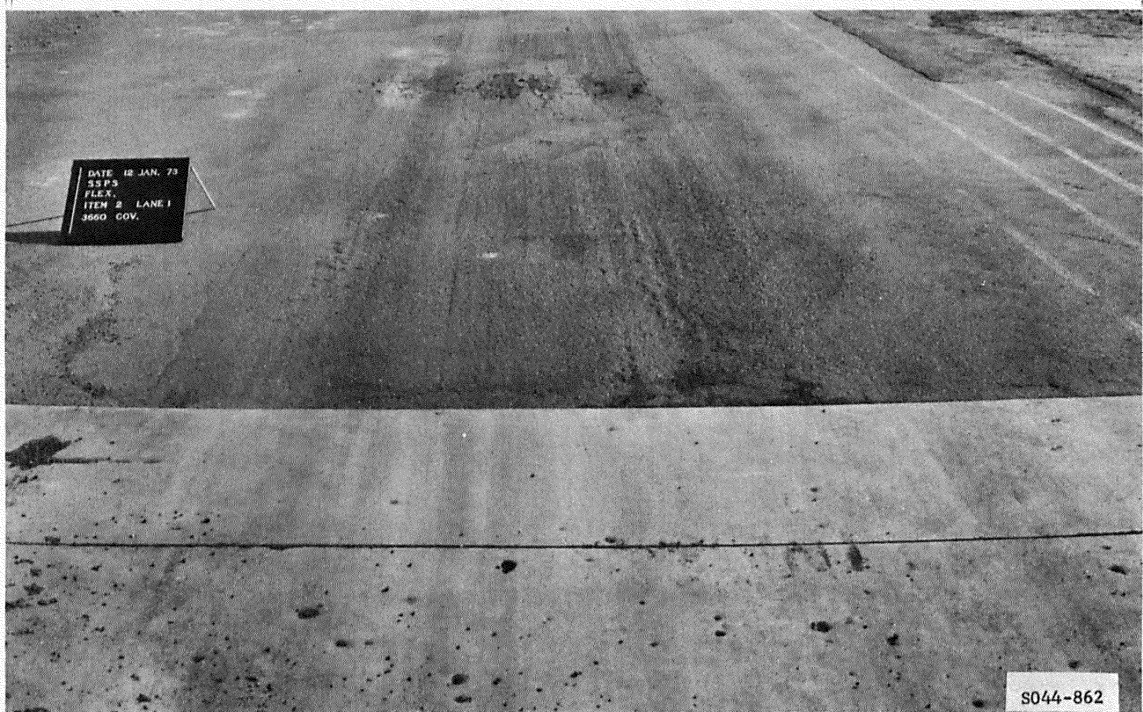
A general view of item 2 prior to traffic is shown in Figure B4. At 1200 coverages, a few transverse hairline cracks were observed near the center of the item where the instrumentation gages were installed. As traffic was continued on the section, the transitions at each end of the item failed and were covered with landing mat in order to continue traffic. At 2500 coverages, cracking around the instrumentation grid had increased (Figure B5); cores taken showed that the cracks were not completely through the asphaltic concrete. The item was considered failed at 3660 coverages, with cracks penetrating the full depth of the asphaltic concrete. The condition of the pavement at failure is shown in Figure B6.

Figure B6. Item 2, lane 1, flexible pavement test section, at 3660 coverages of 200-kip twin-tandem assembly

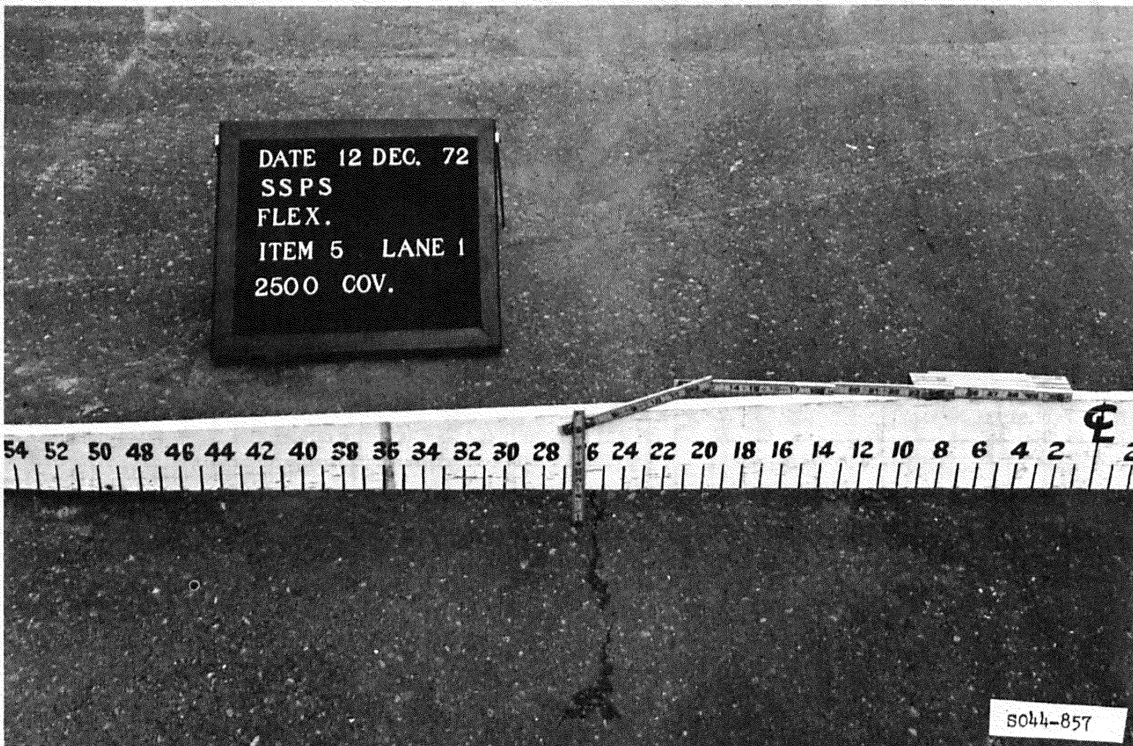
A general view of item 5 prior to traffic is shown in Figure B12. At 1200 coverages, shallow hairline cracks were observed near the west end of the item (Figure B13). Traffic was stopped on the item after 2500 coverages because cracks penetrated the full depth of the asphaltic concrete and the item was considered failed. Figure B14 shows the condition of the item at the time of failure.

Figure B14. Item 5, lane 1, flexible pavement test section, at 2500 coverages of 200-kip twin-tandem assembly

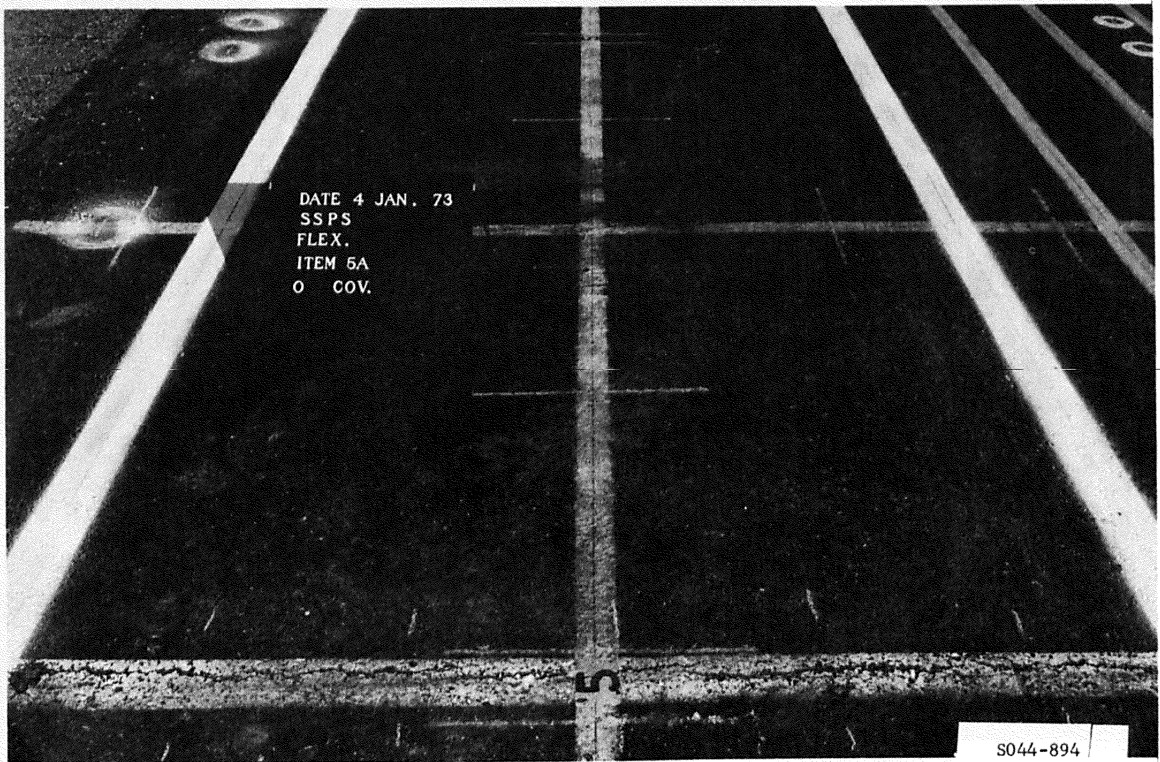
Figure B60. Subitem 5a, lane 3, flexible pavement test section, prior to traffic

A general view of subitem 5a prior to traffic is shown in Figure B60. At 170 coverages, moderate cracking had occurred at the west end of the subitem, and a longitudinal crack had developed in the traffic lane near the south edge. An observation pit was opened at the east end of the subitem, and cracks were noted in the lightweight concrete sub-base course that coincided with cracks in the asphaltic concrete surface. At 240 coverages, cracks were severe (Figure B61), and the subitem was considered failed.

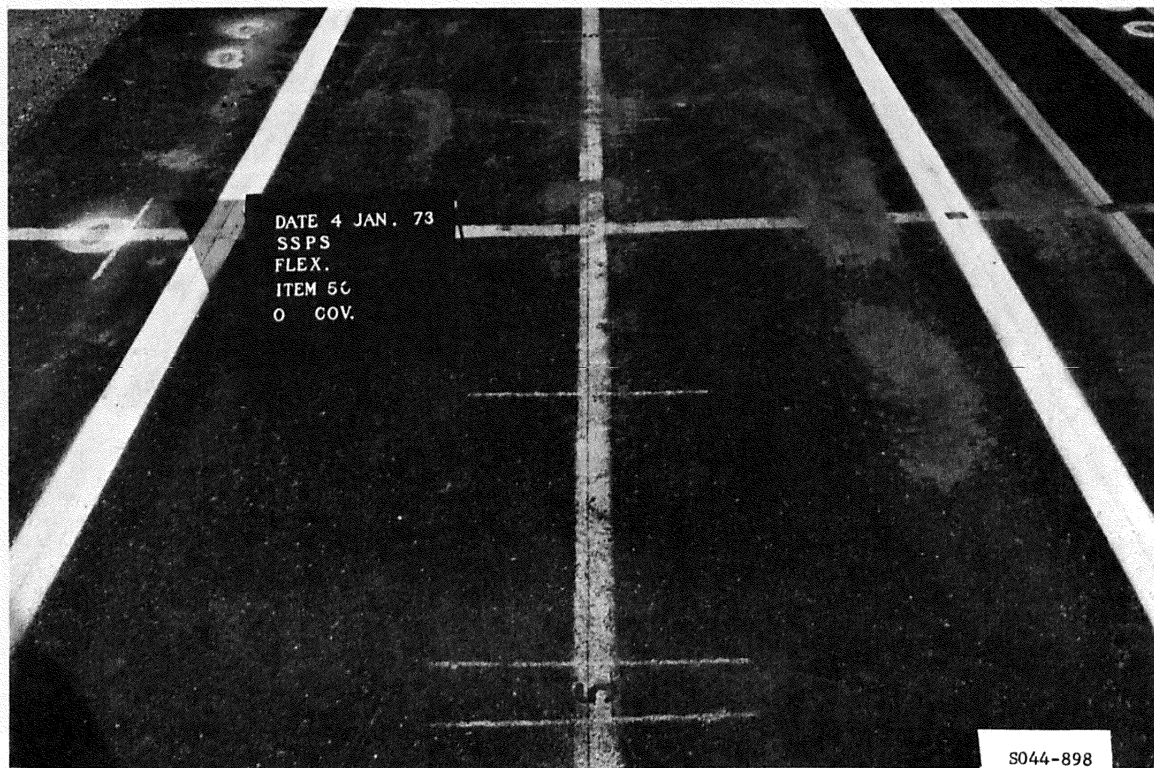
Figure B64. Subitem 5c, lane 3, flexible pavement test section, prior to traffic

A general view of subitem 5c prior to traffic is shown in Figure B64. At 130 coverages, numerous cracks were observed in the pavement surface that did not appear to penetrate the full depth of the asphaltic concrete. At 240 coverages, the cracks had penetrated the full depth of the asphaltic concrete surface, and the item was considered failed. The condition of the pavement at failure is shown in Figure B65.

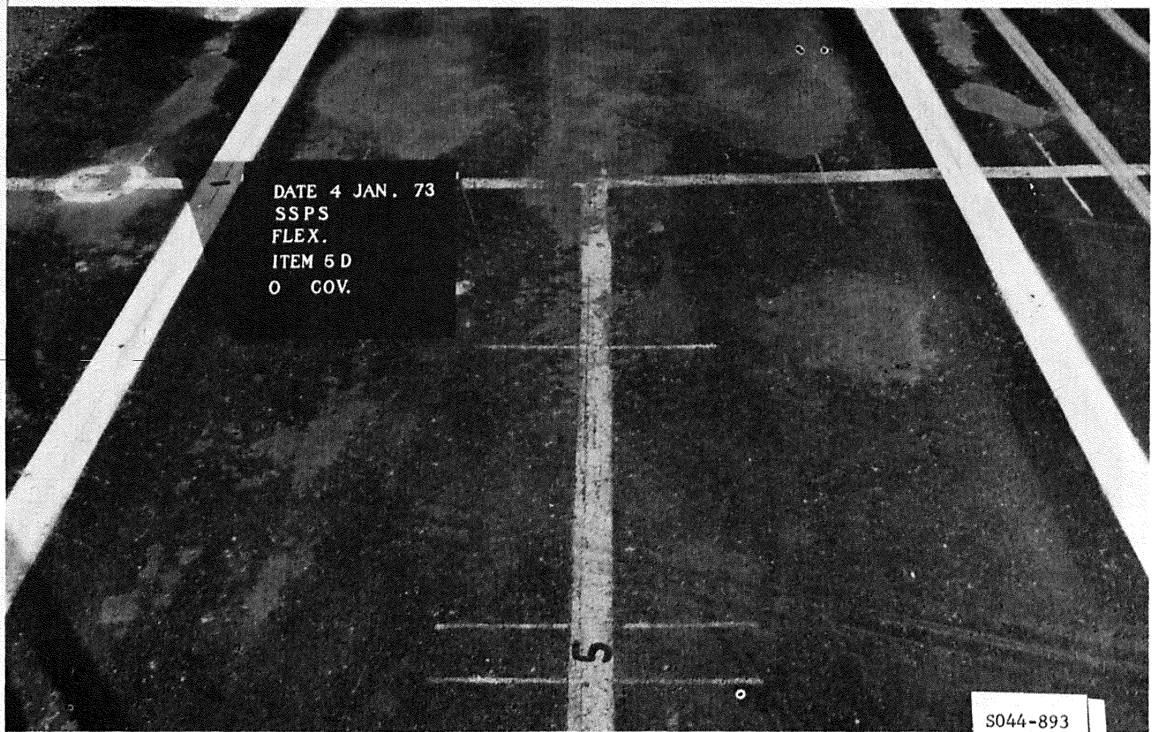
Figure B66. Subitem 5d, lane 3, flexible pavement test section, prior to traffic

A general view of subitem 5d prior to traffic is shown in Figure B66. At 130 coverages, cracks were observed in the pavement surface that did not appear to penetrate the full depth of the asphaltic concrete. At 240 coverages, the cracks had penetrated the full depth of the asphaltic concrete surface, and the item was considered failed. The condition of the pavement at failure is shown in Figure B67.
