MISCELLANEOUS PAPER S-68-22

A STUDY OF THE CONDITION OF PIEZOMETERS IN THE 1949 INSTALLATION AT REID-BEDFORD, LOUISIANA

November 1968

U. S. Army Engineer Waterways Experiment Station
CORPS OF ENGINEERS
Vicksburg, Mississippi

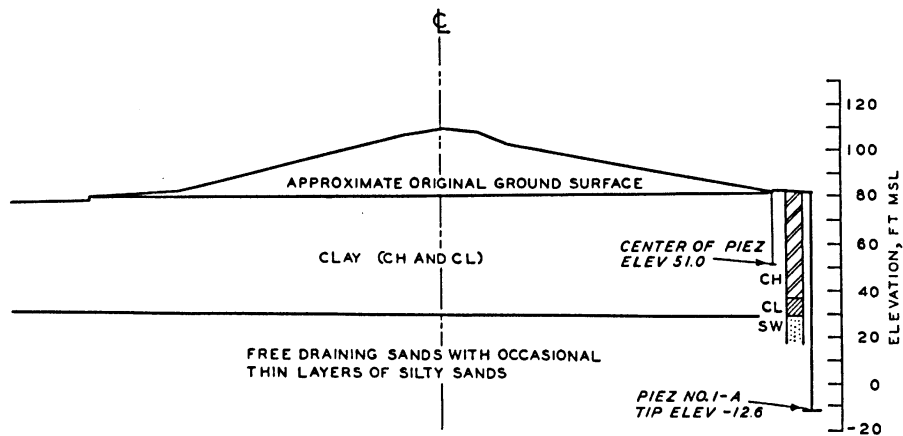
- d. The Cherry Creek, Casagrande, and wellpoint piezometers had a relatively long useful life even though severe corrosion of the standpipes had occurred. No maintenance had been performed on any piezometers for a period of 17 years prior to the study.

15	Drive point	Drilled	No	30.3 (total)	Standpipe not cor- roded; partially clogged near lower end	7
1A	Wellpoint	Drilled	No	26	Standpipe badly corroded	8

Photograph 8. Encrustation and corrosion of wellpoint piezometer 1A
