MISCELLANEOUS PAPER S-69-5

# EVALUATION OF MO - MAT GROUND COVER FOR USE IN ARMY DEPOT OPEN-STORAGE AREAS

January 1969

U. S. Army Engineer Waterways Experiment Station  
CORPS OF ENGINEERS  
Vicksburg, Mississippi

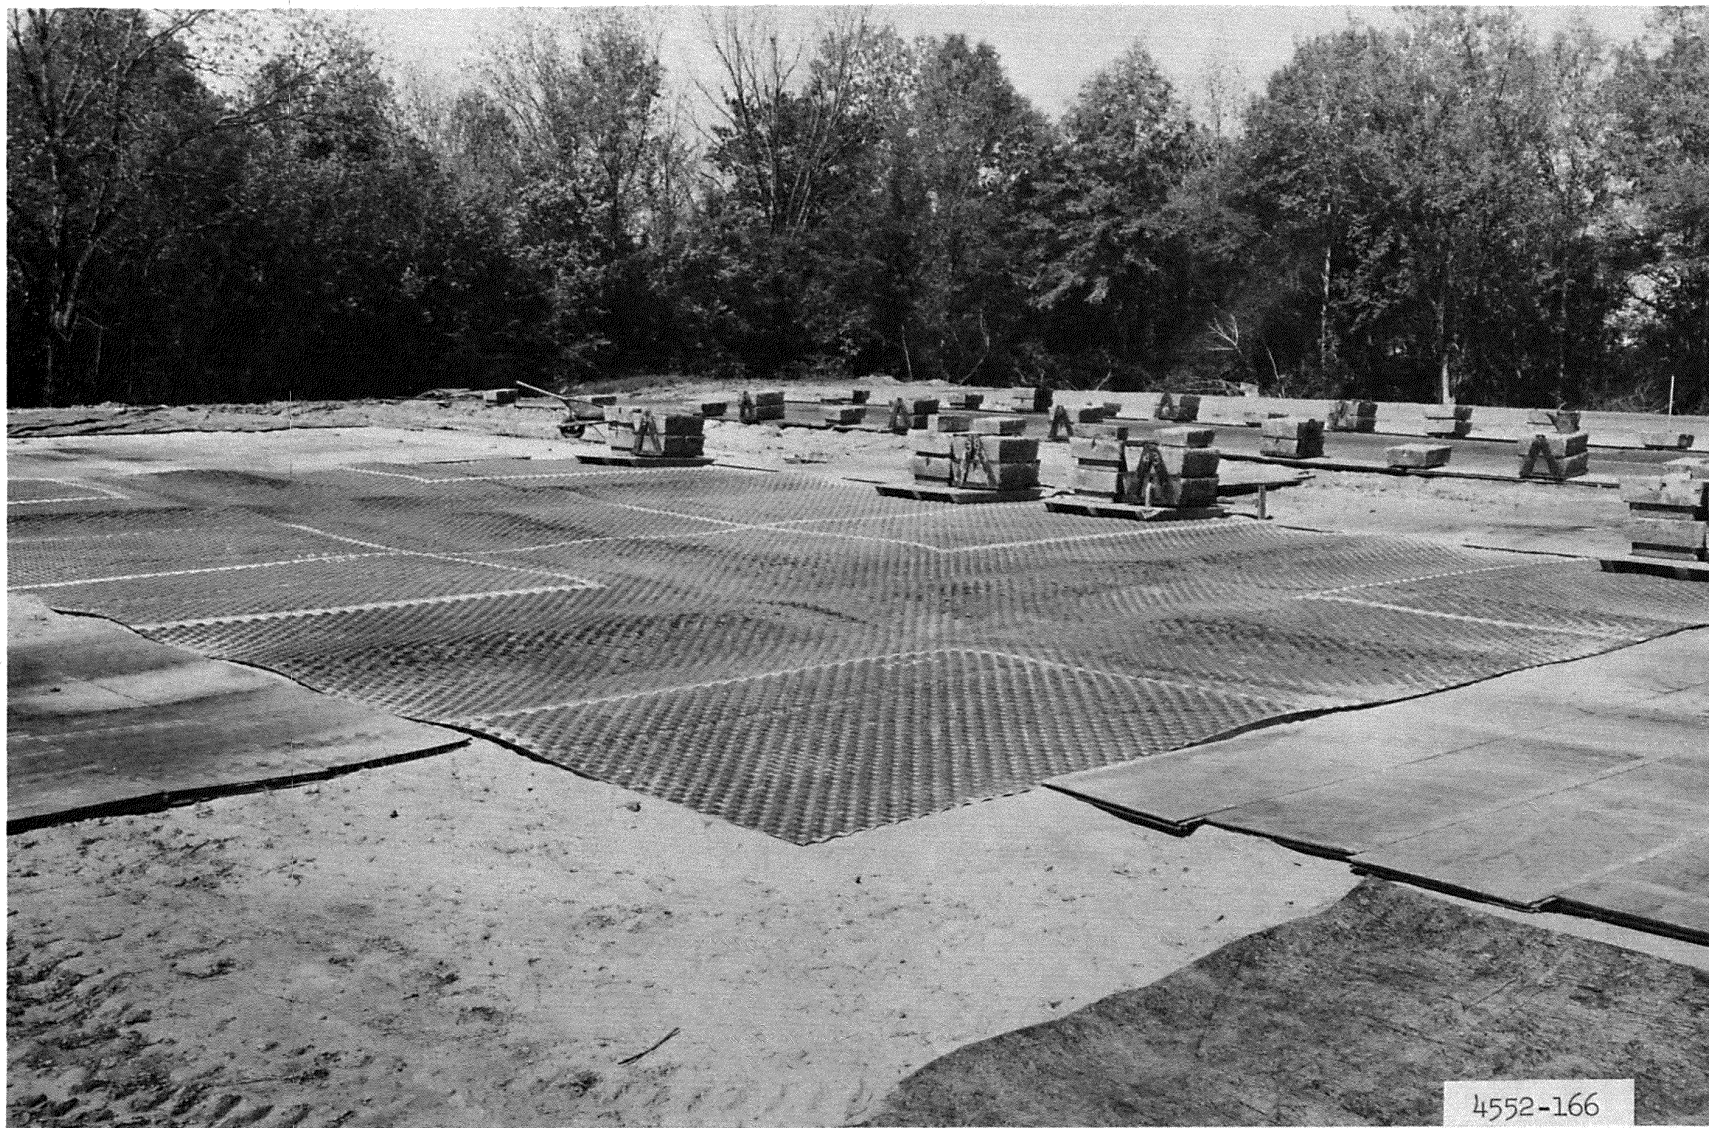
Photograph 19. Test section 1 after completion of cycle 1

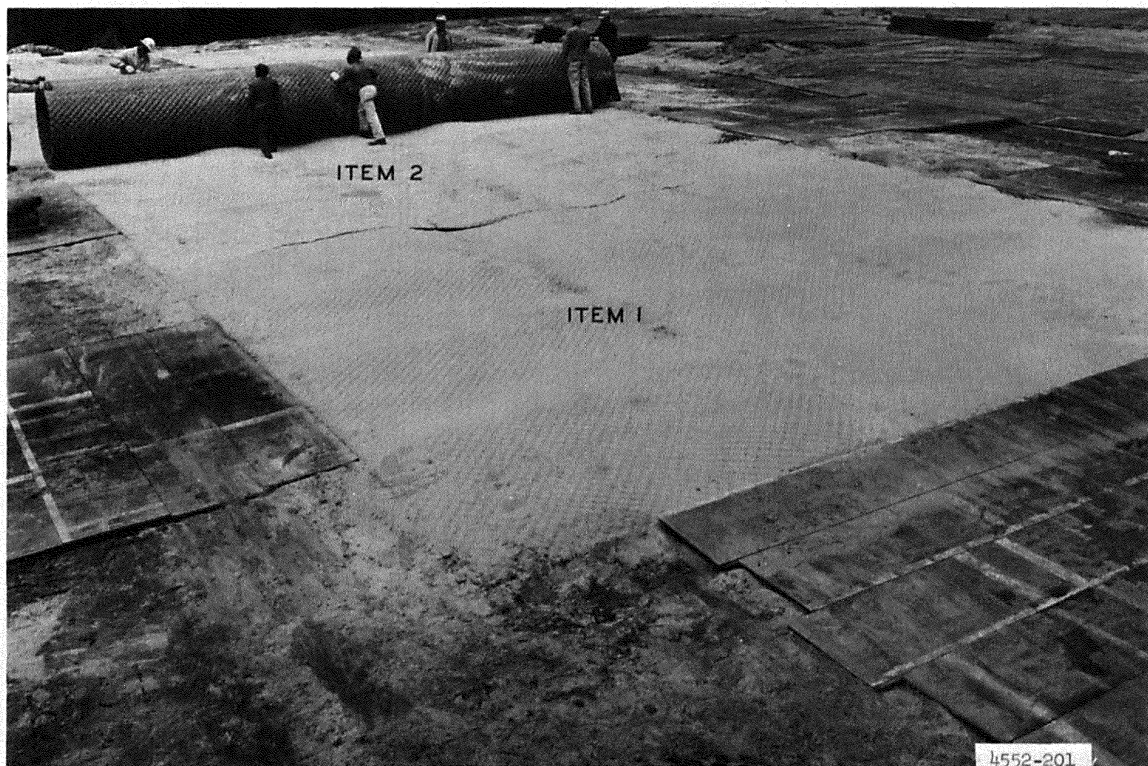
19. At the completion of traffic testing, the mat was rerolled by four men. The mat was considered reusable providing some maintenance work was done to repair the damaged joint. The test items, after the removal of the mat, are shown in photograph 26.

Photograph 26. Removing the mat from test section 1 after the completion of testing

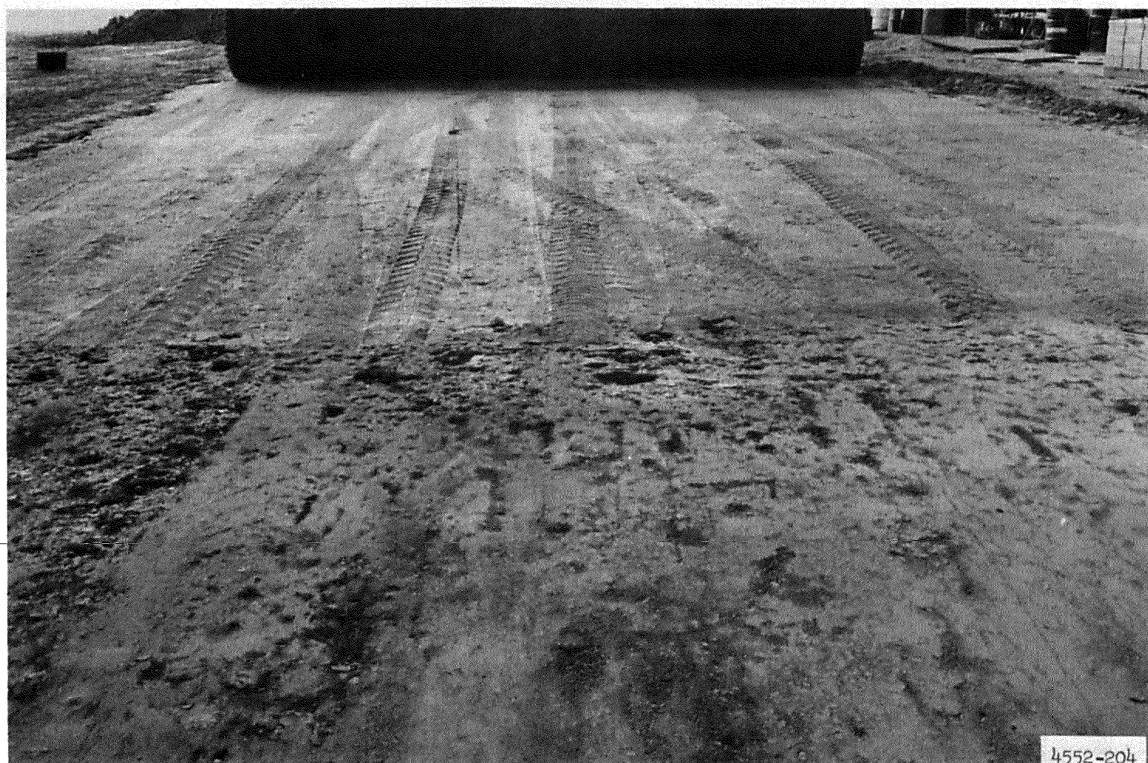
22. The mat was placed on the test section in the same manner as it was placed for test series I (photograph 27). However, prior to mat placement, a new joint was constructed to replace the failed joint that resulted from test series I. The failed joint was sawed out, and new rivet holes were drilled on 4-in. centers. The new joint was then constructed as described in test series I and after a 72-hr curing period, the mat was rolled onto the test section.

Photograph 27. Subgrade prior to placing MO-MAT on test section 2

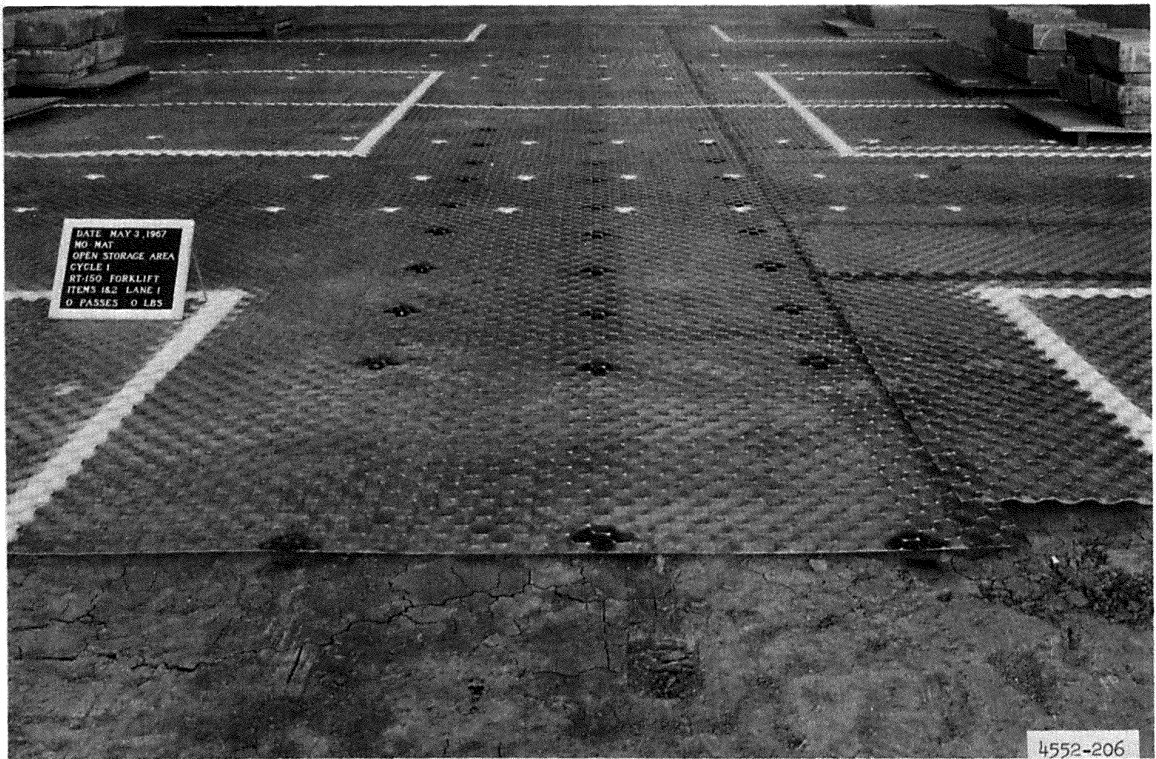
23. The test section was divided into three traffic lanes oriented as in test series I. The test section layout is shown in plate 9. Prior to traffic, pallets loaded to 8000 lb each were placed on both edges of the mat in designated areas shown in plate 9. The completed test section prior to traffic is shown in photograph 28.

Photograph 28. Test section 2 prior to traffic

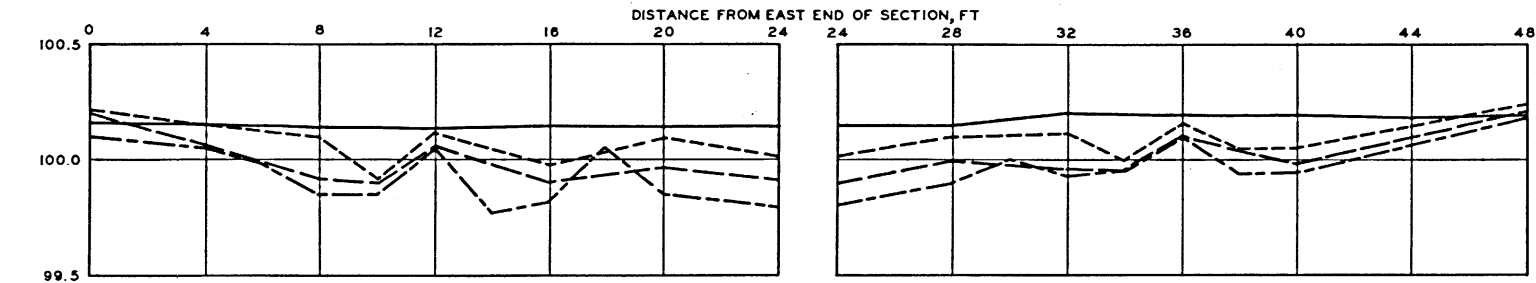
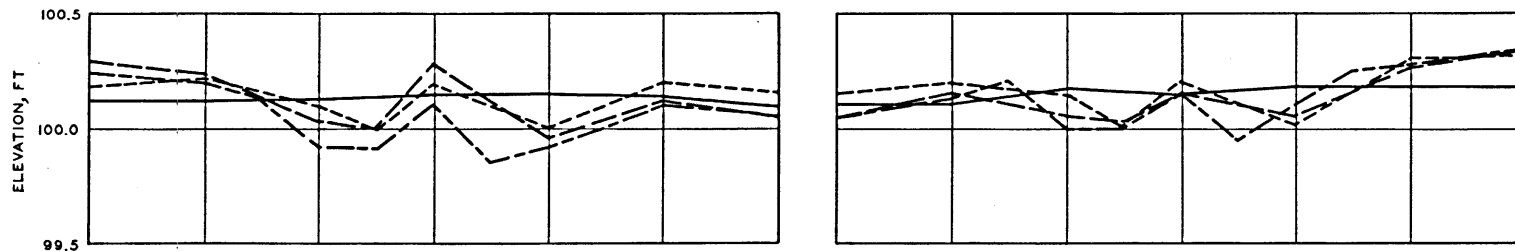
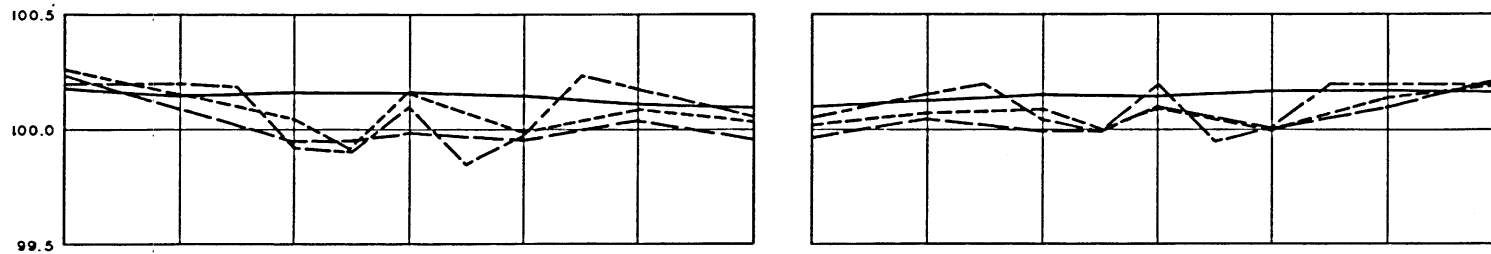
LONGITUDINAL PROFILES  
 TEST SECTION I, LANE I

18. Cycle 7 consisted of 200 passes of the RT-150 forklift loaded to the maximum payload of 15,000 lb. The effect of this increased loading was evident as the traffic progressed. In lane 1 after 150 passes, two rivets had pulled through the mat, and at 170 passes, the overlap joint had completely failed for approximately 10 ft. After completion of this cycle, 25 rivets had pulled through the mat (photograph 24). Deep rutting developed in all traffic lanes (photograph 25). Cycle 8 consisted of 20 passes per lane of the RT-150 forklift with the 15,000-lb payload. No additional damage was done to the mat. The test section was considered failed when the testing was stopped; however, the adhesive joint was actually the only part of the mat to fail structurally during the investigation. Profiles and cross sections are shown in plates 7 and 8.
