Special Report 79-20

INFRARED THERMOGRAPHY OF BUILDINGS

1977 COAST GUARD SURVEY

Stephen J. Marshall

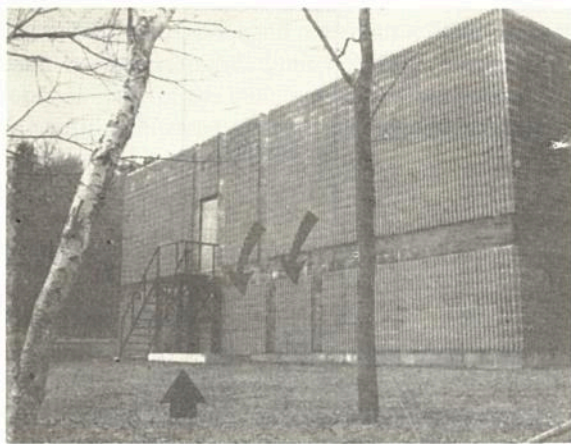
Figure 9. South face of new section at Marshfield station.

The Boston Communication Station (Fig. 8) in Marshfield, Massachusetts, consists of a 20-x-9-m single-deck old section built of concrete block in 1942, and a two-deck 17-x-14-m new section built of split ribbed block in 1972. Figure 9 is a photograph of the south face of the new section taken from the south-east corner. The face is of split-ribbed masonry blocks stacked vertically in line with poured insulation and waterproofing. Figure 10 shows a thermogram of this face taken from the same perspective. The horizontal

and vertical regular blocks outlining the split-ribbed sections are very warm. Note that the horizontal foundation is warm except where it is poured out around the cellar door (large black arrow, Fig. 9). The square split-ribbed panels to the right of the door have nonuniform patterns which are darker and colder near the bottoms of the panels, tapering off near the tops (arrows, Fig. 10). This suggests settling, missing or wet insulation near the top portions of the panels. Many areas on the three faces of the new section exhibited this effect.

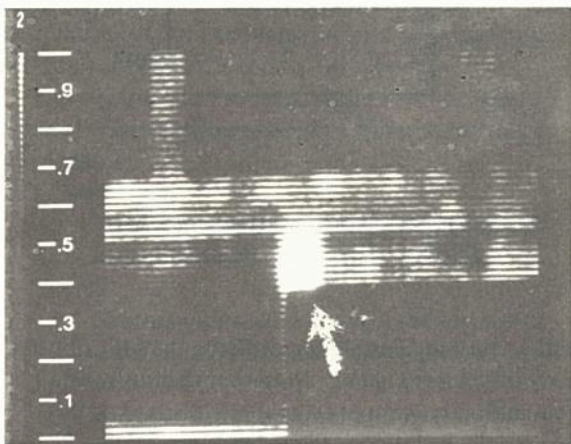
Figure 11. Closeup of floor beam on the east face.

Figure 11 is a closeup thermogram of some of the conventional concrete blocks separating the split-ribbed sections horizontally along the first floor level of the east face. The outlines of some of the individual blocks can be seen as well as a mottled pattern that suggests moisture. This mottled pattern is hard to reproduce on the photographs but is quite clear on the CRT screen. The square white object in the center of the thermogram is the butt end of a floor beam on the z-axis; that is, it lies perpendicularly to the plane of the thermogram and disappears into the picture. Another warm beam end appears less clearly in the middle of Figure 12.

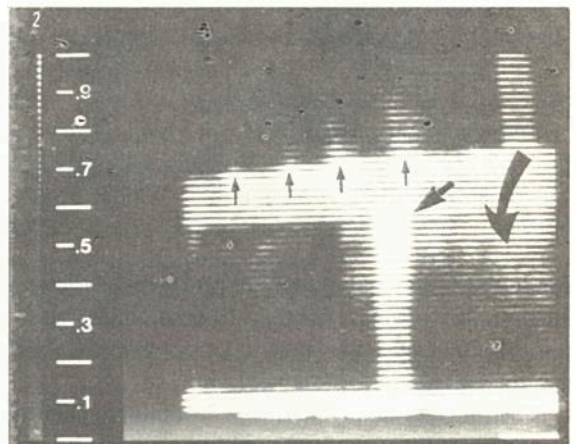
Figure 12. Outlines of 2x4 studding on the east face.

Figure 12 is a closeup of another group of east face split-ribbed panels showing the mottled pattern and the warmer areas near the tops of the panels. In addition, the bottom of the upper panel shows evenly spaced

anomalies that suggest spacings equal to the distance between internal 2x4 studding (small arrows, Fig. 12). Figures 13 and 14 are two more examples of the mottled pattern on the east and west faces of the new building. Figure 13 shows two large, circular, warm areas. In Figure 14 the vertical split-ribbed patterns can be made out on the thermogram as well as the outline of the normal blocks in the horizontal section above.

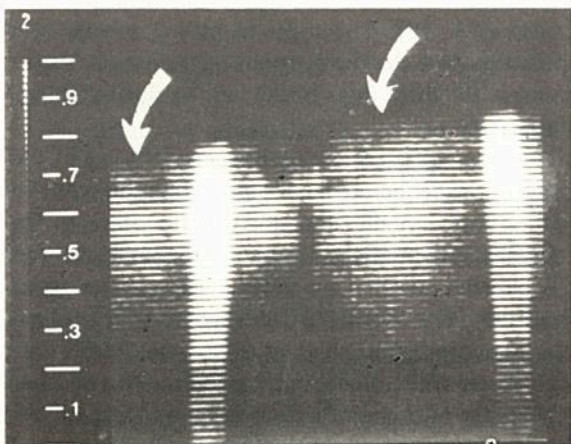
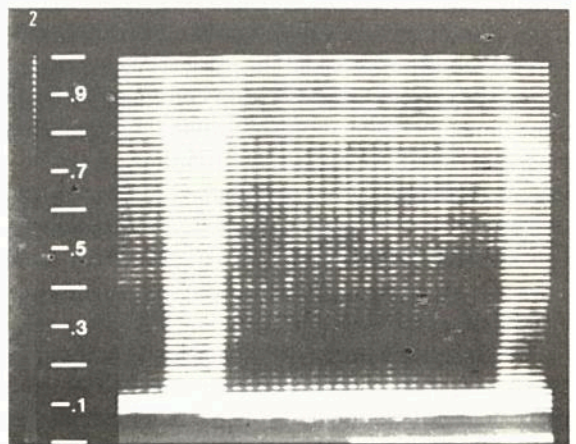
Figure 13. Nonuniform thermal patterns on the east face.

Figure 14. Nonuniform thermal patterns and block outlines on west face.

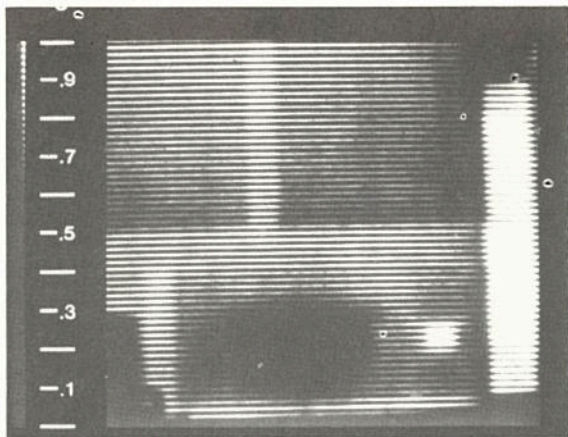
Figure 17. Comparison of cooler new section and warmer connecting section.

Figure 15 is a photograph of the east face of the new section with the east face of the glass connecting unit, and Figure 16 shows the east face of the old section. Figure 17, a thermogram of the east face of the new section, exhibits the familiar horizontal and vertical warm pattern separating split-ribbed panels. In addition, a small vent is visible in the lower right-hand corner. The glass interconnecting section at the right of the thermogram is much warmer than the new section face. The connecting section, at the left in Figure 18, is also much warmer than the old section. A cold and evidently well-insulated covered vent appears distinctly in Figure 18 but is hardly visible in the photograph. The blocked-in area where the old window opening was decreased in size to accommodate a smaller new window unit appears warmer than the face of the building itself (small arrows, Fig. 18). Figure 19 is a closeup of the east face of the glass connecting section. The hot vertical chimney appears cooler than the glass which surrounds it. These external chimneys waste a great deal more heat than chimneys constructed in the middle of a building. In this case the glass loses even more heat than the chimney, suggesting that this type of glass construction is not very energy efficient in cold weather.

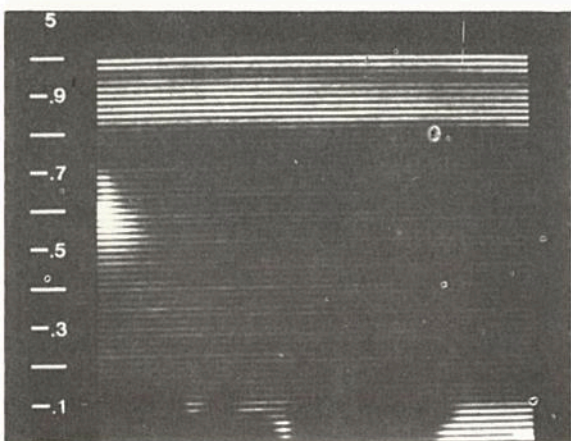
Figure 24. Cool wall of south face.

the south face, which reveals an excessive amount of heat loss through the glass transom and around the door. The door itself appears insulated. The concrete block walls appear uniformly insulated and in Figure 24 the actual outlines around each block can be recognized. The foundation is excessively warm, as are the concrete blocks immediately above the transom level and the horizontal precast beams above them.

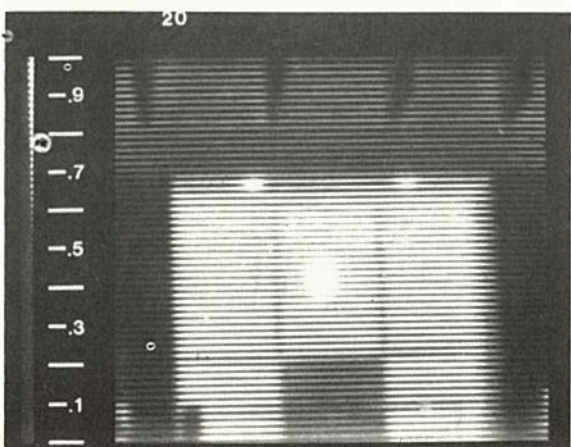
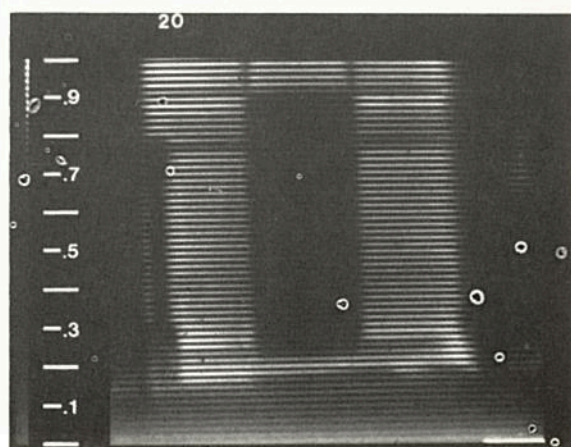
Figure 25 is a photograph of the main entrance on the east face of the building. It contains an excessively large glass area. There is no vestibule and the upper and lower open stairwells are just inside the door. Thermograms in Figures 26 and 27 were taken at a scale of 20, indicating that the glass is a very bad insulator compared with materials in other main entrances. The door itself appears to be uniformly dark and no leakage appears around it even though this door is heavily used.

Figure 26. Glass surrounding main entrance door.

Figure 27. Main entrance door.

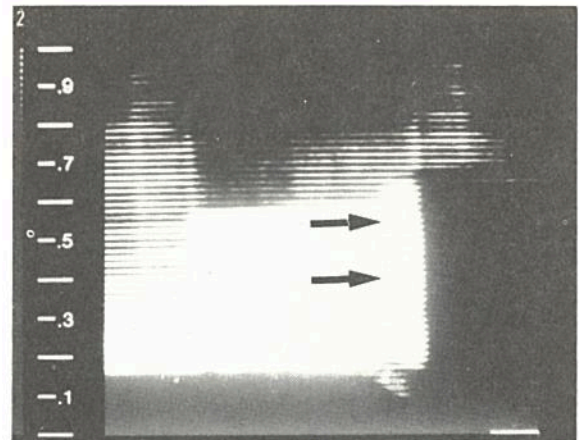
Figure 29. Boiler room window and transformer in northeast corner.

Figure 28 is a photograph of the east face of the building near the northeast corner. The object in the lower right-hand corner is the transformer, and the boiler room window is immediately to the left. Figure 29 is a thermogram of this area which shows the hot, left rear section of the transformer housing at midnight (arrows). All lights were out and personnel asleep at this hour, and so the station's electrical load was minimal. Several of the other stations also showed hot transformers (see for example, Fig. 46 and 59). Figure 29 also shows that the boiler room window is much warmer than the other windows. Since this room is

Figures 29 and 31, both thermograms of the same location on the building, illustrate the effects of adjusting the camera's sensitivity. In Figure 29 the sensitivity was decreased in order to get the best reproduction of the hot window and transformer at the expense of overdarkening the wooden window panels. In Figure 31 the sensitivity was increased to lighten the wooden window panels for the best reproduction at the expense of washing out the transformer and hot window. These thermograms show that the thermographer cannot "manufacture" or create heat loss anomalies. He can only adjust the *total* picture for the best possible reproduction by choosing the proper scale and control setting.

unoccupied, the window could be replaced with an insulated porcelain panel or other type of insulating unit.

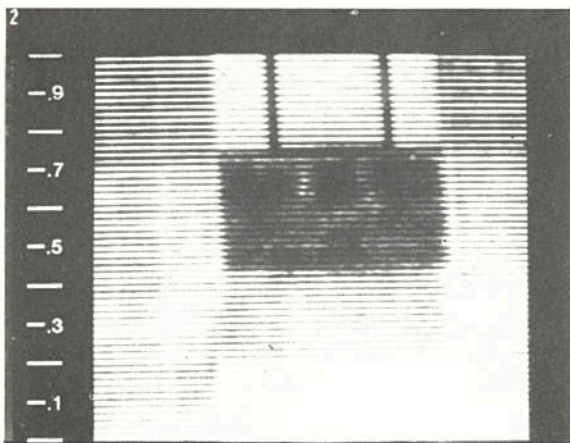
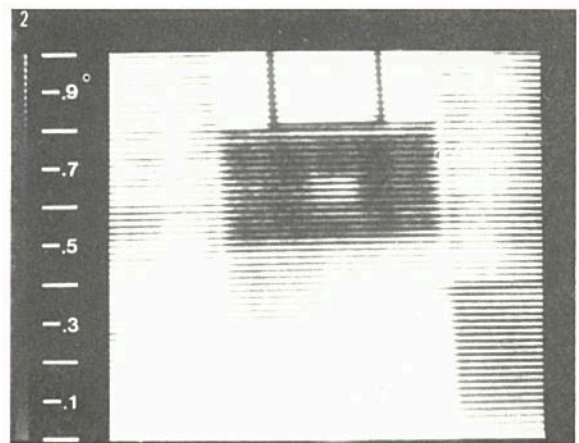
Figure 30. Thermal patterns in wooden panels separating first and second deck windows.

Figure 31. Radiator and 2x4 outlines under second deck window.

Figures 30 through 33 show thermograms of typical first- and second-deck window units separated by what appear to be underinsulated wooden panels. Figures 30 and 31 show that the upper panels in both cases are cooler than the lower panels, and that an indistinct pattern appears in the center of each upper panel — apparently the outline of the room heaters and vertical 2x4 studs.

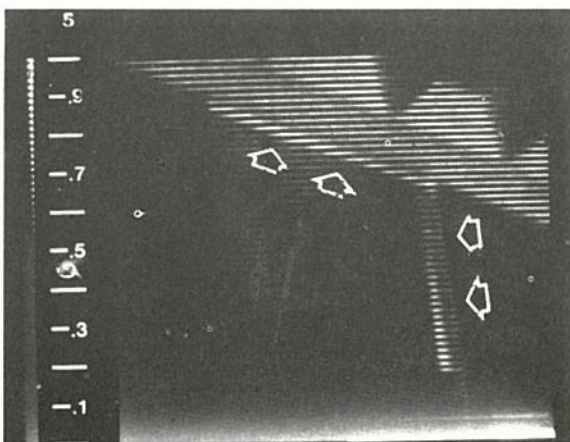
Figure 32. Exfiltration at window/wall interface.

Figure 32 shows upper and right-hand leakage between the window frame and concrete block wall interface (arrows). Figure 33 shows horizontal leakage between the upper and lower panels and between the panels and the concrete block wall (arrows). These wooden panels should be compared with the much superior insulated porcelain panels at the Portland Base (Fig. 93-97).

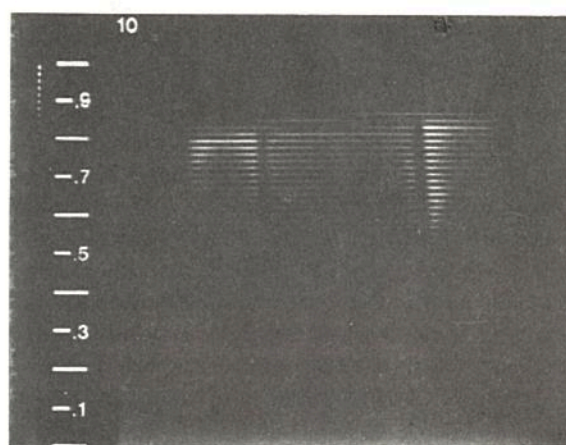
Figure 38. Closeup of communications center window on north face.

confirmed by a closeup shot in Figure 38 of the north face window. Infiltration patterns on the glass can clearly be seen vertically along the left and right-hand glass/meeting rail interface. There is also leakage along the top horizontal window frame/brick interface.

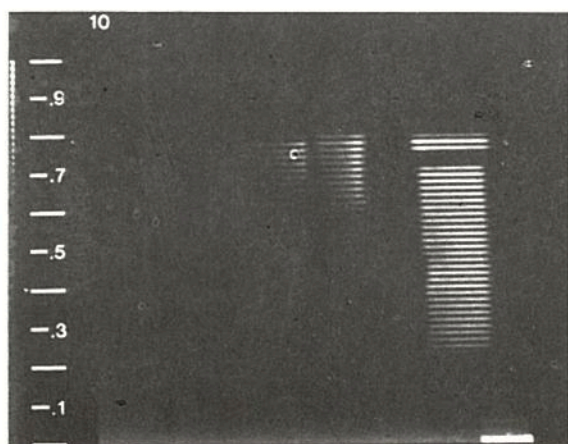
Figure 39. Glass door on west face of mess deck.

Figure 39 is a thermogram of the west face of the mess deck. It shows excessive leakage through the single-pane glass door and glass transom above the door. All glass doors and transoms should be avoided in cold regions, from an energy conservation point of view, in favor of some type of insulated door. Although leakage is occurring in the upper right corner of the double-pane window unit to the left of the door, this window, and the one on the right in Figure 35, are still much cooler than the door glass. All three units are in the same large room.

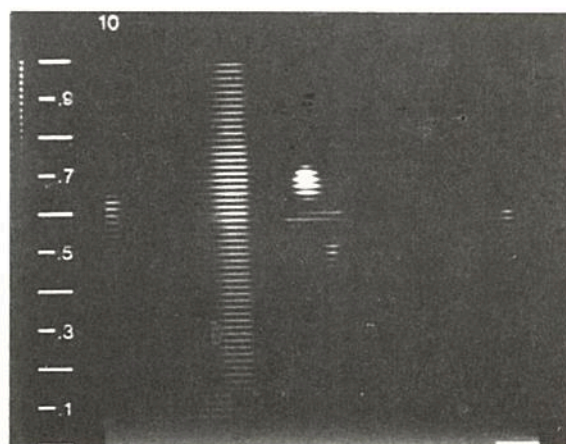
Figure 40. Warm vertical window on north face of unheated stairwell.

Figure 40 is a thermogram of the north face of the stairwell which is just to the right and out of view in Figure 35. The narrow vertical pattern is the warm window glass extending from the foundation to the tower of the stairwell. The thermogram indicates that the stairwell is excessively warm, and since it is not heated, it must be robbing heat from the building (chimney effect). Perhaps these vertical windows should be replaced with insulated panels on the north face to conserve energy. The door is indicated on the thermogram immediately to the right of the glass pattern as the horizontal and vertical patterns below the circular pattern which is the light above the door. It indicates that the door leaks at its top interface but not as badly as many other stairwell doors at other stations.

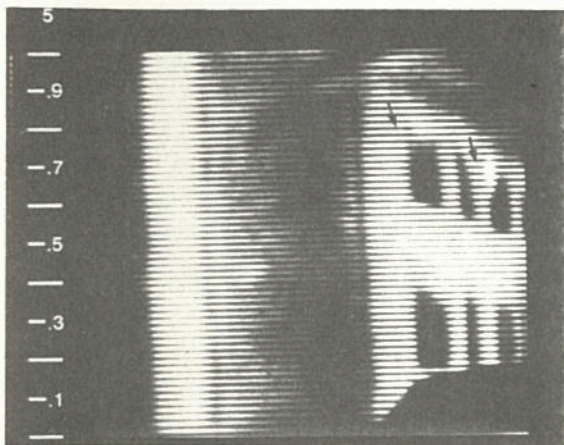
Figure 43. Solar effect on southwest corner.

south face. You will notice that these thermograms indicate that the building's south face is warmer than the window glass because the brick appears uniformly white and the glass uniformly dark. This could be the effect of the sun, since thermograms were taken at approximately 1940 hours. The west face, however, does appear cool, and one would expect the west face to exhibit the same solar effects. The cooler west face is shown as the left portion of Figure 43. At first it was thought that thermograms taken during this solar effect would have little or no value, but Figures 43 and 44 indicate that leakage around window openings appears much more prominently at greater distances due to the large contrast between the black glass and the white heat loss. This can readily be seen in the upper portions of the first and third windows of the second deck in Figure 43 (small black arrows) and the first deck windows to the right of the entrance in Figure 44 (small black arrows). This leakage occurs even though all the drapes were drawn on the south face and all windows were checked by the duty officer to ensure that they were closed. The window immediately to the right of the entrance in Figure 44 is in the boiler room, which is quite tight as compared to boiler room windows at other stations. The main entrance in Figure 44 is also good, as compared to some main entrances with vestibules at other stations. The left pane of the upper left window in Figure 45 (black arrow) has excessive leakage even though the drapes were drawn and the window closed.

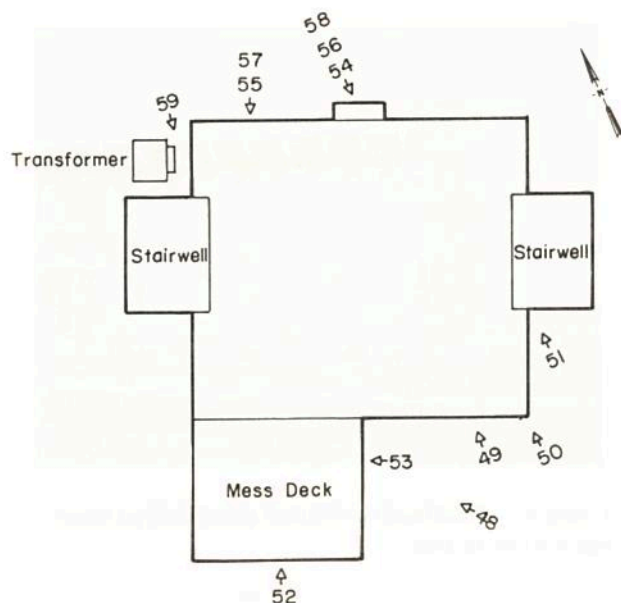
Gloucester Station (Fig. 47), in Gloucester, Massachusetts, consists of a 24x23-m concrete masonry barracks with brick exterior built in 1974, and a heated brick boathouse (not surveyed). Figure 48 is a photograph of the southeast corner of the three-deck barracks and the mess deck at Gloucester Station. Figure 49 is a thermogram of the right-hand portion of the second and third decks, with the windows of the bathrooms near the center. The right-hand panes appear cooler than the left-hand ones, which appear warmer than the other glass panes on this face. The third-deck vent to the right of the window is closed, while the second-deck vent is open with its exhaust fan operating. The pattern made

Figure 47. Gloucester Station, Gloucester, Massachusetts.

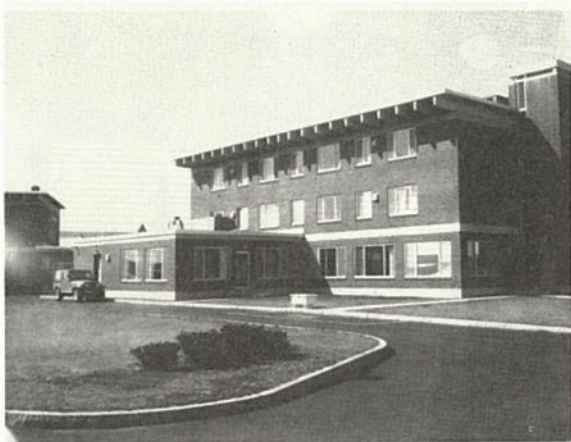
Figure 48. Southeast corner of Gloucester station.

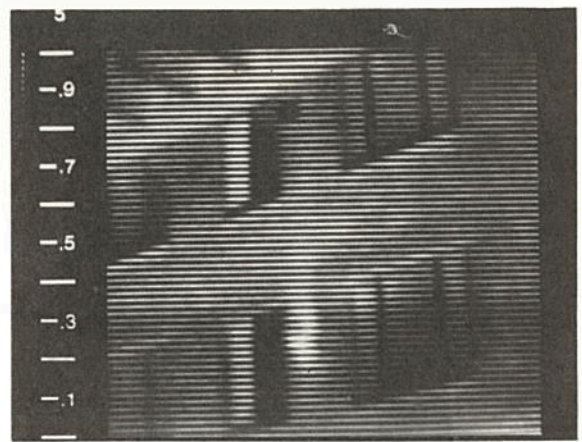
by this vent is not as intense as the plume from a vent on the north face (Fig. 55). Evidently the wind is drawing the warm air from the building's north face but inhibiting its outflow on the south face.

Figure 49. Windows on southeast face.

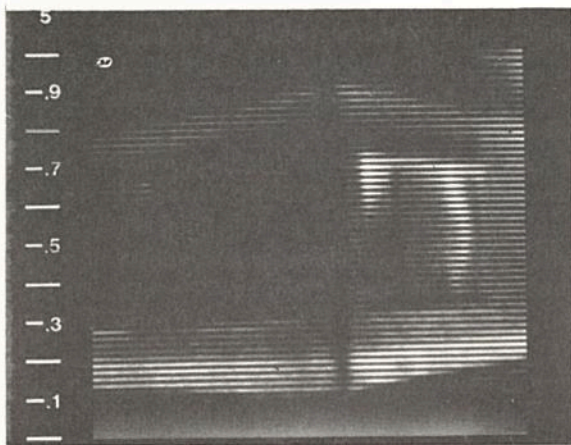
Figure 50 is a thermogram of the communications center windows located on either side of the southeast corner of the first deck. Both windows are openings for the same room, yet the window on the left (south face) is uniformly dark or cool while the window on the right (east face) appears to badly sprung. It has a serious infiltration pattern along the right vertical meeting rail as well as the upper portion of the left glass panel. The foundation also appears warmer than the wall at this station.

Figure 50. Communications center windows.

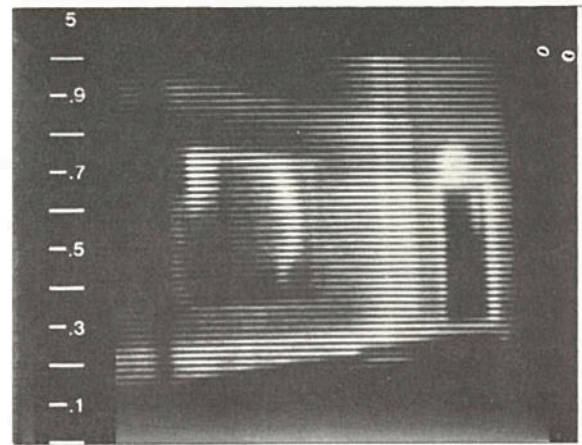
Figure 51 is the stairwell door to the right of the east face communications center window. It shows heat loss completely around the door as well as through the small glass panel in the door. The vertical stairwell windows are indistinctly warm but cooler than the door/wall interface. A warm vertical construction joint also appears immediately to the left of the stairwell windows. The horizontal second deck is indistinctly visible in both Figures 50 and 51.

Figure 51. Stairwell door and vertical construction joint.

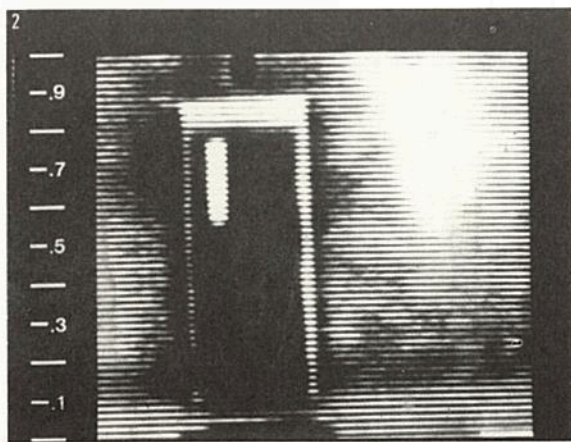
Figure 52 is a thermogram of the galley door on the south face of the mess deck behind the jeep in Figure 48. Note that the light above the door is off and the light fixture cold. Leakage is evident around the door, especially along the top and right-hand interfaces. This thermogram was taken at 2249 hours, long after the galley equipment had ceased operation, although this door is used frequently by station personnel at night.

Figure 52. Galley door on south face of mess deck.

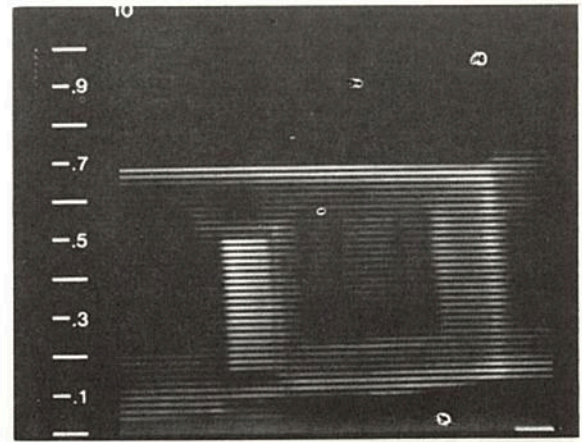
Figure 53. East face of mess deck.

Figure 53 is a thermogram of the glass door in the east face of the mess deck which is nominally at the same inside temperature as the galley. However, this thermogram, taken at scale 10, shows that the windows on either side of the door, which all open into the same room, are much more energy efficient. The light above this door is also turned off.

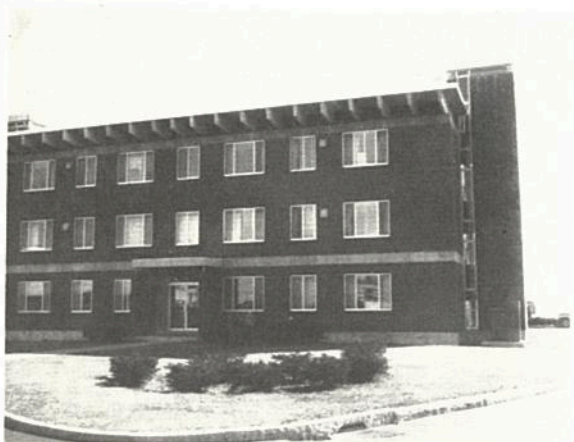
Figure 54. West section of north face of Gloucester station.

Figure 54 is a photograph of the north face, west section of the Gloucester Station. Figure 55 is a thermogram of a vent to the right of the second deck bathroom window. The plume of hot air from the vent is blowing down and to the right or west even though the wind was from the south-southwest at 18 knots.

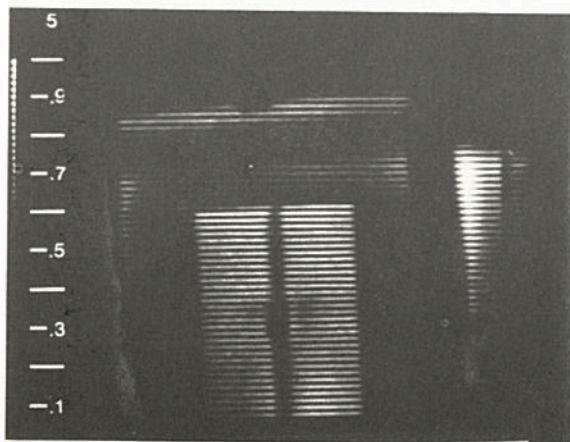
Figure 58. Boiler room window to right of main entrance door.

Figure 58 is of the glass main entrance door, which displays some heat loss at scale 5, despite a closed vestibule inside. Of more concern, however, is the exceedingly warm window immediately to the right of the main entrance. Windows of the unoccupied boiler room could be replaced with insulated panels to conserve energy. In Gloucester Station's case, the boiler was not providing sufficient heat for the building

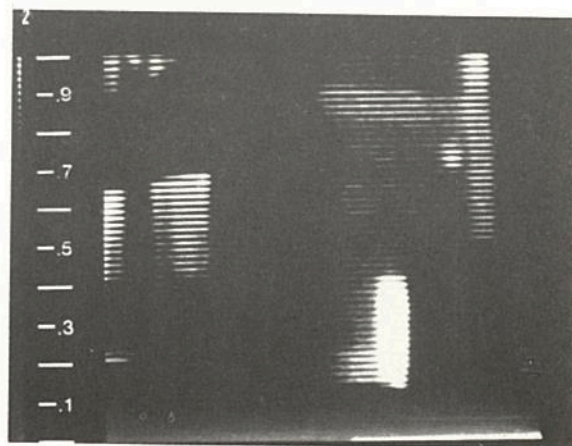
Figure 59. Hot transformer at 2316 hours.

and so most of the personnel had electric heaters in their rooms. The tremendous electrical load at 2316 hours is illustrated in Figure 59 by the hot transformer in the lower right corner of the thermogram, which corresponds to the lower right of the Figure 54 photograph. The vertical stairwell windows and the horizontal second floor can also be seen behind the transformer.

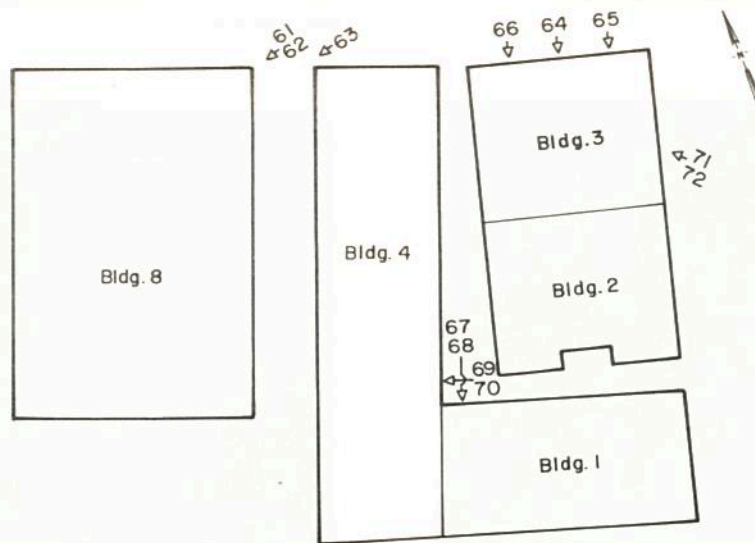
Boston Support Center (Fig. 60) in Boston, Massachusetts, consists of several brick buildings built in the 1890's and early 1900's: building 1 (43x23-m 5-deck), building 2 (34x27-m, 5-deck), building 3 (34x26-m, 5-deck), building 4 (79x24-m, 5-deck), building 8 (60x42-m, 7-deck) and several smaller structures. Figure 61 is a photograph of the northeast corner of building 8, which was recently renovated. Figure 62, a thermogram of building 8, shows that the left or east face is warmer than the right or north face. This may indicate that the hallways which are parallel to this east face are warmer than the offices along the north face. Also several outlines just to the right of the corner suggest former windows that have been covered over. Figure 63 shows that building 4 (to the left) is much warmer than building 8. Building 4 and the other older unrenovated buildings are all much warmer than building 8, and this is only one of several clues to the fact that station personnel are having trouble maintaining and regulating the temperatures in the older buildings.

Figure 60. Boston Support Center, Boston, Massachusetts.

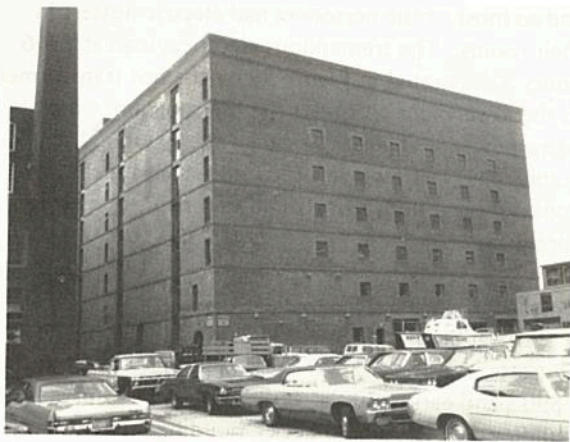
Figure 61. Northeast corner of recently renovated building 8.

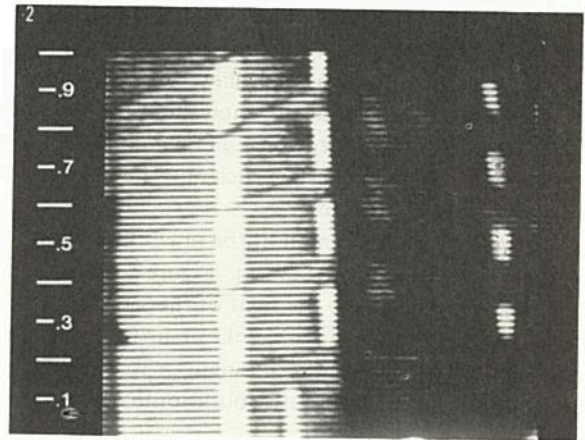
Figure 62. East face of building 8 on left and north face on right.

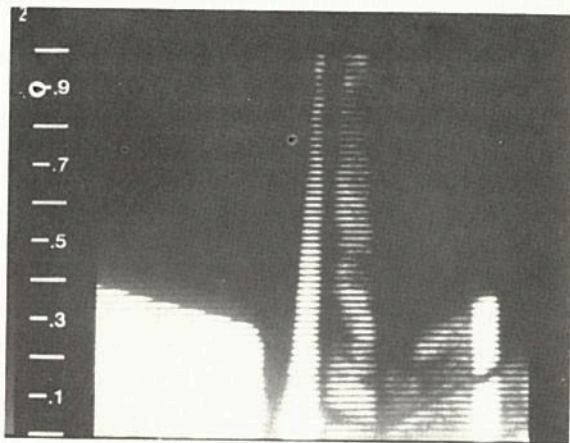
Figure 63. Building 4 on left appears warmer than building 8 on right.

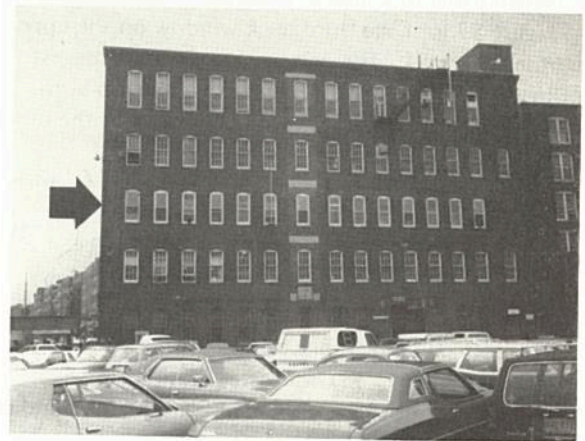
Figure 64 is a photograph of the north face of building 4, and Figures 65 and 66 are thermograms of the

Figure 64. North face of building 4. Arrow points to new windows.

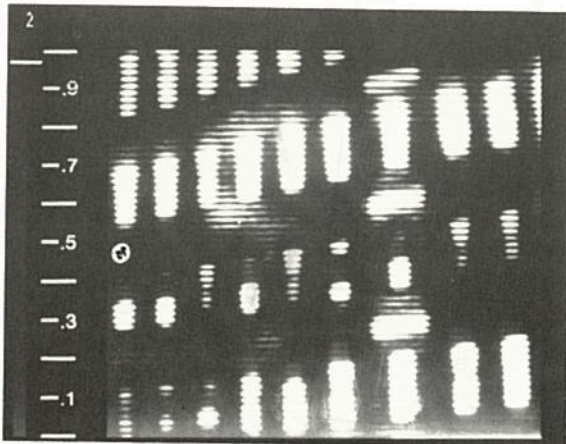
Figure 65. Thermal outlines of new windows and original windows.

north face. In addition to the somewhat obvious heat loss patterns due to open windows and/or storm windows, Figures 65 and 66 show the comparison between some new windows on the third deck and the original windows. In Figure 65 the second horizontal row from the bottom consists of new windows, and the warm rectangular area of each window is of smaller area than that of the old windows, although all windows are the same size. Also several of the windows have dark cool patterns which indicate how well the storm windows would work if kept closed. The warm granite stones between the vertical stairwell windows can be seen to the right of center in Figure 65. The third horizontal row in Figure 66 is of the third-deck windows to the right of the stairwell. In Figure 65, the fourth-deck windows to the left of the stairwell exhibit a large circular warm pattern on the brick. This type of typical pattern showed up on many of the faces of all the older buildings and indicates heat loss problems in the brick walls themselves.

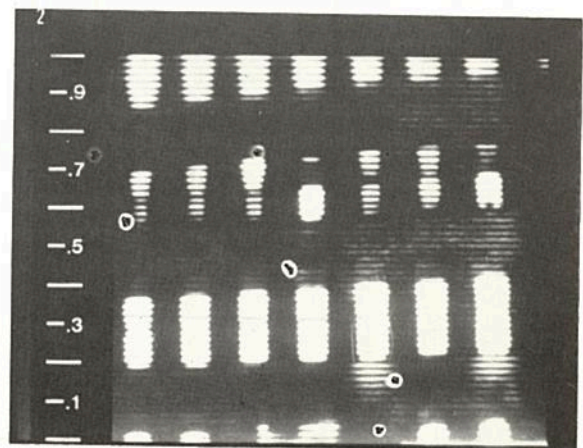
Figure 66. Thermal patterns of some of the new windows.

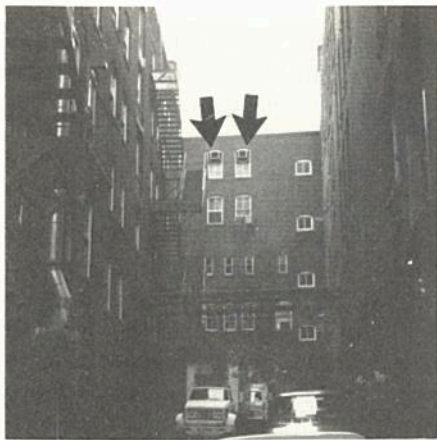
Figure 67. Arrows indicate air conditioner units on north face of building 1.

Figure 67 is a photograph of the north face of building 1 taken from the passageway between buildings 2 and 4. Note the two air conditioner units in the windows on the top deck. Figure 68 is a thermogram of these two windows. It shows how the windows themselves and the air conditioner units are dark or cool but the area to the left and right of each air conditioner leaks badly. The brick wall exhibits a cool pattern along the top deck but a warm pattern along the deck below it.

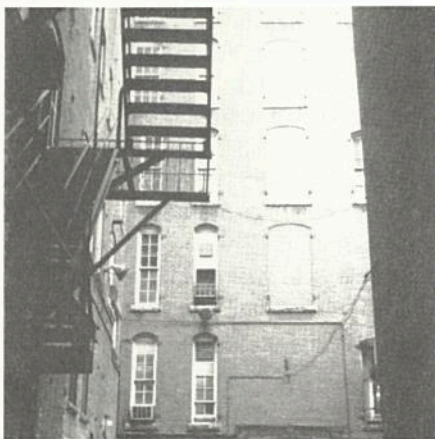
Figure 69. Bricked-in windows on east face of building 4.

Figure 69 is a photograph of the east wall of building 4 taken from the passageway between building 1 and building 2. The corresponding thermogram, Figure 70, shows how one of the bricked-over windows is

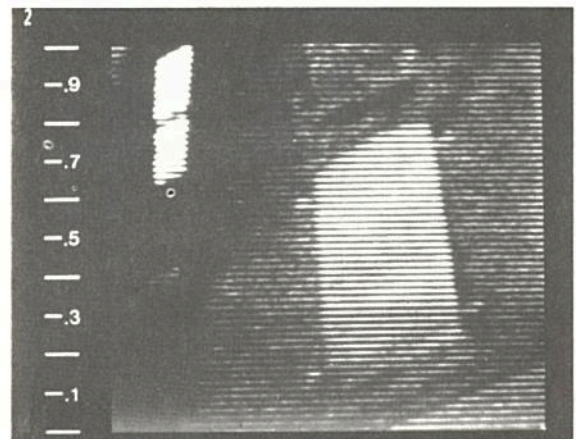
Figure 70. Bricked-in window and surrounding brick wall.

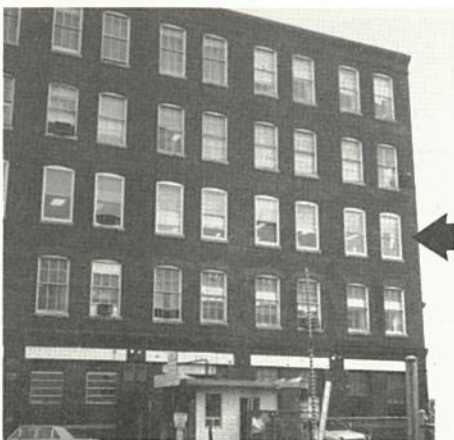
Figure 71. Upper decks on east face of building 3.

Figure 71 is a photograph of the north section of the east face of building 3. The new windows on the third deck (black arrow) exhibited the same improved thermal patterns as those on the north face in Figures 65 and 66. Figure 72 is a thermogram of some fourth and fifth deck windows. This and other thermograms of the rest of the fourth and fifth decks show that these top two decks were very much warmer (scale 20) than the lower ones. It has been our experience that buildings exhibiting extremely warm top decks and much cooler lower ones, together with numerous open windows in the winter, have a very serious temperature regulation problem. Invariably we find that only one single zone thermostat controls the whole building. Corrections to the heating system, such as using multiple zones, must be undertaken in addition to installing energy efficient windows and properly insulated walls.

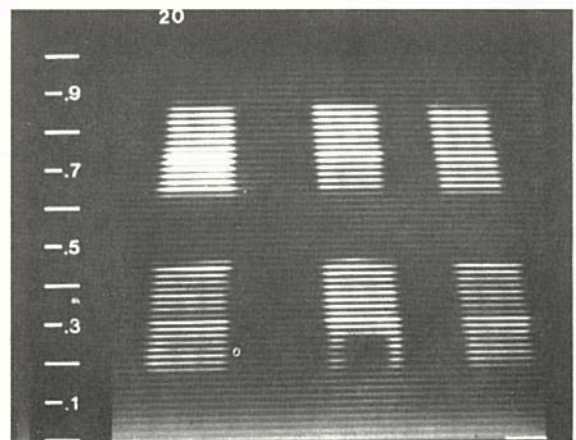
Figure 72. Extremely warm top deck windows on east face of building 3.

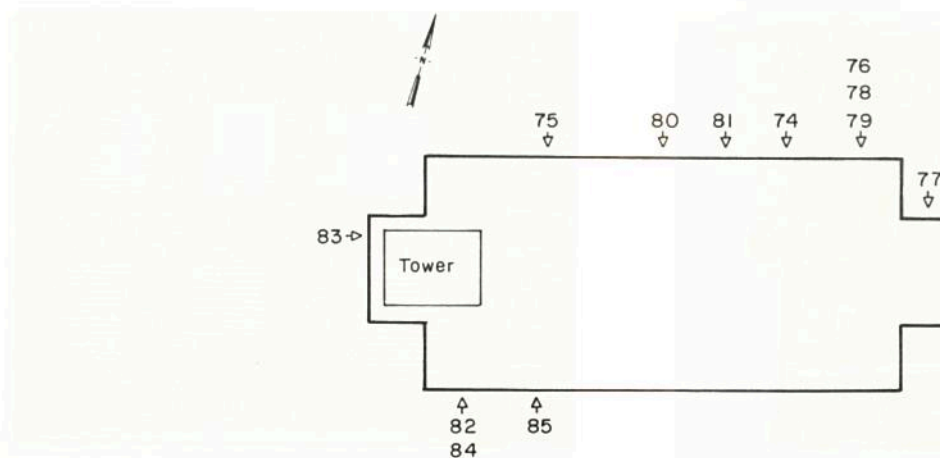
The Portsmouth Harbor Station (Fig. 73) in New Castle, New Hampshire, consists of a 35×12-m concrete masonry barracks with brick exterior built in 1967, a 18×9-m reserve building with brick exterior, and a motor pool with concrete block exterior. Figure 74 is a photograph of the east section of the north face of the two deck barracks and Figure 75 is the west section of the north face. Figure 76, a thermogram of the east section of the north face, shows a badly sprung stairwell door, a garage door with excessive leakage

Figure 73. Portsmouth Harbor Station, New Castle, New Hampshire.

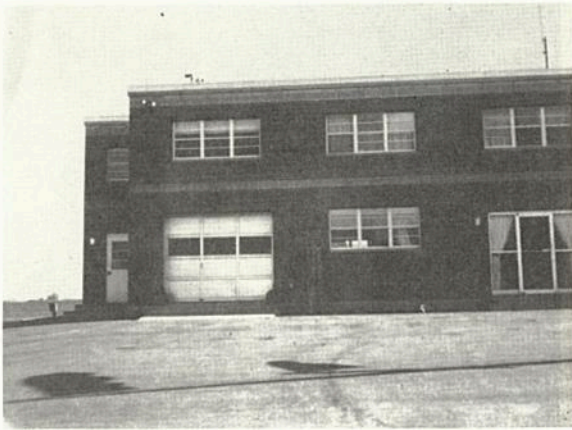
Figure 74. East section of north face of Portsmouth Harbor station.

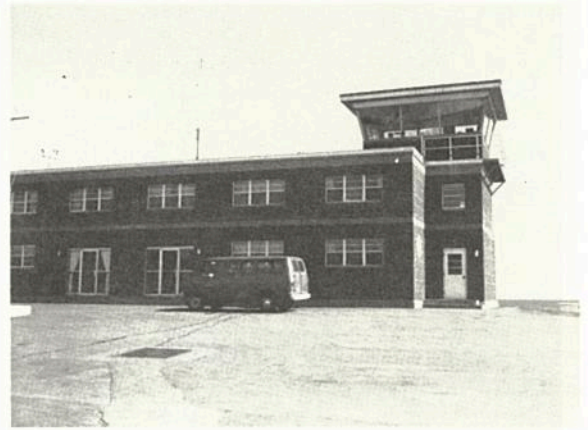
Figure 75. West section of north face of Portsmouth Harbor station.

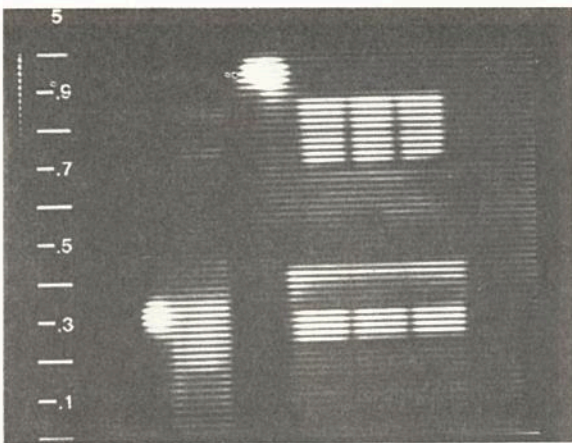
Figure 76. Stairwell door badly sprung, garage door and second deck window.

through the glass windows and the top horizontal interface, a second-deck window exhibiting excessive leakage, in spite of the fact that the drapes are drawn, and the vague outline of a radiator under the window.

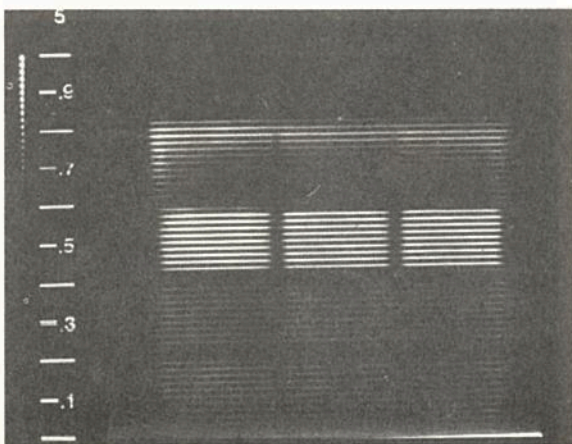
Figure 78. Garage door in northeast corner of building.

Figure 78 is a closeup of the wooden garage door showing the excessive top horizontal leakage and the warm window glass. However, this garage door was not as bad as those at some of the other stations. Figure 79 is the window over the garage door taken at scale 10. All the windows on the north face were closed and had drawn drapes but still exhibited some leakage. This station often has the problem of the entire north face being very cold and the entire south face very warm.

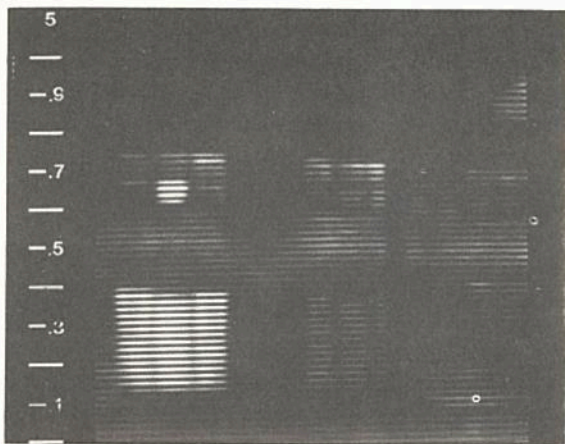
Figure 80. Comparison: entrance on right with vestibule, and entrance on left without vestibule.

In Figure 80 (a thermogram of the west section of the north face) other window heat loss problems can be noticed and the faint outlines of heaters under the windows are evident. In addition, the two all-glass doors are compared thermographically. The one on the left, for the Teletype Repair Office, is warmer than the main entrance on the right which has an enclosed vestibule. Figure 81 is a closeup thermogram of the glass teletype repair door which uses the camera's isotherm function. The irregularly shaped sinusoidal isothermal patterns on the glass are typical of isothermal patterns observed on windows and doors that have heat loss problems. It is suspected that these patterns

are related to the amount of infiltration, where it is taking place, and whether it is infiltration or exfiltration. Further research needs to be done in order to learn the cause of these interesting patterns.

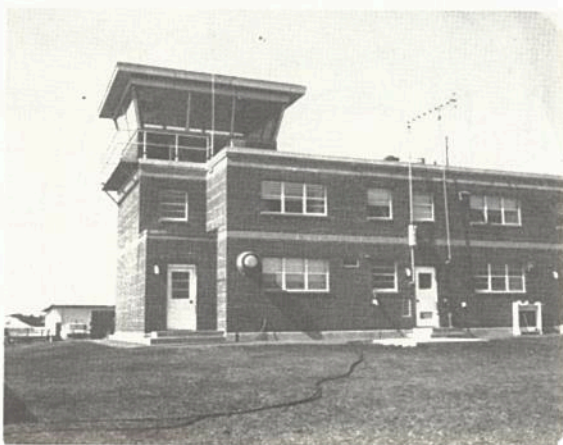
Figure 82. Southwest section of south face of Portsmouth Harbor station.

Figure 82 is a photograph of the west section of the south face of the barracks and Figure 83 is a thermogram of the west face (extreme left in Fig. 82), the right-hand section being the stairwell under the tower. The west face of the barracks stairwell exhibited a mottled pattern but the west face of the left-hand portion (where the mess area is located) did not. The round spot on the wall is a sign. For some reason, this station had a mottled pattern only on a portion of the west face which is minimal in size compared to moisture patterns at some of the other stations.

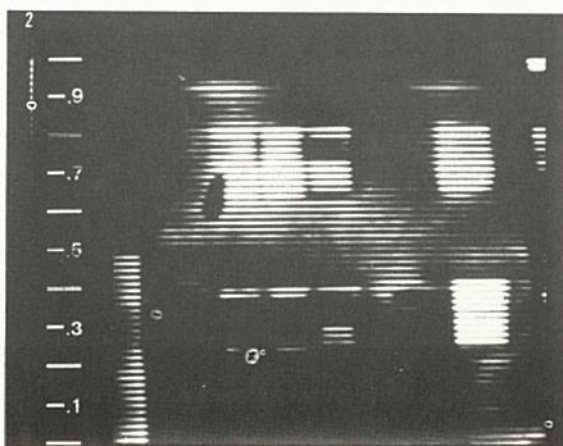
Figure 84. Open second deck windows on south face.

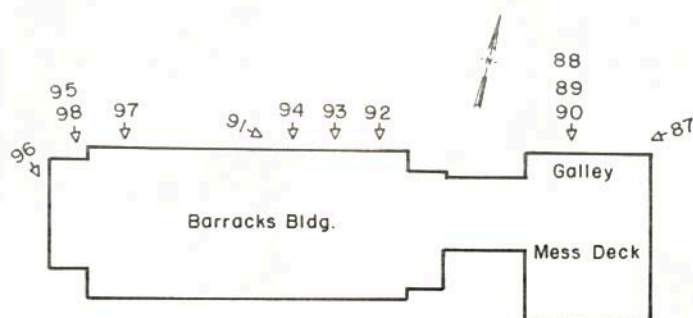
The Portland Base (Fig. 86) in South Portland, Maine, consists of a 71- x 13-m concrete masonry barracks with brick exterior built in 1967, an 24x13-m

Figure 86. Portland Base, South Portland, Maine.

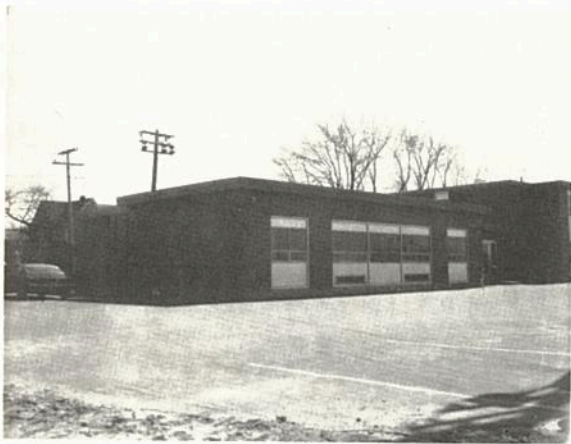
Figure 87. Northeast corner of mess deck of building 6 at Portland Base.

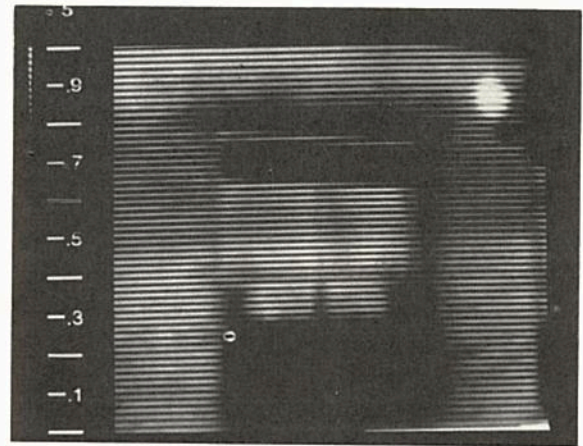
Figure 88. Window on north face with insulated porcelain panels.

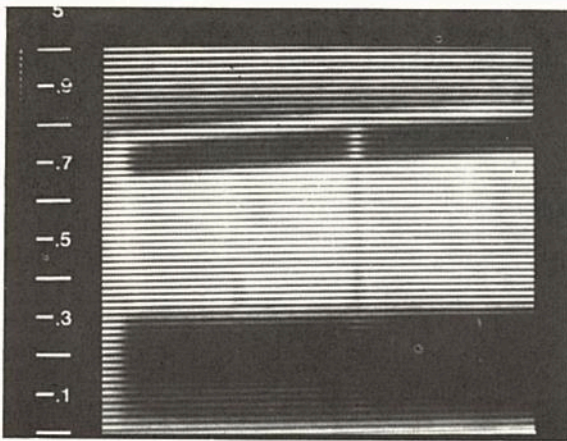
Figure 89. Panels above and below the glass appear cool.

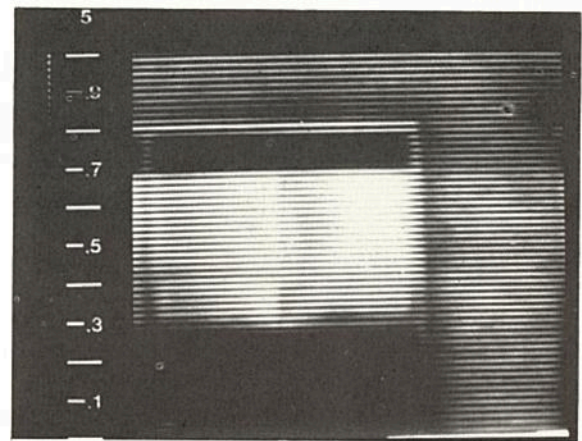
Figure 90. Interfaces around panels.

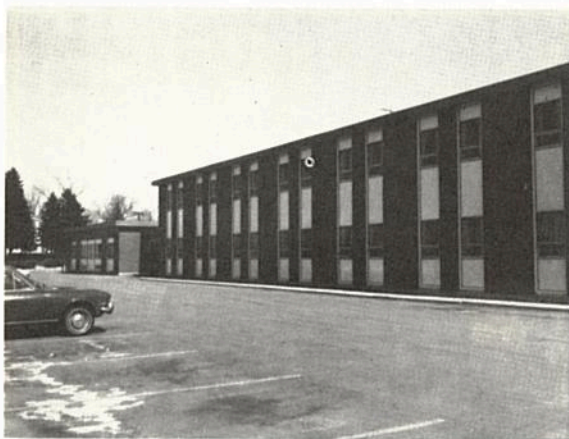
Figure 91. North face of two deck barracks section of building 6.

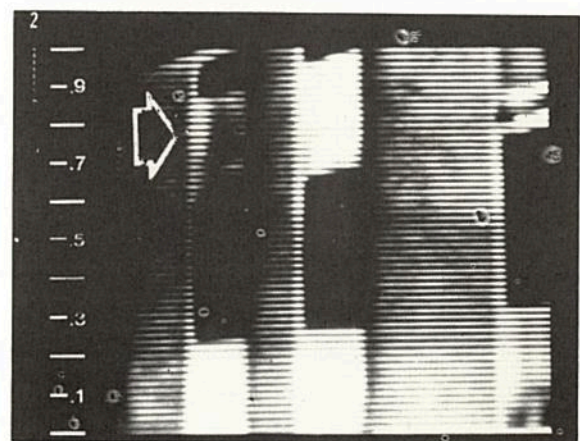
Figure 92. Thermal pattern on second deck window (arrow).

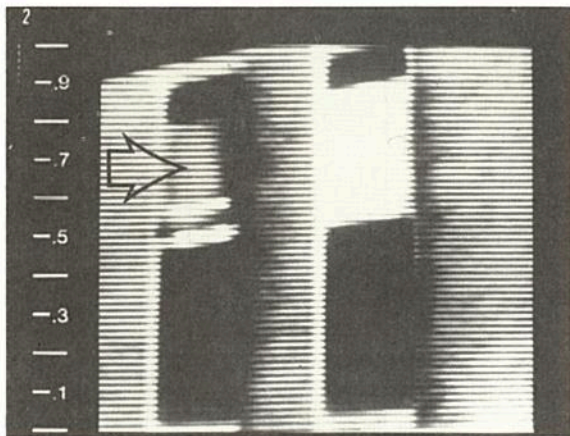
Figure 93. Second deck window opened, lower section.

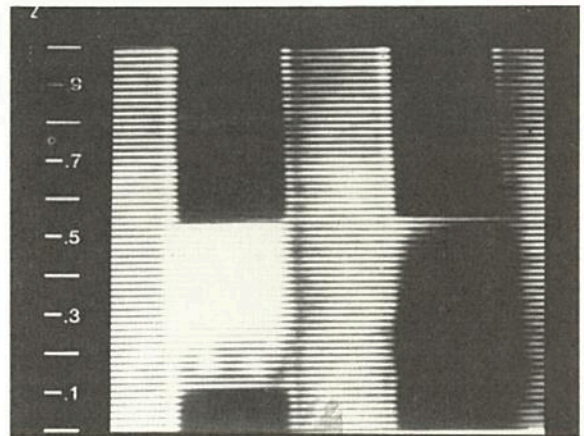
Figure 94. Cool porcelain panels, note cool window on right.

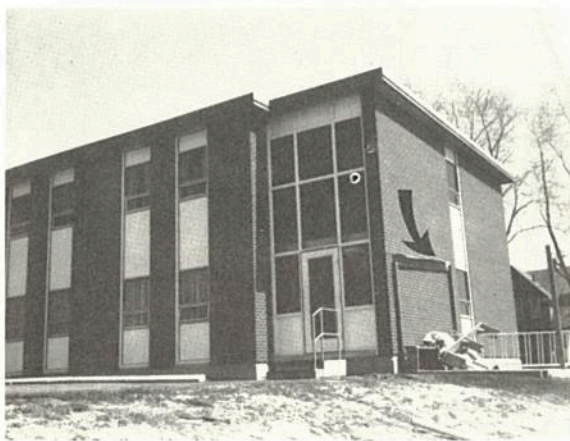
Figure 95. Northwest corner of two-deck barracks section of building 6.

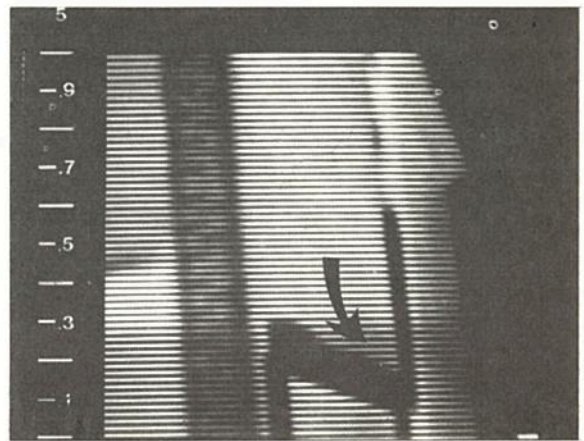
Figure 96. Porcelain panel between first and second deck windows.

Figure 91 is a photograph of the north face of the two-deck barracks section of building 6 with the mess deck in the background. Note the white insulated porcelain panels between the first- and second-deck windows, above the second-deck windows, and below the first-deck windows. Figures 92-94 are thermograms of these window sections that show the superiority of these panels (black rectangular patterns between upper and lower windows) as compared with the wooden panels between upper and lower windows in the Hull Station (Fig. 30 and 31). Figures 95 and 96 show a wooden frame stored against the west wall, which points towards the interface between the porcelain panel and the first deck window. The porcelain panel is just as dark (cold) as the wooden frame at ambient temperature (7.2°C).

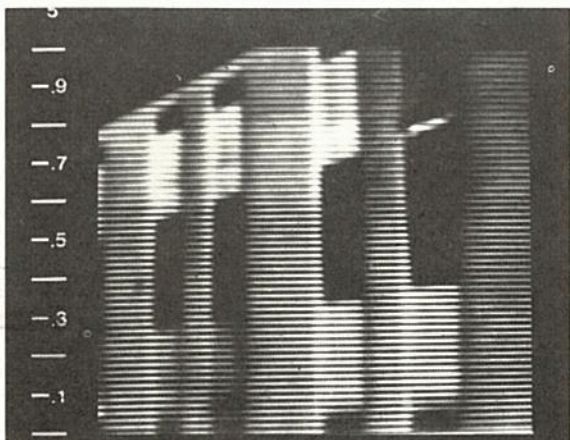
Figure 97. Cool porcelain panels, note cool window on upper right.

Four types of window patterns are evident in Figures 92-94 and 97. Most of the windows are uniformly white but two are almost black, as seen in the right-hand window in Figure 94 and the right-hand upper window in Figure 97. The left-hand upper window in Figure 92 (arrow) shows a dark vertical pattern in the middle with a white pattern at the vertical edges, while the upper left window in Figure 93 (arrow) shows the reverse. What these patterns mean is not clear; it could be the effect of drawn drapes, opened lower portions of the windows, or room heaters that were turned off. In any event it seems clear from the even rectangular patterns of the windows and panels at scale 2 that this type of construction is vastly superior for energy conservation in cold regions to that of other stations.
