Special Report 79-20

INFRARED THERMOGRAPHY OF BUILDINGS

1977 COAST GUARD SURVEY

Stephen J. Marshall

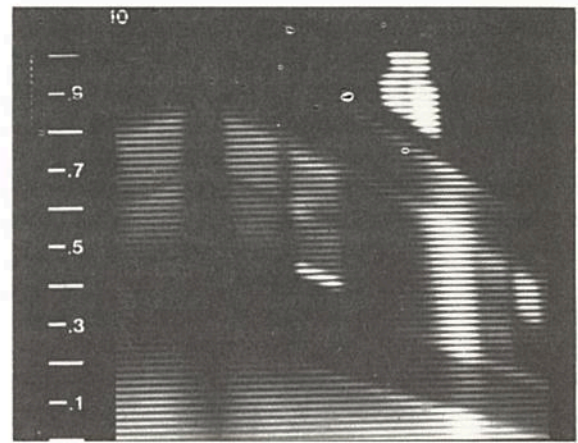
Figure 103. Vertical thermal pattern from chimney.

Figures 103 and 105 are thermograms of the north face of the Boothbay Harbor building showing the loss from the chimney. Figure 103 shows the second deck, and the darker area, through which the chimney thermal pattern passes, is the large wooden Coast Guard sign on the building wall. Most of the stations had external chimneys, and it would be logical to assume that valuable heat could be saved if future buildings were constructed with the chimneys in the middle of the buildings, as in older buildings. Perhaps stack heat reclaimers could be installed to reclaim some of this heat lost from the present chimneys.

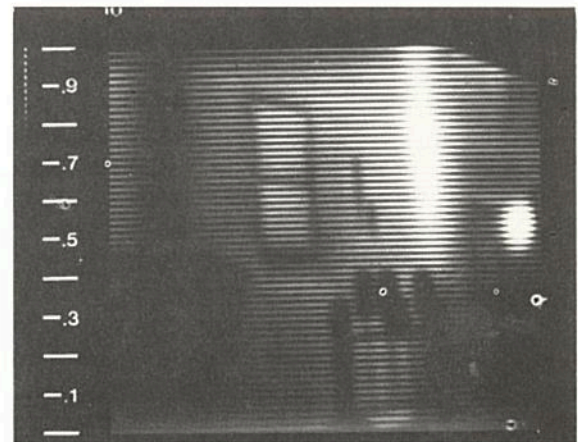
Figure 105. Vertical thermal pattern from chimney on north face of building.

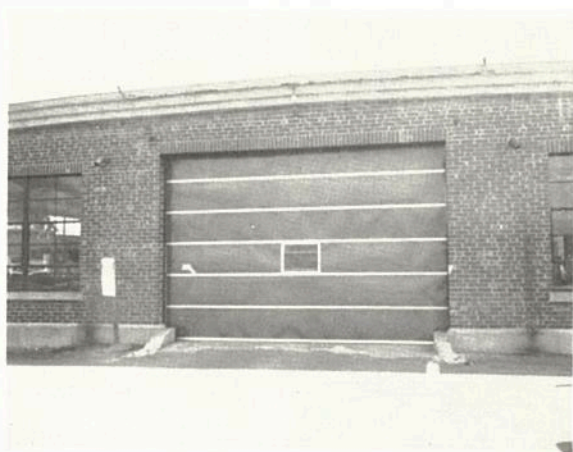
Figure 106. Insulated fiberglass overhead door at New Hampshire Highway Garage.

be vastly superior to most was an insulated fiberglass door installed on the north face of the New Hampshire Highway Garage* in Concord, New Hampshire.⁸ Figure 106 is a photograph of the door and Figure 107 is a thermogram of that door. This thermogram shows an almost completely black pattern, except for the small single window area and the top horizontal interface, which is probably due to the constant daily use that this door experiences. For orientation purposes, the white rectangular white area on the left of Figure 107 is the window on the left in Figure 106.

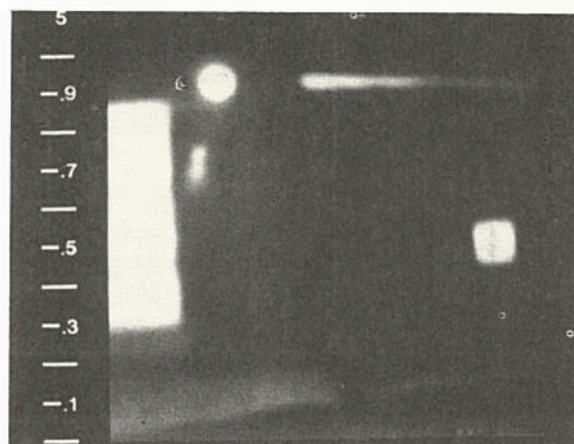
Figure 107. Thermogram of insulated fiberglass door.

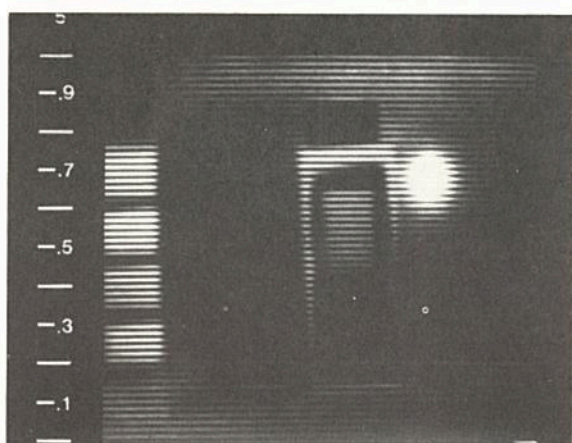
Figure 108. Closeup of overhead door and boat crew door on east face.

Figure 108 is a closeup thermogram of the door to the right of the overhead garage doors in the east face. It shows the typical thermal pattern of a sprung door recognized and confirmed in Figure 78 and evident at a majority of the stations. This particular door gets very heavy usage as it is the passageway from the communications center to the boat dock used by the boat crews.

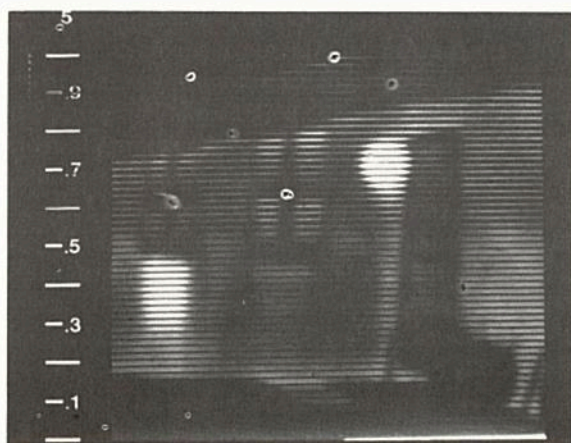
Figure 110. Rarely used galley door on west face.

Figure 109 is the galley door on the west face of the building which is never used except as an emergency exit. Figures 110 and 111 show how tight and thermally sound the door is. Figure 110 also shows that the window immediately to the left of this door does not have a radiator pattern under it — only because there is no radiator under this galley window.

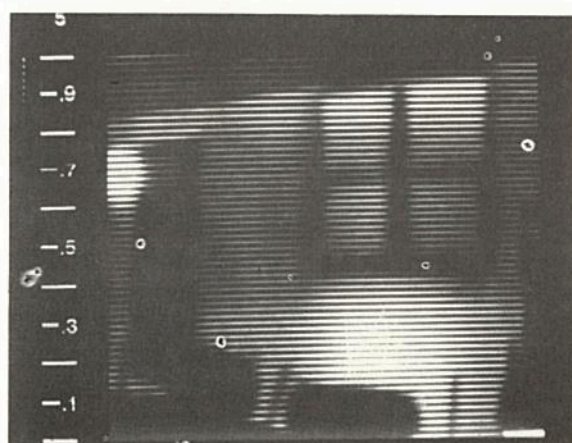
Figure 111. Radiator under window radiates through wall on west face.

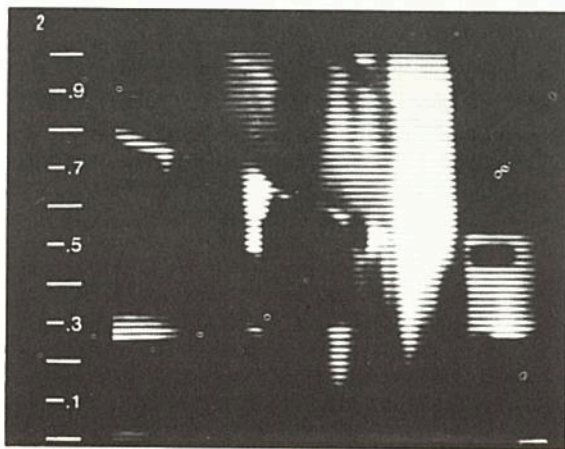
Figure 116. Window and door exfiltration leakage and solar effect.

Figure 116 is a closeup of the door immediately to the left of the chimney showing leakage around the top and upper right-hand portions of the door. The window to the left shows top horizontal interface leakage, and a dark upper glass panel and warmer lower glass panel. The radiator pattern under the window can be seen, as well as a rare example of lower horizontal window/wall interface leakage. This lower leakage does not normally show itself, presumably because the weight of the window units usually assures a better fit at the bottom interface. In addition, this illustrates that any vertical interface leakage at the left or right window/wall interface can best be discovered by viewing windows and doors at approximately 45° rather than perpendicularly. The cold closed vent can also be seen in Figure 116 and the white object in the upper left of the door is a spotlight.

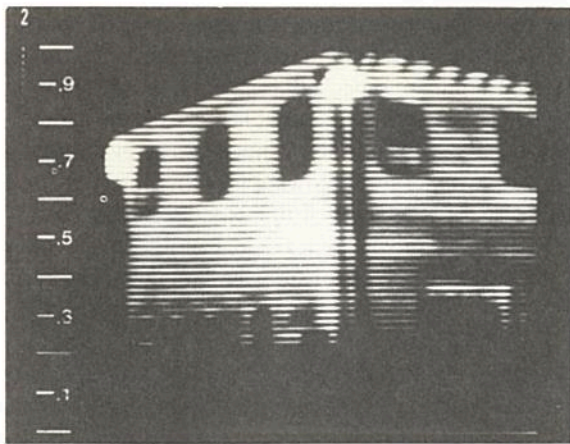
Figure 120. Excessive leakage from glass main entrance.

Figure 120 shows the leakage from the all-glass doors in the main entrance, but the all-metal double storage doors immediately to the left of the main entrance appear uniformly dark. The leakage above the other two garage doors is evident in Figures 120 and 121, and a few of the windows have small white areas indicating that the storm windows are left partially open all night.

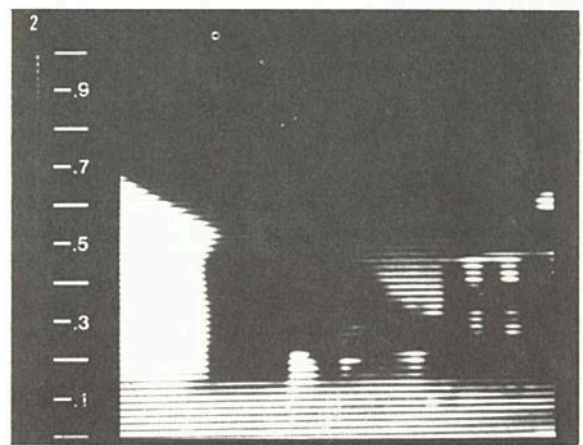
Figure 122. Brick building on left and wooden building on right.

Figure 122 is a thermogram that compares the temperature of the east face of the brick Administration Building with the south face of the wooden supply building. The brick building is much warmer and the wooden building does not display the solar thermal effects, indicating that wooden buildings cool off much more quickly than brick buildings.

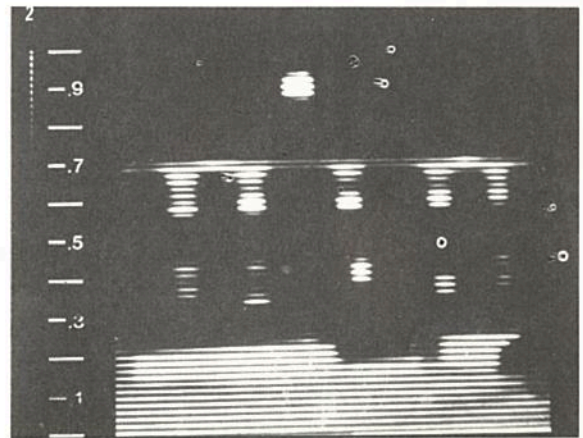
Figure 124. Thermogram of wooden building.

Figure 123 is a photograph of the southwest corner of the wooden supply building, an old barracks built in the 1940's. The blueprints show 7.5 cm of blanket insulation in the stud bays and in the ceiling. Figure 124 is a thermogram of the south face and shows leakage typical of all the wooden buildings surveyed at the various stations. The foundation is very warm, and the warmth in the eaves indicates inadequate insulation in the attic. Numerous closeups of any portion of the stud bays show cool bays and warm studs, indicating that insulation is present. It can also be seen that the warm chimney is at the center of the building, the radiators do not show through the walls, and the front entrance has an enclosed vestibule. These features show that architects in the 40's were more committed to energy conservation in buildings than many seem to be today.

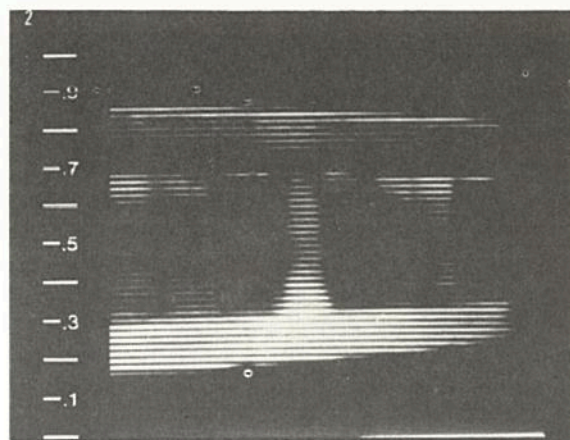
Figure 127. Mess deck windows on south face.

brick exterior built in 1969, a 15×10-m wooden duplex, a motor pool with brick exterior, a heated boathouse with brick exterior, and several single-story housing units. Figure 126 is a photograph of the east face of the Jonesport Station mess deck and Figure 127 is a thermogram of the south face windows of the mess deck. These windows are of the horizontally sliding aluminum type, and they exhibit leakage along the vertical meeting rails and along the top horizontal interface. Figure 128 is a thermogram of the window unit on the east face of the mess deck which was sprung by the wind and which leaks quite badly whenever there is wind-driven rain from this direction. The thermogram of this window in Figure 128 shows that the first vertical meeting rail from the right is in poor condition and the top horizontal interface leaks badly.

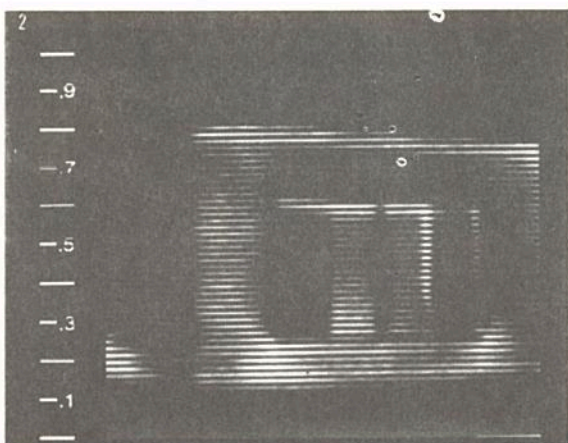
Figure 128. Badly sprung window unit on east face of mess deck.

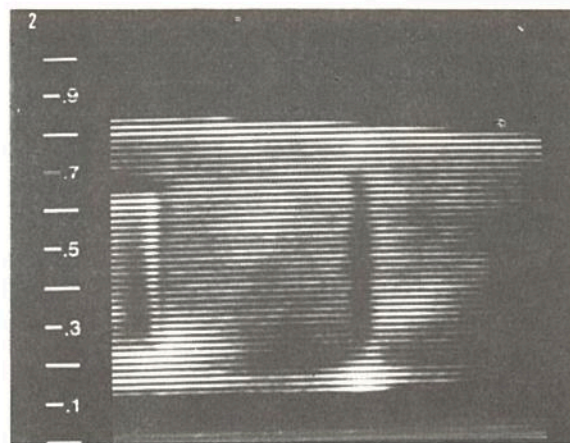
Figure 129. Cool foundation on east face of mess deck.

Figure 129 is a thermogram of the wall to the right of this window, which shows (along with Fig. 128) that the floor slab at this station is cooler than the wall — the opposite of conditions at most of the stations. The dark vertical stripe shown in Figure 129 is a cavity containing pipes to the dishwasher in the galley.

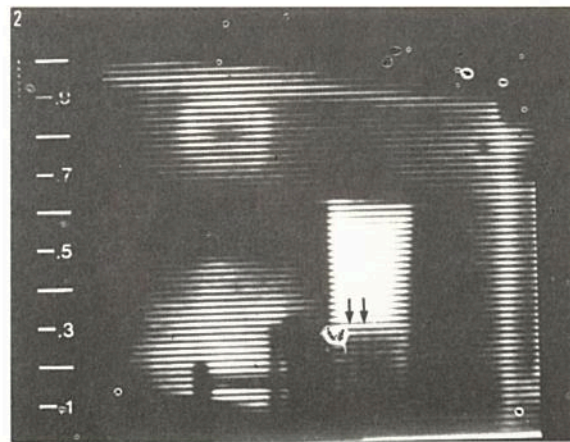
Figure 131. Galley door on the northwest face.

Figure 130 is a photograph of the north face of the galley, the connecting section, and the east section of the two-deck barracks. Figure 131 is a closeup thermogram of the galley door located in the northwest section of the galley. In addition to the noticeable leakage through the glass panel in the door, the vertical ribs in the lower portion of the doors can be seen (small arrows). The upper left-hand pattern is a vent, the metal portion of which is cool but the area around it is warm. The warm pattern in the lower left wall area is coming from a small locked room to the left of the door that contains a freezer. The warm vertical construction joint interface with the connecting section can be seen at the right-hand edge of the thermogram.

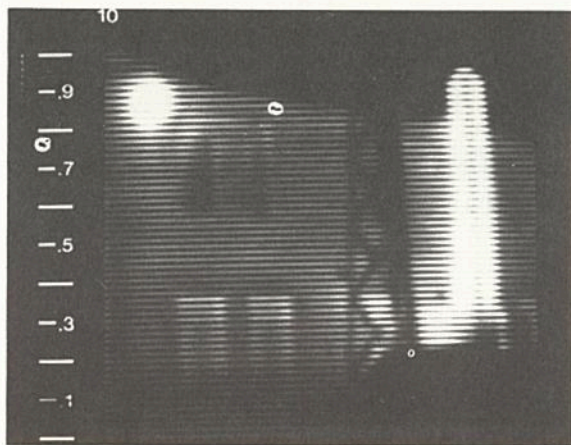
Figure 134. Chimney that is warmer than glass window transoms.

Figure 133 is a photograph of the west section of the north face of the two-story barracks. Figures 134, 135, 136 and 137 are thermograms of selected portions of this north face which do not exhibit the familiar radiator leakage under the windows. All the windows are closed, demonstrating that this station has six heating zones each separately controlled and comfortably

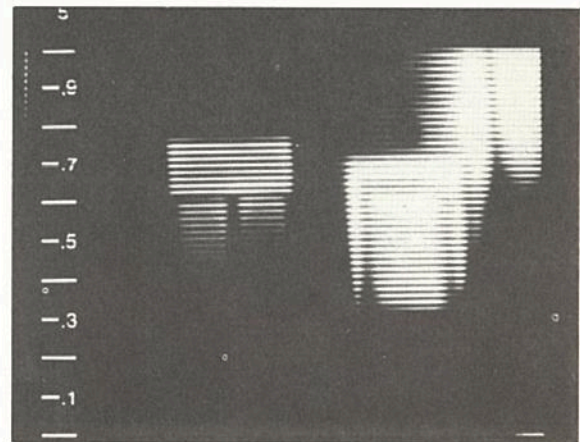
Figure 135. Exfiltration around upper half of door.

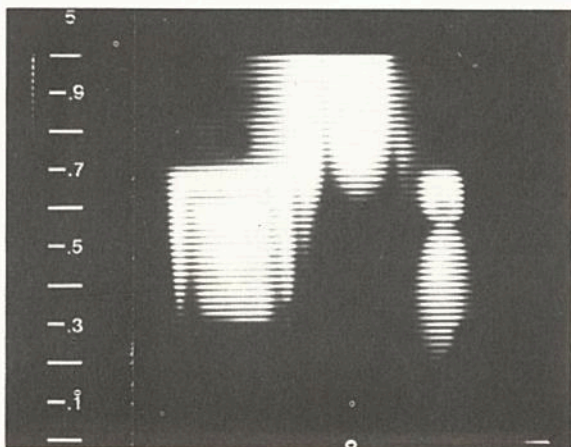
Figure 136. Plume of warm air from vent to right of chimney.
