Demonstration of Antimicrobial Corrosion-Resisting Interior Coating Systems for Military Facilities in Warm, Humid Locations

Final Report on Project F10-AR04

June 2017

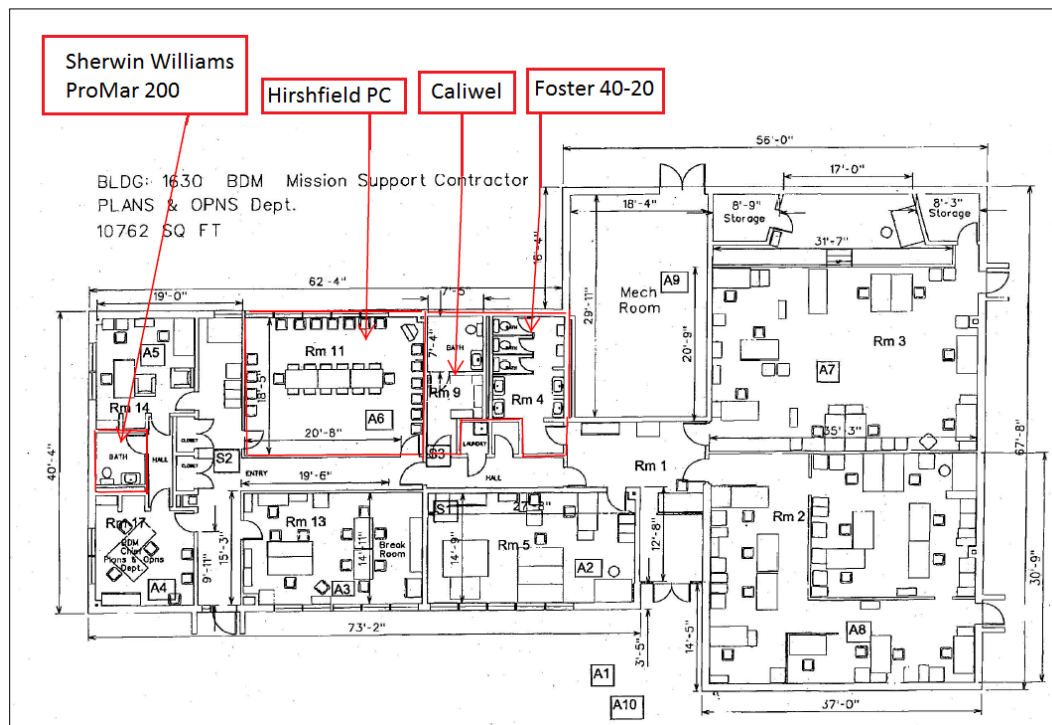
Figure 3. Coating test locations in Building 1630.

Figure 3 shows the coating locations within the demonstration site (Building 1630).

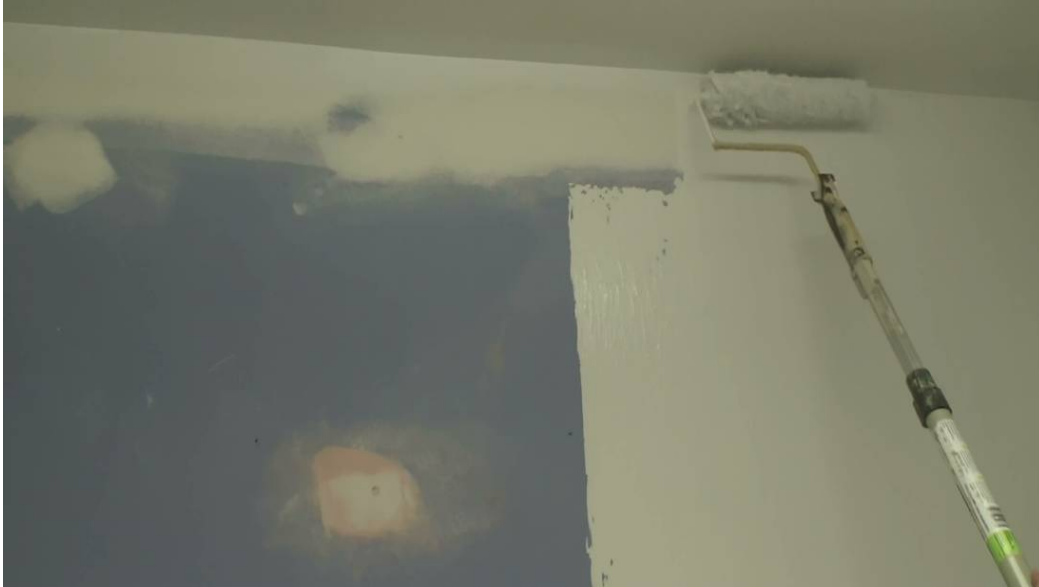
Sherwin Williams ProMar 200 acrylic primer was used to prime all gypsum surfaces that were repaired or newly refurbished. Walls in Room 4, Room 11, and the restroom near Room 14 had been primed with Sherwin Williams ProMar 400 acrylic primer by the DPW general contractor prior to the start of this project. Figure 4 shows primer being rolled on a new

gypsum board in Room 9 with a 1/2-inch nap roller. A 3-inch nylon brush was used to apply primer to the areas where a roller could not be used. The primer was given 4 hours to dry before applying the antimicrobial top-coats.

Figure 4. Sherwin Williams ProMar 200 acrylic primer applied to new gypsum board installed in Room 9.

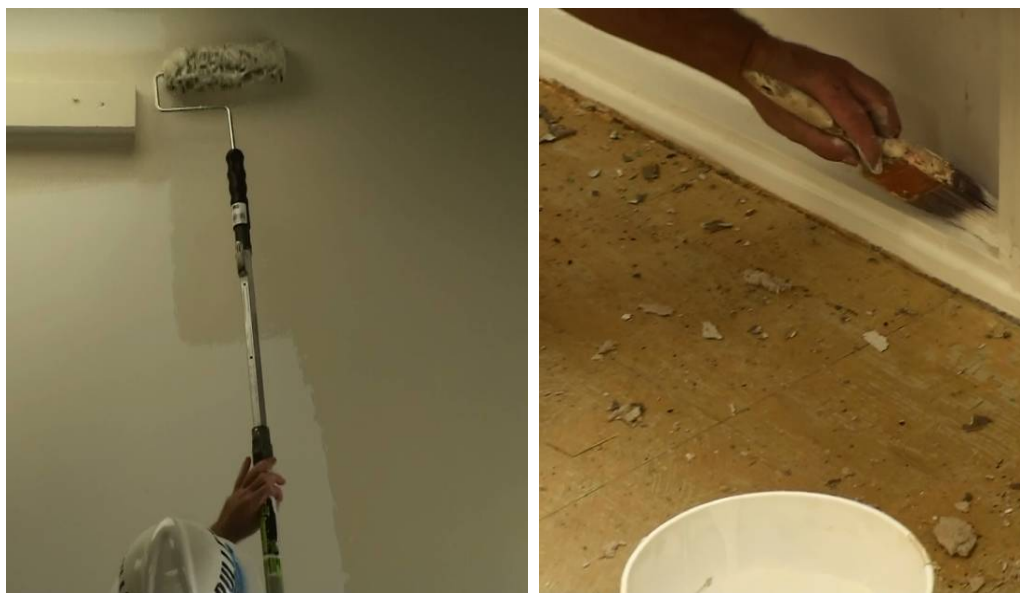
Figure 5 shows the Sherwin Williams control and the Hirshfield's coatings, as applied with a 1-inch nap roller and a 3-inch nylon brush. The brush was used for places such as corners and small areas that a roller could not reach. Each coating was applied to the walls to provide 4–6 mils of wet film thickness (Table 1). Wet film thickness was measured using a standard wet film thickness gauge (Figure 6).

Figure 5. Coating application using 1-inch nap roller (left) and nylon brushes (right) for Sherwin Williams and Hirshfield's coatings.

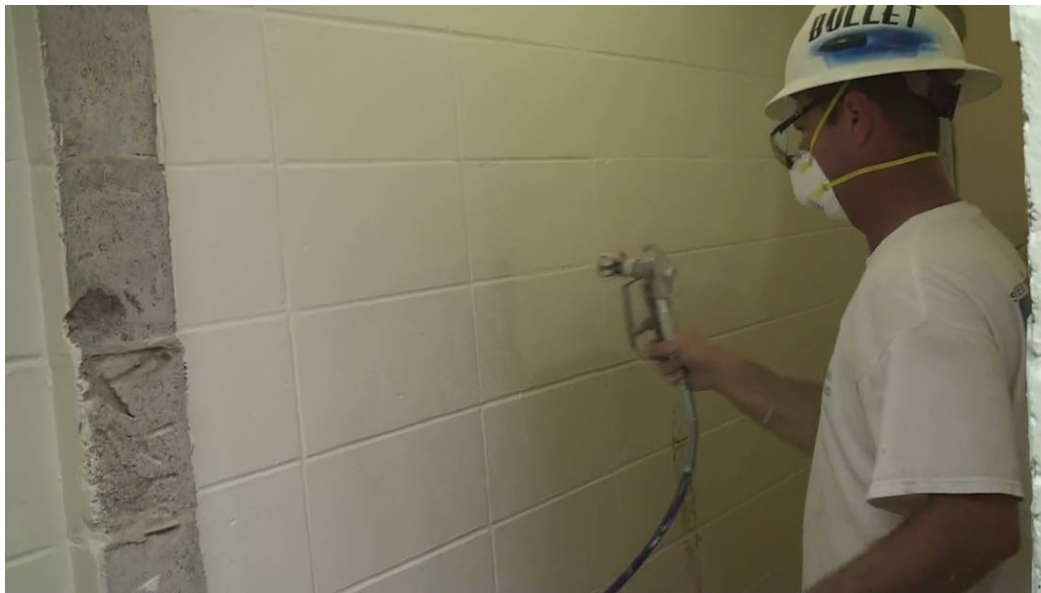
sprayer with a 100-foot hose and a 521 tip that was set at 3300 psi. The Caliwel coating was less viscous than the Foster coating, and it was sprayed using a Graco Nova 390 electric airless sprayer, as shown in Figure 7. A 50-foot hose and a 515 tip at 3300 psi were used to apply 4–6 mils of wet film thickness to the walls. The spray coatings were applied holding the spray gun approximately 10–12 inches from the wall surface. No thinner was added to any of the coatings. The coatings were given approximately 24 hours to dry before applying a second coat. The first coat was applied at an average ambient temperature of 78°F and 84% relative humidity. The second coat was applied at an average ambient temperature of 80°F and 87% relative humidity.

Figure 7. Coating application using conventional airless sprayer for Caliwel and Foster coatings.

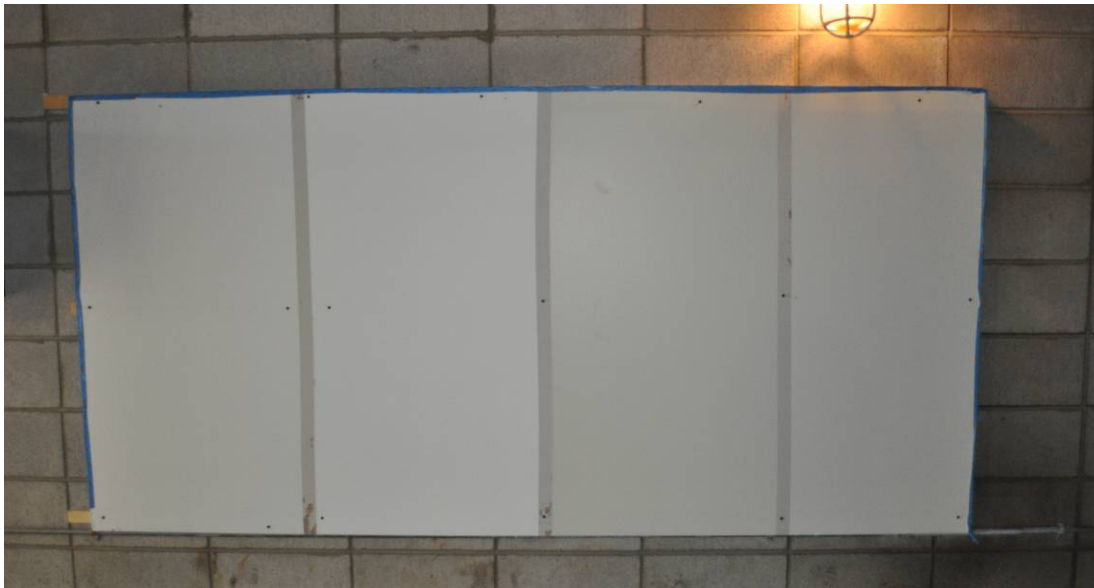
A sheet of gypsum wallboard was securely mounted to a masonry wall in the mechanical room using 1 x 2 in. furring strips, as shown in Figure 8. The surface area of the wallboard was divided vertically into four equal areas, and each area was primed with Sherwin Williams ProMar 200 and

then painted with one of the four coating systems. The topcoats were applied in the same manner as described in section 2.2. A second coat was applied approximately 24 hours after the first coat. The test site was revisited after 4, 8, and 12 months of exposure to evaluate the performance of the coatings inside the building and on the test sections.

Figure 8. Gypsum board coated with Sherwin Williams ProMar 200, Hirshfield's Platinum Ceramic, Caliwel, and Foster 40-20 (left to right) in 2 x 4 foot sections and hung in the mechanical room of Building 1630.
