POTAMOLOGY INVESTIGATIONS

Report 21-1

SAND - FILLED BAGS AS DIKE MATERIAL POTAMOLOGY RESEARCH PROJECT 9

U. S. Army Engineer District, Memphis CORPS OF ENGINEERS Memphis, Tennessee

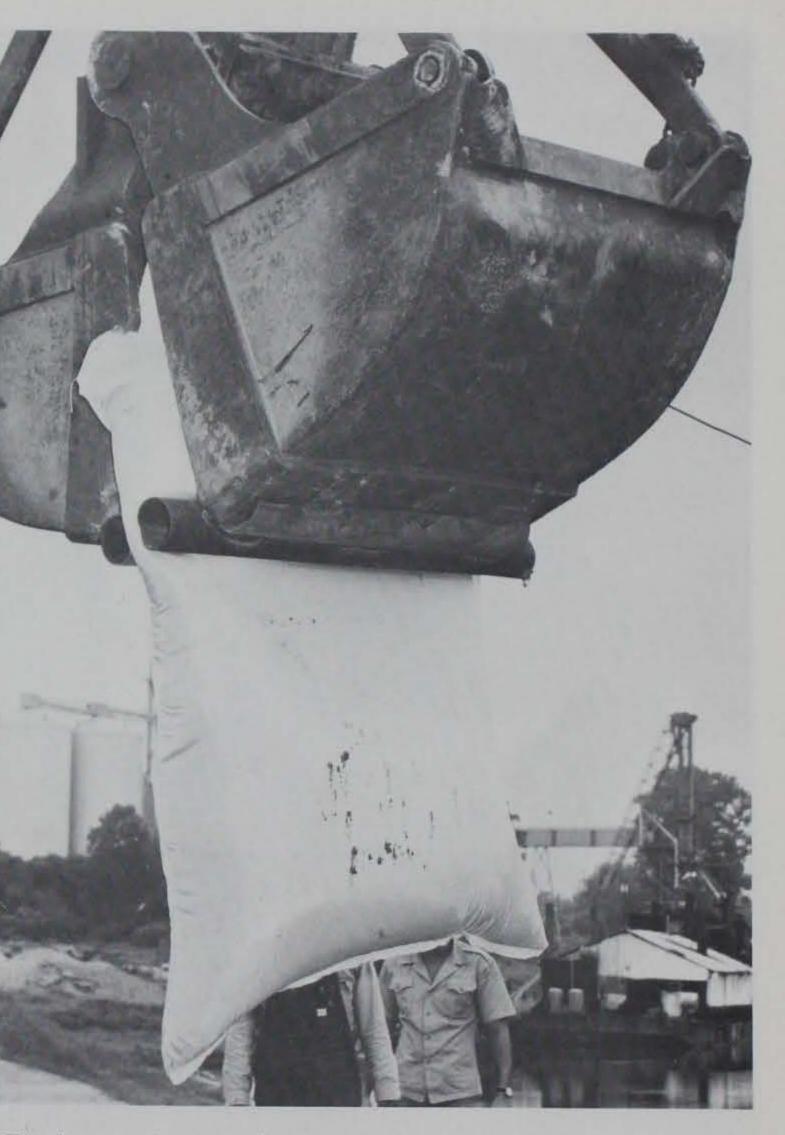
Photograph 7. Clamshell removing nylon bag from plywood box

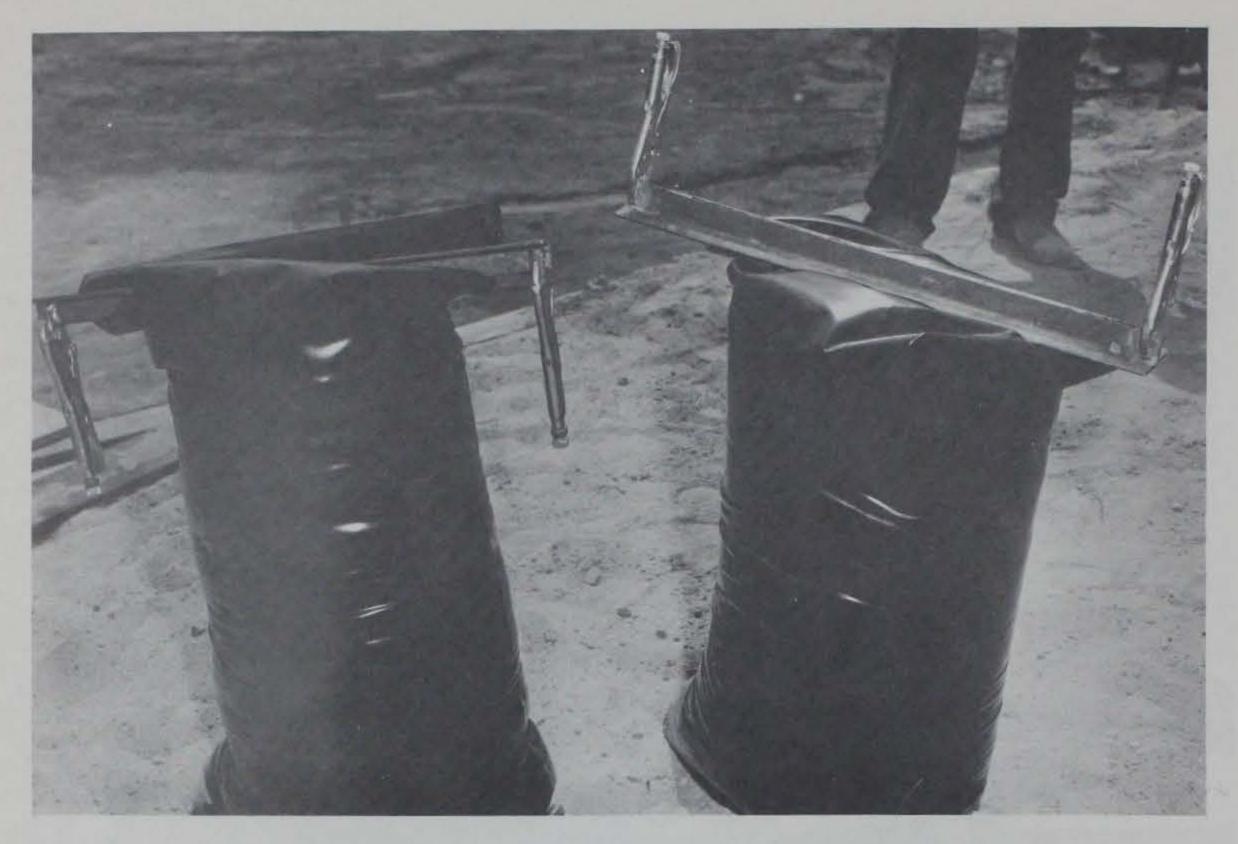
10. <u>Plastic.</u> The fastening of the plastic bags presented some problems. A device furnished by Union Carbide Corp., consisting of a clamp for holding the open ends of the bags while heat was applied for sealing, proved to be unsatisfactory (see photographs 9 and 10). The method was slow, and many of the seals were not sufficiently strong to withstand normal handling. It was determined that this failure was due to excess dust in the work area which prevented proper sealing. This would preclude

Photograph 9. Two methods used in applying clamping device for heat sealing of plastic bags

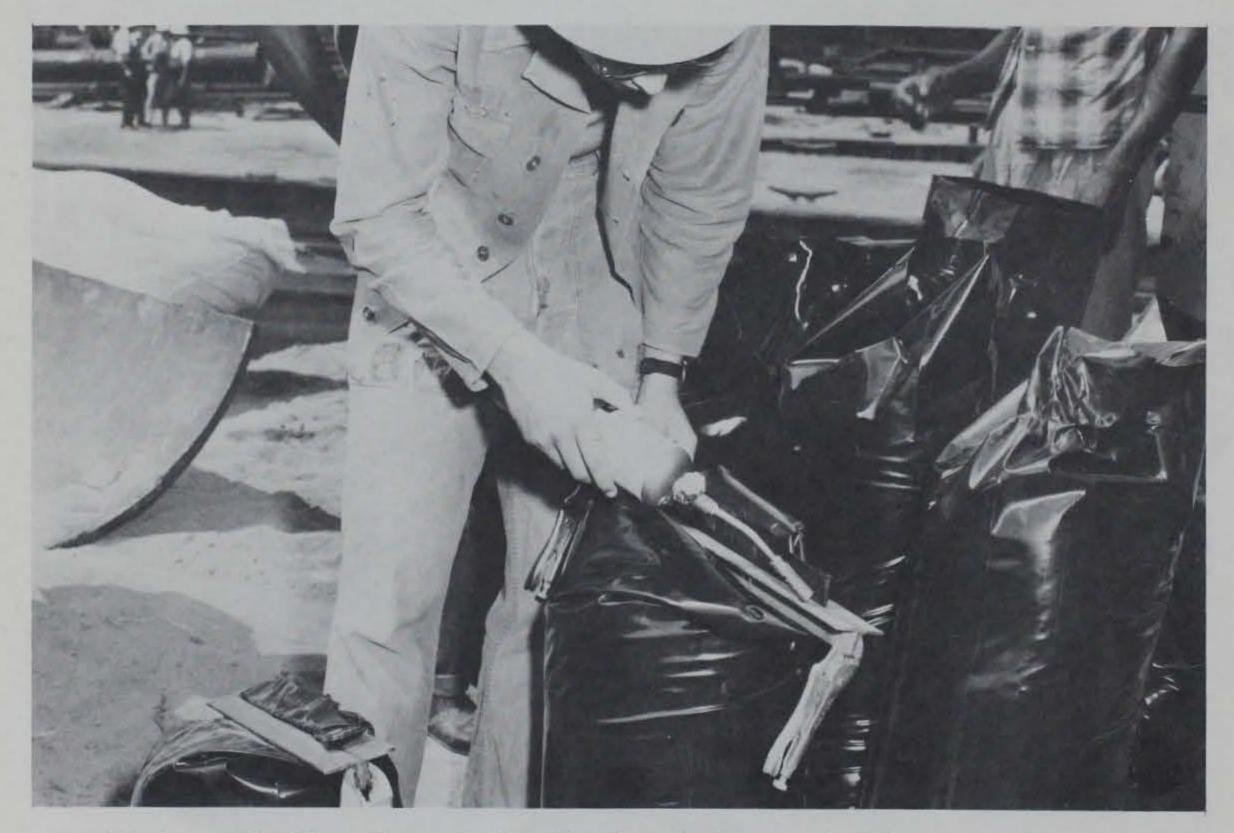
Photograph 10. Top of plastic bag being sealed by heat from a small propane torch

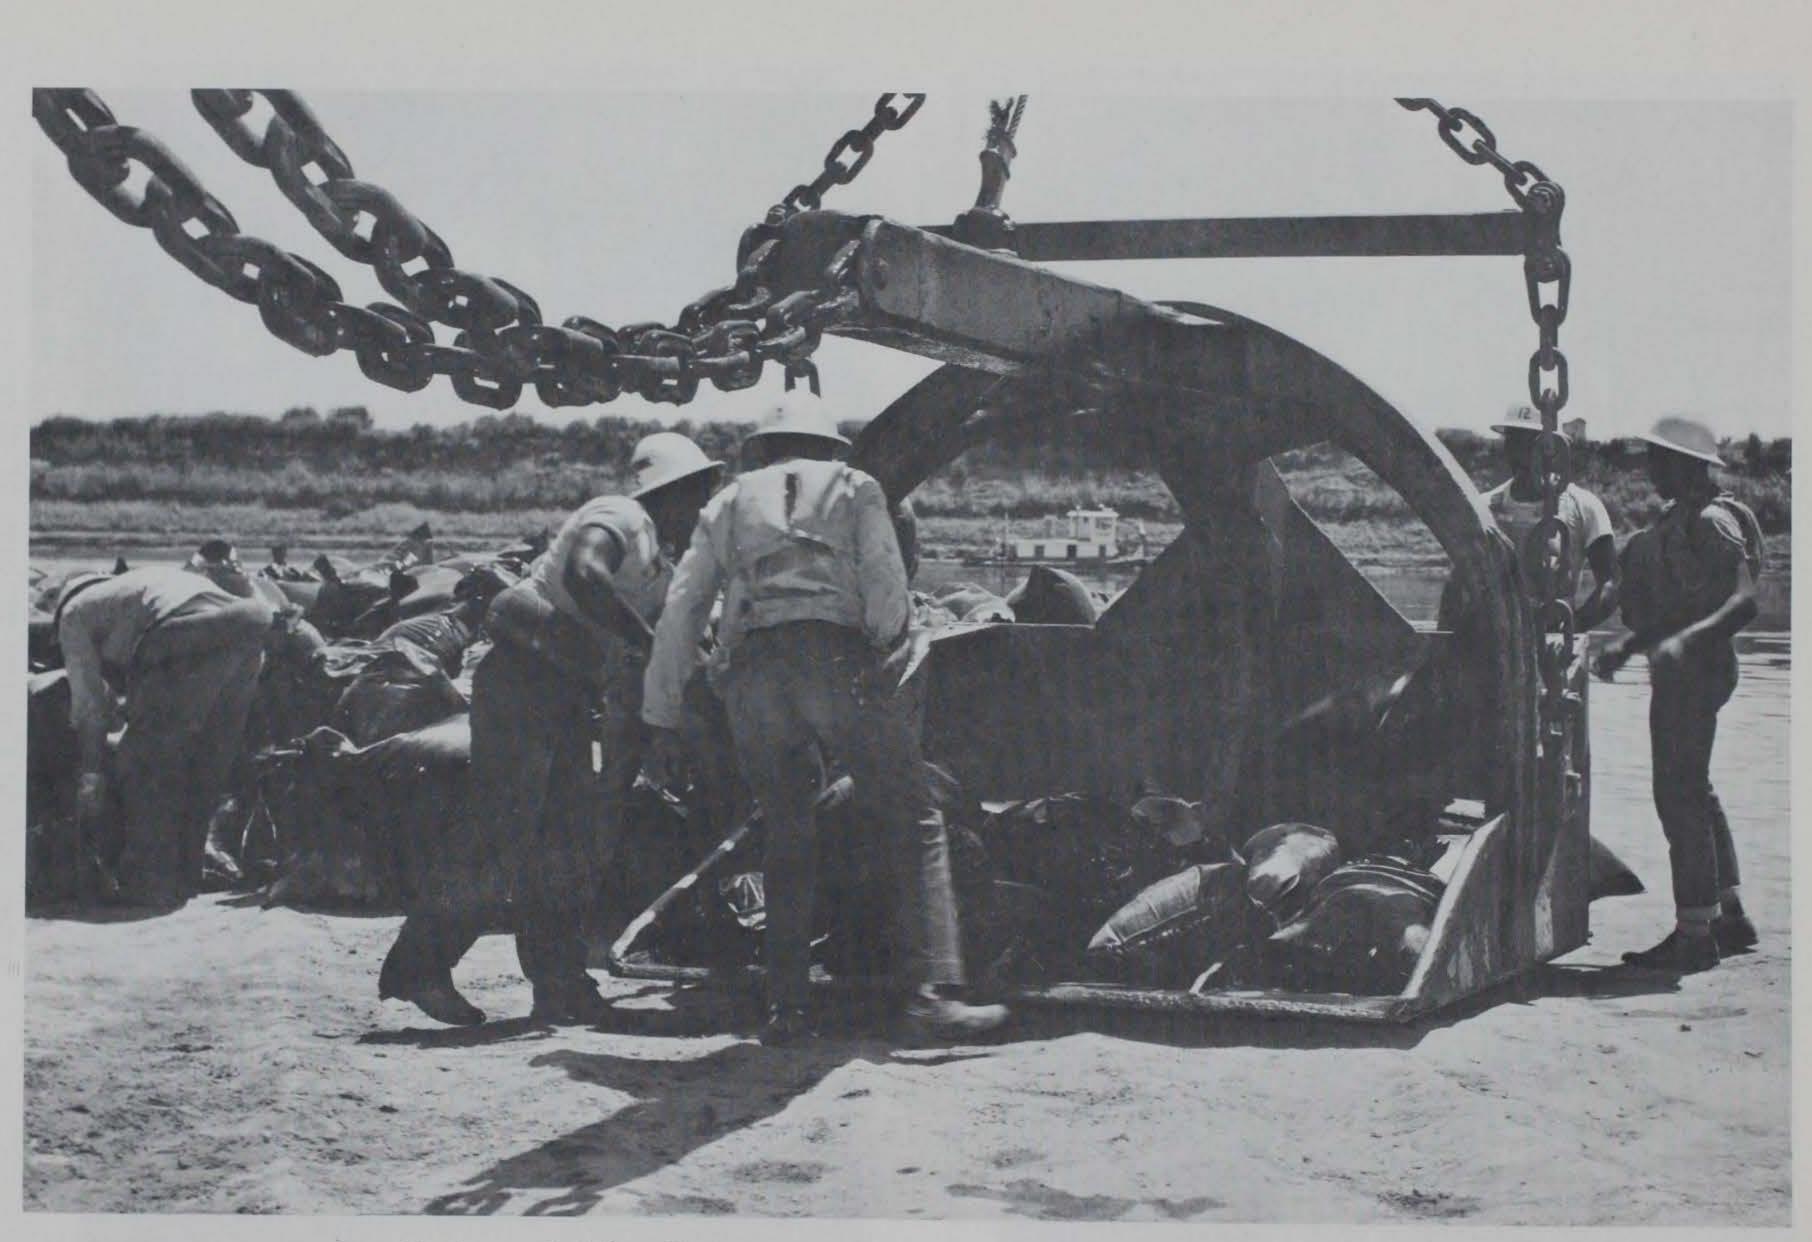
12. <u>Plastic.</u> Handling of the small plastic bags by clamshell was not practicable, and the best method was found to be by the use of a "rock bucket," or skip-type bucket (see photograph 16). The bags were loaded into the bucket by hand (about 25 bags per load) and dumped mechanically into the structure. A filled bag could be handled easily by two men, and eight men were used in loading the skip. Damage to the bags in handling was negligible.

Photograph 16. Workers loading plastic bags into skip bucket

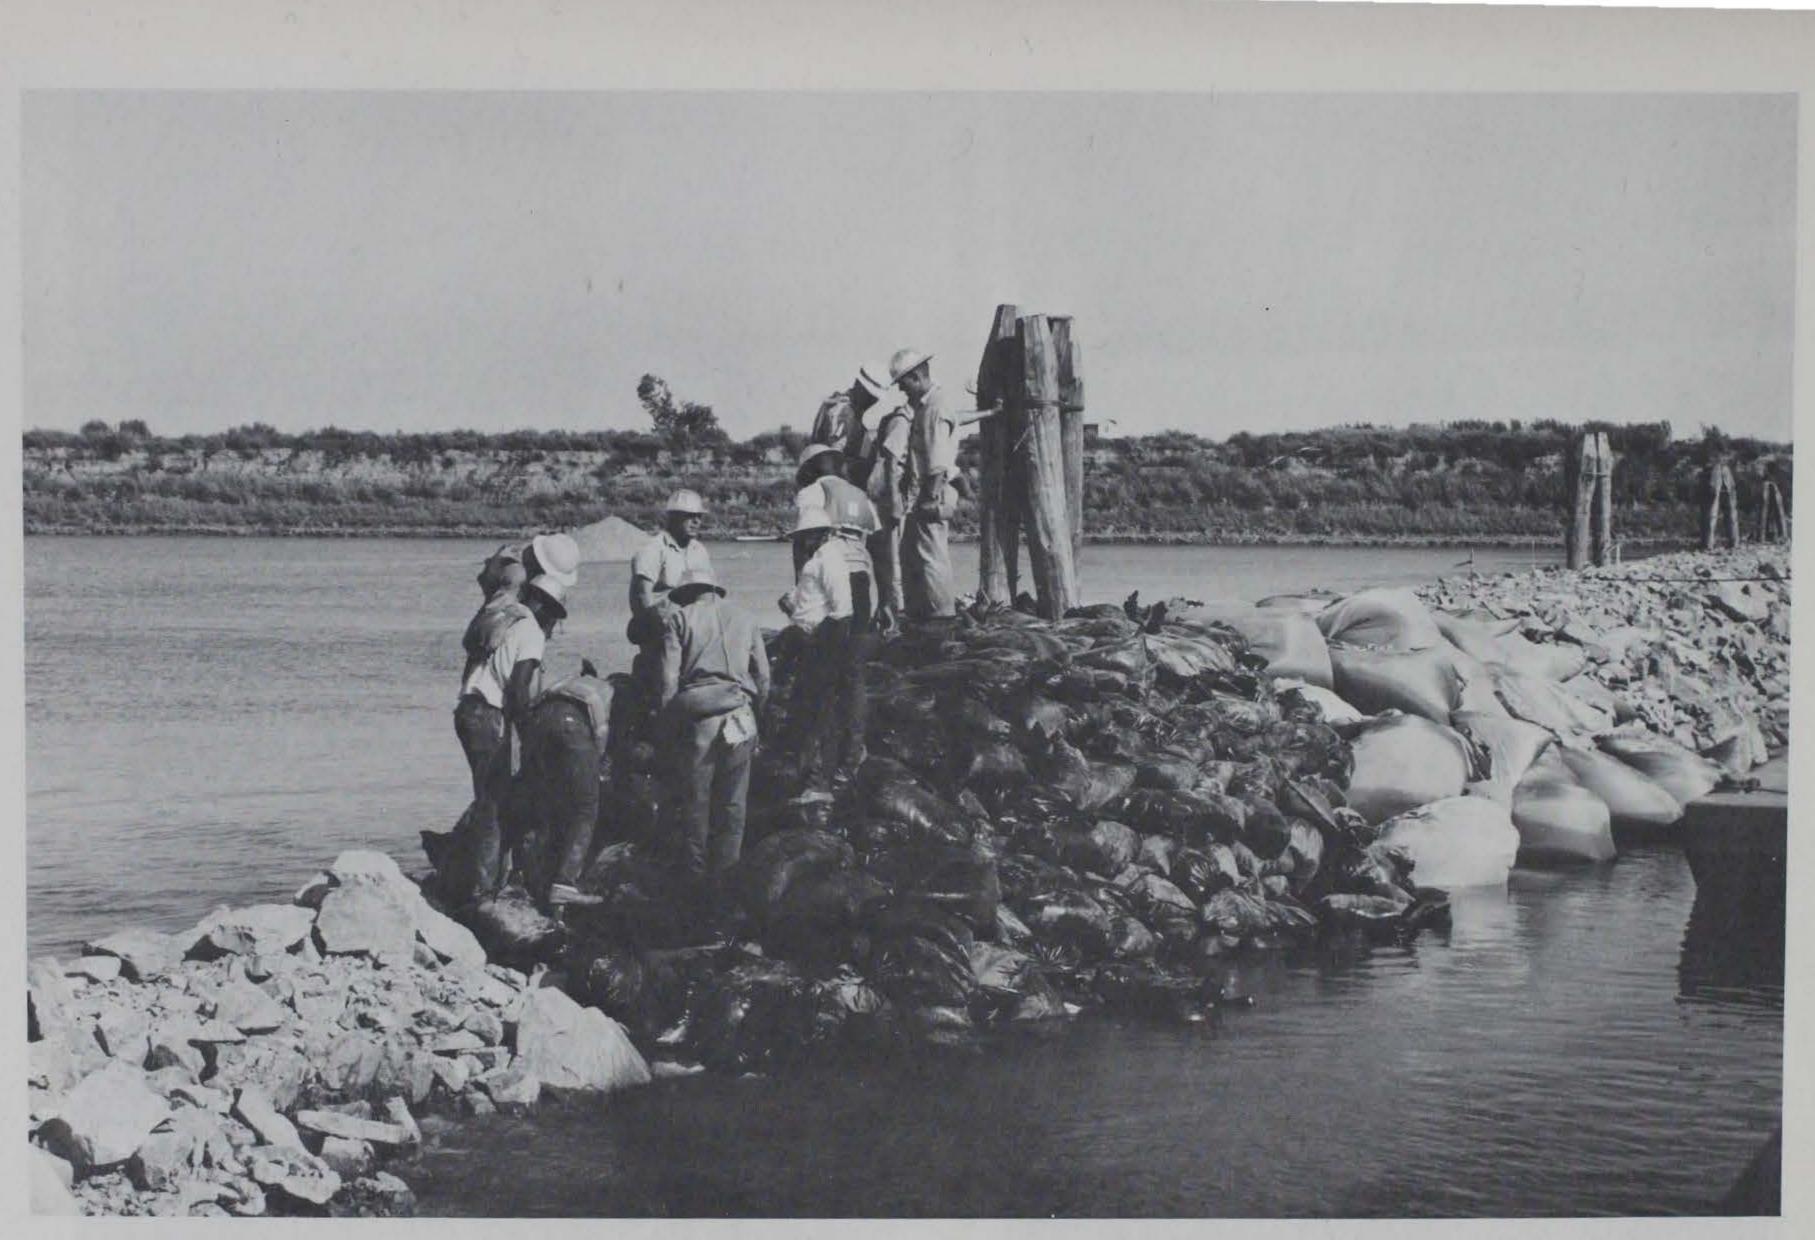
plastic bags, hand-placing of the bags above the water surface was necessary to provide the proper cross section. Consequently, a more compact fill with some interlocking of the bags was achieved (see photograph 20). During the final phase of construction on the test section, the 90 clear plastic bags, described in paragraph 10, were placed below the water surface on the downstream side of the plastic portion of the test section. Photographs 21 and 22 show completed sections of nylon and plastic bags. Coating of nylon bags

Photograph 20. View looking landward from below dike line. Workmen are hand-placing plastic bags
