Guided Wave Testing of Trunnion Rods at West Point Dam, Georgia

by Jason D. Ray, Richard W. Haskins, and James A. Evans

PURPOSE: This Coastal and Hydraulics Engineering Technical Note (CHETN) describes trunnion rod crack detection testing using the portable guided wave test system on a sample of the trunnion rods located at West Point Dam, Georgia, in January 2016. It is also intended to be used as a guide for test efforts at other sites.

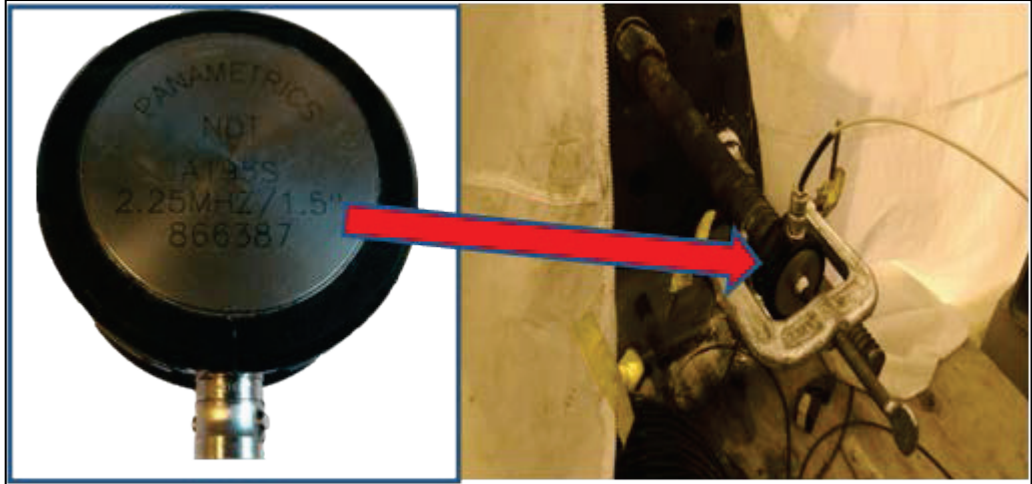
TEST METHOD: All rods for each pier were tested before moving to the next pier. First, each rod was visually inspected for proper placement of the transducer on the rod end (Figure 7). At West Point Dam, preparation for proper transducer placement involved cleaning the rod ends of caked-on grease using a putty knife. Safety procedures were observed, being careful to stay out of harm's way by standing clear of any possible projection of the rod.

Figure 7. Panametrics transducer (left) and transducer clamped on rod (right).

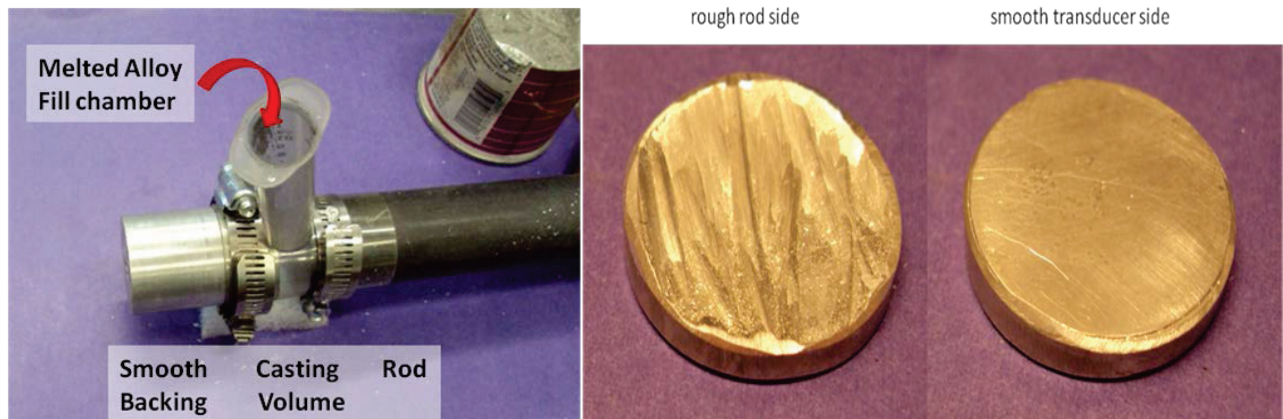
Figure 8. Trunnion rod end casting assembly and sample casting.

If cases where the rod ends are too rough to make adequate contact with the transducer, a Fields metal casting may be made of the rod end to interface to the transducer (Figure 8). This procedure will eliminate the need for grinding or cutting off the rod ends. This will decrease the risk of having a rod break and project out of the tube.

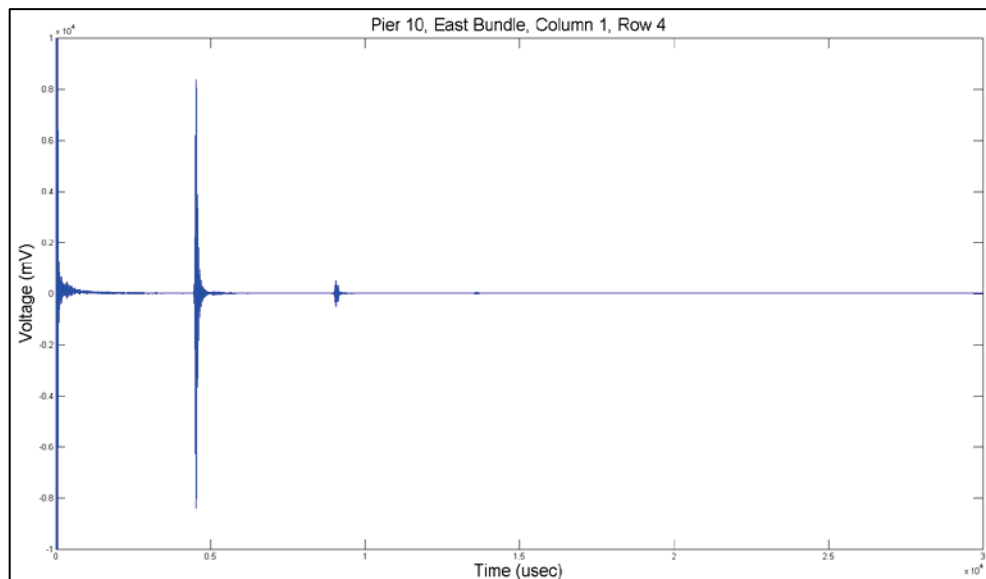
Figure 10. Typical acoustical guided waves response from rods.

Though the rods were of similar length, diameter, and visible condition, the level of the output varied from rod to rod. These results can be contributed to several factors, including the angle and the condition of the fixed end of the trunnion. All of the rods tested, with the exception of one (Figure 11), displayed a variation of the typical response shown in Figure 10.
