# **Guided-Wave Inspection of California Department of Water Resources Tainter Gate Trunnion Rods**

Inspection of Oroville Dam, Thermalito Bypass, and Pyramid Dam

Jason D. Ray, Richard D. Brown, and James A. Evans

September 2019

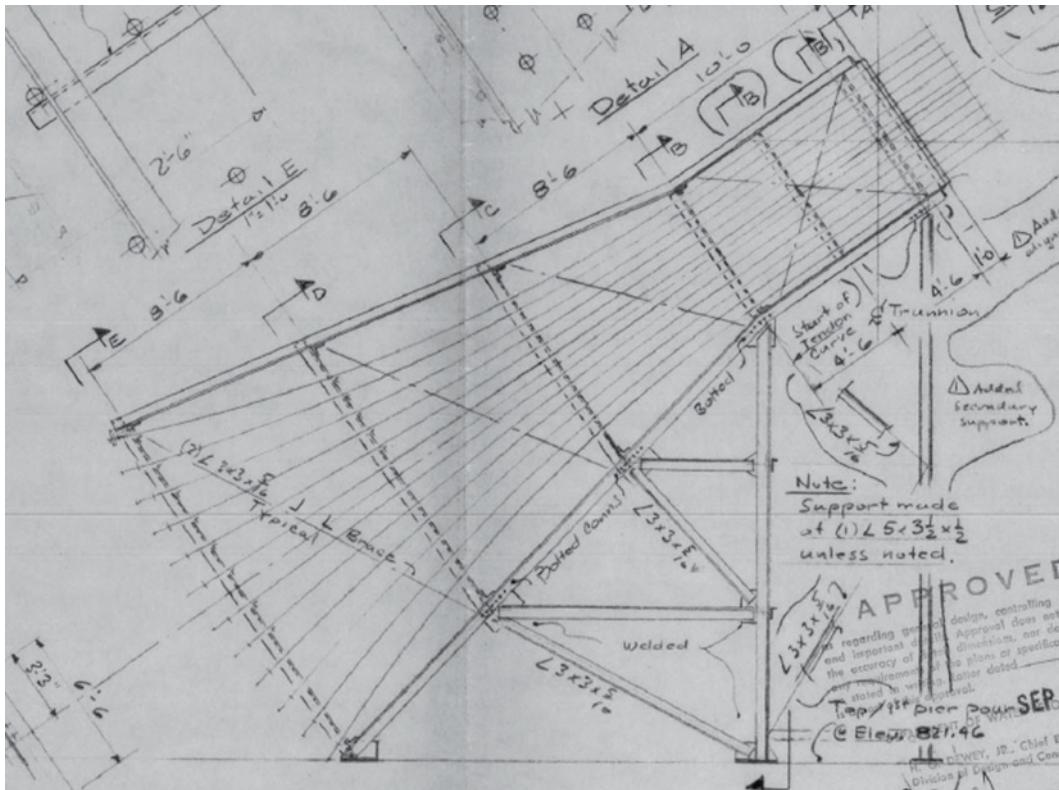
Figure 3. Rod curvature at Oroville Dam.

Drawings of the trunnion bundles at the Oroville Dam, Oroville, California, Thermalito Bypass, Oroville-Thermalito Complex, and Pyramid Dam, near Castaic, Southern California, show that the original installation of the tendons required them to be installed in such a fashion, that while the exposed ends run parallel to each other, the dead end is curved to a higher and higher degree, proceeding up and down the rows of the bundles. Oroville Dam is shown in Figure 3 and the Thermalito Bypass is shown in Figure 4. Due to the smaller number of rods, it is assumed that greater curvature was not necessary at the Thermalito Bypass. Pyramid Dam is shown in Figure 5.

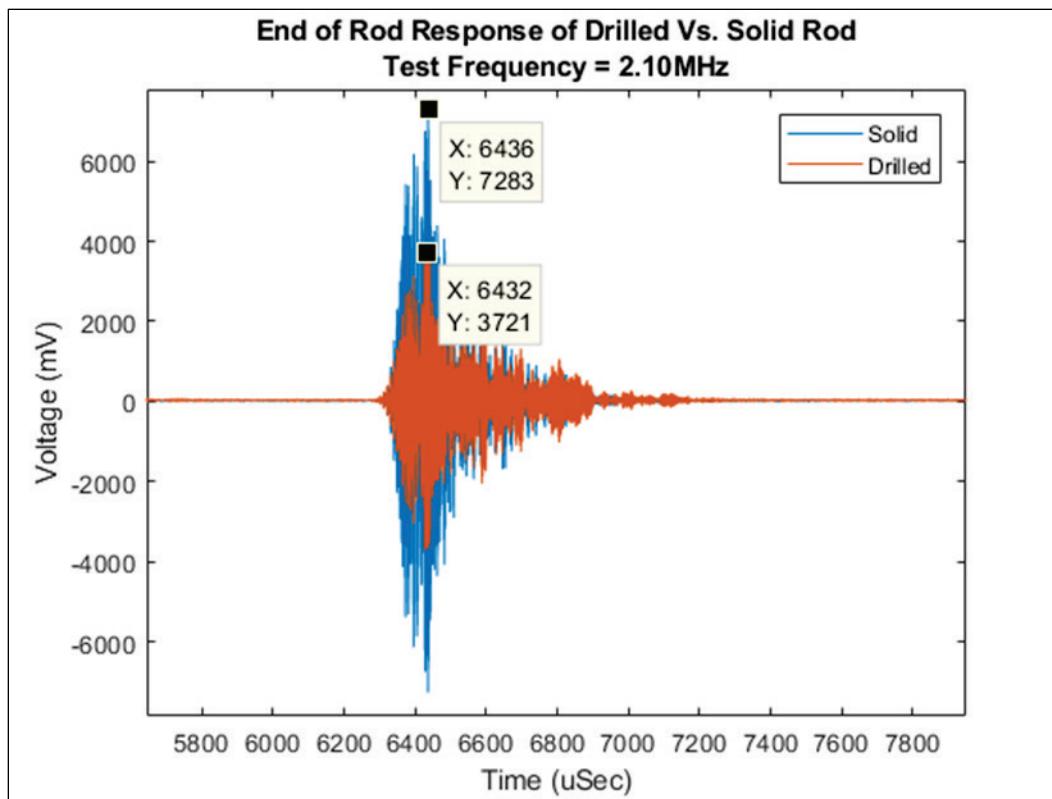
Figure 6. Drilled vs. solid tendon.

Through the use of the trunnion rod test bed at ERDC, the effects of having the end drilled on a 60 foot long, 1.25 in. diameter rod was compared to a solid specimen. The results of the first end of rod rebound at the test bed are shown in Figure 6.

The drilled tendon end resulted in a decrease in end of rod response amplitude of 5.8 decibels (dB). This showed that while there is a decrease in how much initial energy is injected, enough energy transfers to propagate the rod length.

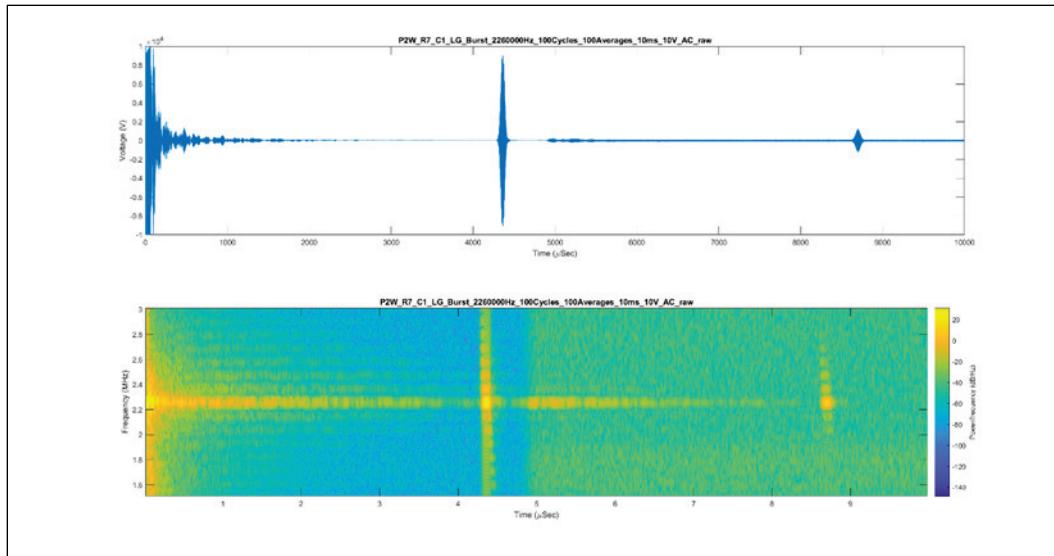
Figure 10. Oroville Dam: Gate 4, west; Row 1, Column 1; no issue.

Rod condition is labeled in one of the following three categories: No Issue, Anomaly, and Possible Defect. The No Issue category represents a rod where based upon the majority of the responses obtained across the dam, these rods provide a clean signal between end of rod rebounds. An example of a No Issue response is shown in Figure 10.

Figure 10 contains two plots that determine rod condition during post processing. The top plot is received when the testing is complete, the return amplitude of the signal expressed in volts on the y-axis and time on the x-axis. The second plot is a time-frequency representation of the same signal. One characteristic of the guided wave response is that the higher mode frequencies return slightly faster than the lower mode frequencies. This provides a fingerprint that surrounds the centralized testing frequency. Any response from an actual reflector would look like this, but more attenuated. The two echoes shown in Figure 10 are from end of rod rebounds.

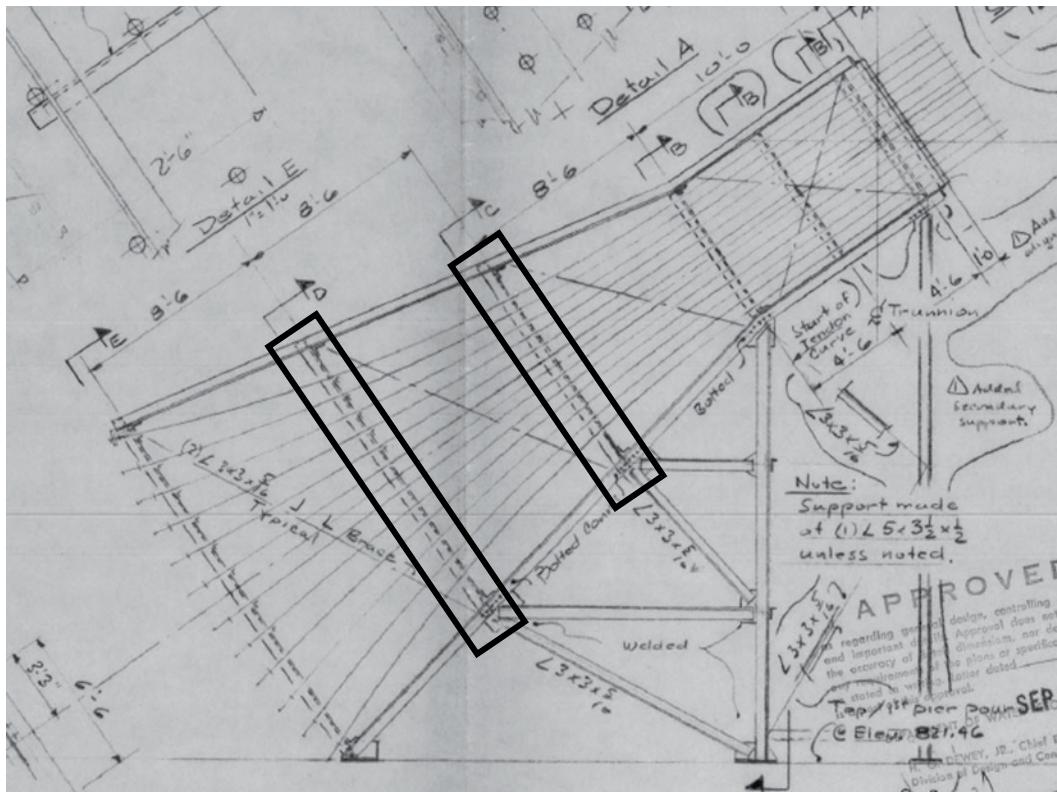
Figure 11: Anchor guide distance.

The Anomaly category is mostly limited to the upper and lower most rods. In addition to the attenuated signal response, the reflectors were noticed before the end of rod response. These reflectors appear at roughly the same point in time for the rods labeled as anomaly. As detailed in 2.1.2, these rods were curved during installation. Due to the frequency of occurrence within the curved rods, it appears that the curvature is the cause for these anomalies. One possibility for this occurrence would be sleeve contact where the rod sleeve rests on internal guides as seen in Figure 11. According to the original drawings, the first of these guides appear at a rod length of 18'6" plus the exposed length of rod. The first anomaly reflector appears around 15' in the rod according to the received data.

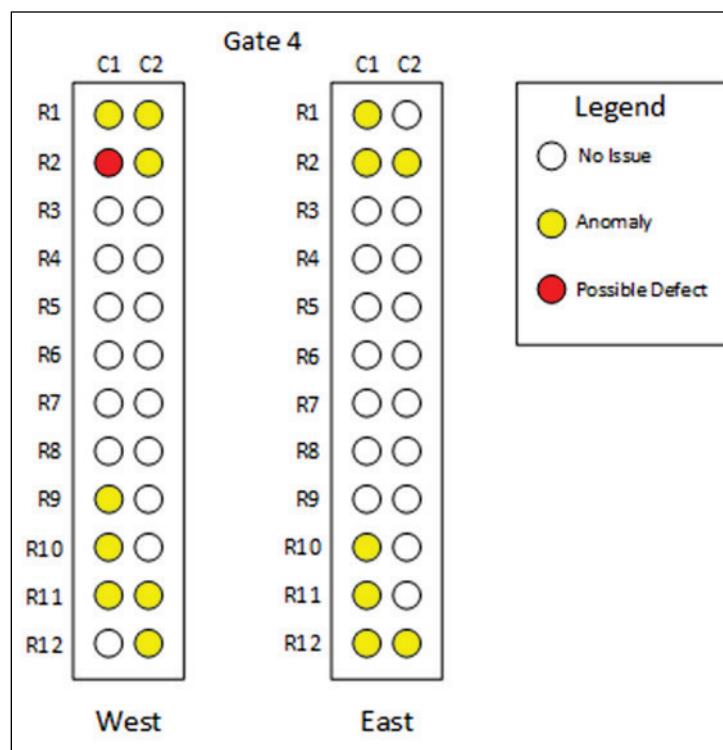
**Figure 20. Oroville Dam, Gate 4 rods.**

Of the 384 rods tested, two rods are labeled as possible defects — Gate 4, west bundle; Row 2, Column 1, and Gate 7, west bundle; Row 2, Column 2. The responses of these two rods are shown in Figure 14 and Figure 15.

Of these two, Figure 14 shows the greatest possibility of being an actual defect. Both the time-voltage and time-frequency plots show a strong signature similar to that of the end of rod response. In Figure 15, the time-frequency signature looks similar to the anomalous rods though the time-voltage plot has a stronger response than other anomalous rods. For this reason it is being classified as a possible defect.

Figures 16–23 show the results of the 384 rods tested at Oroville Dam. Rods labeled as No Issue are white; Anomaly are yellow; Possible Defect are red. The gate order of the dam in Figure 16 is from the orientation of looking upstream.

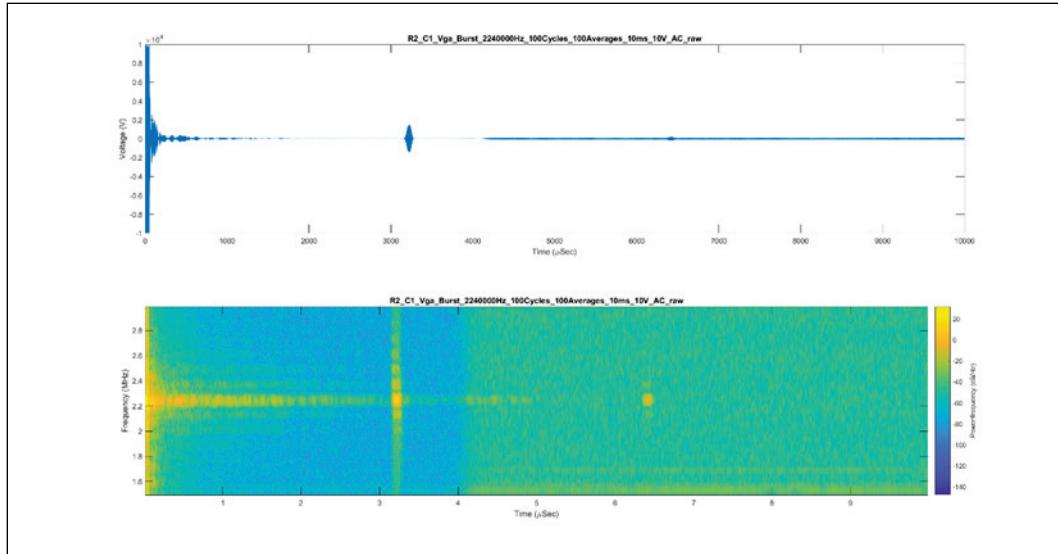
Figure 26. Thermalito Bypass: east; Row 2, Column 1; no issue.

As with Oroville Dam, the more curved rods showed evidence of reflectors while the straighter rods came back with no evidence of issues. 16 rods were tested, Figure 26 shows the results of one of the rods showing No Issue. Figure 27 shows the results of one of the rods being labeled as an anomaly.

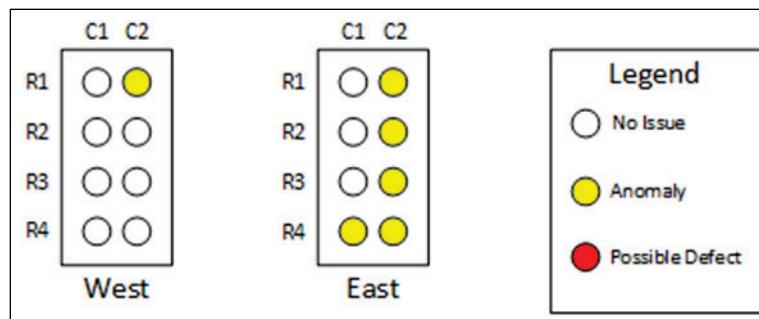
Figure 28. Thermalito Bypass rods testing results.

Figure 28 shows the results of the 16 rods tested at the Thermalito Bypass gate. Rods labeled as No Issue are white; Anomaly is yellow; Possible Defect is red.

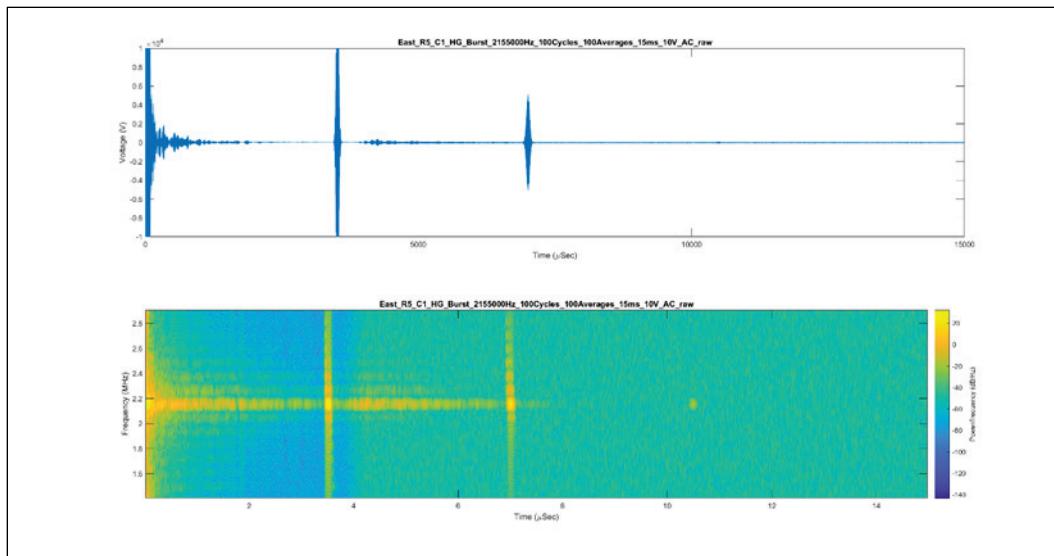
Figure 31. Pyramid Dam: east; Row 5, Column 1; no issue.

Figure 31 is an example of a rod showing No Issues. Further evidence supporting the theory that rod curvature causes anomalies in the data; the rods at Pyramid Dam exhibited reflectors on the rods that bend upward and downward within the dam. This effect is seen in Figure 32.

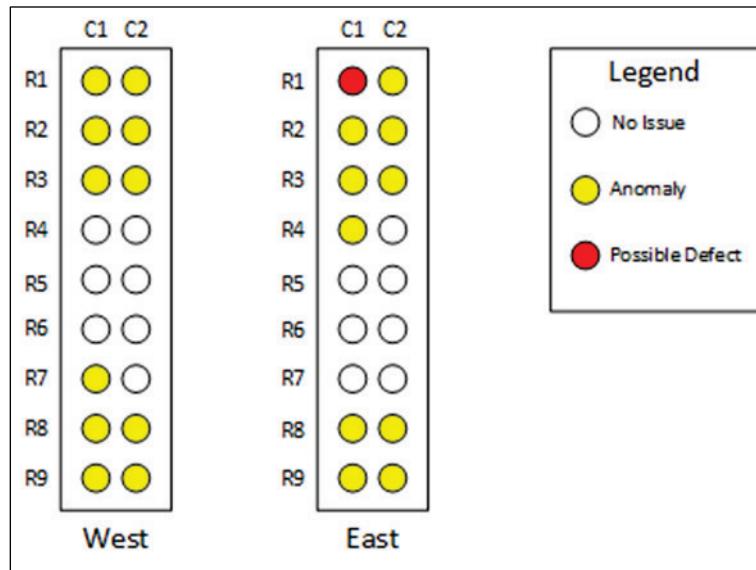
Figure 34. Pyramid Dam rods testing results.

Very similar to the Oroville rod response of Figure 14, Figure 33 shows a possible defect on rod east bundle; Row 1, Column 1. Even though the response time of this anomaly is similar to the other curved rods, the amplitude is much greater than the others.

Figure 34 shows the results of the 36 rods tested at the Pyramid Dam. Rods labeled as No Issue are white; Anomaly is yellow; Possible Defect is red.
