Review of Long-Term Maintenance Plans for the South Jetty, Grays Harbor, Washington

*by Special Subcommittee of the Committee on Tidal Hydraulics and
Coastal Engineering Research Board*

June 1995

Final report

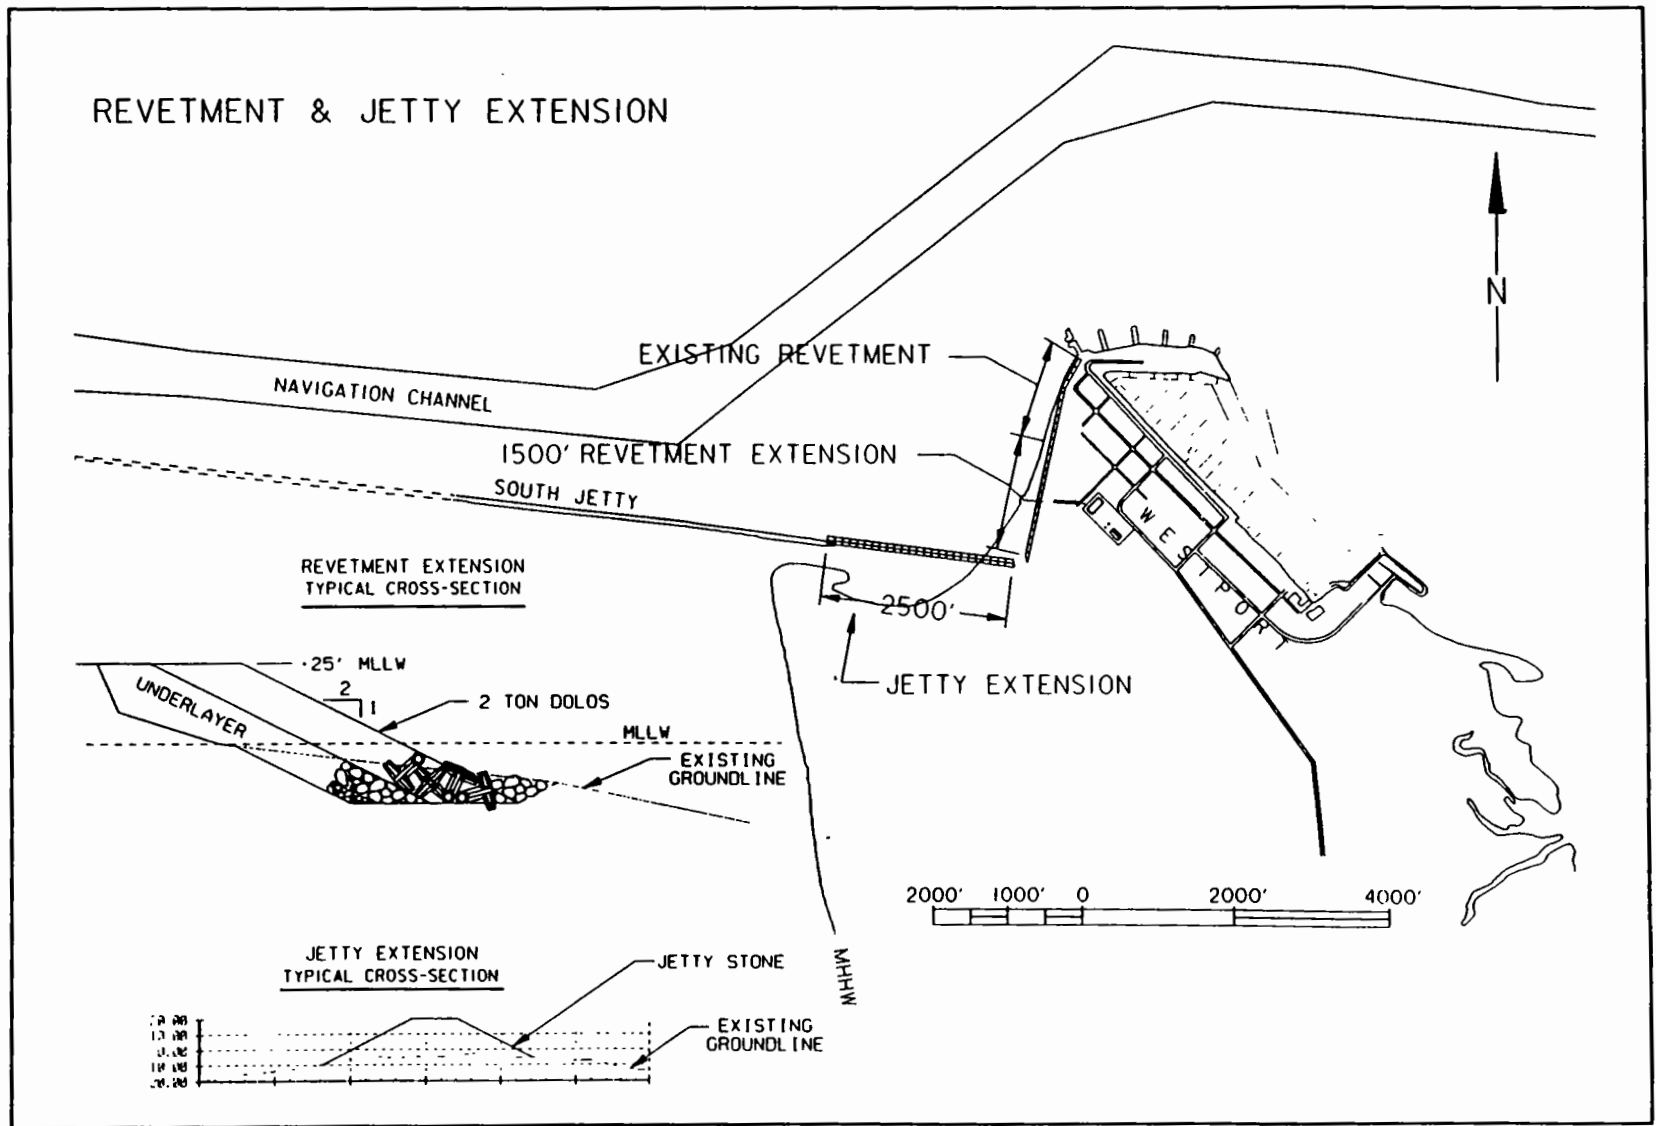
Figure 16. South jetty extension and revetment alternative

47. This alternative is shown in Figure 16. It includes a 2500-ft eastward extension of the jetty to the junction of a 1500-ft southward extension of the Westport revetment. Protection against erosion in the Half Moon Bay area and of Point Chehalis against waves and currents in the entrance would be provided. This plan would also provide assurance that the entrance channel would not be captured by South Beach erosion in the breach area. Curvature of the jetty near its junction with the revetment extension to provide a smooth alignment along the channel bend would reduce construction and maintenance costs. No means of reducing erosion of South Beach is shown.

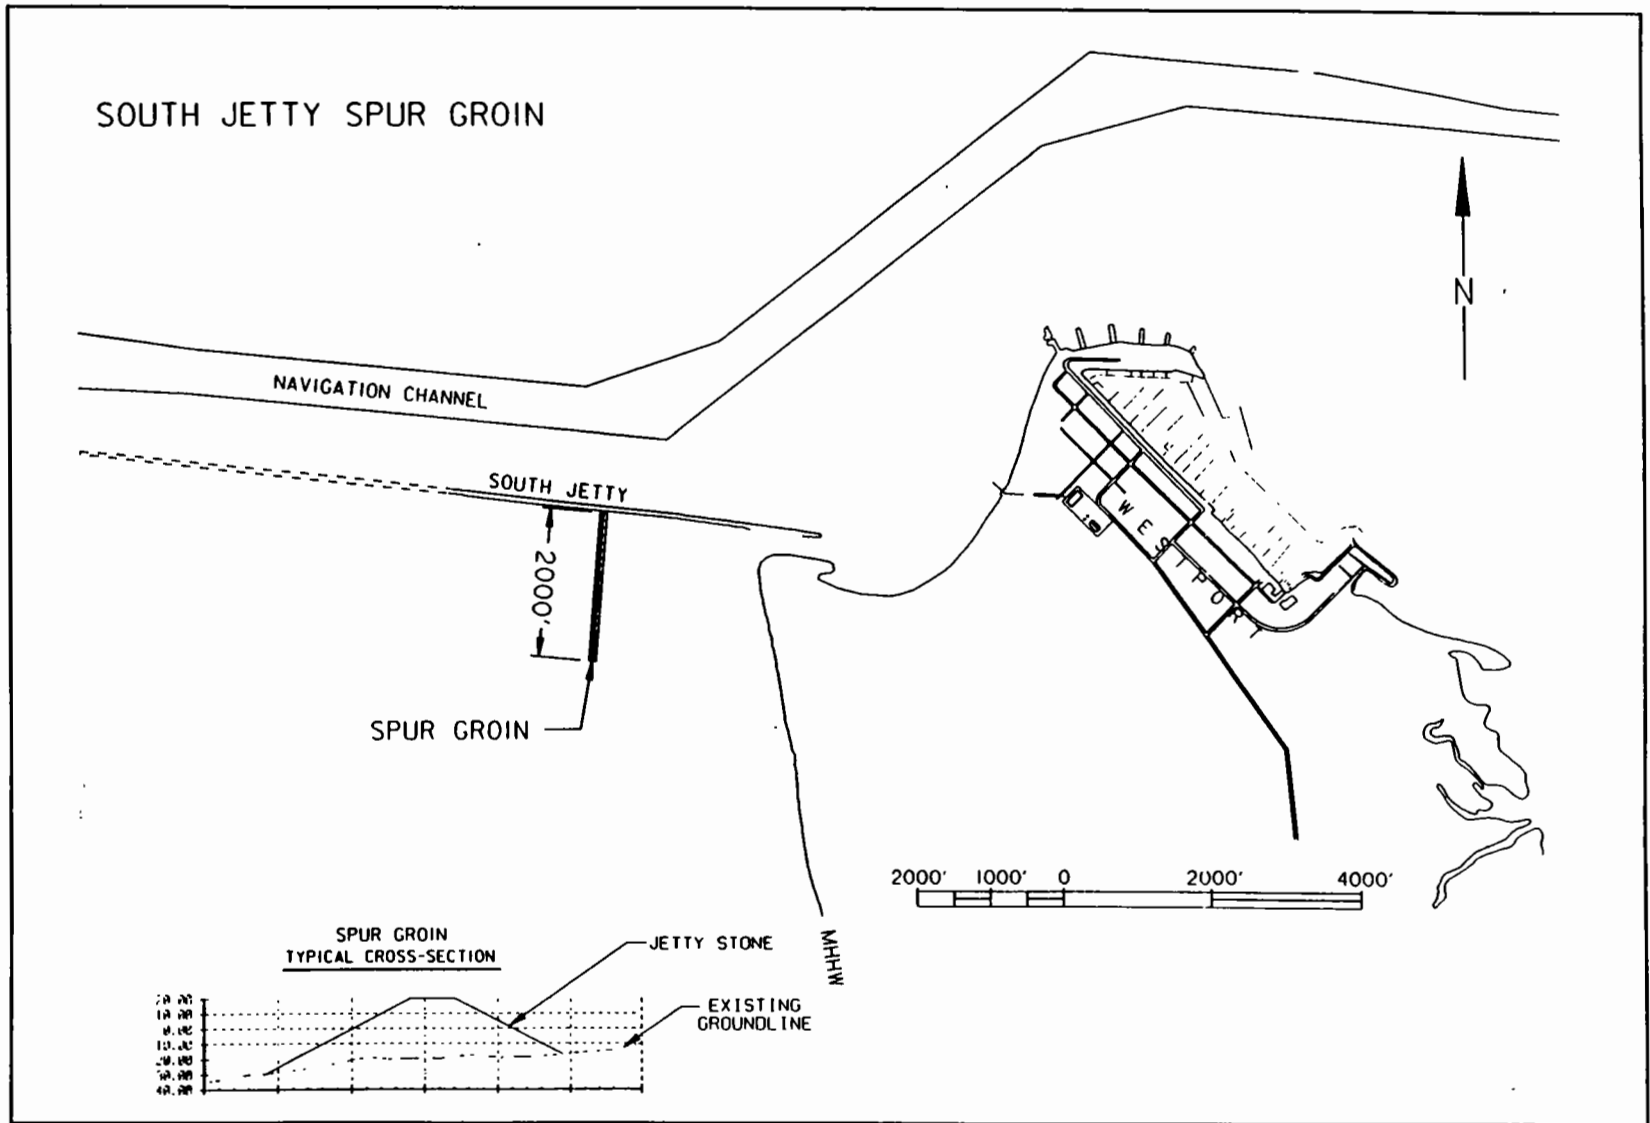
Figure 17. Spur groin alternative

48. This alternative is presented in Figure 17. It includes a 2000 ft groin perpendicular to and on the south side of the South Jetty located about 2000 ft from its east end. No direct closure of the breach is indicated; however, the intent of the groin is to interrupt the seaward current along the jetty and to facilitate accumulation of sand in the breach area and out along the south jetty. This alternative could provide long term protection of the jetty but would require expensive maintenance. It would not diminish erosion in Half Moon Bay. Its efficacy depends on a supply of sand from the south, possibly augmented by placement of dredged material. Design of such a groin should include computations of northward littoral transport and possibly a physical model study to determine optimum location and length of the groin.

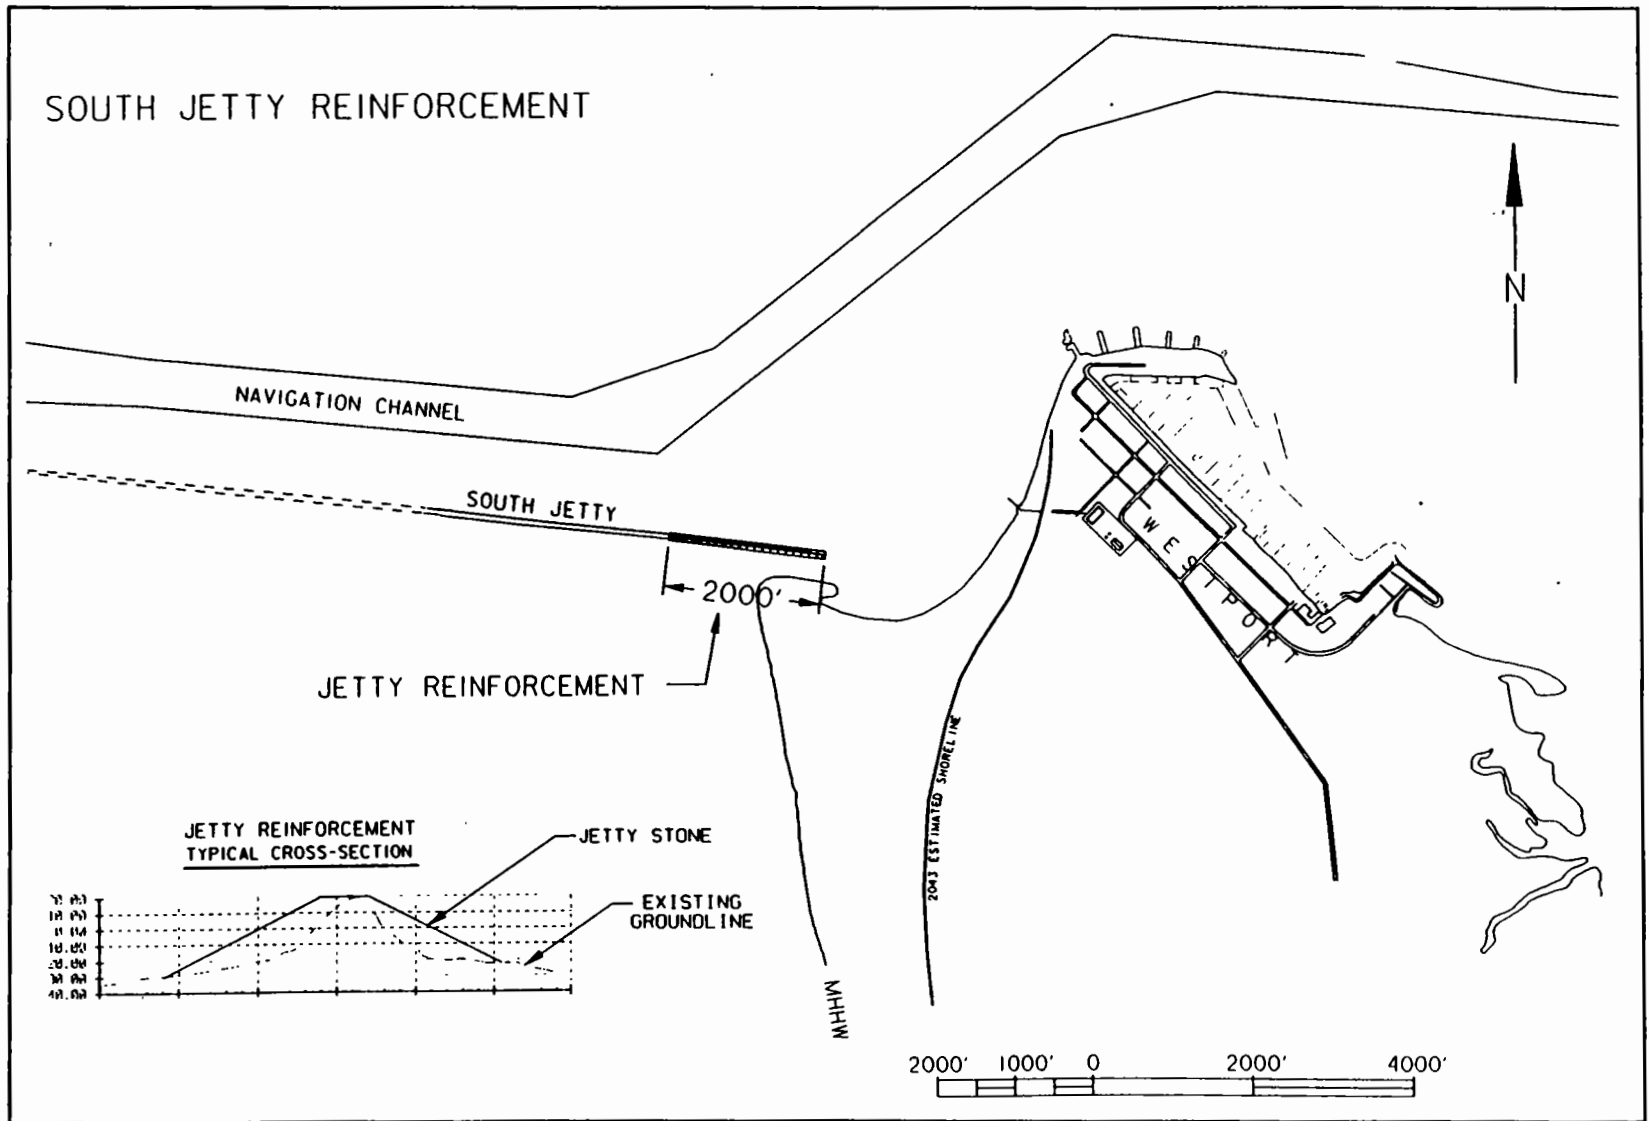
Figure 18. South jetty reinforcement alternative

49. This alternative is presented in Figure 18. It includes reinforcement of 2000 ft of the east end of the south jetty. It would maintain stability of the structure in the presence of continuing erosion of South Beach and Half Moon Bay. Continuous monitoring of the beach would be required, and risk of capture of the navigation channel by erosion of the breach would persist.

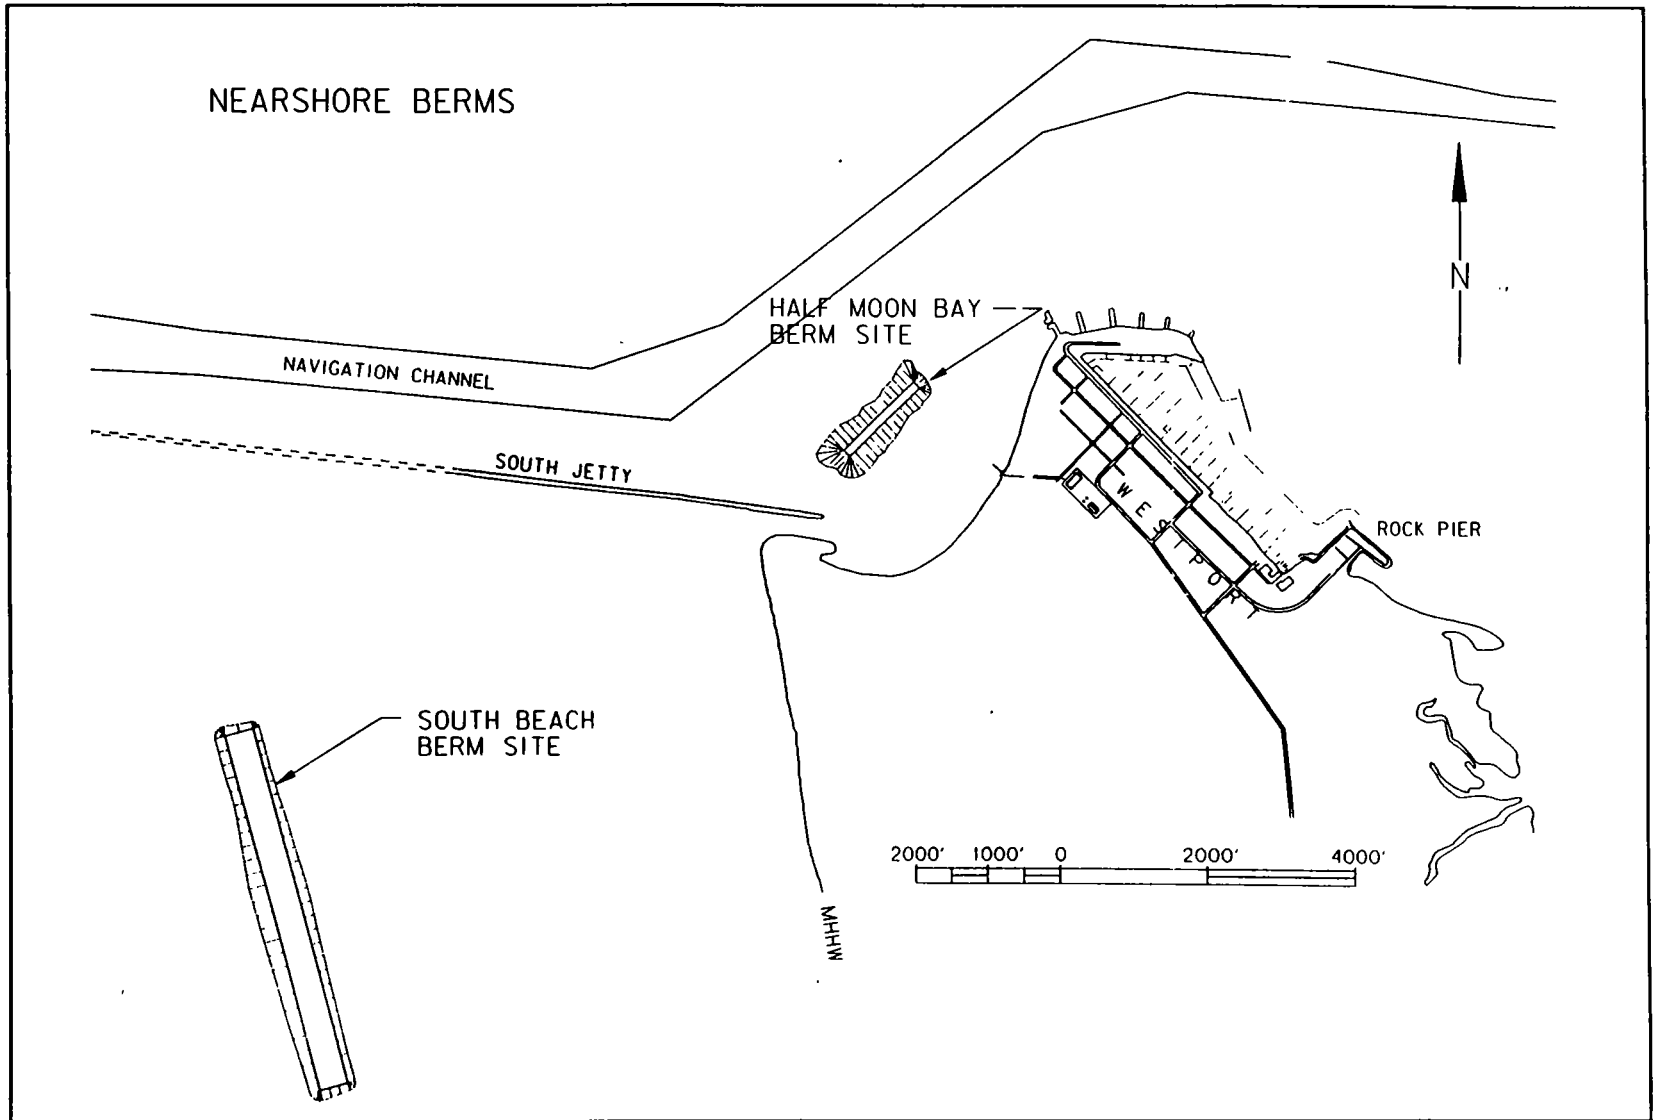
Figure 19. Nearshore berm alternative

50. Annually resupplied nearshore berms shown in Figure 19 would be placed in Half Moon Bay and near the north end of South Beach. The purposes of these berms would be to reduce wave action and supply sand to the beaches. Up to 500,000 cubic yards a year of sandy dredged material could be placed between the -20 and -40 ft contours near South Beach. The berm would cover an area 5000 ft long by 500 ft wide. An initial berm 2000 ft long containing 385,000 cy of sand was placed at the 40-ft contour during September and August, 1993, and an additional deposit is planned at the 30-ft contour in September, 1994. An initial 185,000 cy berm was placed in Half Moon Bay in 1992 and an additional 200,000 cy was added in May, 1994. Placement of these berms costs little above the cost of the previous disposal operations, and the practice should be continued to retard shoreline erosion.

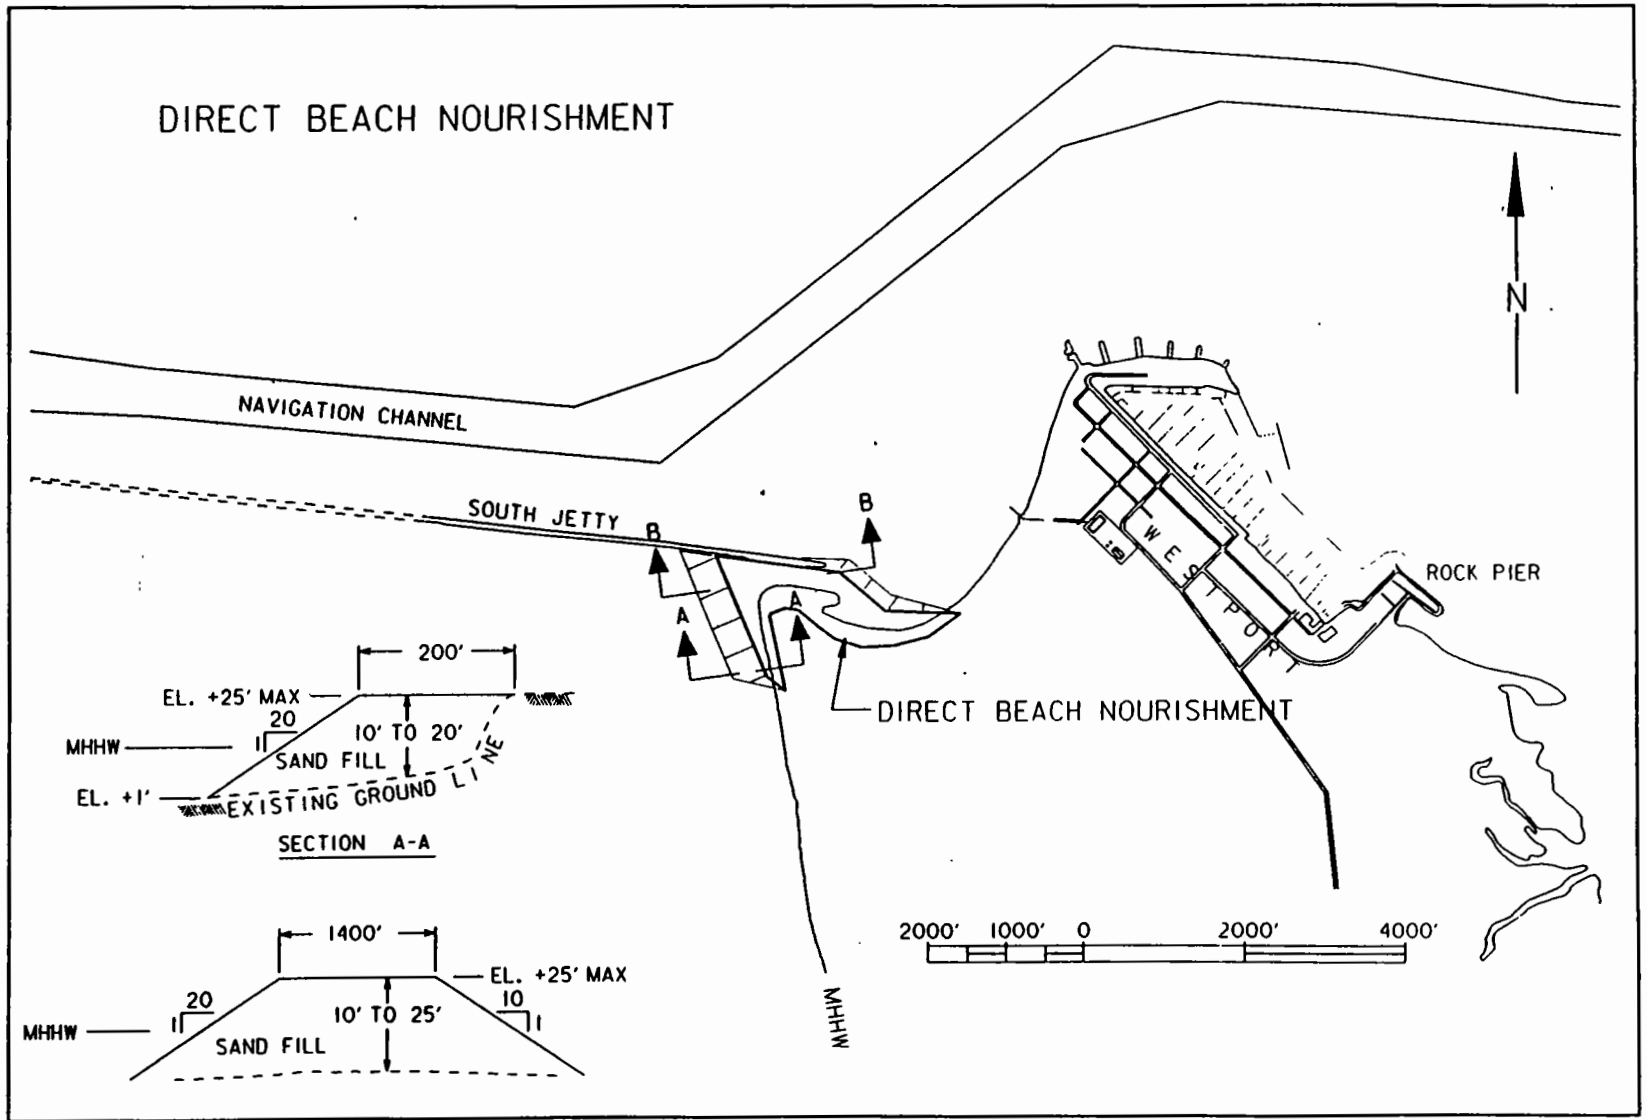
Figure 20. Direct beach nourishment alternative

51. Placement of dredged material directly on the beach in the breach area as shown in Figure 20. The elevation of the top of the fill would be above that of the jetty to reduce the prospect of overtopping and to allow for settlement, and the width in the direction of the breach would be nearly twice that of the pre-breach sand neck. The eastern edge of the should extend from the eastern end of the jetty as shown in Figure 20 to protect the park facilities from erosion by waves diffracted by the end of the jetty. Approximately 500,000 cy of suitable material is dredged annually from the Entrance, Pt. Chehalis, and South reaches that could be placed at this location at a cost of \$4 to \$5 per cubic yard above present maintenance costs. The quantity of material dredged from these reaches is becoming smaller each year as the system adjusts to the 1990 channel modifications. Additional material, in diminishing amounts, is dredged from the bar, but the cost of transporting it to the beach would be prohibitive. Timing of this alternative is subject to fishery concerns, dredging schedules, and weather. To be a viable long term solution, this alternative would require a commitment to supplement sand from diminishing maintenance dredging with material dredged for nourishment.

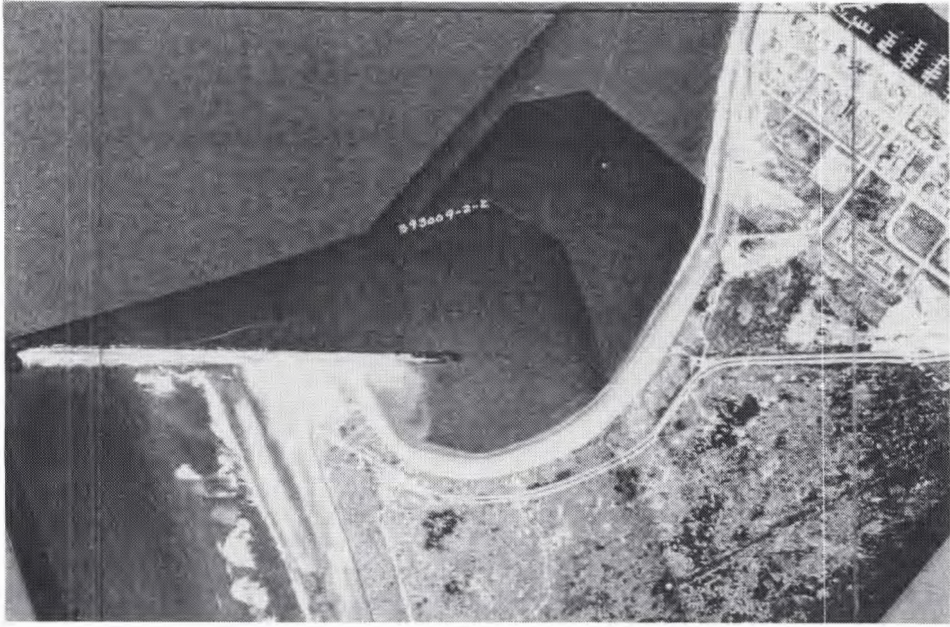
Photo 3. 23 May 1993, tide elevation -1.6 ft mllw, approximate scale
1 in. = 1,400 ft

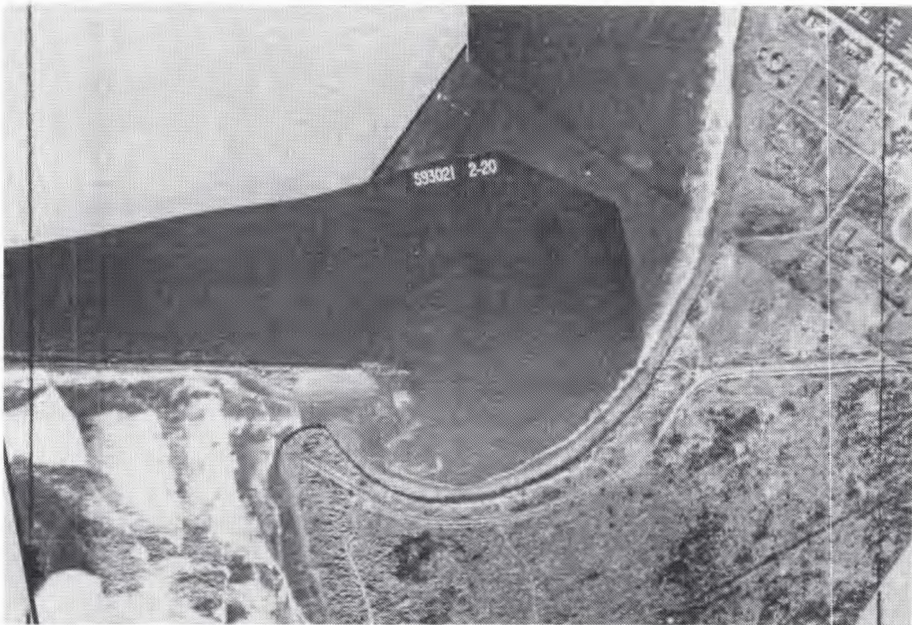
Photo 4. 17 December 1993, tide elevation +6.5 ft mllw, approximate scale
1 in. = 1,400 ft

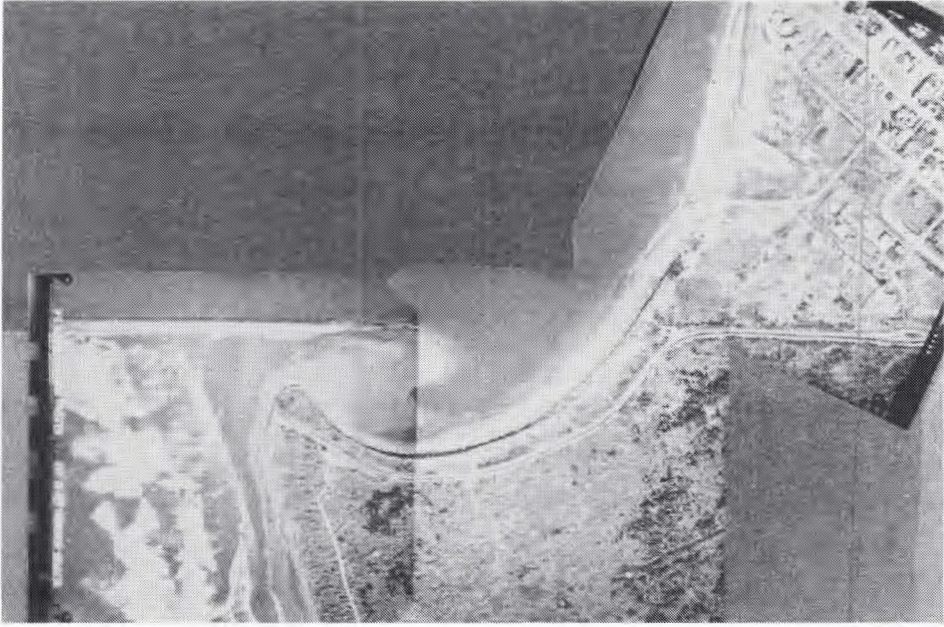
Photo 5. 2 February 1994, tide elevation +2.0 ft mllw, approximate scale
1 in. = 1,400 ft

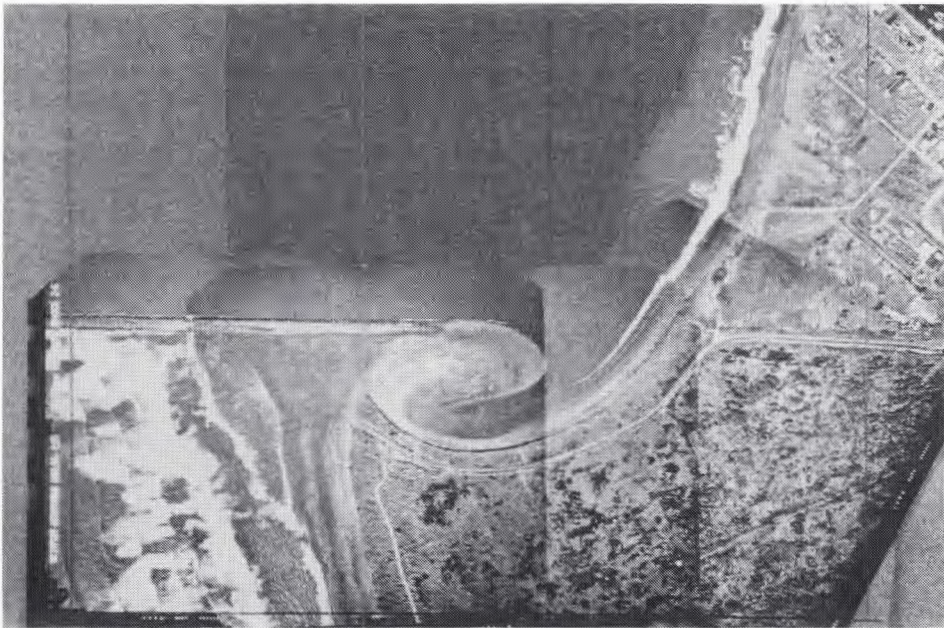
Photo 6. 6 March 1994, tide elevation +1.3 ft mllw, approximate scale
1 in. = 1,400 ft
