Alternatives for Large Crater Repairs using Rapid Set Concrete Mix®

Lulu Edwards, Haley P. Bell, and Marcus L. Opperman

June 2021

Final report

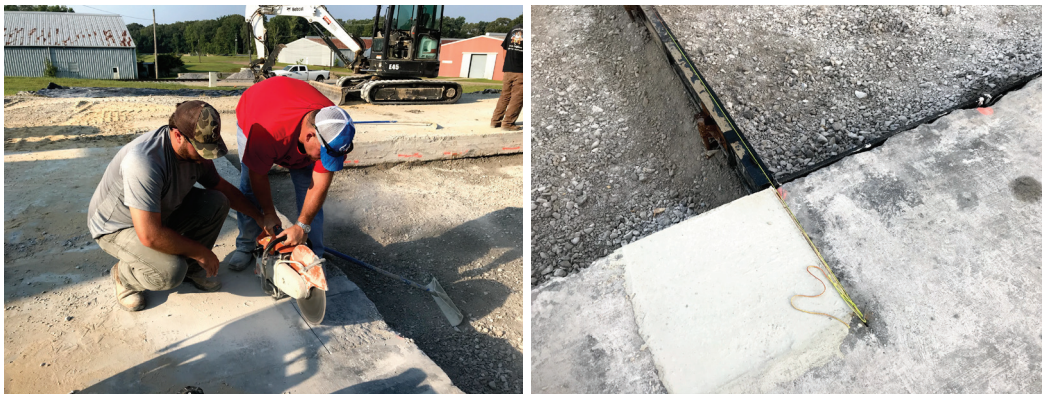
Two of the existing parent slabs on the test section next to the area (west end) for Repairs 1, 2, 3, and 4 had some minor damage. So, the two adjacent slabs were replaced with 13 in. of PCC prior to the crater repair testing. However, pavement distresses in the form of joint spalls were noted on the west-end parent slabs after 2,000 passes (1,709 coverages) of the C-17 load cart on Repair 1 were applied. The joint spalls steadily increased in severity as Repairs 2 and 3 were trafficked. The joint spalls were repaired with small patches prior to the start of Repair 5 as shown in Figure 34. The damage to the parent slabs did not seem to have an effect on the pavement condition of the crater repairs.

Figure 34. Patching high-severity joint spalls on the parent slabs adjacent to the repair area.

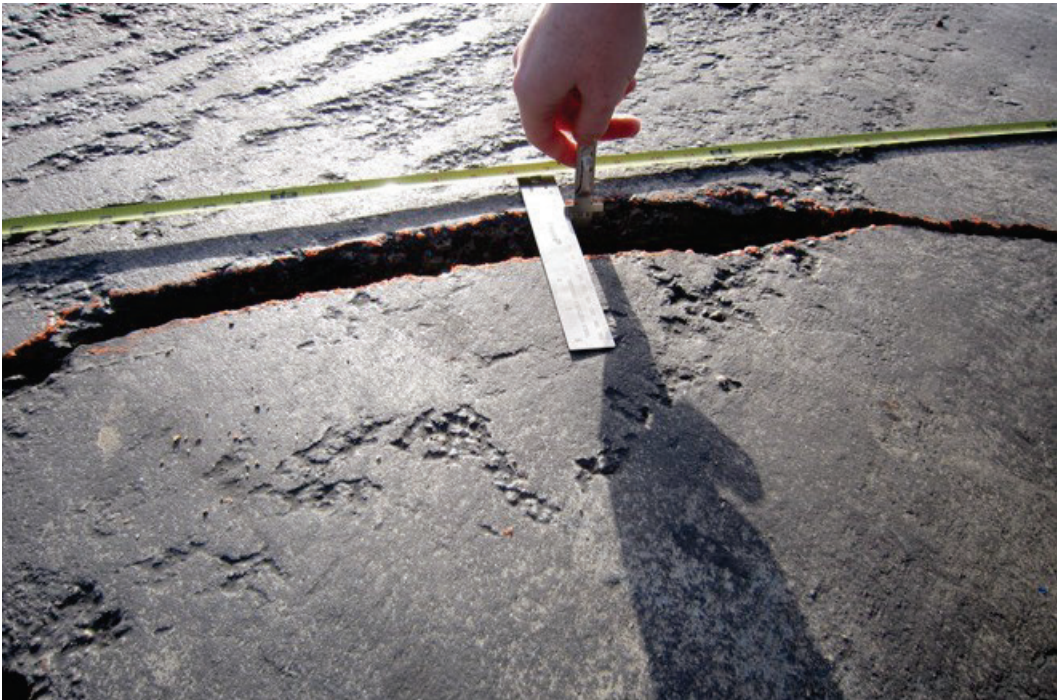
Figure 37. Measuring center crack depth.

Trafficking was stopped after 3,584 passes (3,063 coverages) due to a tire hazard on one of the interior corner breaks, which was approximately 3.25 in. wide and 3.25 in. deep (Figure 35 [c] and Figure 37). Figure 35 (d) shows the spalling on the east edge at 3,584 passes (3,063 coverages).

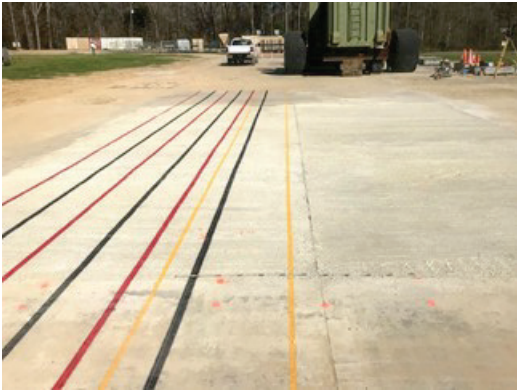
Figure 39. Repair 2 progression of distresses.

The rapid-setting concrete surface and crushed limestone base course thicknesses were 10 and 14 in., respectively, for Repair 2. Failure of the repair occurred after approximately 100 passes (85 coverages) due to a high-severity joint spall on the western edge. The repair was also close to failure on the eastern edge due to a high-severity joint spall. The progression of distresses with increasing traffic can be found in Figure 39.

The repair had a few shrinkage cracks on the surface that were observed prior to trafficking (Figure 40). The shrinkage cracks appeared on the surface soon after each quadrant was placed. Linear cracks and interior corner breaks were observed on the surface after just 18 passes (15 coverages). After 112 passes (96 coverages), the repair was shattered in three of the four quadrants, and high-severity joint spalling was observed on the trafficked edges; the repair exceeded the failure criteria. A tire hazard was not present, so the repair was trafficked beyond failure for assessment. After 224 passes (191 coverages), the dimensions of the joint spalls had not progressed from dimensions measured at 112 passes (96 coverages). However, spalling on the parent slabs along the western edge of the repair had occurred (Figure 41). The center of the repair was cracked in a circular shape (interior corner breaks) at 224 passes (191 coverages), as shown in Figure 42. The interior corner breaks indicate that the combination of the slab thickness and foundation strength/thickness was inadequate to support the heavy load.

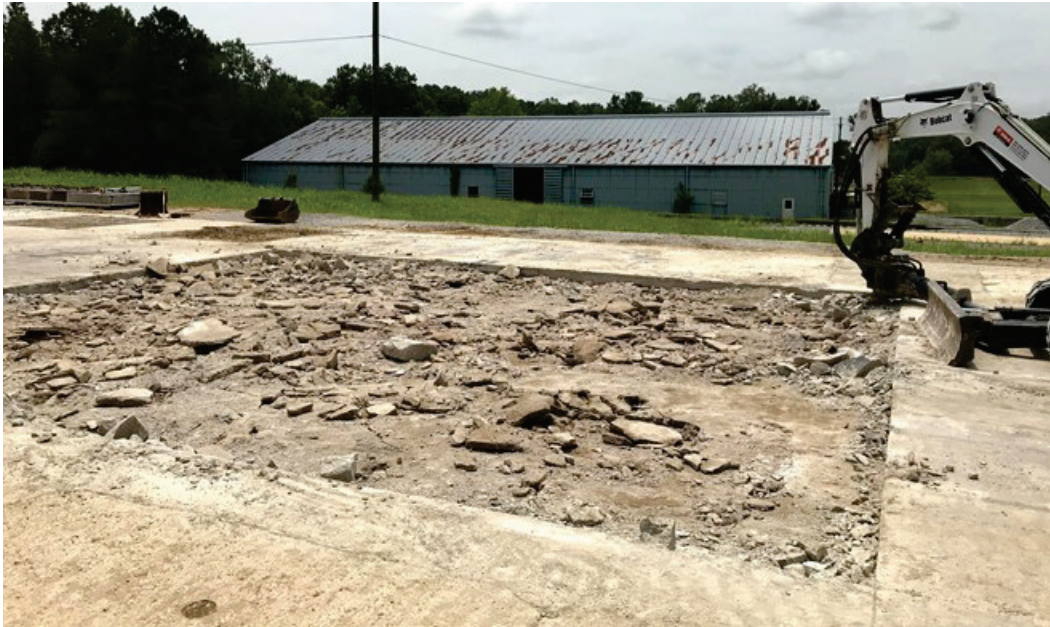
Figure 44. Rapid-setting flowable fill during the backfill breaking and removal process.

The rapid-setting flowable fill was placed in 2-in.-thick lifts for Repair 2, rather than the typical 3- to 4-in.-thick lifts. This was done in an attempt to increase the water percolation into the flowable fill. However, as can be seen in Figure 44, after excavation, each lift of the

material appeared to be delaminated. Figure 45 shows that the layers delaminated in the same thickness it was placed.

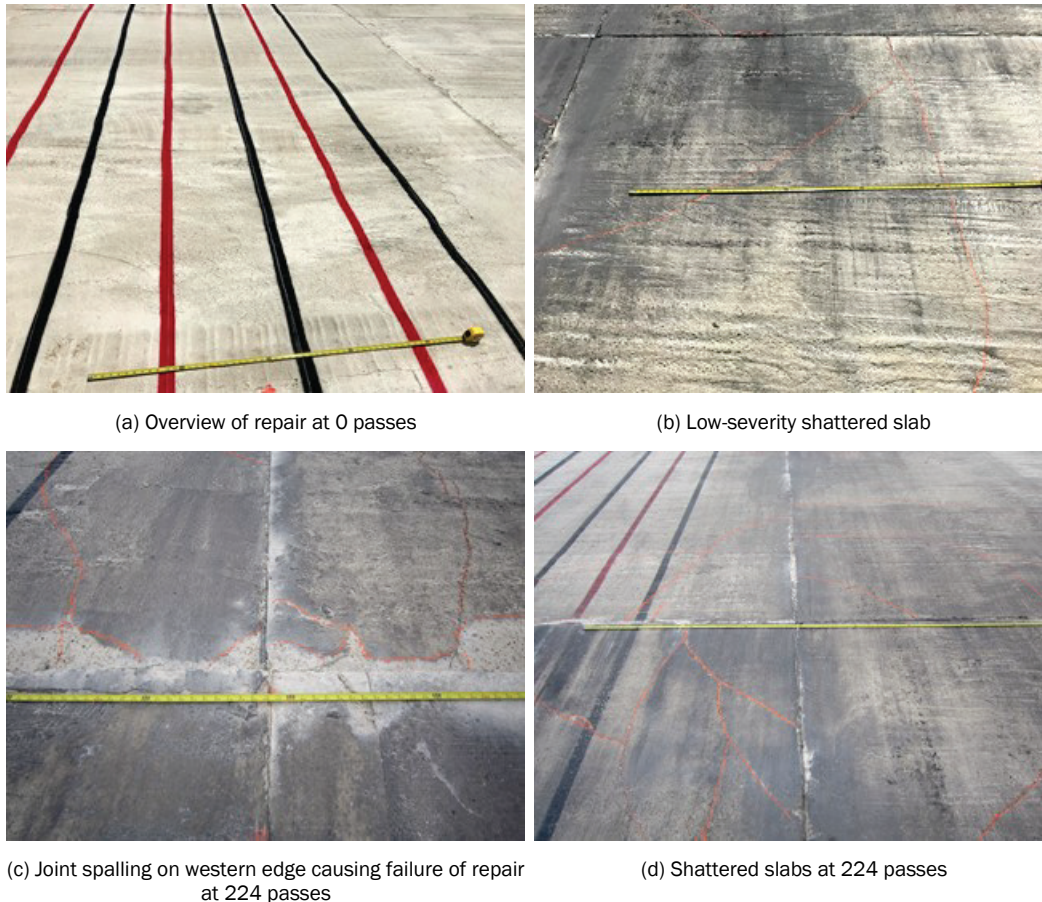
Figure 46. Repair 4 progression of distresses.

Repair 4, consisting of 10 in. of Rapid Set Concrete Mix® over 20 in. of crushed limestone base material, withstood 225 passes (192 coverages) of C-17 load cart traffic before failing. Repair 4 had a few shrinkage cracks develop in one quadrant during the concrete curing process. By

112 passes (96 coverages), cracking occurred at all four interior corners, and multiple linear cracks developed in three of the four quadrants. Two quadrants were classified as low-severity shattered slabs. After 225 passes (192 coverages), all four quadrants were shattered and were more severe than the distresses observed at 112 passes (96 coverages). High-severity joint spalling developed along the western trafficked edge resulting in the repair's failure. The FOD produced from the pavement distresses ranged from 1/8 to 1.5 in. The progression of distresses with increasing traffic can be found in Figure 46.

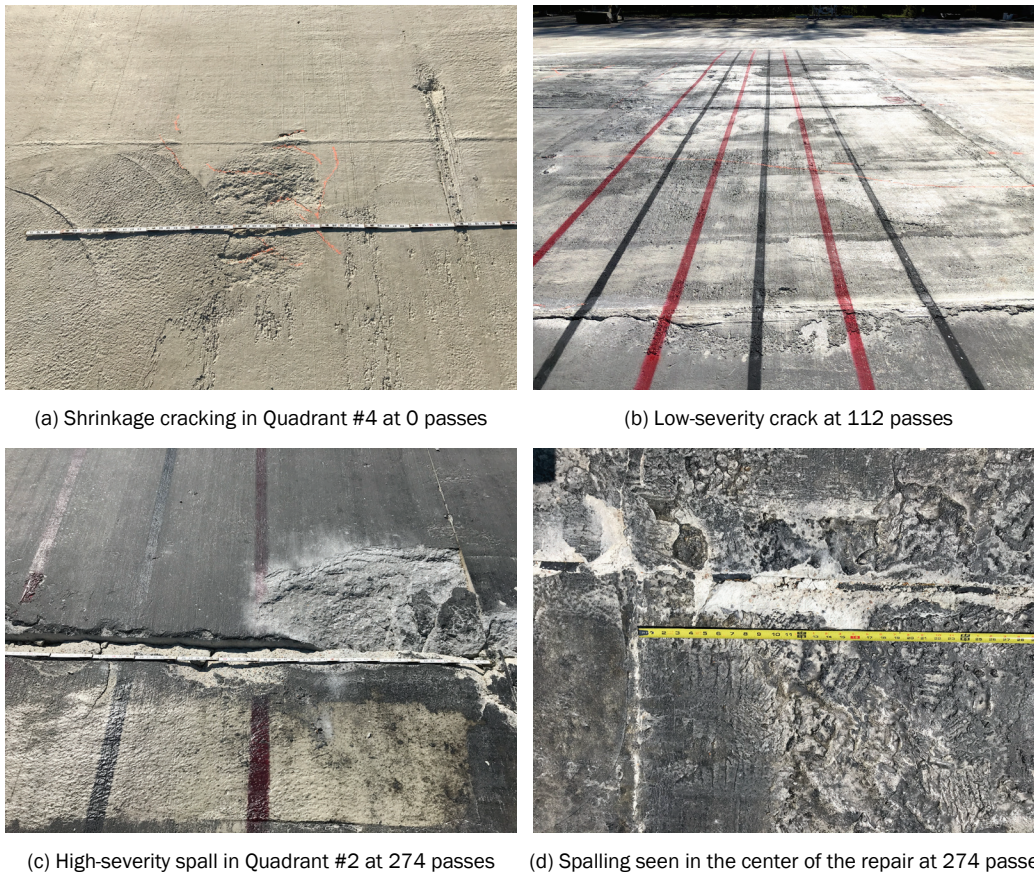
Figure 48. Repair 5 progression of distresses.

Repair 5, consisting of 10.5 in. of Rapid Set Concrete Mix[®] over 20 in. of crushed limestone, was a repeat of Repair 4 except that the strength of the crushed limestone base course was much higher with a CBR of 100%. Both Repair 4 and Repair 5 failed at approximately 225 passes (192 coverages) due to high-severity joint spalling. Repair 5 seemed to deteriorate at the same rate as Repair 4. This indicates that the base strength may not influence repair performance as much as surface thickness. The progression of distresses with increasing traffic can be found in Figure 48.

All four quadrants of Repair 5 had minimal shrinkage cracks after placement of the rapid-setting concrete surface. After 112 passes (96 coverages), linear cracks developed in two quadrants, but no joint spalling was observed. Traffic was stopped at 224 passes (191 coverages) where three of the quadrants developed low-severity shattered slabs, and both the western and eastern trafficked edges had high-severity joint spalling. The most severe joint spall was 88 in. long, 9 in. wide, and 2 in. deep with 1- to 2-in.-sized FOD and, therefore, the repair was considered failed.

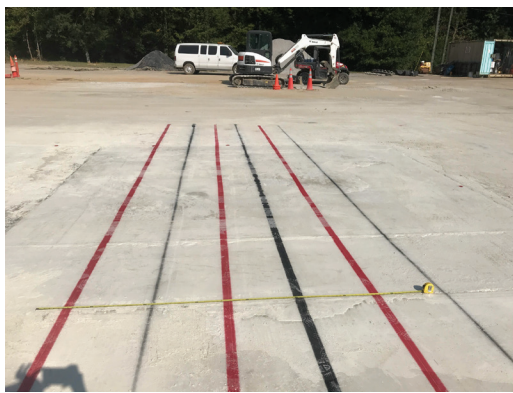
Figure 53. Repair 7 progression of distresses.

Repair 7 was conducted after the replaced parent slabs had cured for at least 28 days. Repair 7 consisted of 10 in. of Rapid Set Concrete Mix[®] over 13.5 in. of cement-stabilized silty sand. The repair failed at approximately 896 passes (766 coverages) with high-severity joint spalling exceeding the failure criteria in two locations. The progression of distresses with increasing traffic can be found in Figure 53.

(a) No visible cracking on repair (Quadrant #3) at 0 passes

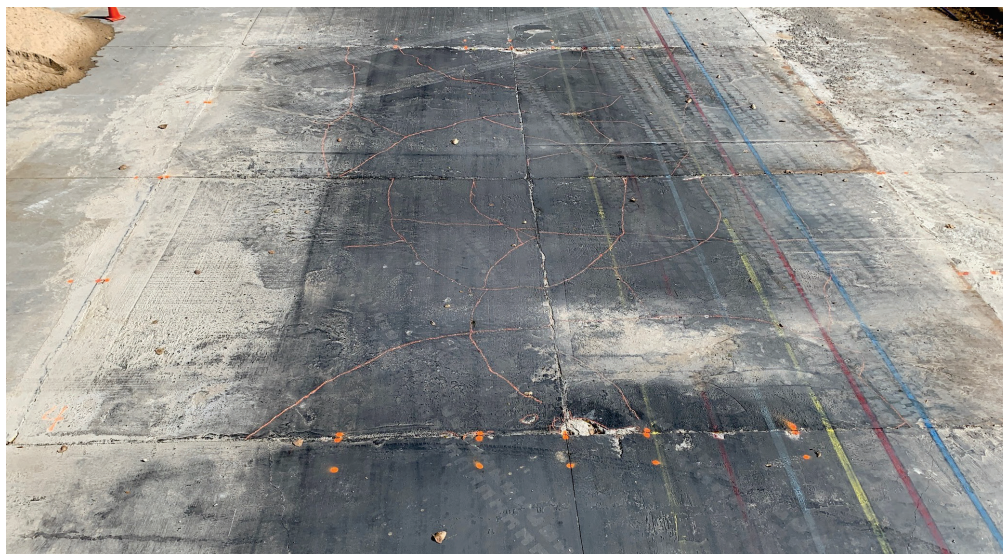
Figure 55. Overview of repair 7 after 896 passes.

The Rapid Set Concrete Mix® surface of Repair 7 had a higher slump than desired, causing an approximate 1-in.-thick paste to form on the surface of all quadrants. Nevertheless, no pavement distresses were noted on the repair before trafficking. After 112 passes (96 coverages), no spalling had developed; however, two quadrants developed interior corner breaks, and all four quadrants developed linear cracking. Joint spalling on the trafficked edges was observed after 336 passes (287 coverages). All four quadrants had low-severity shattered slabs (Figure 54), and the joint spalls became more severe after 448 passes (383 coverages). No additional cracking was observed after 784 passes (670 coverages); however, the joint spalls did progress in size. After 896 passes (766 coverages), a few additional low-severity linear cracks developed, and two joints spalls exceeded the failure criteria defined for this study (Figure 55).
