Deconstruction Feasibility Assessment of Warehouse District Facilities at Fort Leonard Wood, Missouri

January 2022

Final Report

Prepared for Fort Leonard Wood
597 Mascen Loop
Fort Leonard Wood, MO 65473

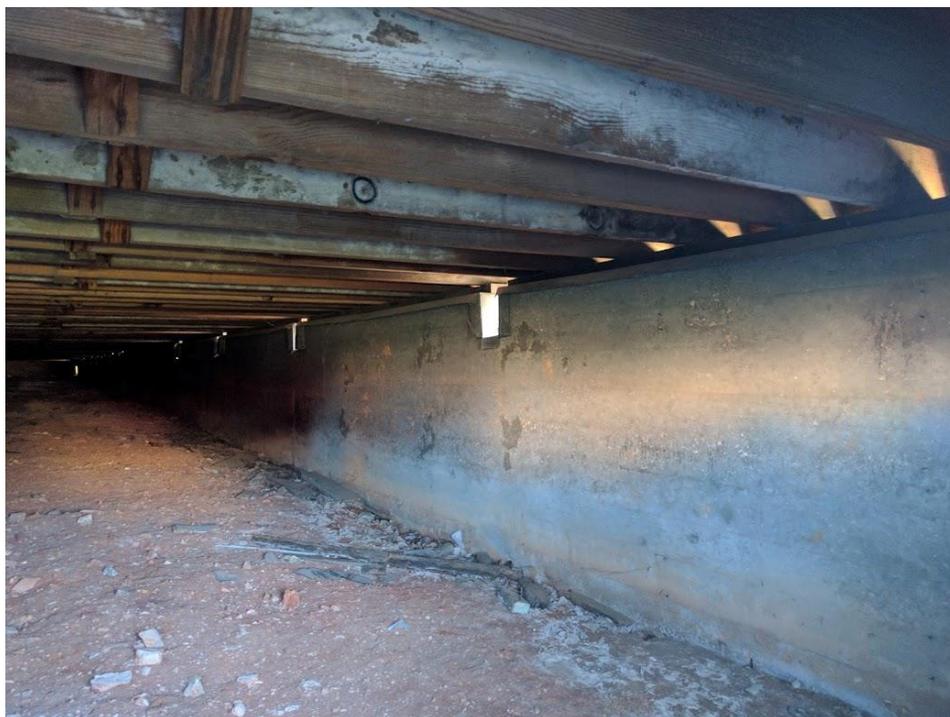
Figure 6. Concrete warehouse footing and flooring joists.

The floor systems of Bldgs. 2338 and 2339 consist of 2 ft × 12 ft joists spaced 12 in. on center spanning the foundation walls (Figure 6). The joists bear on 2 in. × 6 in. sill plates, and 2 in. × 12 in. band joists run the length of the building at the exterior walls. The floor deck was observable from the crawlspace. The construction of the floor system is conducive to equipment operation during deconstruction; construction details reported on a placard in an identical building indicate that the floor is designed to support 150 lb/ft² (Figure 7).

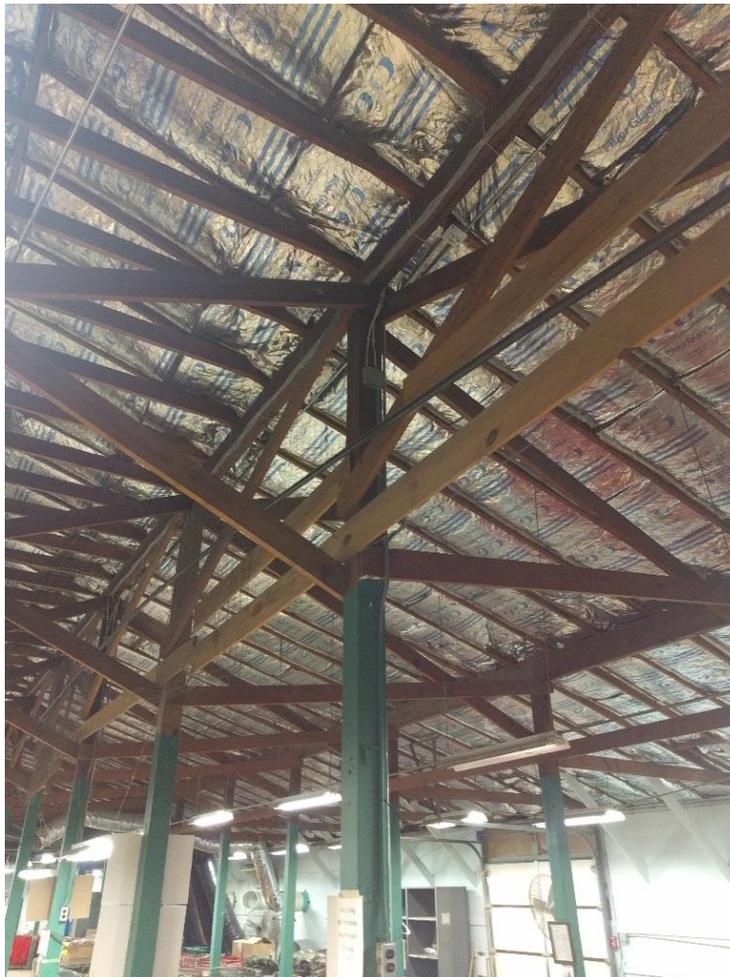
Figure 8. Typical wooden warehouse ceiling truss structure.

Vertical loads are supported by 6 in. × 6 in. columns on a 9 ft × 12 ft grid. Columns are braced both laterally and longitudinally by 2 in. × 6 in. braces of varying lengths. Columns carry two 2×12s at each row that run the length of the building. Figure 8 shows the general configuration. Connections are nailed, not bolted.

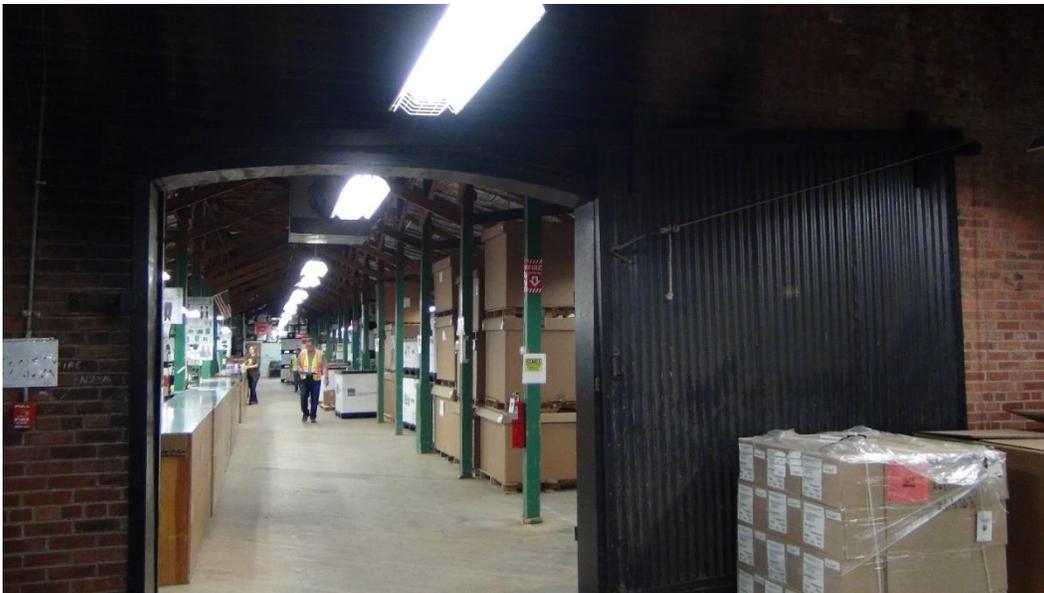
Figure 14. Large sliding corrugated door separating two adjacent warehouse buildings.

A thick firewall separates the two halves of the warehouse. The firewall's brick construction includes a large sliding corrugated metal door, which has potential for sale to an architectural salvage entity. Figure 14 shows the corrugated metal door separating the two adjacent warehouse buildings.

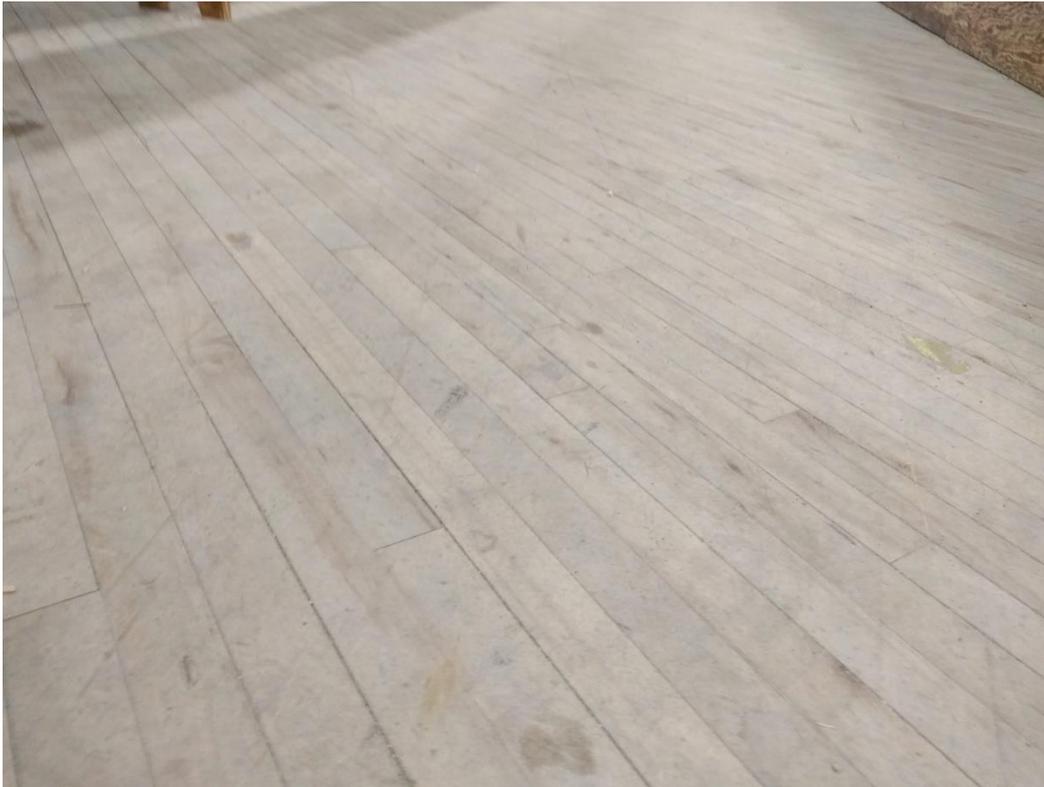
Figure 15. Typical warehouse floor, finished hardwood slats.

The support beams are 6 in. square beams spaced 9 ft apart. The truss structure between the beams are 2×6s in the short direction and 2×10s in the long direction. All the lumber is dry and shows no signs of decay.

The warehouse floor is a diagonal maple flooring resting on the 2 in. × 12 in. floor joists (Figure 15). The office areas in the model building are finished with insulation, wall paneling, acoustical ceiling tiles, carpeting, and extra lighting.

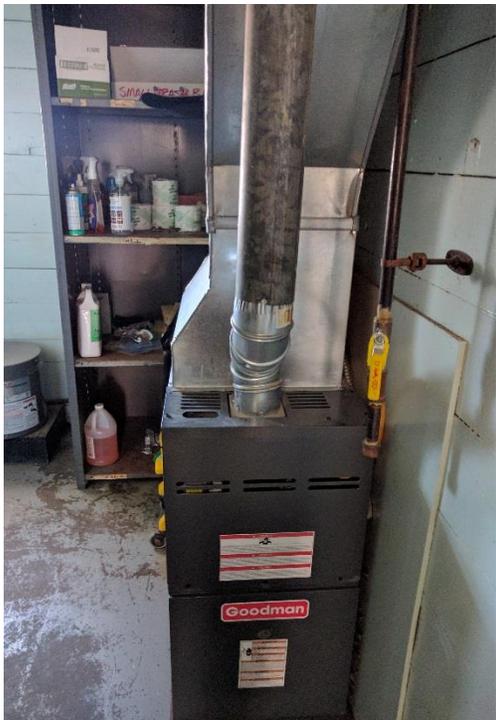
Figure 18. Typical furnace for office spaces and restroom facilities.

The bathrooms each contain a modern furnace unit (Figure 18) with sheet metal ducting to the adjacent office spaces. The units are small and in good condition. Outside the building, six A/C units are connected to the building by large diameter flexible ducting (Figures 19 and 20). There is one ceiling-mounted fan coil unit in each main warehouse area (Figure 21).

The boilers in many of the buildings could be reused; however, since units like these have a limited lifespan and will eventually need to be replaced anyway, reuse may not be very cost effective.

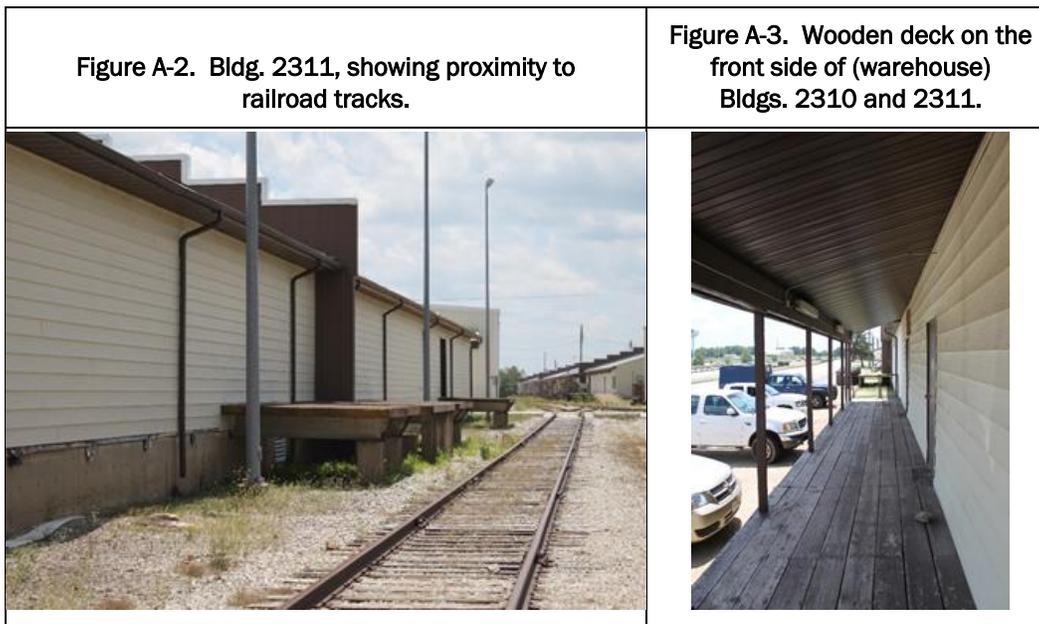
The concrete loading docks on the back side of the warehouse, which are in good repair, are no longer in service. A 50 ft long by 6.75 ft wide wooden deck on the front side of the Bldg. 2310 side of the building (Figure A-3) has an (assumed) aluminum covering.

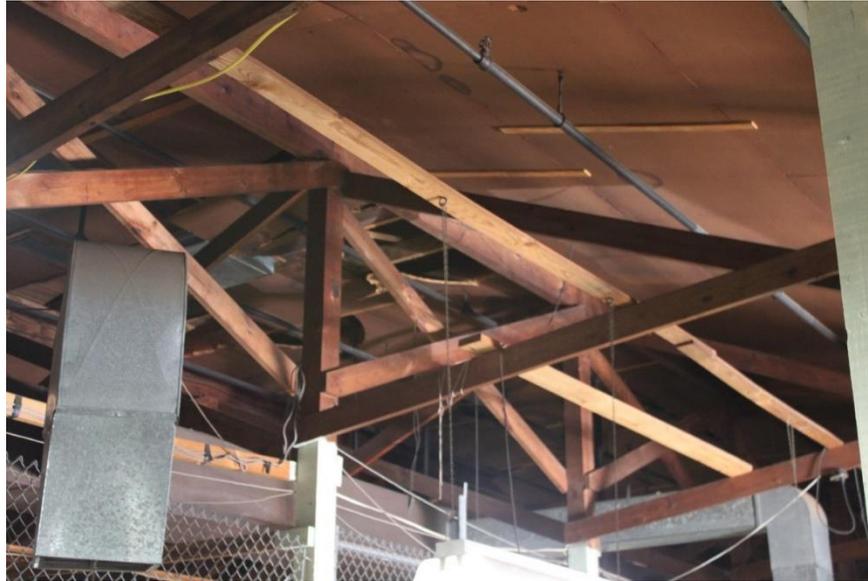
Figure A-5. Structural wood available for recovery.

The total structural wood available (Figure A-5) for recovery is approximately 40,000 board ft.

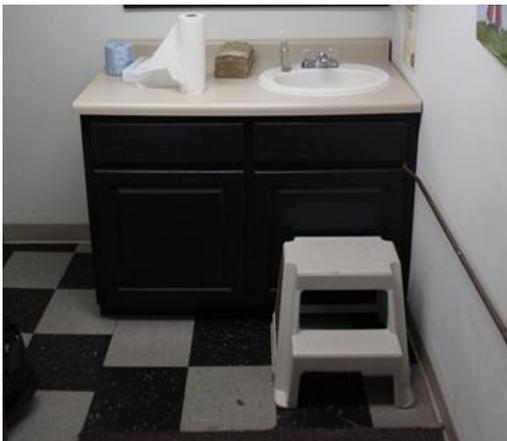
Figure A-12. Bathroom sink console.

The Bldg. 2310 half of the building contains one set of bathrooms. Each bathroom contains one toilet and one sink. The sinks (Figures A-12 and A-13) are in reasonable condition and could be reused in another location. However, the toilets, which have old-style flush valves, are unlikely to be reusable. An unknown amount of iron pipe feeds both bathrooms.

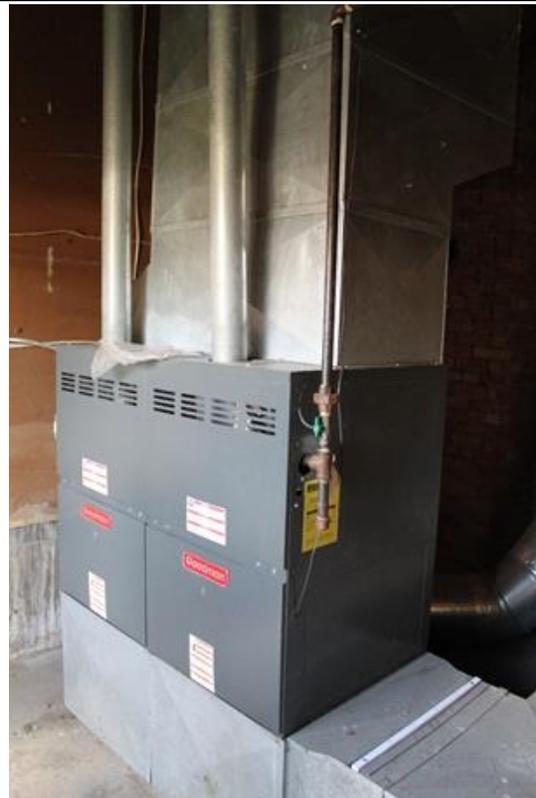
Figure A-15. GMH8 Goodman furnace.

Only the Bldg. 2310 side of the building has mechanical equipment: two furnaces and one air-conditioner (Figure A-14). All are in fair condition and could be reused in similar environments. The larger furnace, a GMH8 Goodman product (Figure A-15) located in the mechanical room, services the storage section of the warehouse via an estimated 120 ft of ductwork ranging from 2 ft² down to 18 in². There is also a brick chimney about 20 ft tall and 3 ft². A smaller furnace (a Ck24-18 Goodman product) and an A/C unit service the office area (Figure A-16).

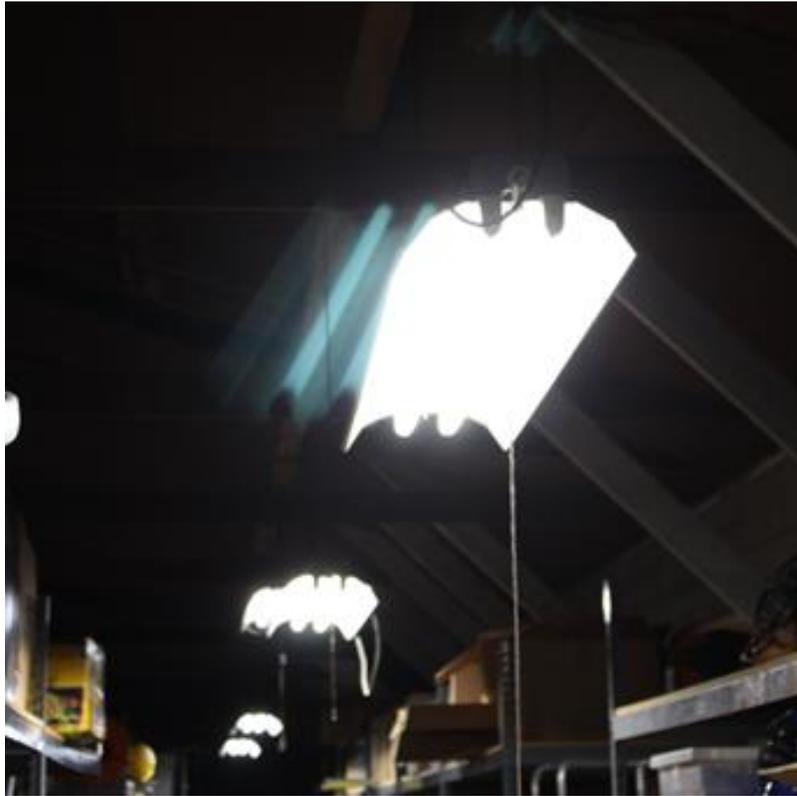
The main storage area in both sides of the building is lit by 4 ft, 2-tube industrial ceiling-hung fluorescent lights spaced along the length of the structure (Figure A-17). There are 50 such fixtures in Bldg. 2310 and 75 in Bldg. 2311. There are also 14 square, 2 ft × 2 ft, lights in the office area and bathrooms of Bldg. 2310.

Figure A-17. Industrial ceiling-hung 4 ft, 2-tube fixtures.

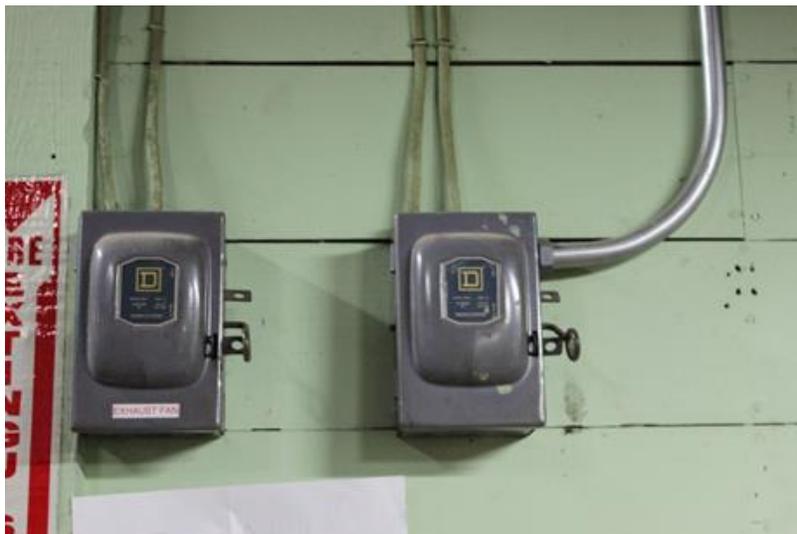
A small amount of electrical conduit was found in Bldg. 2310. All electrical paneling and boxes are easily accessed and in fair condition, though they will need updated breakers for reuse (Figure A-18).

Figure A-18. Accessible electrical boxes.

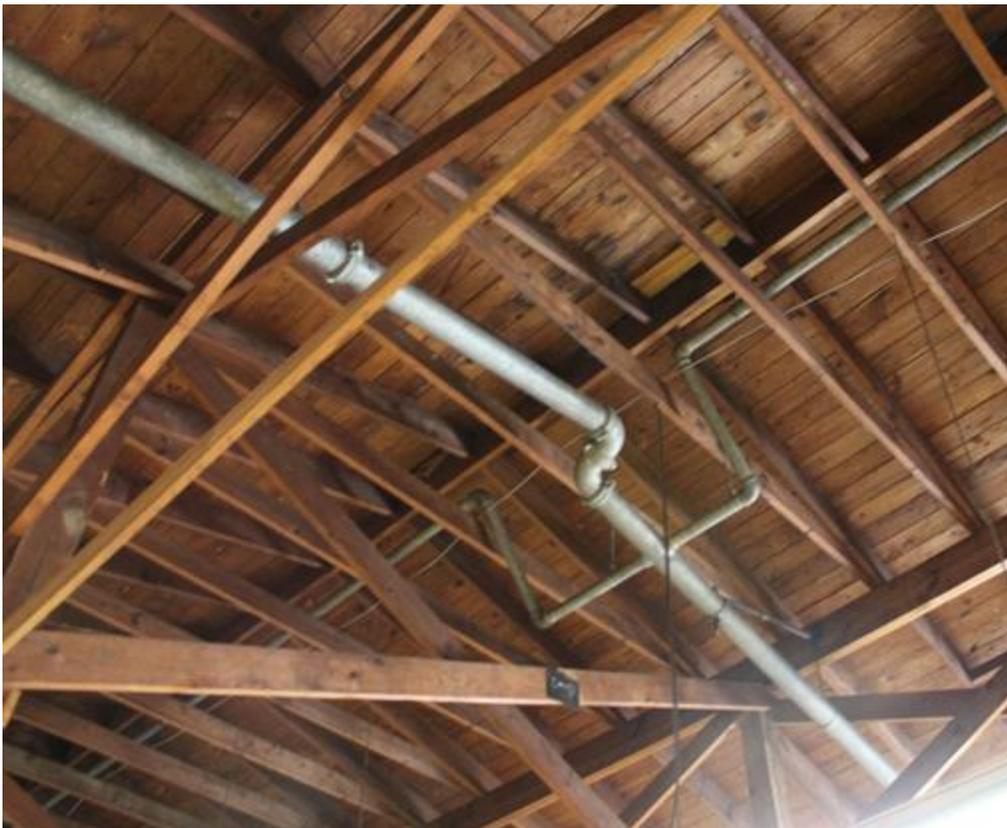
Both halves of the building have a sprinkler pipe network (Figure A-19). It is likely that the piping in Bldg. 2311, which is composed of galvanized

threaded pipe, has been replaced. The piping in Bldg. 2310, which is composed of black iron threaded pipe, is probably part of the original construction. Table A-1 summarizes the type and quantity of sprinkler pipe in Bldgs. 2310 and 2311.

Figure A-19. Pipe network for the sprinklers.

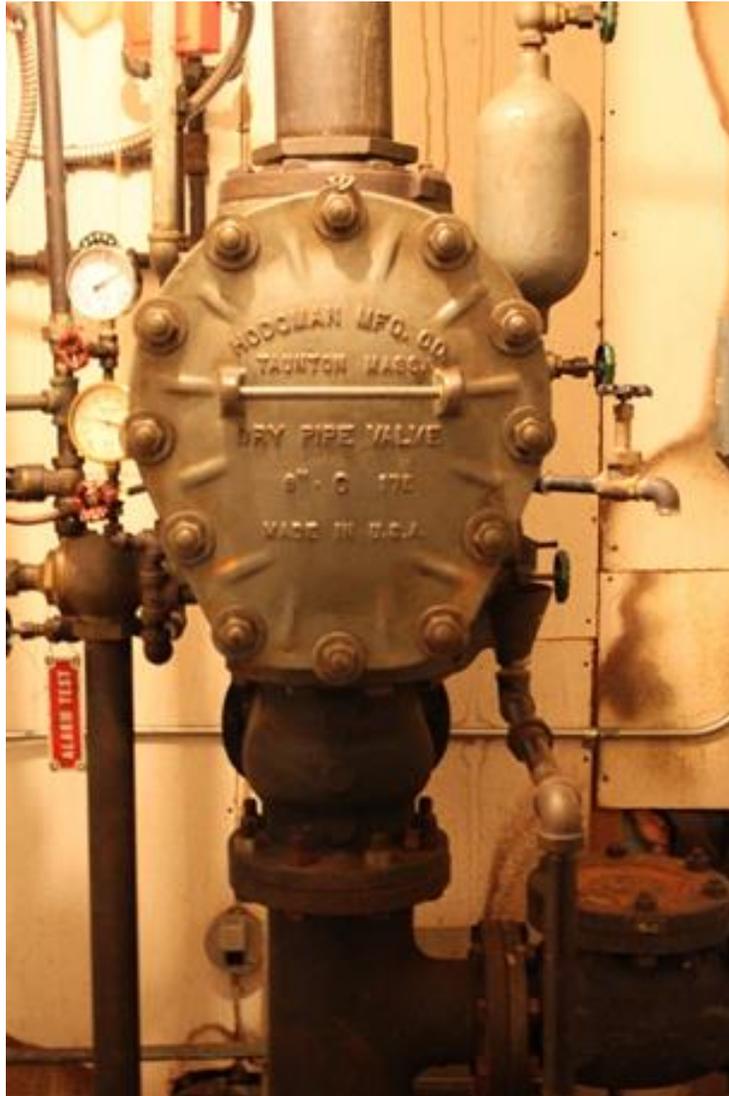
There is a standpipe for each separate system (Figures A-20 and A-21), each isolated in a constructed room inside the warehouse.

Figure A-20. Pipe valve for sprinkler system.

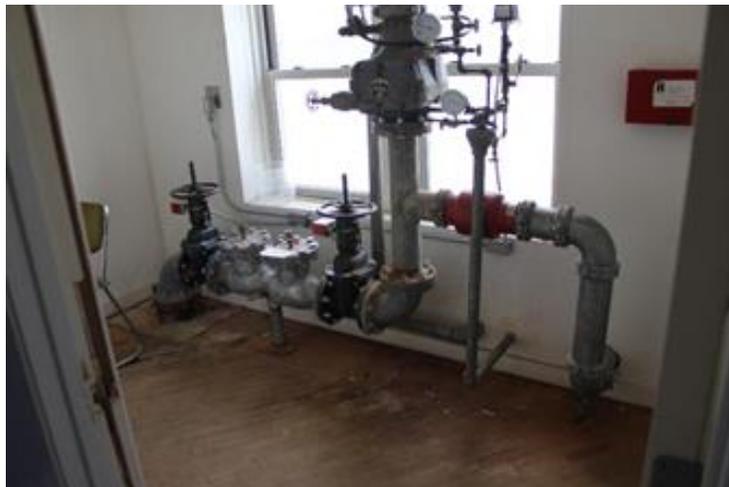
Figure A-21. Standpipe for sprinkler system.

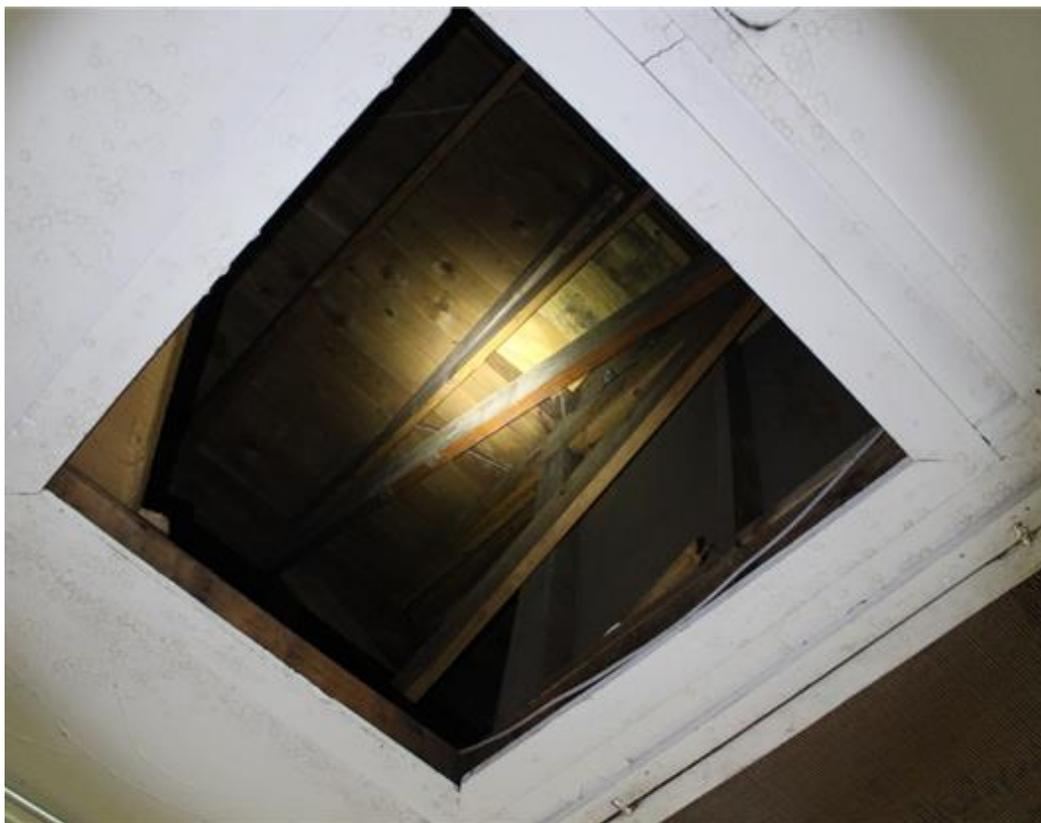
Figure B-3. Opening in roof system showing 2 in. × 8 in. rafters.

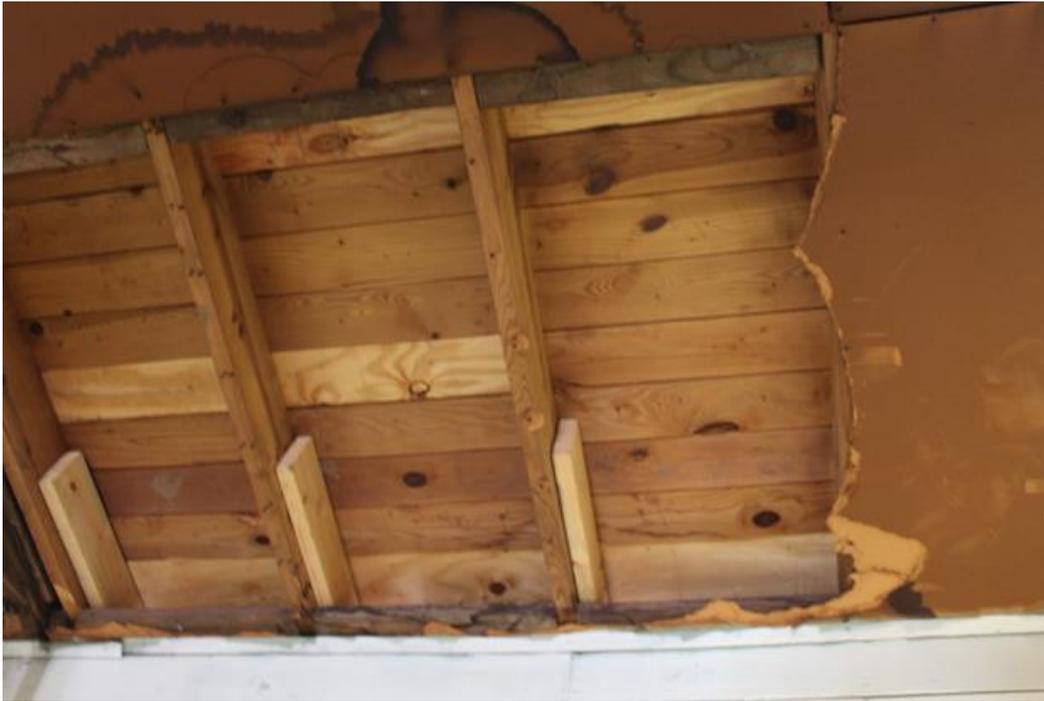
Figure B-4. Opening in roof system showing braced rafters.

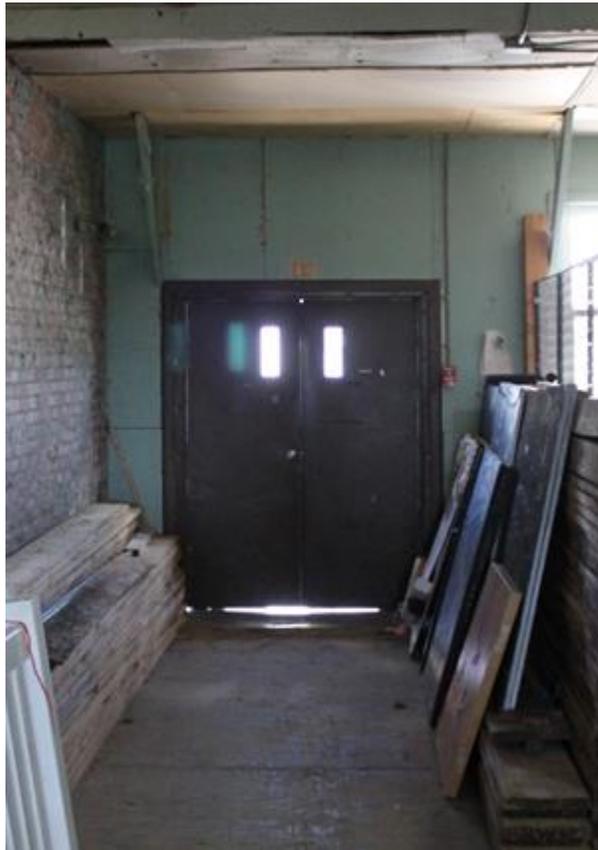
Bldg. 2330 has one 30 in. × 80 in. exterior single door and three 60 in. × 80 in. double doors, all in good condition (Figure B-5). The loading doors have all been capped with plywood panels (Figure B-6).

Figure B-5. Exterior 60 in. × 80 in. double doors.

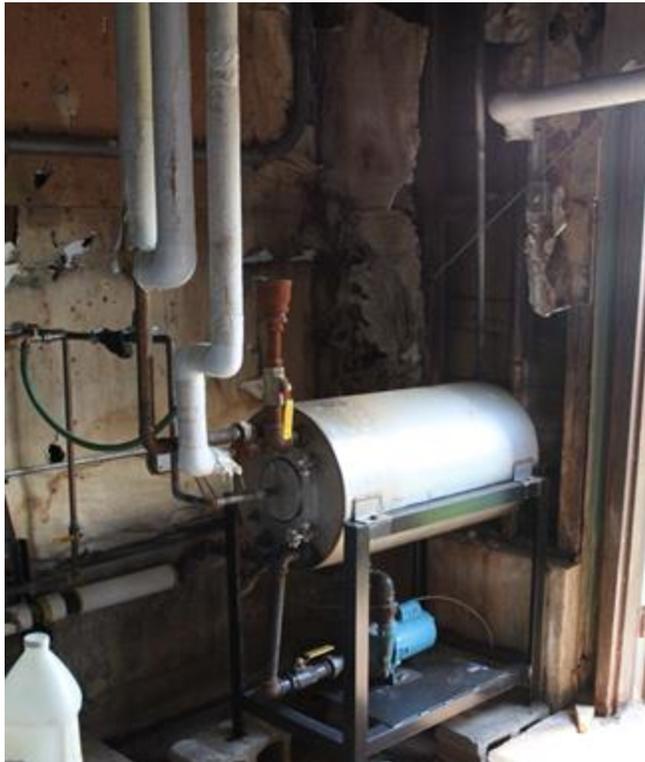
Figure B-8. Smith Cast Iron Boiler, model No. 28A-9.

The mechanical room houses a Smith Cast Iron Boiler, model No. 28A-9, which services both Bldgs. 2330 and 2331 (Figure B-8). Bldg. 2331 is serviced with exterior, aboveground supply and return lines mounted on stands approximately 5 ft above the ground. The interior of Bldg. 2330 is heated with at least seven overhead radiators located at ceiling height. There is approximately 600 ft of heating system piping of indeterminate diameter.

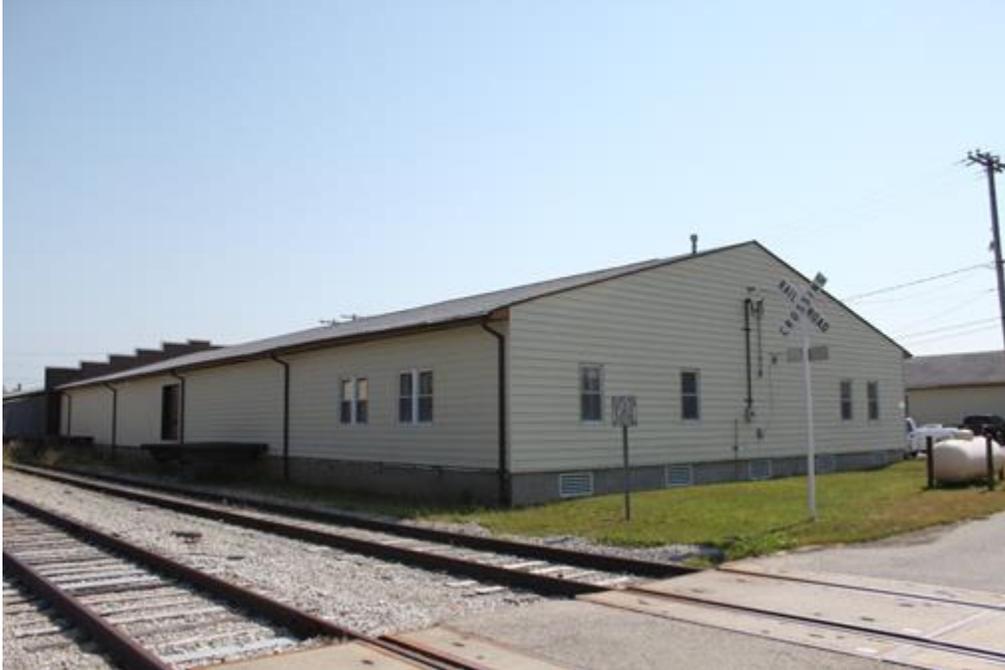
large equipment since the east and west faces of the building are boxed in by railroad tracks and power lines. The area is generally level and should provide a fair amount of space for deconstruction. The concrete loading docks on the back side of the warehouse, which are in good repair (Figure C-2), are no longer in service.

Figure C-2. Bldg. 2332, showing easy road access.

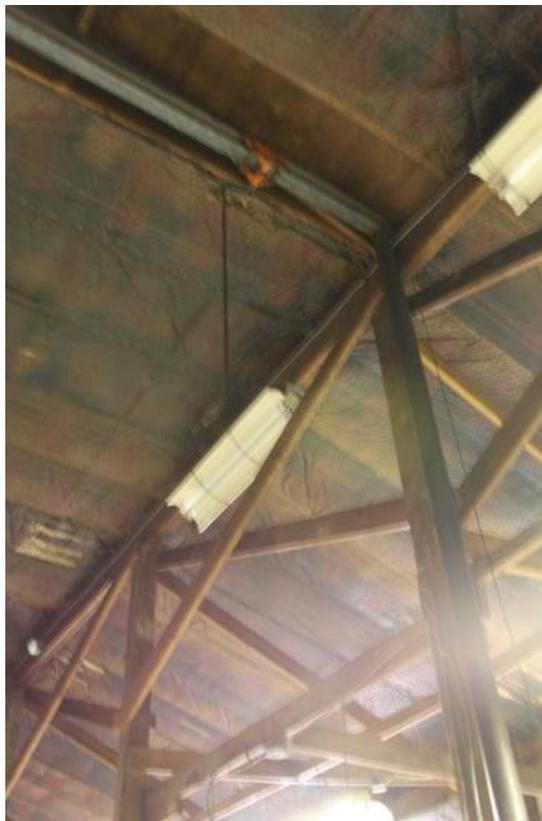
Figure C-3. Bldg. 2332 roof system, rafters spanning the ridge to the exterior walls.

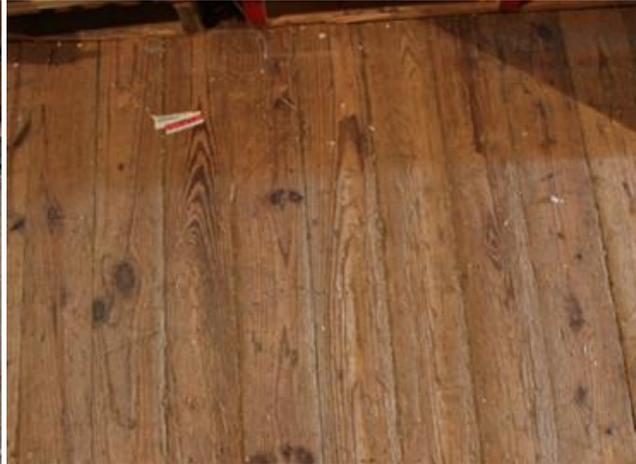
The flooring in Bldg. 2332 is covered with several layers of plywood and linoleum. The top layers are in poor condition (Figure C-4). Underneath it is a tongue-and-groove wooden floor (Figure C-5), which is different from

Figure C-5. Tongue-and-groove subfloor.

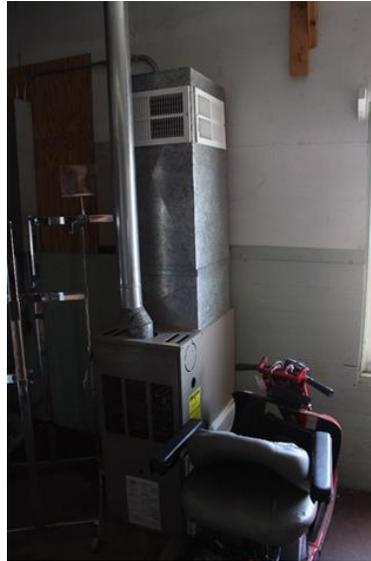
Bldg. 2332 has no mechanical room, although there are two furnaces inside the storage section of the warehouse (Figure C-6). The larger of the two furnaces distributes heat through an estimated 130 ft of ductwork.

Figure C-6. Furnace in warehouse storage section.

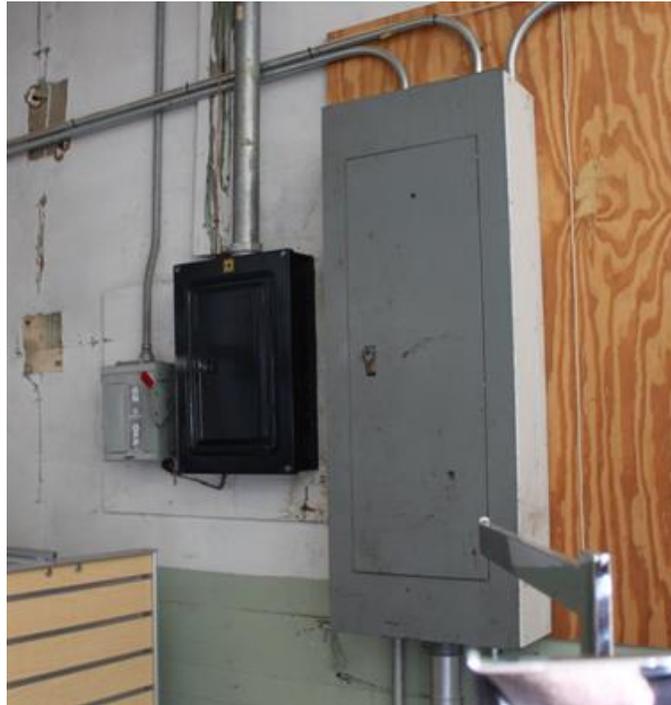
There is a small amount of electrical conduit found in Bldg. 2332. All electrical paneling and boxes are easily accessed (Figure C-7) and in fair condition although they will need updated breakers for reuse.

Figure C-7. Electrical box in Bldg. 2332.

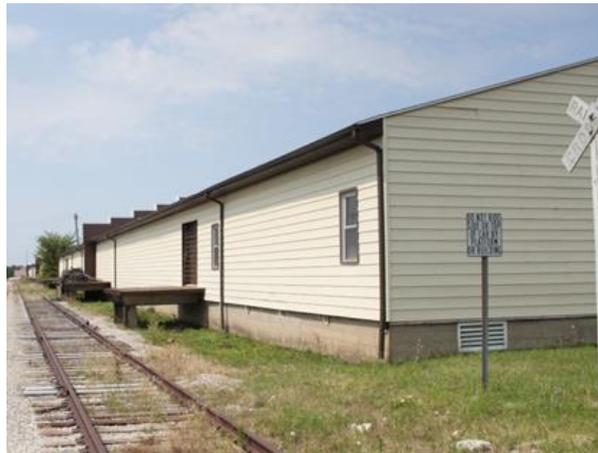
The building is close to and is easily accessed from the nearby roads. The surrounding area provides prime locations for equipment and material storage. The areas adjacent to the building afford little room for tall or large equipment since the east and west faces of the building are boxed in by railroad tracks and power lines (Figure D-2). The area is generally level and should provide a fair amount of space for deconstruction.

Figure D-2. Bldgs. 2344 and 2345, showing proximity to railroad tracks.

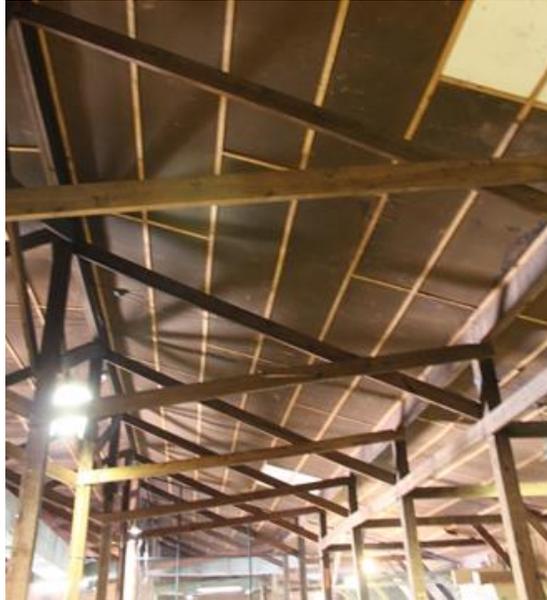
Figure D-4. Bldgs. 2344 and 2345 wooden roofing system.

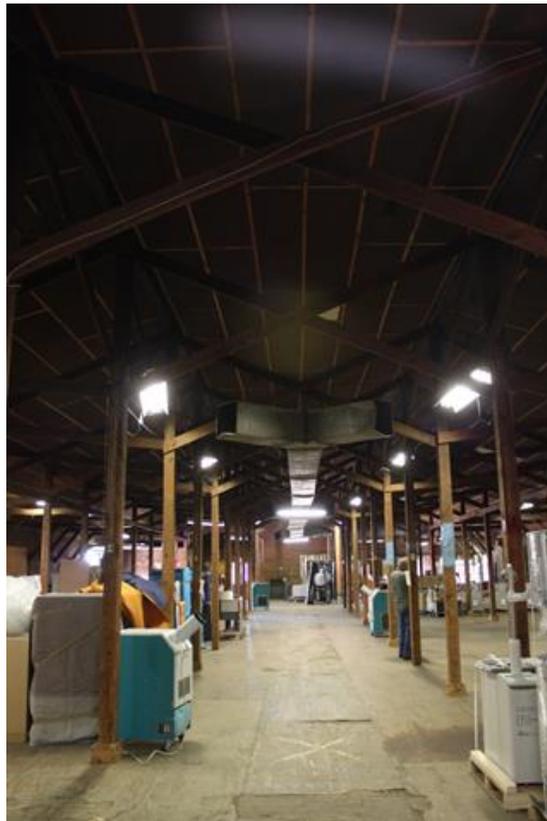
Figure D-5. Bldgs. 2344 and 2345 roofing system, lengthwise view.

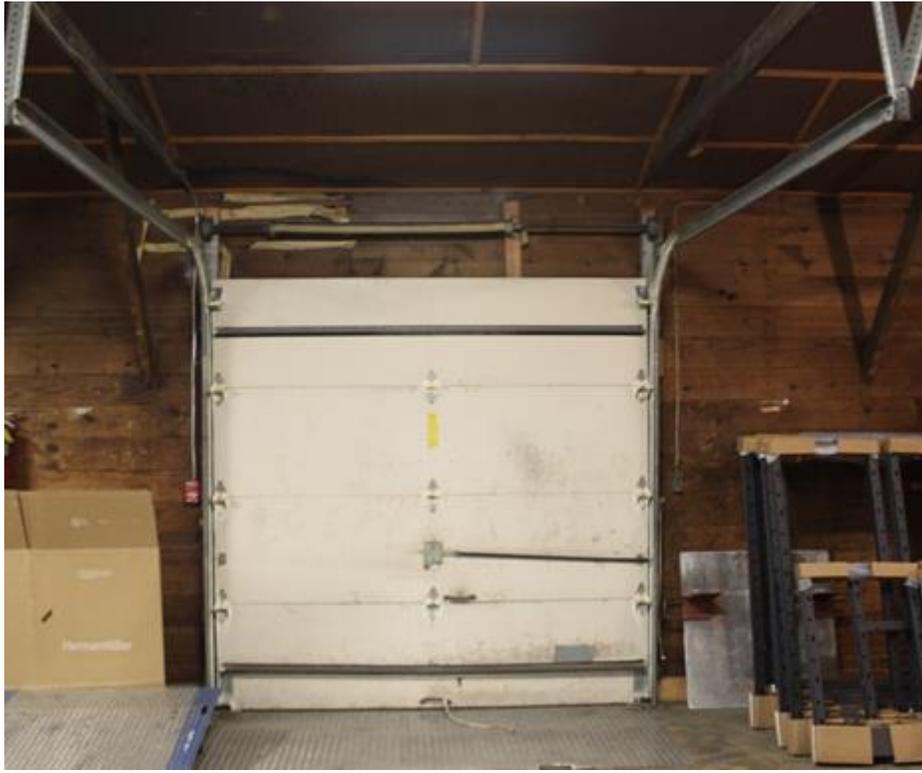
Bldg. 2345 has three, 8 ft × 8 ft overhead metal doors, all in serviceable, reusable condition (Figure D-6). Bldg. 2345 also has one exterior 30 in. × 80 in. single door, also in good condition. Bldg. 2344 has two overhead doors and one exterior single door, both in good condition.

Figure D-6. Overhead metal door in Bldg. 2345.

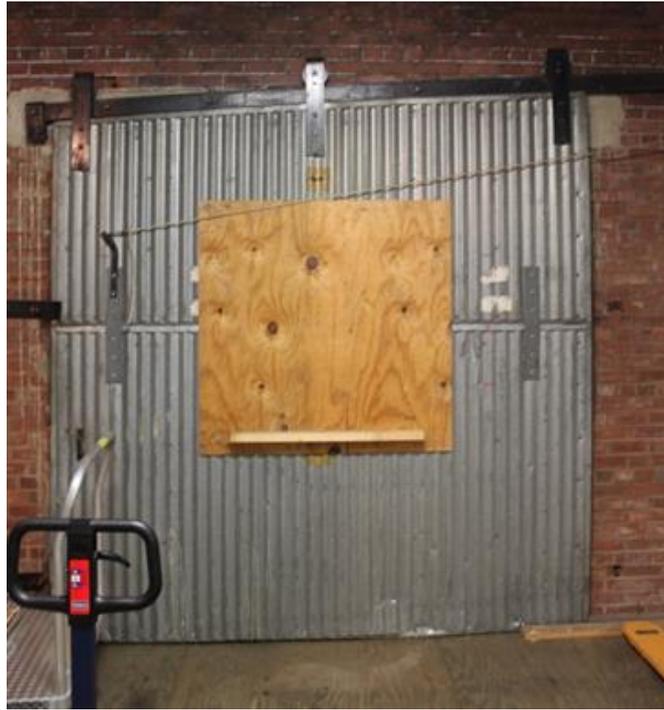
The two halves of the warehouse are separated by a brick firewall; two large corrugated metal doors on either side of the firewall (Figure D-7) allow passage through the center of the building. The doors are in good condition and have potential for reuse.

Figure D-7. Large corrugated metal doors on either side of the fire wall in Bldg. 2345.

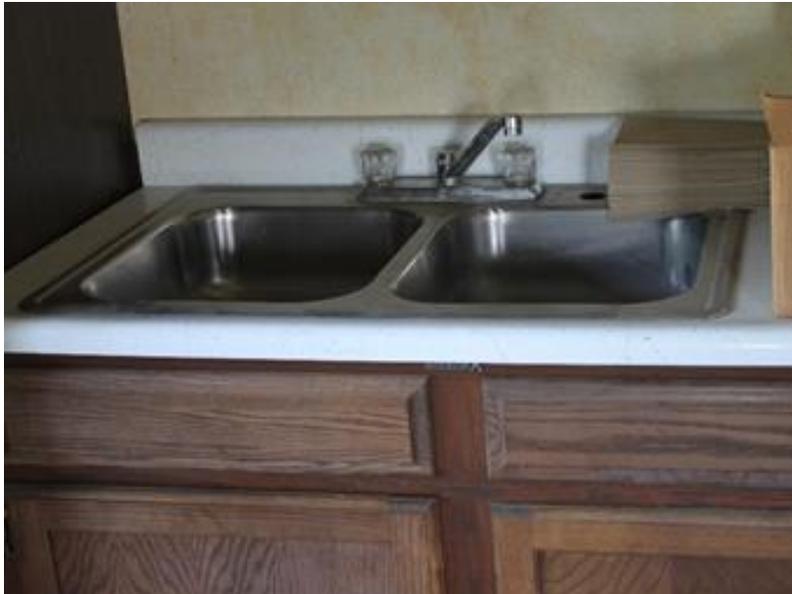
Figure D-10. Typical sink in Bldg. 2345.

The Bldg. 2345 half of the building contains two bathrooms that, together, contain three toilets, two urinals, and two sinks. The toilets have old-style flush valves, and the sinks are damaged (Figures D-10 and D-11), so they are unlikely to be reusable. An unknown amount of iron pipe feeds both

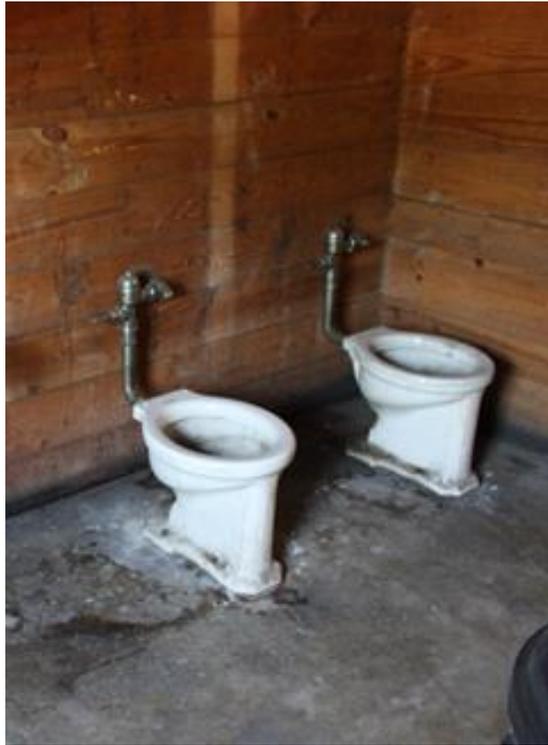
Figure D-12. Toilets in Bldg. 2345.

bathrooms. The bathroom in Bldg. 2344 has similar fixtures: a sink, urinal, and two toilets (see Figure D-12). These are in slightly better condition than those in Bldg. 2345, so they may be reusable, although it is unlikely. The office space has a double basin sink (Figure D-13) that is in good condition and could be reused.

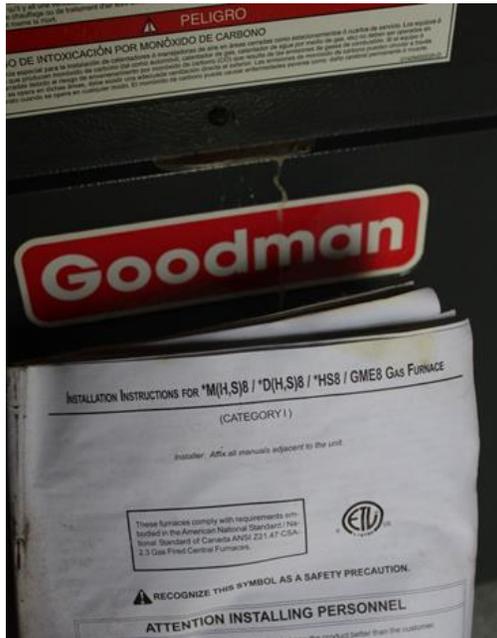
Figure D-14. Label on Goodman furnace.

On the Bldg. 2345 side of the building, a mechanical room houses a Goodman furnace (Figure D-14). The furnace is in fair condition and could be reused in similar environments. The furnace serves the warehouse through an estimated 120 ft of ductwork ranging from 2 ft² down to 18 in². The mechanical room in Bldg. 2344 houses a furnace with a similar amount of ductwork (Figure D-15) and a water heater that serves the sinks (Figure D-16).

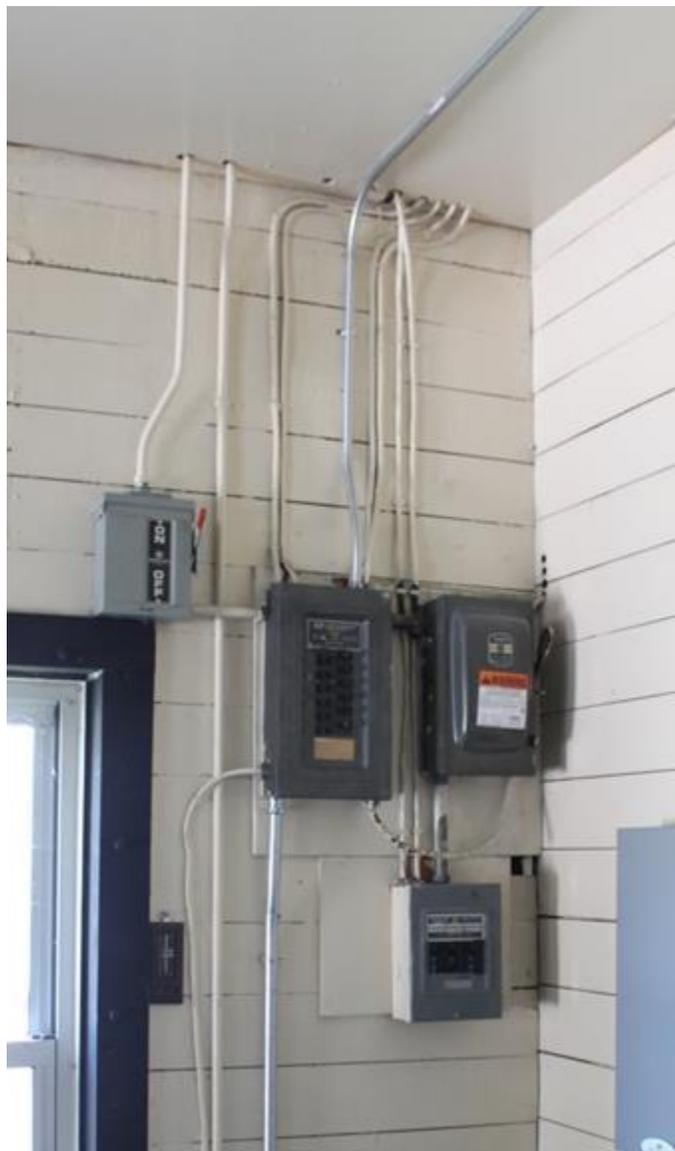
Figure D-17. Electrical paneling and boxes in Bldg. 2310.

There is a small amount of electrical conduit found in Bldg. 2310. All electrical paneling and boxes are easily accessed and in fair condition, though they will need updated breakers for reuse (Figure D-17).
