TECHNICAL REPORT REMR-CS-13

**REHABILITATION OF NAVIGATION  
LOCK WALLS: CASE HISTORIES**

James E. McDonald

December 1987

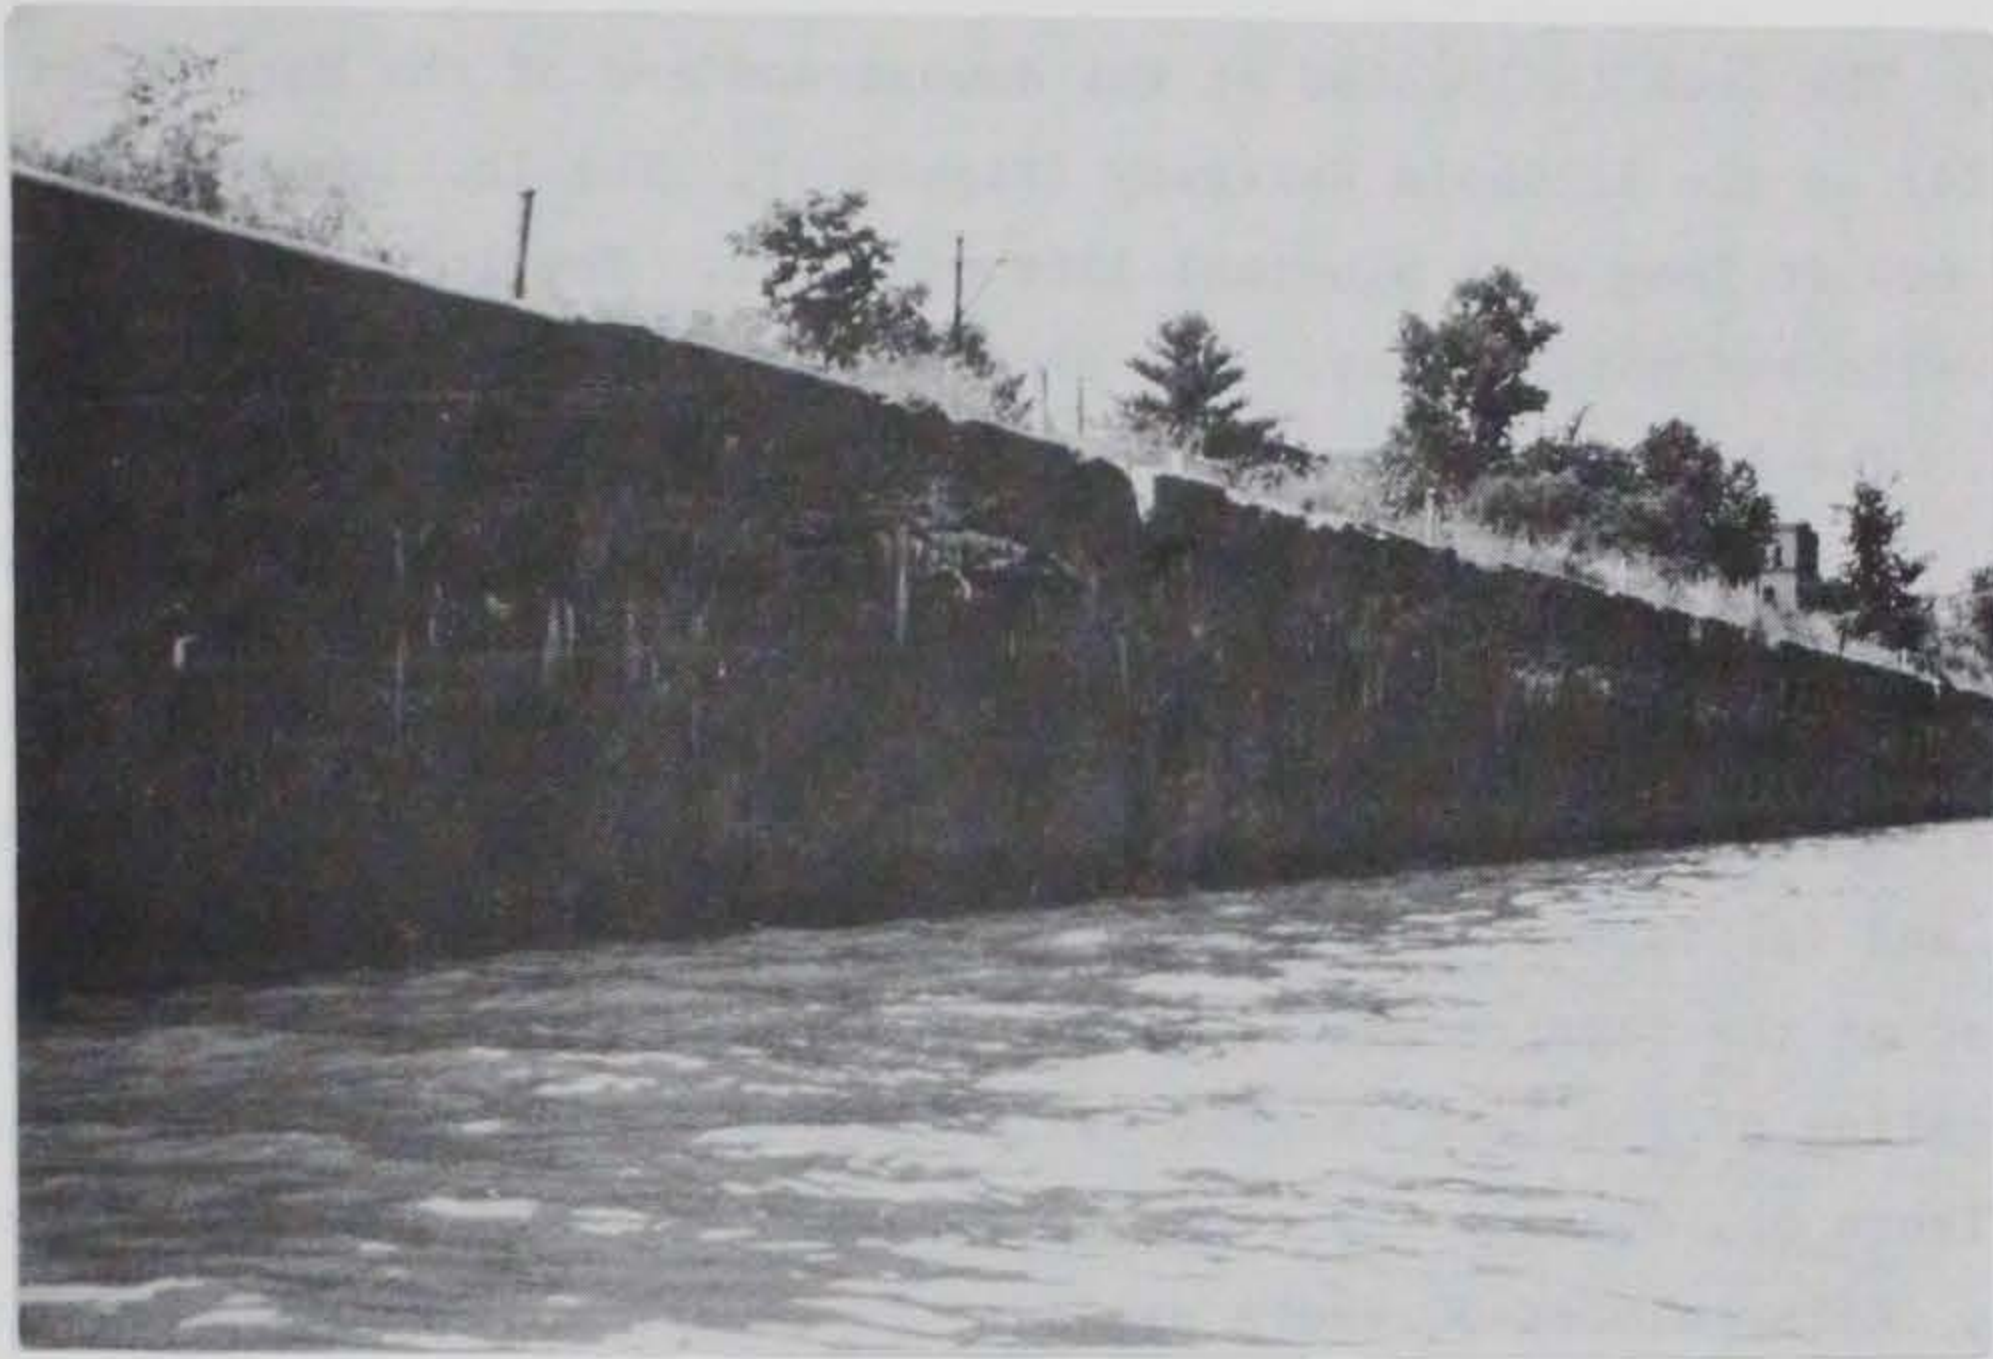
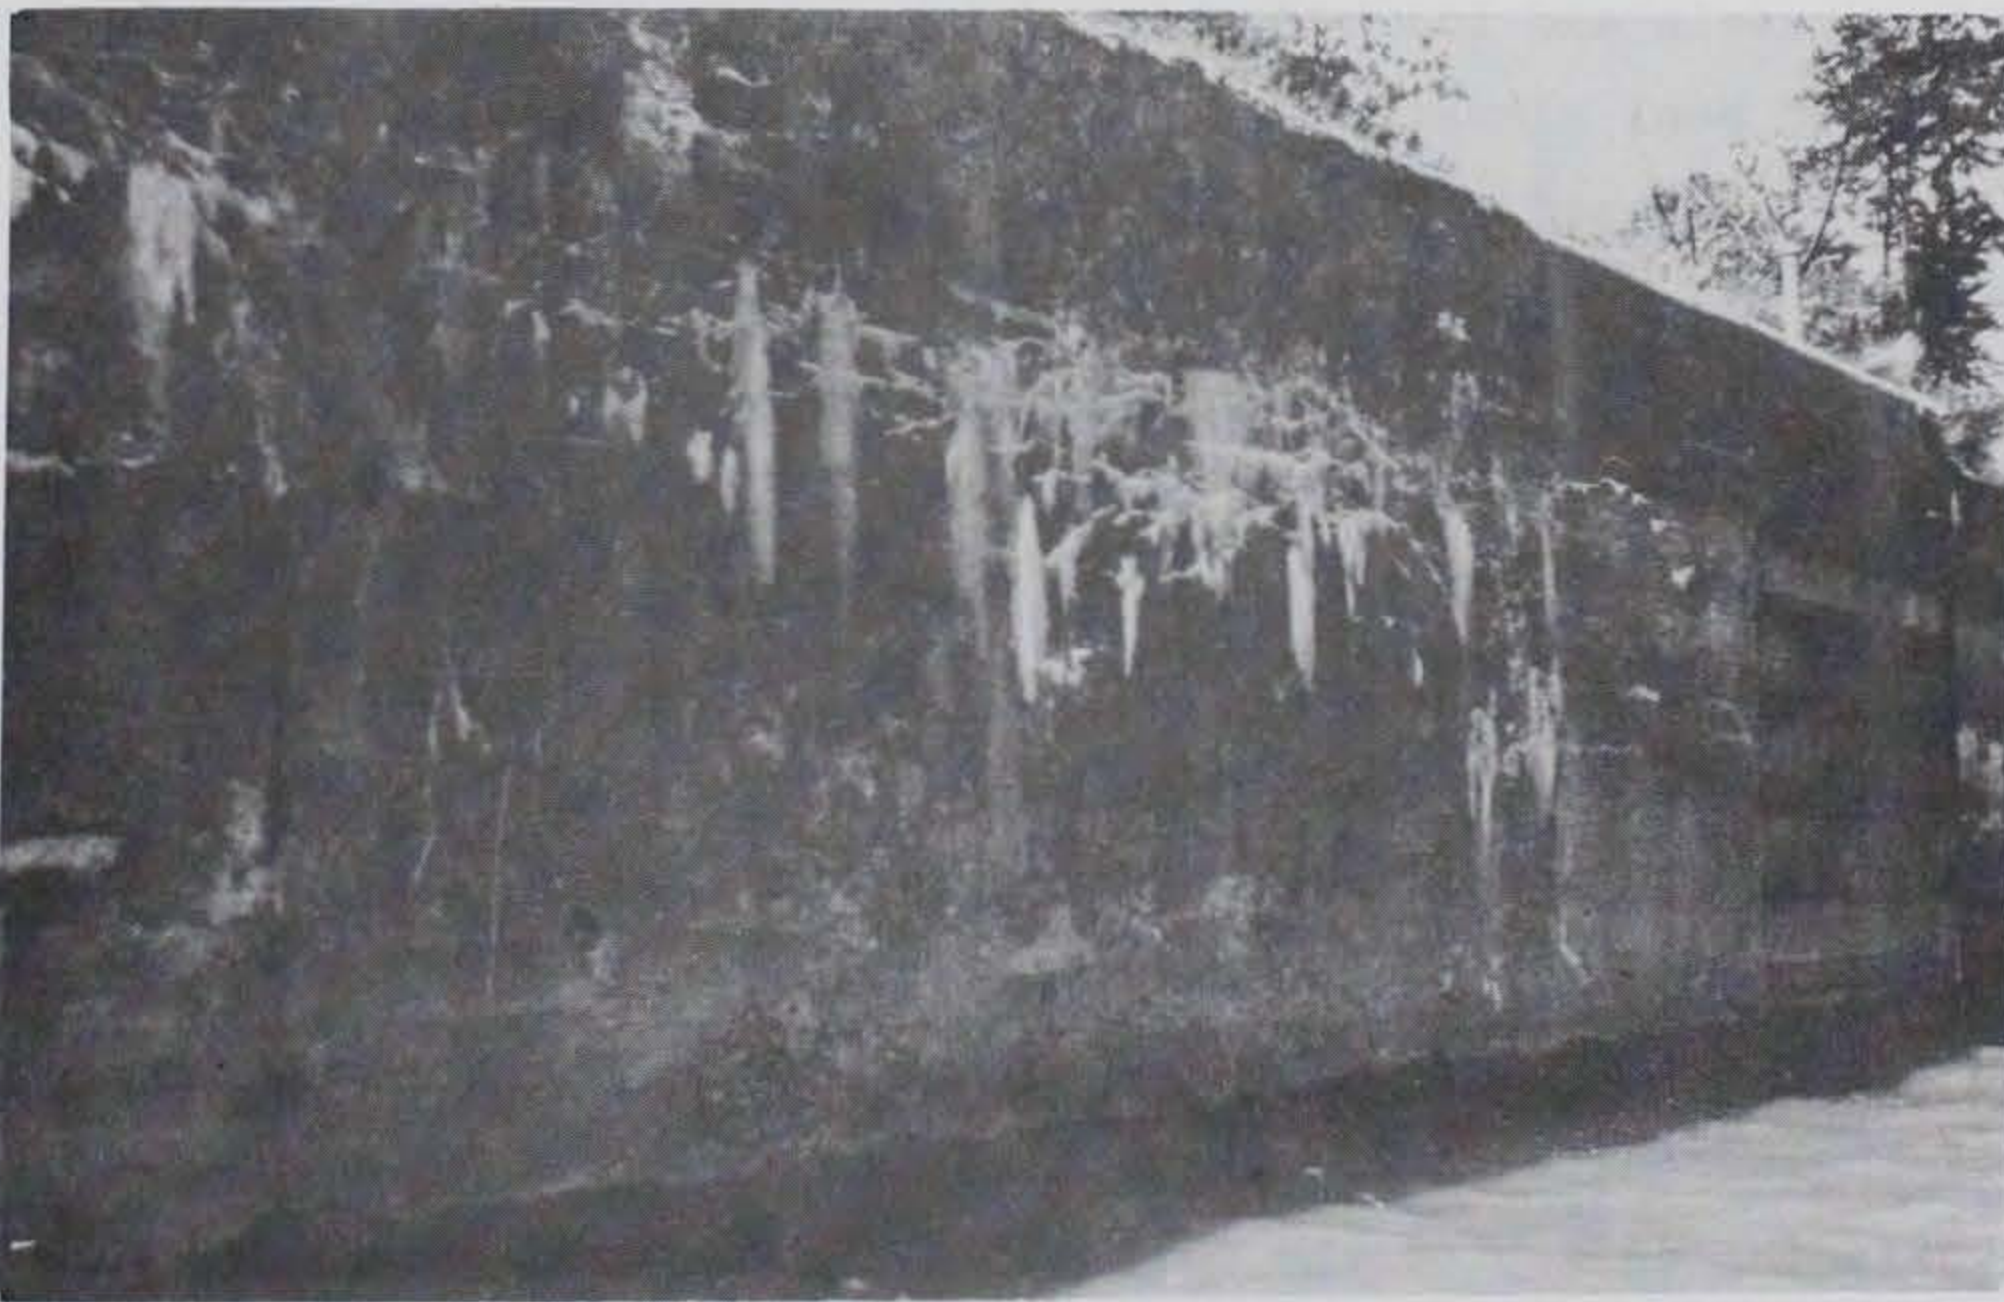
Figure 3. Condition of land wall, July 1985,  
Lock No. 5, Monongahela River

23. Lock No. 5 was removed from service and, with the exception of the land wall, razed in conjunction with the construction of Maxwell Lock and Dam in 1964. A visual examination of the remaining wall in July 1985 showed that the preplaced-aggregate concrete had some cracking and leaching (Figure 3) but overall appeared to be in generally good condition after 35 years exposure.

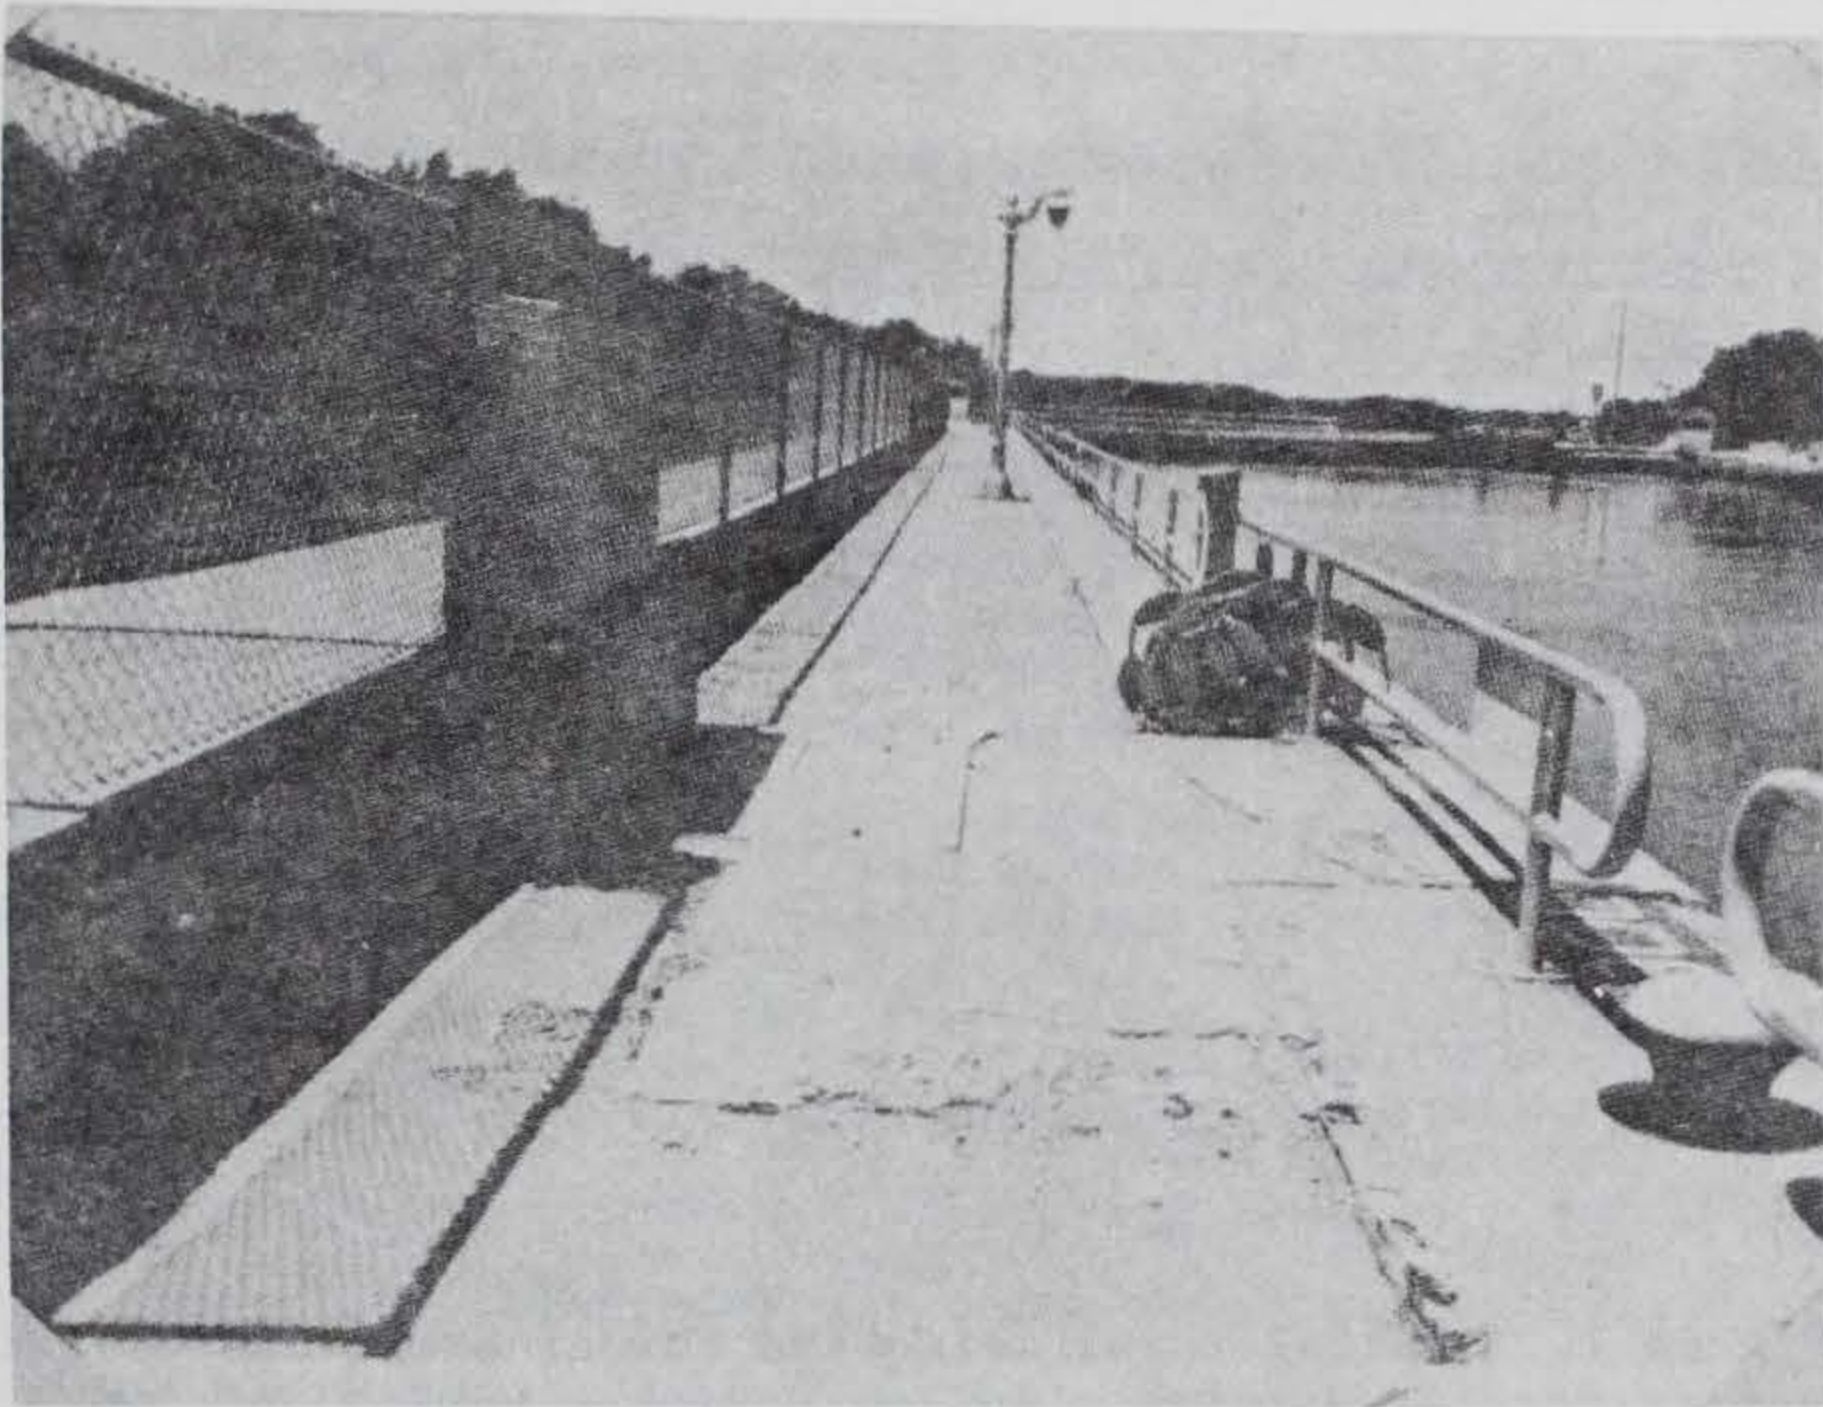
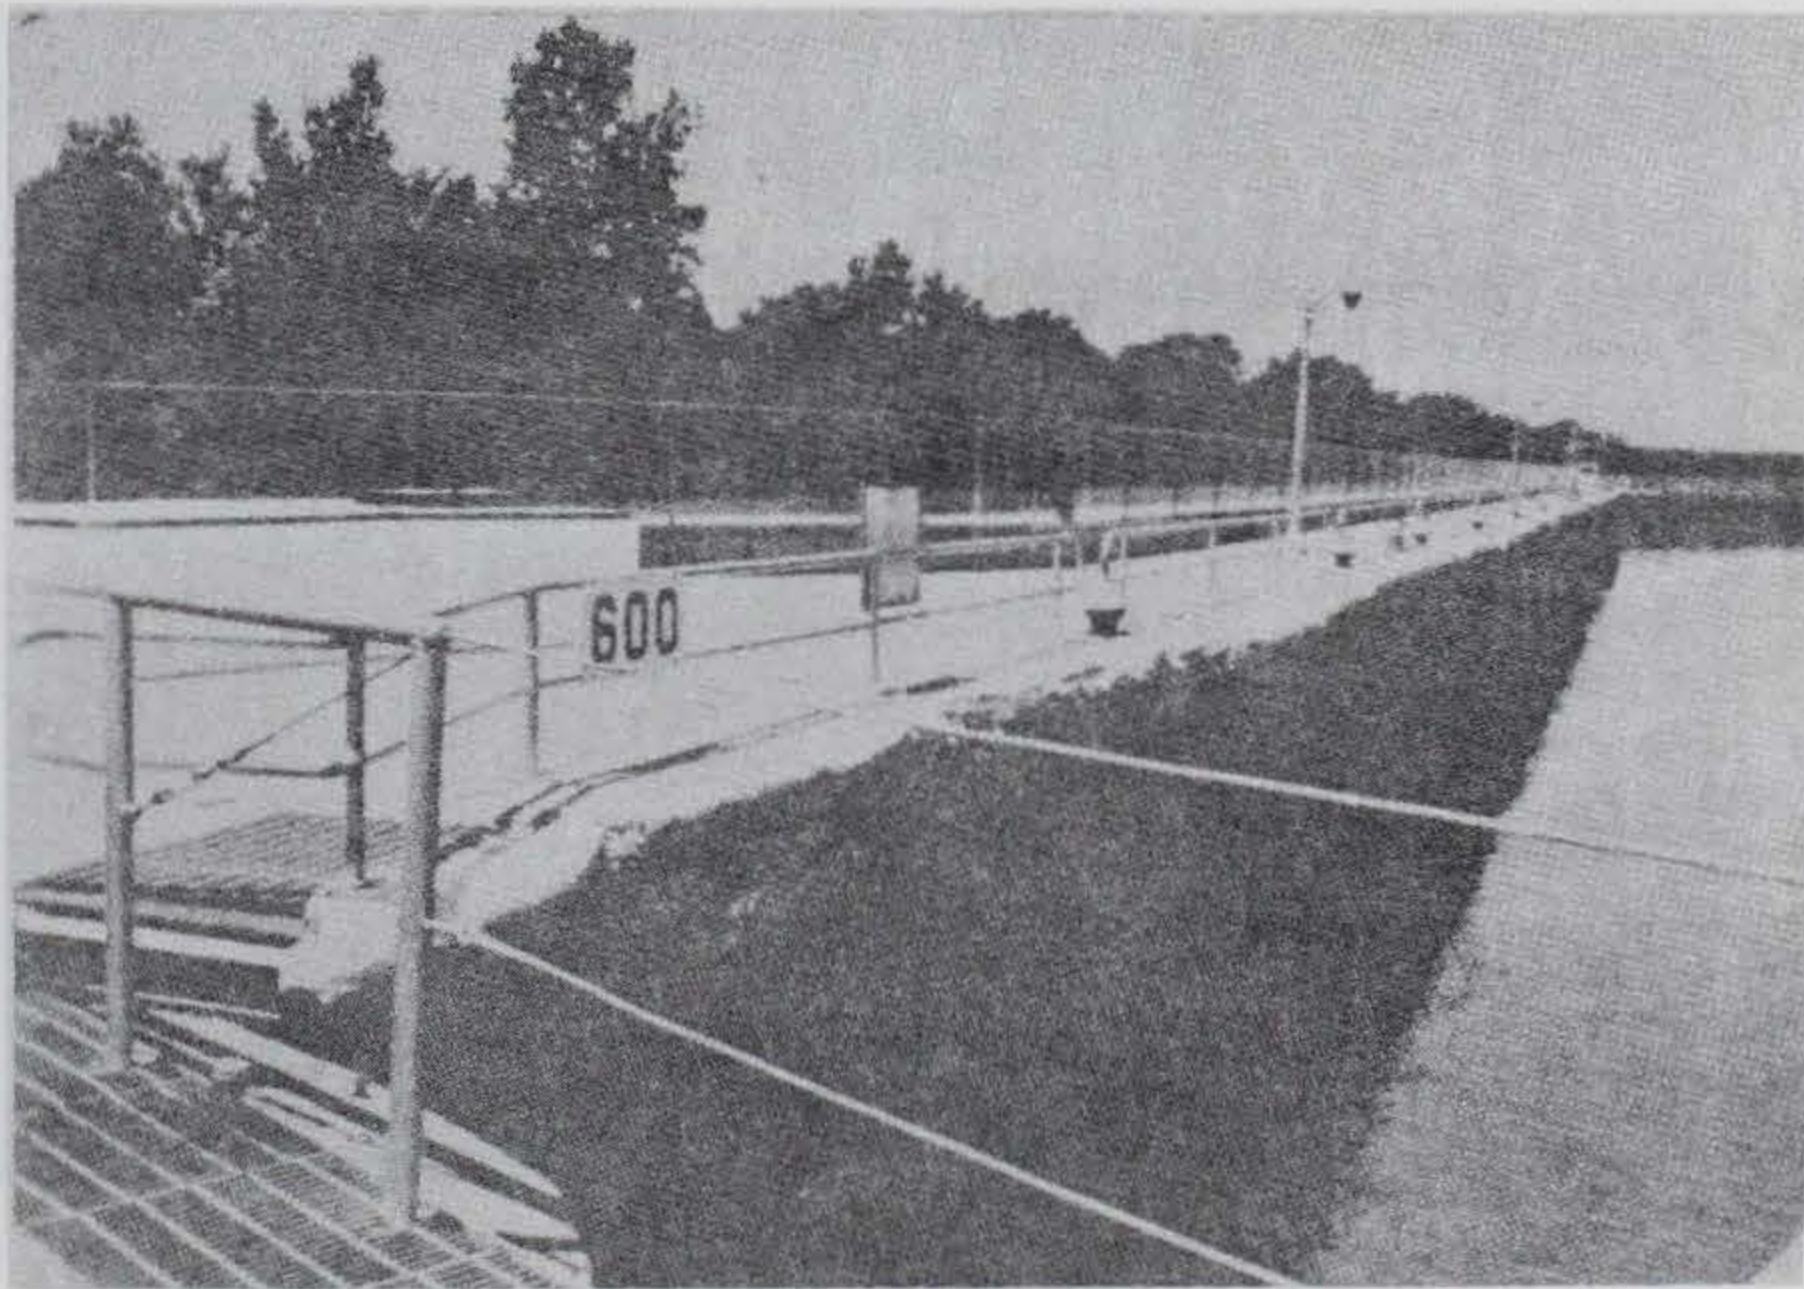
Figure 6. Typical concrete deterioration, 1962, Marseilles Lock

26. After almost 30 years exposure to severe weathering, horizontal concrete surfaces had scaled to an average depth of 3/4 in. Similar conditions existed on vertical surfaces, particularly at the joints. In addition, abrasion by vessels and ice had chipped concrete surfaces, particularly at upper and lower pool elevations and at the top of the wall (Figure 6). As a result, it was proposed to resurface portions of the top surface of the lock walls (Chicago District 1963). Also, portions of the vertical surfaces near the top of the walls were to be resurfaced and corner armor installed (Figure 7). This work was completed in 1965 at a cost of \$80,000.

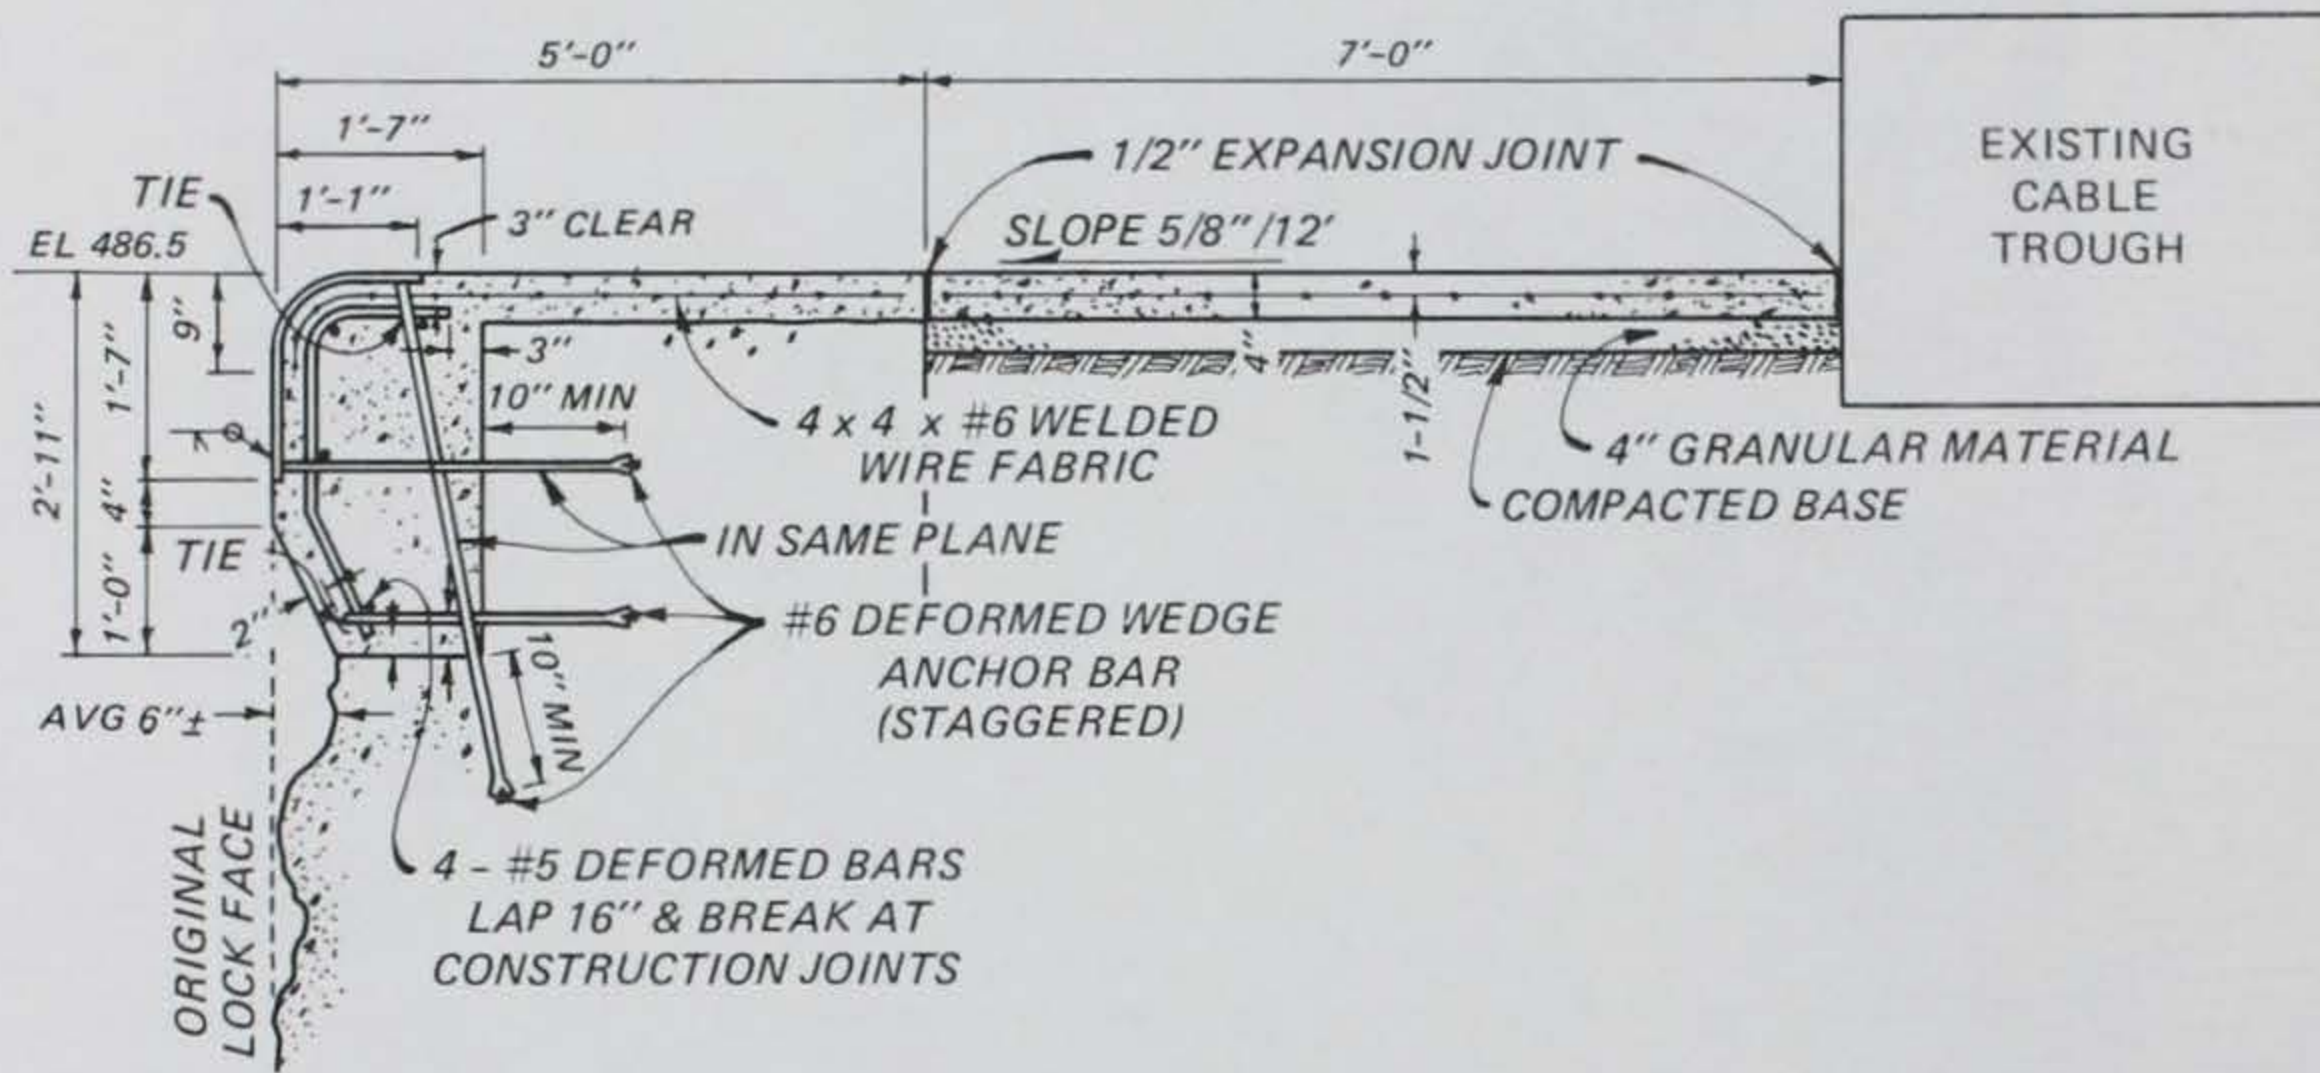
Figure 7. Typical resurfacing and corner armor installation details, 1965, Marseilles Lock

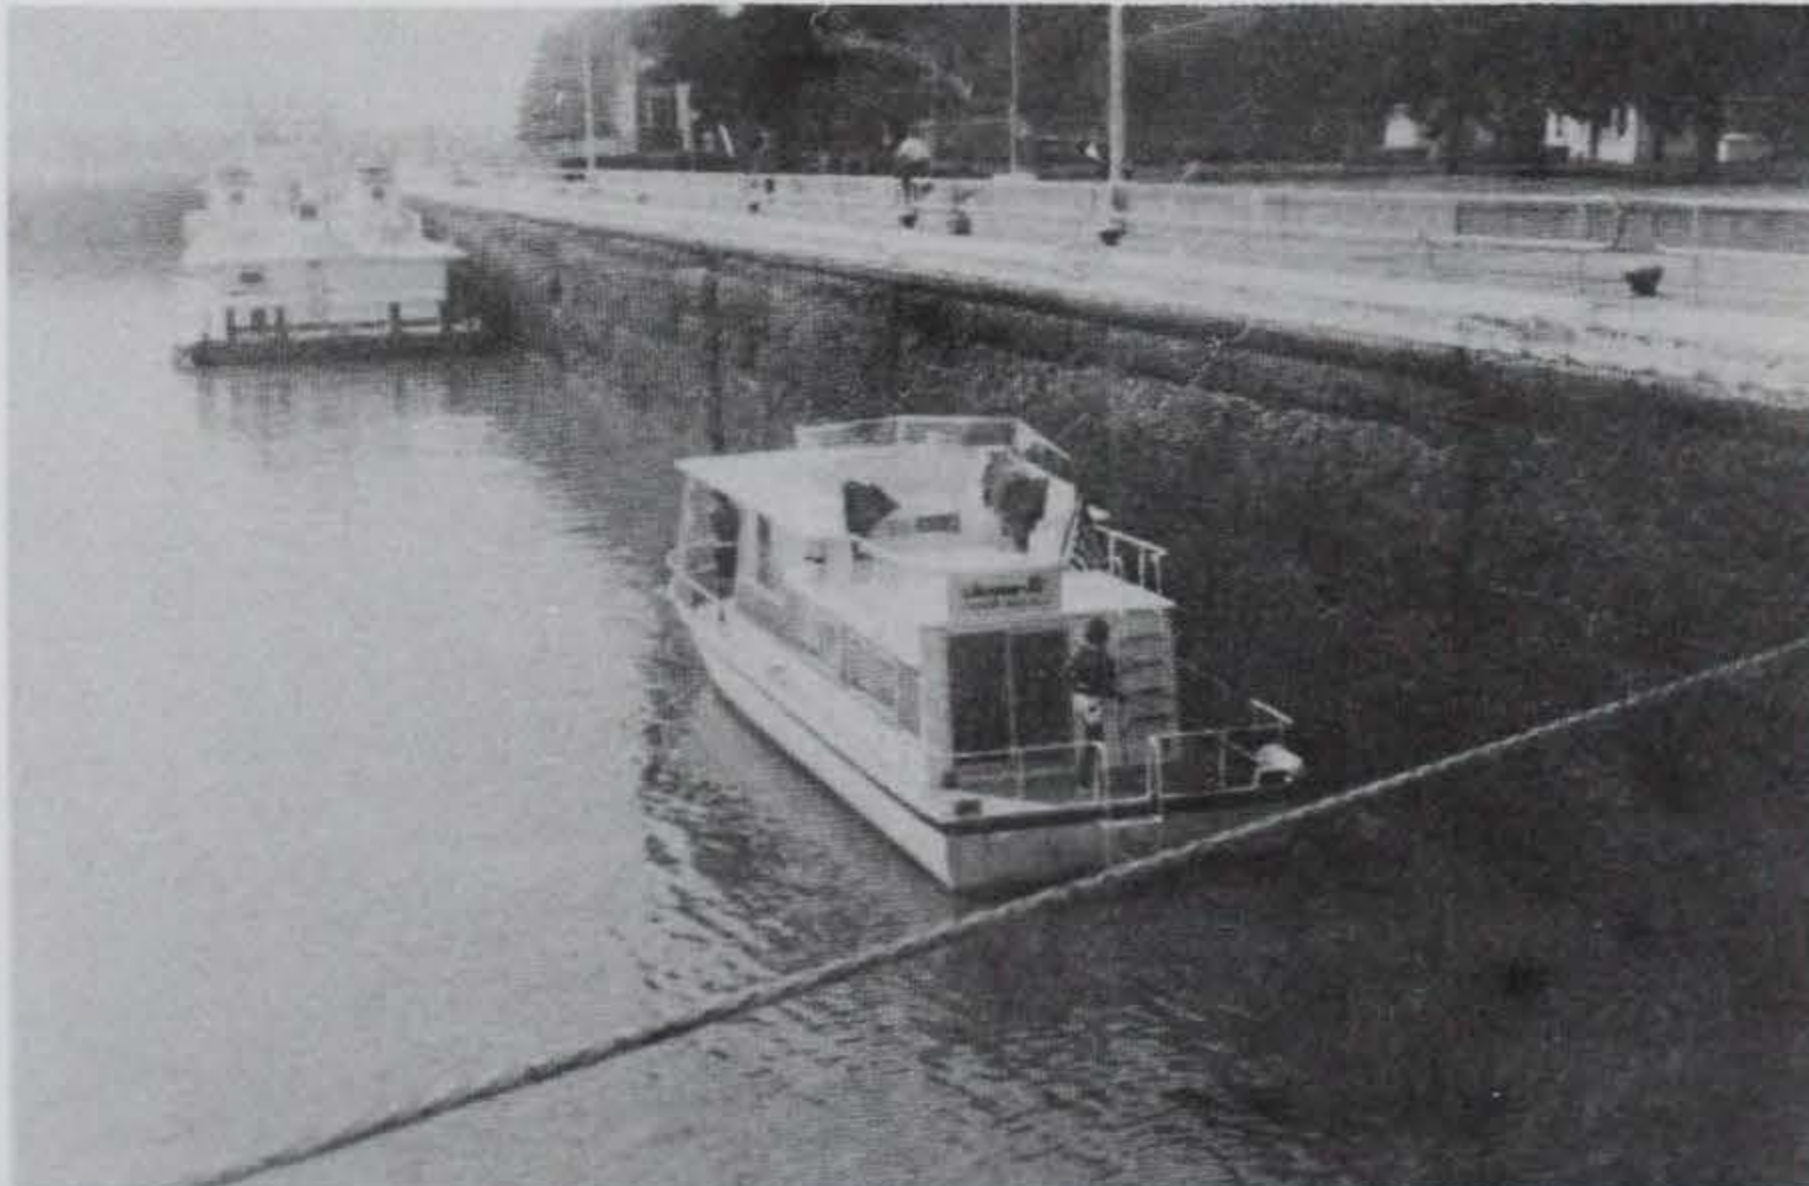
28. The second periodic inspection was conducted in August 1972. Concrete resurfacing on top of the north lock chamber wall was in good condition; however vertical surfaces were severely deteriorated, particularly at monolith joints (Figure 8). Similar conditions existed on the south wall with the addition of a few minor cracks on top of the wall. The chamber walls had eroded to the point that the downstream miter gate was vulnerable to barge

Figure 8. Severe deterioration of north lock wall, 1972, Marseilles Lock

traffic when the gate was in the open position. It was concluded that if allowed to progress, loss of section through erosion would impair the stability and integrity of the lock walls. Therefore, it was recommended that the lock chamber walls be resurfaced. Since such a repair would have to be accomplished with a minimum of lock downtime, the Office of Chief of Engineers (OCE) suggested that precast concrete stay-in-place forms be studied as a potential repair technique. The Little Rock District (1963) had investigated this system of forming for new construction, and the Bureau of Reclamation had used it in the restoration of Barker Dam (Davis 1948).

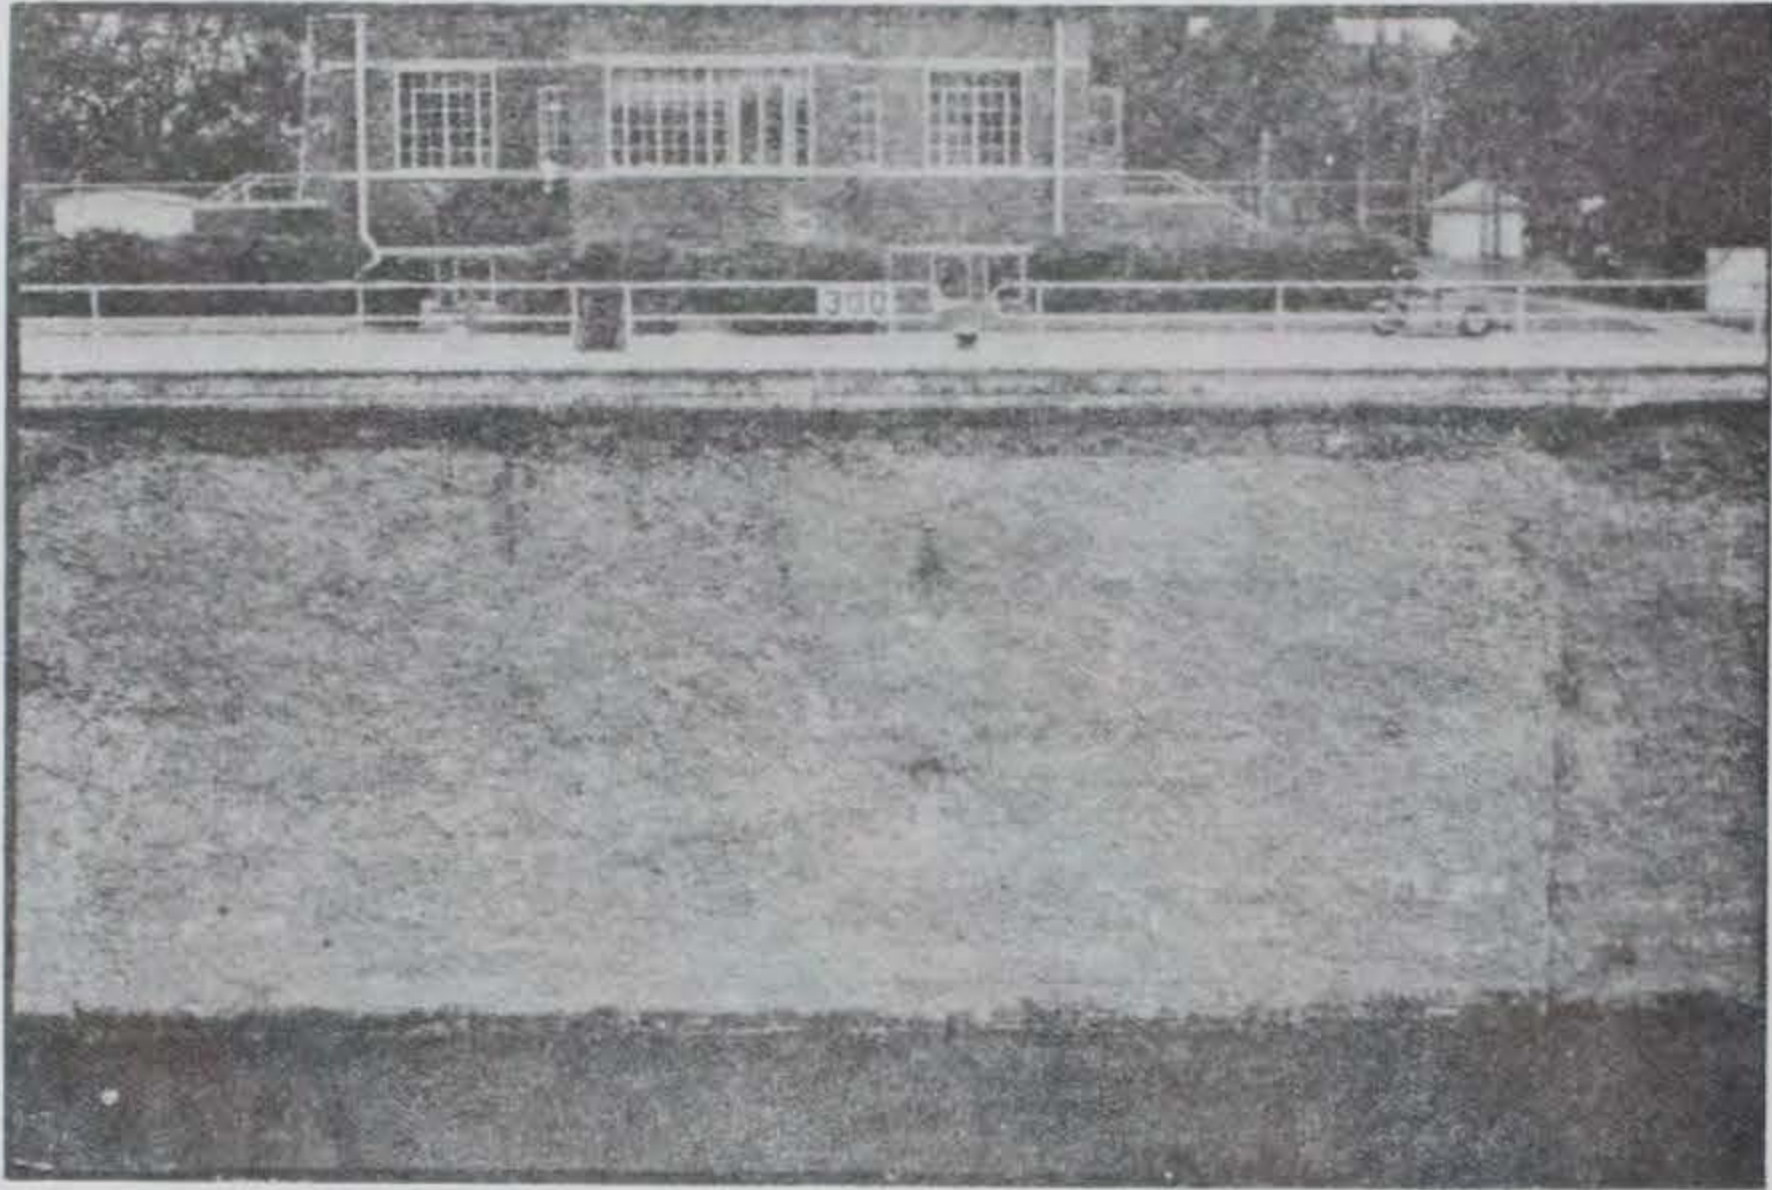
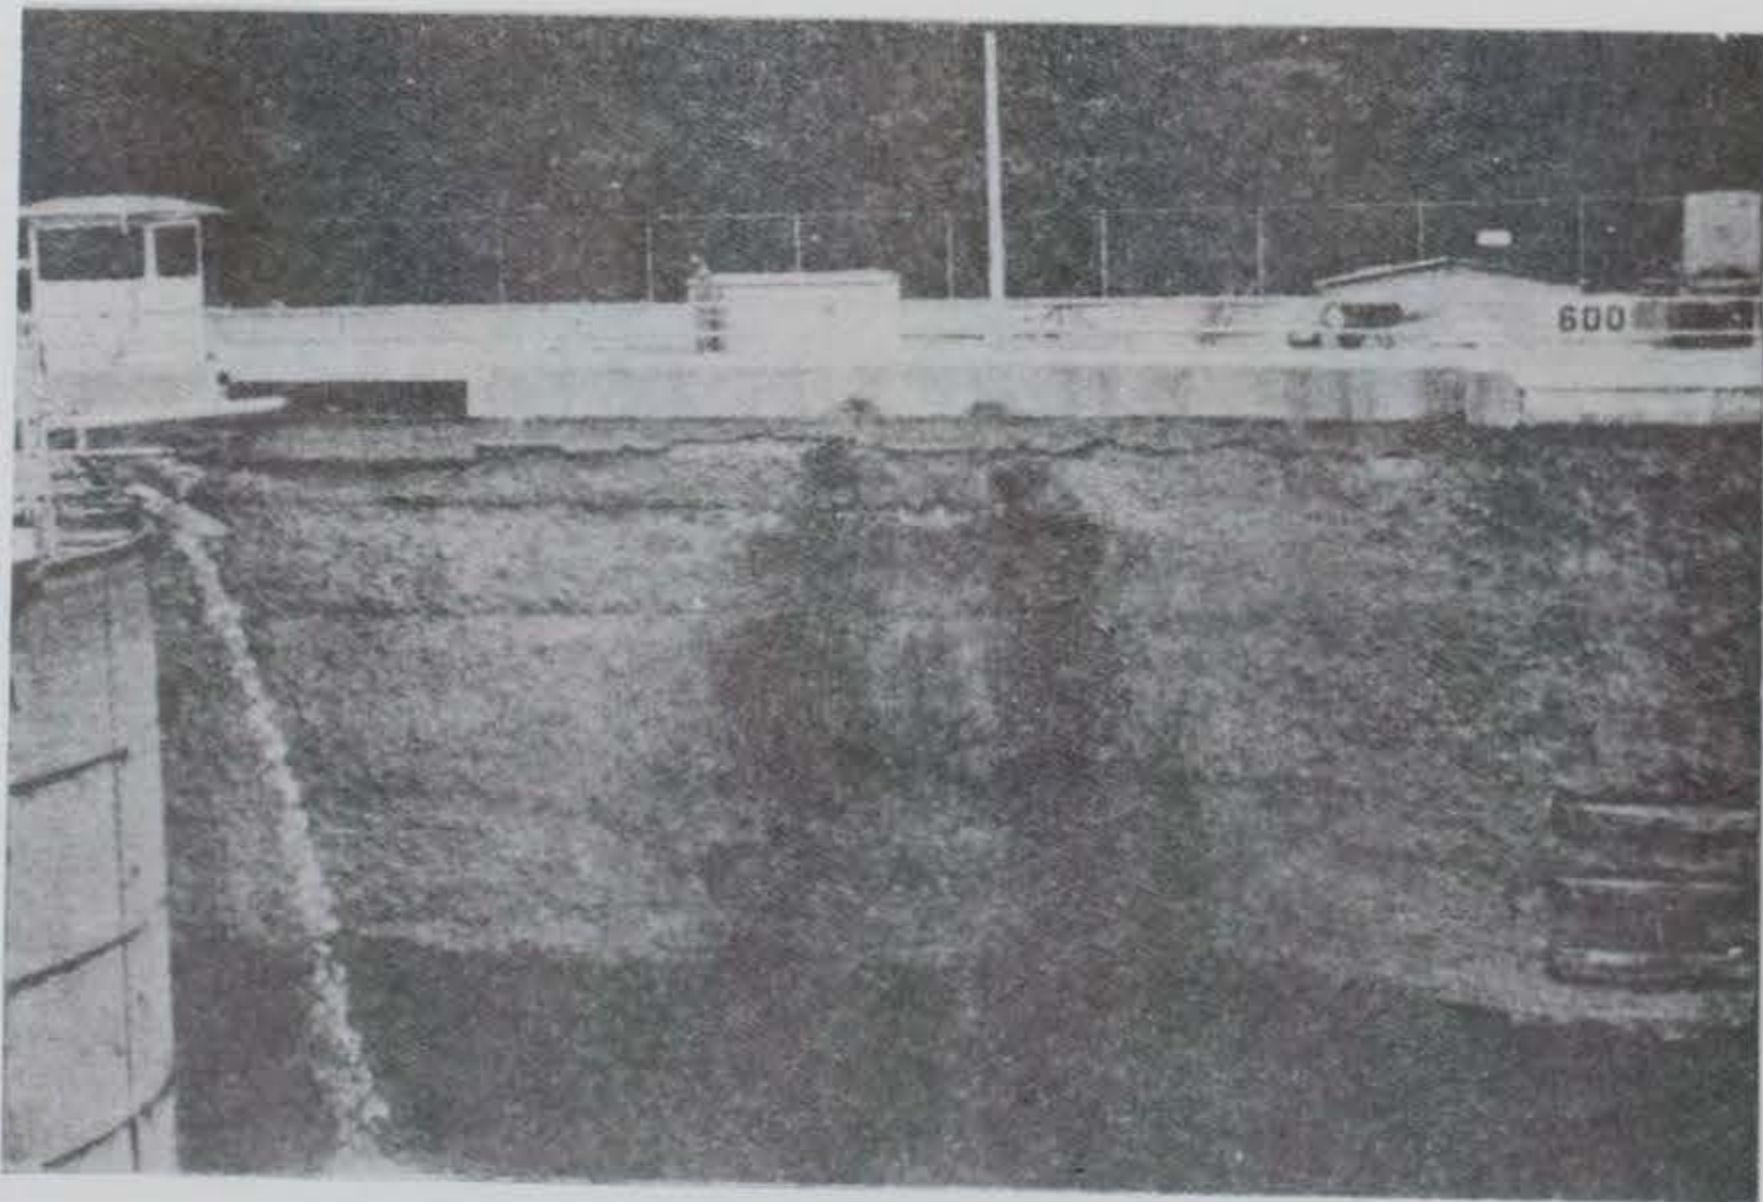
Figure 9. Typical concrete conditions, 1973,  
Marseilles Lock

The maximum depth of erosion (1.10 ft) was measured in a few isolated areas. The surface of a typical monolith (31) is shown in Figure 9, and the results of the survey on the monolith are shown in Figure 10. Erosion of the concrete ranged from slightly above low pool elevation to approximately 2 ft below the top of the wall with the most severe erosion in the upper portion of the walls.
