TECHNICAL REPORT REMR-CS-13

**REHABILITATION OF NAVIGATION  
LOCK WALLS: CASE HISTORIES**

James E. McDonald

December 1987

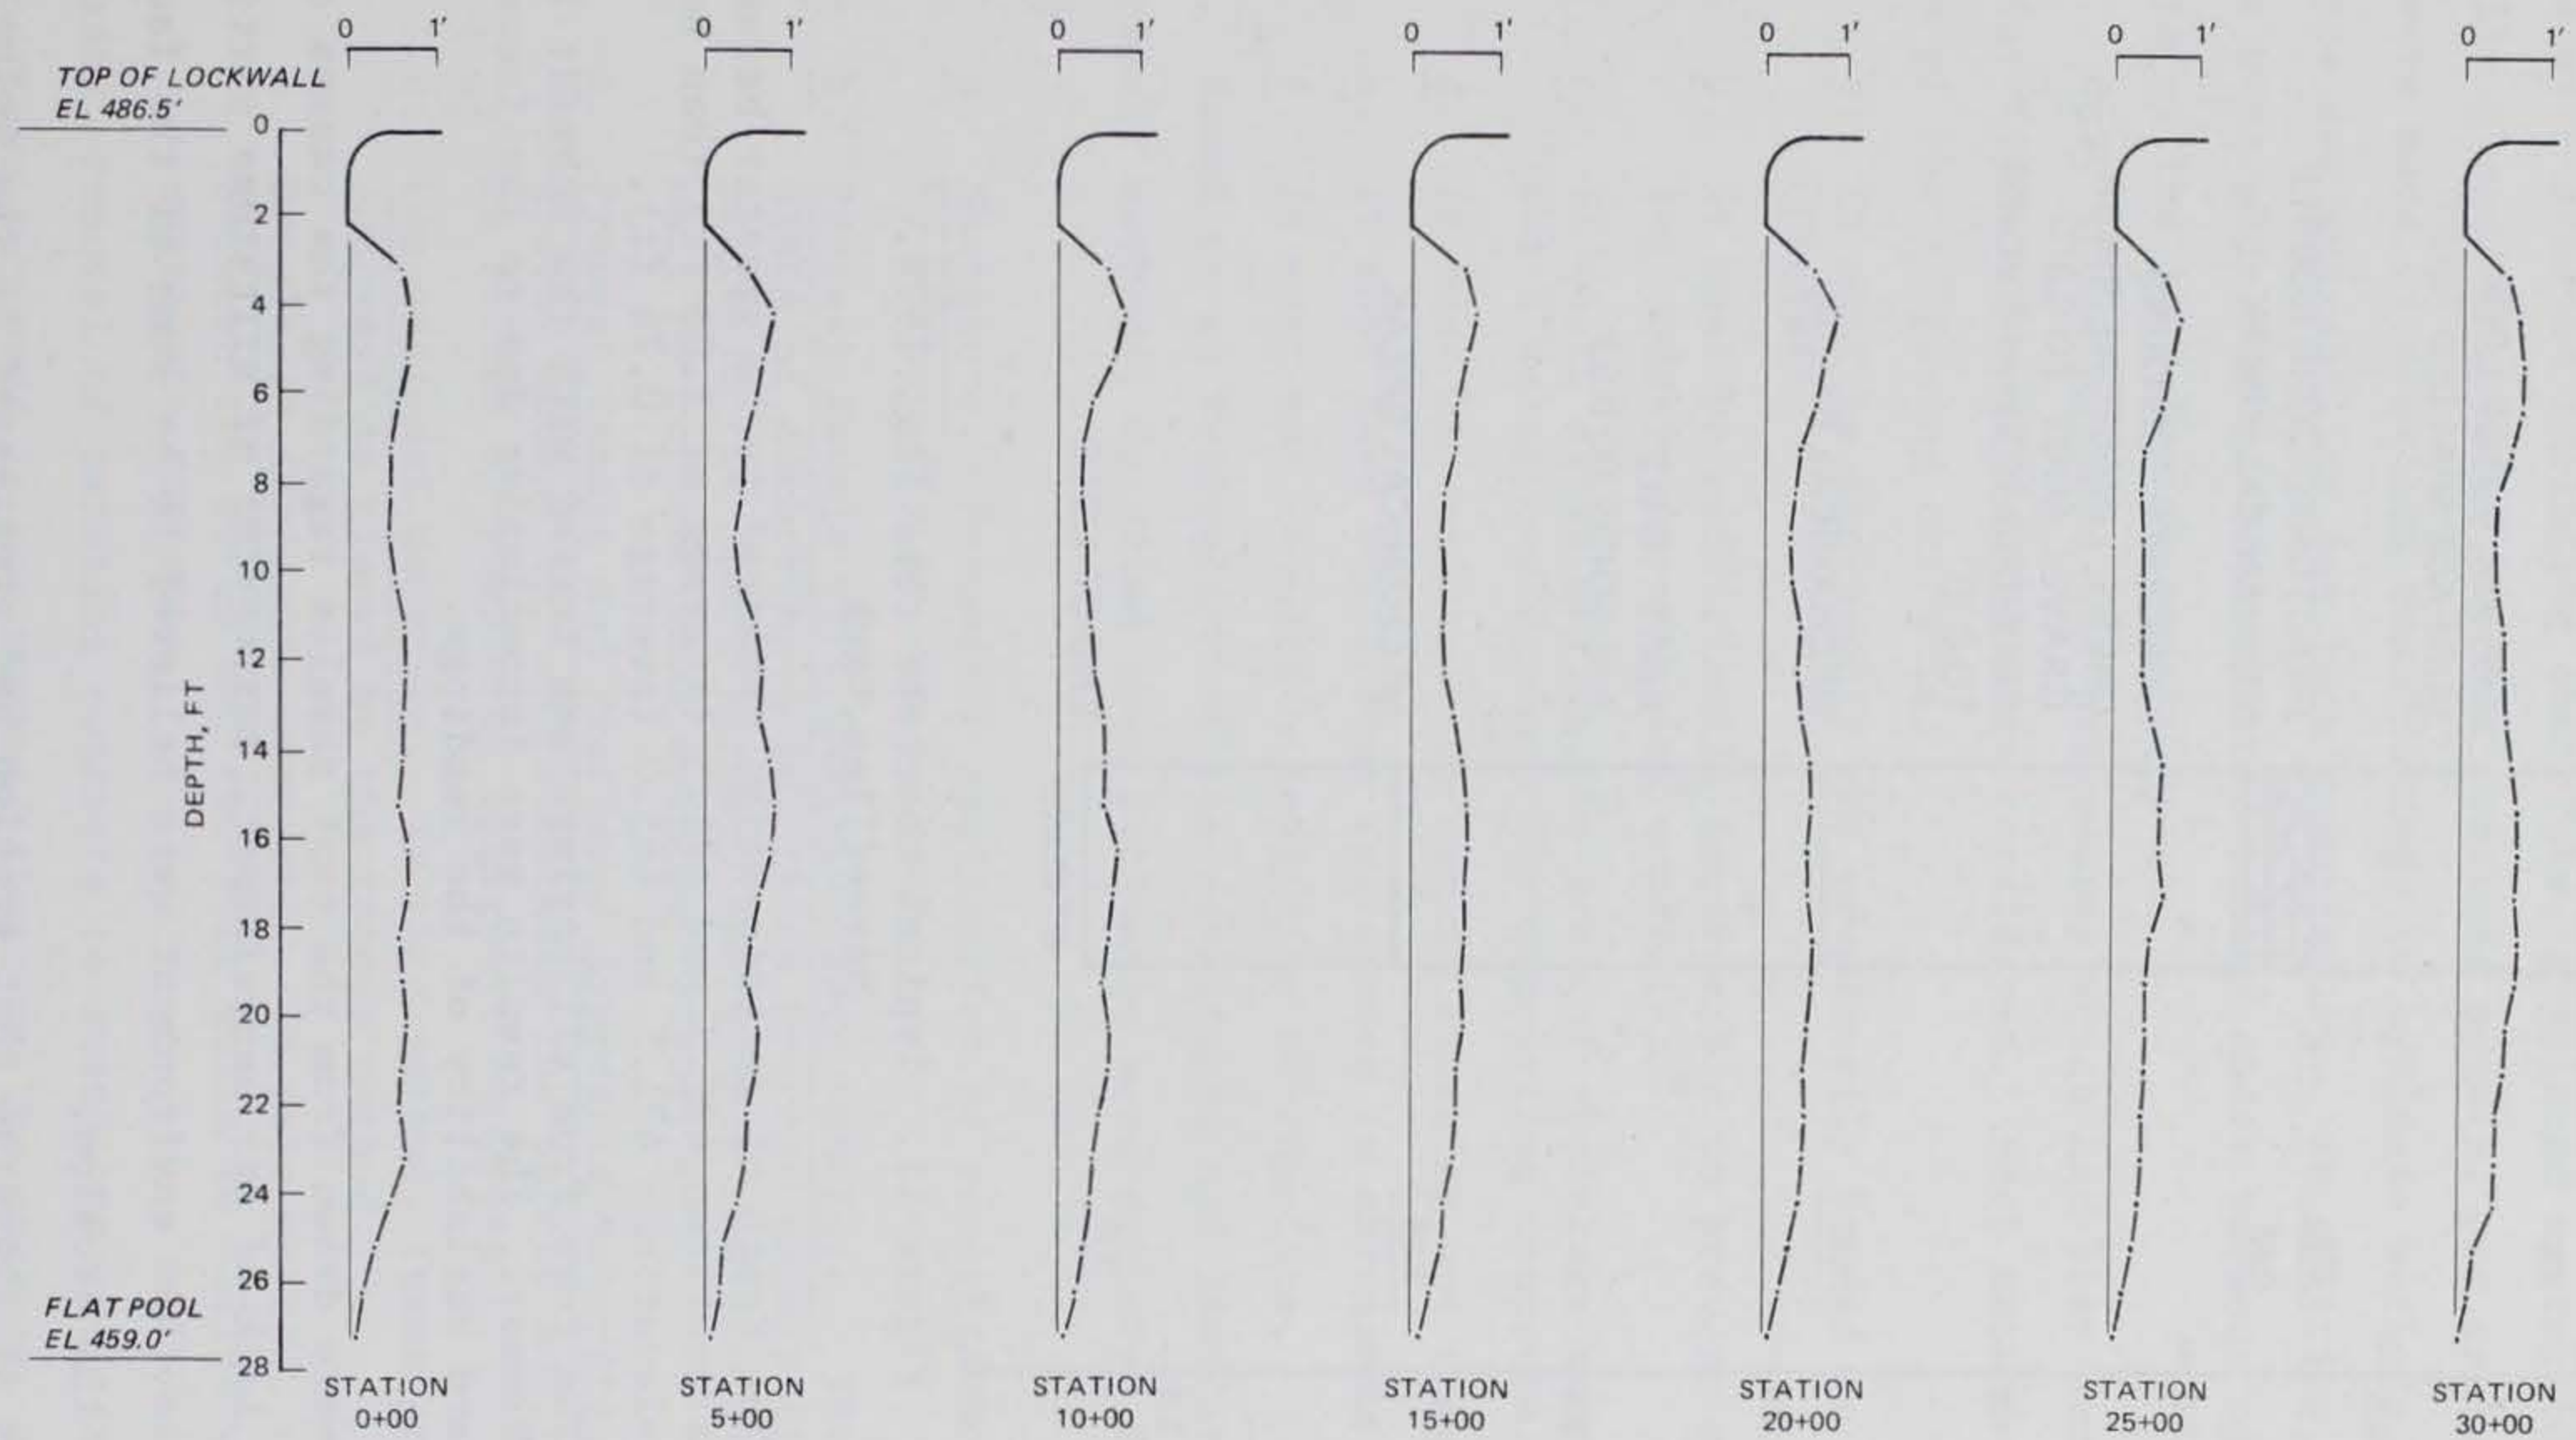
The maximum depth of erosion (1.10 ft) was measured in a few isolated areas. The surface of a typical monolith (31) is shown in Figure 9, and the results of the survey on the monolith are shown in Figure 10. Erosion of the concrete ranged from slightly above low pool elevation to approximately 2 ft below the top of the wall with the most severe erosion in the upper portion of the walls.

Figure 10. Cross section of monolith 31, 1973, Marseilles Lock

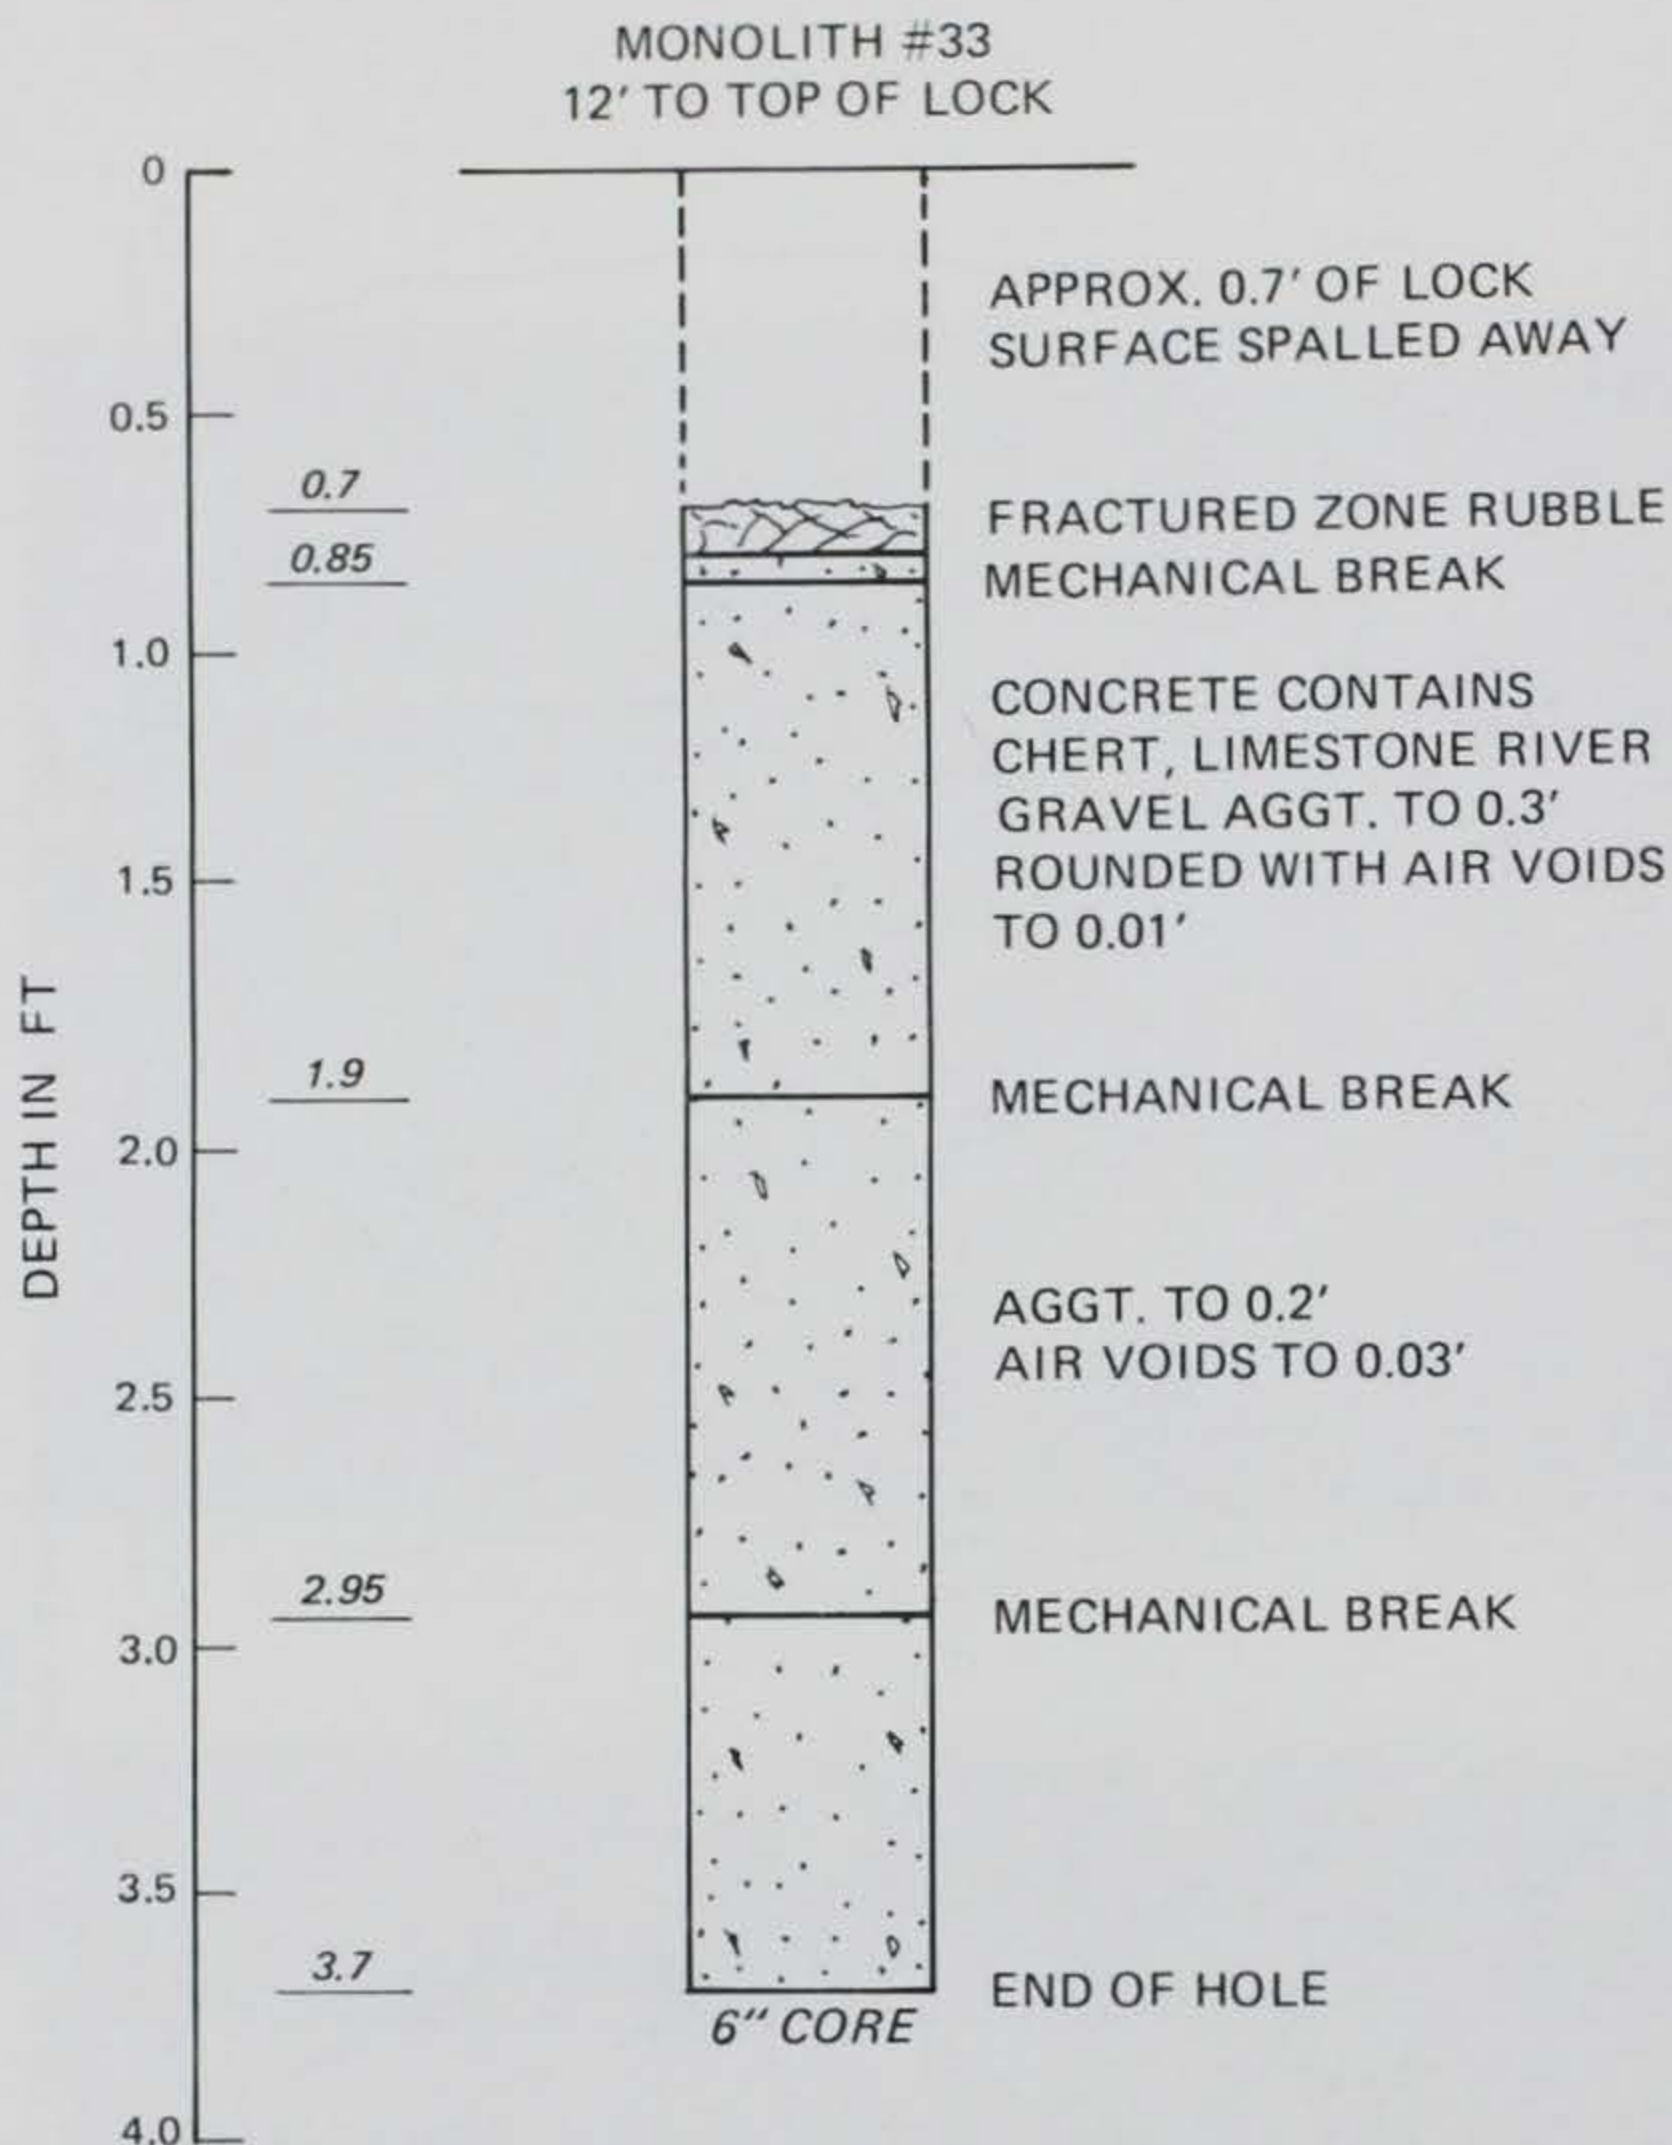
30. A program to assess the quality of the remaining concrete and to establish the depth of deteriorated concrete was also conducted. Six horizontal concrete cores, 6-in. diameter by about 3 ft long, were obtained from each wall and tested at the Ohio River Division Laboratory (Chicago District 1974). A typical log of the concrete core is shown in Figure 11. Specimens for compressive strength tests were taken from those portions of the cores located a minimum of 0.7 ft behind the existing face of the wall. Compressive strengths ranged from 5,070 to 7,760 psi with the average of nine tests being 6,440 psi. No increase in strength was noted with increasing depth; in fact, the deeper test specimens generally exhibited lower compressive strengths. Depth of fracturing in the concrete, as determined by petrographic examination, ranged from 0.1 to 1.1 ft with an average depth of 0.5 ft. Other observations based on the petrographic examination are summarized in the following:

- e. The series of fractures parallel to the lock wall surface which were present in the top portion of each boring appeared to be due to freeze-thaw action.

- h. The concrete contained no entrained air.

Figure 11. Typical concrete core log, 1974, Marseilles Lock

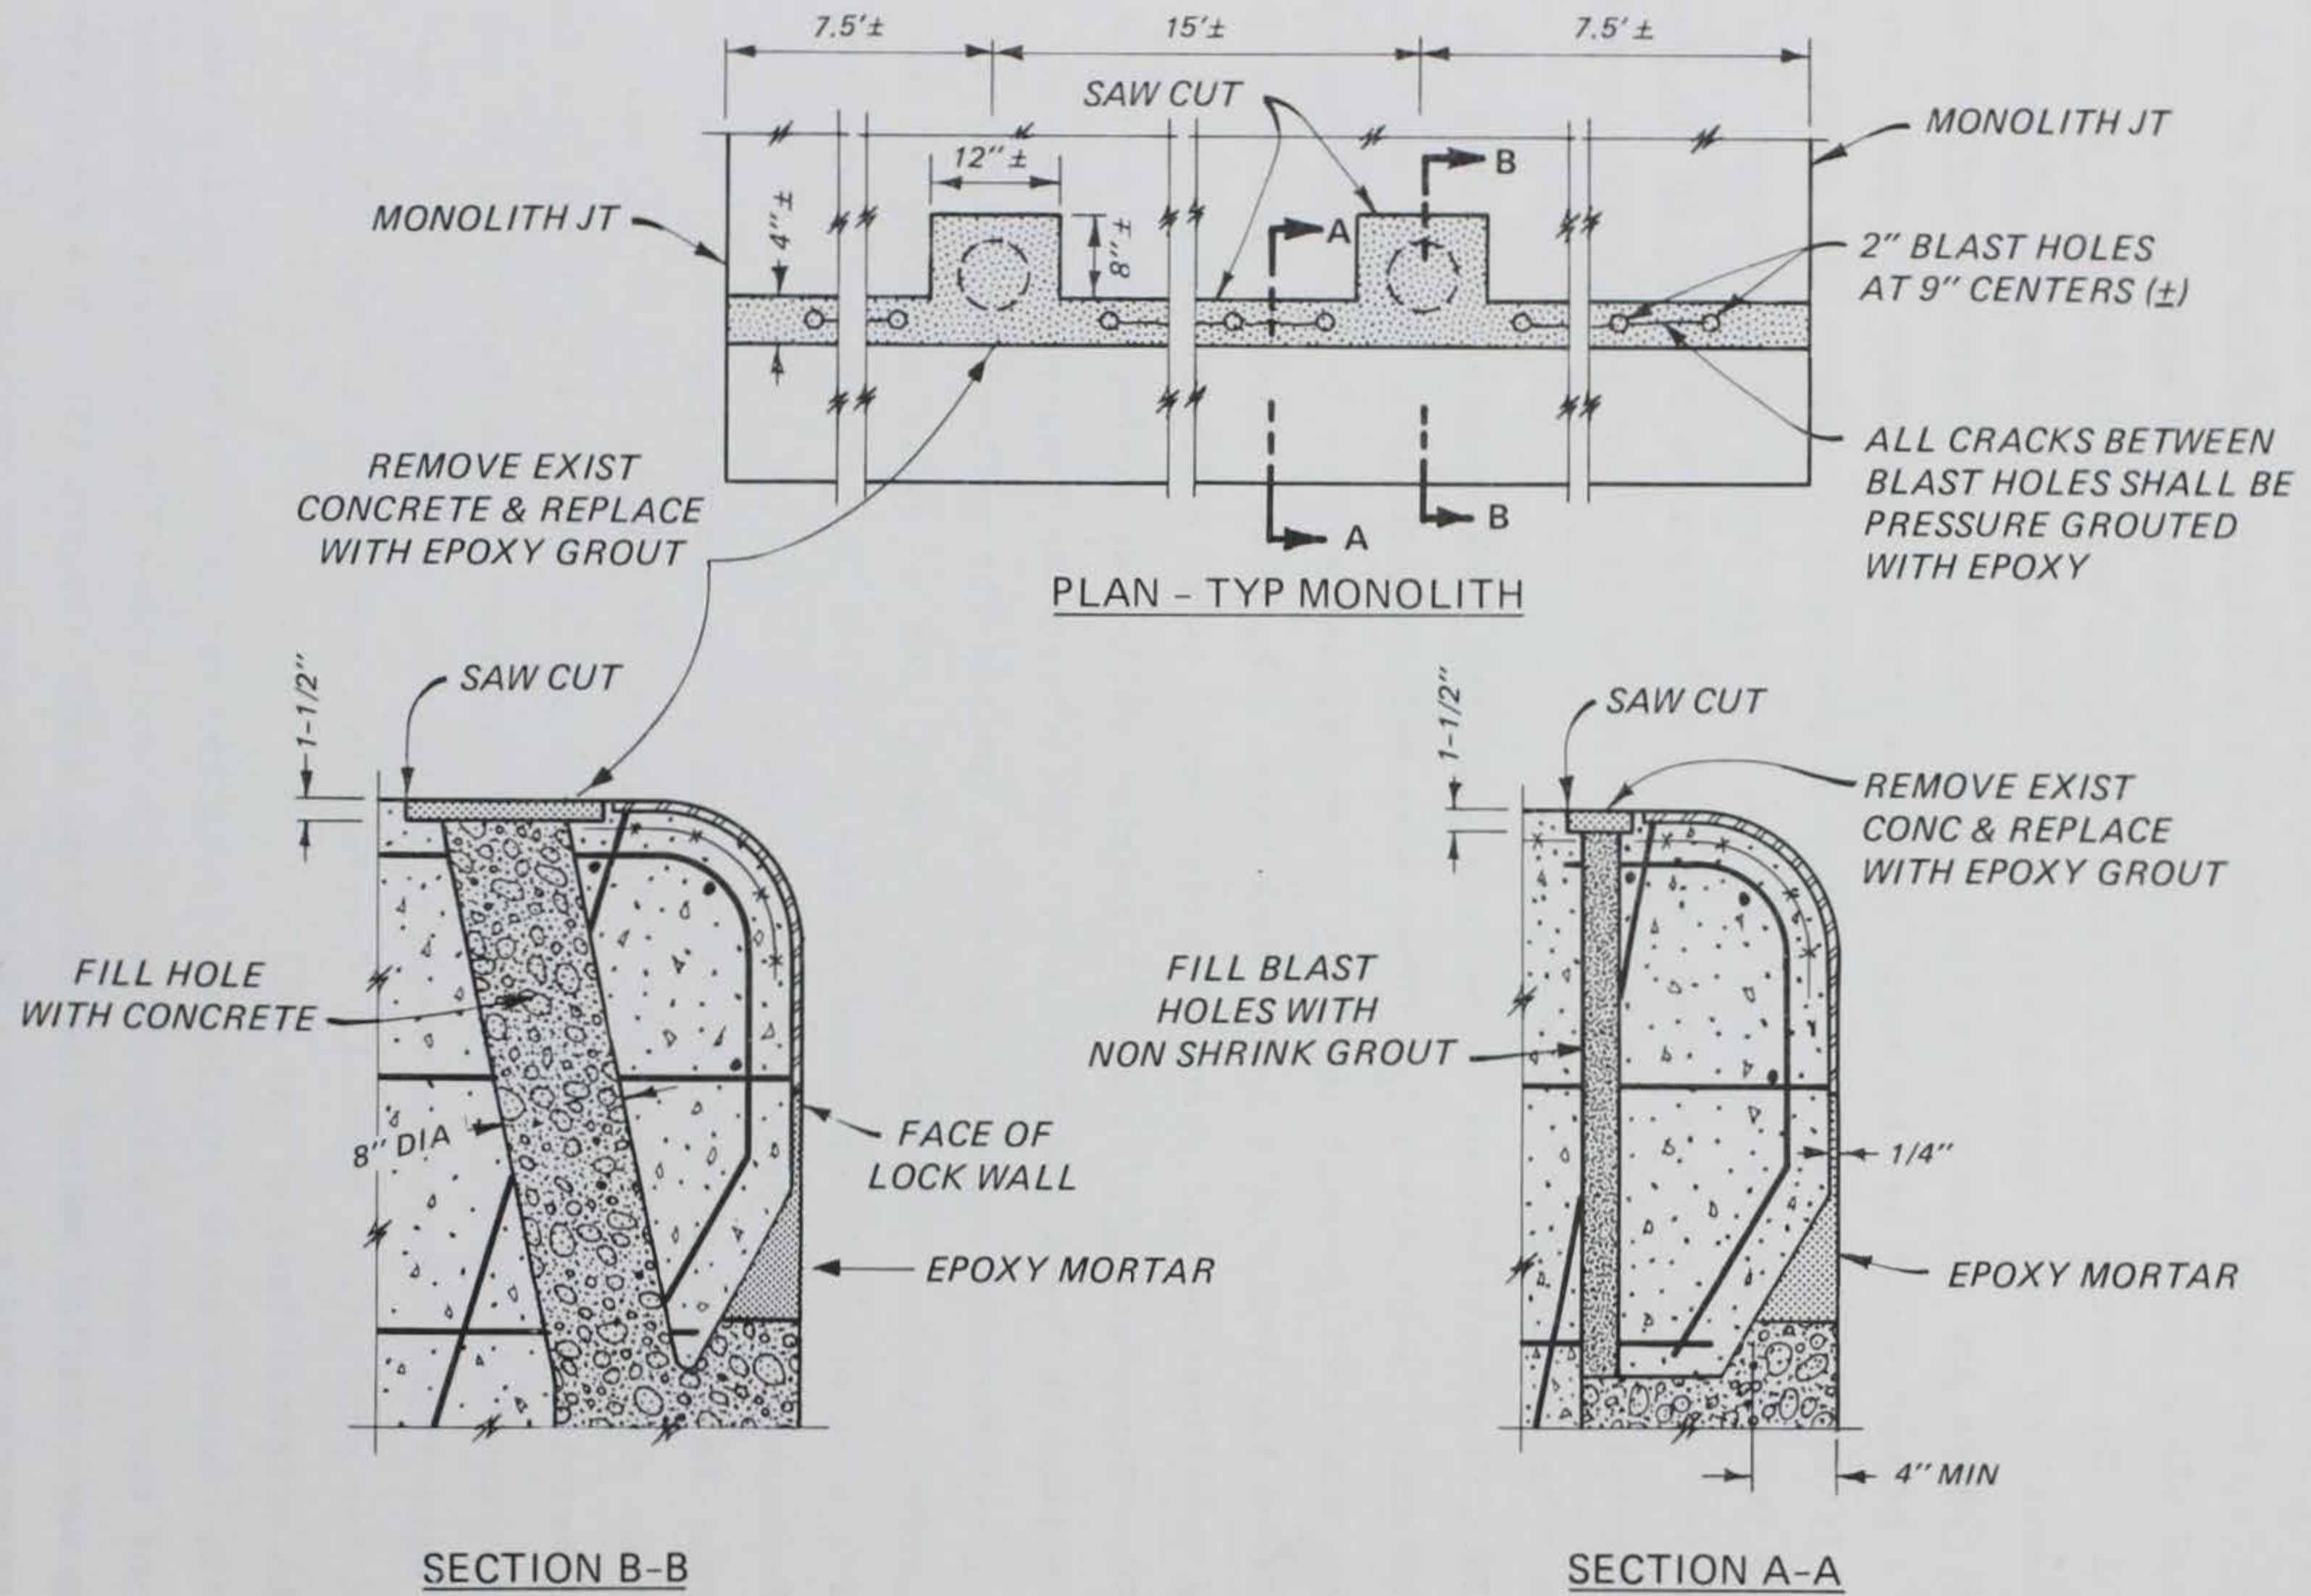
Figure 13. Resurfacing details, Marseilles Lock

41. Corner armor previously installed was left in place during resurfacing of the chamber walls. Blast holes and holes for concrete placement by pumping were drilled behind the existing armor (Figure 13). The replacement concrete was placed to the underside of the resulting overhang. The cavity between the new concrete and the existing concrete was filled with epoxy

mortar. Tremie holes and blast holes were filled with nonshrink grout and were topped with a layer of epoxy mortar. The cracks that resulted from the blasting operations were pressure grouted with epoxy. Below the top of the wall, resurfacing details were the same as for Dresden Island.

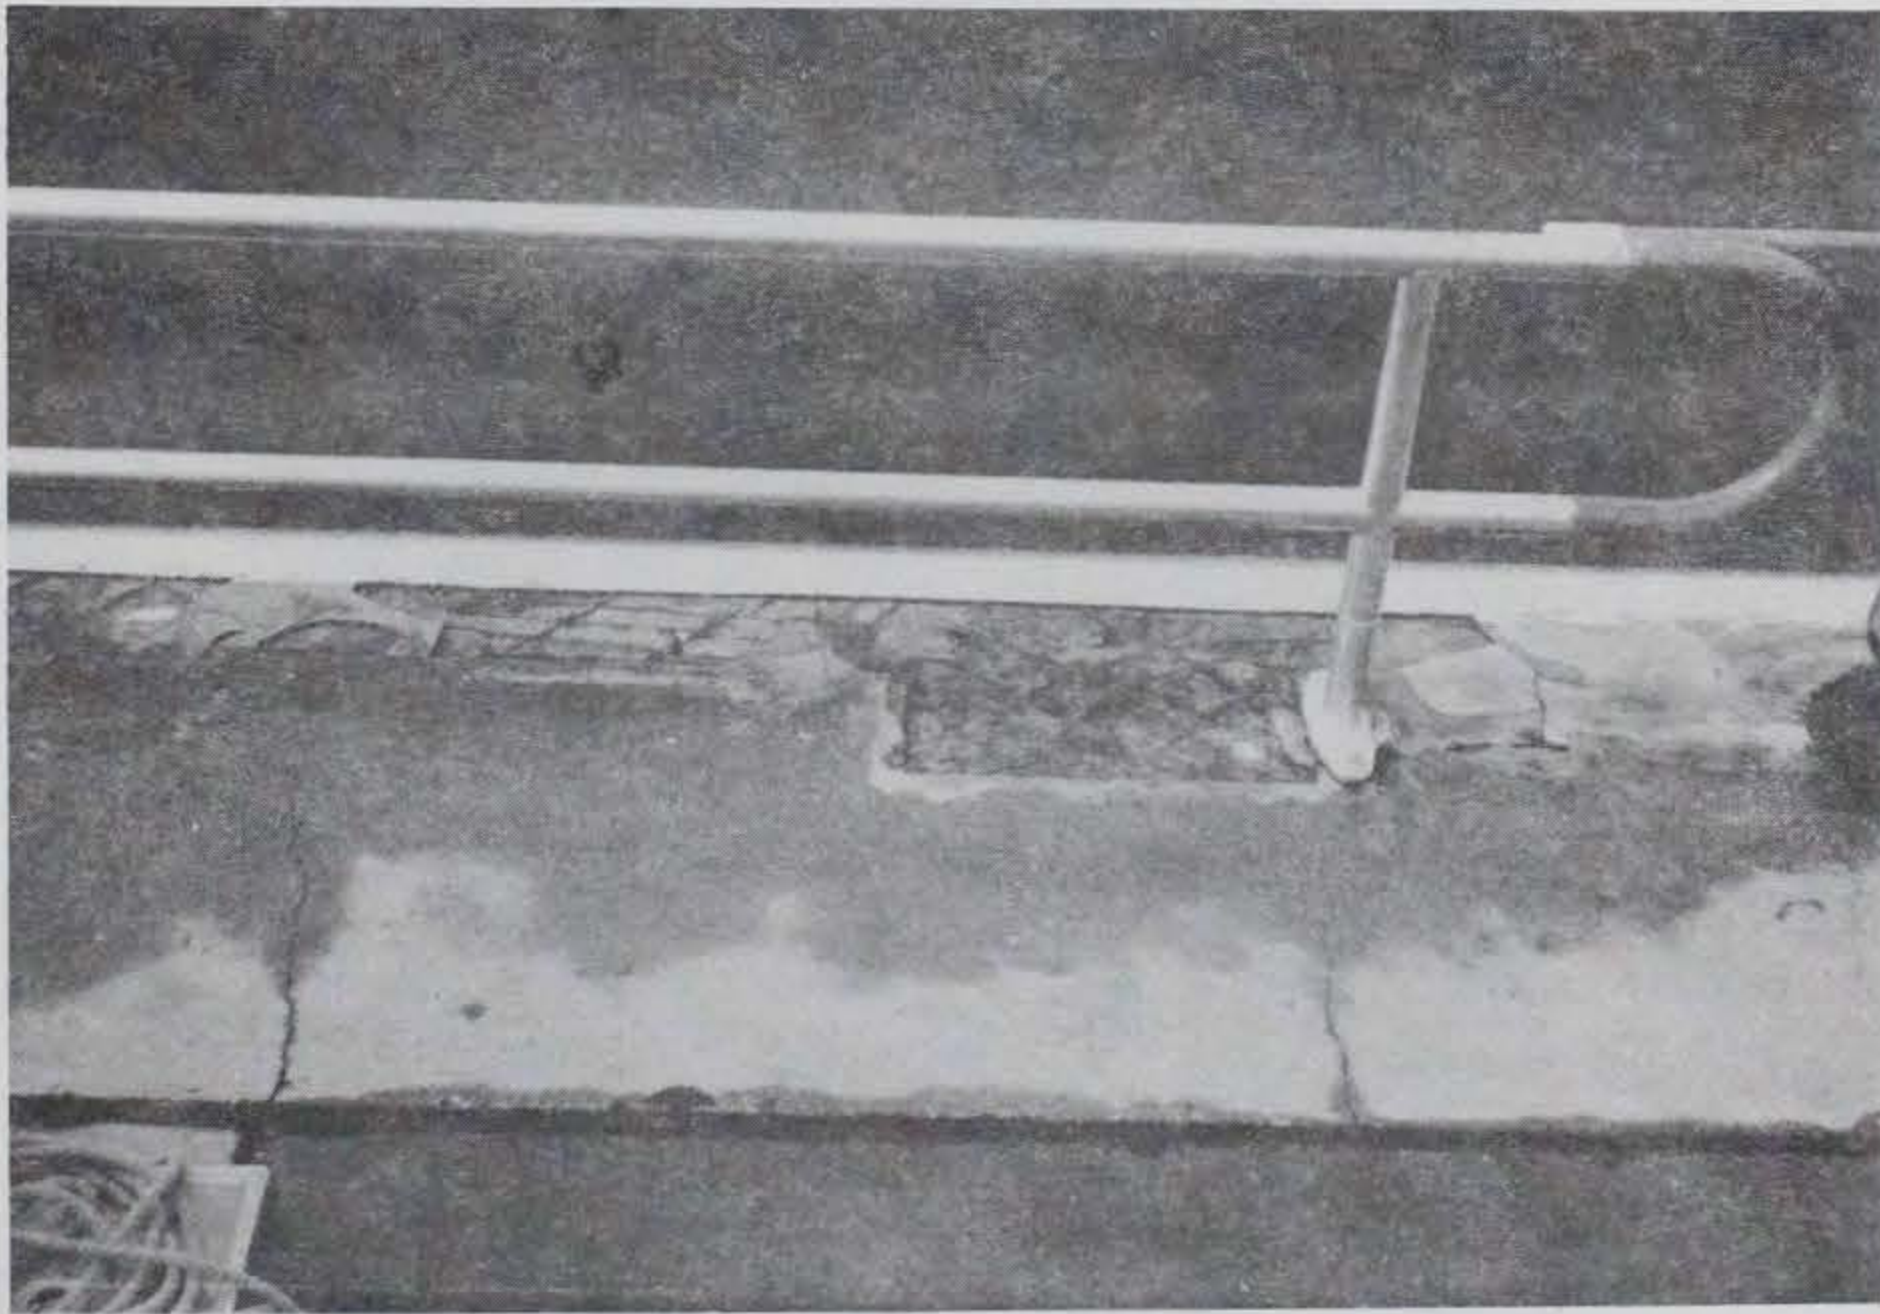
43. The epoxy layer at the top of the lock also delaminated (Figure 15). A large percentage of the epoxy overlay has spalled off, is cracked, or has disintegrated. A large thermal coefficient of expansion of the epoxy mortar as compared to that of the concrete is the most likely cause of failure.

Figure 15. Typical delamination of epoxy overlay, May 1985,  
Marseilles Lock

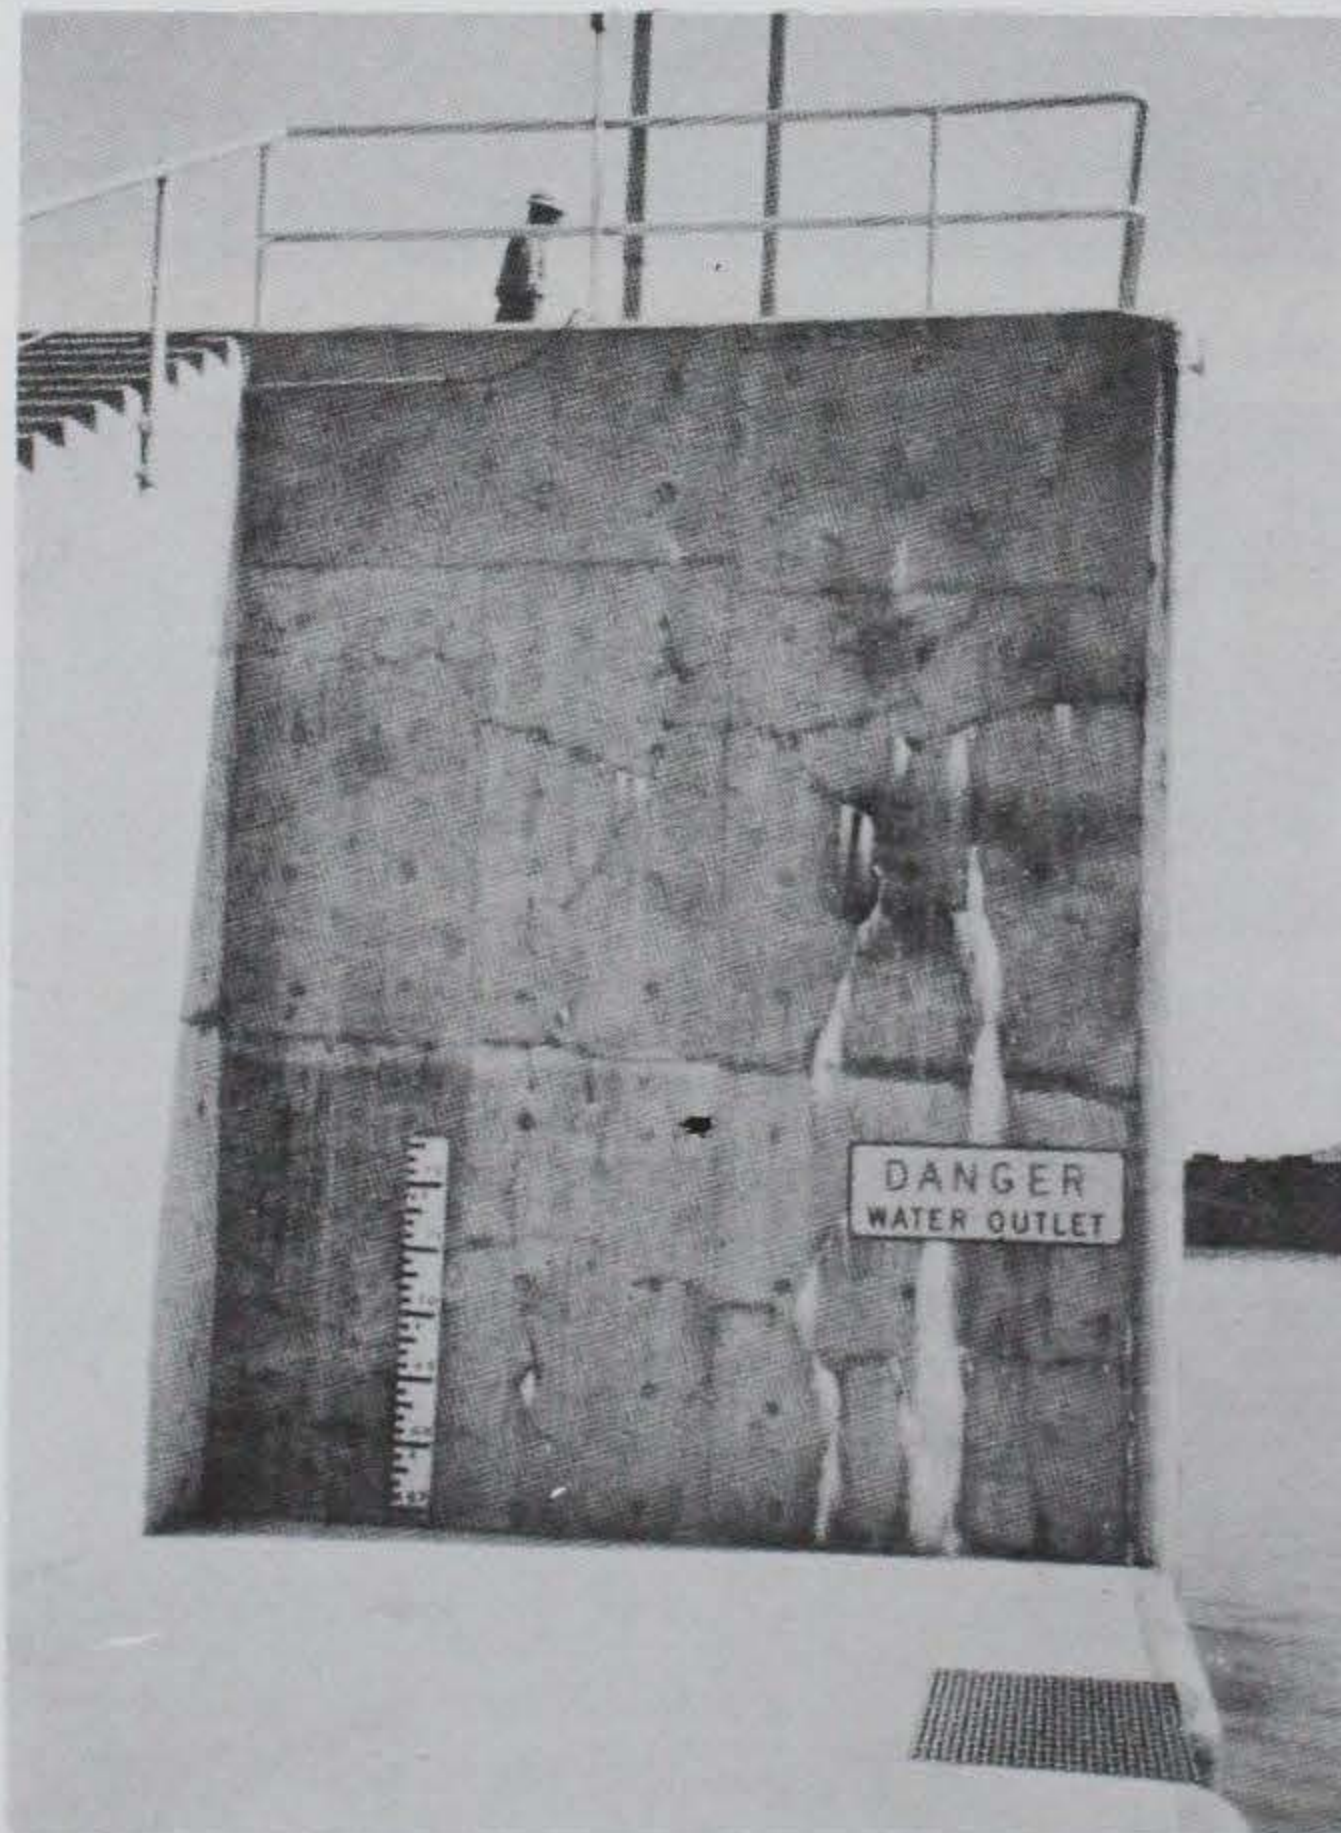
- (1) The top surface of the concrete in the upper right emergency gate bay monolith is moderately scaled. The upstream right gate monolith has reflective cracks that are typical of all resurfaced gate monoliths. There are weeds growing out of the monolith joint next to the downstream right service gate.
- (2) The sidewalk adjacent to the right lock wall monoliths has subsided. According to the lockmaster, Walt Gatza, the problem began with dewatering of the lock chamber for rehabilitation work. Mud jacking was undertaken in 1978 to raise the slabs, but the problem remains.
- (3) The lock chamber walls are generally in good condition, although there is some minor cracking and occasional epoxy spalled out on the top edges.
- (4) The downstream vertical faces of monoliths 55 and 56, resurfaced in 1978, have large shrinkage cracks and some leaching (Figure 16).

Figure 16. Cracking in downstream face of monolith 55, September 1982, Marseilles Lock

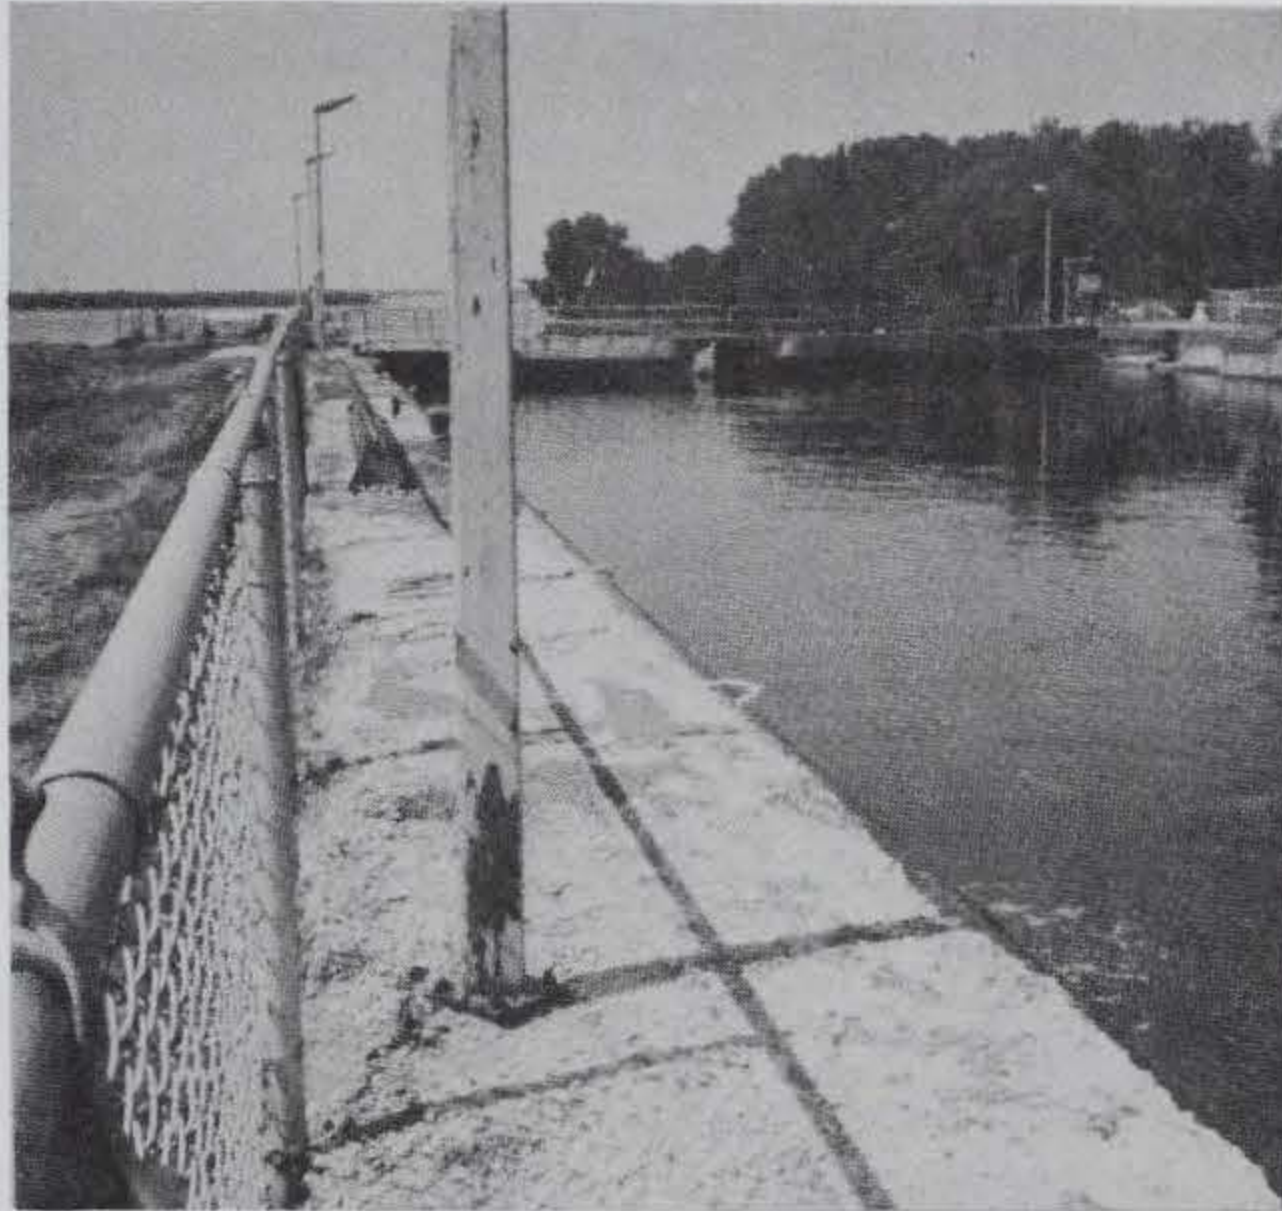
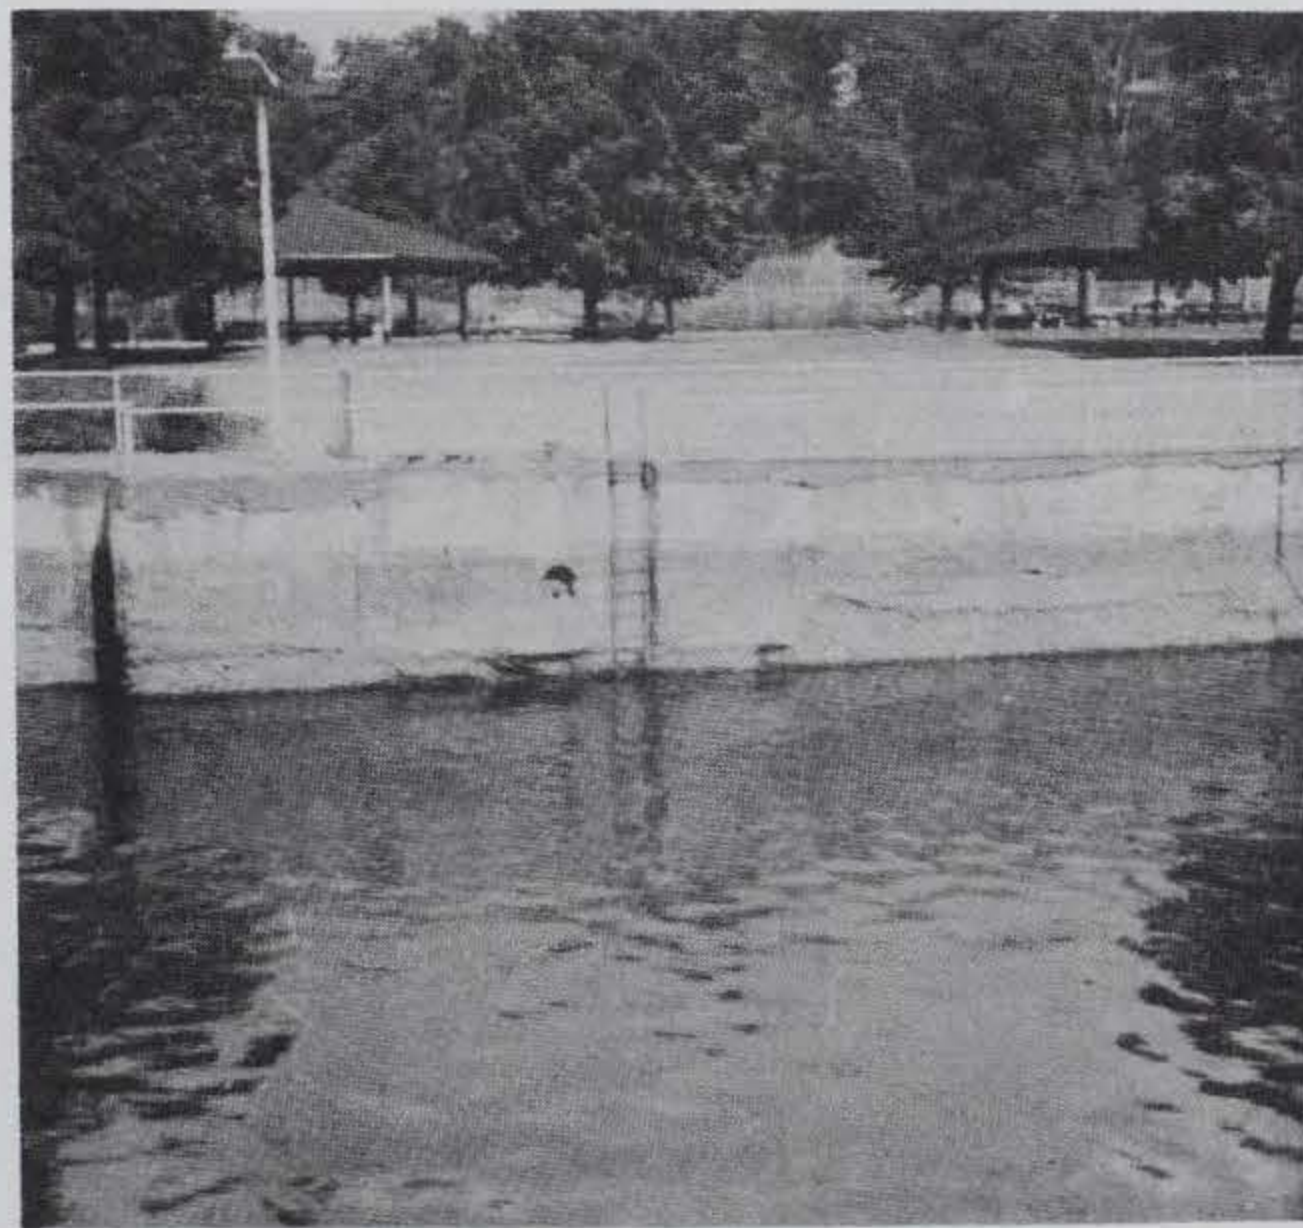
Figure 18. Typical concrete deterioration, 1977, Old Lock No. 14, Mississippi River

- c. The concrete in the top of the riverside wall was deteriorated to a depth of about 10 in. The 6-in. concrete cap on the landside wall was in good condition; however the concrete beneath the cap was deteriorated to a depth of about 12 in. The downstream gate monolith on the riverside wall exhibited a similar condition (Figure 19). The depth of deterioration on vertical surfaces ranged from 2 to 7 in.

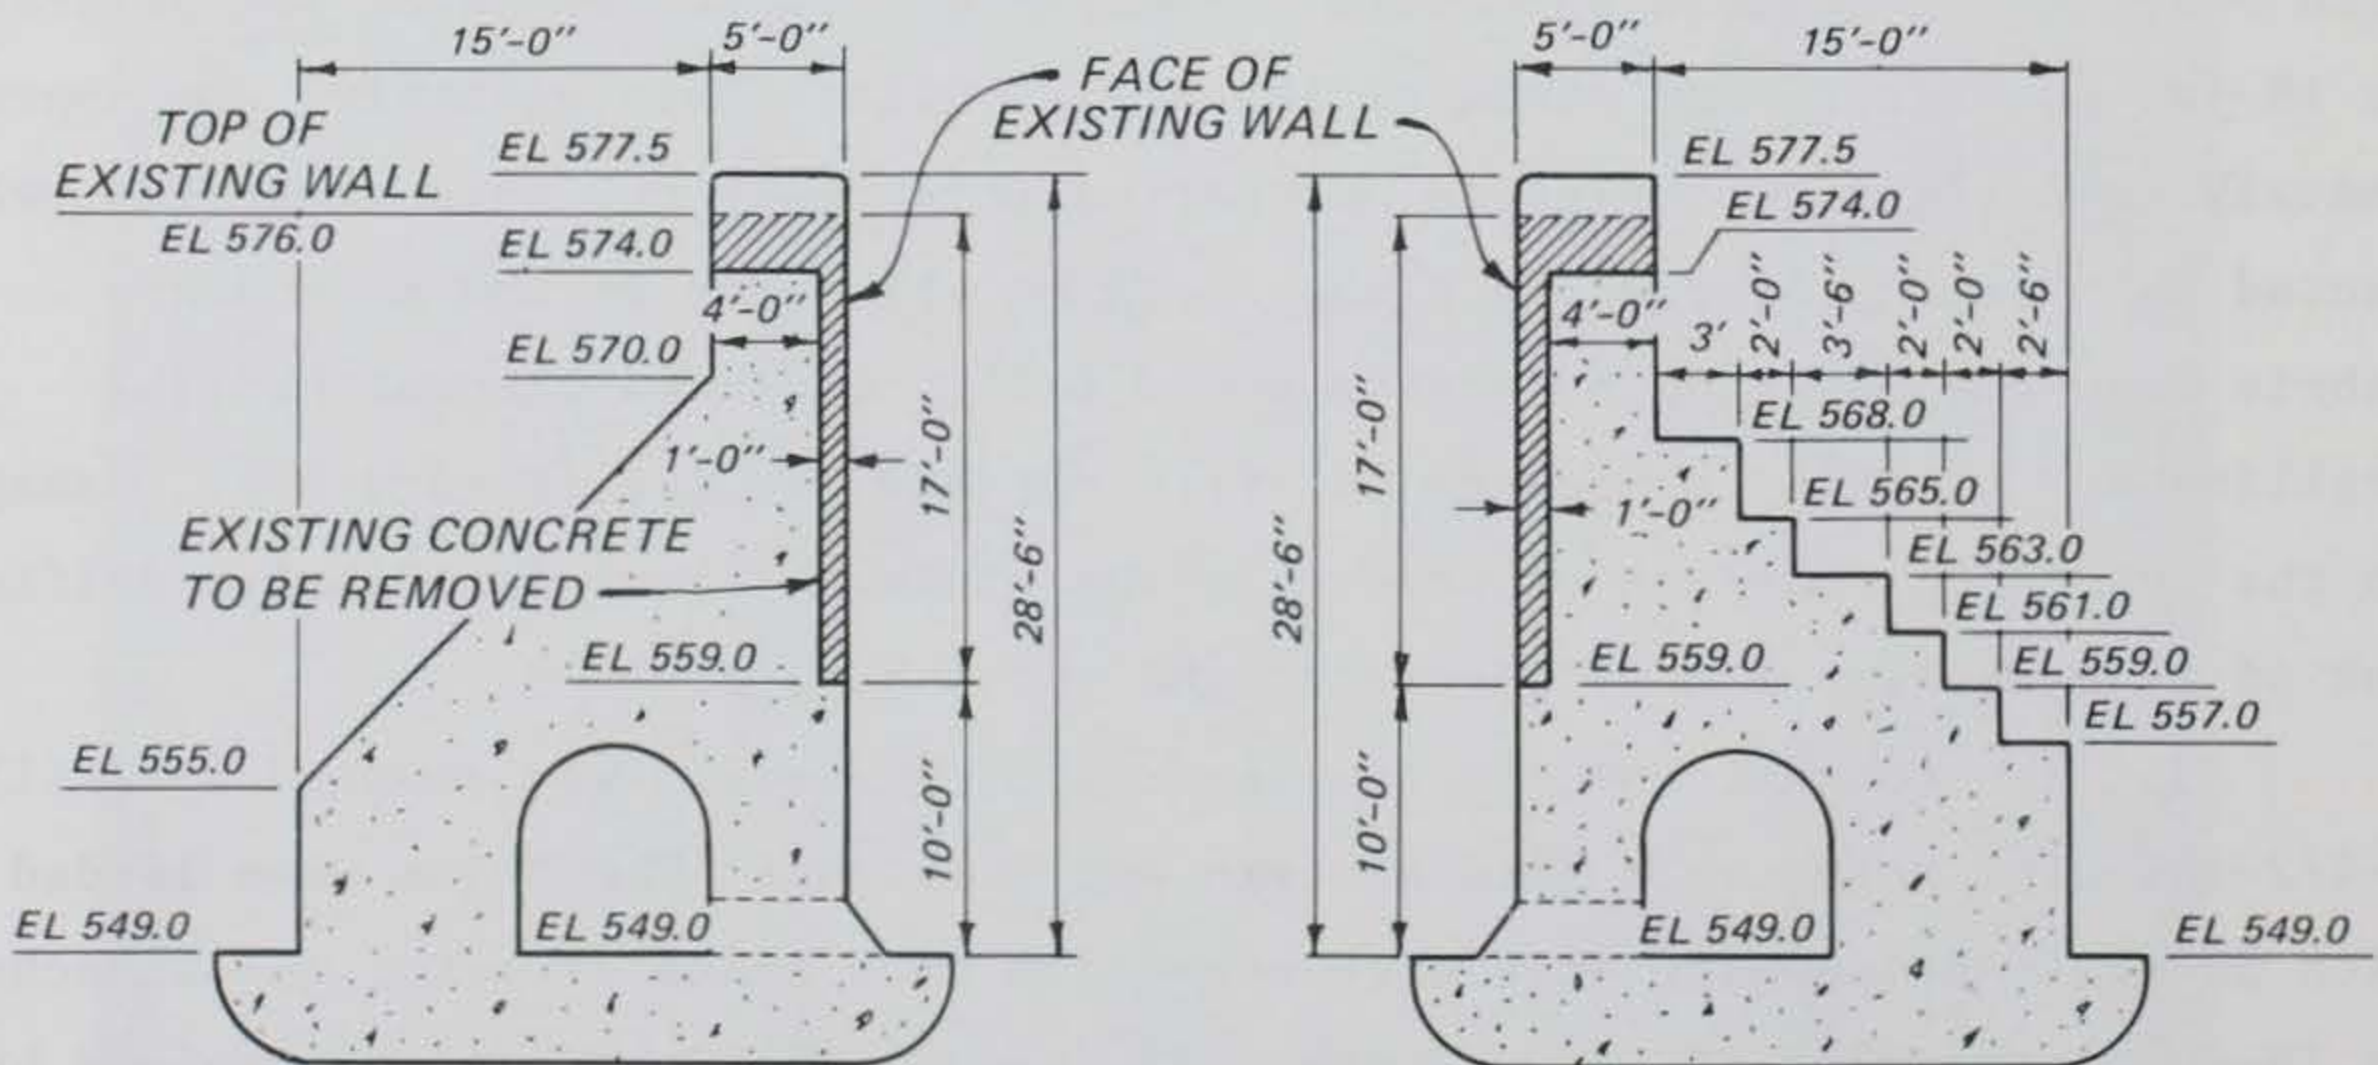
Figure 21. Typical sections showing extent of concrete removal and replacement, Old Lock No. 14, Mississippi River

51. Concrete deterioration on vertical surfaces was generally confined to those areas of the lock walls above low water level (Figure 20). Therefore, concrete removal and replacement was confined to the top 17 ft of the walls except for the outer gate monoliths where extensive concrete removal was necessary to accommodate new gates and operating machinery (Rock Island District 1980). Twelve inches of concrete was removed from the vertical face of the walls, and two feet of concrete was removed from the top of the walls (Figure 21).
