TECHNICAL REPORT REMR-CS-13

**REHABILITATION OF NAVIGATION  
LOCK WALLS: CASE HISTORIES**

James E. McDonald

December 1987

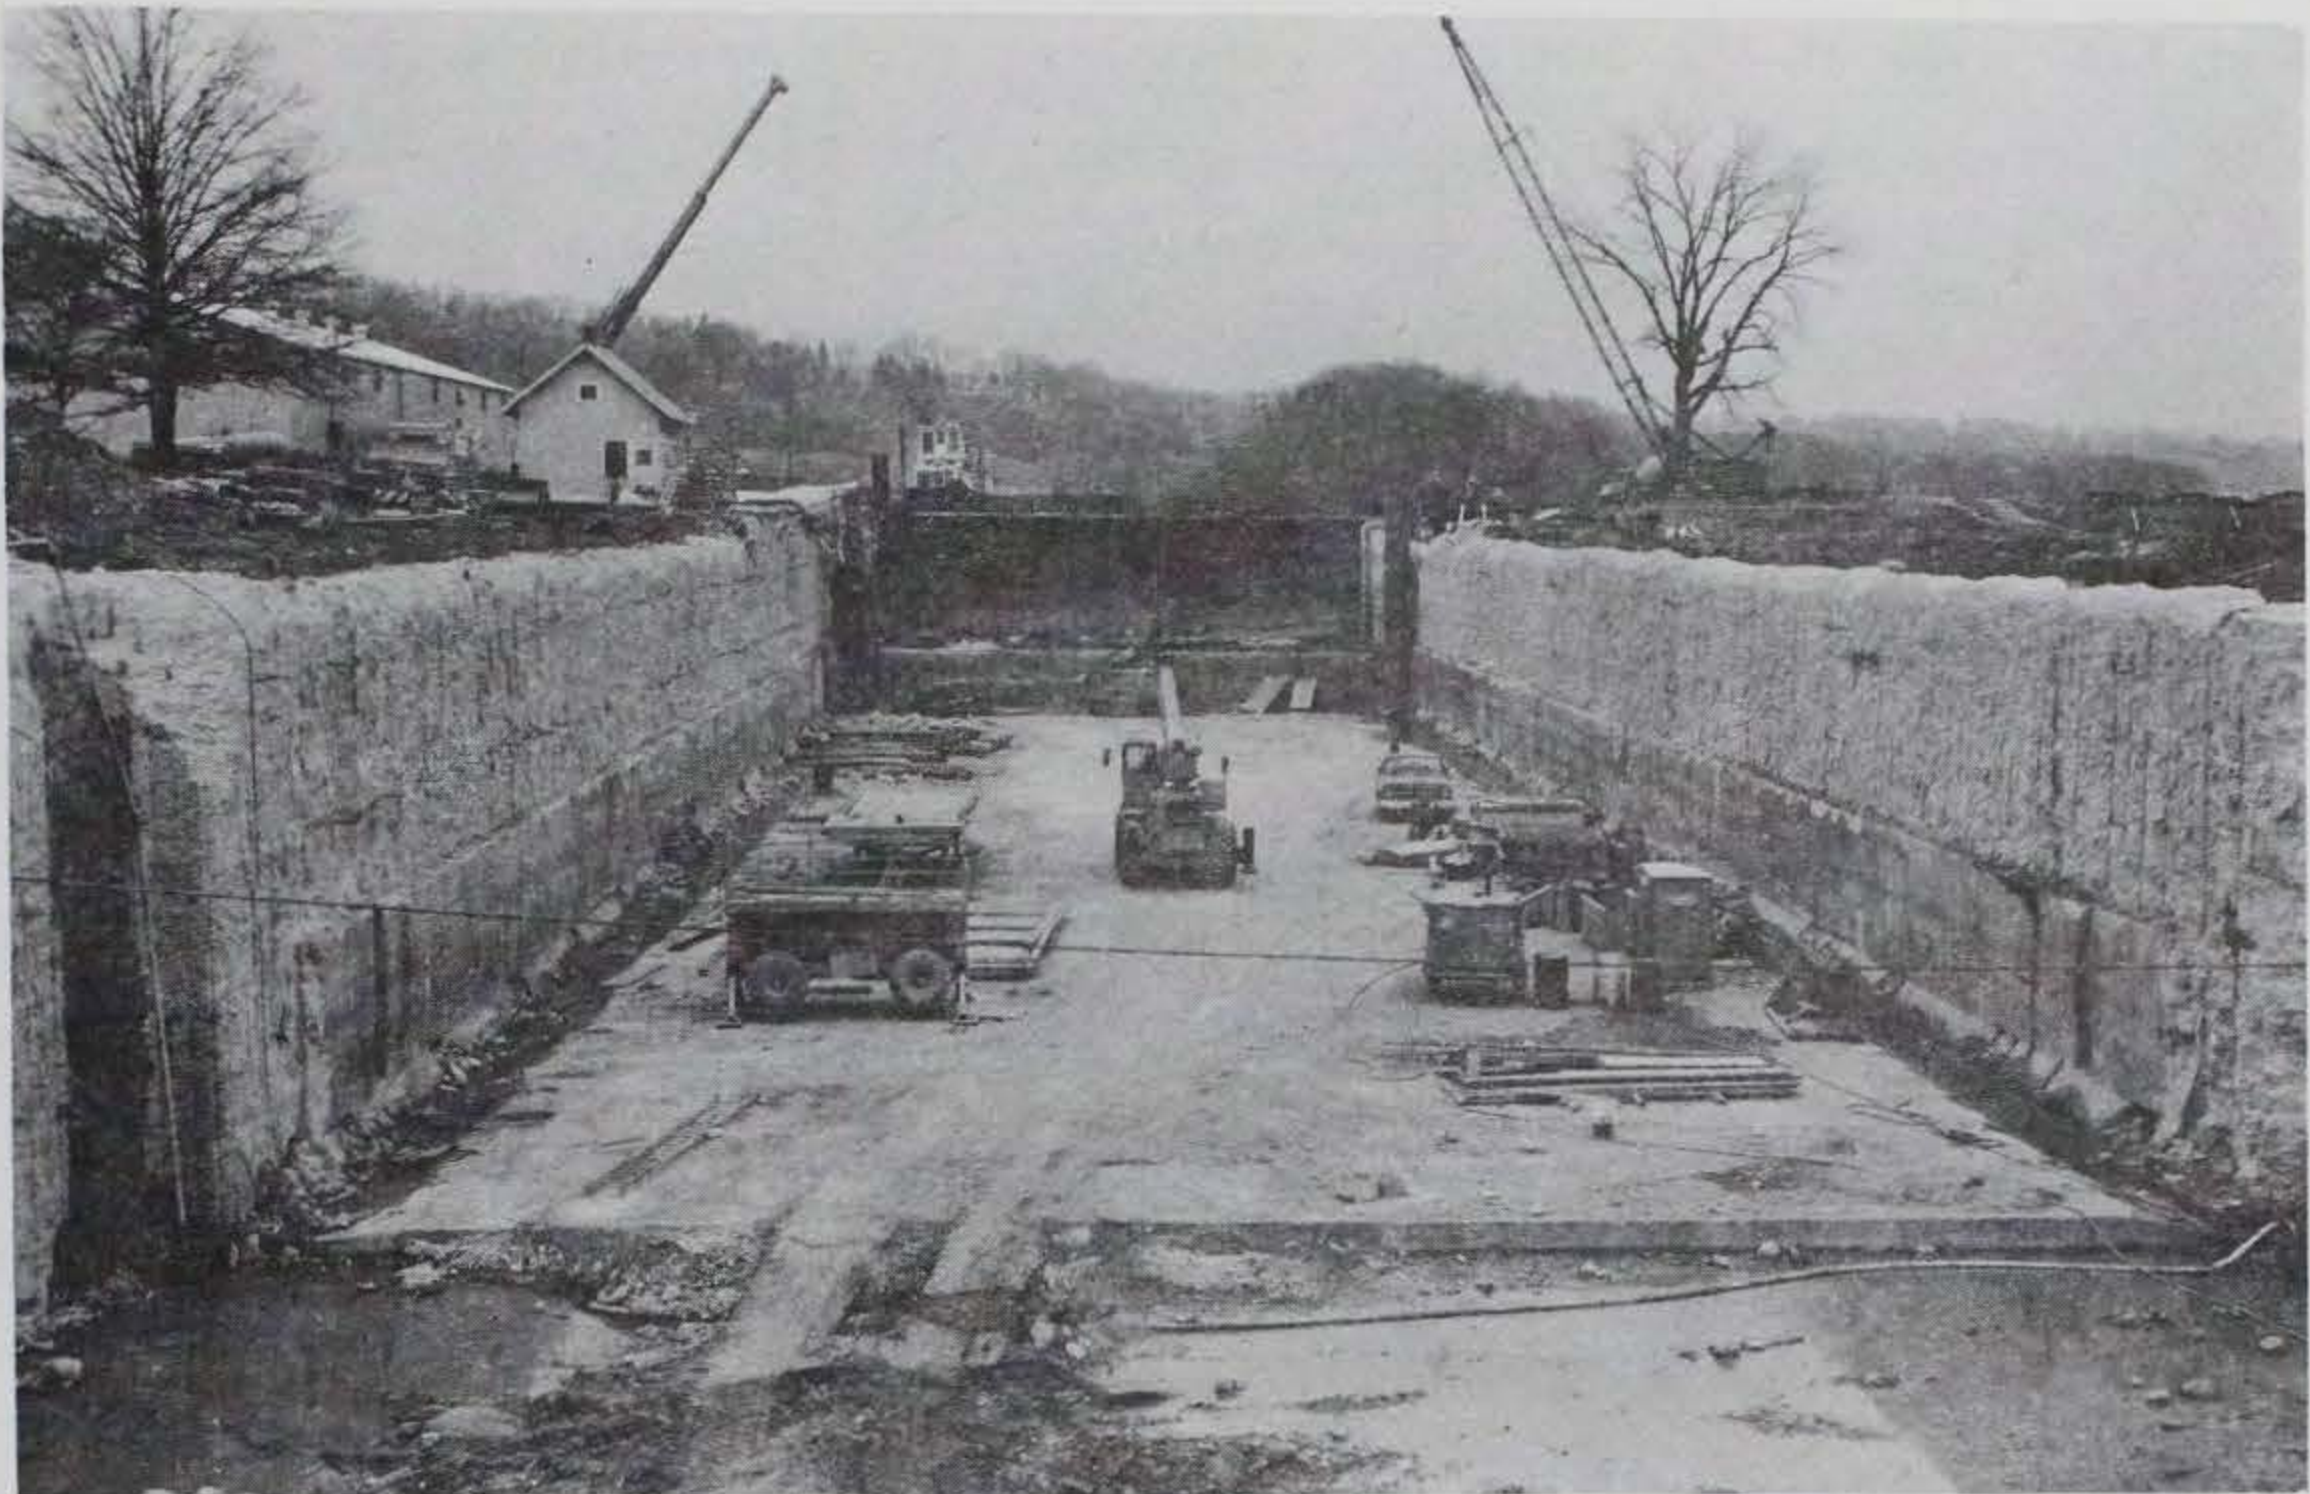
Figure 22. Lock walls following removal of deteriorated concrete, April 1980, Old Lock No. 14, Mississippi River

52. Removal of the concrete on the vertical face of the walls was accomplished by line drilling 2-1/2-in.-diam holes on 12-in. centers, loading with 50-grain detonating cord with one-fifth of a stick of water gel attached at 18-in. intervals, and stemming the entire hole. This explosive was approximately equivalent to 600-grain detonating cord. The new lock floor was protected from damage by placing timber mats on the floor in the area where debris from the blasting operation would fall. Concrete removal by line drilling and blasting proved to be efficient and precise (Figure 22). Damage to the remaining portions of the walls was minimal. Some drill holes drifted out of alignment, but most were straight and accurate.

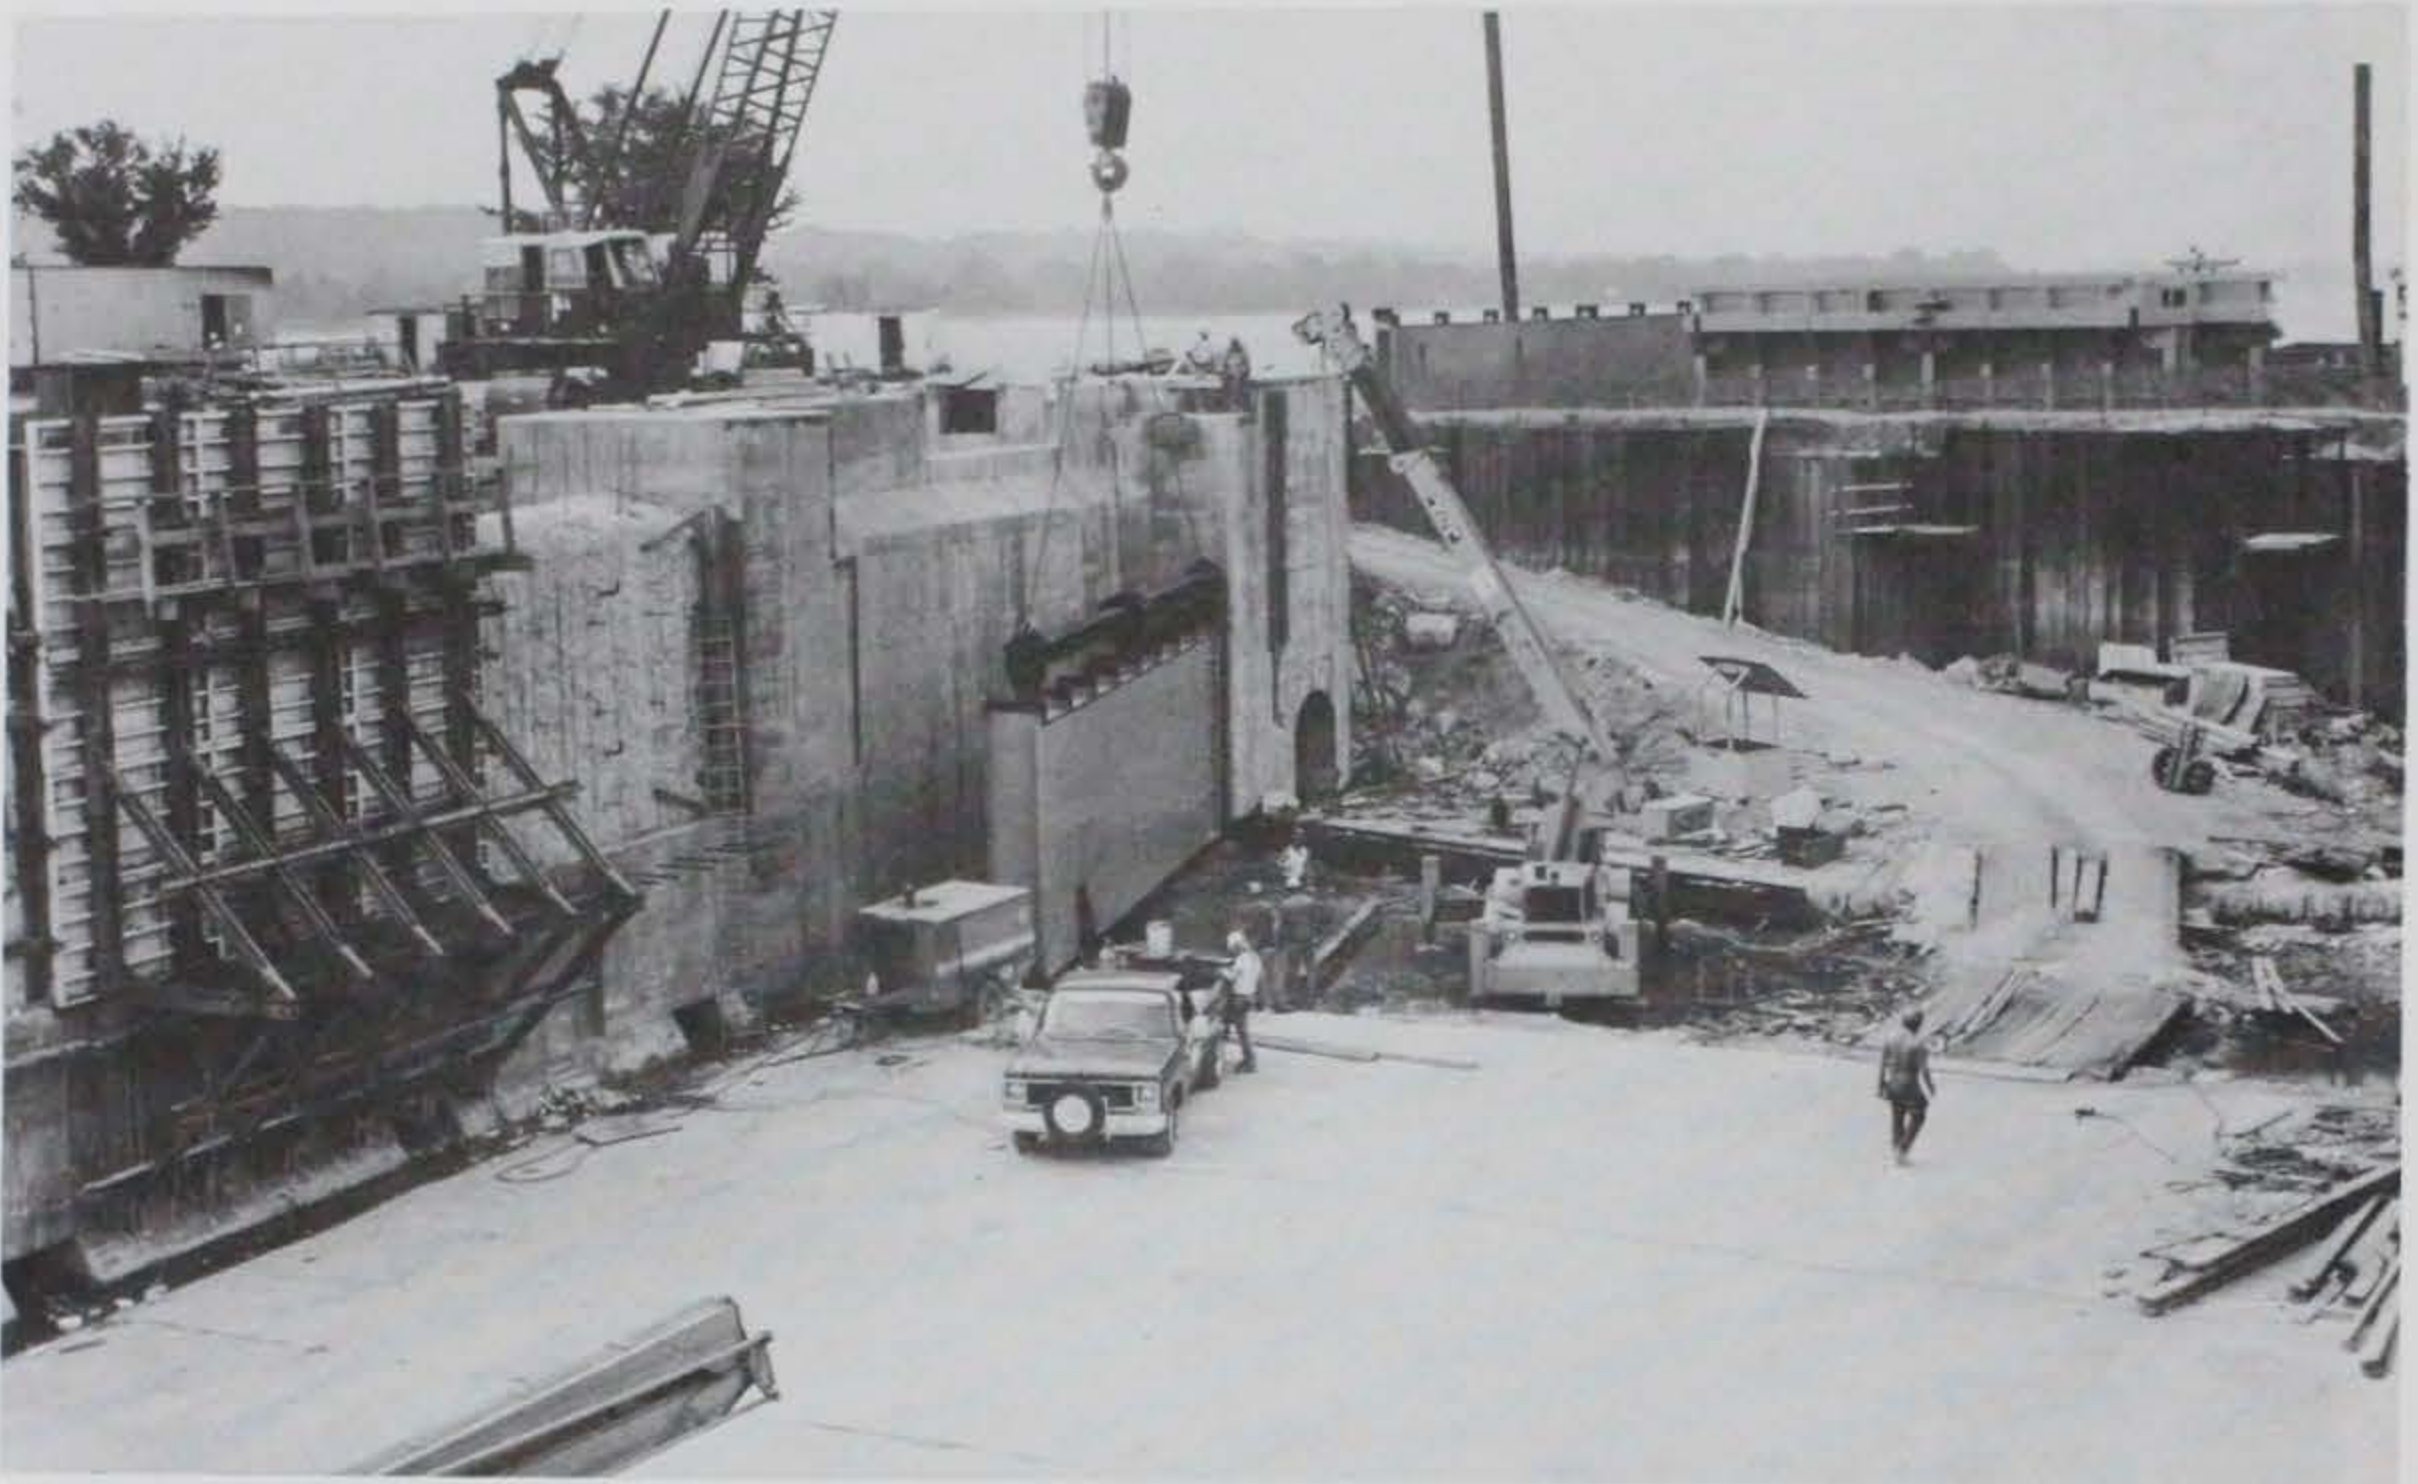
Figure 23. Concrete forming system and gate installation, August 1980, Old Lock No. 14, Mississippi River

54. The replacement concrete was anchored to the existing concrete by No. 6 dowels spaced 4 ft on centers. The dowels were grouted into the existing concrete using prepackaged polyester resin grout cartridges. A reinforcing mat, No. 6 bars on 12-in. centers each way, was placed near the face of the replacement concrete for crack control. Forms for the new concrete were attached to the existing wall (Figure 23).

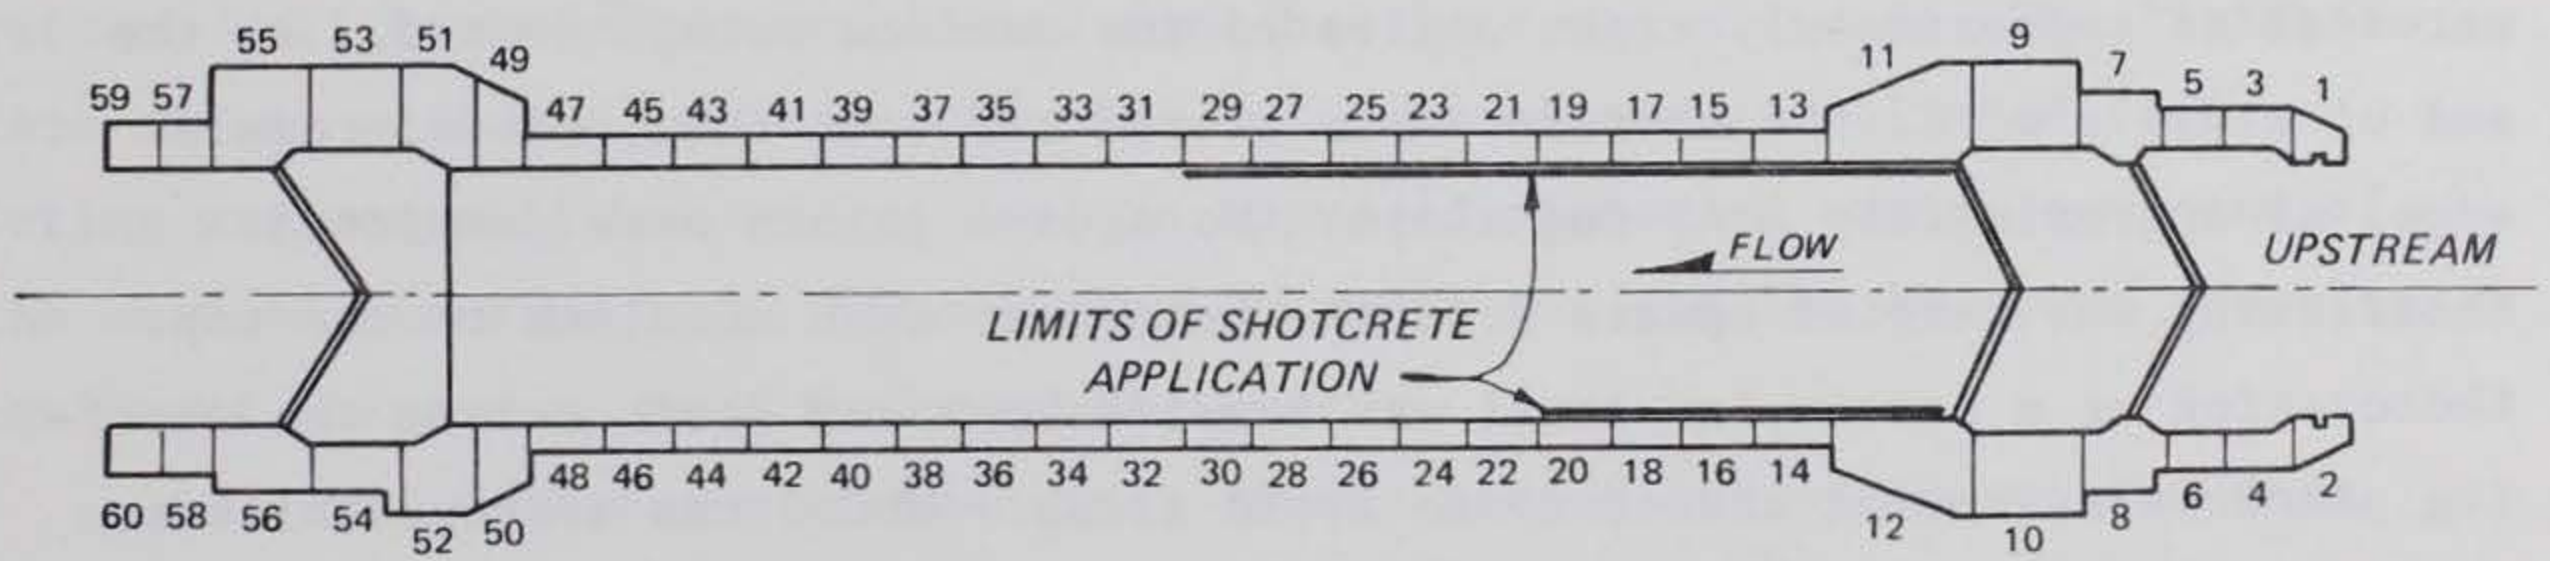
61. In 1954, deteriorated portion of the lock chamber walls and the gate bays of the upper and lower service gates were resurfaced. Resurfacing in the lock chamber (Figure 26) extended over the even numbered monoliths 12 through 20 for the land wall and over the odd numbered monoliths 11 through 29 for the river wall. Also, portions of the back side of the river wall were resurfaced. Resurfacing consisted of removal of weathered concrete and refacing with anchored and reinforced shotcrete (Gunitite).

Figure 26. Wall monoliths that were refaced with shotcrete, 1954, Dresden Island Lock

62. A minimum of 4 in. of concrete was removed back of the finished faces of walls at the work locations. Where existing concrete walls had wholly or partly disintegrated surfaces, the finished faces were reestablished by means of bronze wire lines stretched between the sound areas of the walls. Following concrete removal, surfaces were sounded and loose or shattered areas of concrete were removed to solid concrete.

64. The concrete surface to receive the shotcrete was thoroughly cleaned and washed with water and compressed air to remove all dust, dirt, and other foreign materials. The prepared surface was moistened not more than one hour prior to placement of the shotcrete, then scoured with an air and water jet and finally with an air jet alone to remove all traces of water.

65. The shotcrete, approximately 1 part cement to 3-1/2 parts sand by dry volume, was mixed in a stationary mixer and transported by conveyor to the shotcrete apparatus (Figure 27). The shotcrete nozzle was held at a distance of 3 or 4 ft from the surface and at such a position as to direct the flowing material at approximately right angles to the surface being covered. At the end of a day's work, the shotcrete was sloped off to a thin, clean, regular edge, at approximately a 45-deg slope. No square joints were permitted. Shotcreting was carried upward from the bottom of each monolith to the top. Shotcreting at a particular level was carried back and forth across the shooting platform as deemed necessary to avoid slump. Where the average thickness for the area being worked was 5 in. or less, the wall was built out to the finished face without waiting for the shotcrete to set. In large pockets, a layer of mesh was used for each layer of shotcrete, and each layer was allowed to set at least 3 hr before successive layers were applied. The thickness of a layer did not exceed 5 in. except in certain limited areas where in a series of successive layers, one layer not greater than 6 in. in thickness was allowed. Shotcreting through more than two layers of mesh was not allowed.

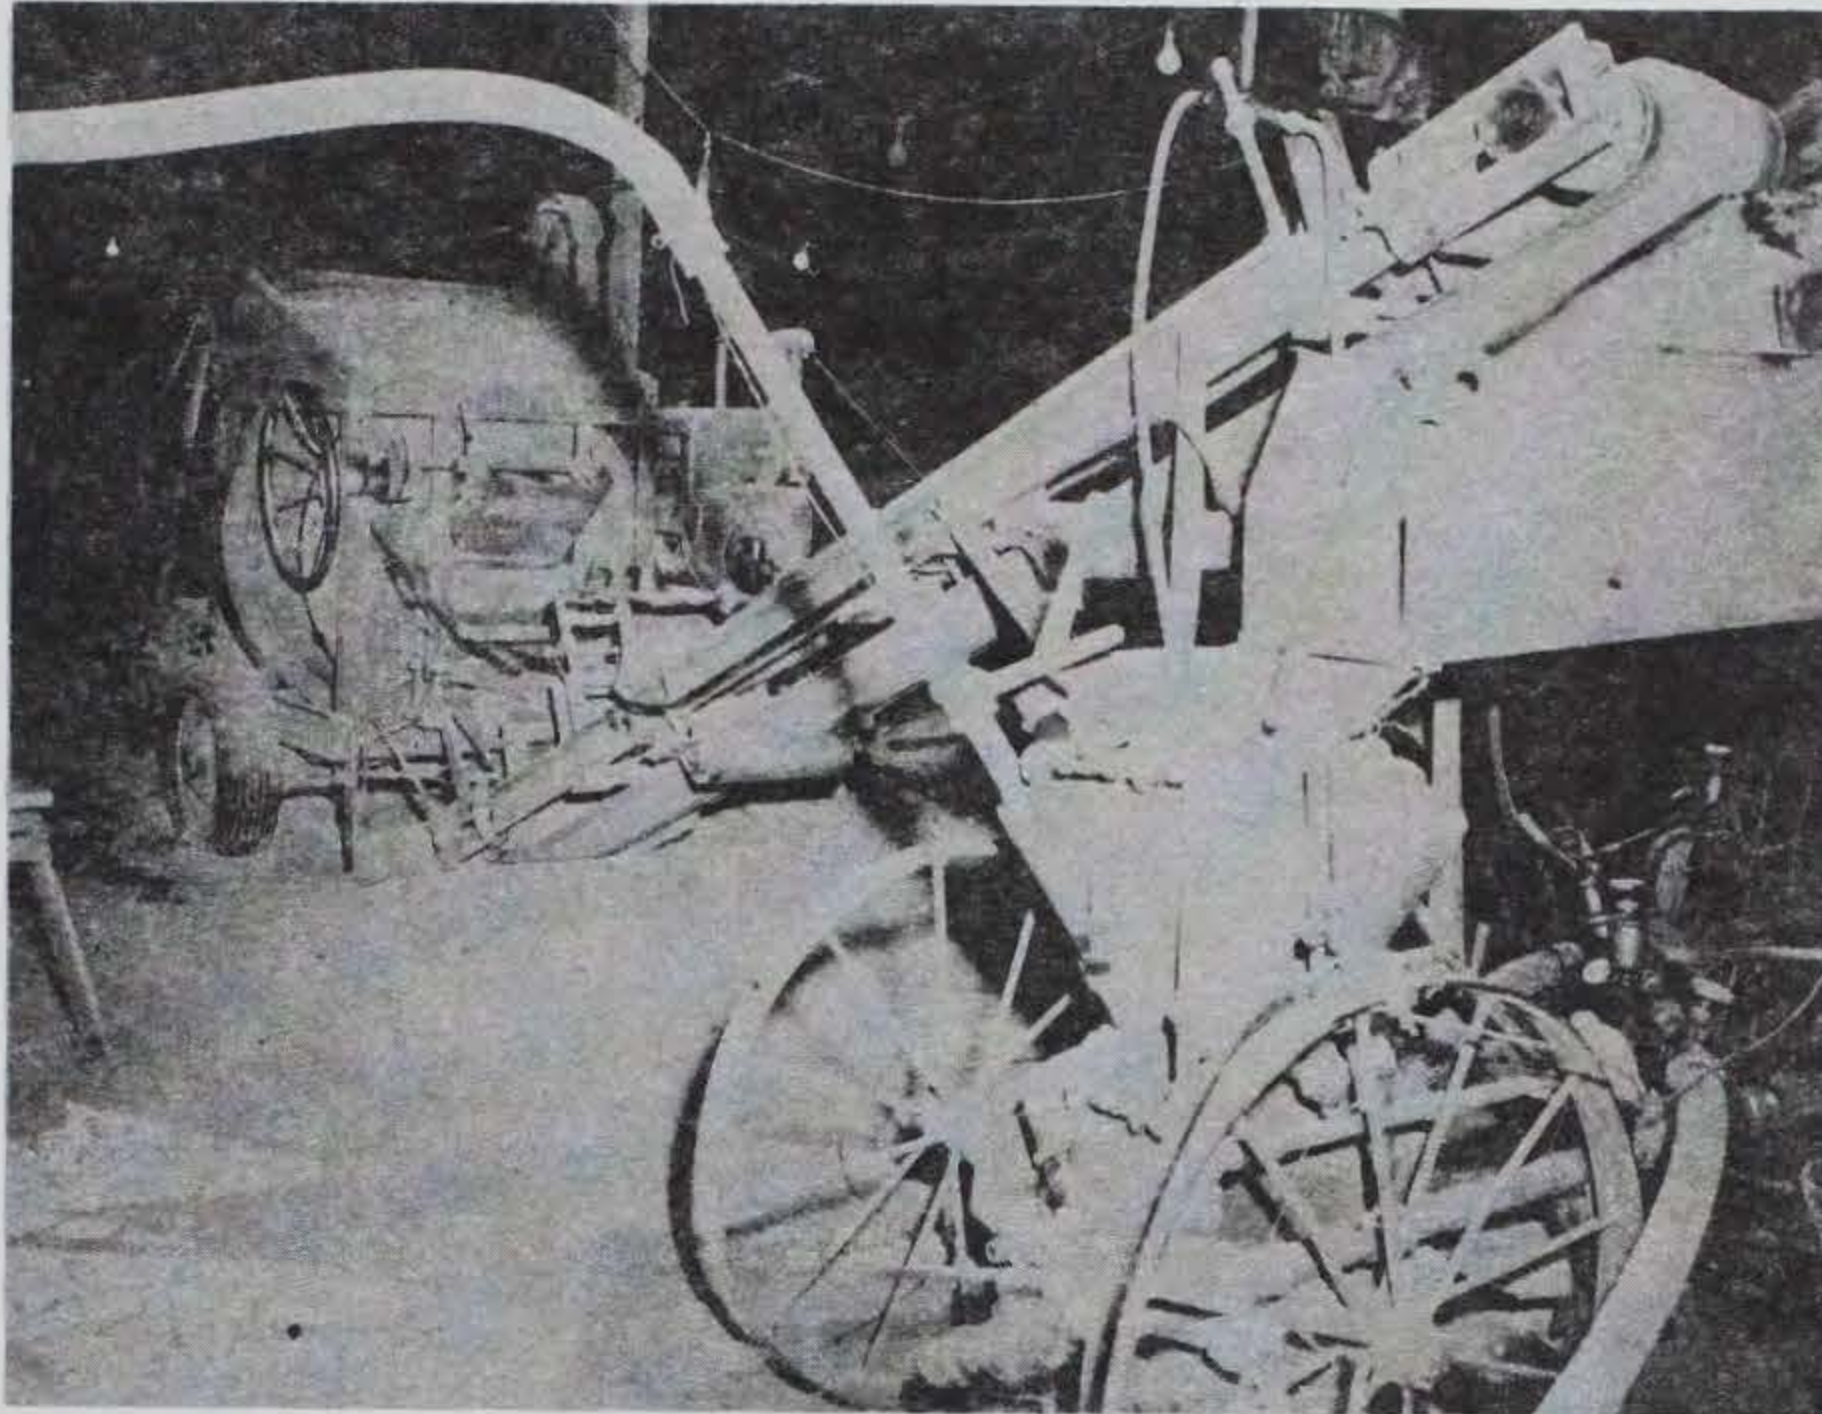
Figure 27. Shotcrete mixing and delivery equipment, 1954,  
Dresden Island Lock

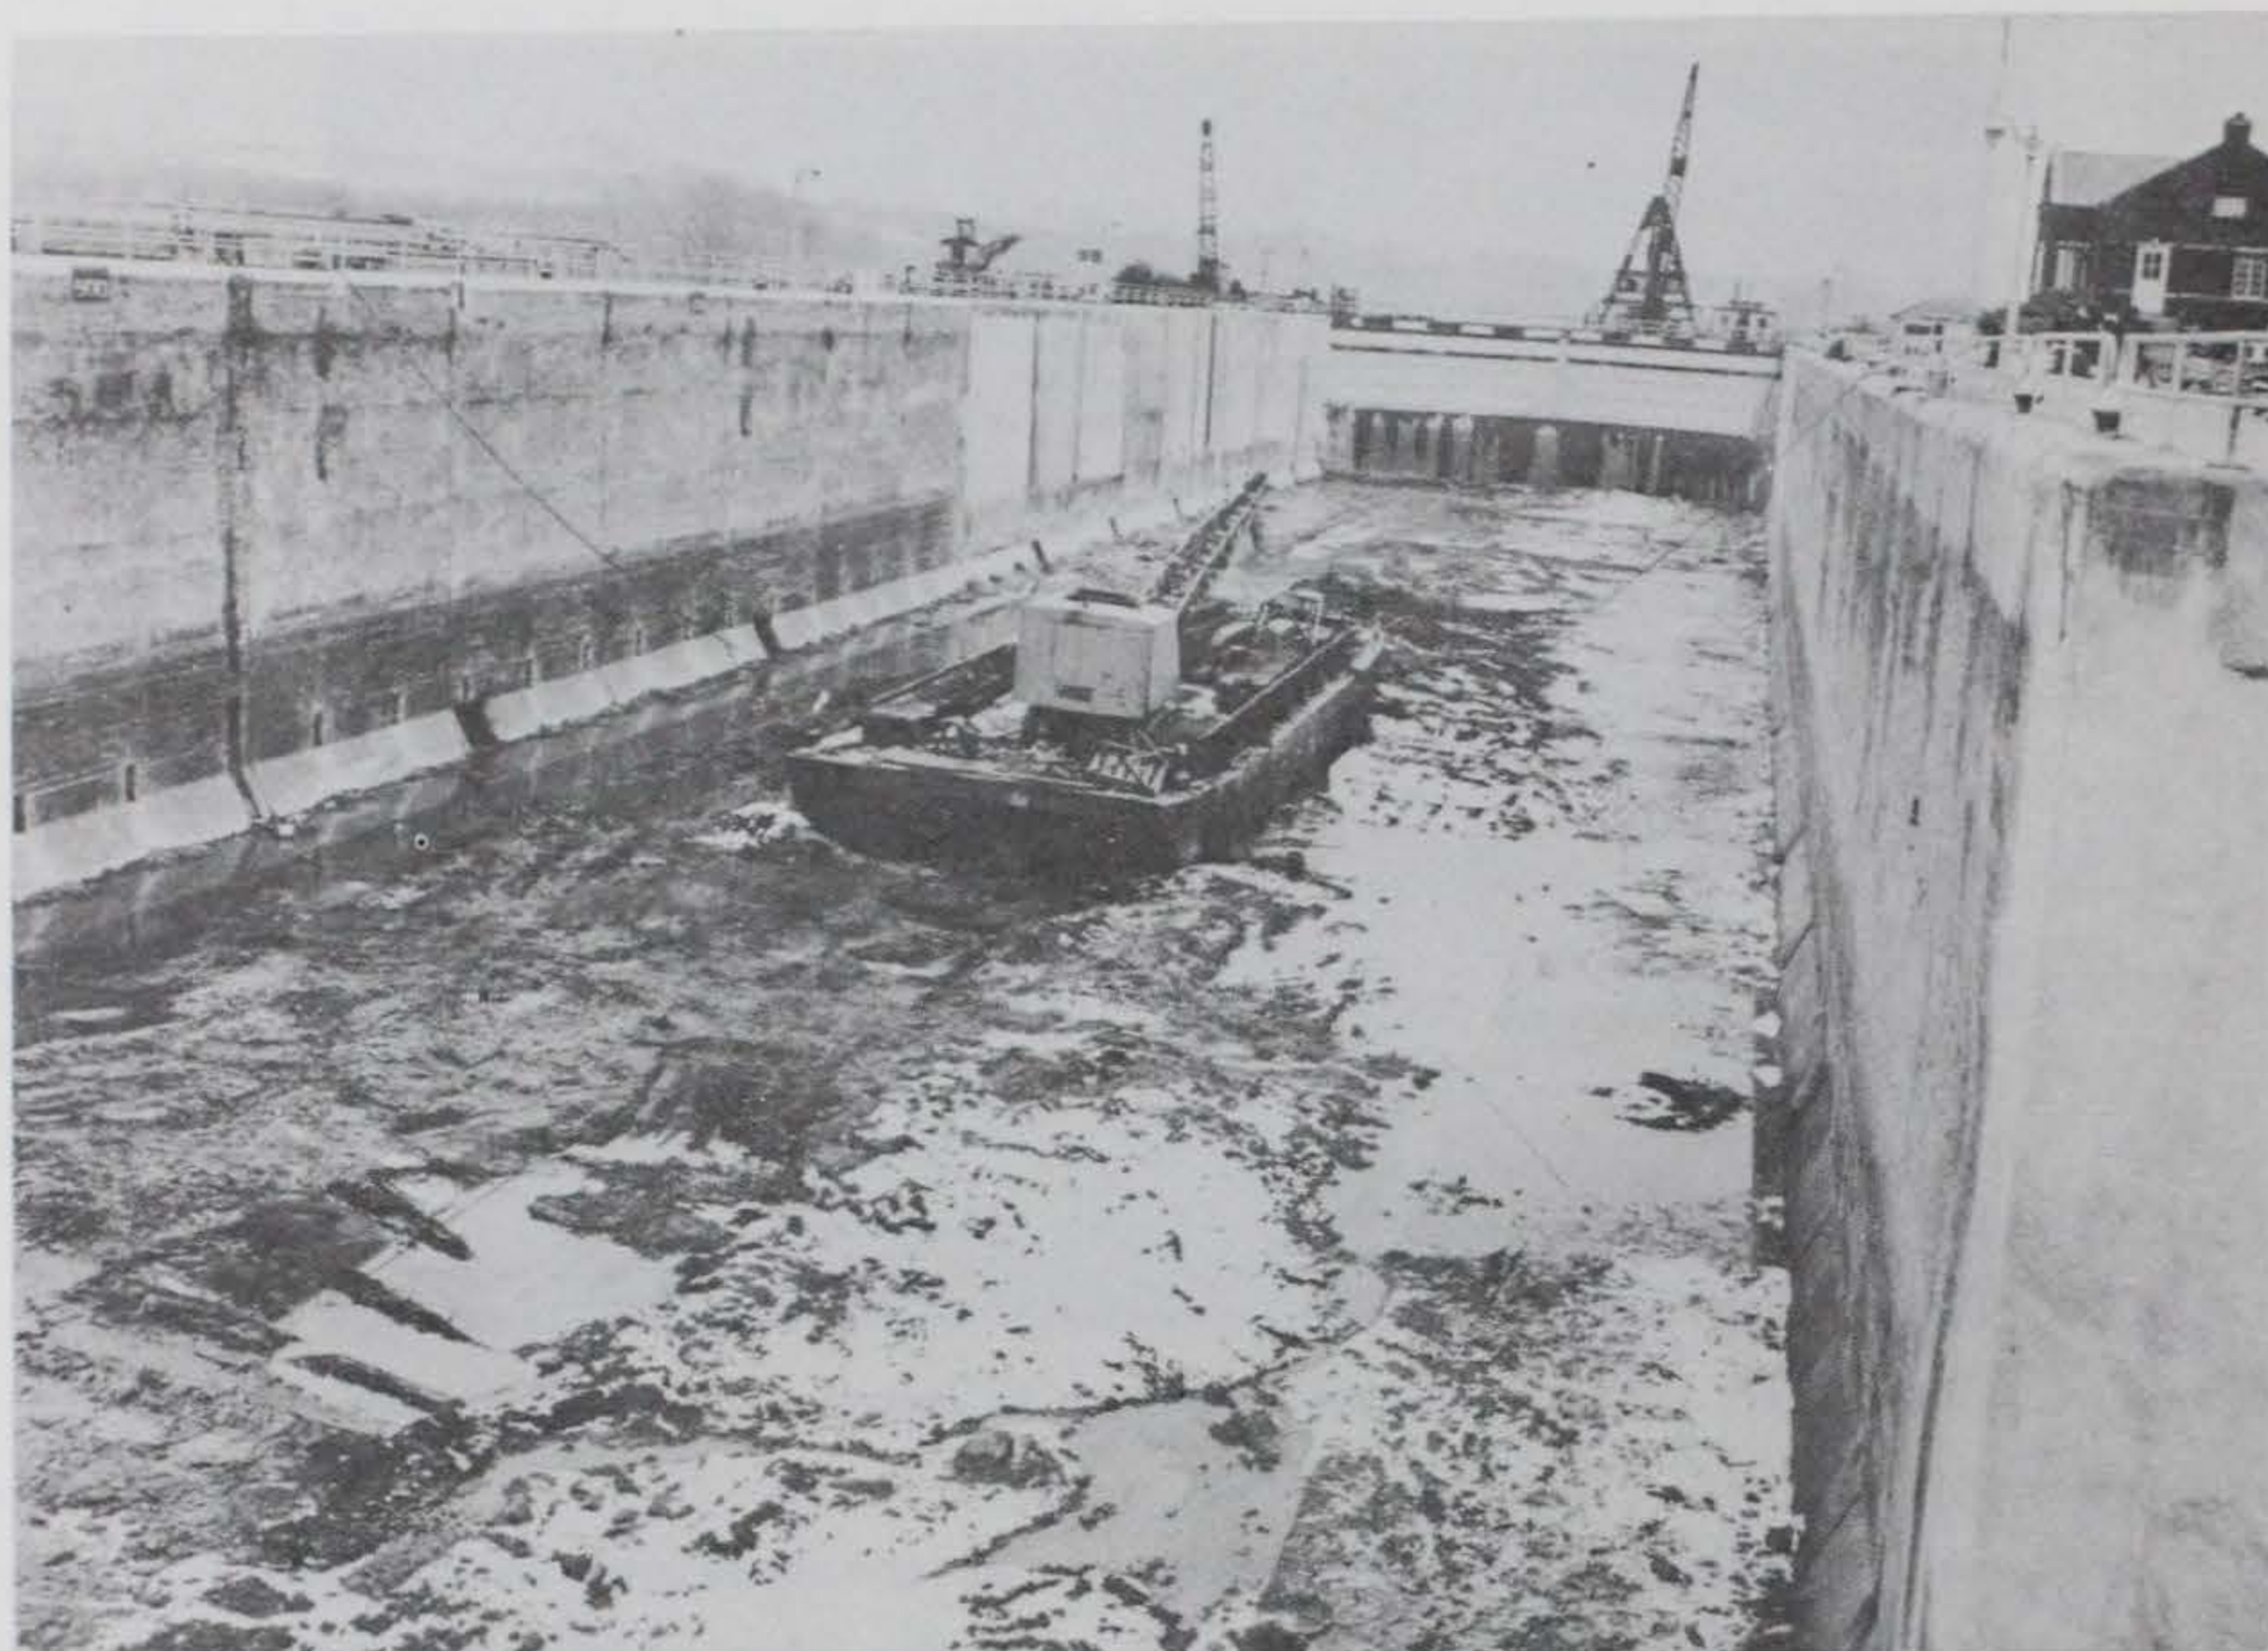
67. All work was performed in a 30-day period during the winter when the lock was shut down. The maximum number of men practical was used working three 8-hr shifts. During the peak construction period, 190 men were engaged in the work. Cost of the resurfacing was \$158,000. The lock chamber immediately prior to flooding following the repair is shown in Figure 28. The shotcrete resurfaced monoliths can be seen in the background.

Figure 28. Chamber immediately prior to reflooding after 1954 repairs, Dresden Island Lock

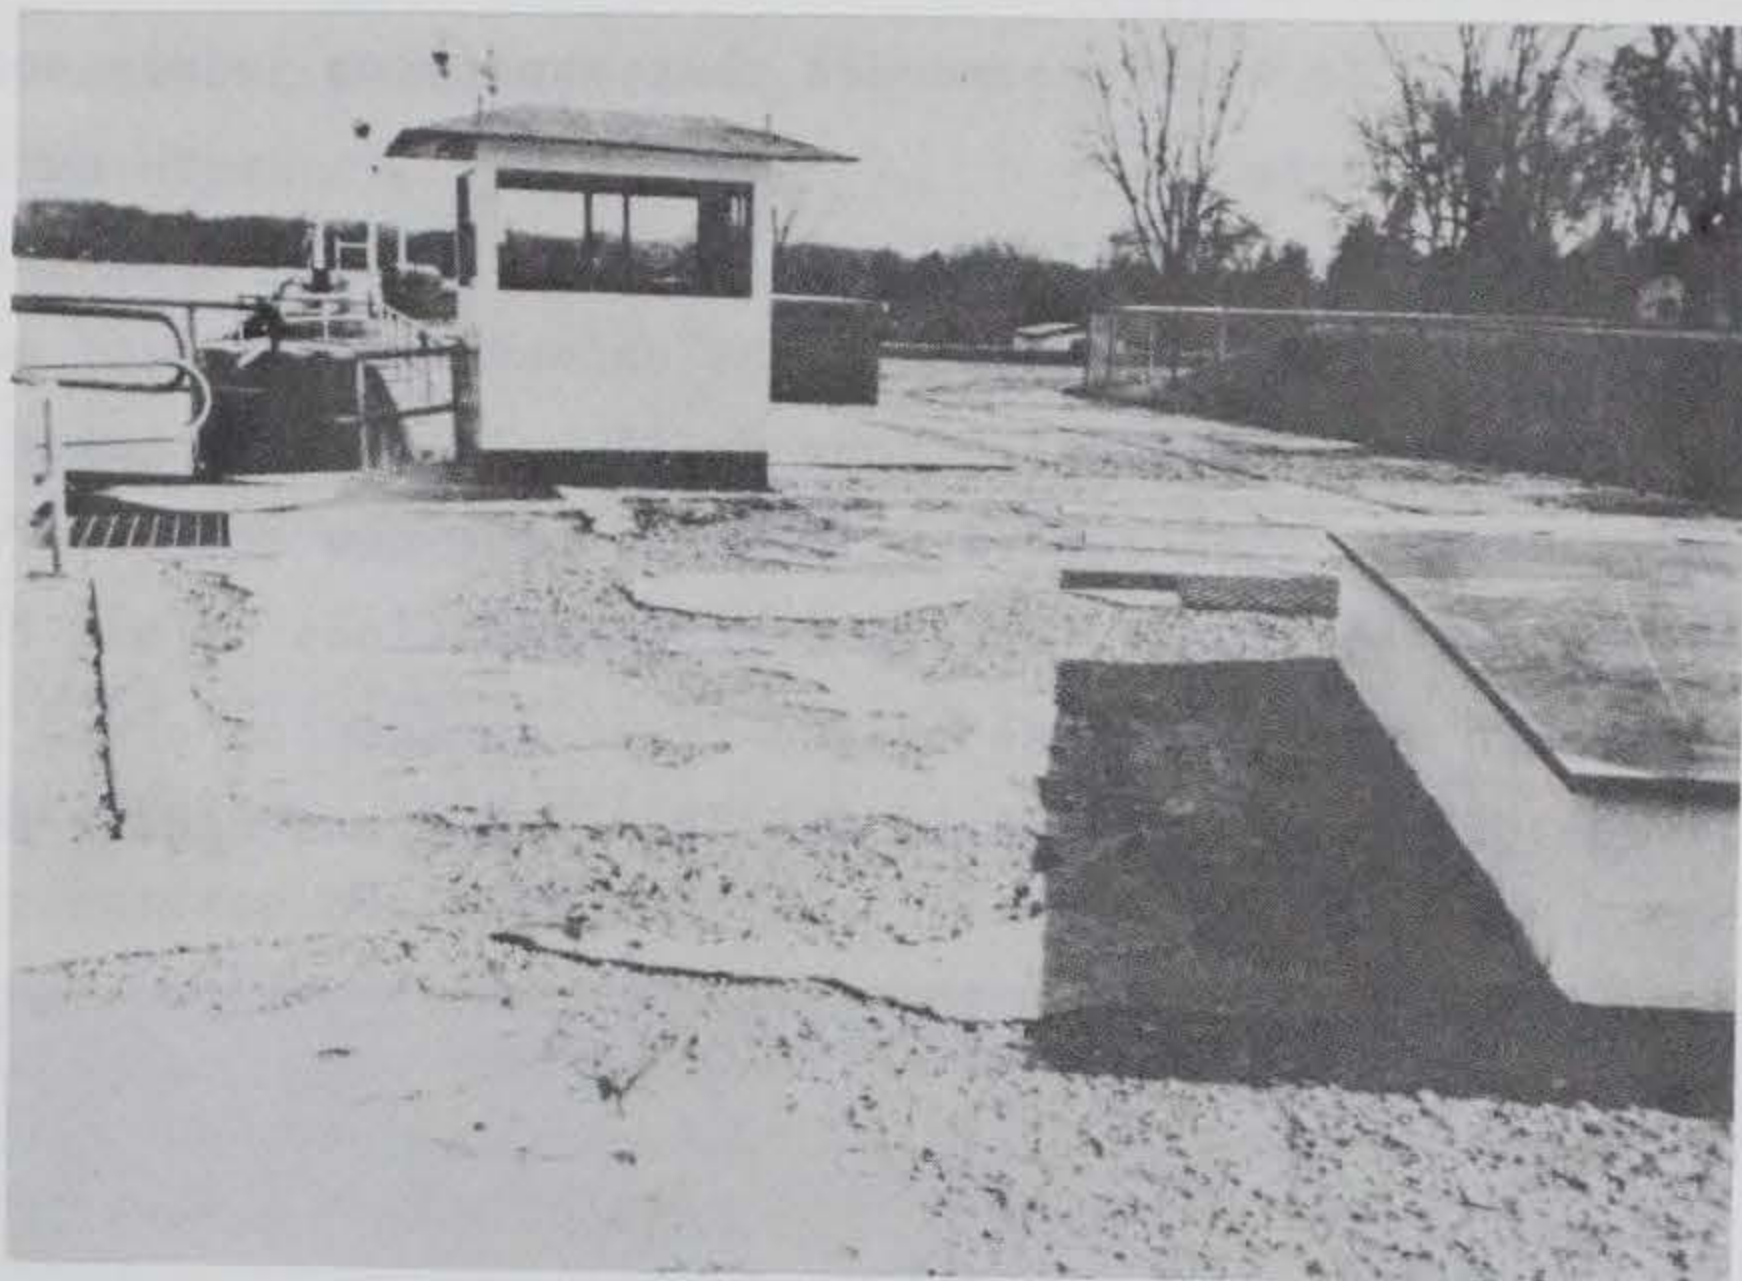
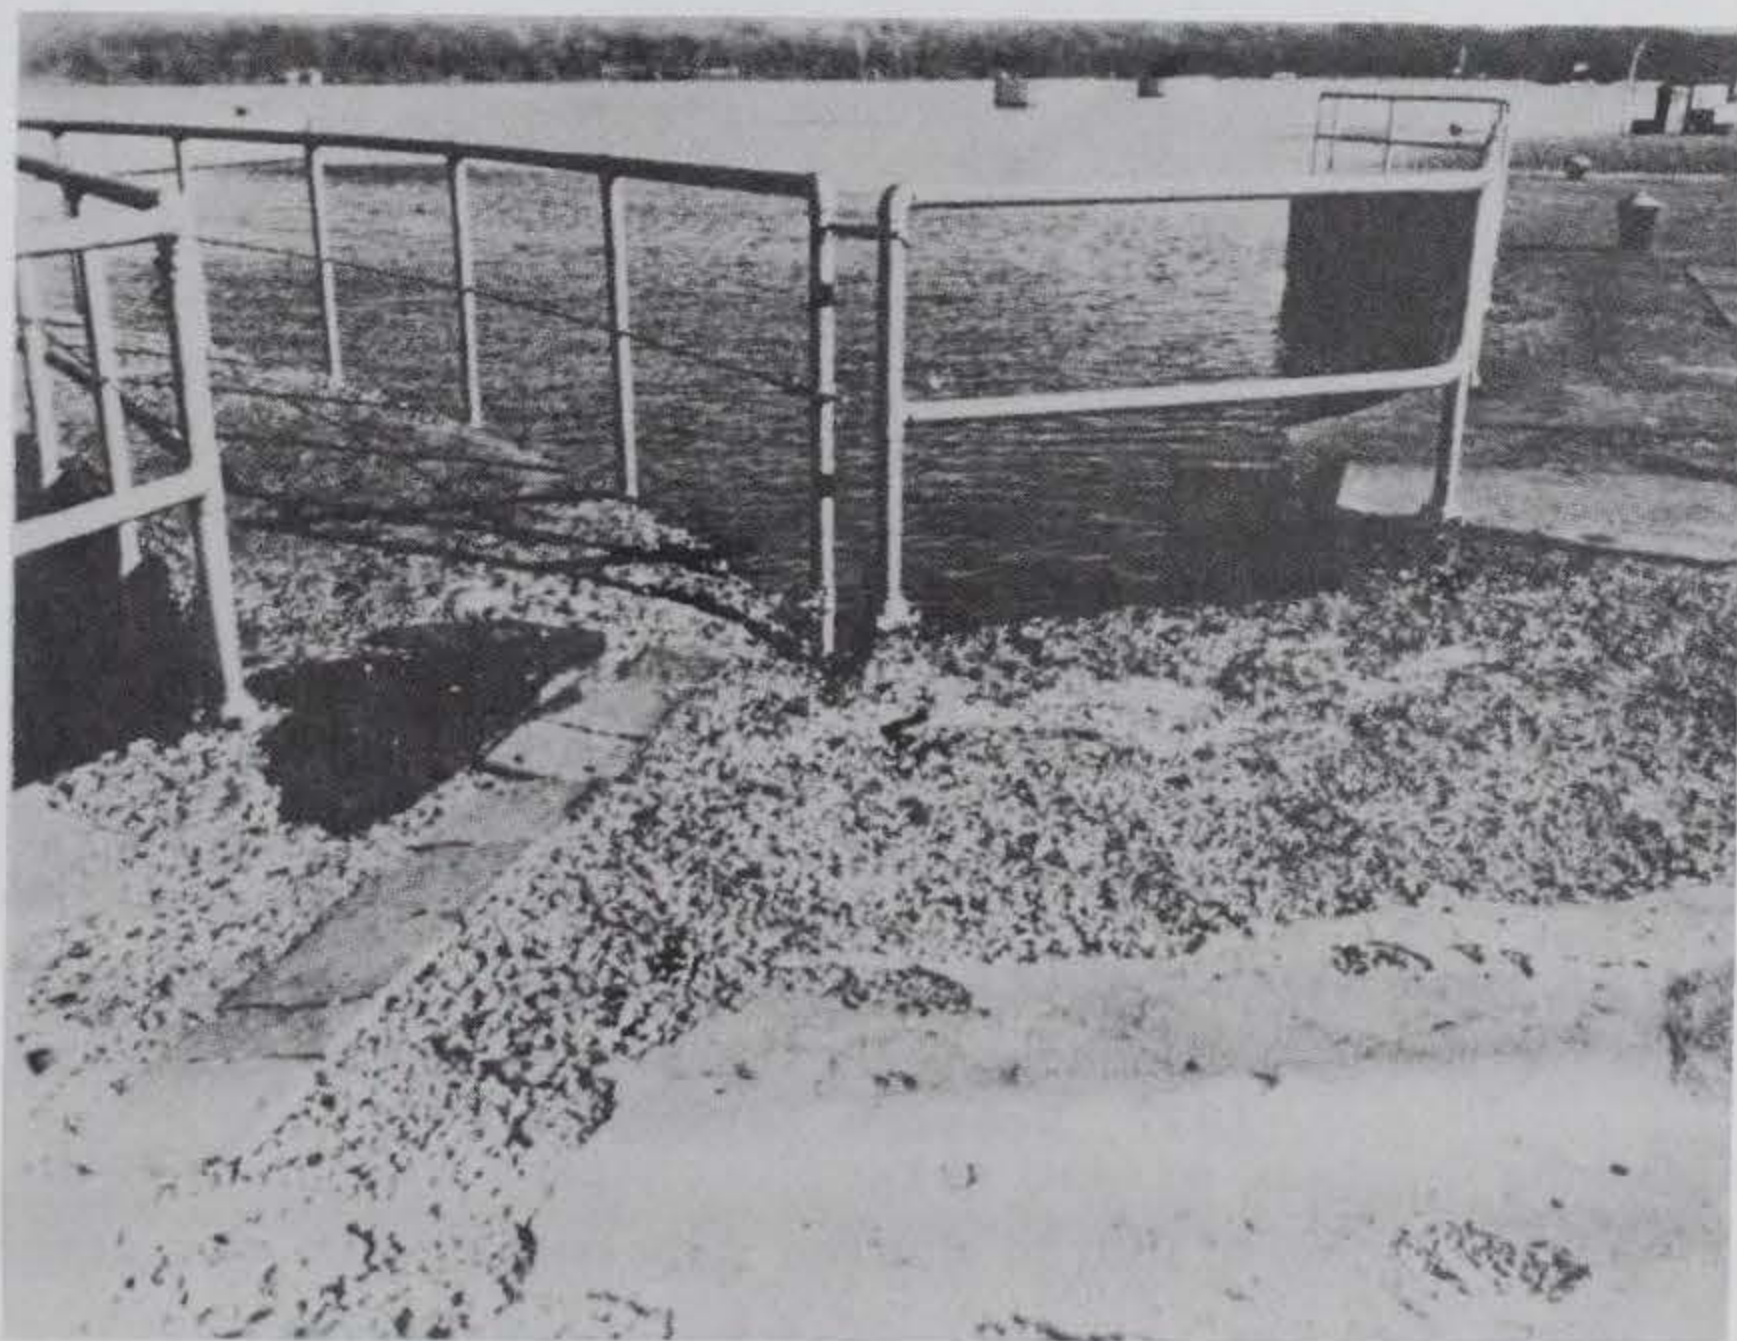
contributed to the concrete deterioration through cycles of freezing and thawing (Figure 29). In 1961, the top surfaces and the upper 3 ft of the vertical walls of the lock were resurfaced. This repair involved removing a minimum of 4 in. of concrete and replacing with new air-entrained concrete reinforced with wire mesh. In addition, corner armor was added to the lock chamber walls.

69. During the second periodic inspection in August 1972, random cracking of the resurfaced concrete on top of the lock walls was observed. This cracking was attributed in part to reflective cracking from the original concrete. Concrete deterioration to depths of about 8 in. was reported for those portions of the lock chamber walls which had not been resurfaced. The concrete and shotcrete lock chamber resurfacing was reported to be in excellent condition except for spalling at the monolith joints. Introduction of expansion joint material at lock wall monolith joints during resurfacing was

Figure 29. Typical concrete deterioration on tops of lock walls, 1961, Dresden Island Lock and Dam

believed to have contributed to spalling at the joints. Since there are no expansion joints in the lock walls, the expansion joint in the resurfaced zone cannot function and only absorbs water which causes spalling through cycles of freezing and thawing. It was recommended that expansion joints not be used in future resurfacing projects.
