TECHNICAL REPORT REMR-CS-13

**REHABILITATION OF NAVIGATION  
LOCK WALLS: CASE HISTORIES**

James E. McDonald

December 1987

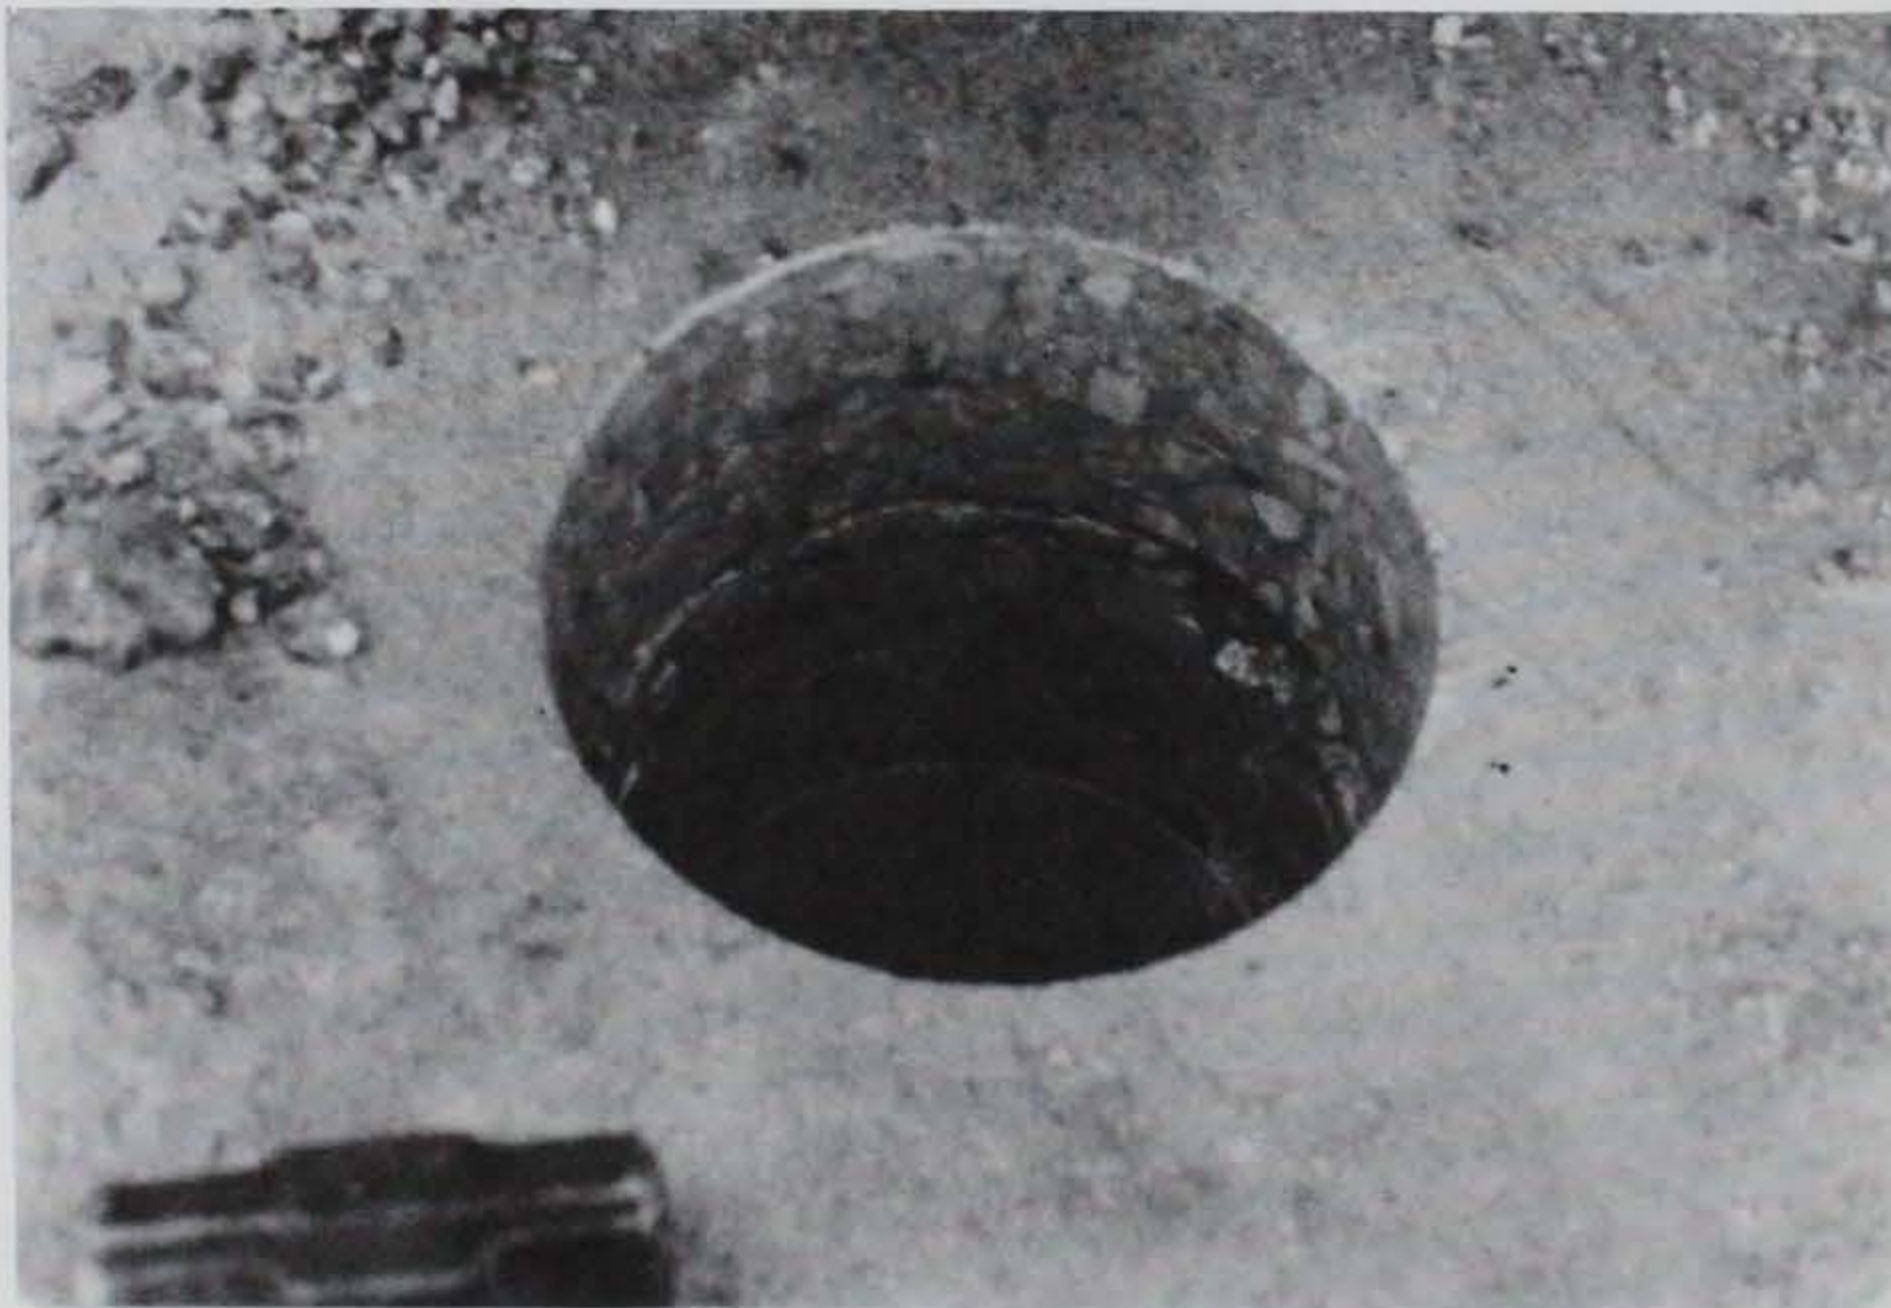
70. An extensive core drilling and laboratory testing program was conducted during 1976 and 1977 to ascertain the extent and cause of concrete deterioration (Stowe et al. 1980a). Four drill holes were located in areas that had been resurfaced with concrete in 1961. The new concrete was found to be structurally sound by itself, but in certain locations it was considered susceptible to barge impact because of the frost-damaged concrete beneath (Figure 30). The original concrete in the lock walls was nonair-entrained

Figure 30. Downhole view showing newer good quality concrete overlay and underlying deteriorated concrete, 1977, Dresden Island Lock

concrete that was well consolidated during placement. It was structurally sound in areas which had not been affected by frost action.

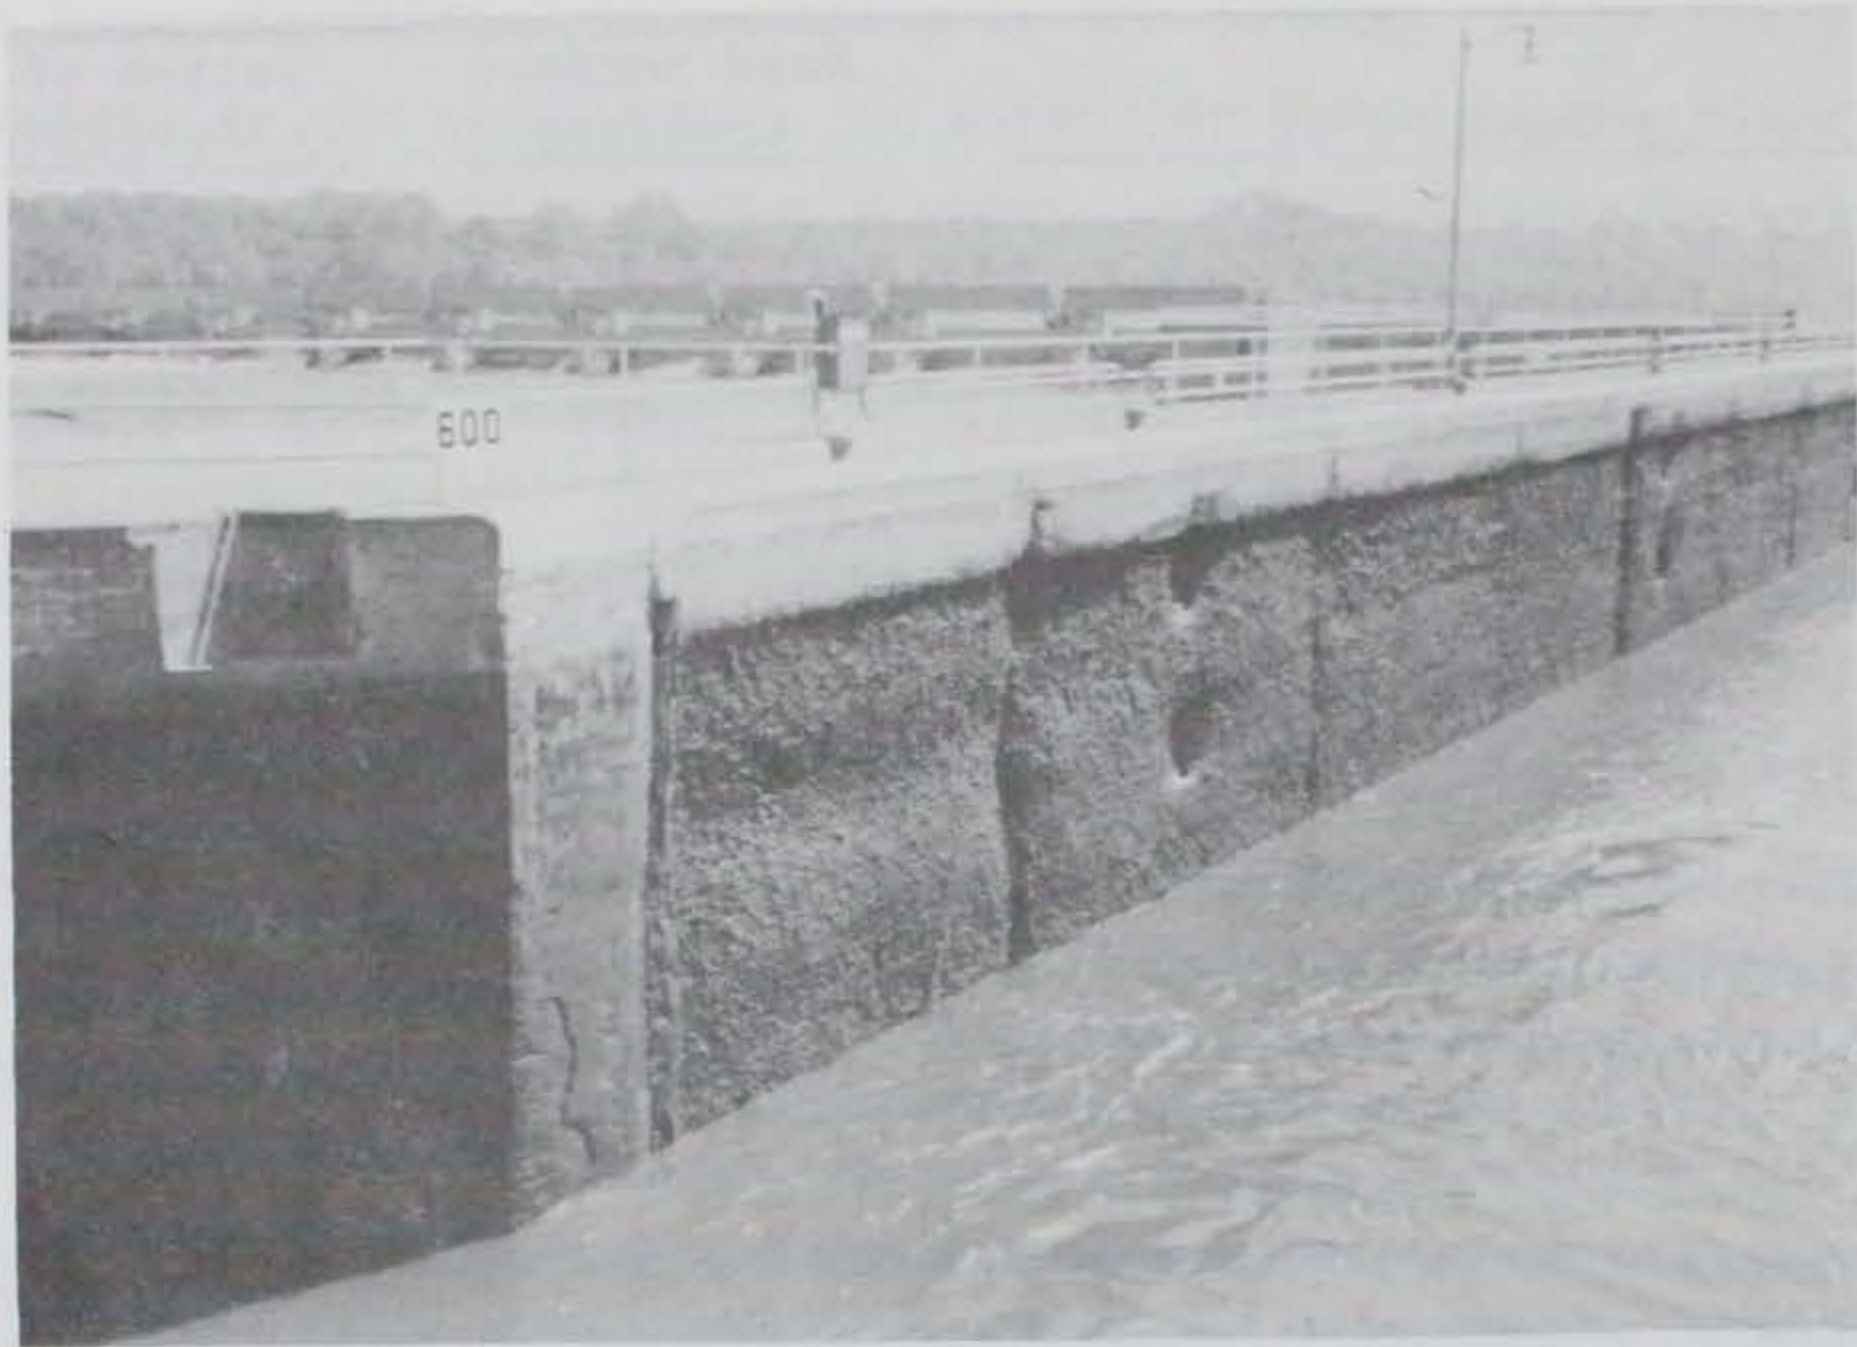
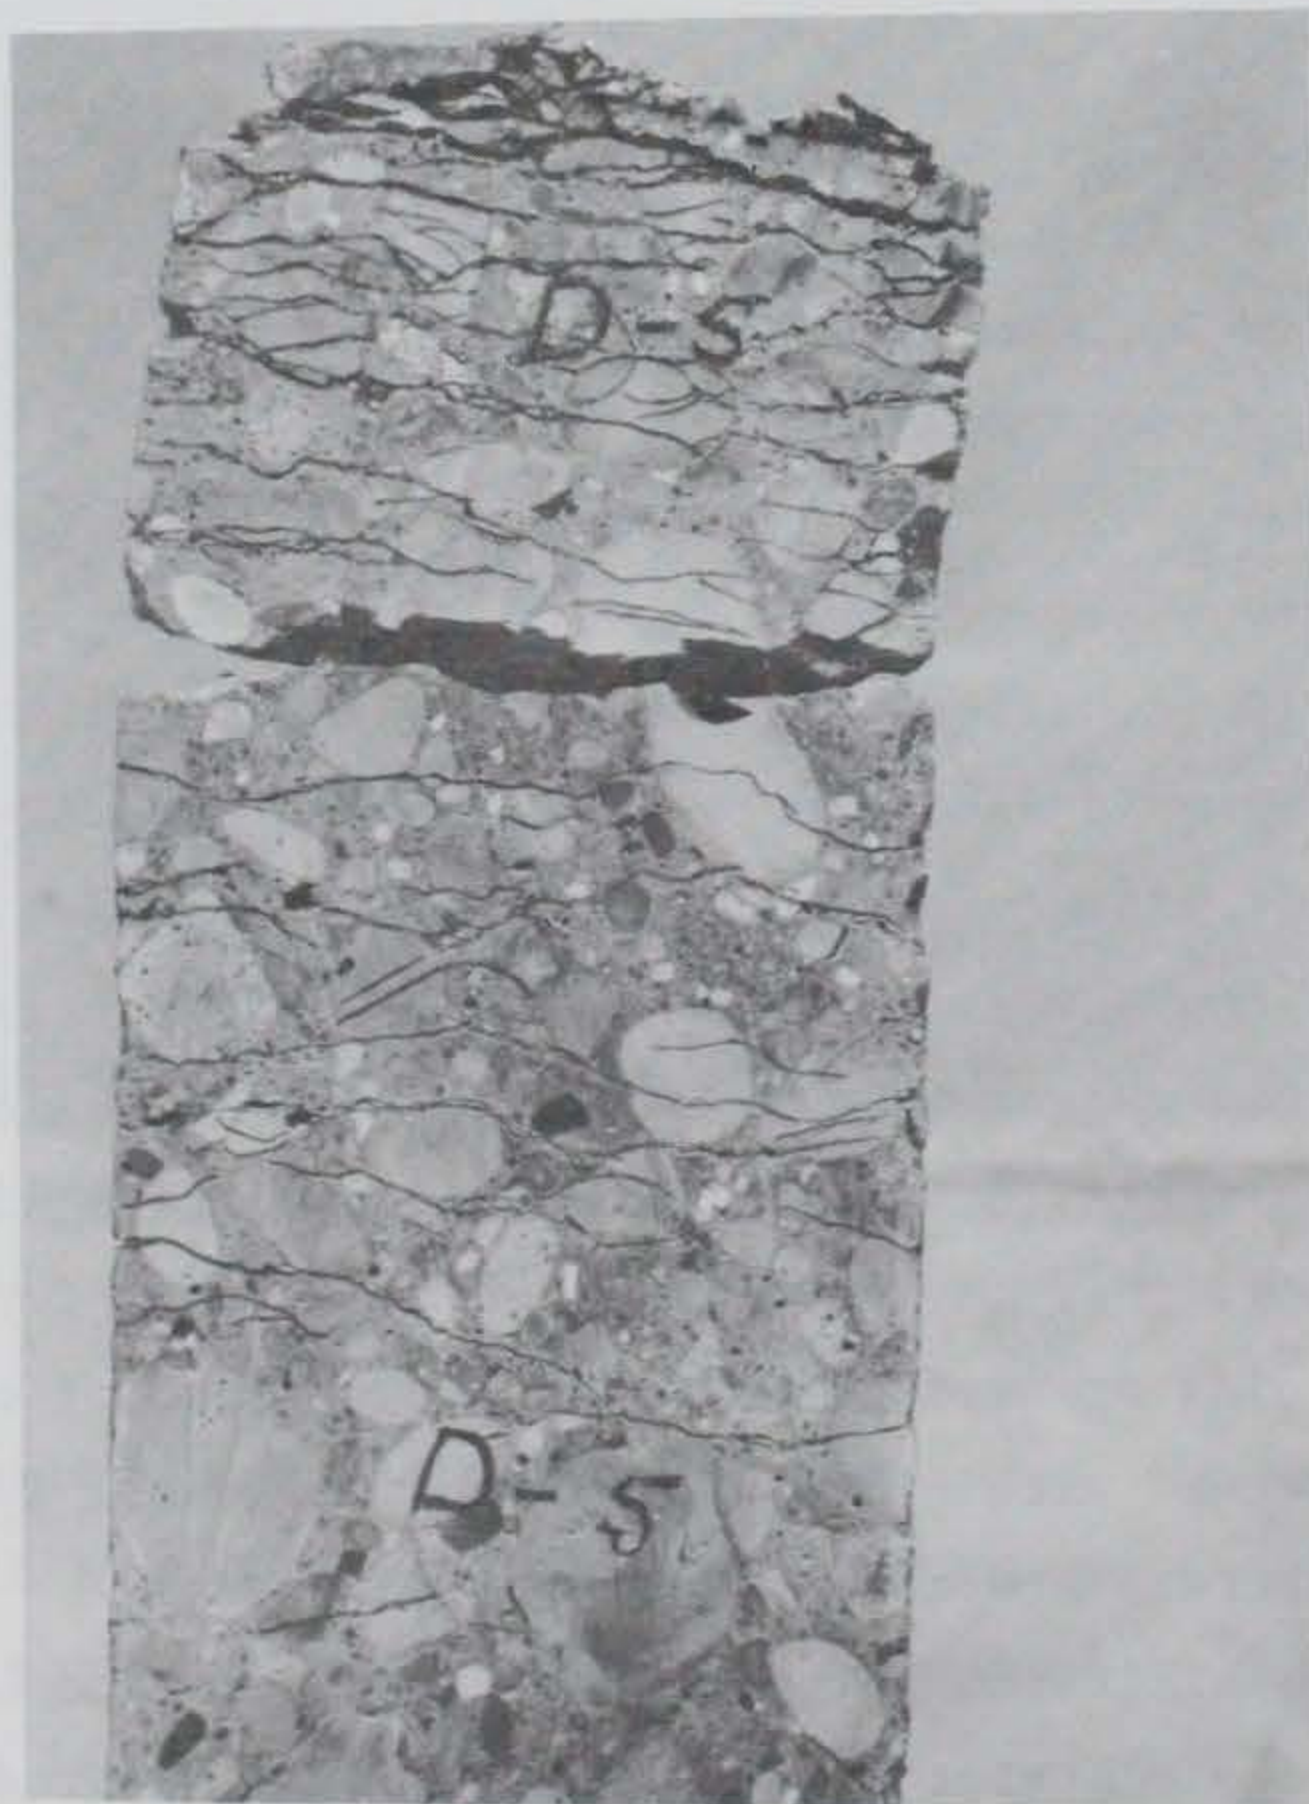
72. Deterioration of the exposed and near surface original concrete ranged from light to severe. About 80 percent of the exposed vertical surfaces of the concrete in the lock walls had been effected by frost action (Figure 31). The average depth of concrete deterioration as determined by petrographic examination were as follows: lock chamber walls, 0.7 ft; river-side of river wall, 0.9 ft; and the upper gate bays, 1.5 ft. Severe loss of concrete was evident at most monolith joints.

Figure 31. Typical concrete deterioration, 1977,  
Dresden Island Lock

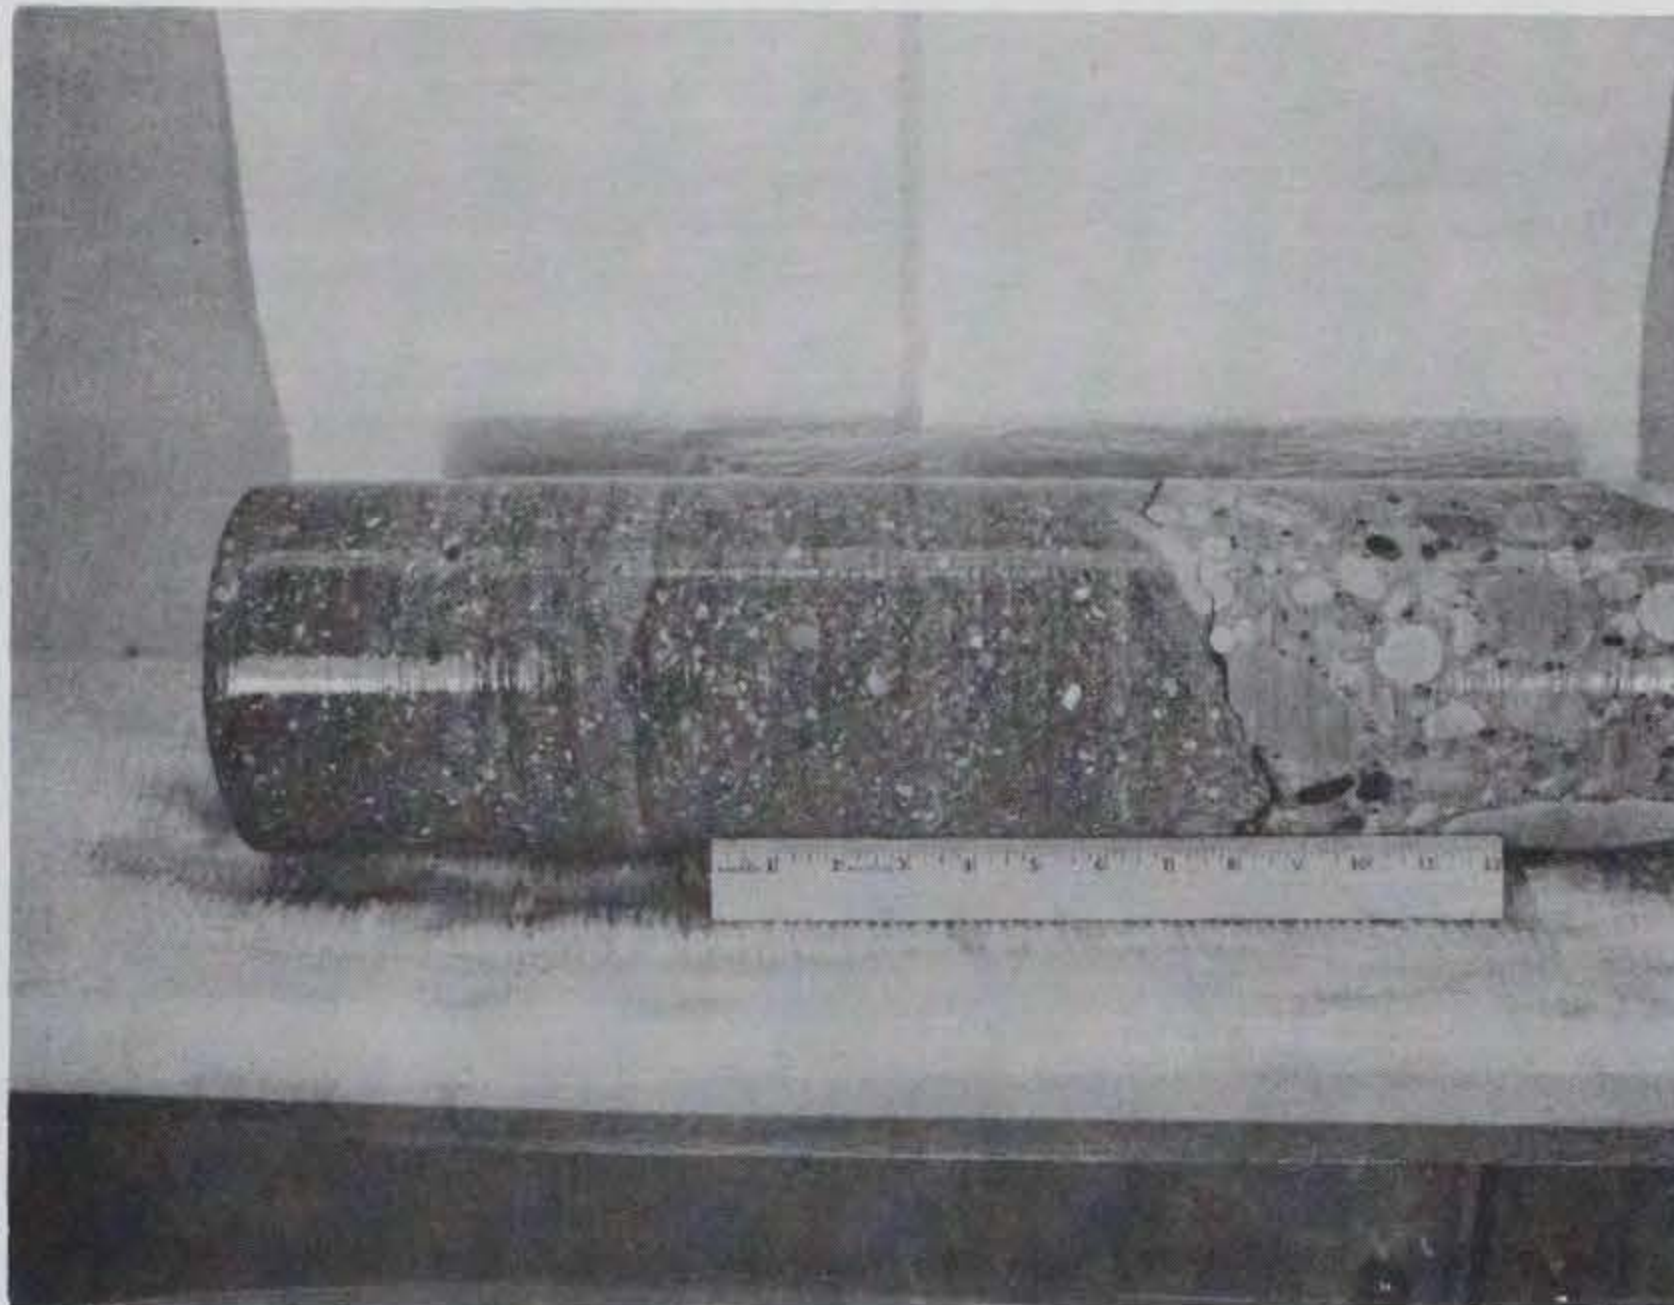
73. Three borings were drilled from inside the lock chamber into the river wall section previously refaced with shotcrete. The shotcrete had a minimum thickness of 12 in. (Figure 32) and exhibited excellent bond to the original concrete. Air-void data determined according to CRD-C 42 indicated the shotcrete had about 3 percent total air with approximately 2 percent of it in voids small enough to be classified as useful for frost resistance. The air-void spacing factors ranged from 0.010 to 0.014 in. While these values are larger than is desirable (0.008 in. is considered the maximum value for air-entrained concrete), they may have imparted some frost resistance. Also, there were no large voids or strings of voids due to lack of consolidation such as have been observed with other shotcrete specimens. Typical surface conditions of the shotcrete are shown in Figure 33.

Figure 32. Horizontal core taken through shotcrete resurfacing, 1976, Dresden Island Lock

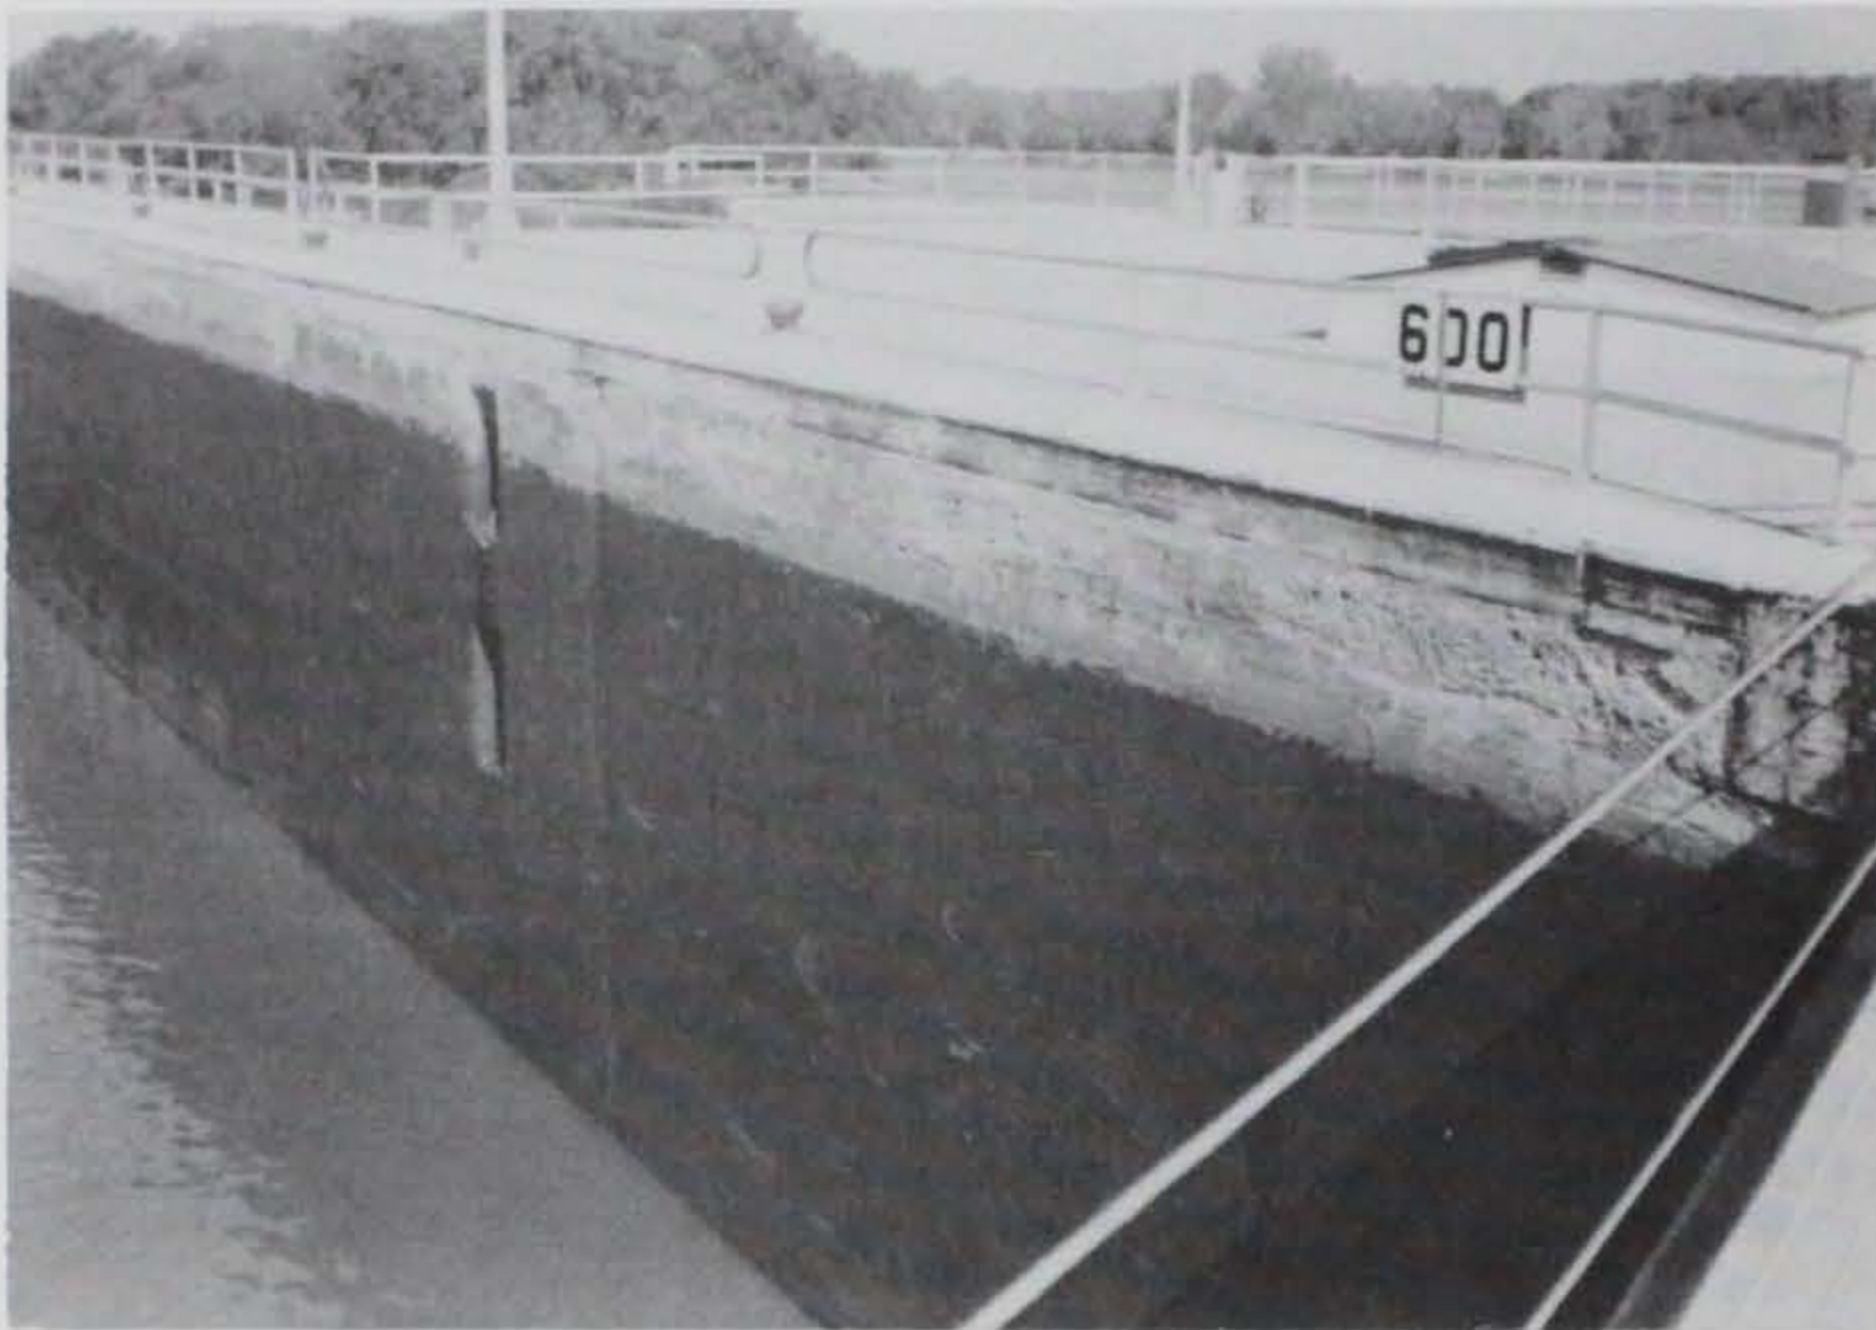
a. River wall

Figure 33. Shotcrete surface conditions, 1977,  
Dresden Island Lock

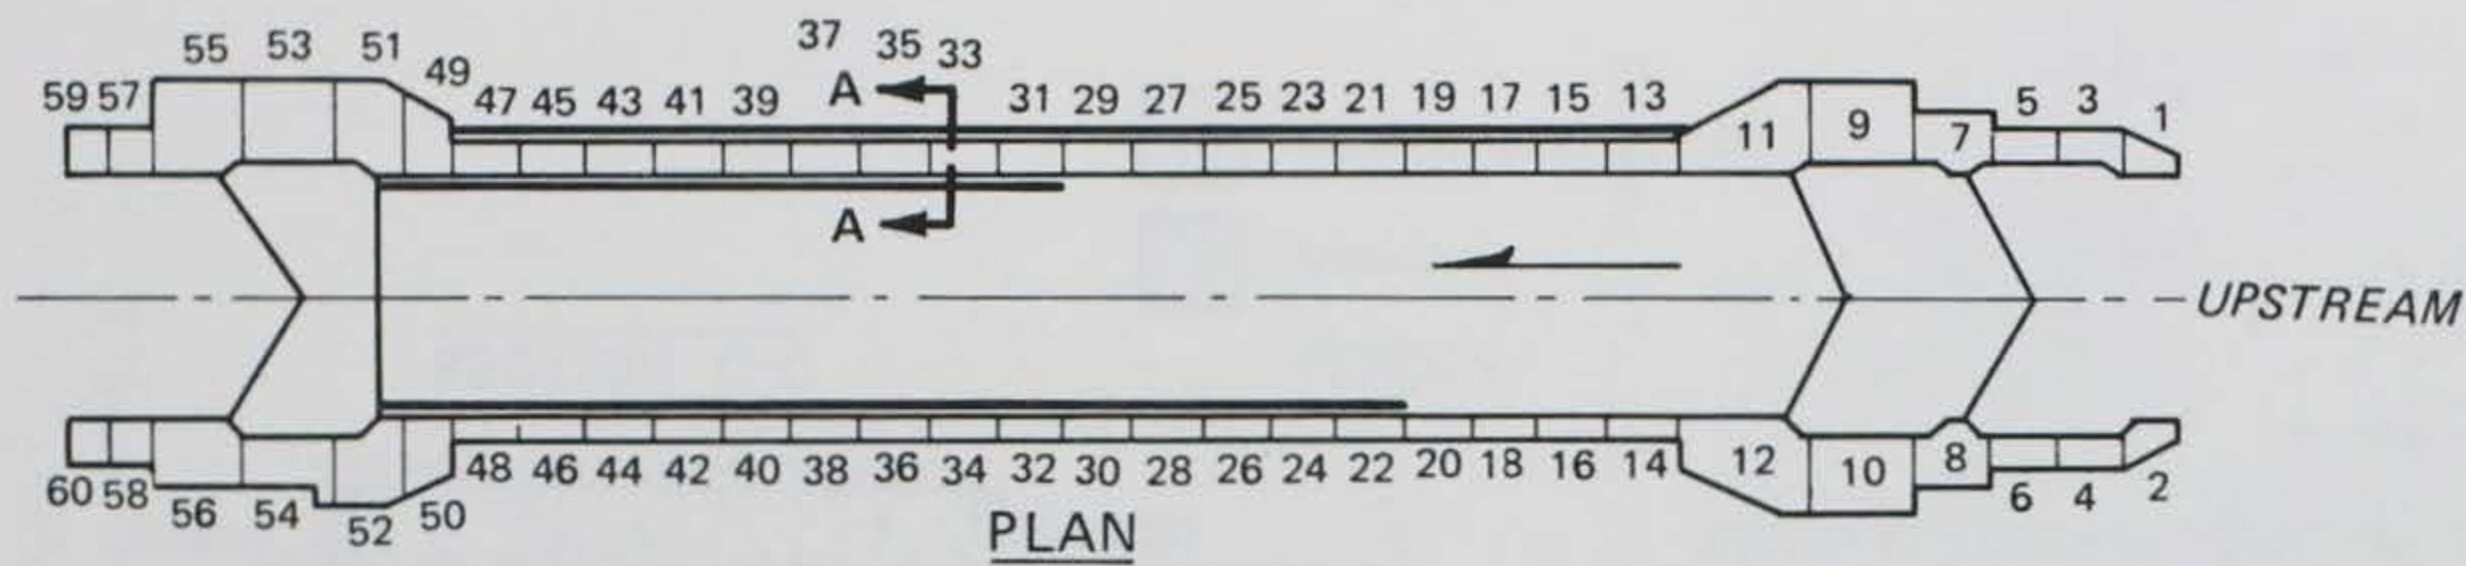
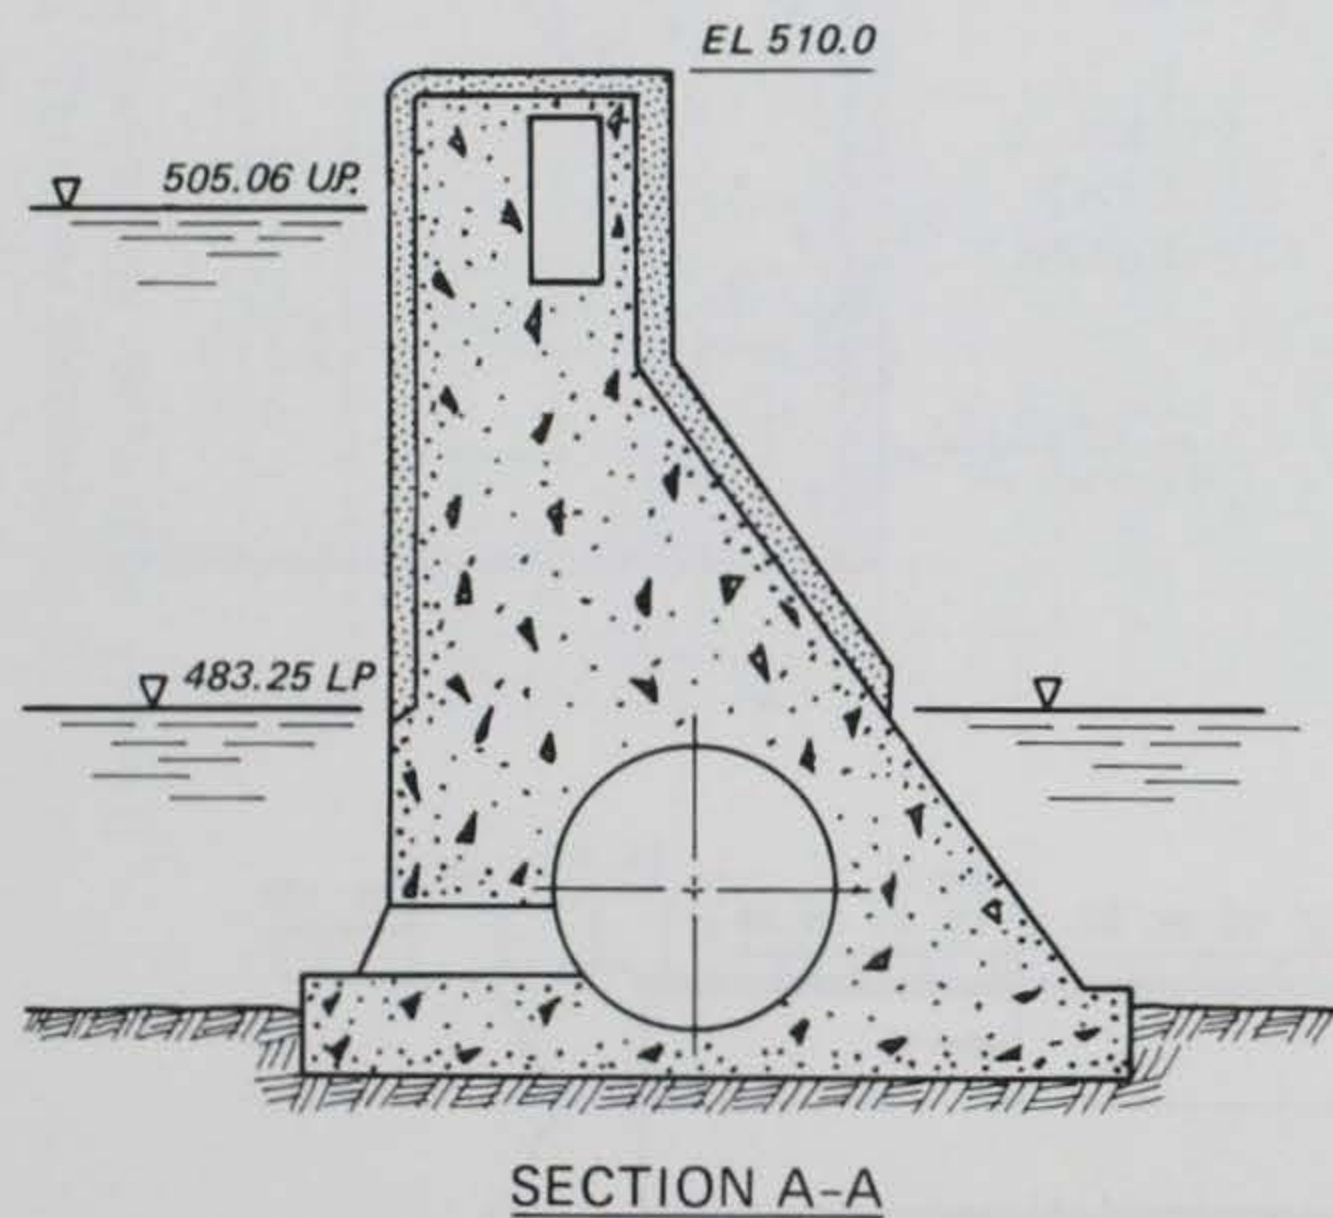
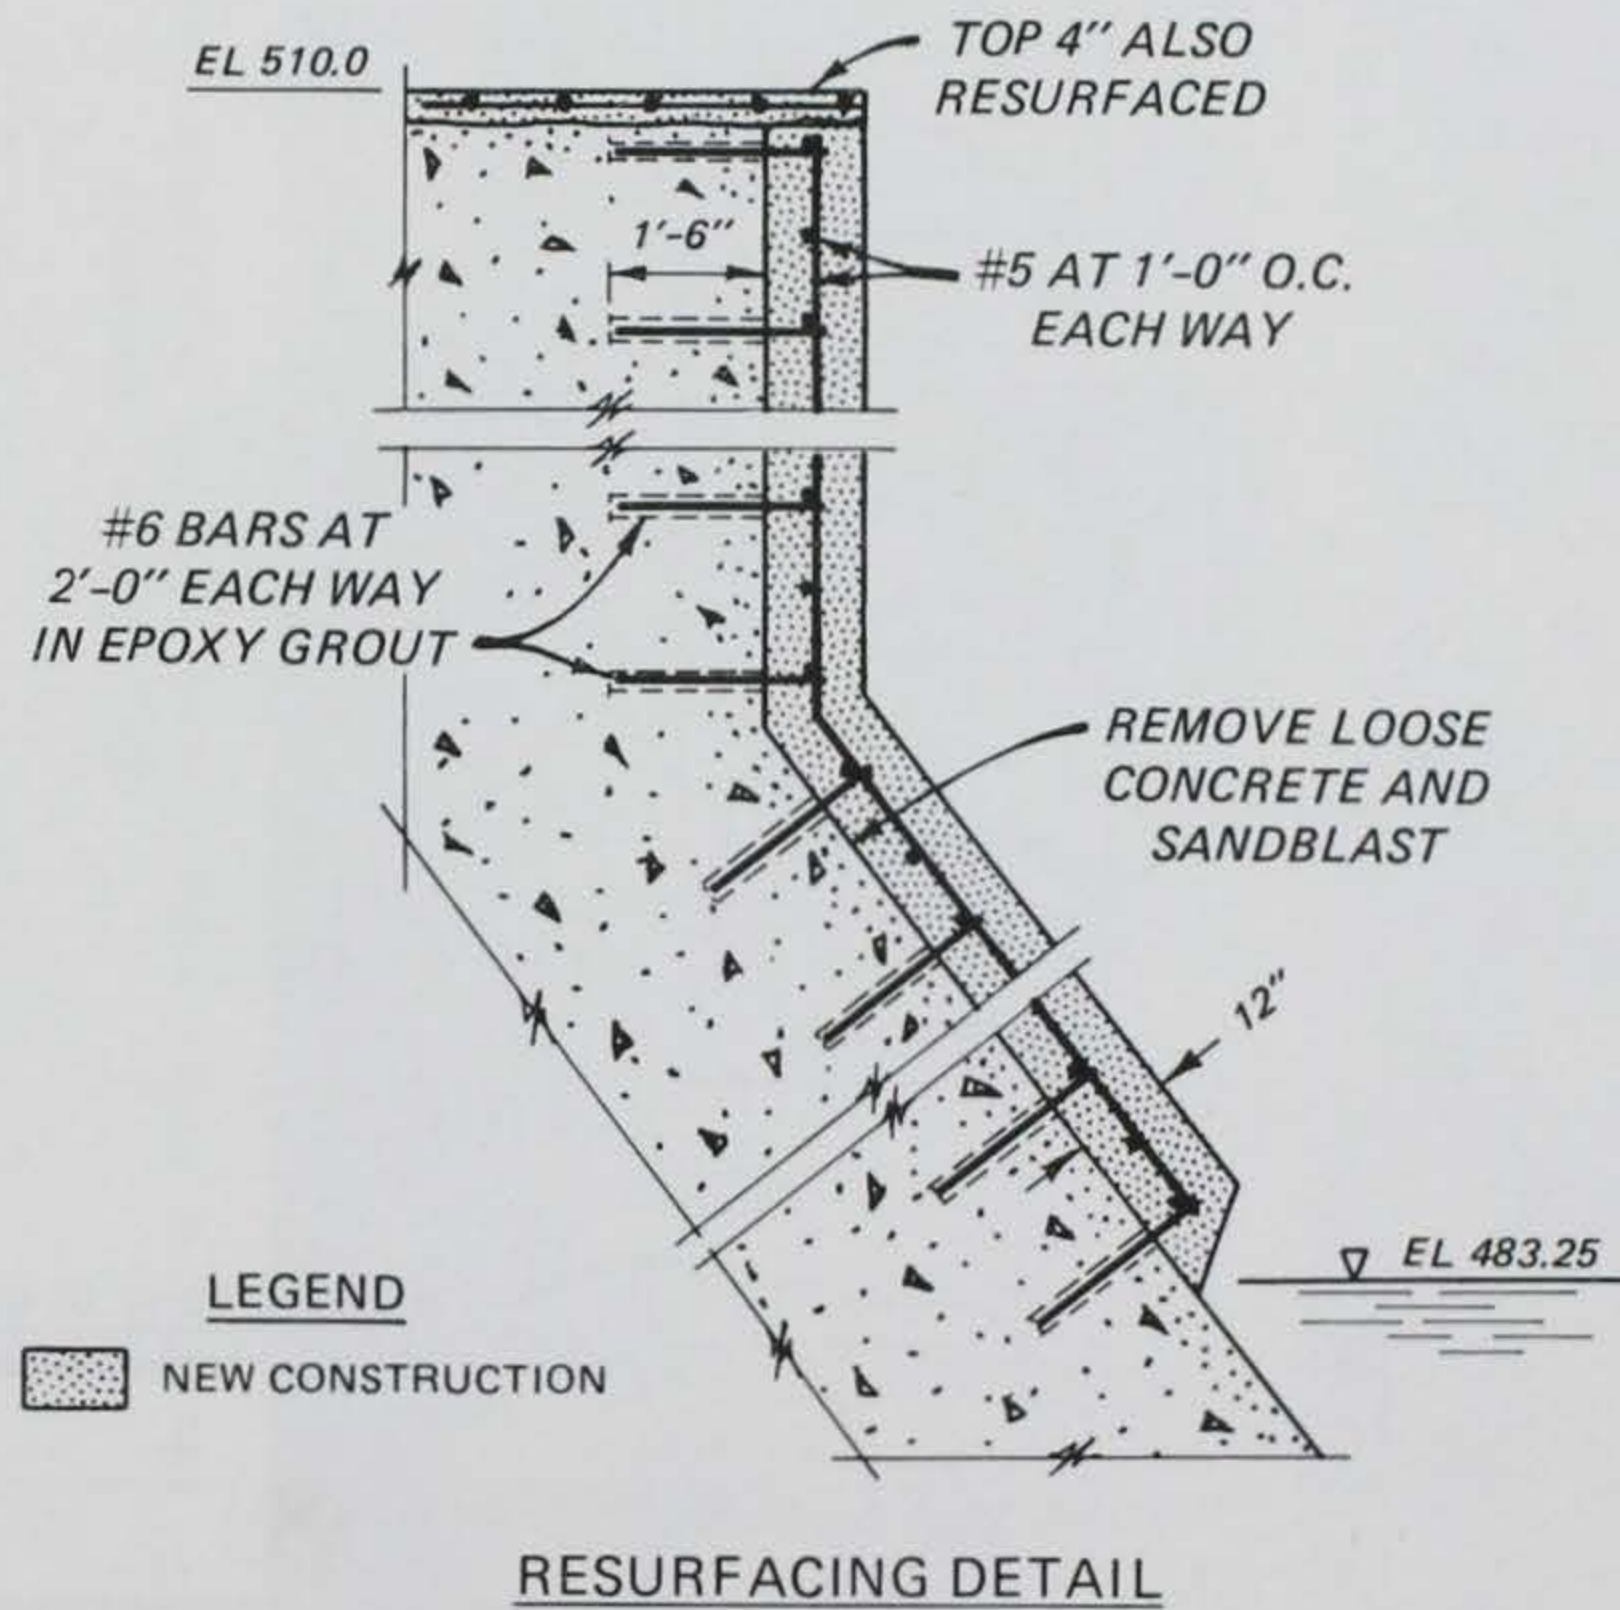
Figure 38. River wall resurfacing, Dresden Island Lock

83. The 12-in. thick concrete overlay on the backside of the river wall was placed over the existing weathered concrete (Figure 38). The new concrete was intended to serve as a sealer and to protect the concrete below from further disintegration. The existing weathered concrete was not removed for reasons of economy. It was believed that with anchored concrete, where structural and user considerations permit, this method may be the optimum repair

79. Following removal of concrete to a depth of 17 in. from the original wall surface, the lock walls were resurfaced as shown in Figures 37 and 38. Concrete anchors were No. 6 reinforcing bars spaced on 2-ft centers each way. The anchors were embedded using two-component polyester resin grout cartridges. Insertion of the anchor into the drill hole ruptured the seal between the two-component resin in the previously installed cartridge. Mixing of the grout was accomplished by spinning the anchor using an electric drill. A straight anchor bar was selected for ease in attachment to the drill chuck. The size, length of embedment, and spacing of the anchors were arbitrarily selected using engineering judgment. To assure adequate embedment of the anchors, pull-out tests were specified. Three anchors were specified to be

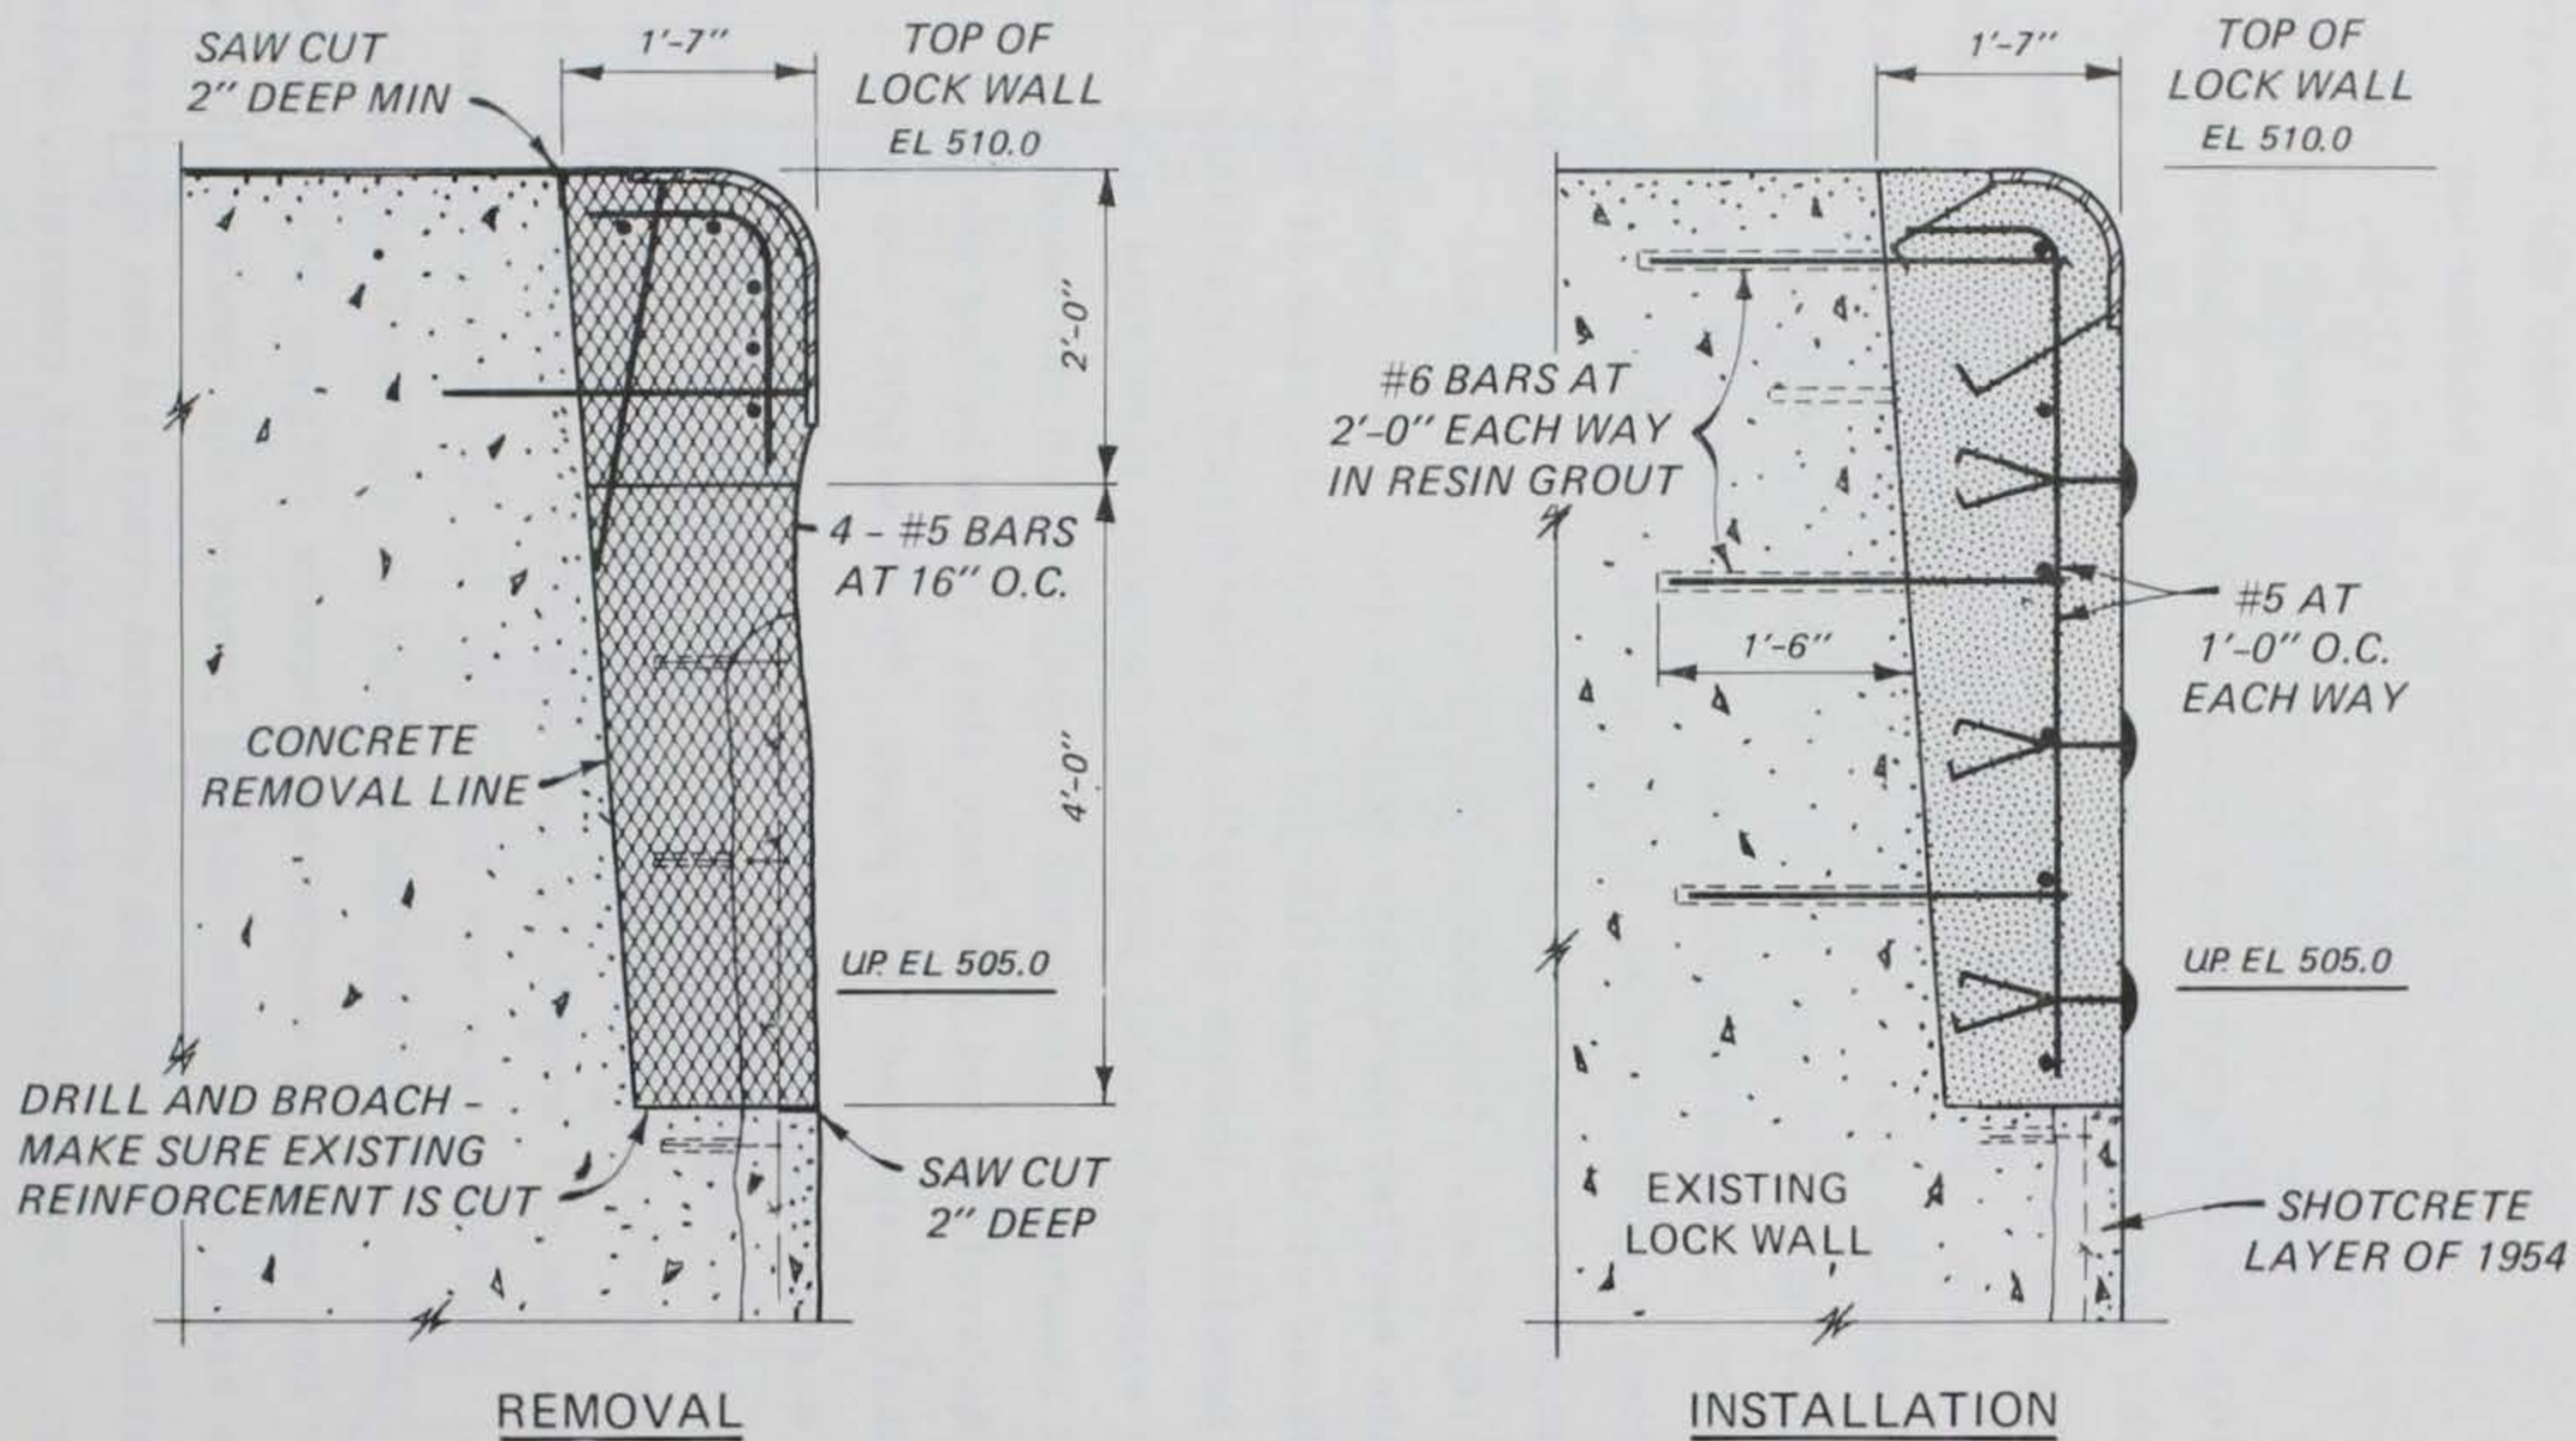
Figure 39. Armor installation in portions of lock wall previously resurfaced with shotcrete, Dresden Island Lock

82. Wall armor was installed in that portion of the lock walls previously repaired by shotcreting as shown in Figure 39. Note that at the bottom removal line drilling and broaching was specified to prevent cracking in the concrete below. Similar armor was installed in the concrete resurfacing.
