TECHNICAL REPORT REMR-CS-13

**REHABILITATION OF NAVIGATION  
LOCK WALLS: CASE HISTORIES**

James E. McDonald

December 1987

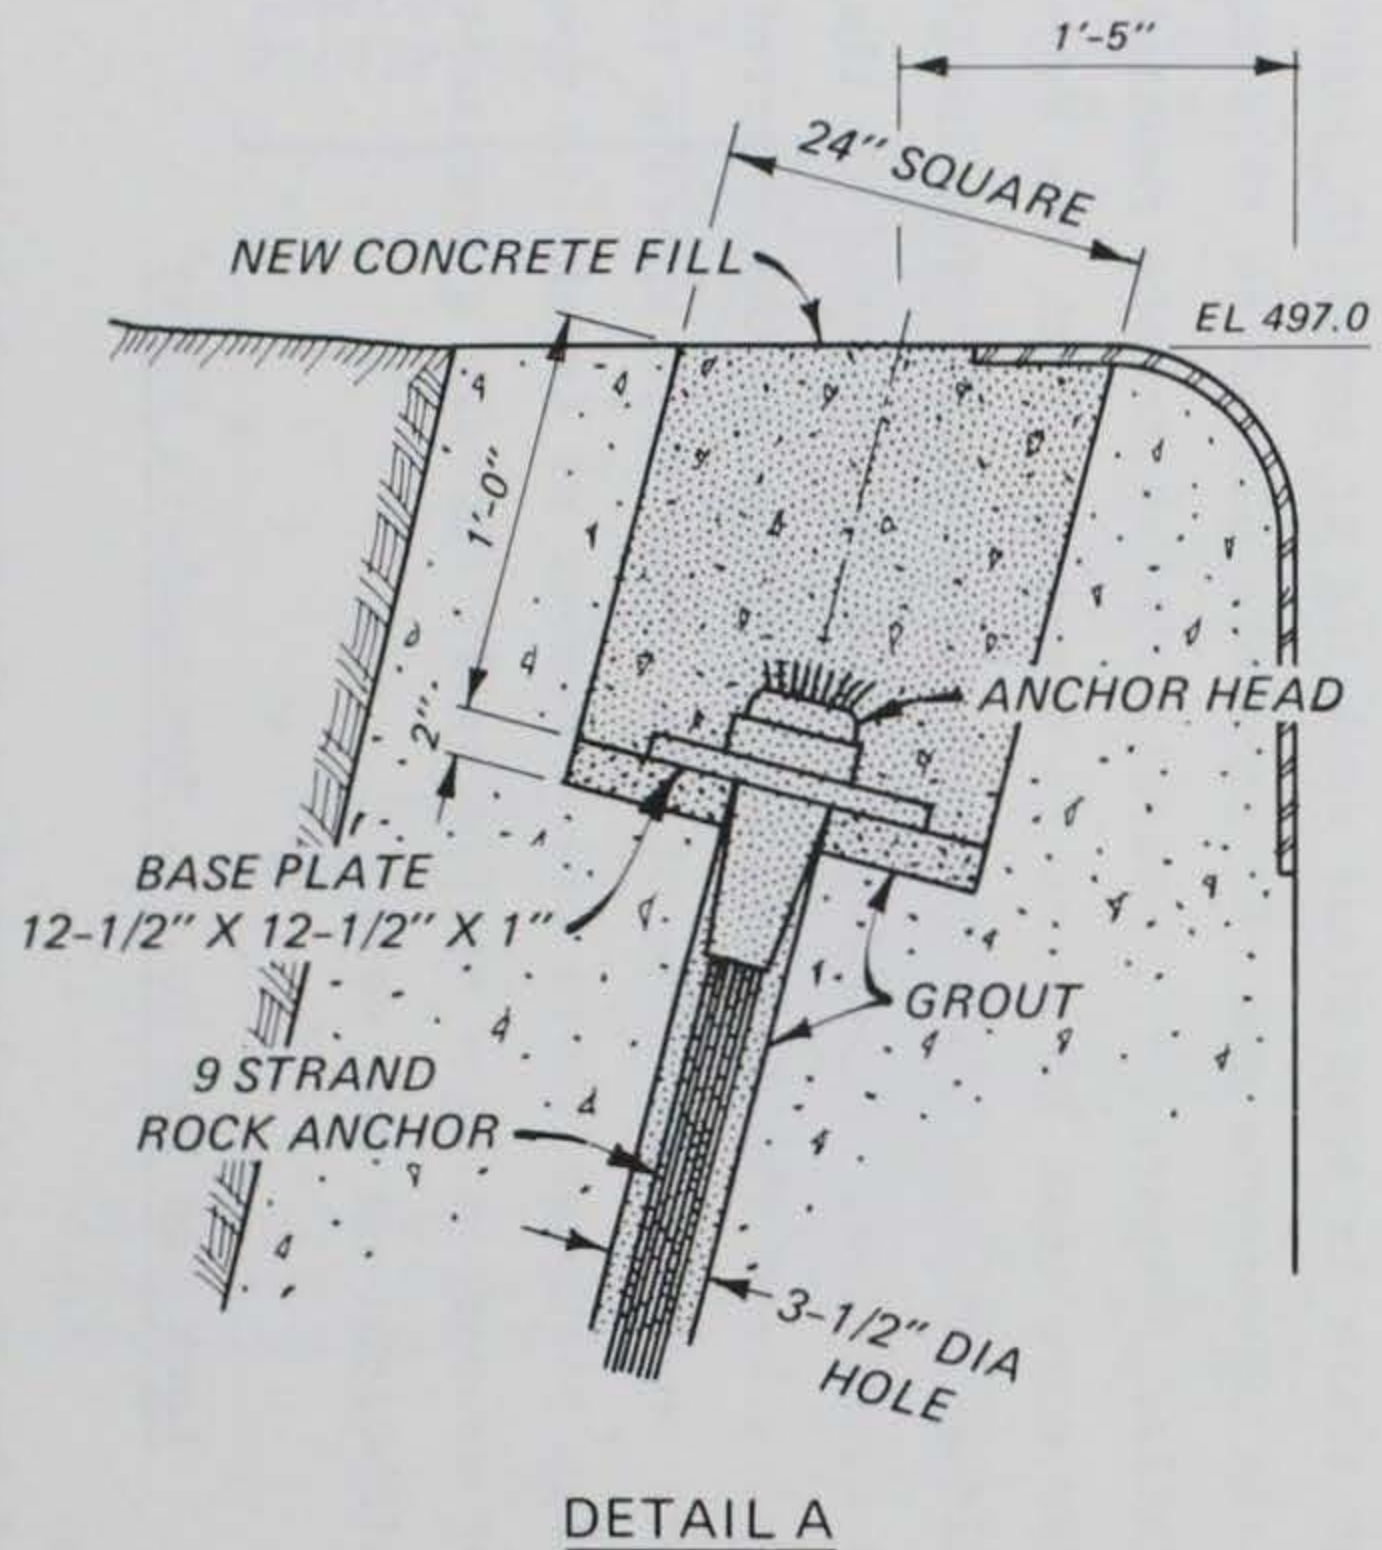
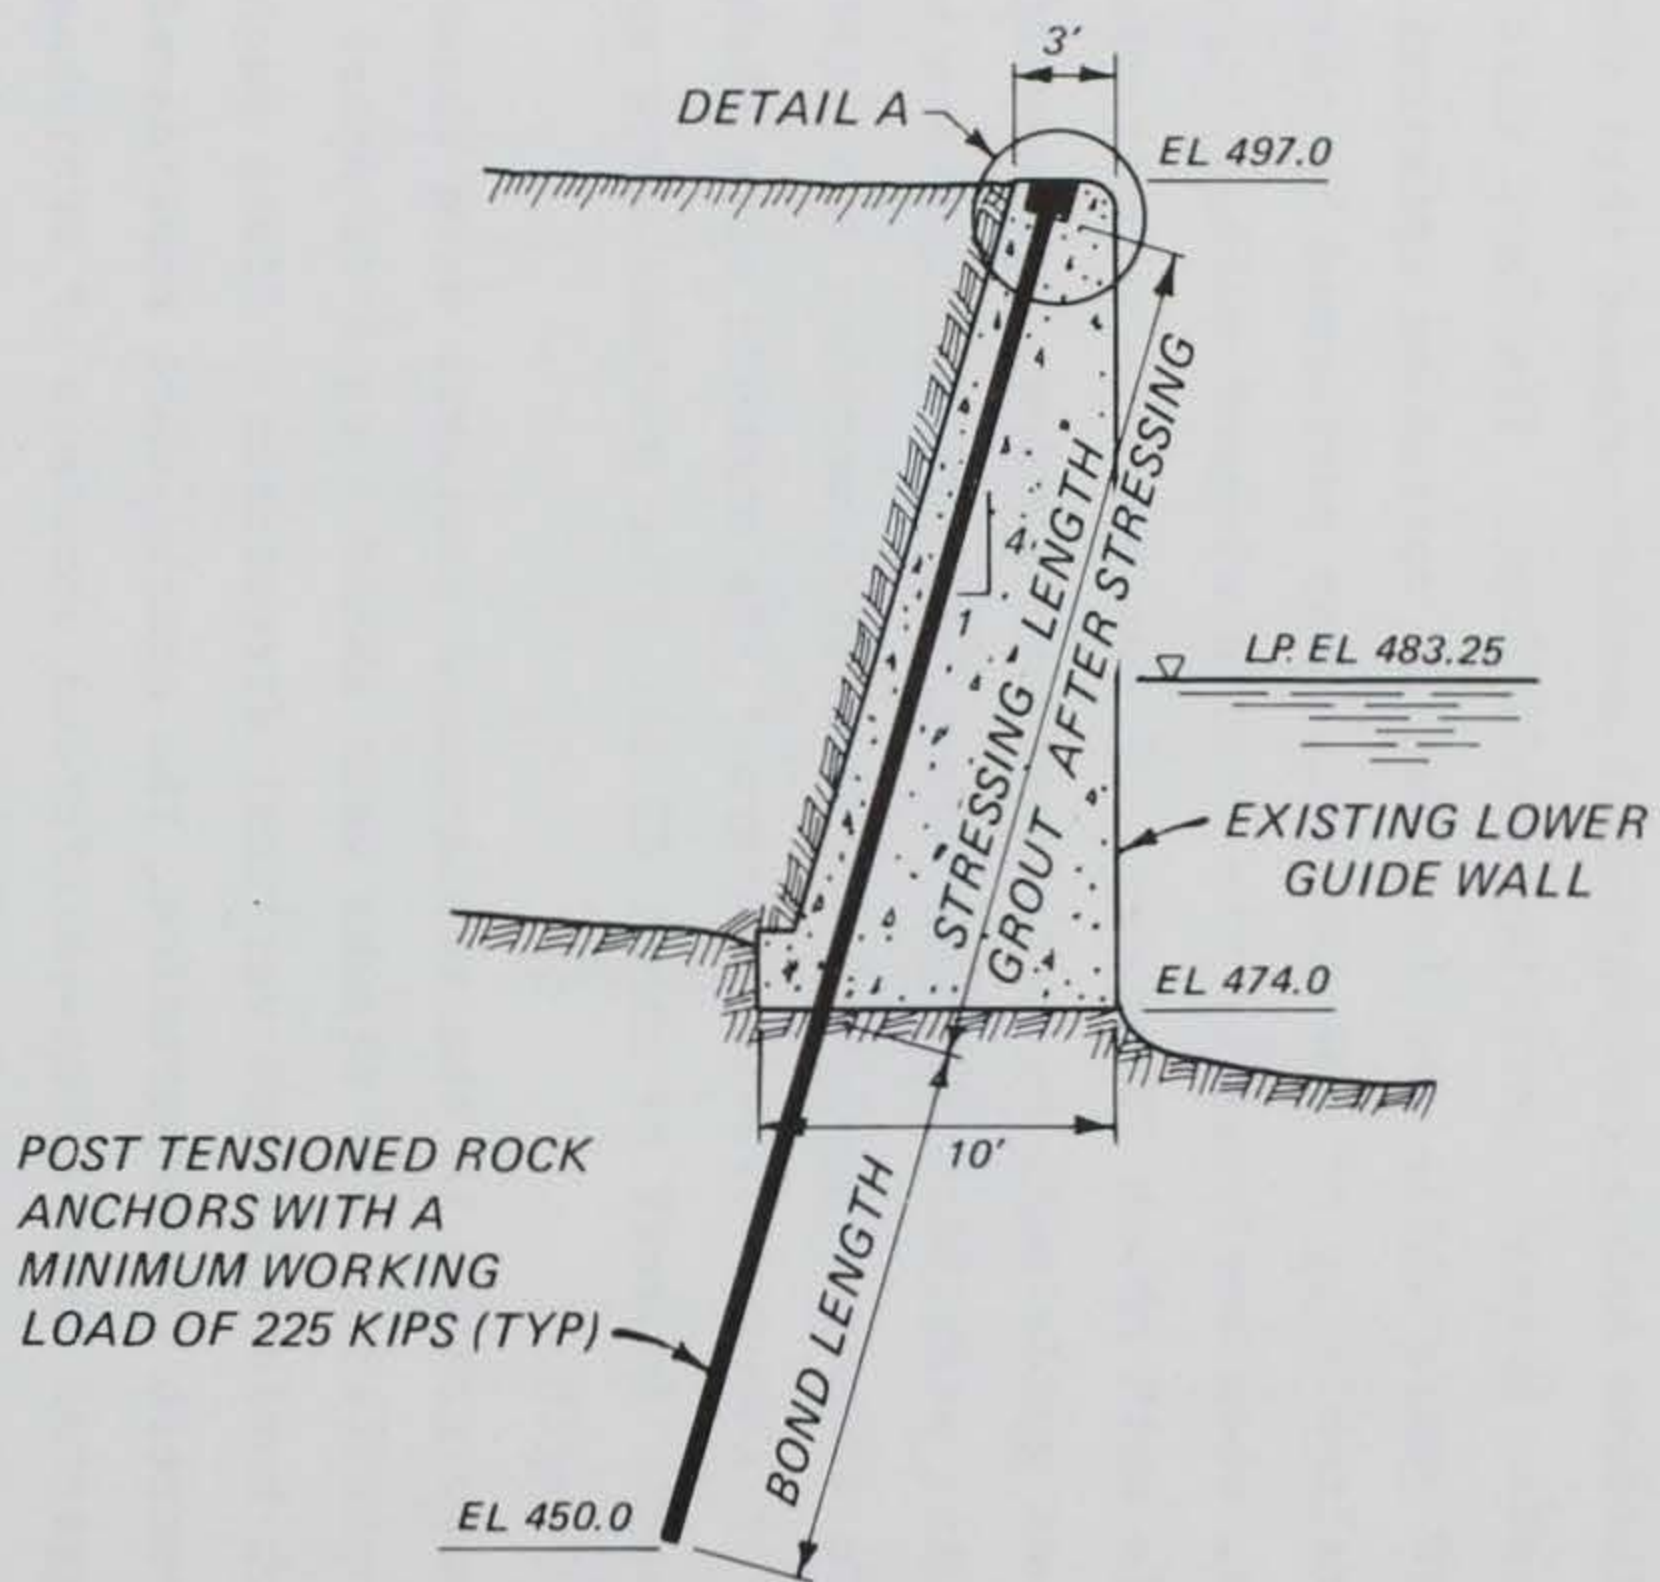
Figure 40. Lower guide wall stabilization, Dresden Island Lock

84. Calculations using conventional methods showed that the lower guide wall was usable under normal operating conditions. The fact that the wall had stood for about 40 years while the lock was in operation appeared to say something about the reliability of the analysis when performed by conventional methods. However, when analyzed by the finite element method, the wall was found to be stable with about 25 percent of the base in compression. Stabilization of the lower guide wall by posttensioned tendons was considered necessary to increase its stability against overturning. The anchors were nine-strand, seven-wire anchors, designed for 225 kips working load (Figure 40). They were spaced at about 7-1/2-ft centers. The anchors were about 48-ft long with a bonding length in rock of about 25 ft. The anchors were embedded in grout their full length.

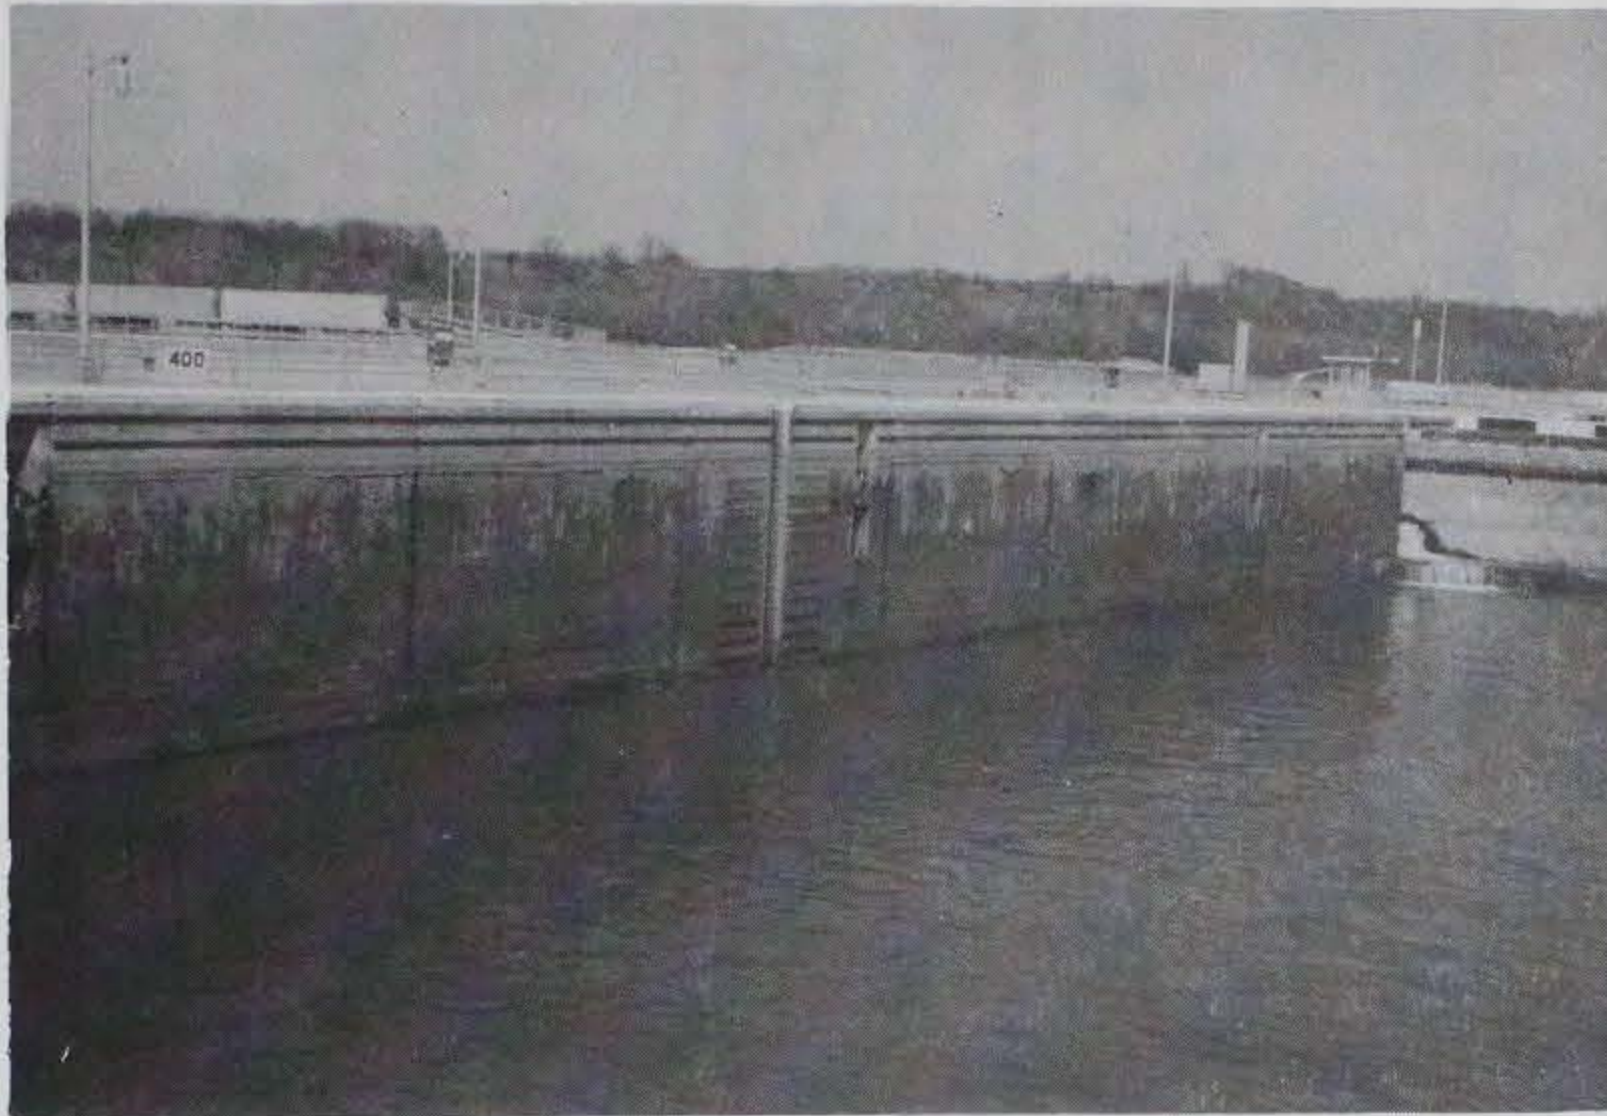
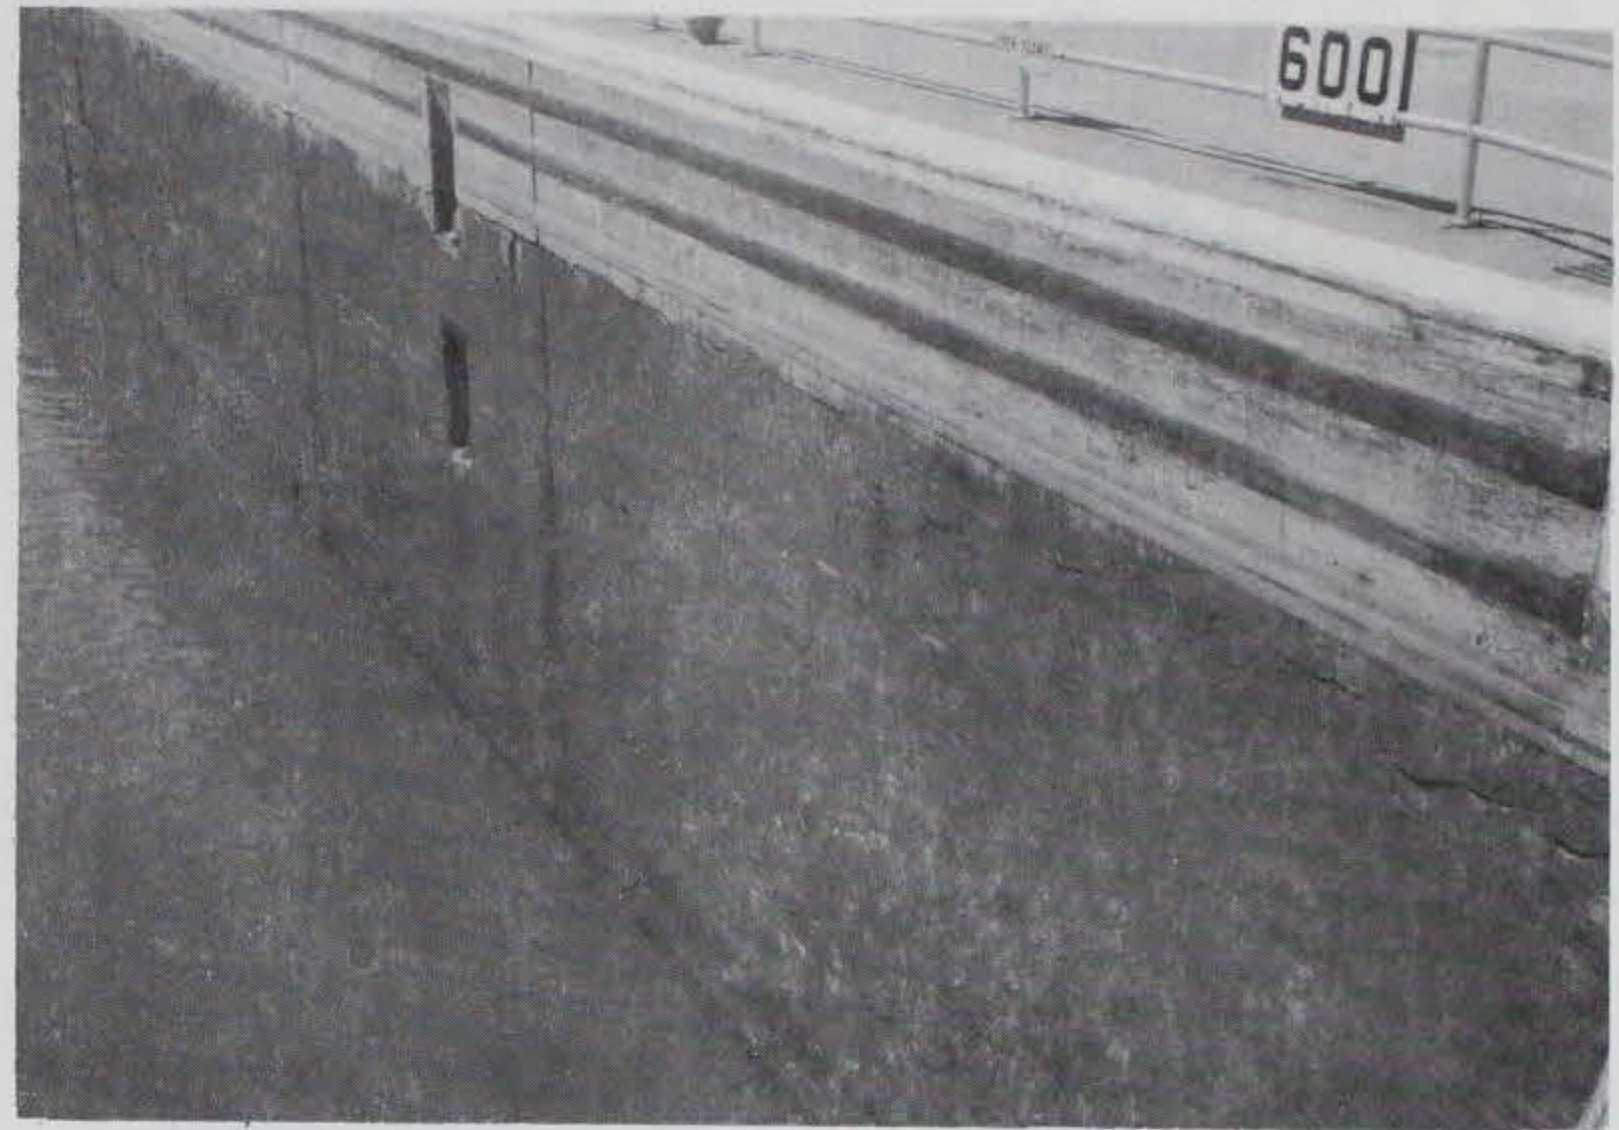
86. Although there is some minor spalling at monolith joints and at the interface between the shotcrete and the concrete placed in 1978 when horizontal armor was installed (Figure 41), overall the shotcrete remains in excellent condition after more than 30 years in service. With the exception of some isolated spalling (Figure 42), the concrete resurfacing inside the lock chamber is in good condition. Cracking previously reported in the replacement concrete has generally been obliterated by staining on the concrete surface. The concrete overlay on the back side of the river wall appears to be in generally good condition although there are a number of cracks in some areas (Figure 43). Minor seepage occurs sporadically through a horizontal cold joint located at midheight on the wall.

Figure 41. Typical condition of wall sections resurfaced with shotcrete, 1986, Dresden Island Lock

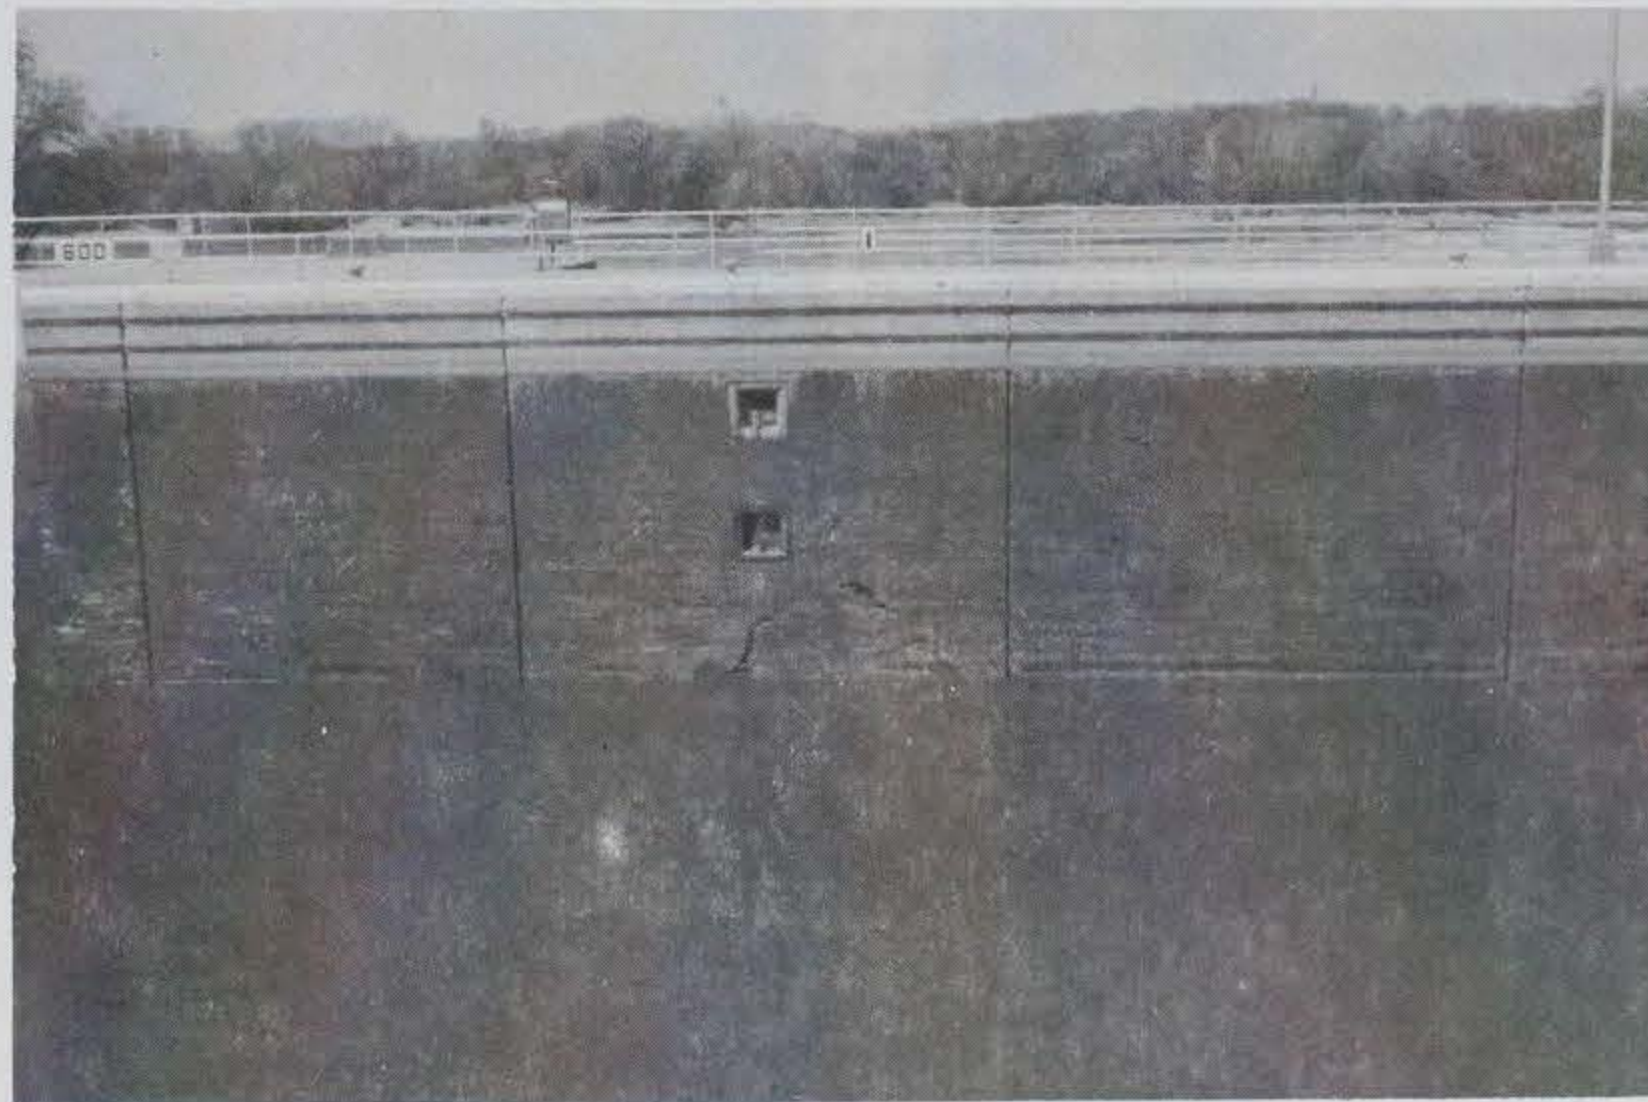
85. Shrinkage cracks in the replacement concrete were observed during the resurfacing operation. The cracks were about 4 to 8 ft apart and generally ran in both horizontal and vertical directions. Since such cracking may accelerate concrete disintegration, the cracks were considered undesirable. It was suggested that fiber-reinforced concrete or shrinkage compensating cement might be beneficial in eliminating such cracking (Juzenas 1979).

Figure 42. Condition of replacement concrete, 1986  
Dresden Island Lock

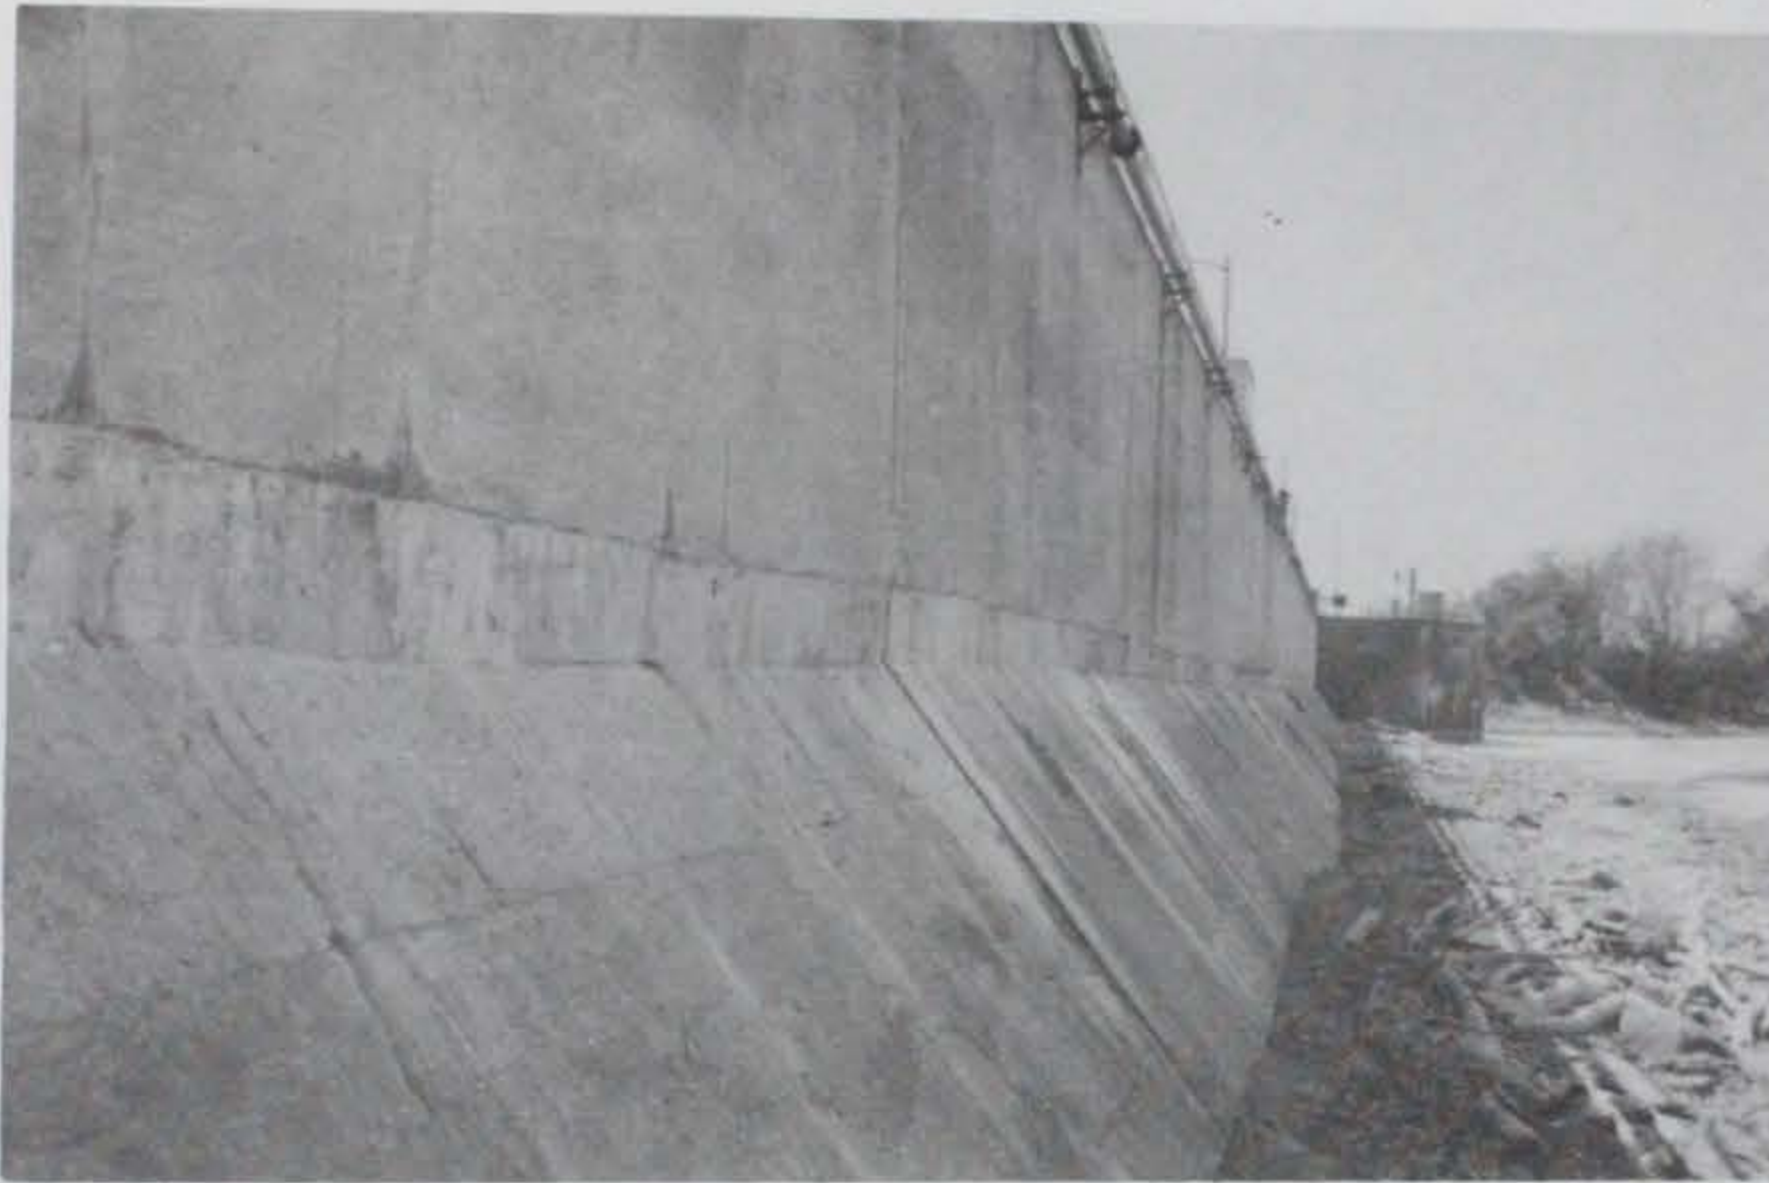
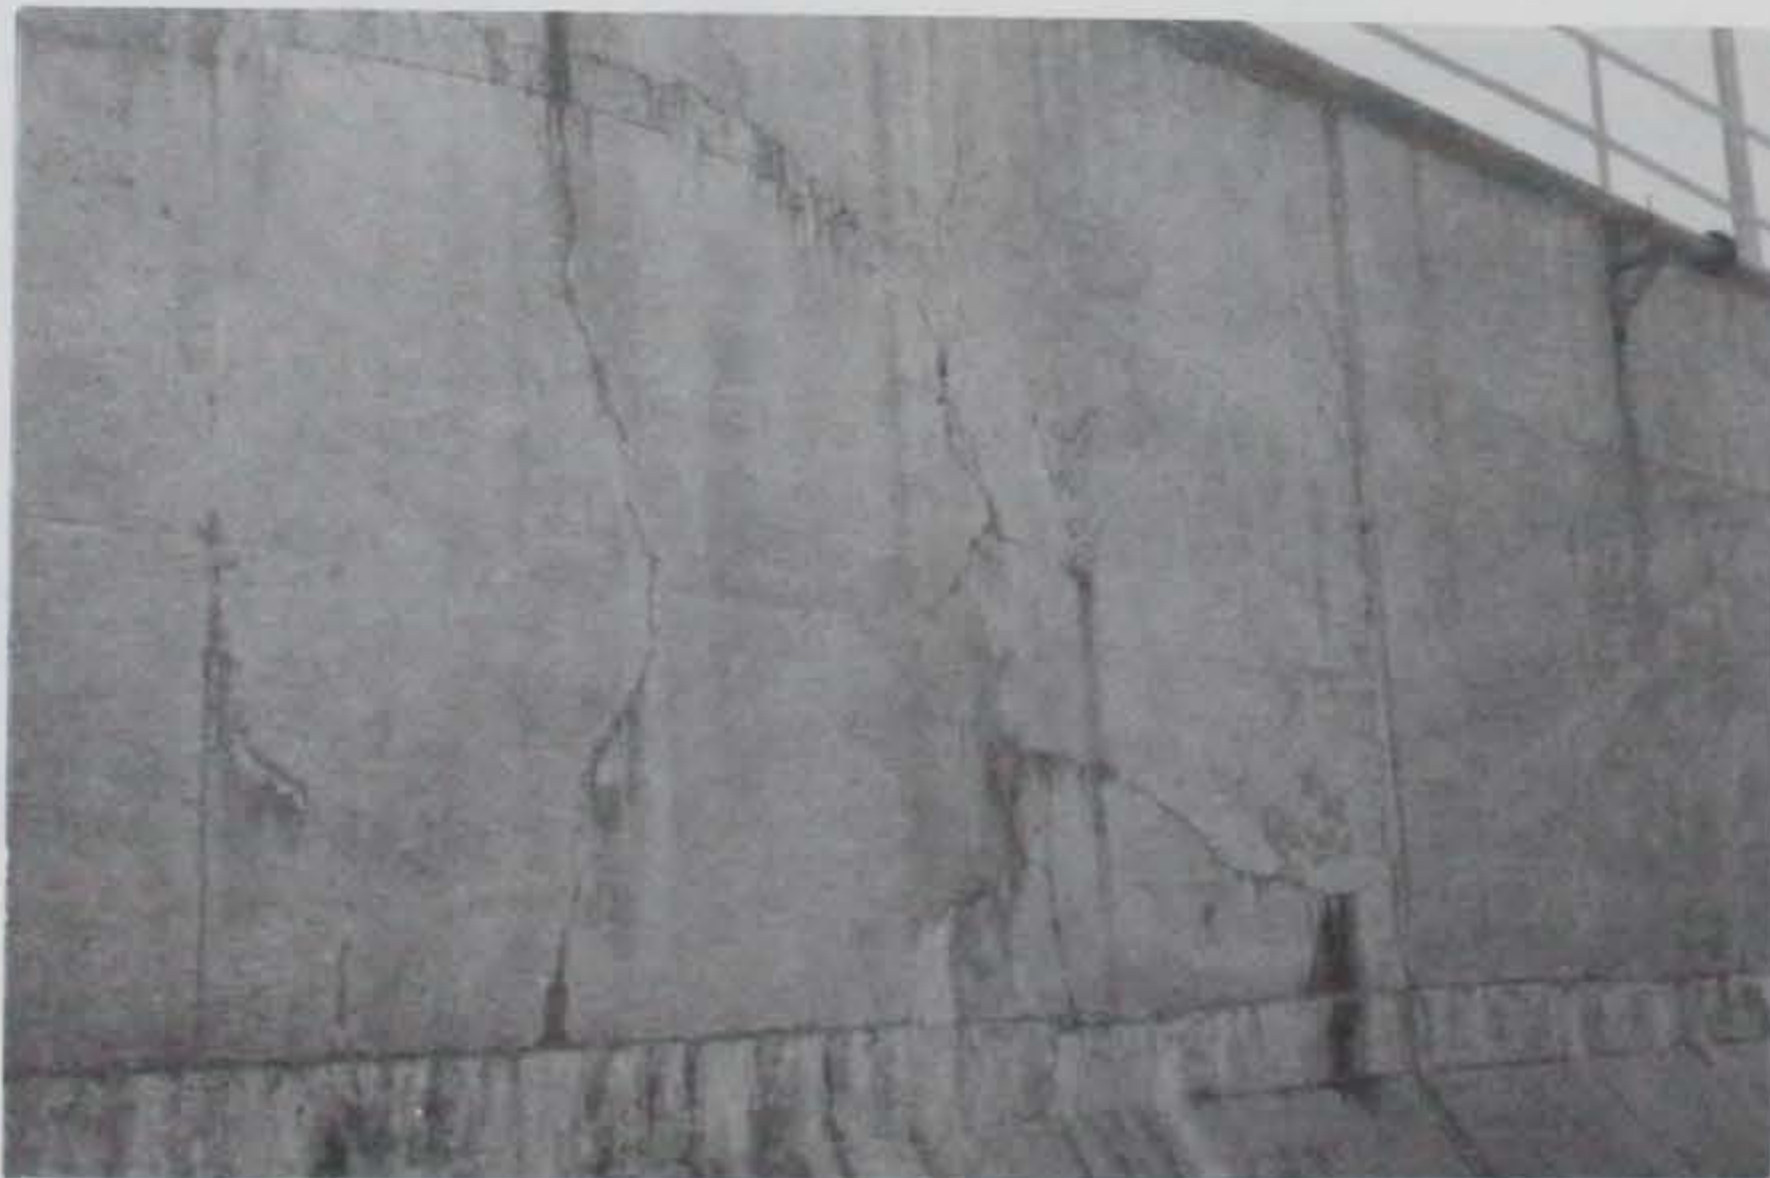
Figure 43. Typical condition of concrete overlay on back side of river wall, 1986, Dresden Island Lock

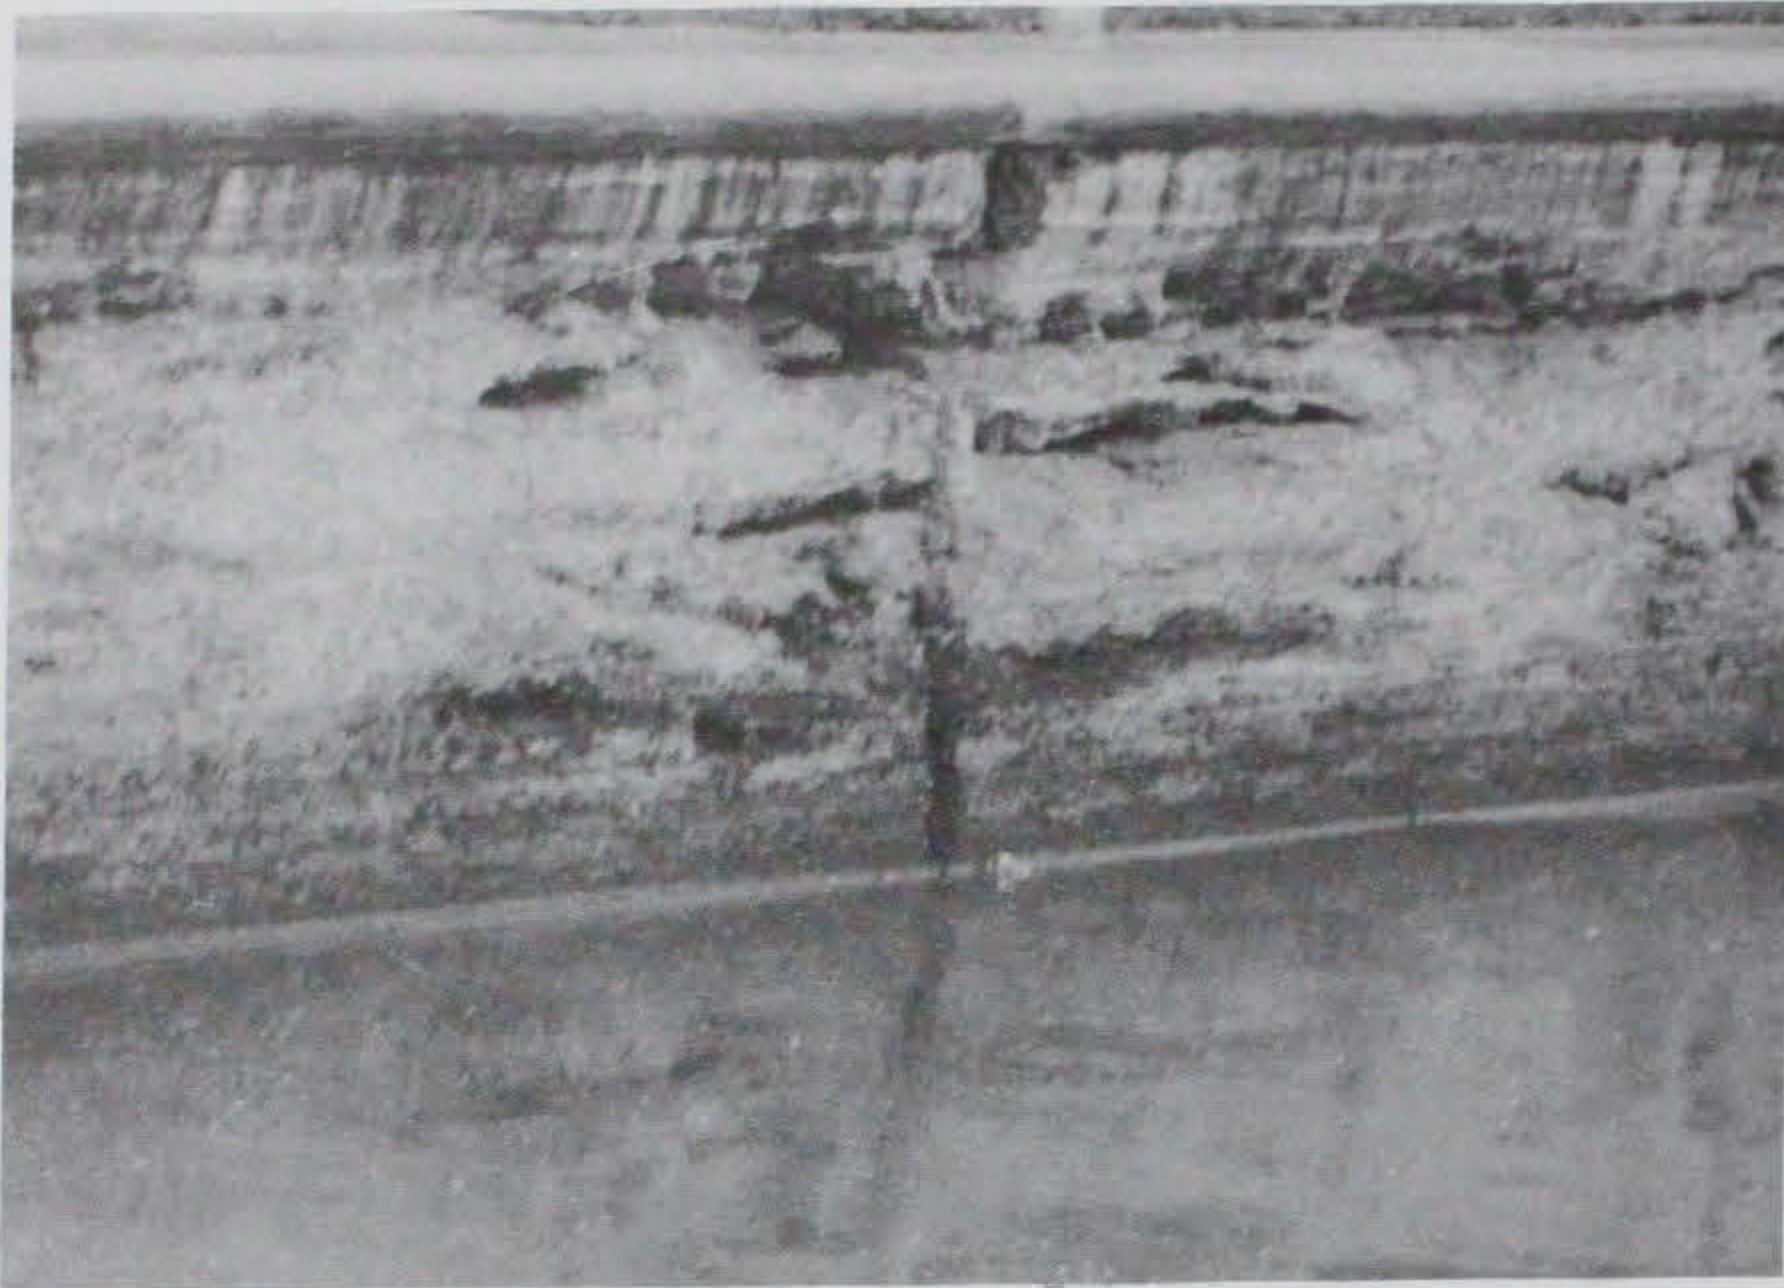
104. The upper guide wall was constructed during the period 1905-1907 and extended in 1926. Severe scouring and gouging had occurred at areas where tows had hit the wall in lining up for lock entry. Wall faces had been scoured back an average of 6 to 8 in. Maximum gouge depth in one reach of the wall was 36 in. (Figure 49). Wall thickness in the area of the gouging is 4 ft from the top of the wall to elevation 731.83 and 5 ft 2 in. between elevations 731.83 and 728.17. Continued scouring and gouging could have resulted in failure of the guide wall. One section from Station 4+25A to Station 6+52A was designated as extremely critical, and the repairs were started by District hired-labor forces in August 1976.

Figure 49. Upper guide wall deterioration, 1974,  
Lock No. 3, Monongahela River

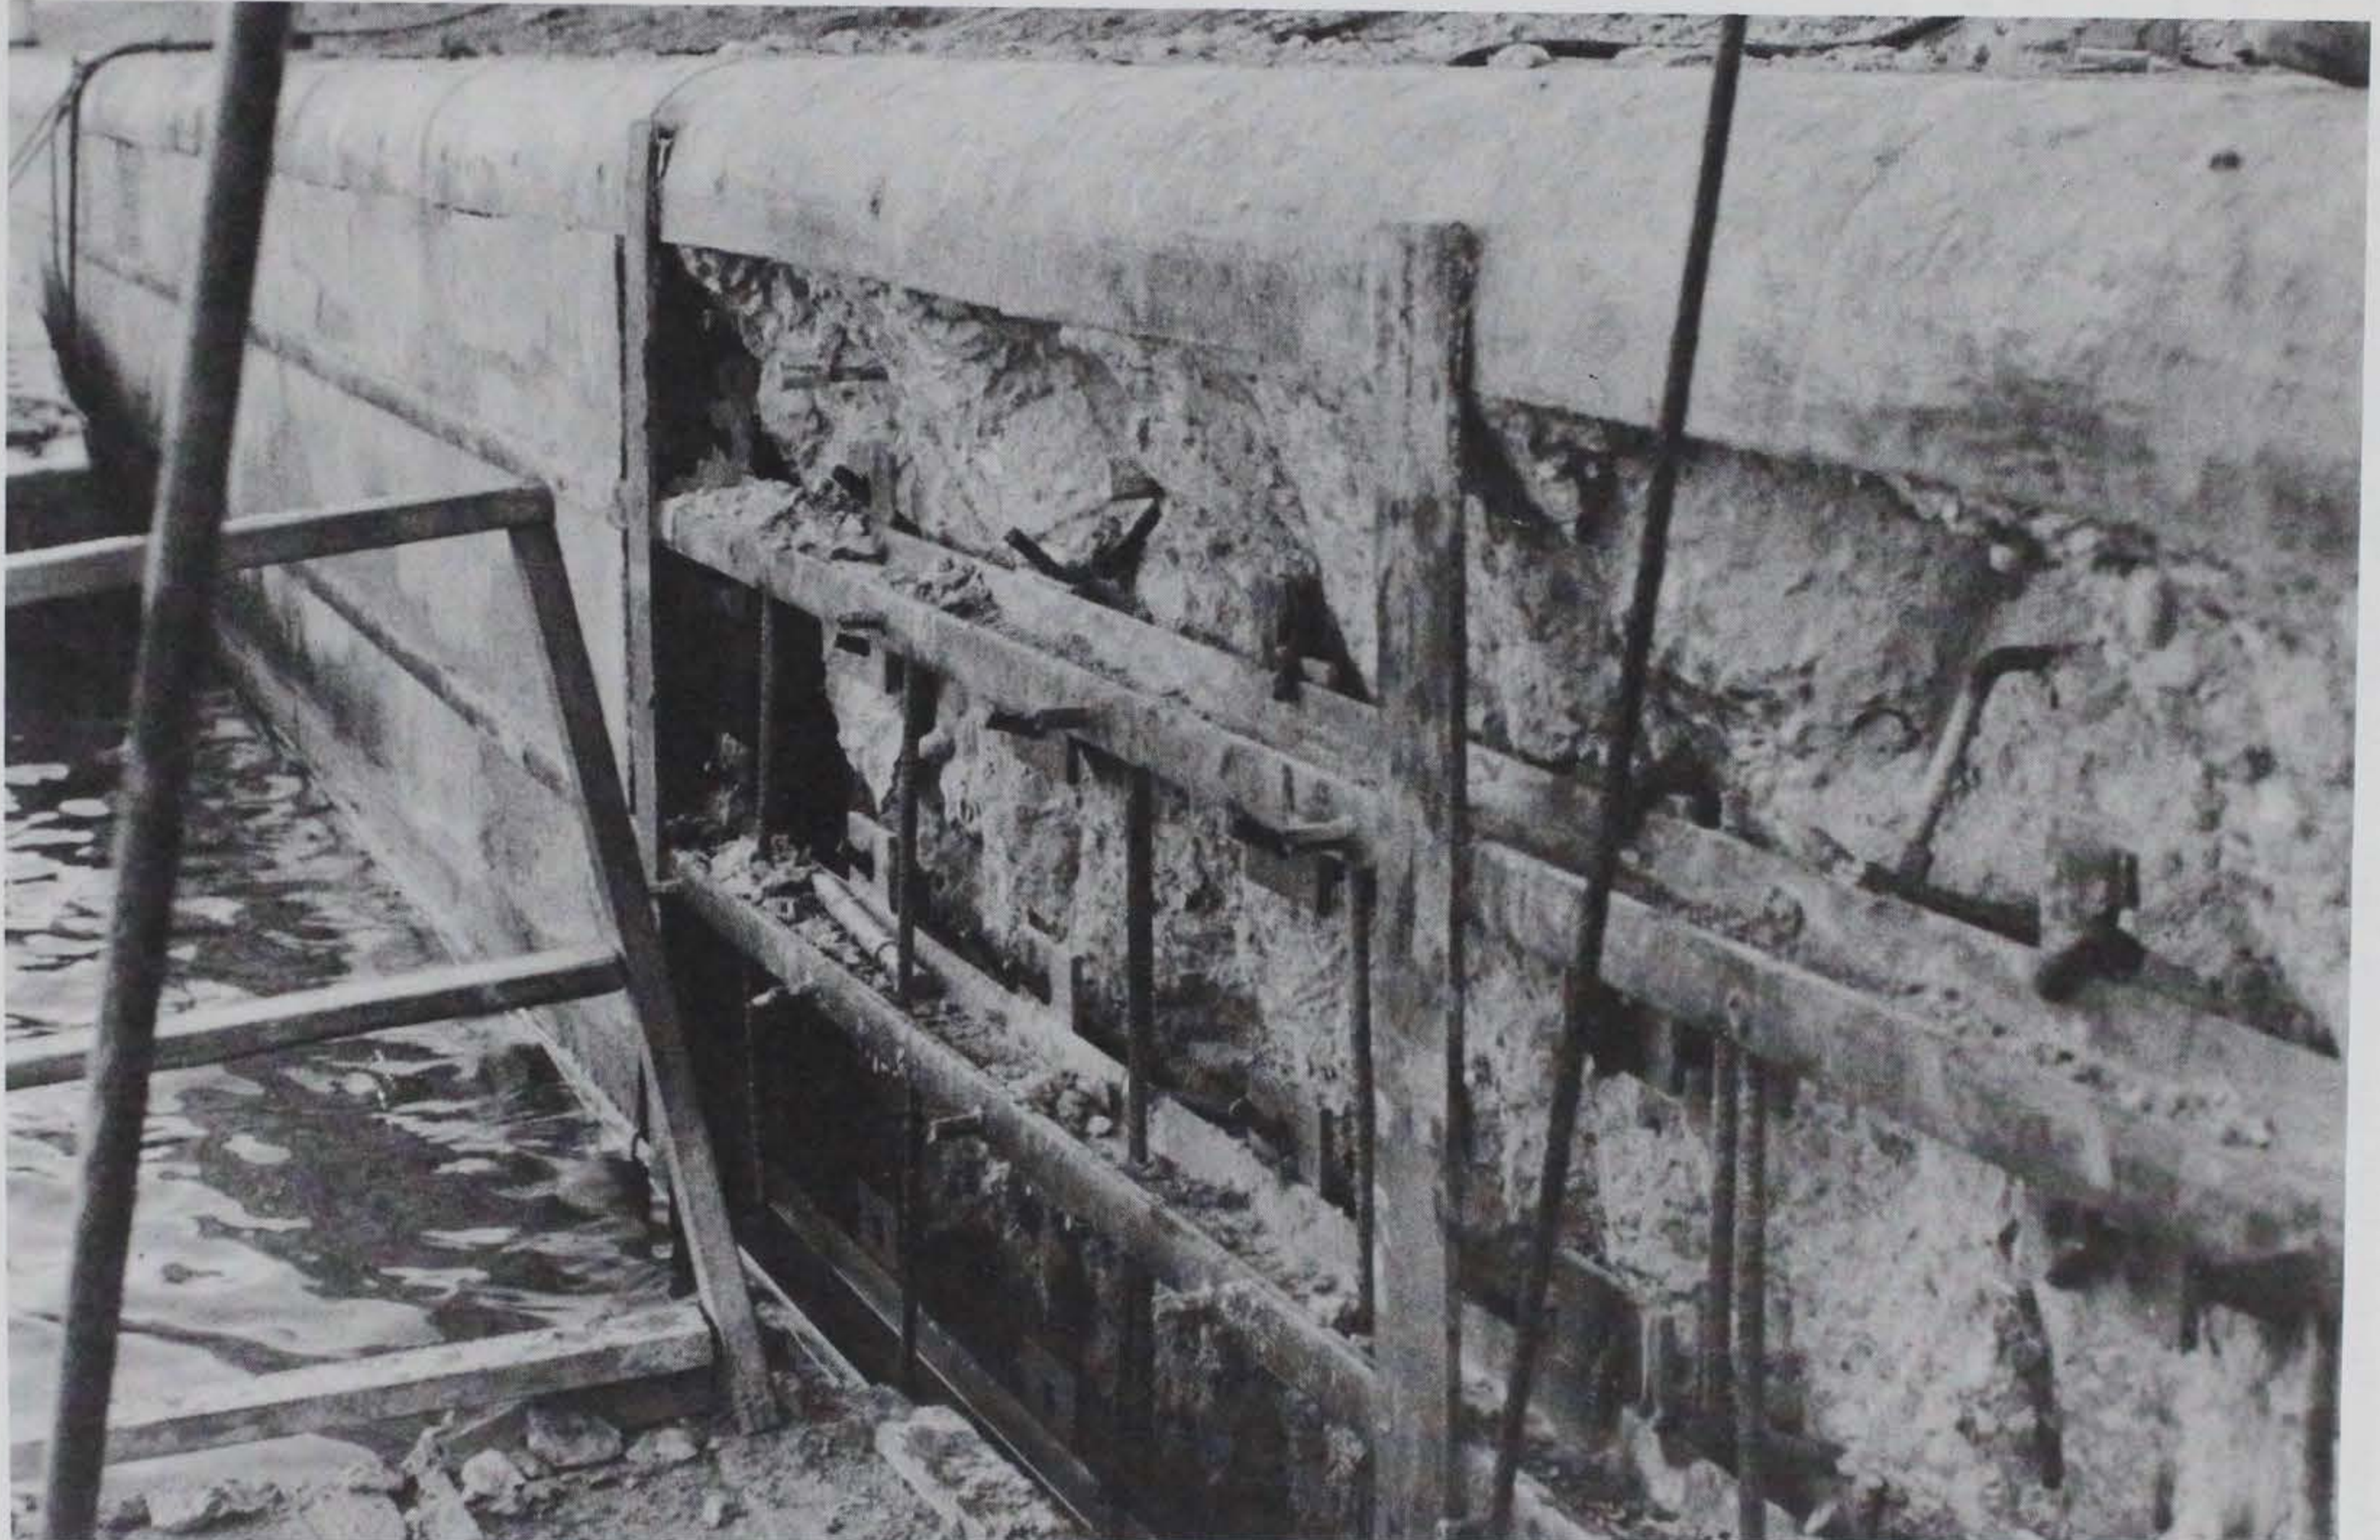
Figure 50. Upper guide wall repairs, December 1976, Lock No. 3, Monongahela River

105. The work was done on one monolith at a time beginning at Station 4+25A. Old concrete was removed from the face of the wall by jackhammer where necessary to provide a minimum depth of 12 in. for the new concrete. The repair extended from the top of the wall to the waterline (approximately 6 ft). After the concrete was removed, No. 7 dowels were grouted into the wall on 2-ft centers. Initially Sikadur Hi-Mod Gel, as manufactured by the Sika Corporation, was used to anchor the dowels. The gel proved difficult to inject into the holes, so a sand-cement grout was used instead. Wire mesh, 6 by 6, No. 6, was attached to the dowels. Three 35-ft sections of used 90-lb railroad rail were positioned in the wall, so the rail would extend 1/2 in. past the face of the wall. The rails were spaced 1 ft 8 in. apart vertically to act as wall armor (Figure 50). When the reinforcing and rails were in place, forms were erected for the wall face and concrete was placed. Ready-mix concrete with Type II cement was used. By mid-December, the work had been completed to Station 5+87A. High water and adverse weather conditions made it impractical to continue. The rest of the upper guide wall was repaired by the
