TECHNICAL REPORT REMR-CS-13

**REHABILITATION OF NAVIGATION  
LOCK WALLS: CASE HISTORIES**

James E. McDonald

December 1987

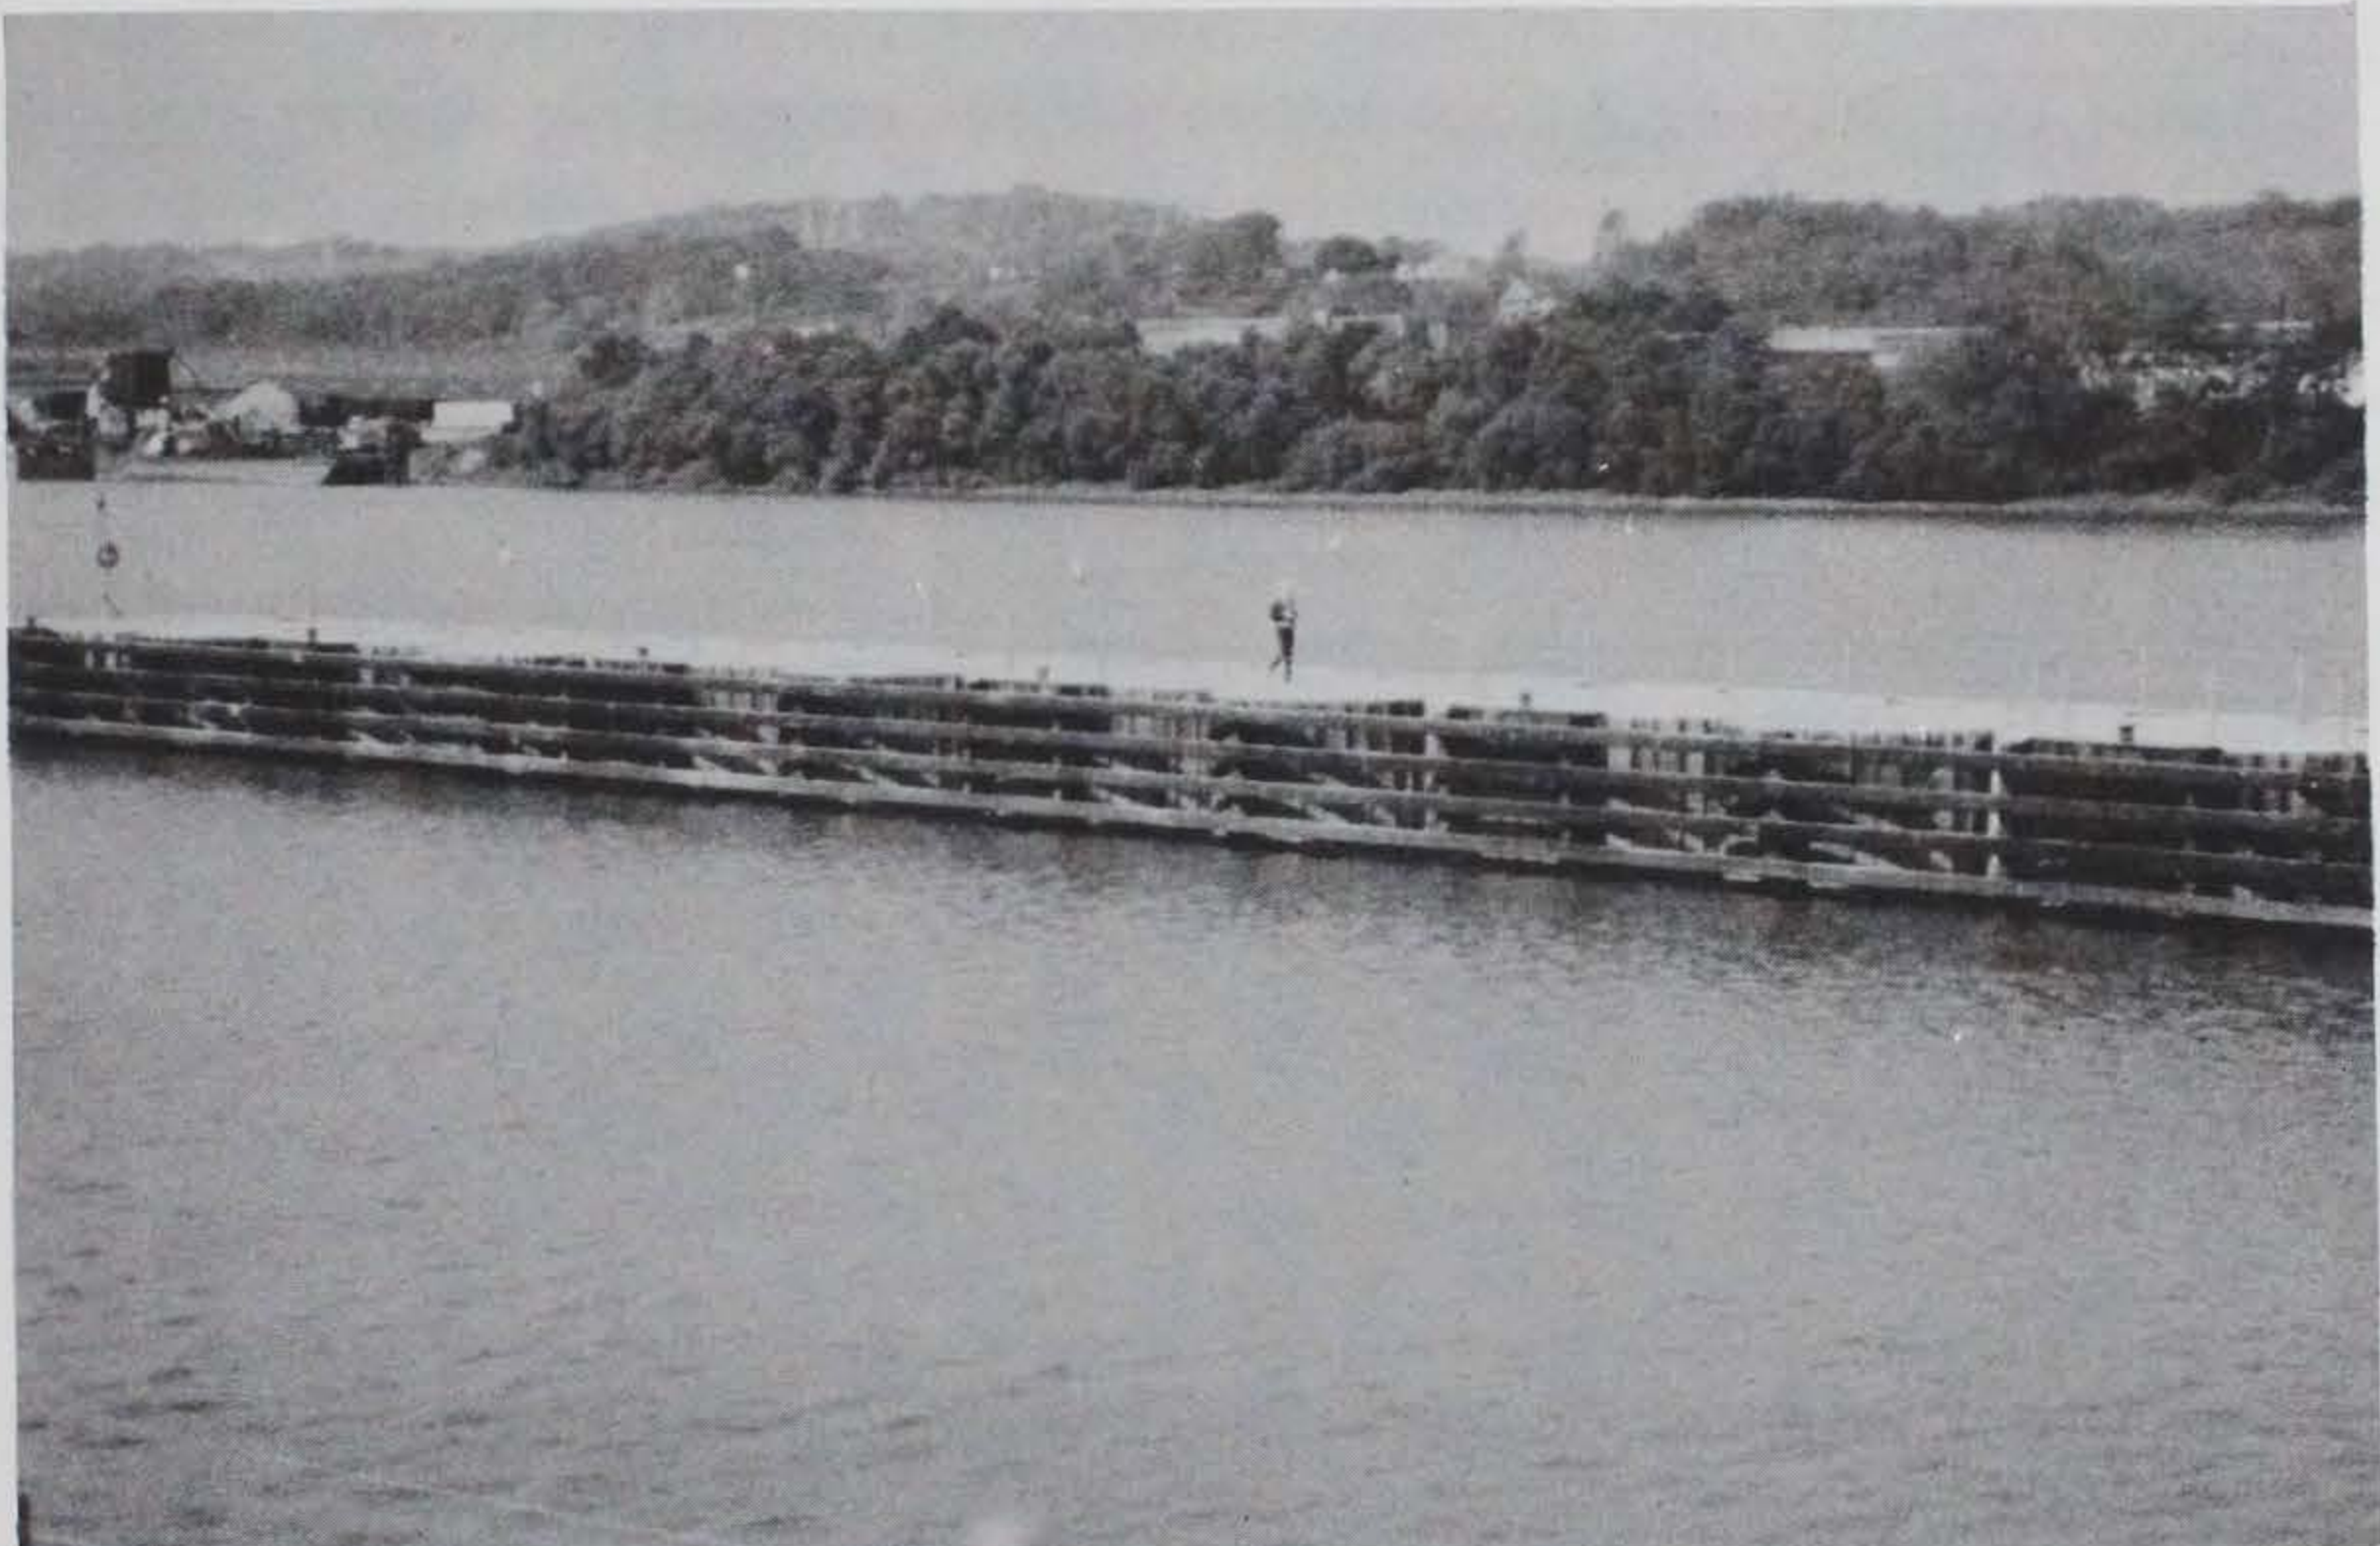
Figure 51. Upper guard wall extension, October 1977,  
Lock No. 3, Monongahela River

total contract price of \$520,448. The contractor, Crain Brothers, Incorporated, had a lot of prior experience with cell construction and thus was instrumental in successfully completing the work on schedule. There was no settlement in any of the concrete caps, and the caps were free of cracks. The uppermost cell, which is concrete-filled, had a few hairline cracks in the top surface.

112. A steel fender system, consisting of four rows of TS 10 by 10 tubing filled with concrete, was constructed on the landside of the cells. The upper guard wall extension (Figure 51) was completed in September 1977 at a

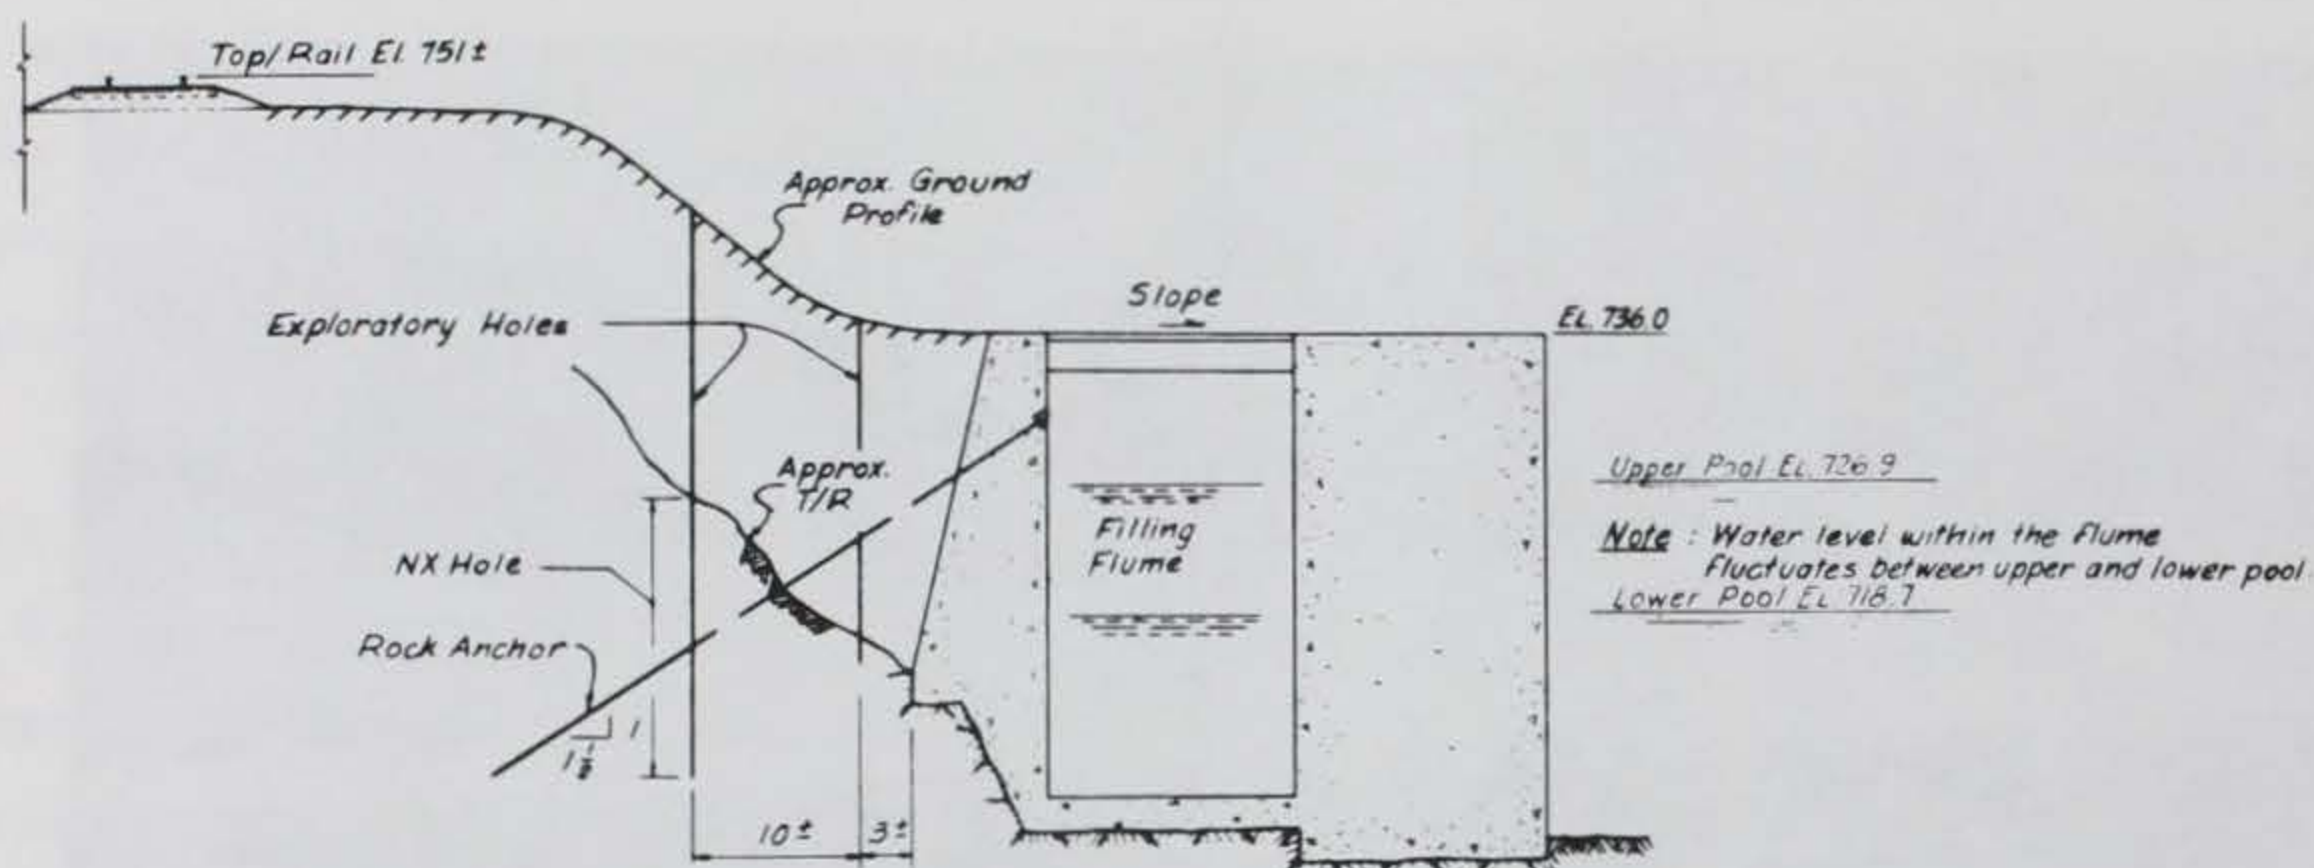
113. The filling flume for the land chamber was constructed in 1924. The landward retaining wall was found to be inherently unstable, relying on the flume deck bearing against the land wall to support it. The deck is of concrete beam and slab construction. Structural cracks extended through the

slabs and beams. The beams were crushed at both ends, and the deteriorated concrete in the beams exposed the reinforcing steel. There was evidence that some movement of the flume wall had occurred. With continued deterioration of the slab and beams, failure of the wall would have occurred.

Figure 52. Section through land chamber filling flume looking upstream, Lock No. 3, Monongahela River

114. It was determined that the best method of stabilizing the flume wall was with rock anchors (Figure 52). The original design called for the

installation of 97 rock anchors on an average spacing of 6 ft. Tendons were to be 1-1/4-in.-diam high tensile steel Dywidag thread bar anchors. Four of the anchors were to be tested to 140 kips or 75 percent of the ultimate bar strength, and all the bars were to be locked off at 112.5 kips or 60 percent of the bar strength. The design procedure was to drill a 4-in.-diam hole through the concrete wall and a 3-1/2-in.-diam hole through the overburden. Then a 3-in.-diam casing was to be installed in the hole. The hole into rock was 3 in. in diameter. The specifications called for testing for watertightness and pregrouting if necessary with subsequent redrilling. The bond length of the bars in rock, 20 ft, was to be grouted with a cement grout, and after a minimum setting time of 7 days, the bar was to be stressed. After stressing and checking, the stressing length of the bar would be grouted for corrosion protection.

Corporation of Wilkes-Barre, Pennsylvania, from 160-ksi minimum steel. The ultimate strength of this bar is 237.6 kips. The spacing was increased to an average of 8 ft, and the total number of anchors was reduced to 72. The testing requirement was modified so that the first 10 anchors installed, and thereafter one every monolith or not less than one out of five be tested to 190 kips, 80 percent of the ultimate strength of the bar. The lock-off load, 60 percent ultimate, was 142.8 kips.

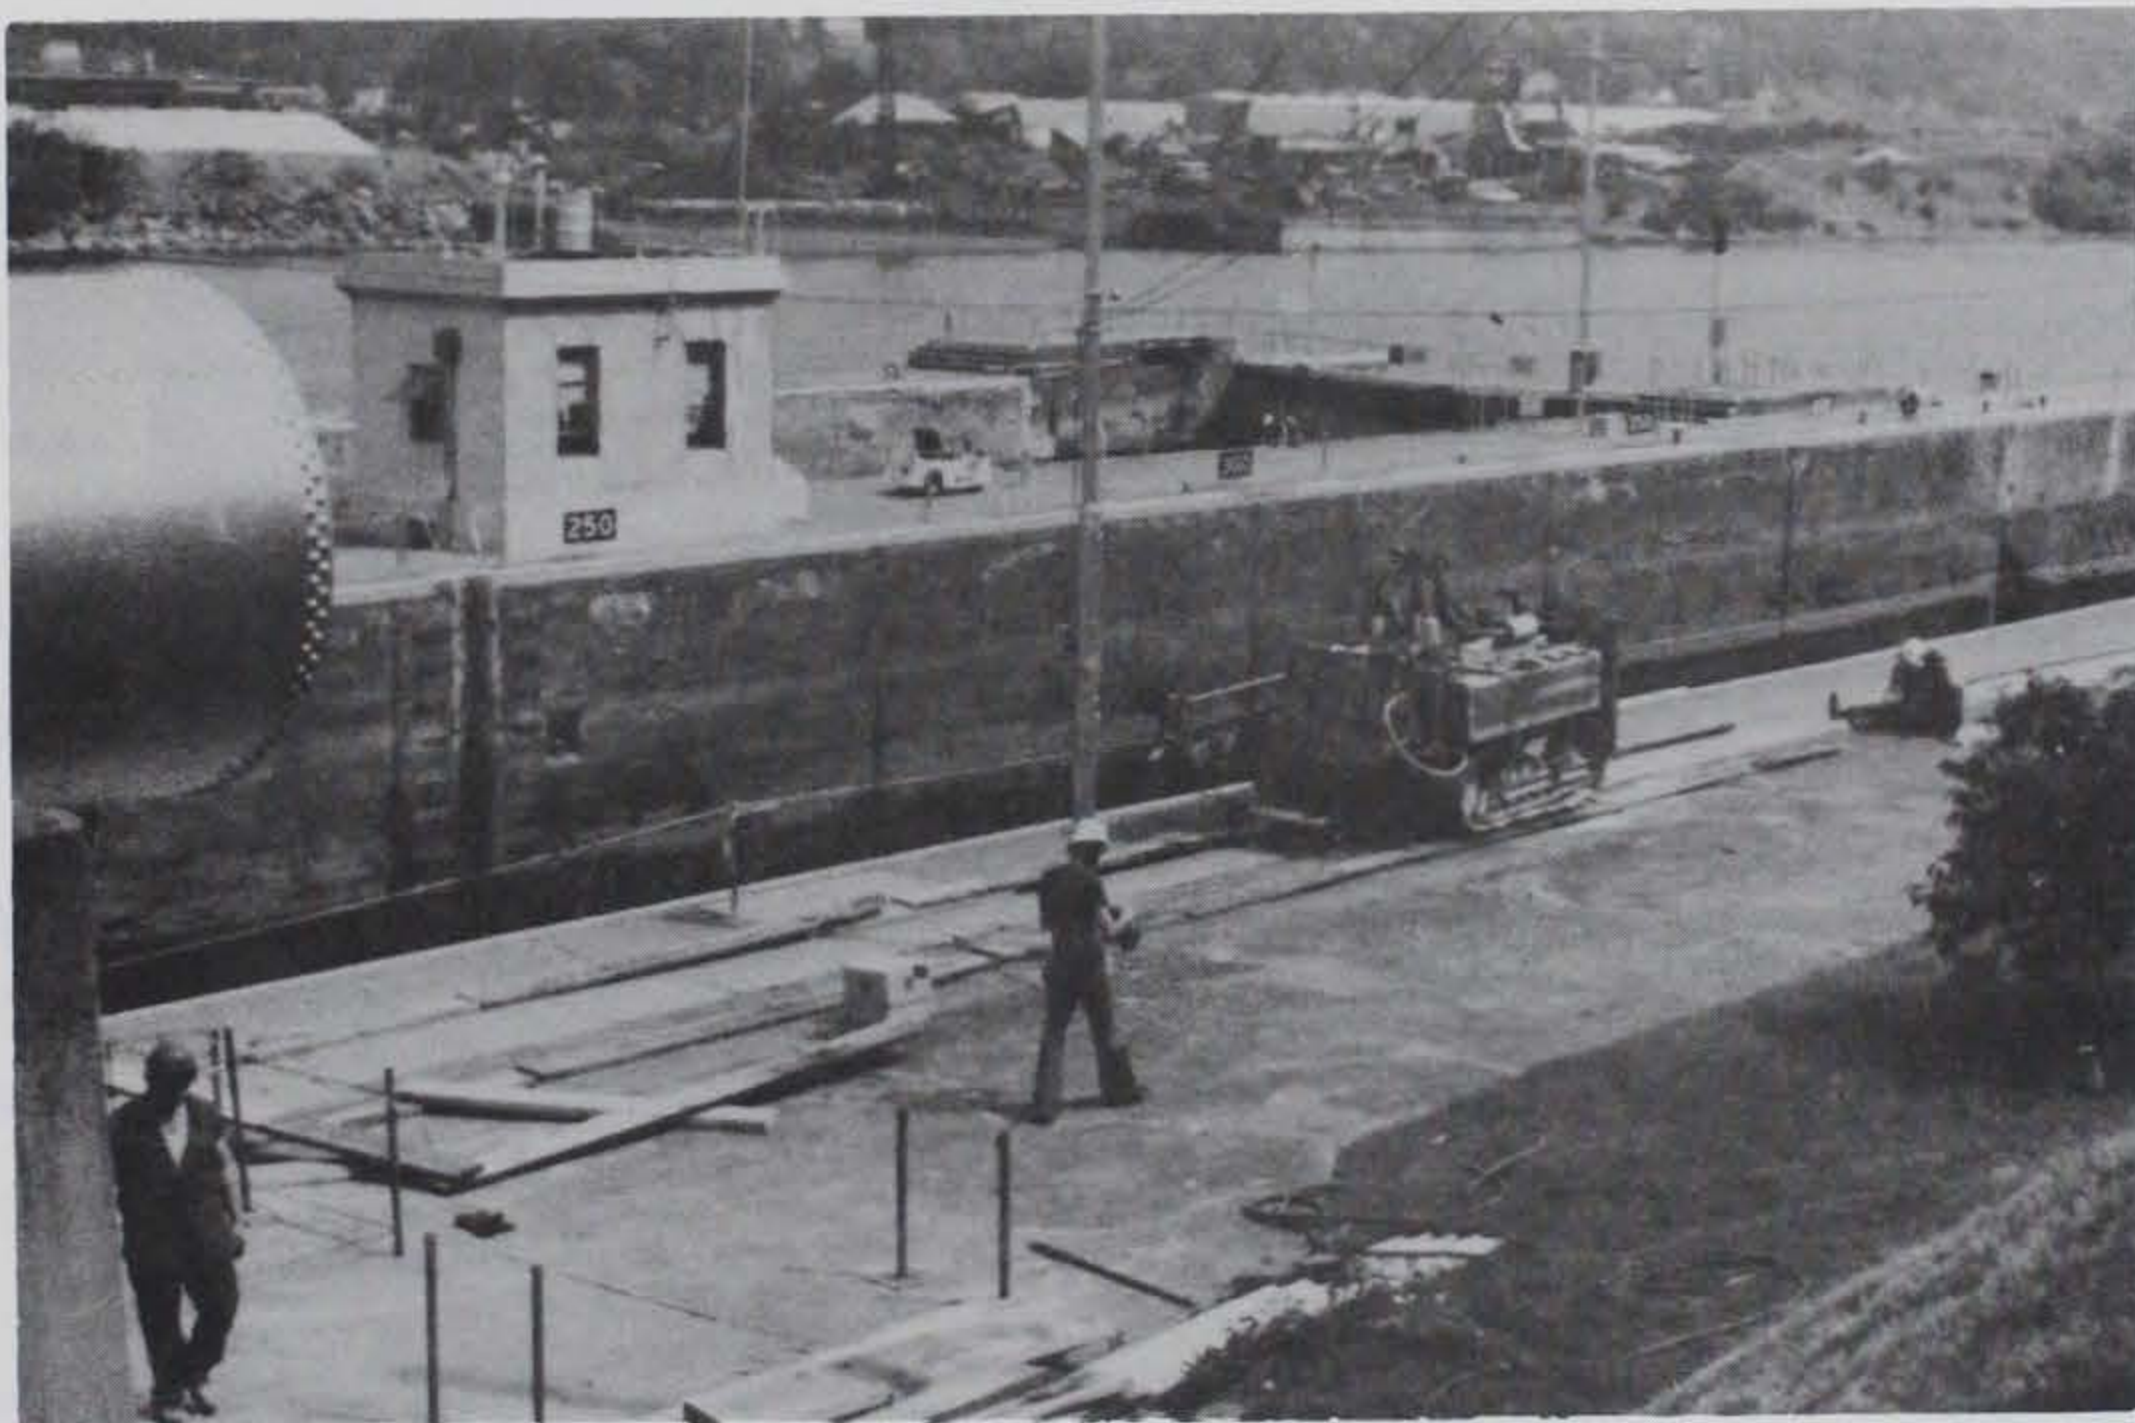
Figure 53. Crawler-mounted drill rig used for anchor installation, Lock No. 3, Monongahela River

116. Anchor boreholes, 4-1/2 in. in diameter, were drilled on a 1.5V on 1H slope through the concrete and the overburden. A standard 4-in.-diam Schedule 40 pipe was placed through the overburden and 1 ft into rock. A 3-1/2-in.-diam hole was then drilled 20 ft into rock. The drilling equipment used by the contractor consisted of a crawler-mounted hydraulic drill rig specially designed and built for anchor installation (Figure 53). Because of the

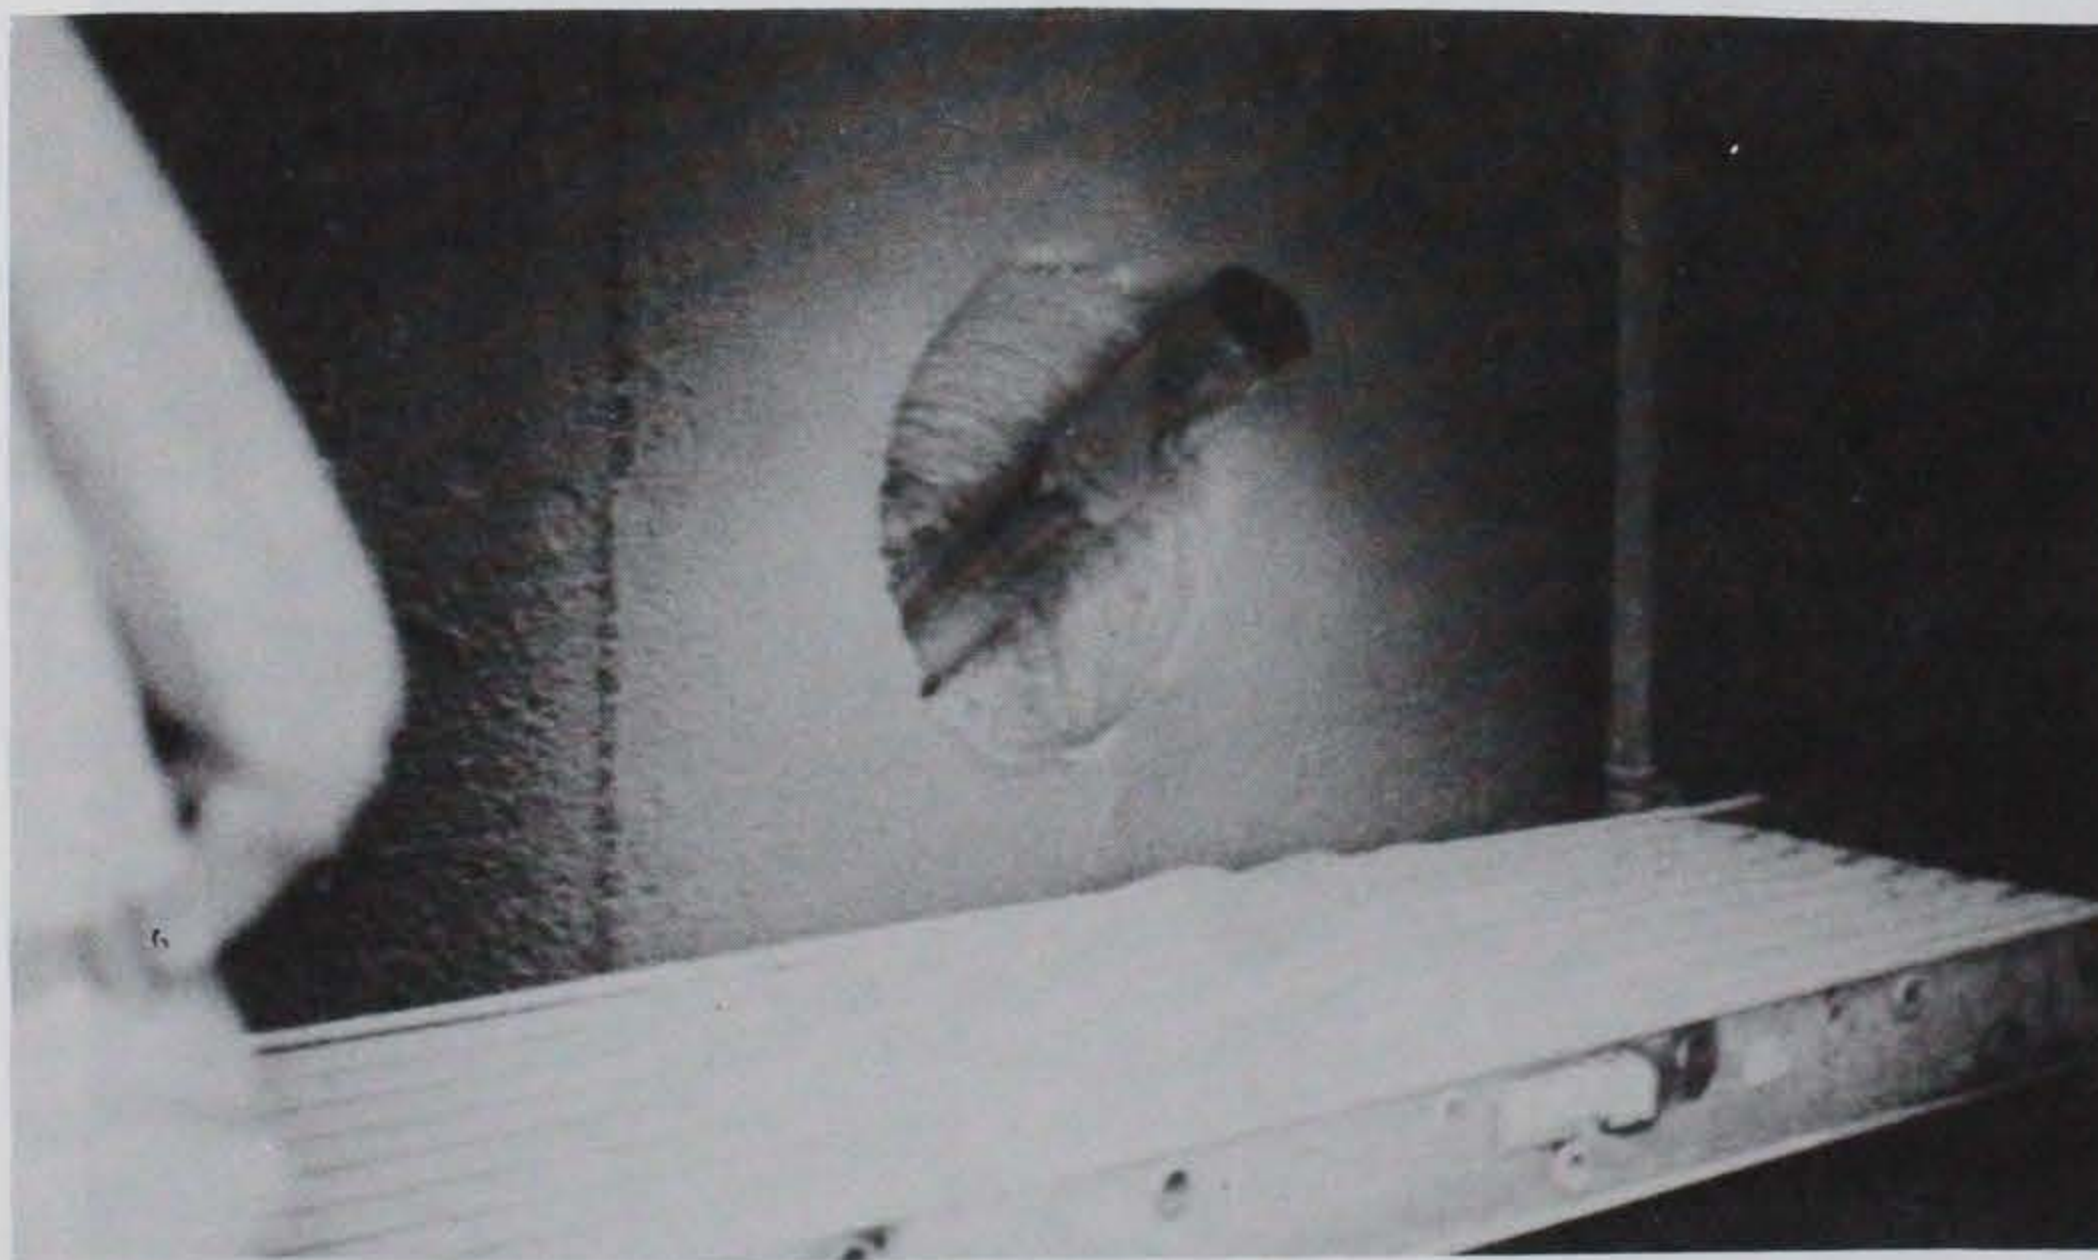
Figure 54. Installation of filling flume anchors,  
Lock No. 3, Monongahela River

because downstream of the operations building the anchor heads are located 5 ft below the top of the filling flume slab (Figure 54). Another difficulty was that high water is fairly common at Lock No. 3, and the contractor had to install scaffolding or work platforms inside the flume that could be easily raised. The contractor had to break an opening in the slab and drill at a 1V on 1.5H slope through the concrete retaining wall and the overburden material while advancing a 4-in. diam casing and, finally, into the rock for a depth of at least 20 ft. The slope and the vertical location of the anchors were optimized by many trials using various slopes and locations. The controlling criterion for the design of the anchors was to keep the resisting-to-overturning moment ratio around 1.3. This value is not usually computed for new structures. In the Pittsburgh District when investigating stability for existing structures undergoing rehabilitation, it is found that this ratio gives a better perspective of possible overturning failure, more than just the percent active base criteria (Krysa 1982).

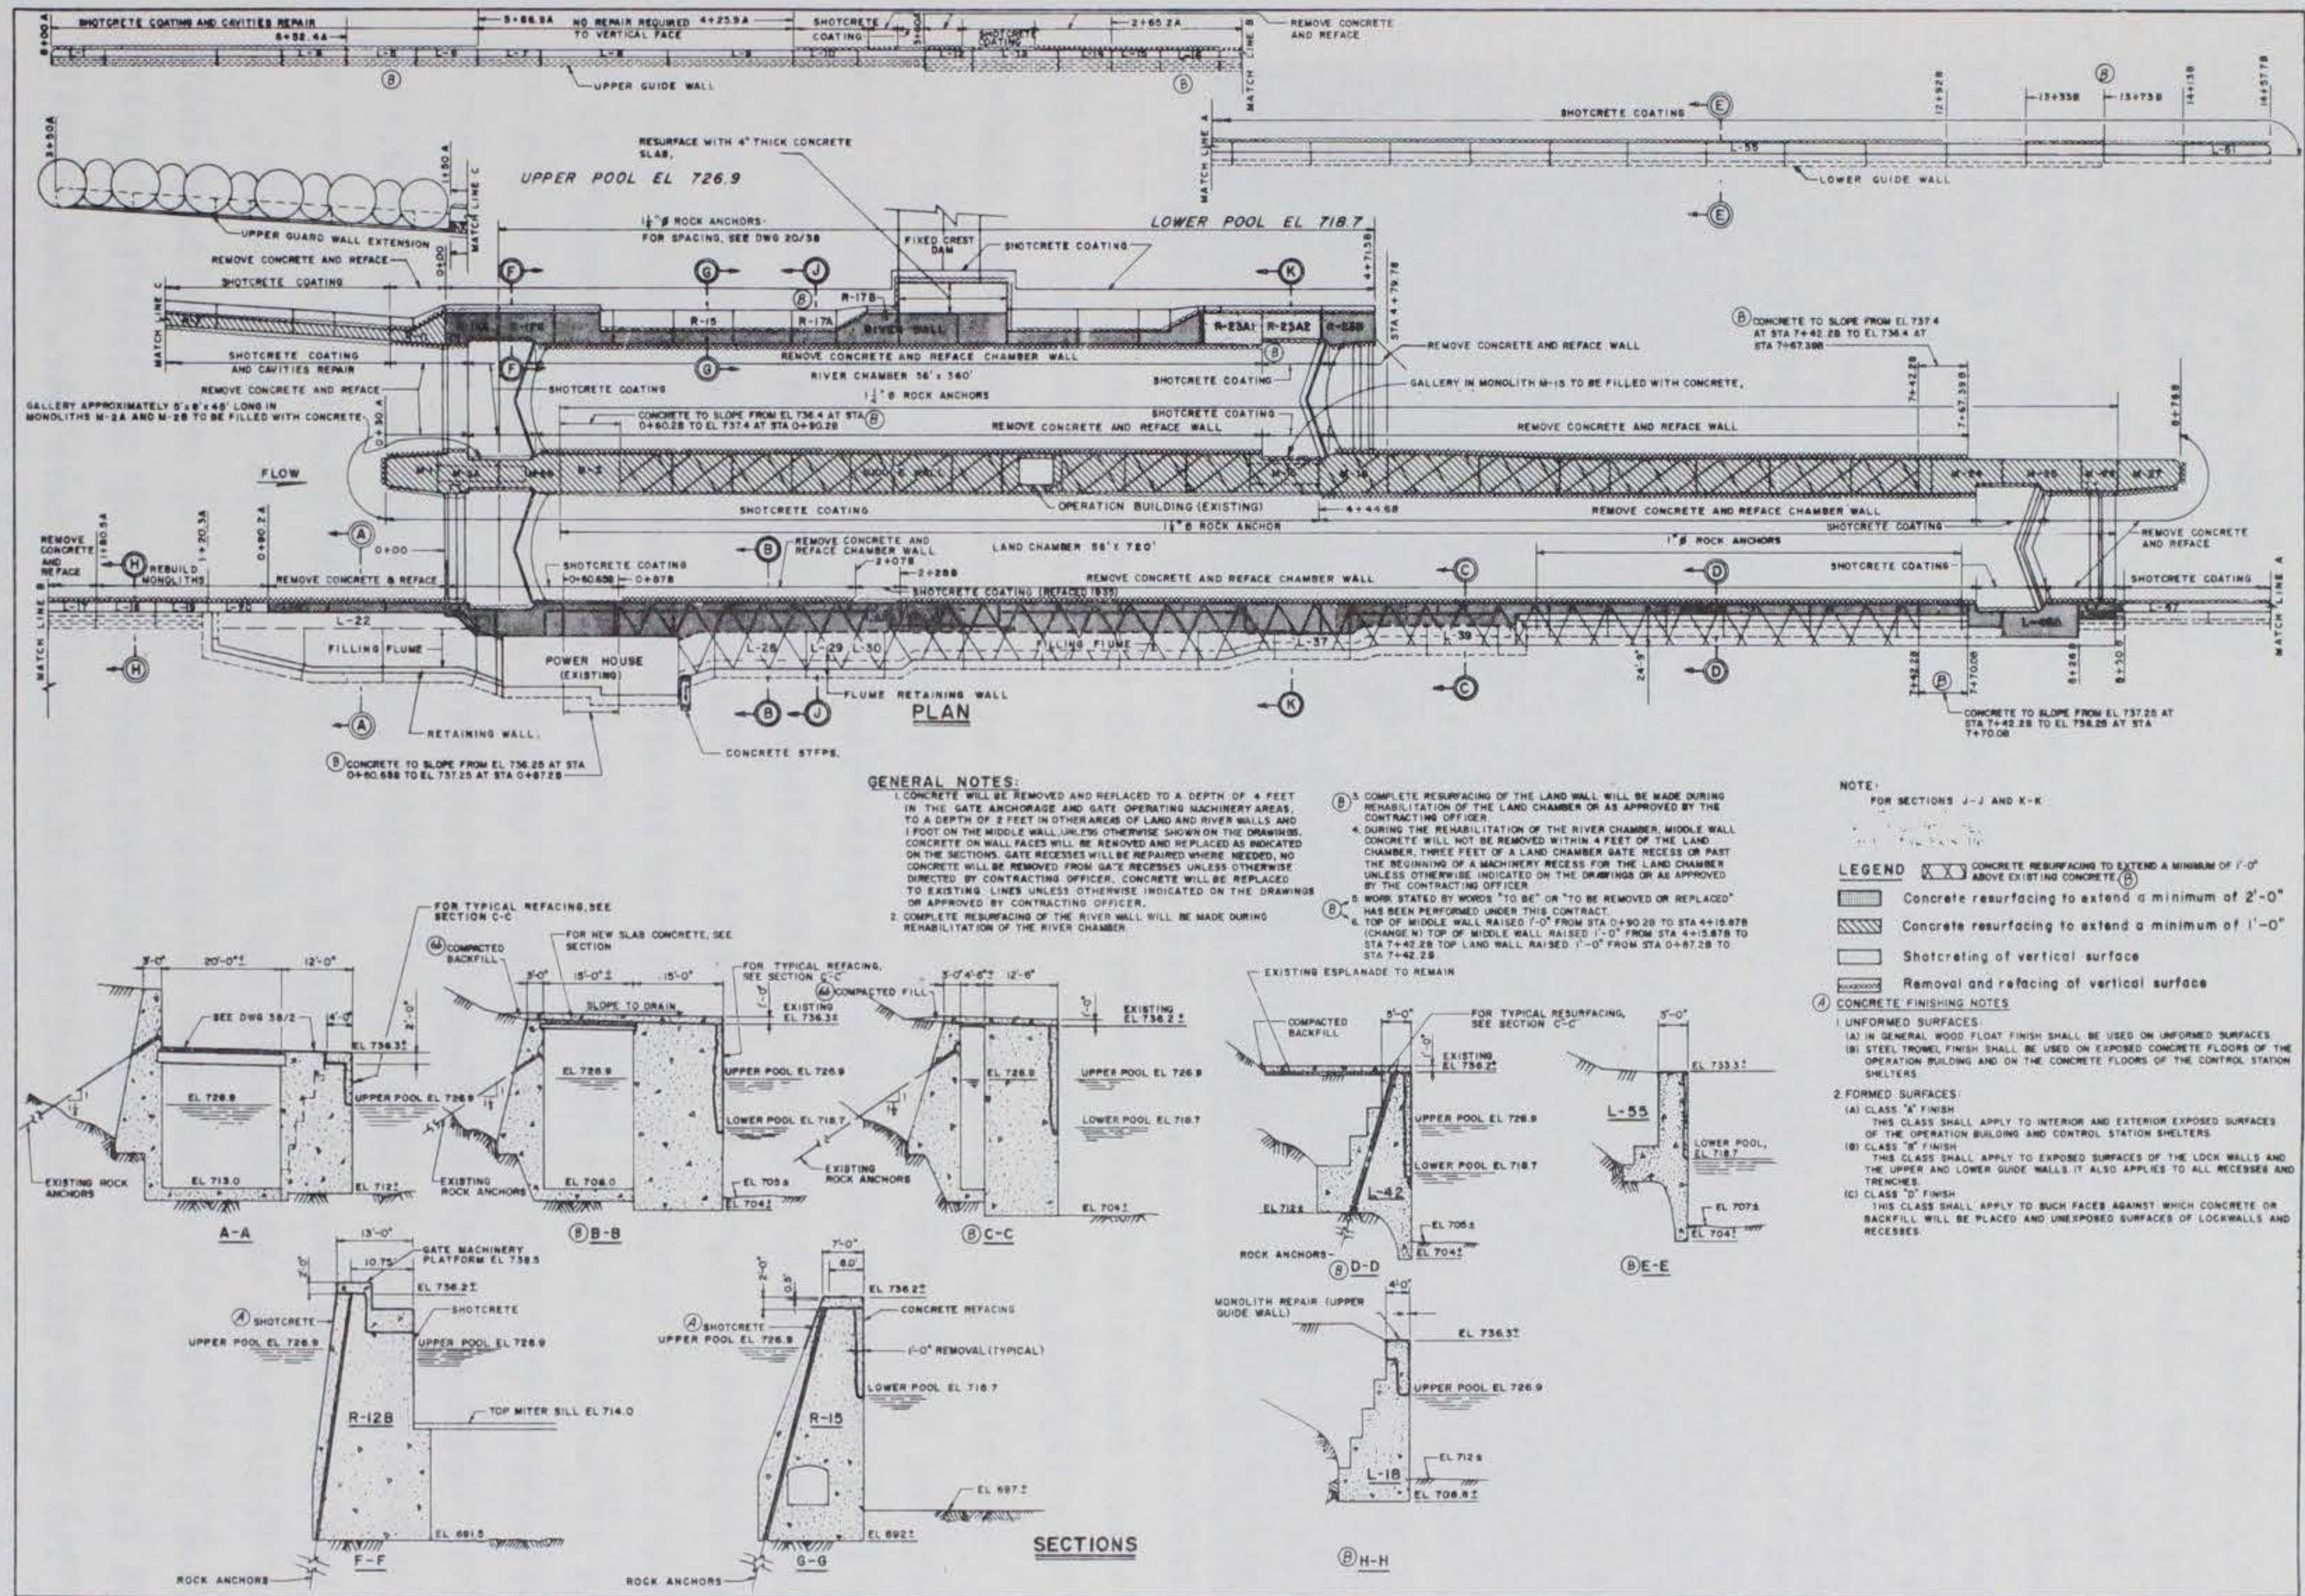
Figure 55. Refacing, resurfacing, and anchoring details, Lock No. 3, Monongahela River

128. A system of rock anchors was designed (Figure 55) to upgrade the stability of the lock walls to the reduced requirements. The original design called for one hundred eleven 1-1/4-in.-diam anchors in the upper guide wall, sixty-two 1-in.-diam anchors in the lower guide wall, twenty-three 1-in.-diam anchors in the land wall, one hundred twenty-eight 1-1/4-in.-diam anchors in the middle wall, and seventy-six 1-1/4-in.-diam anchors in the river wall. The anchors on the land and guide walls were to be locked-off at 20 percent of ultimate, 25 kips for the 1-in. bars, and 40 kips for the 1-1/4-in. bars. The anchors on the middle and river walls were to be locked off at 60 percent of ultimate, 112.5 kips.

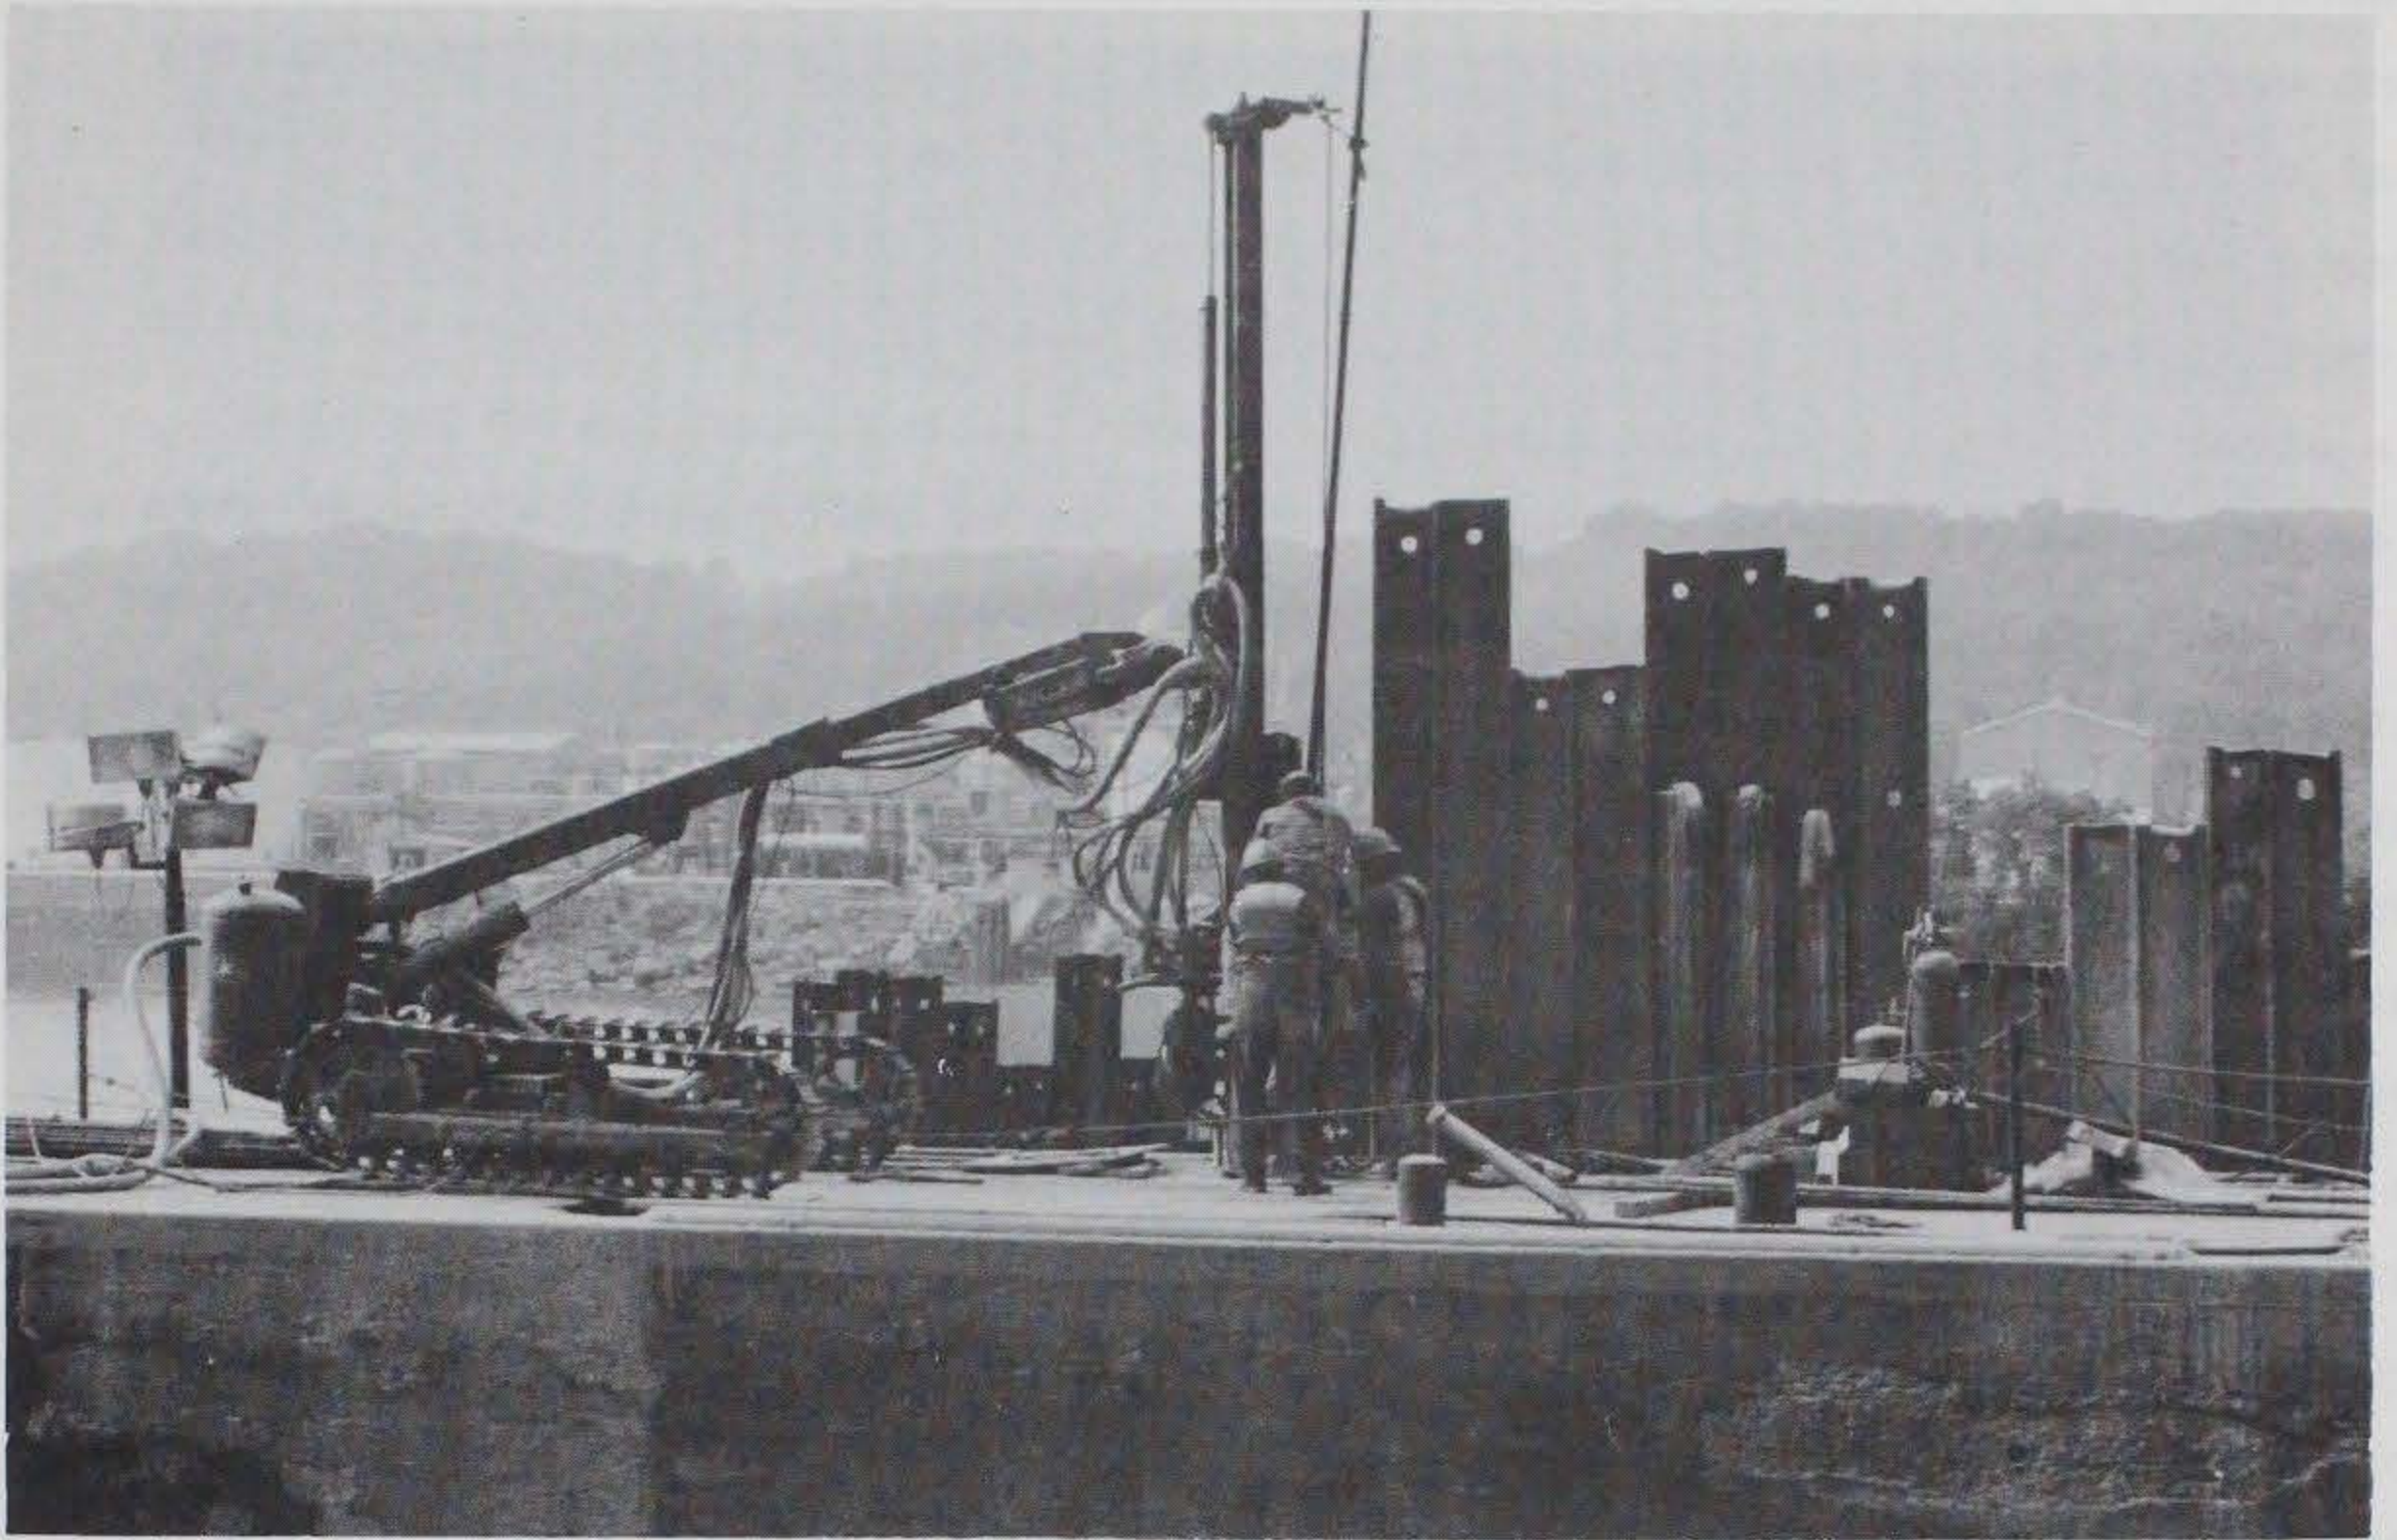
133. Shortly after beginning work on the middle wall anchors, ECI complained that the holes were caving and the anchor rods could not be installed. There were 15 middle wall anchors on the prime contractor's critical path. ECI claimed that increased progress could be achieved by pregrouting. In the interest of expediting the overall project, the Corps agreed to allow ECI to pregrout the first 15 holes, but stipulated an alternative solution should be found. The 15 anchors were installed (Figure 56), but with no improvement in the rate of work. The contractor continued to have drilling problems. At a meeting on 11 October 1978, the Corps directed ECI to install a 3-in.-diam casing in the 4-1/2-in.-diam hole prior to drilling the 2-1/4-in.-diam hole. The Corps had concluded that the material in the hole that the contractor claimed was from caving was actually the drill cuttings. The change in hole diameter from 2-1/4 to 4-1/2 in. was causing a pressure drop which allowed the cuttings to fall back into the hole. The drilling was being impaired by the cuttings. The 3-in. casing improved this condition, and there were fewer

Figure 56. Rock anchor installation, middle wall, September 1978,  
Lock No. 3, Monongahela River
