TECHNICAL REPORT REMR-CS-13

**REHABILITATION OF NAVIGATION  
LOCK WALLS: CASE HISTORIES**

James E. McDonald

December 1987

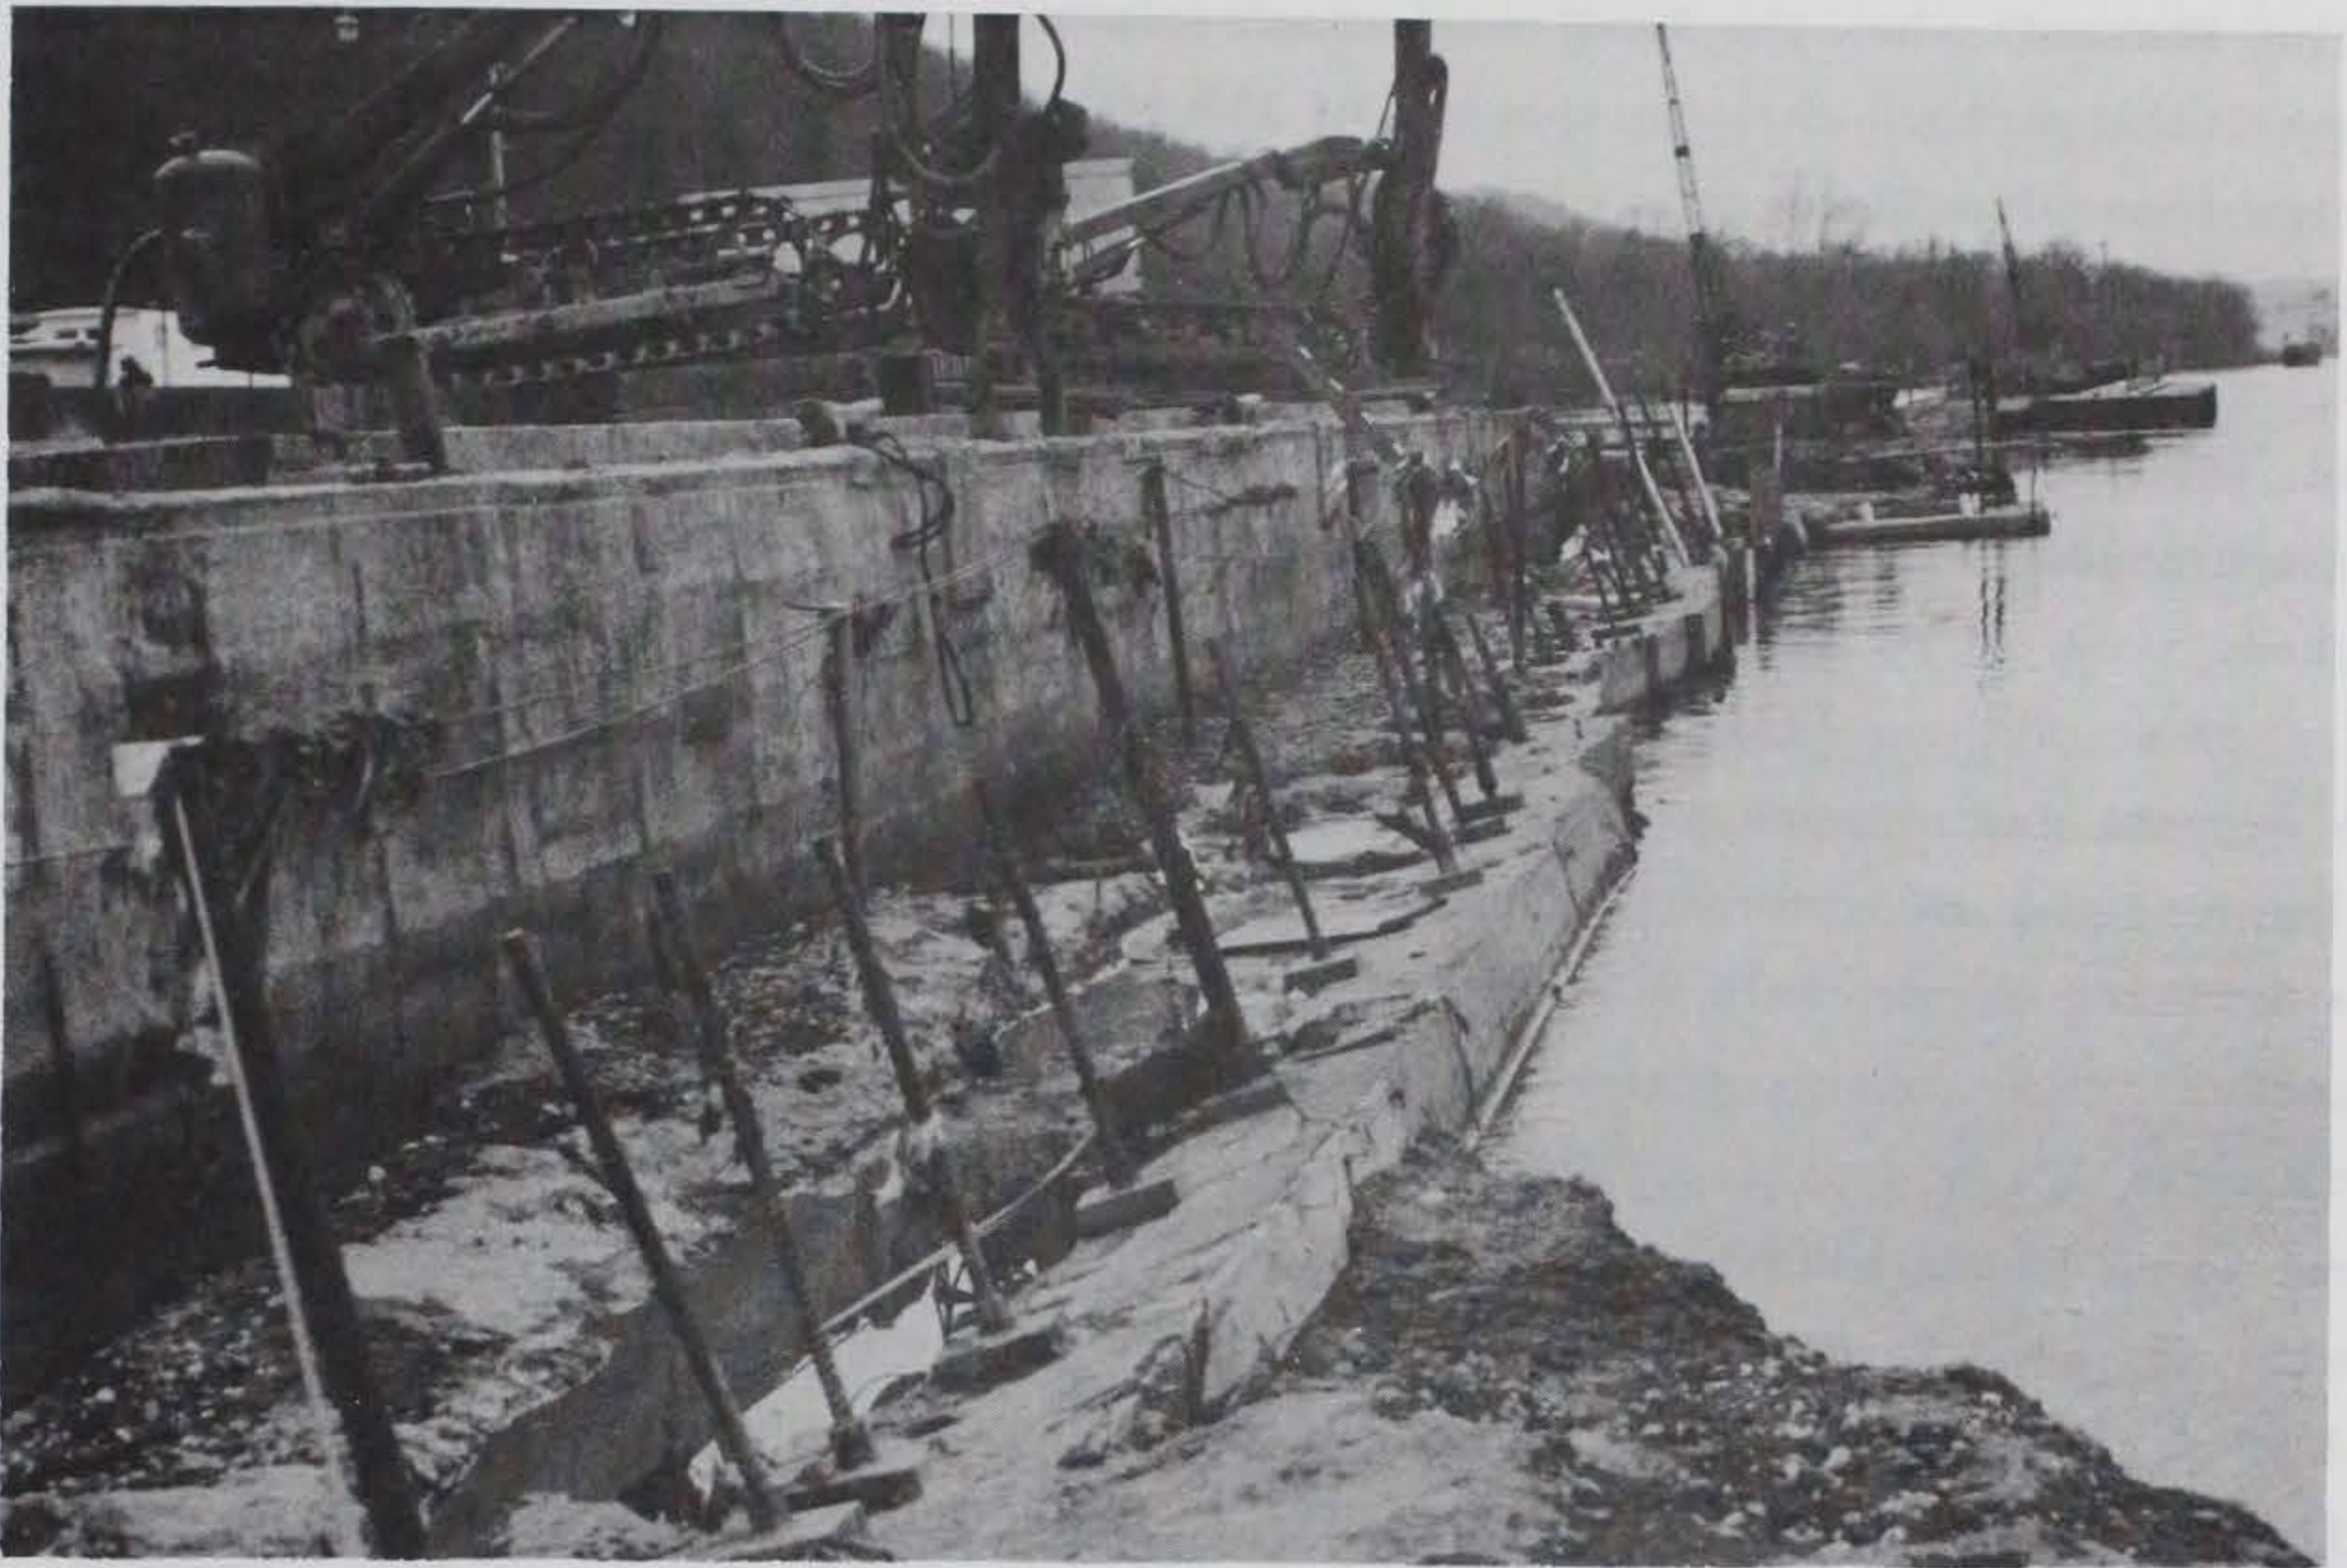
Figure 60. Rock anchor installation, cut down top of river wall, March 1979, Lock No. 3, Monongahela River

138. In the interest of better consistency and progress in the anchor installation, the Corps recommended a cement grout system be used to anchor the bars. In March 1979, the contractor changed his procedures to drilling a 4-1/2-in.-diam hole full length and using cement grout. The anchors were tensioned after 9 days, and the stressing length was grouted. This method produced more consistent results and far fewer failures and thus was used to install approximately one-fourth of the anchors on the middle wall and three-fourths of the anchors on the river wall (Figure 60).

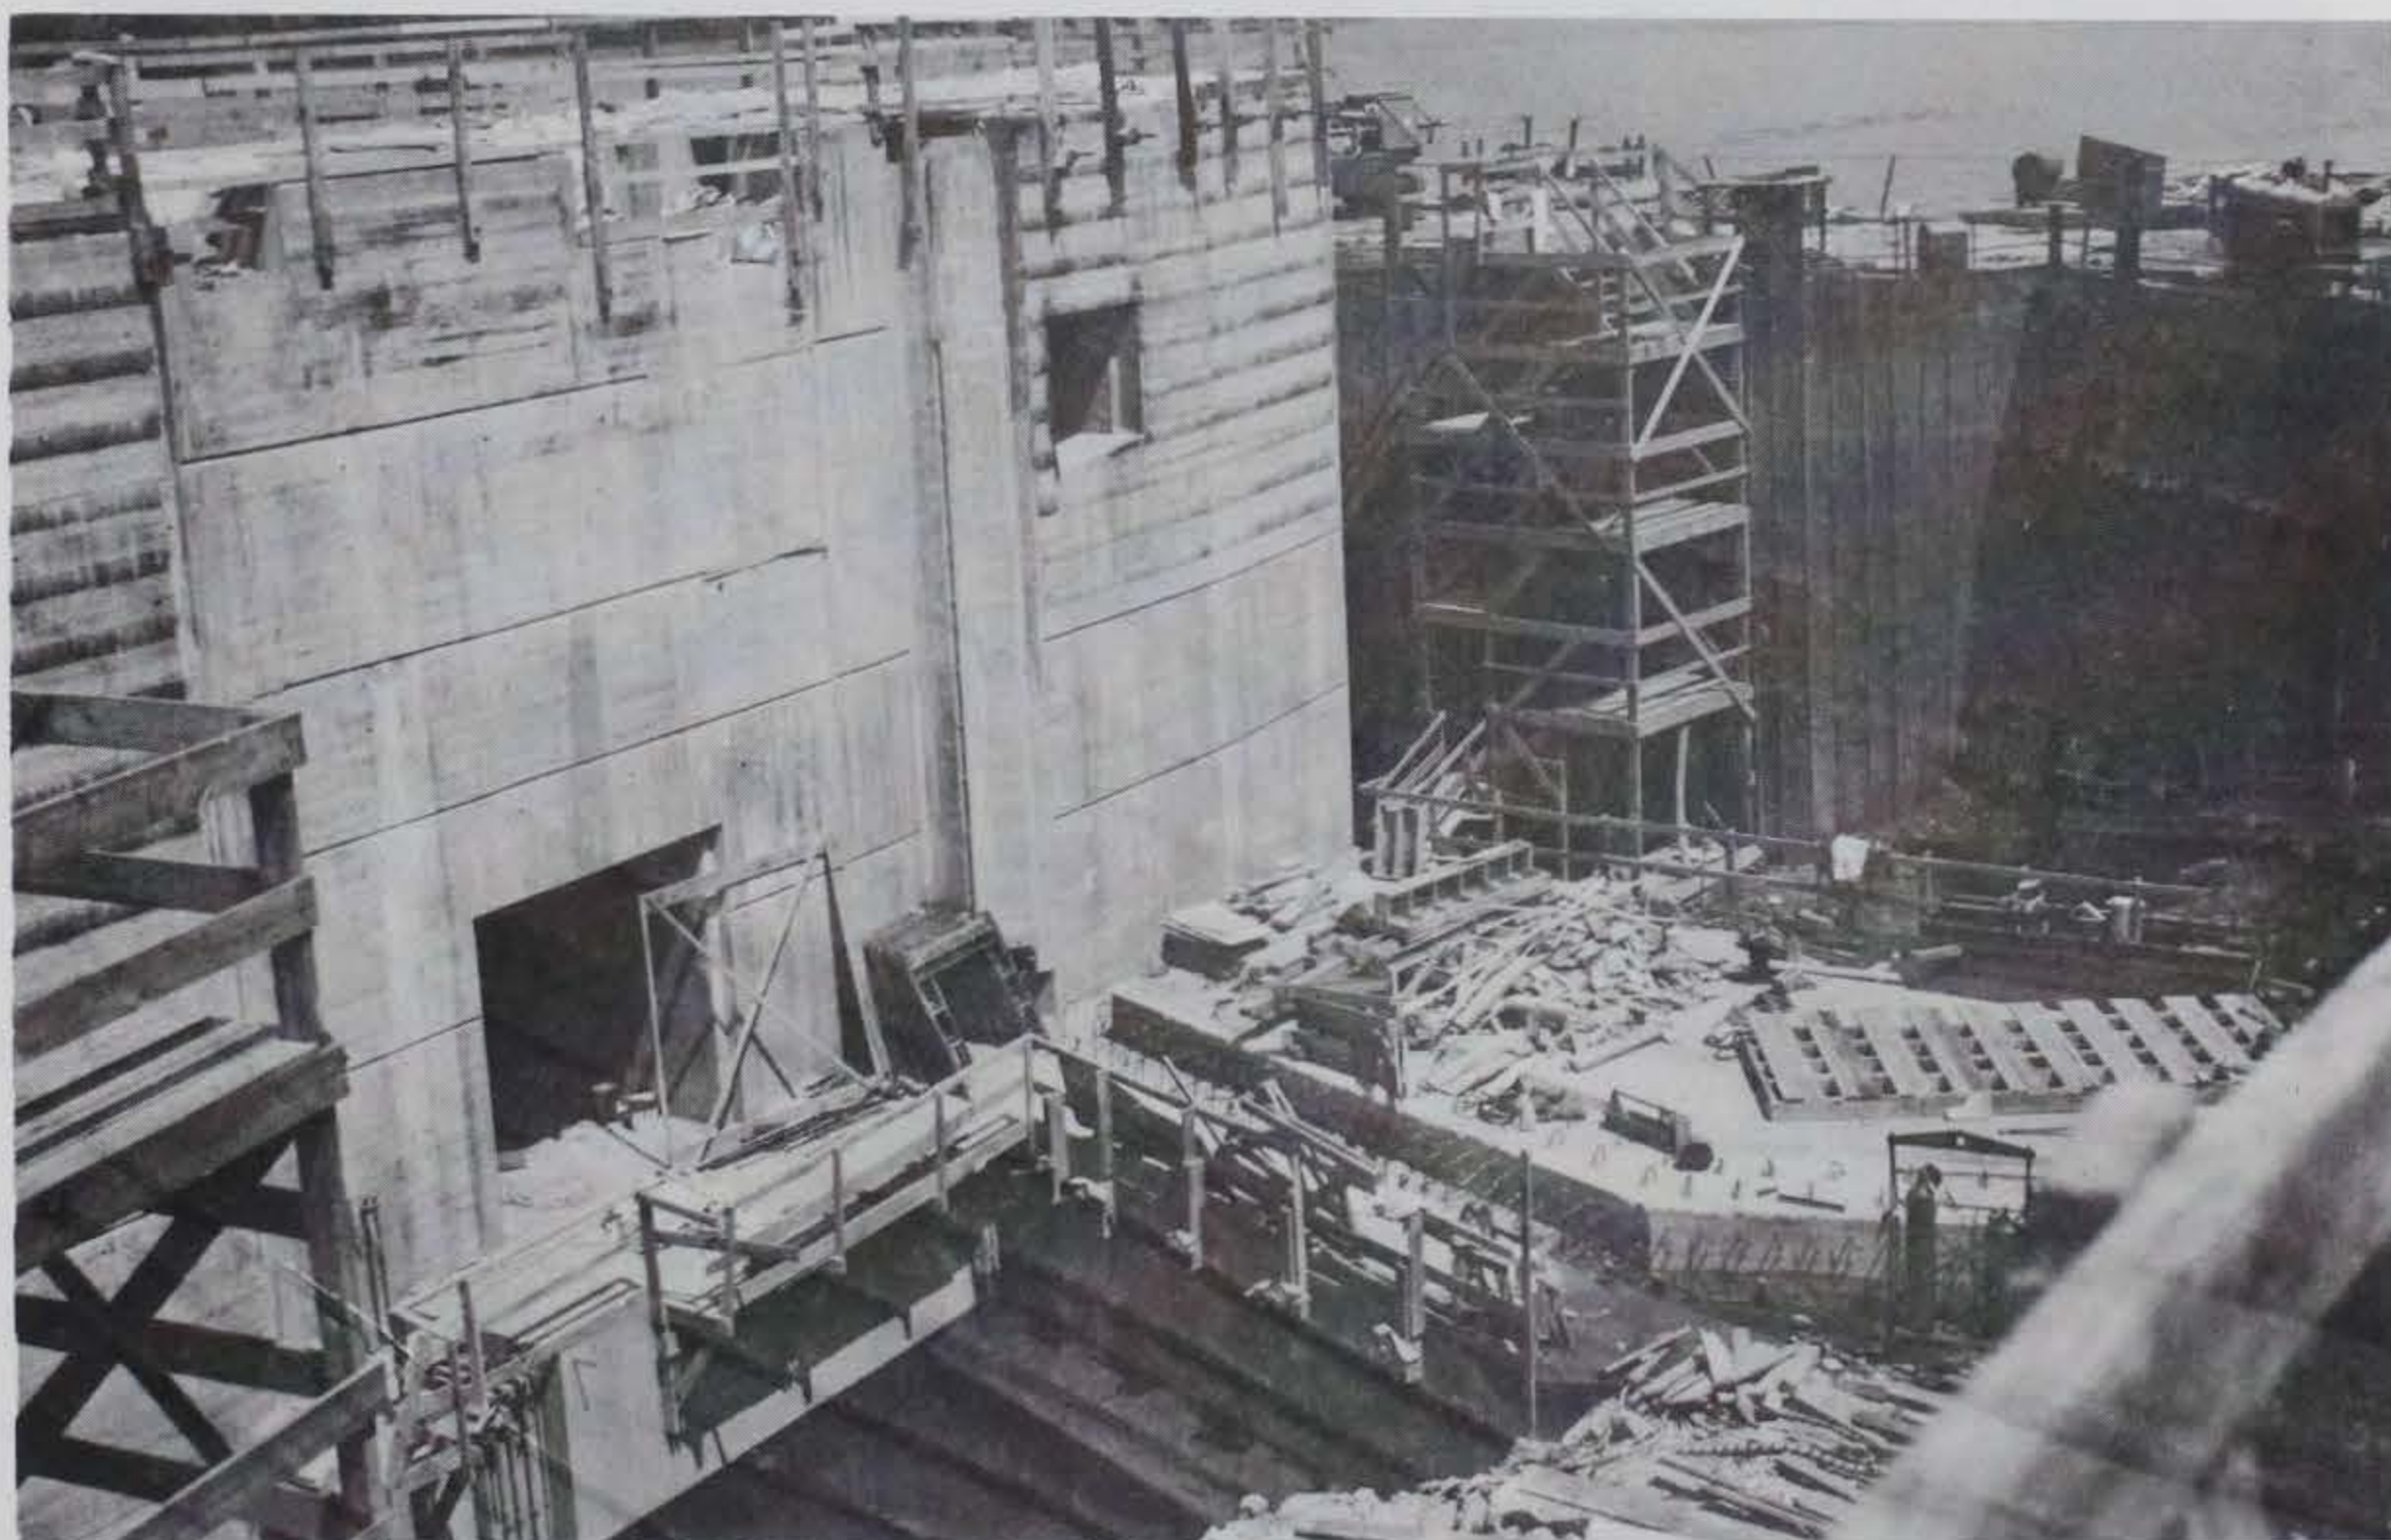
Figure 61. Construction of new river wall monoliths and miter sill, August 1979, Lock No. 3, Monongahela River

145. A U-shaped steel sheet-pile cell cofferdam attached to the middle wall was used to construct the new river wall monoliths, R-24 and R-25, and the new miter sill, in the dry (Figure 61). Bedrock was excavated for the foundation. Wall monoliths R-24 and R-25, which are 61.5 ft high, were placed

in 10 lifts. The concrete was green cut between all lifts. The concrete for the monoliths and the miter sill was the contractor's 5-bag mixture. To increase the emptying capacity of the extended chamber an 8- by 8-ft vertical slide gate was installed in monolith R-24 (Figure 61). The slide gate is operated by a vertically mounted hydraulic cylinder.

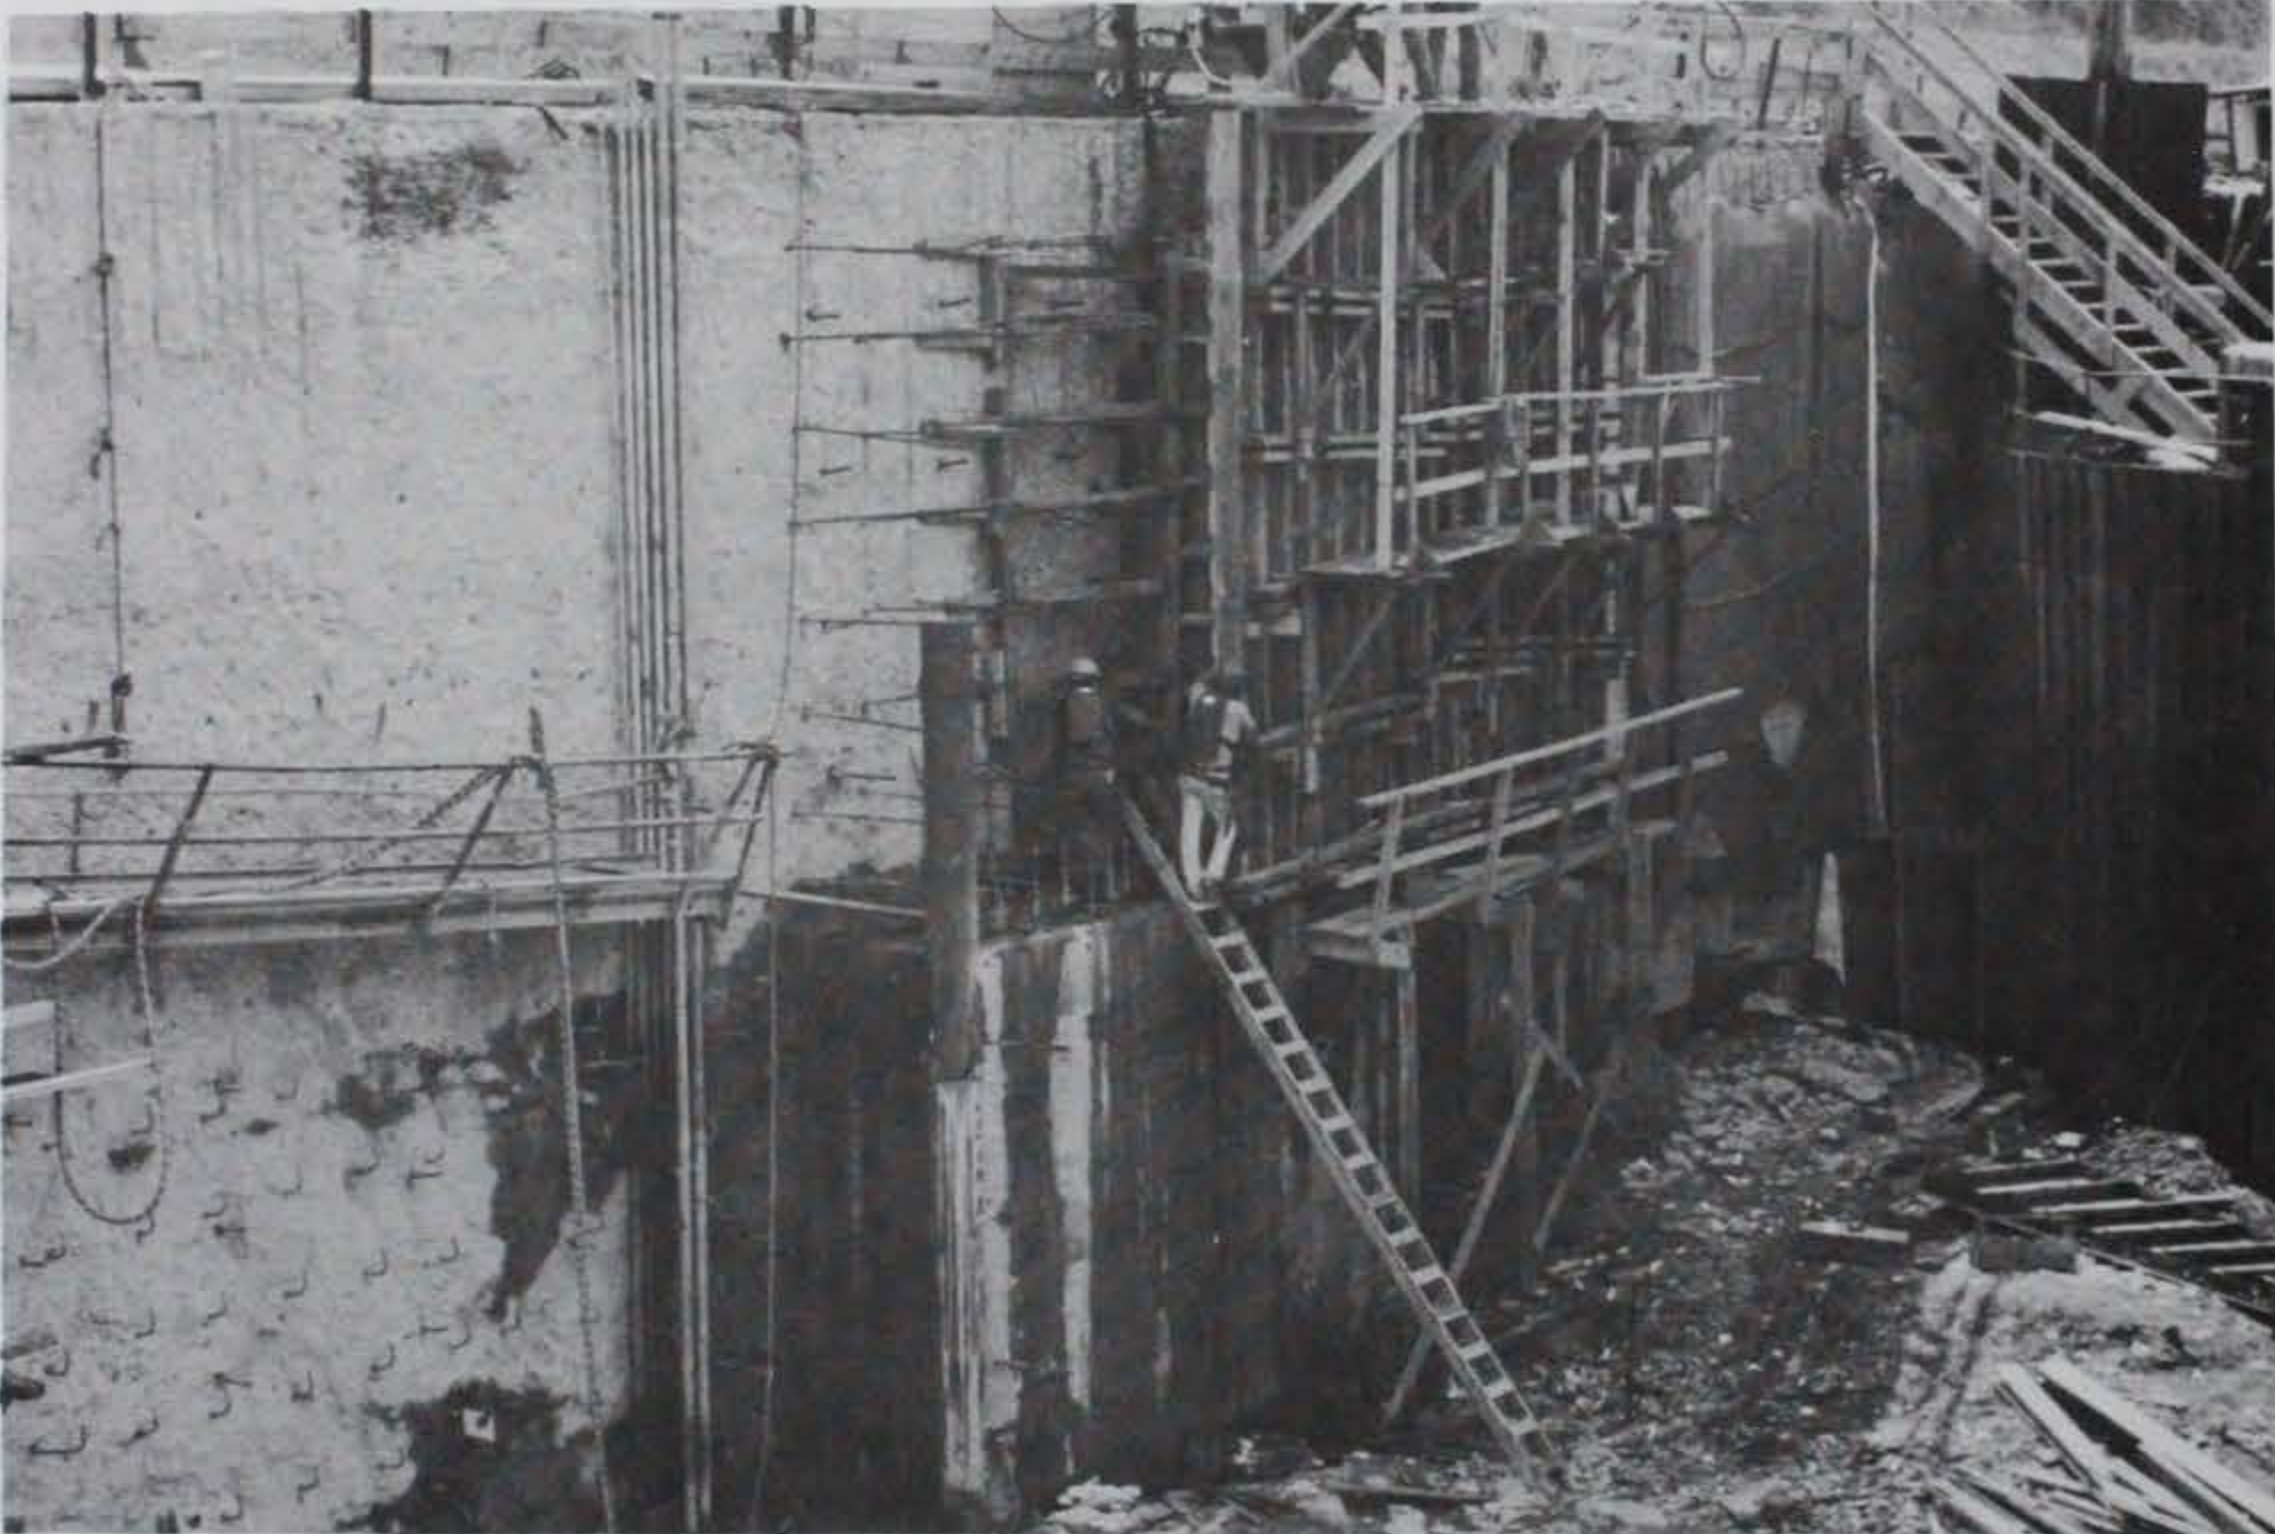
Figure 62. Construction of new downstream gage recess in river face of middle wall, August 1979, Lock No. 3, Monongahela River

146. To provide a miter gate recess in the middle wall, the river face of monoliths M-24, M-25, M-26, and M-27 was modified (Figure 62). One foot of

concrete was first removed from the face by line drilling and blasting some sections and chipping others with a Hoe Ram impactor mounted on a backhoe. The monoliths were then refaced with 1 ft of concrete at the ends to meet the existing walls and 4 ft in the area of the new gate recess. The replacement concrete was anchored to the existing wall with No. 6 and No. 8 dowels on 2-ft centers and reinforced with a vertical mat of No. 5 bars on 1-ft centers. After 4.5 ft of concrete was removed from the top of the wall, the new gate machinery and anchors were installed and new concrete was placed.

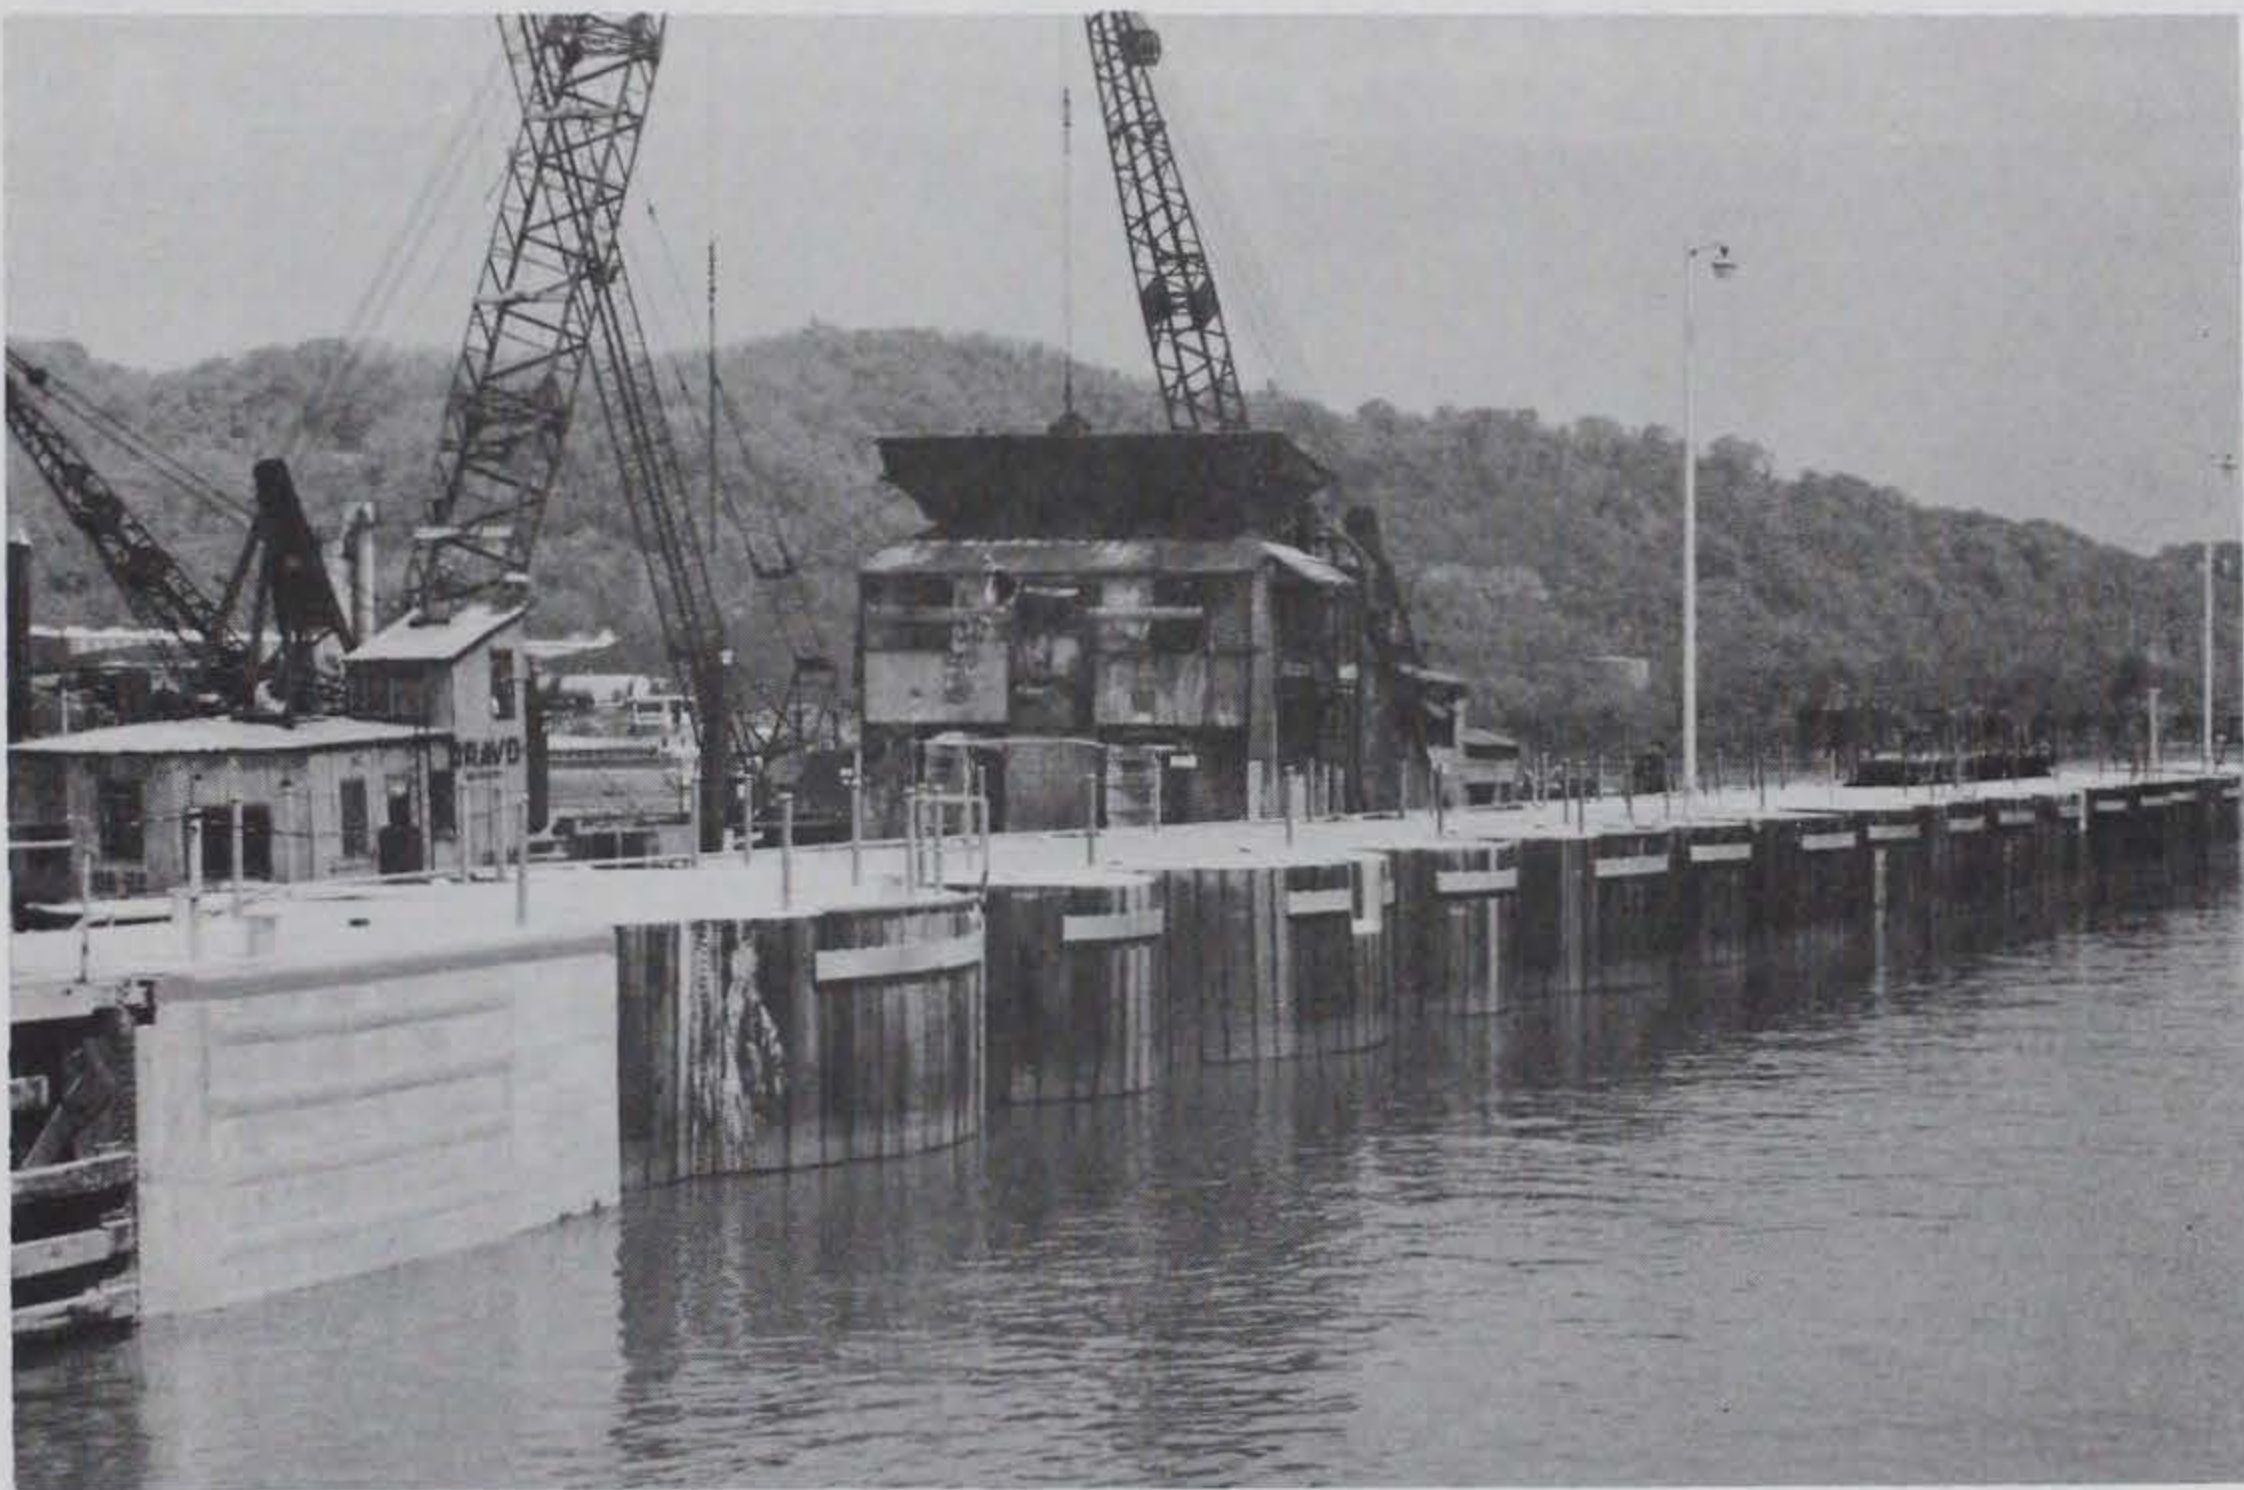
Figure 63. Completed river wall extension, May 1980, Lock No. 3, Monongahela River

when the concrete caps on most of the cells and arcs settled to as much as 6 in. on the riverside. A diving inspection was conducted to determine whether cell fill was being lost because of parted interlocks or erosion below piling. The divers found neither condition, and it was concluded that the settlement was caused by fill compaction and would cease.

148. The river chamber extension was placed into operation in May 1980 (Figure 63). Initially, there was some concern about the sheet-pile cells

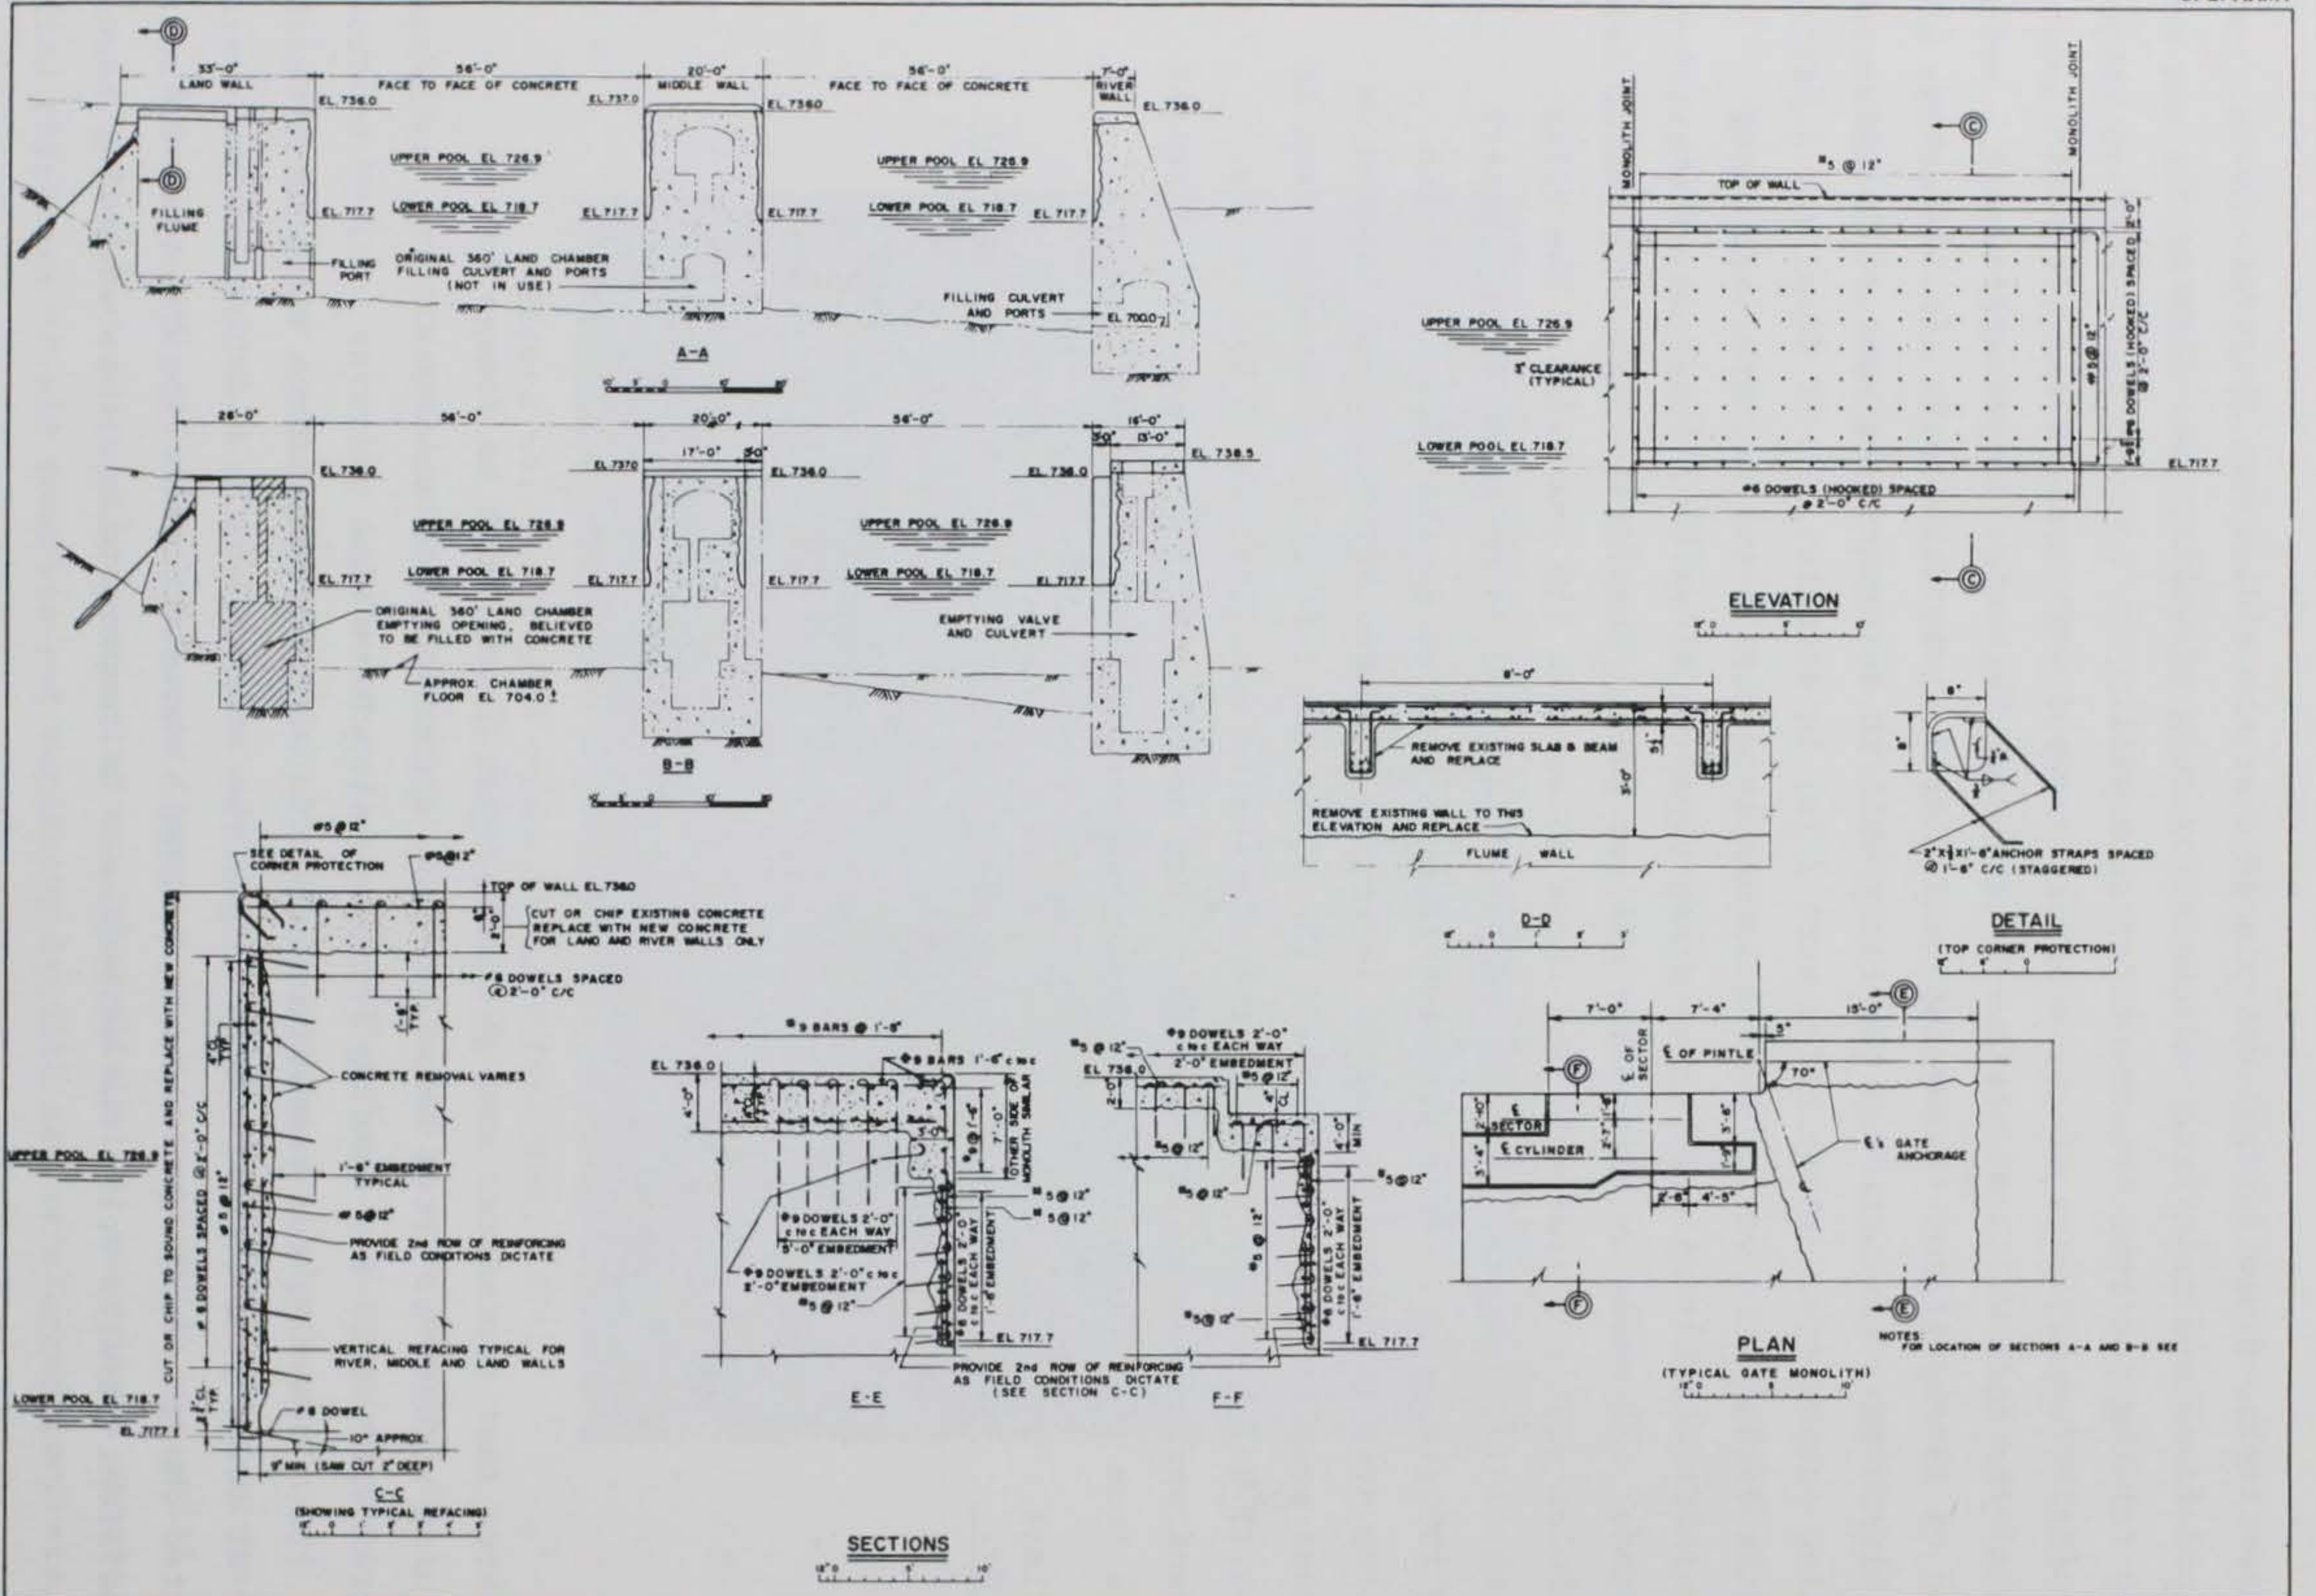
Figure 65. Resurfacing details, Lock No. 3, Monongahela River

In other areas, a new surface was placed over the old, using shotcrete for vertical faces and reinforced concrete for tops of walls. See Figures 55 and 65 for the designed treatment for each wall.

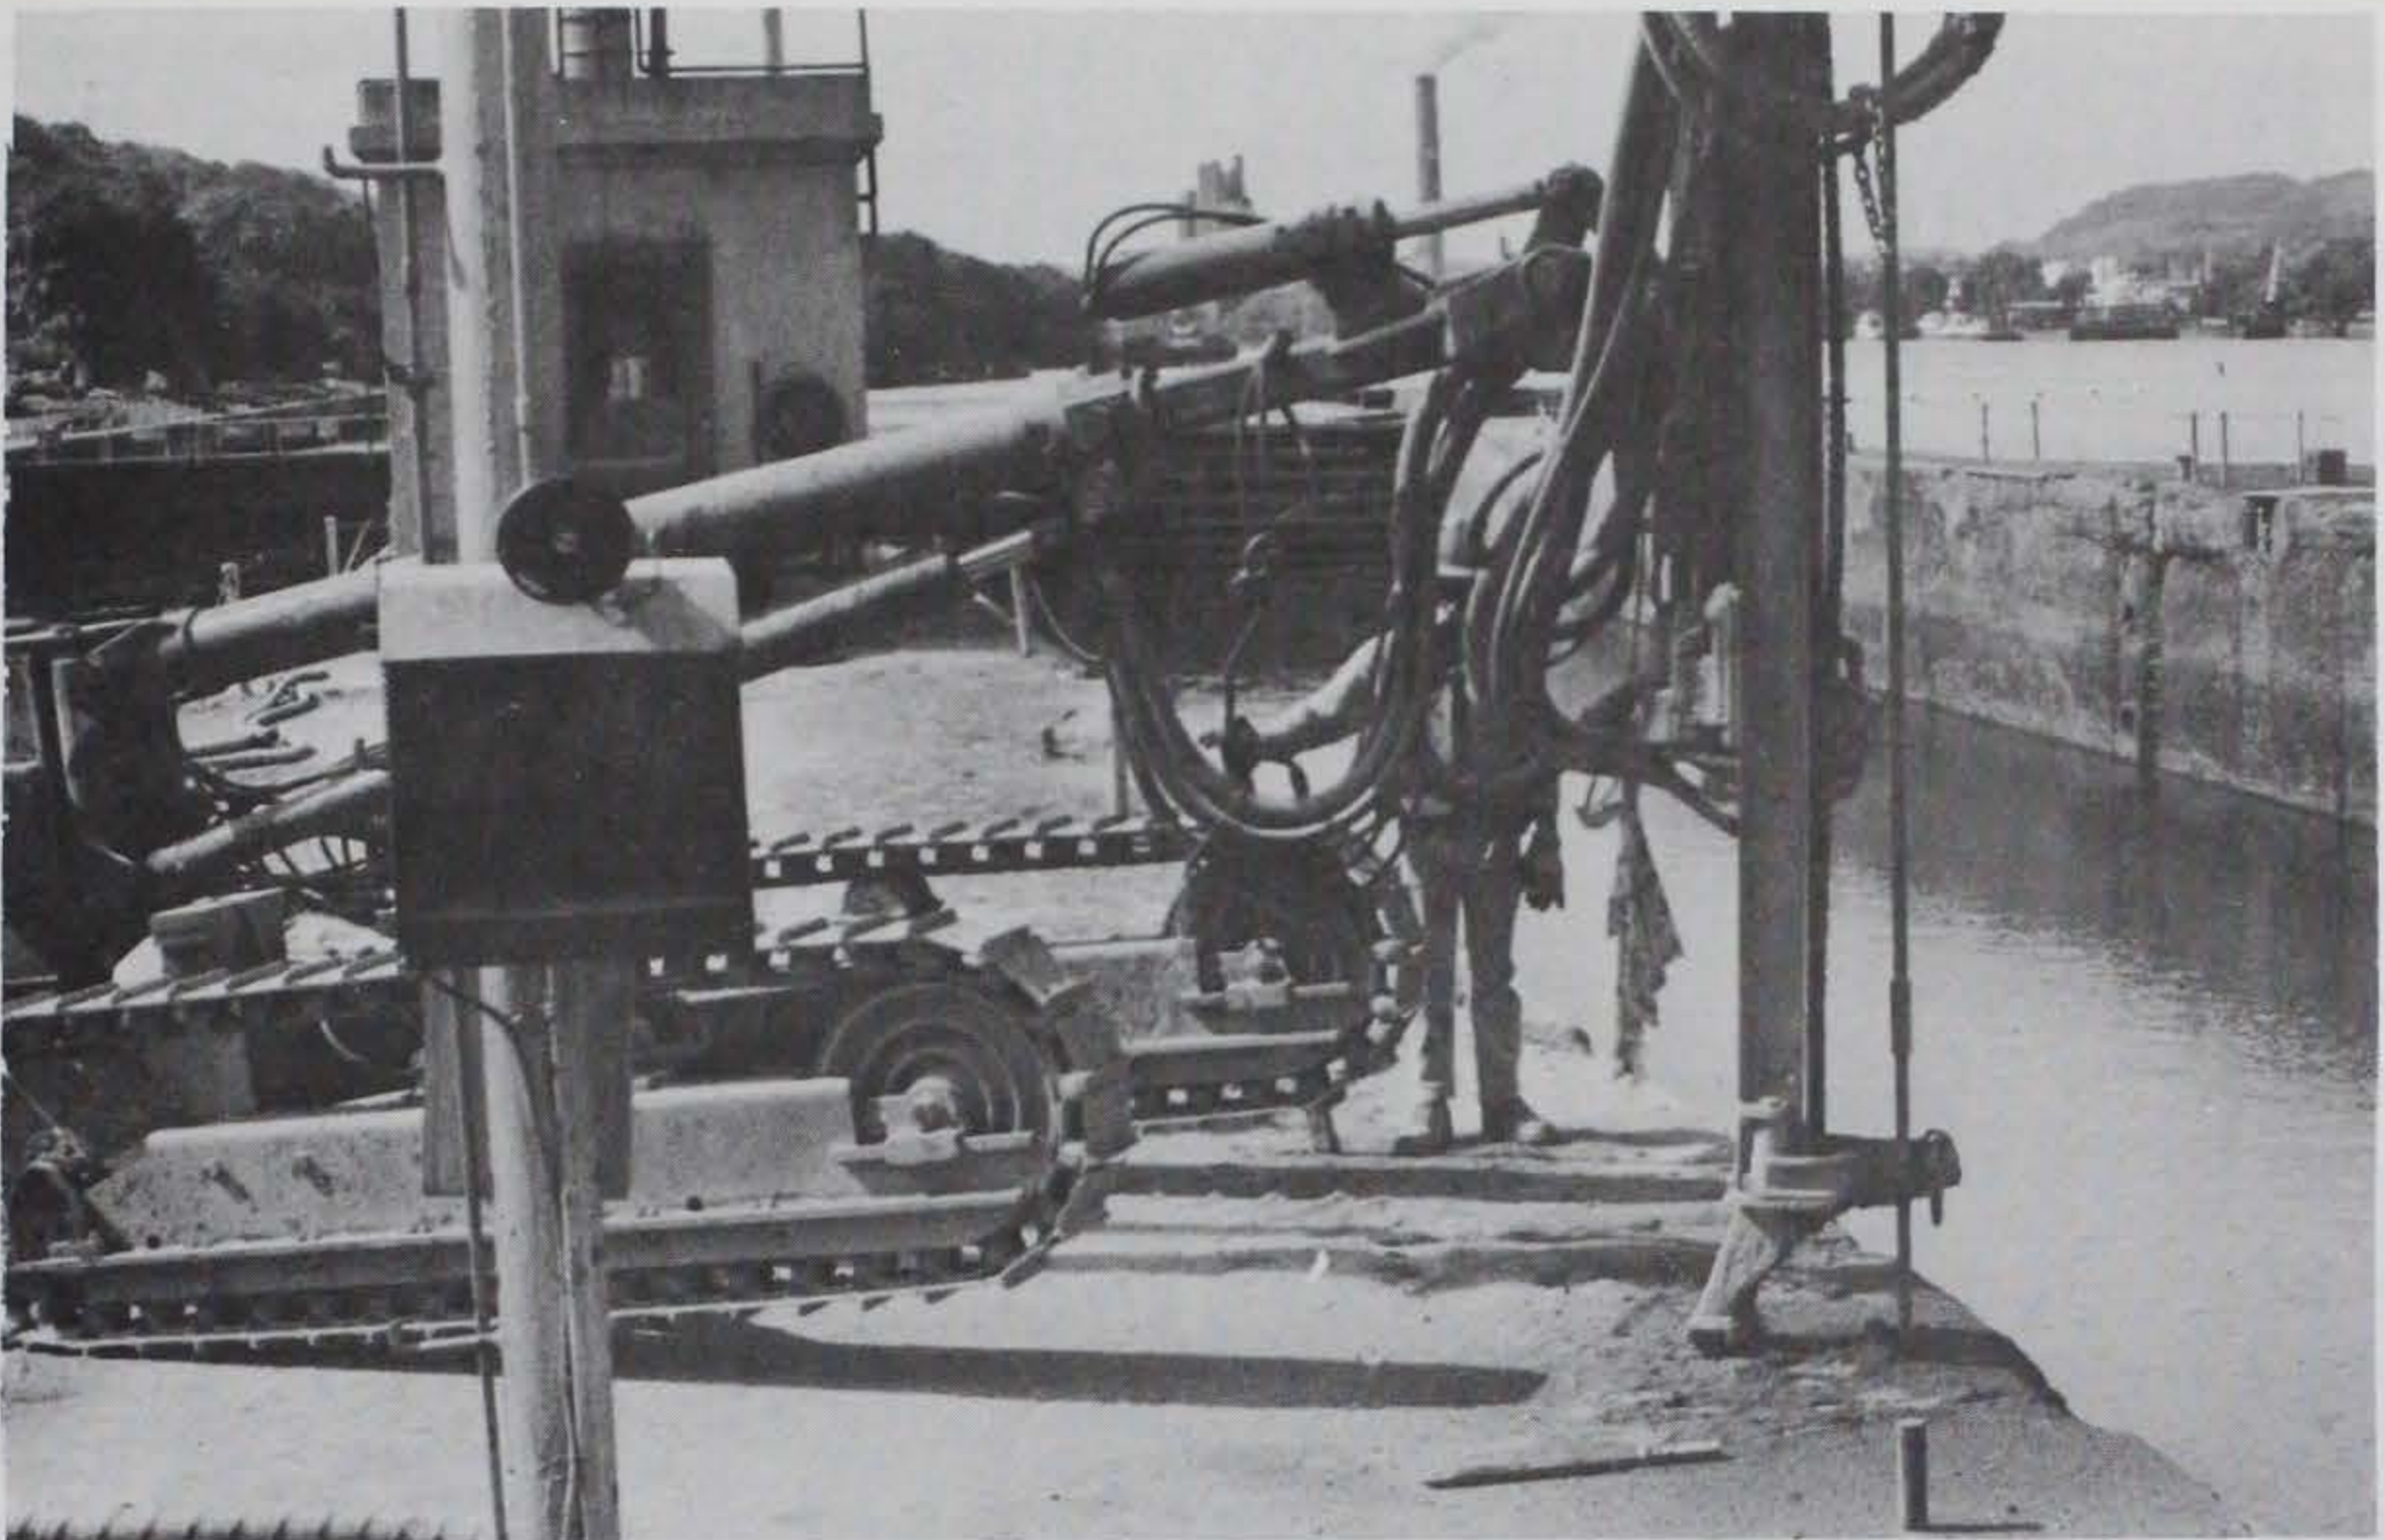
Figure 66. Line drilling prior to blasting, September 1978,  
Lock No. 3, Monongahela River

151. The majority of the concrete removal work was for the vertical faces of the lock walls at various locations. To remove the concrete, a scheme of line drilling (Figure 66) and blasting was developed. In 1978, two test blasts were conducted on the river wall to determine the most efficient blasting parameters. Blast holes were 2 in. in diameter, 19 ft deep, and 1 ft from the face of the wall. Each hole was loaded with two or more lengths of 50-grain/ft detonating cord taped along opposite sides of a 1-1/2-in.-diam wood pole. Stemming in the collar was wet sand. The first blast involved four holes with 200 grains/ft and three holes with 150 grains/ft. The holes were on 12-in. centers. The second blast involved 13 holes on 6-in. centers using 100 grains/ft. Four transducers were located in the vicinity of the blasting area to record vibration intensity. Transducer No. 1 was located on the test monolith, directly behind the blast and 1 ft from the outside face of the wall; No. 2 was on the adjacent downstream monolith; No. 3 was on the adjacent upstream monolith; and No. 4 was on the middle wall monolith directly across from the test monolith. Test data are summarized as follows:
