TECHNICAL REPORT REMR-CS-13

**REHABILITATION OF NAVIGATION  
LOCK WALLS: CASE HISTORIES**

James E. McDonald

December 1987

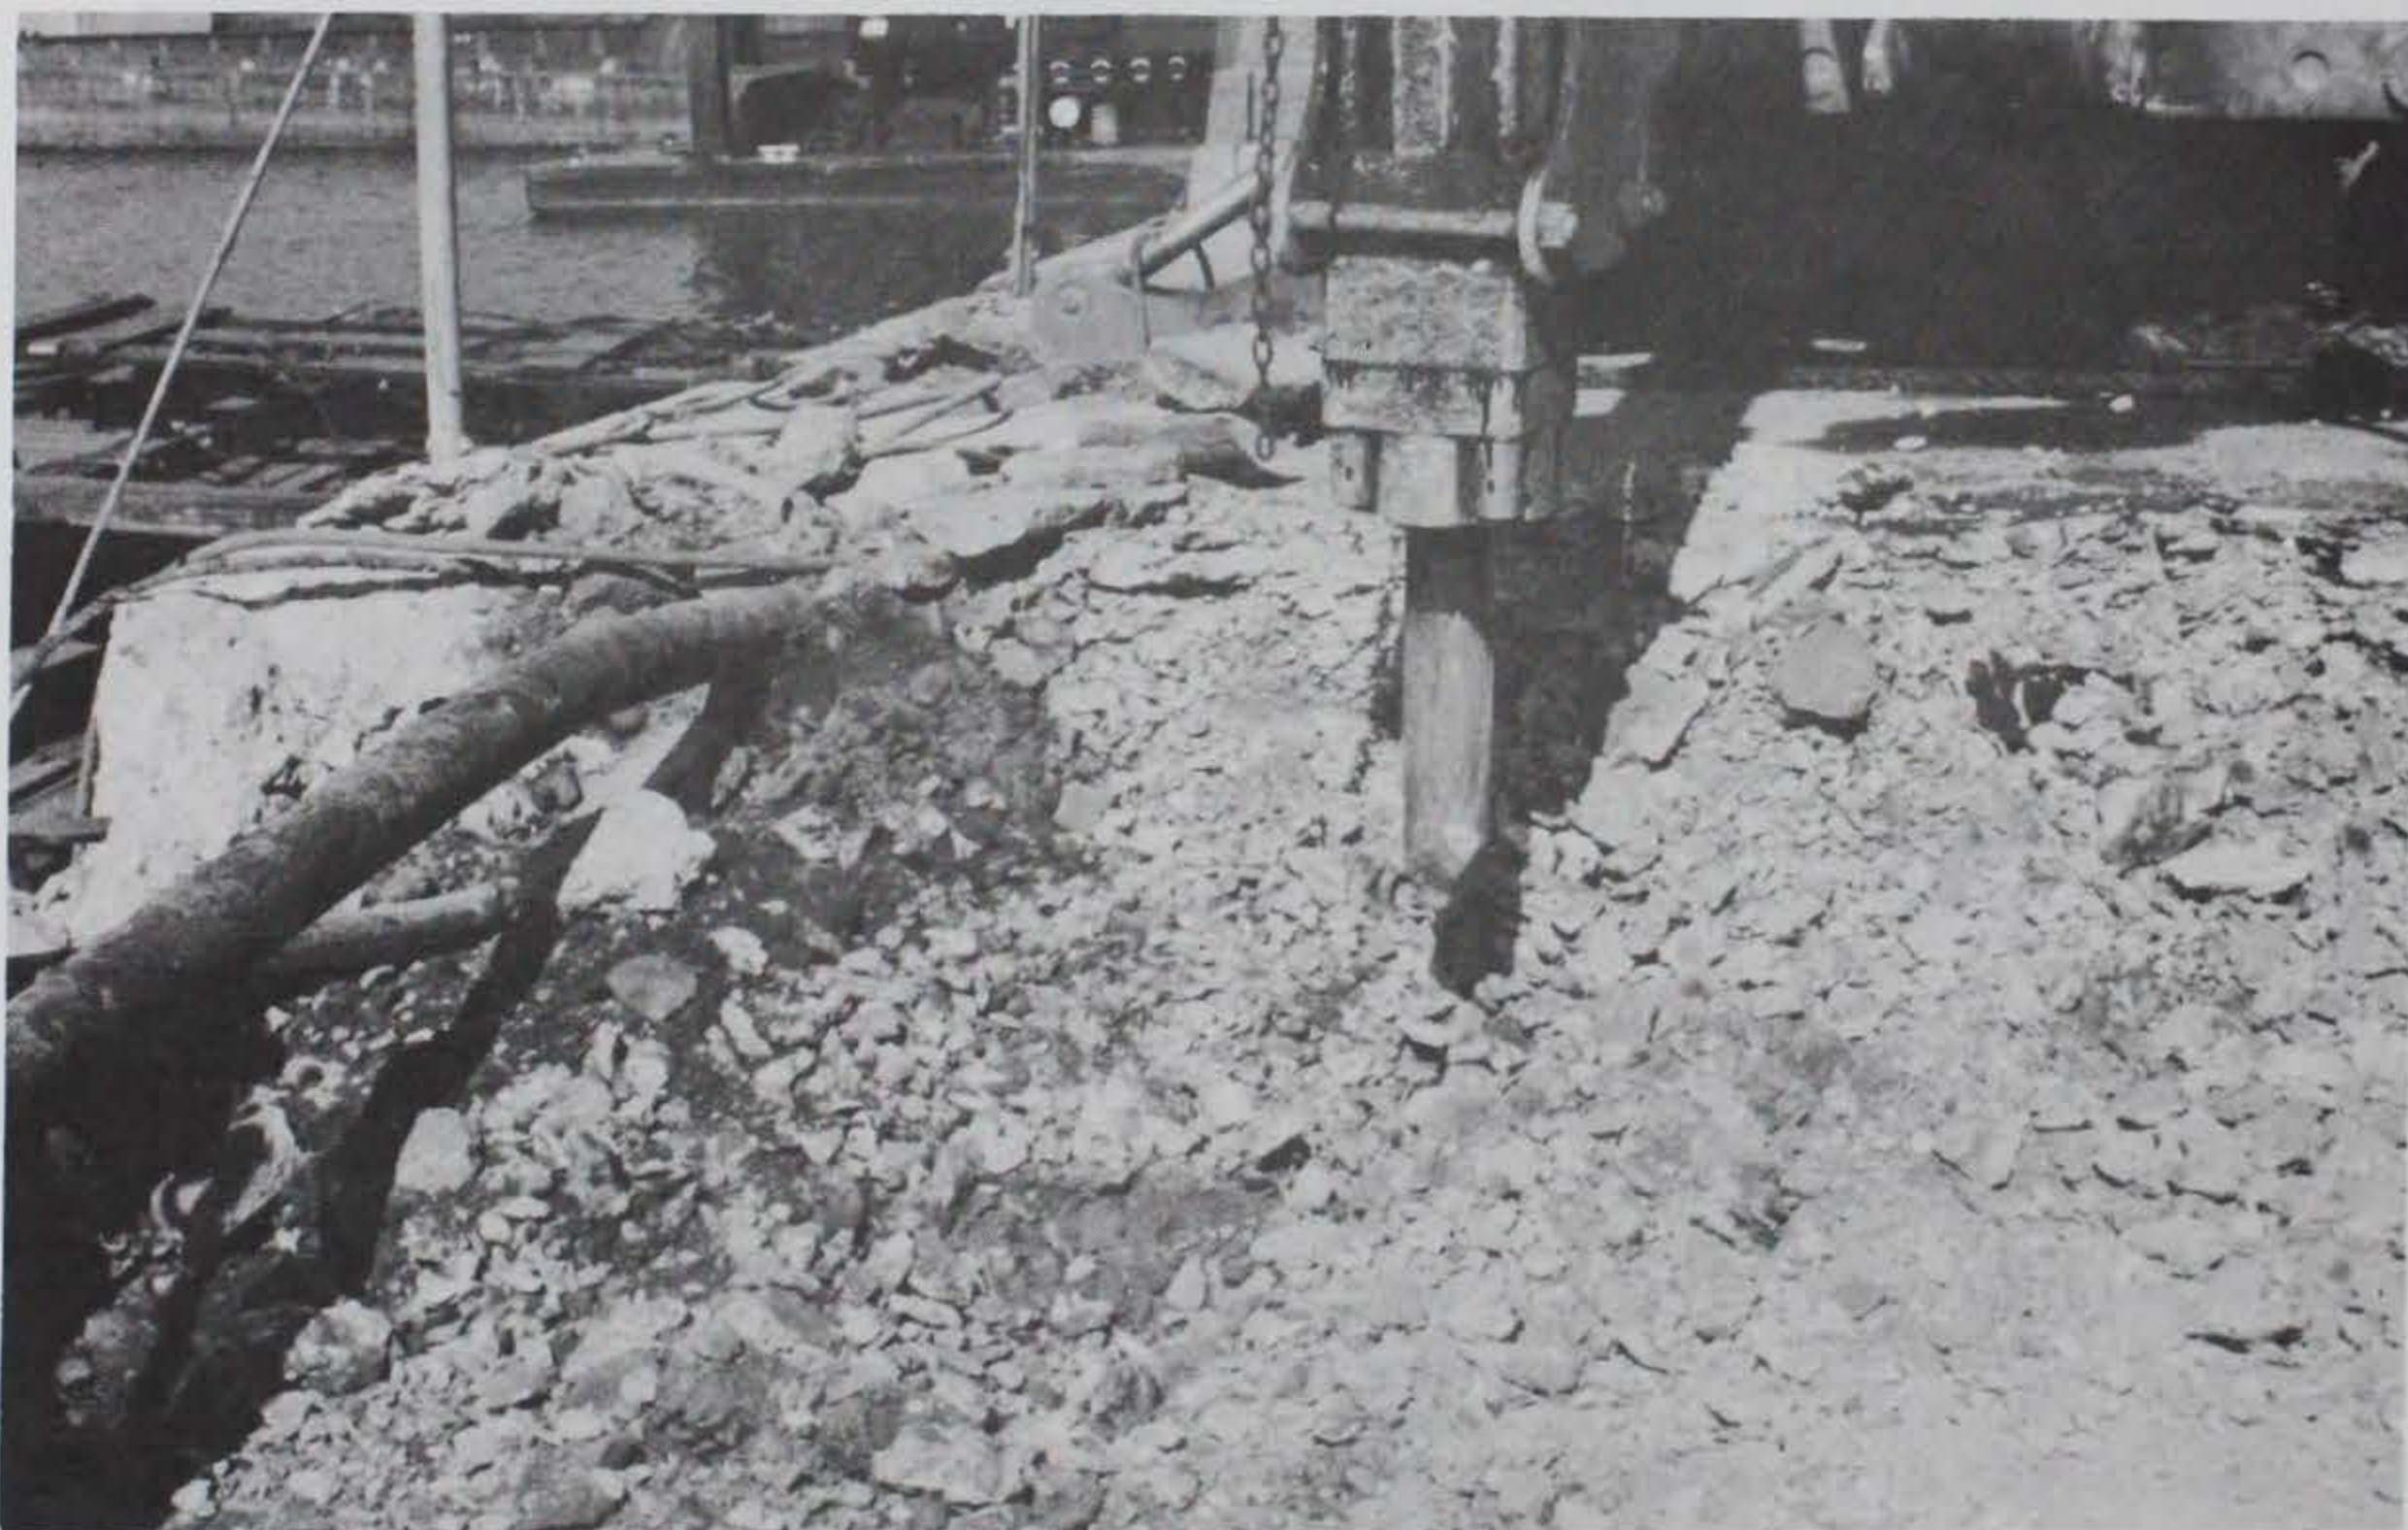
Figure 67. Concrete removal with Hoe Ram Impactor, October 1978, Lock No. 3, Monongahela River

154. Originally, the top surfaces of the land and river walls were to be cut down 2 ft and the top of the middle wall cut down 1 ft. When work began on the middle wall, it was discovered that there was inadequate cover over the gallery for removal of 1 ft of concrete. Instead, the middle wall was capped with 1 ft of concrete. The contractor later proposed as a VE proposal the same treatment for the land wall and the lower portion of the middle wall, and it was approved. The only areas to be cut down on the land and middle walls were under the gate anchorages and operating machinery. The river wall was the only wall to be cut down and resurfaced to the original elevation. Removal of the top surface concrete was done with jackhammers and a Hoe Ram mounted on a backhoe (Figure 67).

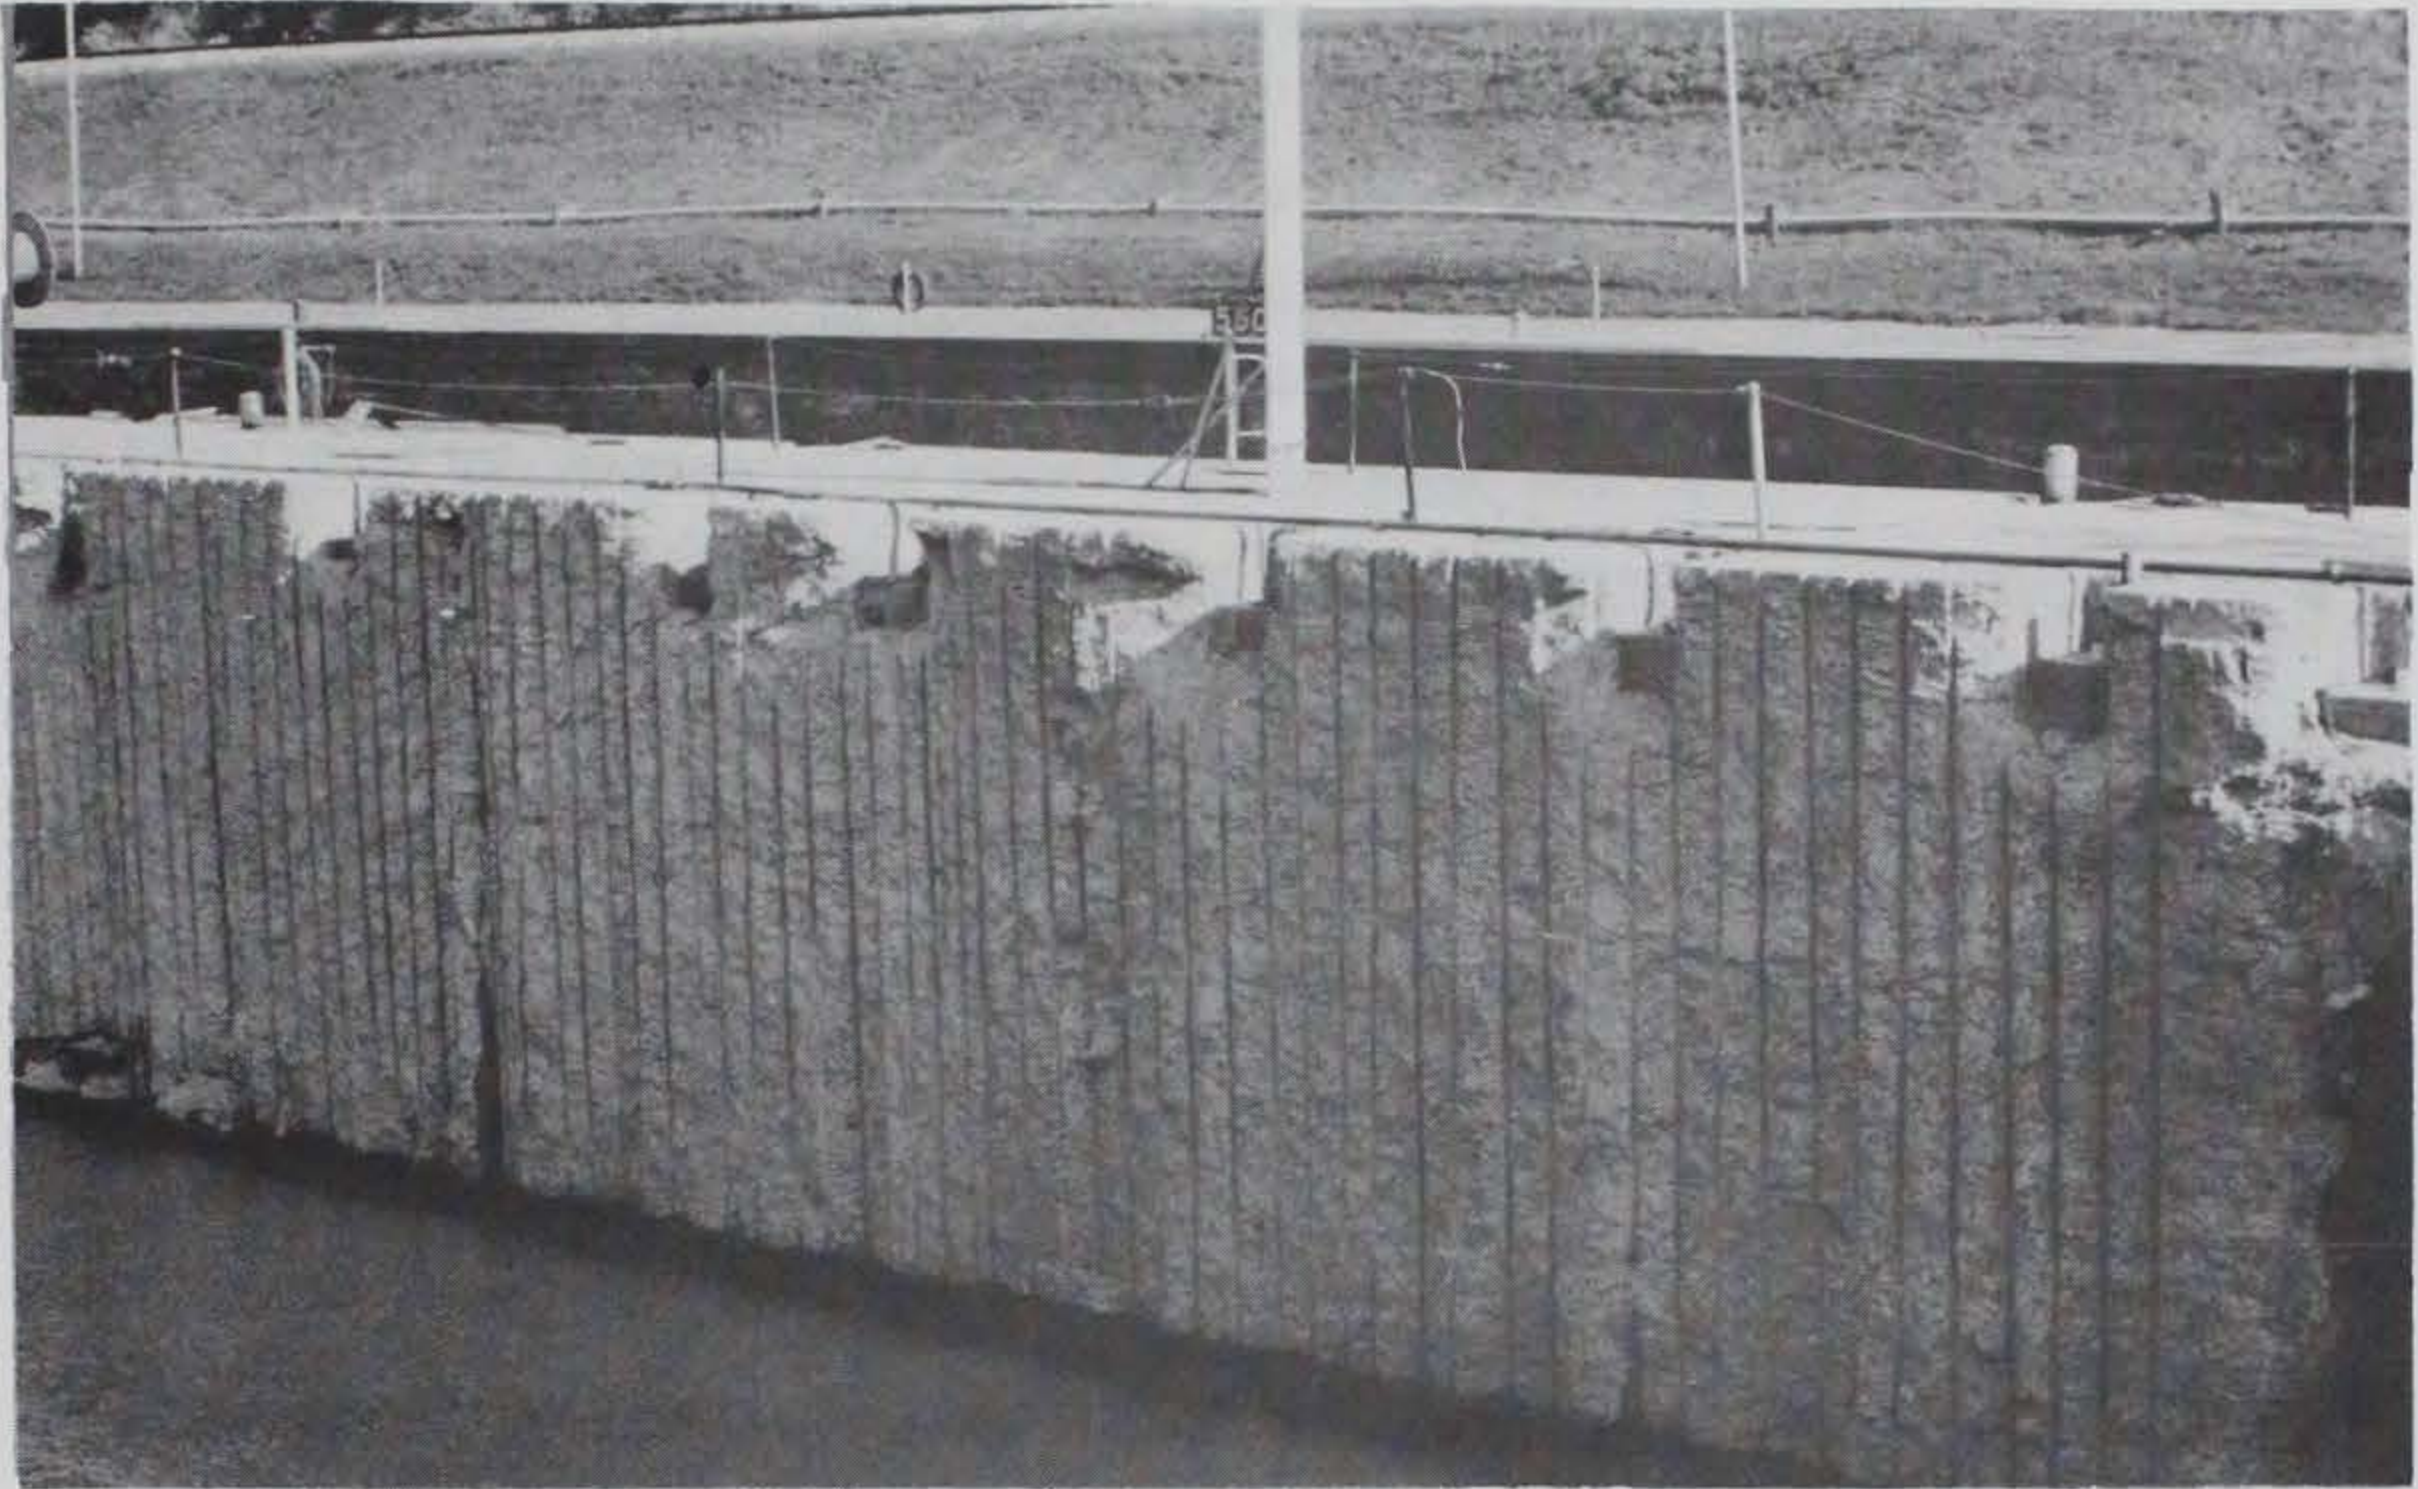
Figure 68. River face of middle wall after blasting, October 1978, Lock No. 3, Monongahela River

155. After the existing concrete was removed from the face of the walls (Figure 68), 1-1/2-in. holes inclined 10 deg below horizontal were drilled on 2-ft centers for No. 6 hook dowels (Figure 69). The dowels were grouted in place with polyester resin grout (Celtite) cartridges. A cartridge was inserted into each hole, and the dowel was installed and spun with an air drill.

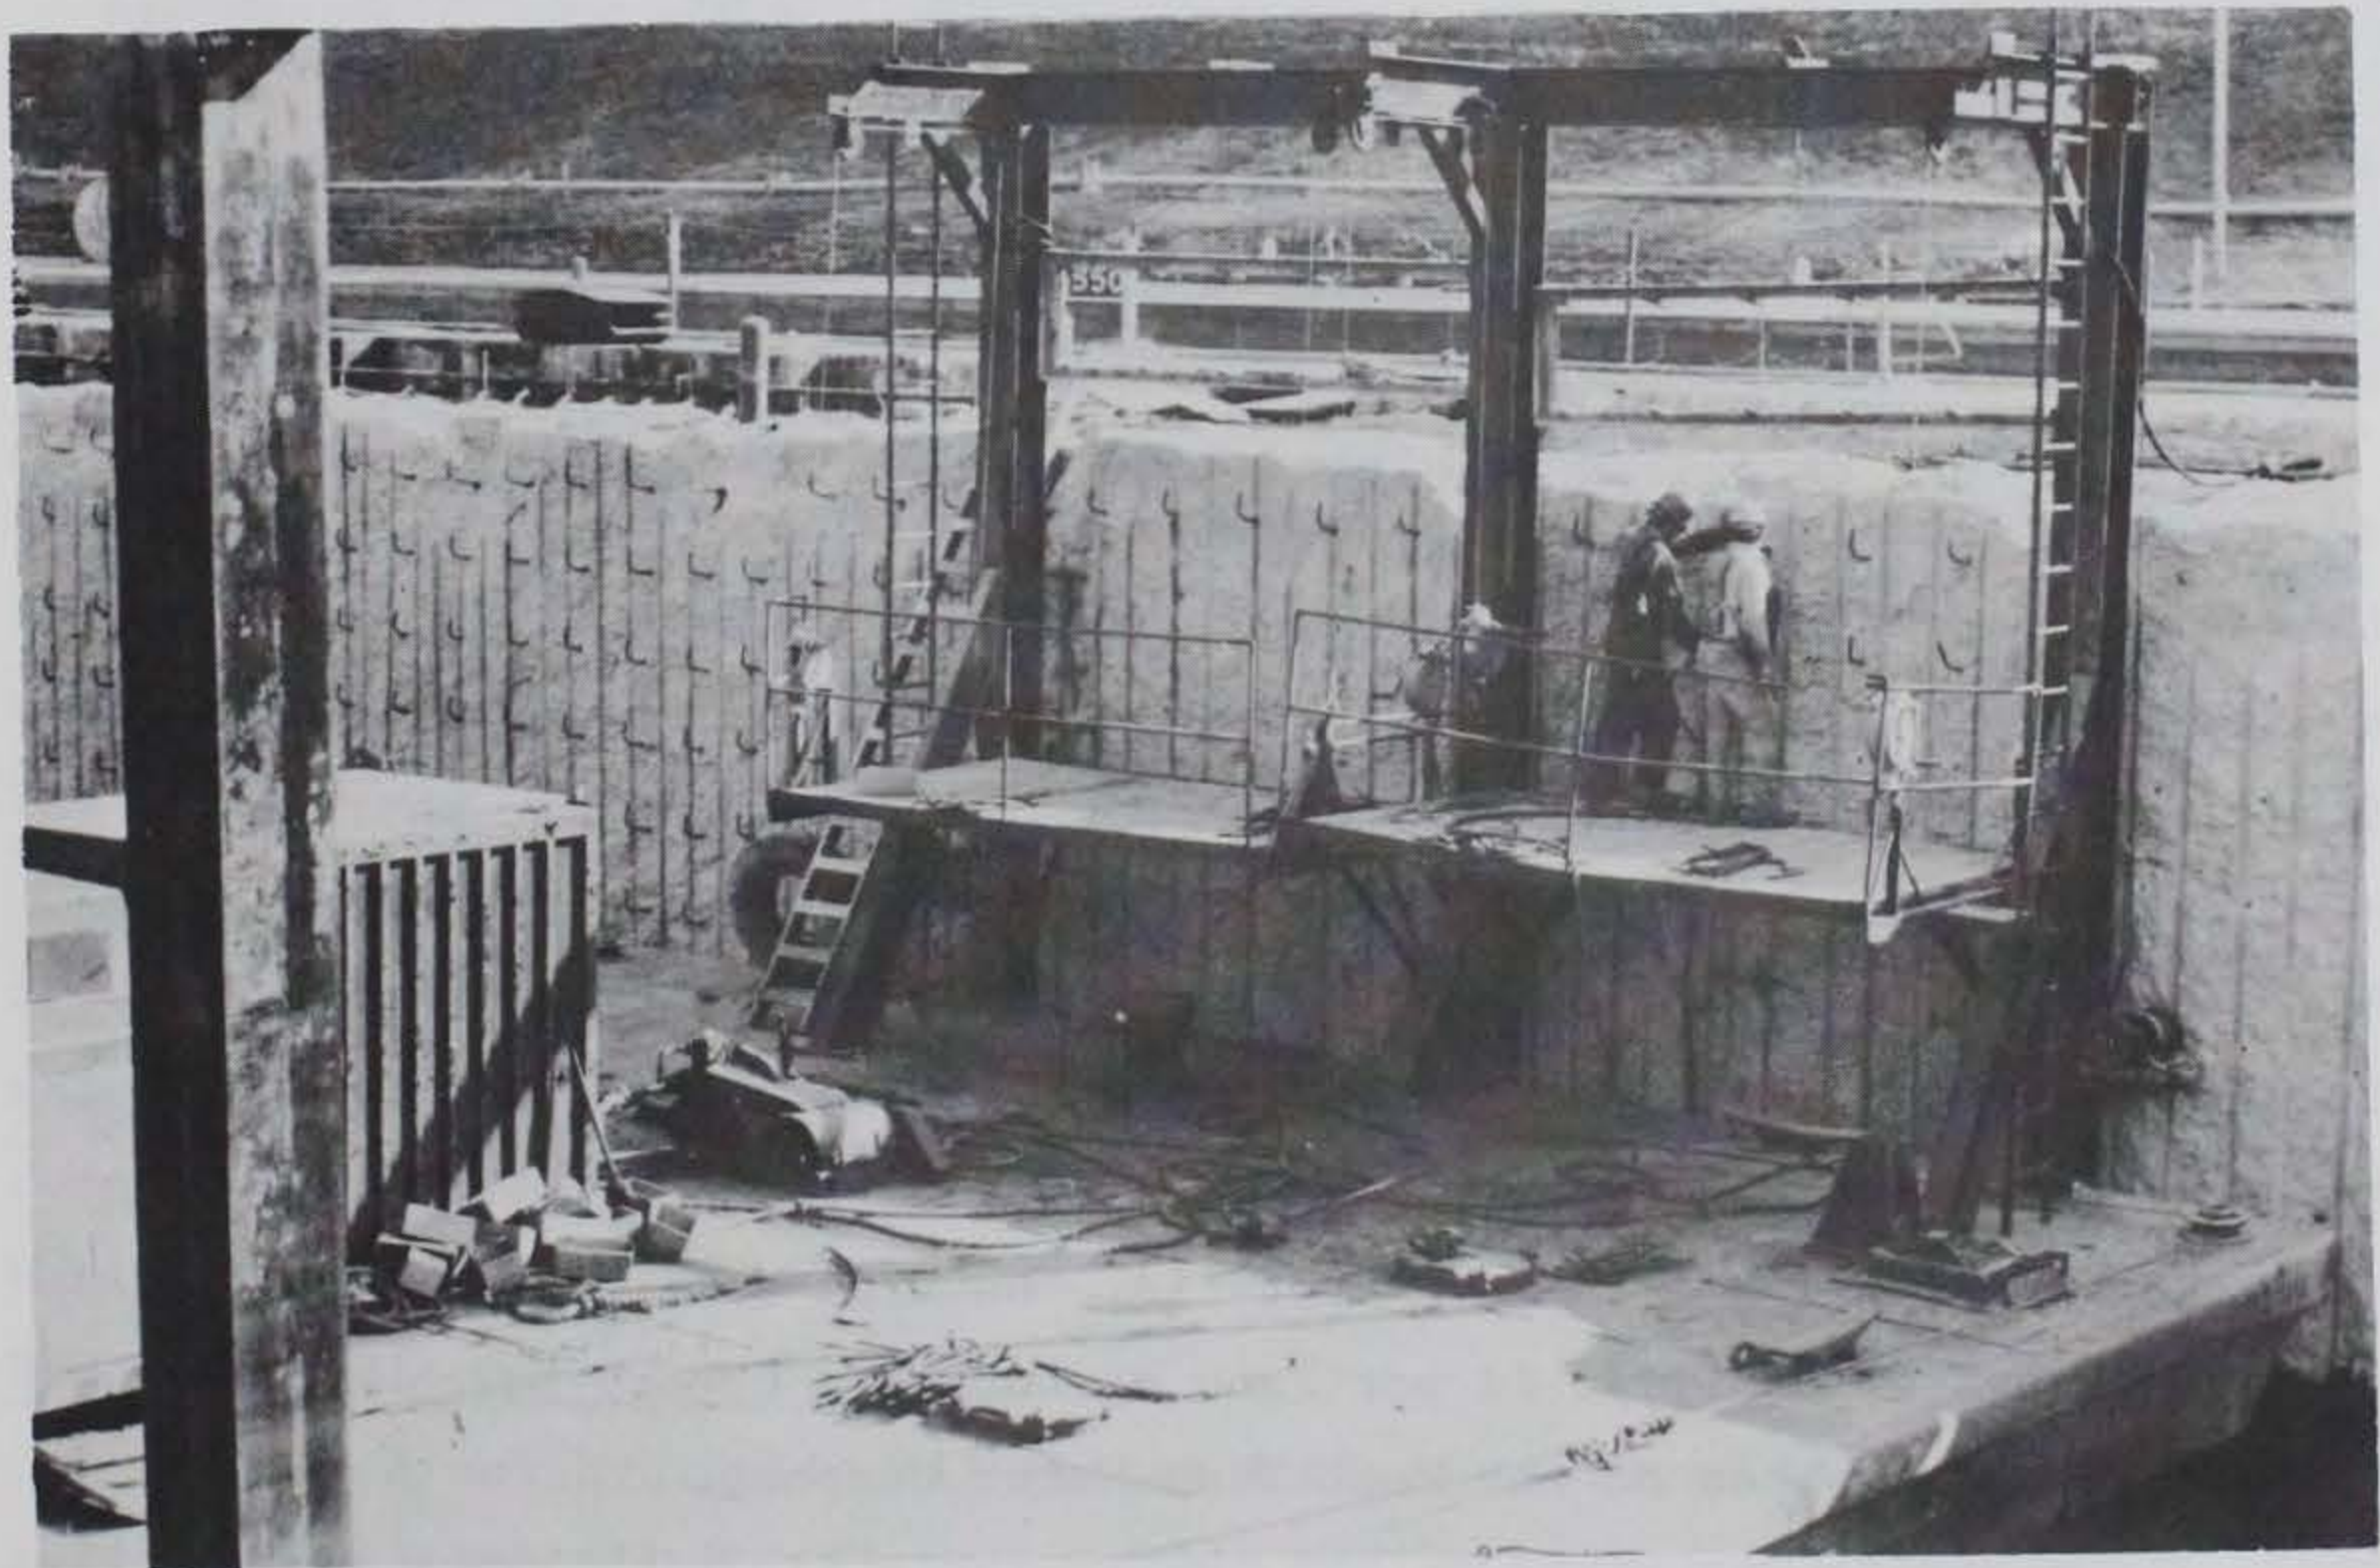
Figure 69. Installation of dowels, November 1978, Lock No. 3, Monongahela River

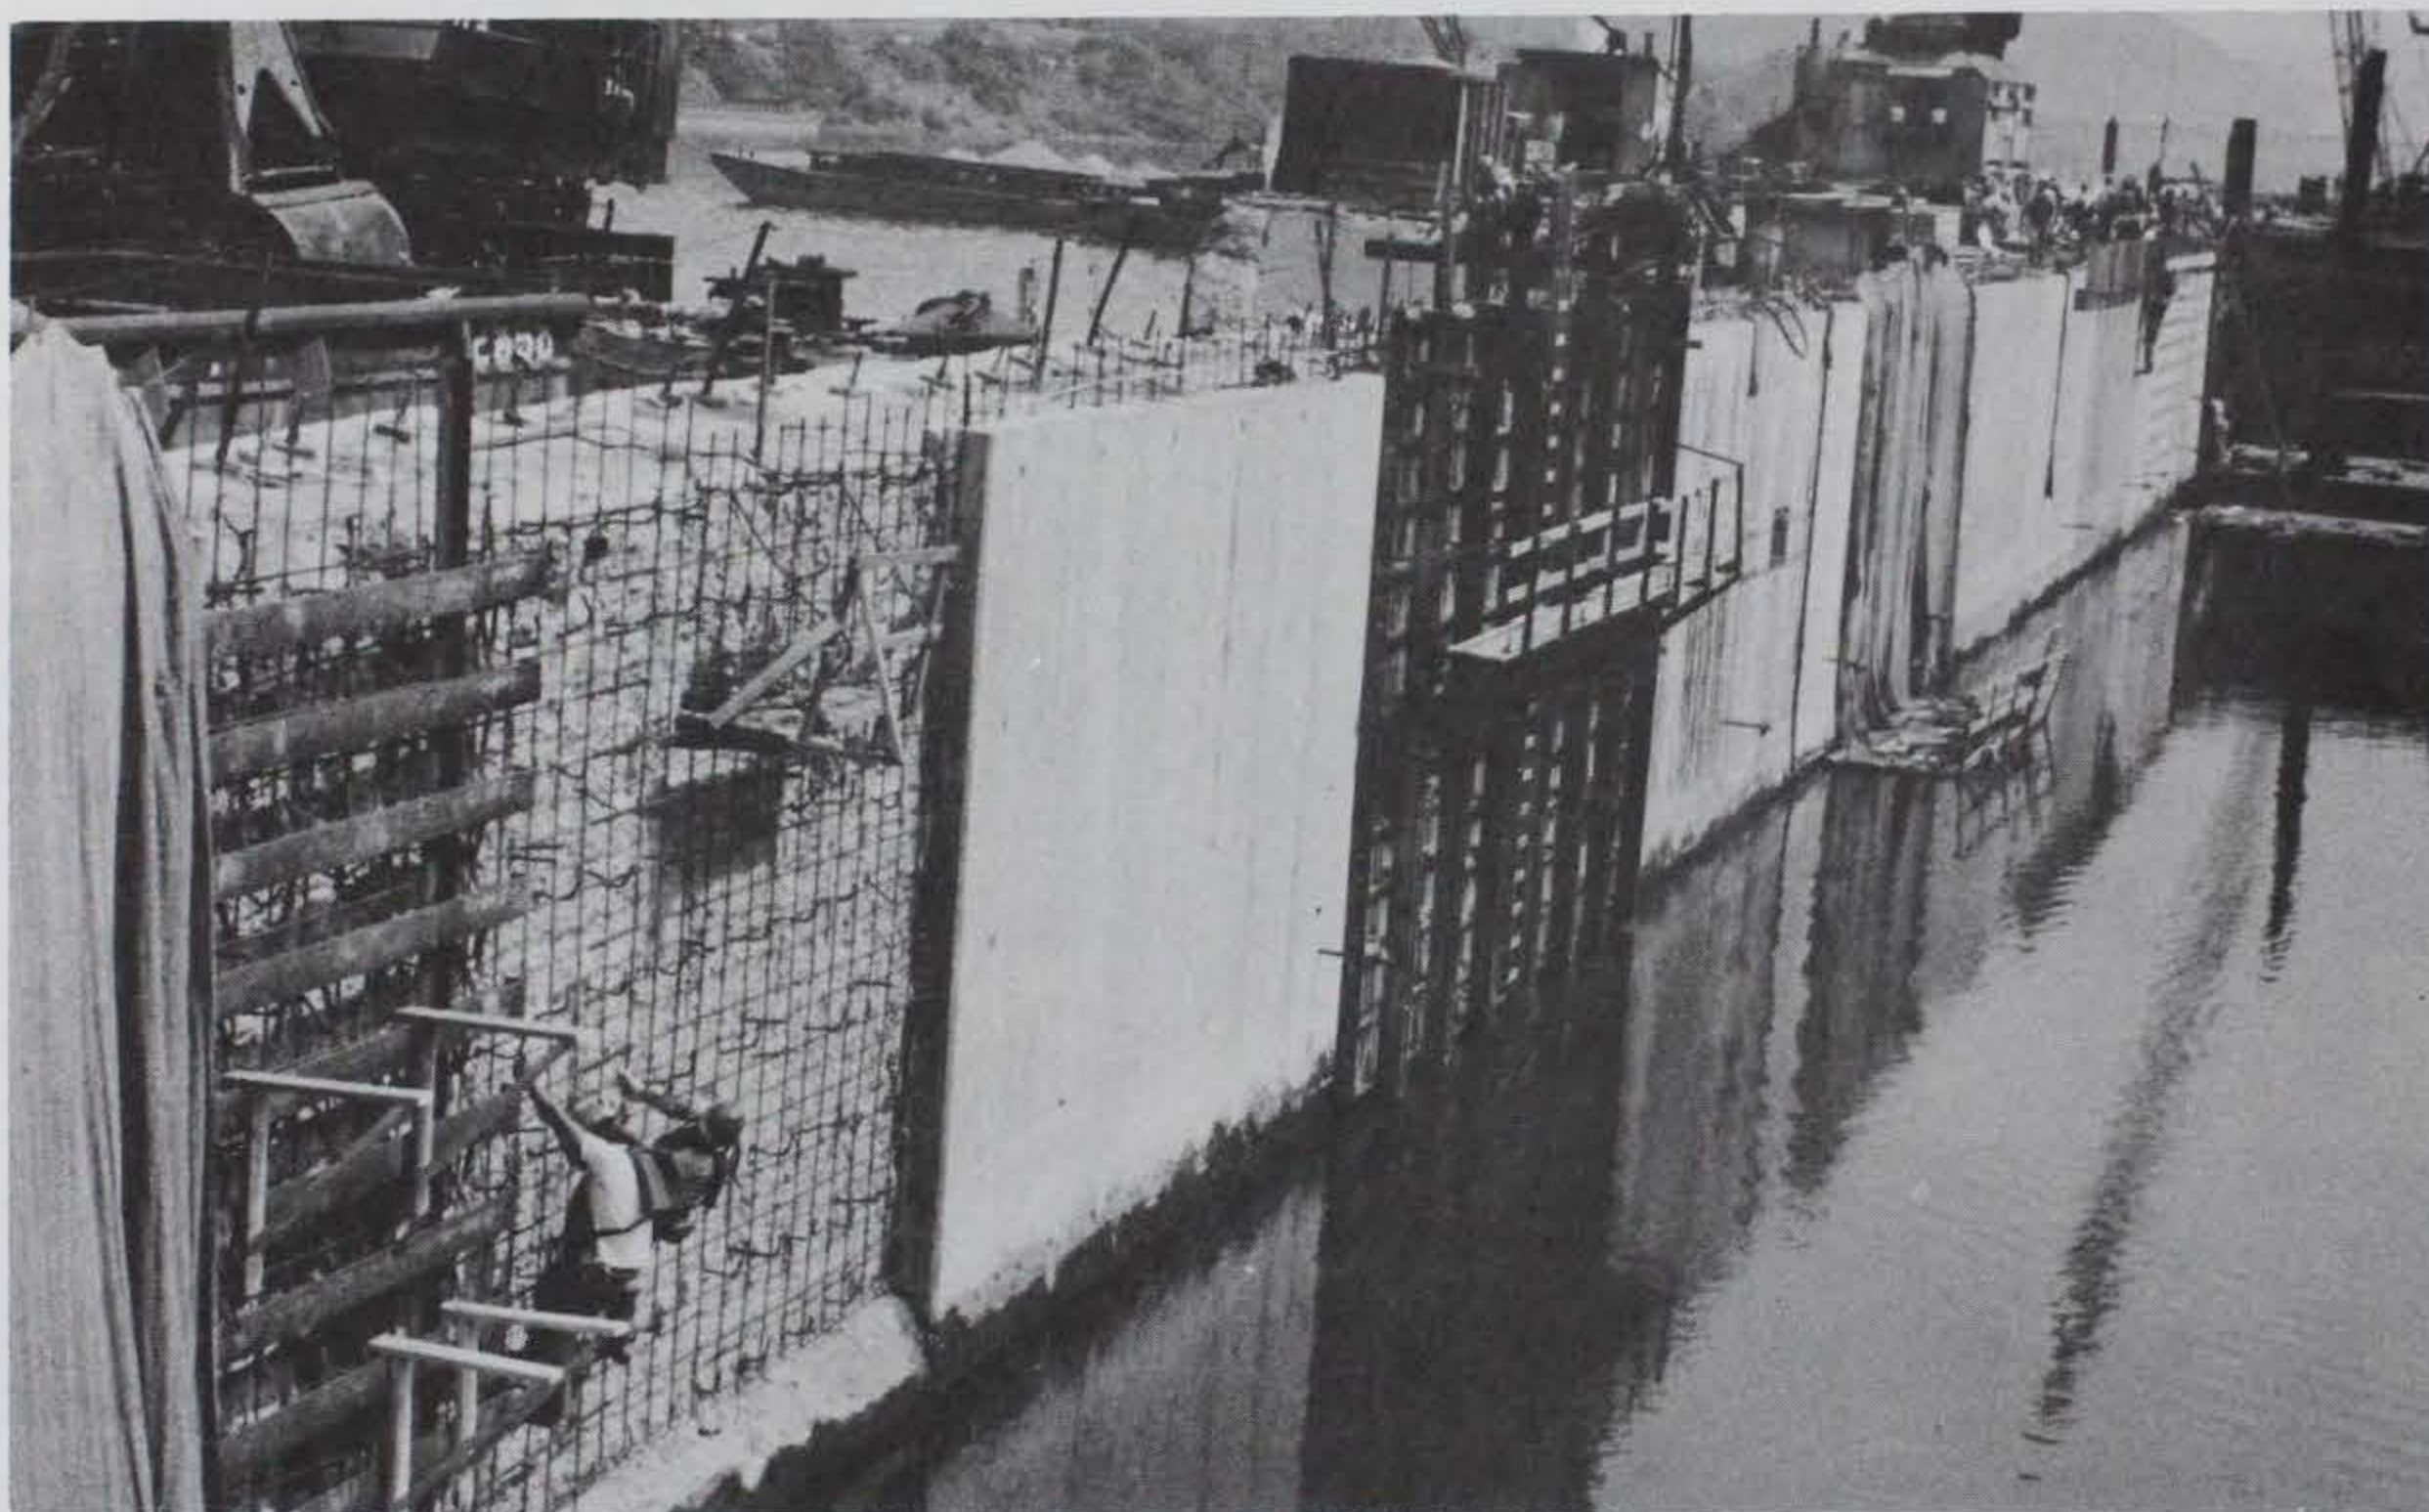
Figure 70. Partially completed land face of river wall, August 1979, Lock No. 3, Monongahela River

A vertical mat of No. 5 reinforcing bars on 12-in. centers was then positioned approximately 4 in. from the eventual face of the wall (Figure 70). Forms were installed, and the concrete was placed using an 8-in.-diam, nonrigid, and PVC tremie pipe. A collapsible pipe was needed because of the narrow spaces around the reinforcing steel. The same dowel installation procedures and reinforcing mats were used when the tops of the walls were resurfaced.

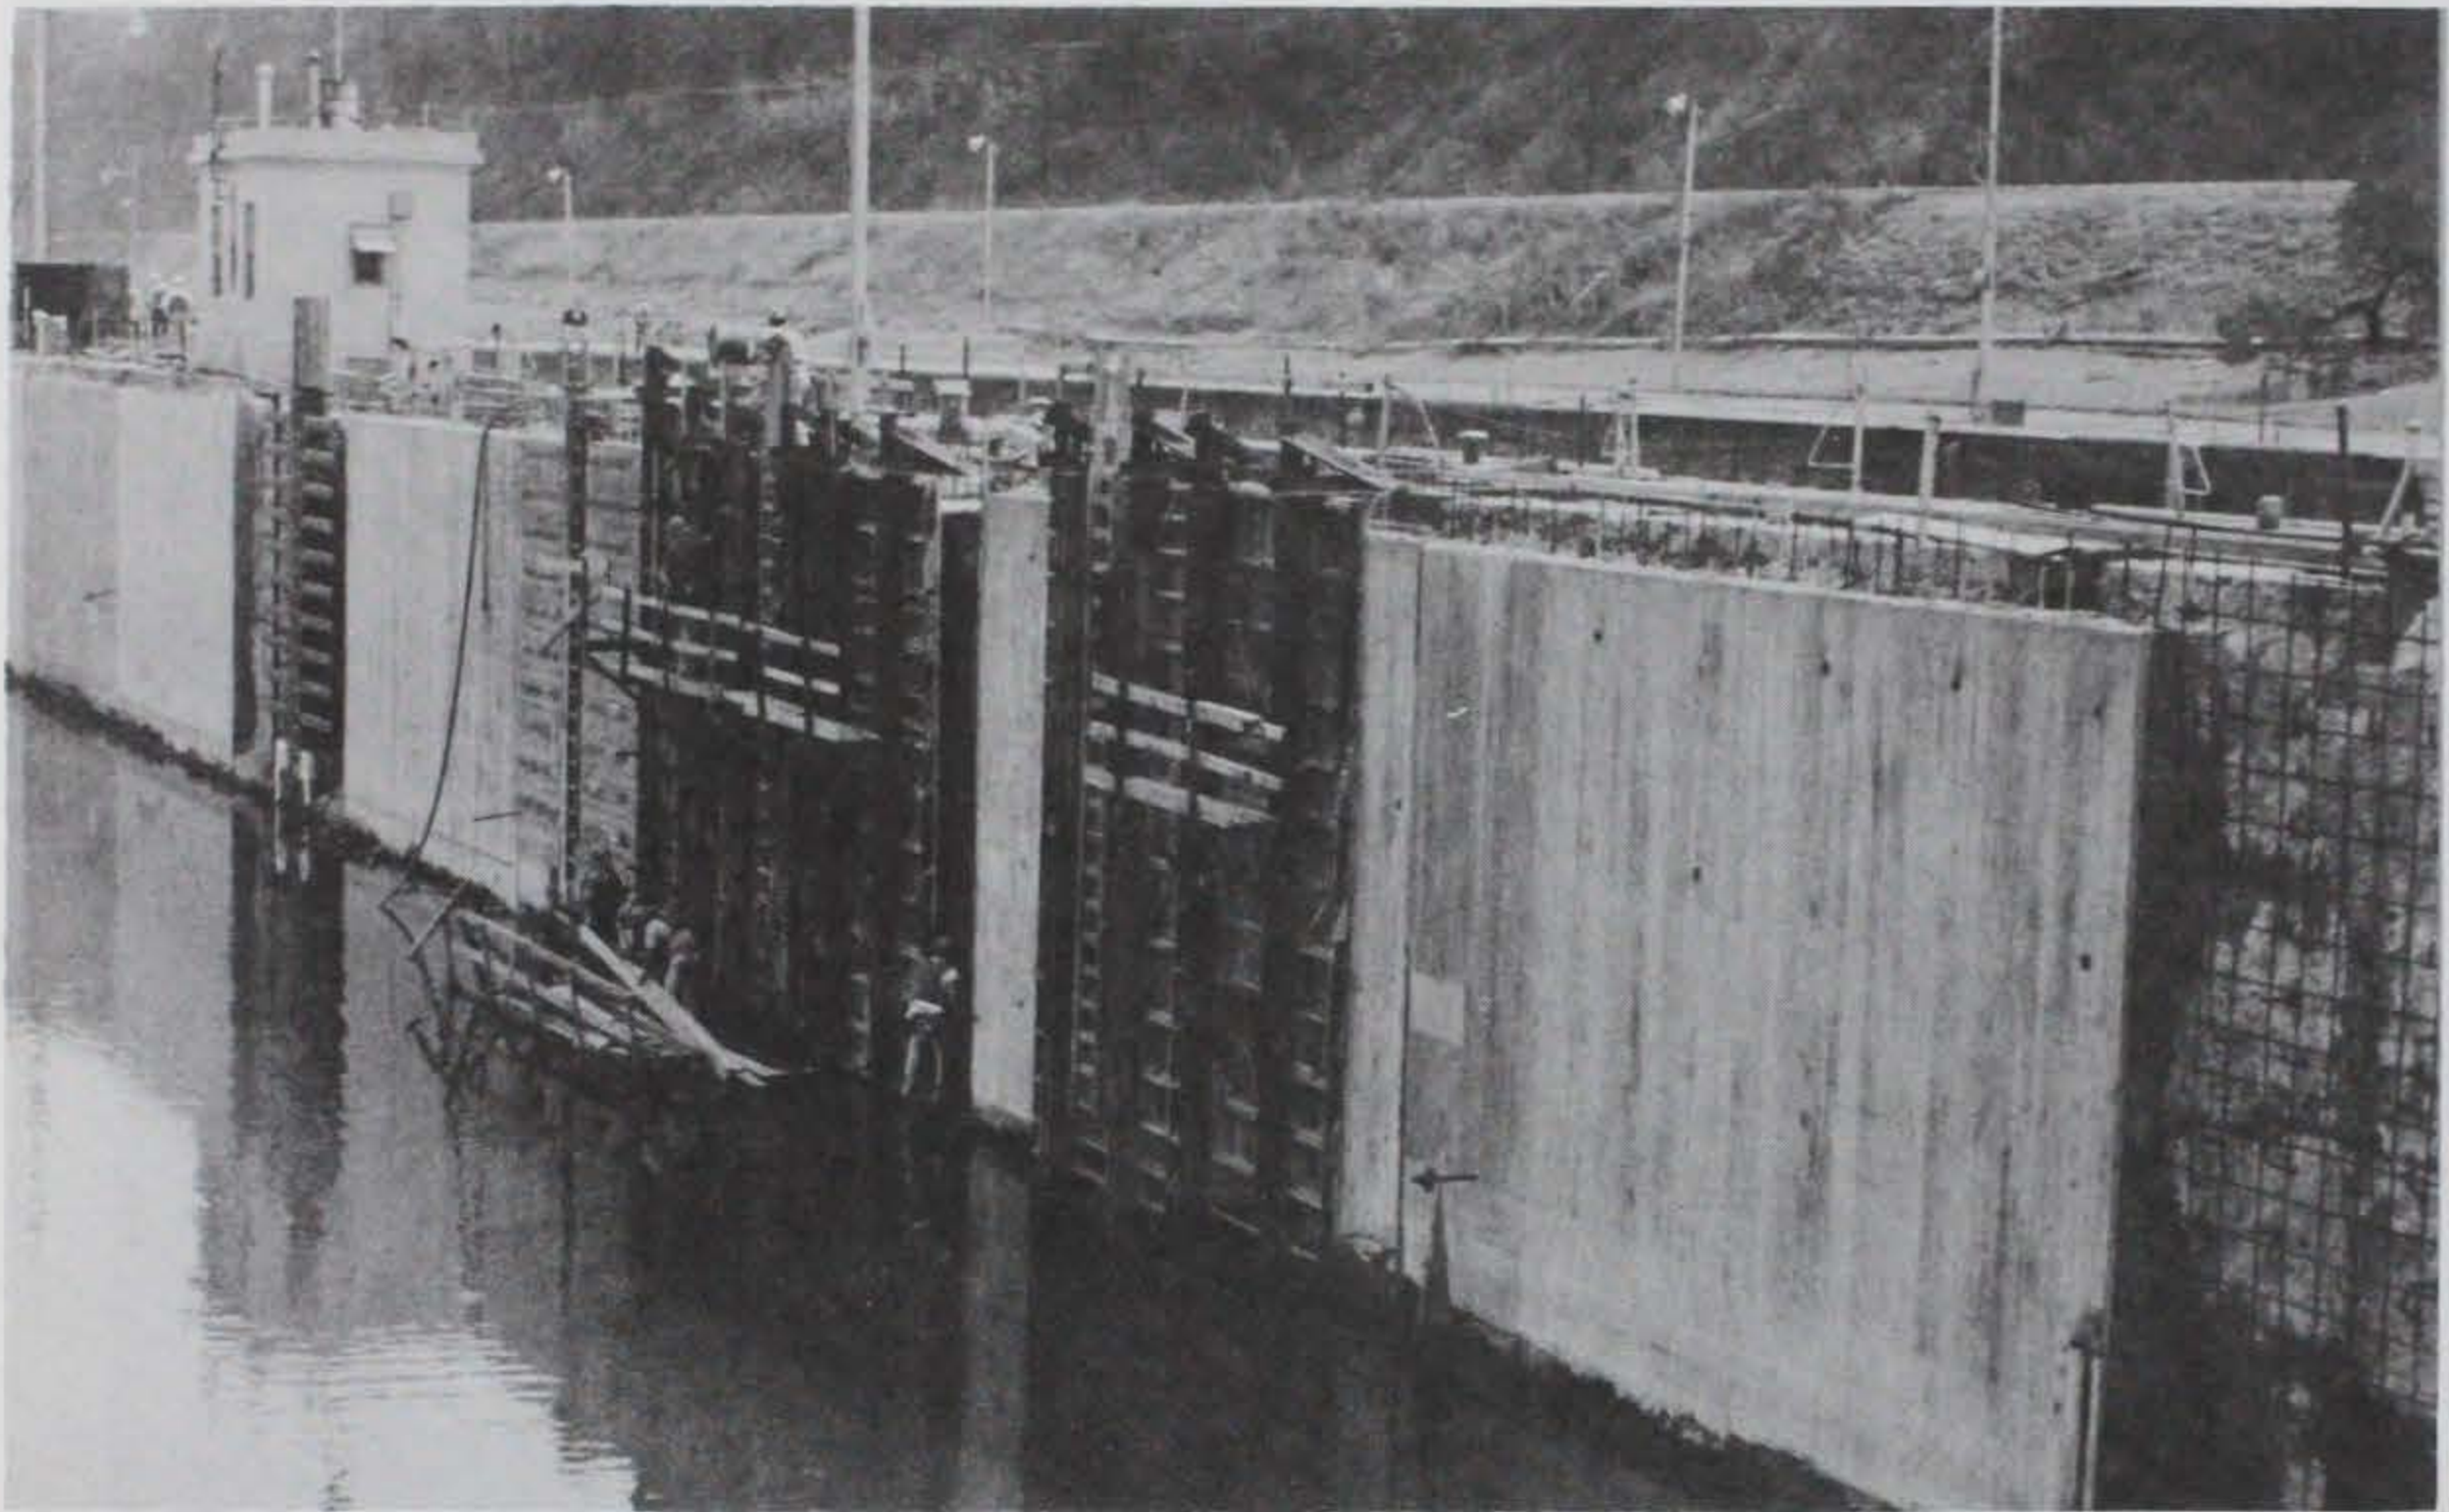
Figure 71. Partially completed river face of middle wall,  
August 1979, Lock No. 3, Monongahela River

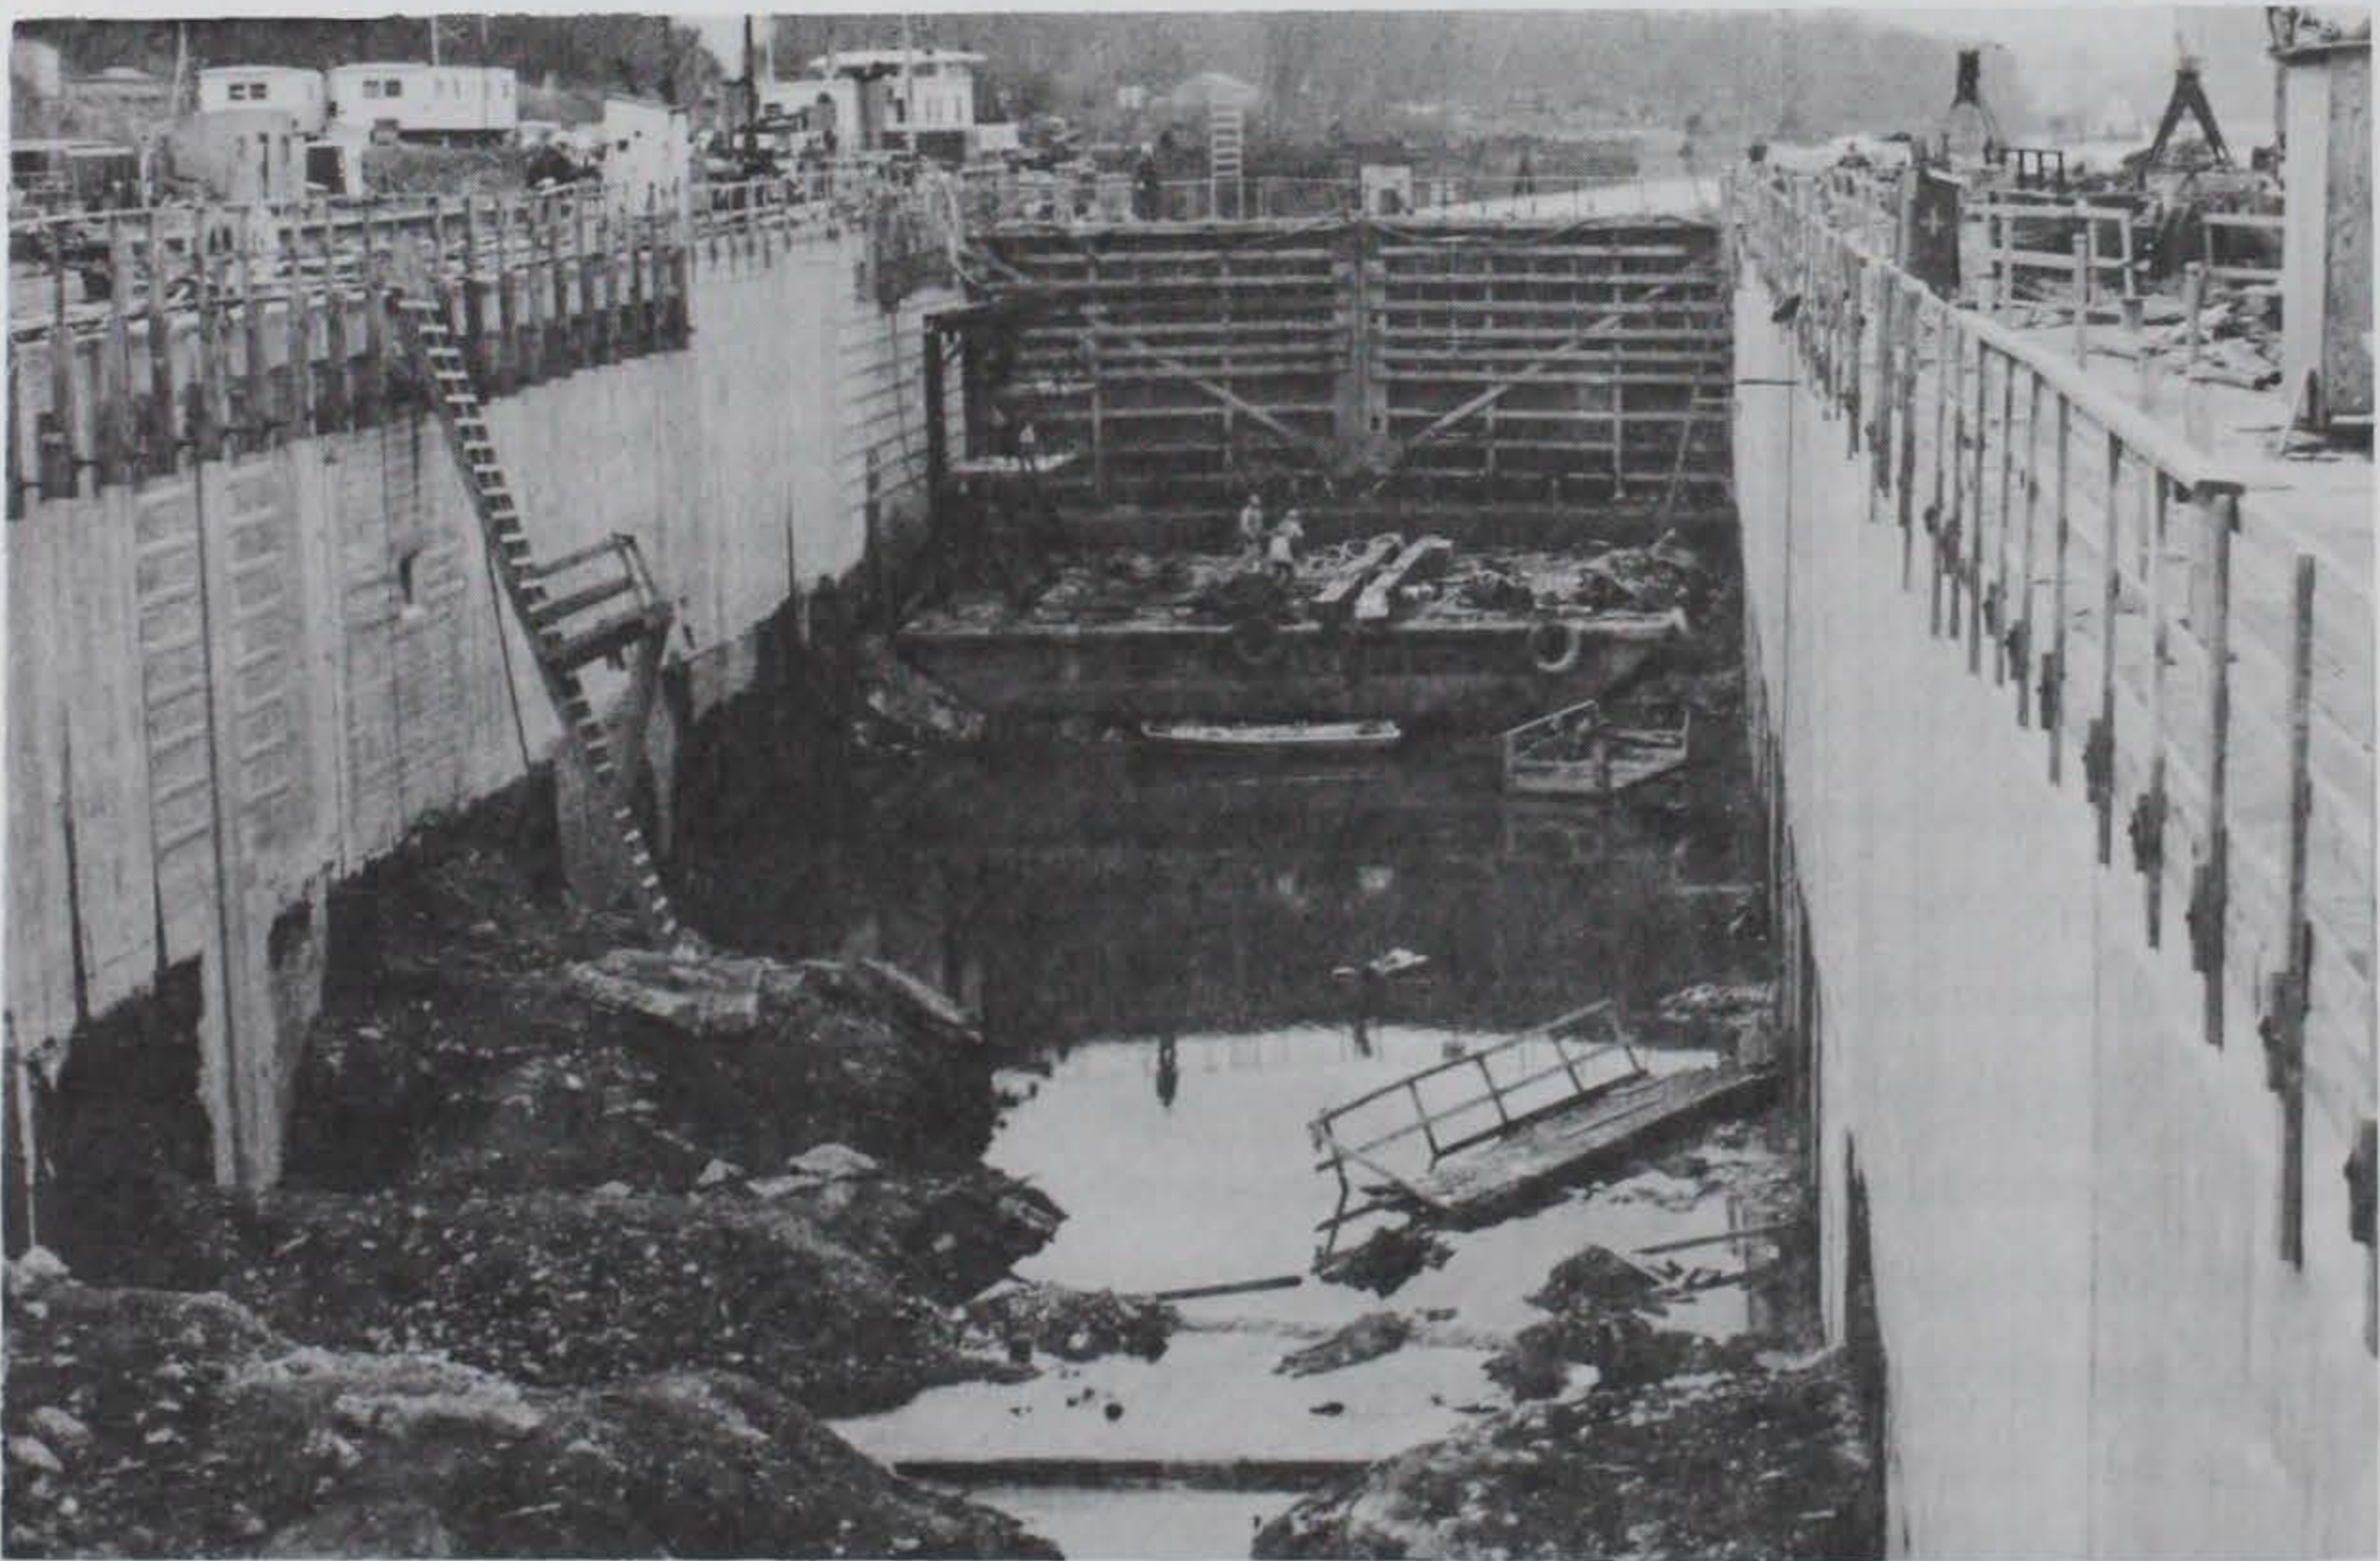
Figure 72. Completed refacing of river chamber, January 1980,  
Lock No. 3, Monongahela River
