TECHNICAL REPORT REMR-CS-13

**REHABILITATION OF NAVIGATION  
LOCK WALLS: CASE HISTORIES**

James E. McDonald

December 1987

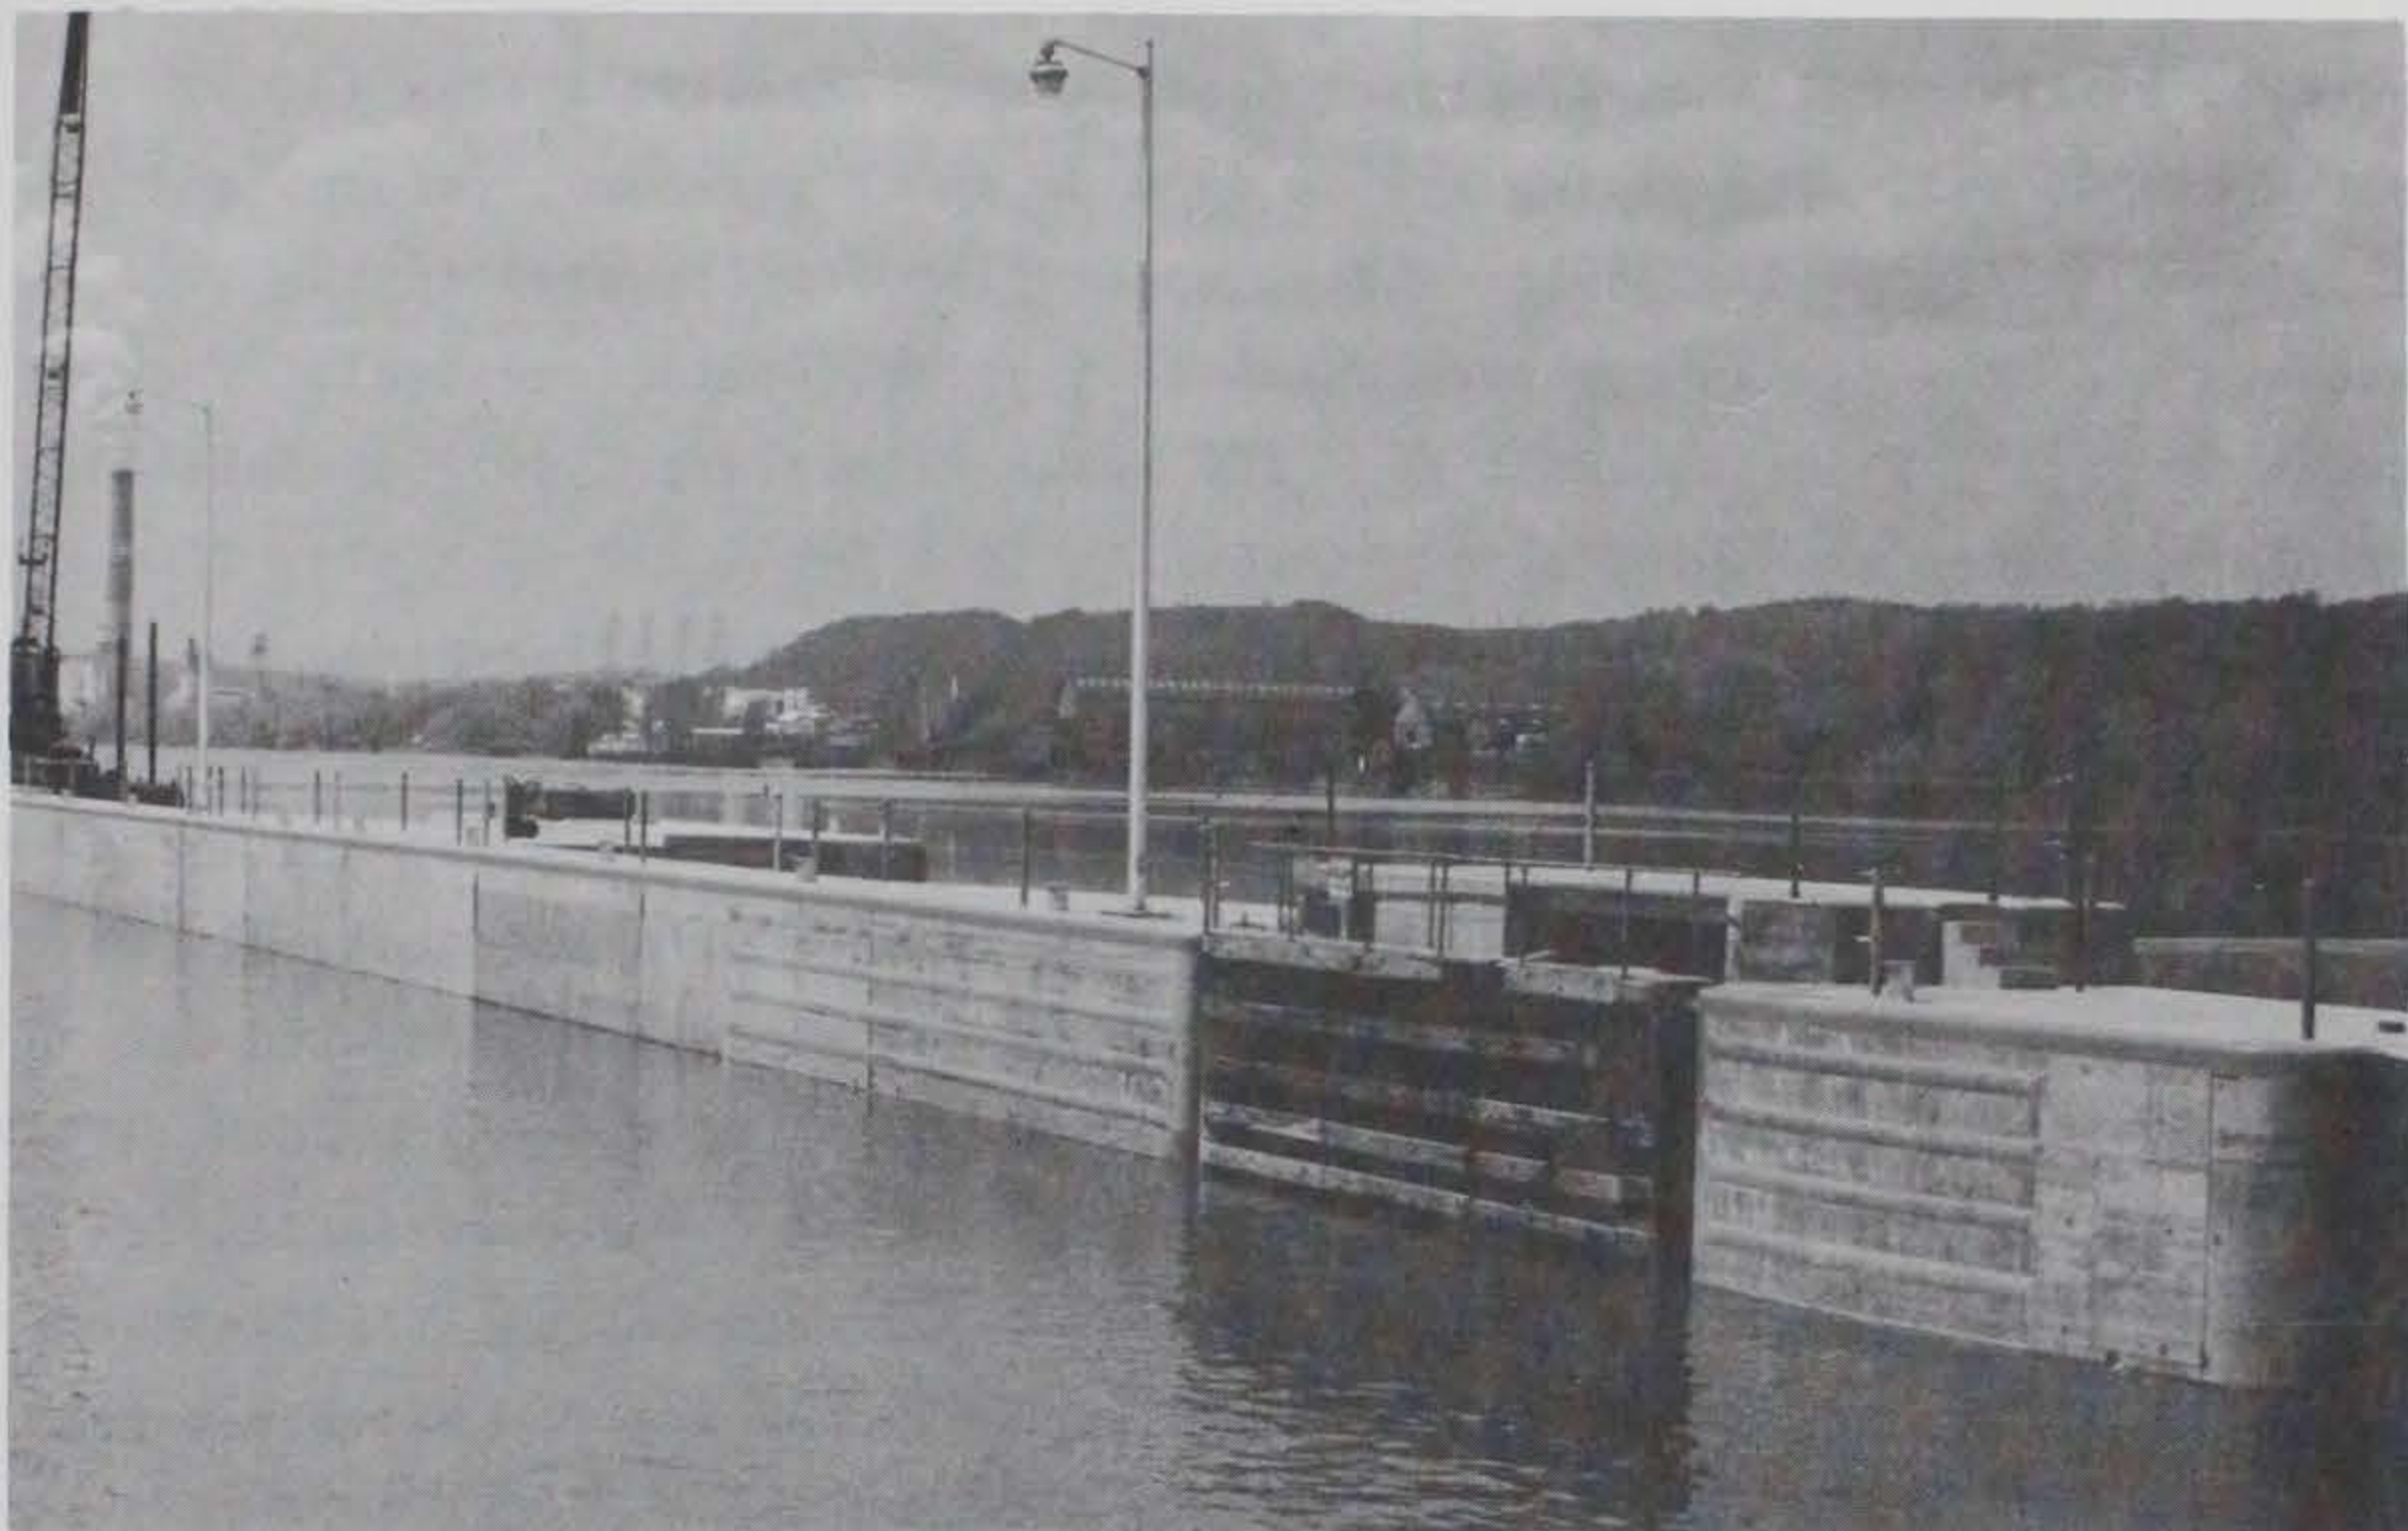
Figure 73. Resurfaced and refaced river wall, May 1980,  
Lock No. 3, Monongahela River

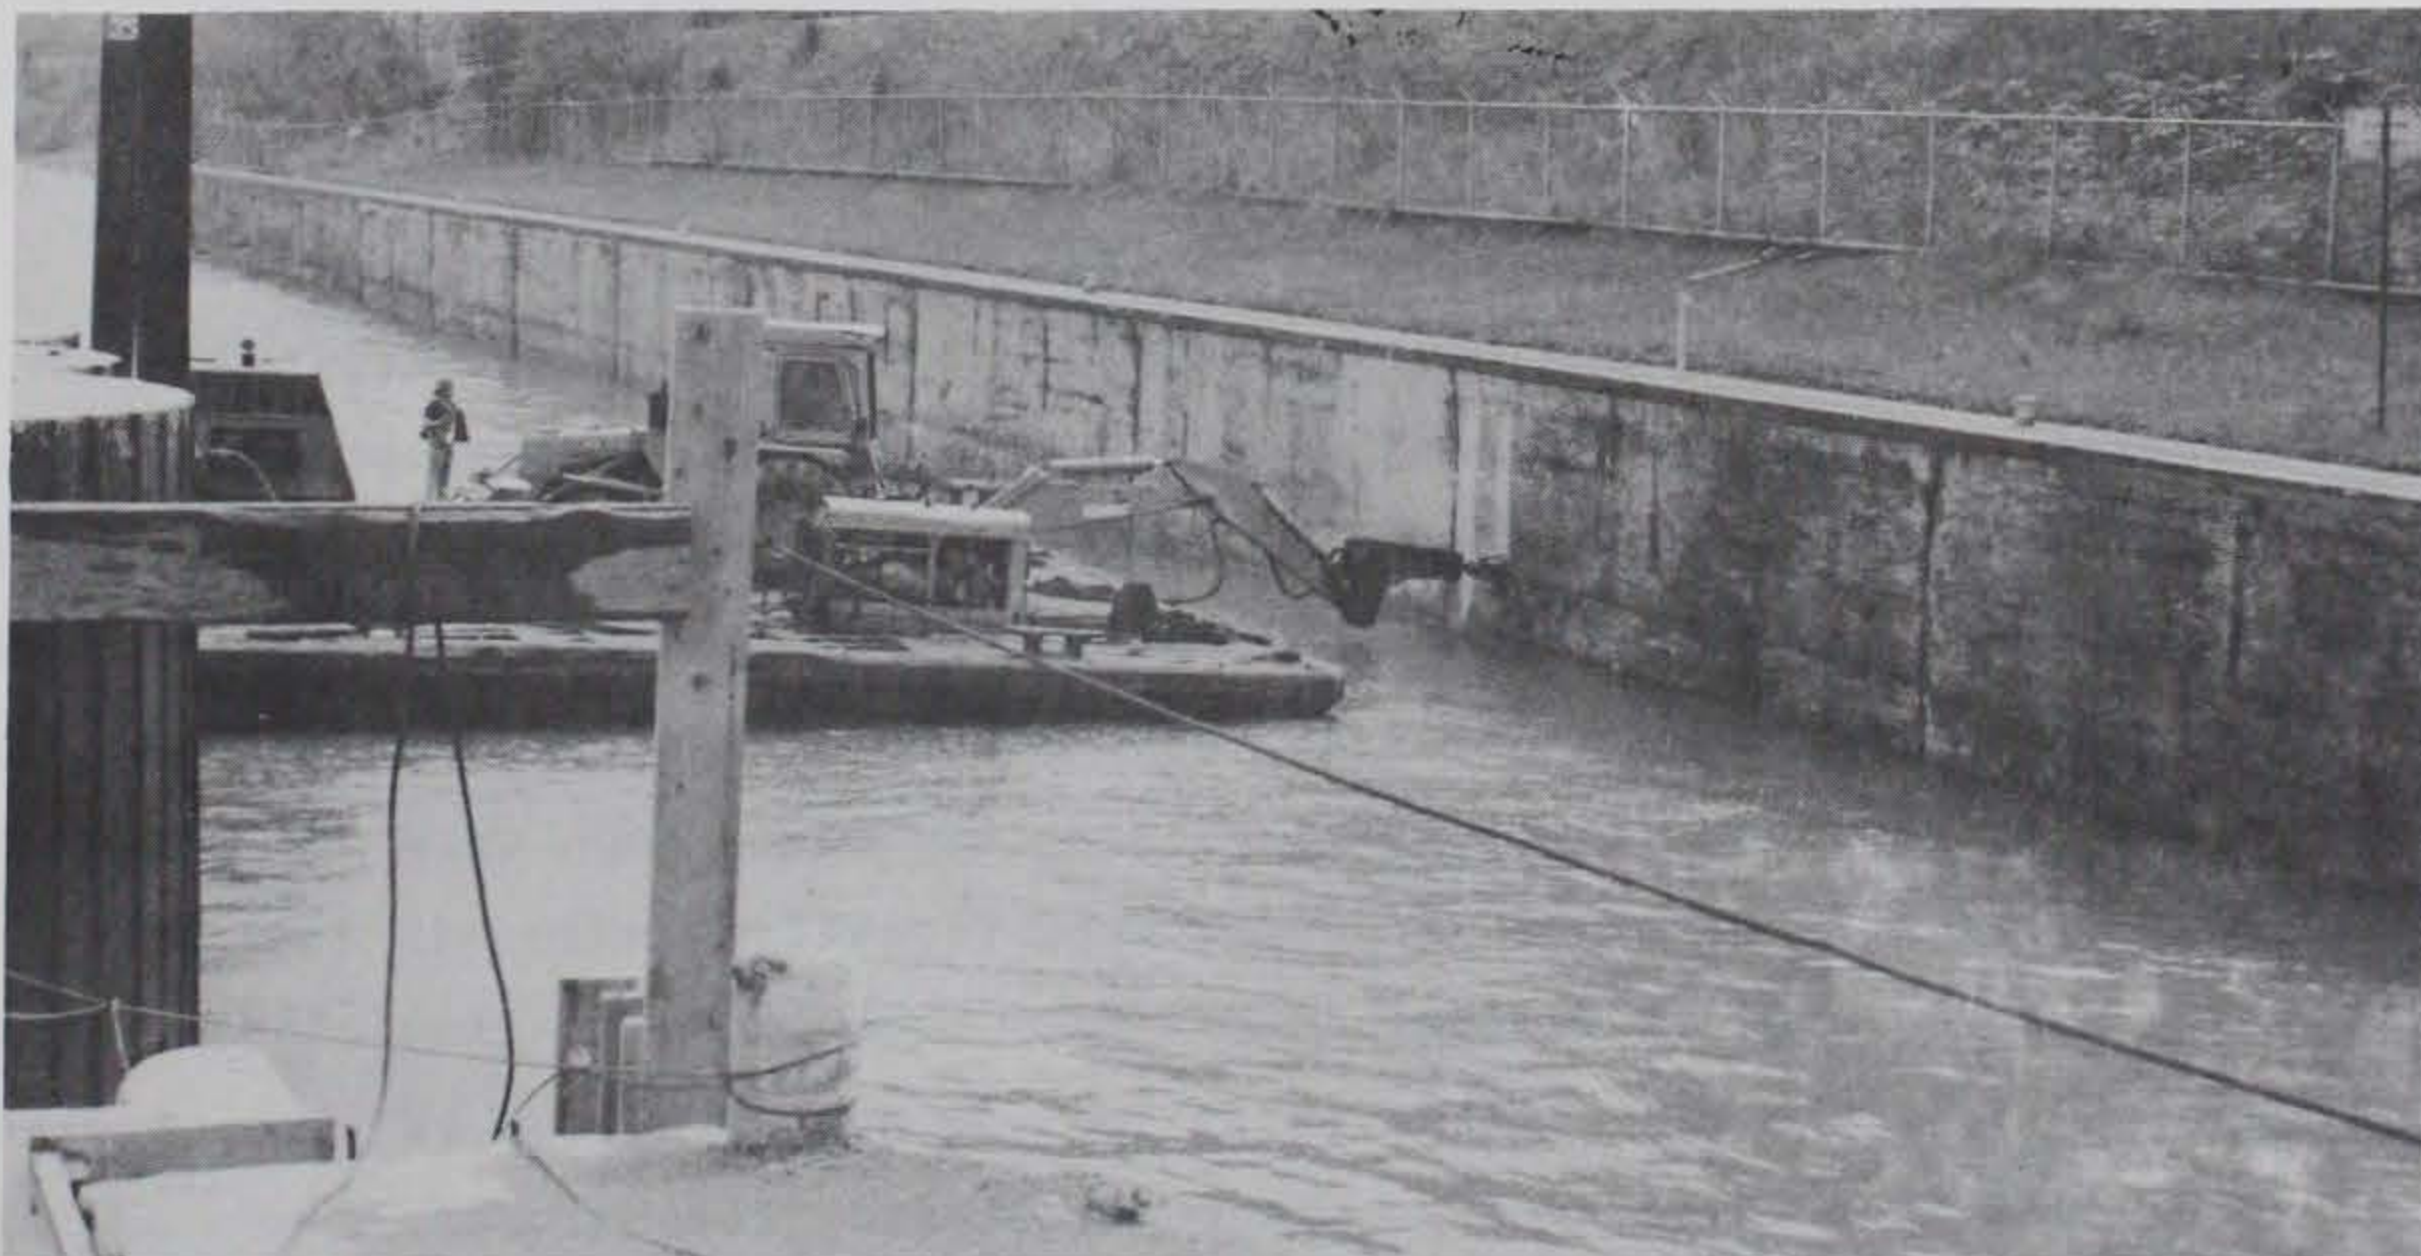
Figure 74. Bush hammer used to prepared lower guide wall for  
shotcreting, May 1980, Lock No. 3, Monongahela River

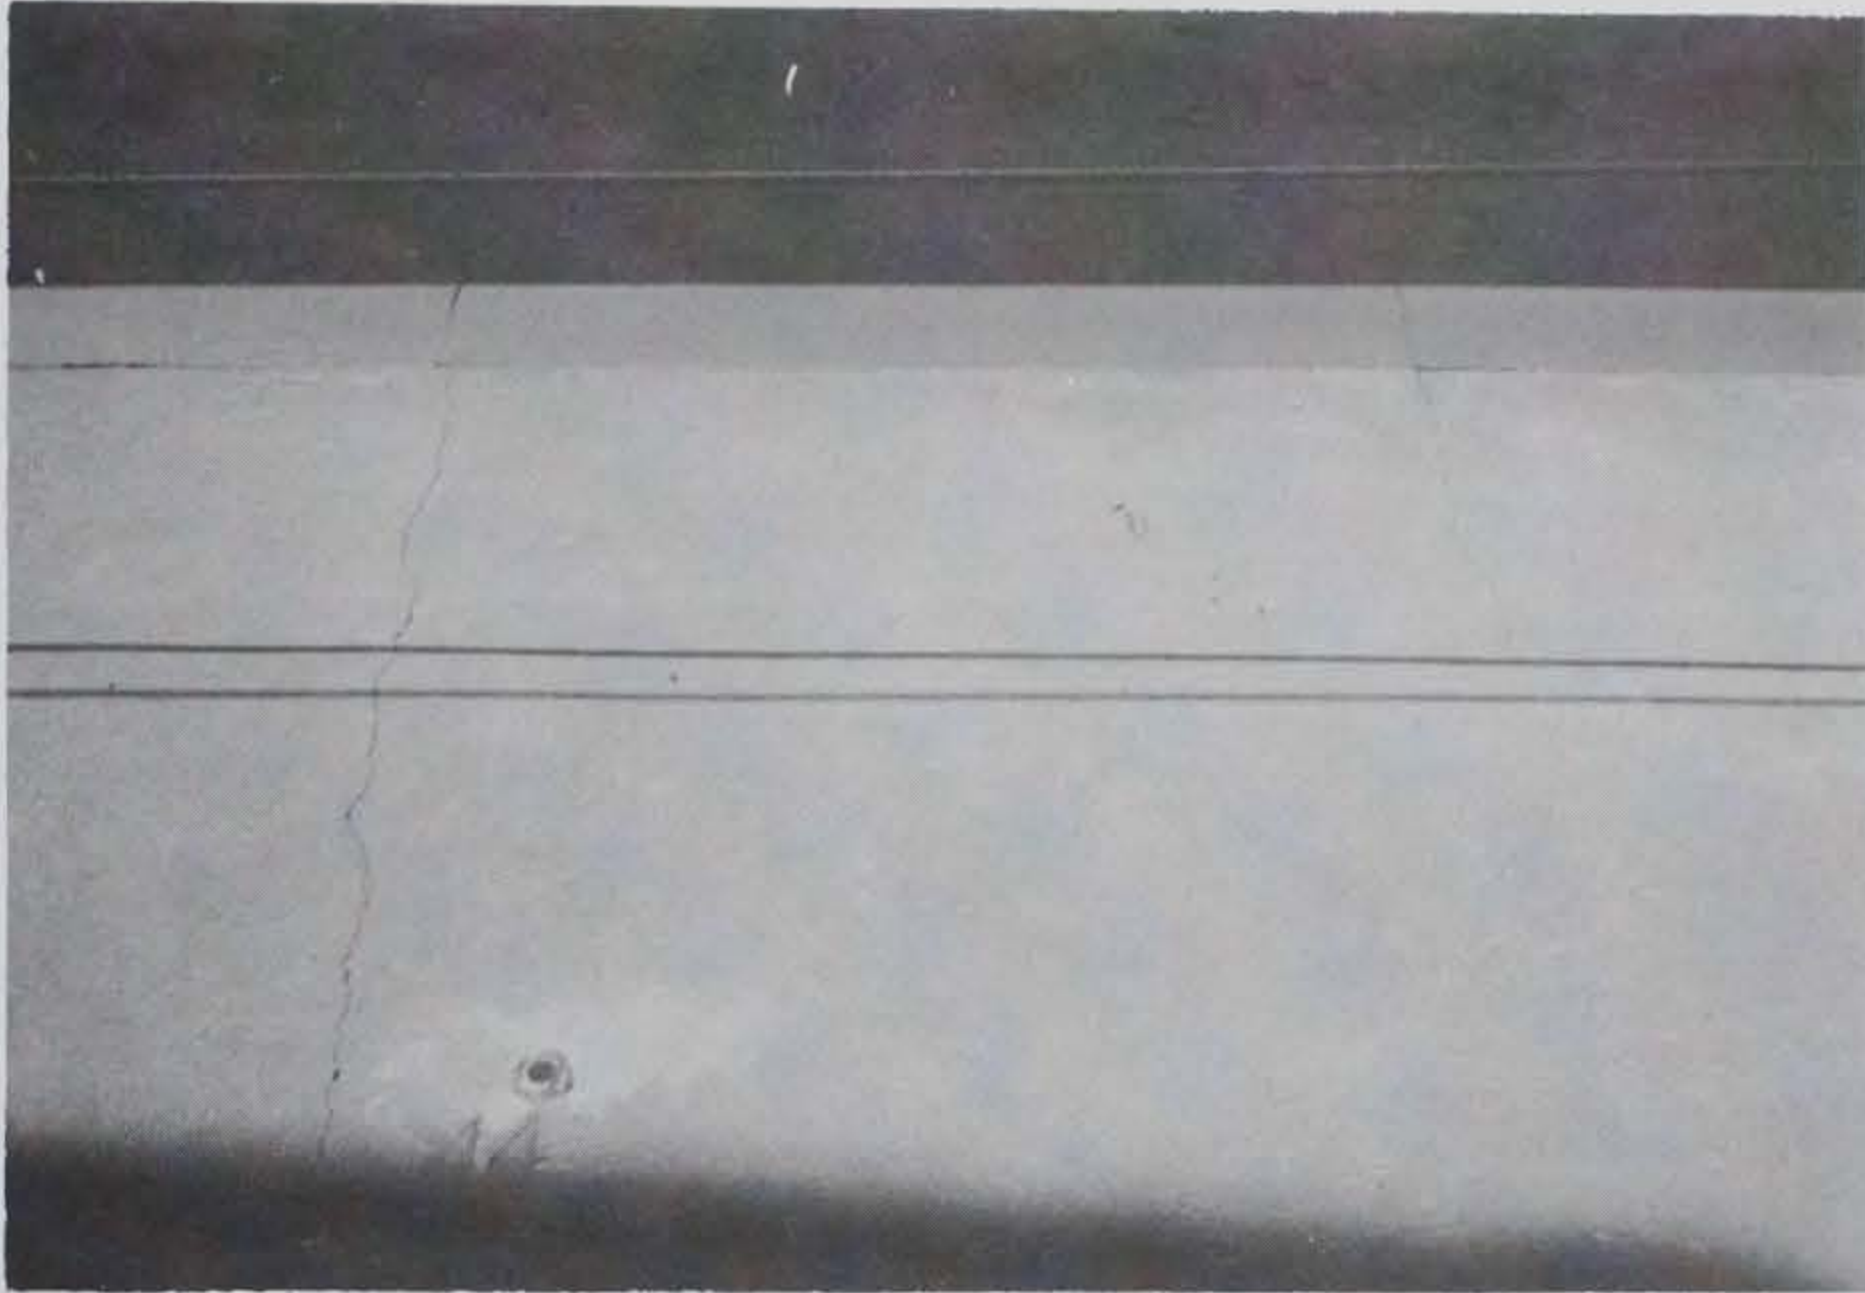
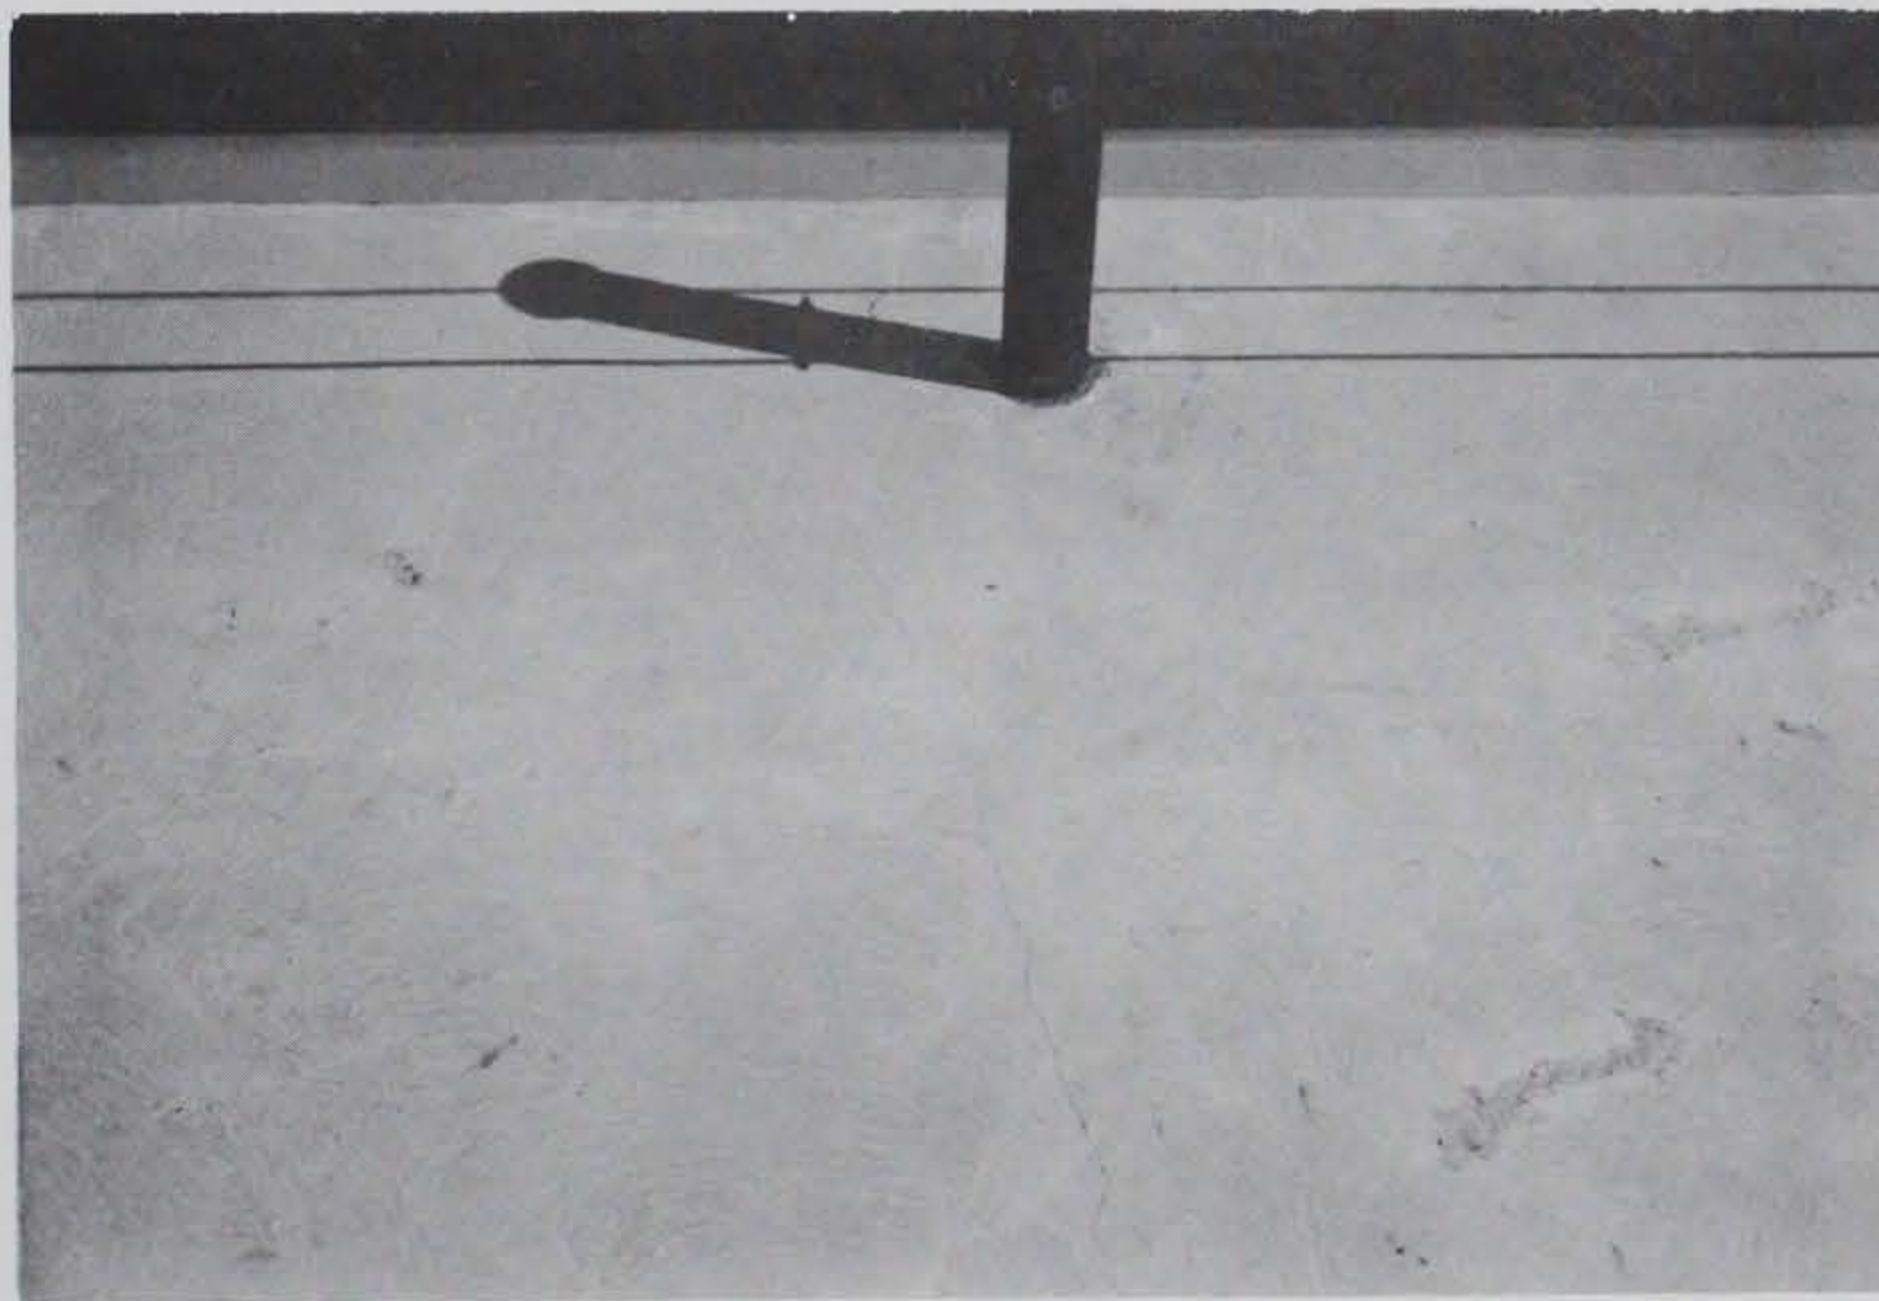
170. In June 1982, isolated cracks were observed in the top surfaces of the lock walls (Figure 75). Most of the cracks are perpendicular to the face of the lock chamber. Although a few cracks were located on approximately 5-ft centers, the regularity noted at other projects was not observed. Rather, the cracks tend to start and terminate at reentrant angles and at joints in the corner protection armor. The thin polymer mortar overlay was debonded and buckled in several places (Figure 76). Failure of the shotcrete overlay appeared to be progressing (Figure 77).

Figure 75. Typical cracks in tops of lock walls, June 1982,  
Lock No. 3, Monongahela River

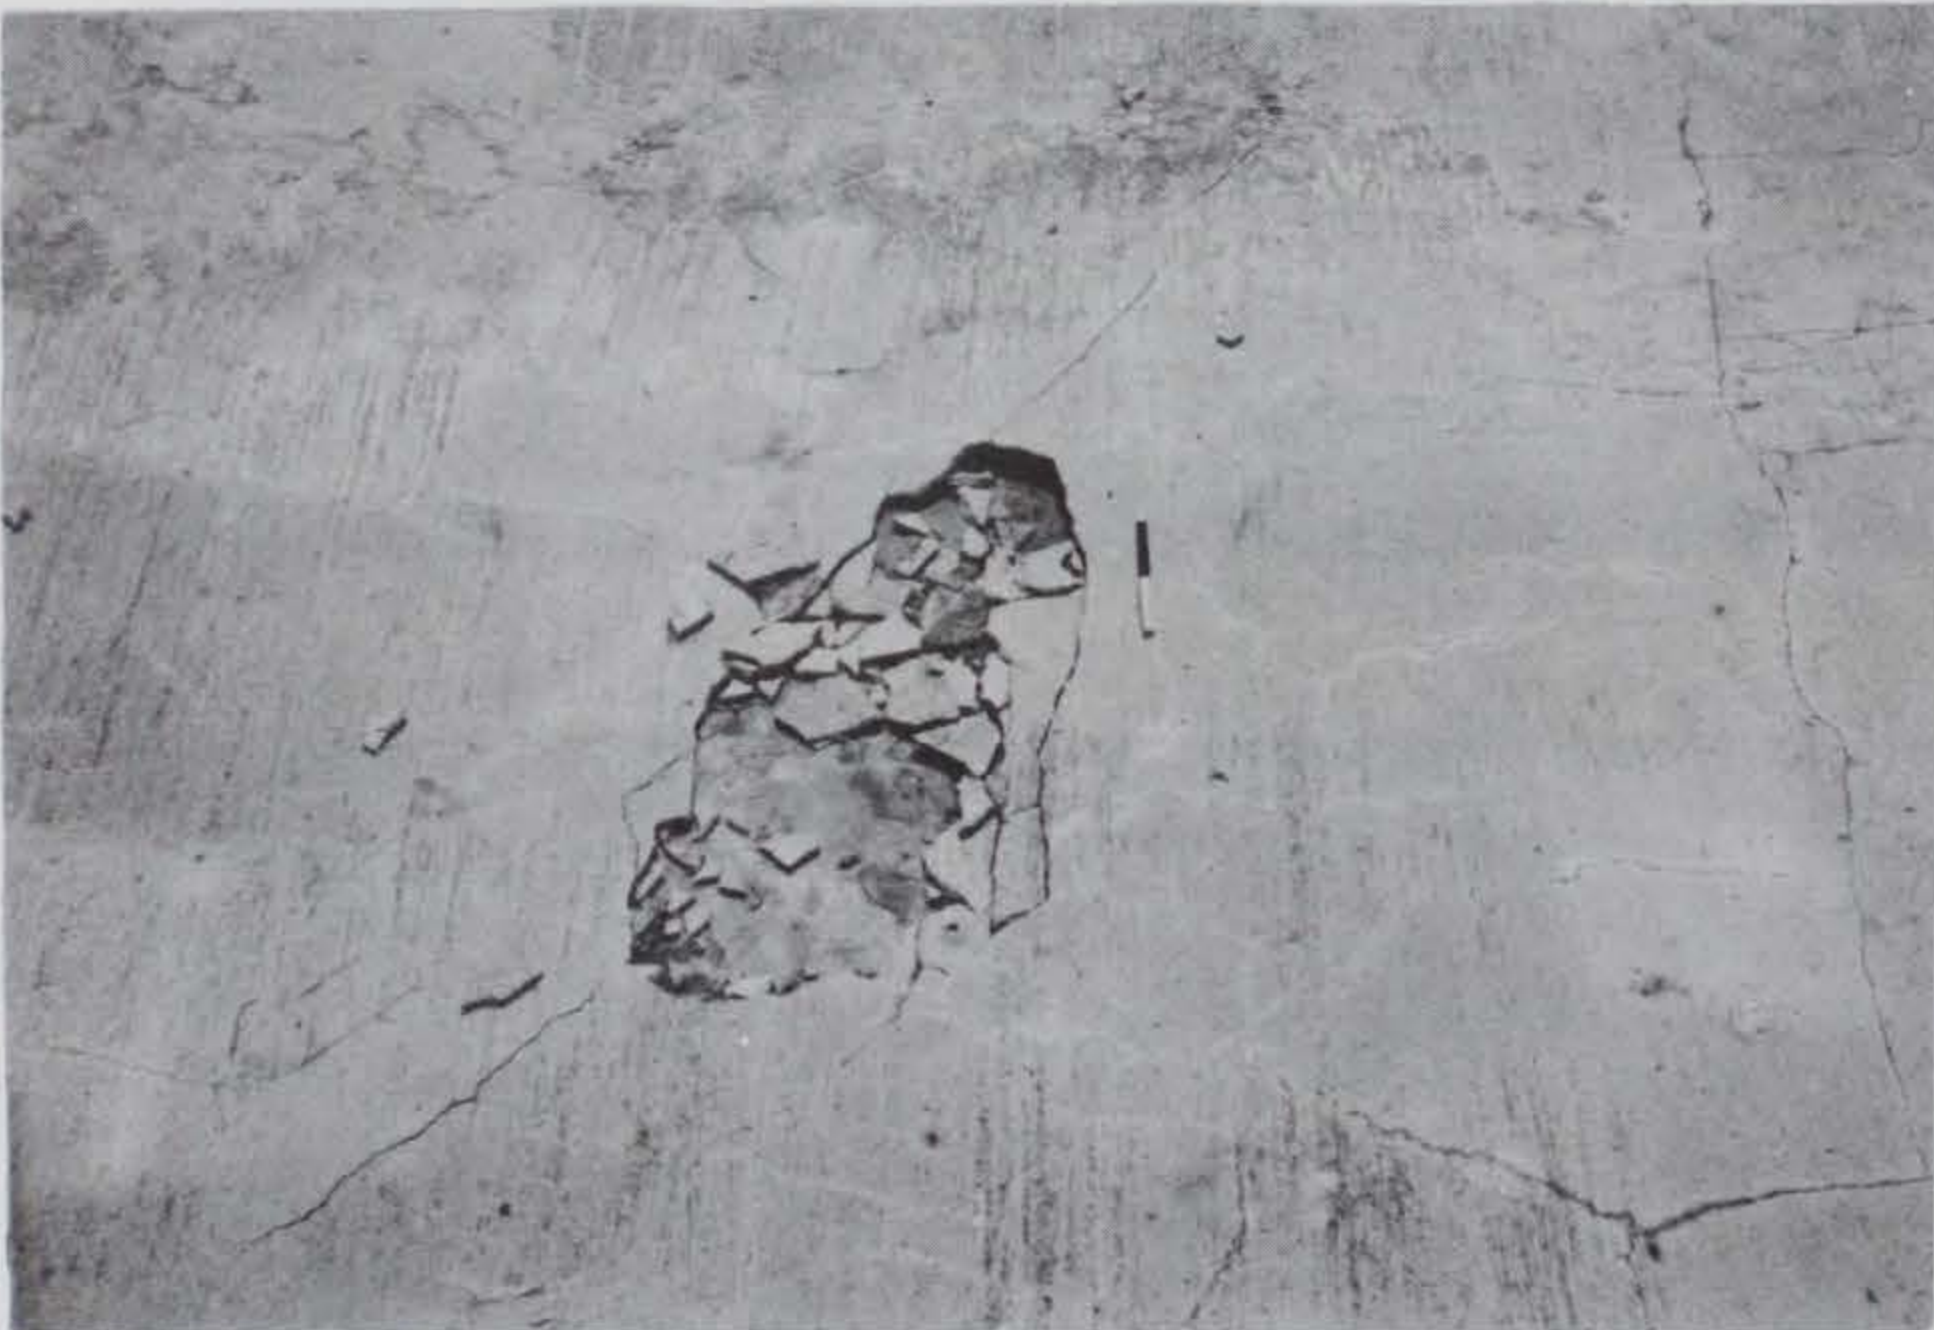
Figure 76. Polymer mortar overlay failure, June 1982,  
Lock No. 3, Monongahela River

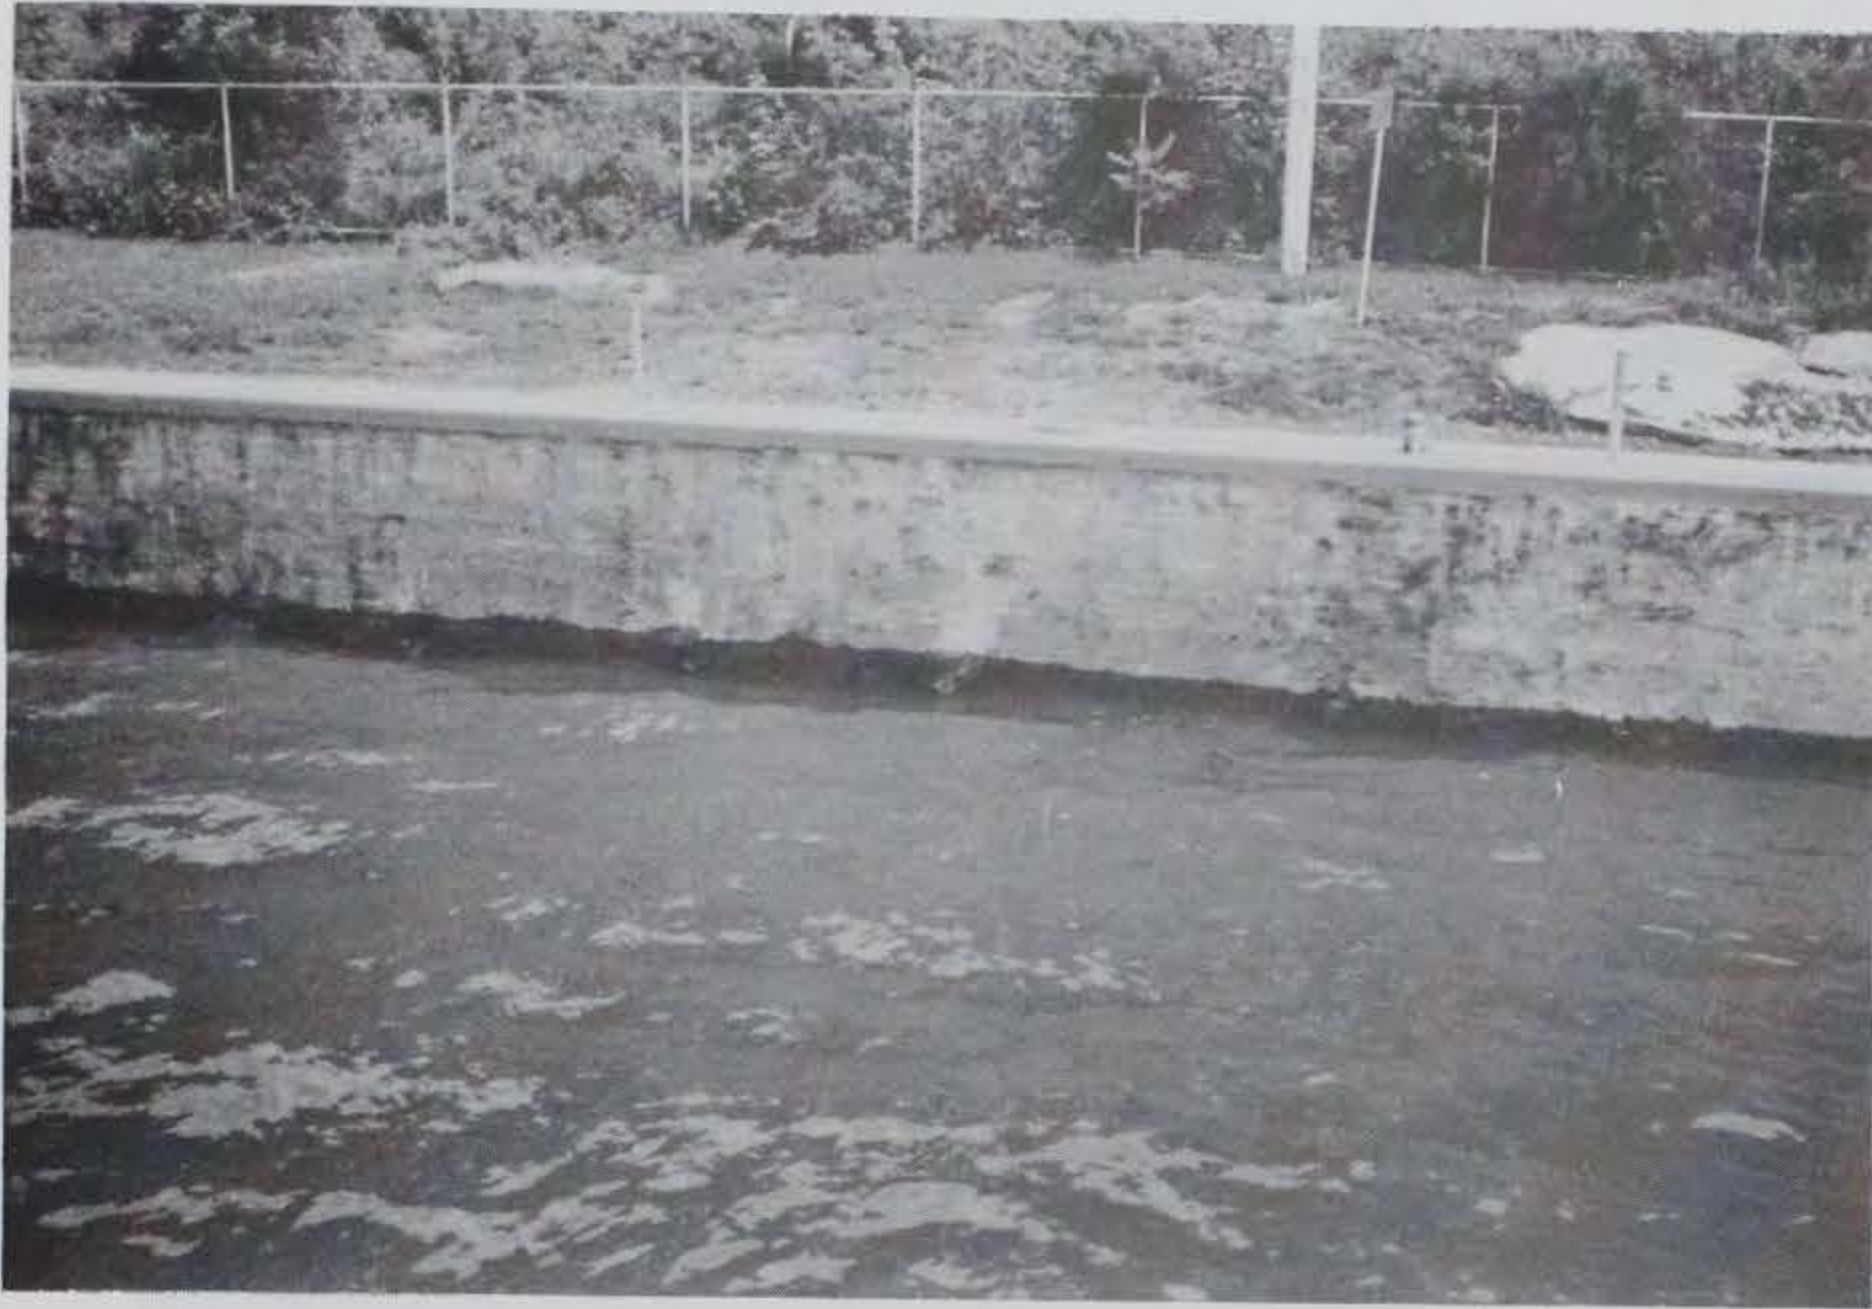
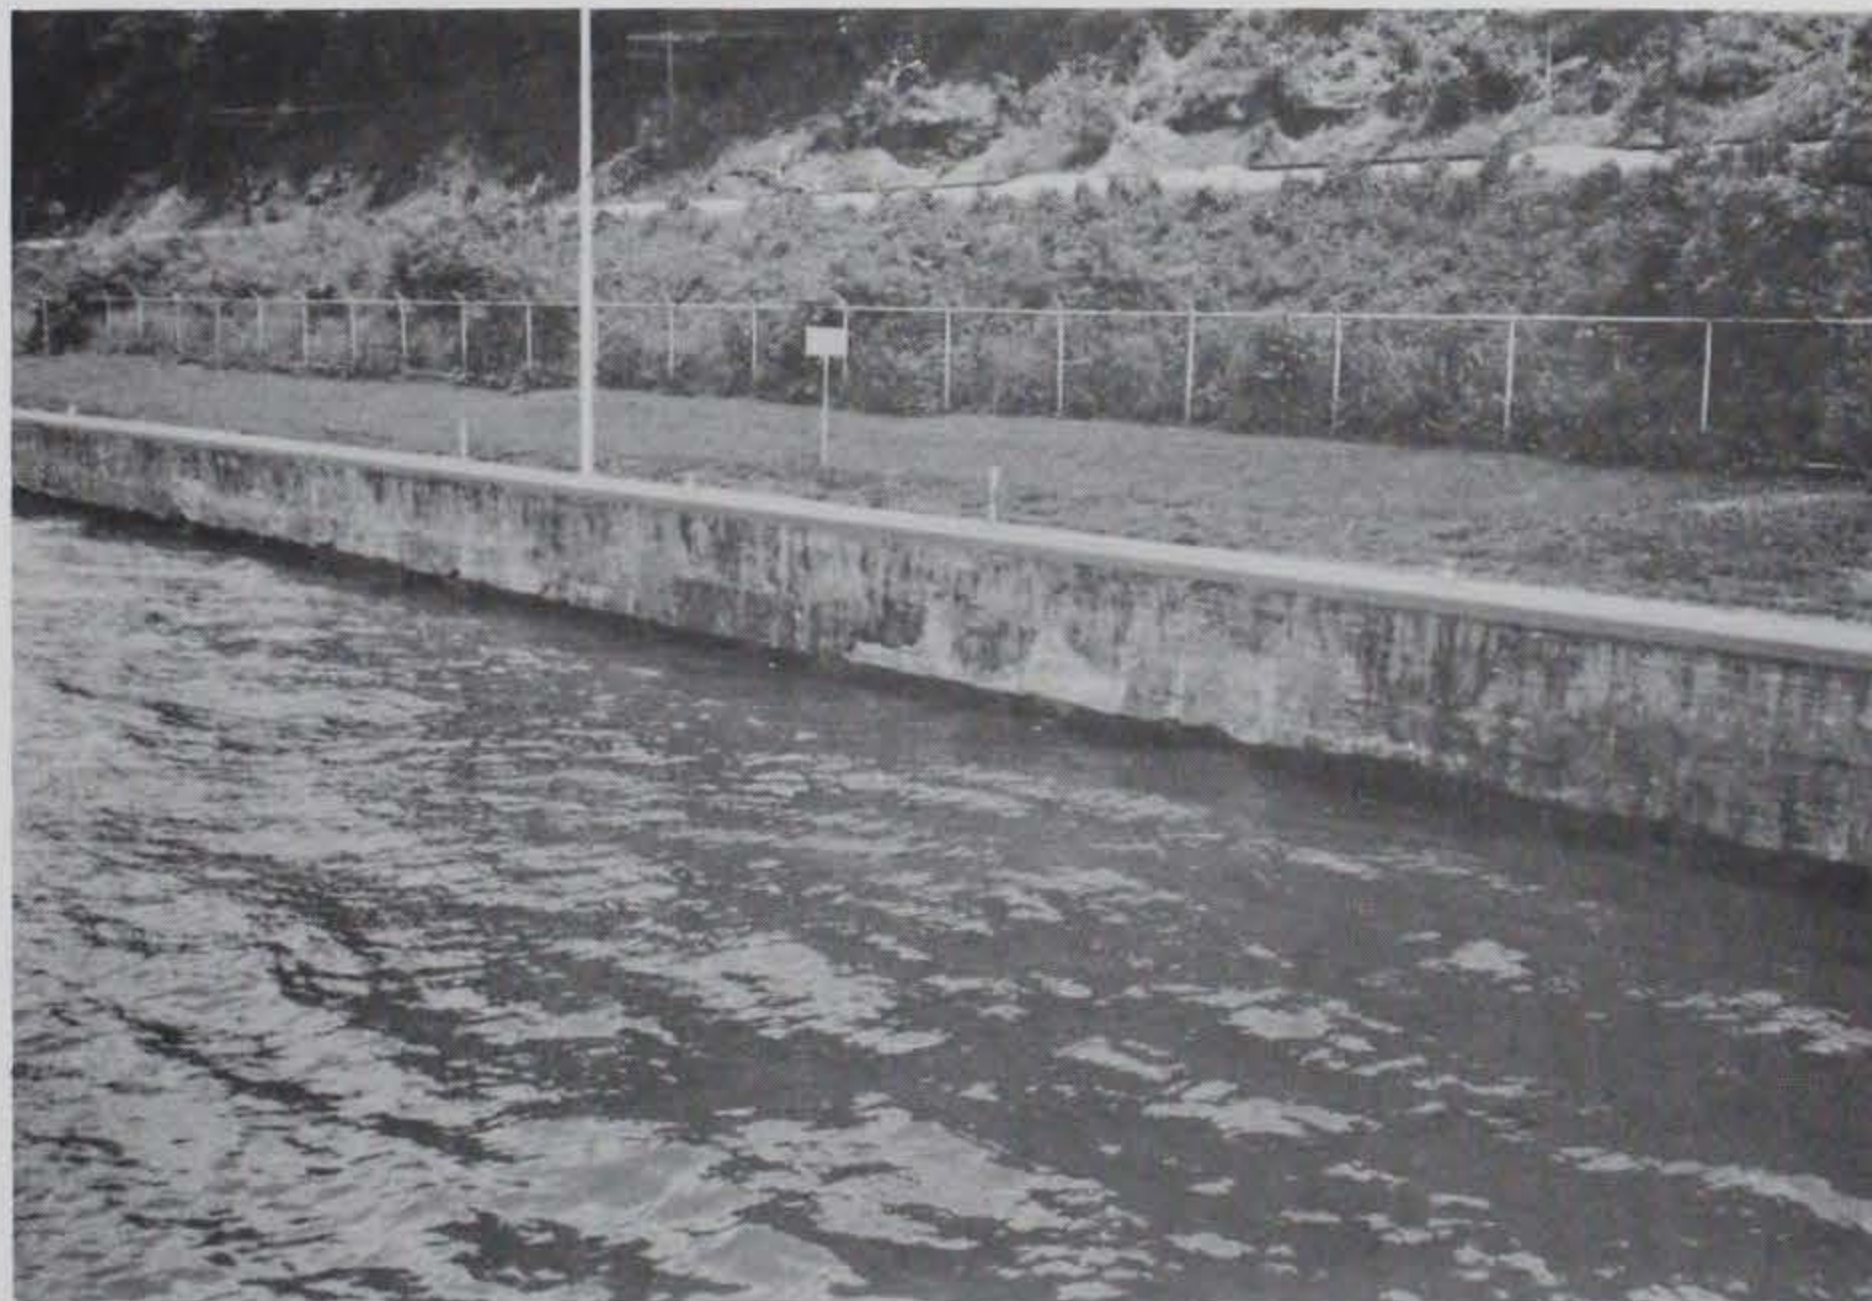
existing gate recesses and various areas on the upper guide wall and middle wall were treated with a thin coating of shotcrete. Several small localized areas of the new shotcrete had been abraded and spalled, evidently by tows entering and leaving the locks. The shotcrete on the riverside of the river wall, an area not subject to tow impact, was in good condition with only minor shrinkage cracking. The performance and wearability of the new shotcrete coating in areas subjected to tow abrasion and impact was unsatisfactory, particularly where the shotcrete was applied in a very thin layer (less than 1/2 in.) over relatively smooth surfaces, and where exposure to impact and rubbing by tows is most severe.

Figure 77. Typical spalling and abrasion of the shotcrete resurfacing on the lower guide wall, June 1982, Lock No. 3, Monongahela River
