TECHNICAL REPORT REMR-CS-13

**REHABILITATION OF NAVIGATION  
LOCK WALLS: CASE HISTORIES**

James E. McDonald

December 1987

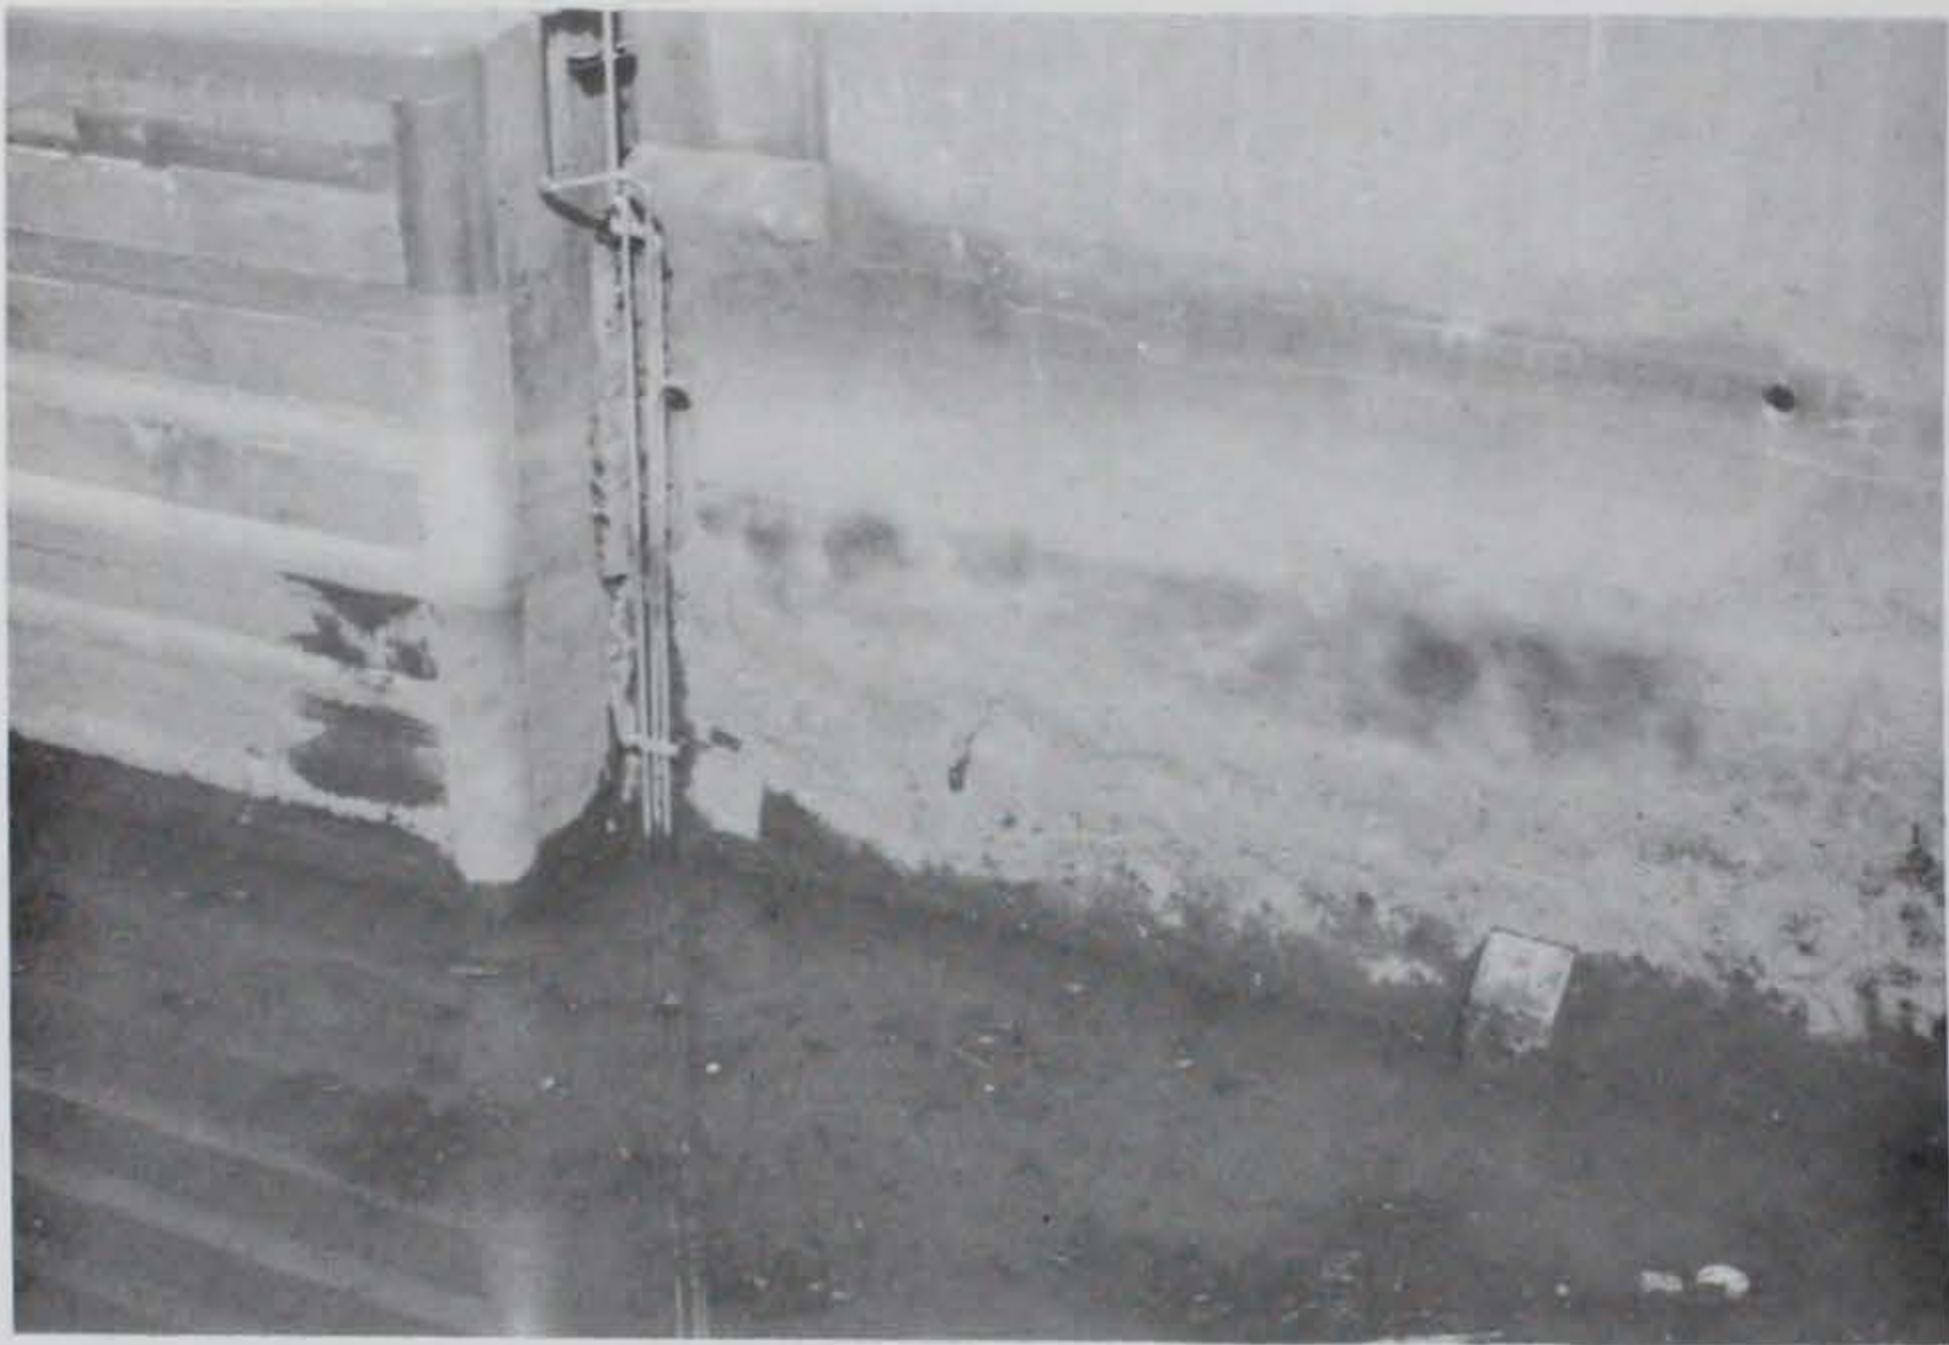
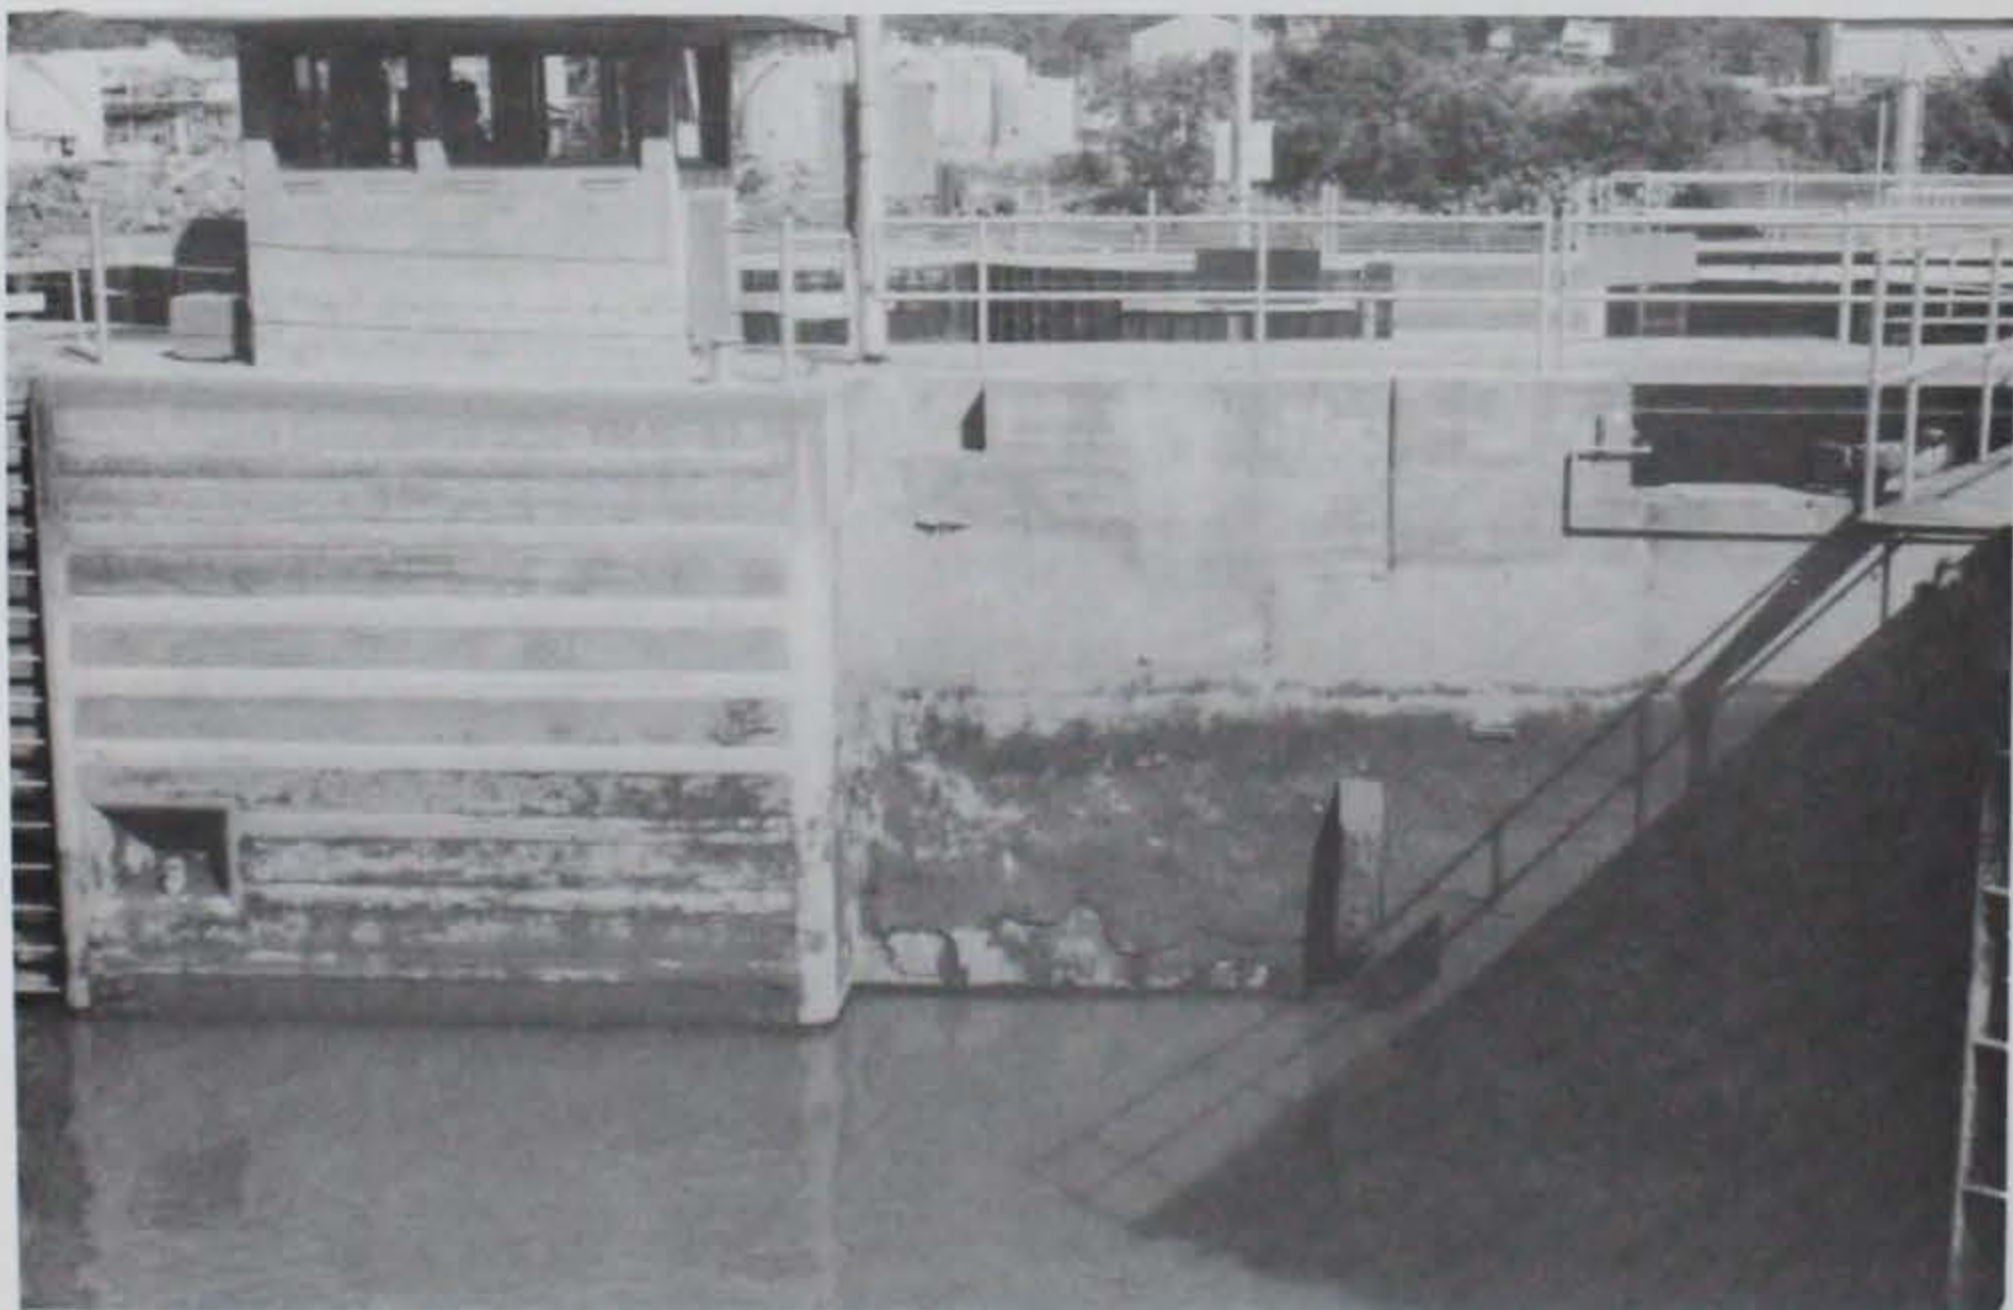
171. In July 1985, additional failures of the shotcrete repairs were reported (Figure 78). Cracks in the top of the lock walls had been caulked with a material manufactured by Thoro System Products. The caulking was done meticulously by project personnel and is not unattractive (Figure 79).

Figure 78. Spalling of shotcrete overlay in gate recess,  
July 1985, Lock No 3, Monongahela River

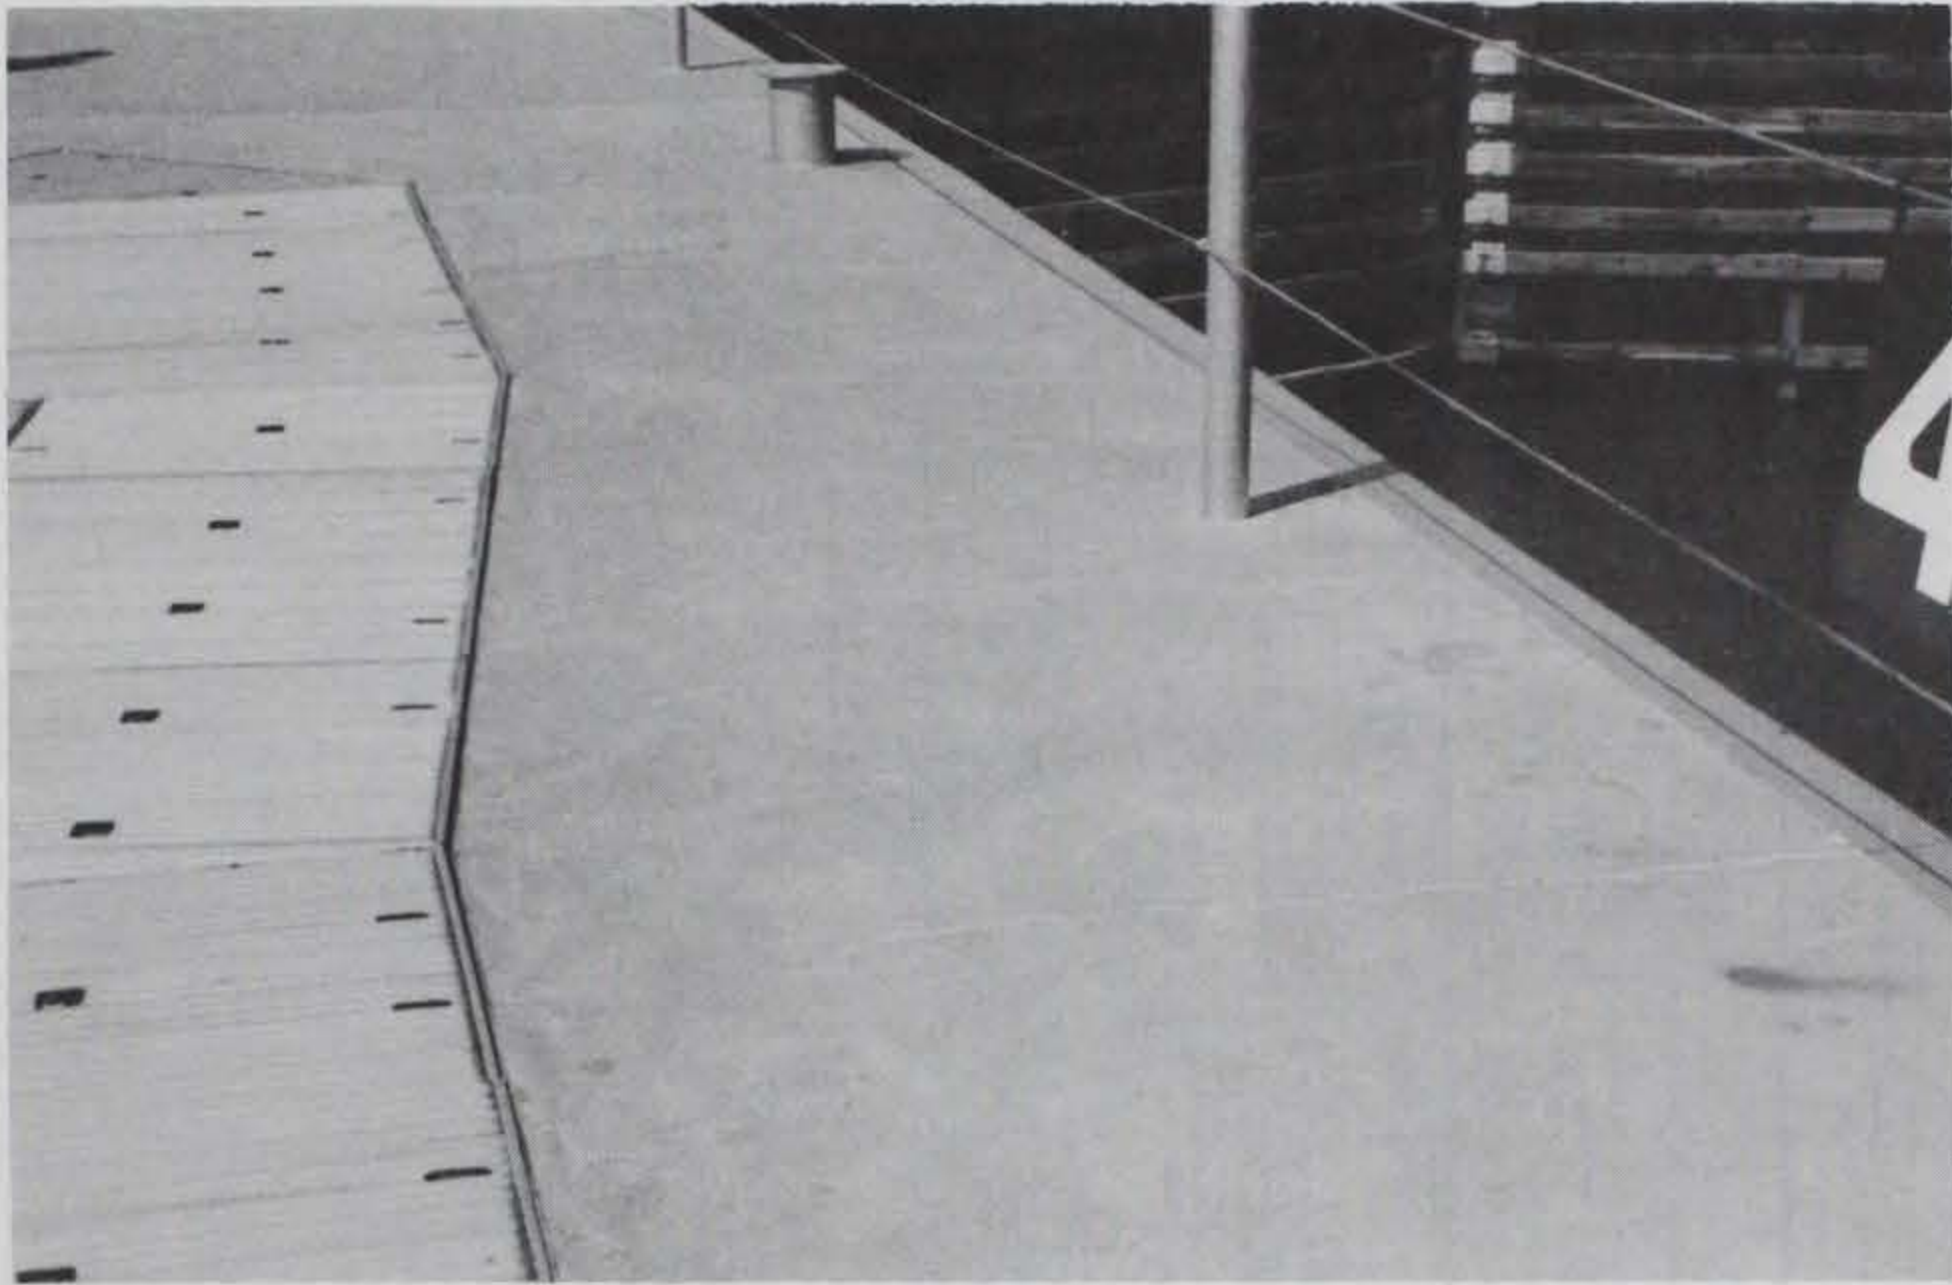
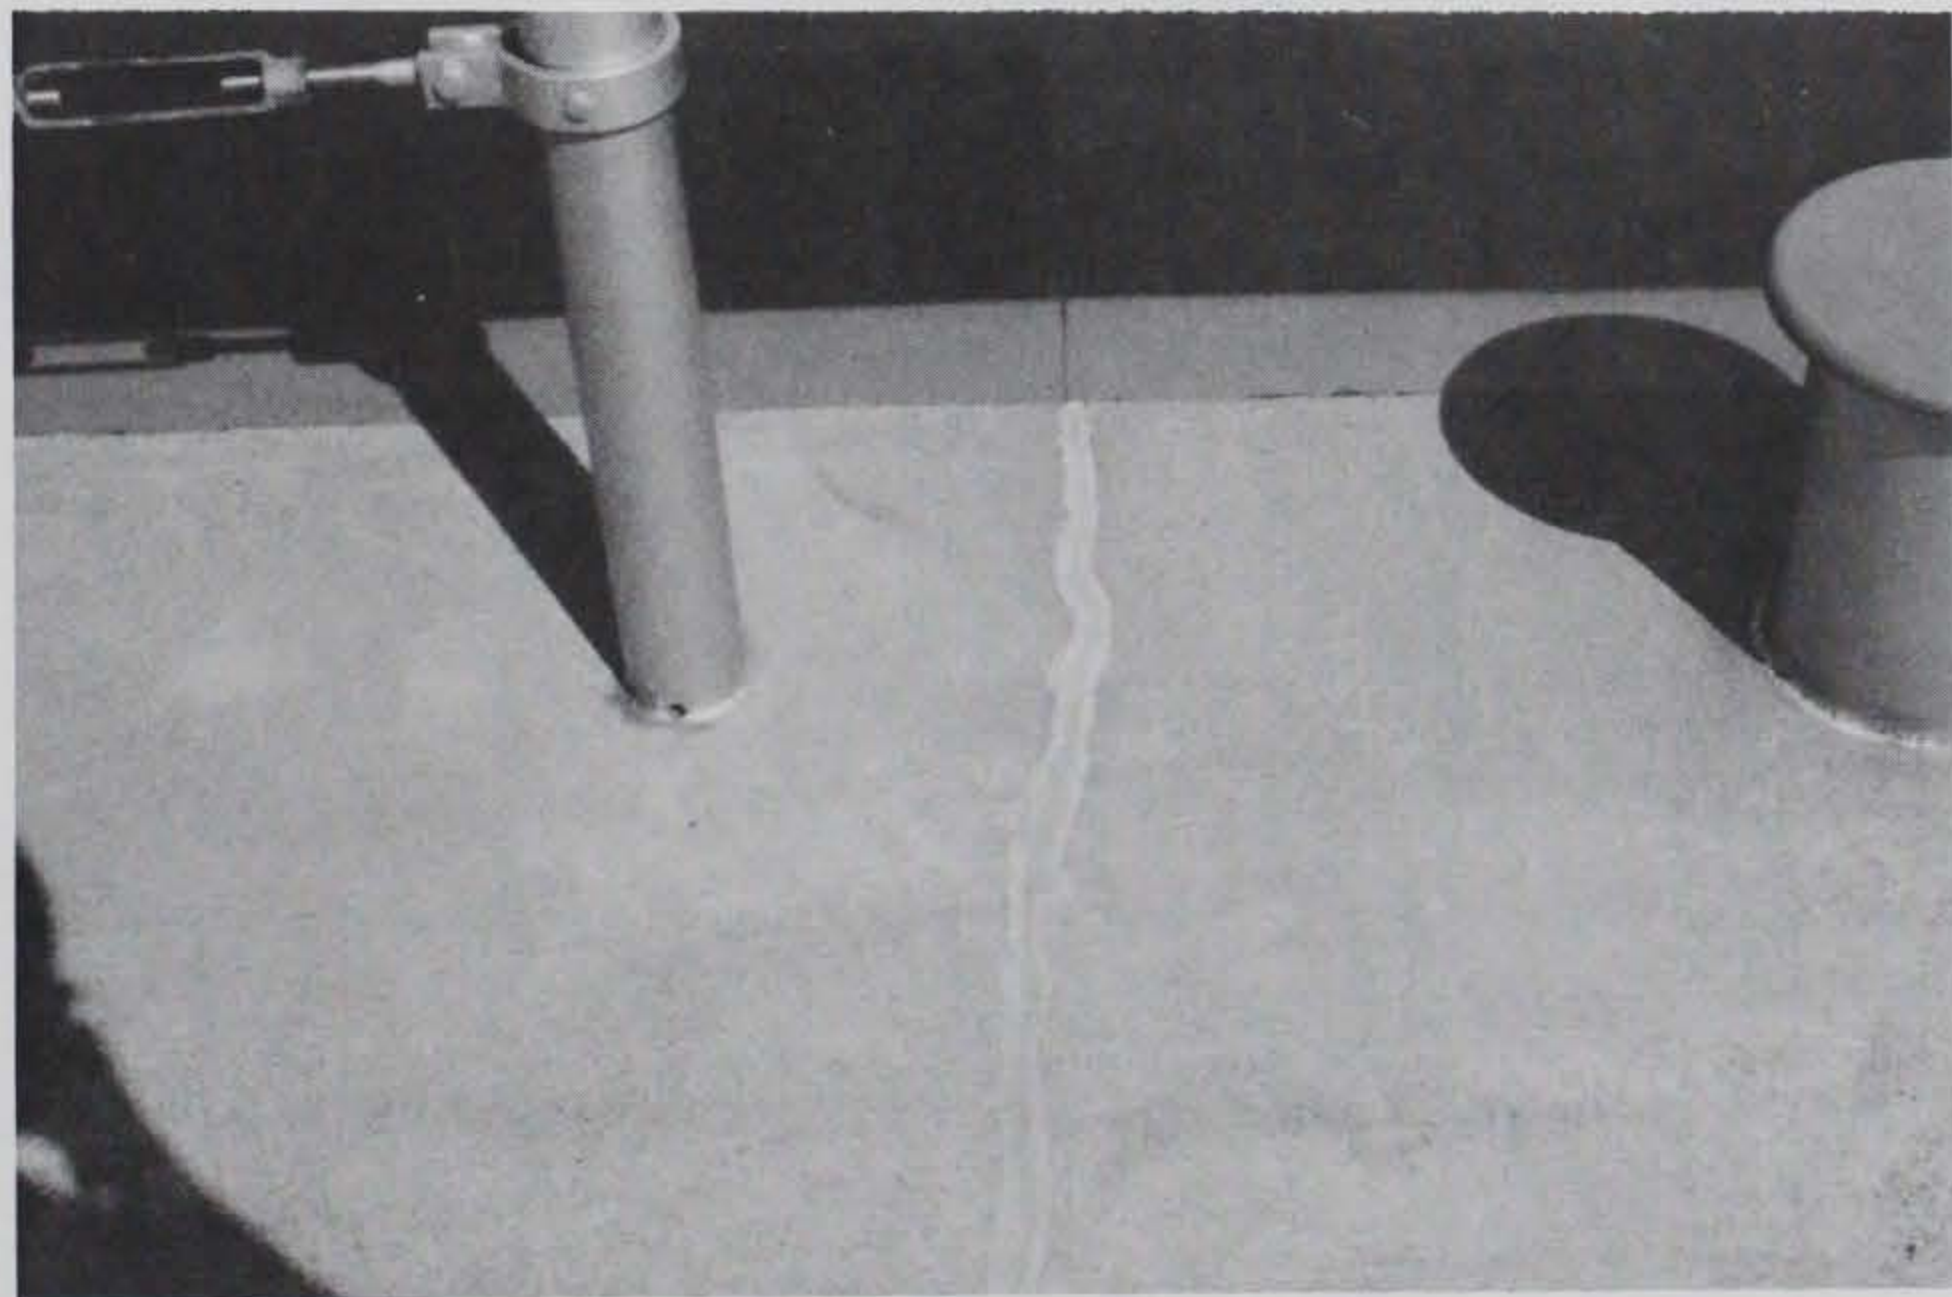
Figure 79. Caulked cracks in top of middle wall, July 1985,  
Lock No. 3, Monongahela River

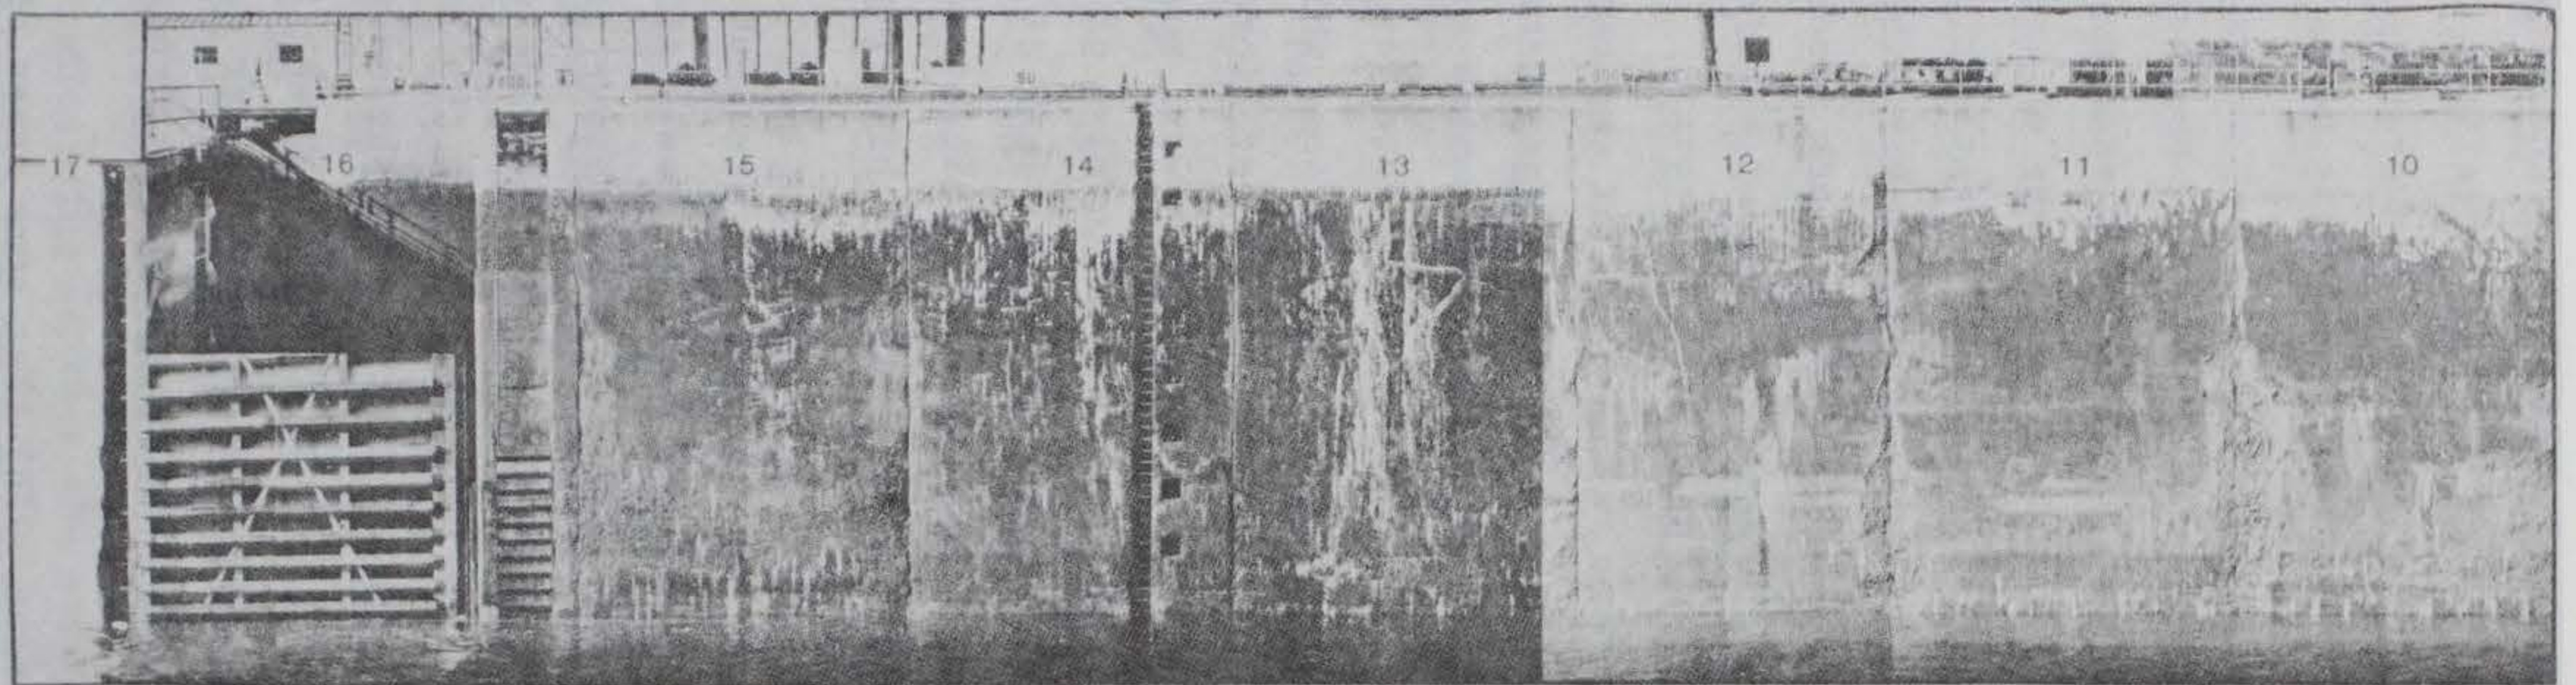
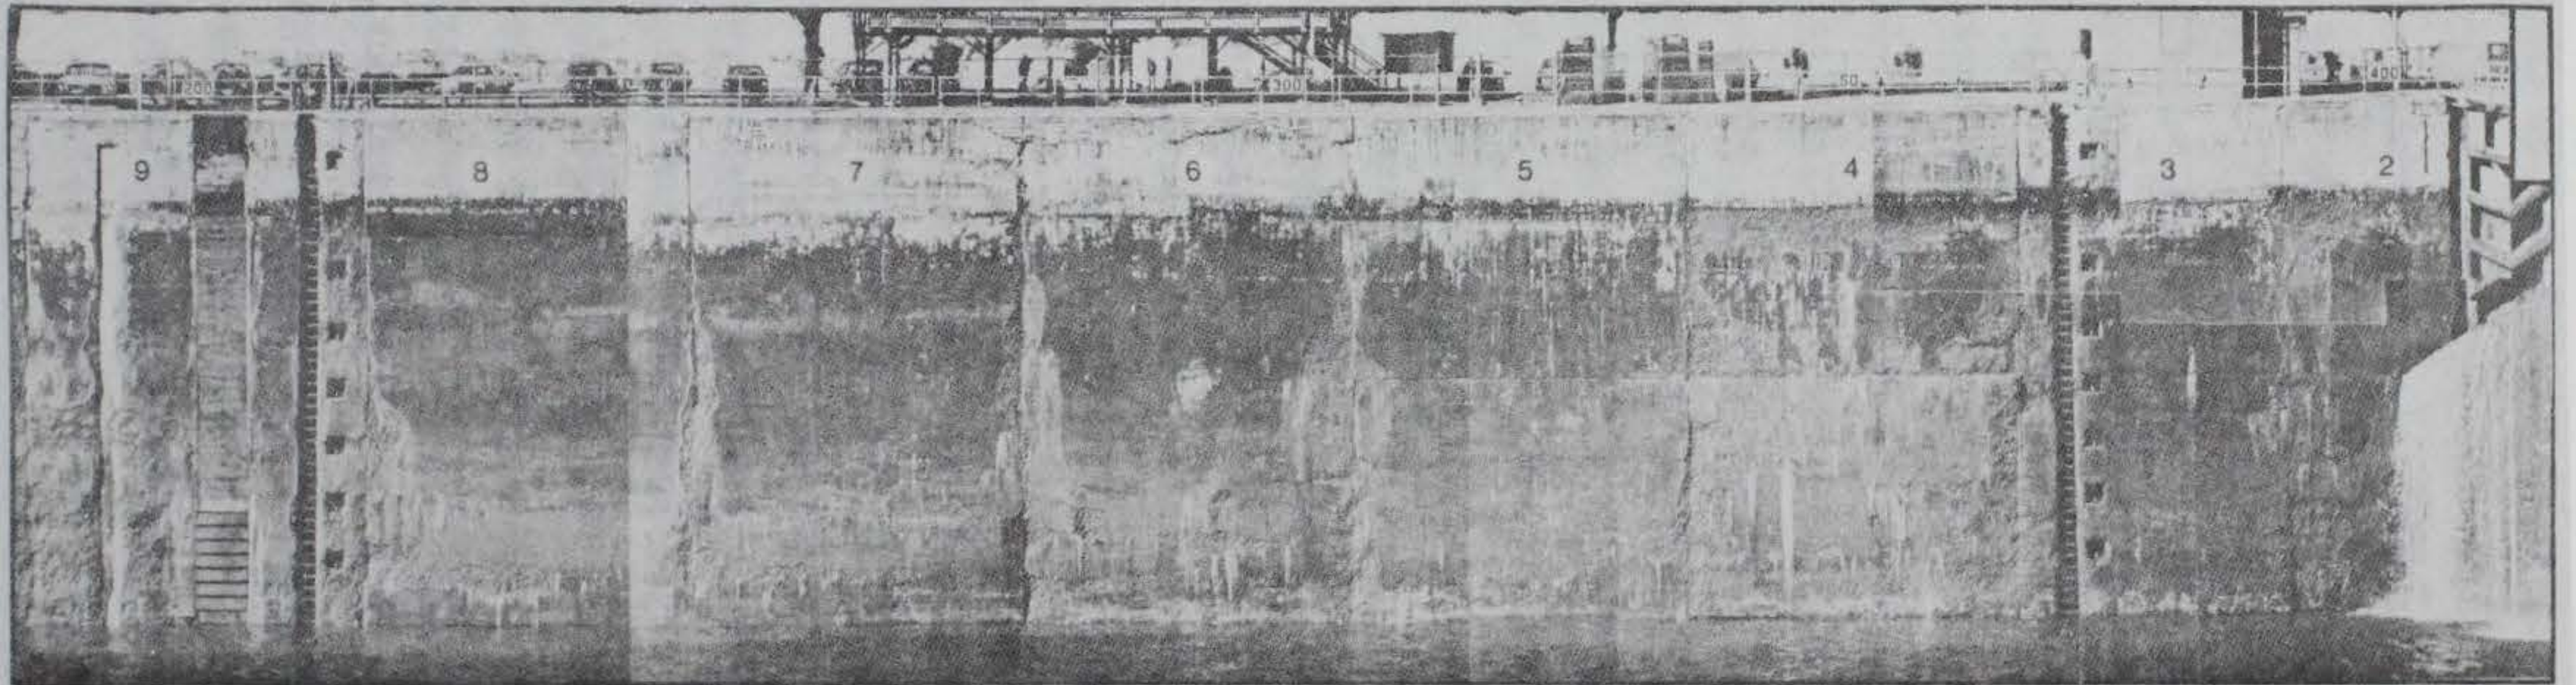
178. Based on the results of the concrete evaluations, it was concluded that the surface of the lock walls was undergoing a slow and steady deterioration from exposure to cycles of freezing and thawing. Typical concrete surface conditions are shown in Figures 82 and 83. The degree of deterioration was greater than was visually evident since there were wall surfaces which appeared sound but were deteriorated behind the surface. Such deterioration was generally characterized by laminar cracking parallel to the wall surface. The susceptibility of the lock concrete to deterioration from cycles of freezing and thawing was attributed to the degree of saturation, the lack of air entrainment, and the presence of porous chert, argillites, and microcracking as a consequence of the alkali-silica reaction or disruption of highly porous particles of coarse aggregate in the near surface zone.

179. The concrete deterioration was not confined to one area but was scattered over the entire lock surface. The surfaces most seriously affected were the top and edges of the walls and slabs, especially those above tailwater. Petrographic examinations of the concrete cores indicated wide variations in the depth of deterioration varying from 0 to 10.5 in. in the land lock and 0 to 15.7 in. in the river lock. Concrete in the walls below tailwater appeared adequately sound. Concrete in the lock floor slabs was in good condition with only superficial spalling at corners and edges. Water quality tests indicated that chemical attack on the concrete by river or groundwater was negligible at the time.

Figure 82. General condition of the land wall, land lock, prior to rehabilitation, Lock No. 1, Mississippi River

184. Based on the field and laboratory evaluations of concrete condition, the following recommendations for reconditioning the lock concrete surfaces were made (St. Paul District 1978):

- a. Remove concrete on all exposed wall surfaces of the land lock to a minimum depth of 15 in., or to sound concrete in deteriorated areas. Removal will be by the preshearing technique using controlled blasting. New concrete will be placed to the original lines.
- b. Epoxy grout cracks and leaky horizontal construction joints to eliminate reflective cracking through the new concrete overlay.
- c. Replace the tops of all lock walls, including edges, to existing line and grade by replacement with conventional concrete.
- d. Seal vertical joints in walls and slabs by application of sealing compound.
- e. Place protective wall armor rubbing strips in selected areas such as along the upper and lower guide walls and the edges of recesses in the land lock chamber.

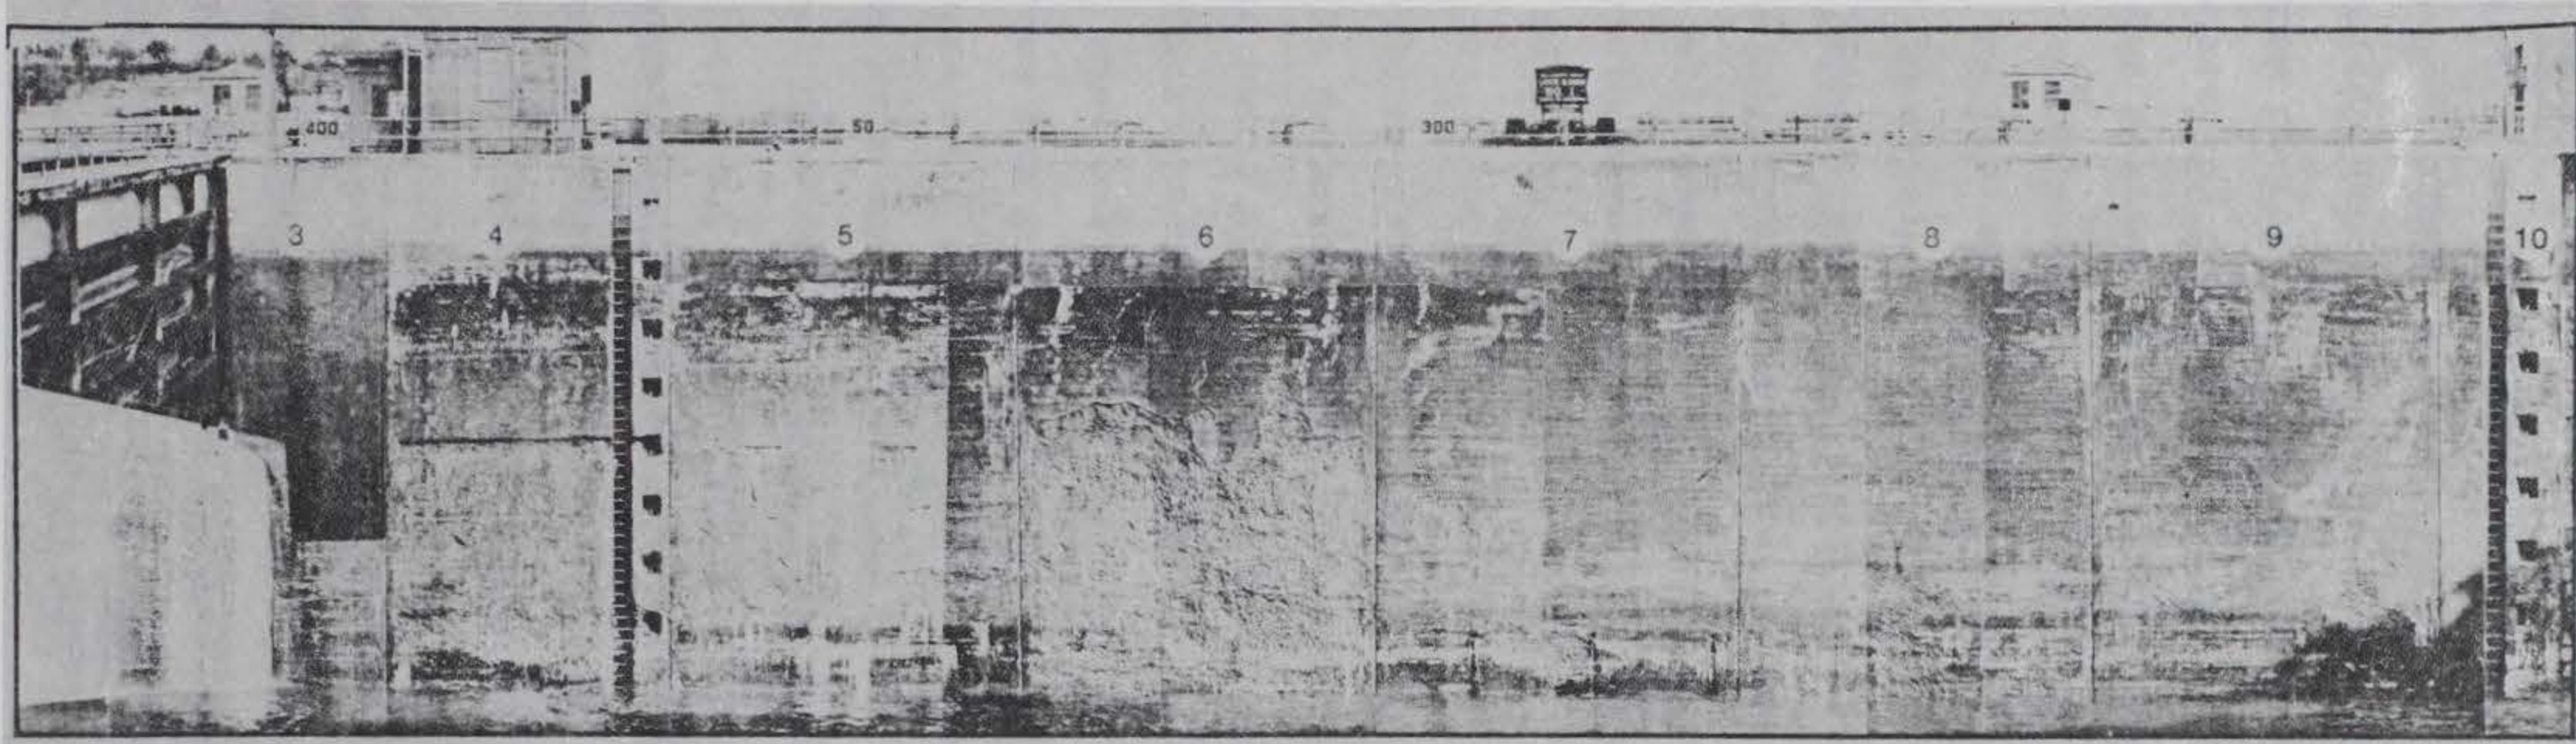
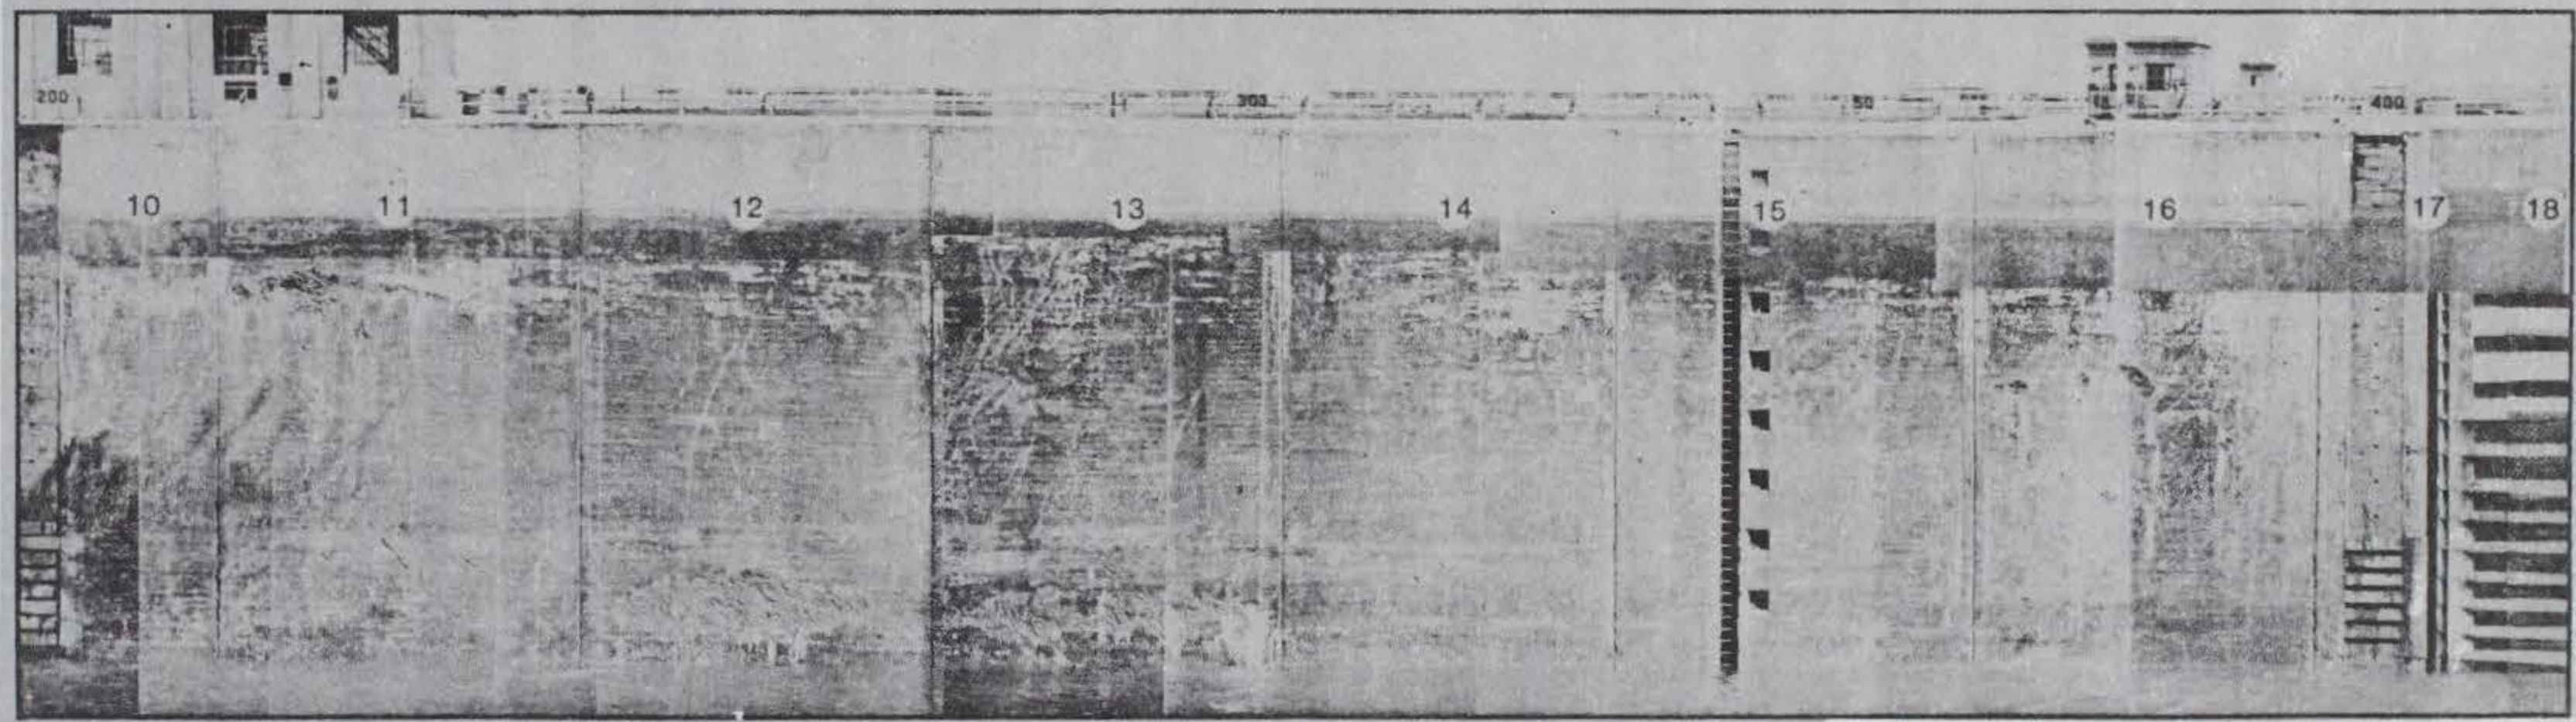
Figure 83. General condition of the intermediate wall, land lock, prior to rehabilitation, Lock No. 1, Mississippi River

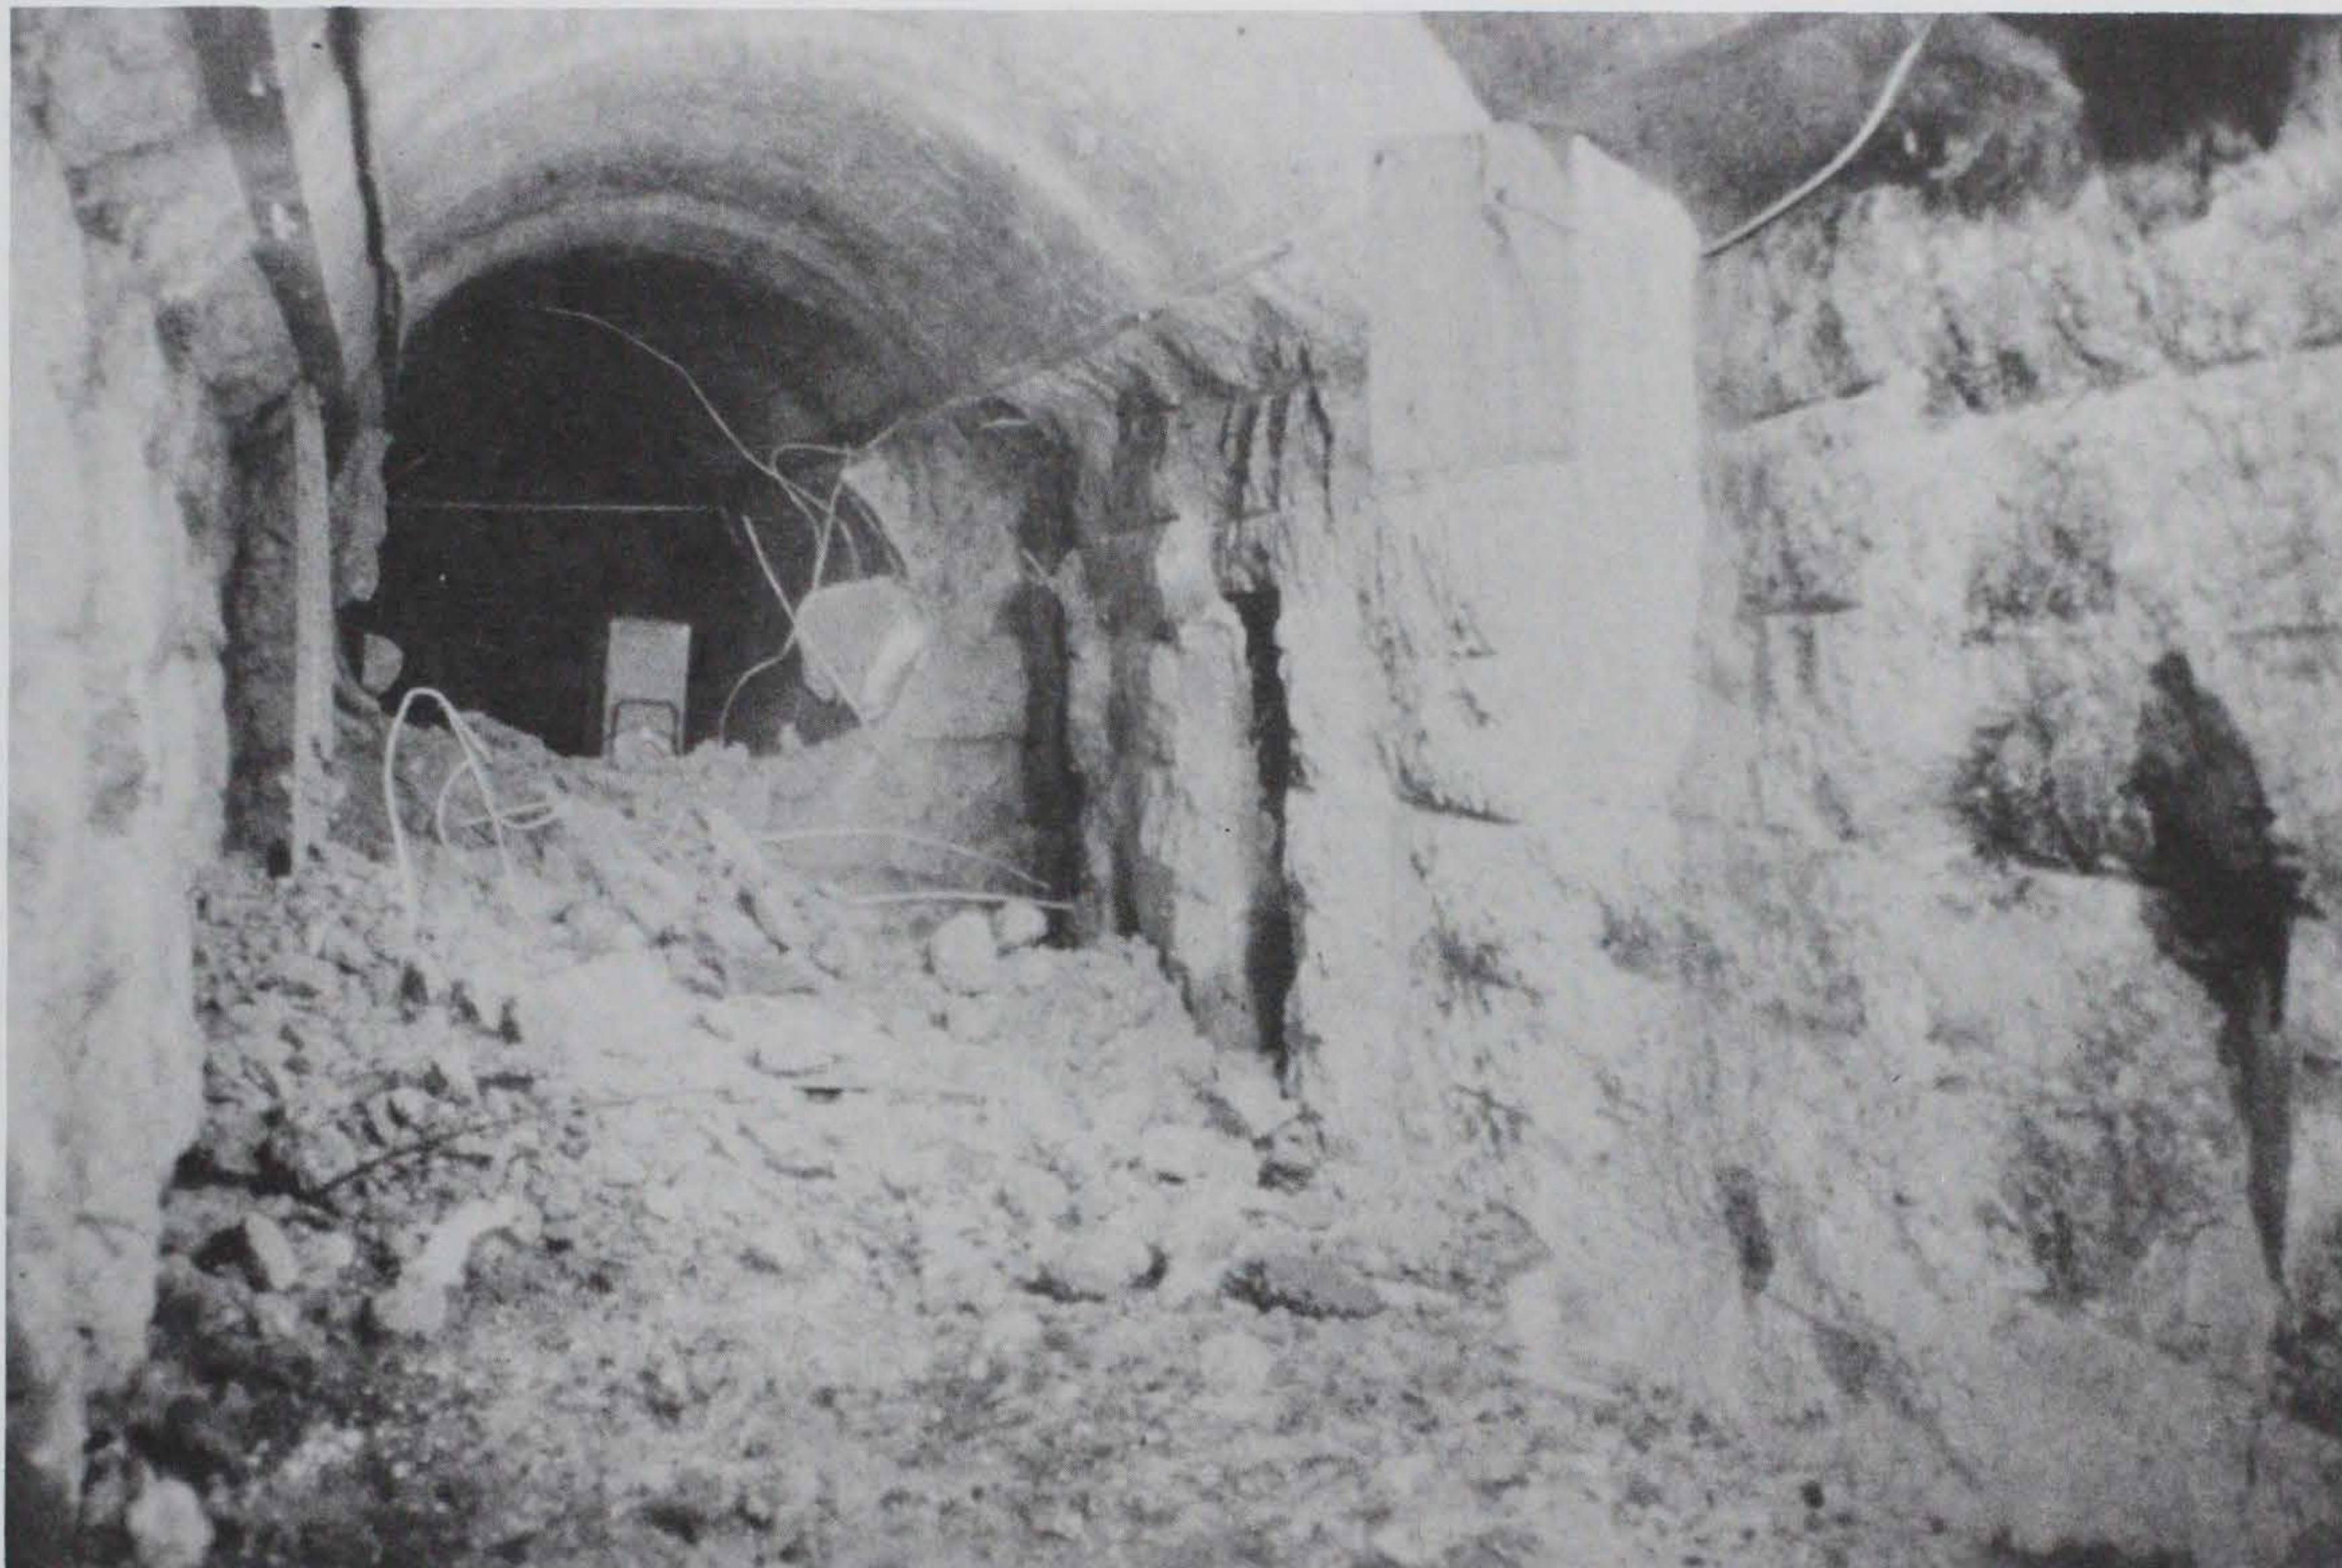
Figure 85. Concrete removal using explosives, Lock No. 1, Mississippi River
