TECHNICAL REPORT REMR-CS-13

**REHABILITATION OF NAVIGATION  
LOCK WALLS: CASE HISTORIES**

James E. McDonald

December 1987

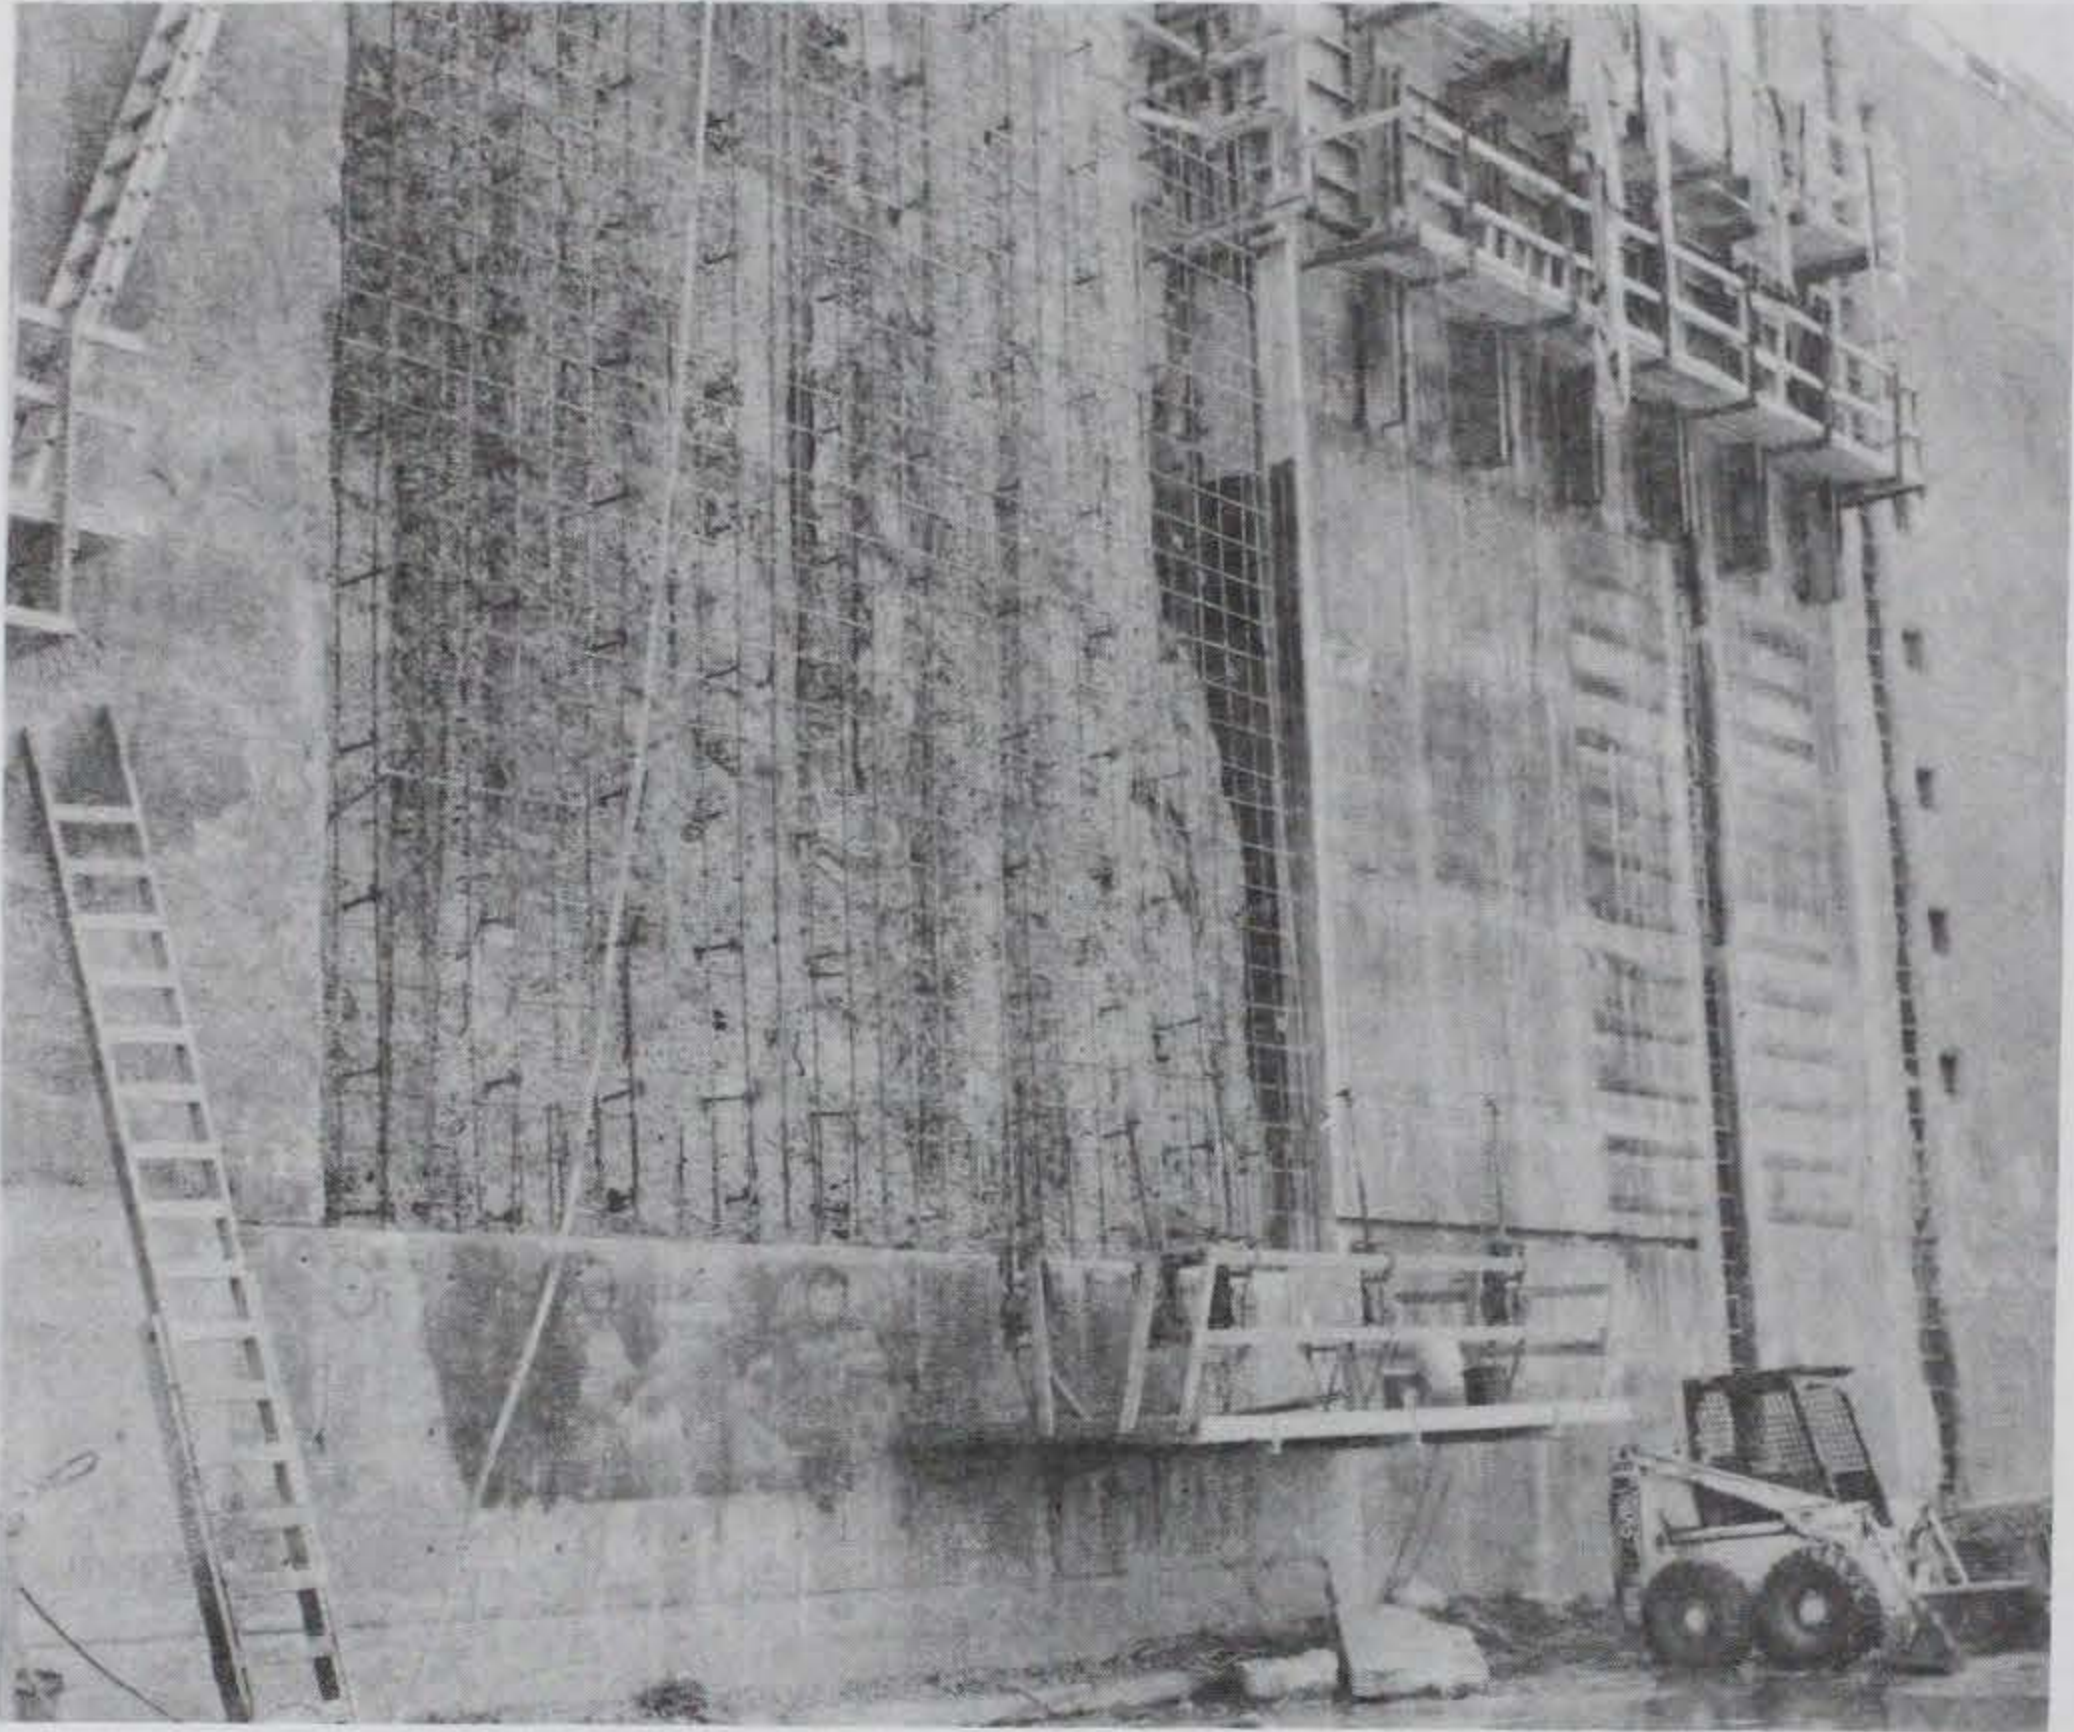
Figure 86. Trial resurfacing monolith L-5 prior to forming (left) and tainter valve monolith L-4 reconstruction, 9 May 1980, Lock No. 1, Mississippi River

202. During May 1980, a trial lock wall resurfacing was conducted on monolith L-5. Prior to resurfacing, existing concrete was removed from the chamber face to an average depth of 18-in. Reinforcing consisted of No. 6 bars on 12-in. centers each way anchored with No. 8 dowels 3 ft on centers (Figure 86). The dowels were embedded 18 in. into the existing concrete with polyester resin cartridges. The area to be resurfaced was formed and placed in two lifts 23 ft high and 30 ft wide. A 3/4-in. thick plywood faced form

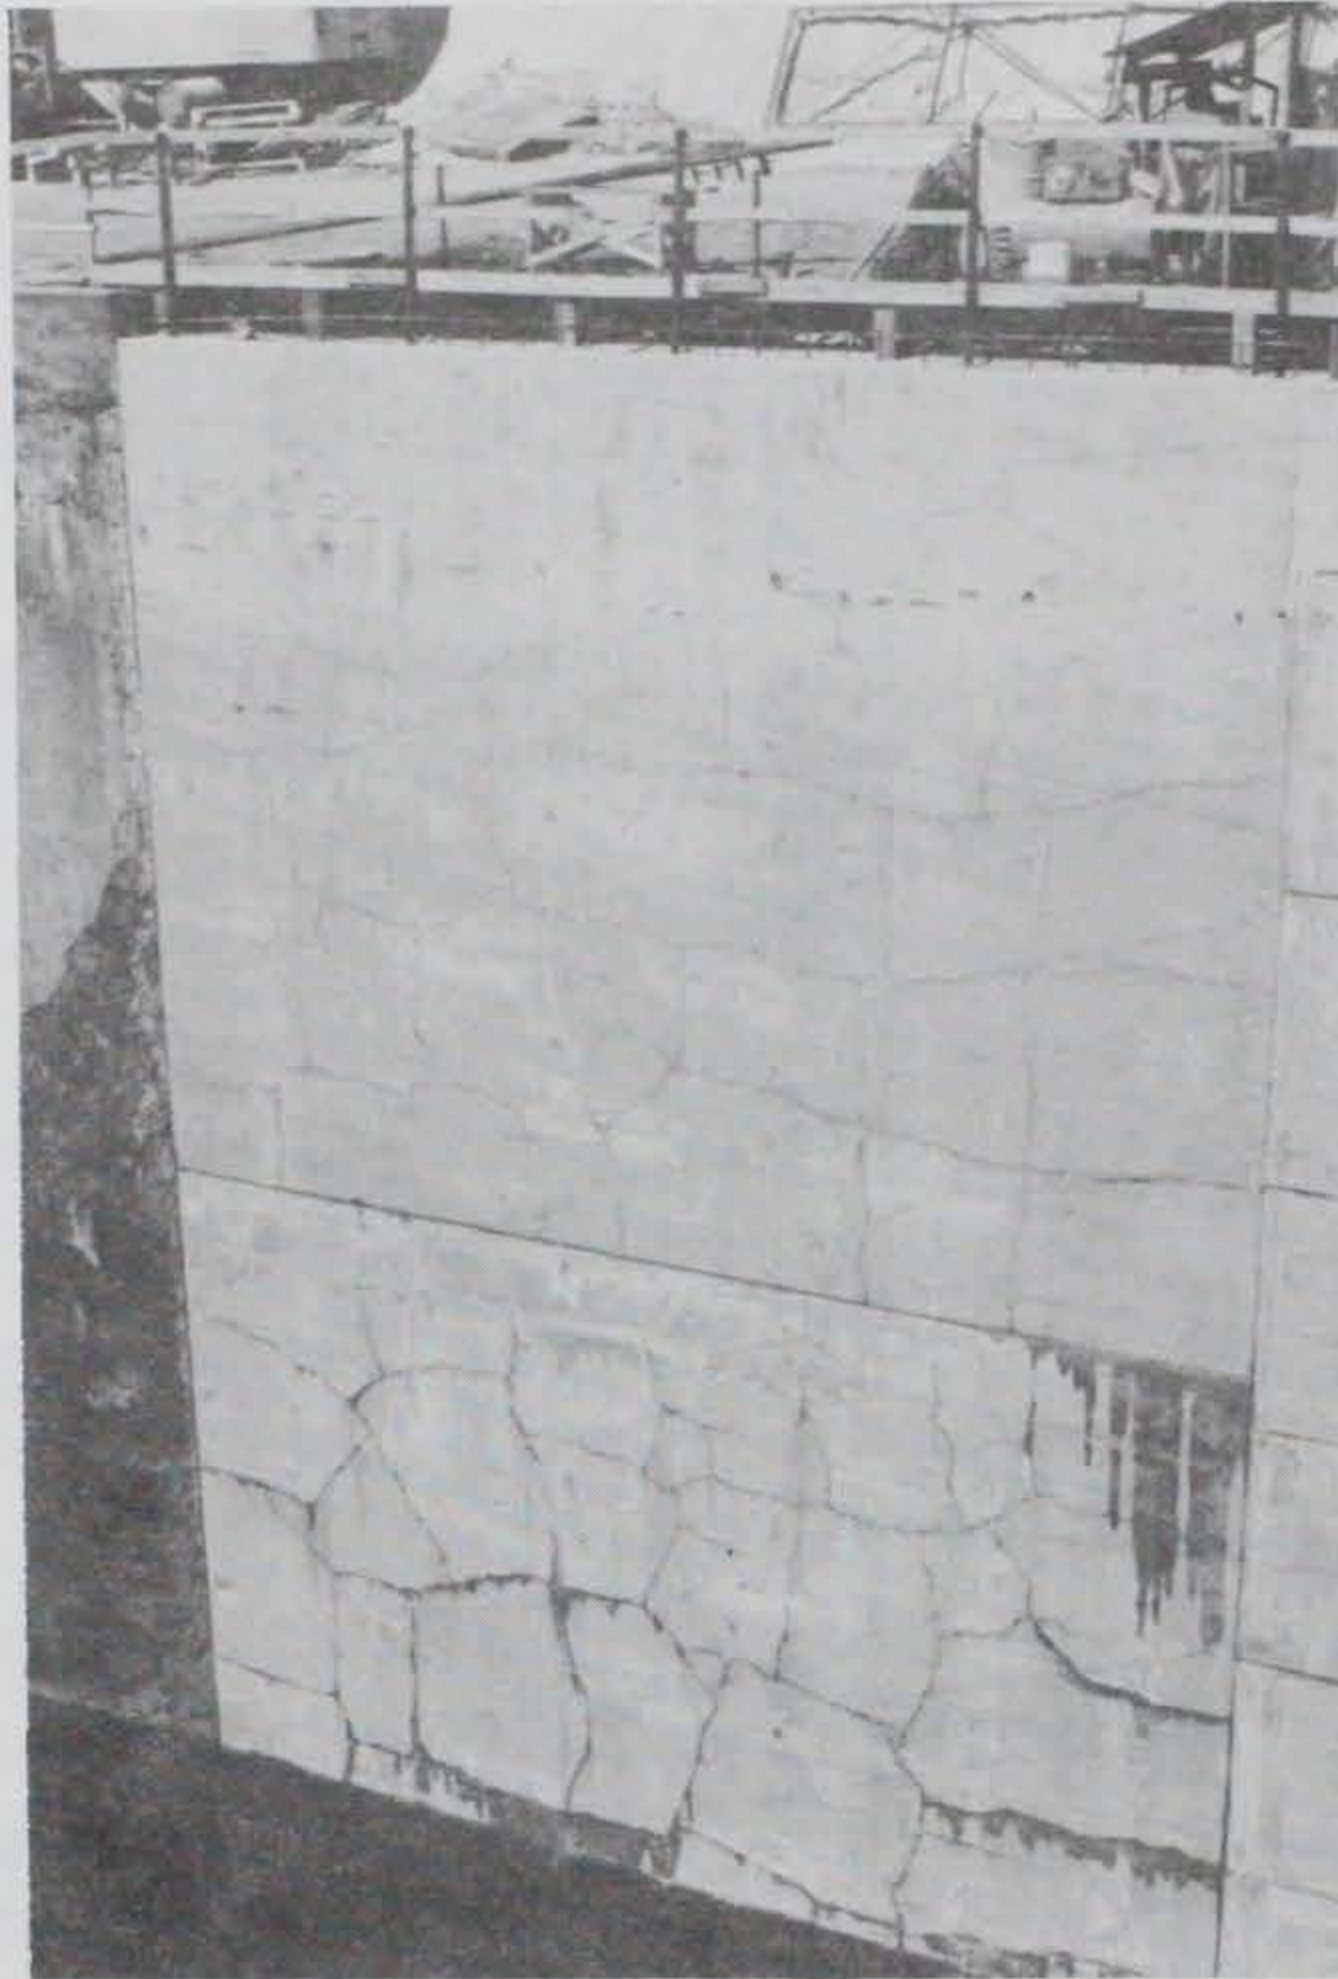
205. On 23 May, the lock chamber was flooded to low pool elevation; on 26 May, the water level was raised to the upper pool elevation. The water temperature was approximately 50 to 55°F. On 27 May, extensive cracking was observed in both lifts (Figure 89). The pattern cracks were generally spaced at 2 to 4 ft intervals. Crack widths at the surface appeared to be essentially constant, less than 0.01 in. wide. It could not be determined when cracking actually occurred, but the cracks were not observed until the lock chamber was placed into operation. Typically, cracks are much more visible after a concrete surface has been wetted since the cracks will retain moisture much longer than the surrounding concrete surface. Similarly, concrete cracking is usually more apparent following application of nonpigmented curing compound.

206. Concrete cores were obtained from each lift as part of the District's investigation into the possible causes of the cracking. Two pairs of 4-in.-diam cores were obtained from each lift. In each case, one core was drilled horizontally along a crack, and a second core was drilled through uncracked concrete in the same vicinity. All cores were drilled to a depth of 4 in. beyond the interface between the existing and replacement concretes. Seven of the eight cores were retrieved with the interface intact. An

Figure 89. Cracking in replacement concrete,  
trial resurfacing monolith, 10 June 1980,  
Lock No. 1, Mississippi River

examination of the cores verified that good bond was obtained between old and new concrete. The examination also indicated that cracking initially developed at the face of the wall and propagated inward to approximately 90 percent of full depth of the resurfacing. There was no indication of reflective cracking although two vertical cracks at the top of lift B were in line with existing cracks in the old concrete. Results of compressive strength tests on selected cores and cylinders cast at the time of placement were as follows:

- a. Use 1-1/2-in. maximum-size aggregate.
- b. Use a concrete mixture proportioned for 3,000-psi compressive strength with a 0.48 water-cement ratio.
- c. Reduce the amount of water-reducing agent to that recommended by the manufacturer.
- d. Use proper and timely curing methods. If membrane curing is used, patching should wait until the curing period is completed.
- e. The temperature of the fresh concrete should be as low as the project specifications allow.
- f. Thoroughly consolidate placed concrete.
- g. Use hot or cold weather placing techniques as appropriate.

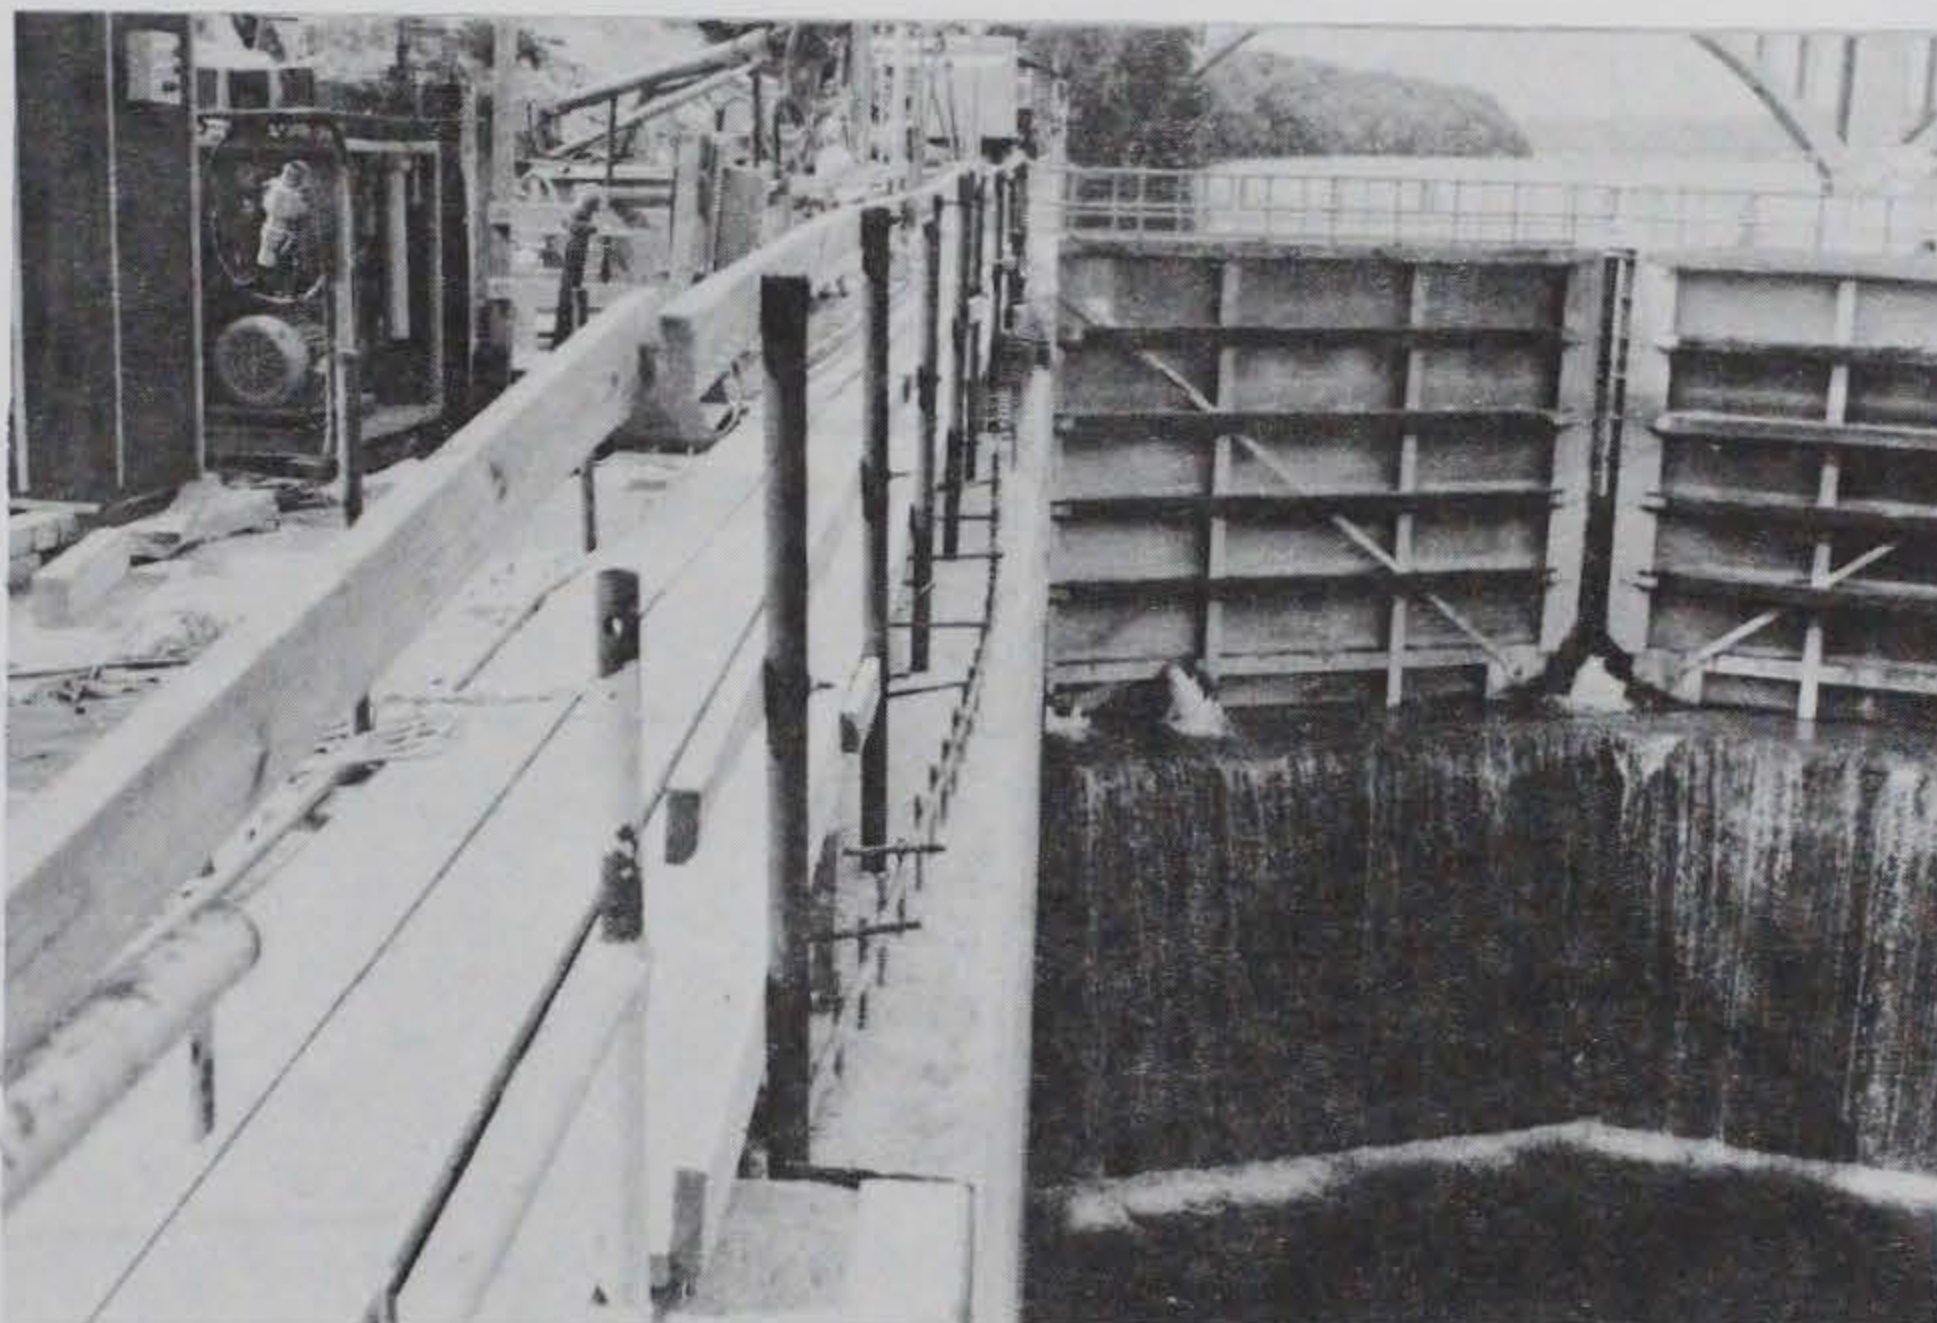
207. It was specified that temperature reinforcement be located 4-in. from the finished lock face. Concrete cores showed the reinforcing steel to be located from 6 to 7 in. from the wall face. Measurements taken after placement of lift B showed the reinforcement at the top of the lift was located from 4-1/2 to 13 in. from the lock face (Figure 90). The improperly positioned reinforcement would have provided little resistance to shrinkage and temperature stresses.

Figure 90. Location of reinforcing steel at top of Lift B, trial resurfacing monolith, 9 July 1980, Lock No. 1, Mississippi River

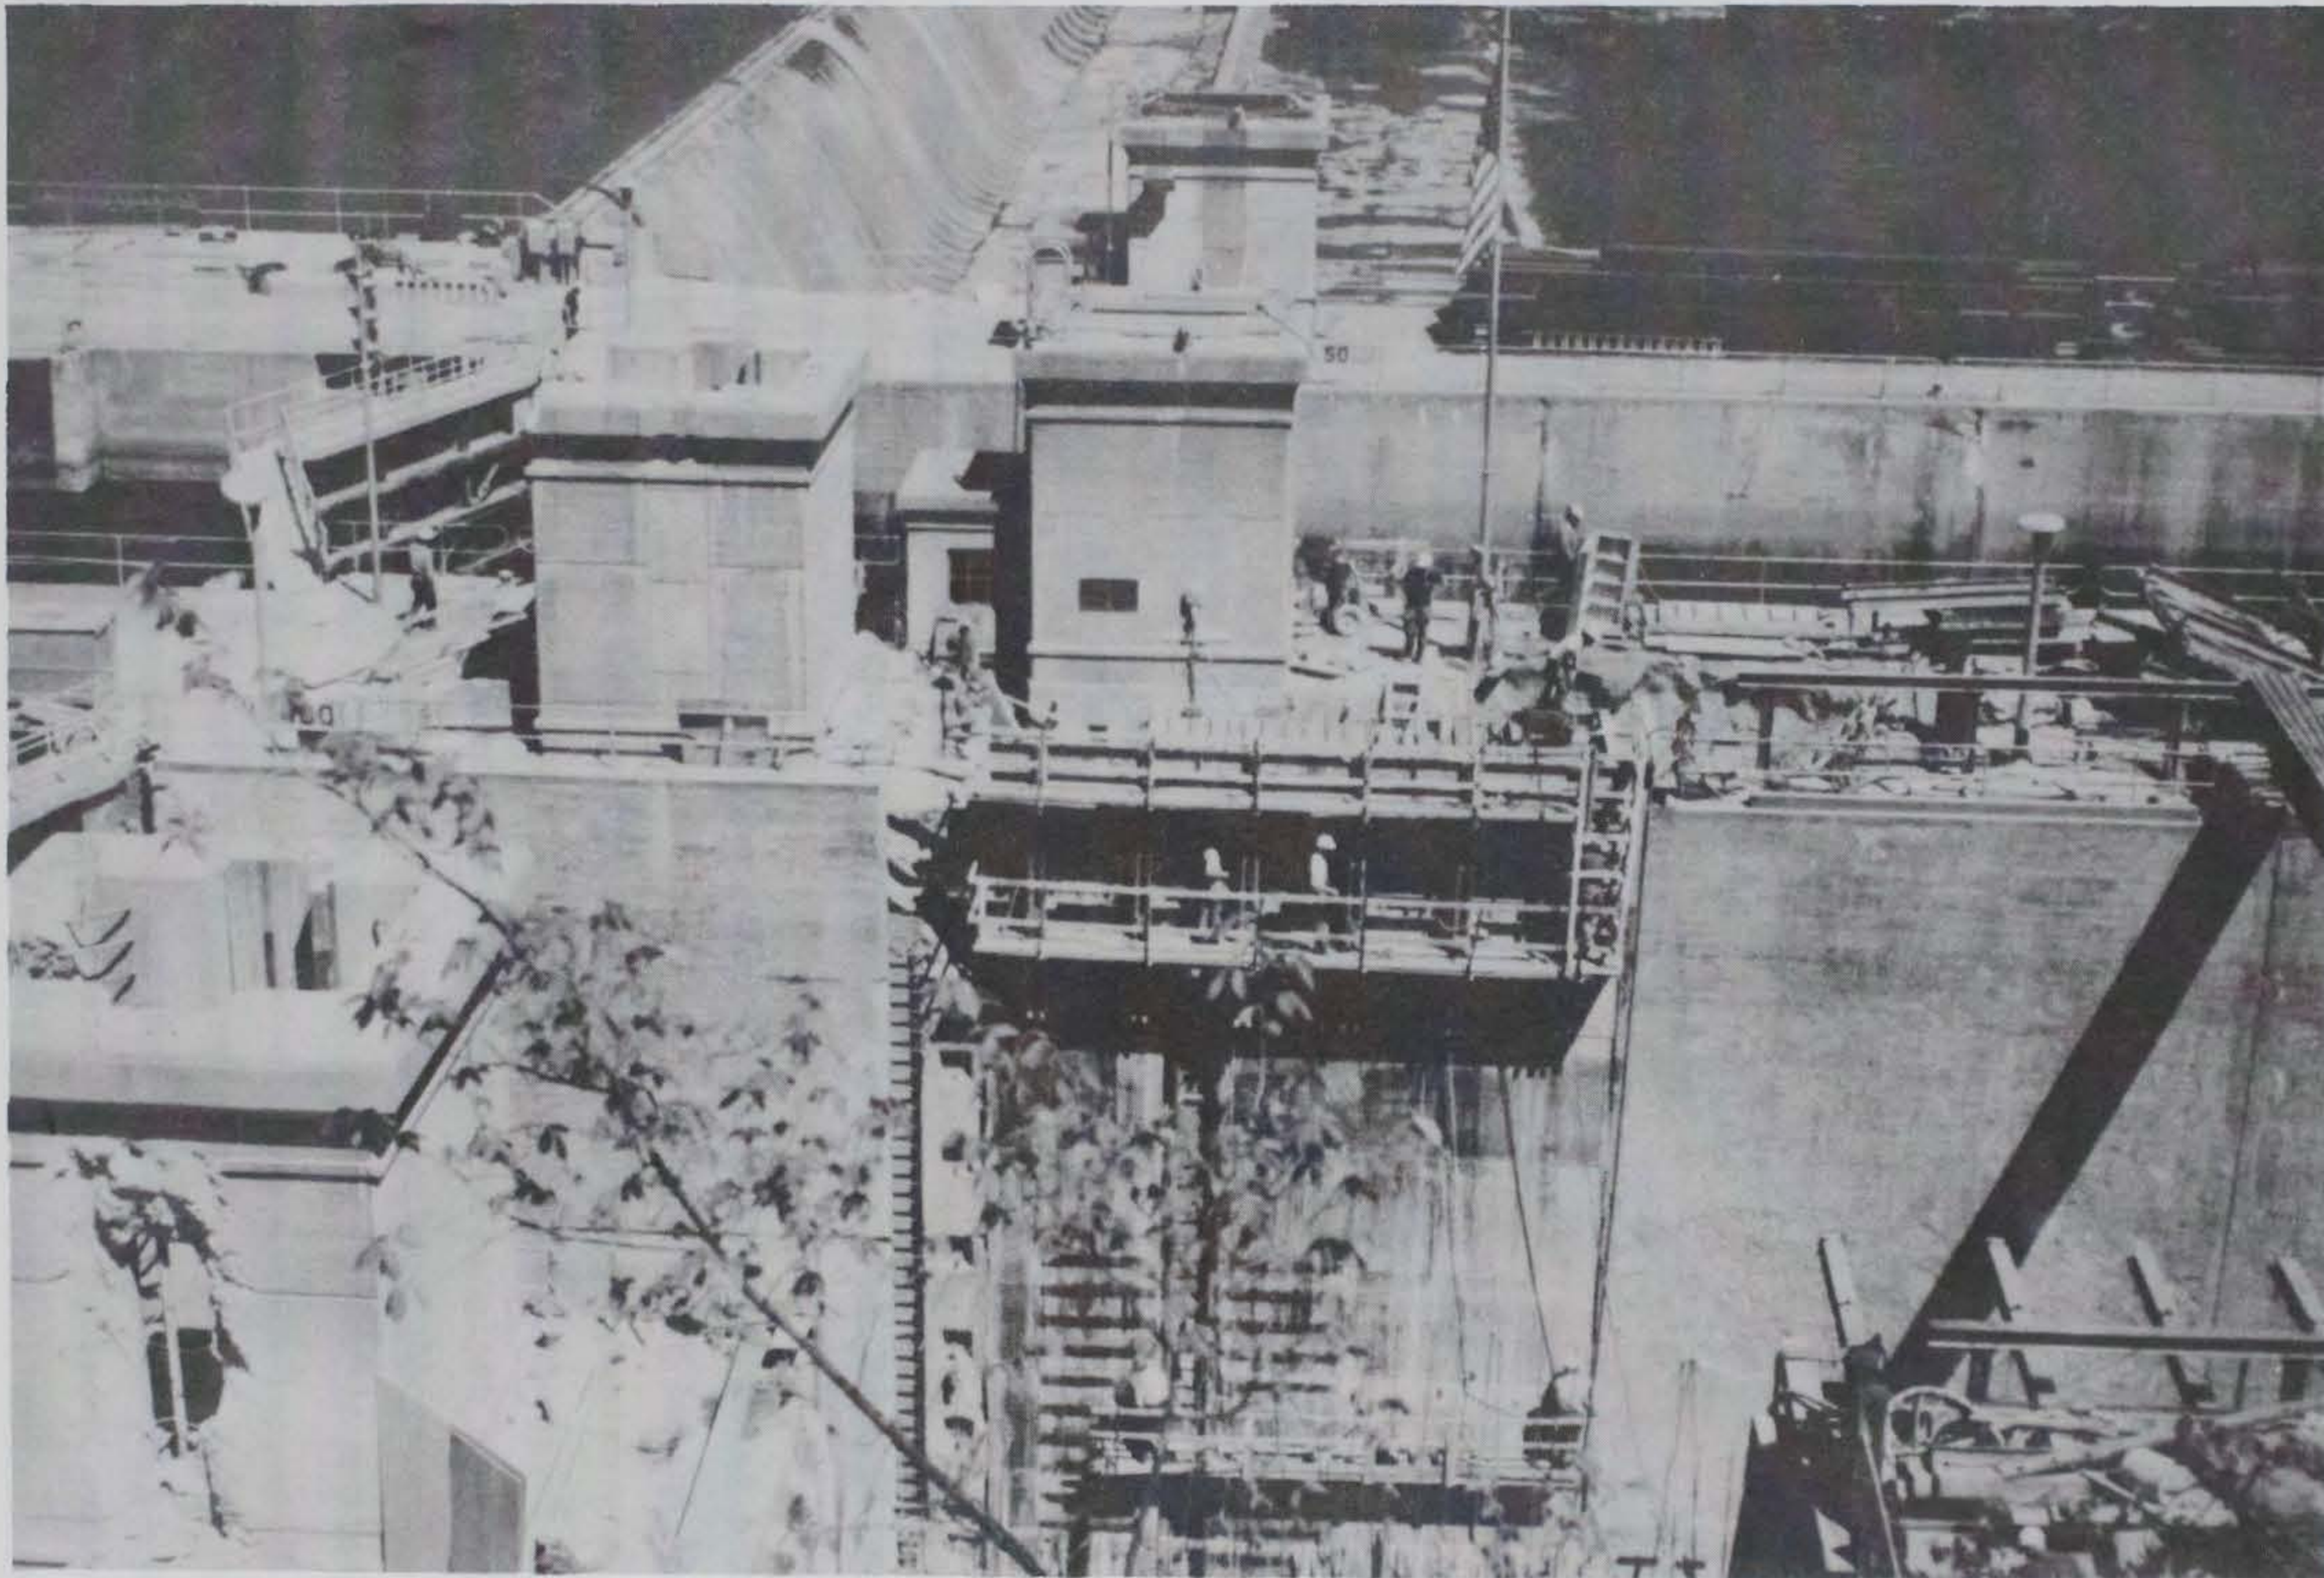
Figure 91. Reconstruction of monolith I-5, Lock No. 1, Mississippi River

211. During the second winter dewatering (1980-81), the new intake and discharge manifold systems were constructed, and the lock walls were resurfaced. Two upstream monoliths on both the intermediate wall and the upper guide wall were demolished and rebuilt (Figure 91) to accommodate the new lock intake system. Thus, the filling ports could be moved from the miter gate recesses, significantly reducing the amount of debris that collects in these recesses. Construction of the new discharge system involved five new mass

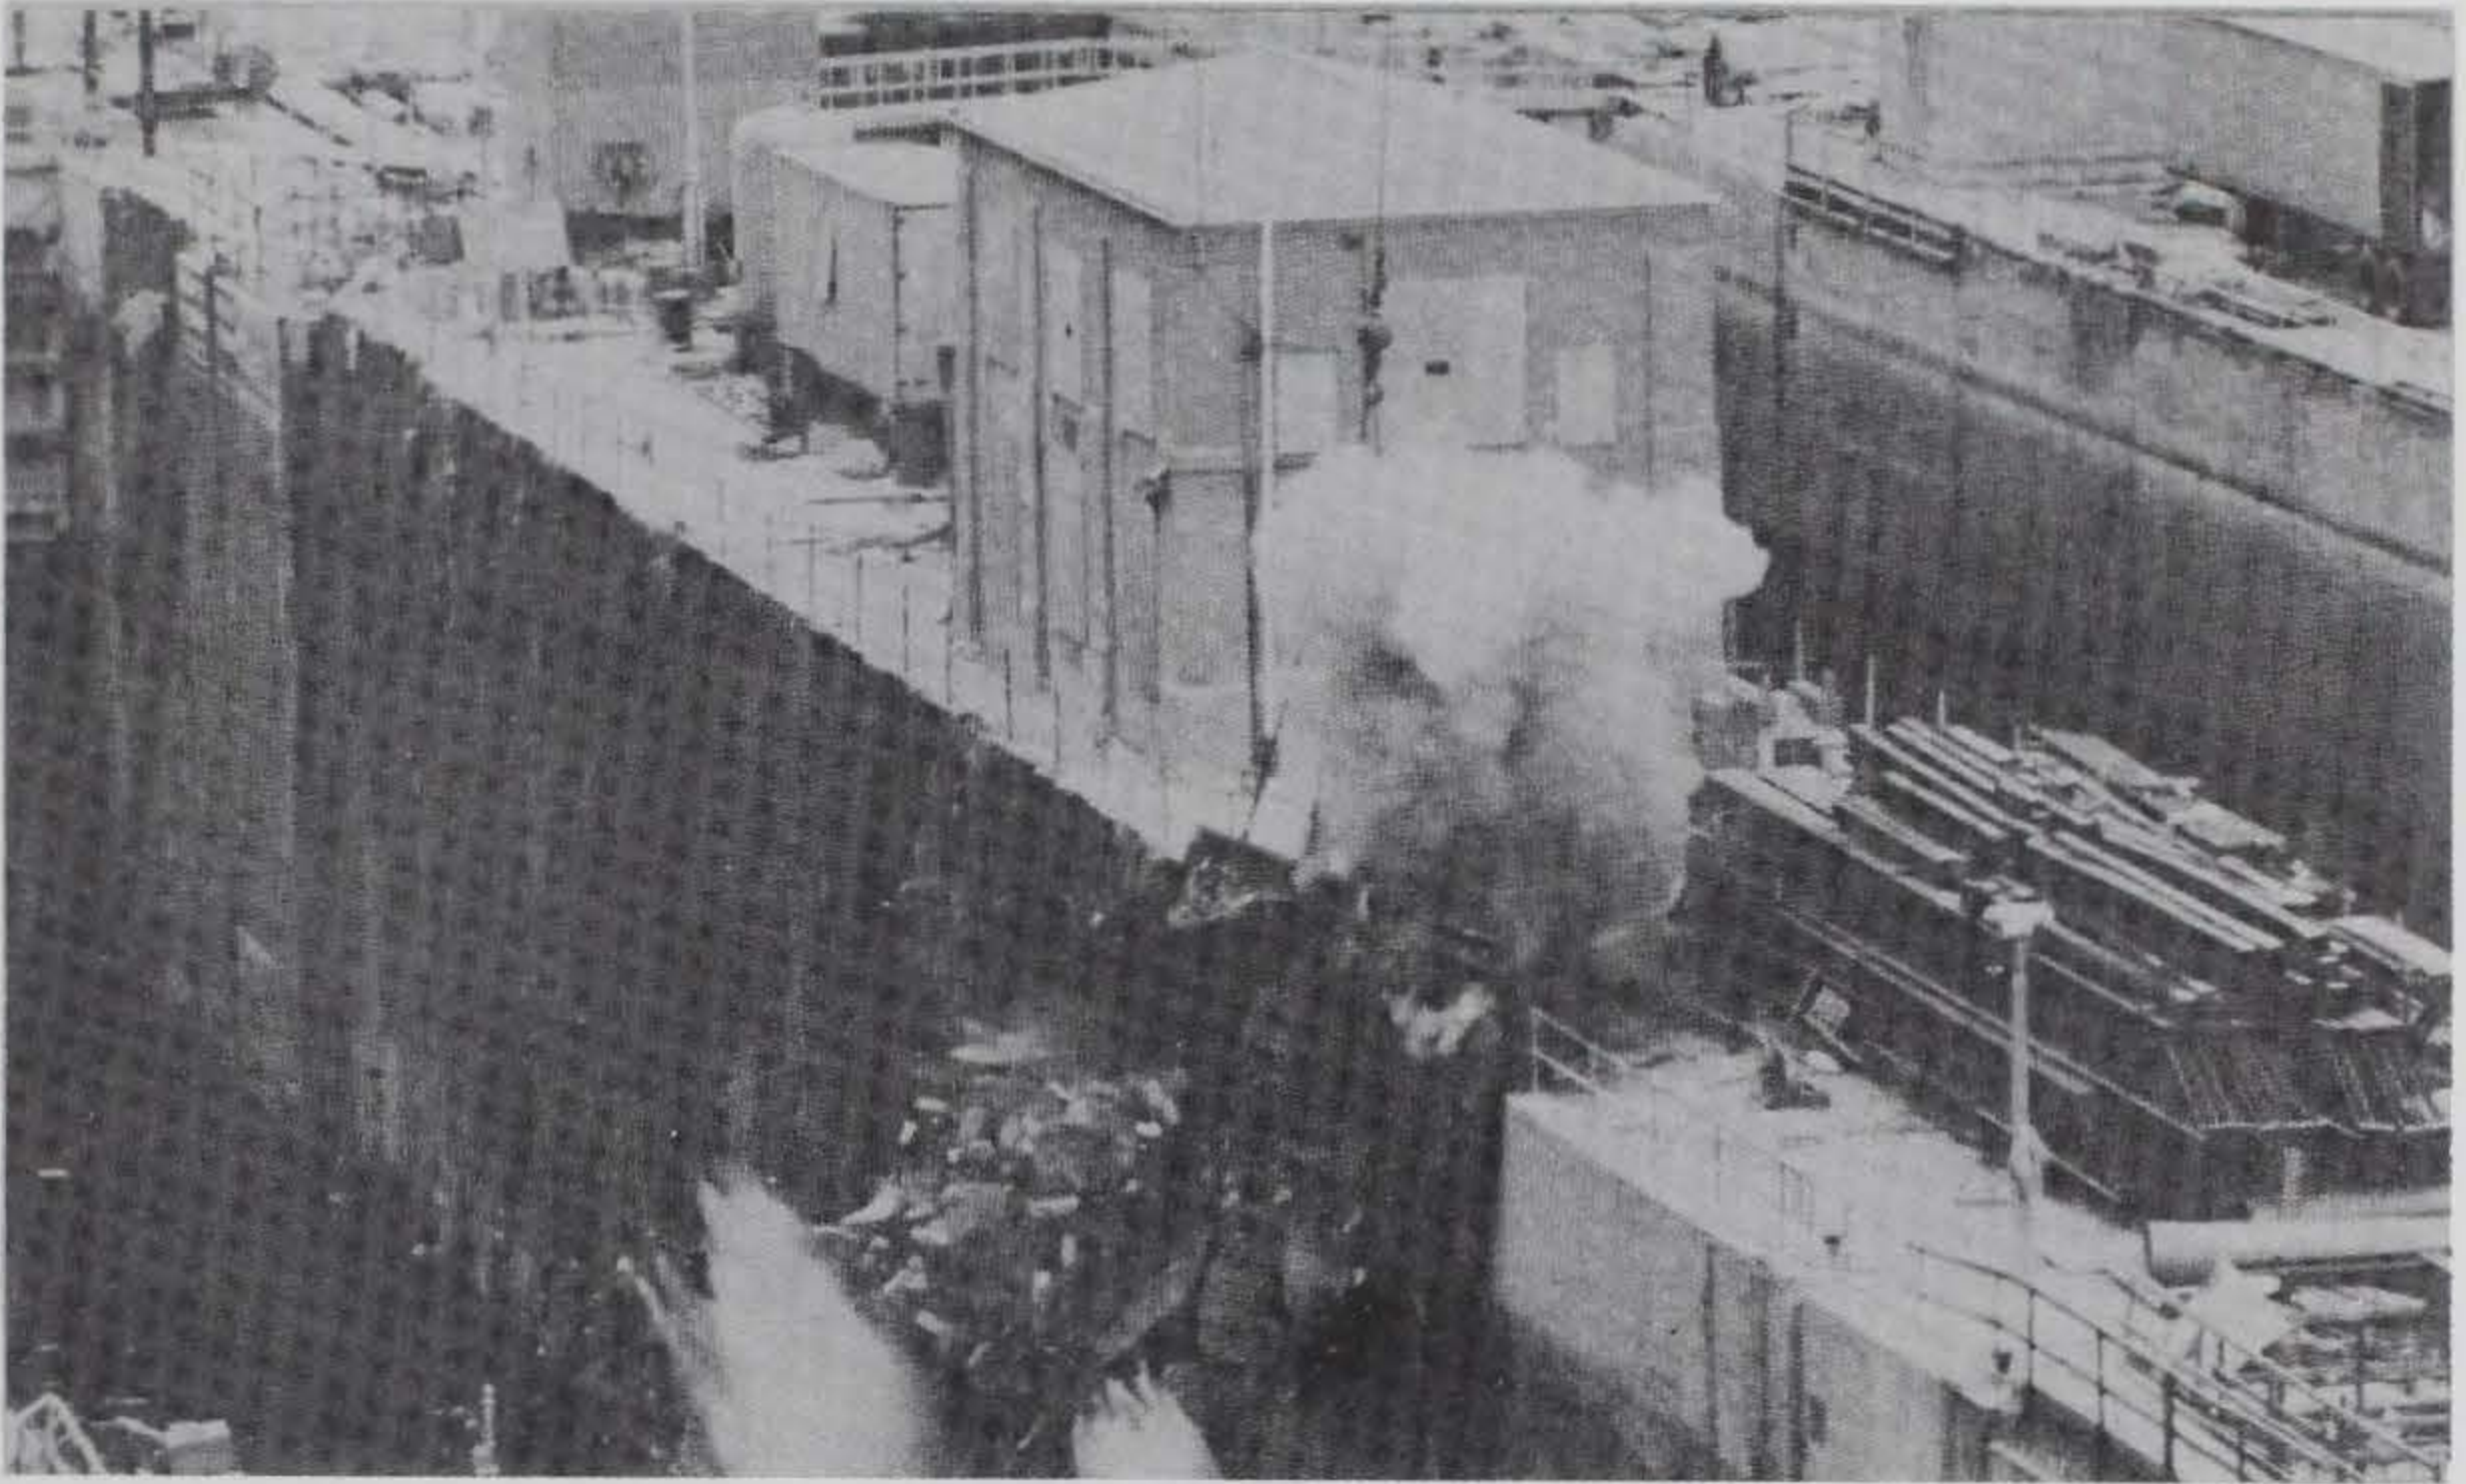
214. Results of the vertical wall removal (Figure 92) varied with respect to the condition and composition of the concrete being removed. Where excessive embedded form tie steel existed, large displaced concrete blocks or slabs frequently remained on the wall suspended by the form tie steel

Figure 92. Concrete removal, land face of intermediate wall, Lock No. 1, Mississippi River

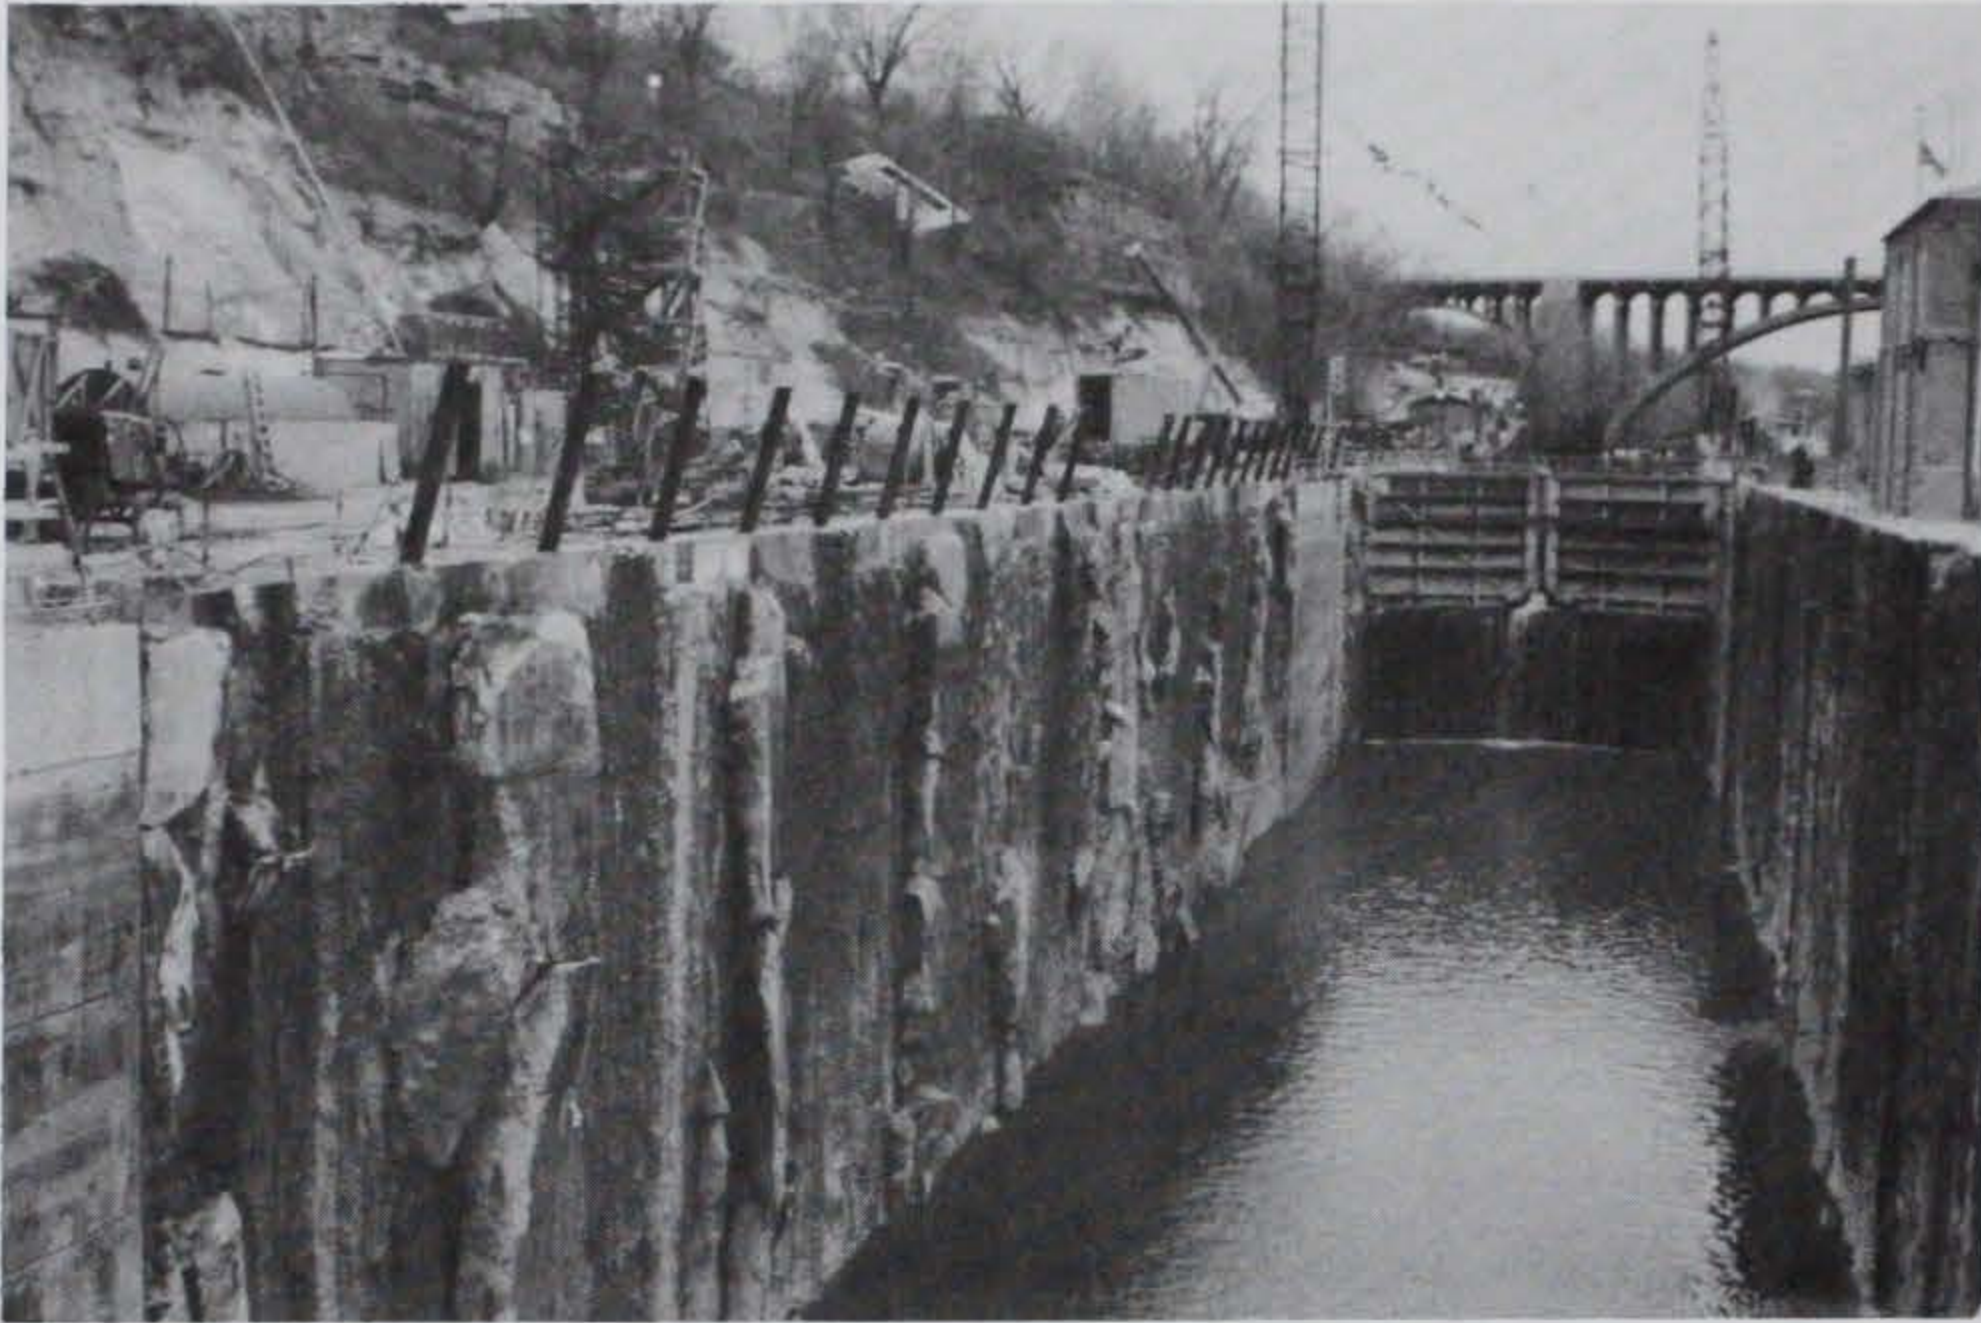
(Figure 93). These blocks occurred most frequently near the monolith joints. This hanging concrete presented a special removal problem requiring considerable removal effort by the contractor. Several "reshots" were necessary where these blocks remained, occasionally requiring even a third shot to obtain adequate removal. In an effort to alleviate this problem, the delays of some charges in the resurfacing shot were changed. However, this change came at a time when trouble causing form tie steel was no longer encountered in typical wall resurfacing blasting.

Figure 93. Hanging blocks of concrete where excessive form tie steel was encountered on the land wall, Lock No. 1, Mississippi River
