TECHNICAL REPORT REMR-CS-13

**REHABILITATION OF NAVIGATION  
LOCK WALLS: CASE HISTORIES**

James E. McDonald

December 1987

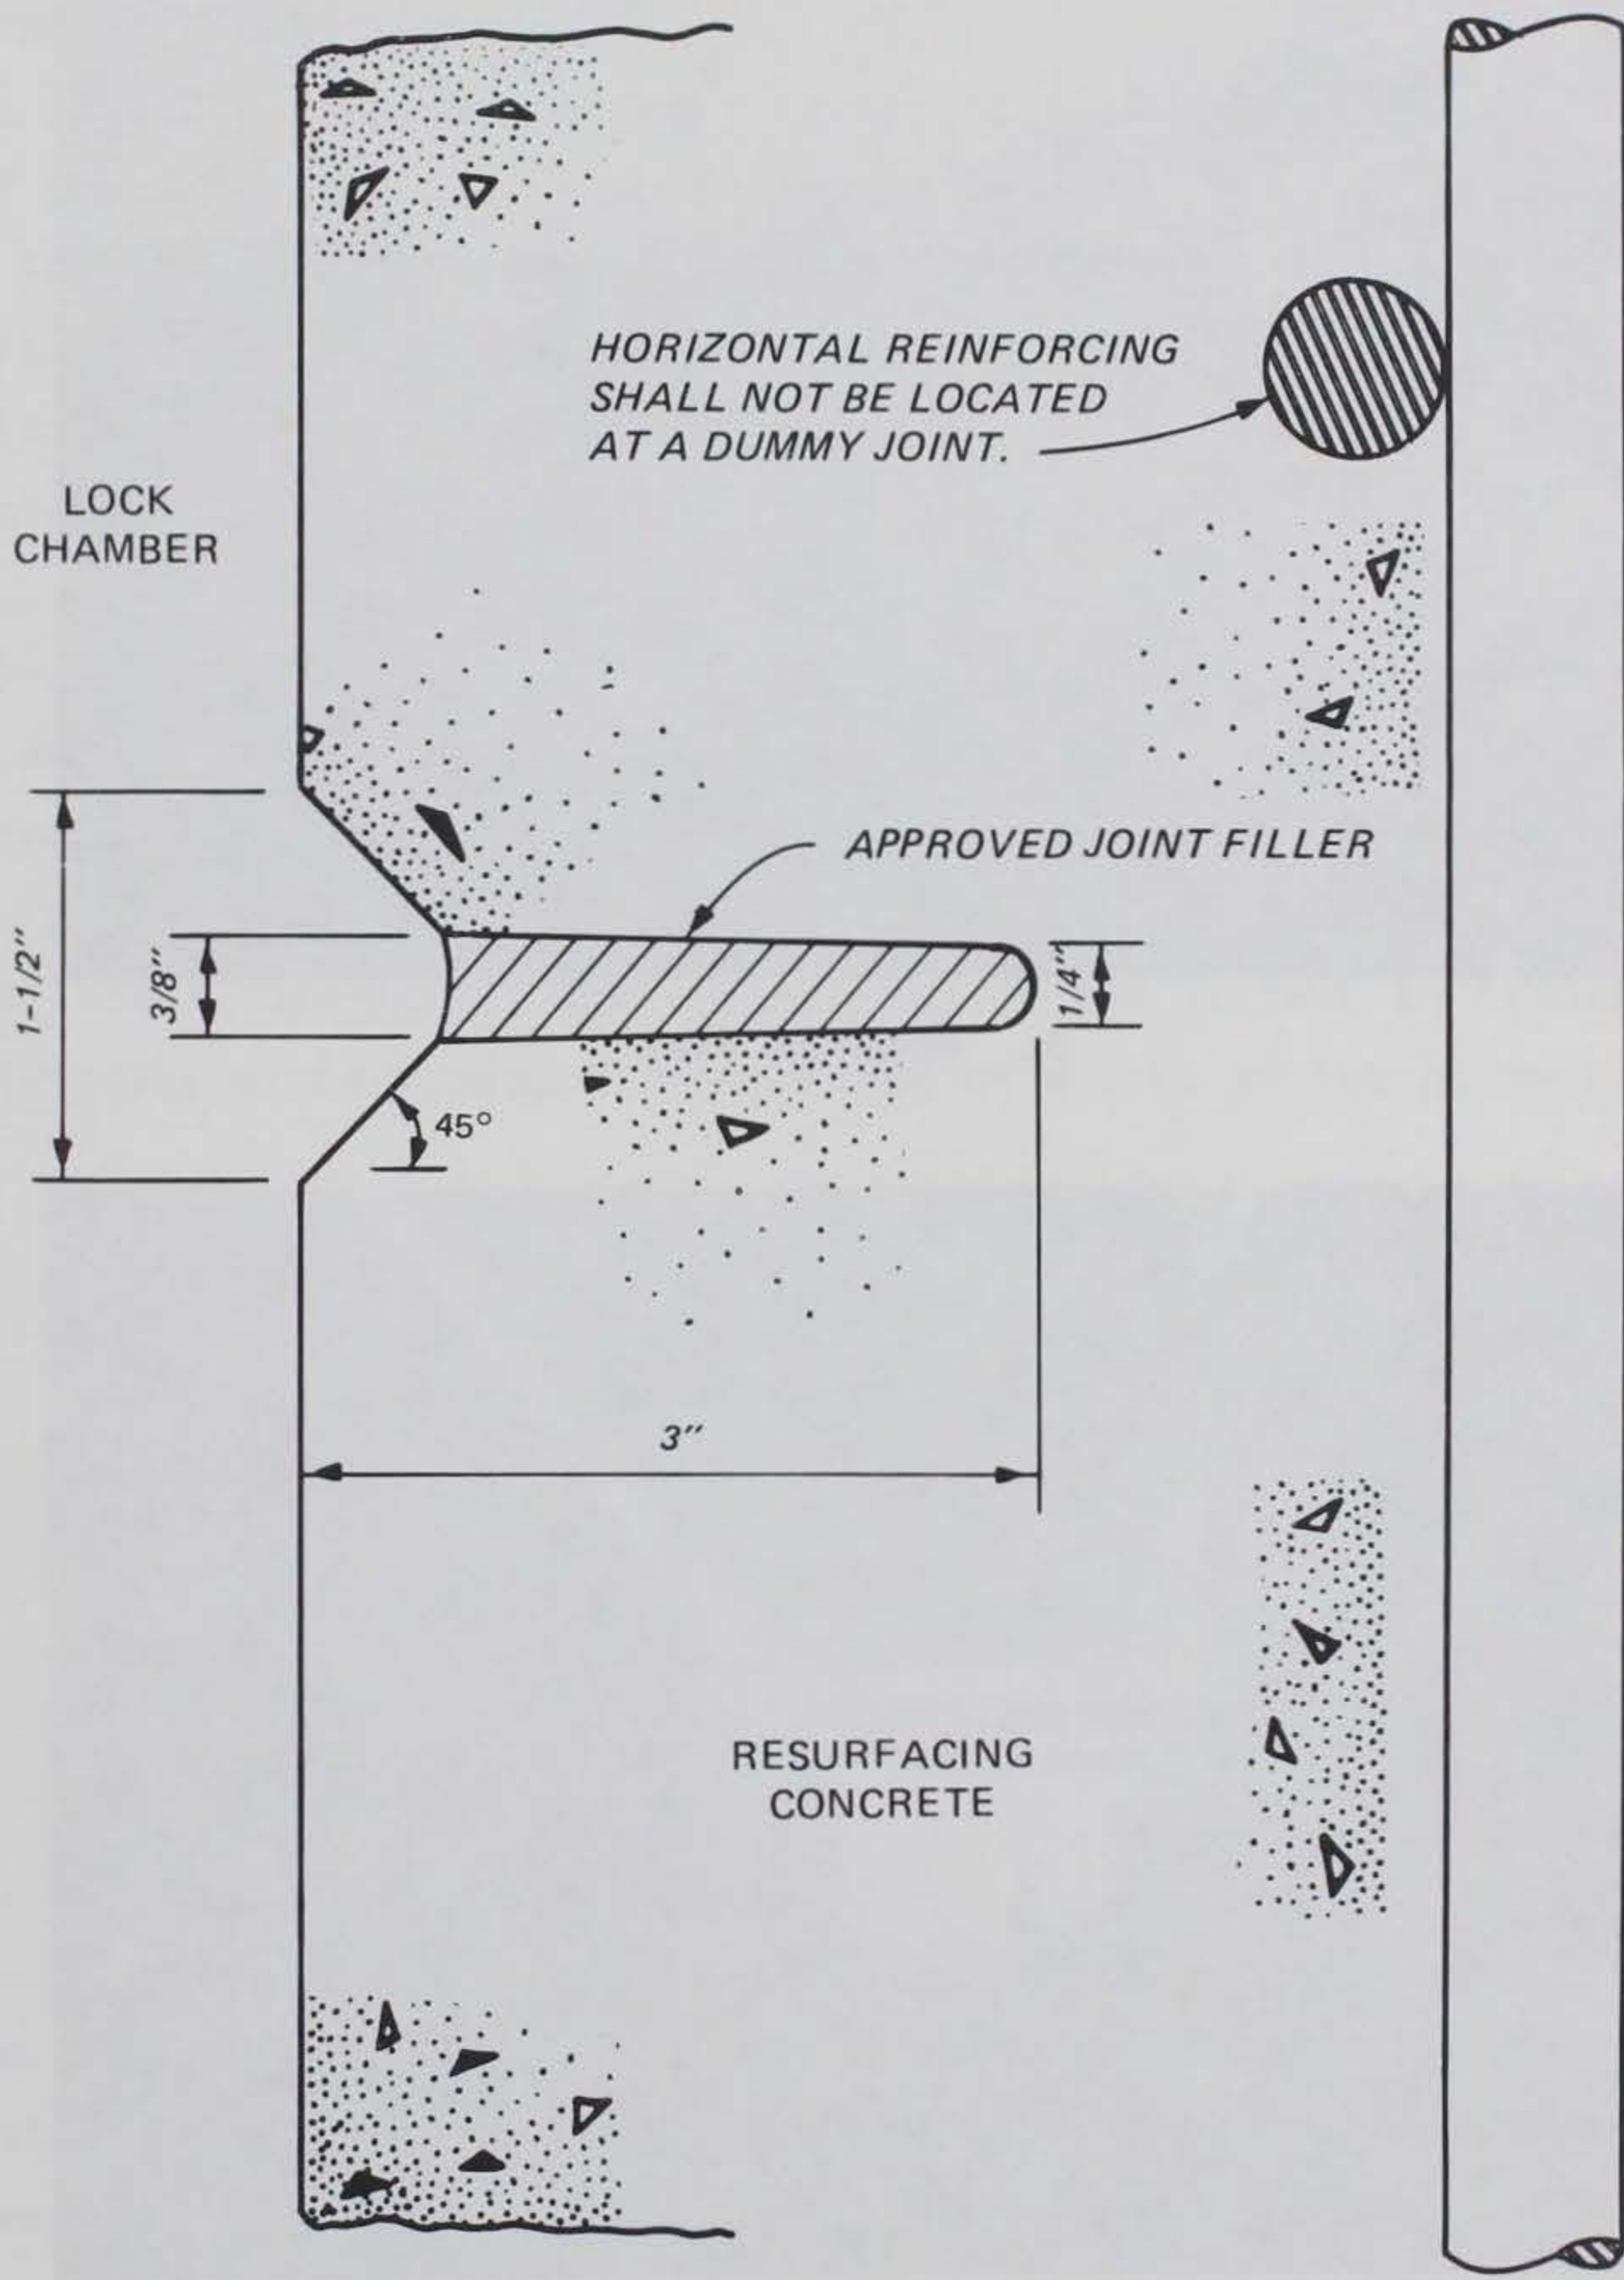
Figure 94. Horizontal dummy joint design, Lock No. 1, Mississippi River

performance were reviewed, and no major deficiencies were found. However, based on results of the trial resurfacing and Corps experiences with other lock wall resurfacing projects, it was anticipated that cracks would occur. In an effort to control such cracking, horizontal dummy joints 5 ft on centers were specified. These joints were specified to be a minimum of 3 in. deep (Figure 94) and to align with horizontal joints in the reconstructed tainter valve monoliths. Vertical joints were not specified because it was thought that they would be more vulnerable to barge impact. One of the resident engineers was assigned sole responsibility for monitoring the concrete placement and quality control to assure that good construction practices were followed within the limits of the specifications.

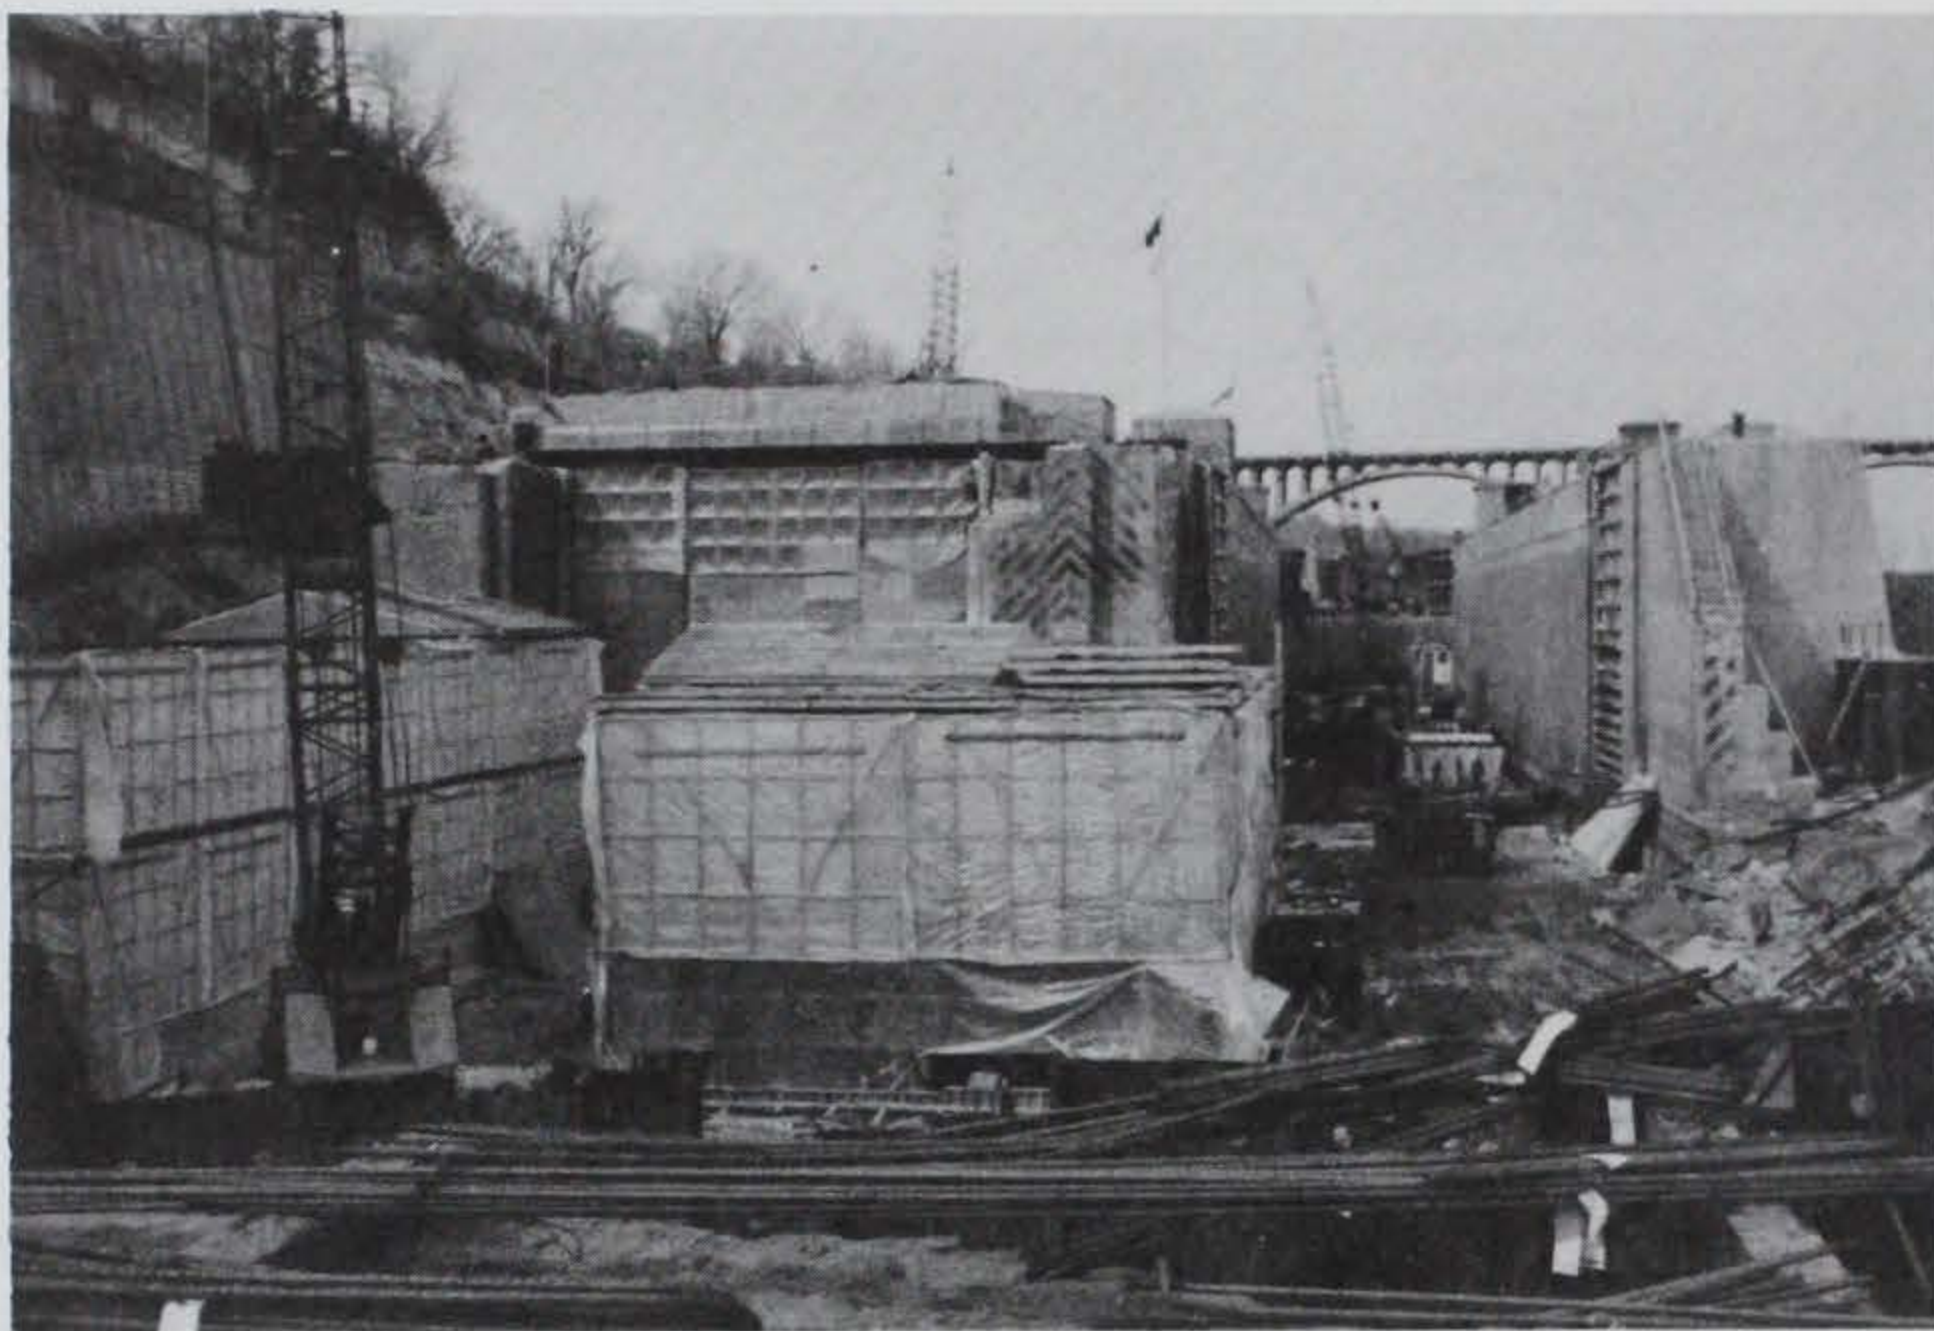
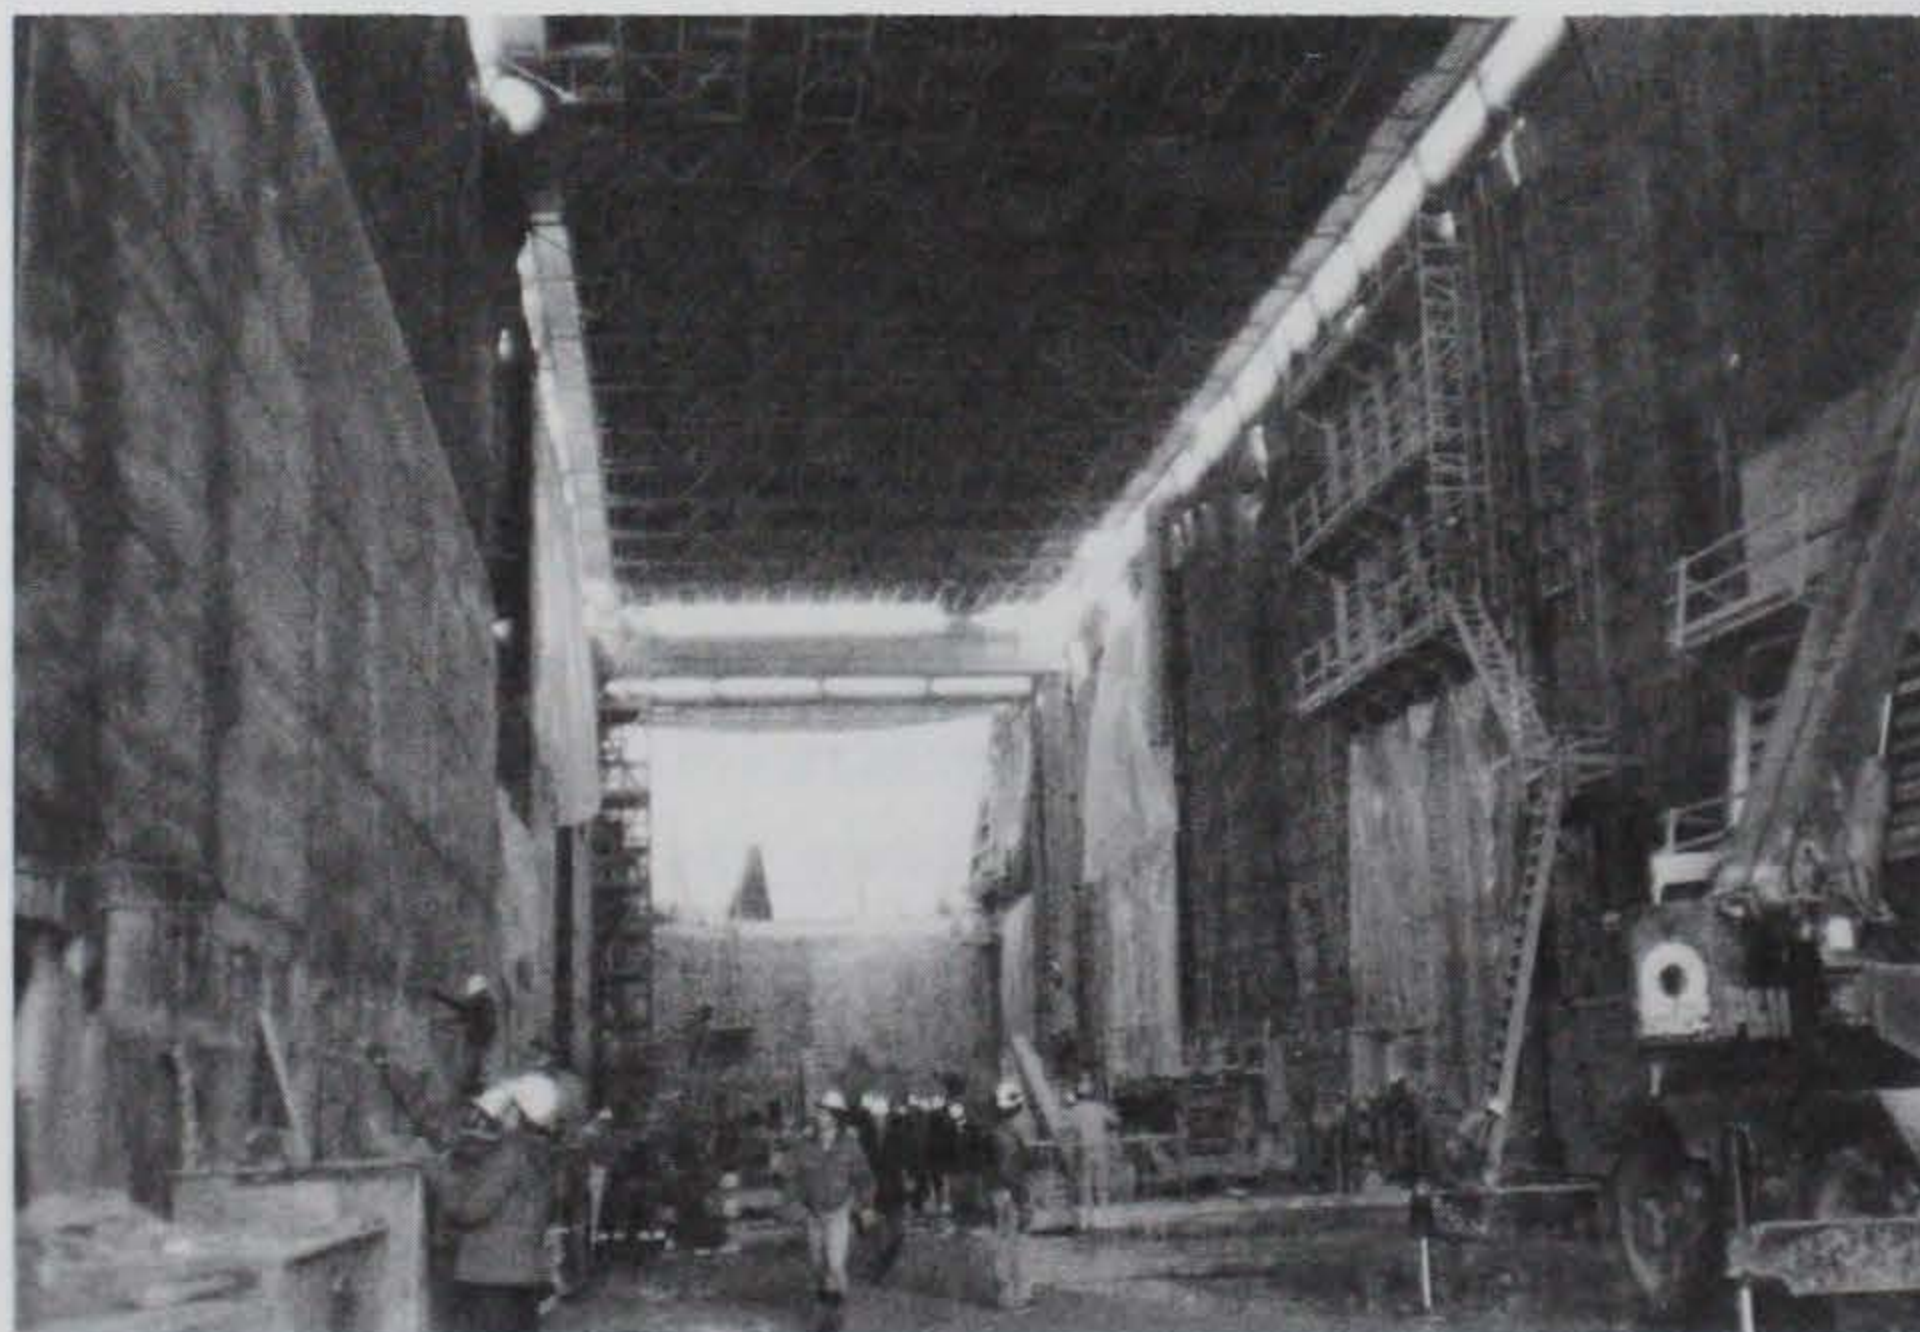
Figure 95. Temporary enclosure over lock chamber,  
Lock No. 1, Mississippi River

217. Following completion of concrete removal, a temporary truss and corrugated sheet metal structure provided by the Corps was placed over the lock chamber (Figure 95). This structure allowed the temperature within the lock chamber to be maintained at a minimum of 40°F during the winter at a site where snowfall is considerable and wind chill factors can range from -20 to -80°F. Hatches and construction elevators provided access from the ground surface to the floor of the lock chamber. The shelter was designed to be easily assembled and disassembled for reuse or salvage, making it an economical

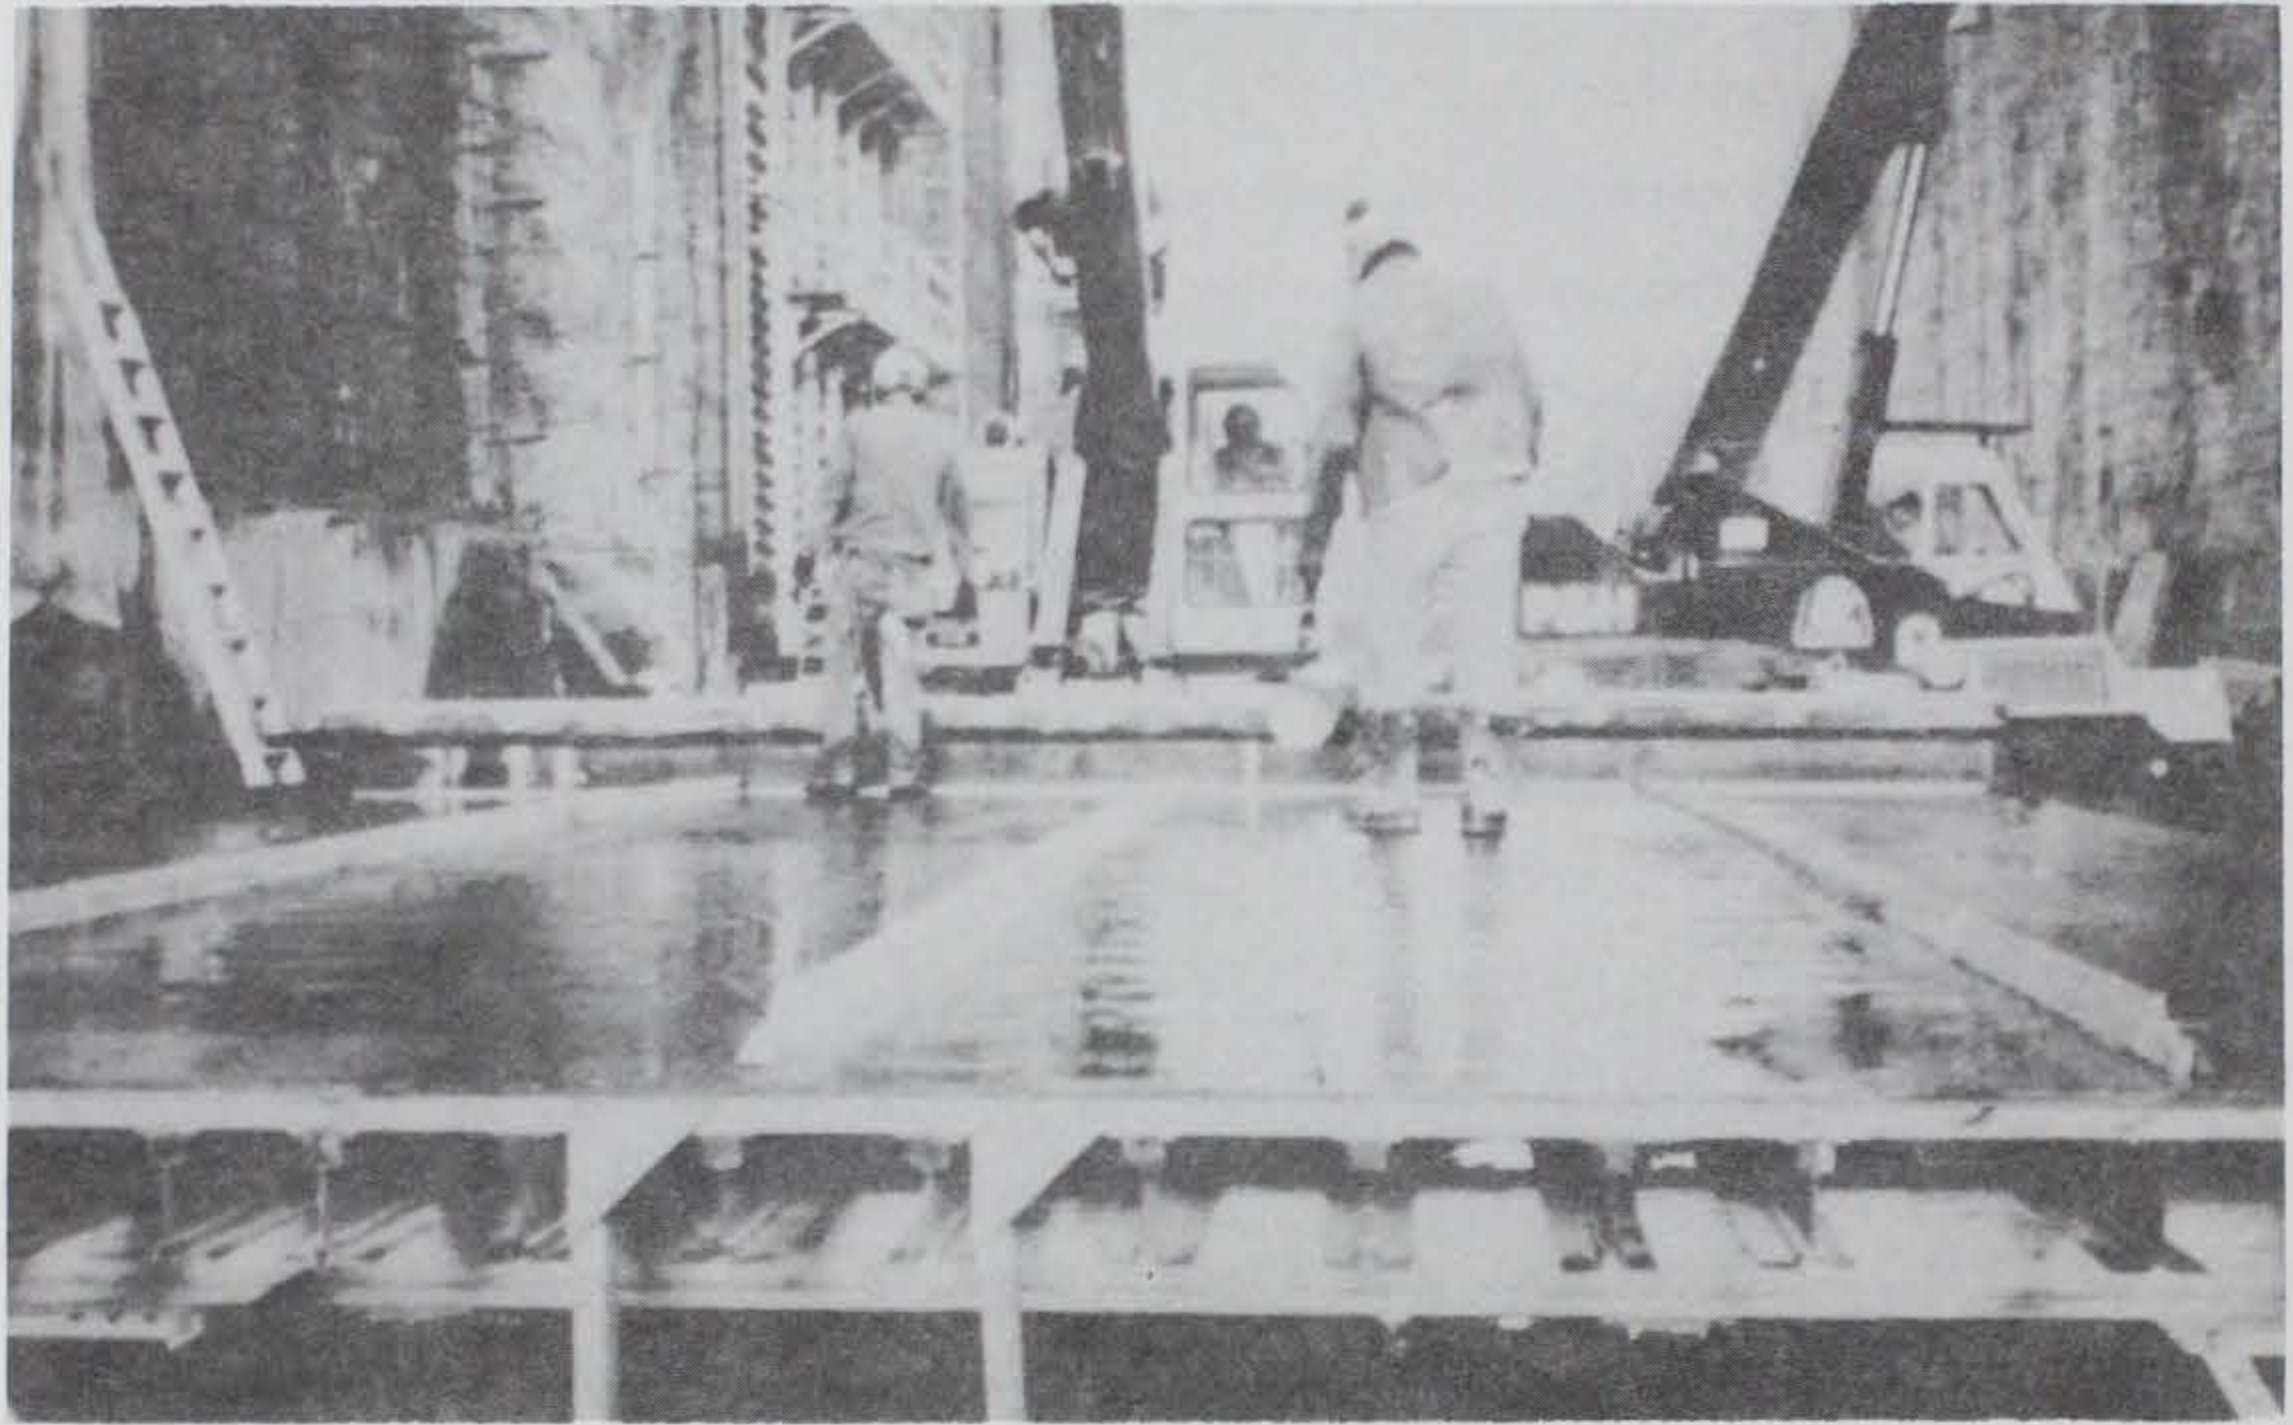
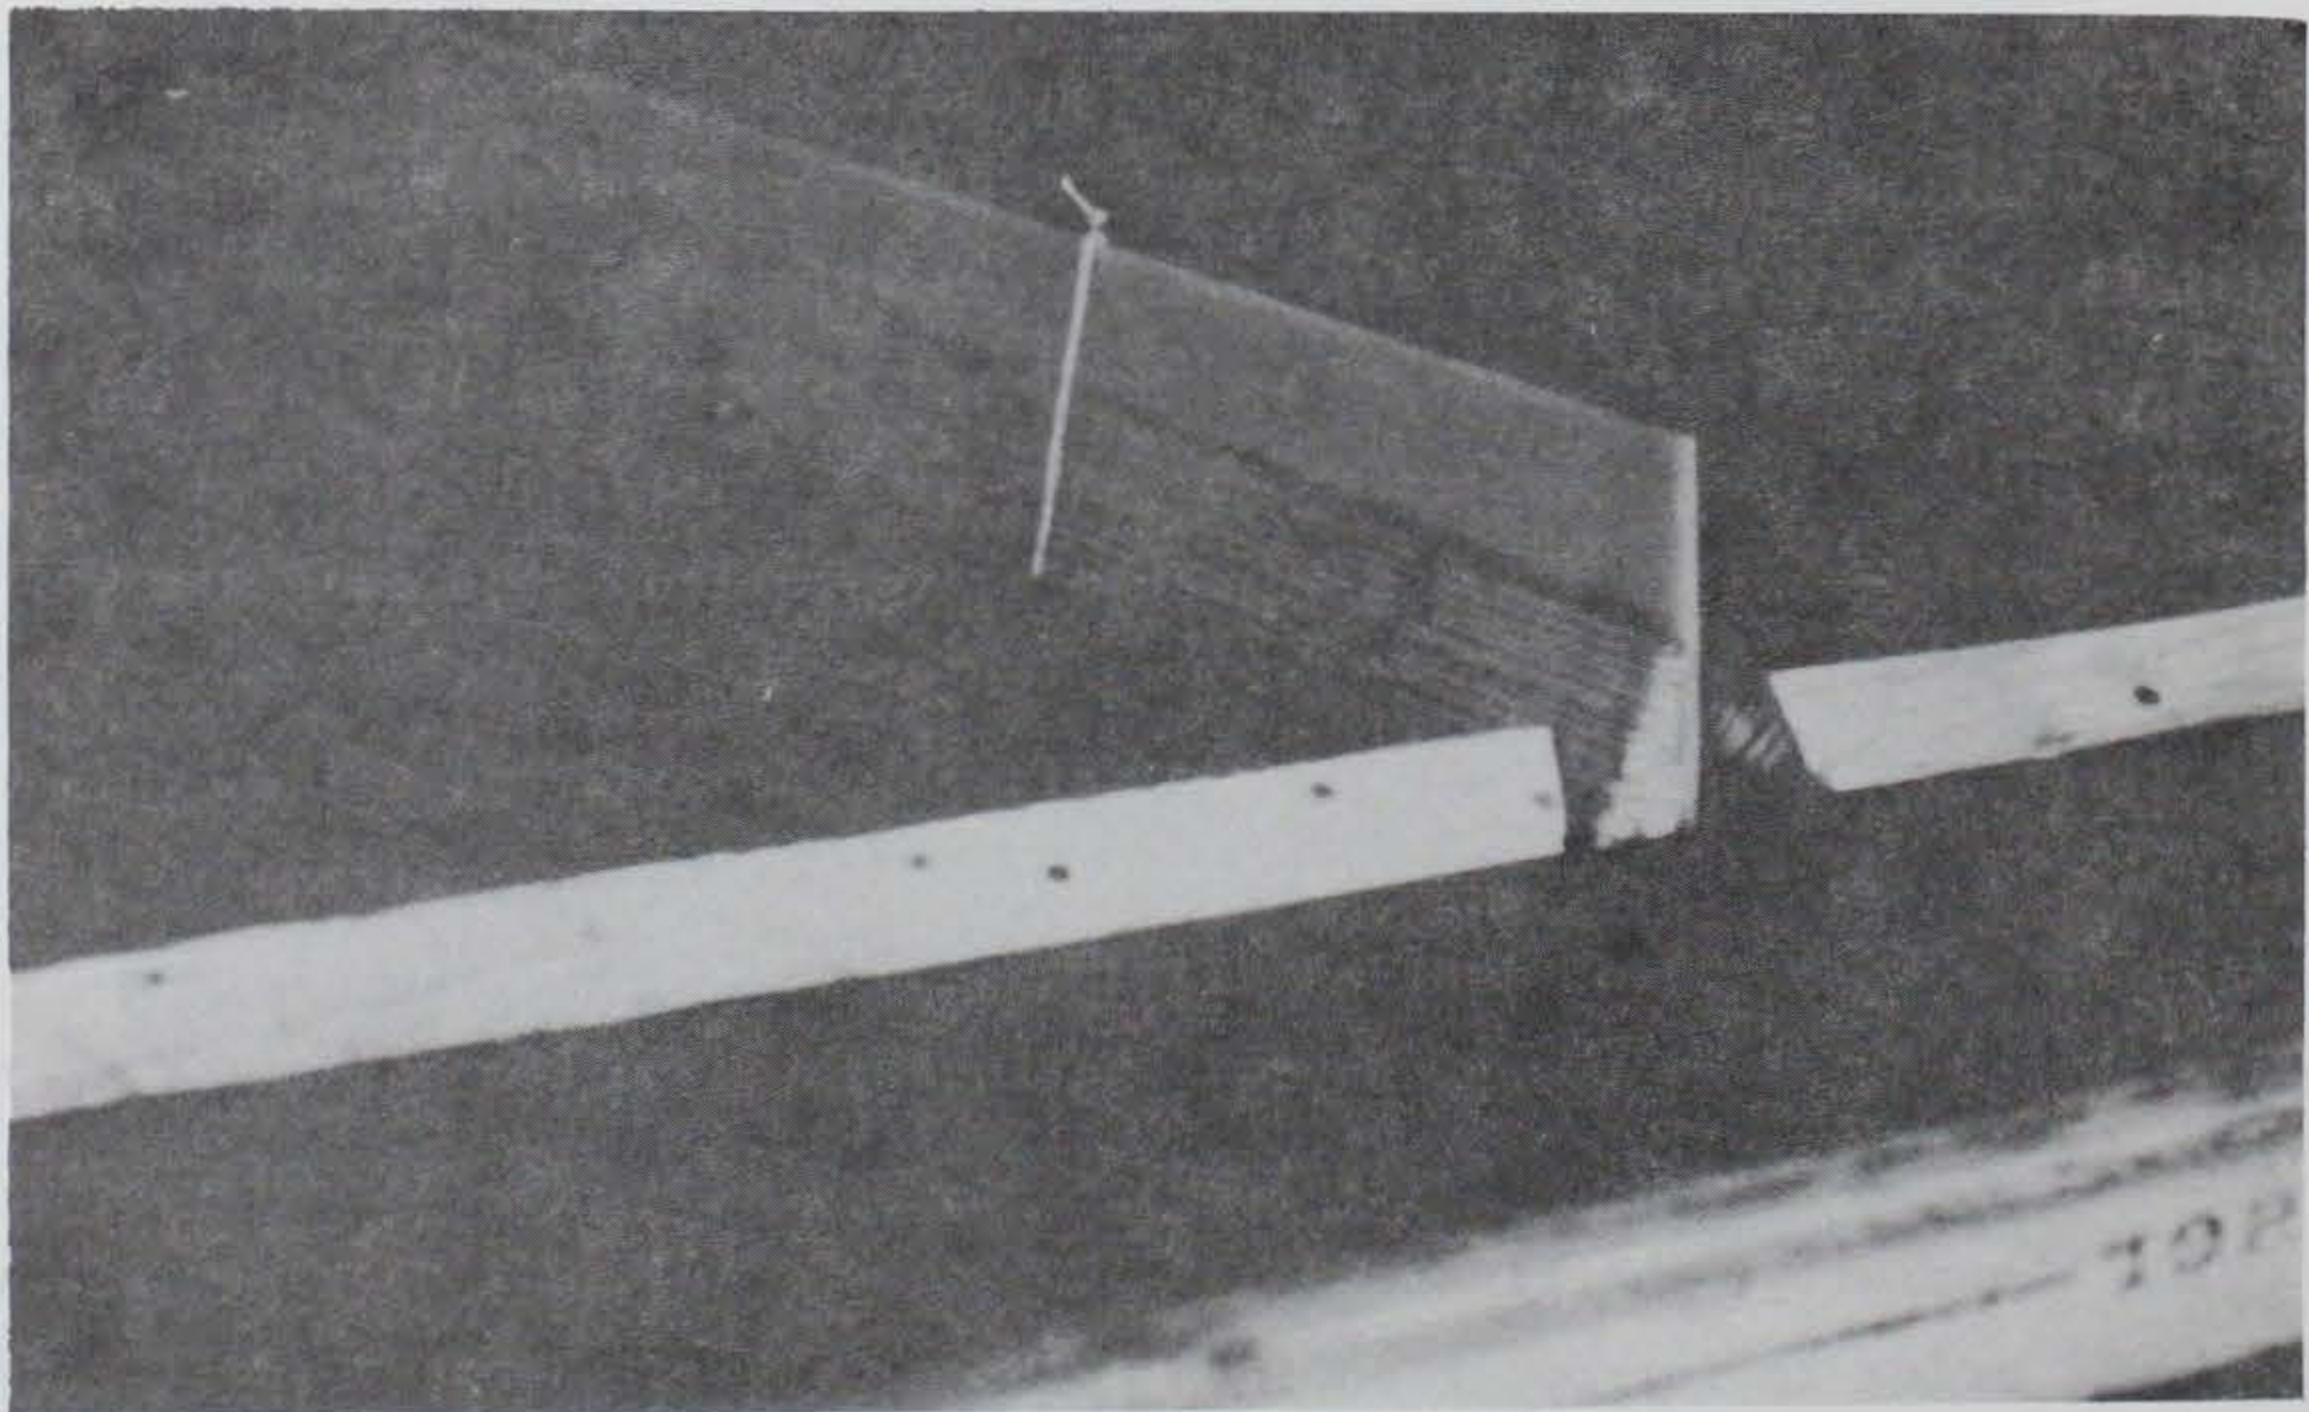
Figure 96. Forming for horizontal dummy joints,  
Lock No. 1, Mississippi River

218. Surface preparation and replacement concrete reinforcement, anchors, and forms for the wall resurfacing were similar to that previously described for the trial monolith. Prior to placing the concrete forms, dummy joints were provided on the form face as shown in Figure 96. Waterstops and joint seals were installed at monolith joints as shown in Figure 97. Two lifts, each 23 ft high, were used to resurface each monolith.

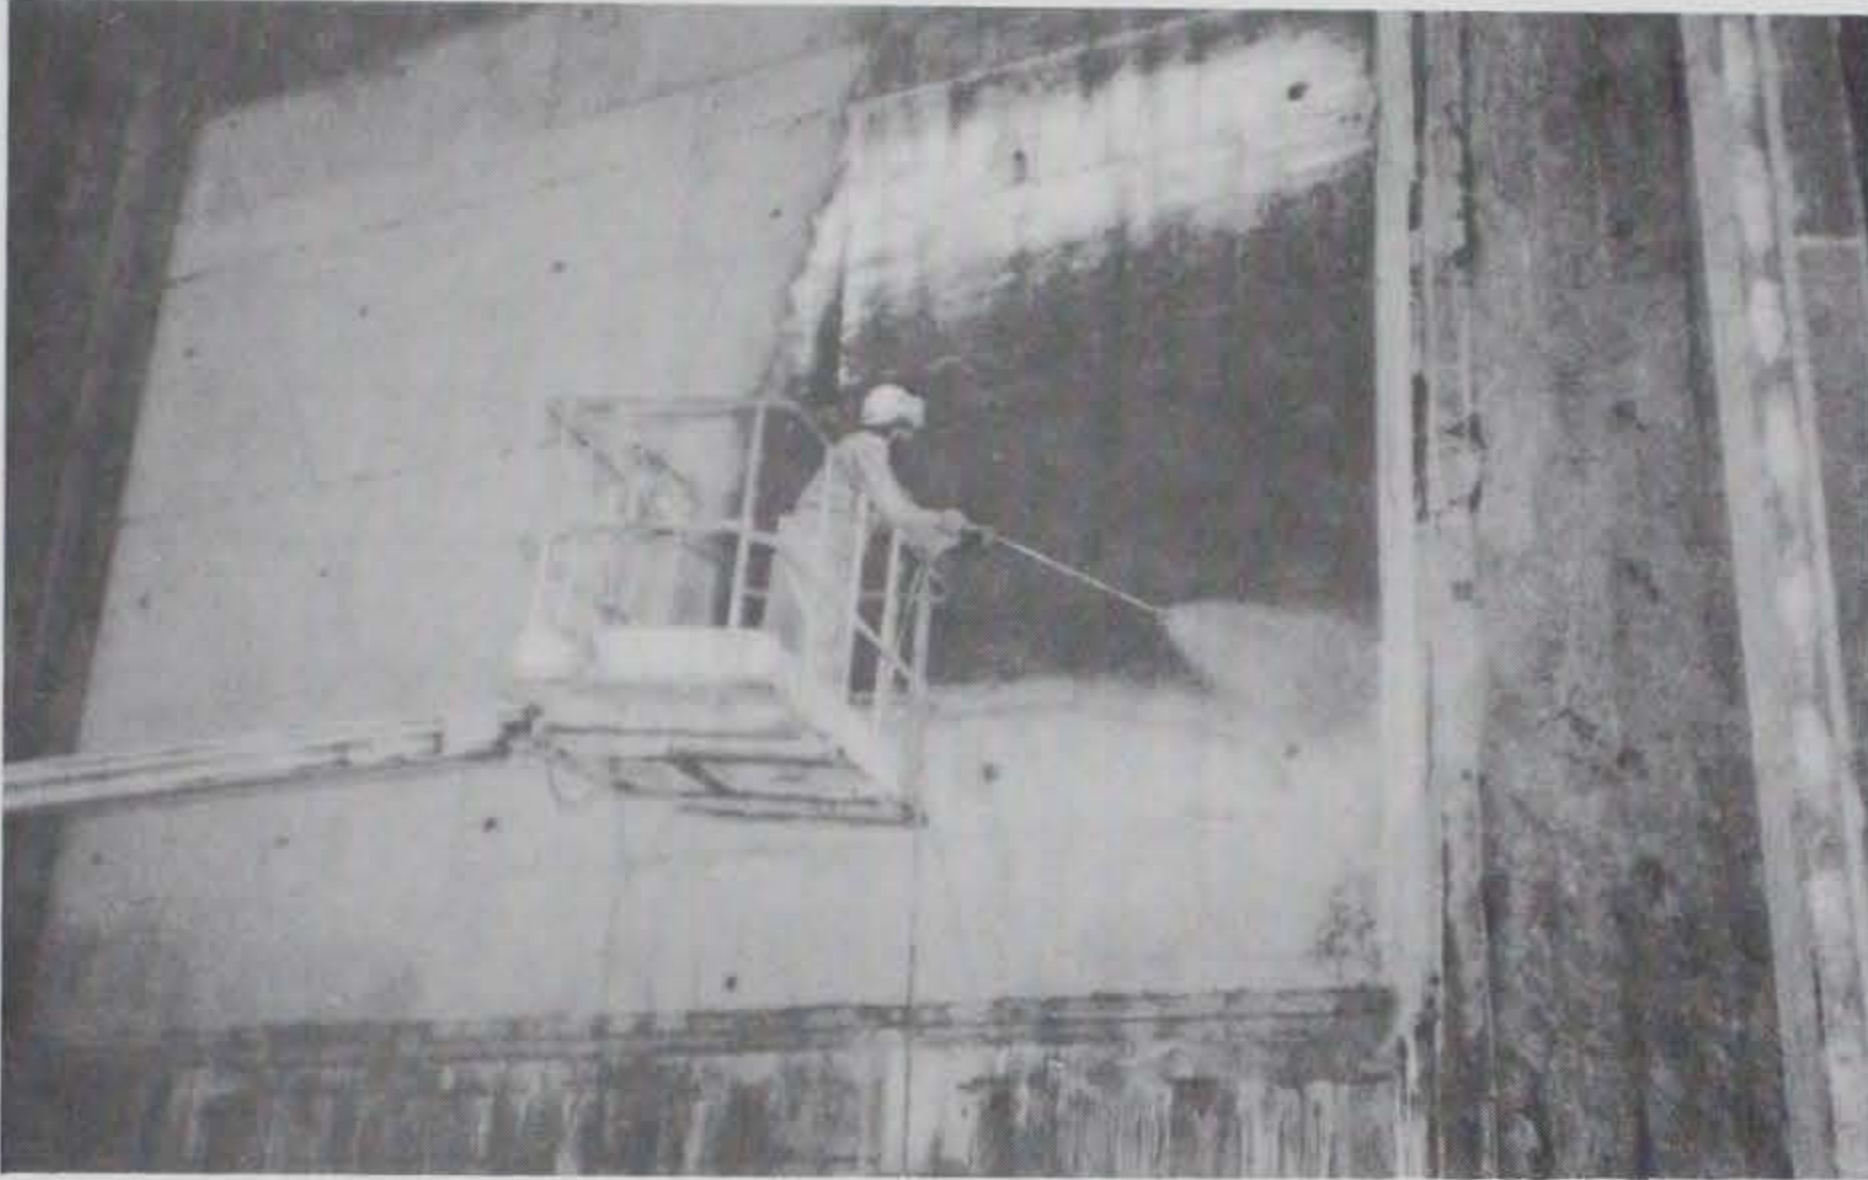
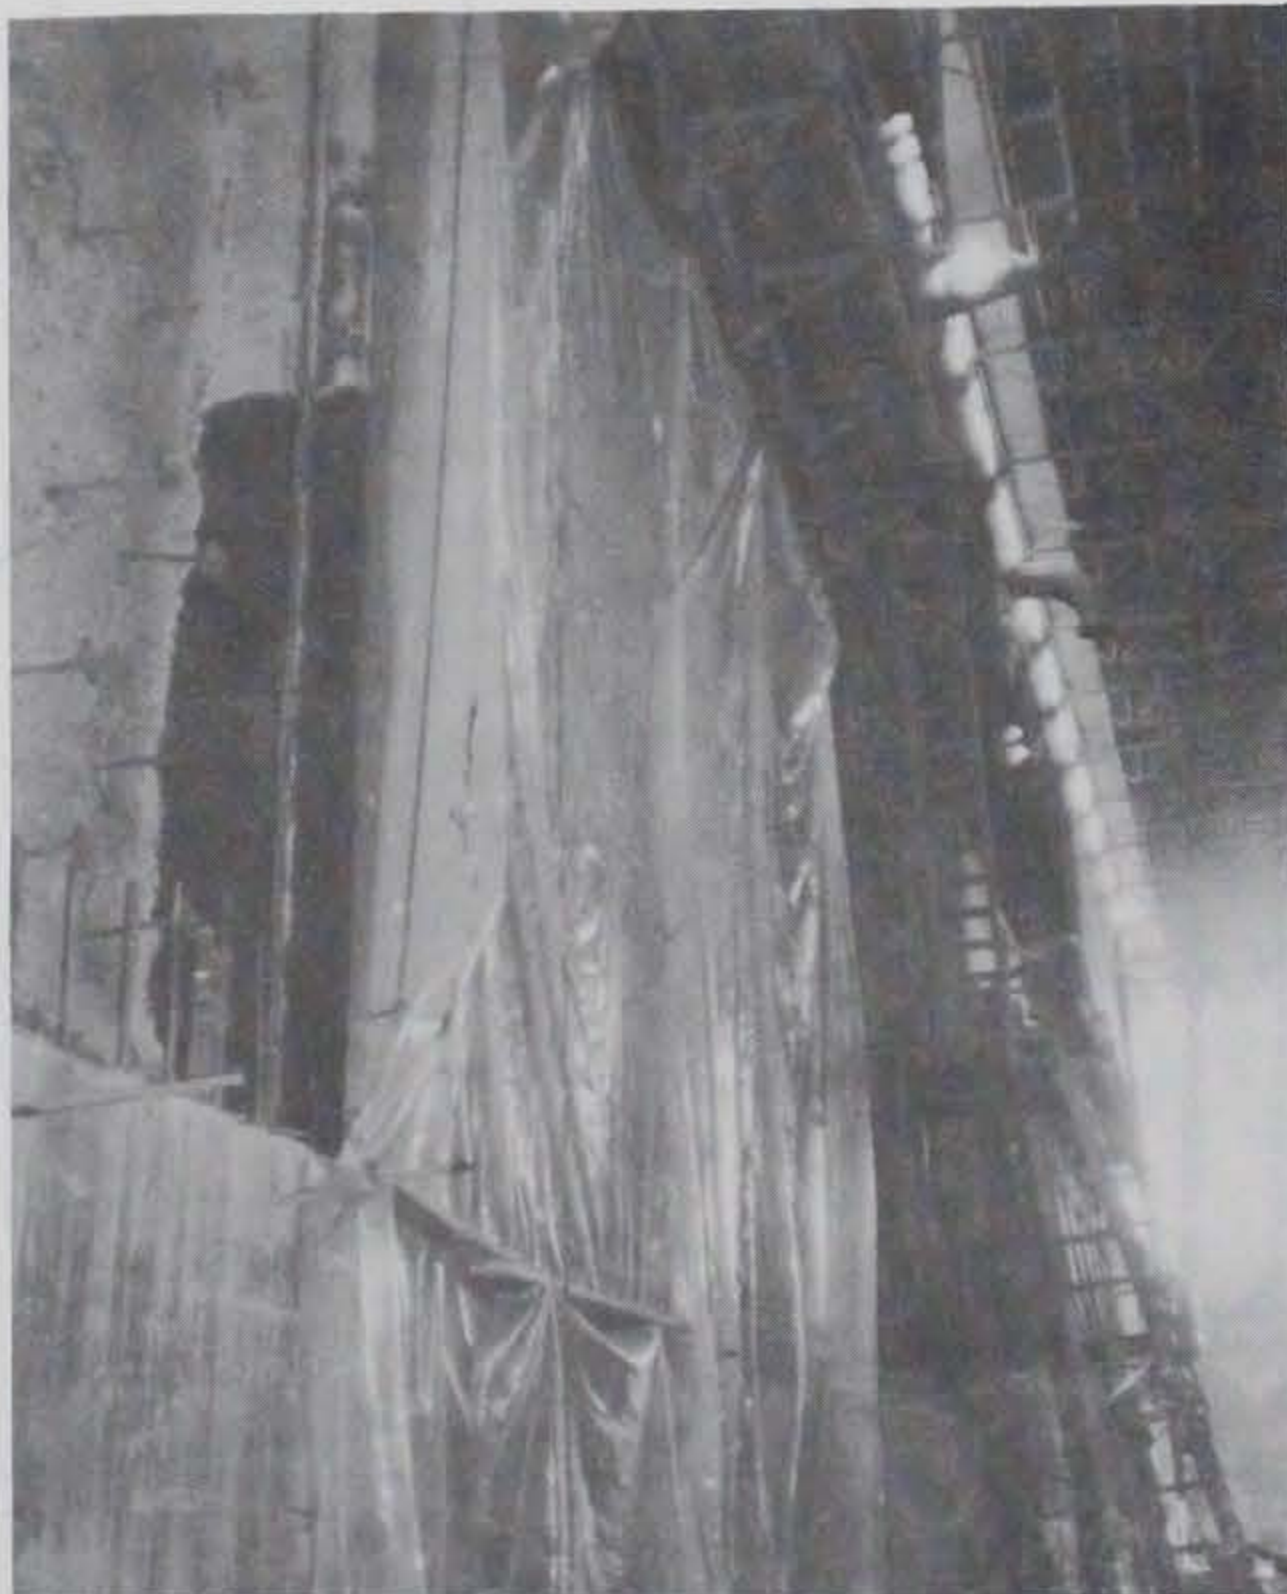
a. Application of curing compound

b. Concrete surface covered with polyethylene

Figure 98. Typical curing of concrete resurfacing, Lock No. 1, Mississippi River

221. After the forms were removed, generally at 1 to 3 days following concrete placement, the contractor had the option of using either moist-curing or a membrane curing compound conforming to CRD-C 300. Membrane curing was used predominantly because of the cold weather conditions. Following application of the curing compound, a polyethylene sheet was draped over the concrete surface for the duration of the curing period (Figure 98).
