TECHNICAL REPORT REMR-CS-13

**REHABILITATION OF NAVIGATION  
LOCK WALLS: CASE HISTORIES**

James E. McDonald

December 1987

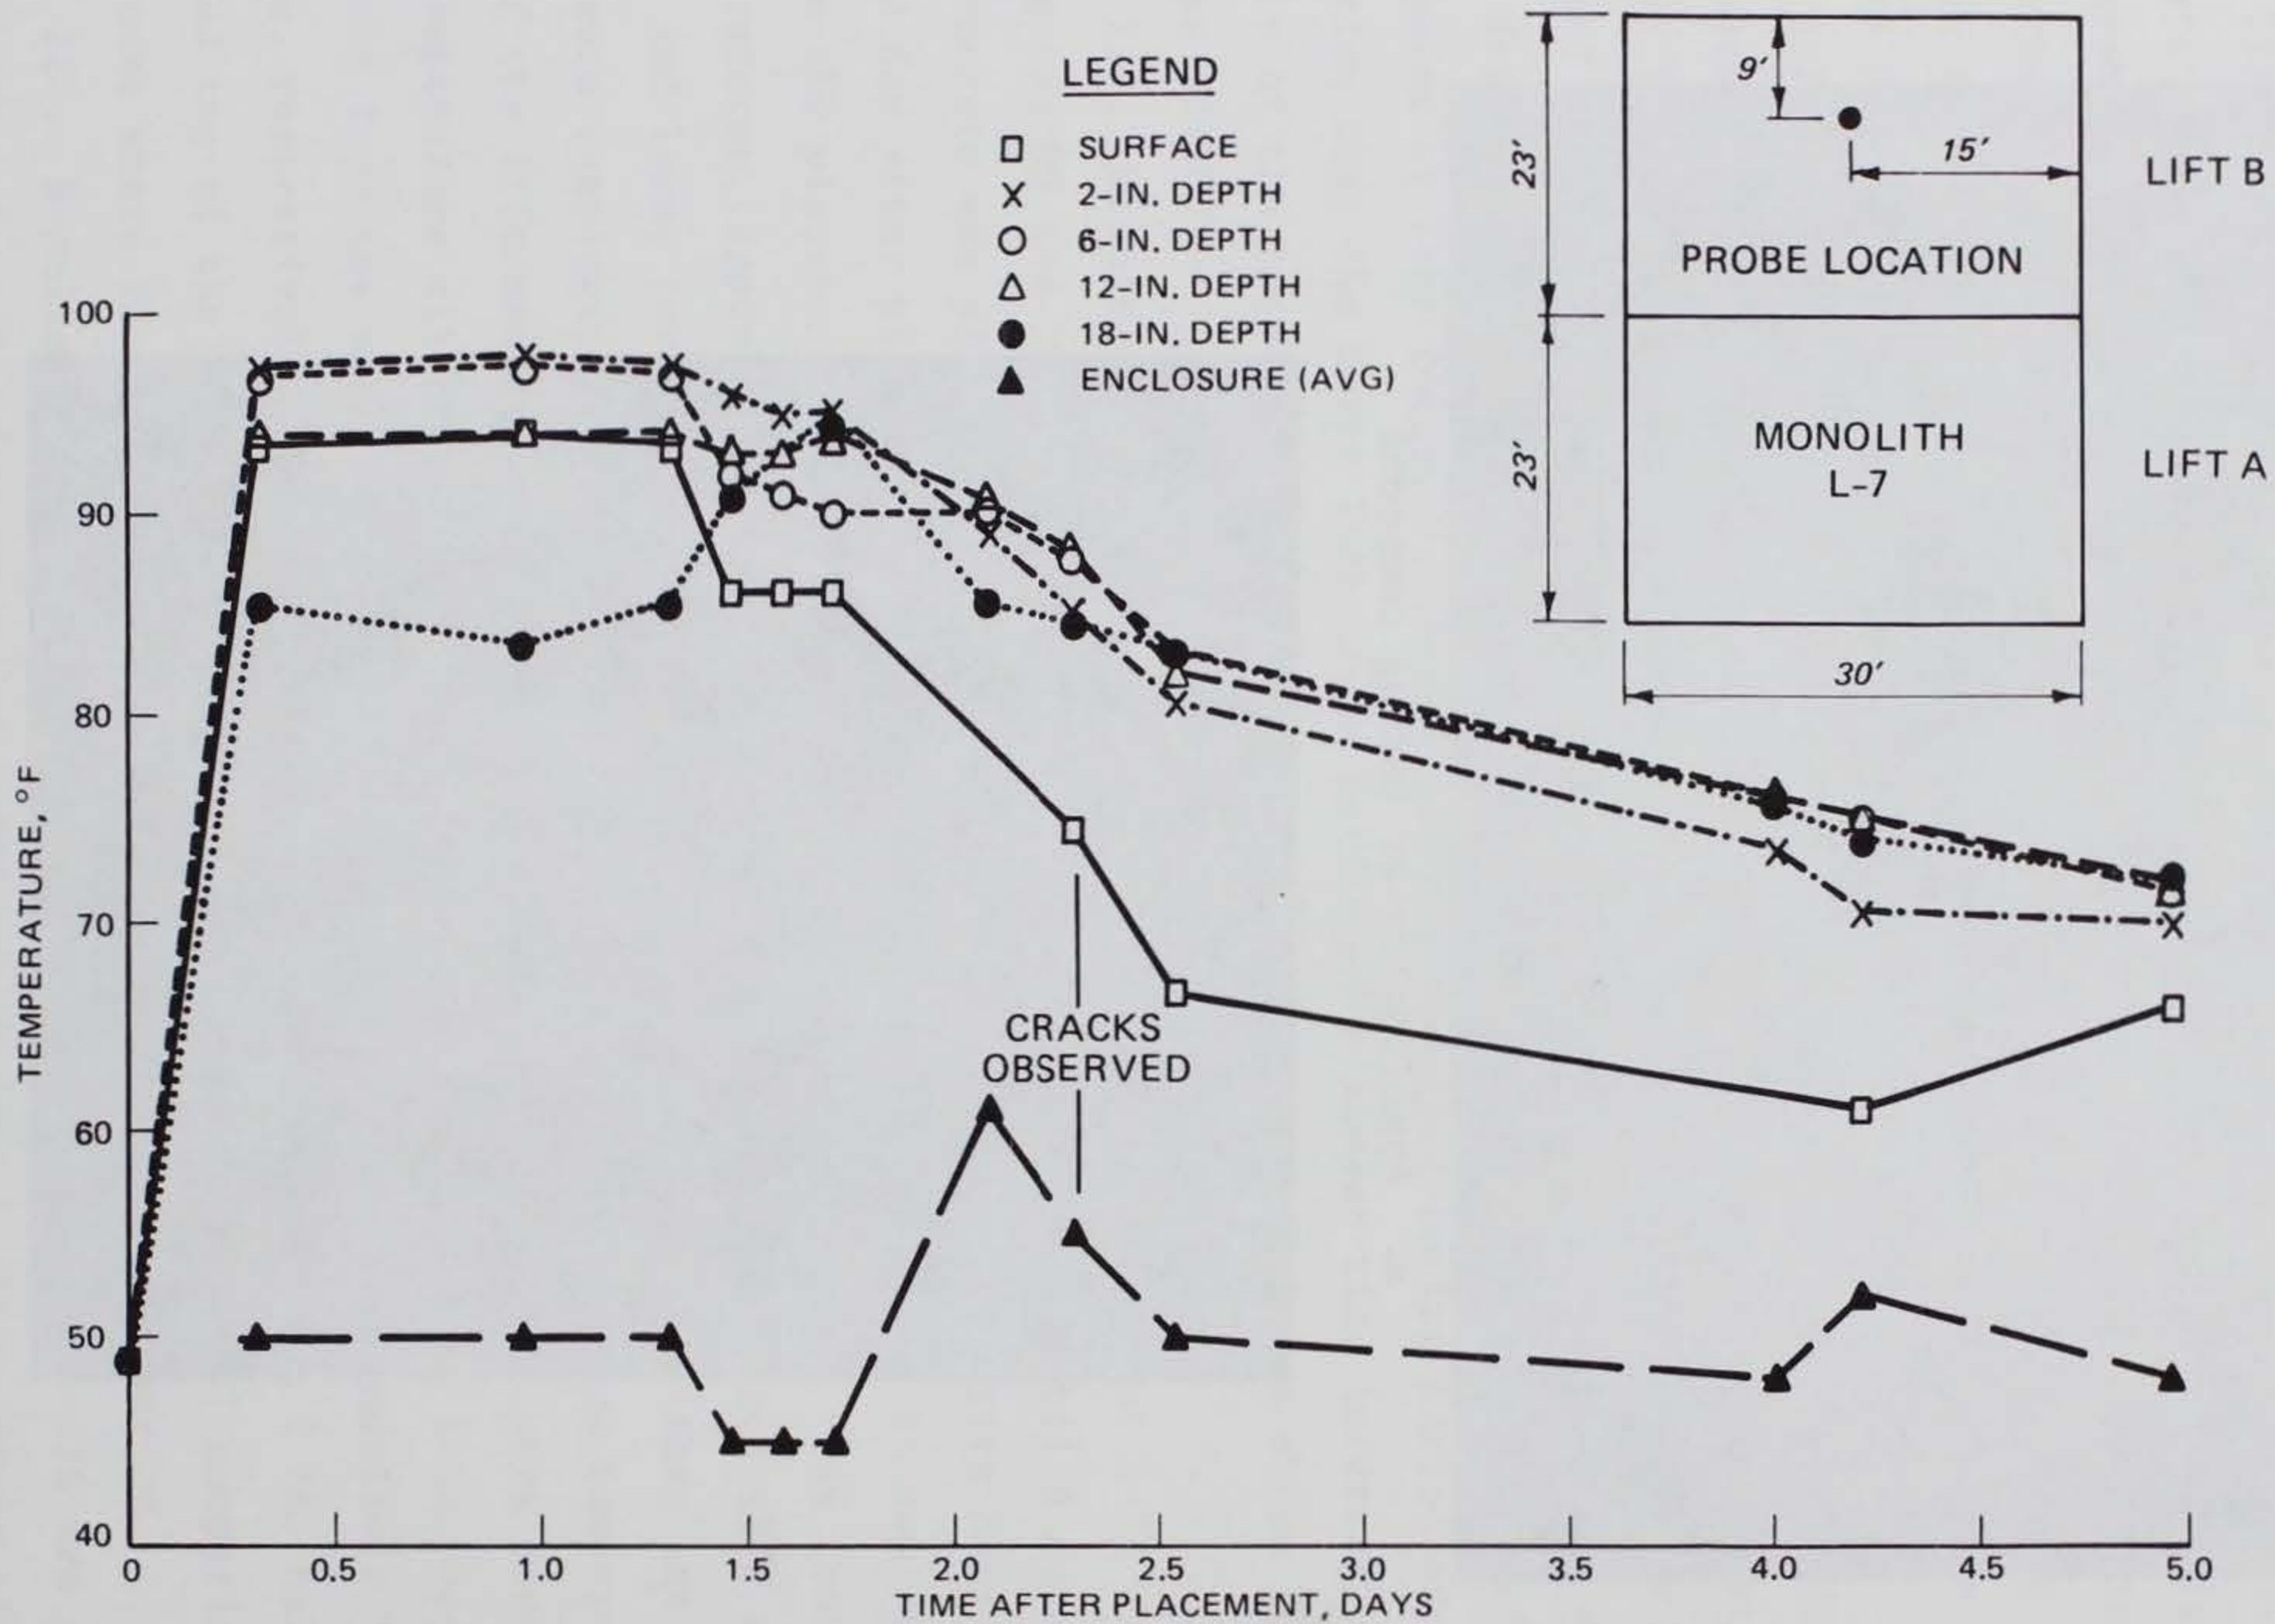
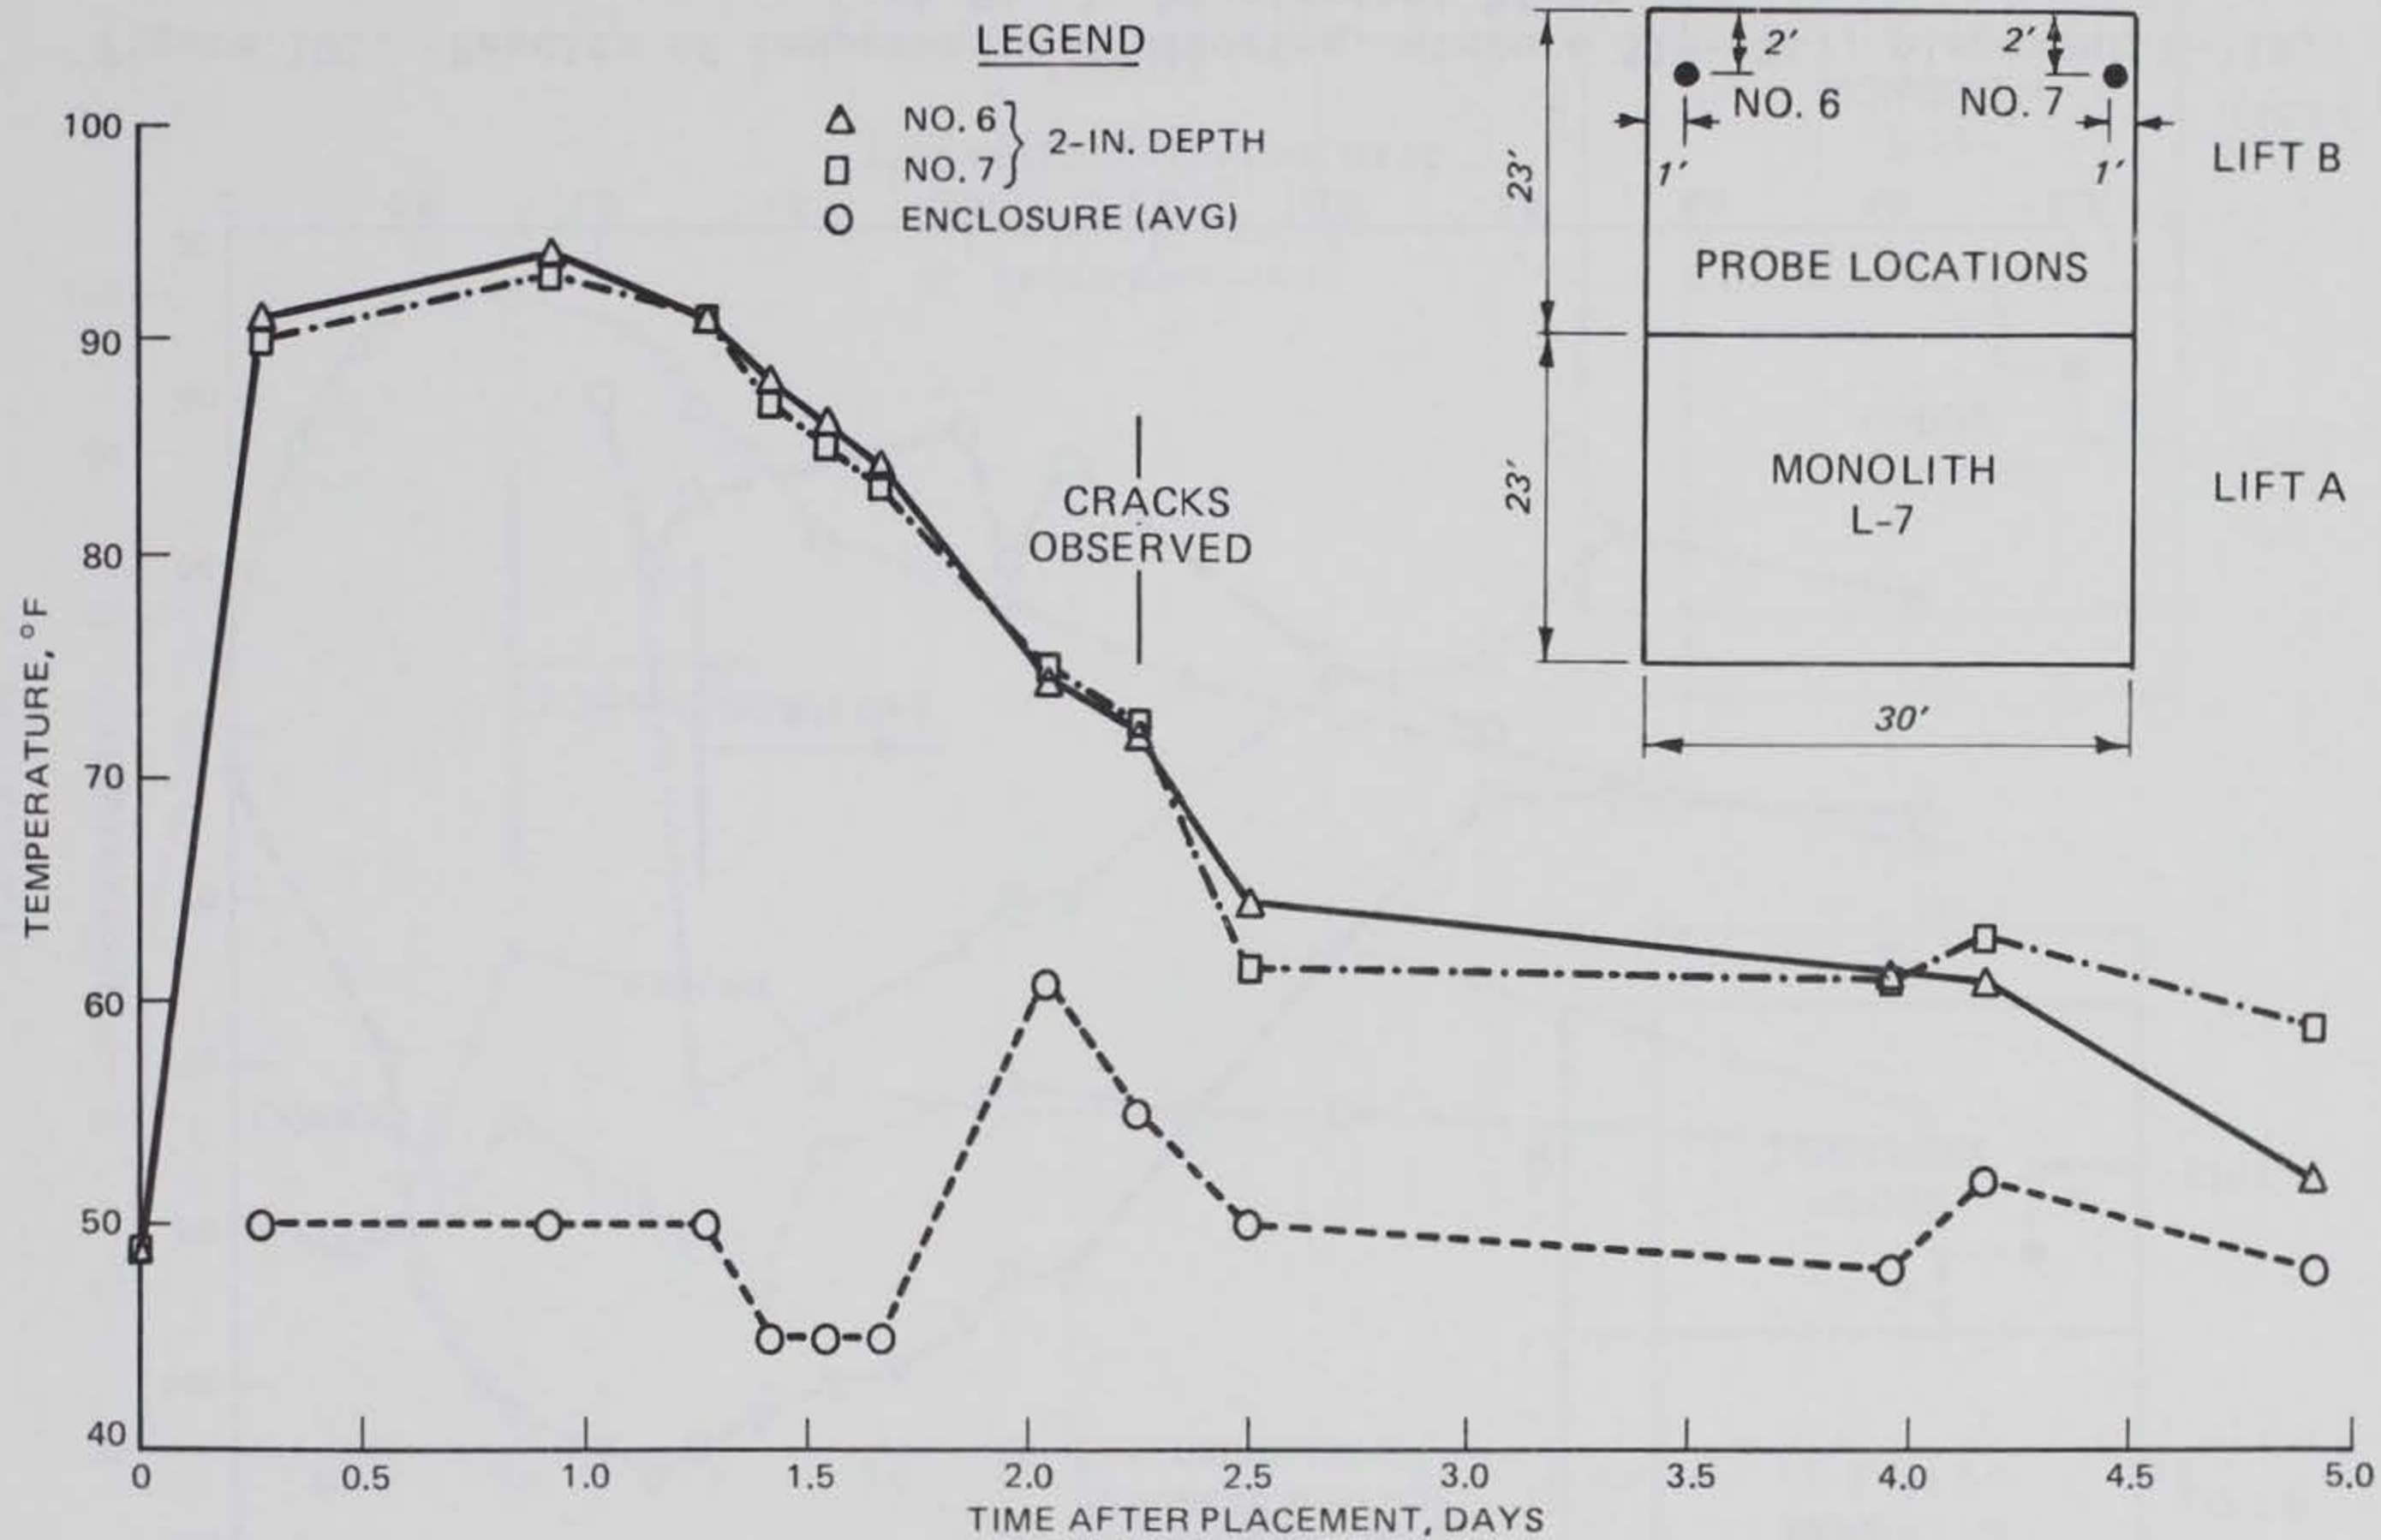
223. Results of the temperature monitoring of placement L-7B are shown in Figures 99 and 100. Although the form was not removed until 6 days after the concrete was placed, cracks were observed on top of the lift during the second day after placement. Temperature probes were located at two levels within the placement, 2 and 9 ft below the top of the lift. Peak concrete temperatures, approximately 24 hr after placement, were 95° and 98°F for the upper and lower levels, respectively, or 45° and 48°F higher than the average enclosure temperature. At the same time, the concrete surface temperature on top of the lift was reported to be 68°F. At the time cracks were observed, the temperature differential between ambient and concrete at 2-in. depth as measured from the wall face was 17° and 30°F for the upper and lower level probes, respectively. However, a temperature probe embedded 2 in. below the exposed top of the lift would have provided a more meaningful comparison in this case where the form was left in place for an extended period.

Figure 99. Results of temperature monitoring, mixture 510-4PA5, placement L-7B, 9 ft below top of lift B, Lock No. 1, Mississippi River

Figure 100. Results of temperature monitoring, mixture 510-4PA5, placement L-7B, 2 ft below top of lift B, Lock No. 1, Mississippi River

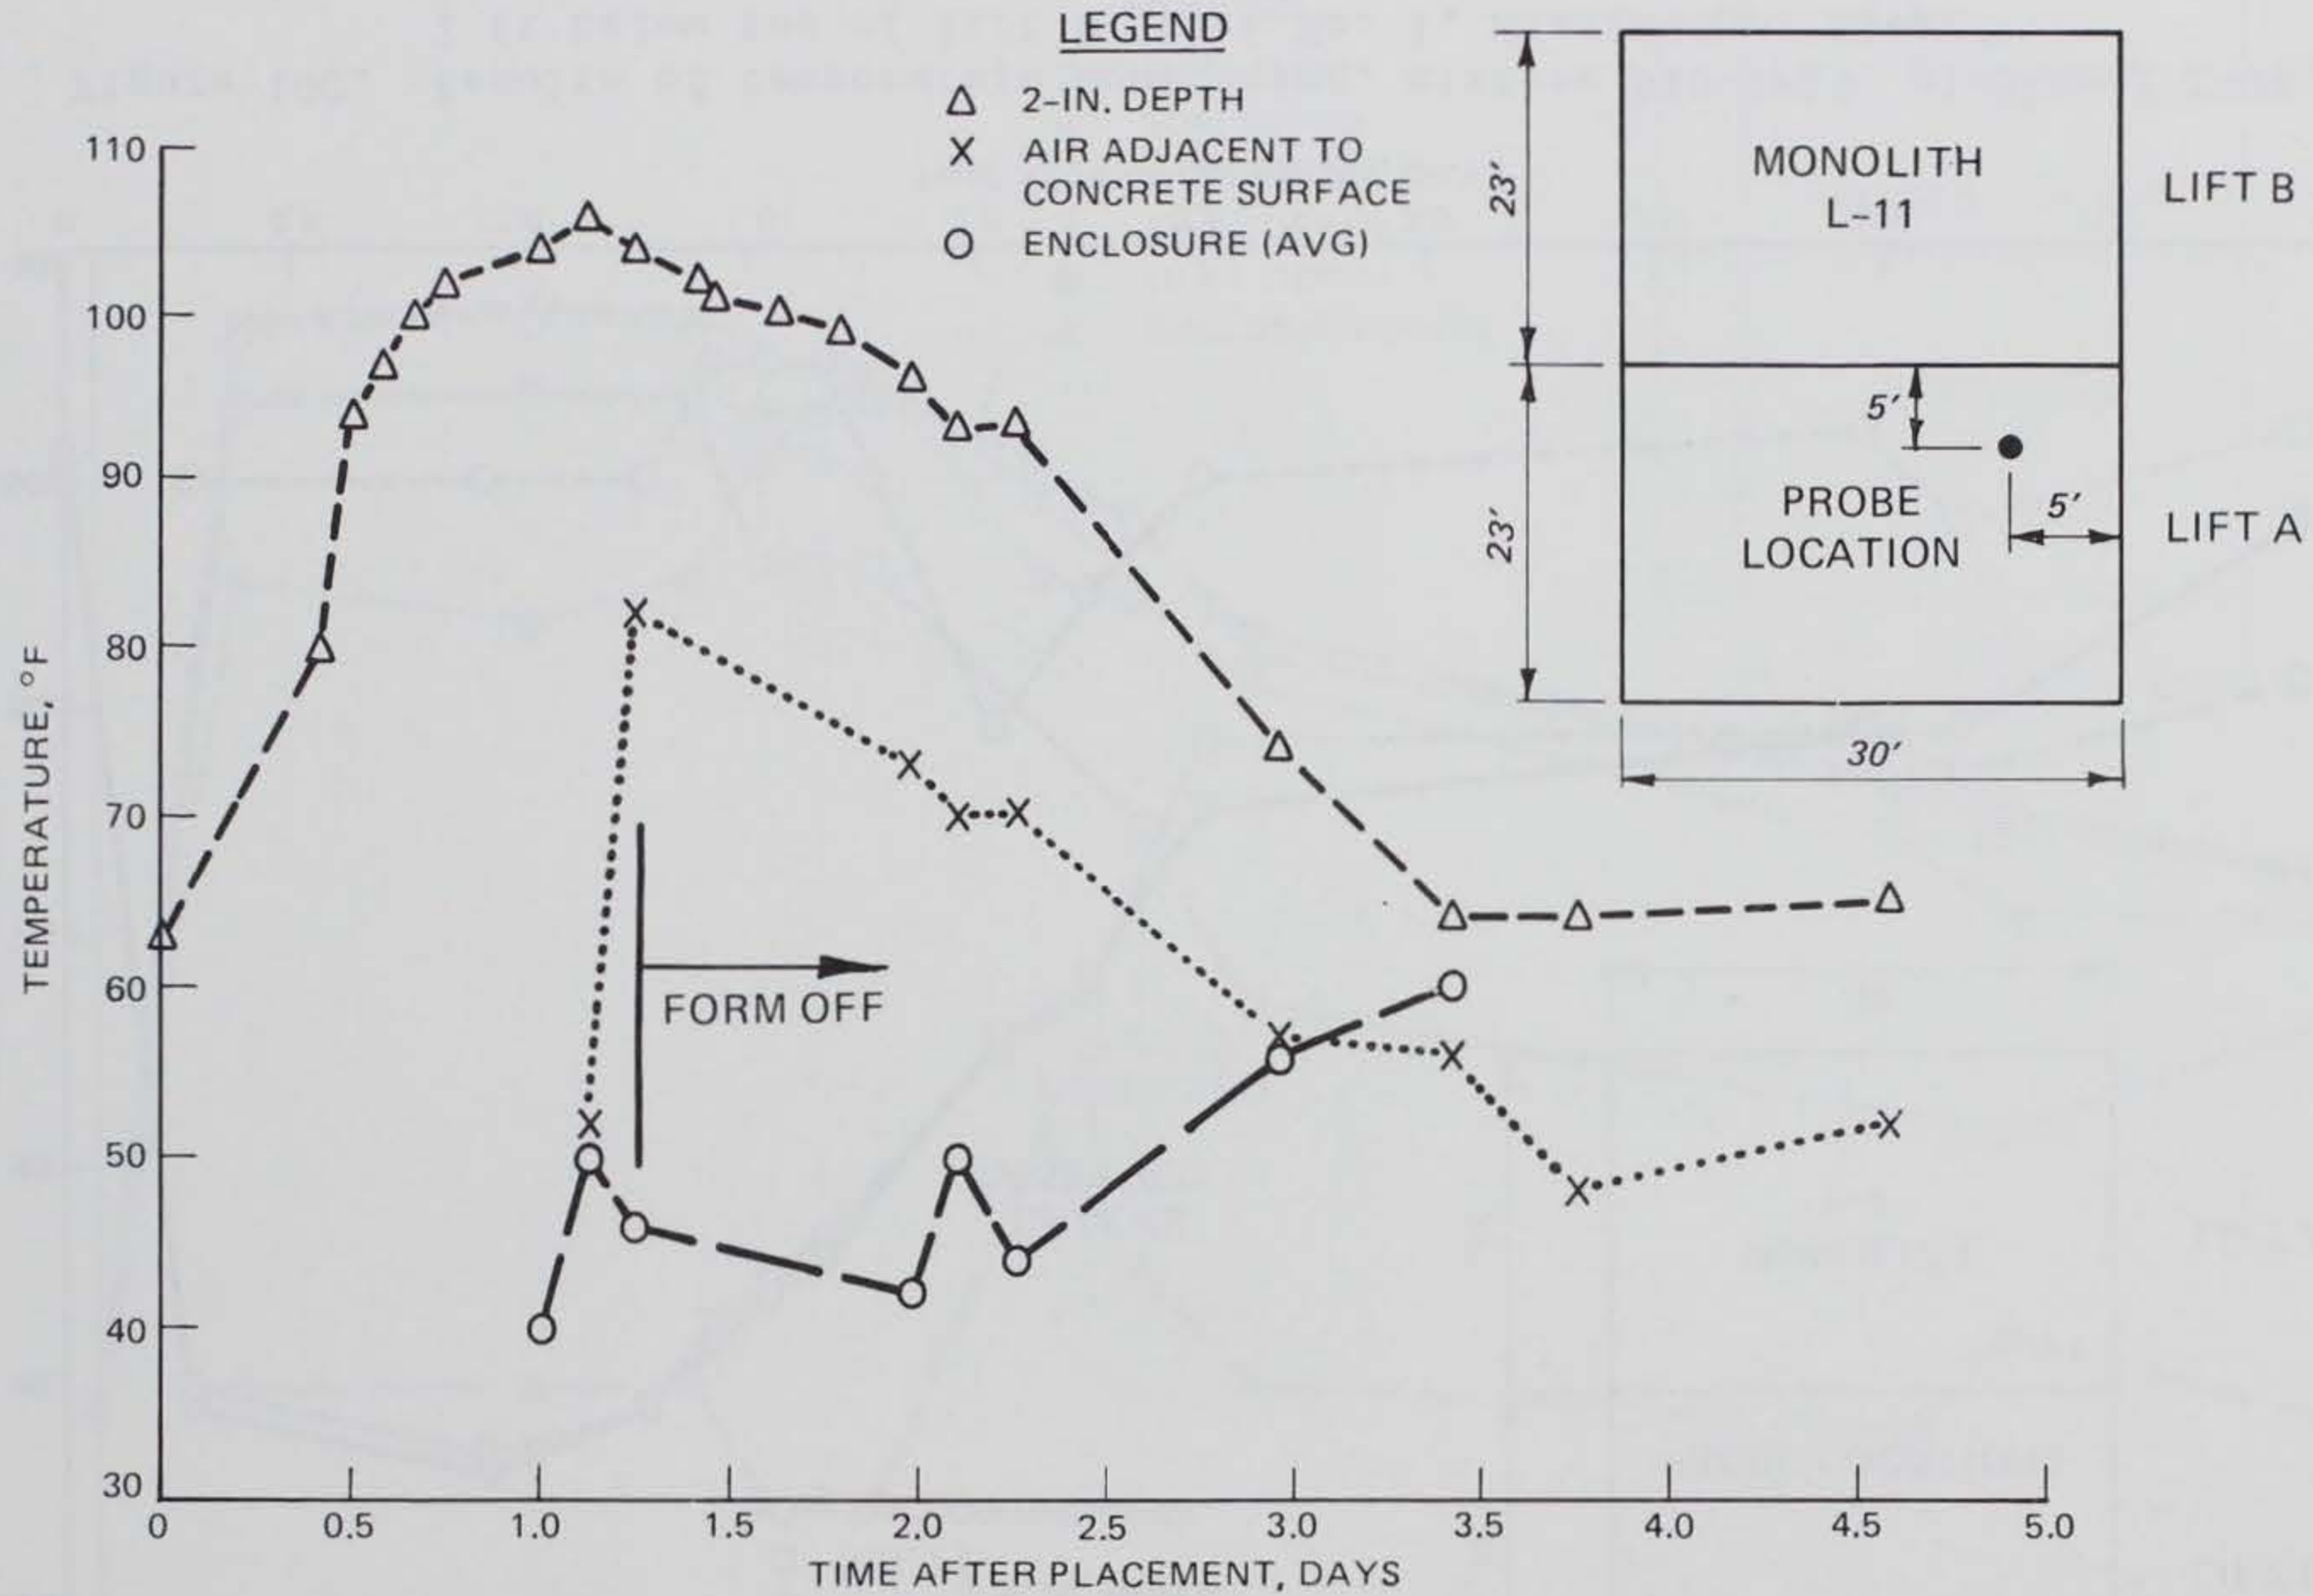
224. Results of temperature monitoring of placement L-11A are shown in Figure 101. A peak temperature of 106°F was recorded, 27 hr after placement, which represents a heat rise of 43°F. The form was removed at this point subjecting the concrete to a temperature differential between ambient and 2-in. depth of 56°F. Covering the concrete surface with polyethylene quickly

Figure 101. Results of temperature monitoring, mixture 510-4PA5, placement L-11A, Lock No. 1, Mississippi River

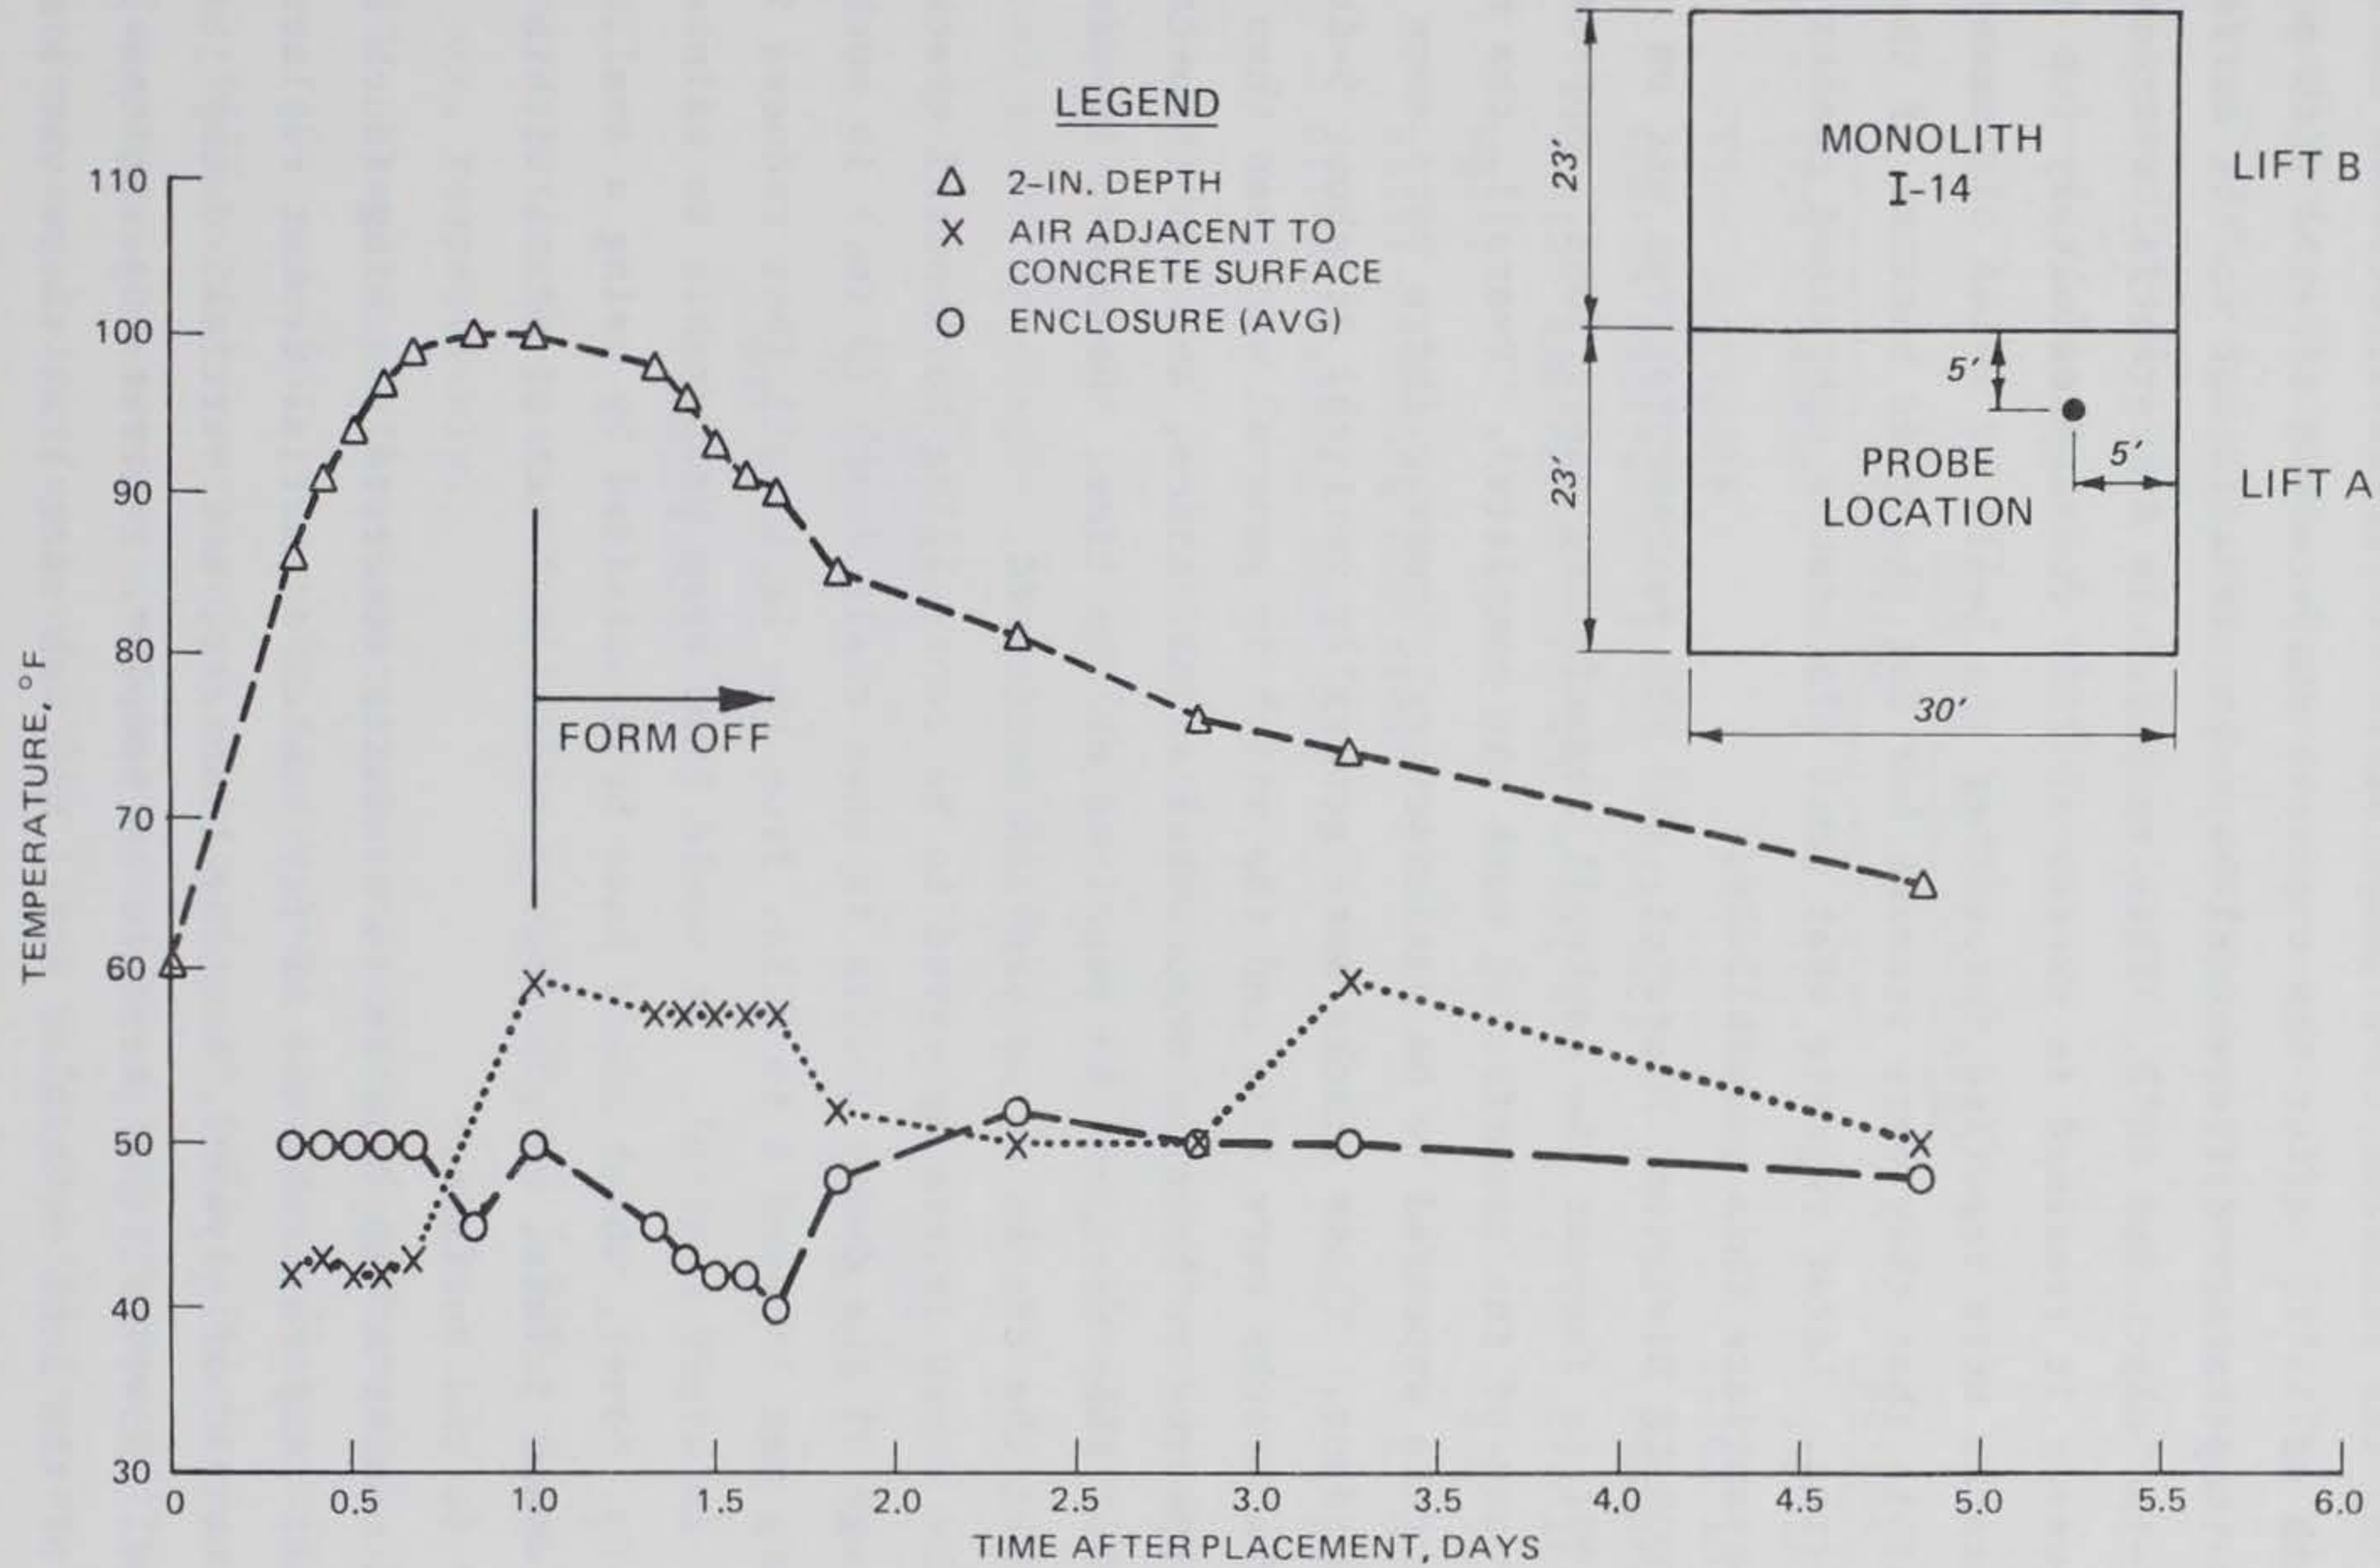
Figure 102. Results of temperature monitoring, mixture 510-4PA5, placement I-14A, Lock No. 1, Mississippi River

reduced the temperature differential between air adjacent to the surface and at 2-in. depth inside the concrete to 22°F. Similar results were obtained for placement I-14A (Figure 102). The form was removed one day following placement, subjecting the concrete to a temperature differential between ambient and 2-in. depth of 55°F. After the concrete surface was covered with polyethylene, the temperature differential between air adjacent to the surface and concrete at 2-in. depth was 40°F. This temperature differential decreased with time; however it remained in excess of 25°F for approximately two days. Although no cracks were reported for either the L-11A or I-14A placements, it is quite possible that they were present but not observed because of the polyethylene covering. Later reports that most placements contained cracks would appear to substantiate this possibility.
