TECHNICAL REPORT REMR-CS-13

**REHABILITATION OF NAVIGATION  
LOCK WALLS: CASE HISTORIES**

James E. McDonald

December 1987

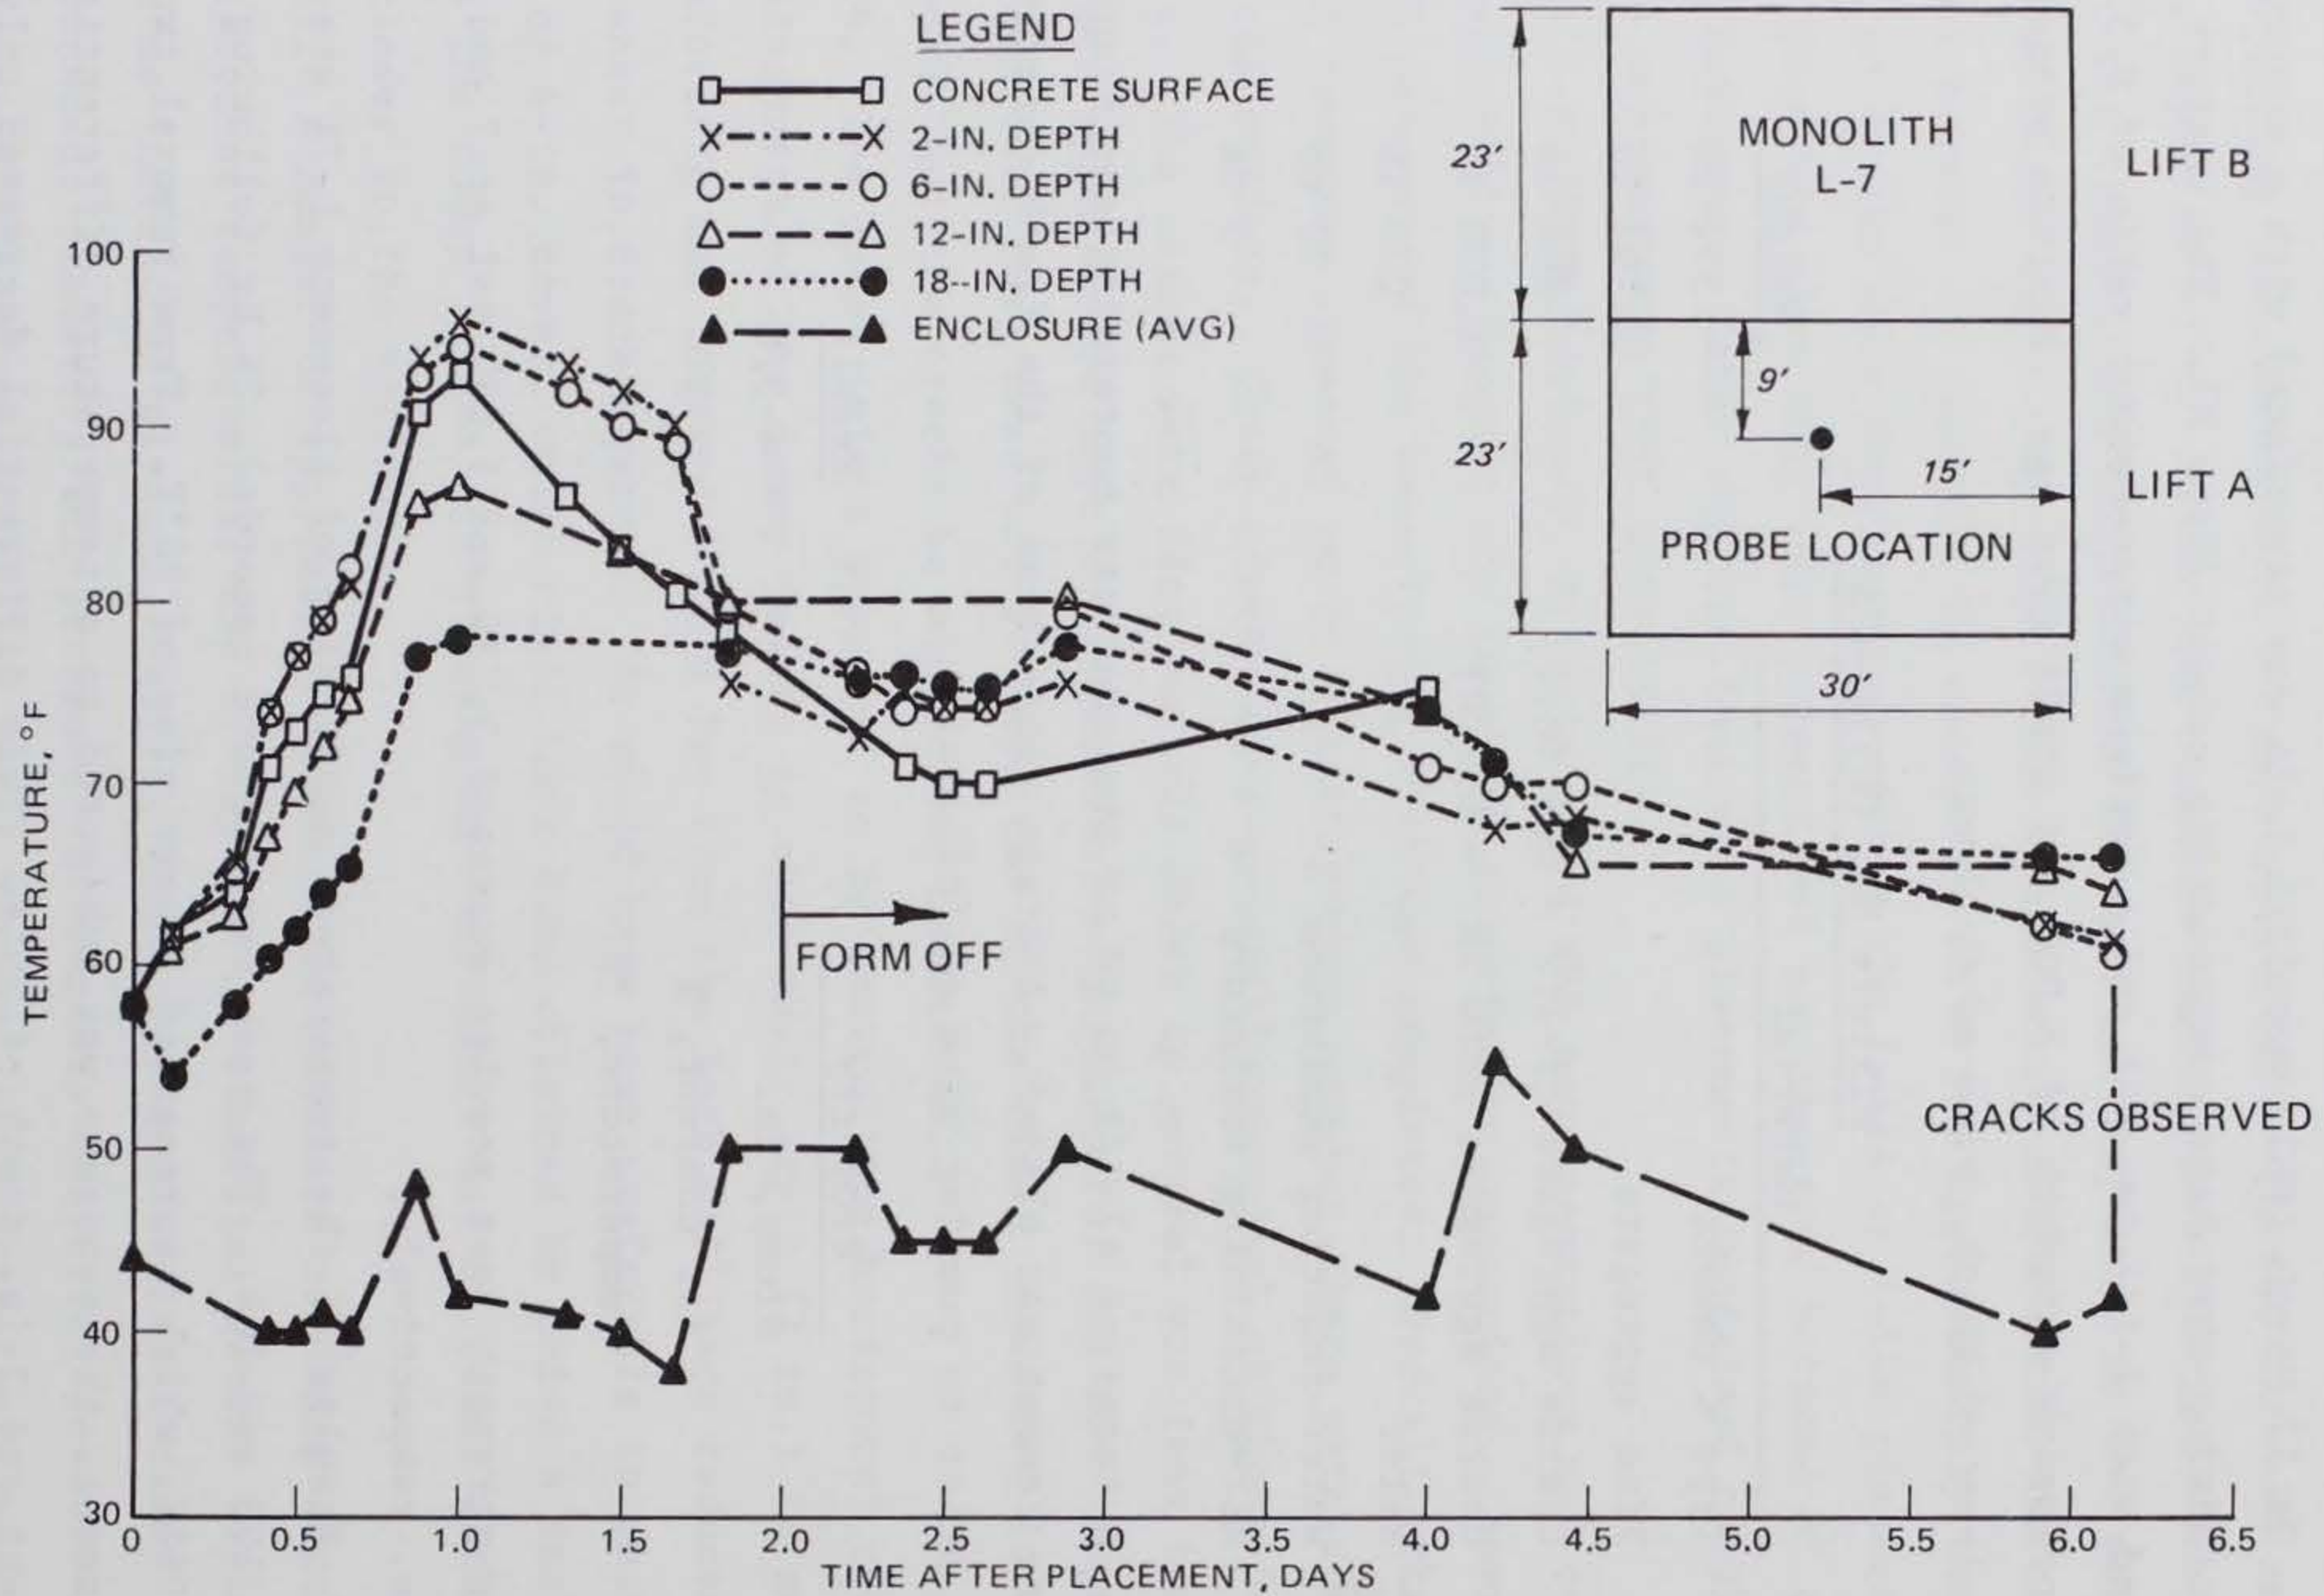
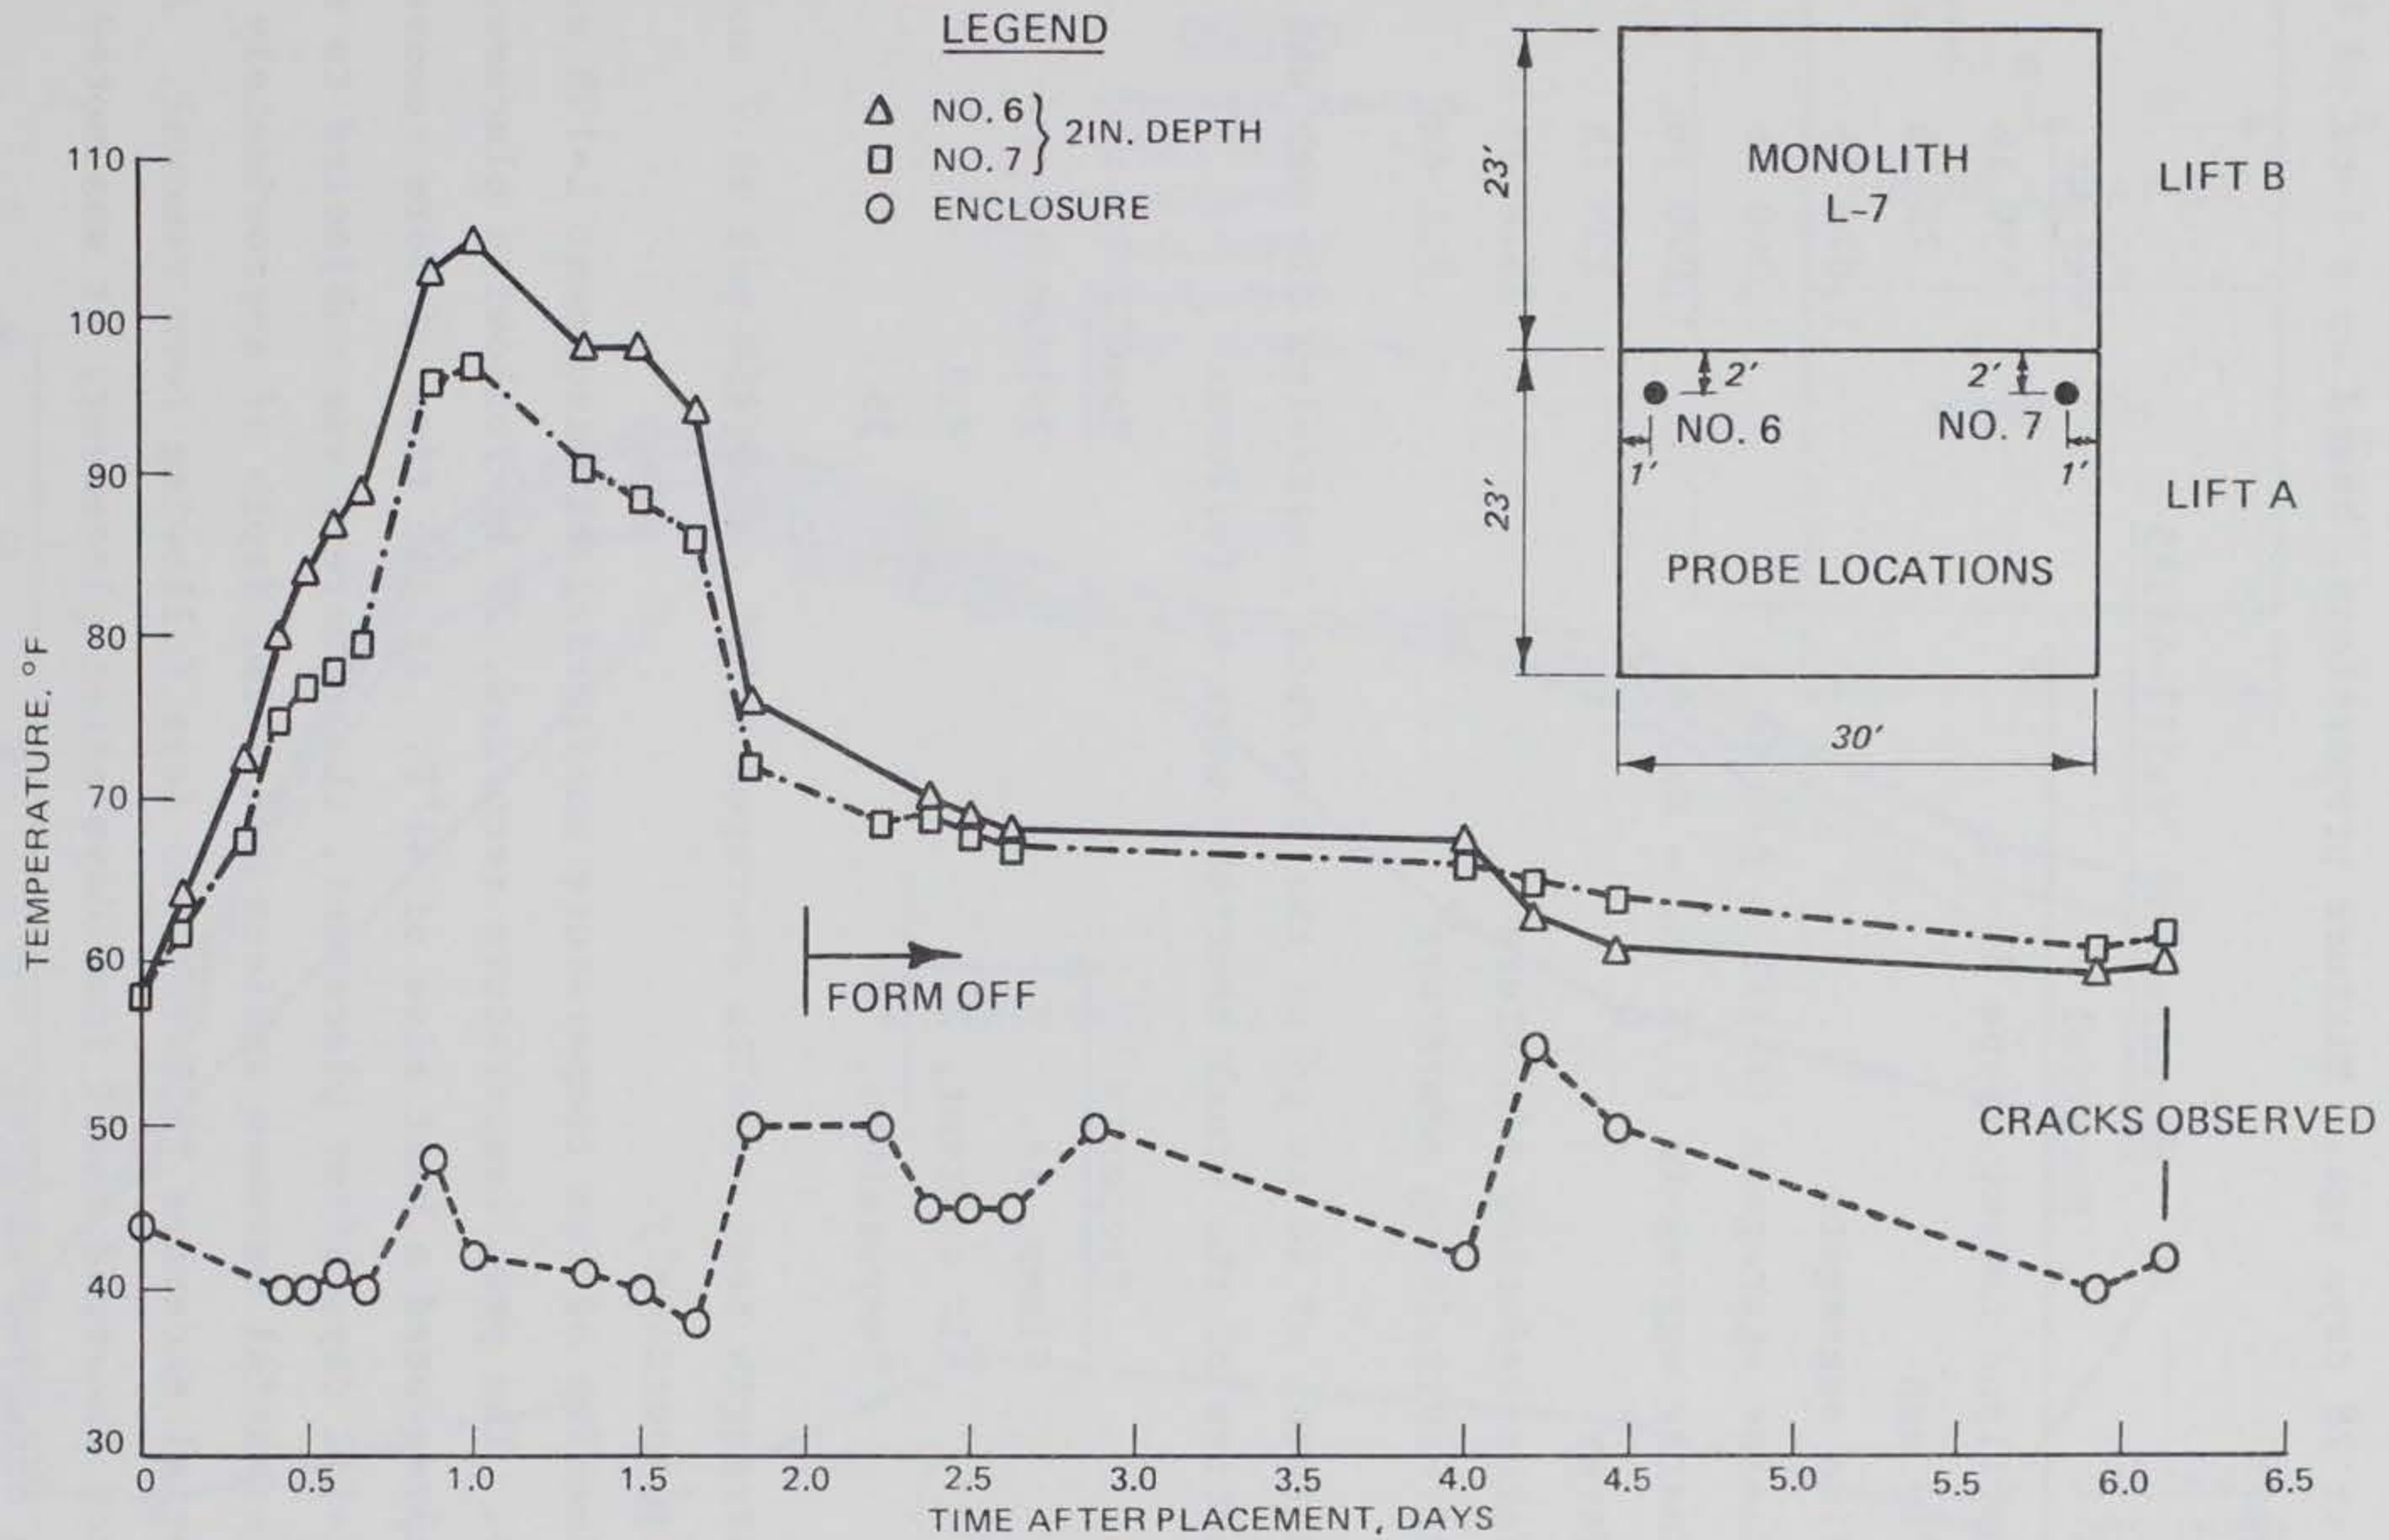
230. Results of the temperature monitoring of placement L-7A are shown in Figures 103 and 104. The peak temperature recorded, 24 hr following placement, was 96°F, which represented a heat rise of 38°F. From removal two days after placement, the concrete was subjected to a temperature differential between ambient and 2-in. depth of 25°F. This differential decreased only slightly during the remainder of the curing period. Cracking similar to that previously observed in the conventional concrete resurfacing was reported. The cracks were not observed until the end of the curing period.

Figure 103. Results of temperature monitoring, mixture CC552-4PA5, placement L-7A, 9 ft below top of lift A, Lock No. 1, Mississippi River

Figure 104. Results of temperature monitoring, mixture CC552-4PA5, placement L-7A, 2 ft below top of lift A, Lock No. 1, Mississippi River

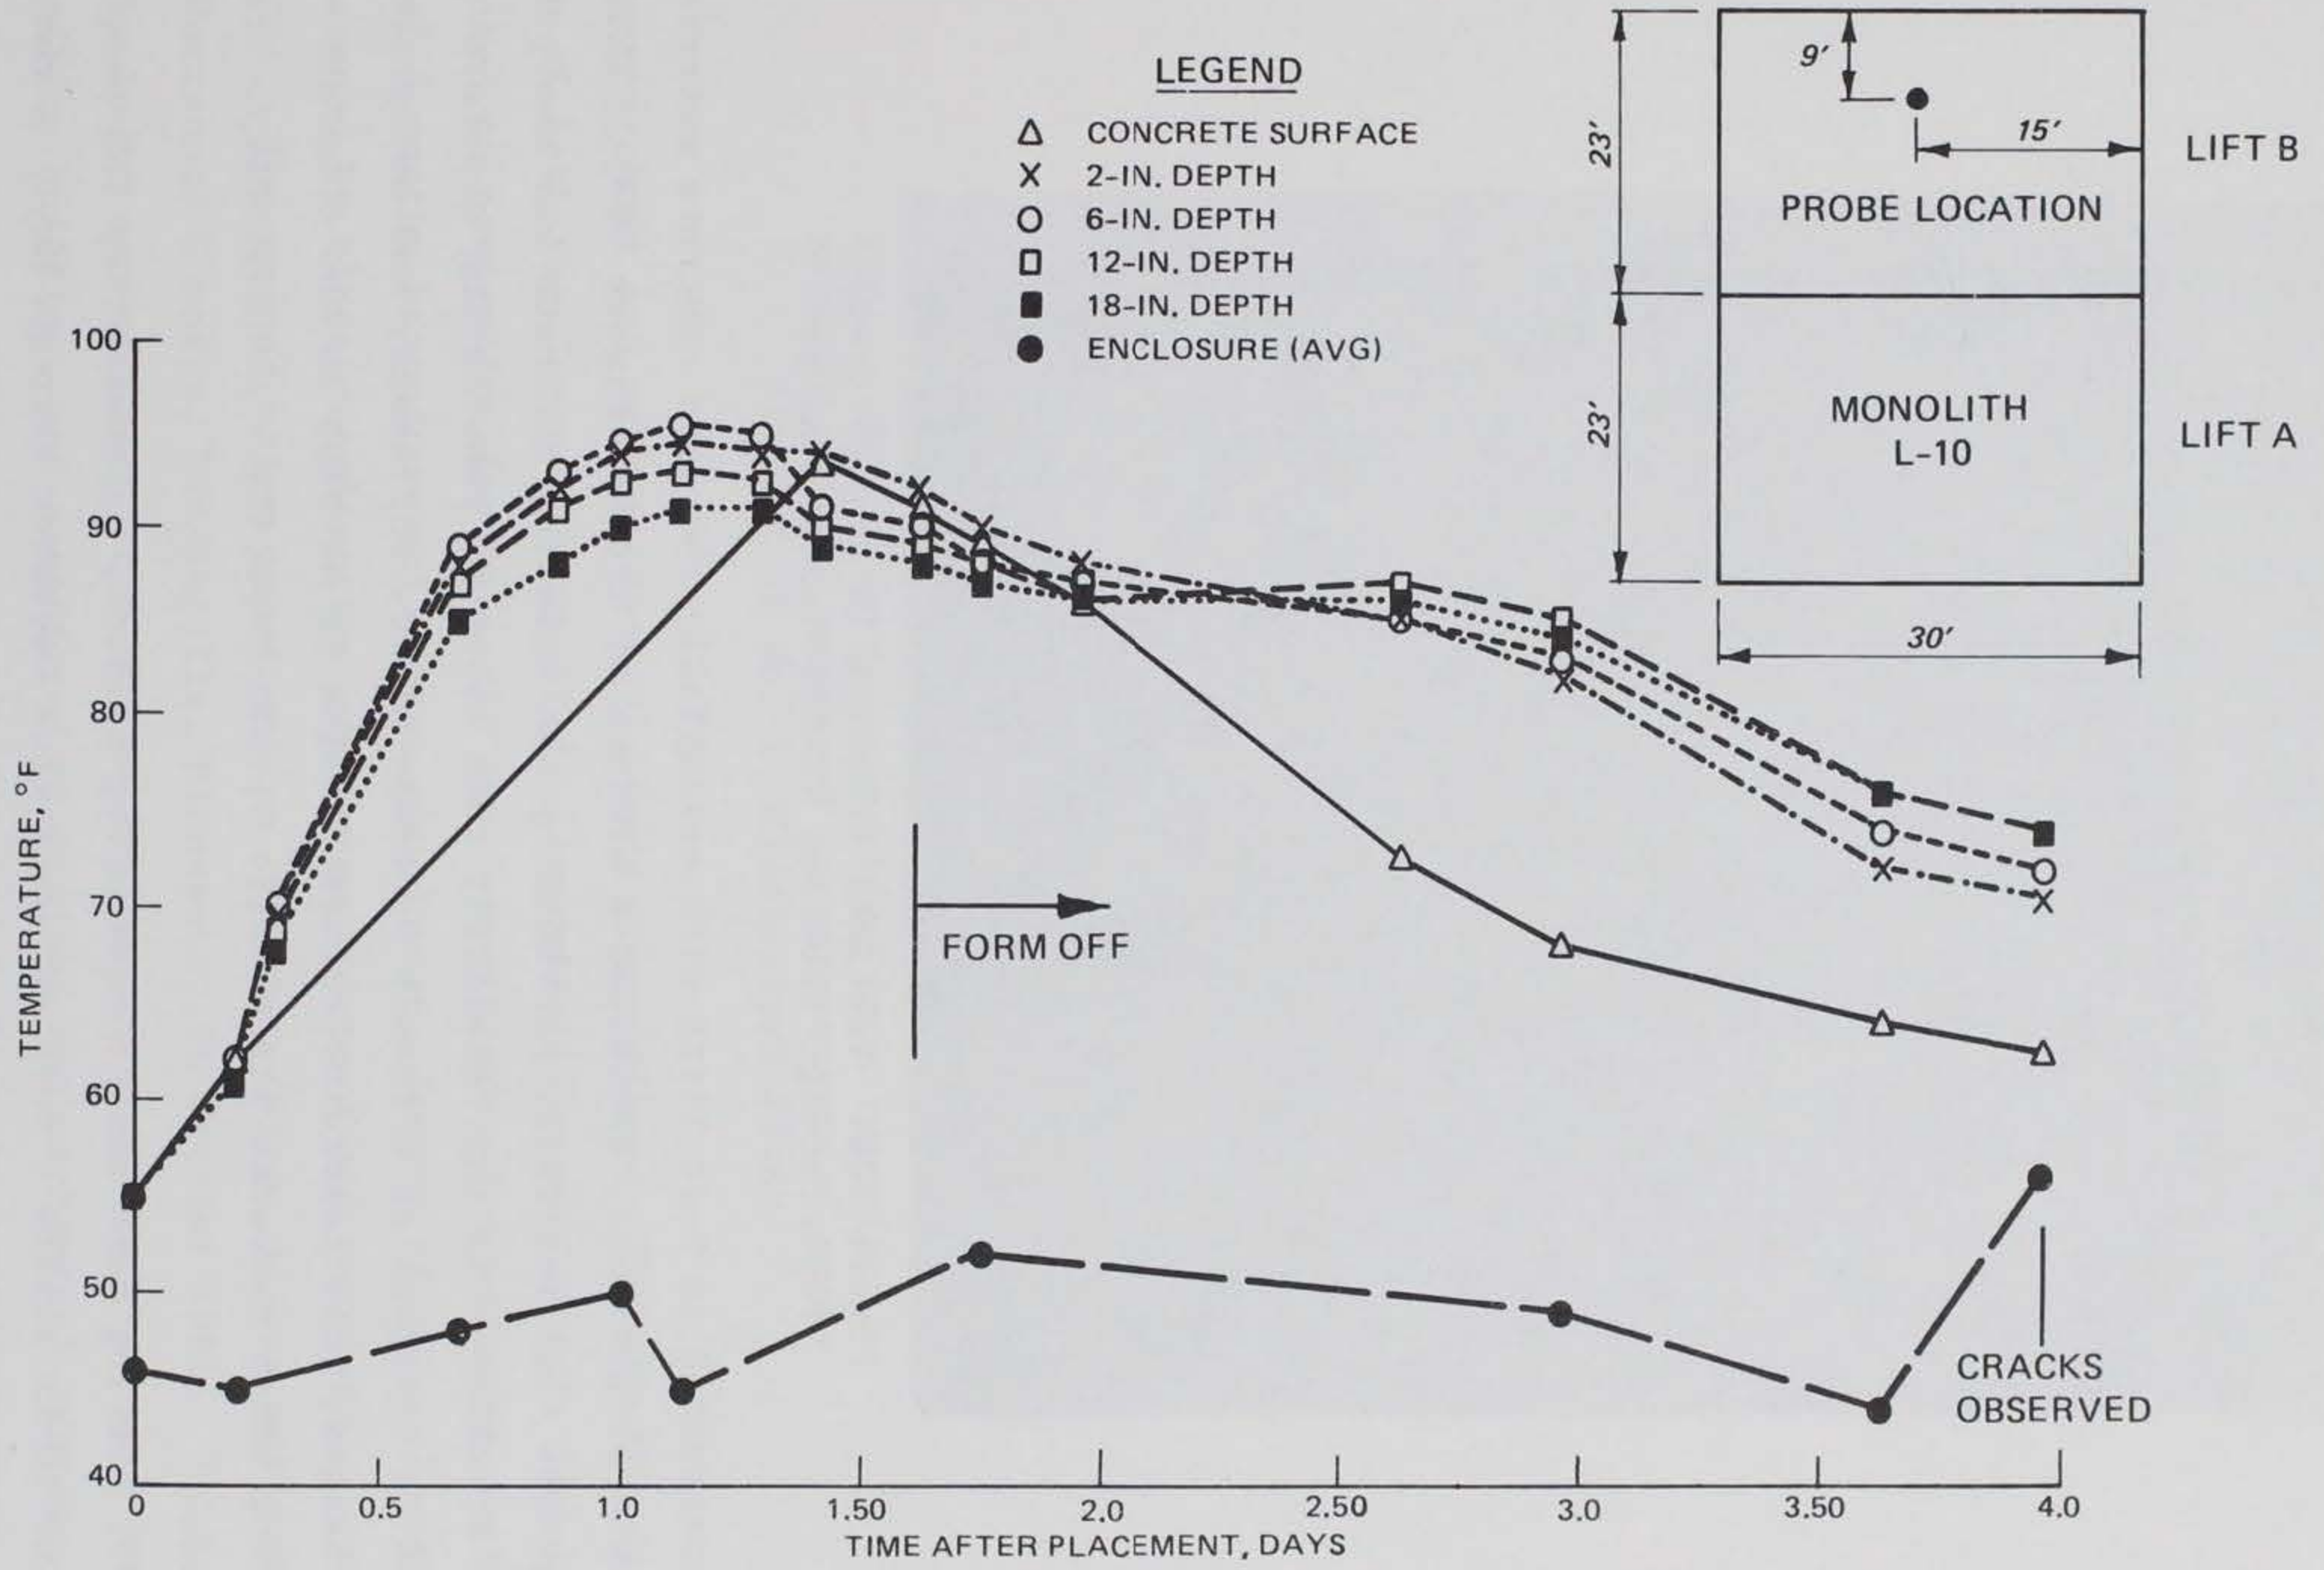
233. Results of the temperature monitoring of placement L-10B are shown in Figure 105. The peak temperature recorded, 27 hr following placement, was 96°F which represented a heat rise of 41°F. At the time of form removal, approximately 1-1/2 days after placement, the concrete was subjected to a temperature differential between ambient and 2-in. depth of approximately 40°F. This differential exceeded 25°F for two days following form removal. Although cracks were not observed until four days after placement, it was noted that they may have occurred earlier.

Figure 105. Results of temperature monitoring, mixture 78x517-4P5A5, placement L-10B, Lock No. 1, Mississippi River

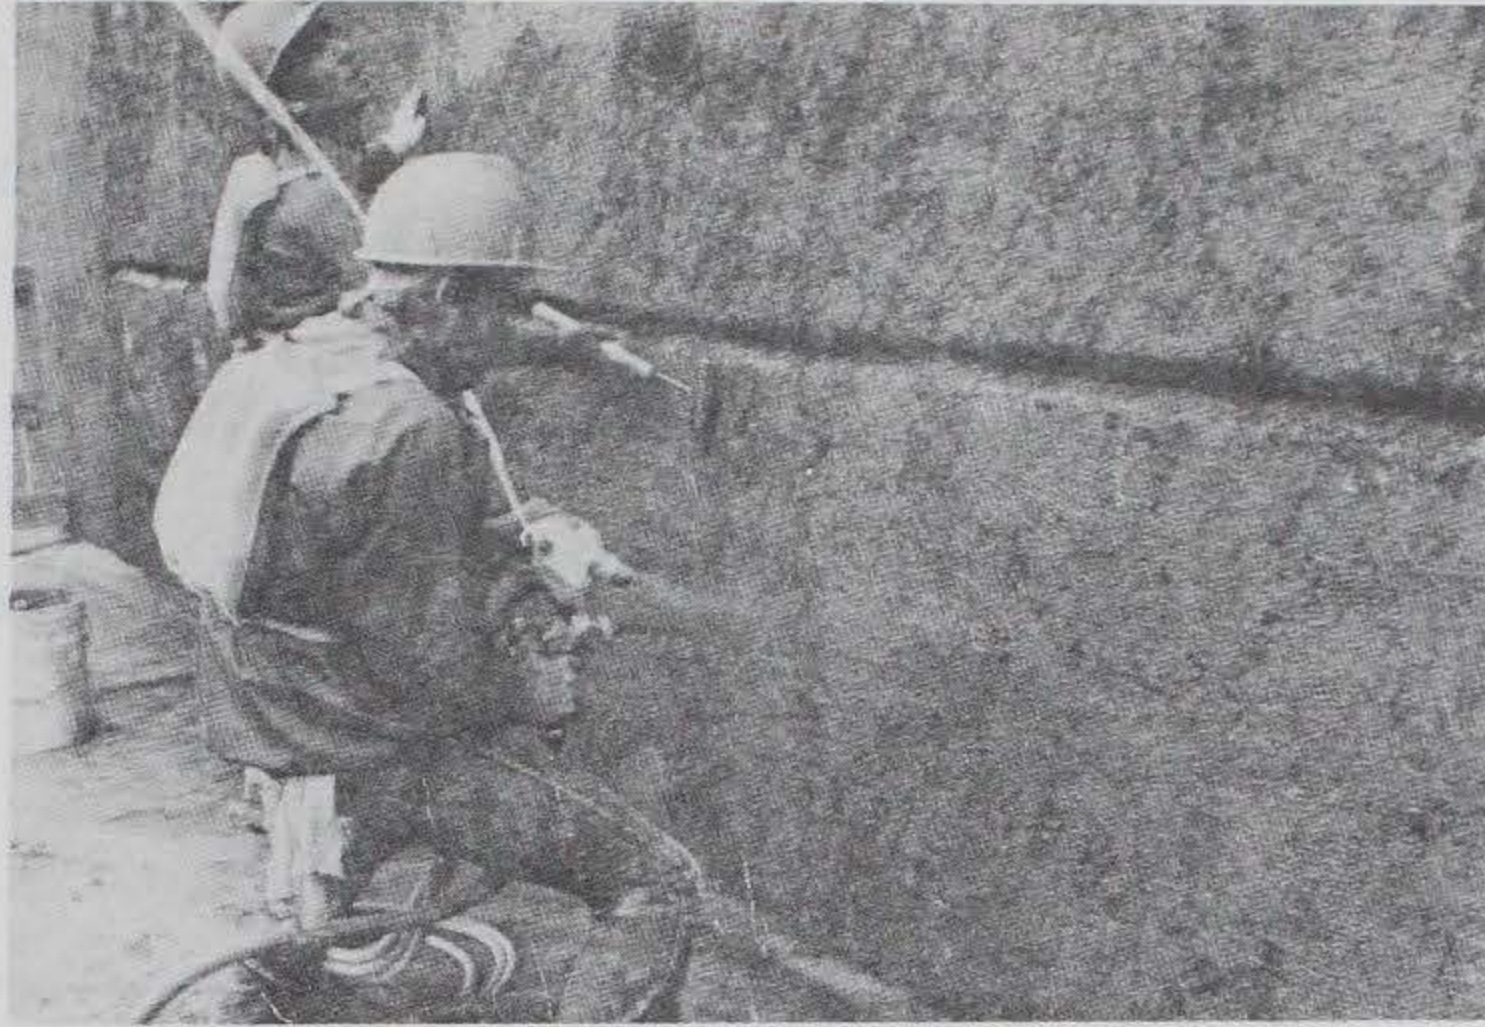
Figure 109. Application of latex-modified, glass fiber-reinforced shotcrete, Lower Monumental Lock

252. The conventional shotcrete was applied in a single layer using the dry-mix process. The glass fiber-reinforced shotcrete was applied using the standard "spray-up" process which applies a wet mixture at low pressure, while the fiberglass fibers are chopped into 4-in. lengths and blown against the surface simultaneously with the mortar (Figure 109). The thickness of material applied was only about 1/8 in. per pass, and the surface was rolled with what looked like a serrated paint roller between passes. This roller pressed the glass fibers into close contact with the mortar. A mat of material resulted which could actually be lifted off in sheets, but which also would sag if too much weight was added too fast. All mixtures were applied to the lock

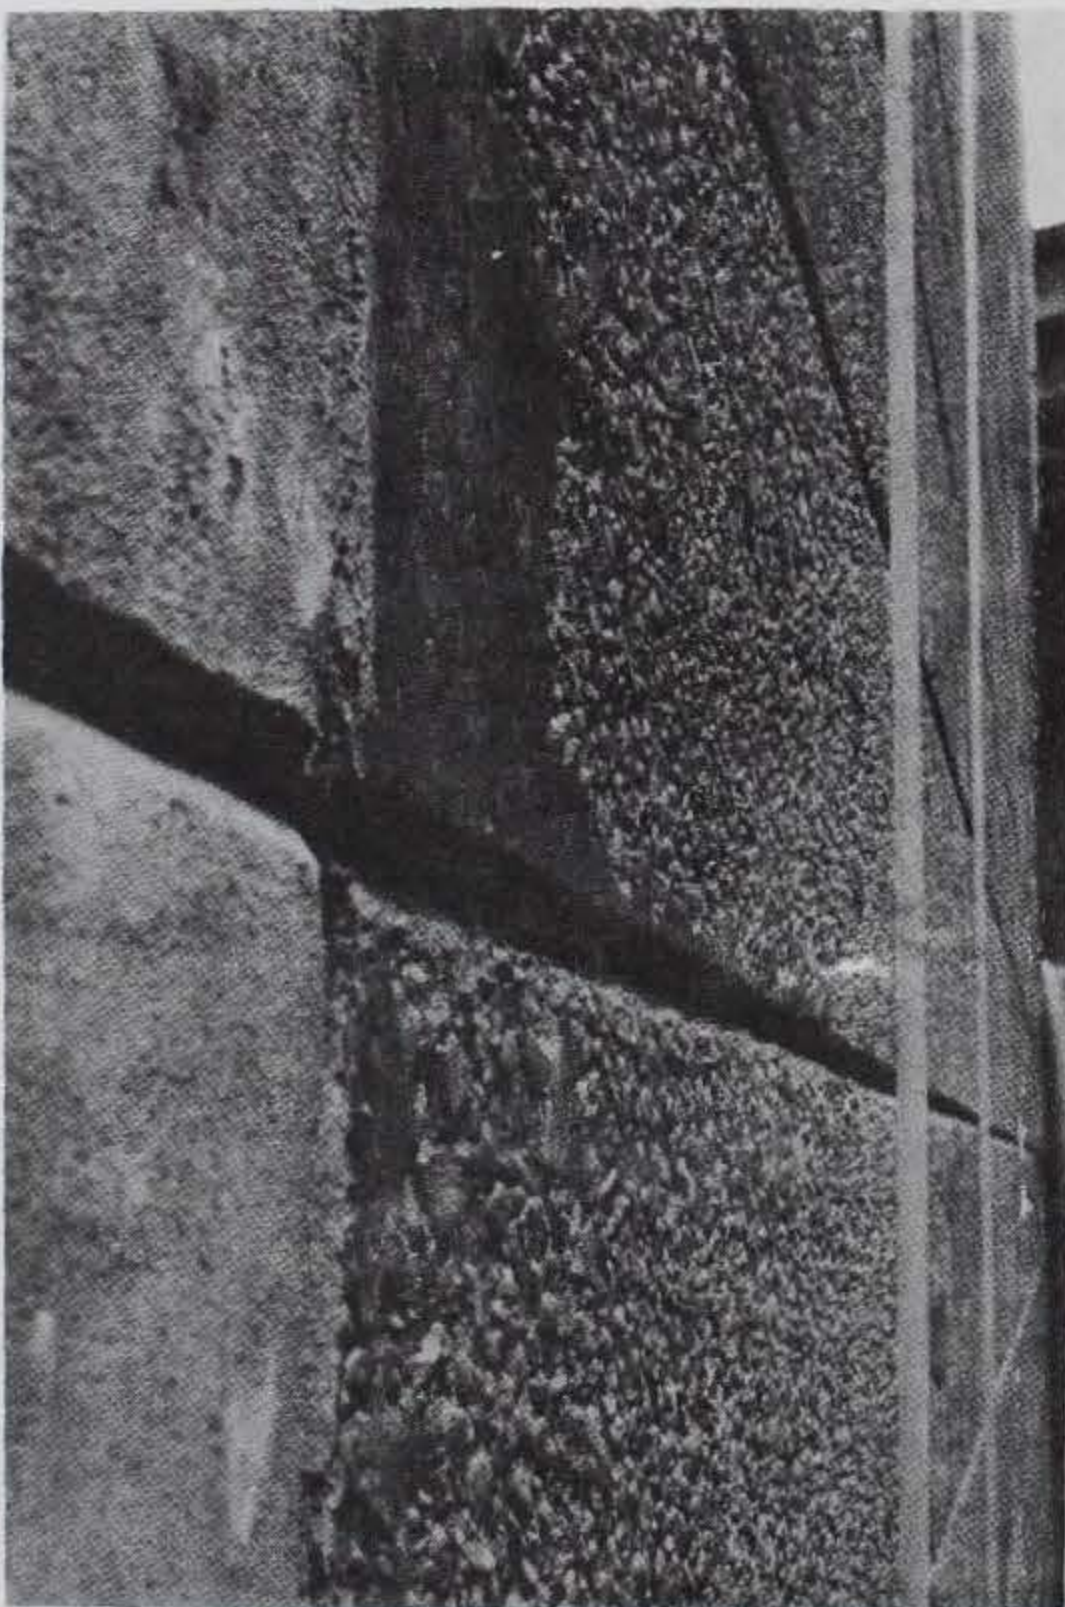
c. A portion of the test section nine months after the repair is shown in Figure 110. One year following completion of the trial repair the test sections were inspected to determine the condition of the various shotcrete mixtures. The condition of each section was described as follows:

Figure 110. Comparison of coated (left) and uncoated areas of wall, Lower Monumental Lock

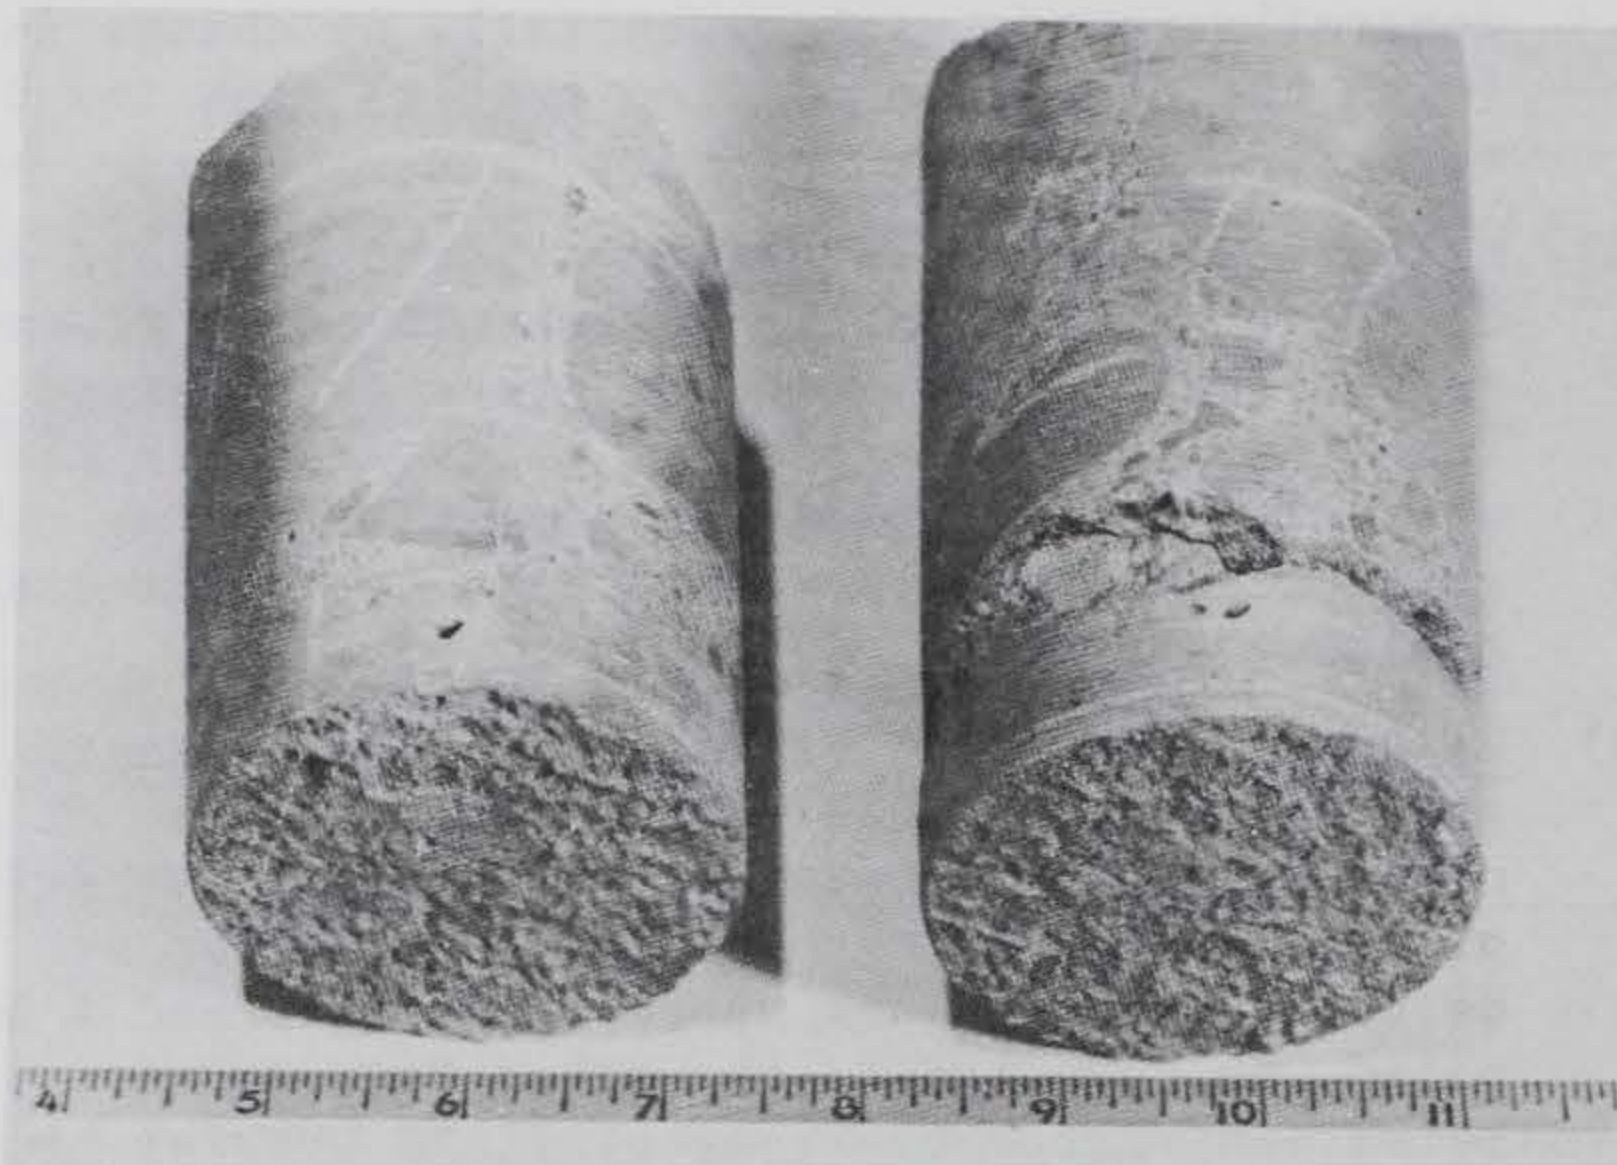
- (6) Mixture 6. No fine cracks were observed in this section. No debonded areas were evident on the upper lifts, but numerous hollow sounding areas were present in lower lift sections, with some sections having completely peeled off in large sheets. However, immediately next to some of the peeled-off areas, the bond of the coating to the substrate was excellent. As with all other sections, the surfaces of sections coated with Mixtures 5 and 6 showed essentially no change in appearance from the previous summer. Visual examinations of cores (Figure 111) indicated that hollow sounding areas were, in fact, delaminated, and the anticipated well-bonded zones were found to be sound. These observations confirmed that the debonding failures were caused by improper surface preparation. The coatings in such instances were found to be bonded to the mortar from the original (unsound) surface, but the weak surface mortar had peeled away from the rest of the concrete, thereby causing the failure.

Figure 111. Typical horizontal cores from test sections showing excellent bond (left) and bond failure at shotcrete-concrete interface (right) due to improper surface preparation, Lower Monumental Lock

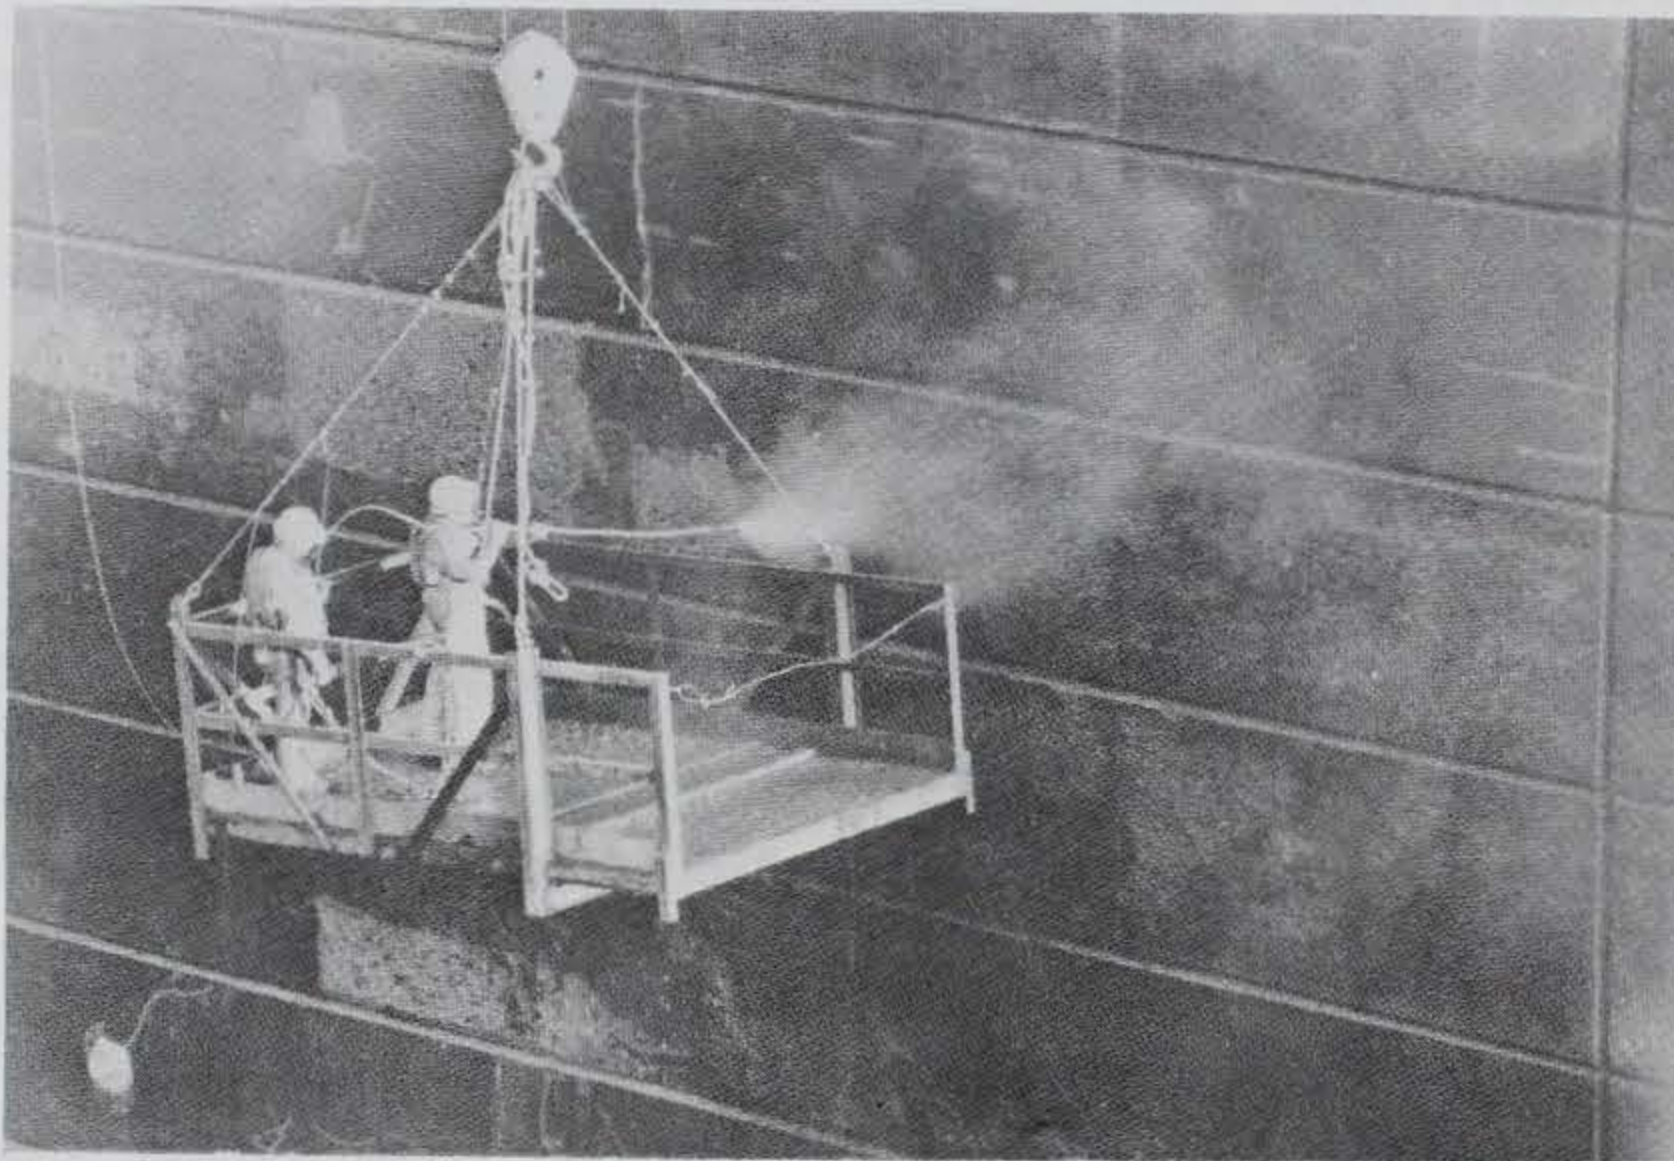
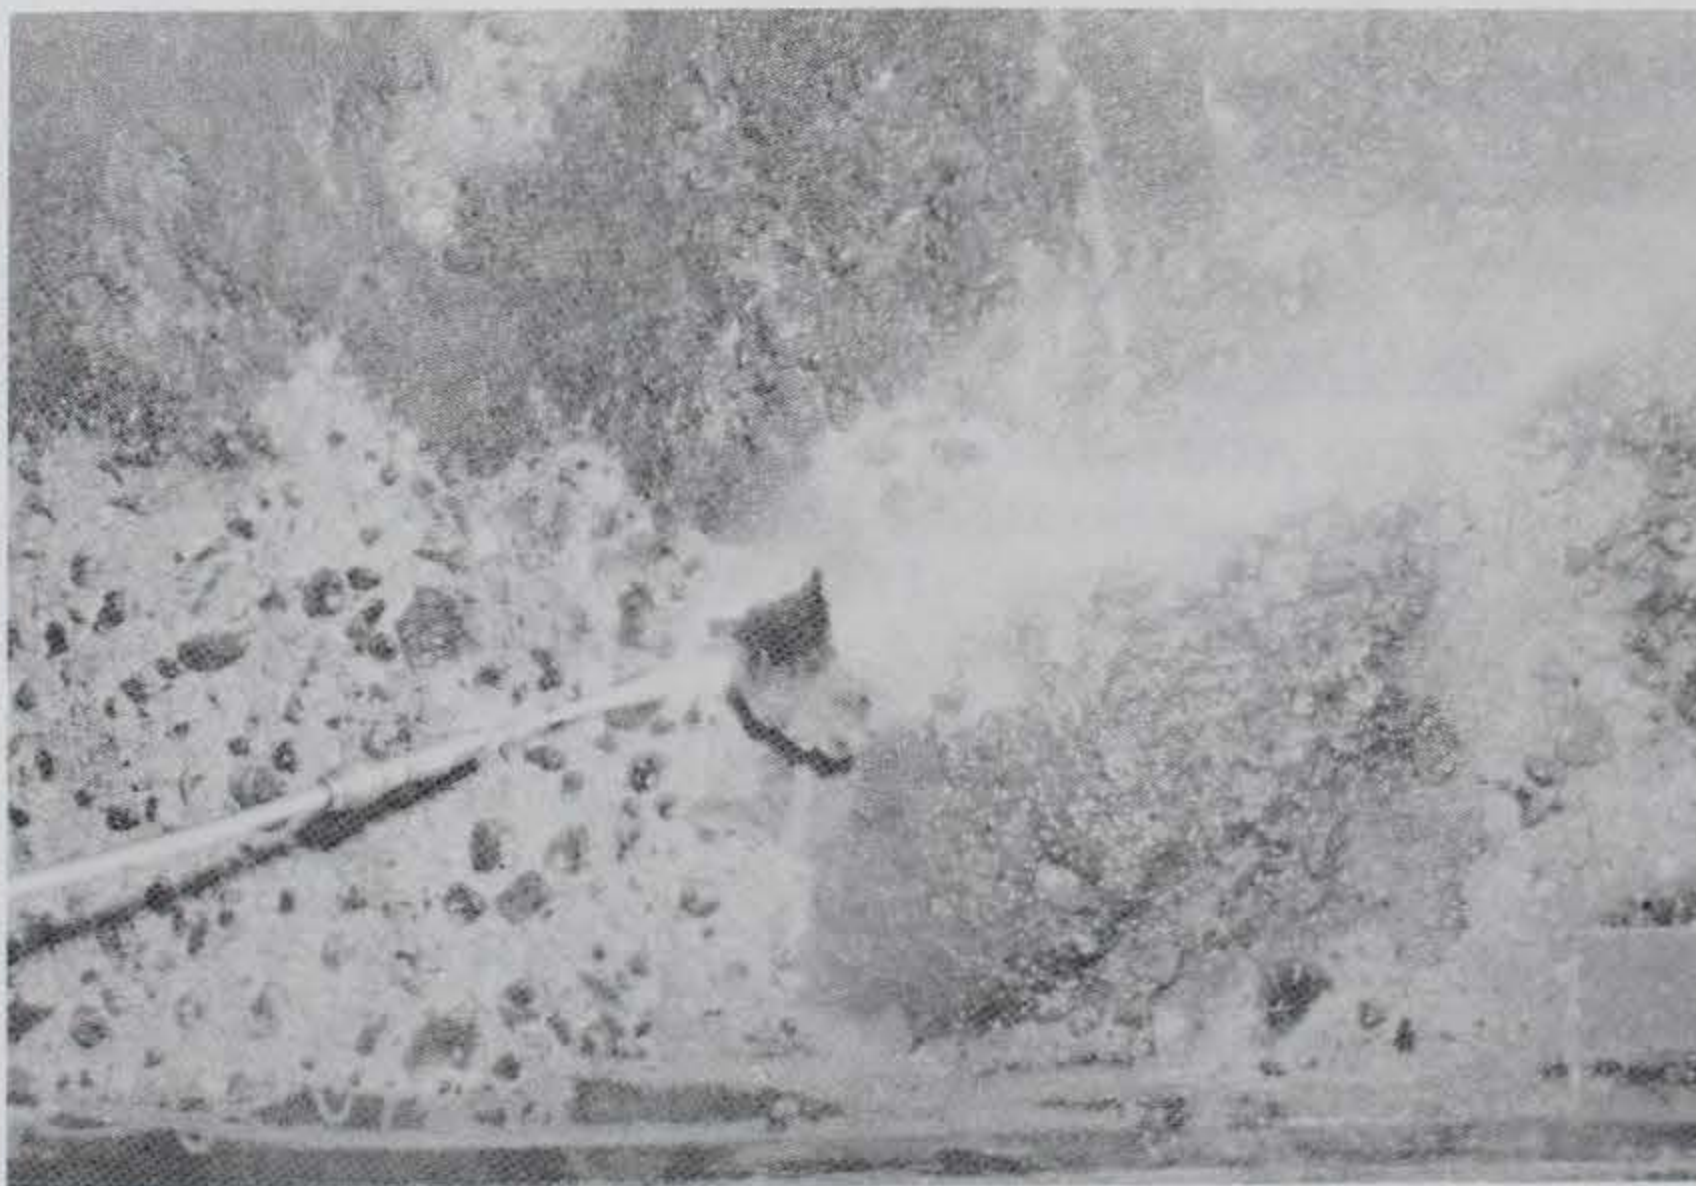
Figure 112. Removal of unsound concrete mortar using a high-pressure water jet, Lower Monumental Lock

the lock chamber walls. Since the success of the repair was totally dependent upon satisfactory surface preparation, several additional surface cleaning trials were made to verify that with properly operating high-pressure water-jet equipment, the surface could be satisfactorily cleaned. Sandblasting equipment, wire brushes, hand chipping, and air-operated scabblers were also tried by the Government designers. The benefit of this experience was passed on to the bidders through a prebid conference, discussion in the technical provisions of the bidding documents, and with photographs of the work (Figure 112) which also became a part of the bidding documents.
