TECHNICAL REPORT REMR-CS-13

**REHABILITATION OF NAVIGATION  
LOCK WALLS: CASE HISTORIES**

James E. McDonald

December 1987

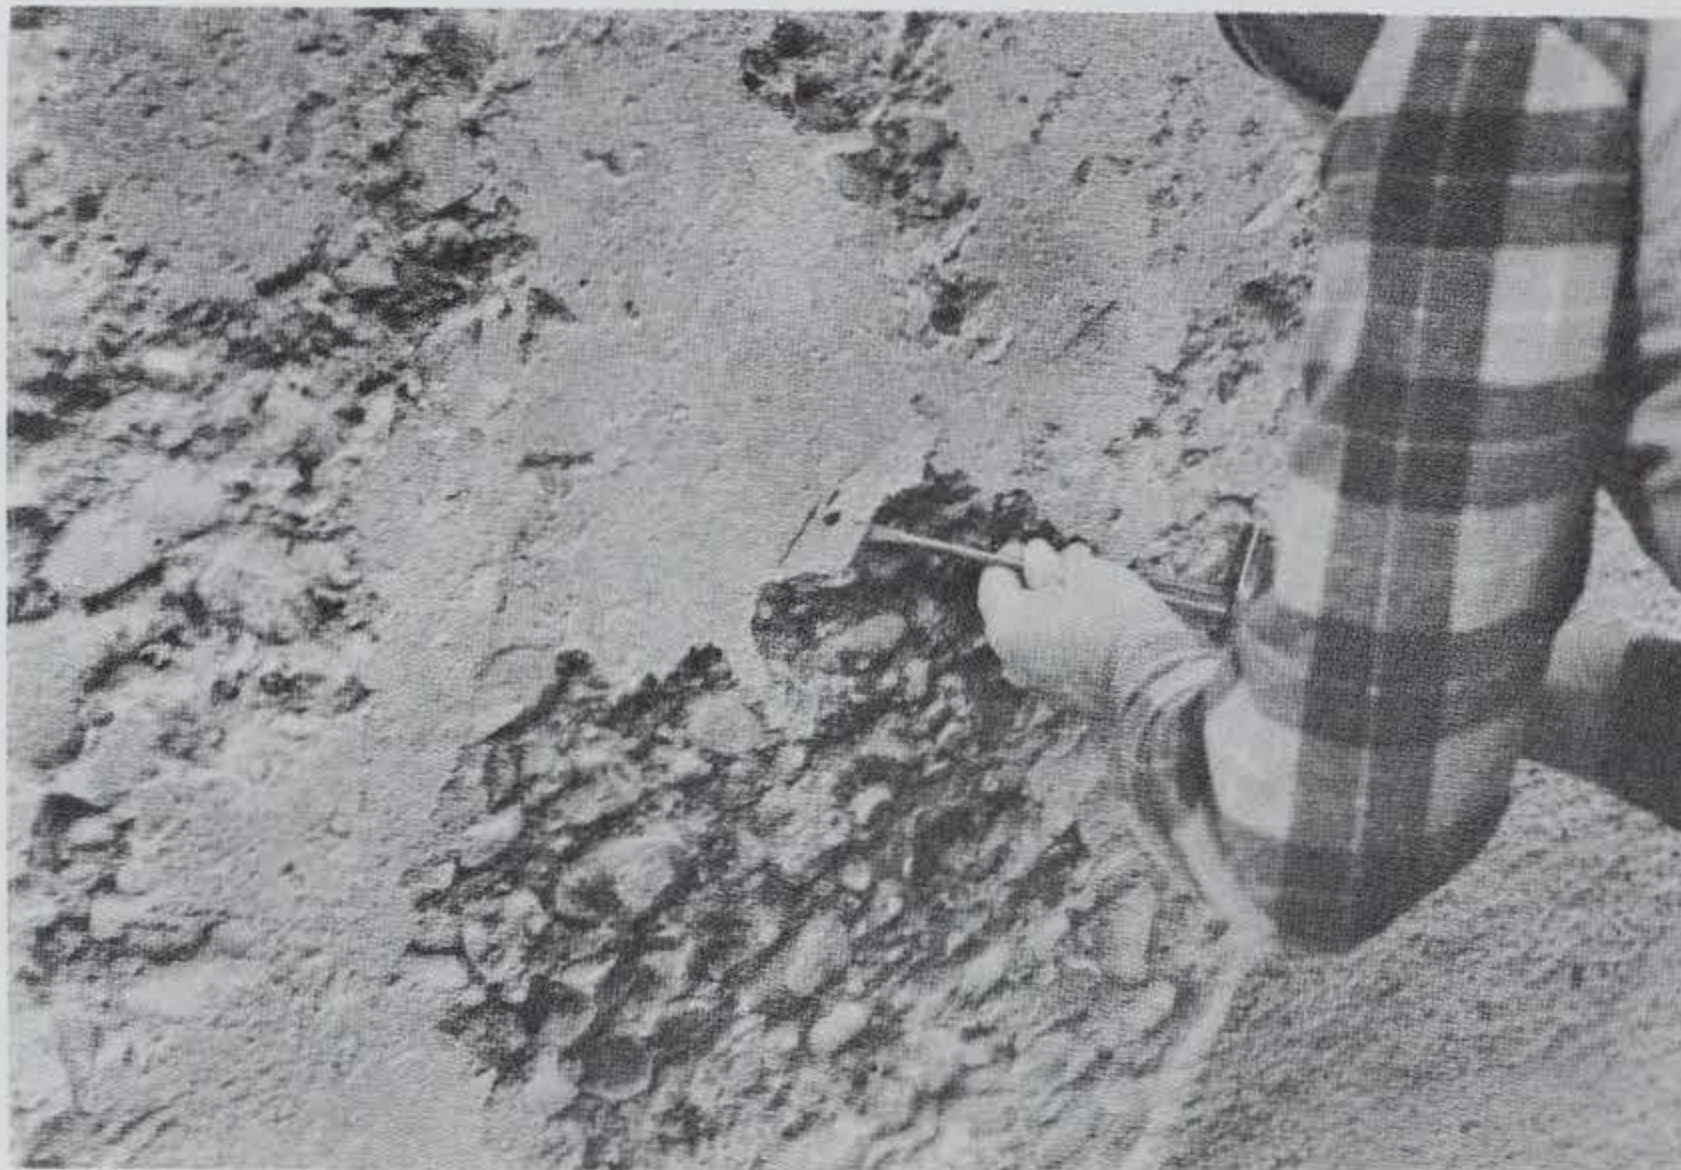
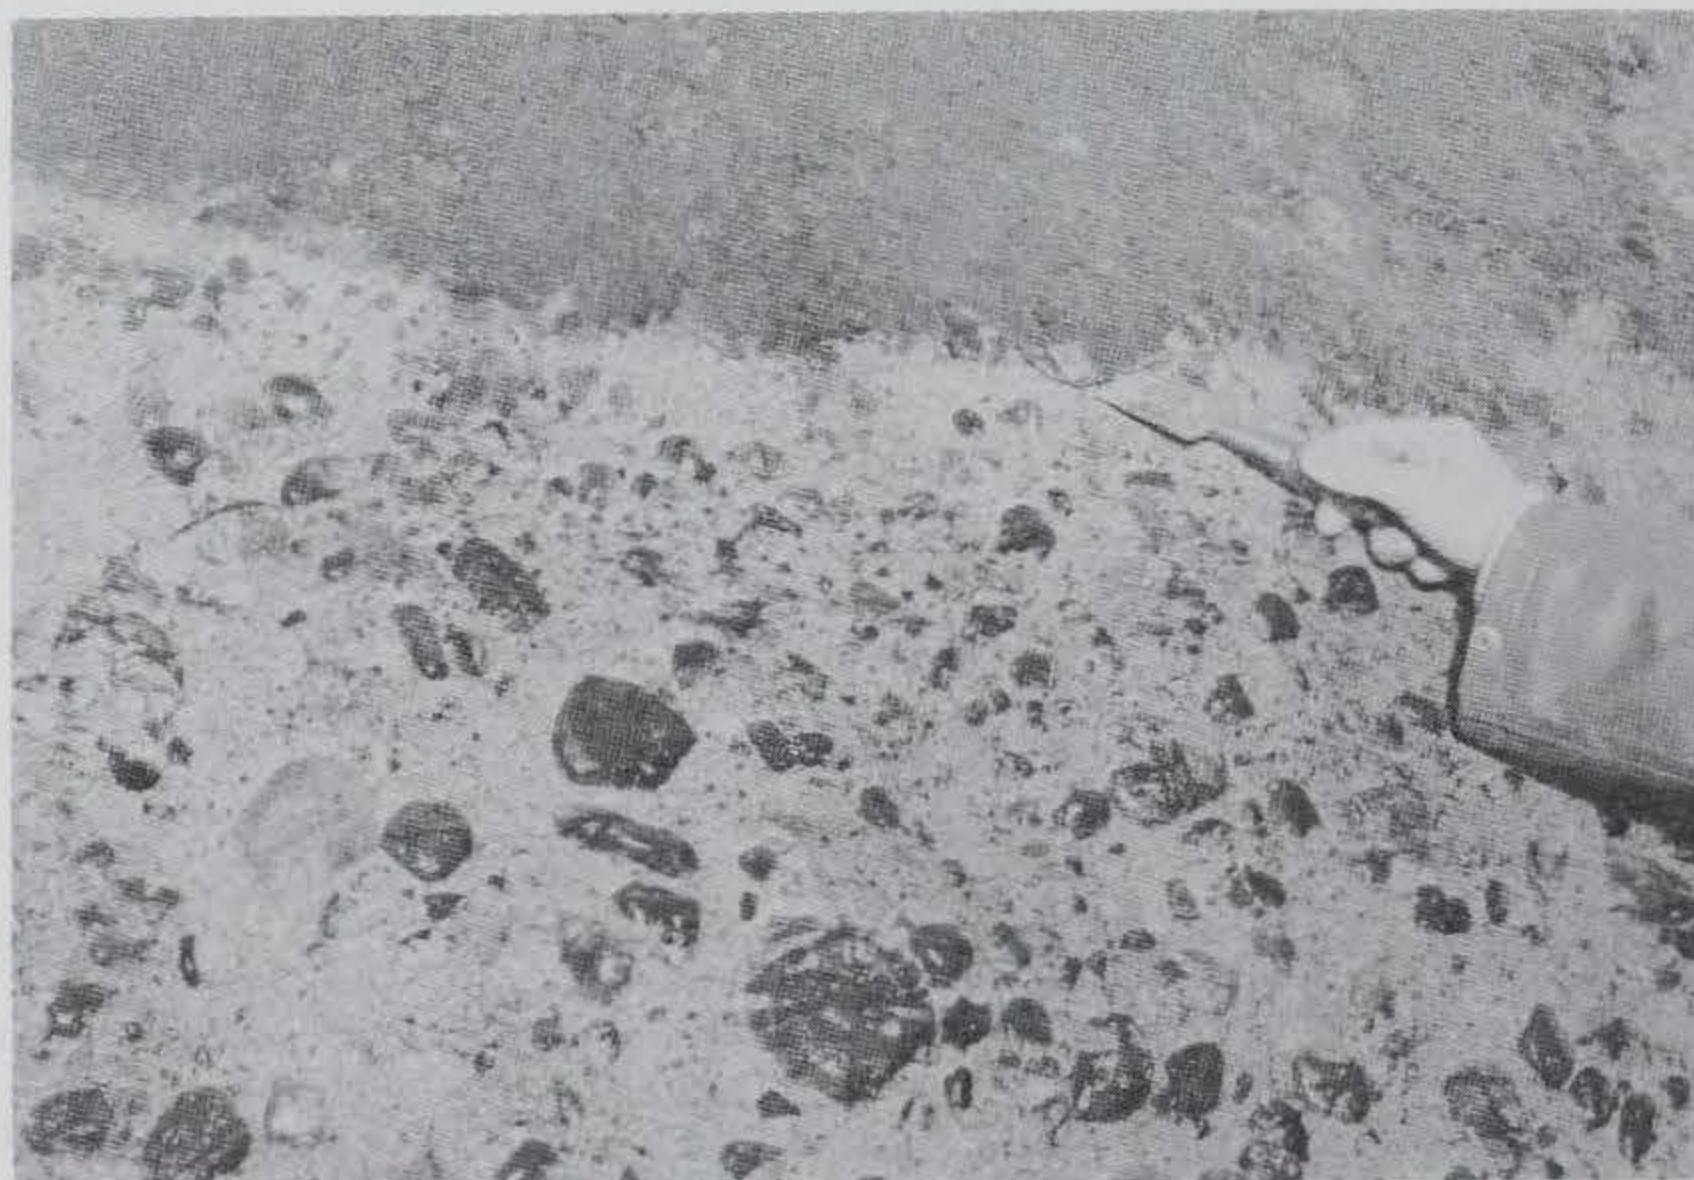
Figure 113. Examples of how easily the unsound surface mortar could be removed, Lower Monumental Lock

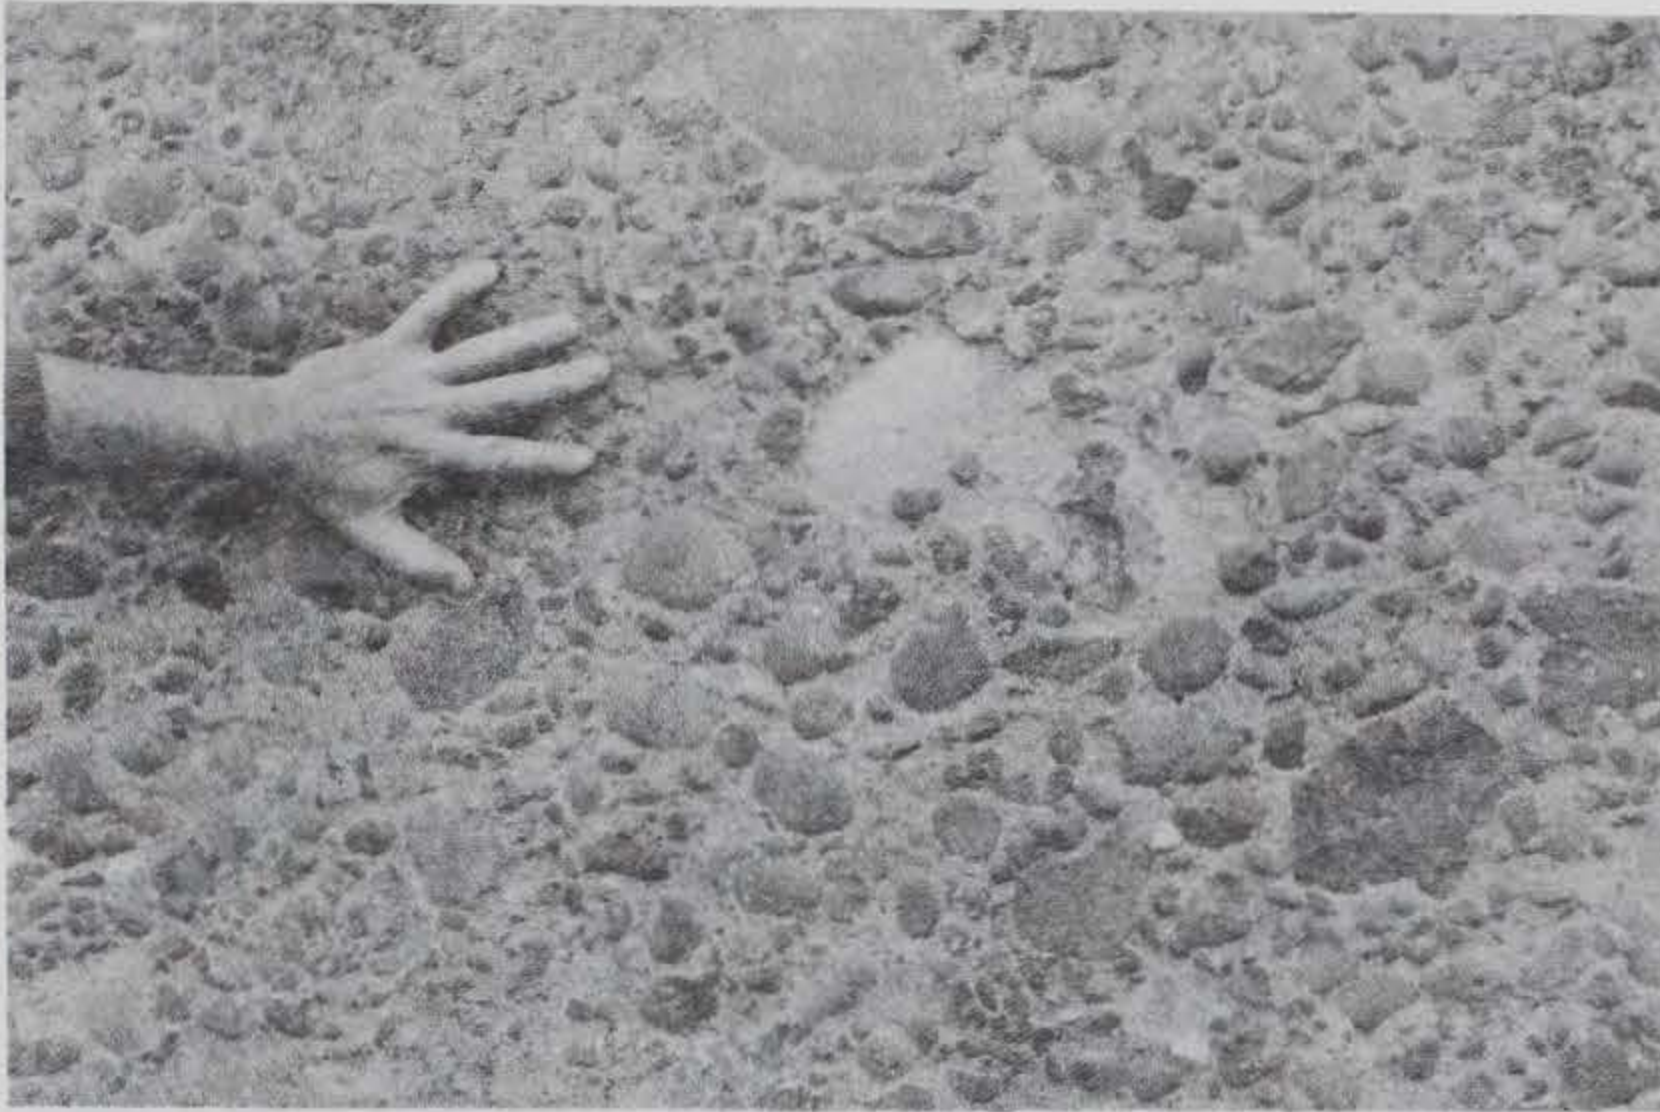
Figure 114. Typical condition of the wall following acceptable surface preparation, Lower Monumental Lock

259. Most of the actual cleaning was done between lockages over a three-week period before the lock outage and actual spray-up coating operations began. High-pressure water-jet equipment was used and normally operated at about 10,000 psi. As the nozzle tips would wear out, the pressure would start to drop to about 7,000 psi. New tips were then installed. Both the pressure and angle of the jet were critical to effectively remove unsound materials. Occasional handchipping was used to supplement the water jet in areas where it just did not clean well enough. Usually the unsound mortar was about 1/4- to 3/8-in. thick and flaked off easily (Figure 113). For most of the area in the lower portion of the lock, scaling had already occurred to a depth of 1/2 to 2 in. in the mortar, severely exposing the large aggregate which itself was quite sound. An example of the wall surface after acceptable surface preparation is shown in Figure 114.

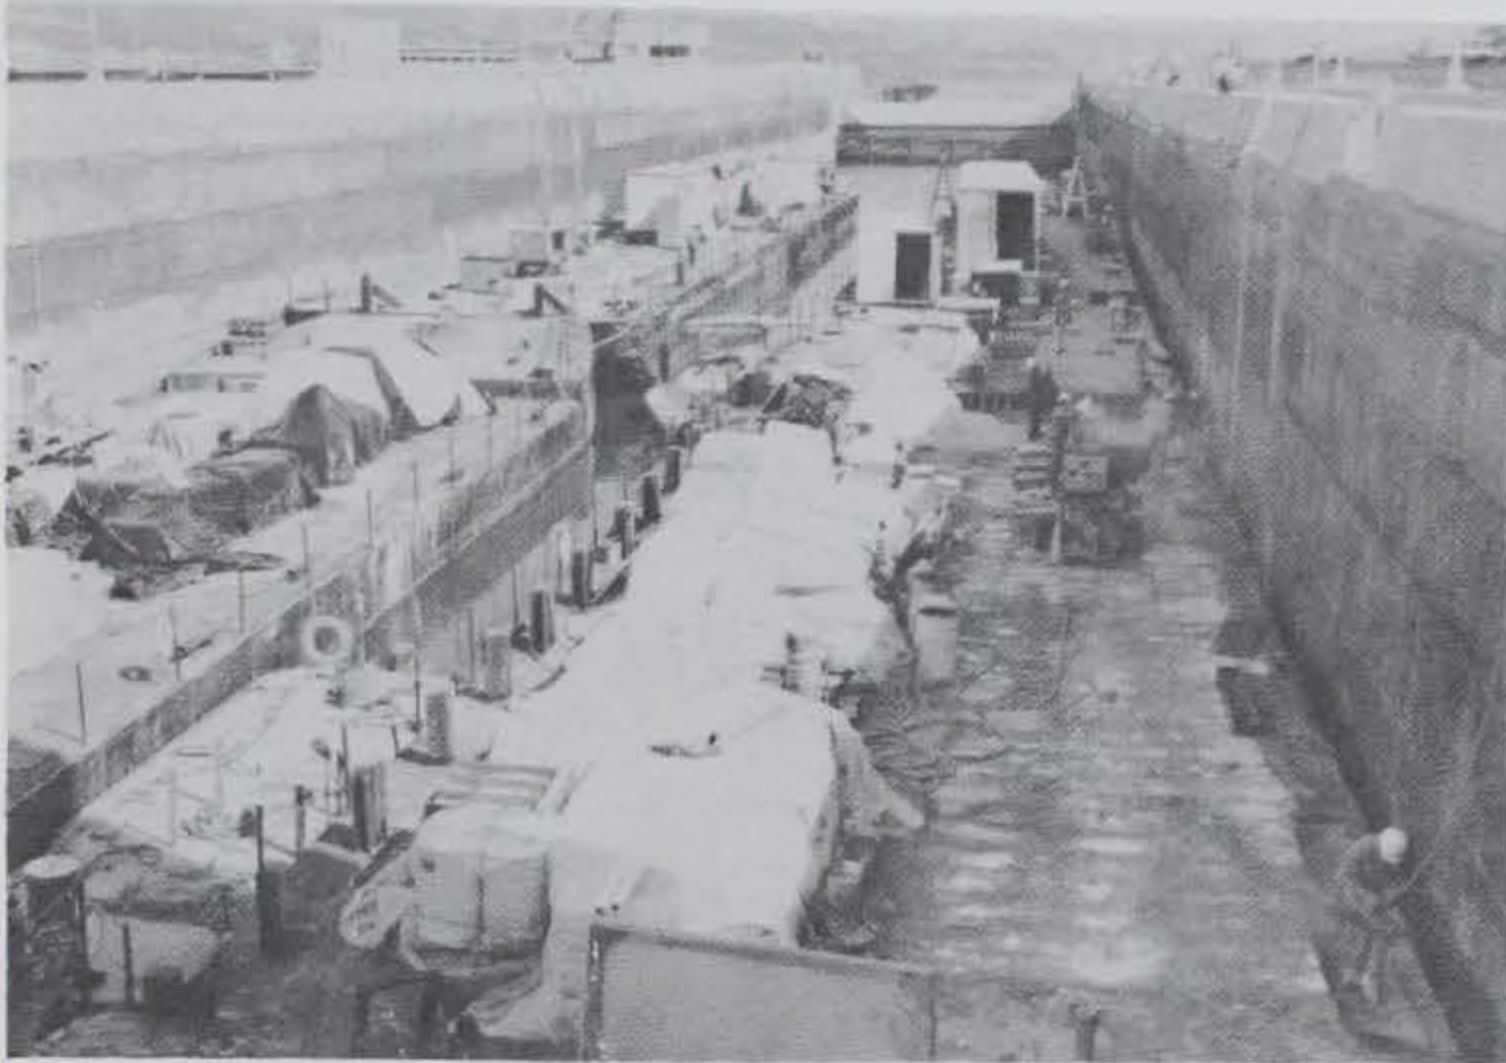
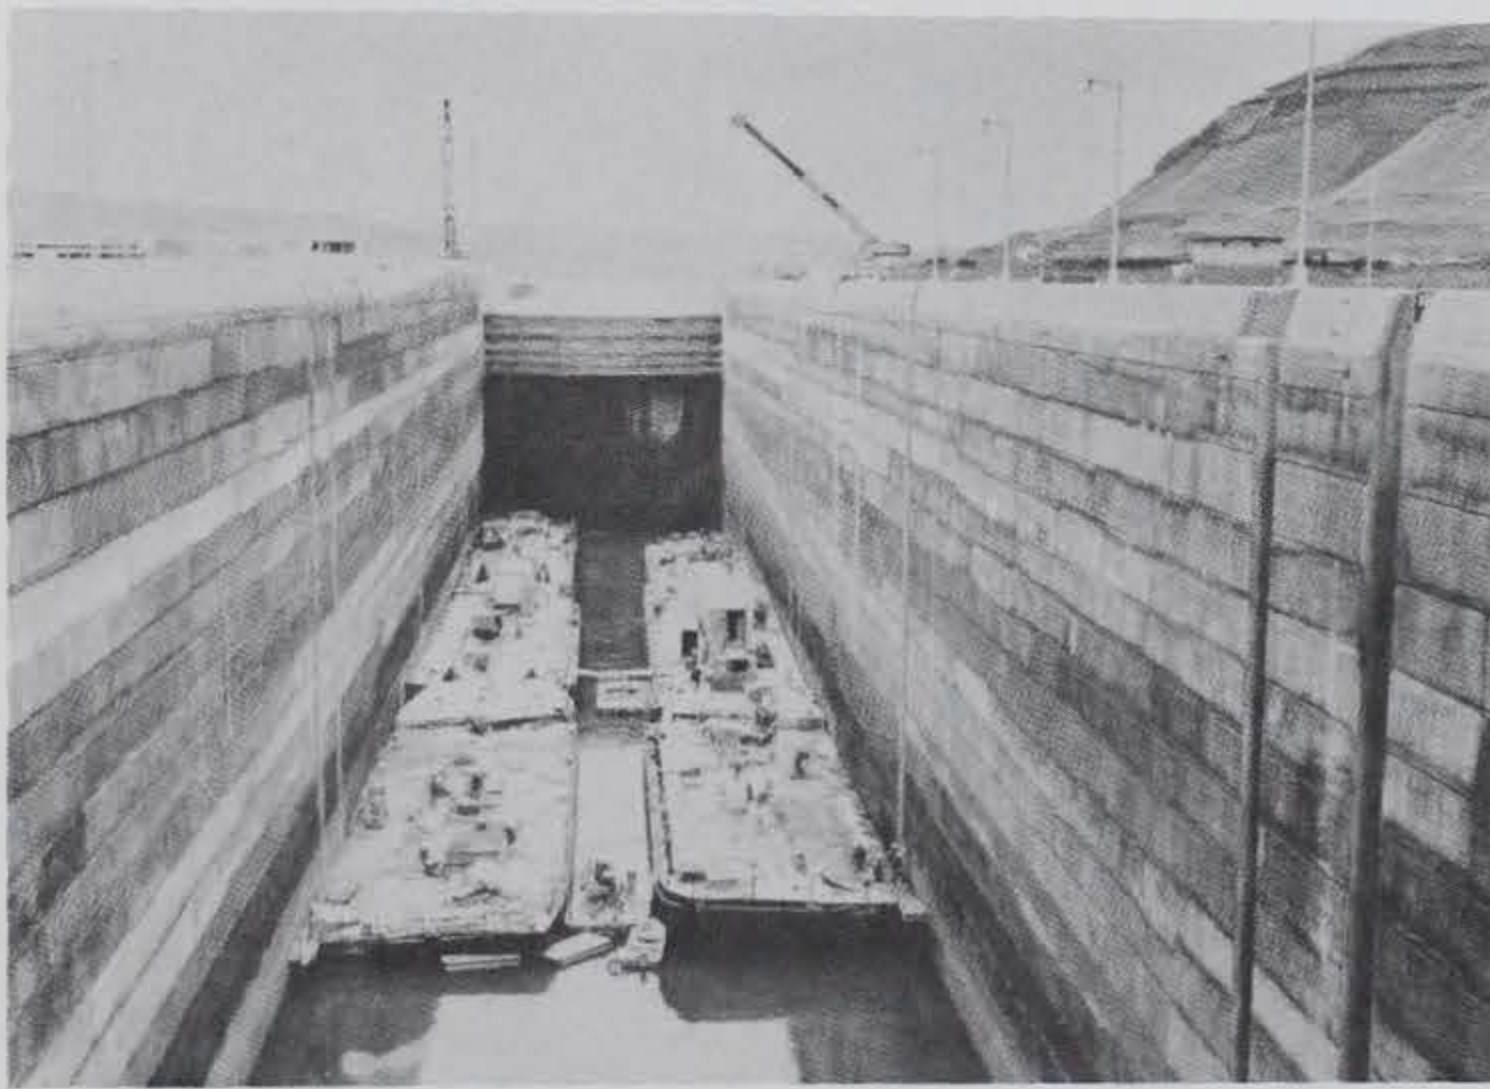
a. Coating application near upper lifts

b. Coating application about 75 percent complete

Figure 115. Floating plant used in coating application, Lower Monumental Lock

264. The contractor chose to work from a floating plant consisting of six barges, three working at each wall and lashed together end-to-end. The barges stretched for about 75 percent of the length of the lock. The lashed barges were braced and welded side-by-side so that they all acted as one unit. At the start of the lock outage, the barges were floated into the lock chamber and positioned. The lock was filled and the contractor began working from the top lift down (Figure 115). After the approximate height of one 5-ft lift was coated from end-to-end on each side, the lock level was lowered about 5 ft and the next lift was coated.

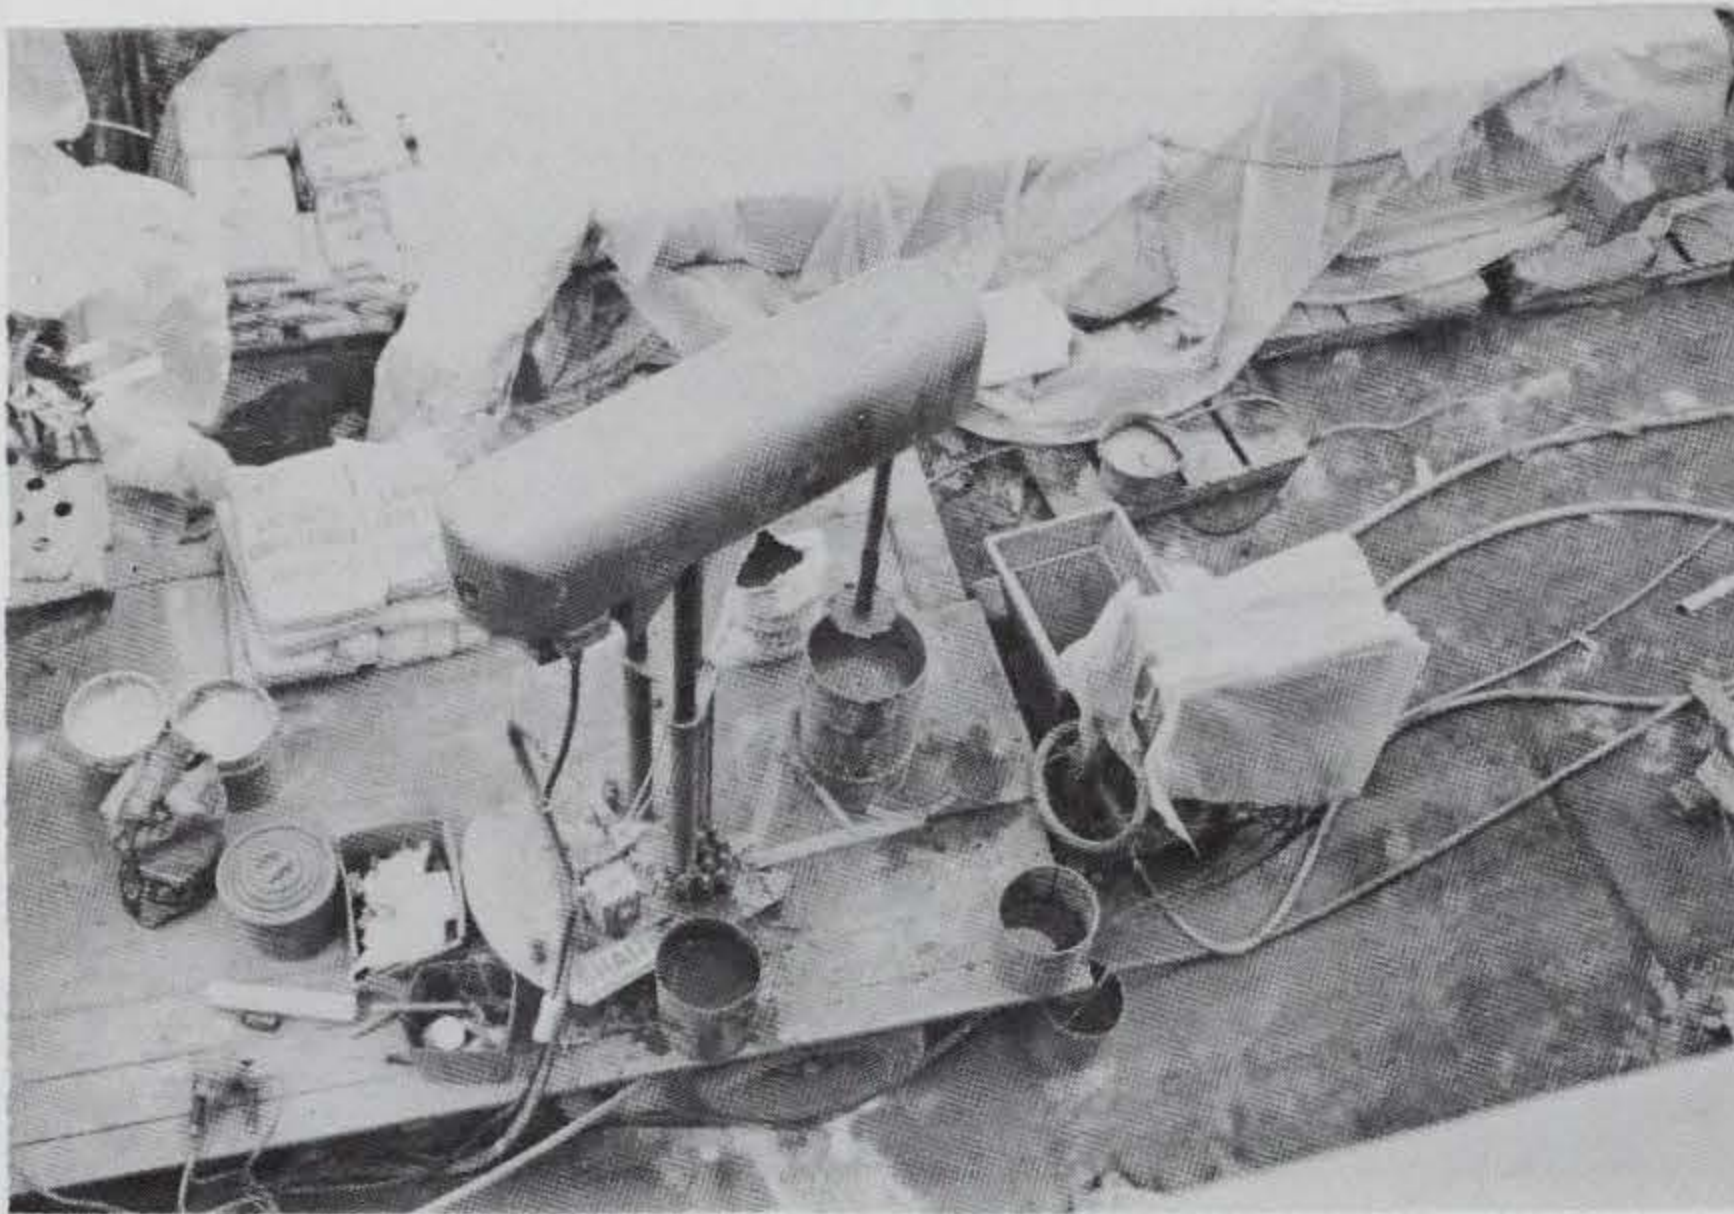
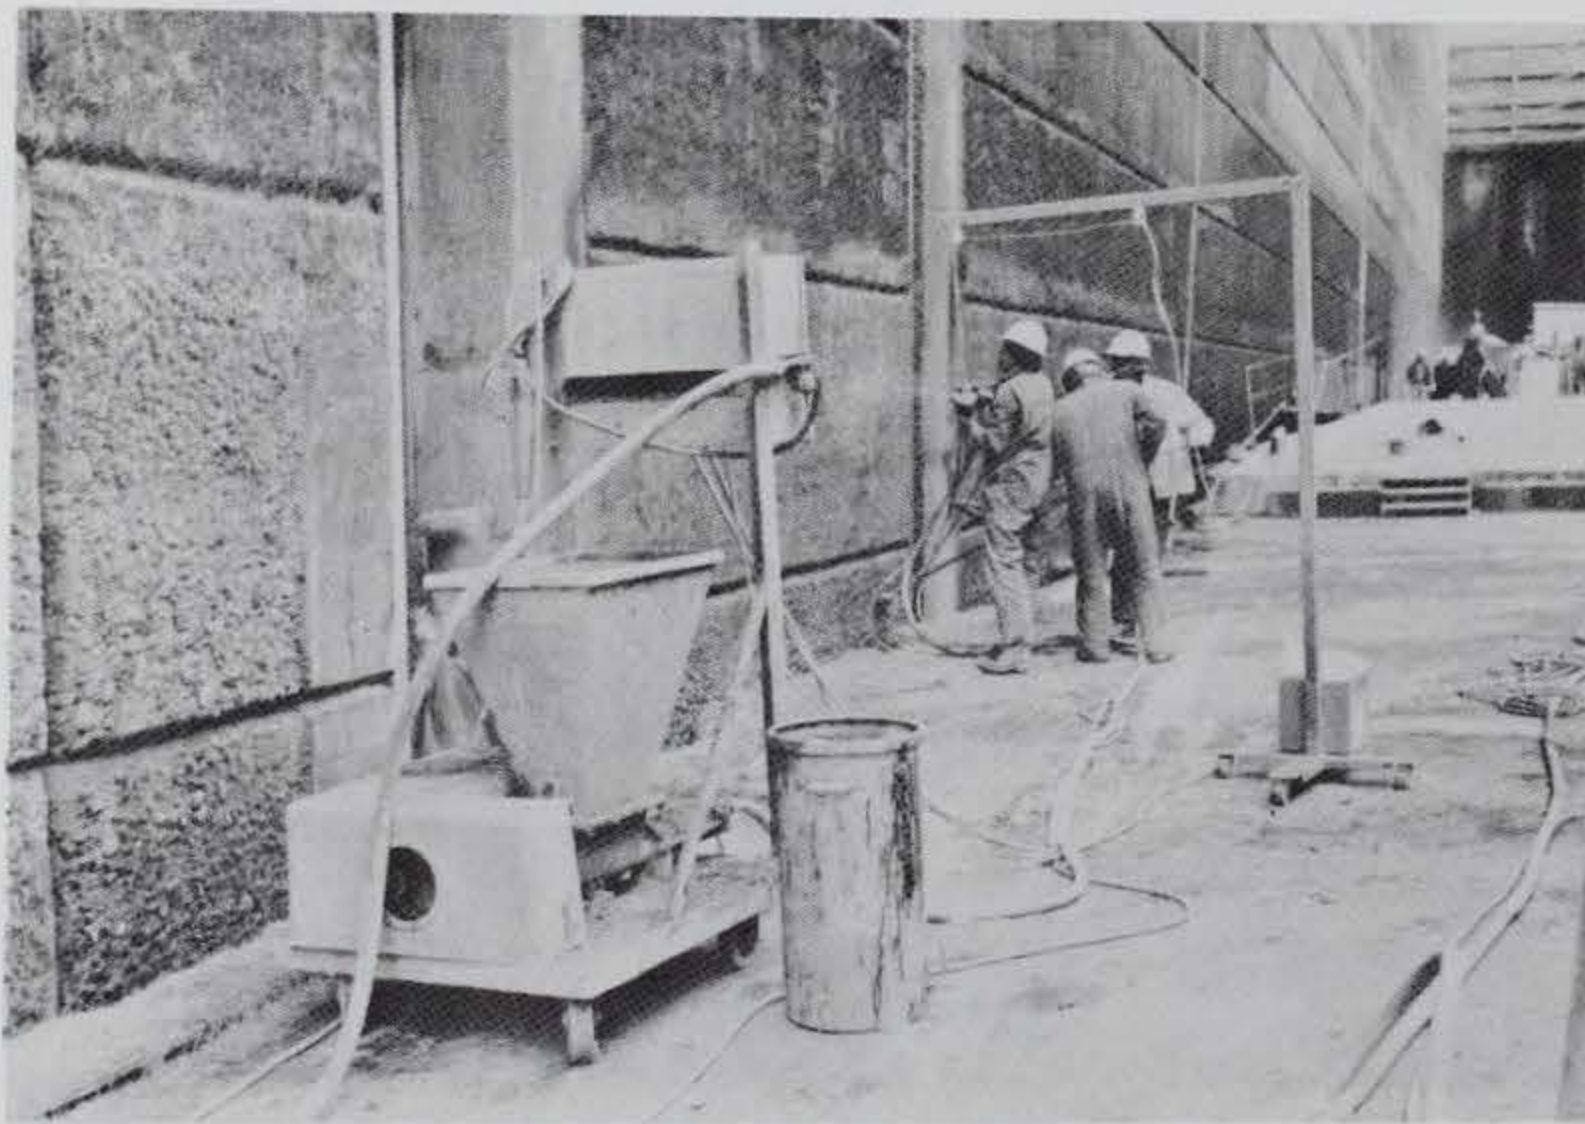
a. High-shear mortar mix

b. Group pump and spray-up unit

Figure 116. Typical "spray-up" station,  
Lower Monumental Lock

265. Each spray-up station (Figure 116) had its own scales, spray-up gear or nozzle, mixer, and pump. Each station was also manned by a full crew consisting of a nozzleman, mixer man, roller man, and usually a helper. As previously described the "spray-up" process used a wet mortar mixture pumped to the nozzle by grout pump and atomized with low-pressure air at the nozzle. While the mortar was sprayed against the wall surface, fiberglass fibers were simultaneously chopped from a continuous strand and blown into the mortar spray from a separate cutter head attached to the nozzle. The material was applied in a thickness of about 1/8 in. per pass and was lightly rolled with what looked like a serrated paint roller between successive passes. This roller pressed the glass fiber into intimate contact with the mortar. A mat of material resulted which was heavily reinforced but which would sag or fall off if too much weight was added too fast. The final surface could be troweled; but although this process made a better appearance, it was unnecessary and if overdone could have been damaging.

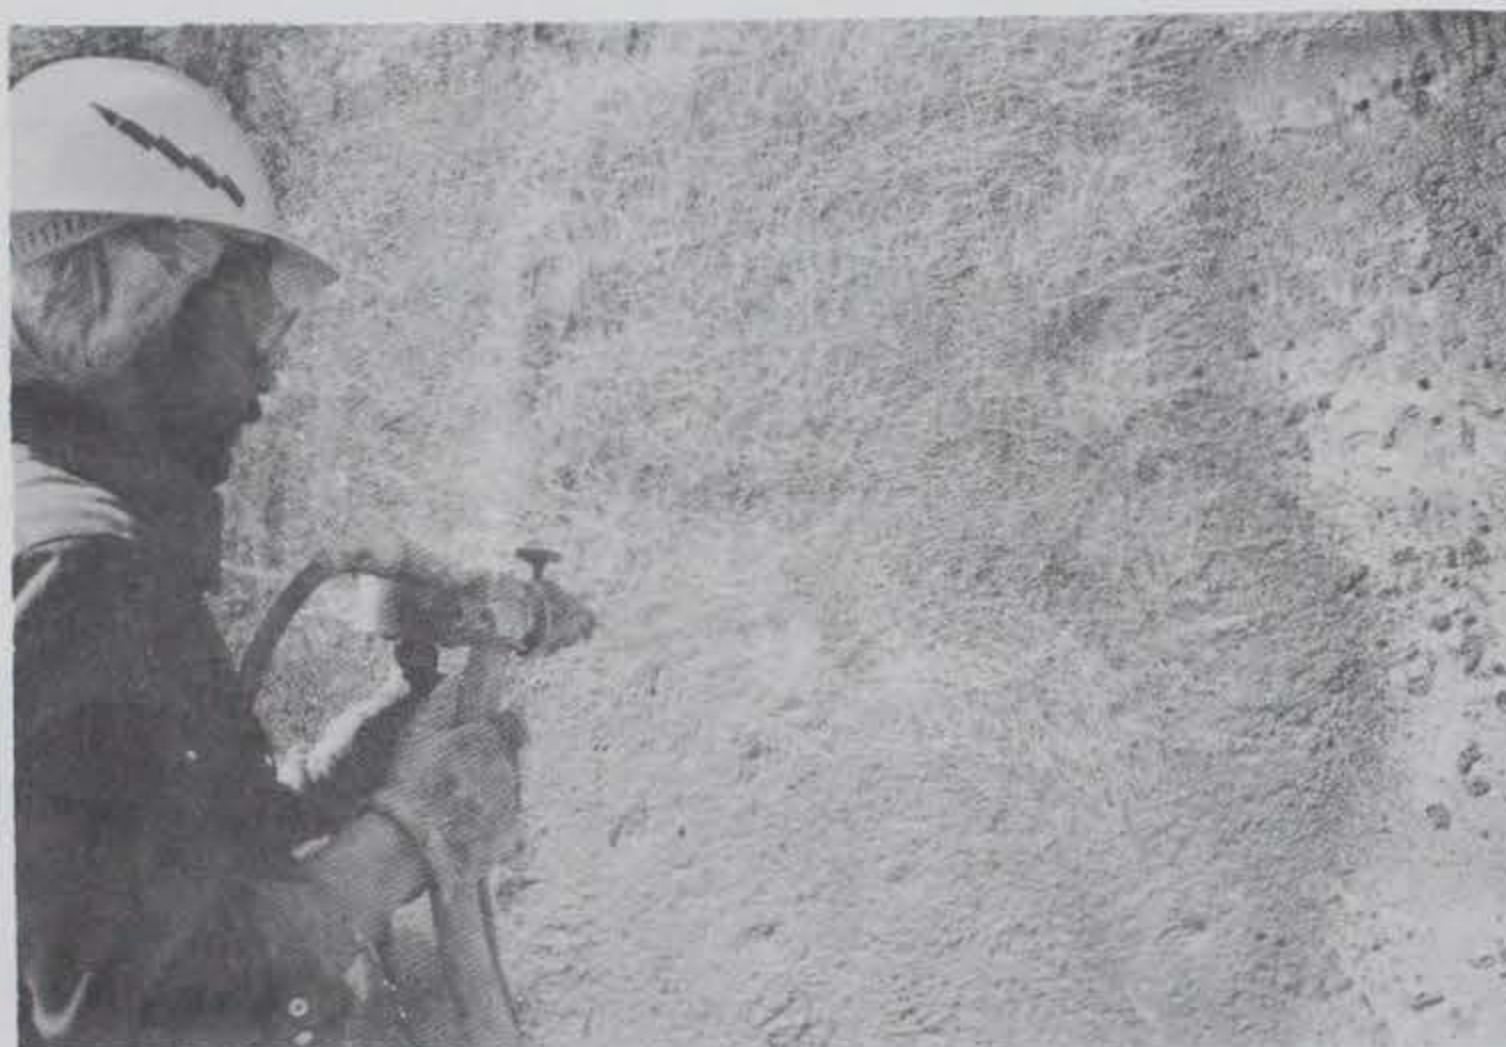
266. As the work progressed from the upper lifts which had less deterioration (Figure 117) to the lower lifts with substantial deterioration, the length of fiber used had to be adjusted. The cutter heads were designed to chop fibers of 1-1/2-, 4-1/2-, or a combination of 1-1/2- with 3-in. lengths. The longer fibers were desired because of their believed tendency to give greater toughness and strain capacity. However, where the depth of relief around large exposed aggregate was about 1/2 in. or more, the long fibers tended to bridge across adjacent pieces of aggregate leaving an air void over the relief between them. Where a combination of 1-1/2- with 3-in. fibers was used, this problem was minimized.

Figure 117. Coating application in an area of minimal scaling near the top of the lock, Lower Monumental Lock

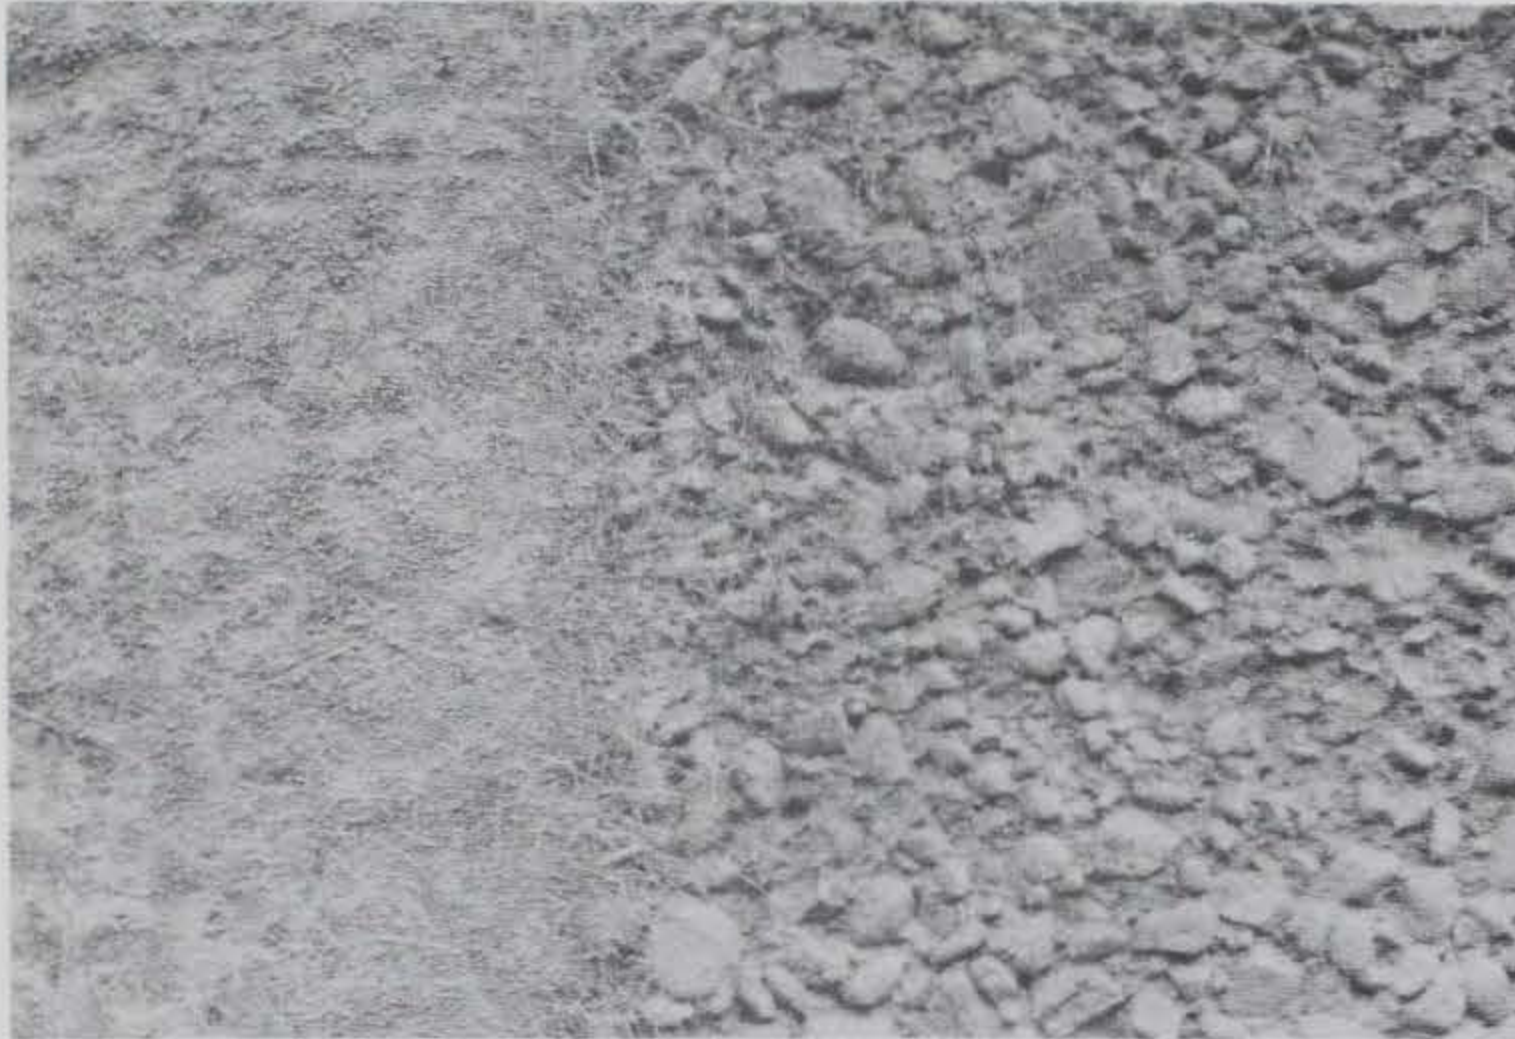
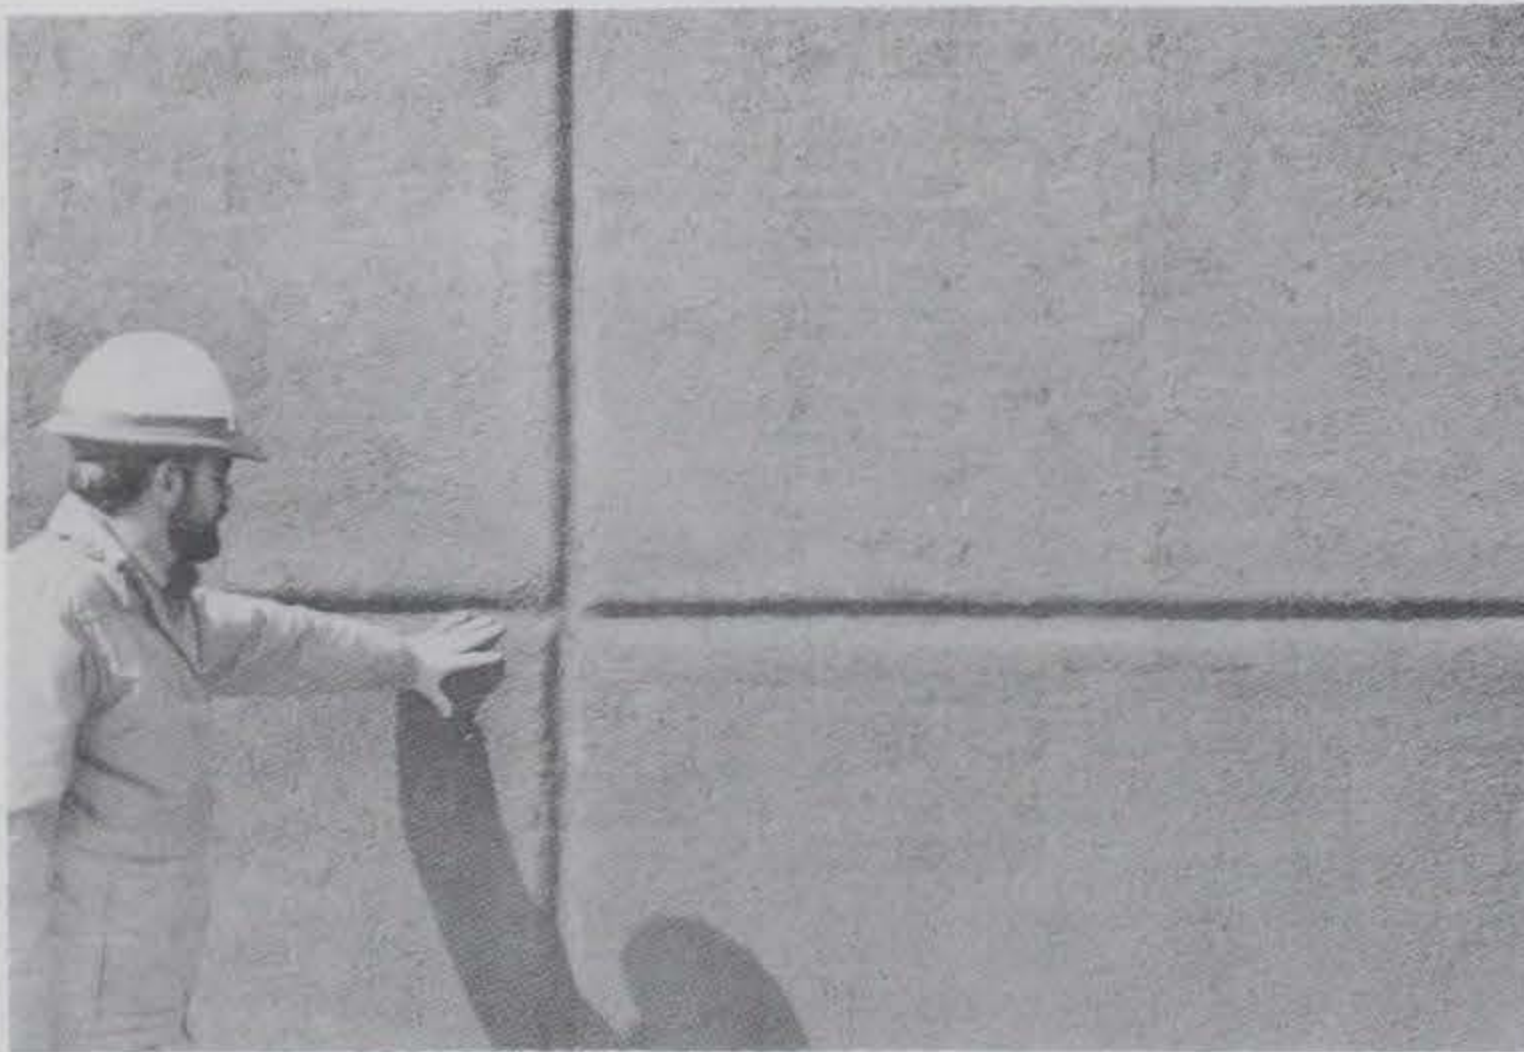
Figure 118. Typical appearance of the wall coating, Lower Monumental Lock

268. The thickness of the in-place coating (Figure 118) varied between 5/16 and 5/8 in. and averaged 3/8 in. In areas where 3-in. aggregate was visible on the lock wall, the thickness over the outside of the 3-in. cobbles was less than 3/8 in., but between the aggregate particles it was more than 3/8 in. Since protection over the mortar between the aggregate was most important, this thickness was considered acceptable. Thickness was continuously checked by stabbing the wet mix with a nail used as a depth gage.

a. Coating of rough, severely deteriorated concrete

b. Coating in the upper lifts which had minimal concrete deterioration

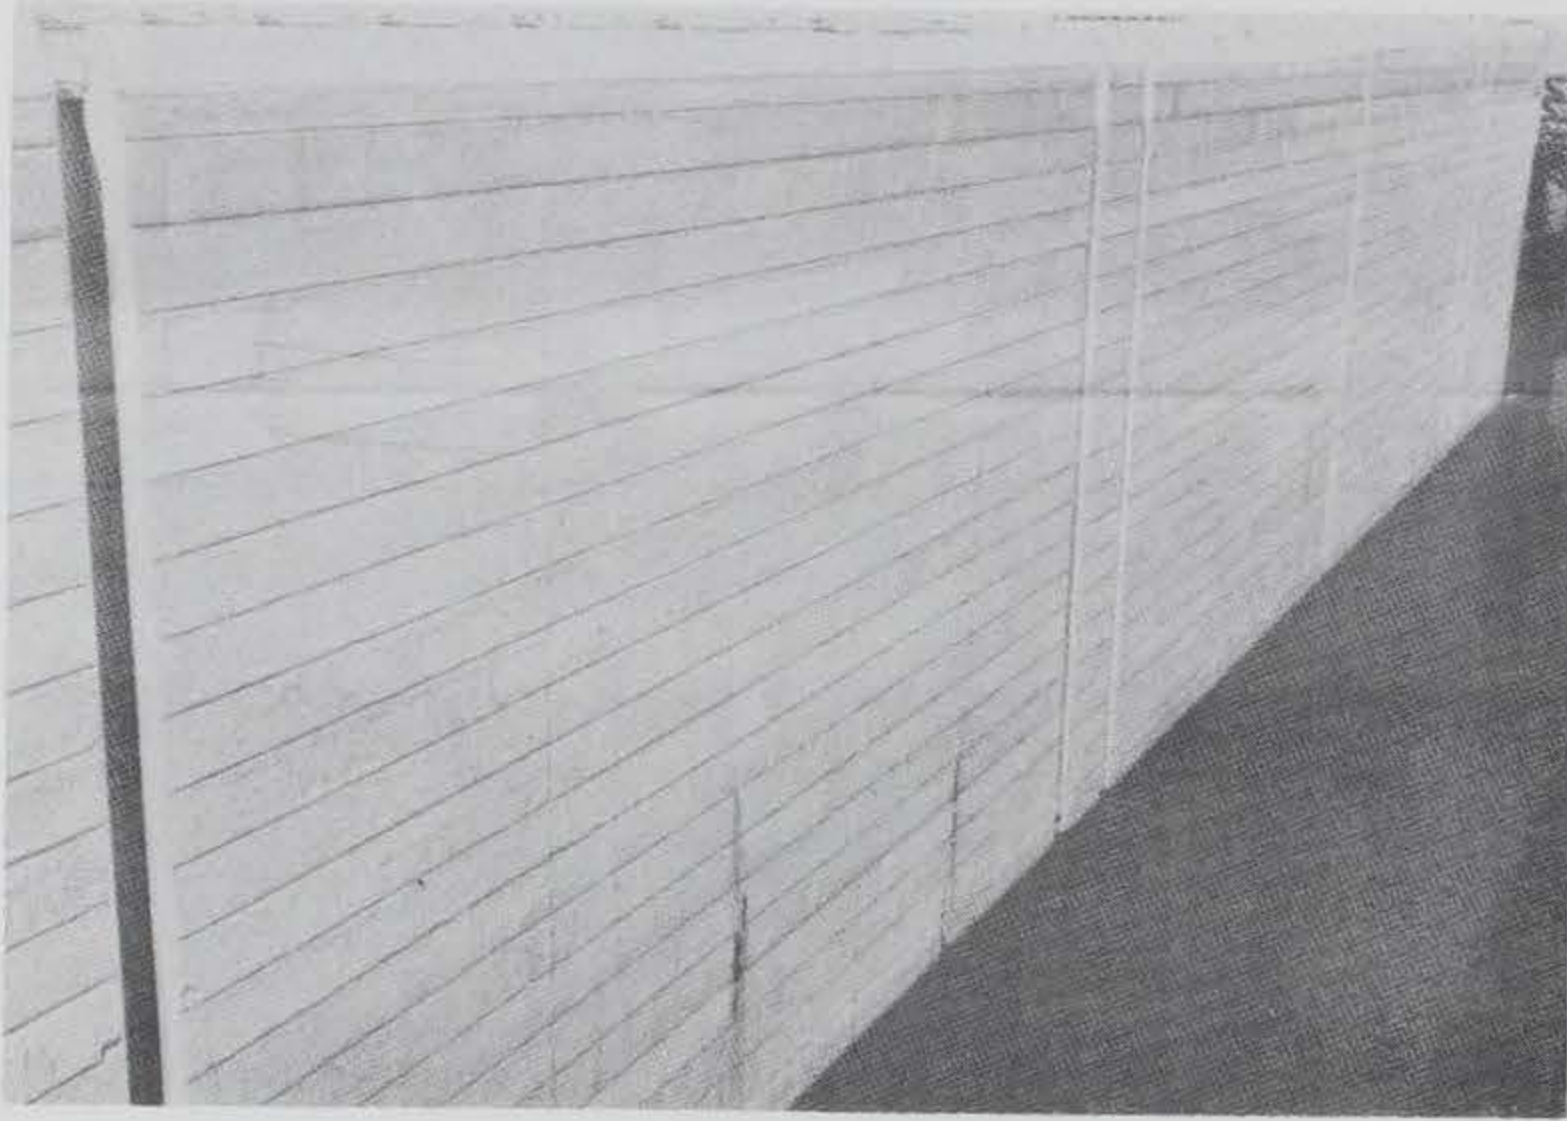
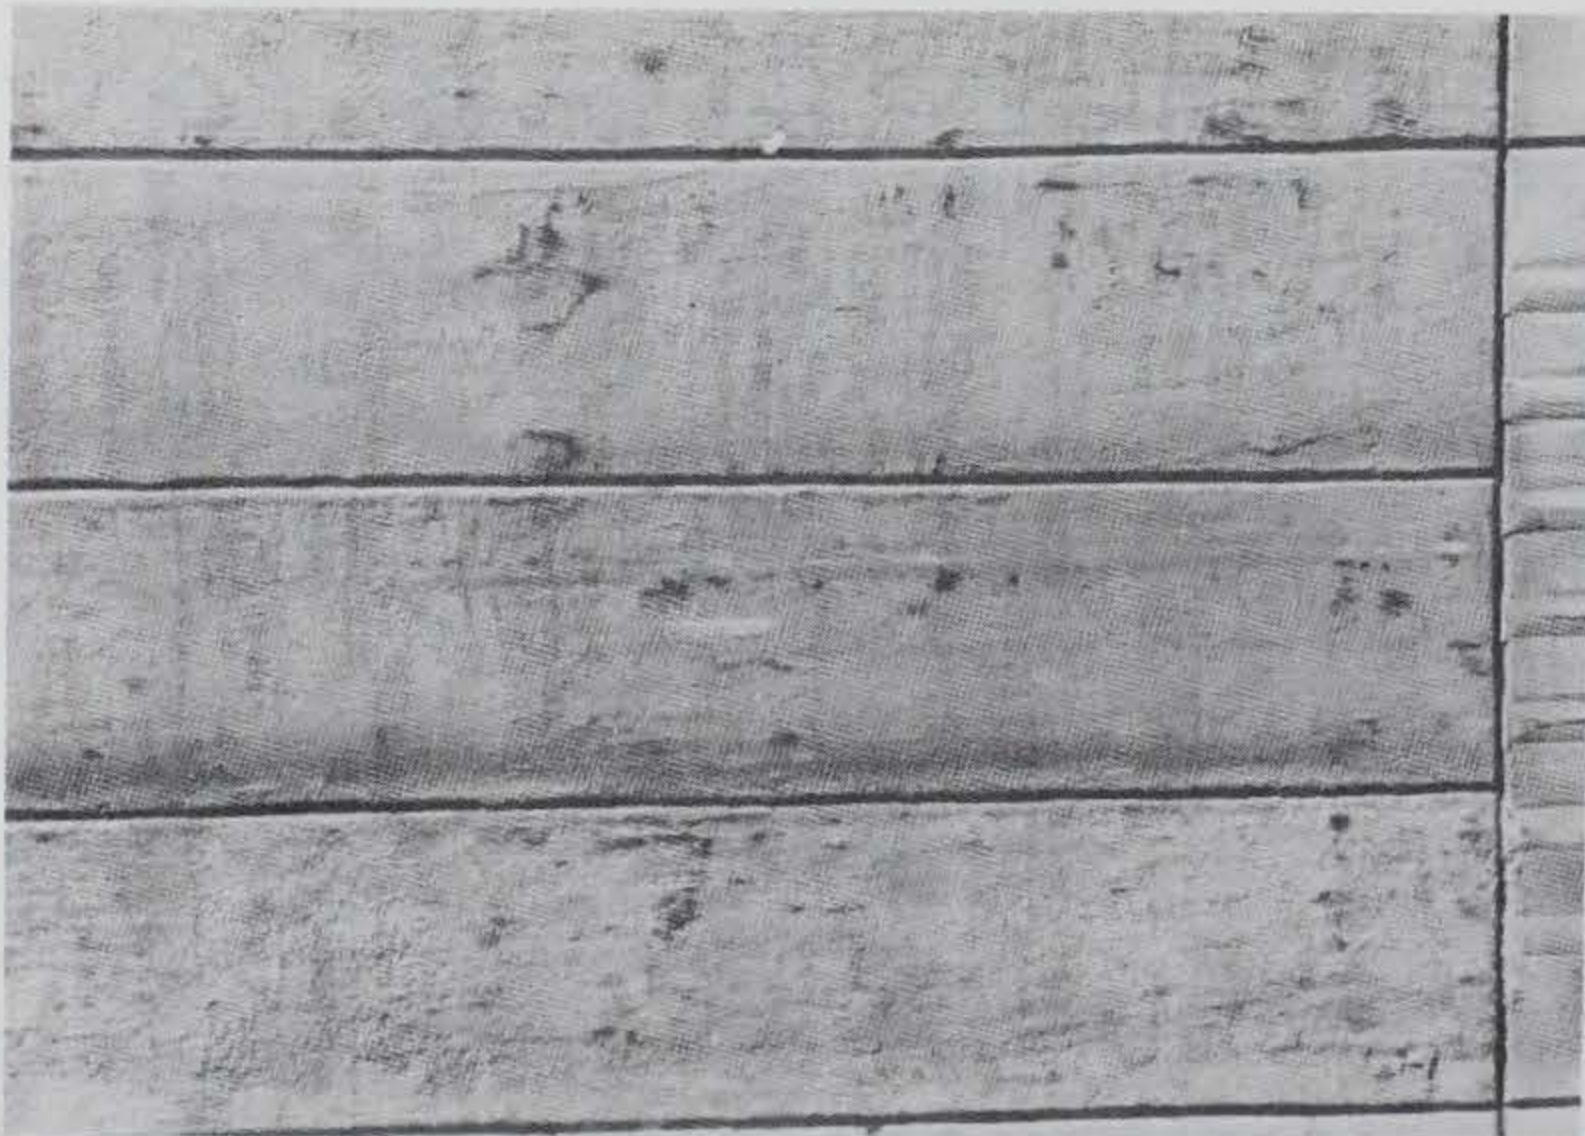
Figure 119. Condition of the coating after about six months in service, Lower Monumental Lock

270. After about six months in service, the coating appeared to be in good condition as shown in Figure 119. During the June 1981 lock outage, approximately one year after the coating was applied, the lock walls were evaluated by soundings, visual examination, and core drilling. Based on soundings at a typical 45-ft wide by 100-ft high section of monolith 15, it was concluded that 99.2 percent of the coating was fully bonded. About 20 unbonded areas were found. Generally, the unbonded areas were about 1 sq ft or less in area and located just below a lift joint or adjacent to a monolith joint. These unbonded areas were attributed to the fact that the workmen who applied the coating had a natural tendency to underspray or underroll near lift joints. Also, because of the nature of the coating material, it usually would pull loose or slough near monolith joints when it was trimmed to maintain the joint line. It would then be rerolled as best as was practical, but apparently this procedure was not totally effective.

a. Overall view of north wall

b. Evidence of barge impact on the coating
