TECHNICAL REPORT REMR-CS-13

**REHABILITATION OF NAVIGATION  
LOCK WALLS: CASE HISTORIES**

James E. McDonald

December 1987

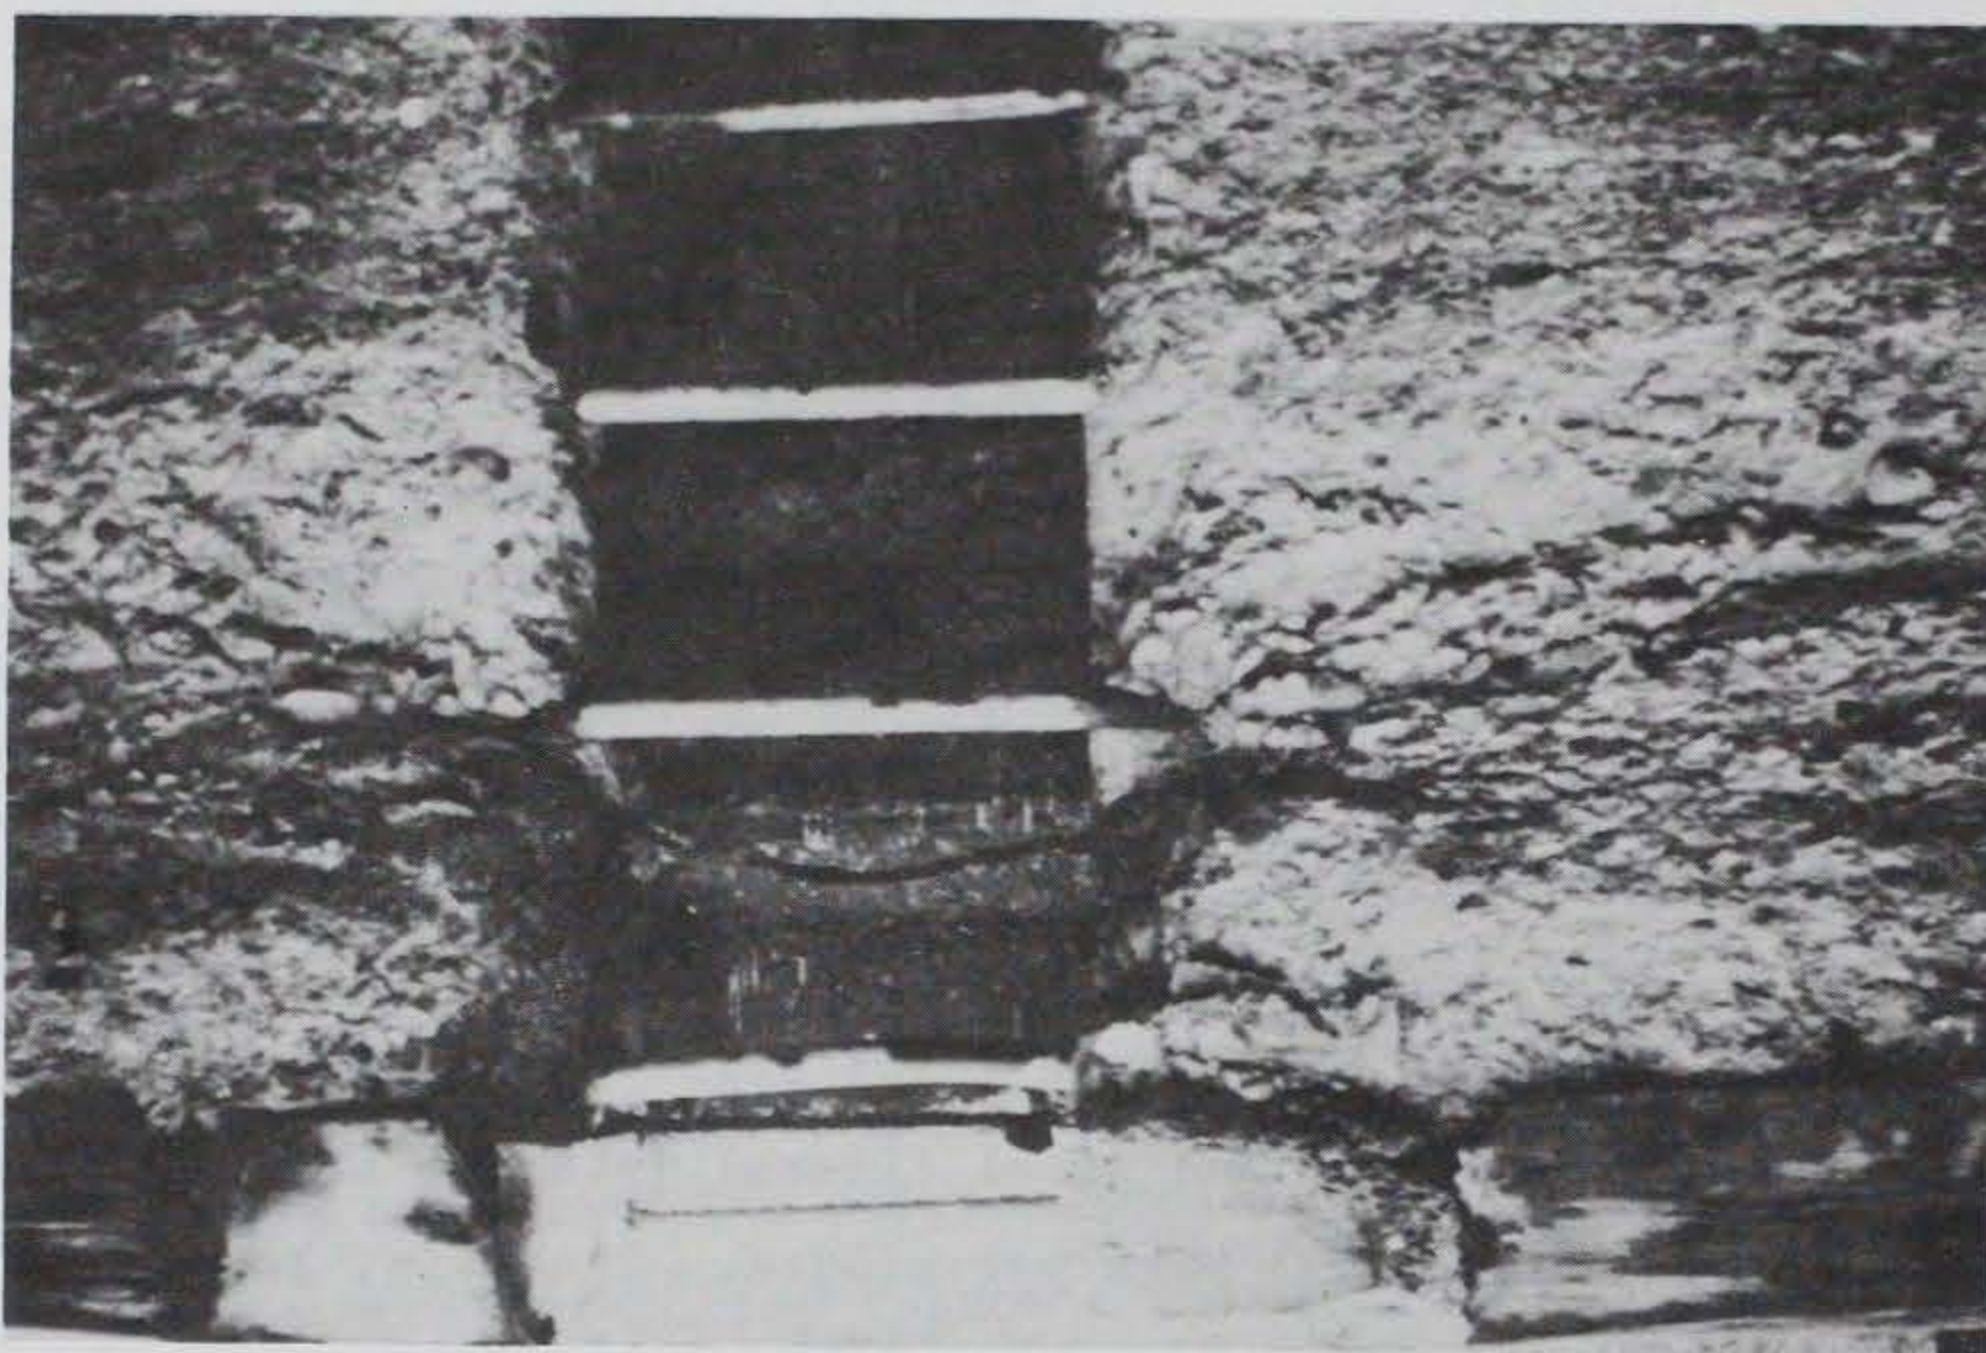
Figure 121. Typical concrete deterioration in upstream guide wall, 1980, Emsworth Locks

284. In November 1980, a demonstration repair was conducted at Emsworth Locks to evaluate the potential of steel fiber-reinforced shotcrete as a repair material. A section of the original upstream guide wall (Figure 121) was cleaned with a high-pressure water jet, and one monolith joint was chipped out in a vee shape to a depth of approximately 6 in. (Figure 122). A strip of joint filler board was placed in the vee joint prior to shotcreting. A dry mix of Fibercrete (sand, cement, and steel fibers) in 60-lb bags was hand-fed into a hopper at a rate of 2 to 3 bags per minute. The 1-in. long steel fibers with hooked ends were 2 percent by weight of the Fibercrete mixture. Water was added at the nozzle via a connection with the local water system. The vee joint was completely filled, and 1 to 2 in. of Fibercrete was placed over the remainder of the test section (Figure 123). Rebound was estimated at less than 10 percent. Although not done for the test section, a striker could be used to shave the wall after it was shotcreted to obtain a smooth surface.

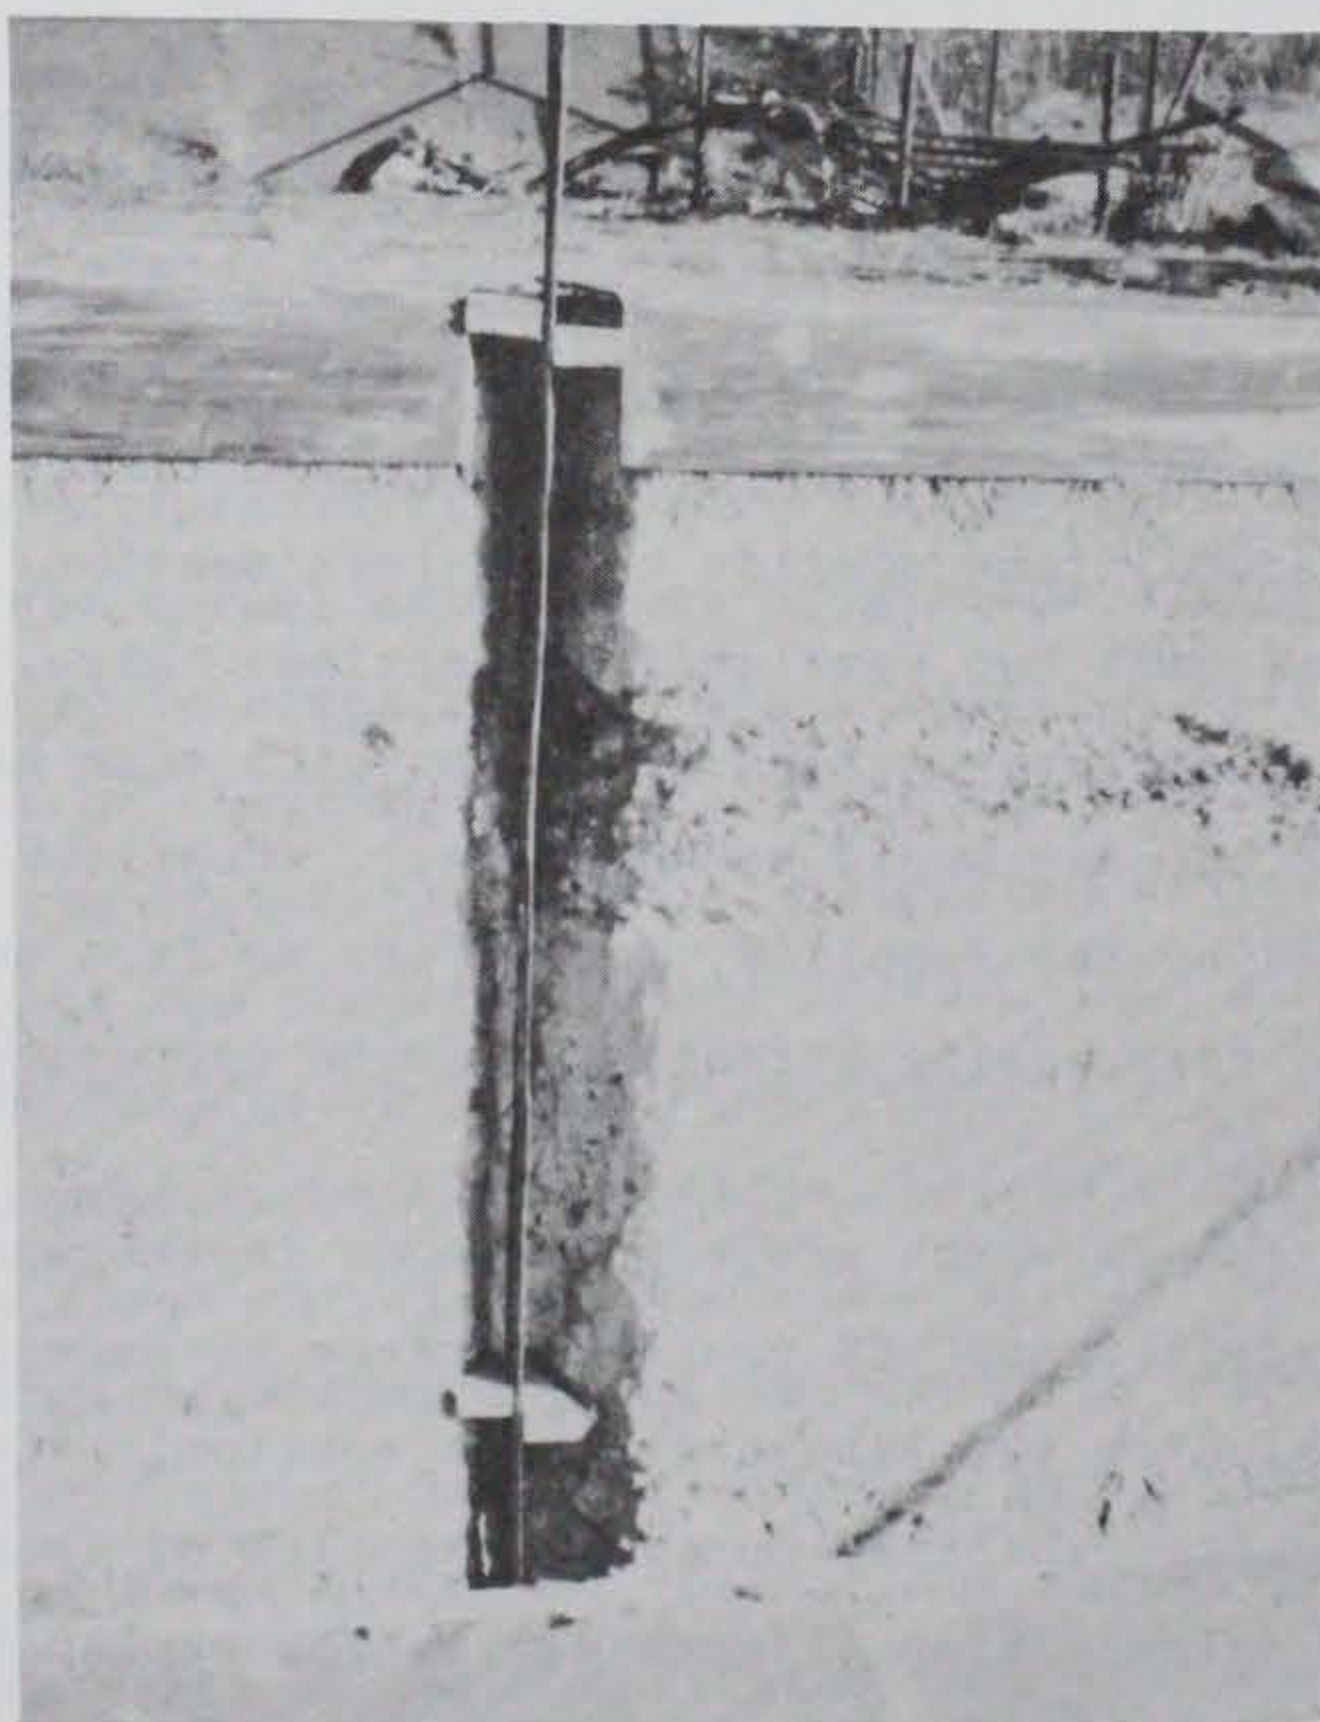
Figure 122. A portion of the prepared test section prior to Fibercrete application, November 1980, Emsworth Locks

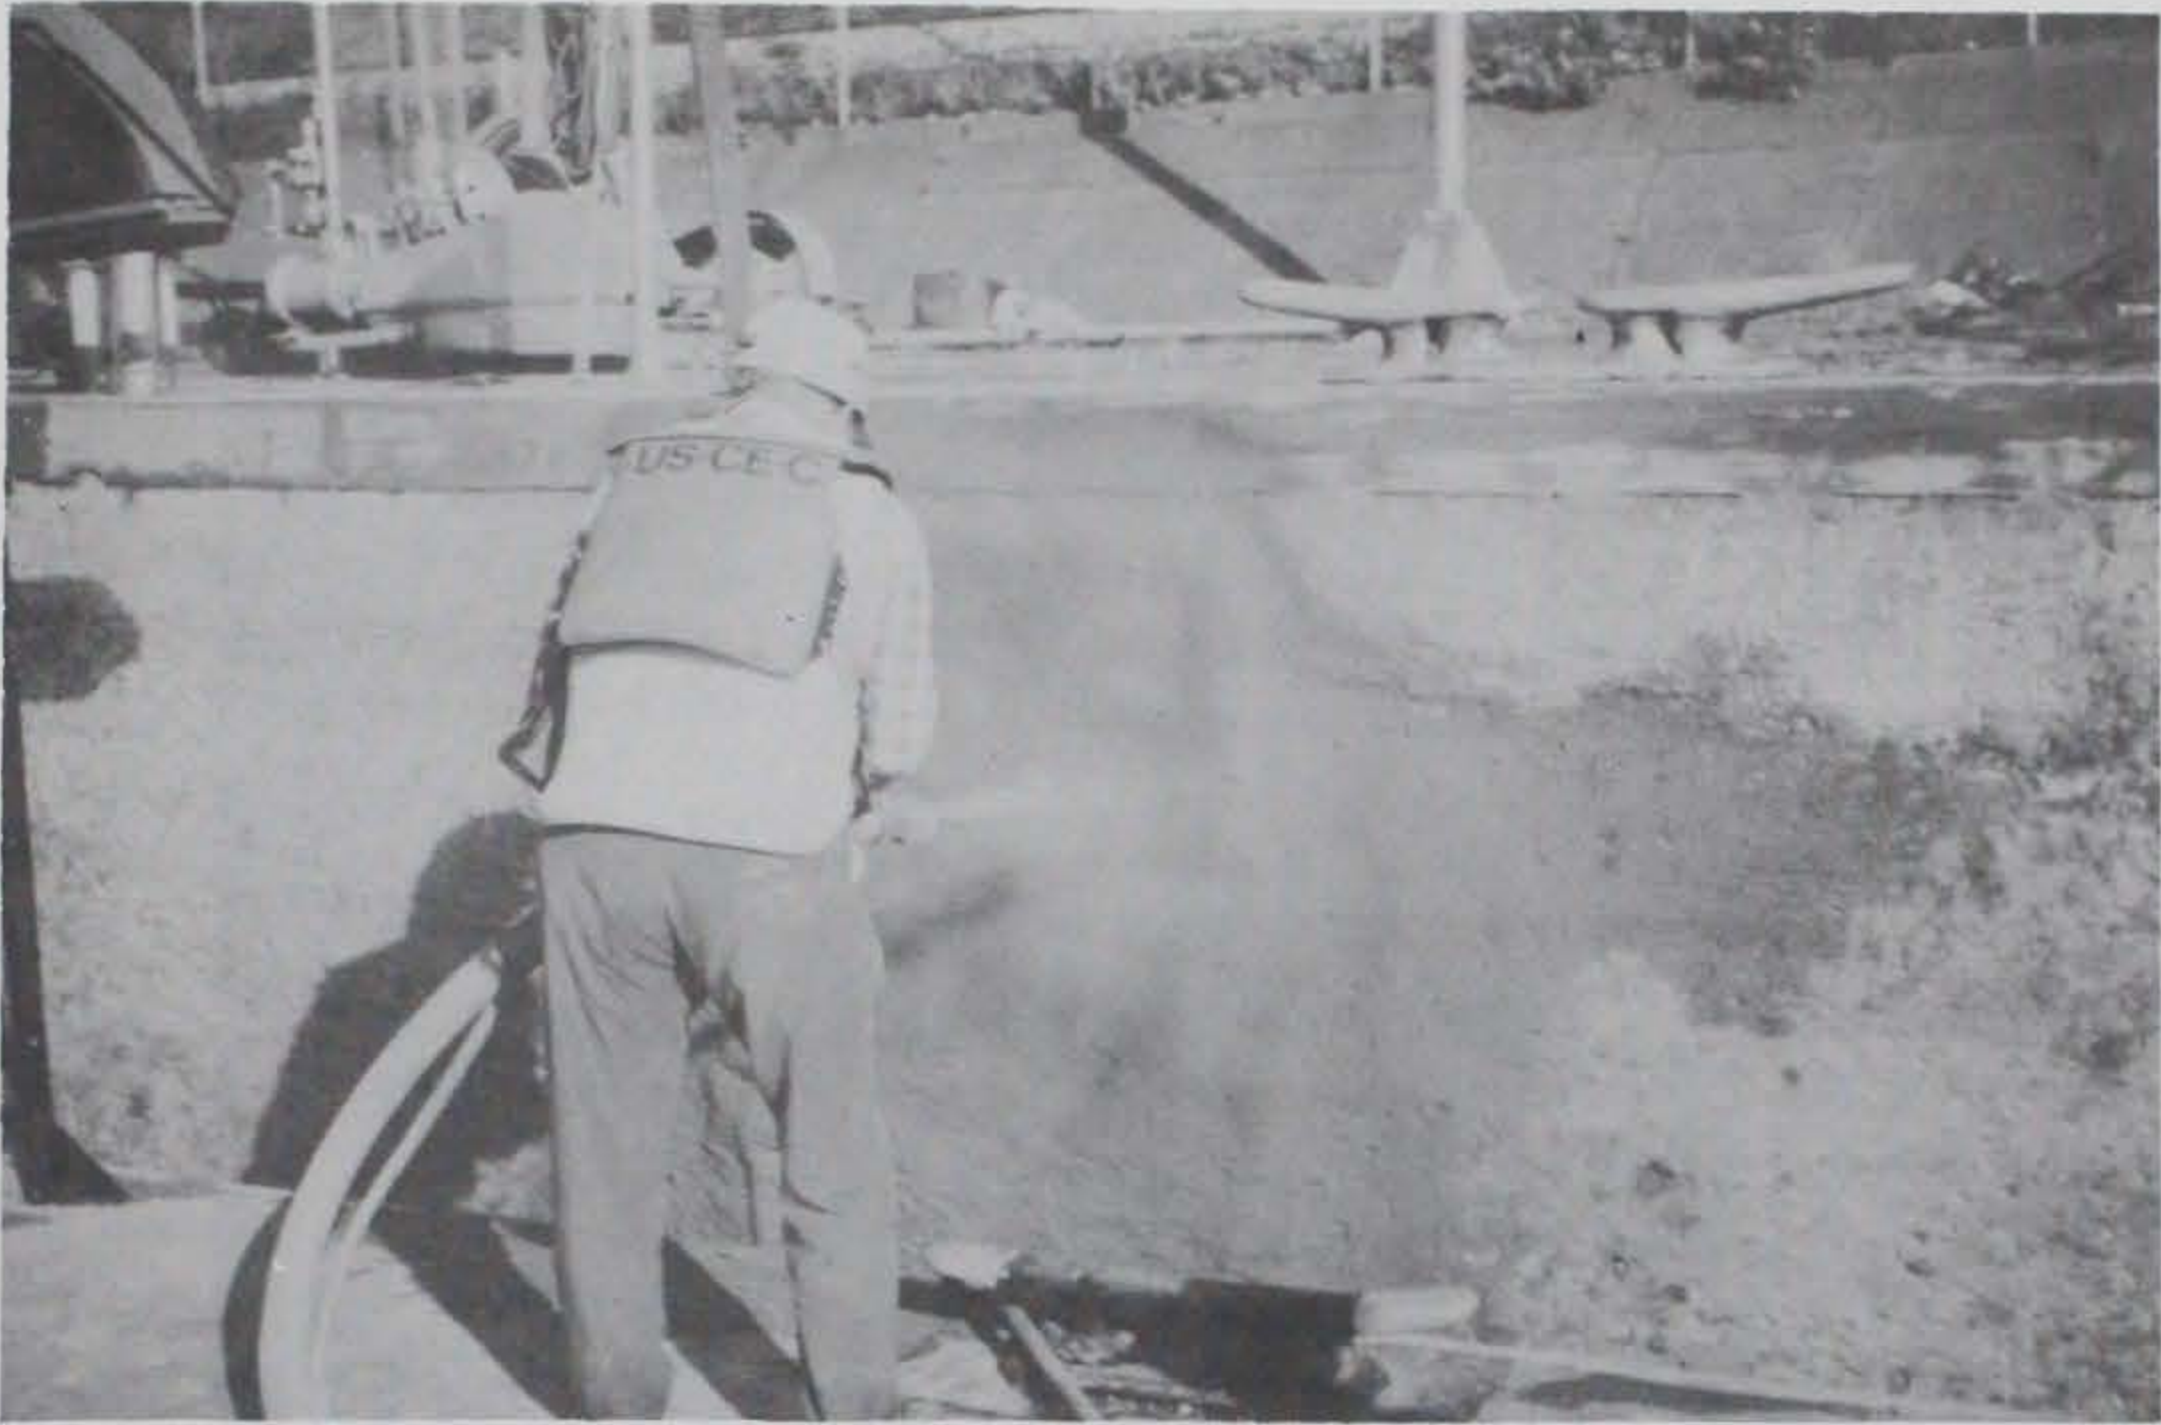
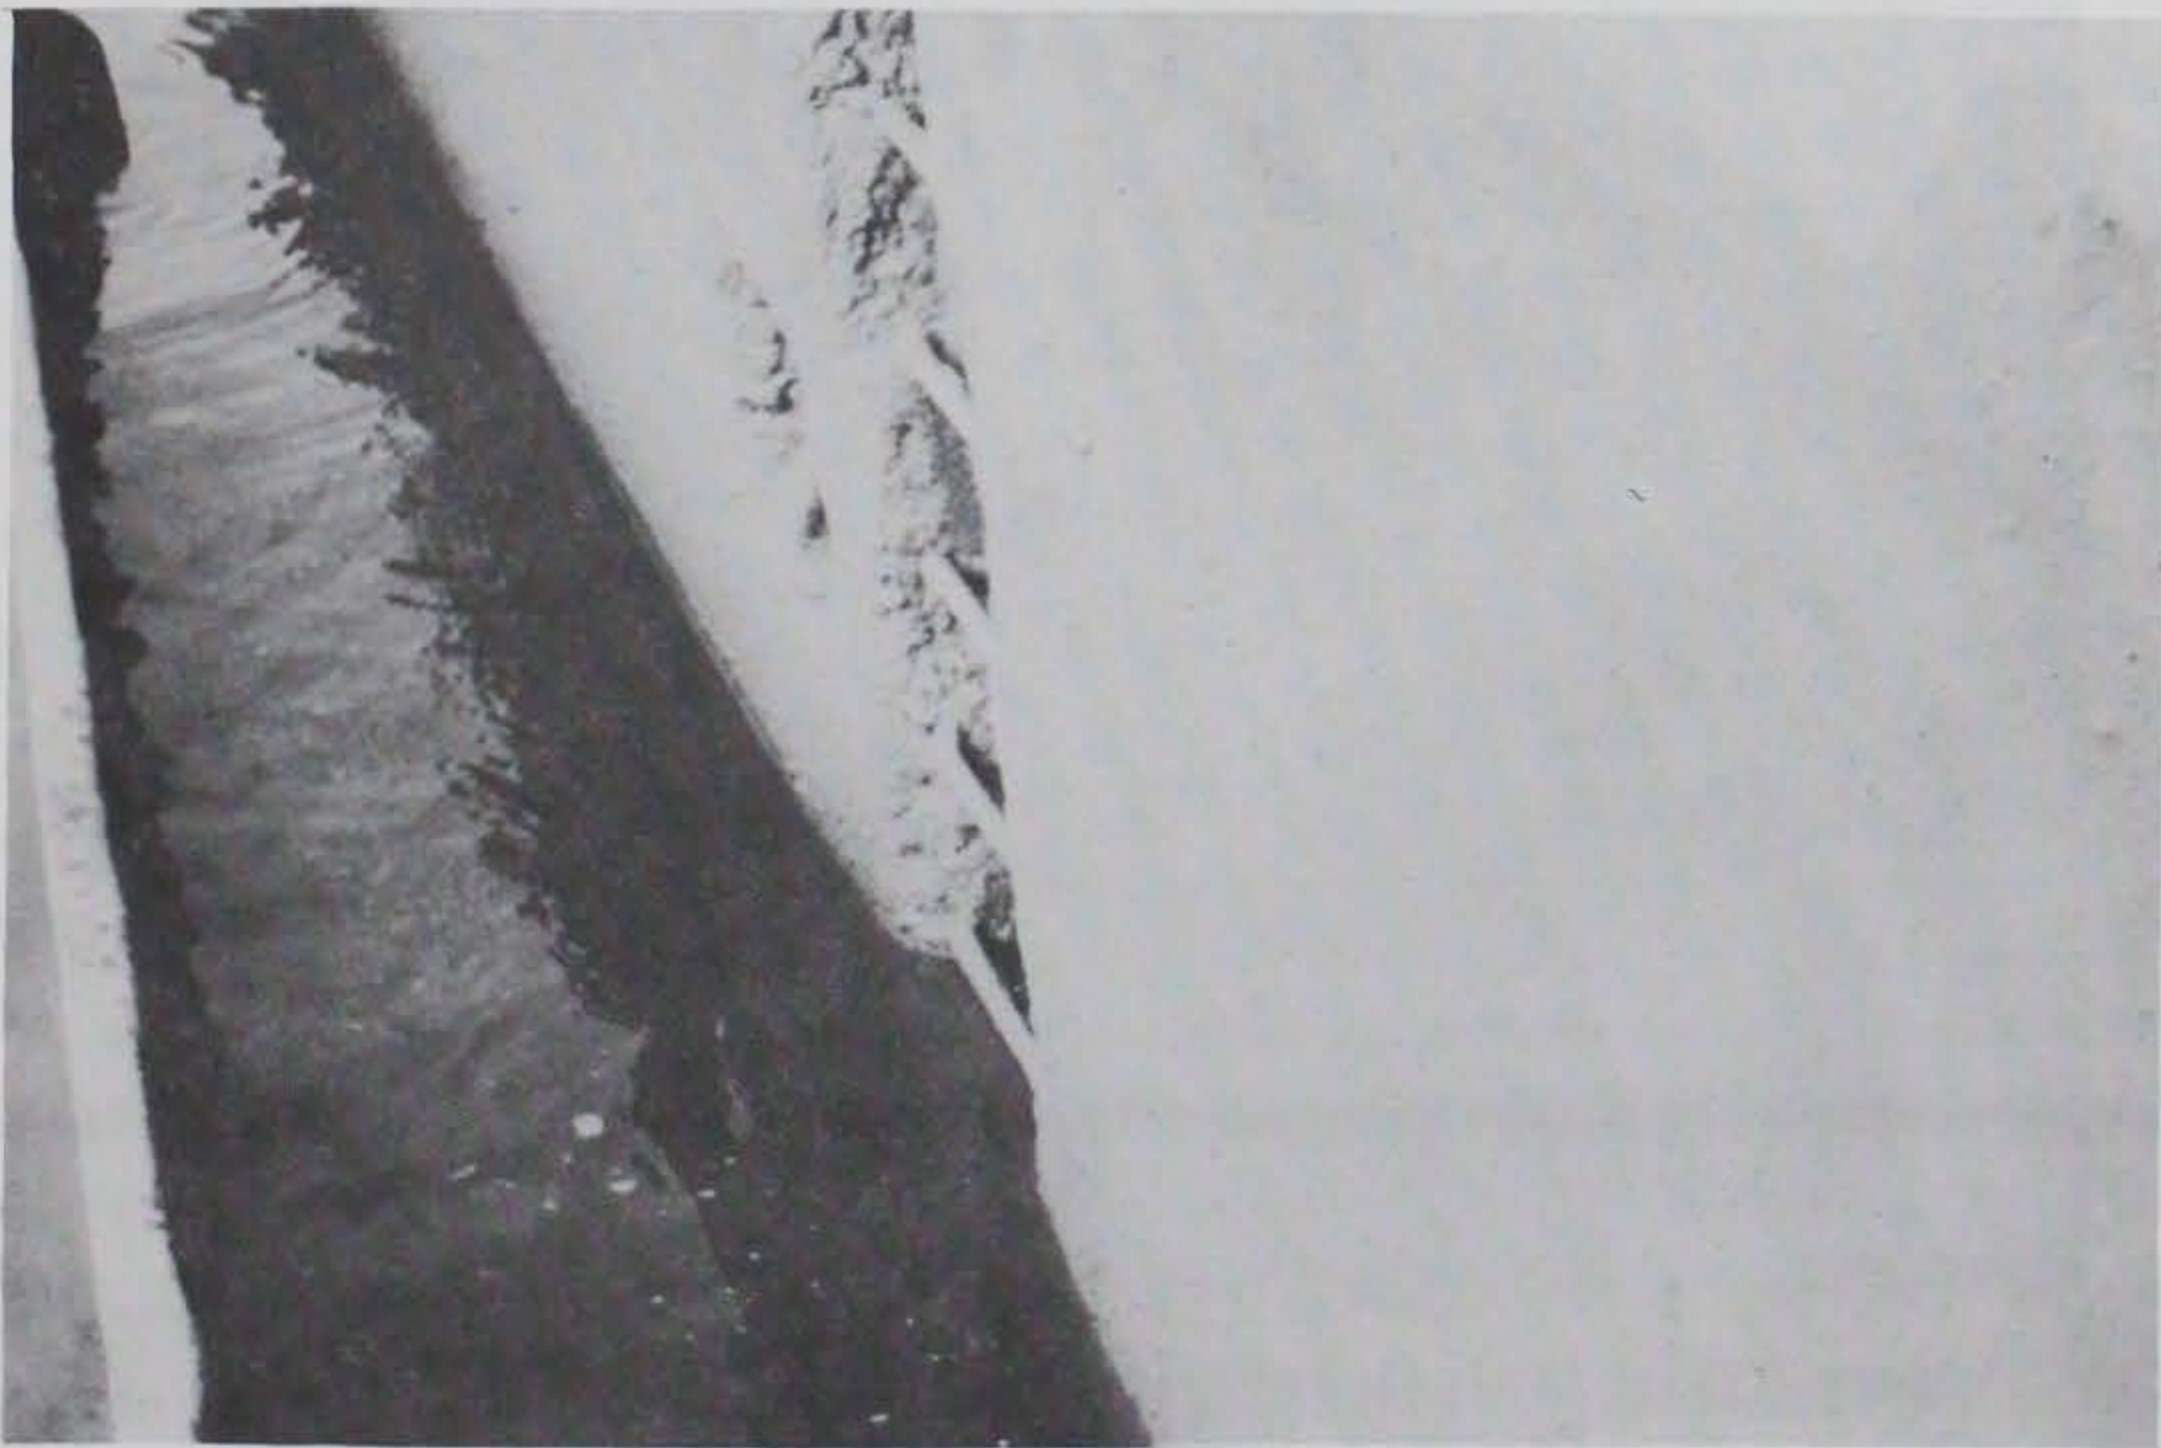
Figure 123. Fibercrete test section, November 1980,  
Emsworth Locks

a. Application

b. Portion of completed test section

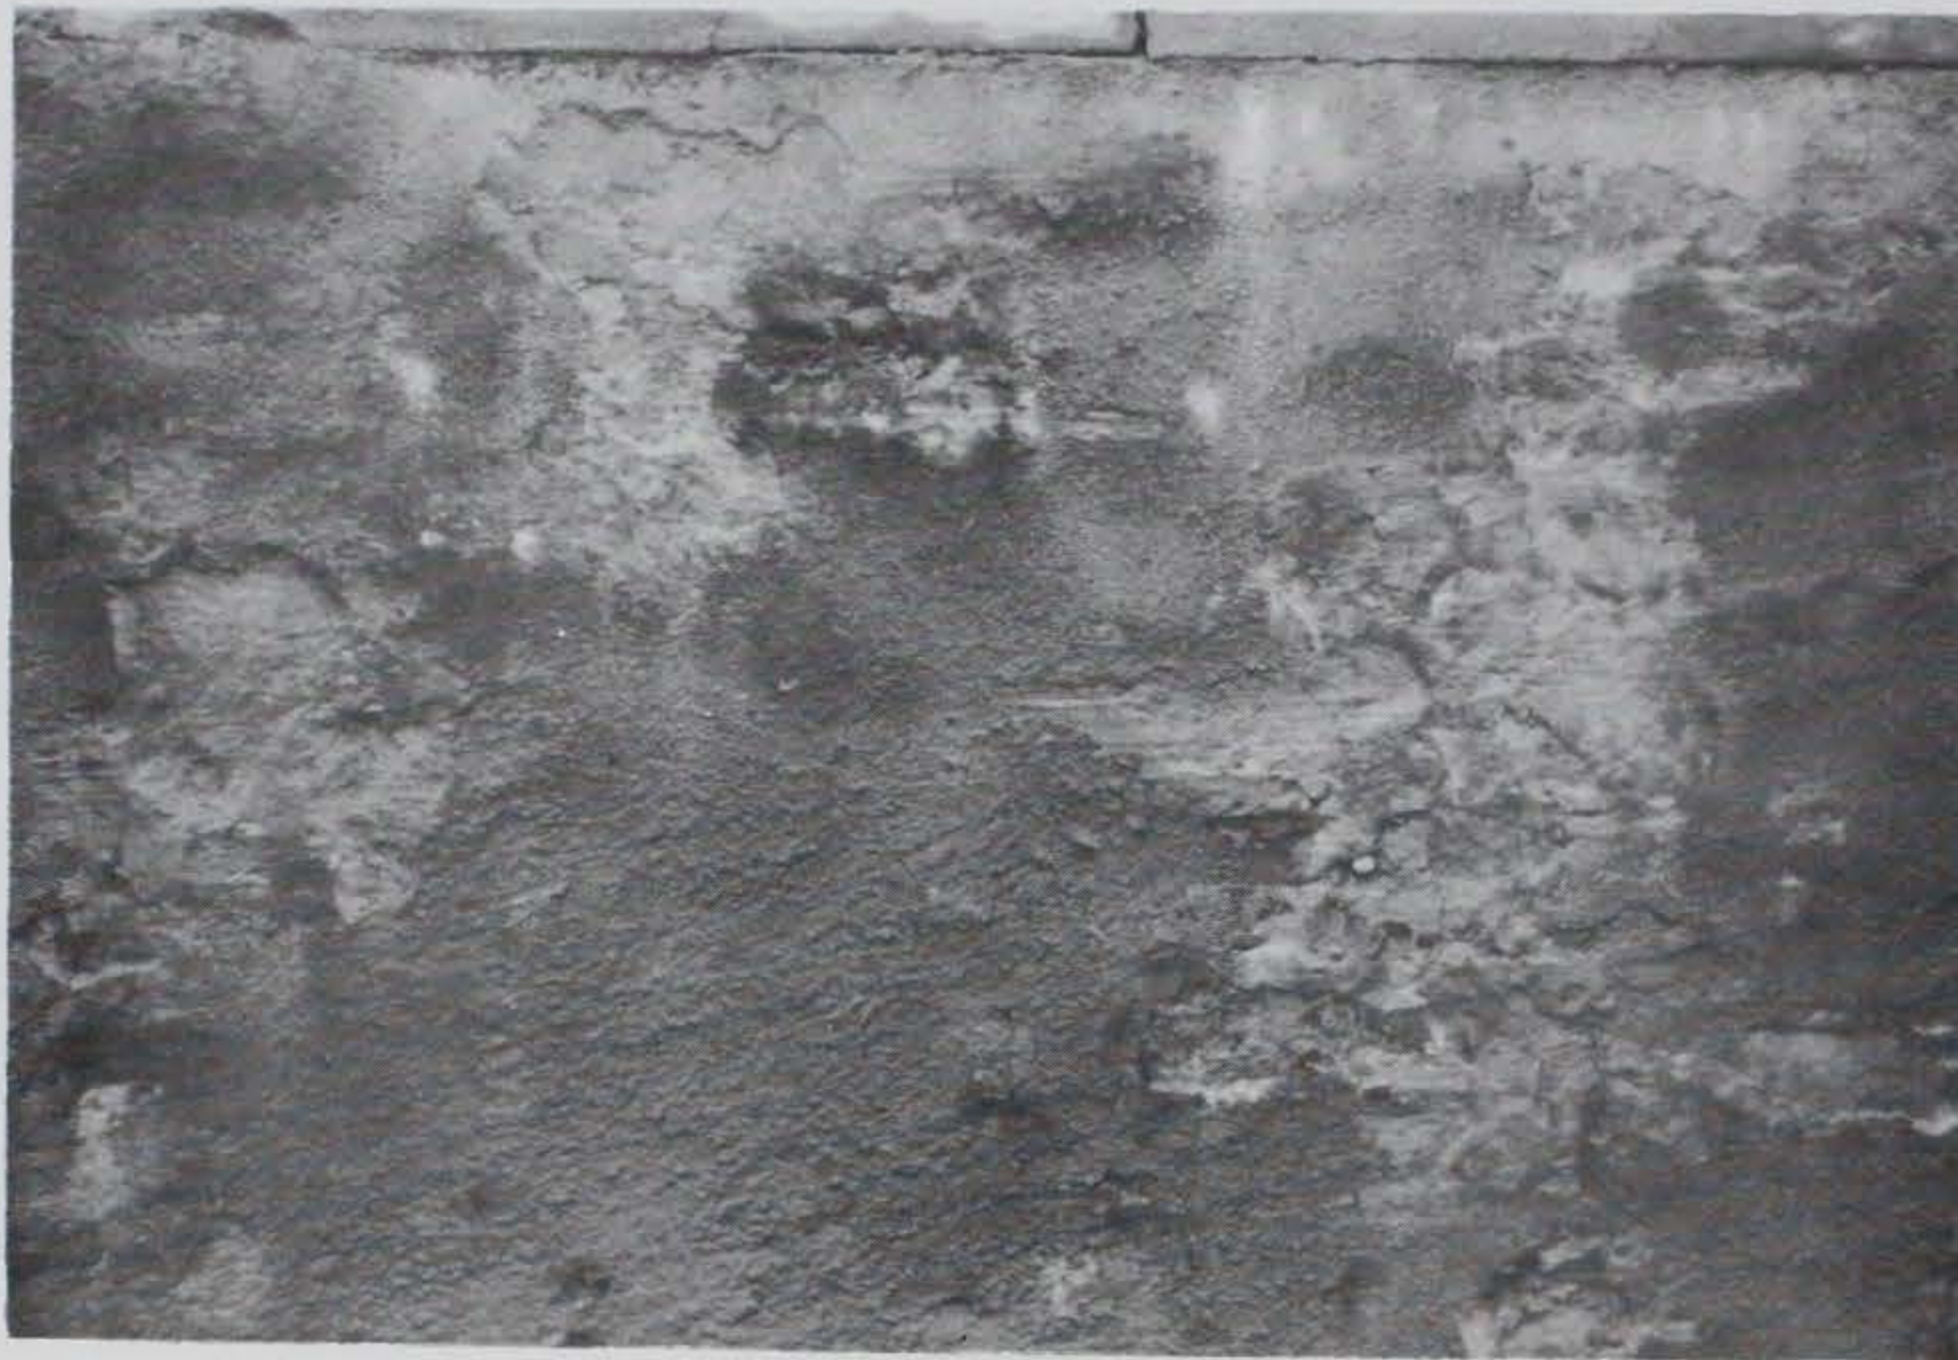
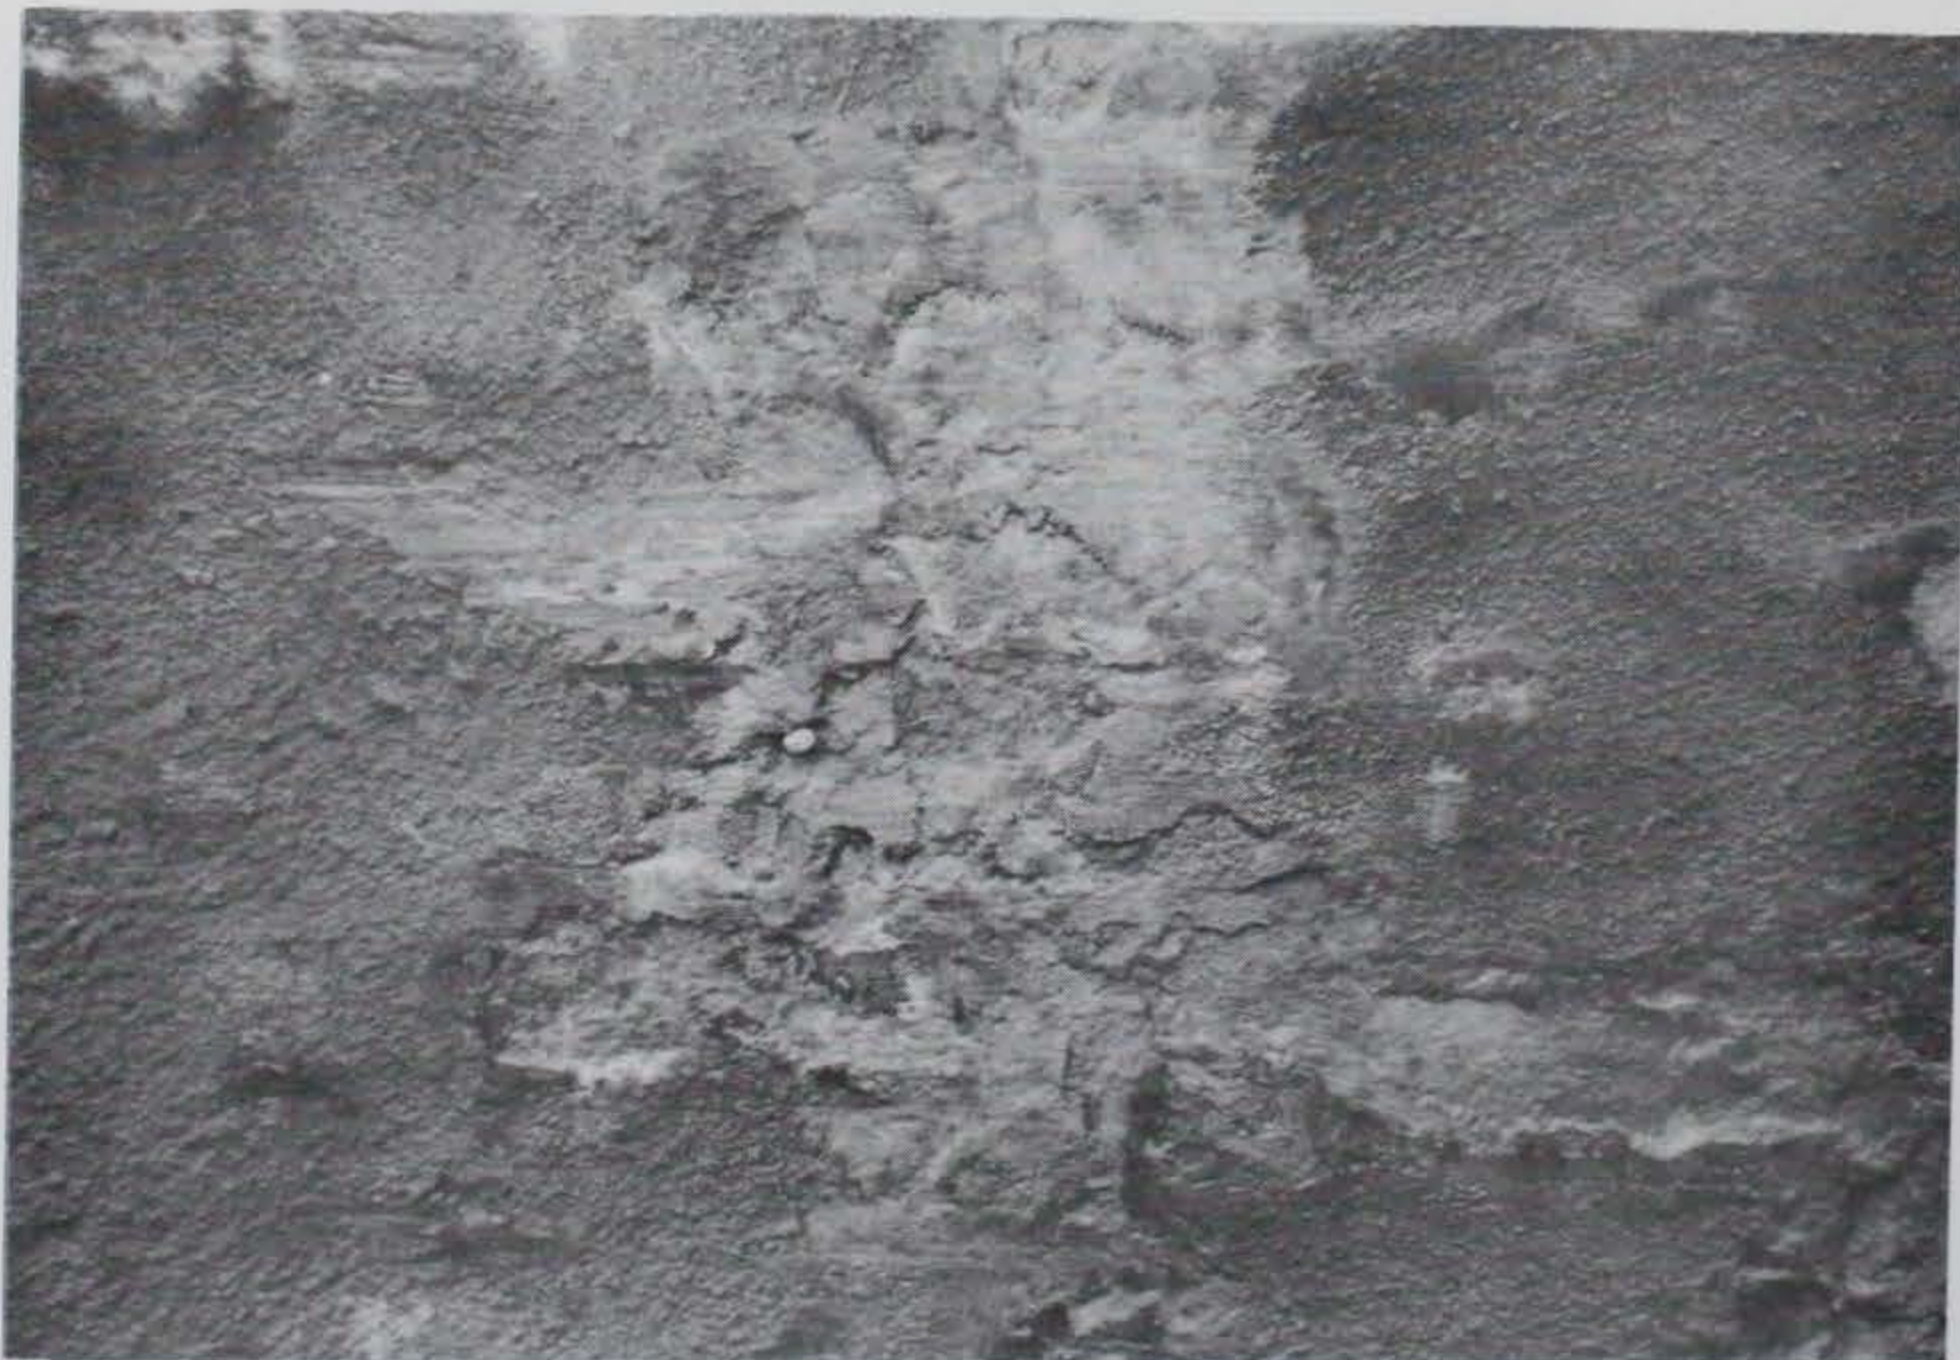
286. A tour of the Emsworth project was made in February 1981 by HQUSACE, Division, District, and WES representatives to examine the condition of the structures, including the Fibercrete test section. After three months in service, the Fibercrete exhibited numerous examples of impact failure, abrasion erosion, and delamination (Figure 124). The explanation for the poor performance of the Fibercrete was that the prepackaged mixture used in the demonstration contained only 60 lb/cu yd of fibers, whereas in the actual

Figure 124. Typical examples of Fibercrete condition, February 1981, Emsworth Locks

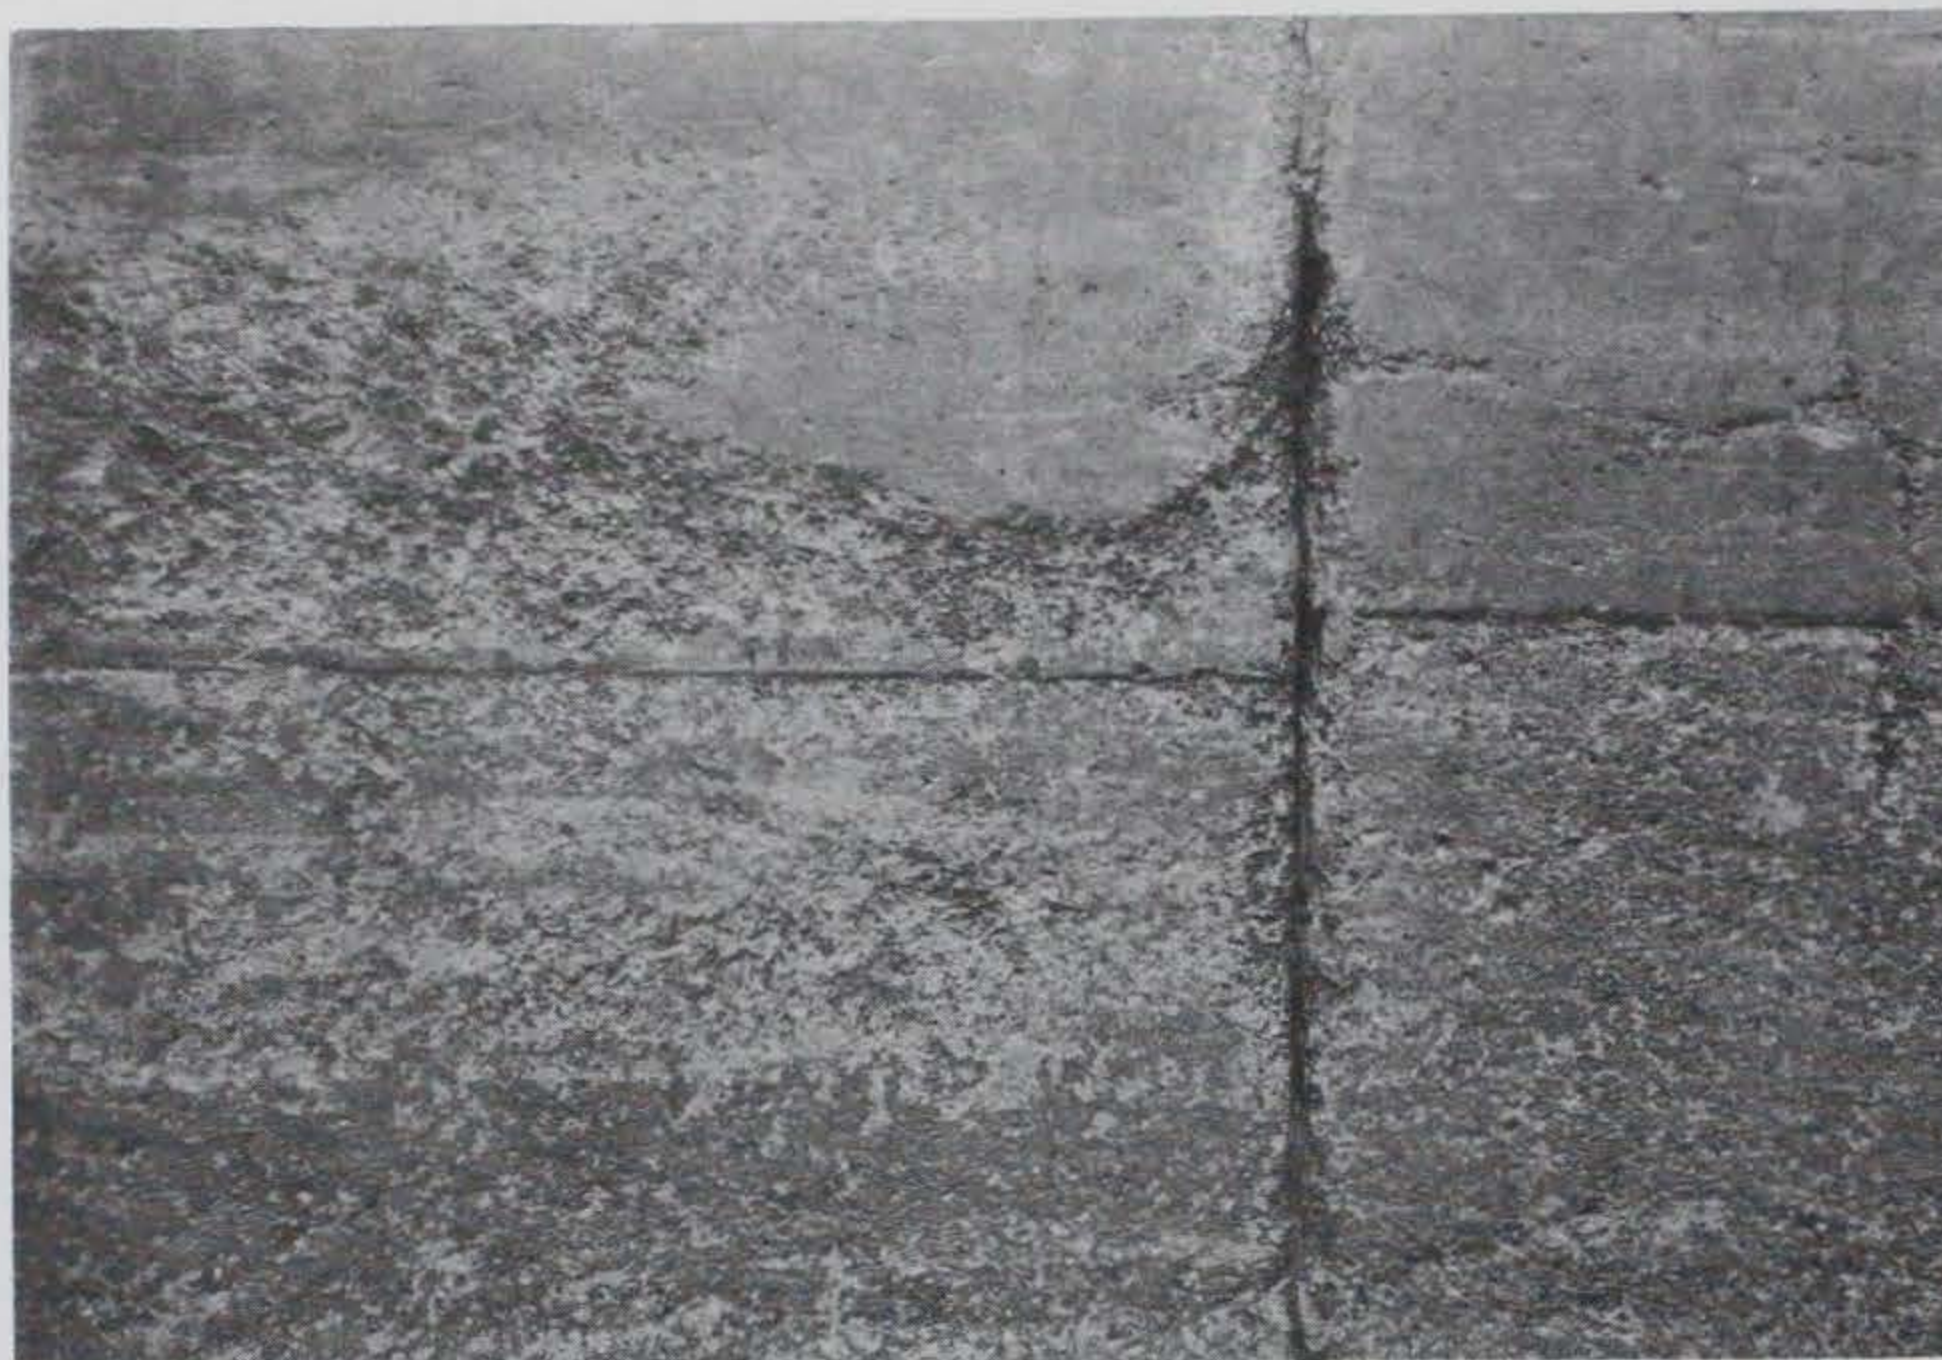
287. Considering that the larger land chamber receives most of the heavy barge traffic and that the nonair-entrained concrete had been in service for approximately 50 years, surfaces of the land lock chamber walls appeared to be in relatively good condition (Figure 125) when inspected in 1981. One exception was the monolith joints (Figures 125 and 126). Concrete and shotcrete in the smaller river chamber appeared to be in more advanced stages of deterioration, particularly the land wall (Figure 127) where the smaller tows and pleasure craft using this chamber tie up. Spalling appeared to have originated in the upper portion of the wall where the shotcrete was relatively thin and surface preparation minimal. Spalling propagated down the wall to the point where shotcrete thickness (approximately 4 in.) was sufficient to contain dowels and wire mesh (Figure 128). In comparison, the shotcrete on the river wall of the smaller chamber appeared to be in much better condition (Figure 129). Fifty to seventy percent of the existing shotcrete in the river chamber was reported as "drummy" when sounded.

Figure 125. Typical concrete surfaces, land lock chamber wall, 1981, Emsworth Locks
