TECHNICAL REPORT REMR-CS-13

**REHABILITATION OF NAVIGATION  
LOCK WALLS: CASE HISTORIES**

James E. McDonald

December 1987

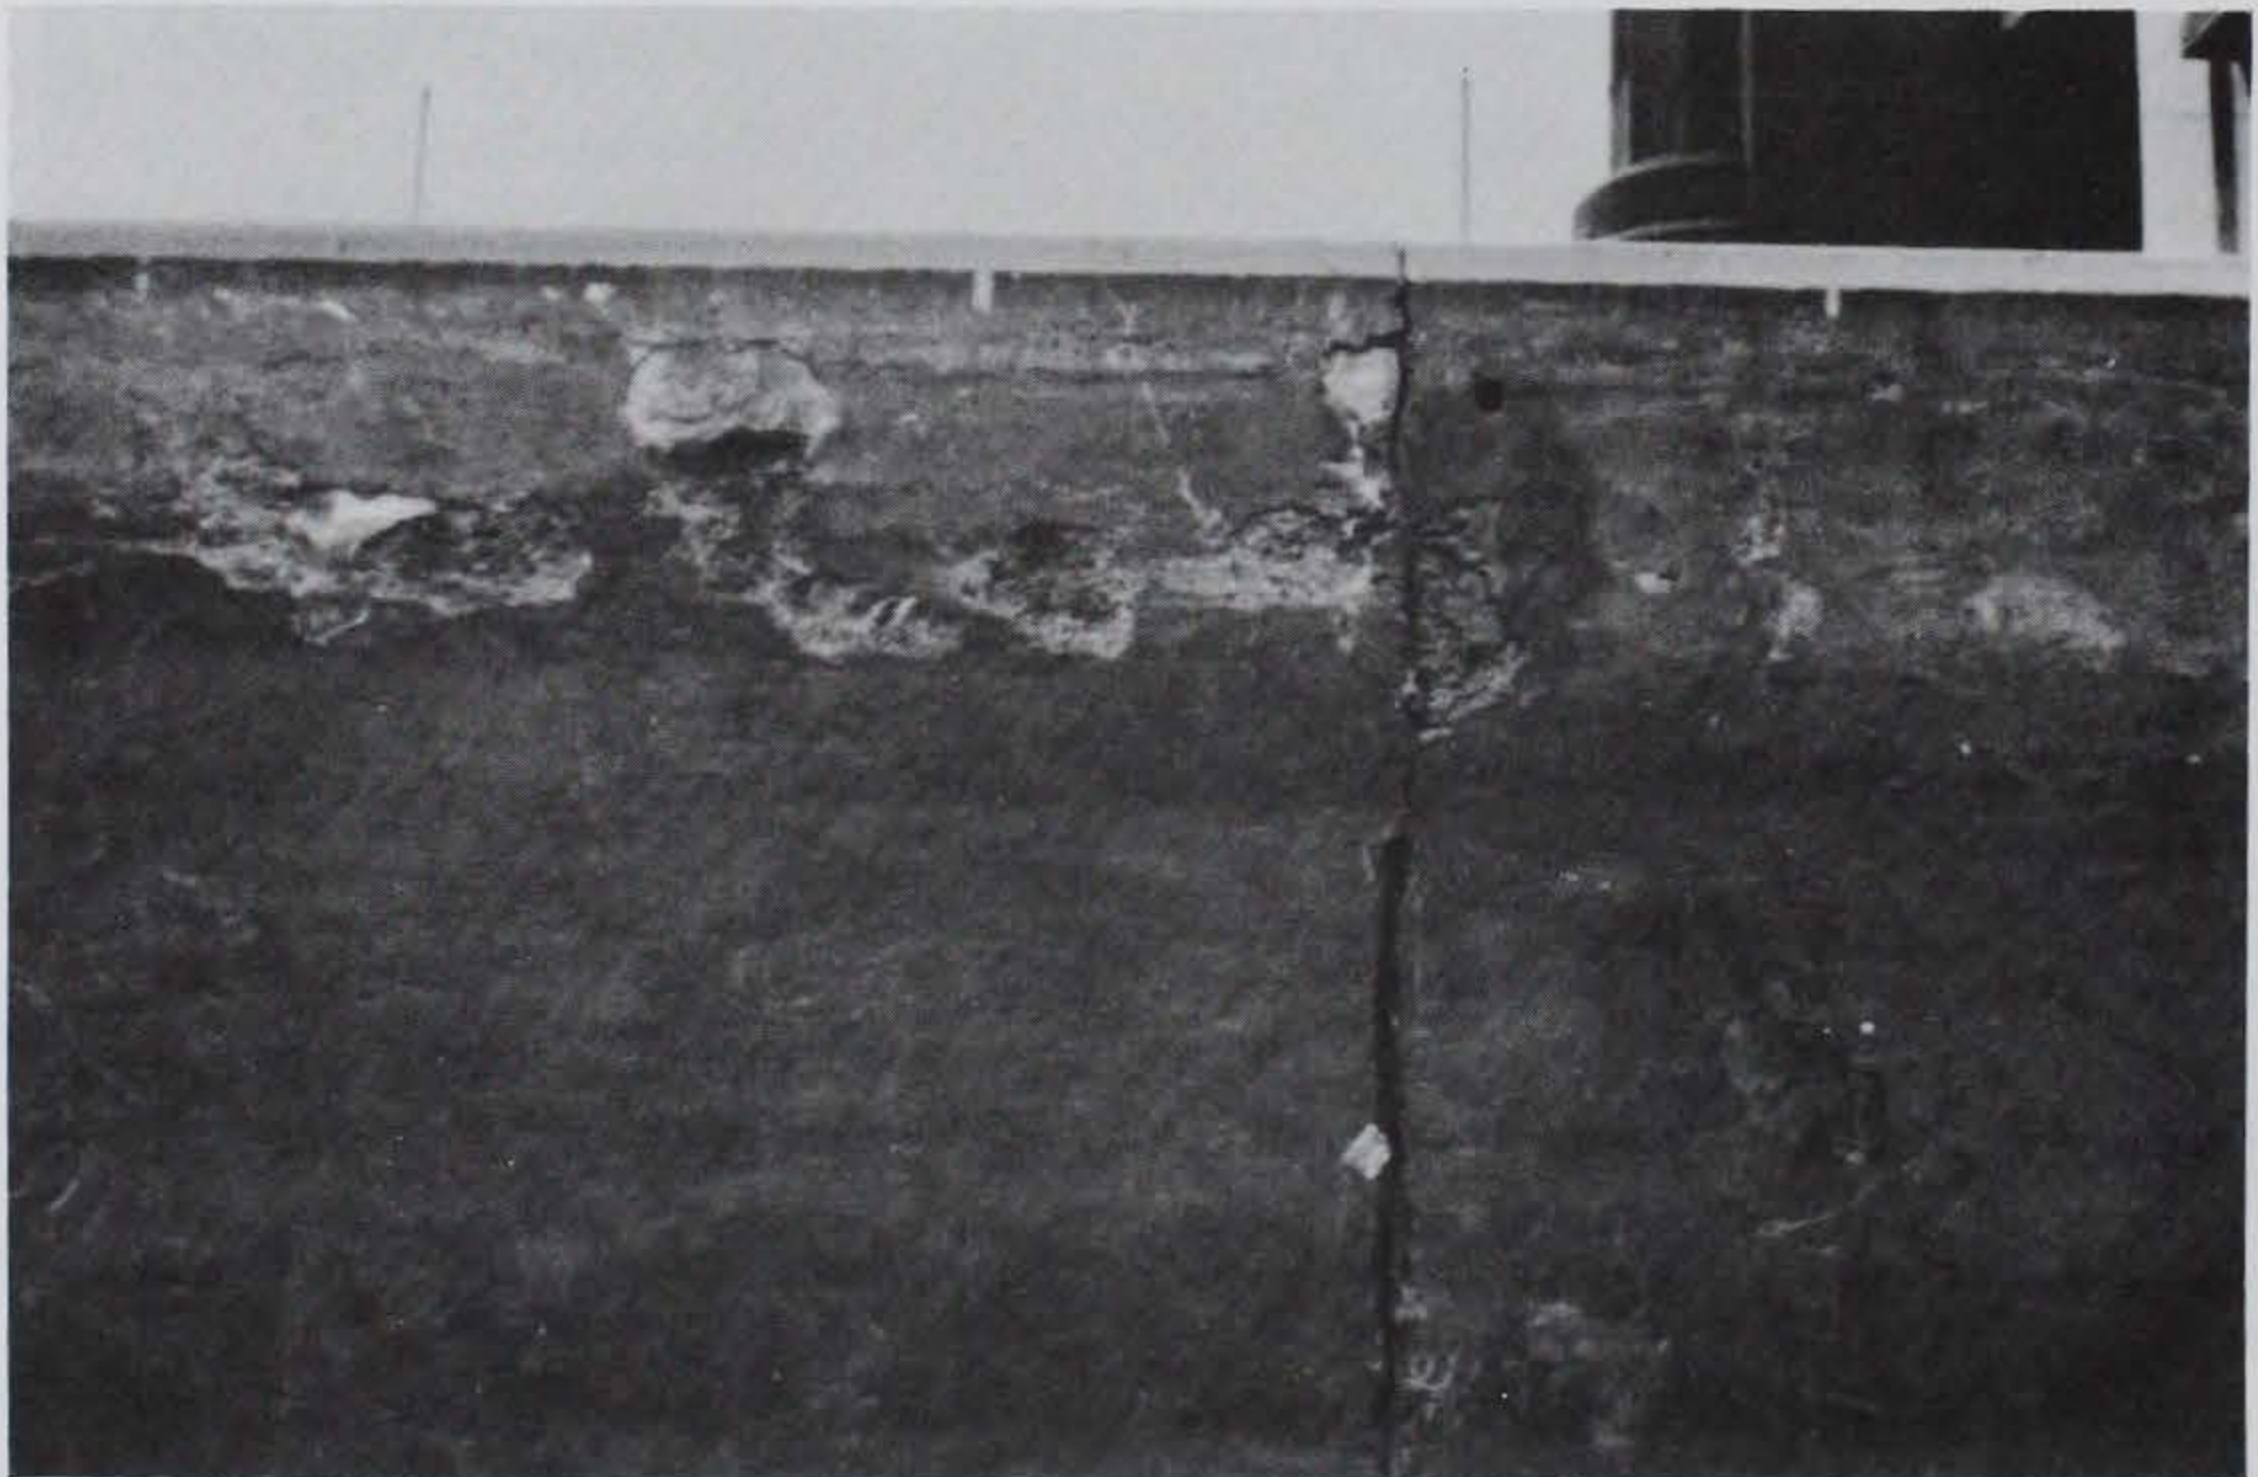
Figure 129. Typical appearance of the river wall in the river lock chamber, 1981, Emsworth Locks

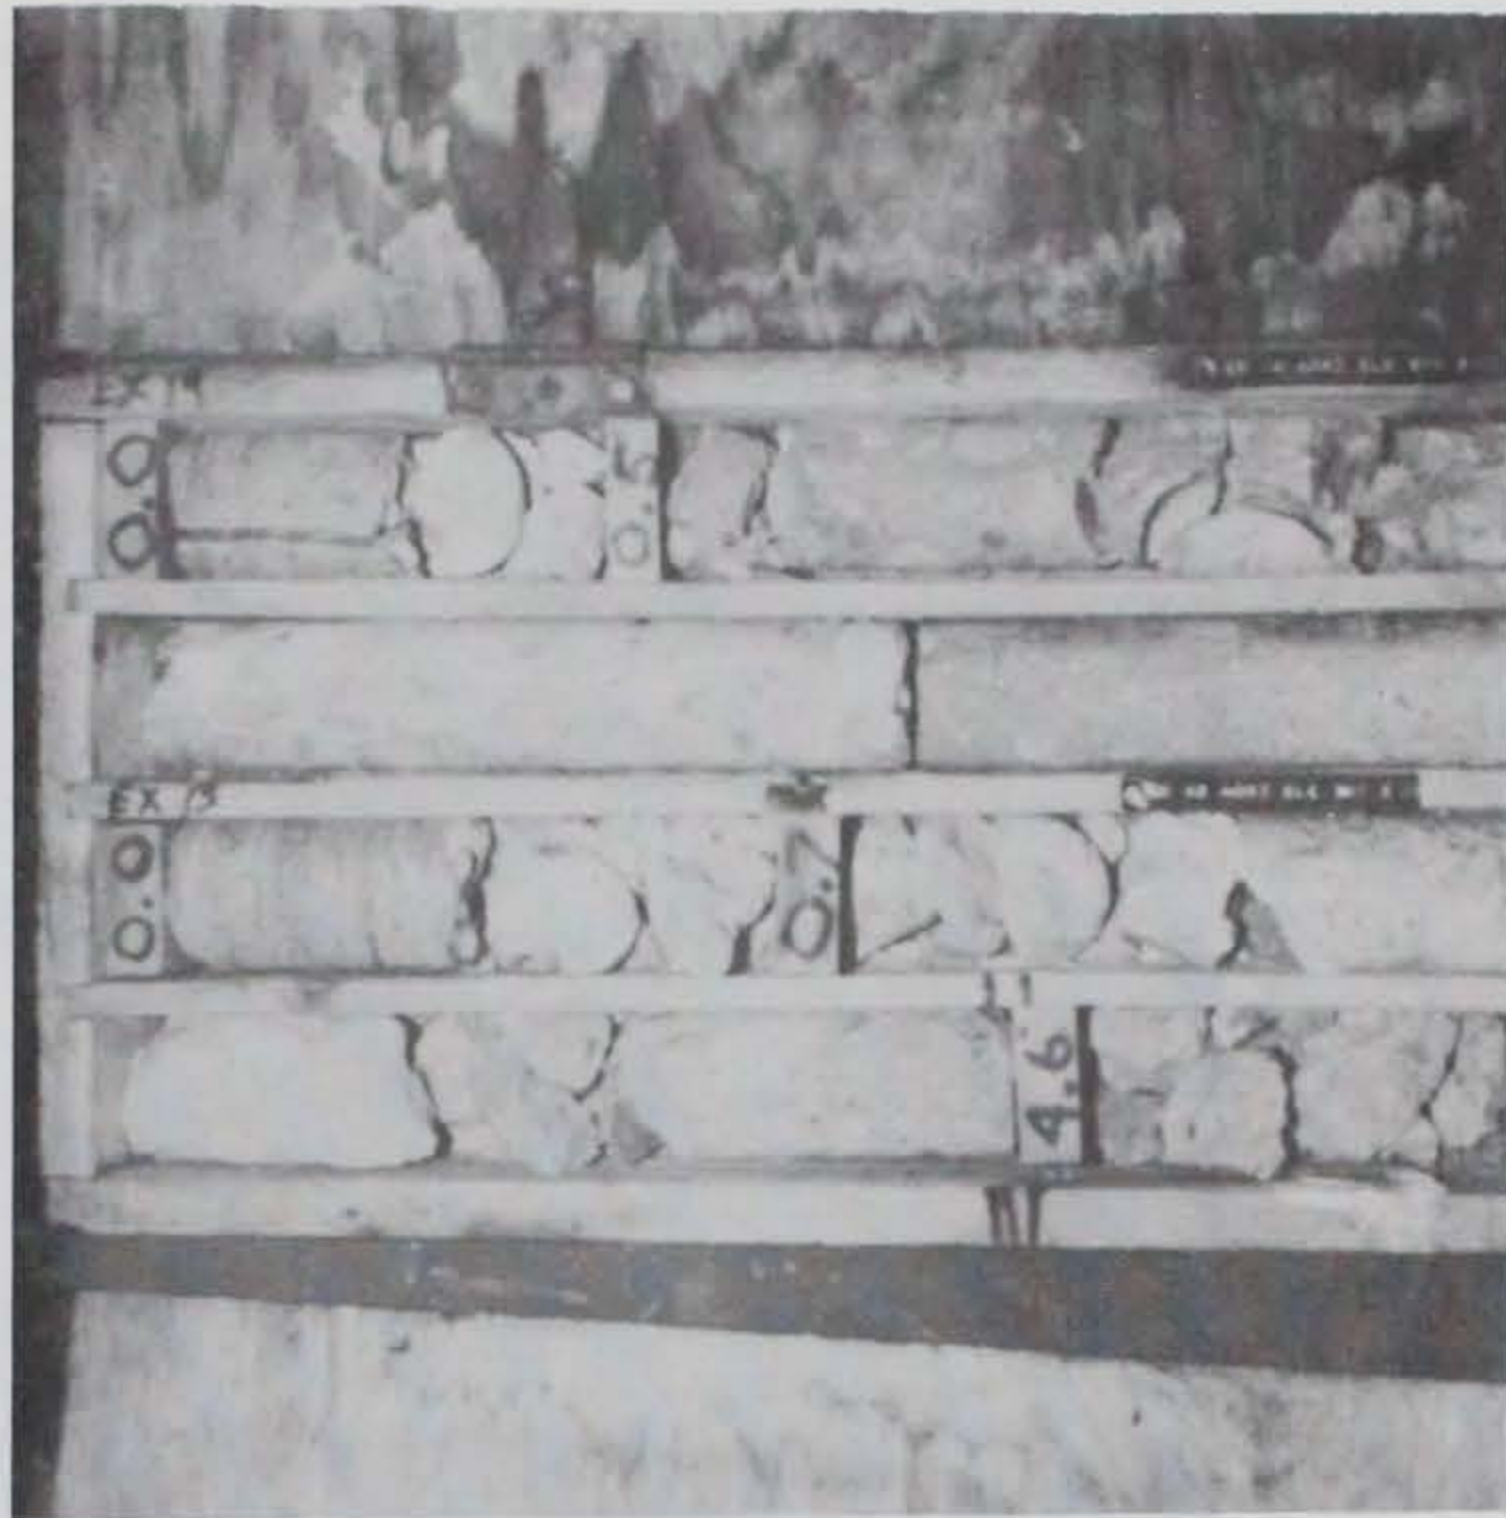
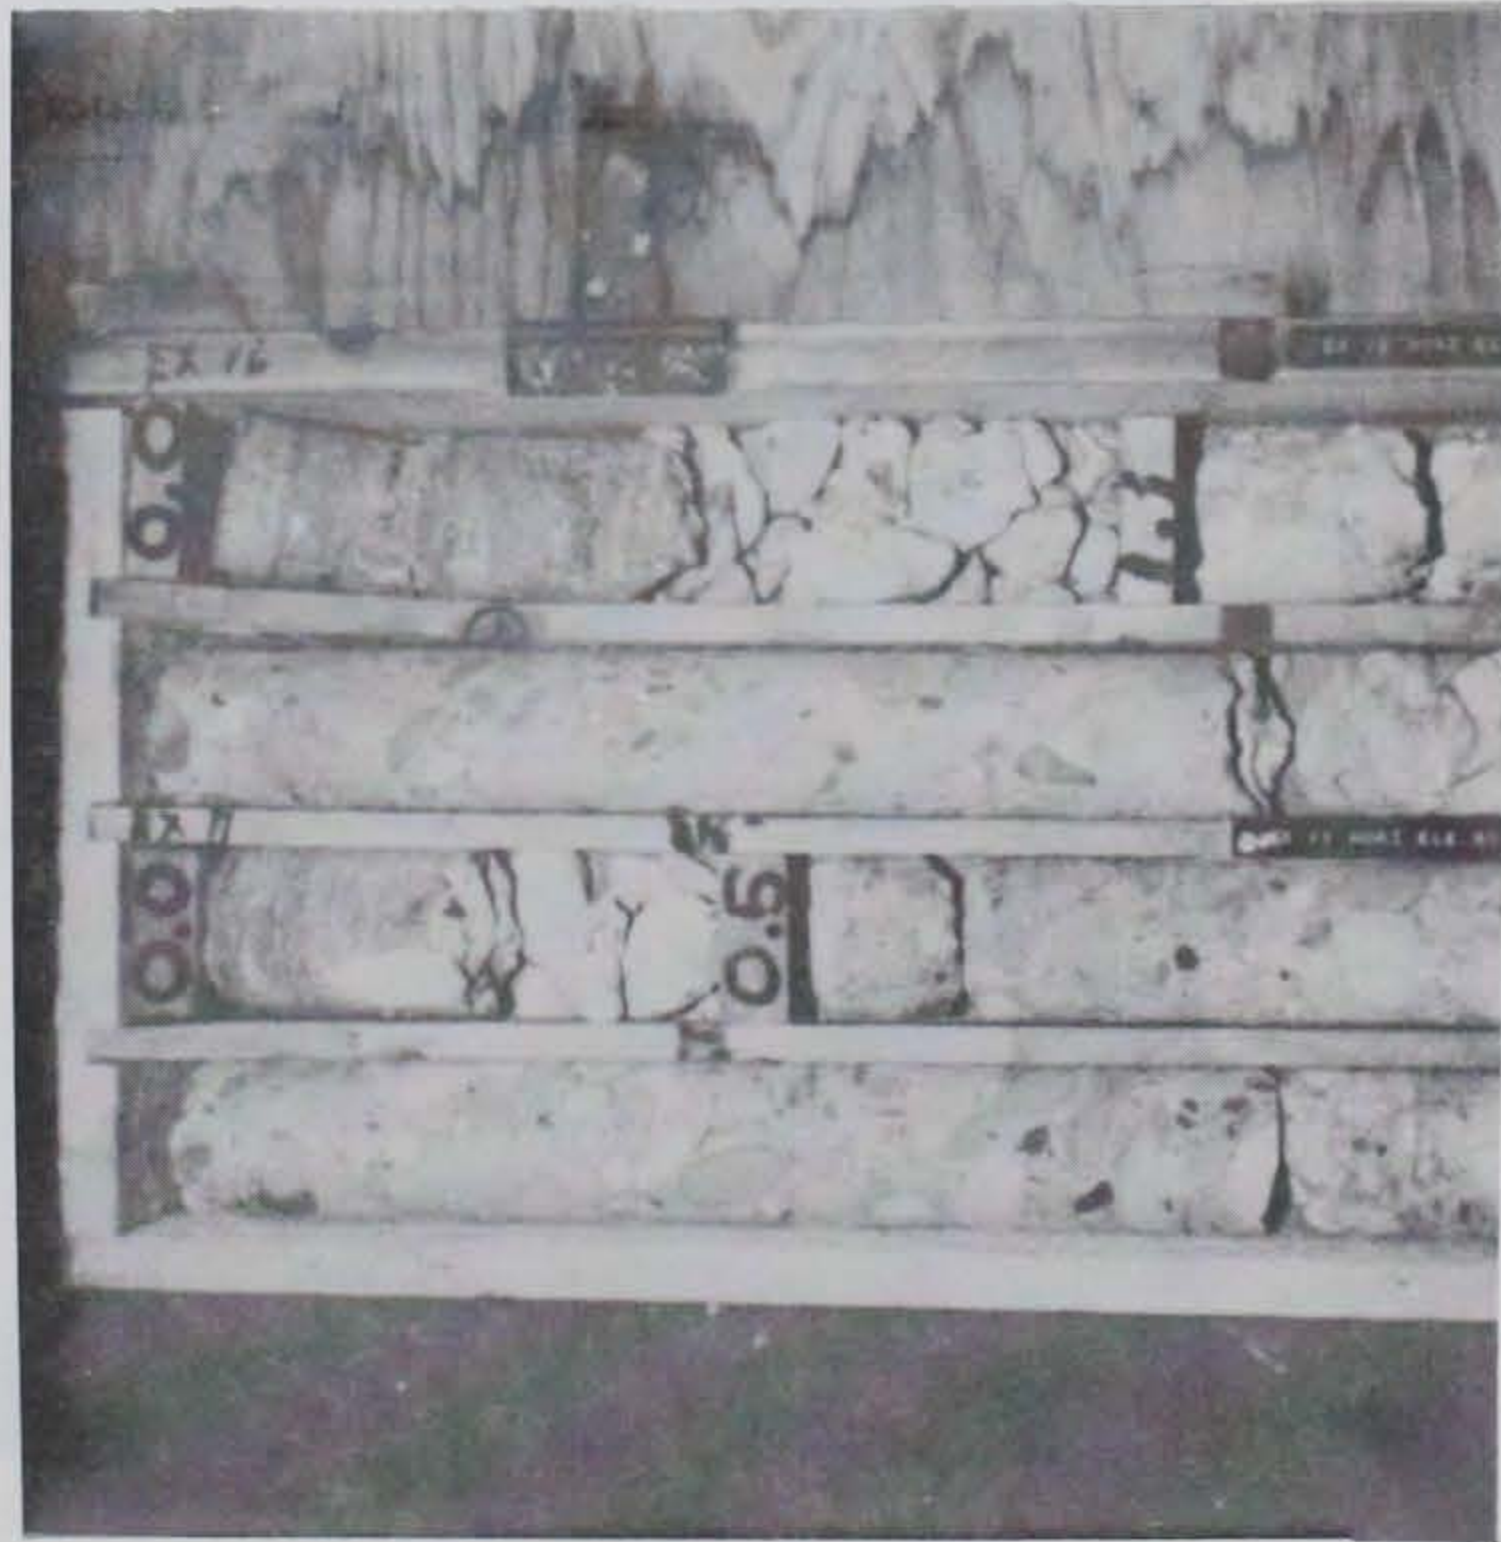
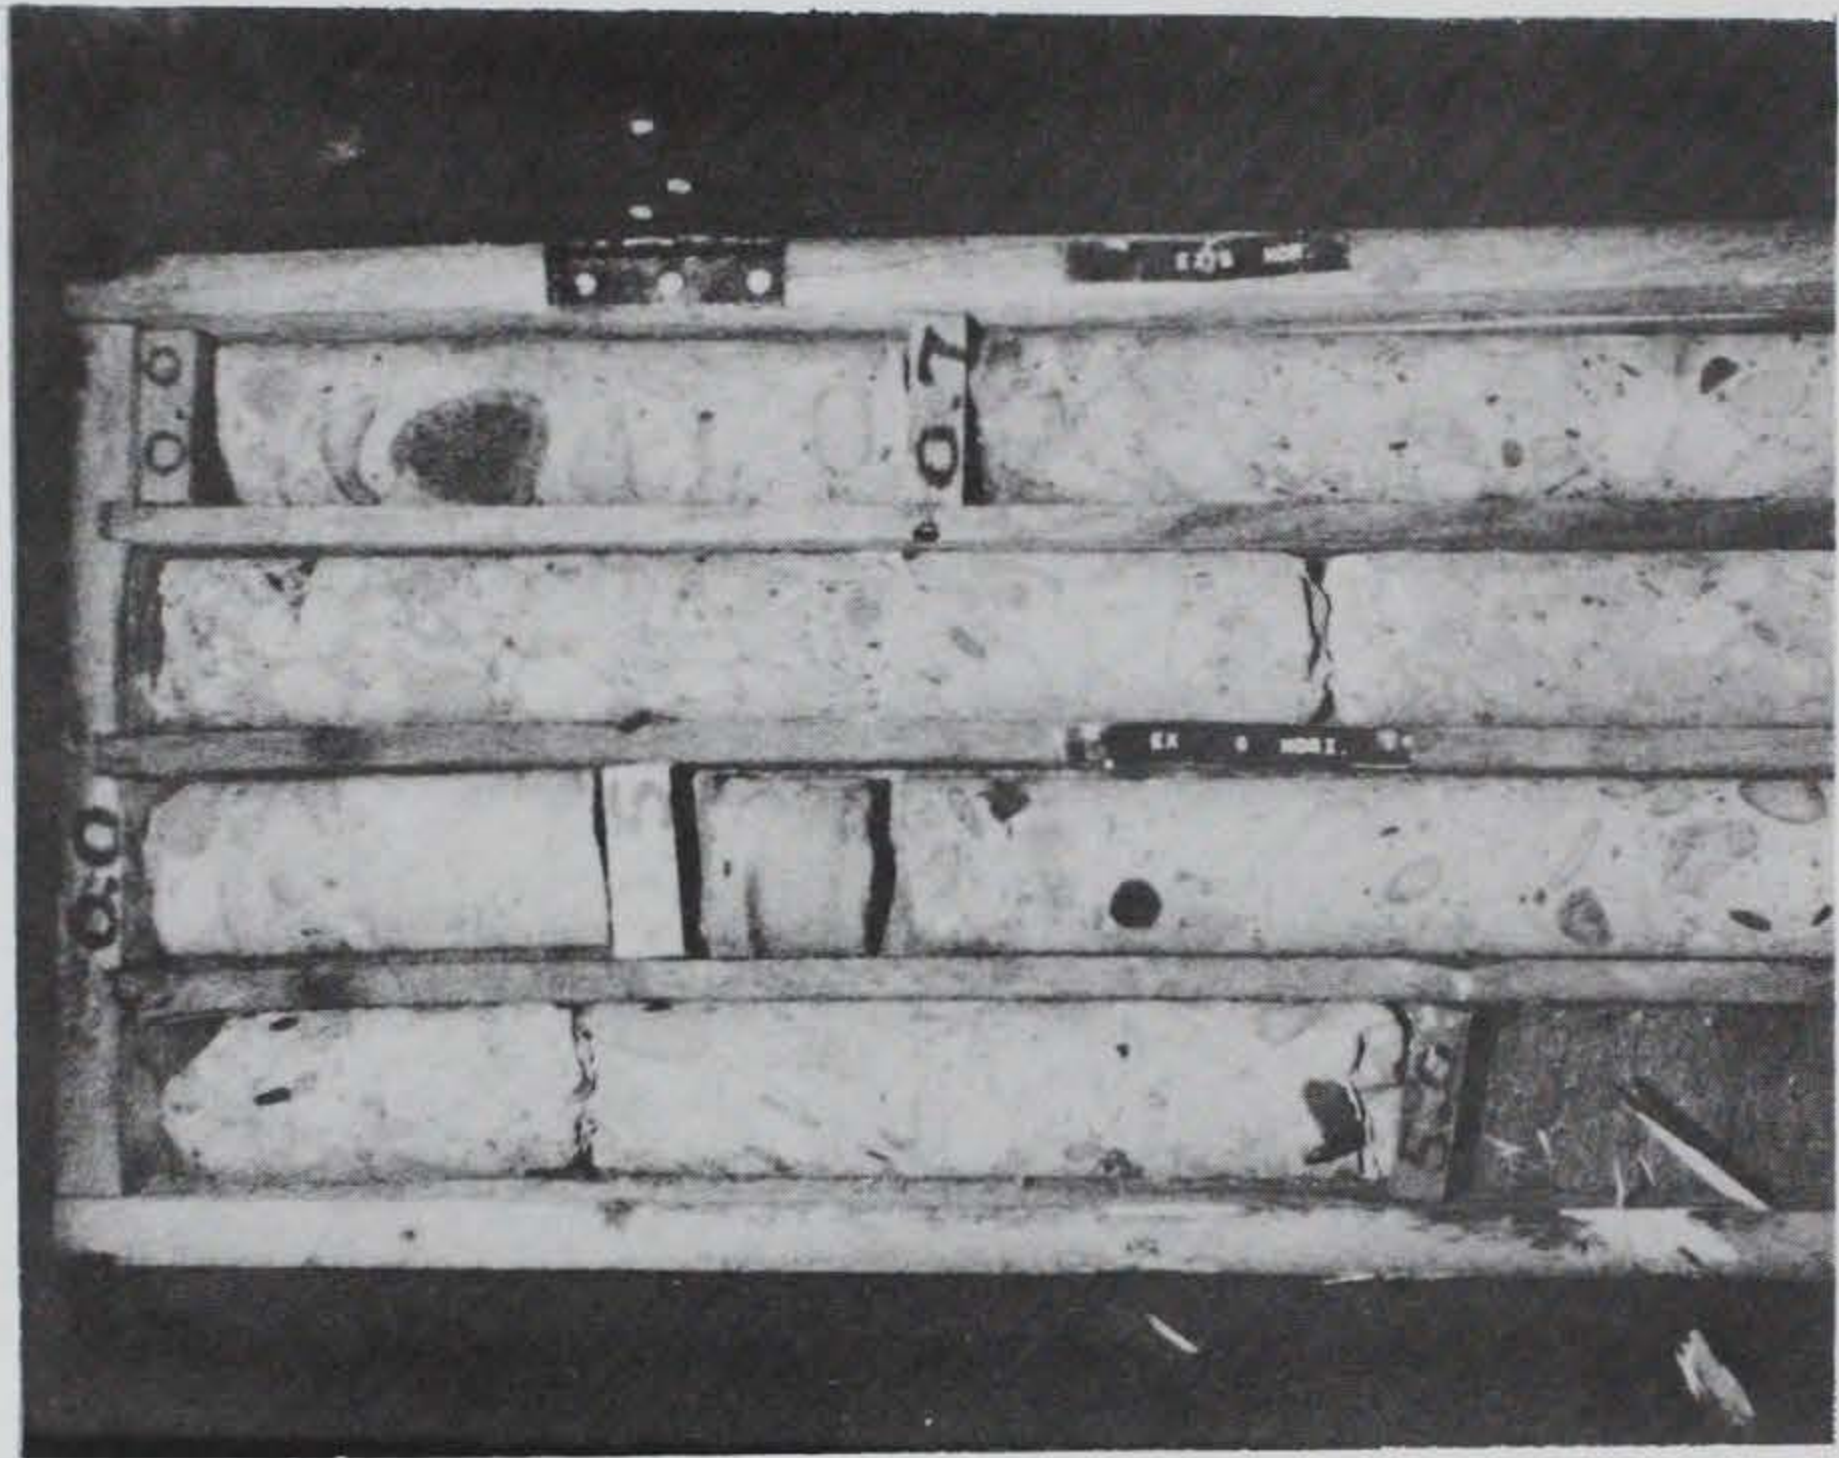
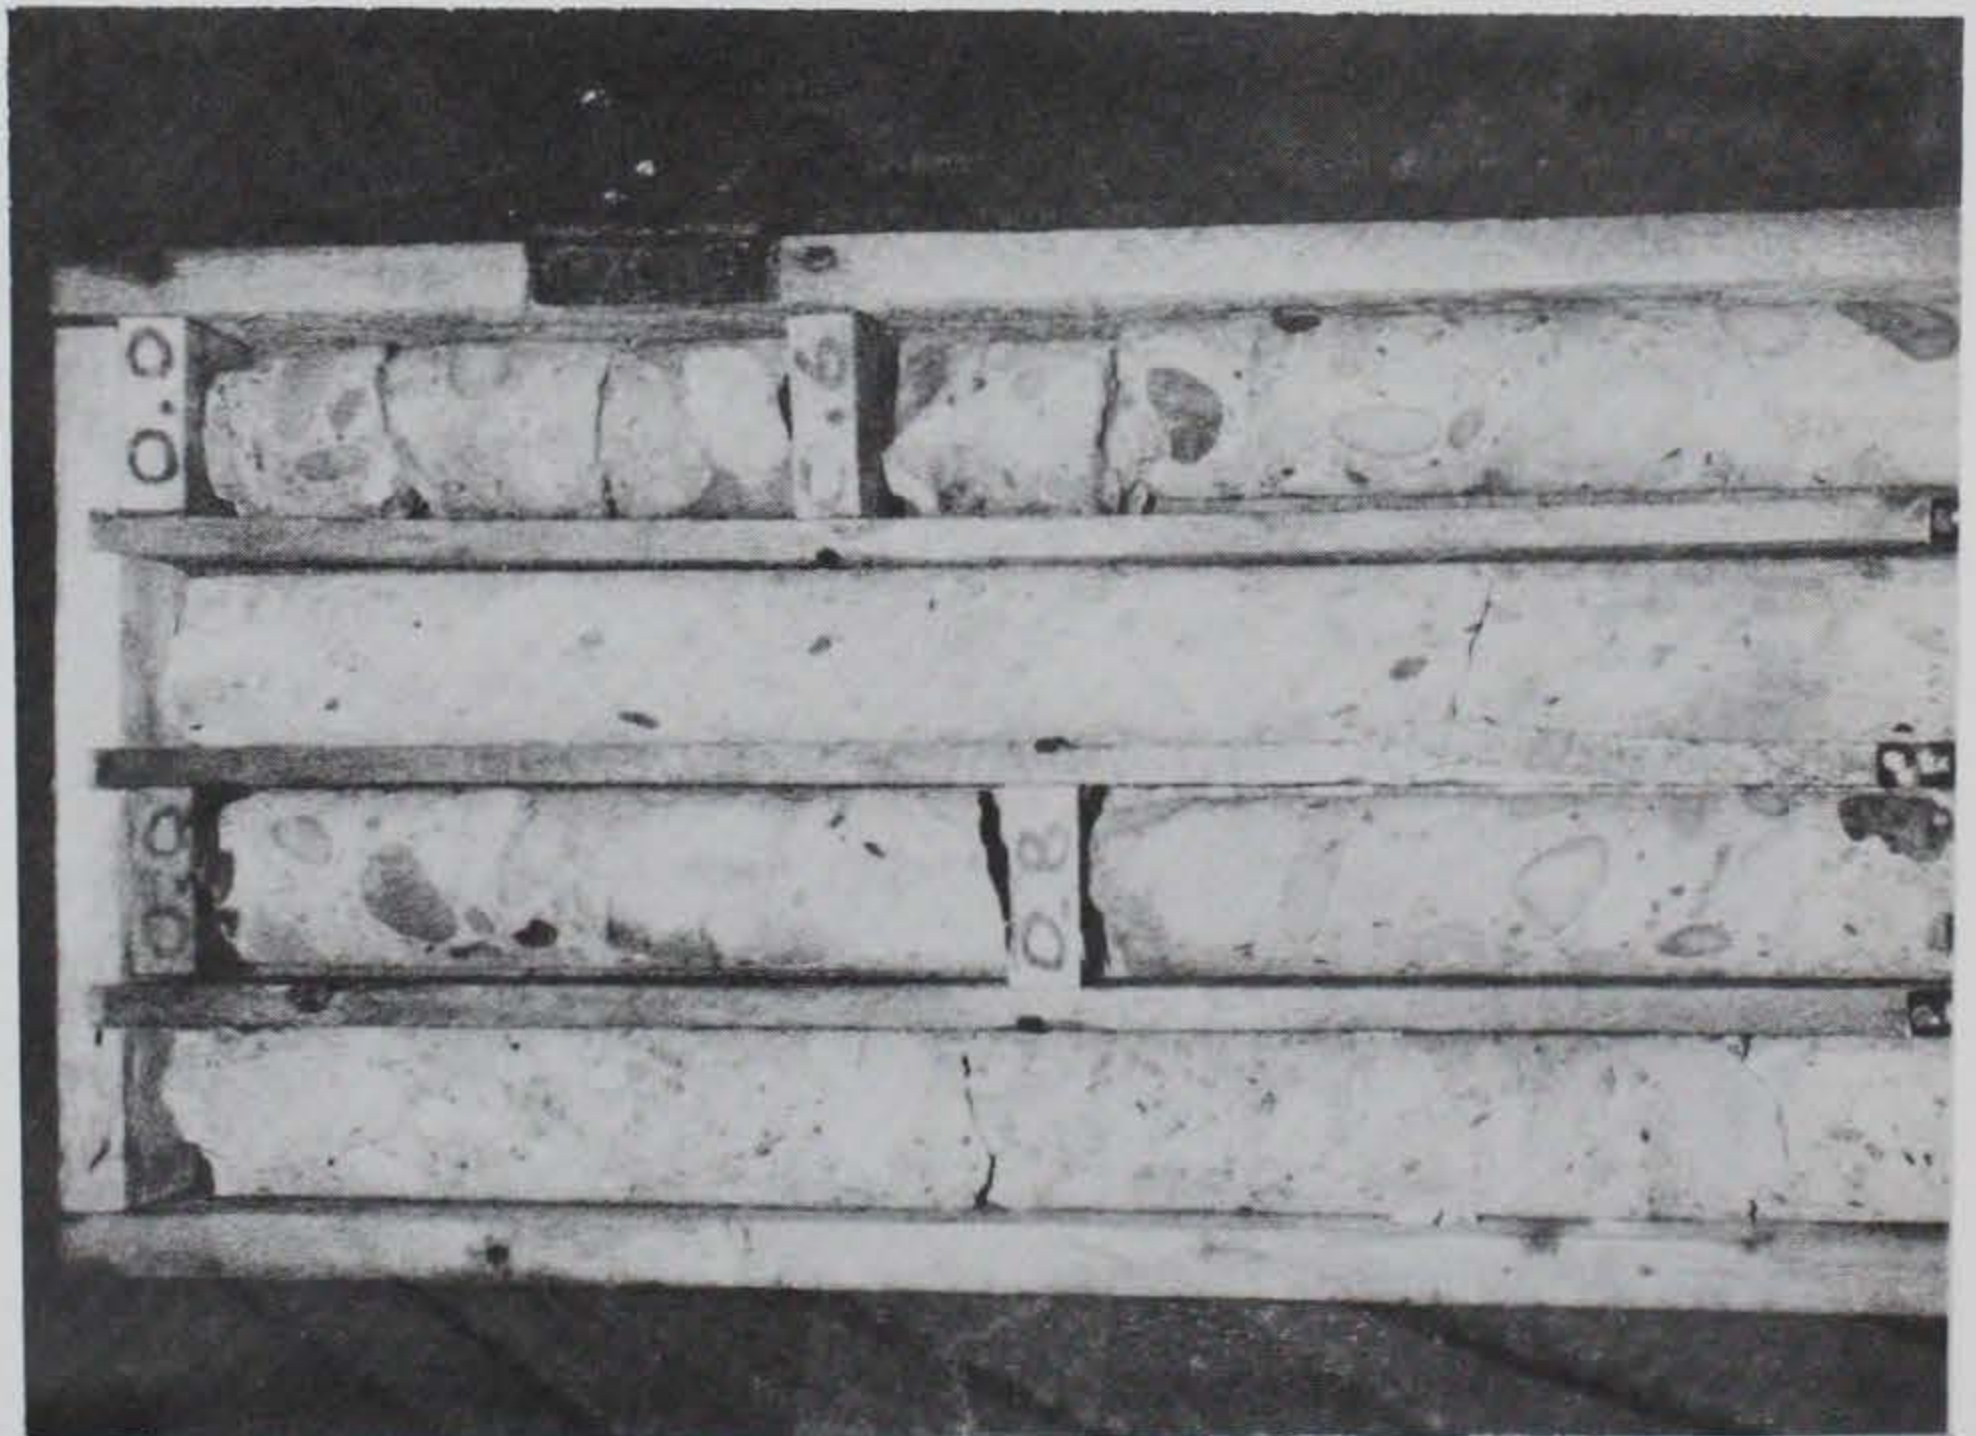
Figure 130. Horizontal cores taken from the river chamber walls, 1973, Emsworth Locks

288. During this inspection, horizontal cores drilled from the lock chamber walls in 1973 were compared. Cores from the river chamber showed the shotcrete to be in generally good condition (Figure 130); however the original concrete behind the shotcrete exhibited significant deterioration probably caused by cycles of freezing and thawing. Cores of similar concrete from the land chamber which were not coated with shotcrete were in generally good condition from the surface inward (Figure 131). These cores appear to be an example of an exterior coating contributing to the saturation of the original concrete with increased deterioration caused by frost action as a result.

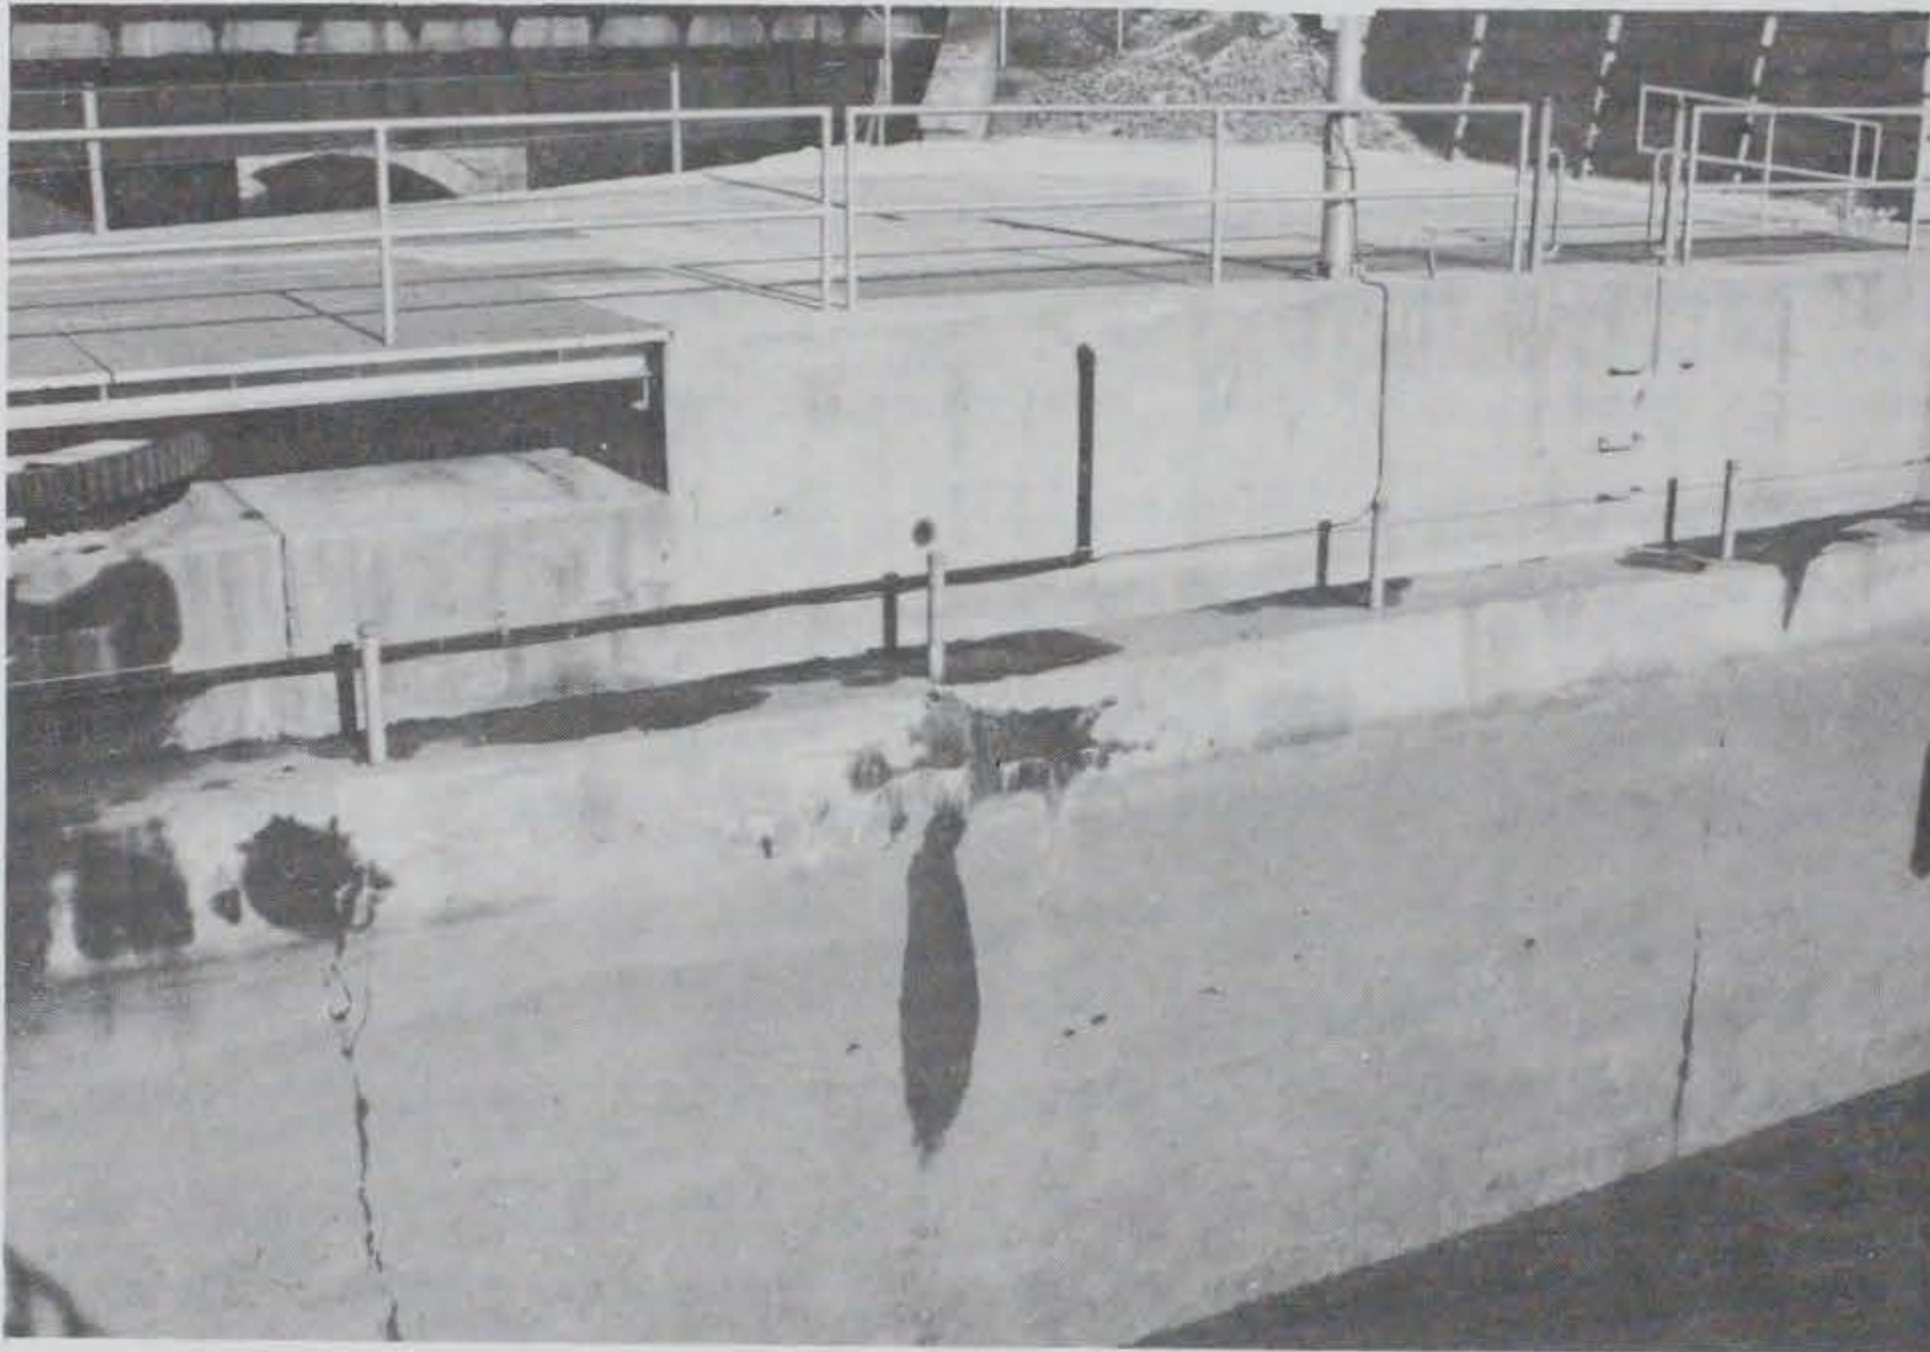
80 percent of the shotcrete coating on monoliths L-37 and L-38 between elevations 692 and 703 was missing to depths of up to 2 in. The coating on monolith L-39 contained a reflective vertical crack which was also present in the concrete below the lower limit of the shotcrete coating. The monolith joint and ladder-way repairs were in good condition. The shotcrete coating applied in the gate recesses was in poor condition with numerous horizontal and diagonal cracks (Figure 136). The majority of these cracks, which ranged in width

Figure 136. Cracking in shotcrete coating, downstream gate recess, land wall, December 1985, Emsworth Locks

from fine to wide, were located above upper pool elevation. According to lock personnel, these cracks occurred almost immediately after shotcreting, perhaps because of the prevailing hot, dry wind at the time of placement. Efflorescence was associated with a number of these cracks. A few cracks were dampened by water, and in several places water seepage through cracks in the coating covered large areas of the coating. Small areas of the shotcrete coating were debonded from the underlying concrete.

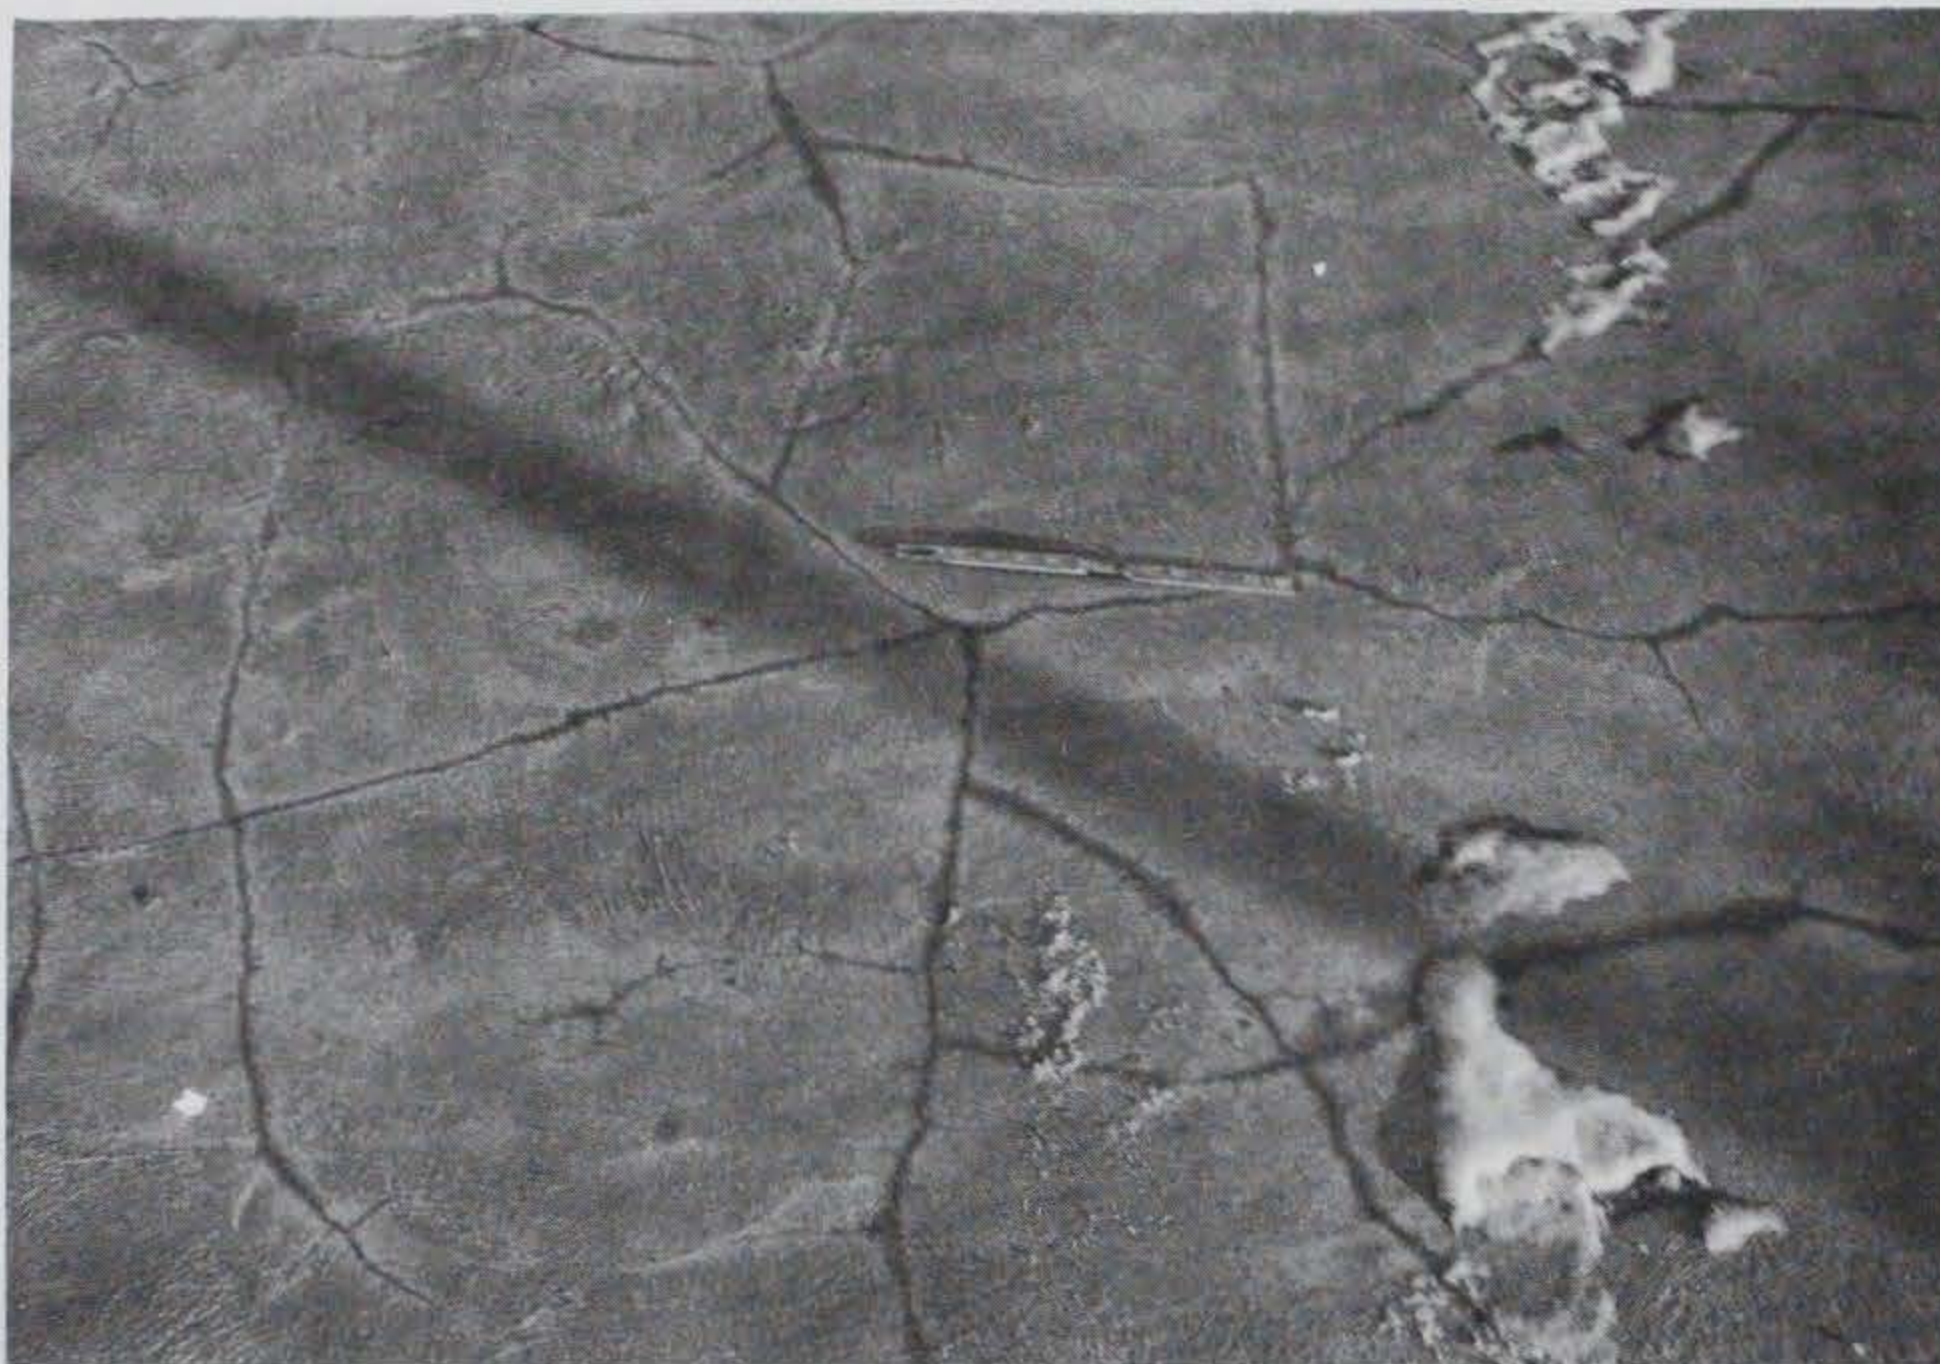
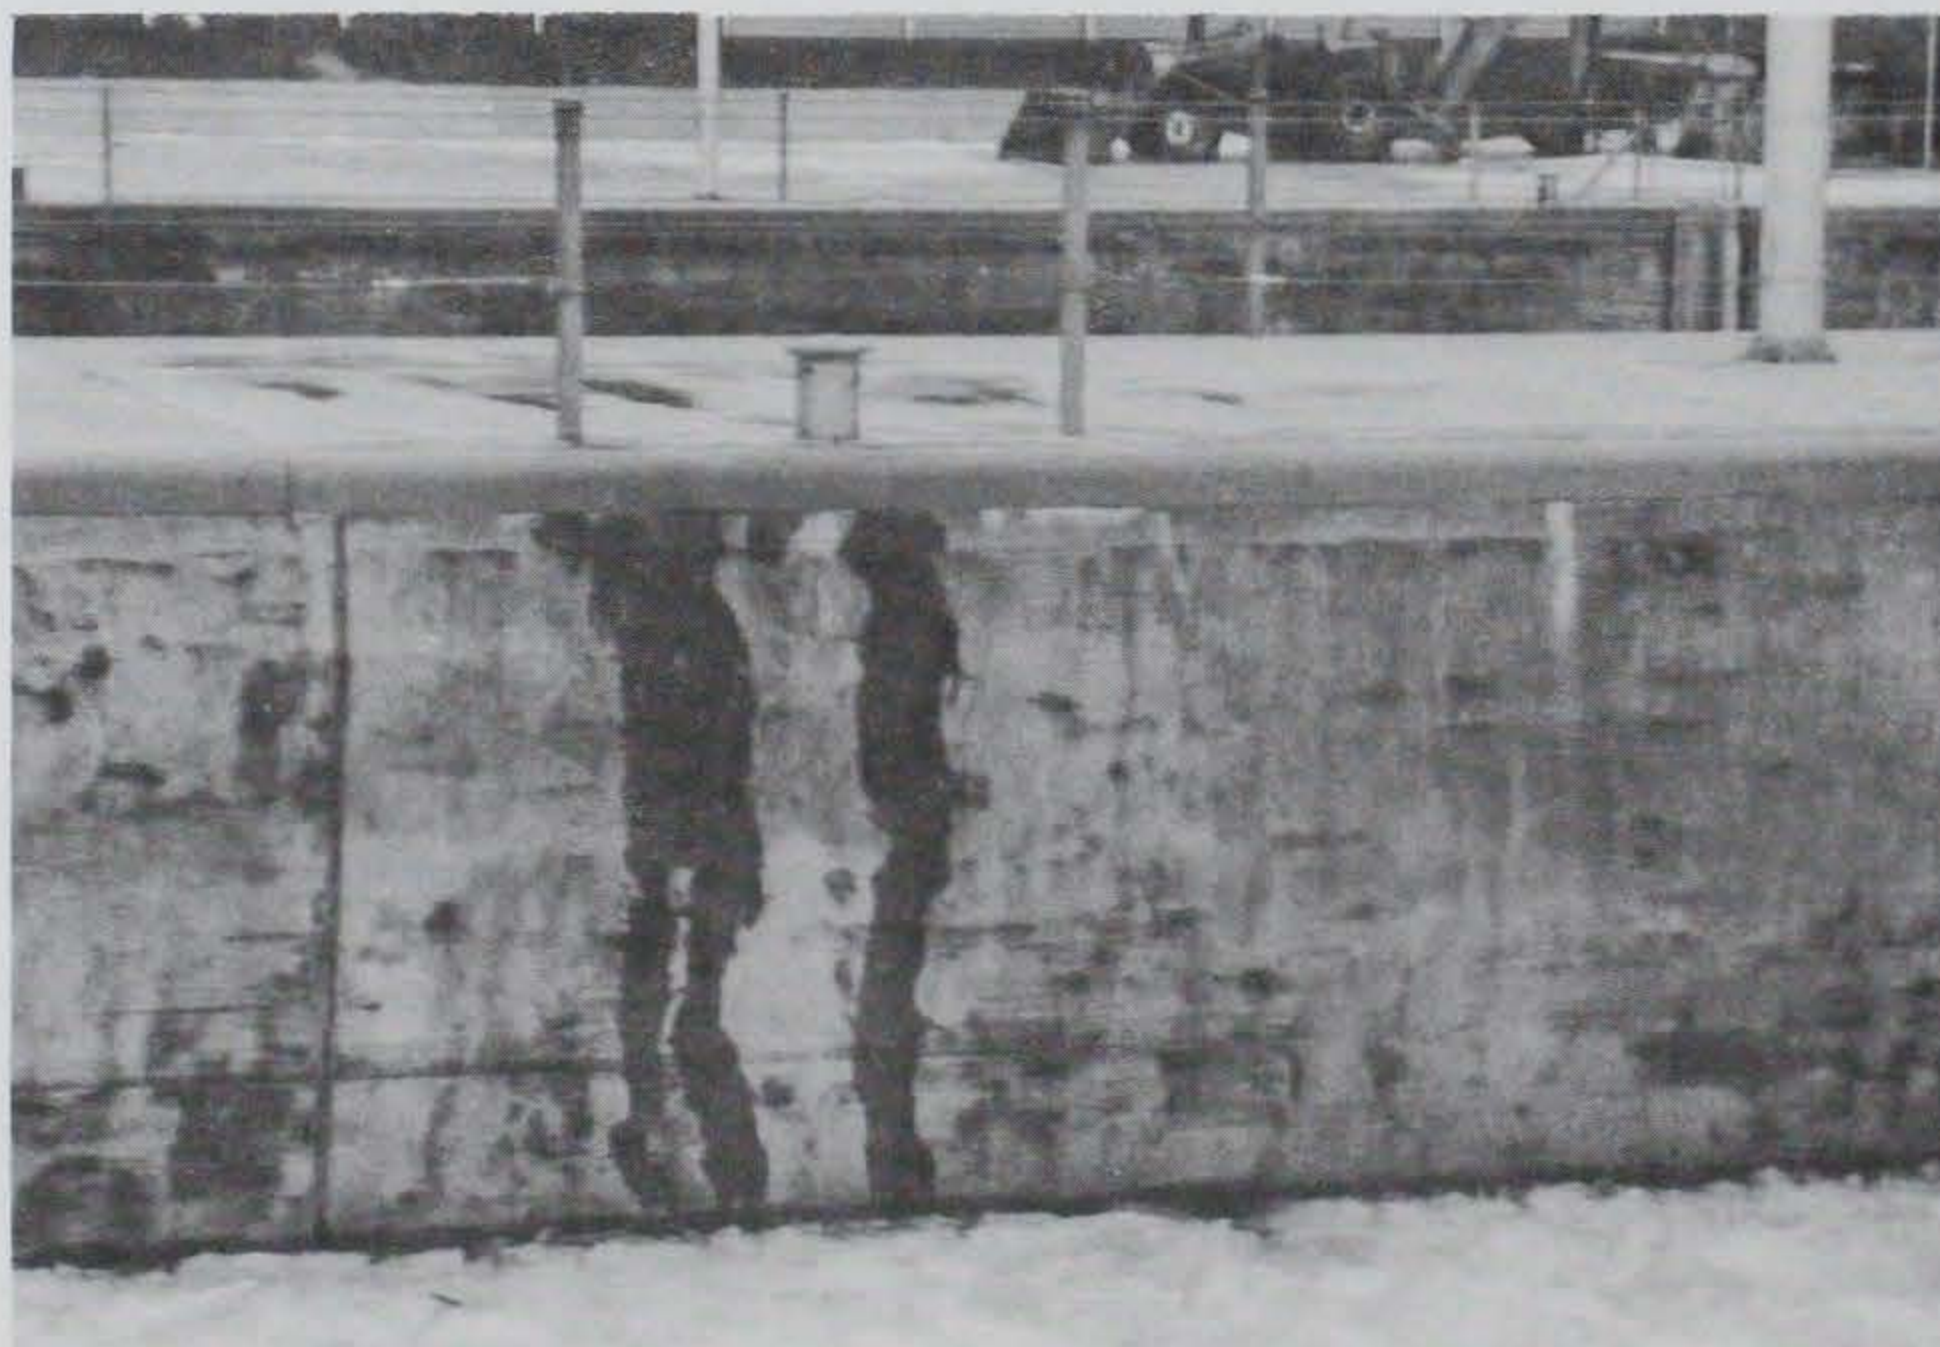
Figure 137. Condition of polymer mortar overlay, monolith M-2, December 1985, Emsworth Locks

and M-2 was in poor condition with extensive pattern cracking (Figure 137). These cracks allow water ponding on top of the monoliths to infiltrate the underlying concrete as evidenced by water seepage on vertical wall surfaces beneath the corner protection armor. The ladder ways and monolith joints repaired with concrete and shotcrete, respectively, were in good condition.

a. Pattern cracking, top surface

b. Seepage on chamber face as a result of water ponding on top surface
