TECHNICAL REPORT REMR-CS-13

**REHABILITATION OF NAVIGATION  
LOCK WALLS: CASE HISTORIES**

James E. McDonald

December 1987

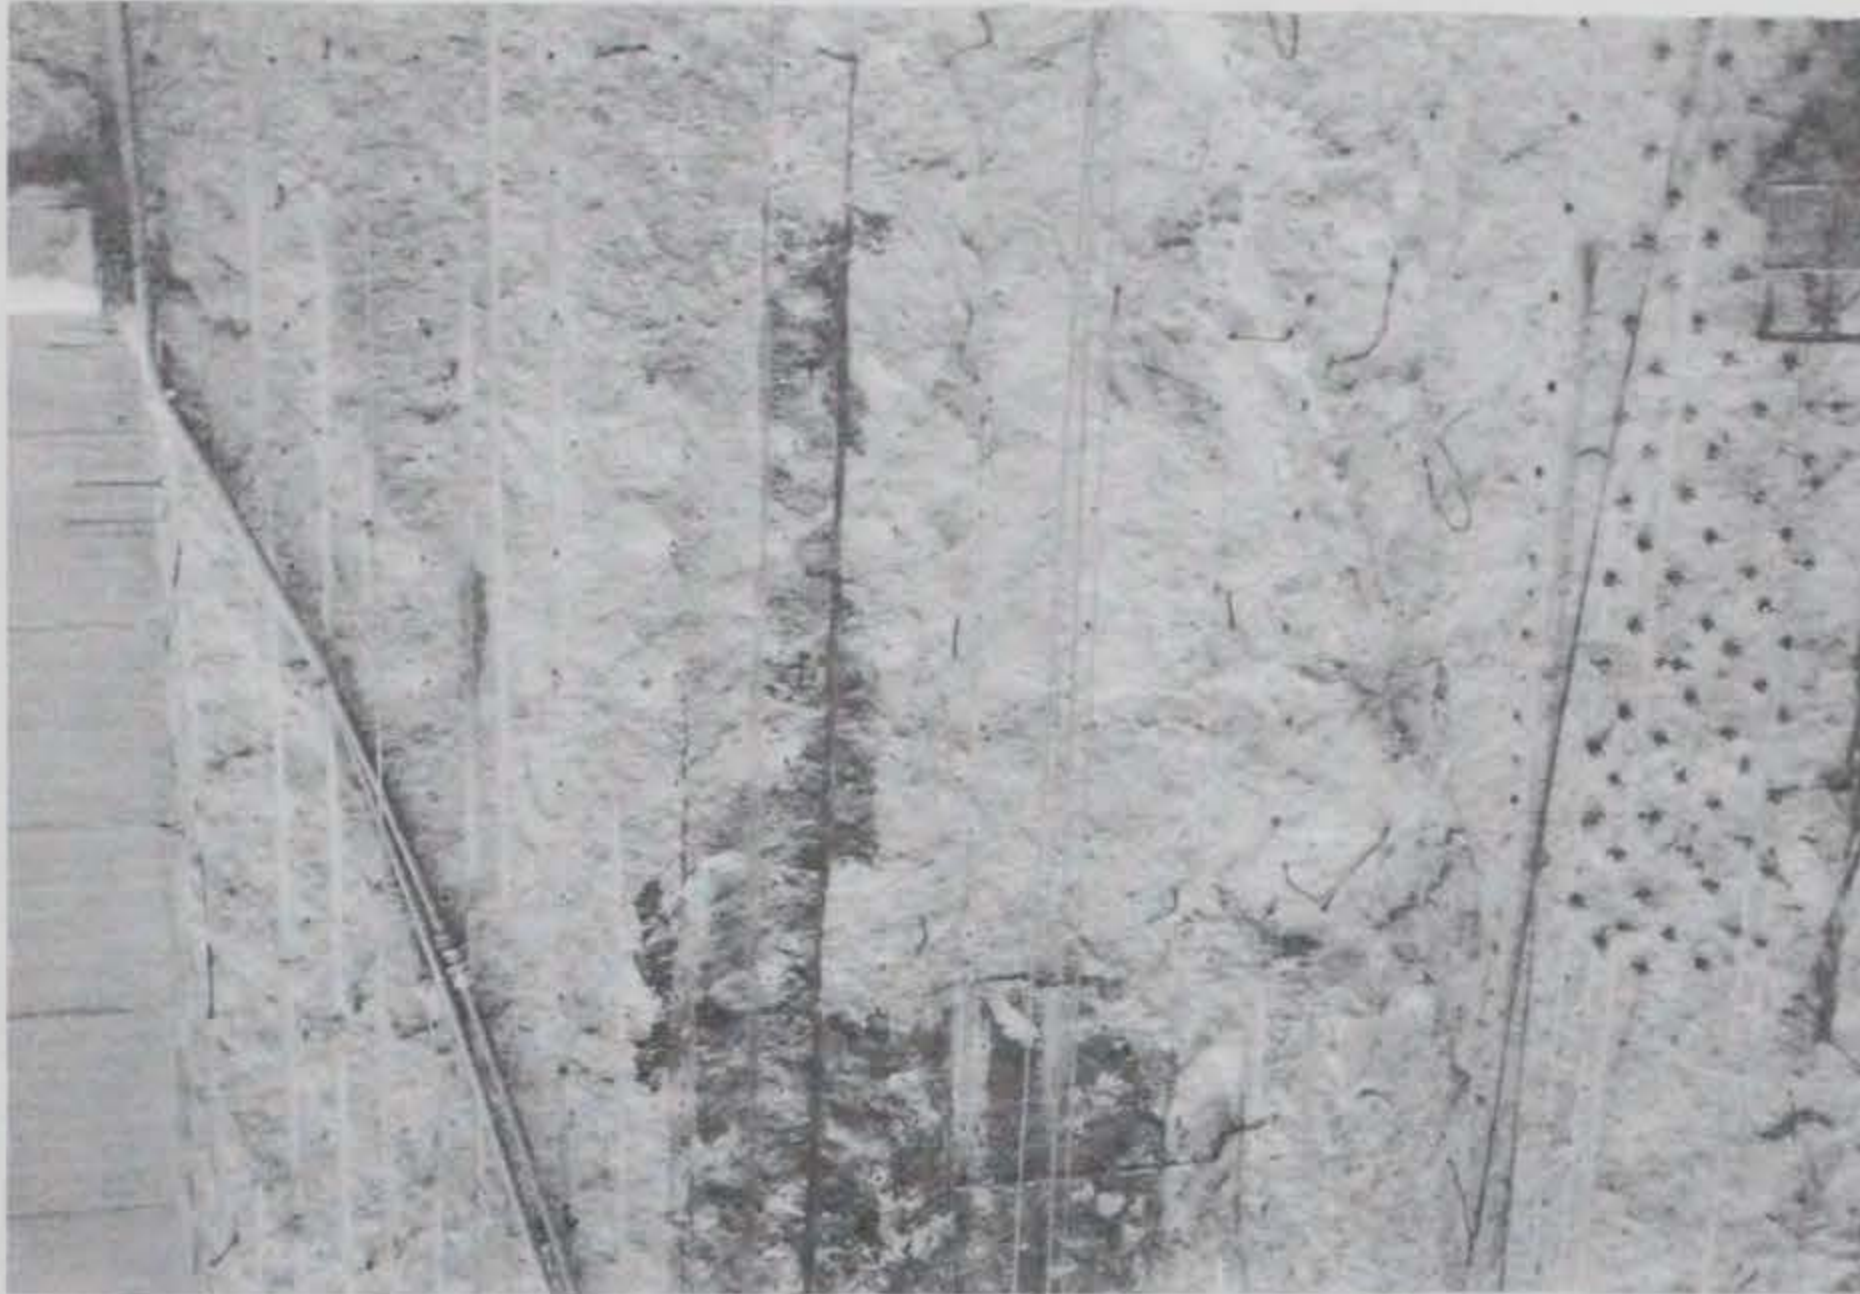
Figure 142. Typical surface following concrete removal, Lockport Lock

314. In order to complete the necessary concrete removal, the remaining holes along the first drill line were loaded with detonating cord and the fractured concrete removed by blasting (Figure 142). A similar procedure was used for succeeding lines of drill holes. Extensive concrete removal by hand using jackhammers was still required to complete the removal operation. The crack behind the quoin anchorage area became a critical path item since the lock could not be reopened until this problem was resolved. The question was whether to remove the loose piece of concrete entirely or to anchor it in place. Since the cracked section of concrete is loaded in compression with the lock at upper pool, it was concluded that it could be posttensioned to the

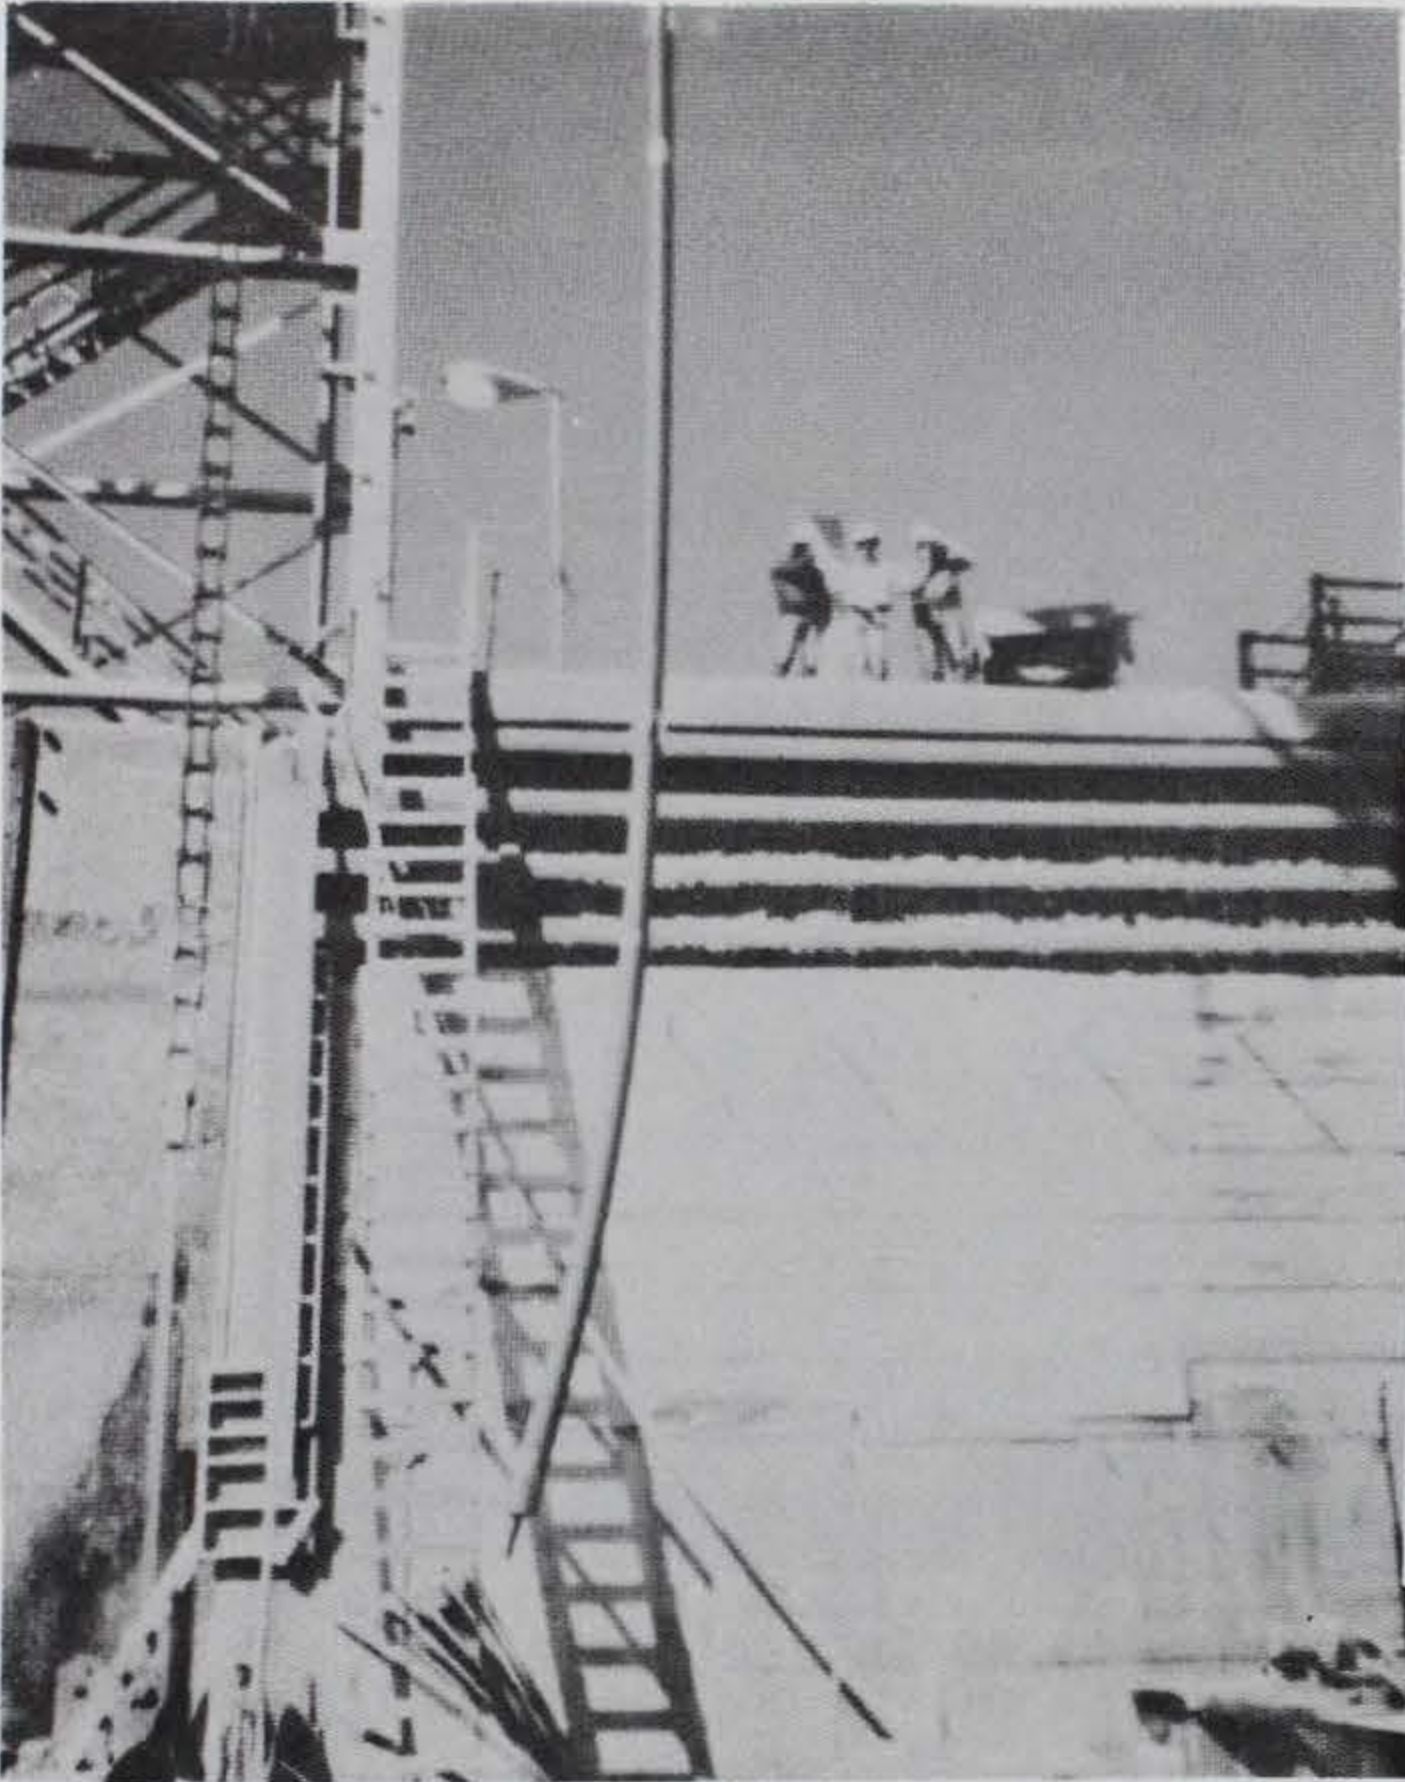
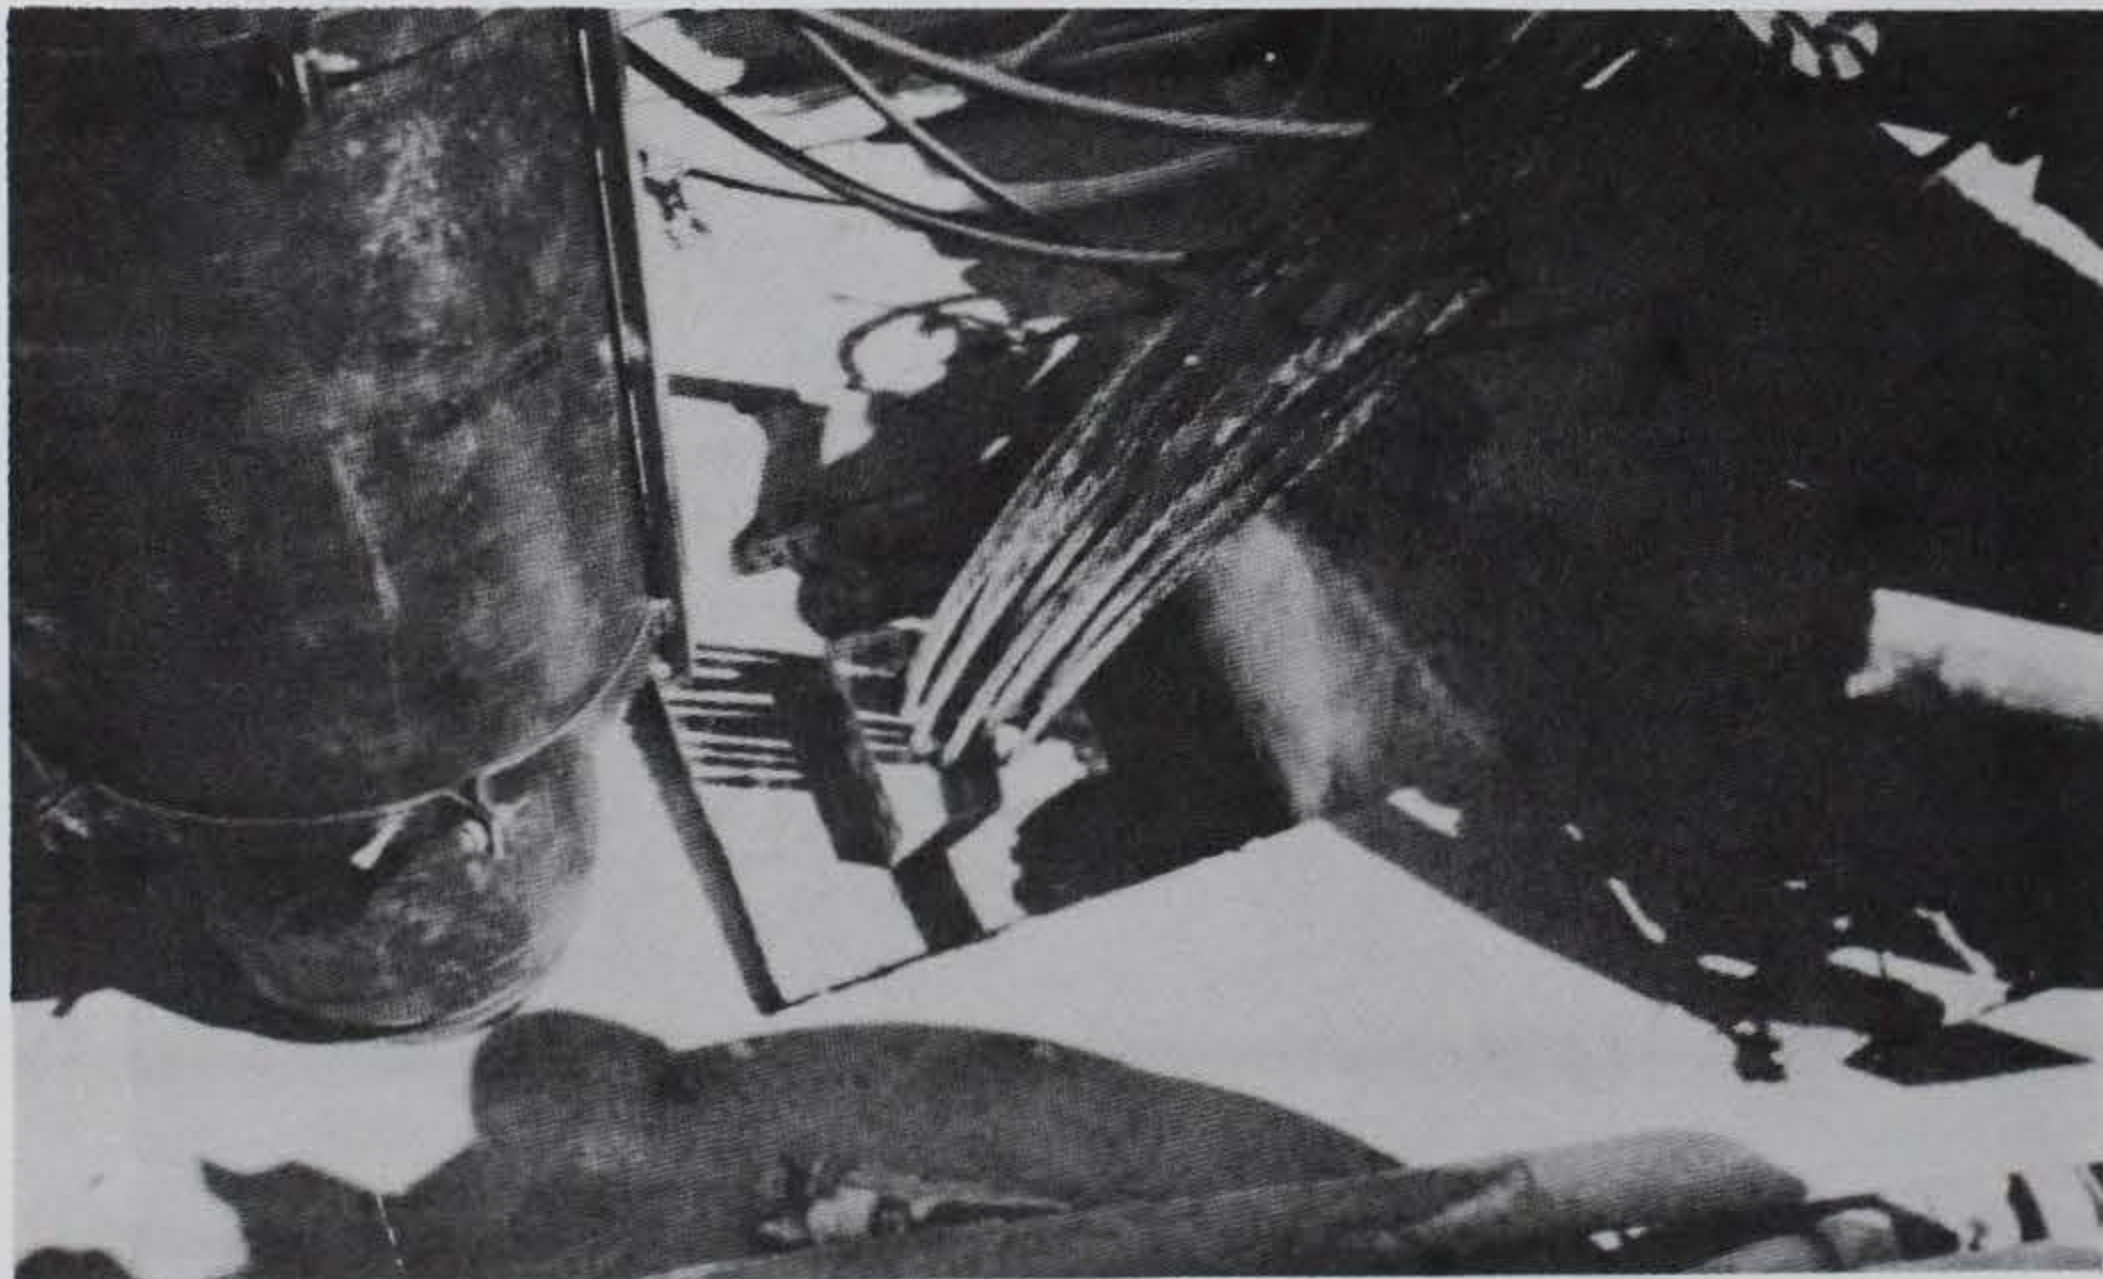
b. Stranded anchor in place prior to posttensioning  
Figure 146. Anchor installation, upper service gate sill,  
Lockport Lock

317. After anchor holes were drilled in each recess, the anchors were installed and the embedment lengths grouted. The stranded anchors were manufactured by Dywidag Systems International, Incorporated, Lemont, Illinois. Each anchor consisted of sixteen 1/2-in. strands, 74 ft long, enclosed in a double corrosion protection system (Figure 146), and seated at 455 kips. The design working load of the anchors was 325 kips. Each anchor was lift-off tested immediately after seating. The maximum loss shown by the lift-off test was 6 percent. Twenty-four-hour lift-off tests were conducted on three of the anchors. The maximum loss for the 24-hr lift-off was 7.5 percent. Upon completion of stressing, the remainder of each hole was grouted, and the recesses were filled with concrete. The stranded anchors enabled the sill to meet current stability criteria and ensure the structural integrity of the upper part of the lock.

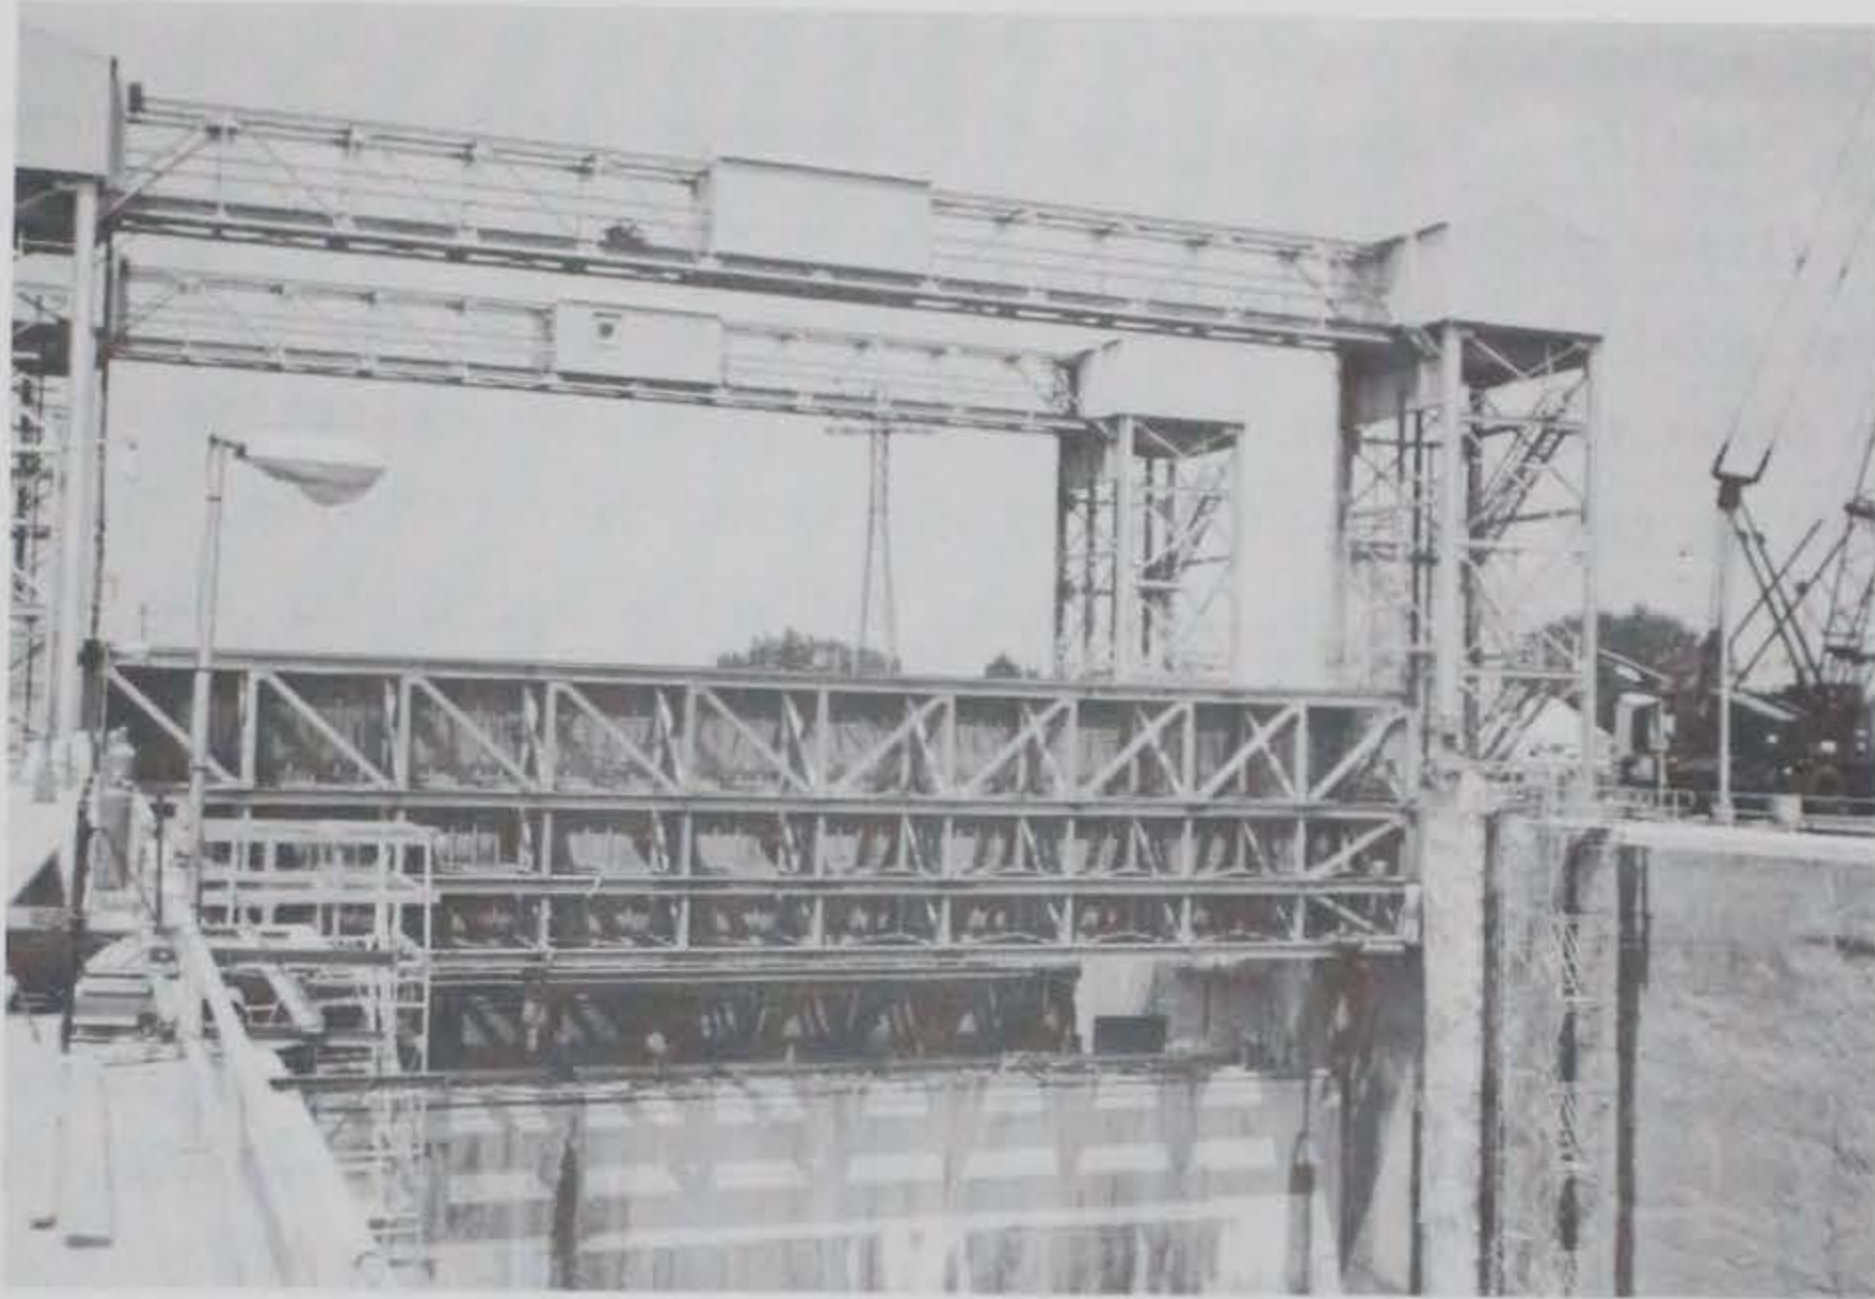
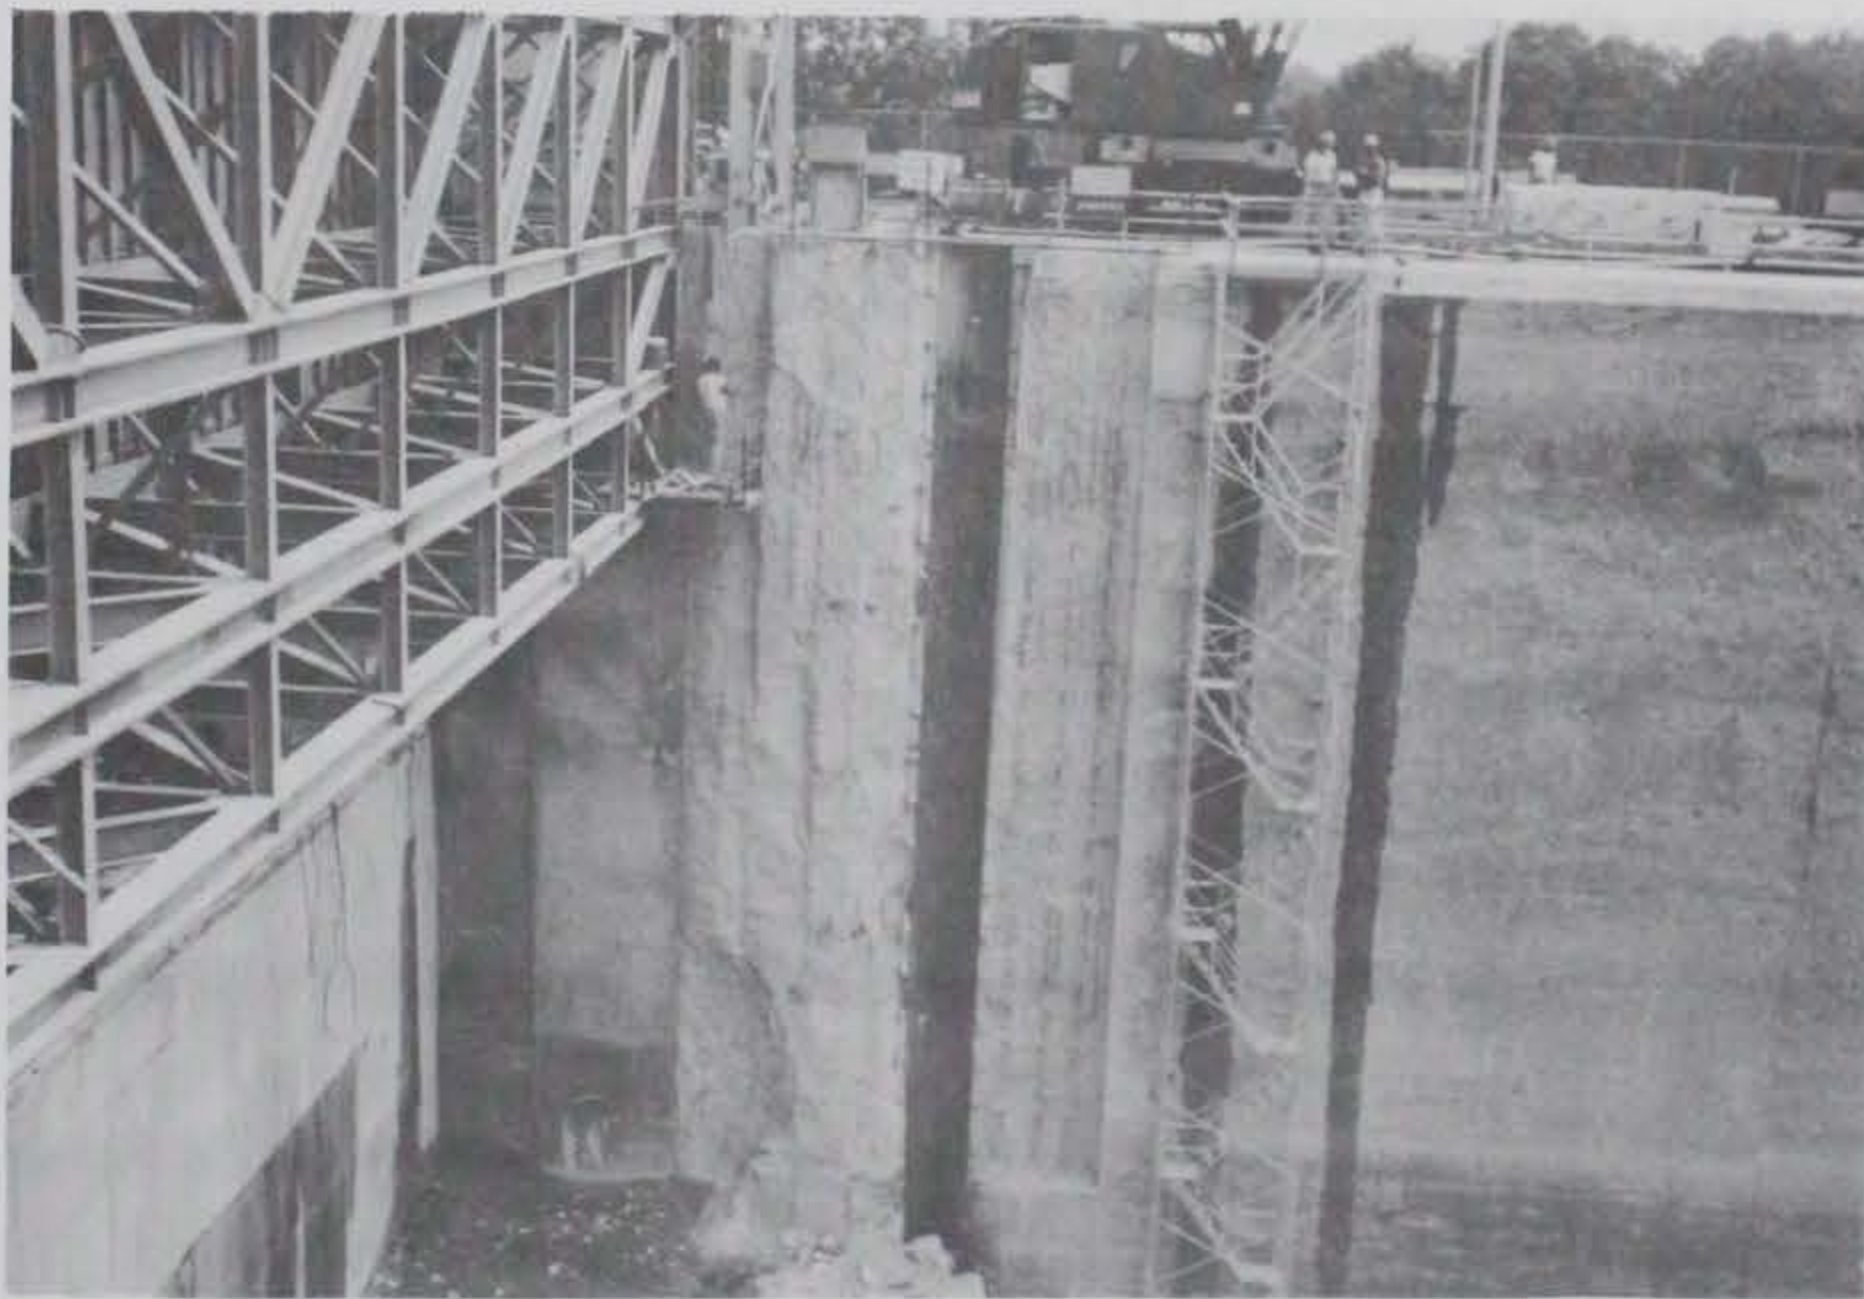
Figure 147. Upper service gate modifications, Lockport Lock

318. The present lifting system for the upper lift gates at Lockport does not allow operation of the gates under a differential head. Emergency closure was deemed necessary to prevent loss of upper pool during a lower miter gate failure from barge impact. The gates were modified as part of Stage I by enlarging the gate recesses (Figure 147) and replacing the friction pads on the gates with rollers. The future installation of new gate machinery (Stage III) will result in the capability of operating the gates under differential head.

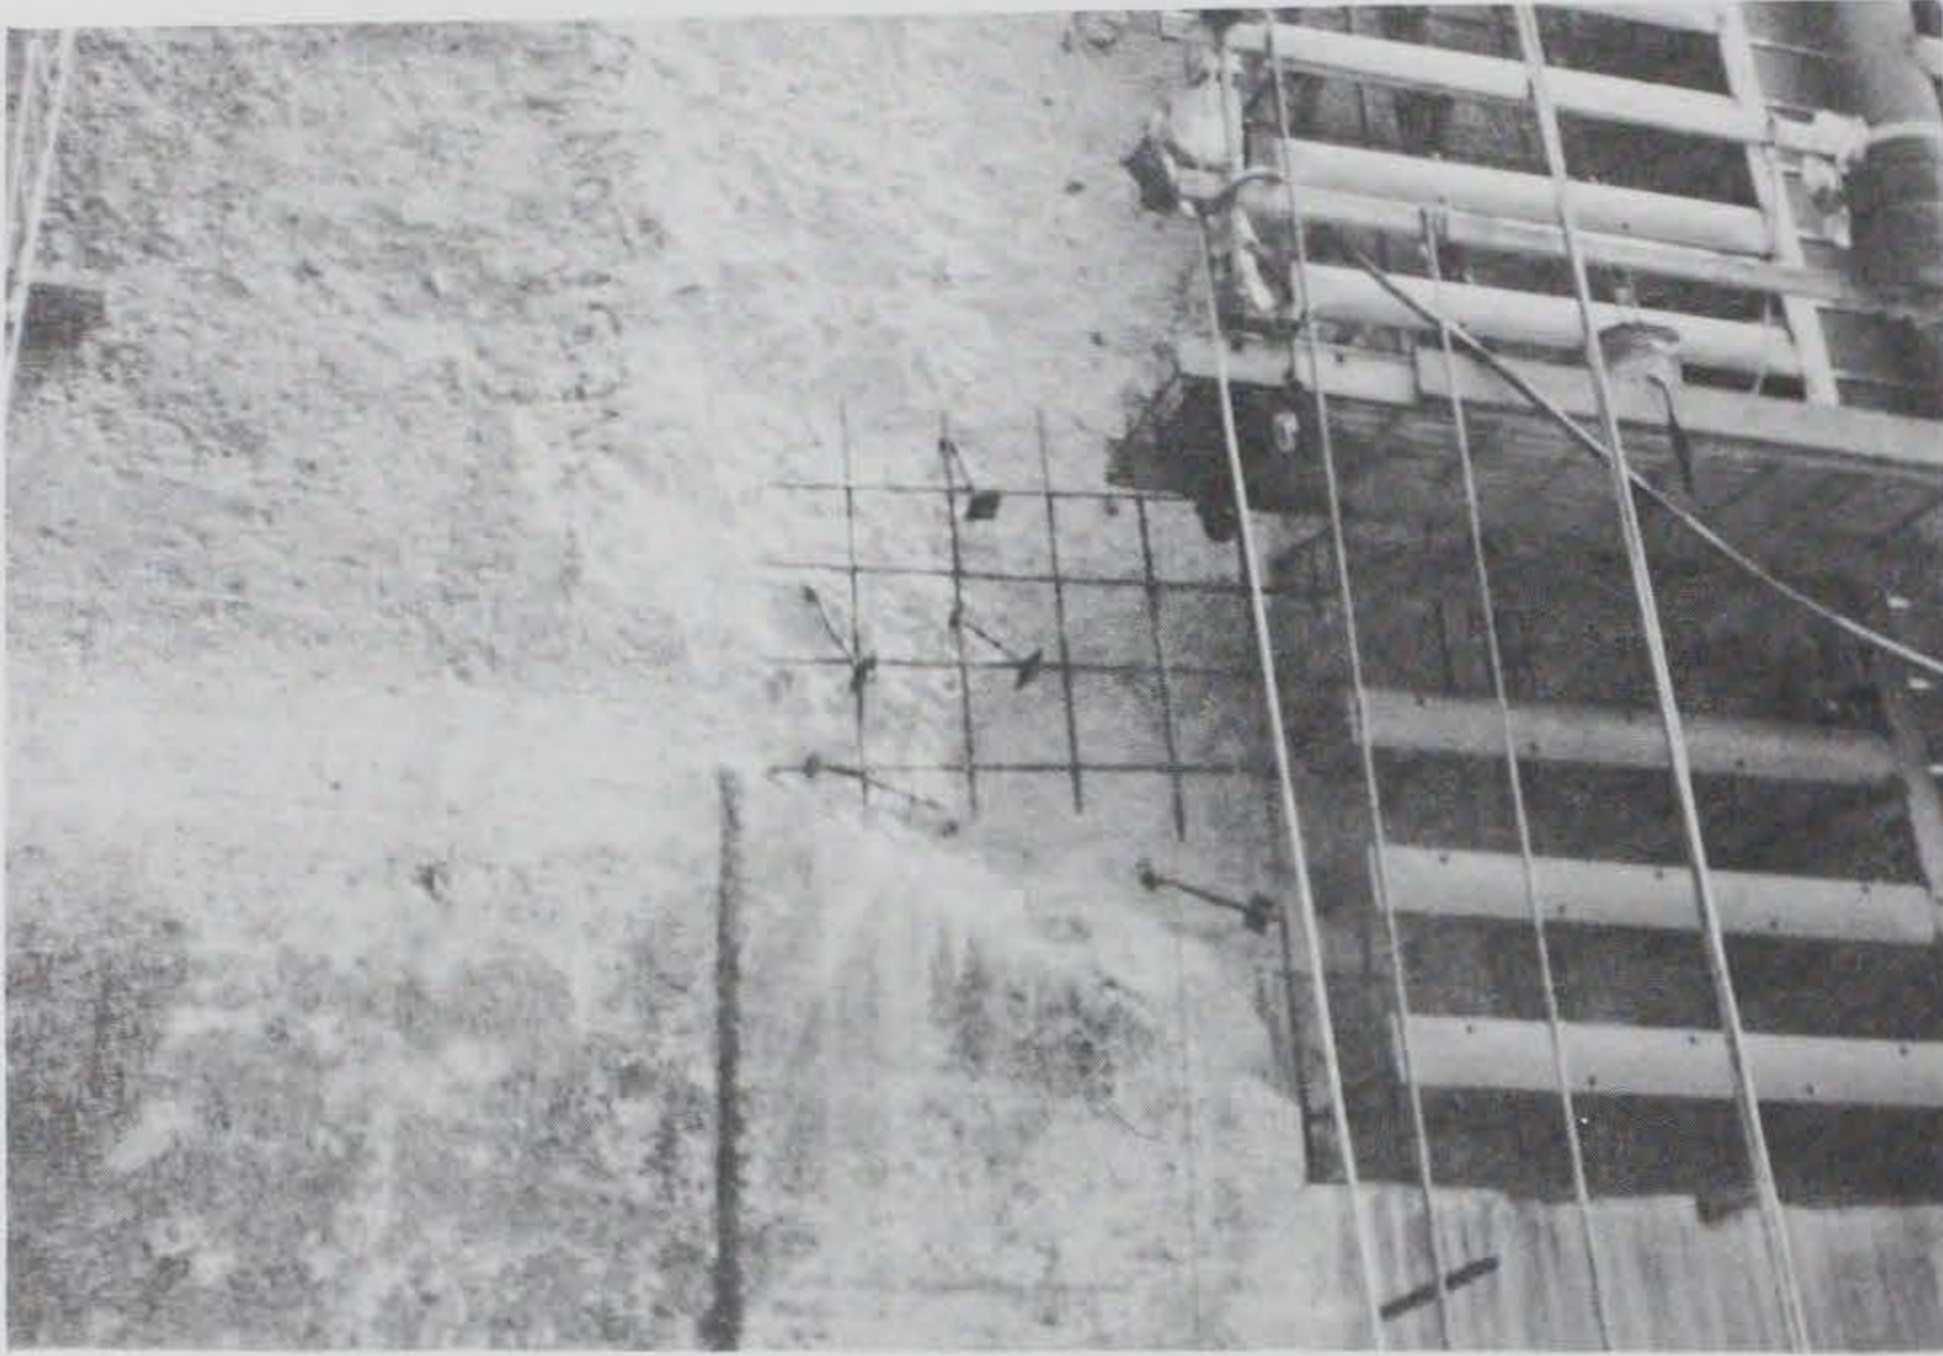
Figure 151. Concrete overbreak during removal,  
Lockport Lock

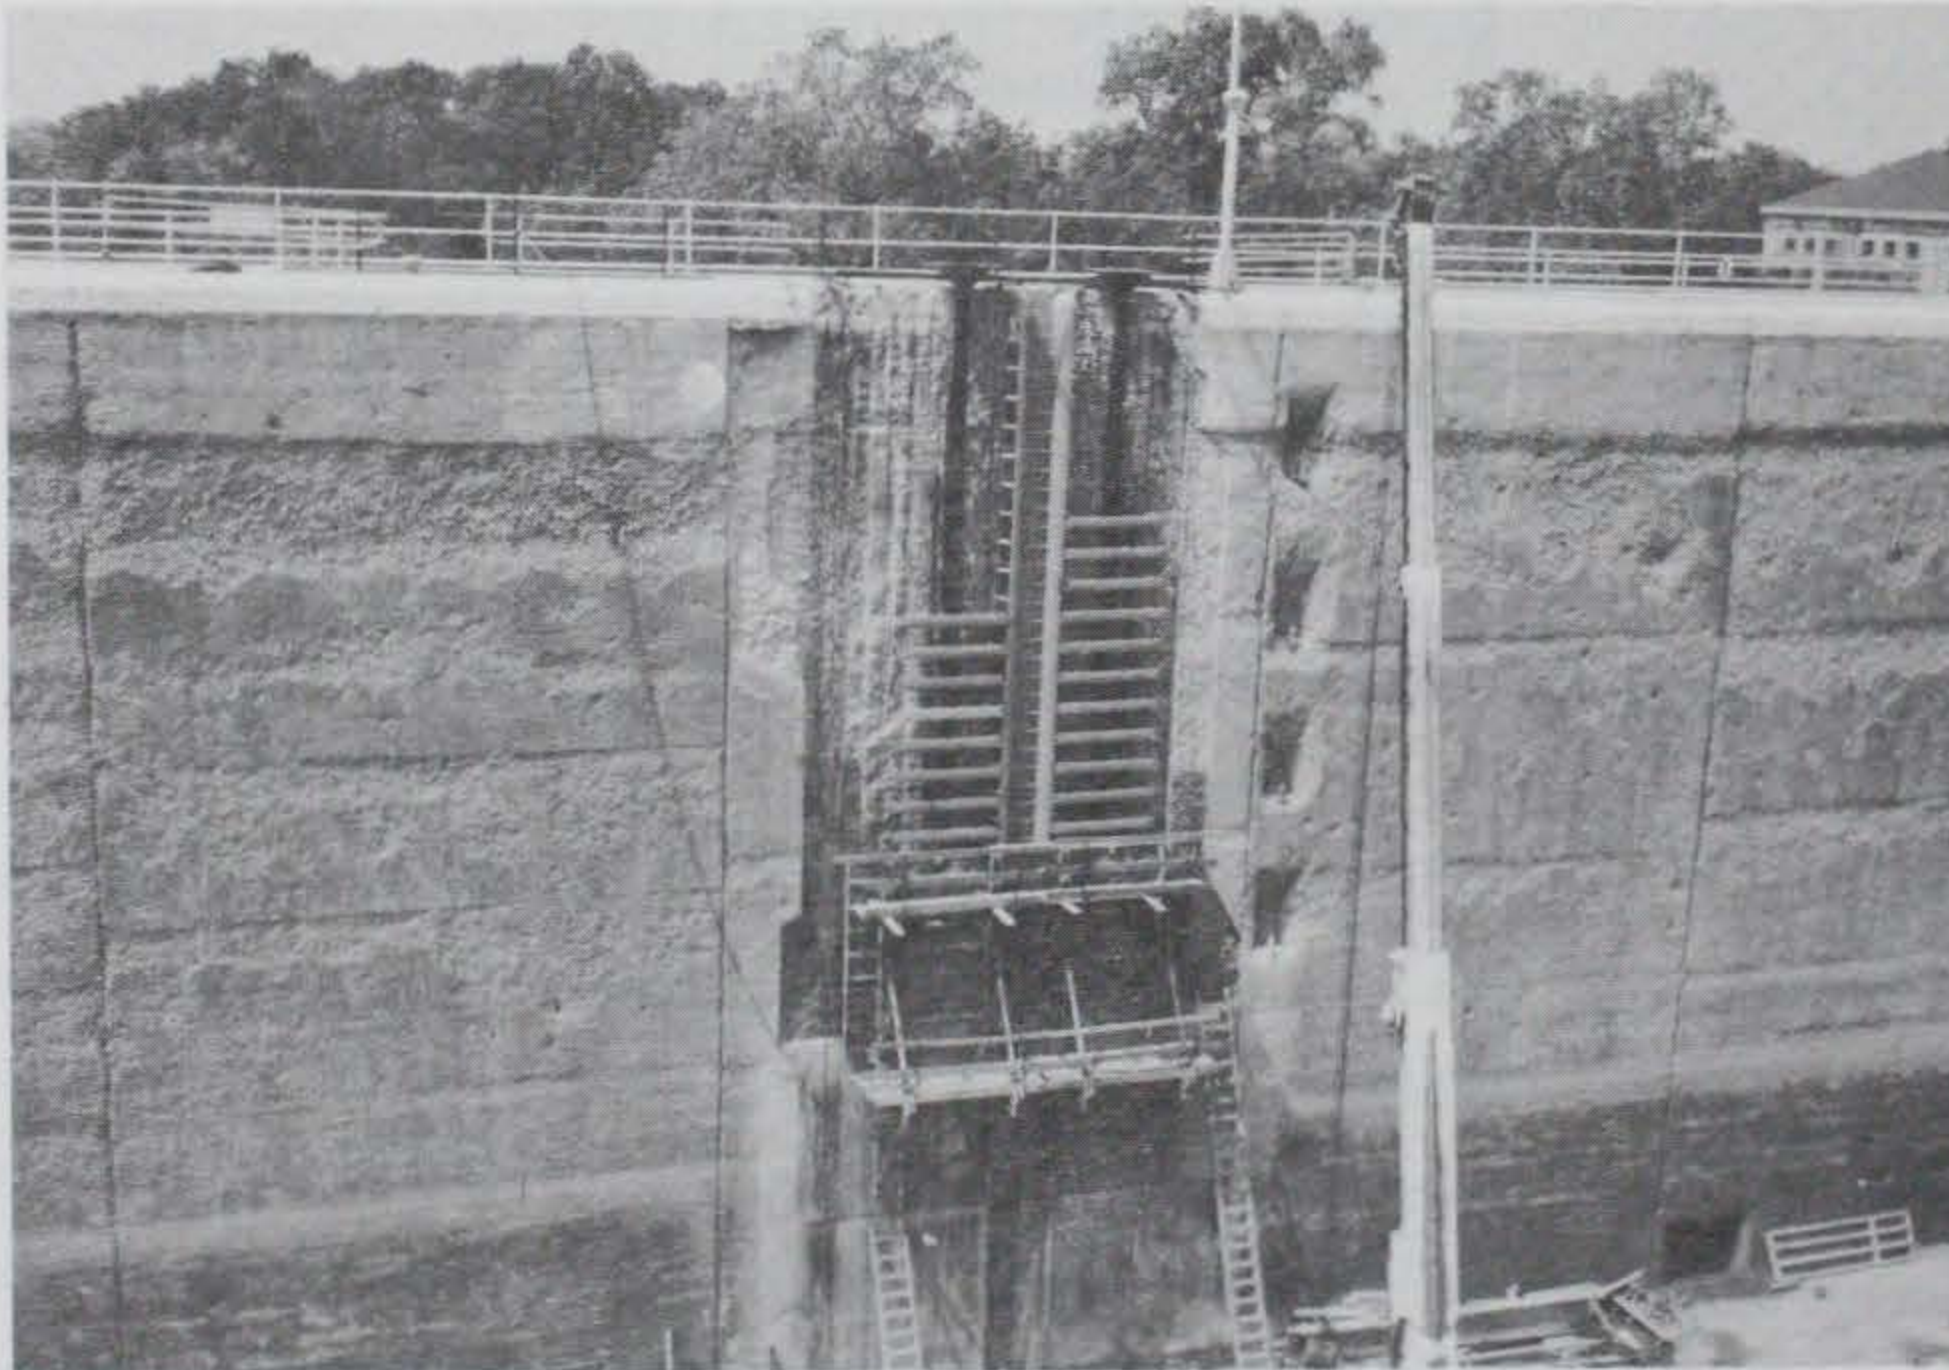
Figure 152. Overbreak area prepared for repair,  
Lockport Lock

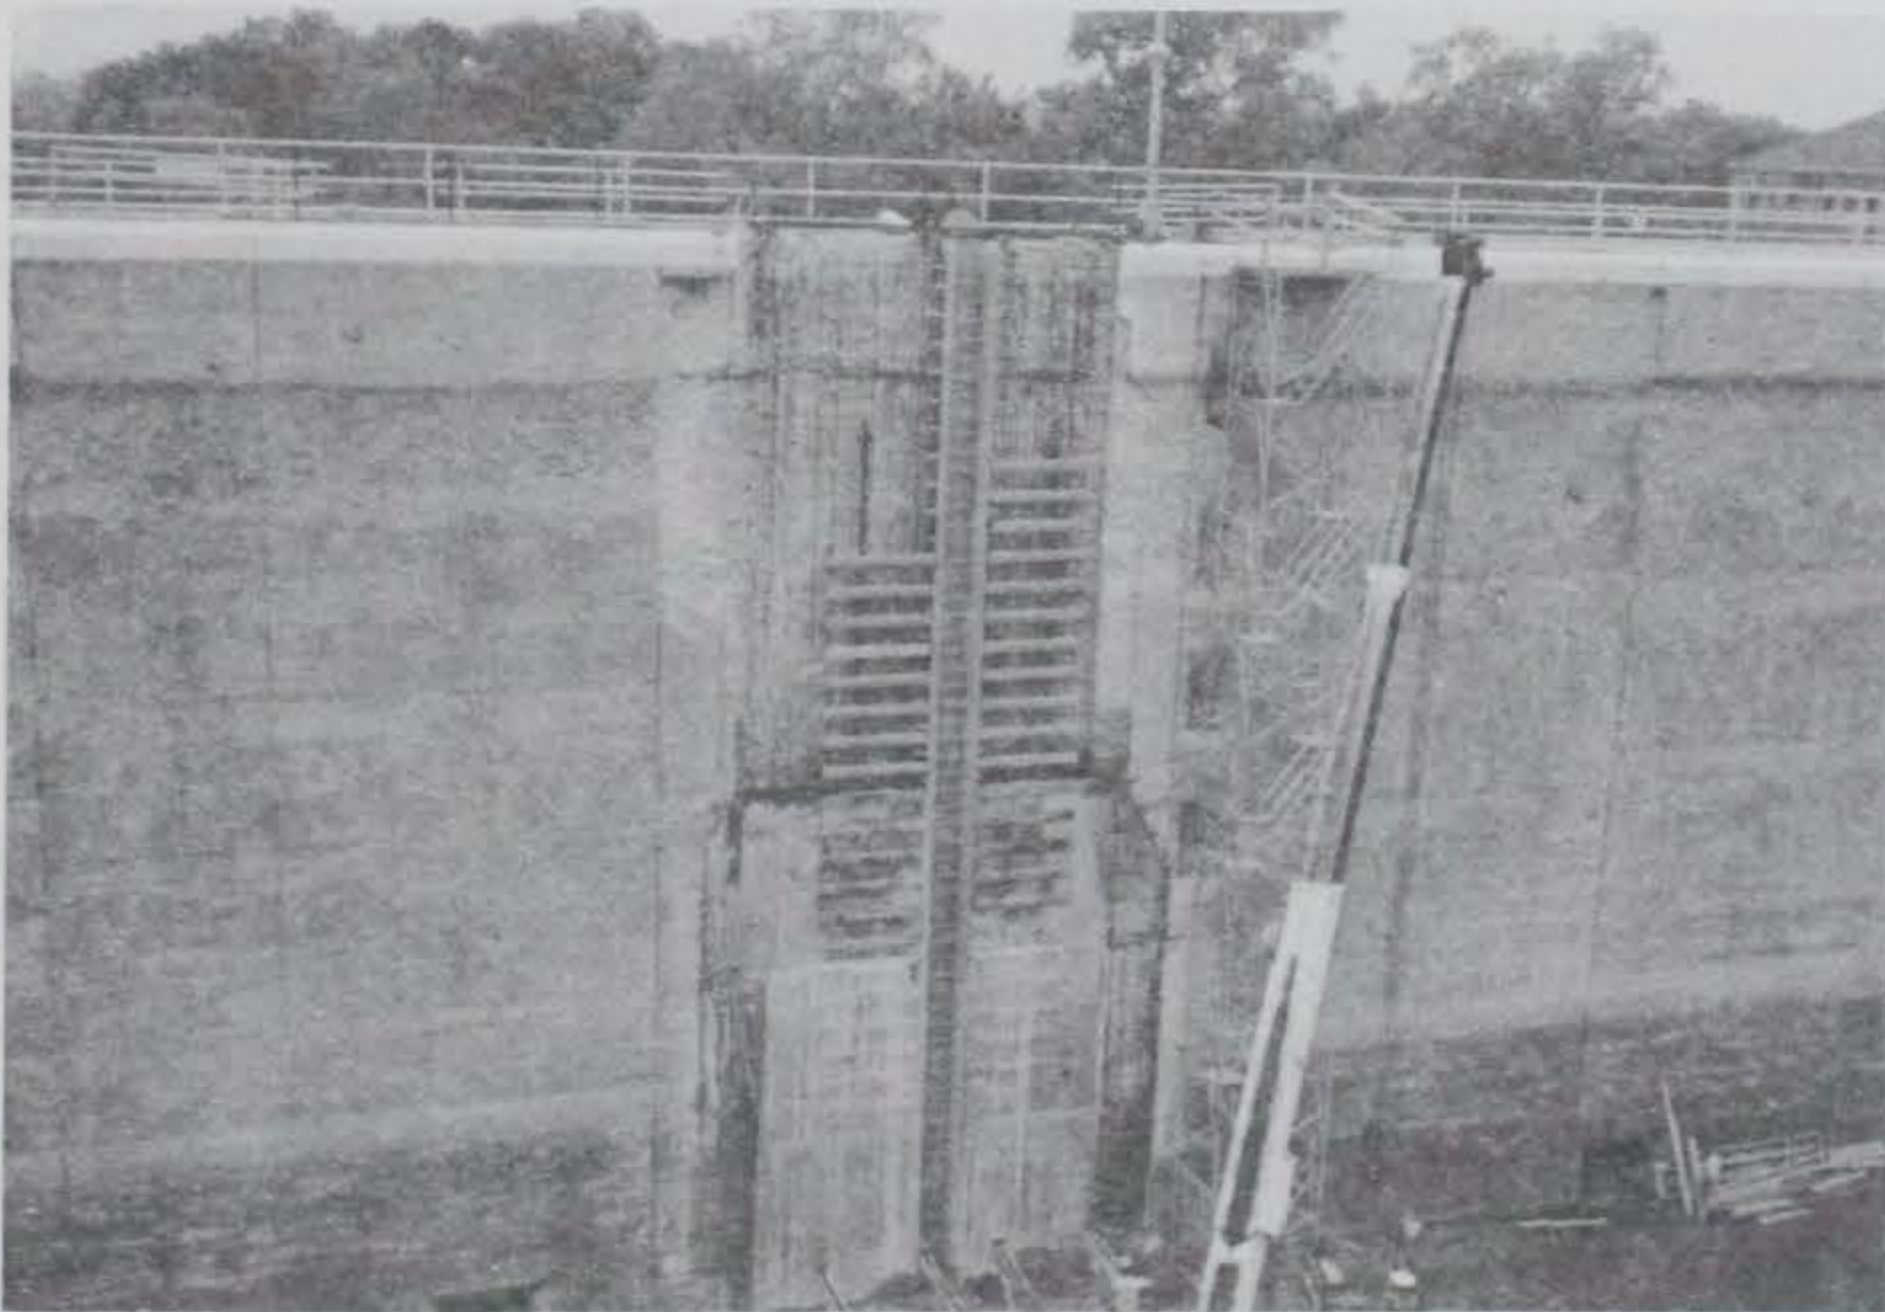
Figure 154. Partially completed ladder section,  
Lockport Lock
