TECHNICAL REPORT REMR-CS-13

**REHABILITATION OF NAVIGATION  
LOCK WALLS: CASE HISTORIES**

James E. McDonald

December 1987

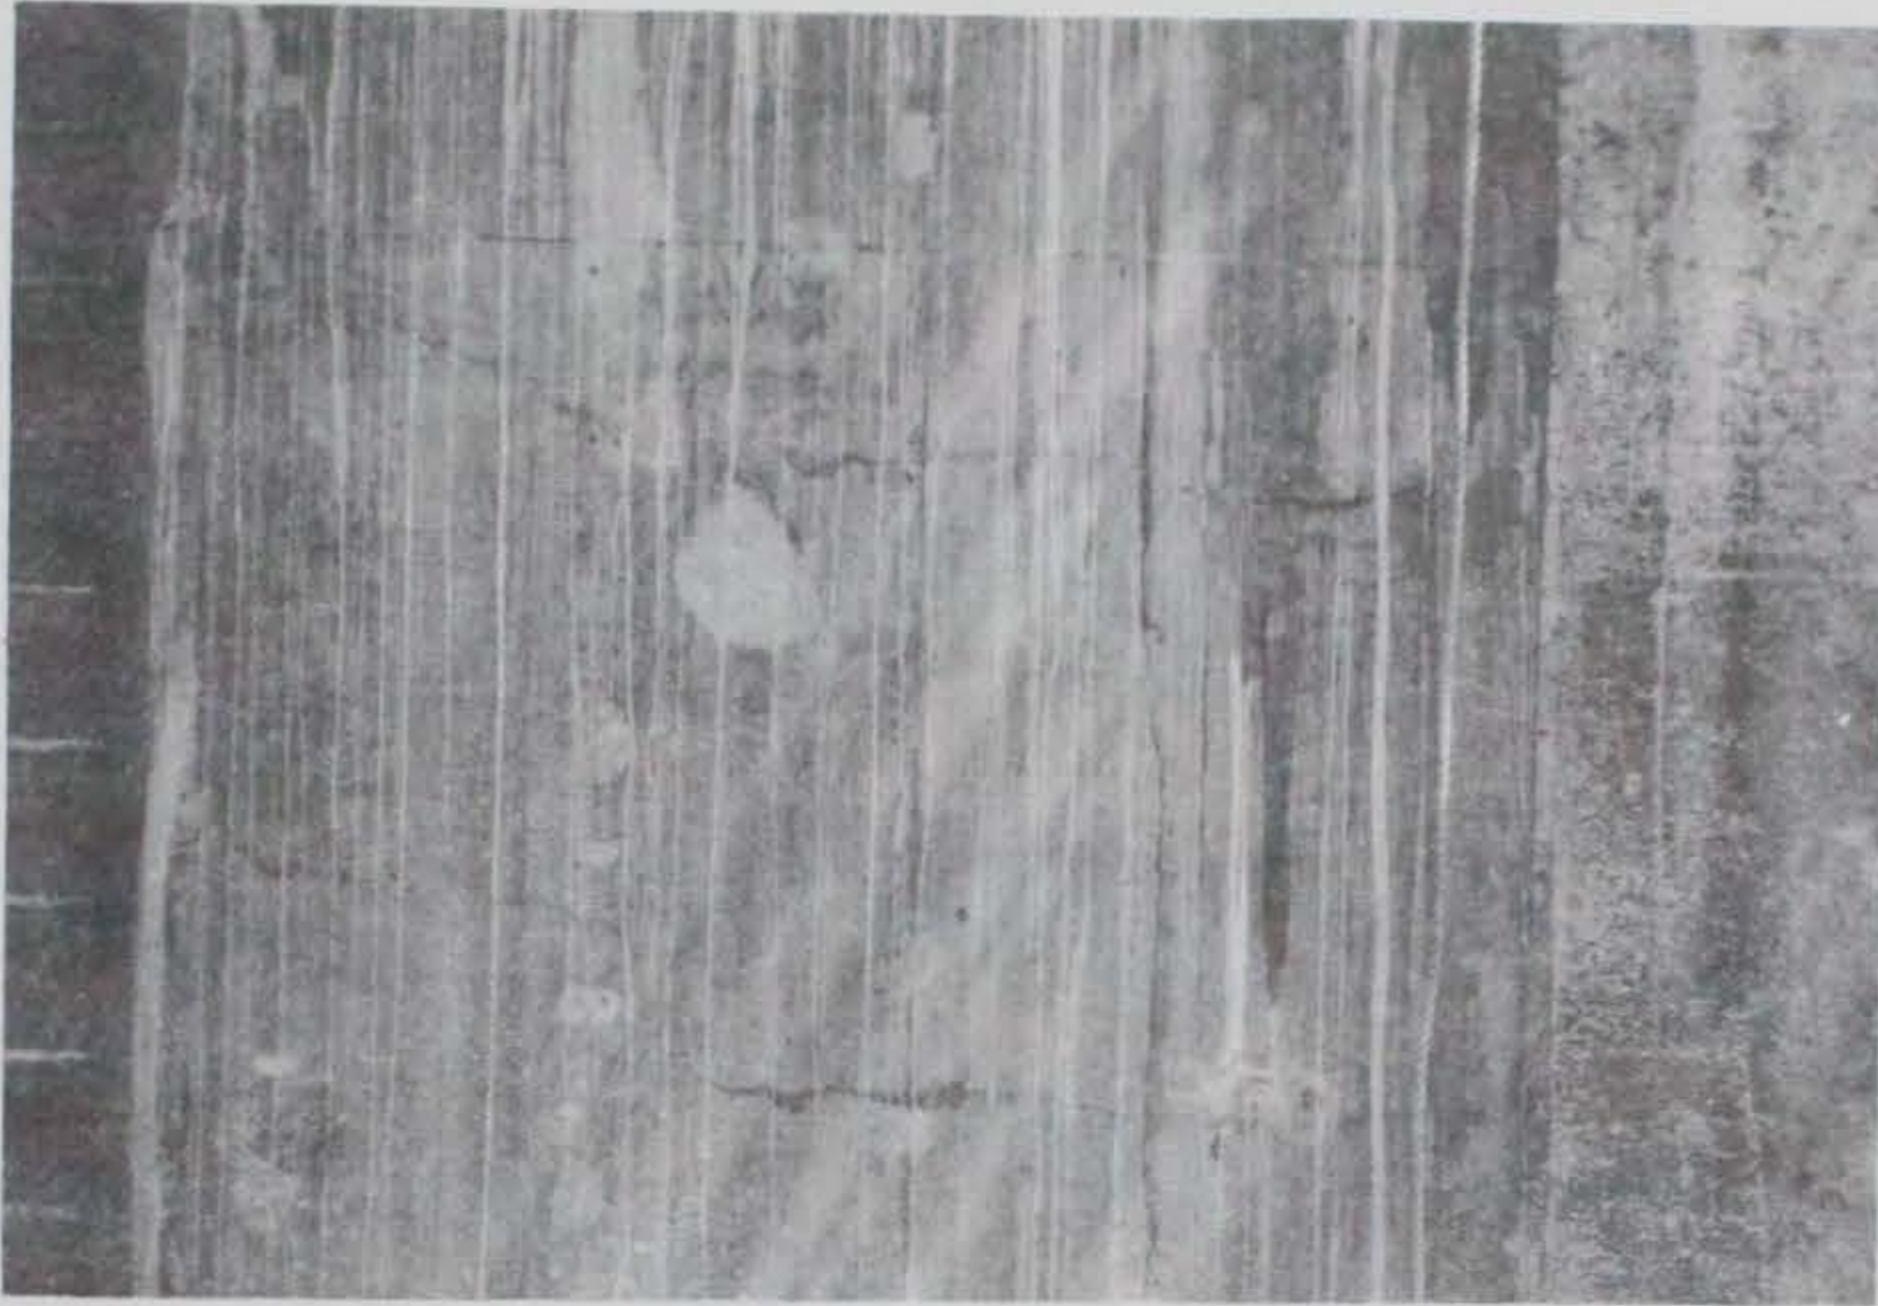
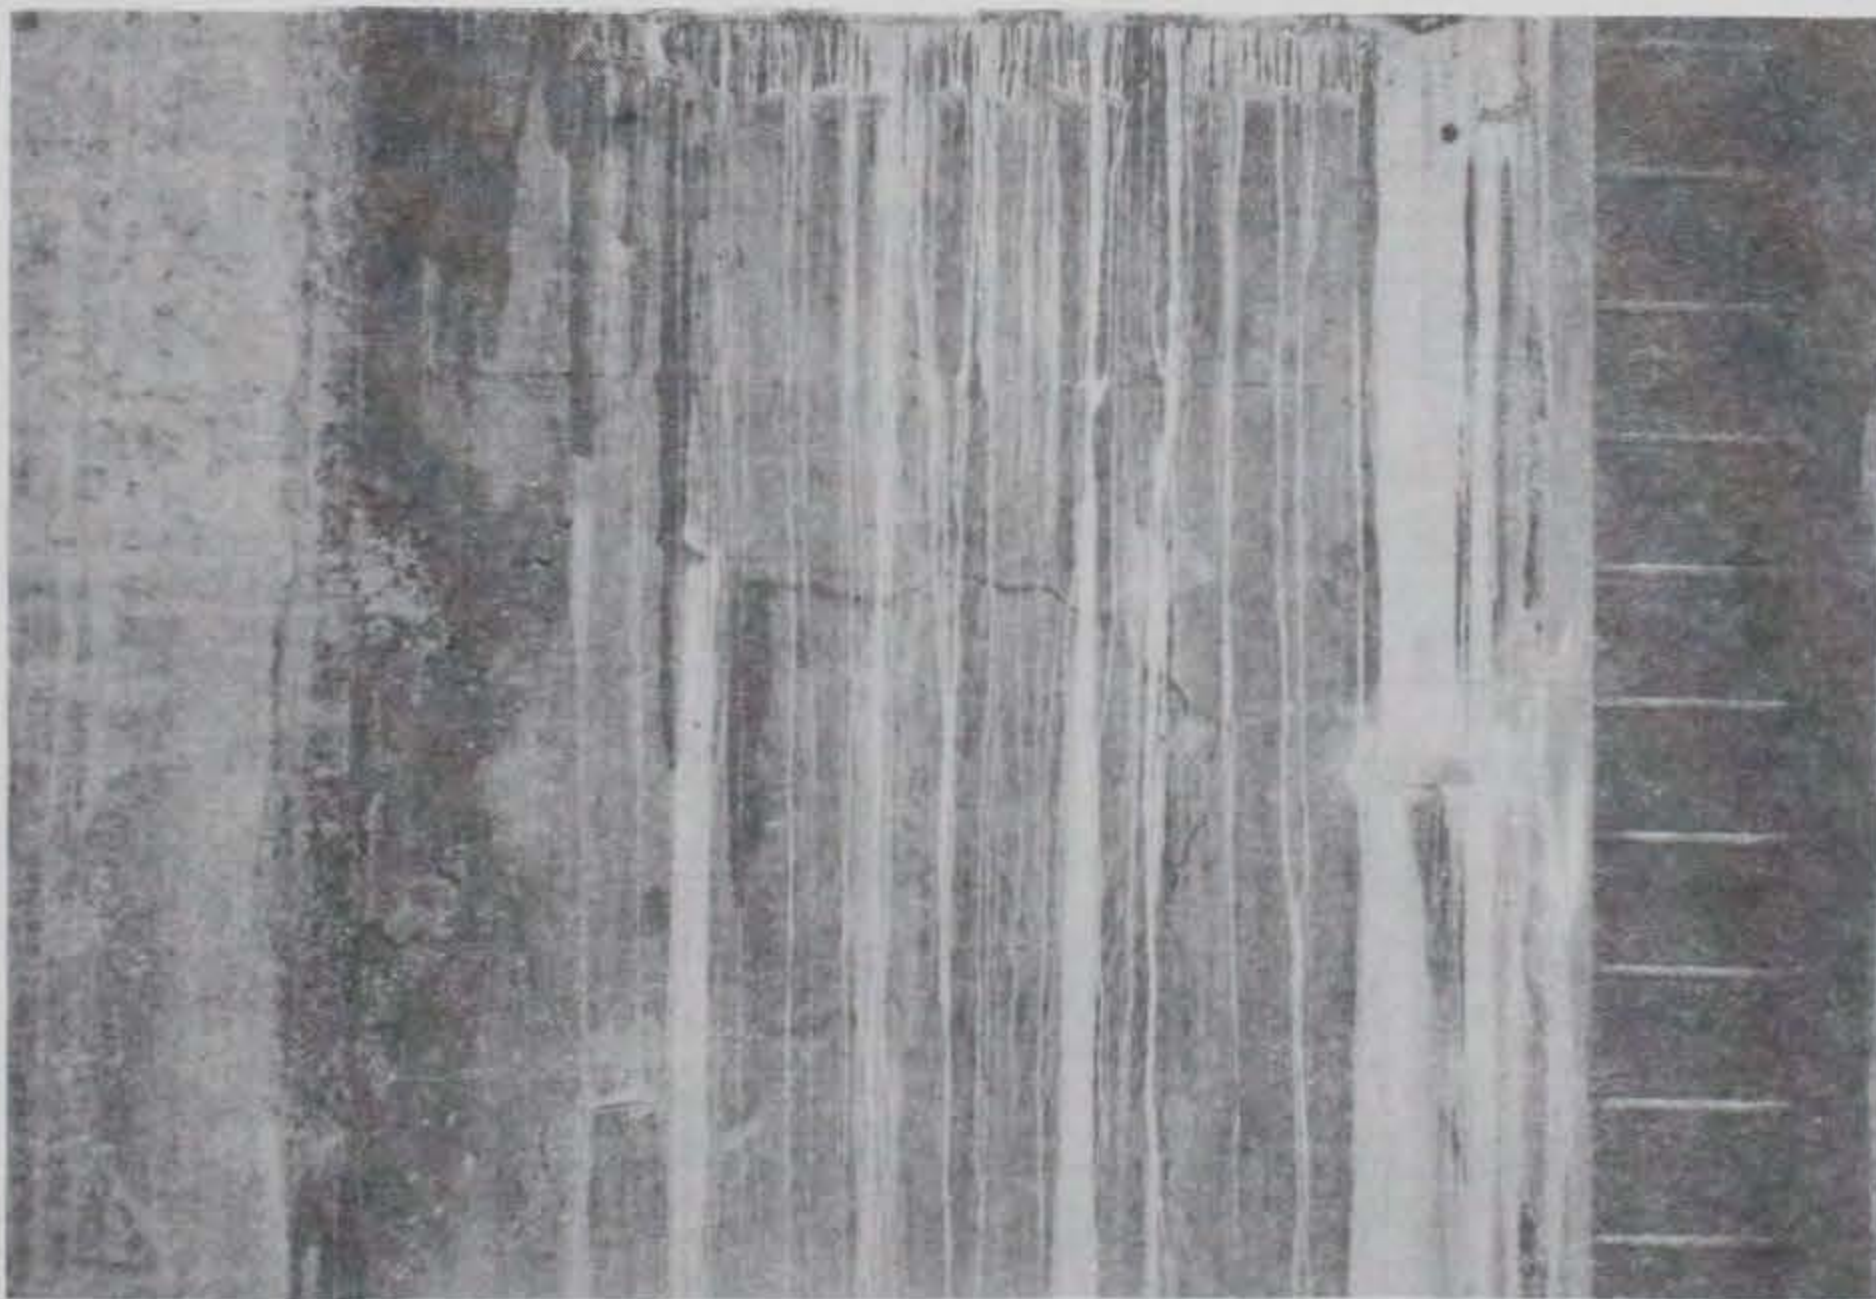
in the replacement concrete, particularly in the lower lifts where armor was not present (Figure 155). The contractor's bid price for ladder installation was approximately \$350,000.

Figure 155. Cracking in the replacement concrete,  
Lockport Lock

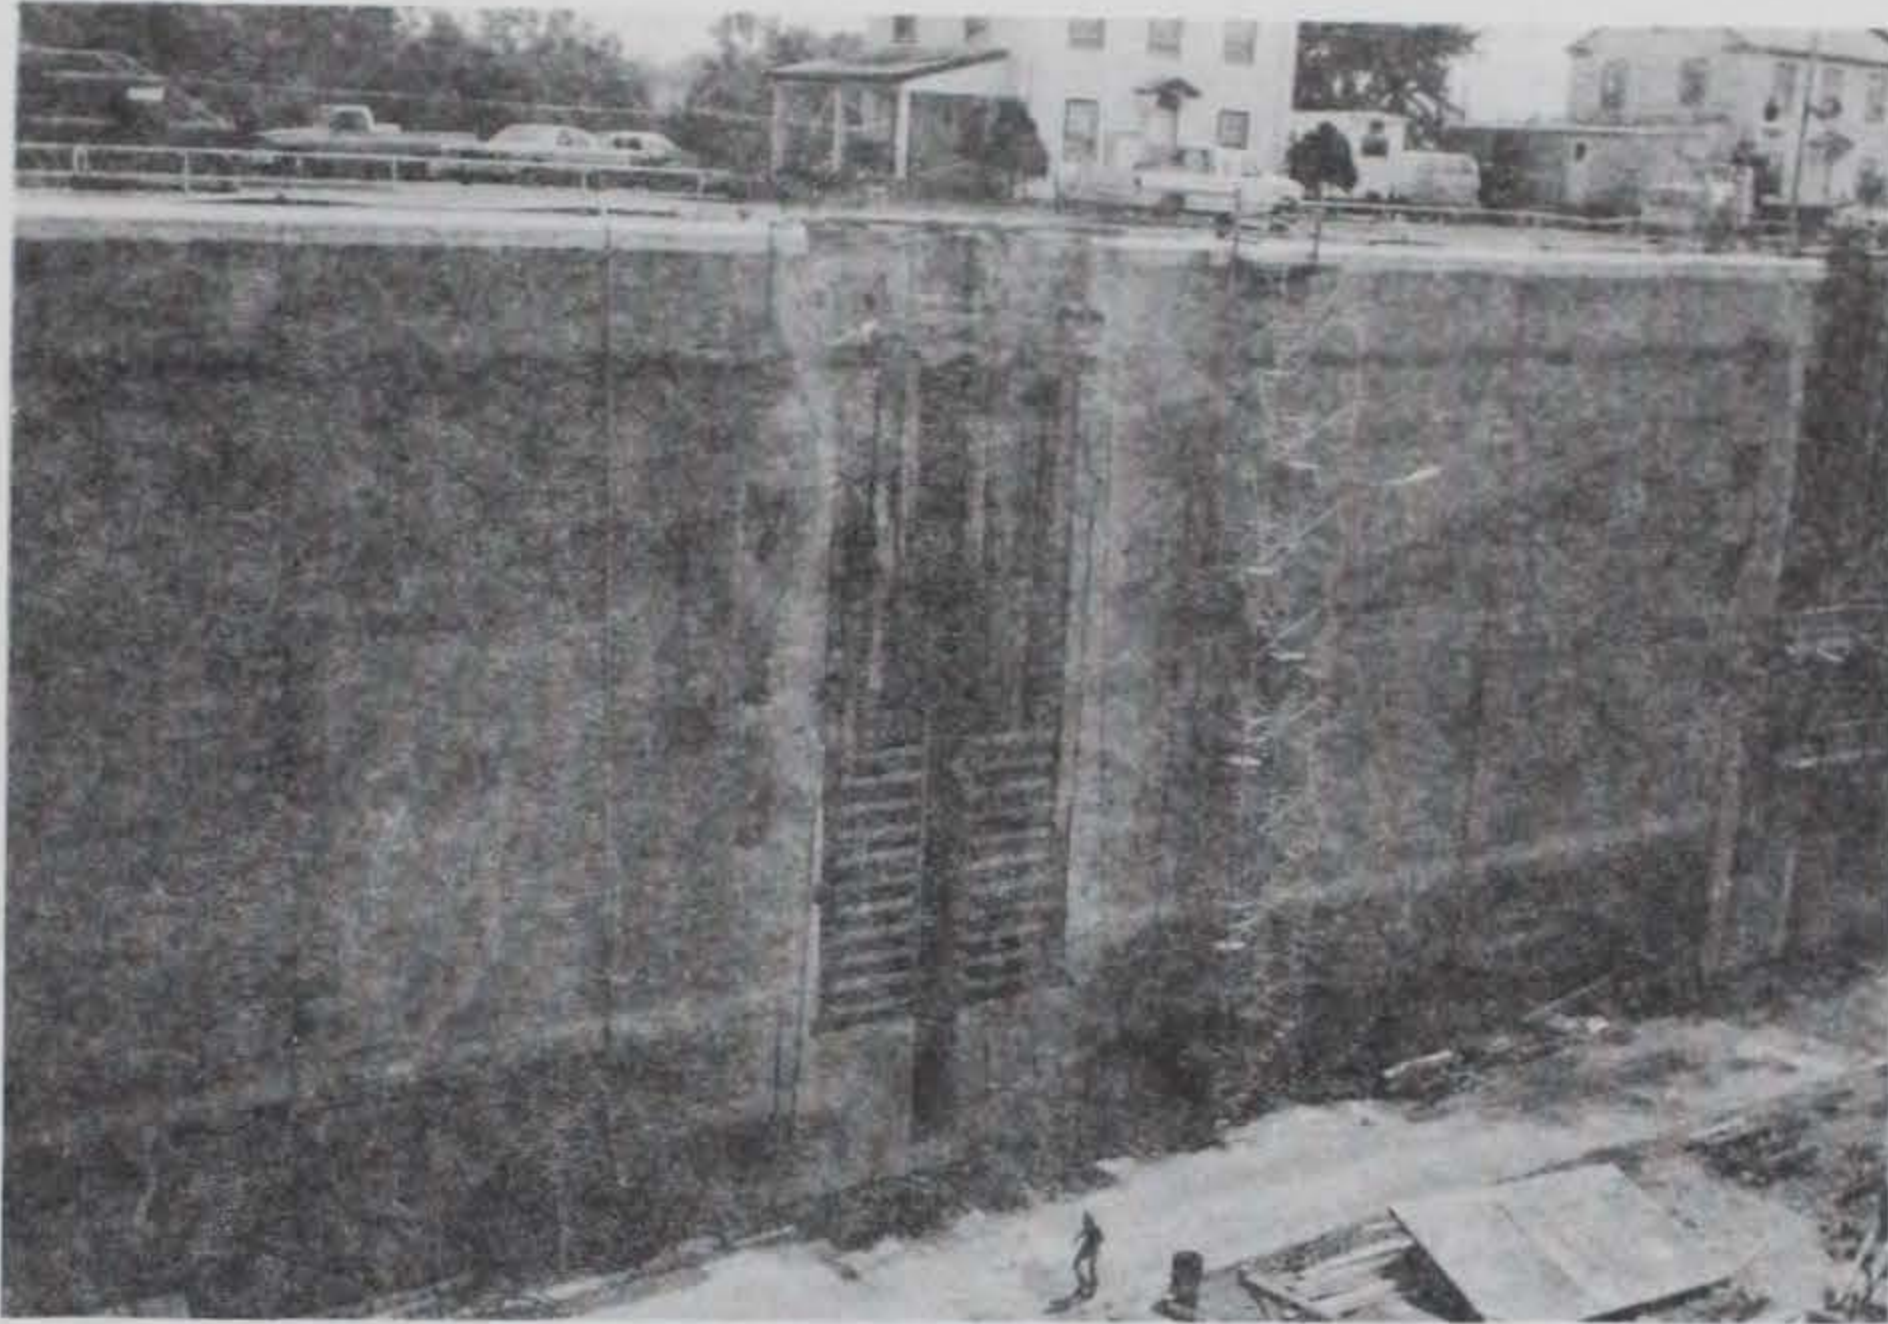
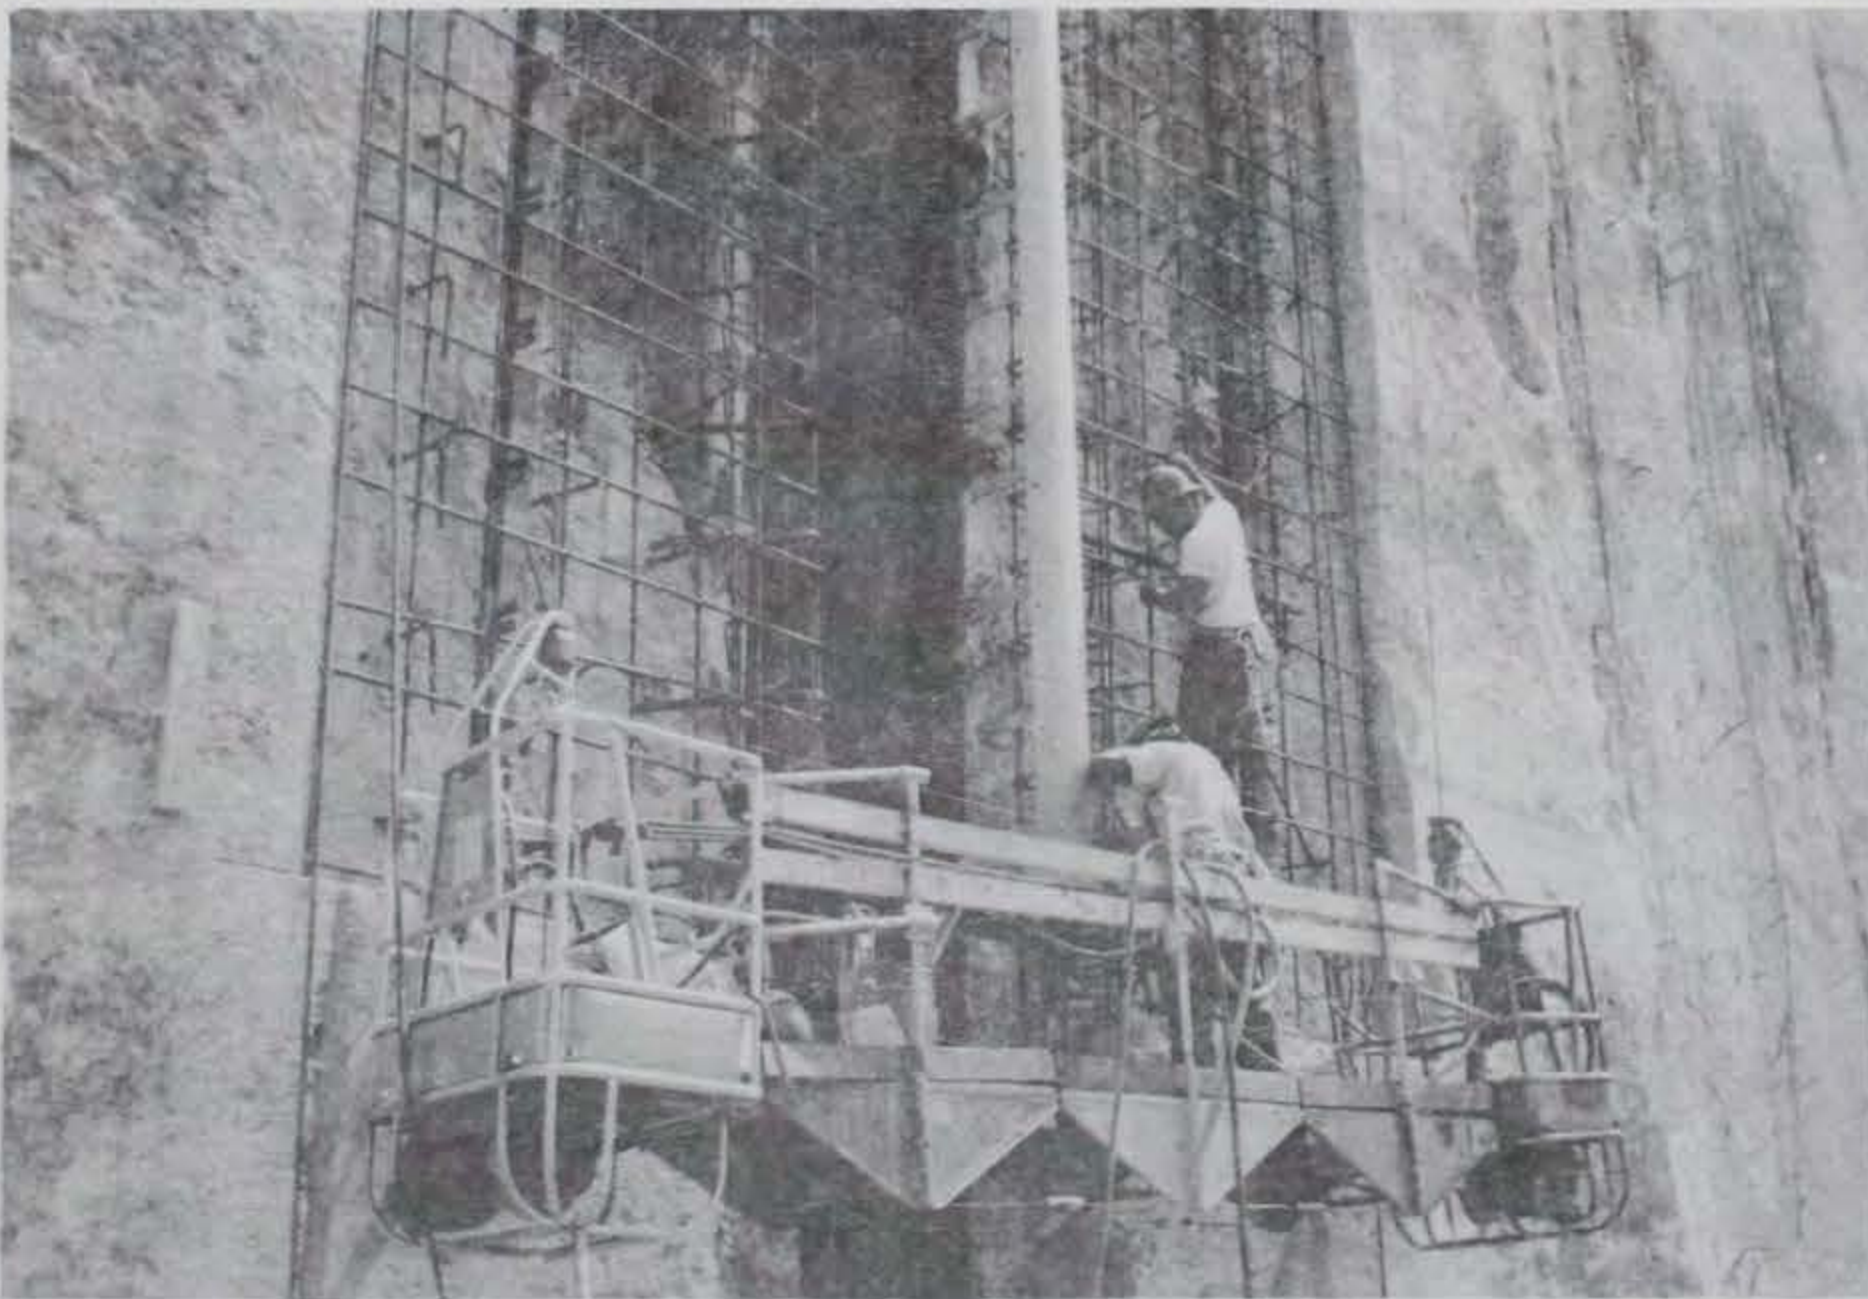
Figure 160. Replacing concrete around a floating mooring bitt,  
Lockport Lock

324. Deteriorated concrete around the floating mooring bitts was removed and replaced with armored concrete as shown in Figures 156 through 160. The replacement required removal of approximately 110 cu yd of concrete. Approximately 470 dowels were used to anchor the replacement concrete. Concrete removal, installation of dowels, forming, and concrete placing were accomplished using techniques similar to that previously described for the exit ladders. The contractor's bid price for this work was approximately \$240,000.

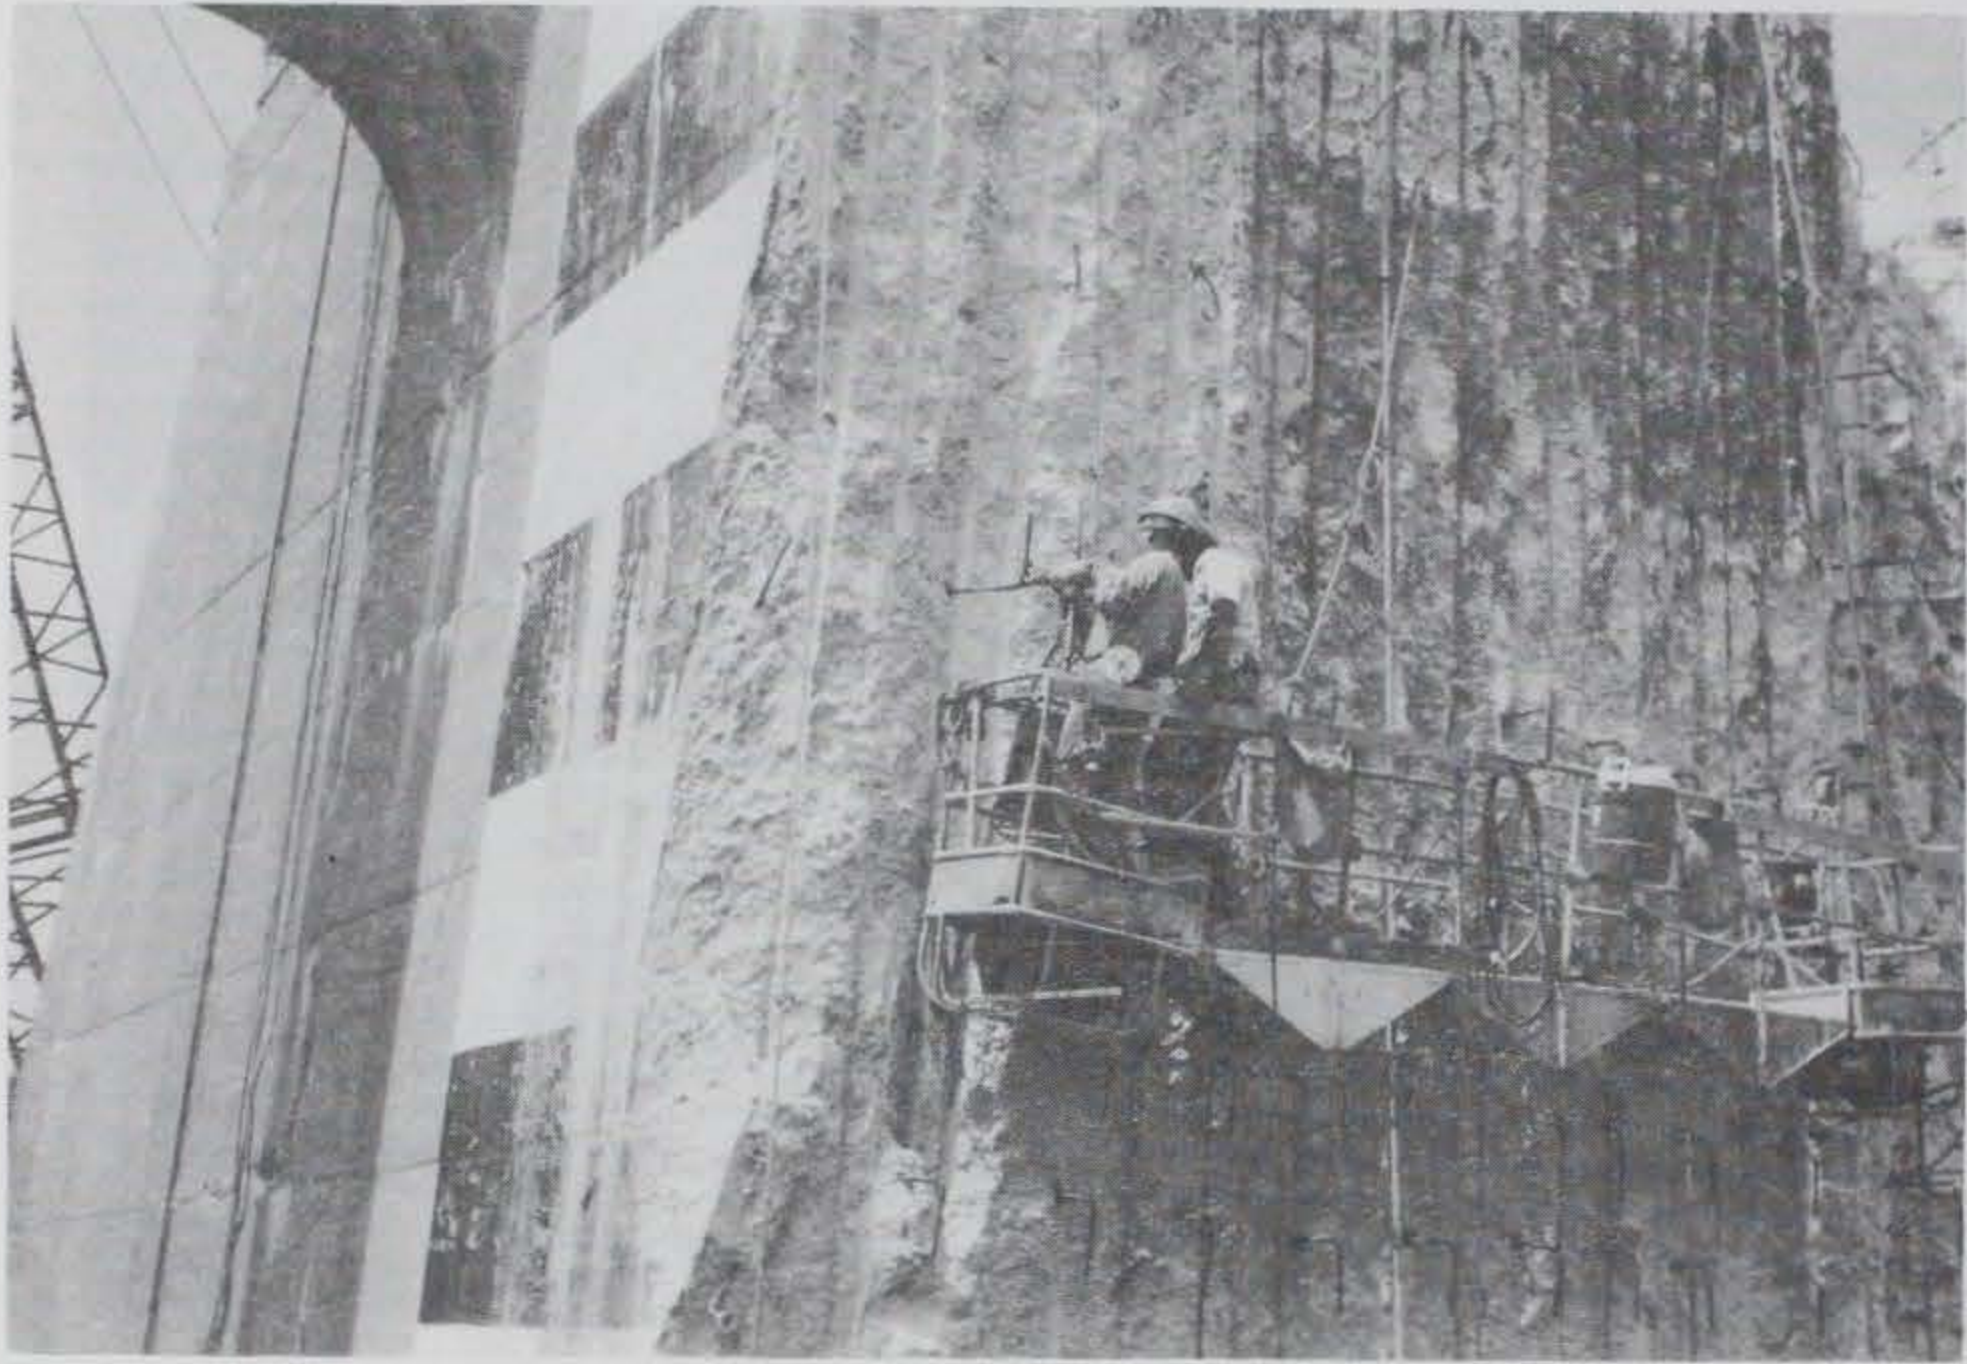
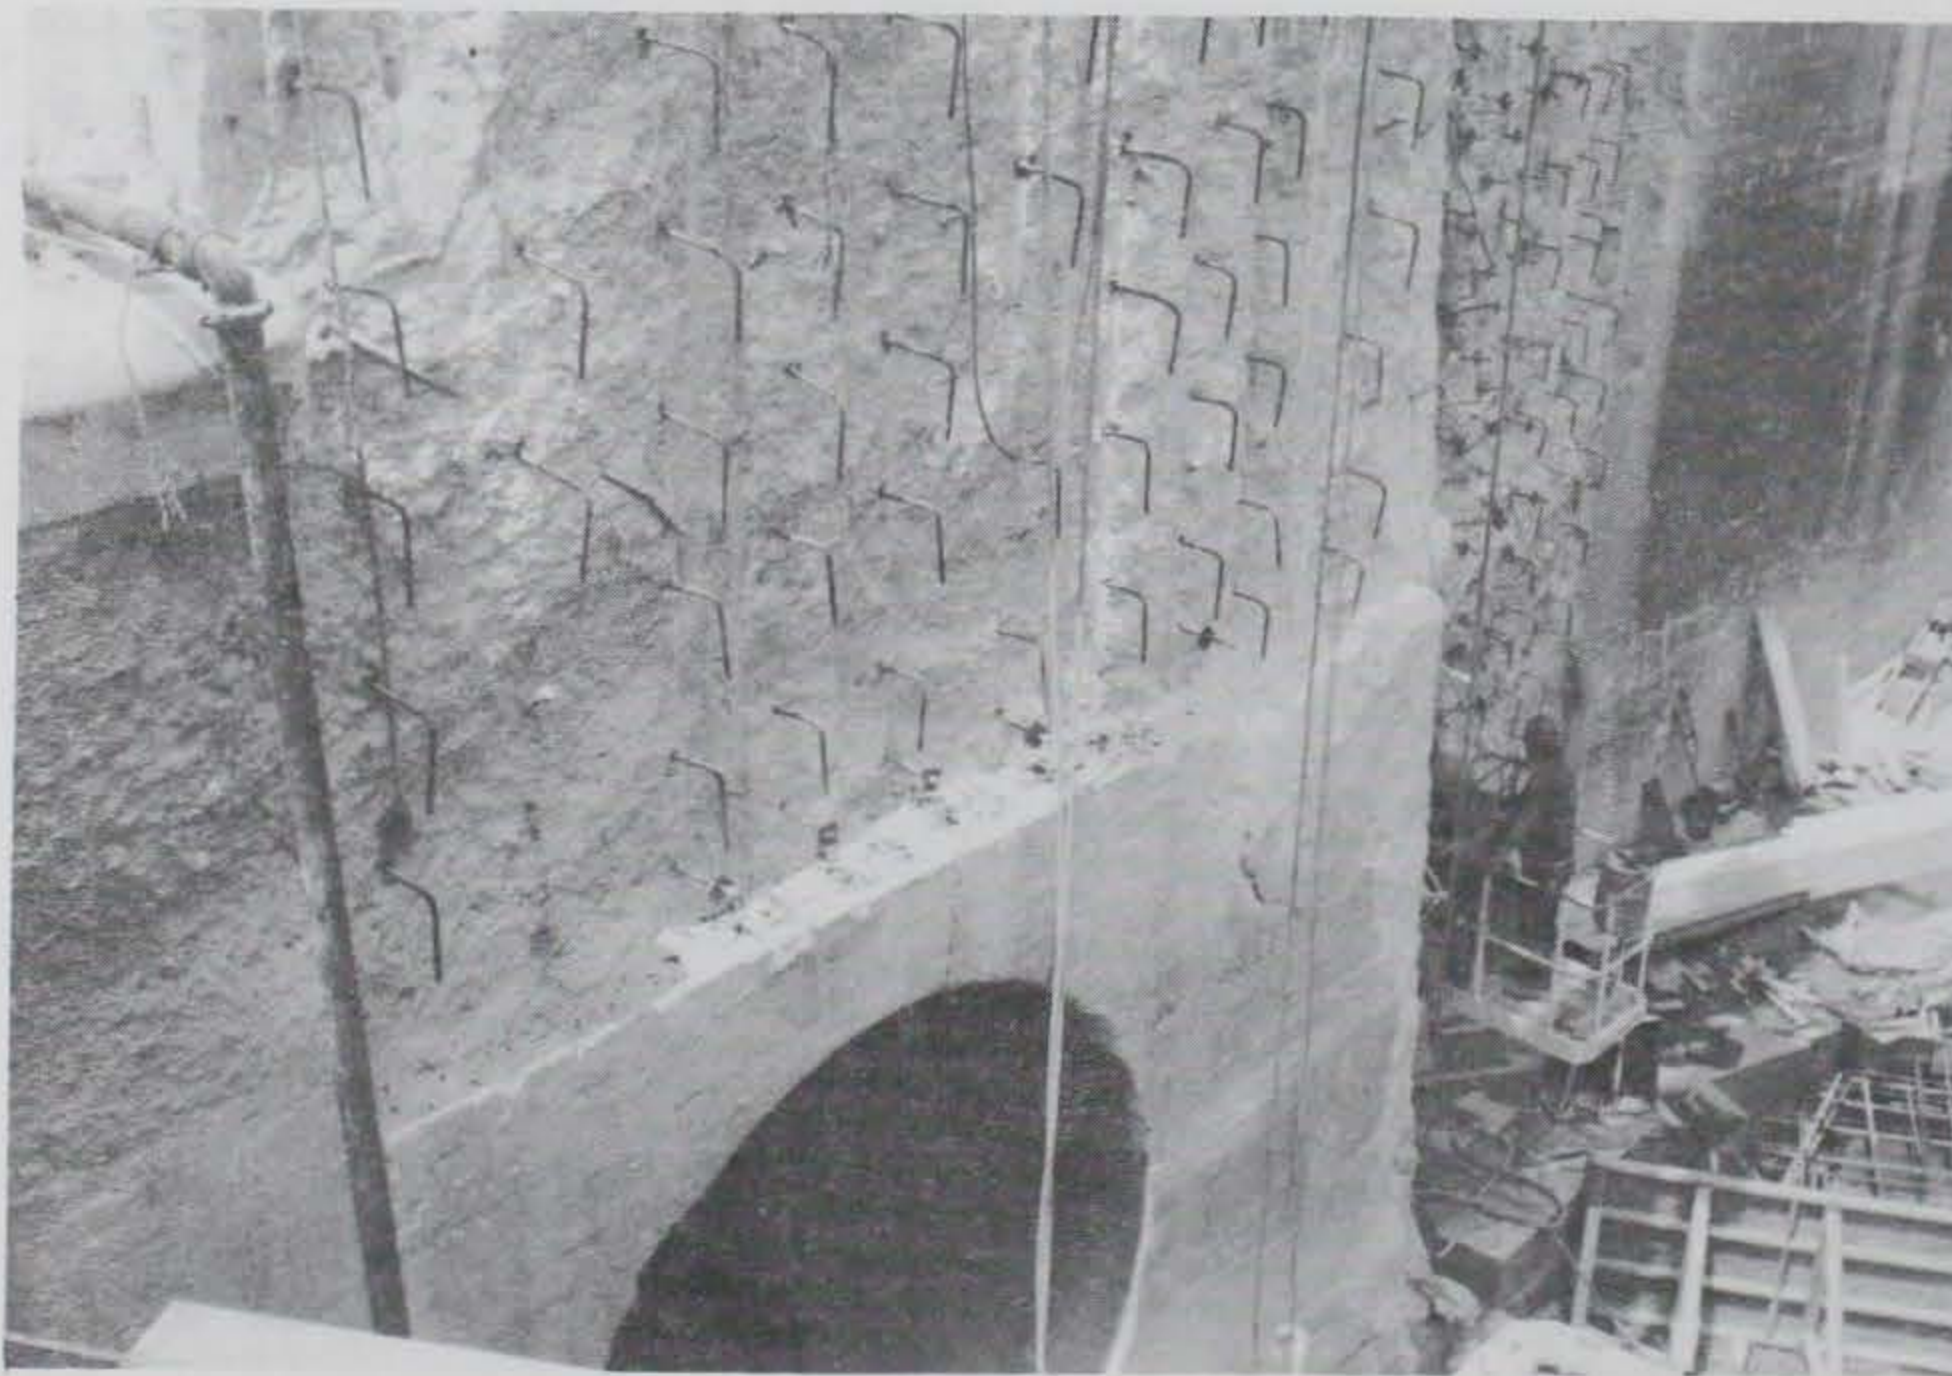
b. Crack in top of culvert to be grouted

Figure 161. Rehabilitation of lower gate bay, Lockport Lock

325. Since the condition survey showed that the maximum depth of concrete deterioration occurred in the lower gate bay, it was completely refaced during the Stage I rehabilitation. The refacing required removal of approximately 335 cu yd of concrete and replacement with new armored concrete. Approximately 960 dowels were required to anchor the replacement concrete (Figure 161). Bid prices for these dowels ranged from \$33 to \$74 each compared to the Government estimate of \$34. A roughly vertical crack which extended from the top of the emptying culvert for a distance of approximately 18 ft was pressure-grouted prior to placement of the new concrete.

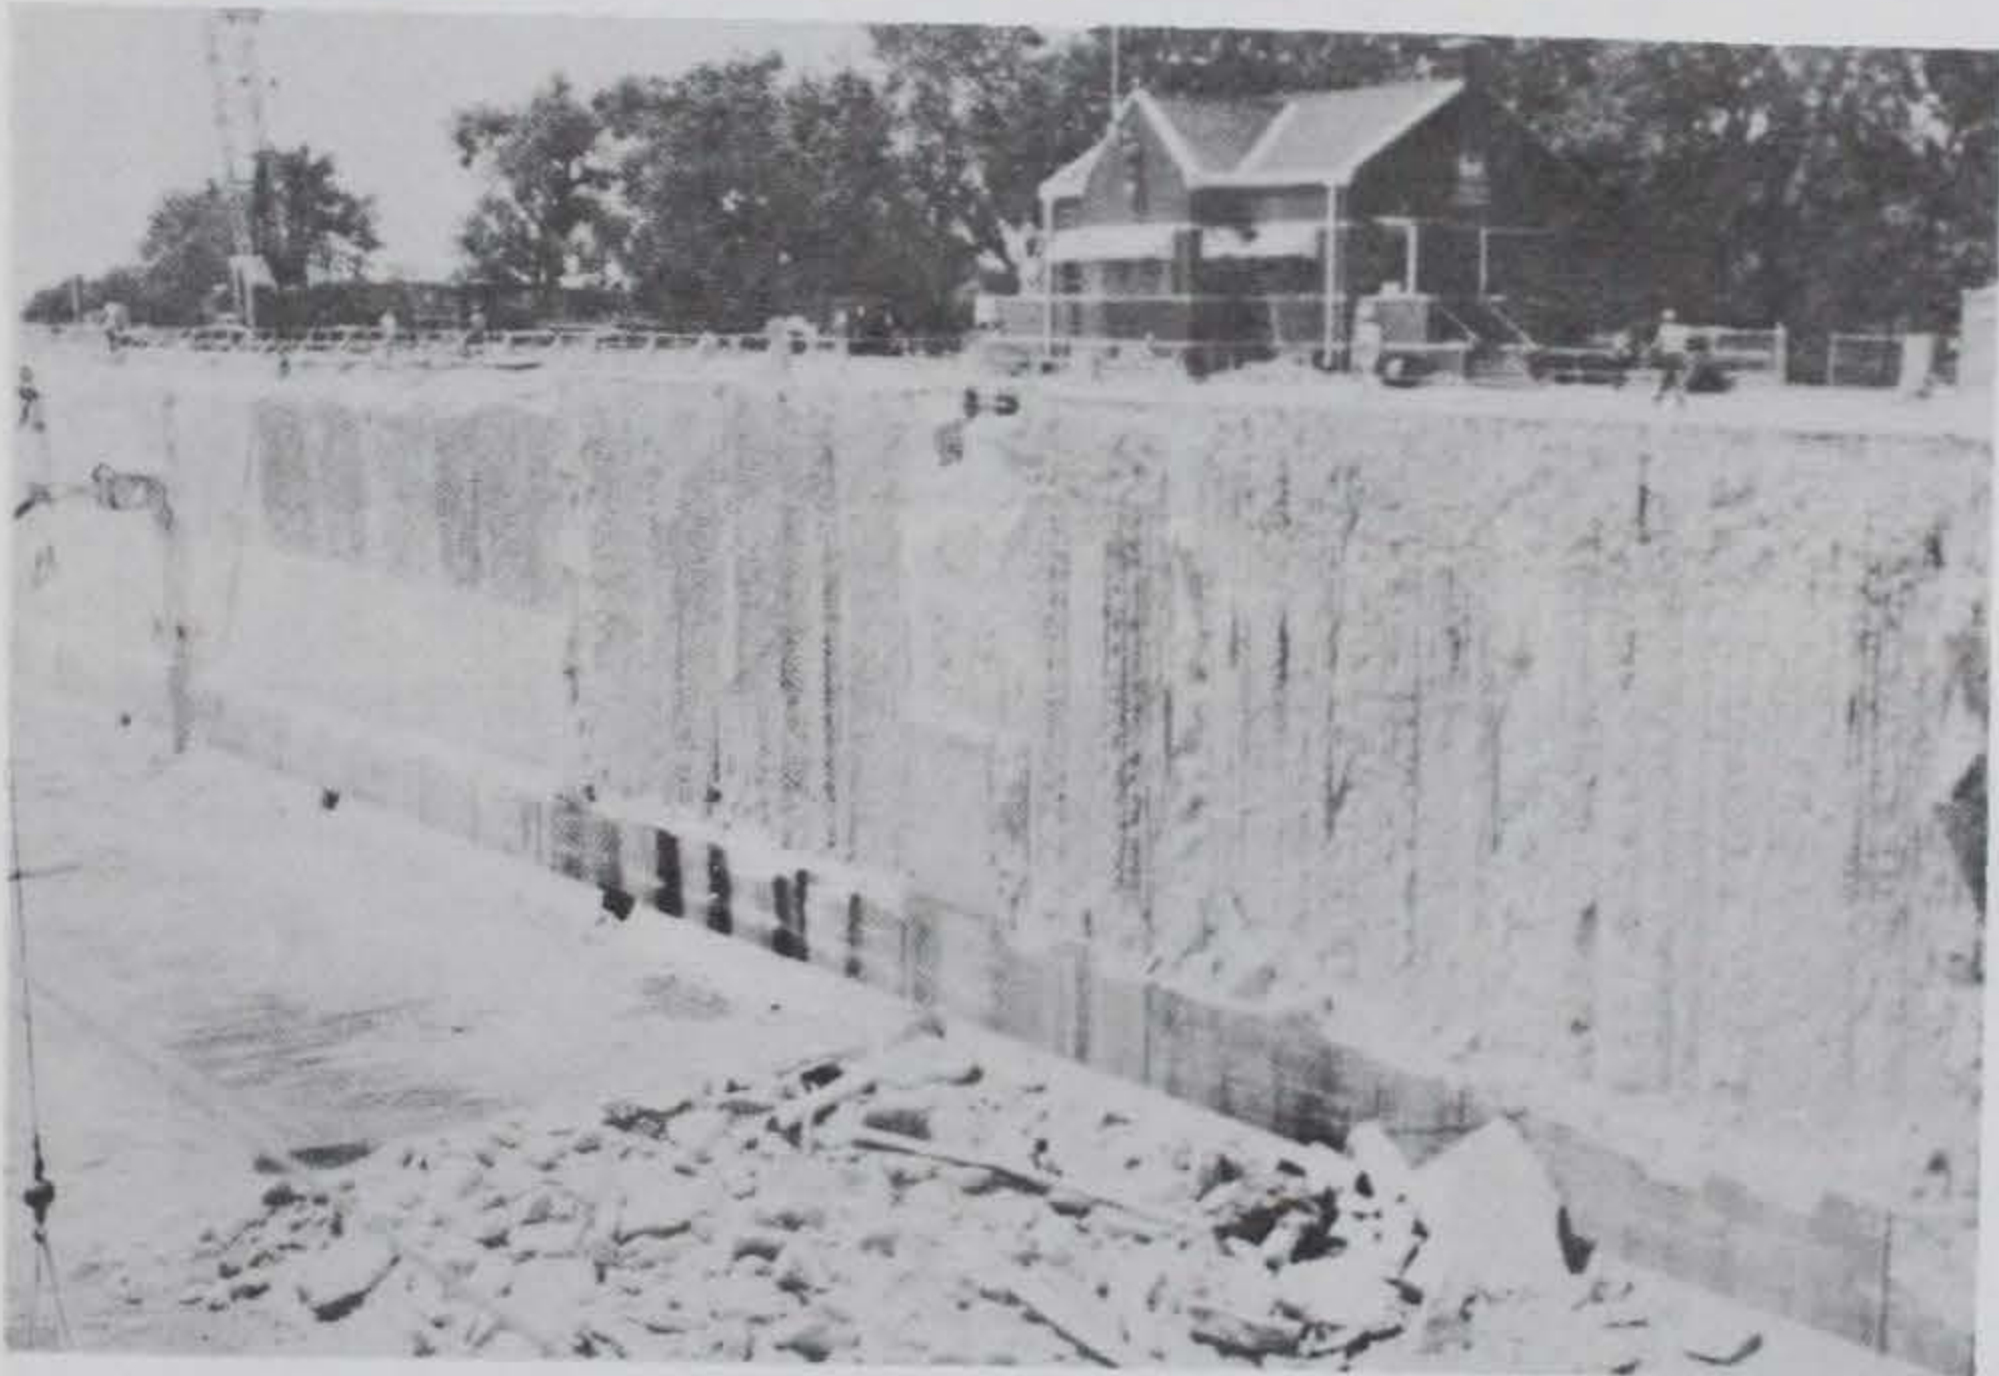
331. Following blasting, the walls were scaled to remove loose concrete still clinging to the wall surfaces (Figure 166). This scaling, normally done by manual processes such as labor crews working from scissor lifts or scaffolding with handheld hammers and chipping tools, is a very costly and time-consuming operation. The Cutter Boom, a modified piece of mining equipment having a rotary head cutter with a series of carbide-tipped teeth that grind away the concrete (Figures 167 and 168), was used to scale the walls at Brandon Road Lock. The efficiency of this equipment probably contributed to the fact that the contractor's bid price for removal of concrete in the lock chamber was \$162 per cu yd as compared to the Government estimate of \$771 per cu yd.

Figure 166. Typical concrete surface conditions following blasting, Brandon Road Lock

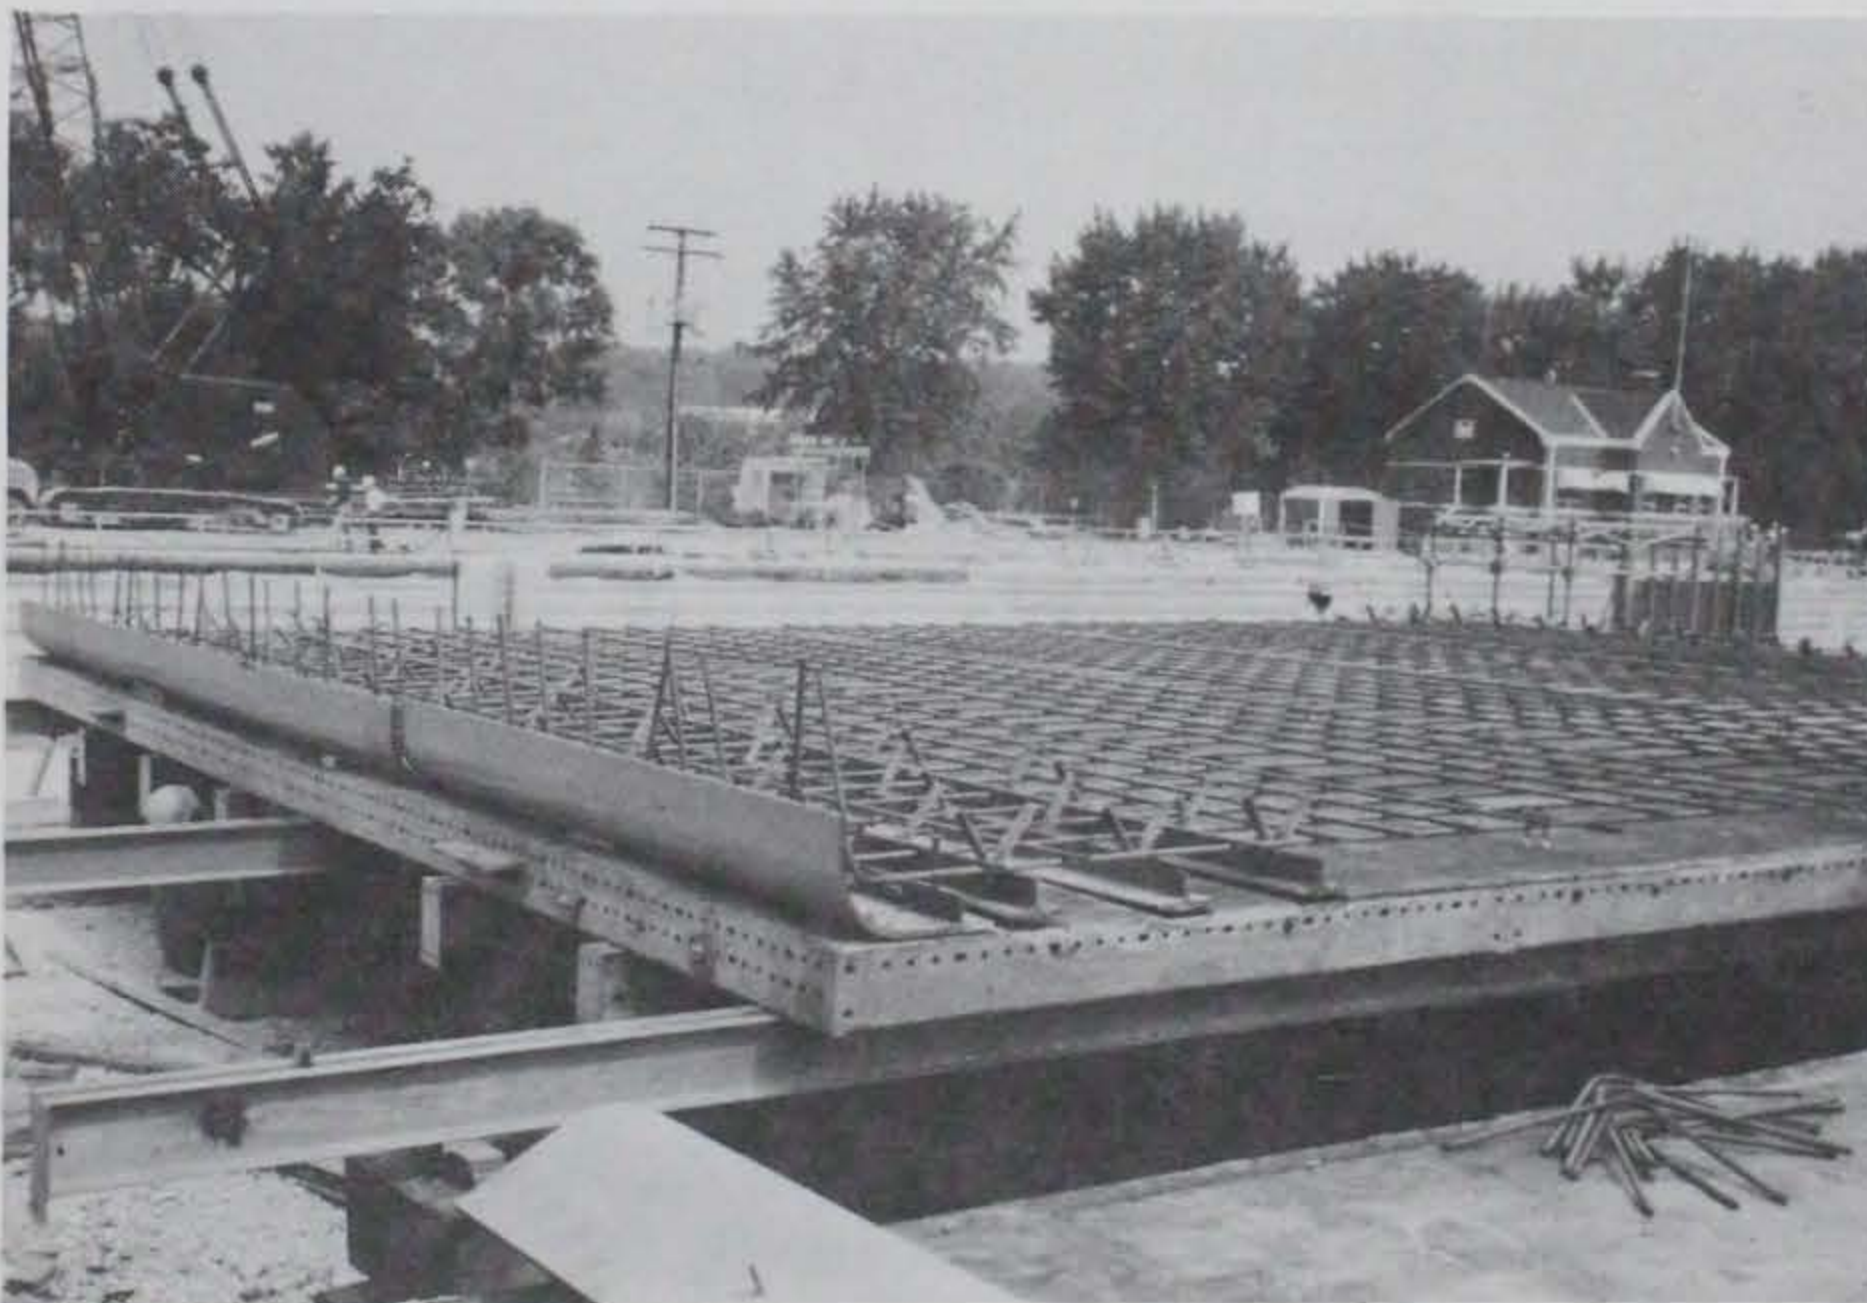
Figure 174. Wall armor and concrete reinforcement in place on the form, Brandon Road Lock

338. Wall armor and concrete reinforcement, No. 6 bars on 12-in. centers each way, were installed on the concrete form prior to placing the form on the lock wall (Figures 174 and 175). A truss system was used to span the lock chamber, thus supporting forms on opposing monoliths of each wall simultaneously (Figure 176). Replacement concrete was placed in a single 40-ft lift for each 30-ft-wide monolith. Approximately 85 and 100 cu yd of Type C concrete was required for landside and riverside monolith placements, respectively. Concrete materials, mixture proportions, and supplier were the same as previously reported for Lockport Lock (paragraph 314). Concrete for resurfacing the vertical walls was discharged into hoppers with elephant trunks of varying lengths (Figure 177). Concrete for the 2-ft cap on the top of the lock walls was discharged directly into the form. Internal vibrators were
