TECHNICAL REPORT REMR-CS-13

**REHABILITATION OF NAVIGATION  
LOCK WALLS: CASE HISTORIES**

James E. McDonald

December 1987

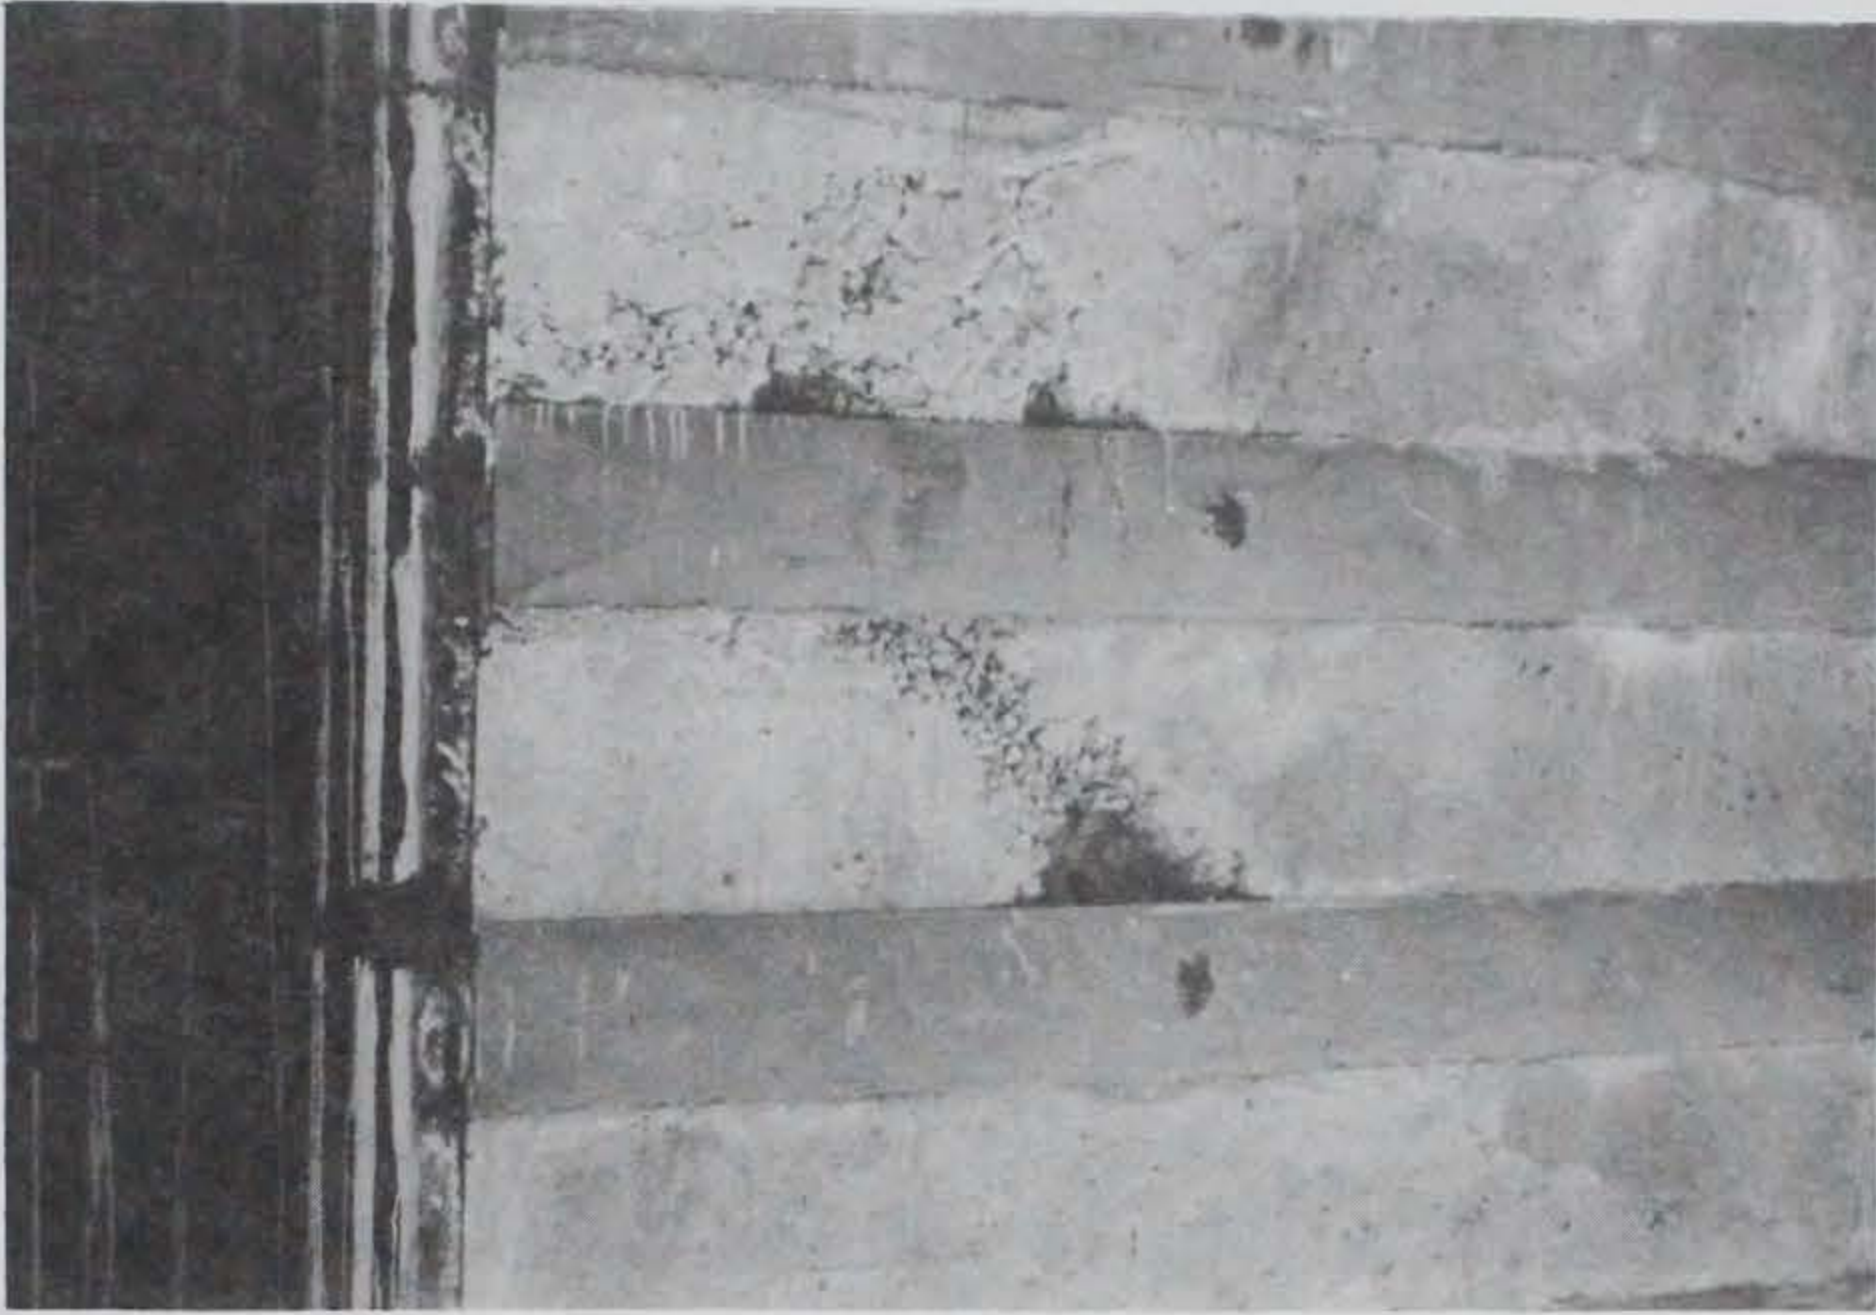
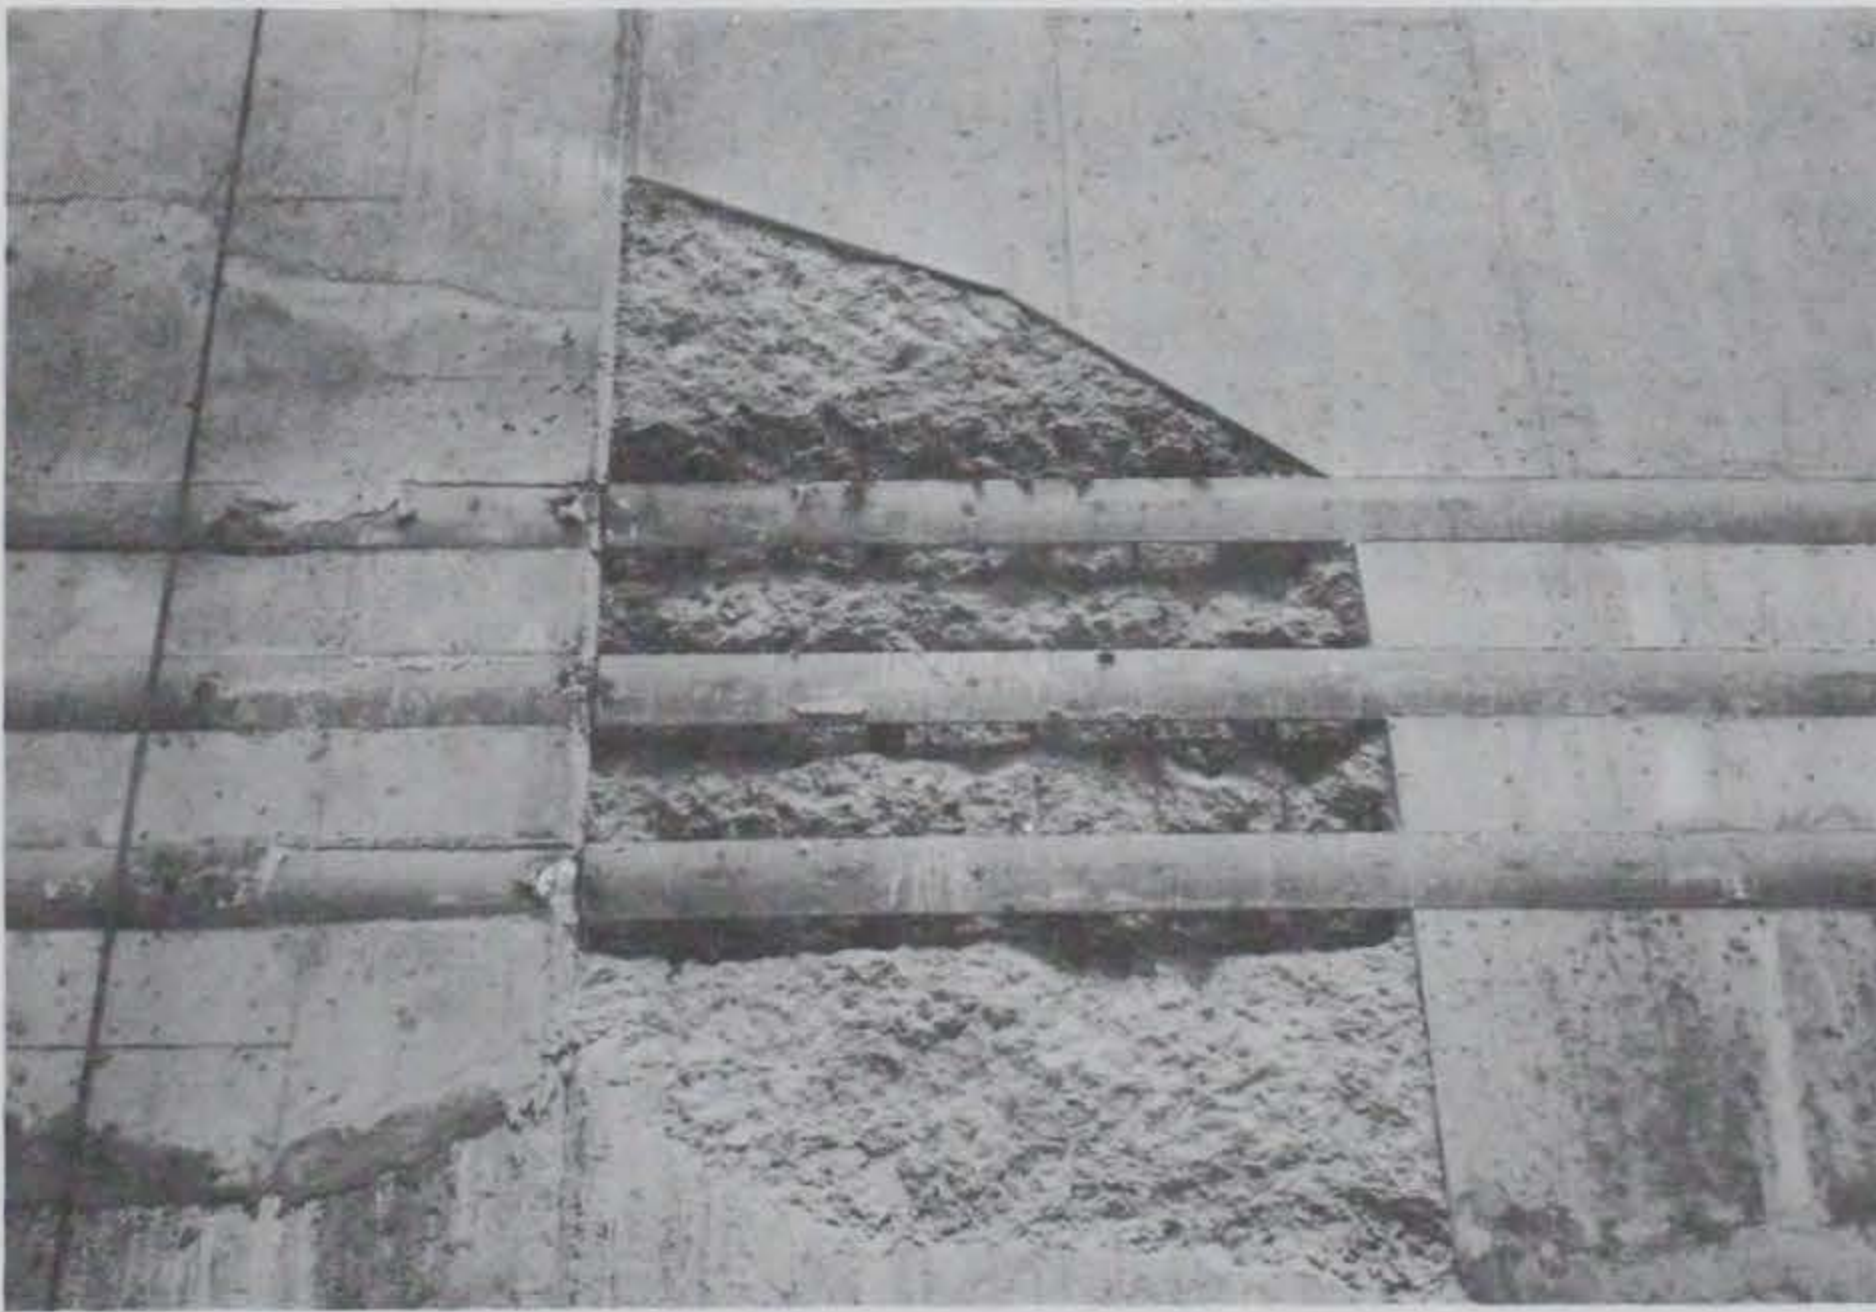
Figure 178. Repair of concrete honeycomb, Brandon Road Lock

used to consolidate the fresh concrete. Because of the limited space and the depth, there was some difficulty in vibrating the concrete near the bottom of the lift in a few monoliths. The perimeter of these isolated areas was saw cut and the concrete chipped to a minimum depth of 2 in. prior to repair (Figure 178).

a. Concrete honeycomb

b. Area of concrete honeycomb prepared for repair

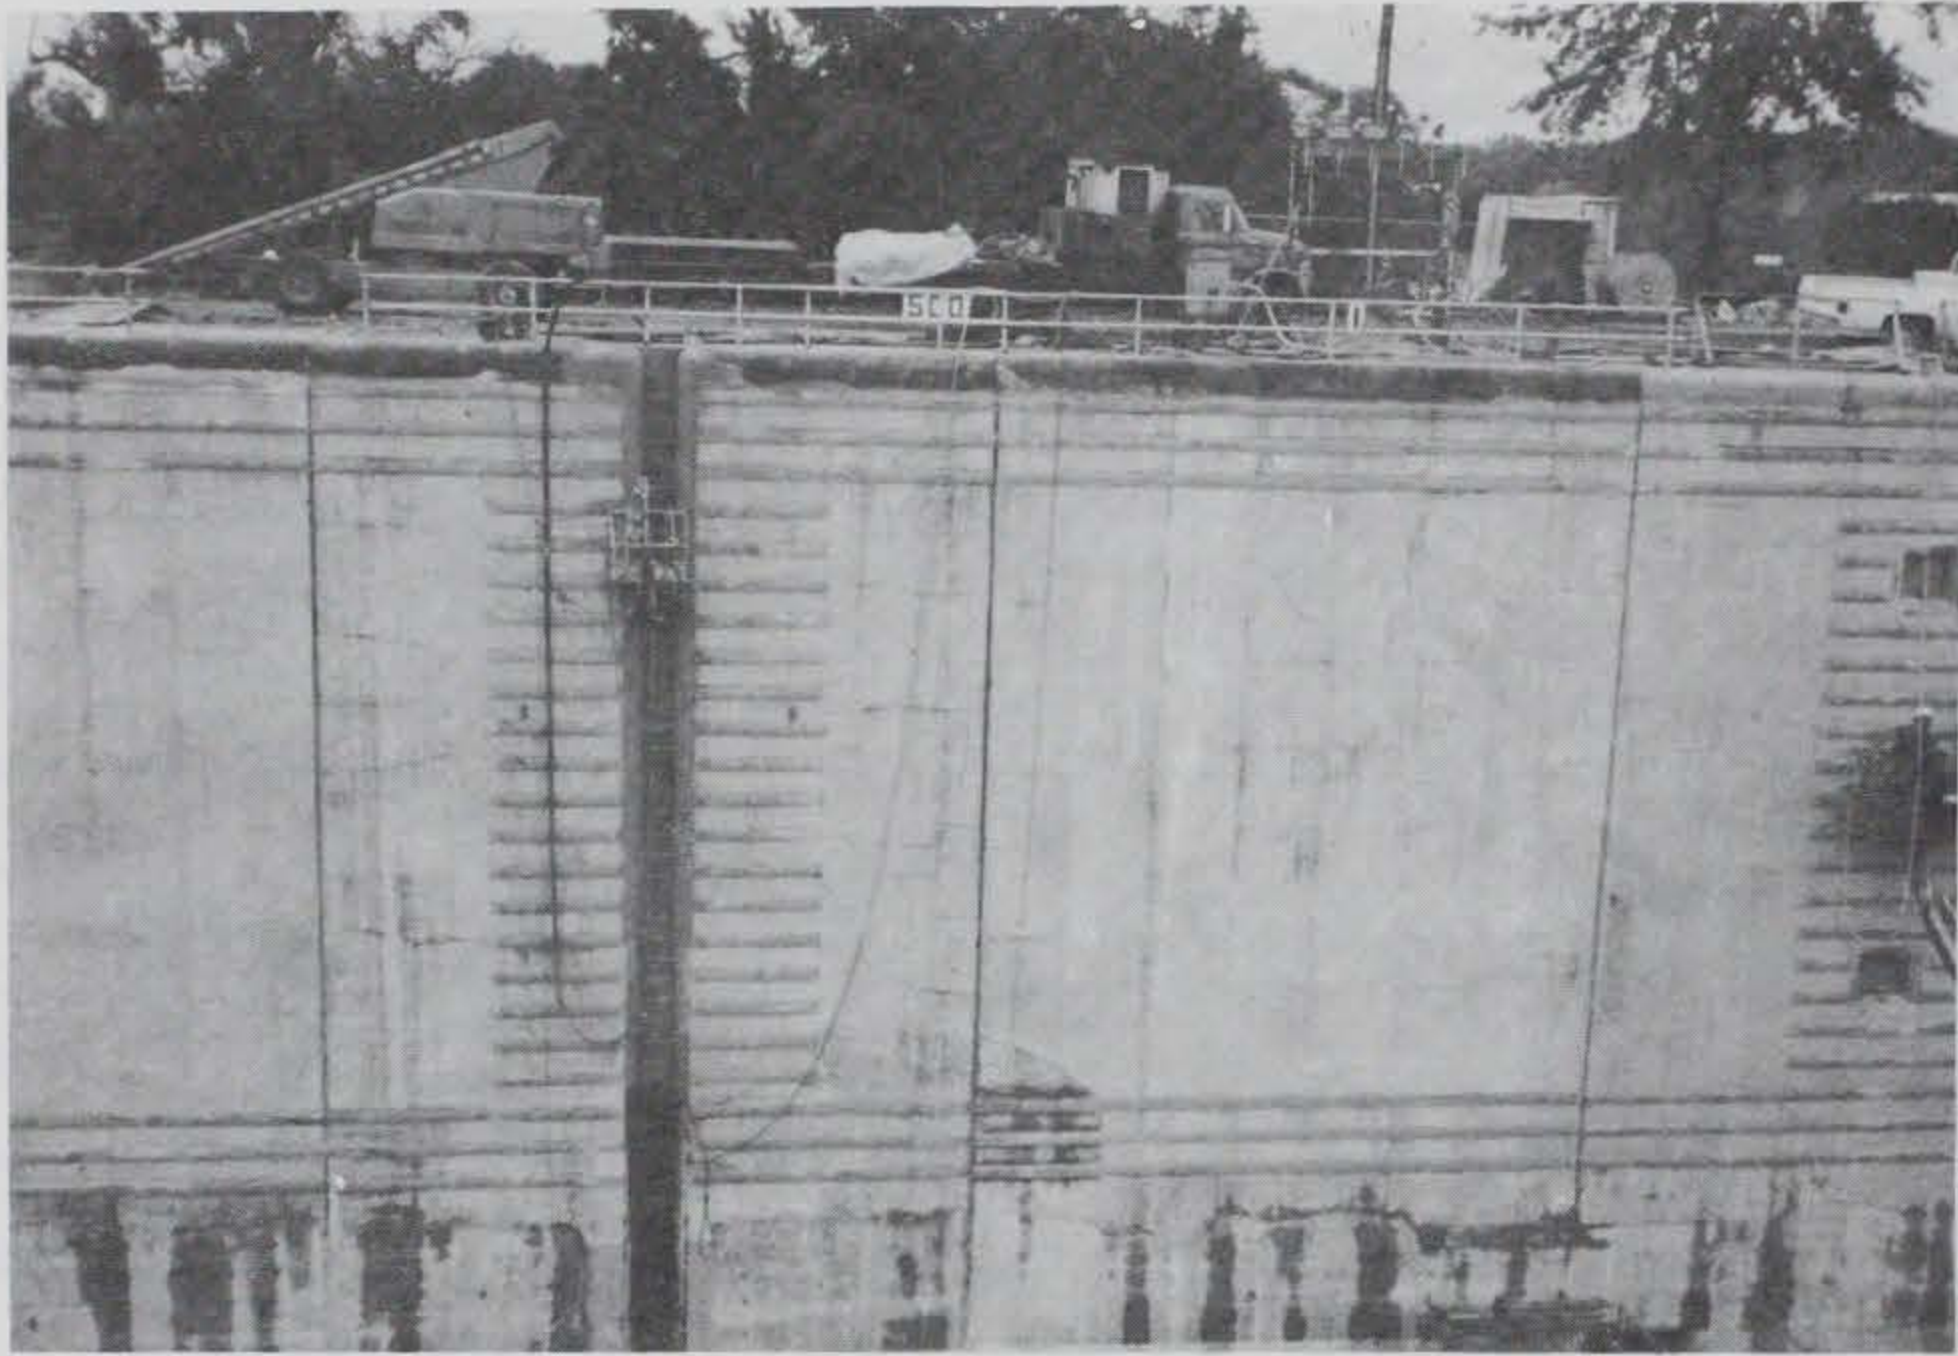
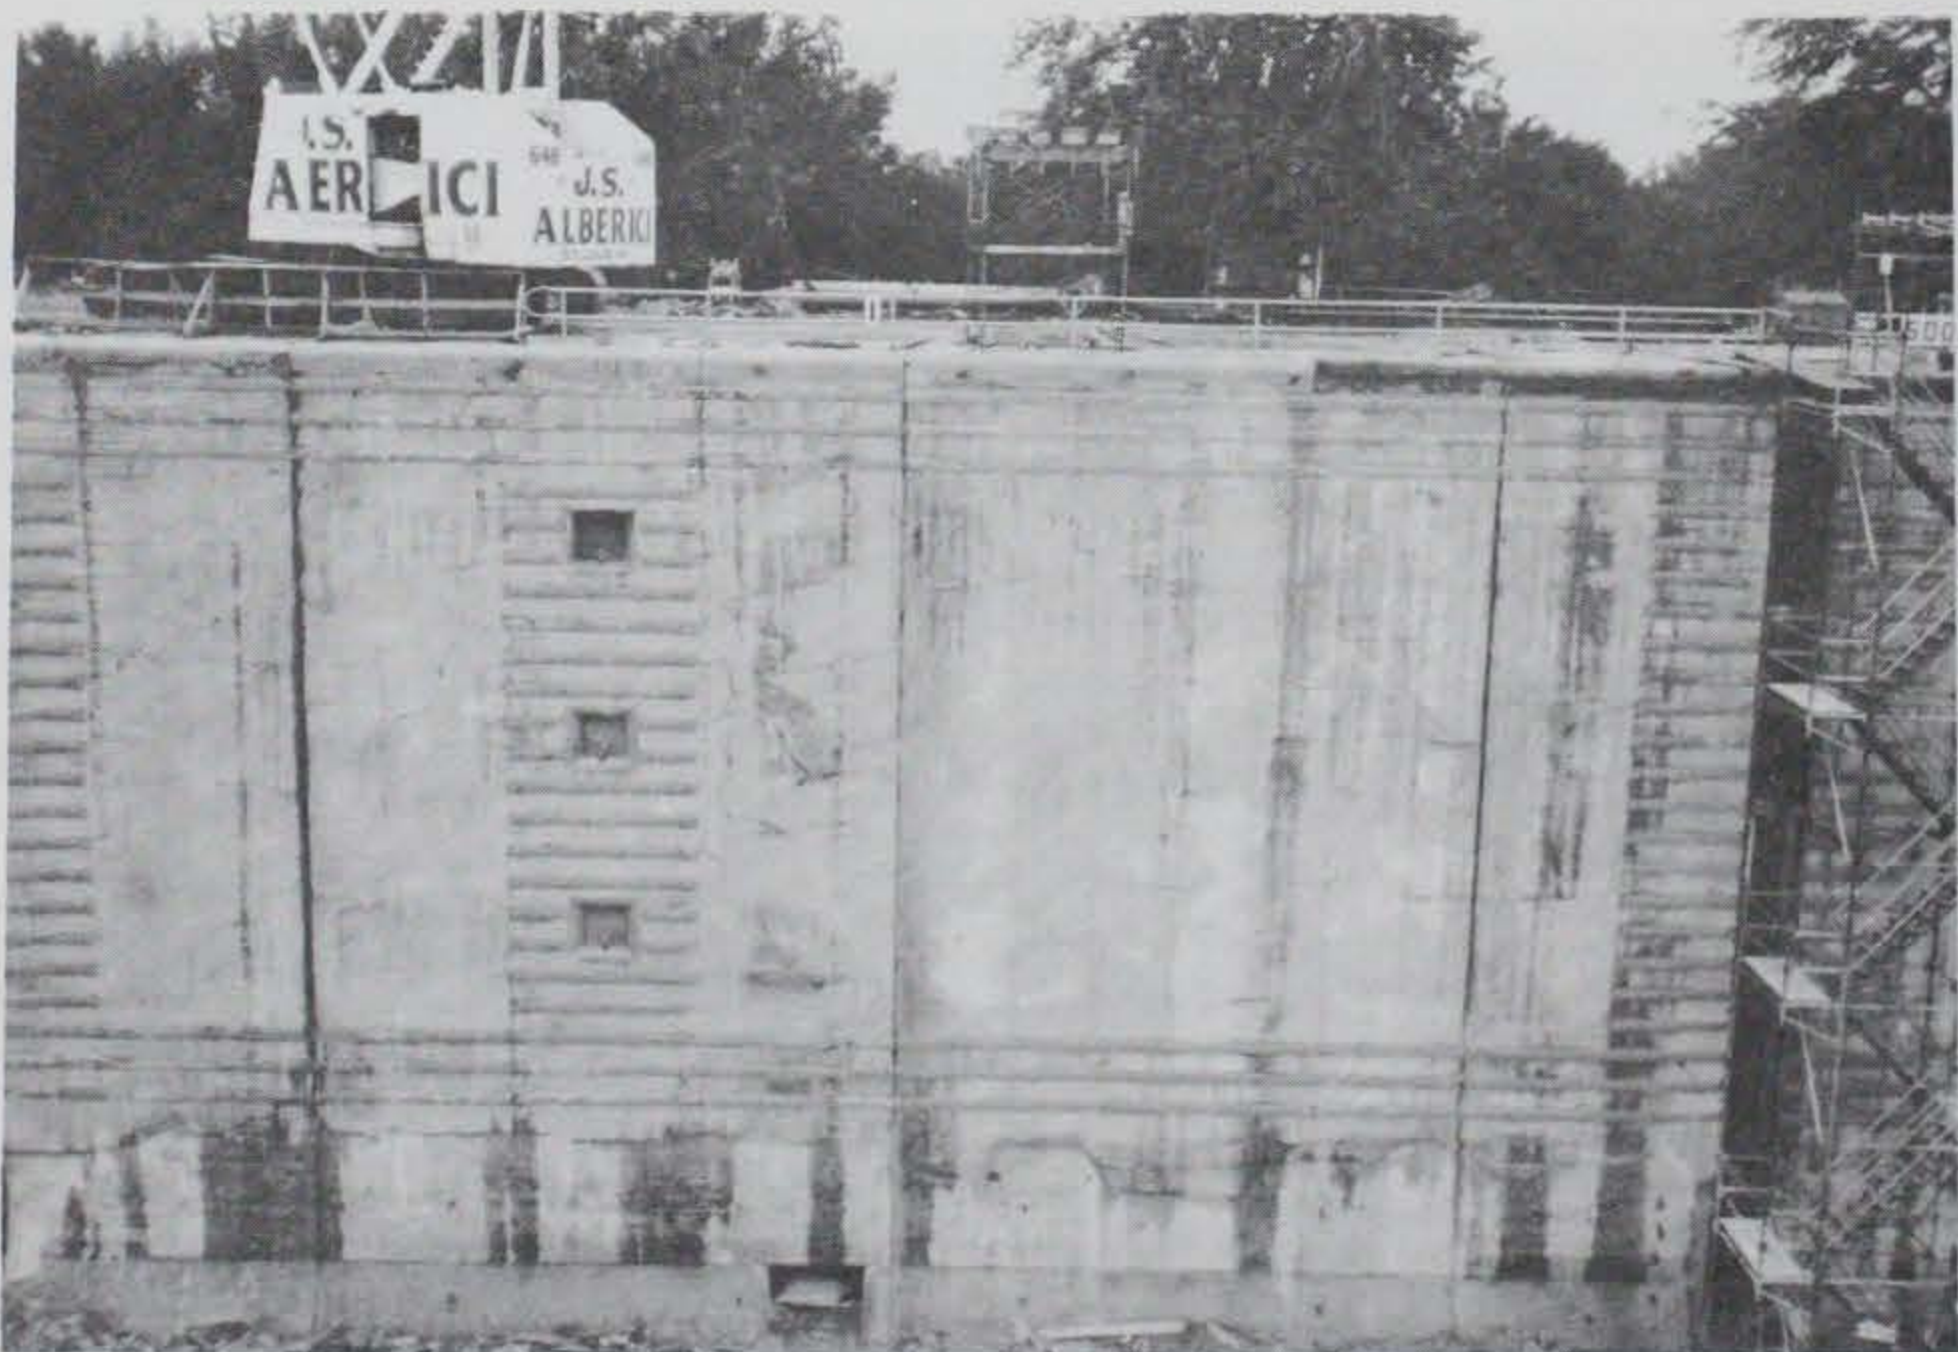
Figure 179. Typical cracking in the replacement concrete August 1984, Brandon Road Lock

a. Landside wall

b. Riverside wall

- n. Removal and replacement of deteriorated concrete may only be cosmetic and in many cases the appearance may not be satisfactory either. Damage from freezing and thawing may only be a few inches deep. Replacement concrete can be expected to crack extensively, even though it is reinforced and anchored.

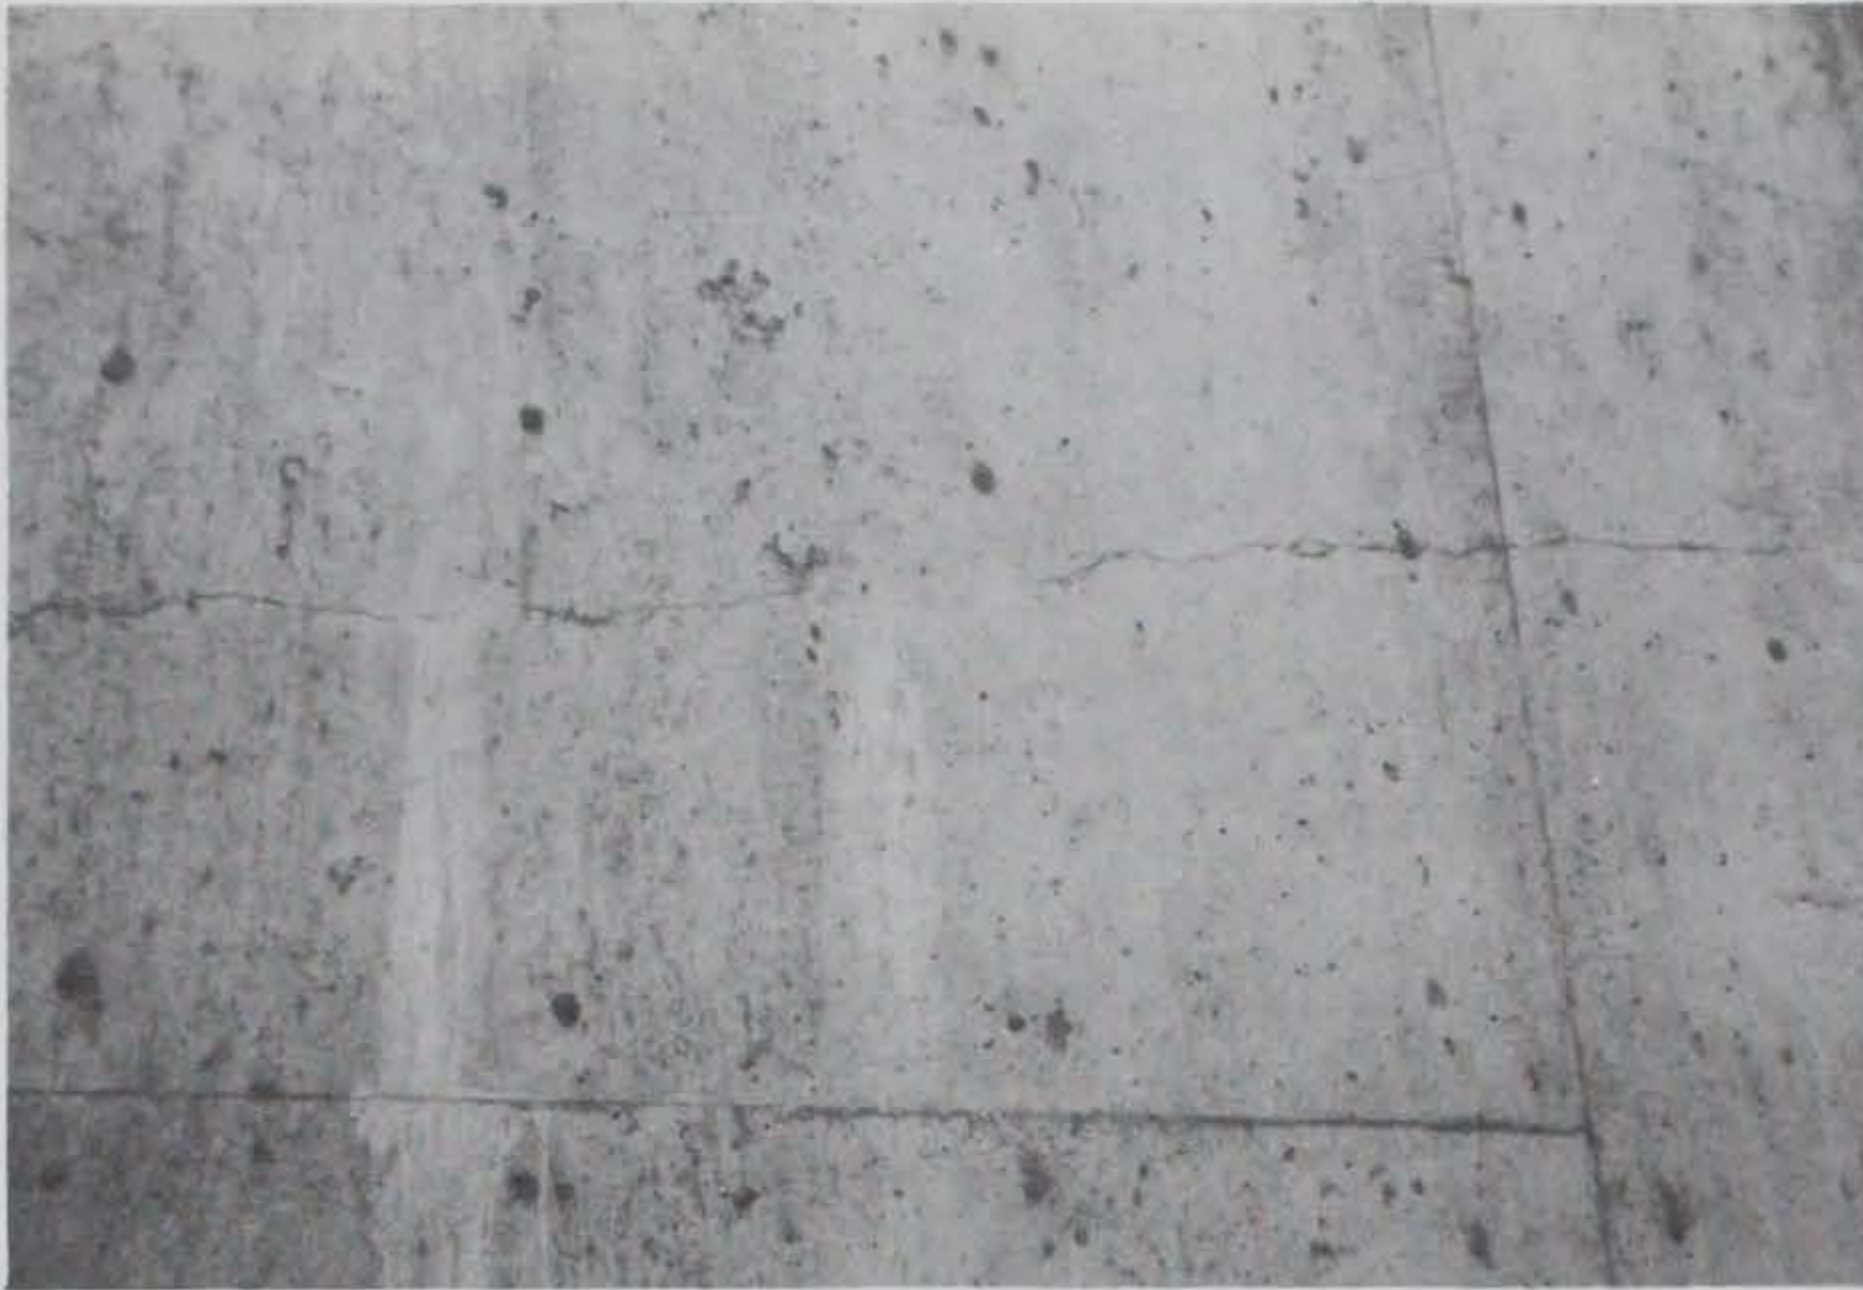
Figure 180. Typical crack in replacement concrete, August 1984, Brandon Road Lock

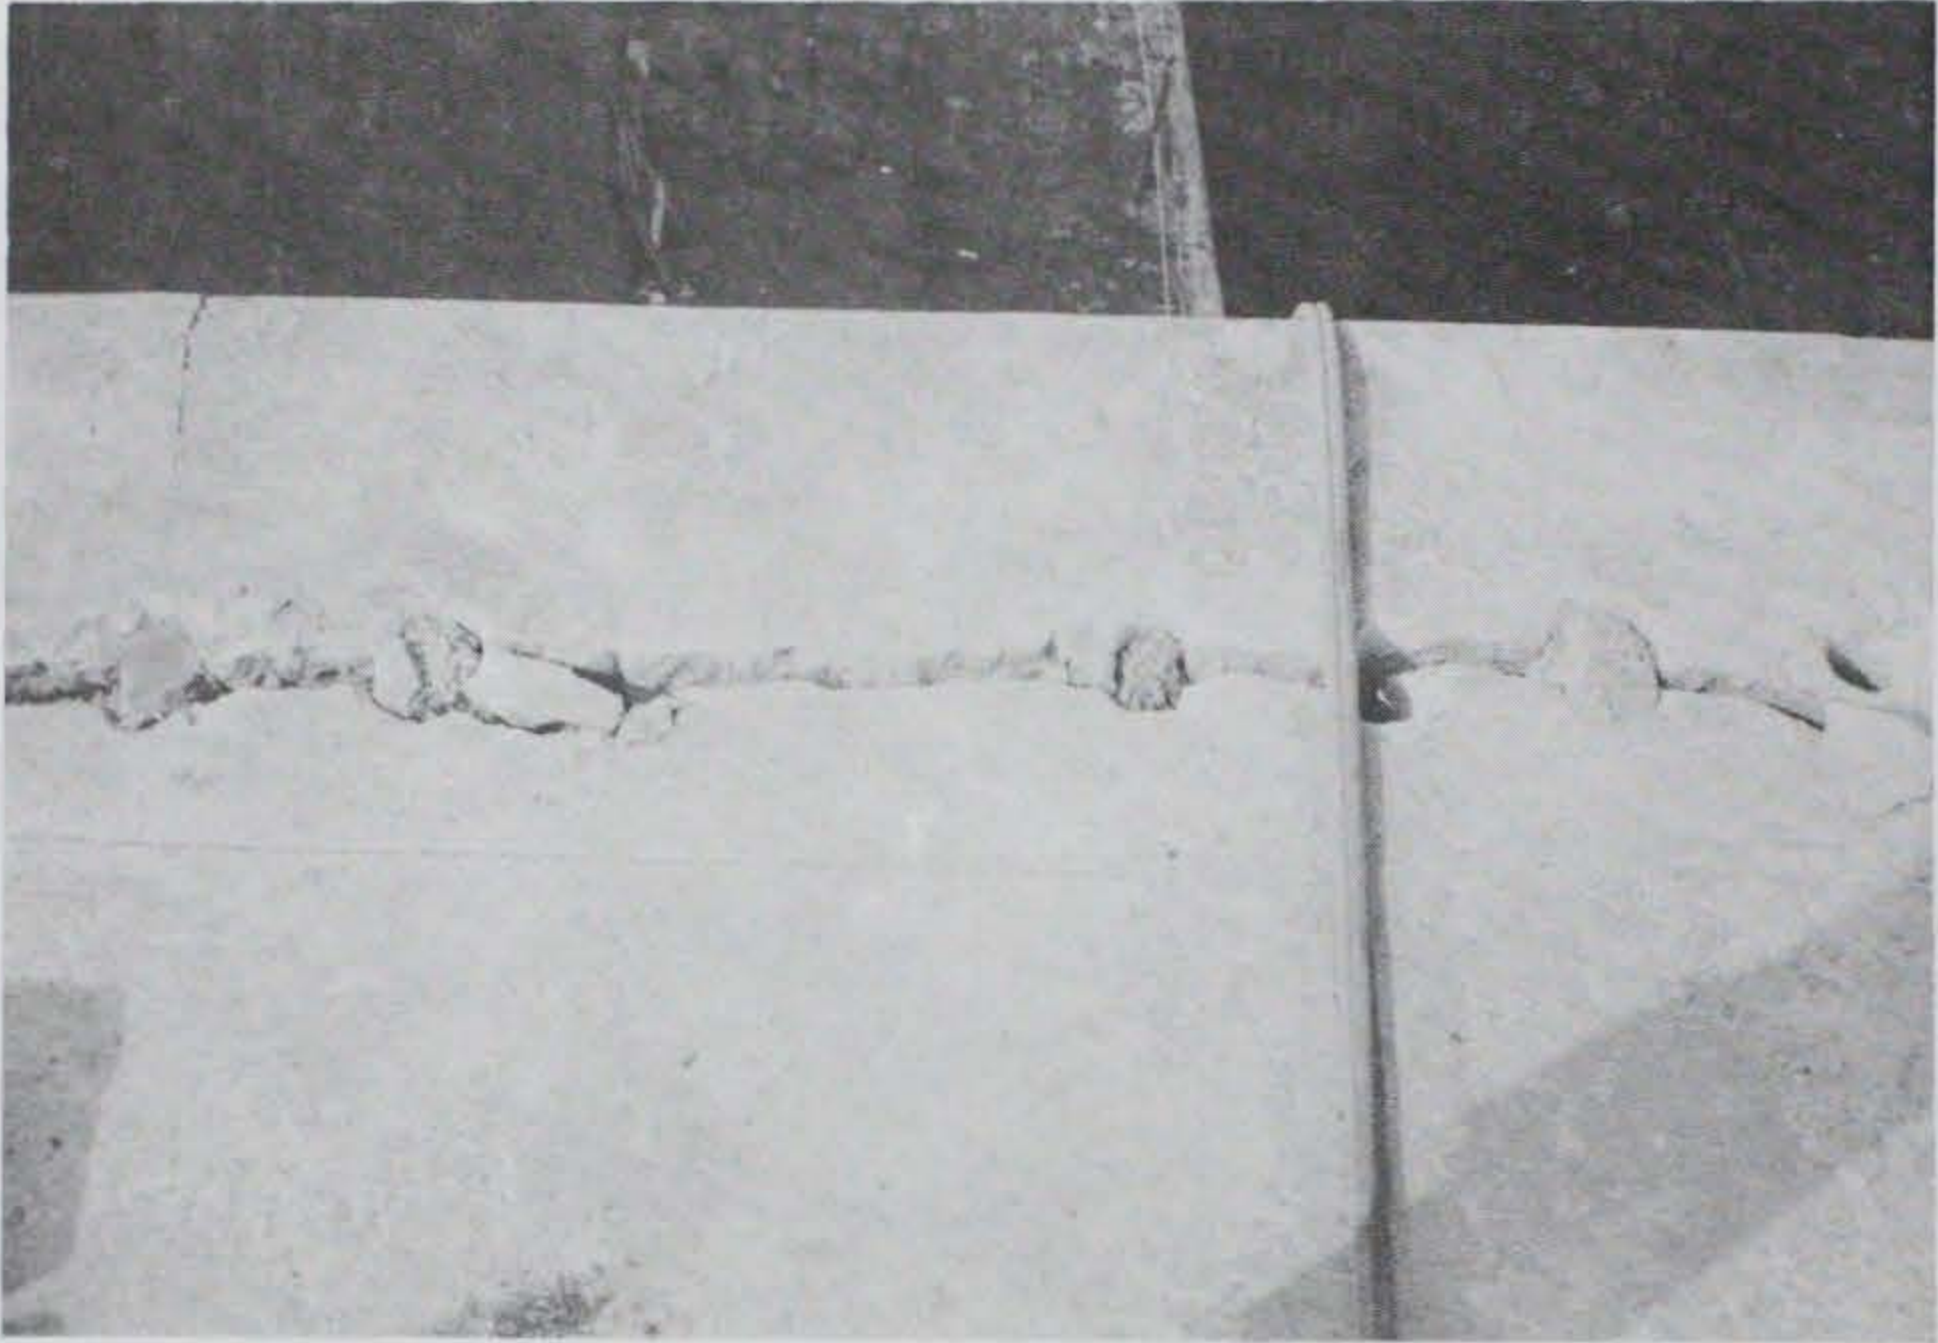
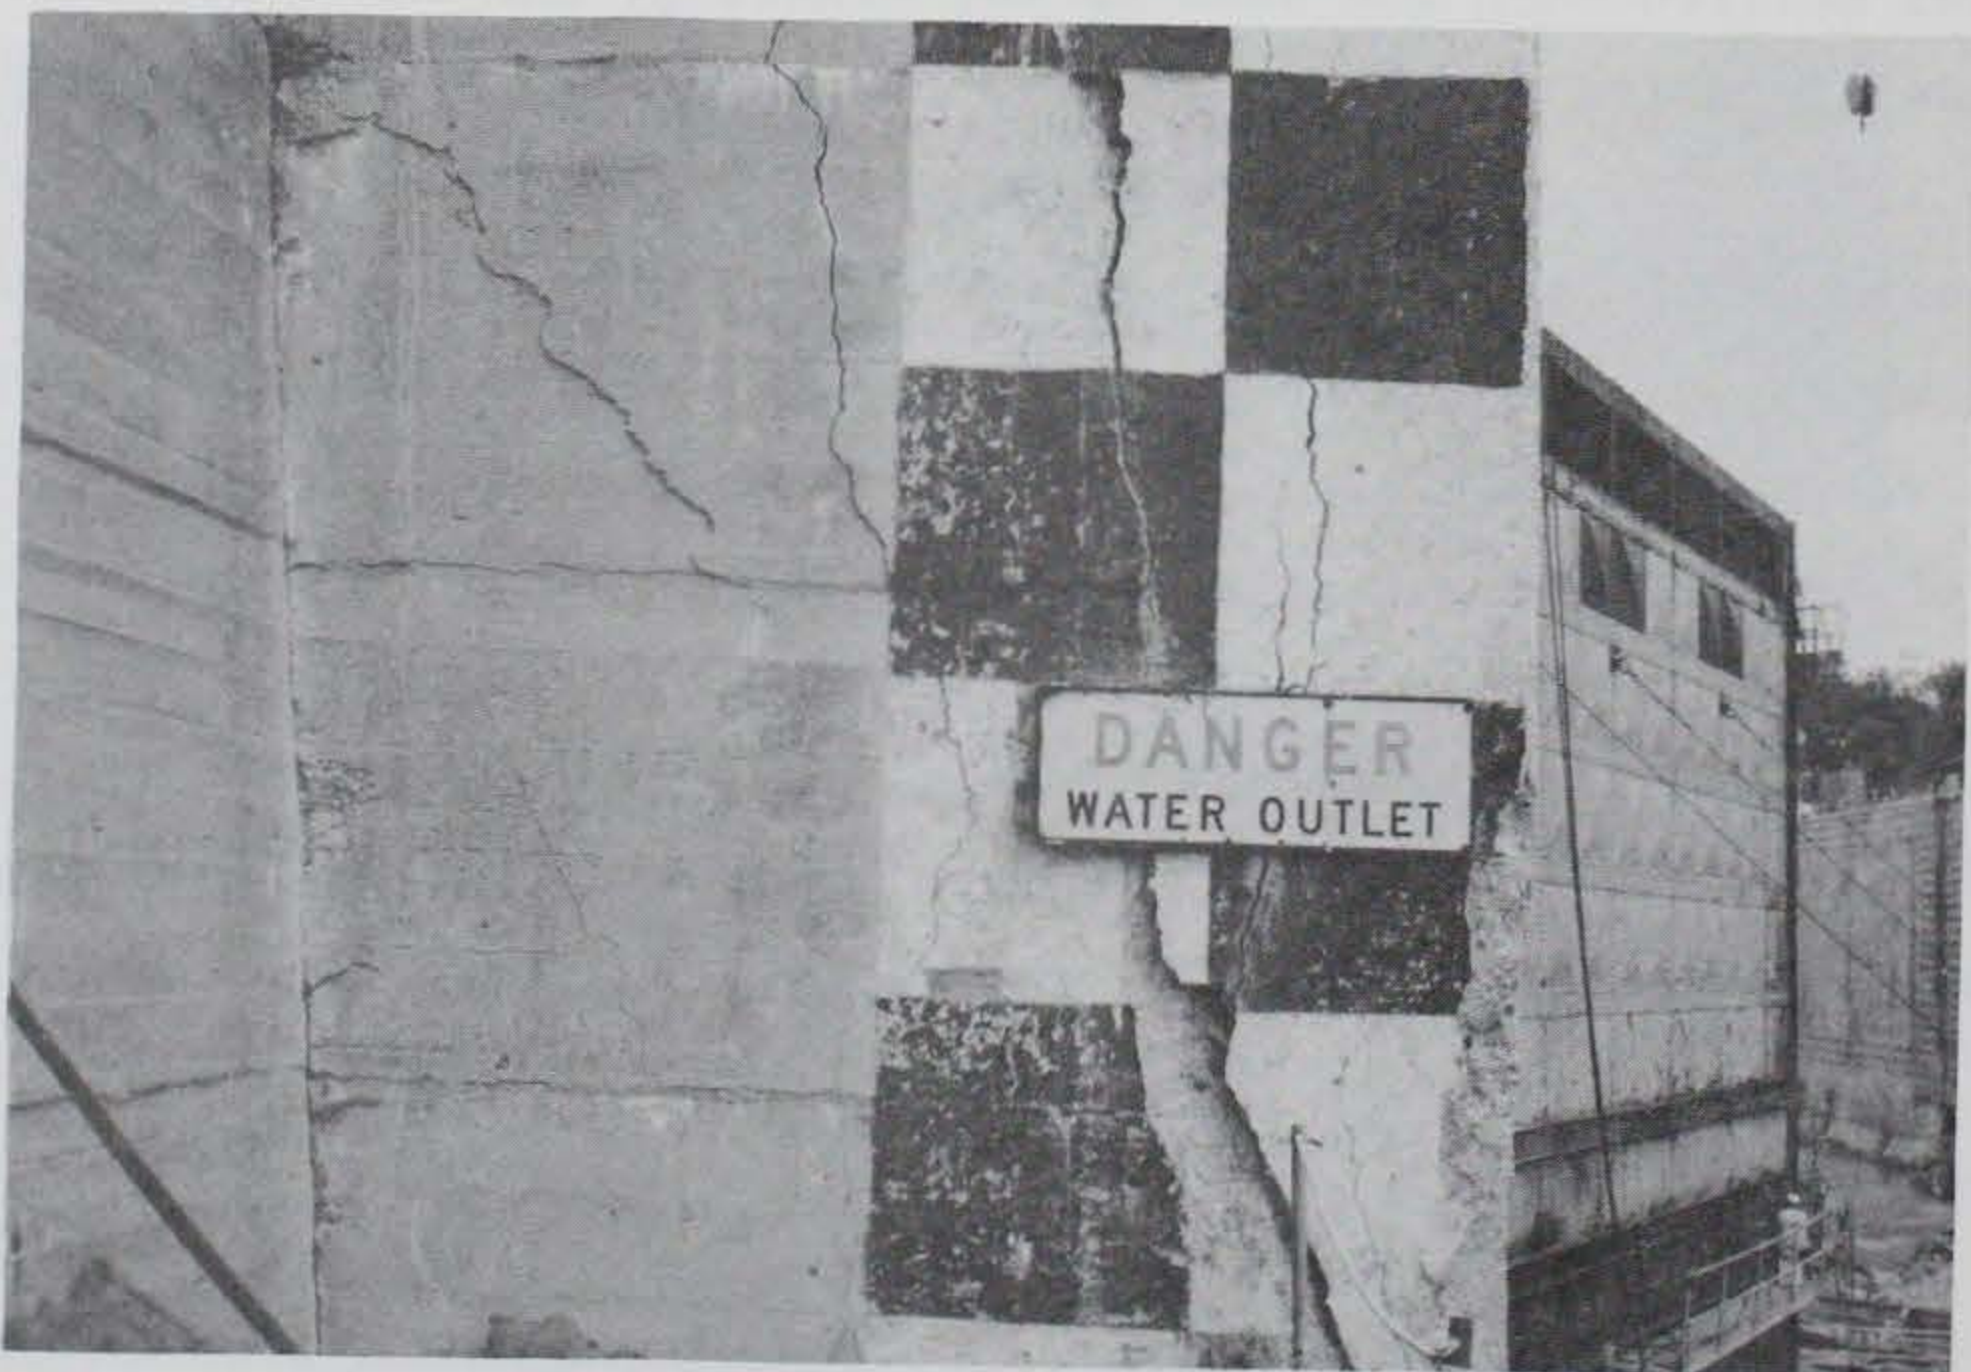
Figure 181. Examples of deteriorated concrete fractured using expansive grout, Brandon Road Lock

these areas was prohibited in the original design. In these areas, the removal line was drilled much the same as for blasting, and the contractor elected to use expansive grout (S-Mite) to fracture the deteriorated concrete face (Figure 181). A crack developed behind the quoin anchorage similar to what had happened at Lockport Lock. Initially, the fractured concrete was removed with handheld and machine-mounted breakers (Figure 182). This method proved to be very time-consuming. In an effort to increase production, removing some of this concrete with explosives was allowed. In these cases, removal was limited to approximately 5-ft intervals for each blast (Figure 183) as compared to full monolith face removal in the lock chamber. Ultimately, the Cutter Boom proved to be extremely effective in grinding off the fractured concrete in these areas (Figure 184). The contractor's bid price for removal of concrete in these areas ranged from \$216 to \$675 per cu yd with an average of \$413 per cu yd. This average cost was approximately 2.5 times the cost of concrete removal in the lock chamber resurfacing.

a. Top of lock wall

b. Vertical face

342. The crack behind the quoin anchorage area was pressure-injected with epoxy grout, and the cracked section was anchored to the main concrete mass with reinforcing steel. The entire area was then resurfaced with an overlay of anchored concrete. No visual structural problems have been noted

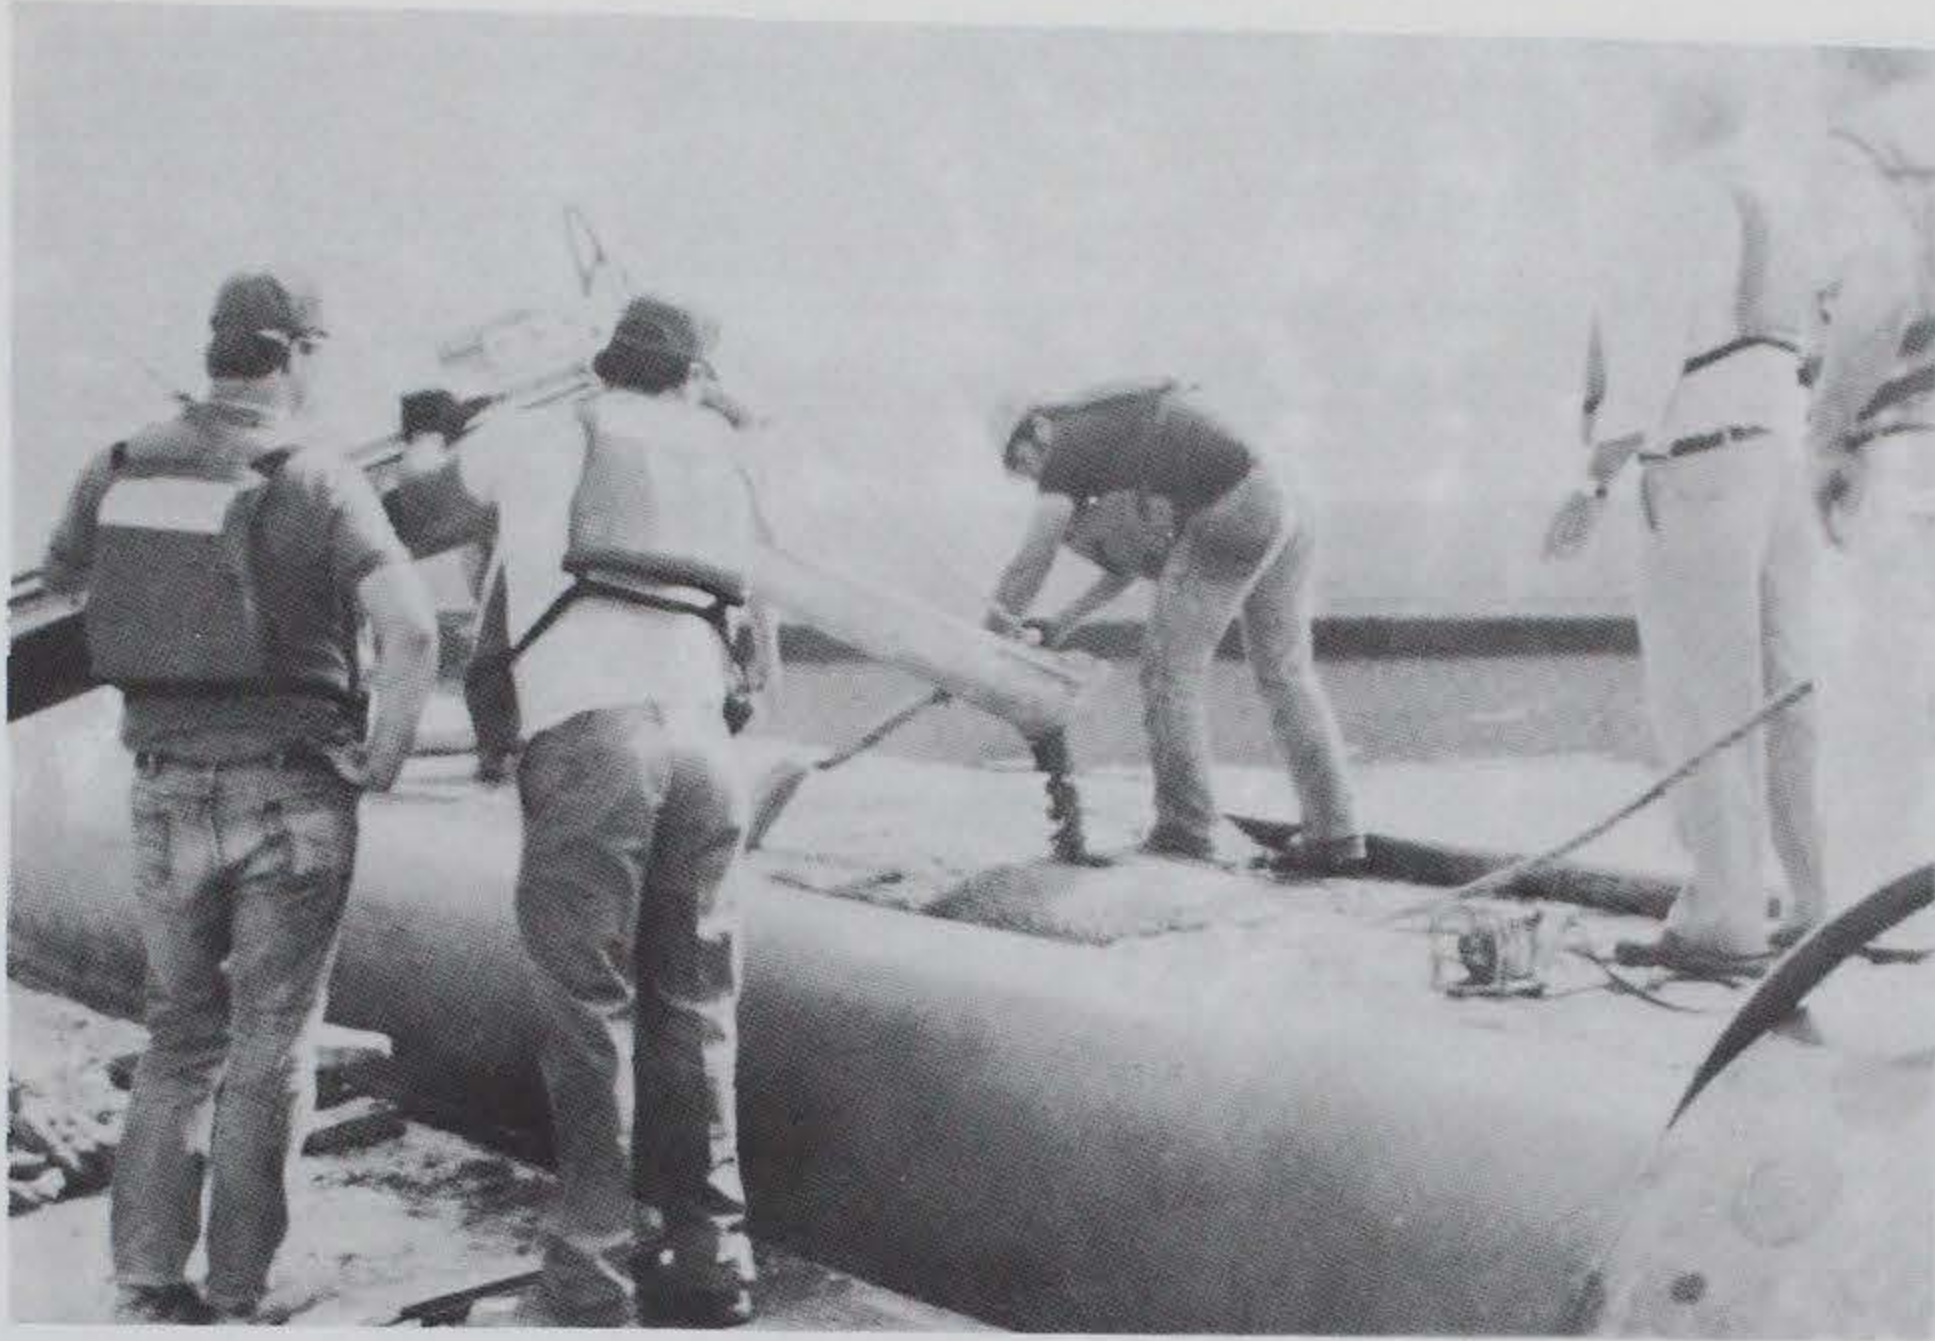
resurfacing operation are shown in Figure 186. Type C concrete was used to reface the upper guide wall. Approximately 2 to 3 in. of concrete was removed from the top surface of the guide wall and replaced with an overlay of latex-modified concrete (approximately 17 cu yd). Latex-modified concrete (Figure 187) was specified in an attempt to reduce the shrinkage cracking problems inherent with conventional concrete overlays. The latex additive made the concrete surface very sticky and thus caused some finishing problems.

Figure 187. Resurfacing top of the upper guide wall with latex-modified concrete, Brandon Road Lock

However, the latex-modified concrete has performed well with a minimum of cracking. The contractor's bid price for latex-modified concrete was \$750 per cu yd, and the total bid price for resurfacing the upper guide wall was approximately \$350,000.
