TECHNICAL REPORT REMR-CS-13

**REHABILITATION OF NAVIGATION  
LOCK WALLS: CASE HISTORIES**

James E. McDonald

December 1987

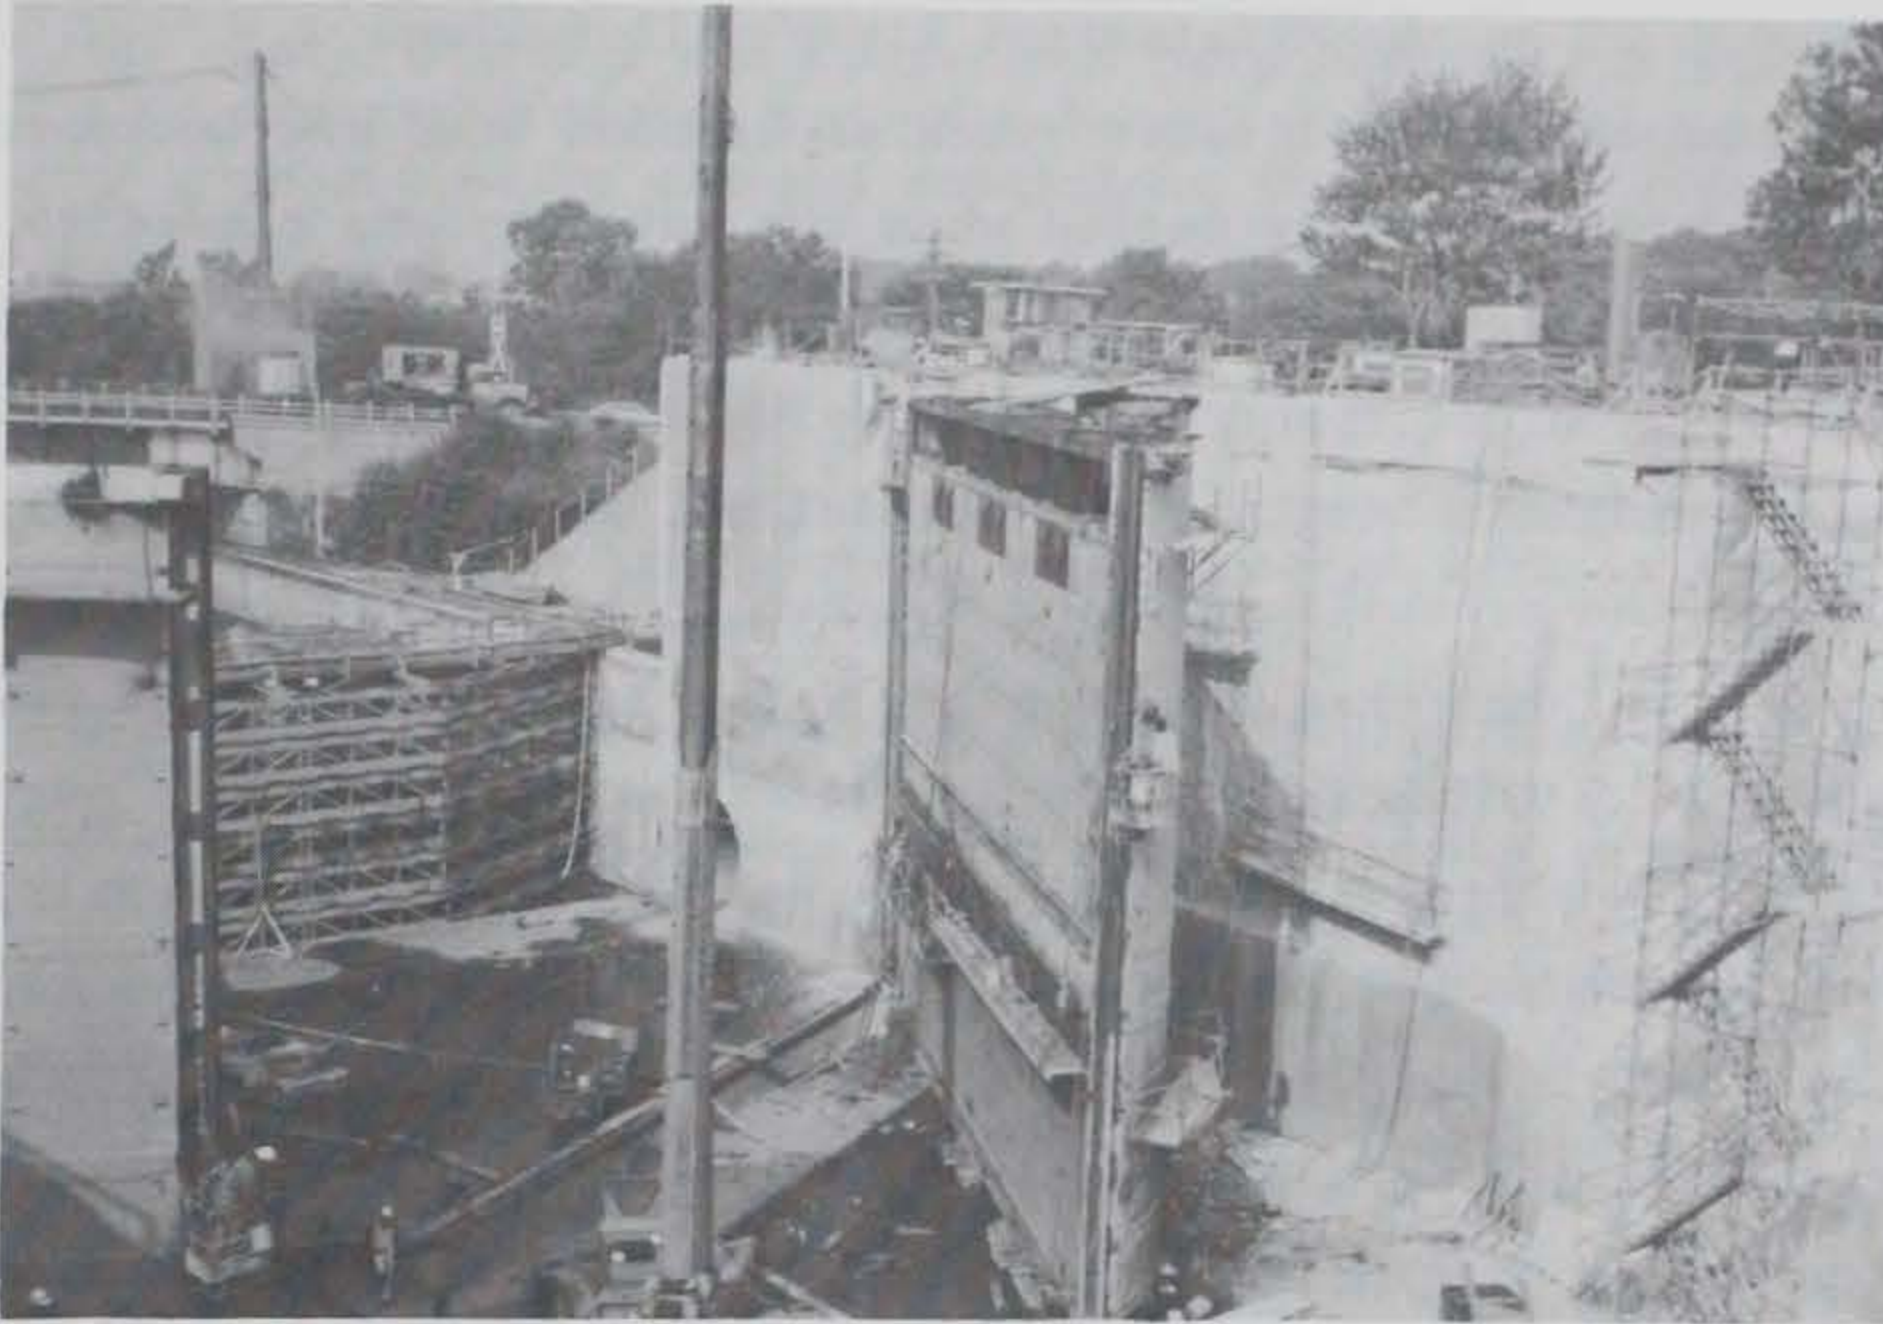
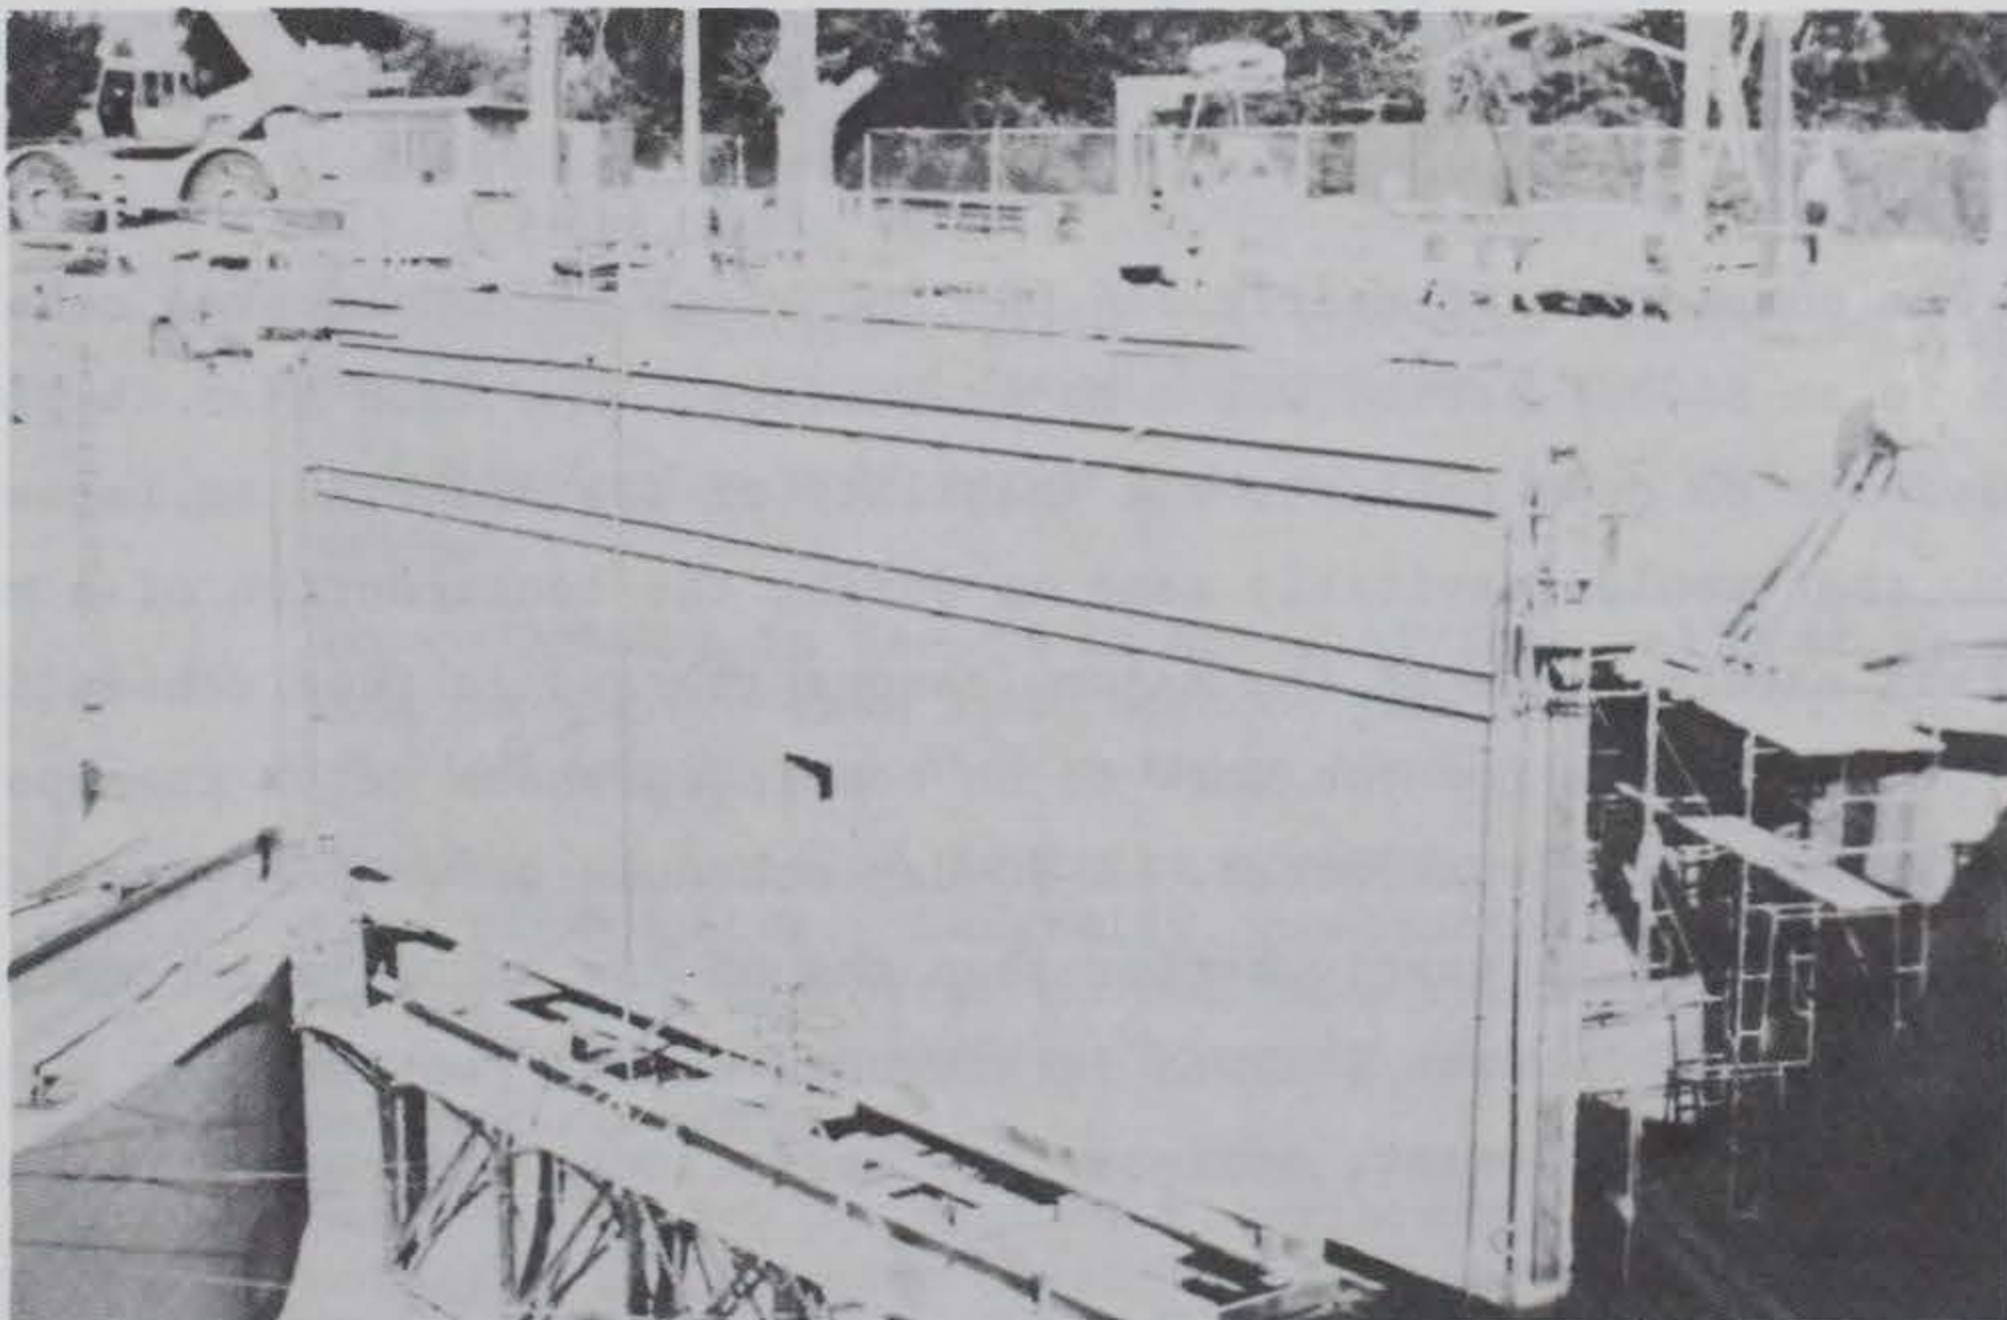
Figure 189. Lock gate rehabilitation, Brandon Road Lock

345. Rehabilitation of the upper and lower miter gates involved replacement of corroded rivets with high-strength bolts, replacement of corroded structural members, and sandblasting and painting of the entire gates (Figure 189). Many additional members that were not identified during the

a. Lower service gate being rehabilitated

b. Rehabilitated upstream miter gate ready for installation
