Evaluation of Cedar Tree Revetments for Bank Stabilization at the Locust Creek Conservation Area, Missouri

Quantifying Bank Erosion Volumes from Preproject to Postfailure

November 2022

Technical Report (TR)

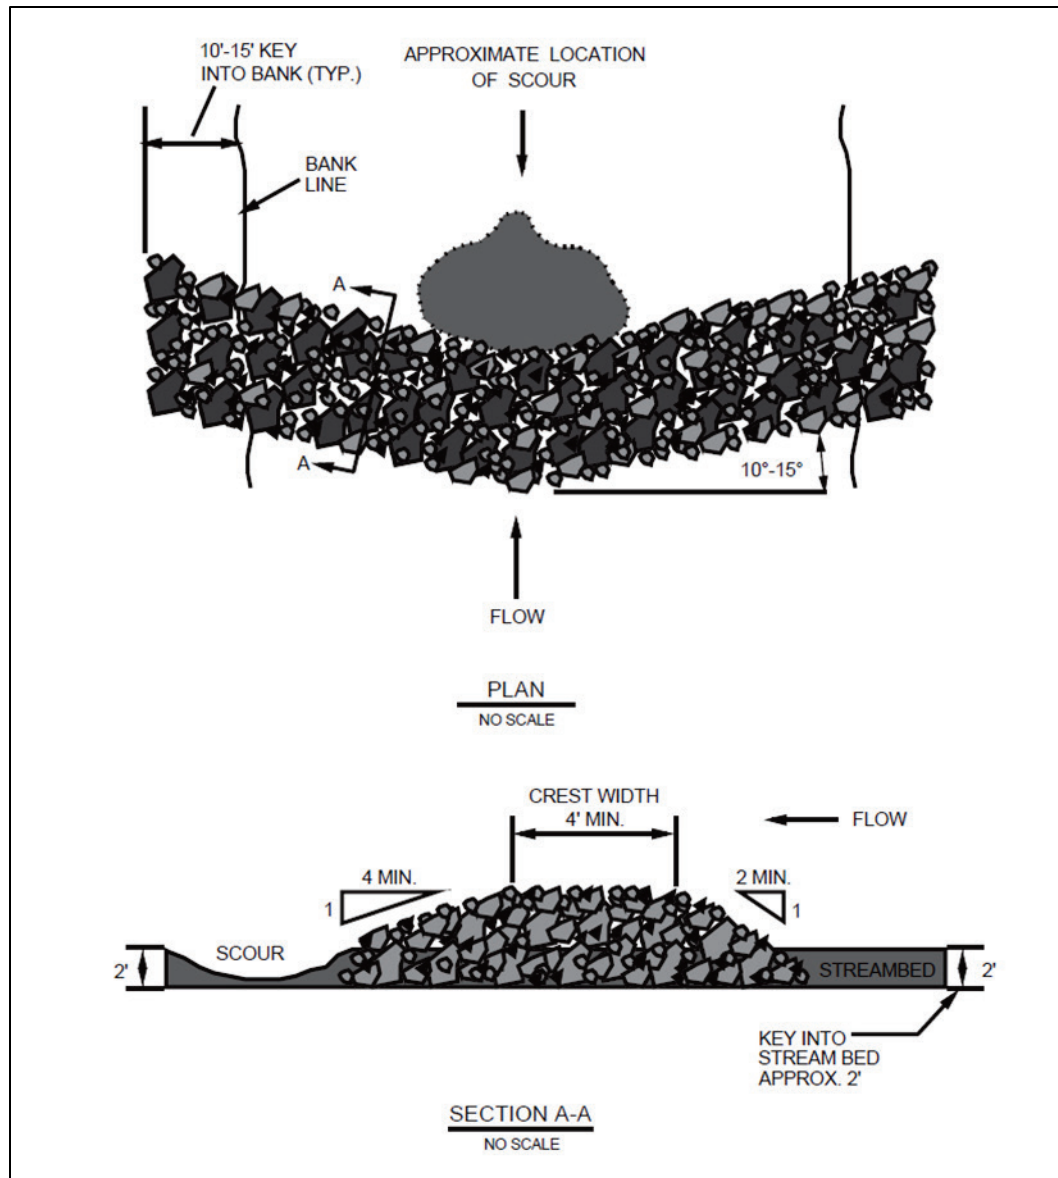
Figure 9. Site 9. Plan and cross-sectional view of the grade-control structure. (Image reproduced from MDC n.d., 15.)

Site 9 received streambank revegetation in March of 1987, a rock grade-control structure in July of 1989 (Figures 9 and 10), and a cedar tree revetment in October 1989. The grade control was constructed with 330 tons of riprap at the downstream end of the site (MDC n.d.). The cedar tree revetment was built with 67 cedar trees, each of which was 12–15 feet long, and was anchored in a double row using duckbill 88 earth anchors

As of the December 2019 visit, the bank at Site 9 was not as steep as those of the other sites, and the riparian corridor was better developed with mature trees (Figure 11). This was most likely the influence of the grade-control structure.

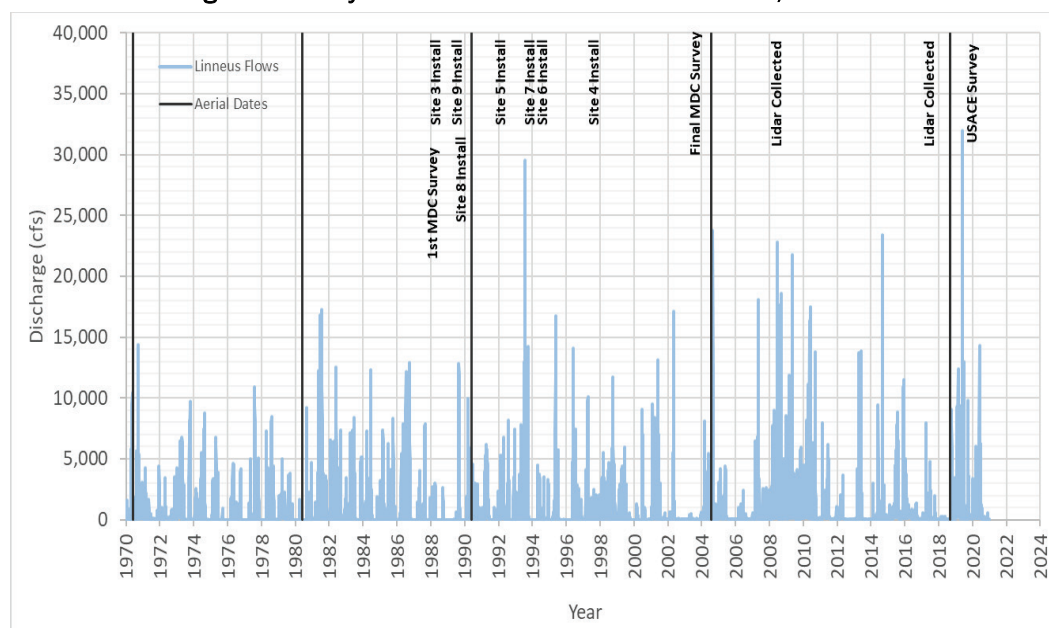
Figure 12. Daily flow rate on Locust Creek at Linneus, Missouri.

Daily flow measurements were not available at the Reger gage but were available 25 miles downstream at the gage near Linneus, Missouri. Figure 12 represents the daily flow at the USGS gage at Linneus. The horizontal line indicates two-year discharge, estimated as 9,270 cubic feet per second (USACE 2020). Dates of aerial photographs are also noted. The number of days the daily flow exceeded the two-year discharge was used to set the erosion rates over differing time periods into hydrologic context. Flows shown in Figure 12 were recorded at a downstream gage and do not represent flows experienced by the project. However, the flows recorded at the gage represent the best estimate of the relative frequency of high-flow events over different time periods.

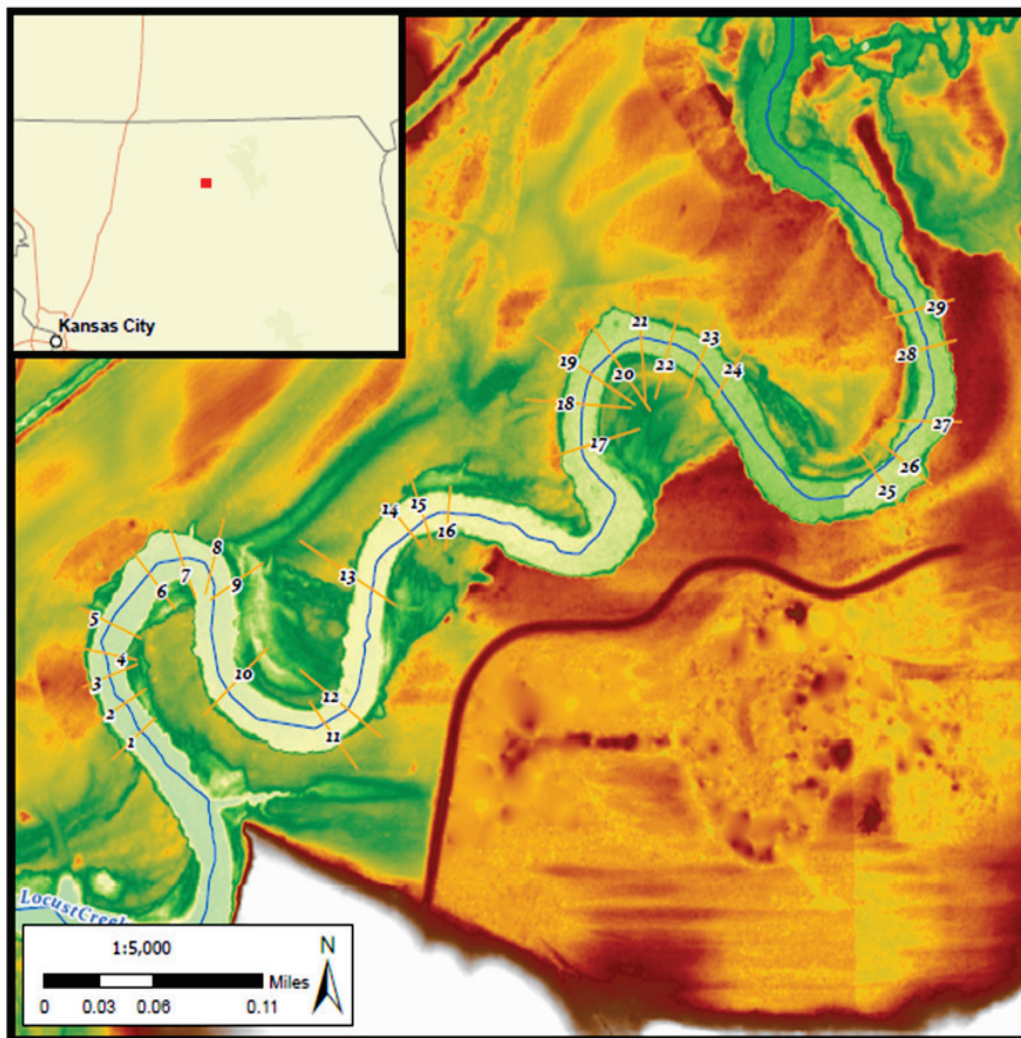
Figure 13. Locations of MDC cross sections for monitoring sites.

MDC monitored the sites and periodically surveyed stream cross sections at the locations shown in Figure 13. The MDC data collected at the sites was supplemented with lidar (when available) and the data collected from

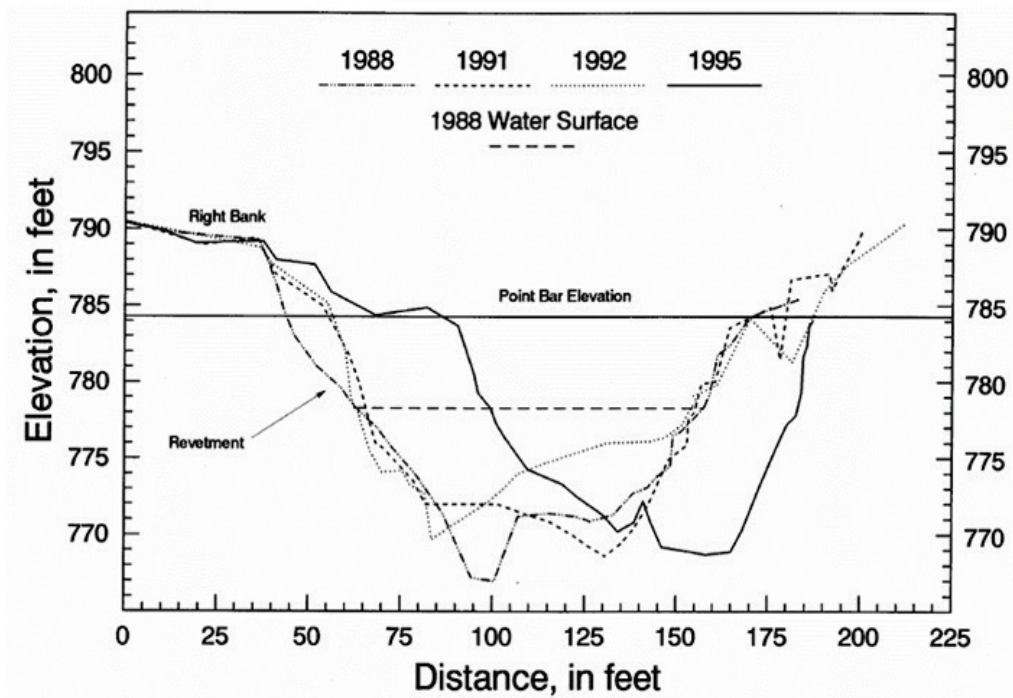
Figure 18. Site 8 transect 1. (Image reproduced from Matheney n.d., 19.)

Note that only historical MDC data are presented for Site 8 because MDC did not resurvey this site after 1995. Likewise, USACE did not survey at Site 8 during the December 2019 site visit.

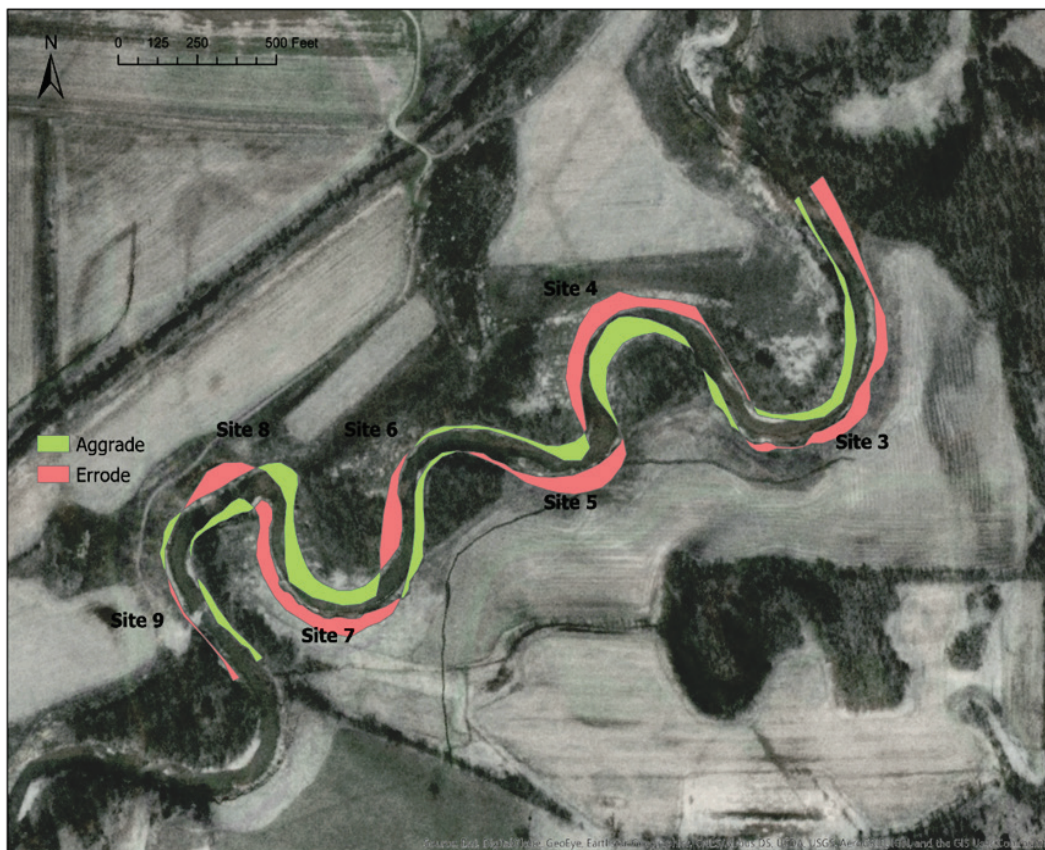
Figure 21. Image, taken in 1990, showing areas of erosion and aggradation estimated using aerial photos.

the surveyed cross sections. Aerial photos from 1970, 1980, and 1990 were obtained from MDC (Appendix) and geo-referenced in ArcGIS. Bank lines were also digitized from 2004 and 2018 aerial photos available on Google Earth. The bank lines were traced for each of the years, and the surface area of erosion and deposition was calculated for each time period (Figure 21).

The dates of the aerial photographs allowed for the computation of erosion and deposition over multiple time periods. The time period from 1970 to 1980 was used to estimate preconstruction erosion rates. Between 1980 and 1990 was also mostly preproject because the first project was not constructed until 1988. The time period between 1990 and 2004 was when most of the projects were built and when the majority of revetments were still in place. After 2004, the projects were no longer being maintained or monitored. At some point after 2004, most of the projects failed. As explained previously, as of the December 2019 site visit, no revetments remained.

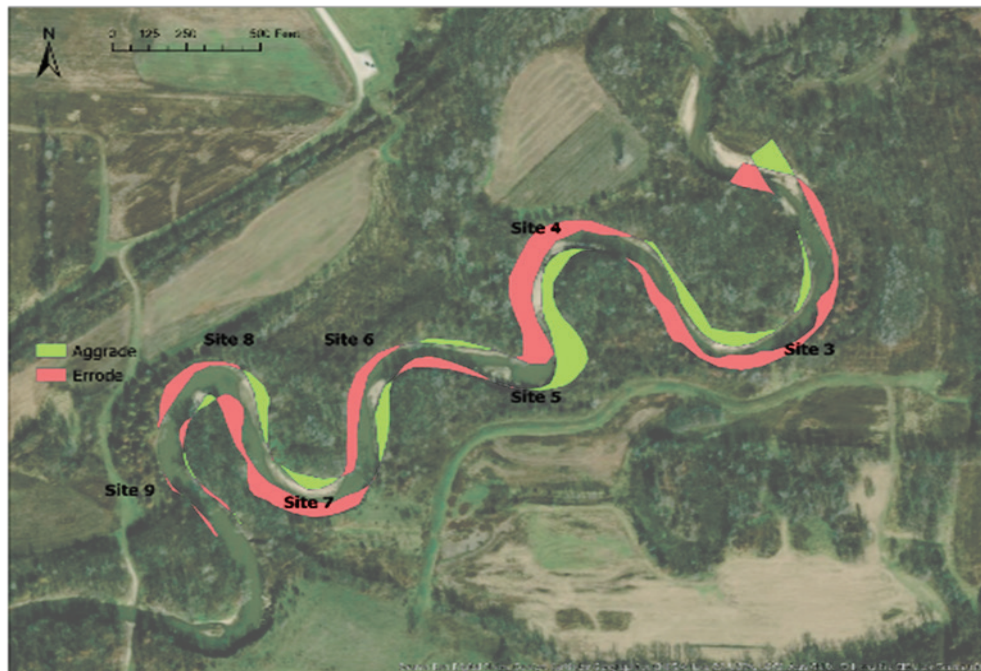
Figure A-1. Image from 2018, showing erosion and aggradation estimated using aerial photos from 2004–2018.

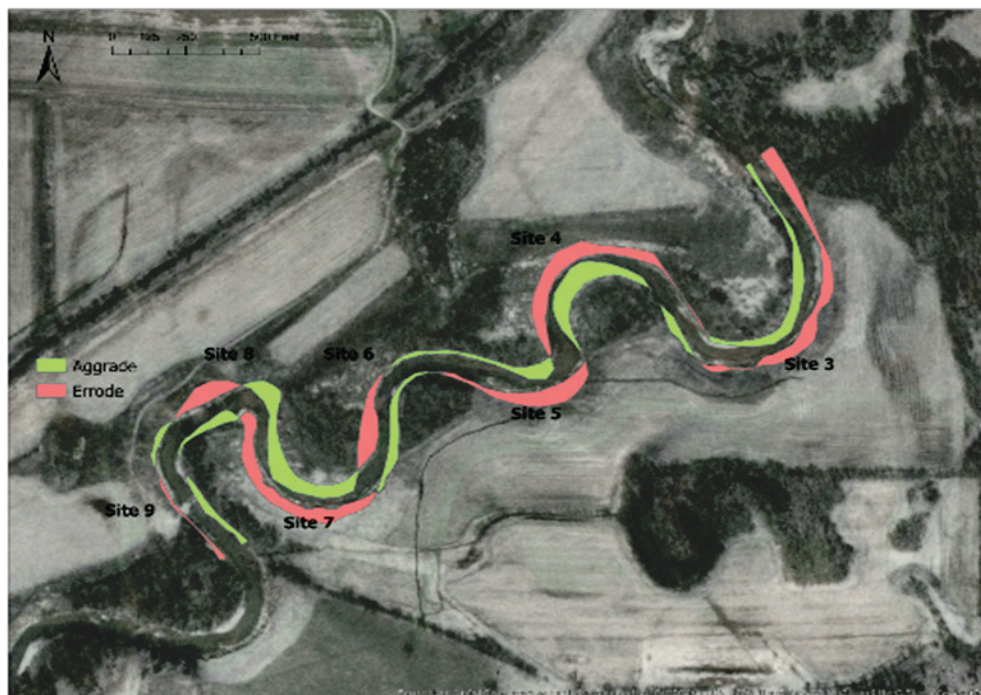
Figure A-2. Image from 1990, showing erosion and aggradation estimated using aerial photos from 1990–2004.

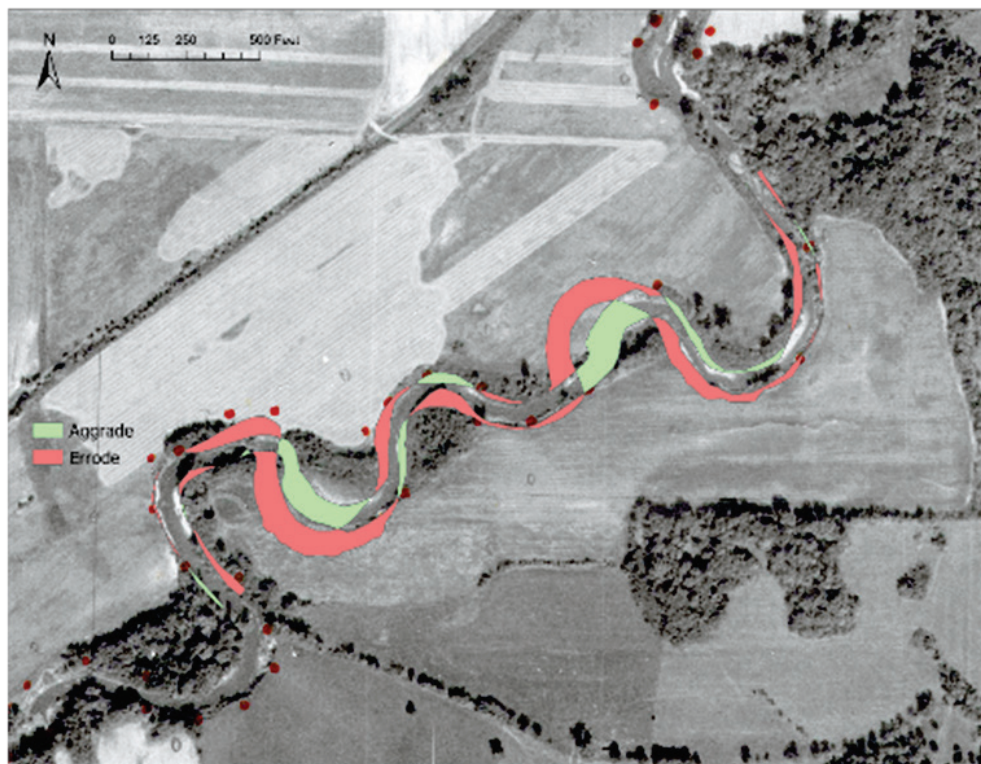
Figure A-3. Image from 1980, showing erosion and aggradation estimated using aerial photos from 1980–1990.

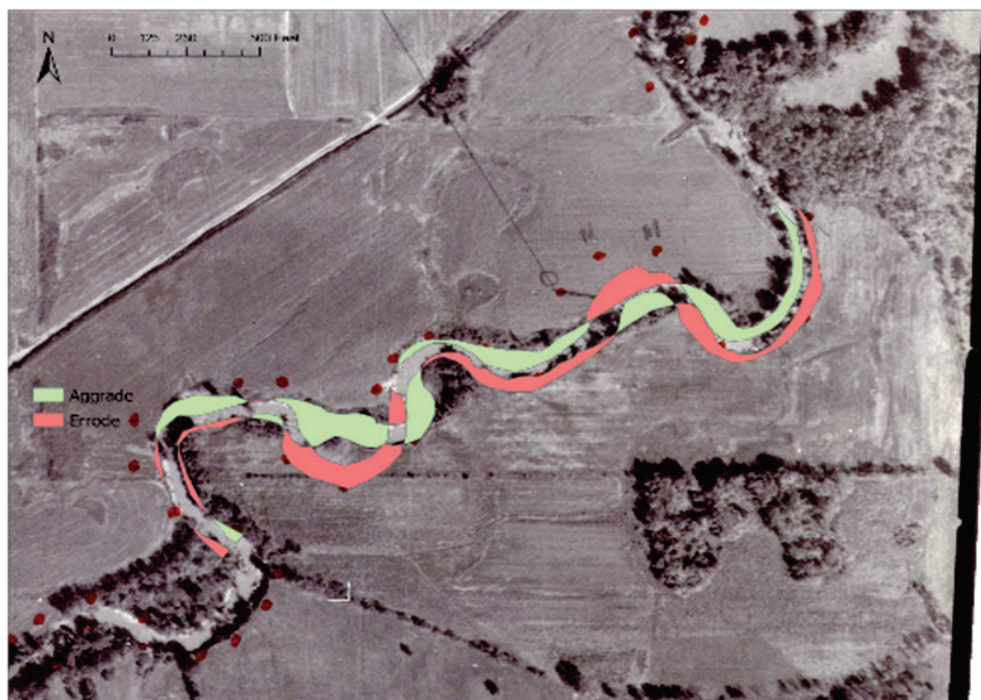
Figure A-4. Image from 1970, showing erosion and aggradation estimated using aerial photos from 1970–1980.
