## **Character-Defining Features of the Buffalo South Mole (South Pier), NY**

Adam D. Smith and Megan W. Tooker

April 2023

Final Technical Report (TR)

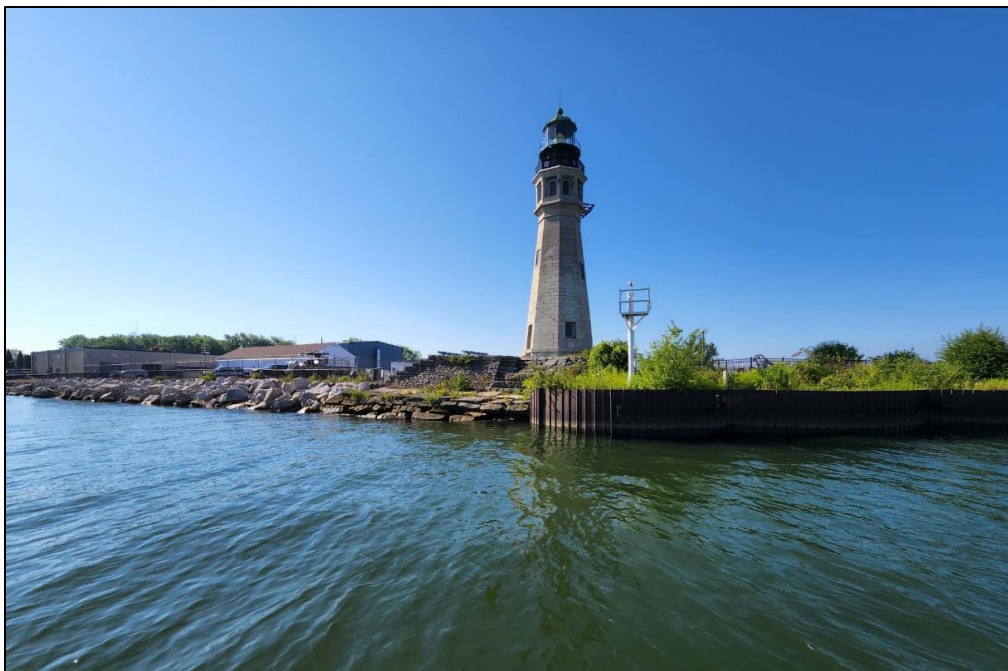
Figure 64. Looking southeast at the 1833 lighthouse and the 1959 steel bulkhead on the western end (photo by ERDC-CERL researchers, 2022).

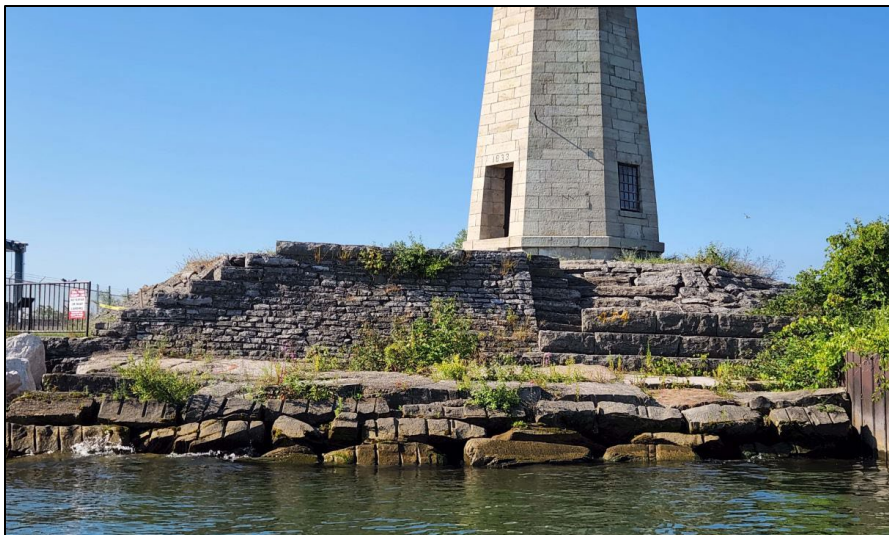
Figure 67. 1833 stone wall on the north side of the 1833 lighthouse, and note removal of stone wall on left side for the construction of the US Life-Saving Service buildings in the 1898–1903 period (photo by ERDC-CERL researchers, 2022).

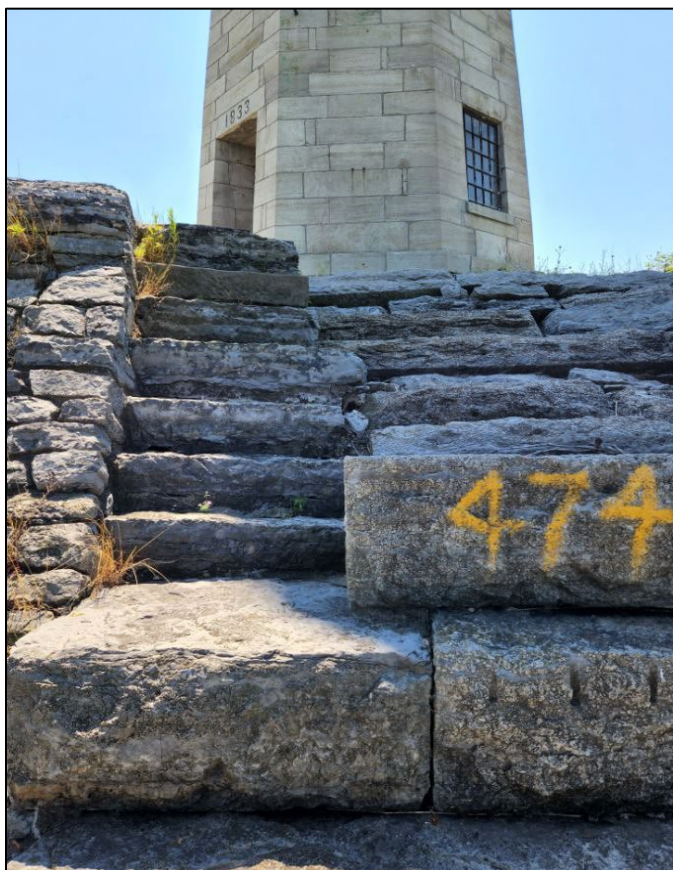
Figure 68. 1833 stone stairs up from tow path to 1833 lighthouse (photo by ERDC-CERL researchers, 2022).<sup>11</sup>

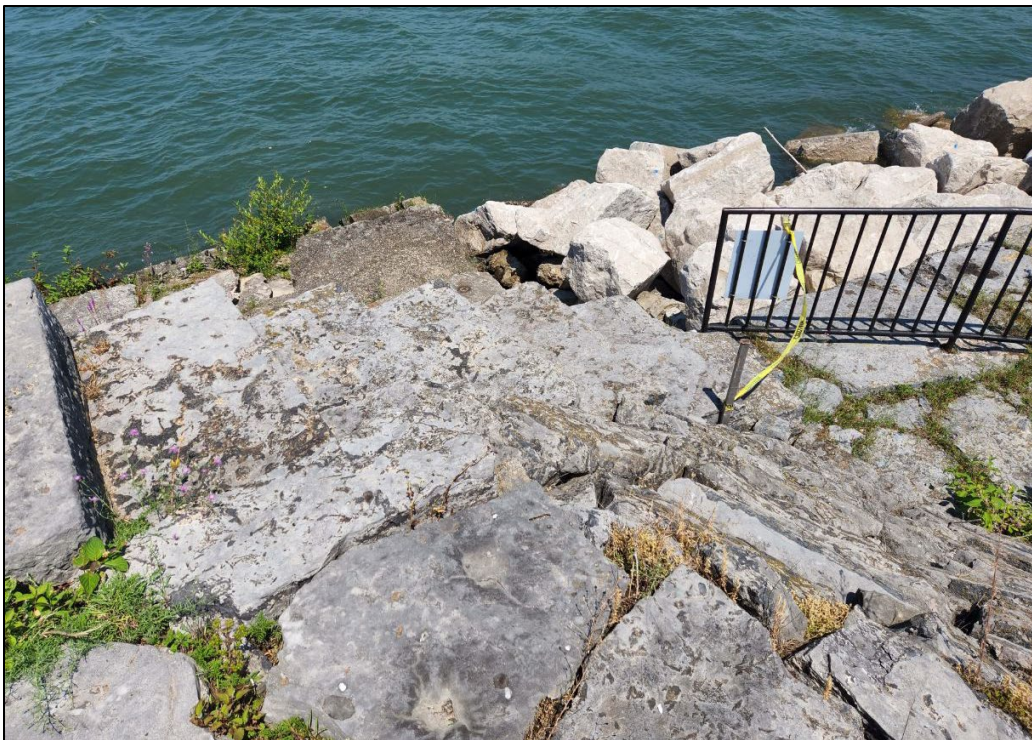
Figure 69. Western end of the 1820s stone wall showing how the wall was lowered in 1898 (photo by ERDC-CERL researchers, 2022).

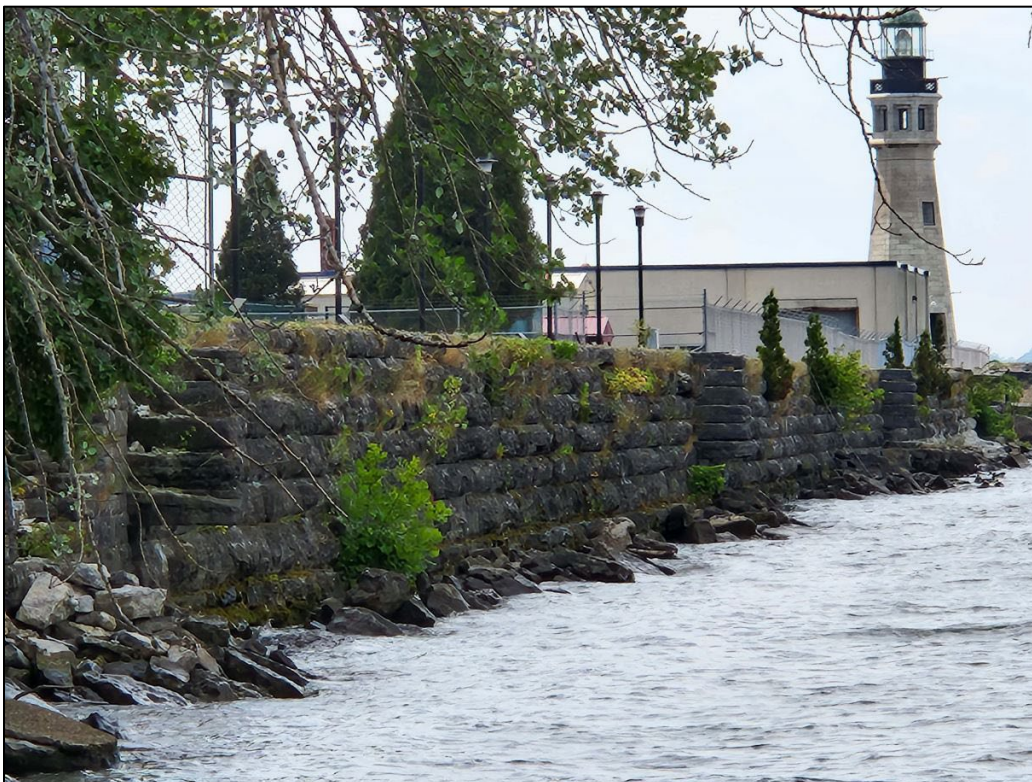
Figure 70. Looking west along the 1820s stone wall (photo by ERDC-CERL researchers, 2022).

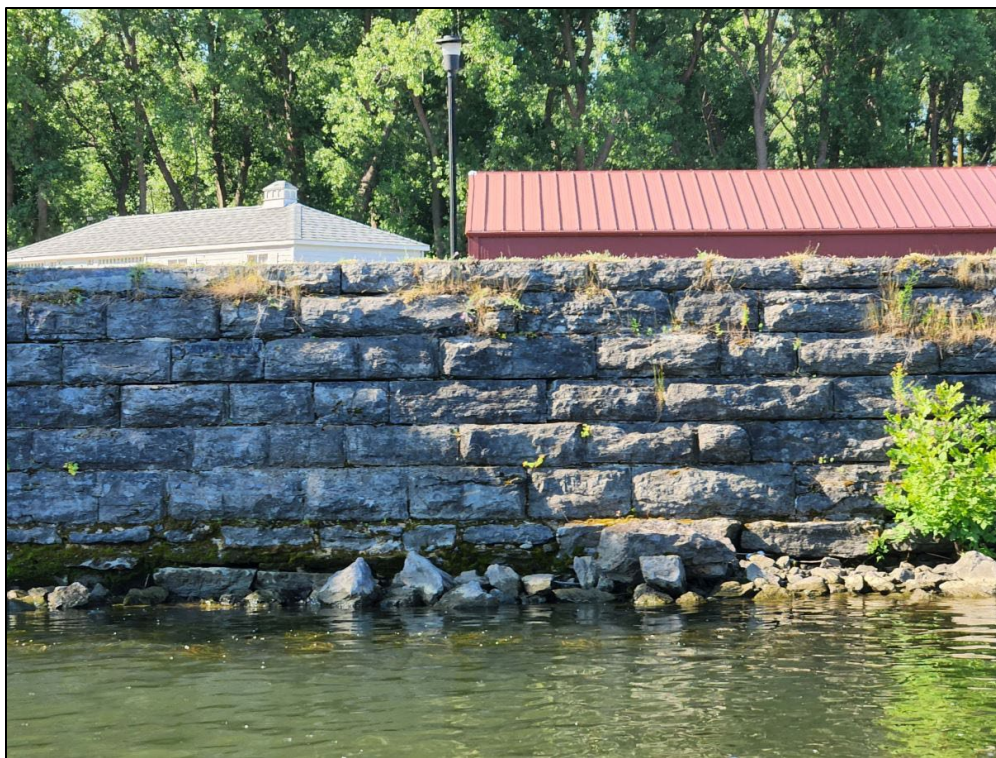
Figure 73. Looking south at the 1820s stone wall showing how this portion is at its original 1820s height (photo by ERDC-CERL researchers, 2022).

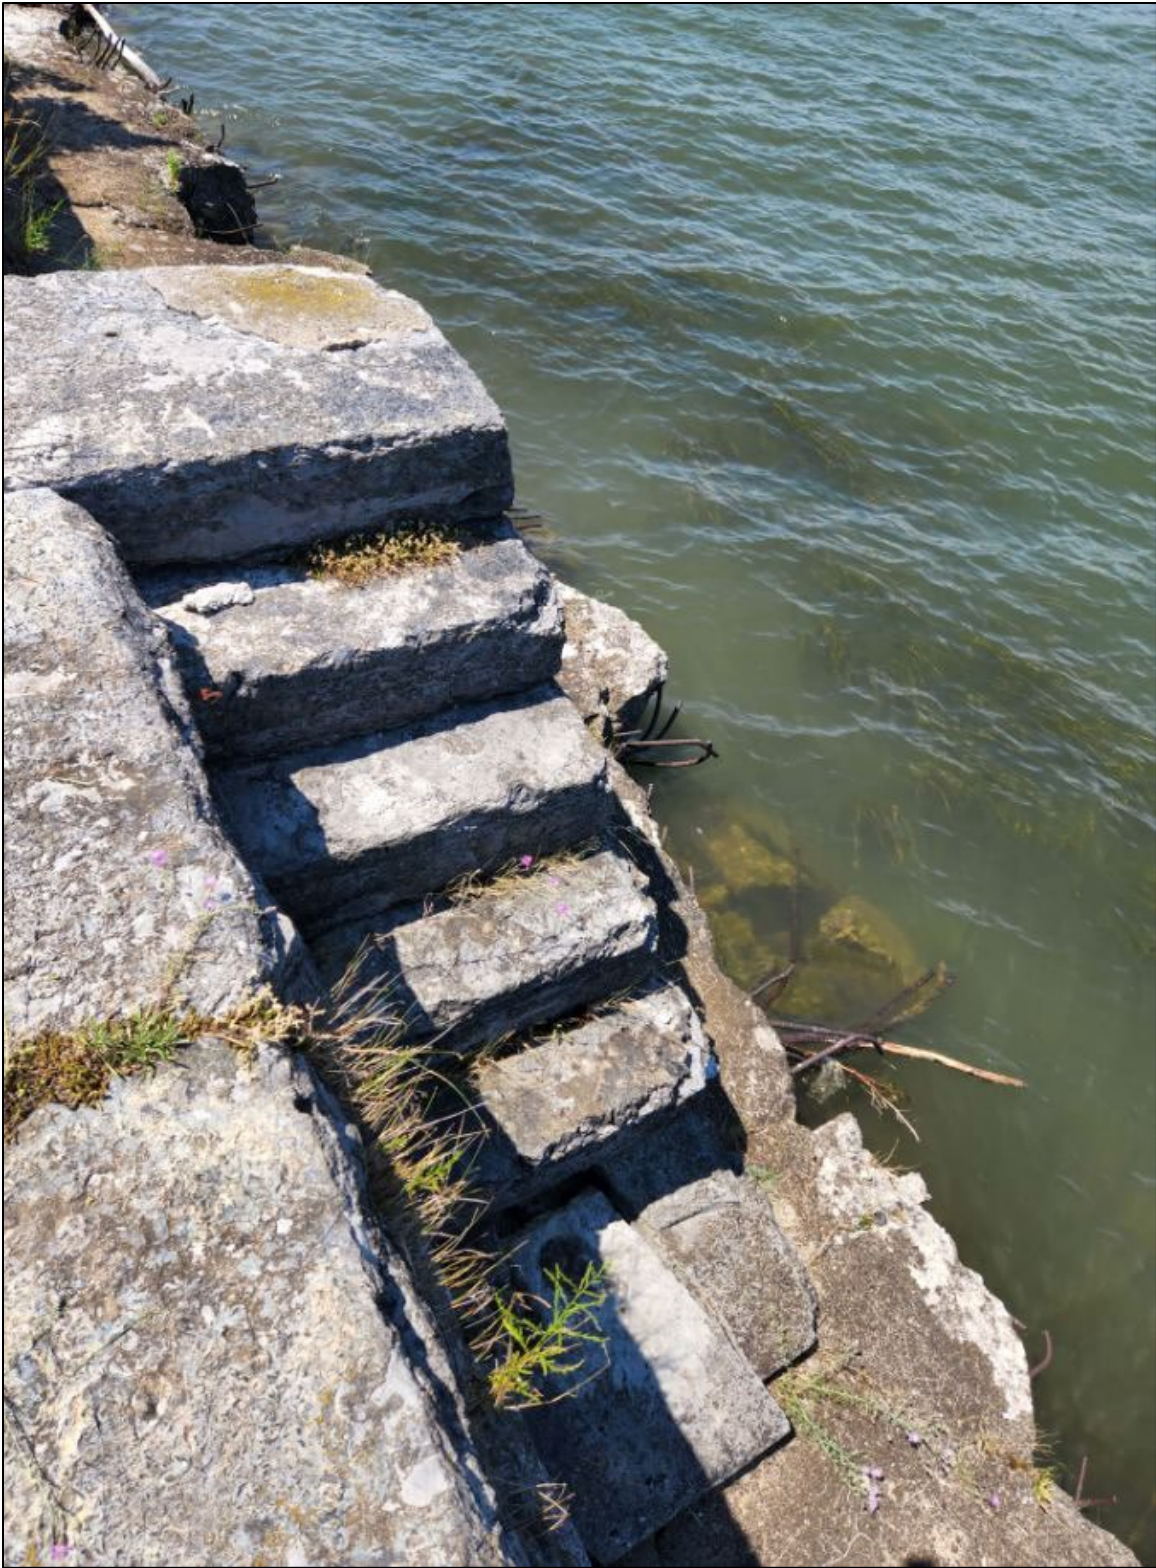
Figure 75. Looking down at the original 1820s stone stairs (photo by ERDC-CERL researchers, 2022).

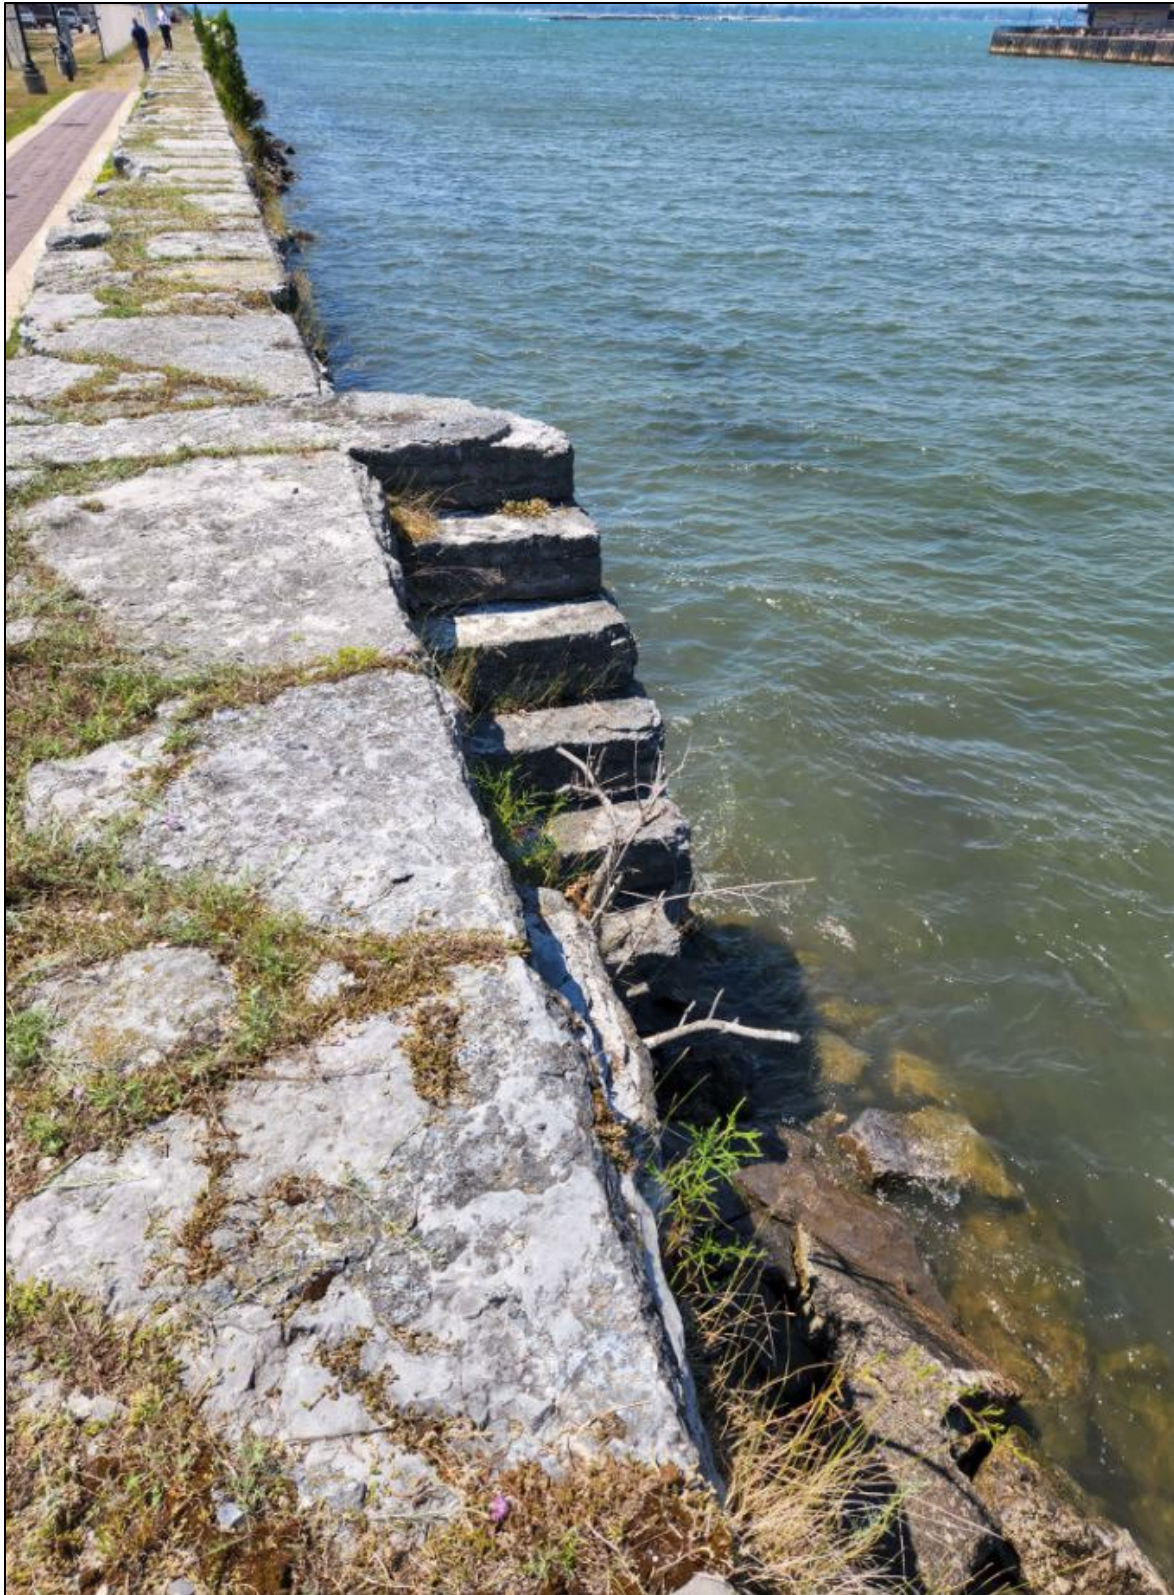
Figure 76. Looking down at the original 1820s stone stairs (photo by ERDC-CERL researchers, 2022).

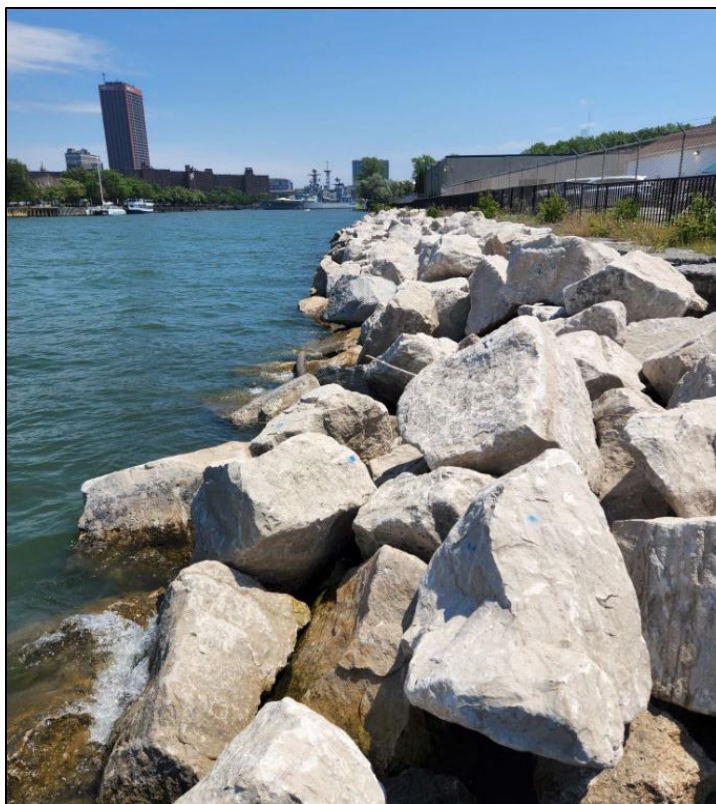
Figure 77. Looking east along armor stone placed along 1820s stone wall in 2021 (photo by ERDC-CERL researchers, 2022).<sup>12</sup>

<sup>12</sup> Note that although not shown in the photograph, there is shotcrete placed on the original stone wall behind the armor stone.

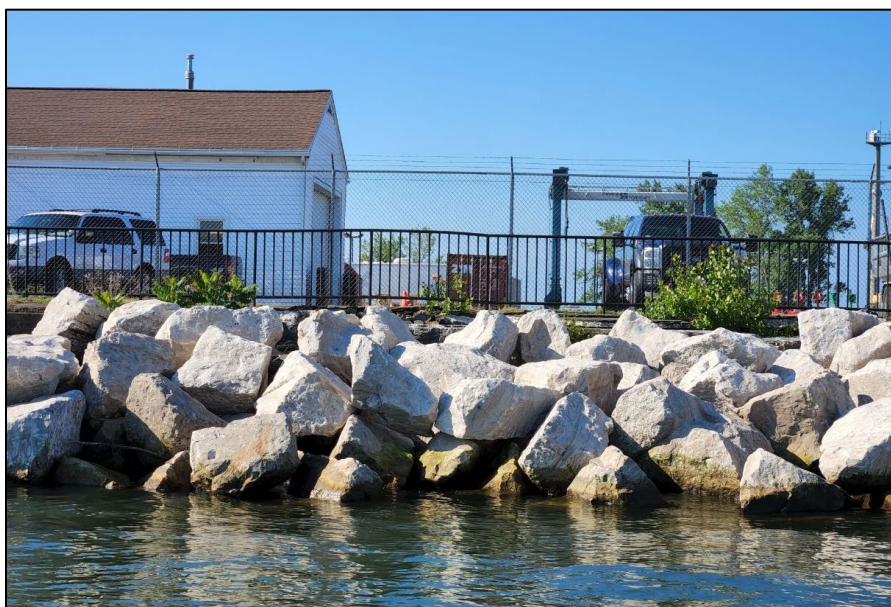
Figure 78. Looking south at the armor stone placed along 1820s stone wall in 2021 (photo by ERDC-CERL researchers, 2022).

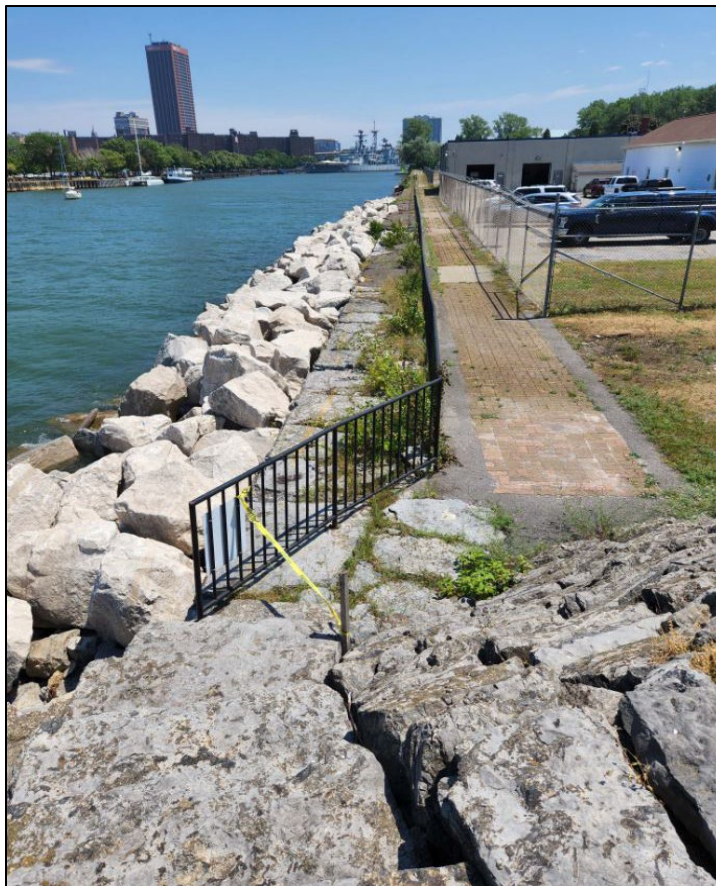
Figure 79. Looking east along concrete paver pathway placed here in 2021 and armor stone placed against 1820s stone wall in the same year (photo by ERDC-CERL researchers, 2022).

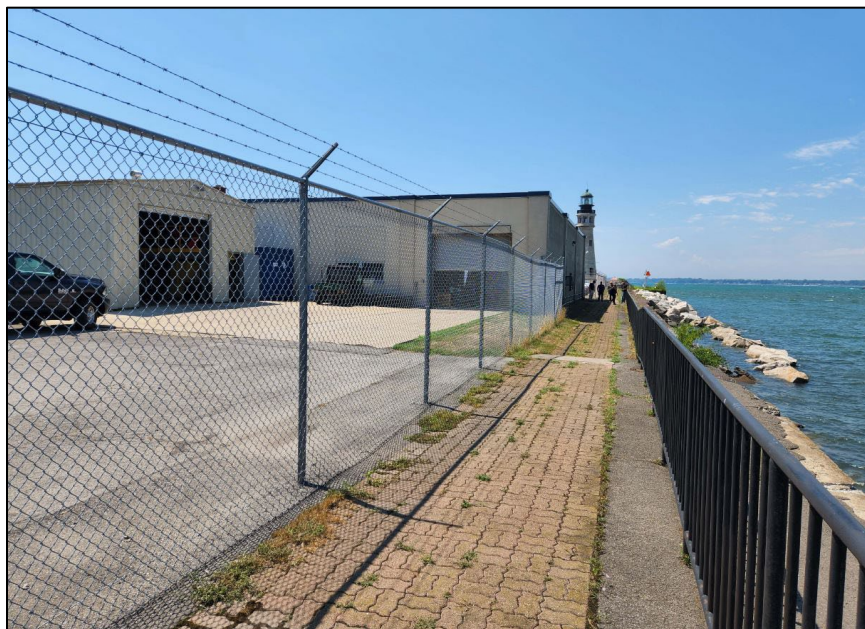
Figure 80. Looking west along concrete paver pathway placed here in 2021 (photo by ERDC-CERL researchers, 2022).

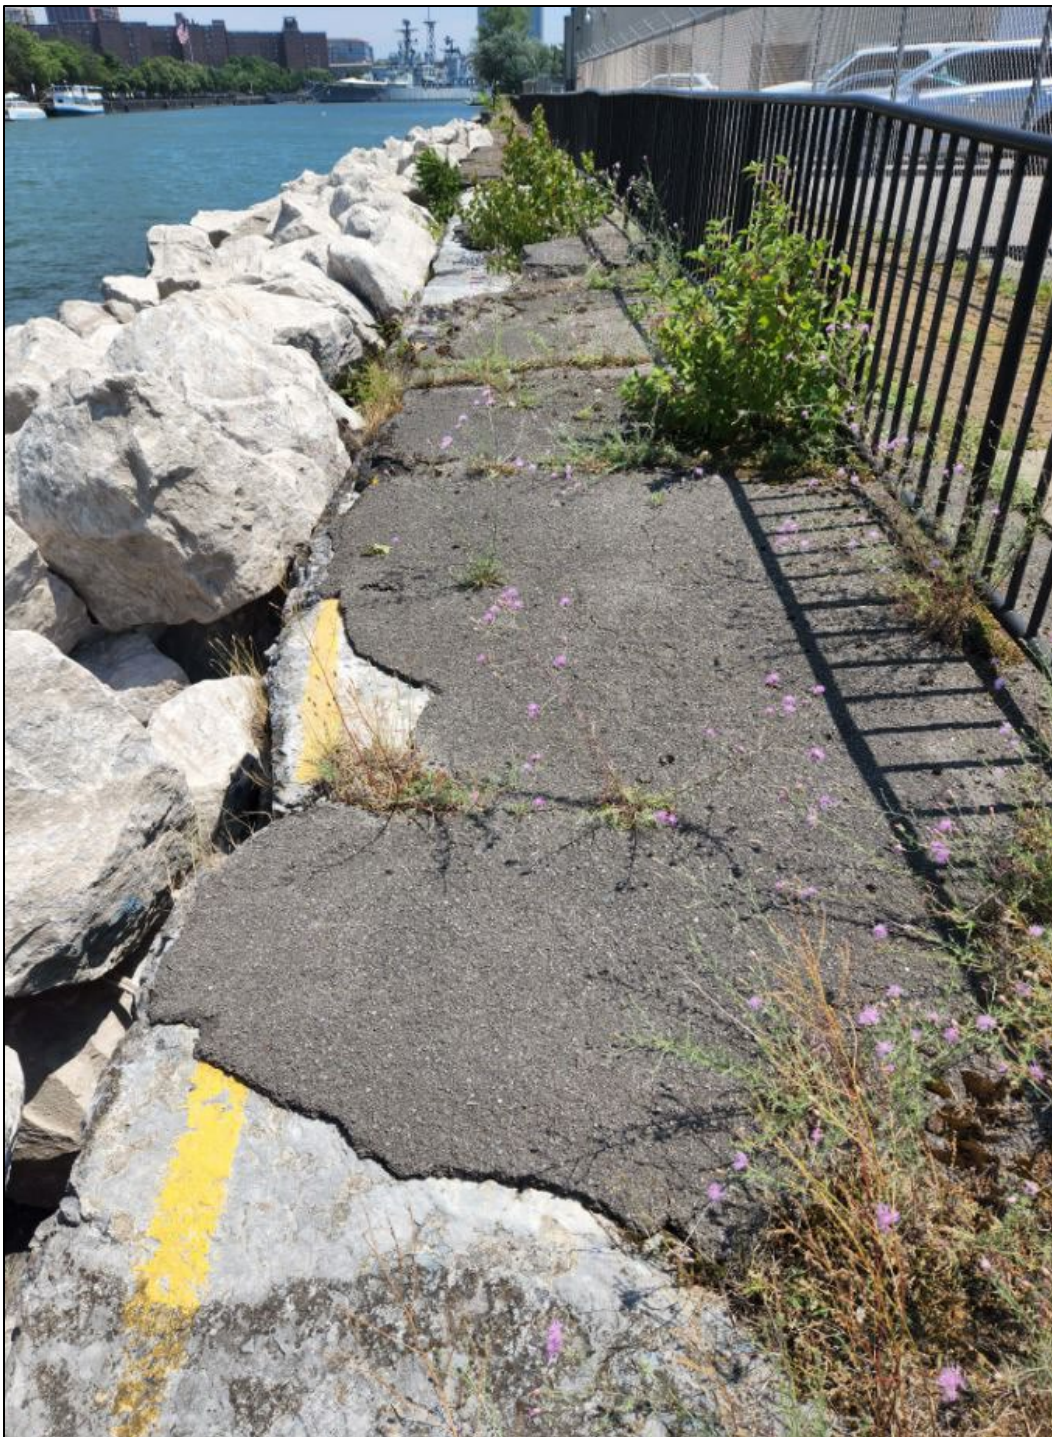
Figure 81. Looking east along asphalt placed on top of shortened 1820s wall and armor stone placed against 1820s stone wall in 2021 (photo by ERDC-CERL researchers, 2022).

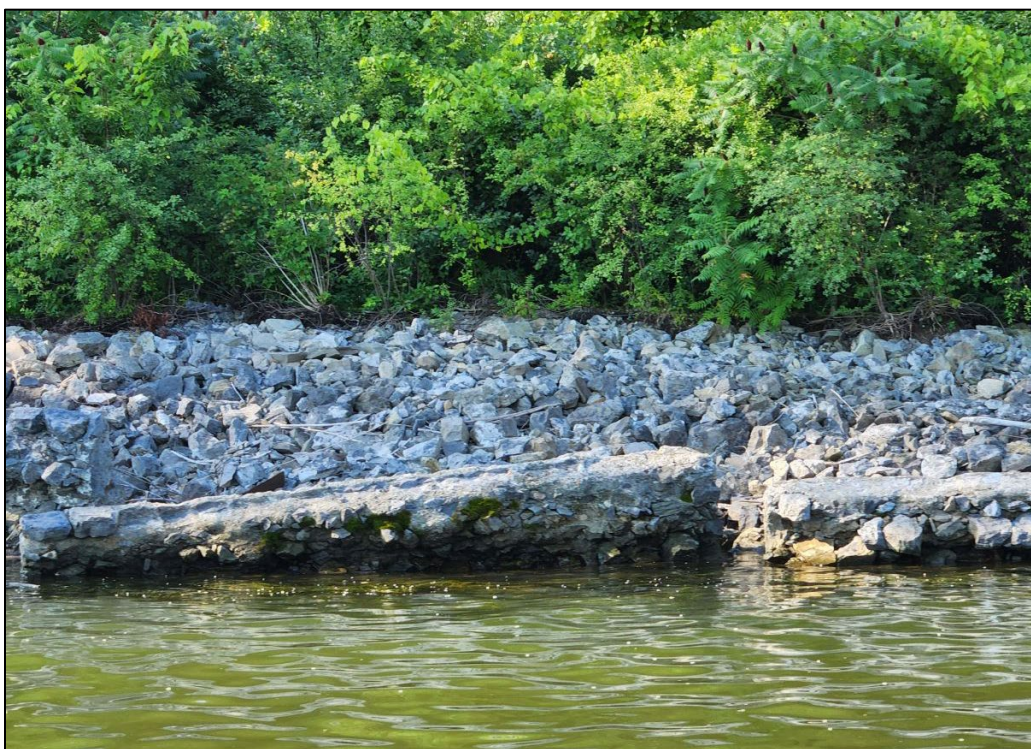
Figure 83. Sloping ground towards river on eastern side of the mole area (photo by ERDC-CERL researchers, 2022).

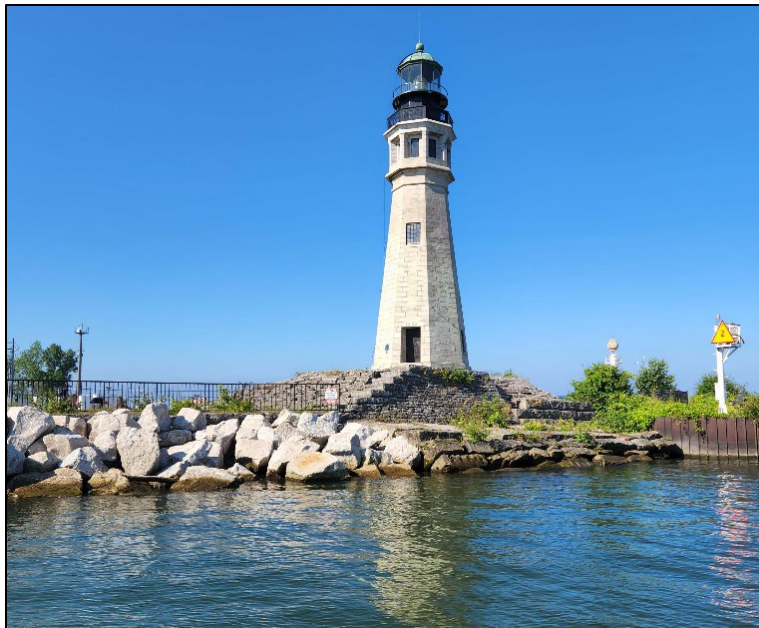
- 1833 stone lighthouse

Figure 86. Looking southwest at the 1833 lighthouse (photo by ERDC-CERL researchers, 2022).

Modifications to the stone talus, stone wall, stone stairs, and underground stone incline should be consulted upon with the New York State Historic Preservation Office. It is recommended to avoid adverse effects and that future modifications to these character-defining features should be in keeping with the Secretary of Interior's Standards for Rehabilitation (the Standards).

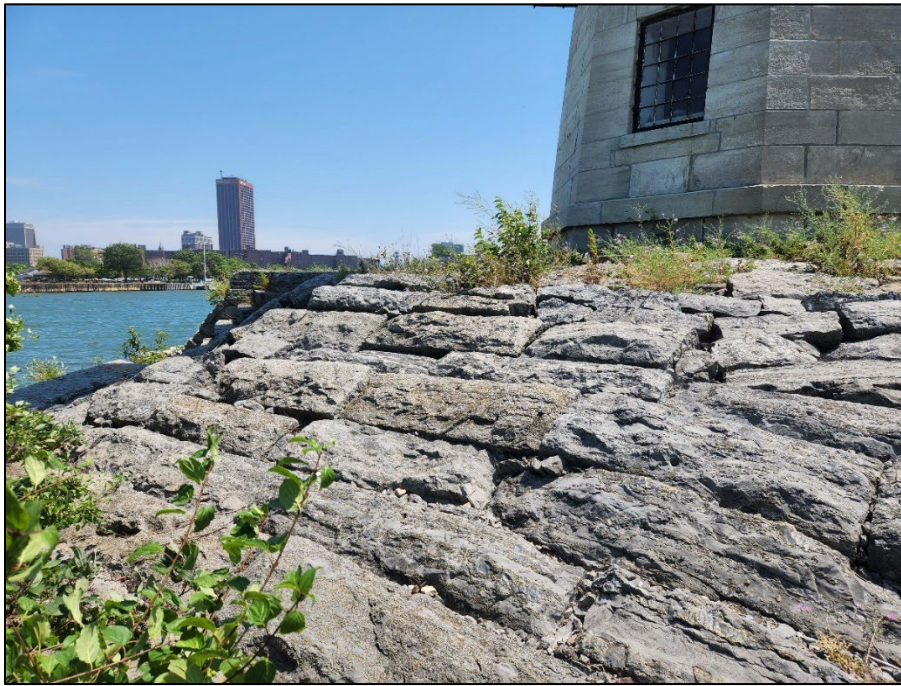
- 1833 stone talus at base of 1833 lighthouse

Figure 87. Detail of the 1833 stone talus at the base of the 1833 lighthouse (photo by ERDC-CERL researchers, 2022).

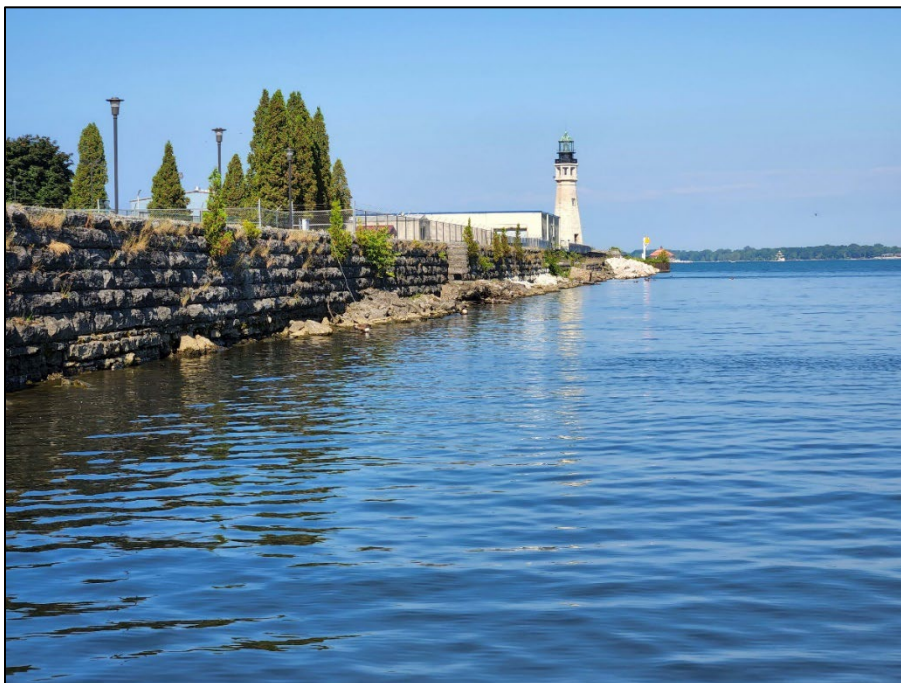
- 1820s stone wall including stone stairs and type of stone

Figure 88. Looking west along the stone wall from the Buffalo River (photo by ERDC-CERL researchers, 2022).
