Beach Erosion and Sediment Processes Study, North East Marina, Erie County, Pennsylvania

Andrew Morang and Jeffrey Melton

June 2001

Final report

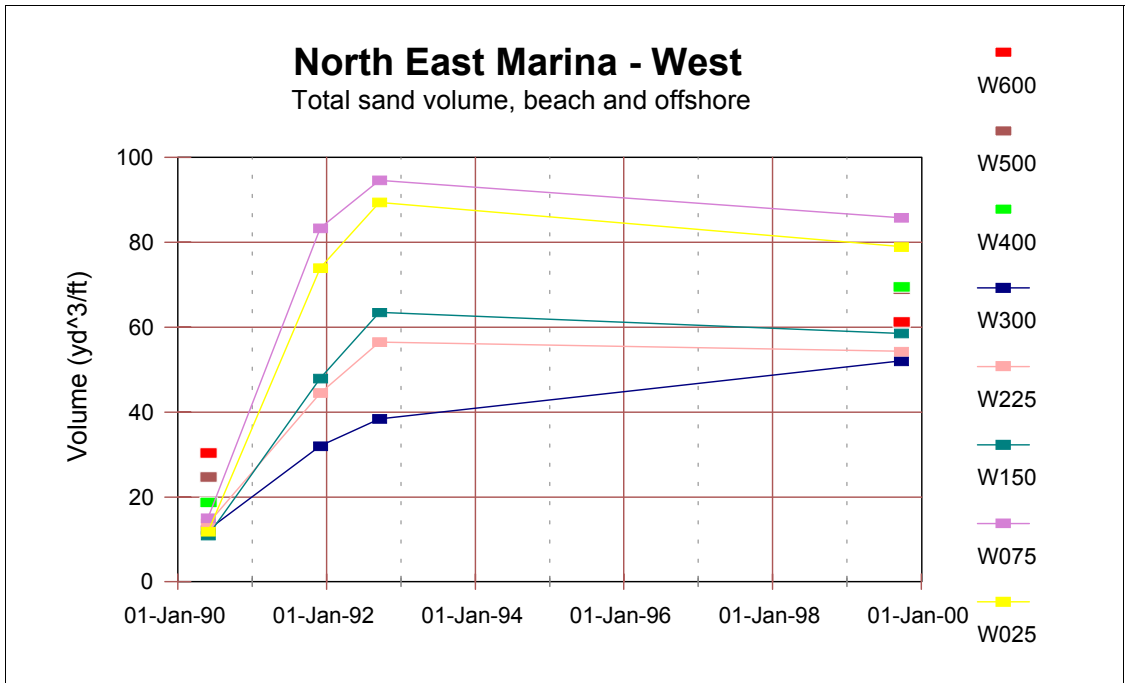
The results are easier to visualize as graphs. Figure 36 shows the volume changes over time for the west profiles. At all locations, volume increased rapidly between 5-30-90 and 9-16-92, during the period of marina construction, especially at lines W025 and W075. These data confirm the visual observations that a large fillet grew on the west side of the marina wall. The recent survey, 9-24-99, shows that the volumes of most of the west lines have stabilized or even slightly decreased. The period of stable overall volume coincides with the years that the PFBC has been bypassing sand from the west to the east side of the project. Only at line W300 did the volume increase from 1992 to 1999, and this is accounted for by the accumulation of sand on the upper part of the beach (see Appendix C). This is private property, west of the area where the PFBC mines the beach during its spring and fall bypassing operations.

Figure 36. Profile volume for lines W025 to W600 west of marina west wall. At W400, W500, and W600, data are only available for 1990 and 1999 and points have not been connected in this plot

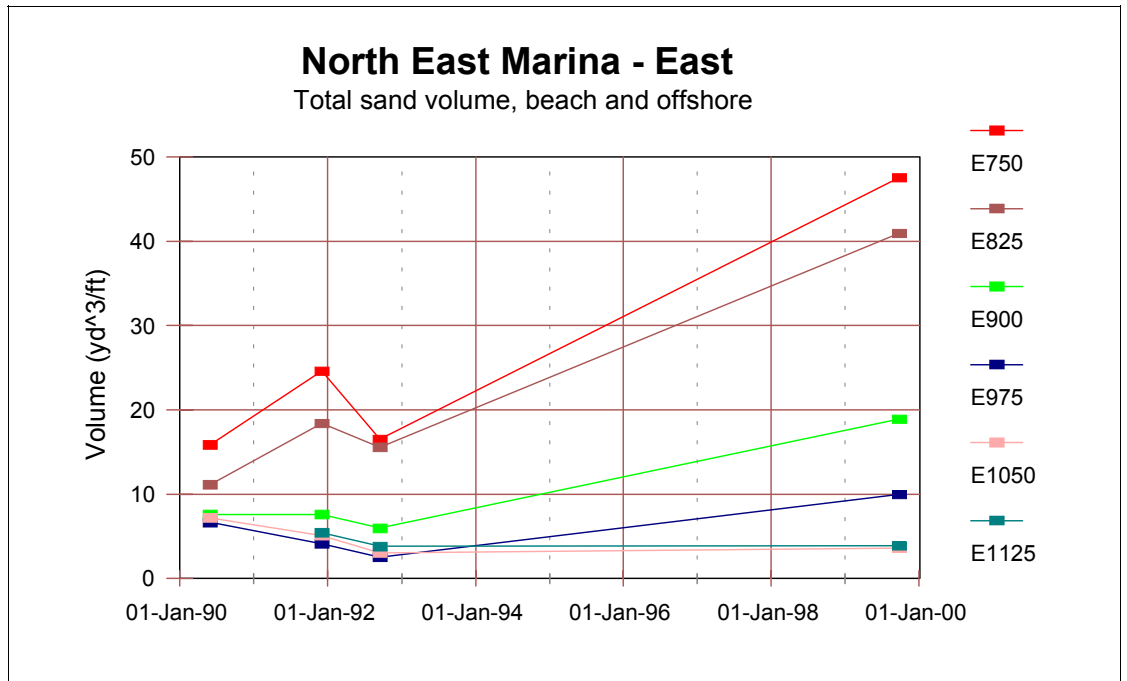
East of the marina, beach volume decreases towards the east (Figure 37). At the two lines closest to the east wall, E750 and E825, volume has more than doubled since 1992. Overall elevation has increased 0.3-0.6 m across the entire

Figure 37. Profile volumes east of marina. Most profiles show an increase in volume since 1992, but E1050 and E1125 are beyond influence of the structure

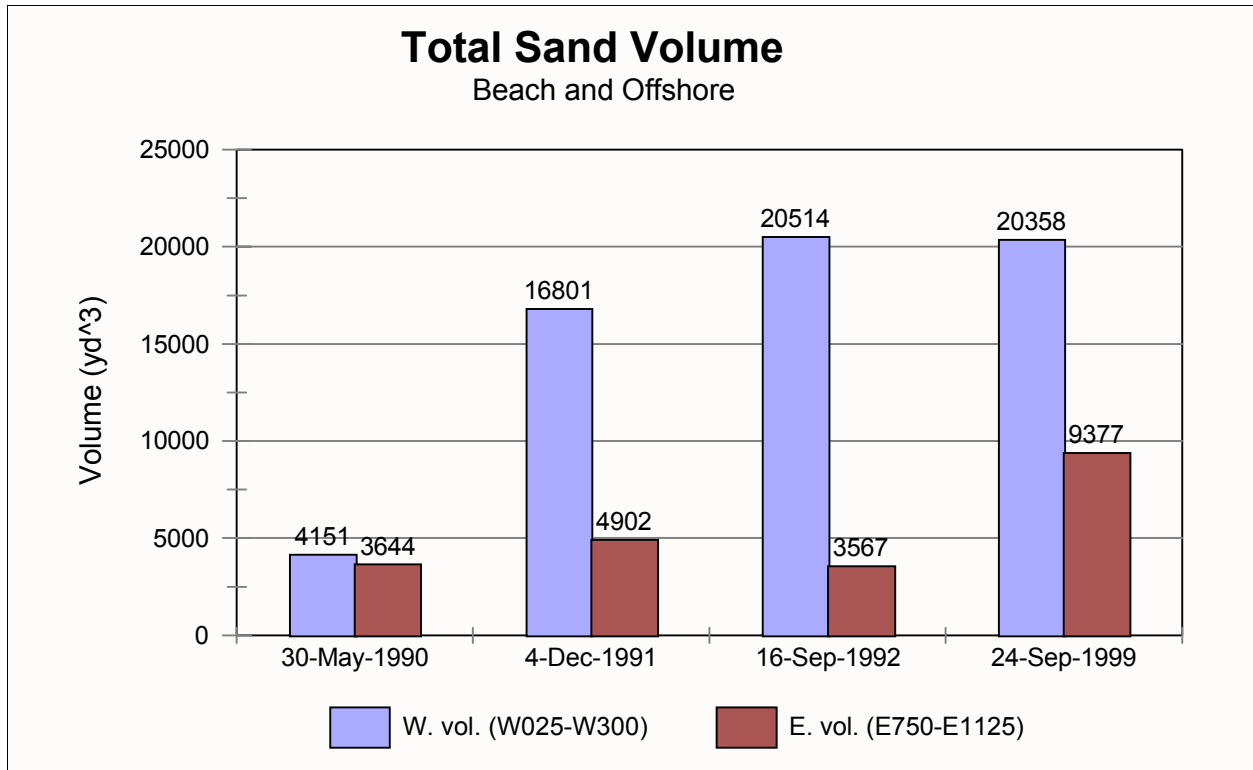
Figure 38 summarizes total volume change over time for the east and the west beaches. The west beach volume between W025 and W300 is almost identical to the 1992 volume, while the east beach has almost doubled. These data indicate that the PFBC has been bypassing a sufficient amount of sand to prevent a volumetric increase on the west side of the marina.

Figure 38. Total volume for west and east beaches. West of marina, volume has been stable since 1992, while to the east, total beach volume has almost doubled

Period 2: Spring 1994 to the present. Pennsylvania Fish & Boat Commission has effectively mitigated the disruption of eastward-directed littoral transport because the volume of sand bypassed during the biannual trucking operations has been approximately the same as the amount of sand brought into the fillet region by littoral processes. In September 1999, the total volume between profiles W025 and W300 remained unchanged at about 20,000 yd³, therefore indicating that the mechanical bypassing has been equal to the input supply (Figure 38).

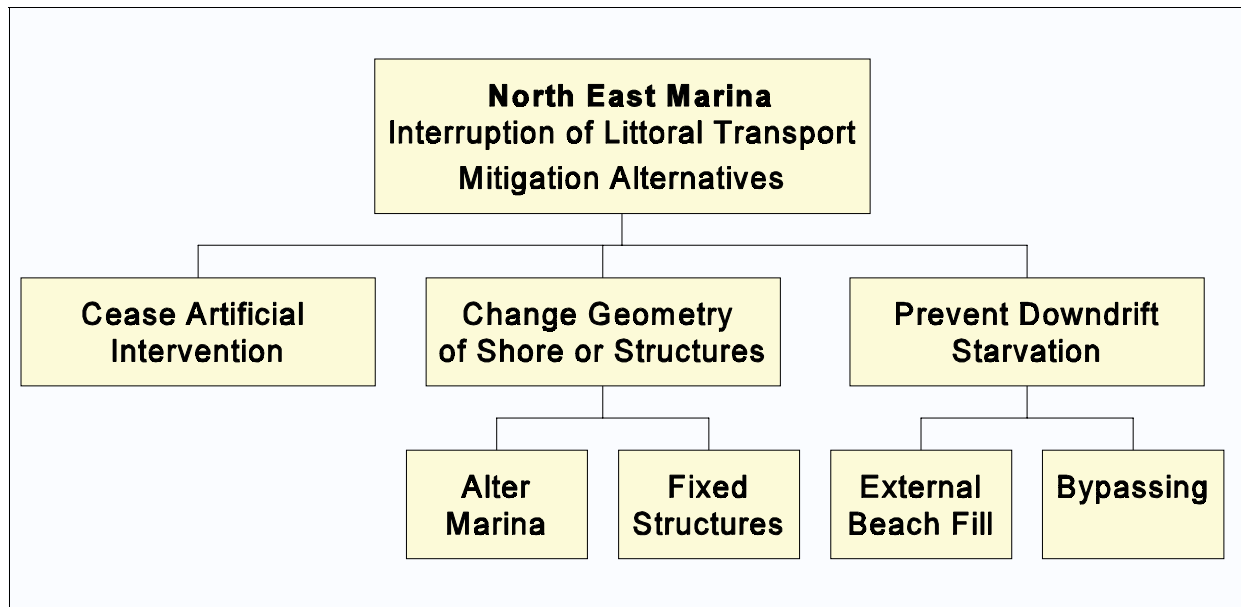
Figure 39. Flow chart of mitigation alternatives
