## **Detection and Evaluation of Scour Protection for Navigation Dams**

John E. Hite, Jr.

August 2008

Final report

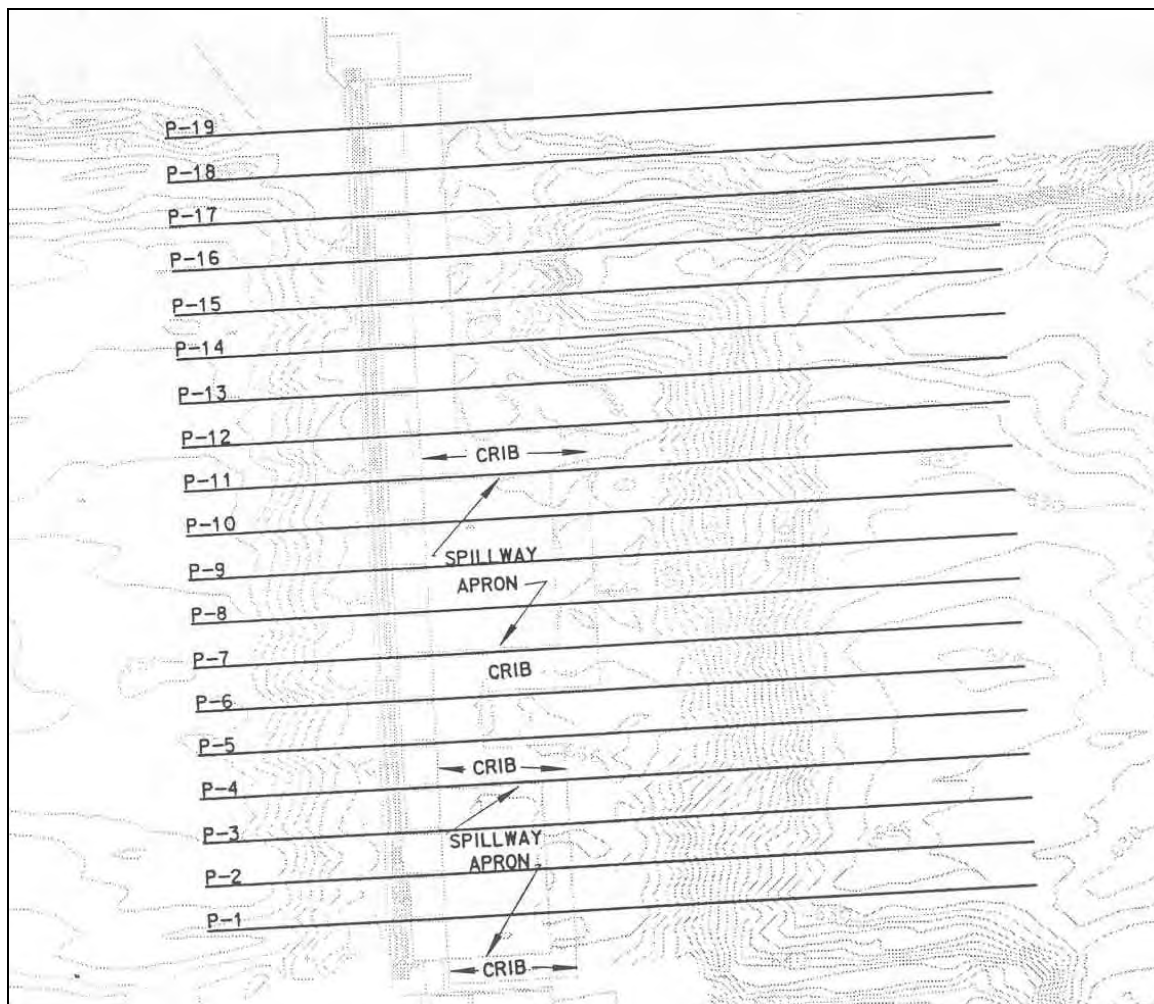
A problem encountered with the hydrographic surveys is the uncertainty of the horizontal location. If the horizontal location is not identified, then the depth data is questionable. The cross-section plots (especially the streamwise plots) often indicate deposition or erosion within the stilling basin. This data becomes suspect and appears that it should be shifted upstream or downstream sometimes 10 to 20 ft.<sup>1</sup> A 20-ft shift horizontally can be a dramatic vertical change greatly reducing the confidence level of the vertical location of the scour protection. Figures 5 and 6 show typical examples of scour profiles measured in the streamwise direction at Lock and Dam No. 2 on the Mississippi River. In Figure 6, the profiles show that significant scour has occurred between 30 and 60 ft downstream from the structure between 2001 and 2003. The riprap appears to have been scoured and deposited on the downslope between 80 and 110 ft downstream from the structure. This type of scoured area would need to be repaired to prevent additional scouring that would threaten the structure.

Figure 5. Example of sounding profiles taken at Lock and Dam No. 2, Mississippi River, flow is from left to right.

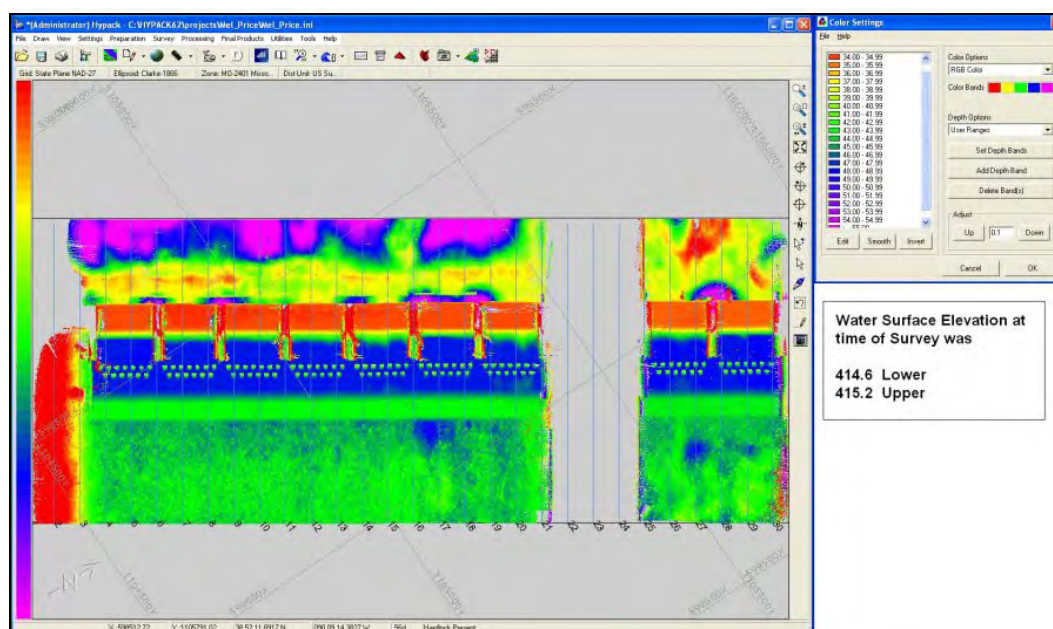
Multi-beam sonar has been used to identify scour near navigation structures. In the spring of 2007, a survey boat equipped with multi-beam sonar working at Mel Price Locks and Dam on the Mississippi River recorded the images shown in Figures 7 and 8. Figure 7 shows both the upstream and downstream portions of the project. Scoured areas can be seen downstream from gate bays 2 and 4 (numbered from right to left) and upstream in front of most piers and the entire gate bay between piers 5 and 6. Figure 8 shows a close-up of the sonar image upstream from gate bay 4. The areas in front of the dam had scoured over 20 ft from the original stone placement. The scour upstream from the dam was not anticipated, and repairs will be needed to prevent further scour in this area. The depths determined from the multi-beam sonar images were verified using a boat and line sounding (Figure 9). These multi-beam images and subsequent verification demonstrate that the multi-beam sonar system can be used to determine scoured areas at navigation projects.

Figure 7. View of areas upstream and downstream from Mel Price Dam from multi-beam sonar (flow is from top to bottom).

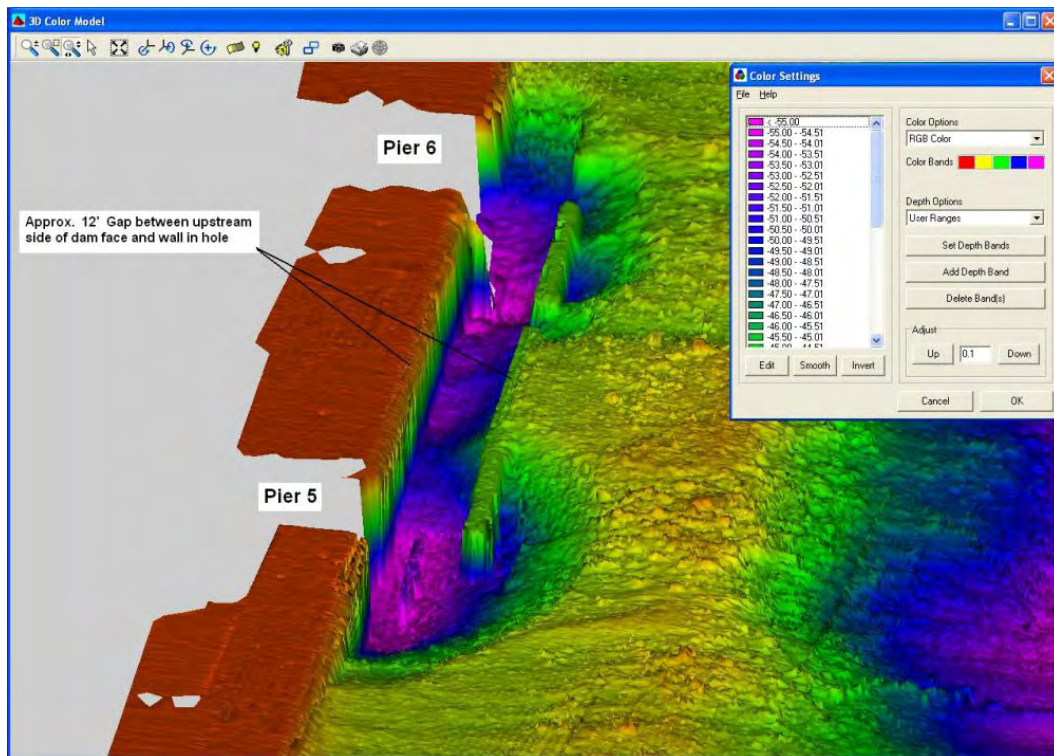
Figure 8. View of area immediately upstream from gate bay at Mel Price Dam (flow is from right to left).

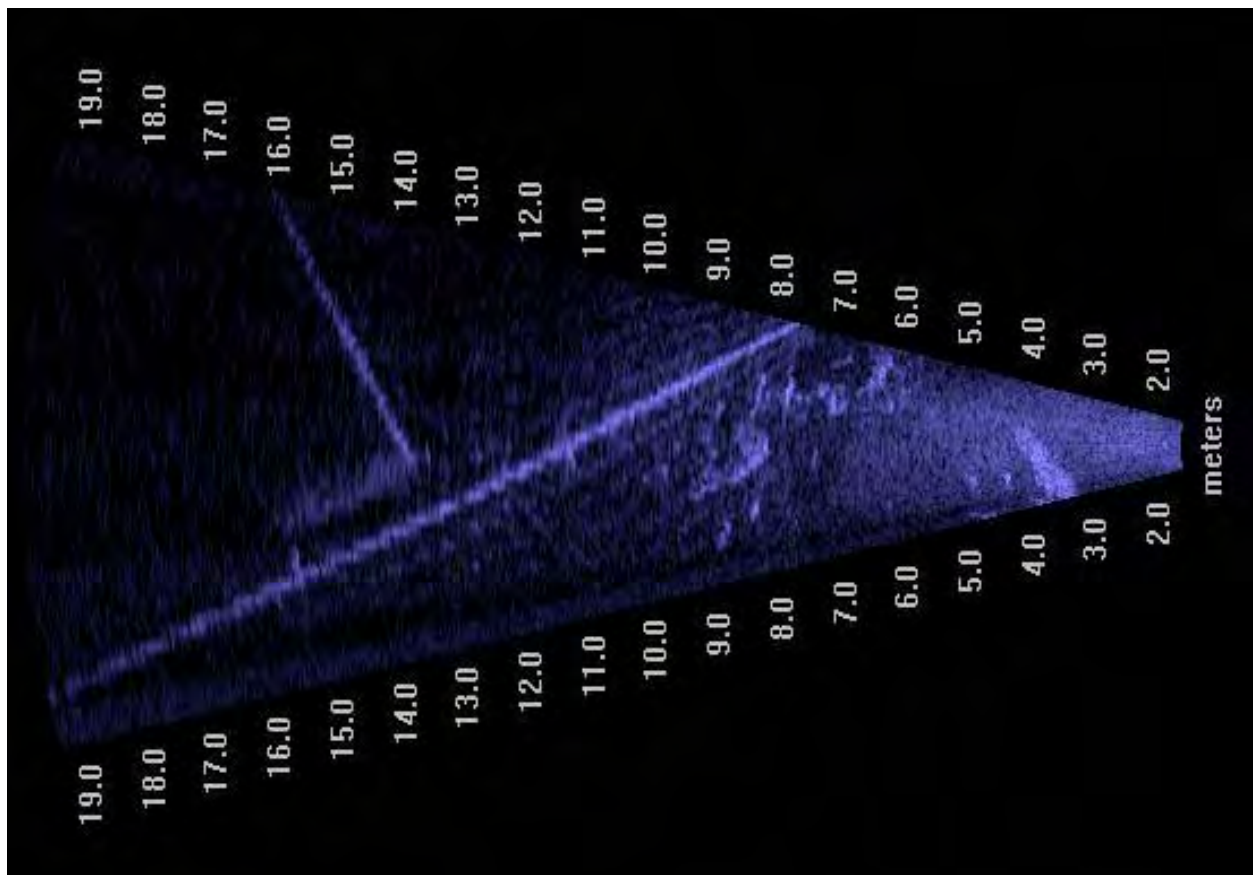
The numbers are the distance in meters from the DIDSON to the feature imaged. The area on the south side of the pier between gate bays 9 and 10 (pier 9-10) is shown in Figure 20. The edge of the apron is the long slightly angled feature and the south edge of the pier 9-10 is the feature normal to this one.

Figure 20. Area just south of the pier between gate bays 9 and 10 (Test 1).

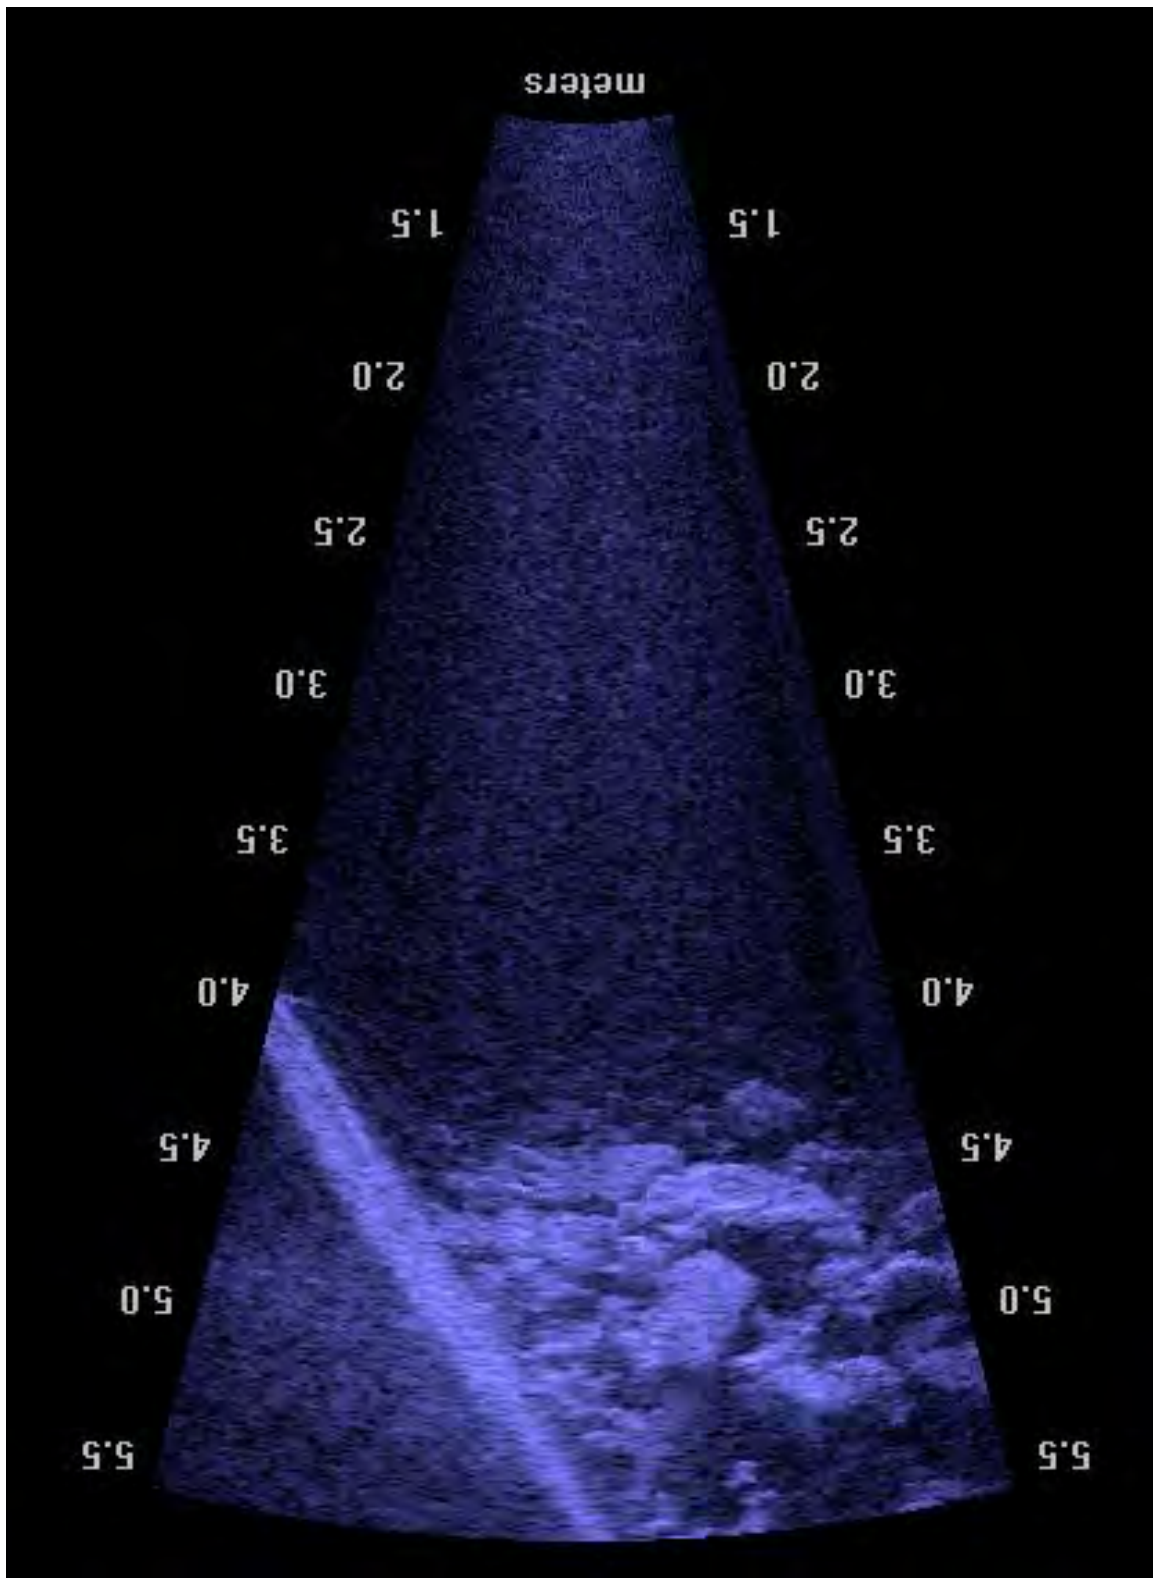
Figure 22. Area just north of pier between gate bays 9 and 10 (Test 2).

At the start of Test 2, the boat was nosed onto the north side of the pier between gate bays 9 and 10 and was facing upstream. The boat location during Test 2 is shown in Figure 21 as the yellow and magenta colored dots. In Figure 11, the DIDSON would be at Y-coordinate 1843, 10 ft downstream from the end of the apron. The DIDSON was lowered 14 ft below the water surface to around el 428. The area in the vicinity of the pier and the south side of gate bay 9 was inspected. The vertical face of the dam apron can be seen in the lower left of Figure 22 along with rock on the bottom. Sunken drift was observed just downstream from the end of the apron (Figure 23).

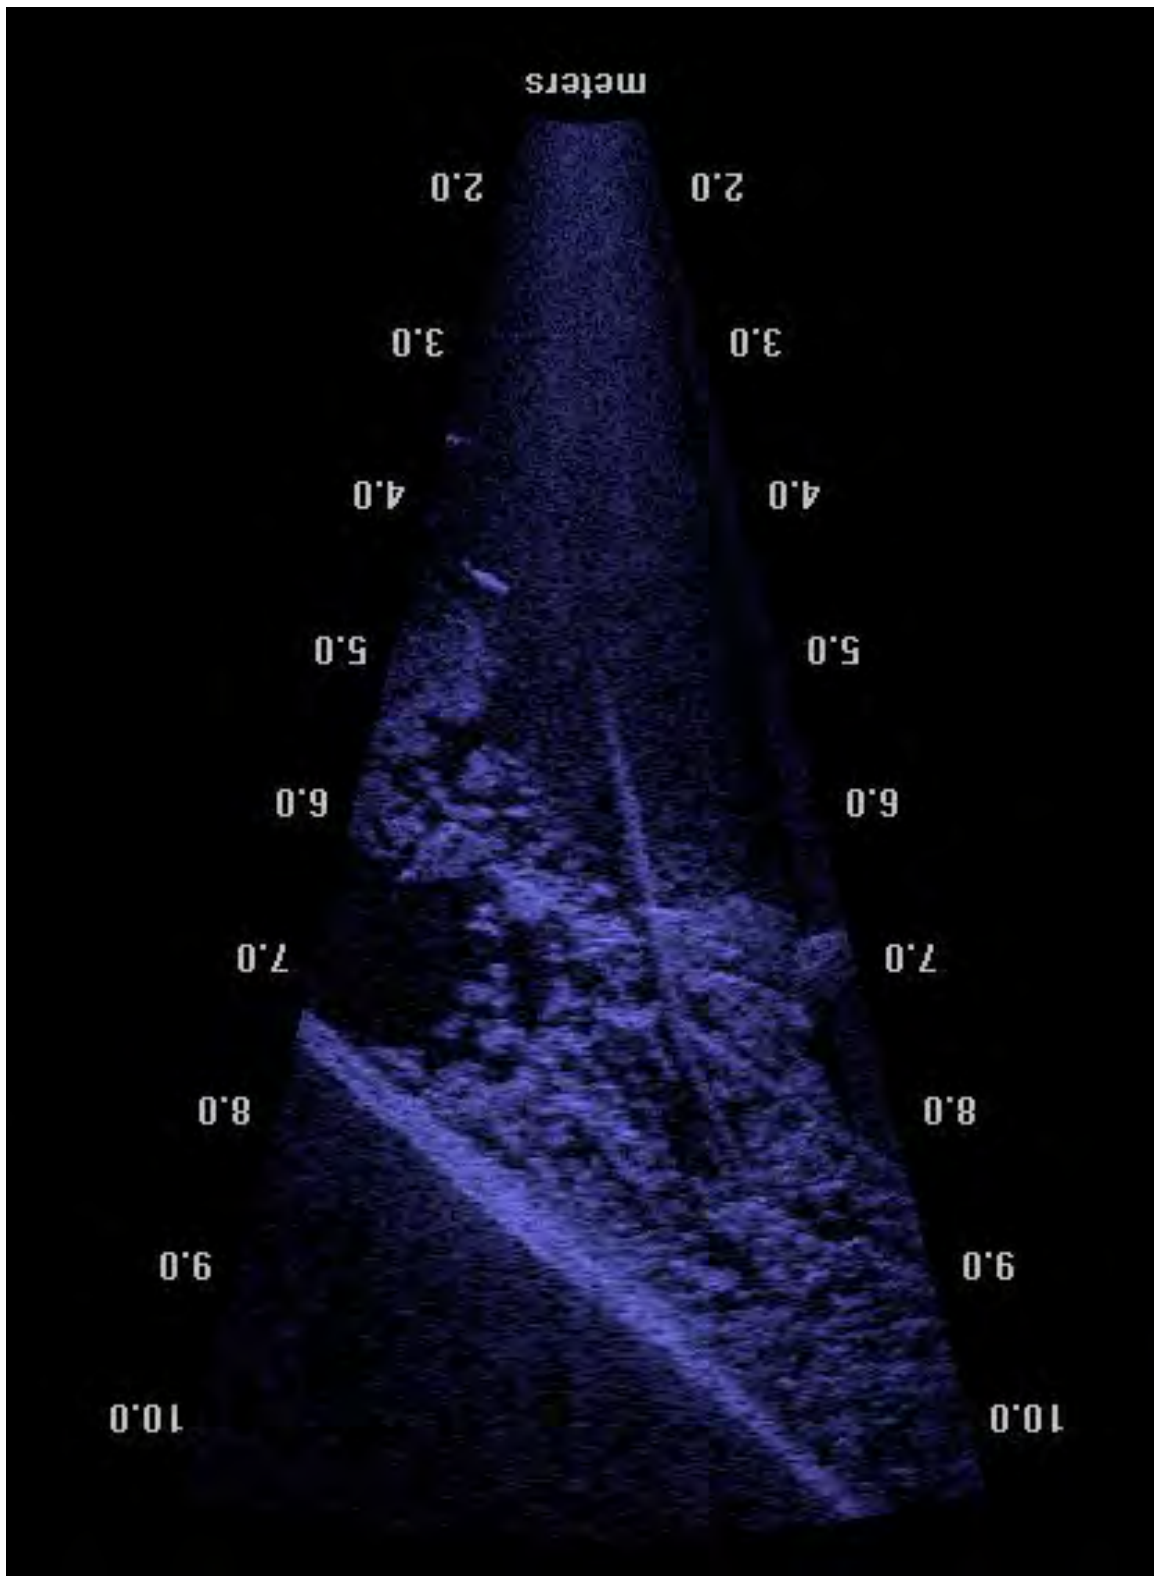
For Test 4, the boat began at the pier between gate bays 9 and 10 and moved downstream and upstream in this general vicinity. The boat track during Test 4 is shown in Figure 25 as the yellow track. The DIDSON was placed 8 ft below the water surface. The river bottom between the middle of gate bay 9 and gate bay 10 was observed and the downstream side of the apron from about 20 ft on either side of the pier between bays 9 and 10 was imaged. Figure 26 shows the area at the end of the apron on the gate bay 9 side (north side) of pier 9-10 and Figure 27 shows the gate bay 10 side of pier 9-10.

Figure 26. Dam apron on north side of pier 9-10 (Test 4).

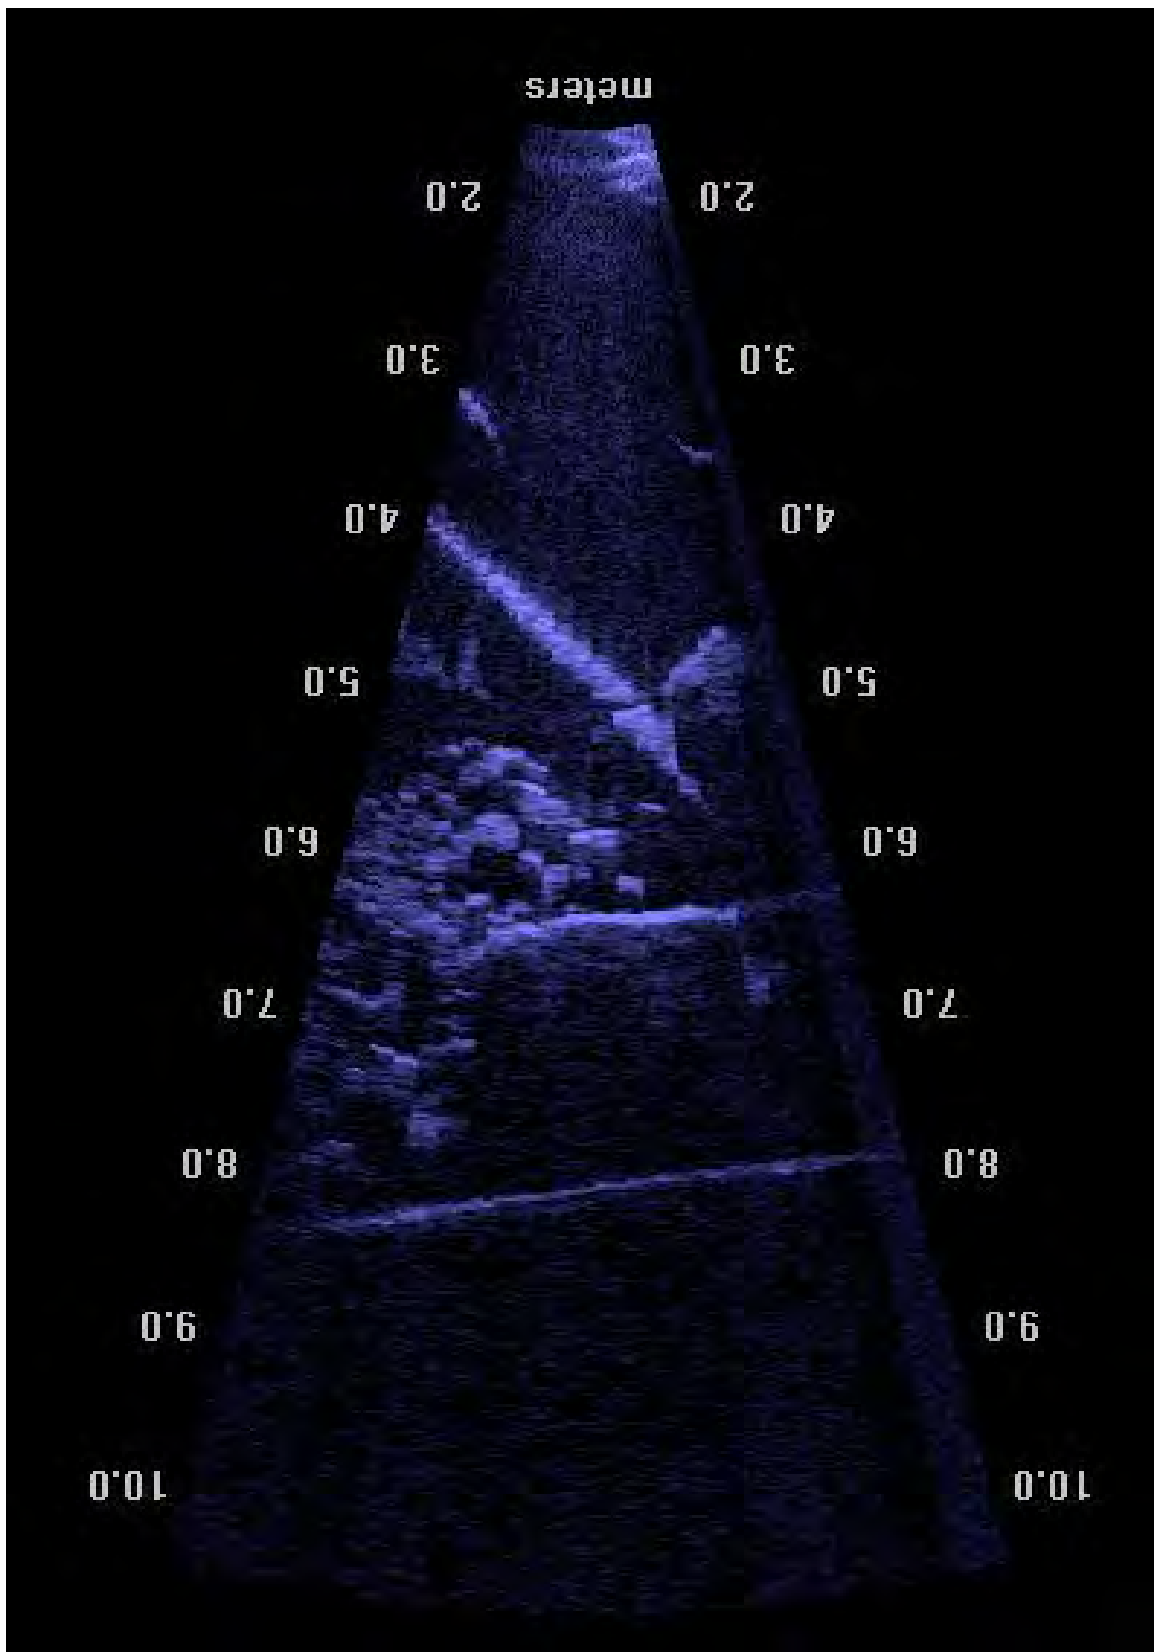
Figure 27. Area on south side of pier 9-10 (Test 4).

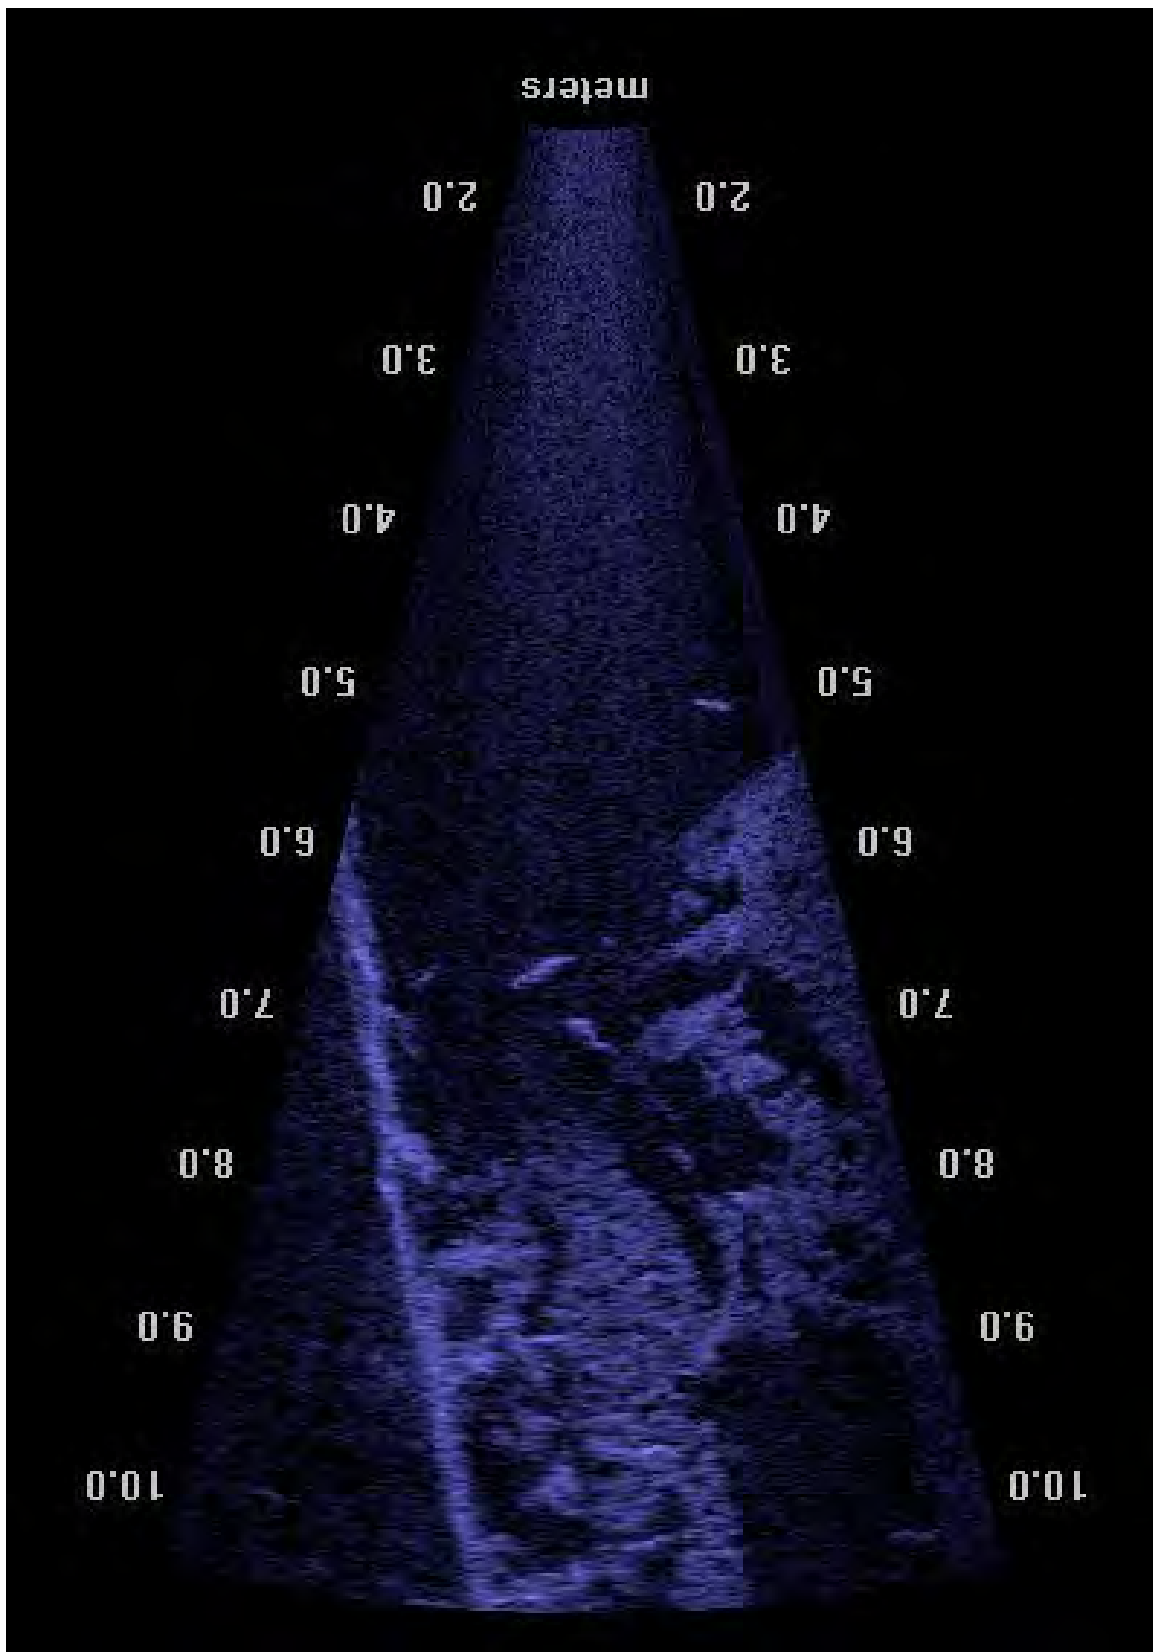
Figure 29. Area north of pier 8-9 (Test 5).

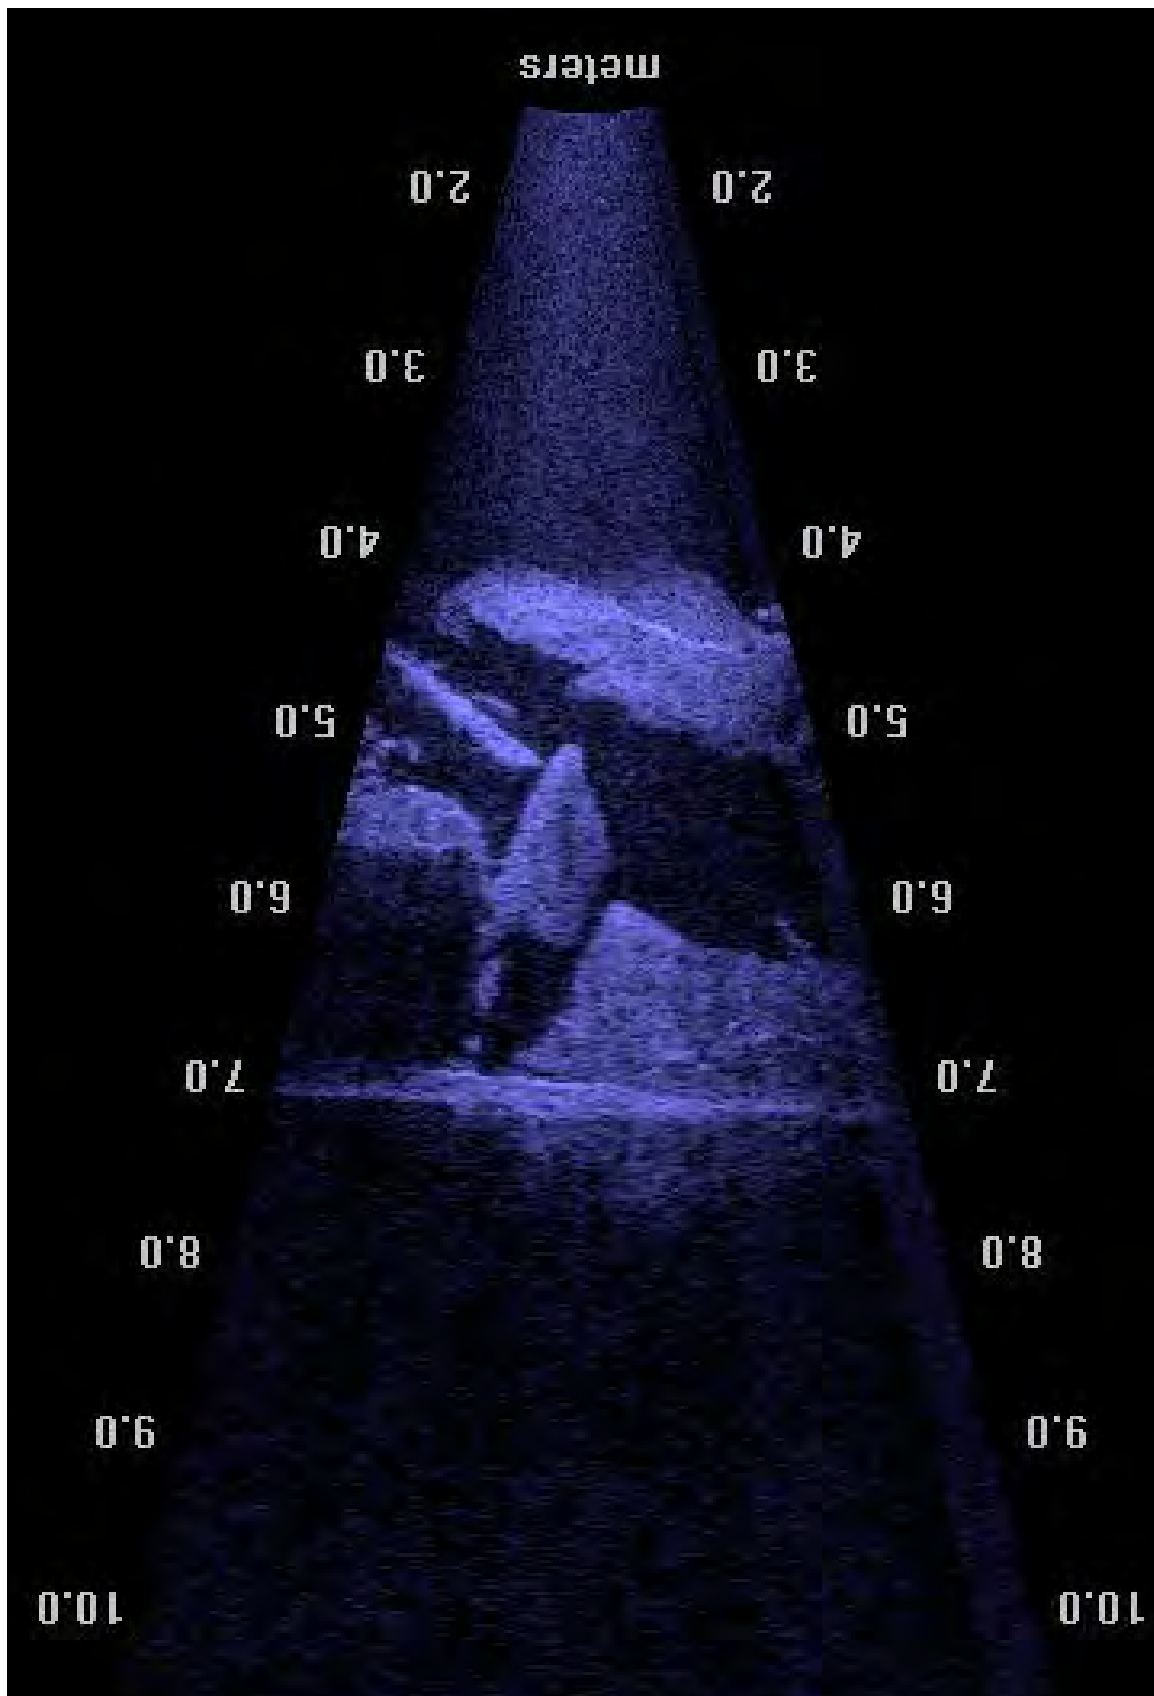
Test 6 was conducted to determine if the DIDSON could be used successfully moving along parallel to the dam. The test was started just north of pier 8-9 and then the boat moved about 20 ft downstream from the end of the apron with the DIDSON at 8 ft below the water surface. The boat track for Test 6 is shown in Figure 25 as the brown colored track. Figure 30 shows an image that was recorded below gate bay 10 about 30 ft south of pier 9-10 and 22 ft from the dam apron.

Figure 30. Image 30 ft south from pier 9-10 looking back toward apron (Test 6).

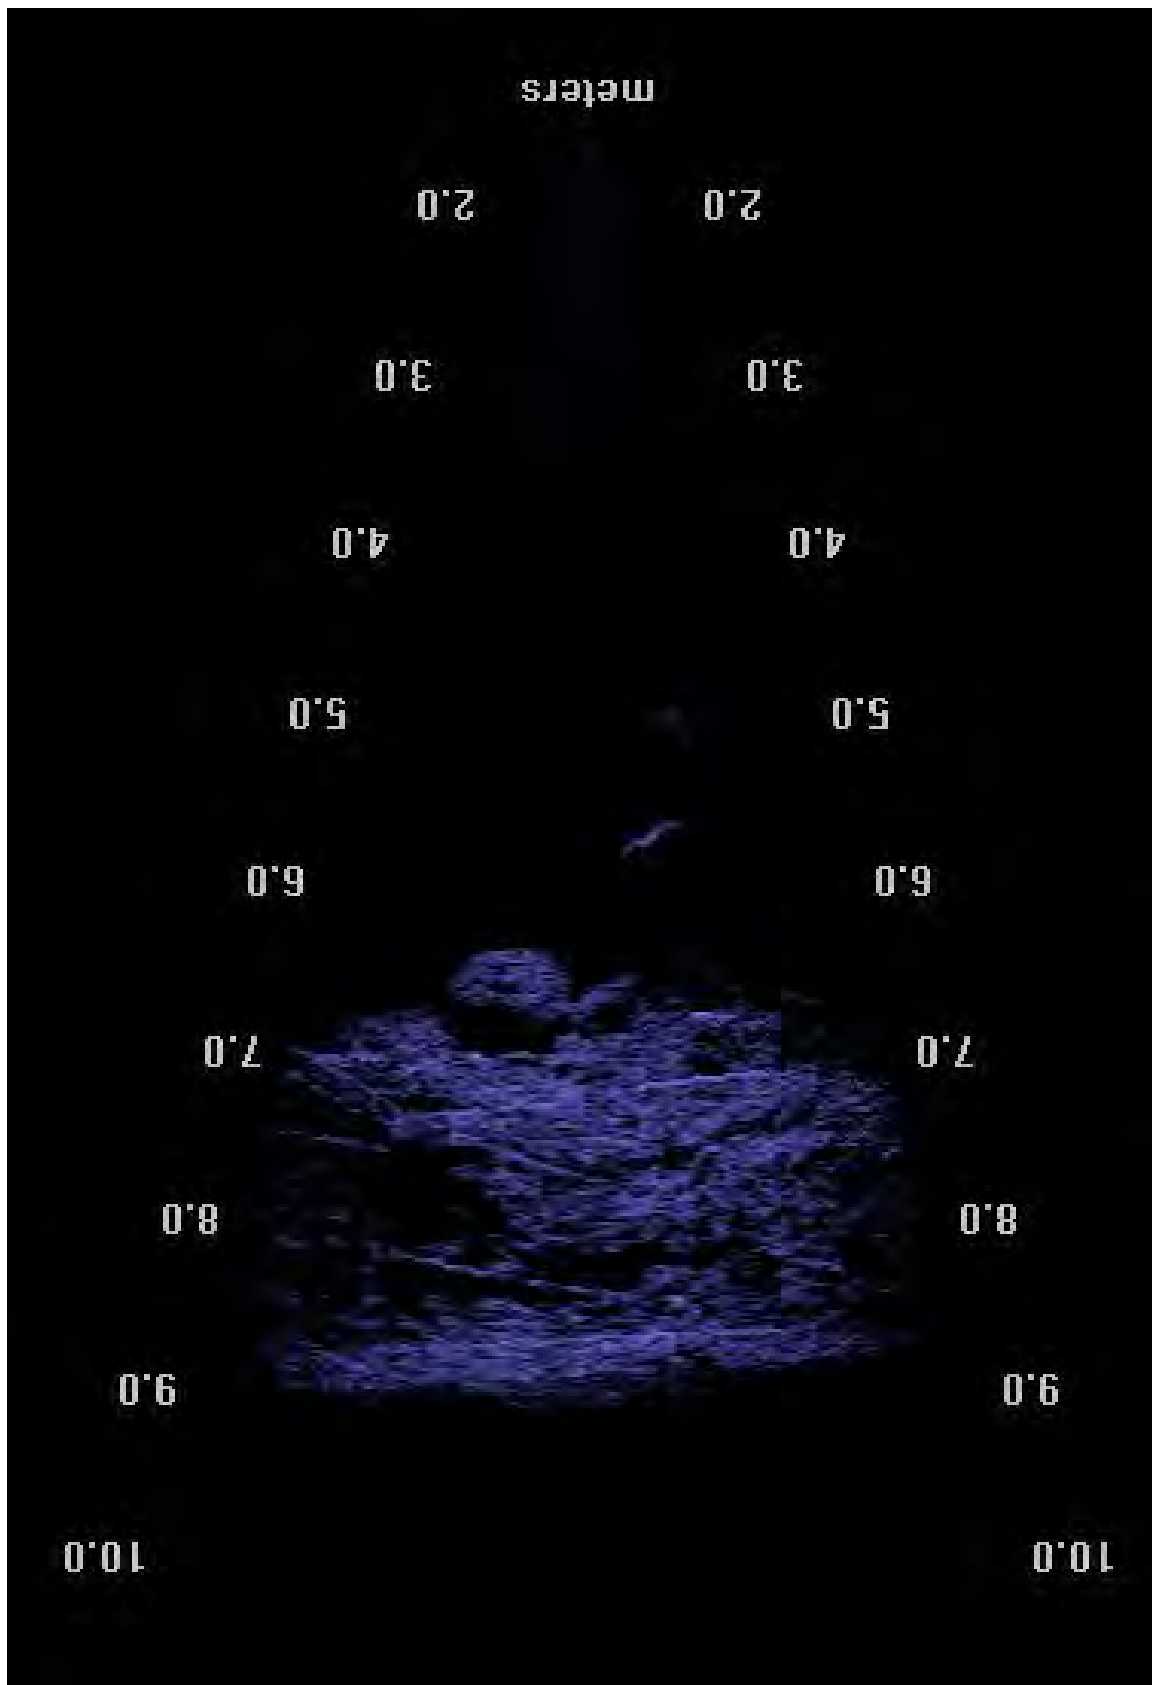
Test 8 began behind gate bay 8 and moved toward gate 10 as seen in Figure 31. The DIDSON was aimed at the area below the apron for this test. The bottom was more than 20 ft from the DIDSON behind gate bay 8 and through gate bay 9 and started to rise as gate bay 10 was approached. Figure 33 is an image of the bottom about 26 ft downstream from the dam apron and near the middle of gate bay 9. For Test 9, the boat was moved farther downstream below gate bay 9 and the bottom in this area was observed. The trolling motor was used to guide the boat during this test to see if a track more parallel to the dam could be accomplished. It was difficult to determine the location of the image real time without seeing a portion of the dam. The boat also tended to move downstream as the track was run. The boat was moved closer to the dam and the area behind gate bays 9 and 10 was observed again during Test 10. Figure 34 shows the area out from pier 9-10 toward the dam apron. The dam apron is the horizontal feature at the bottom of the figure.

Figure 33. Image of bottom 26 ft from dam apron in middle of gate bay 9.

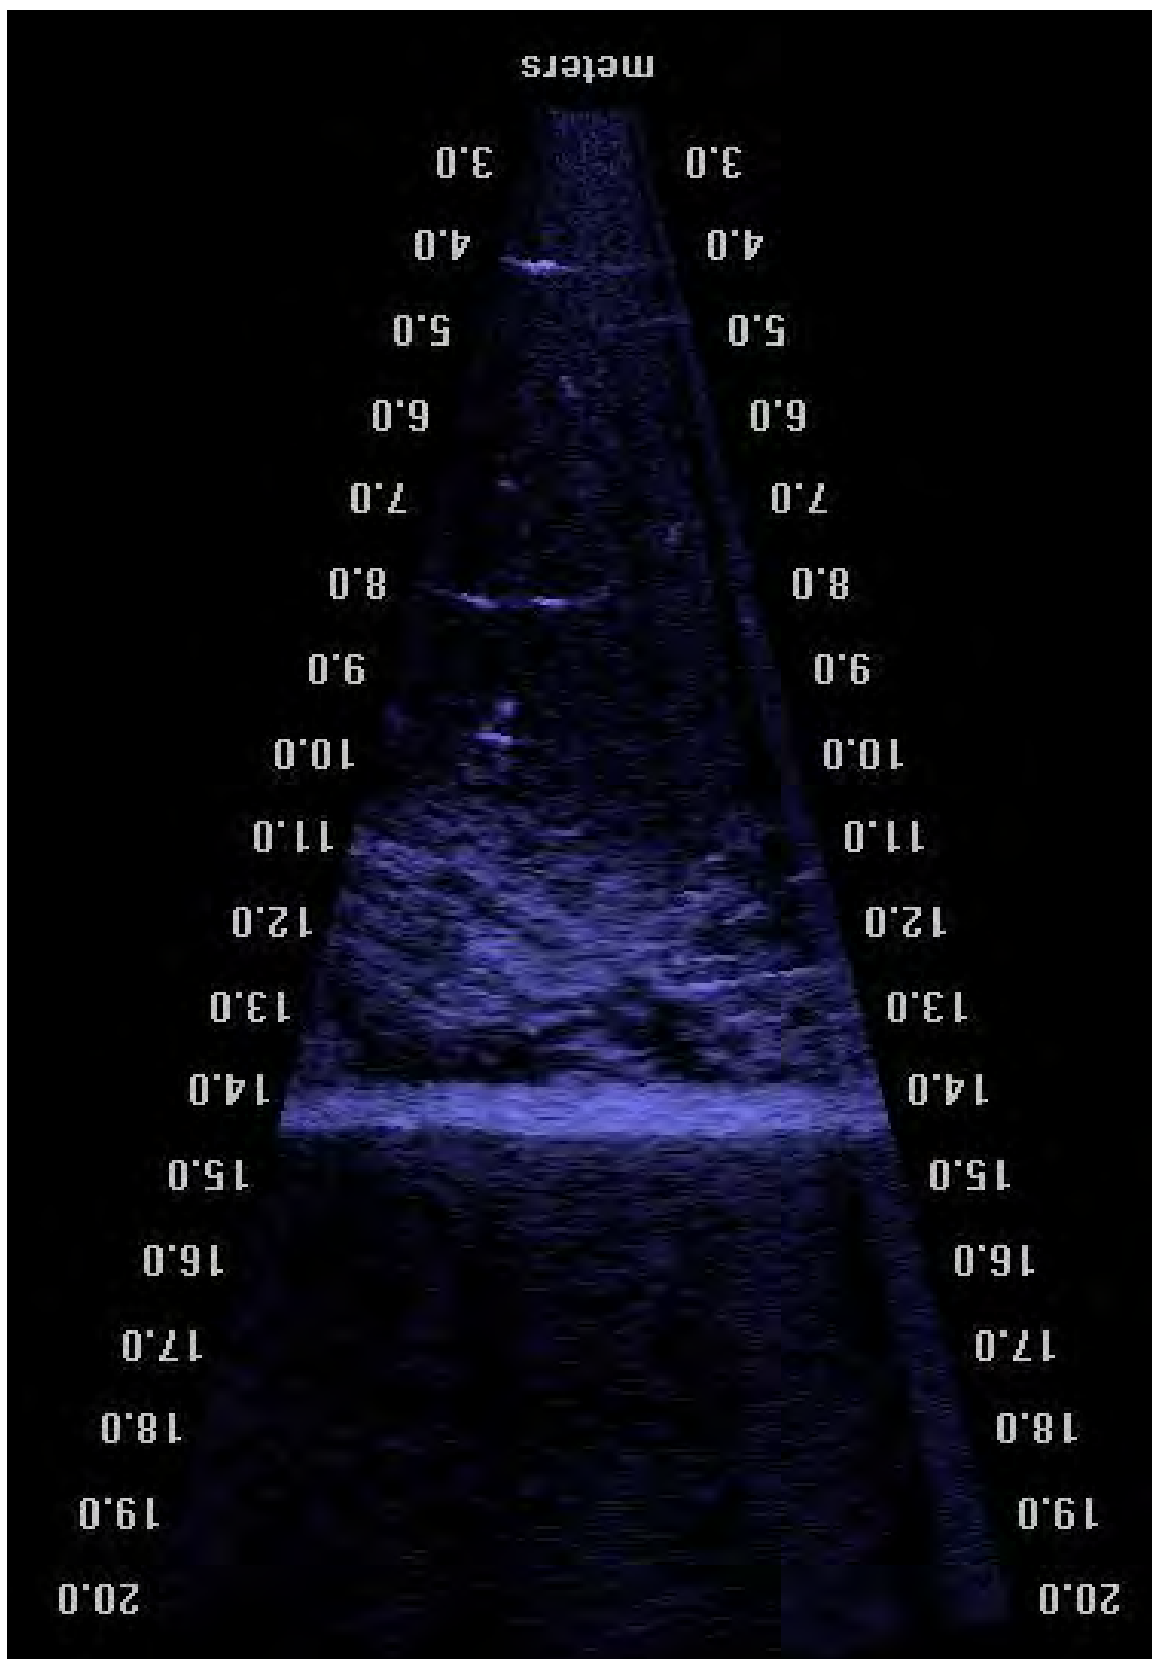
Figure 34. Area downstream from pier 9-10 towards the dam apron (apron is horizontal feature at bottom).
