Performance of Insulated Pavements at Newton Field, Jackman, Maine

Maureen A. Kestler and Richard L. Berg

May 1992

Prepared for
FEDERAL AVIATION ADMINISTRATION
DOT/FAA/RD-92/8

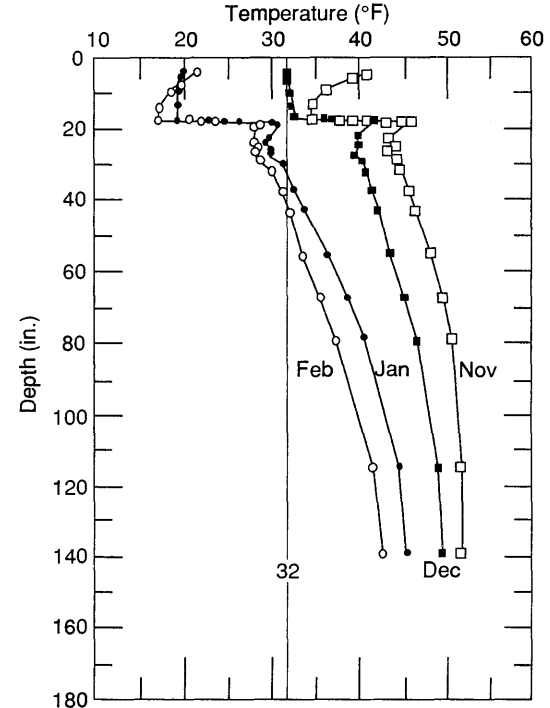
d. Subsurface temperatures at Newton Field, station 4+50, winter 1987-1988.

A distinct temperature discontinuity occurs immediately beneath the insulation on the runway (Fig. 13d). Two vertical thermocouple assemblies, one located both in and above the insulation and the second located entirely below the insulation, are separated horizontally by approximately 5 ft. It is believed that the temperature discontinuity between the thermocouple assemblies is caused either by damage to the insulation or by the horizontal separation of the insulation panels. The problem probably occurred during construction. Evidence of this problem was encountered during construction near stations 4+50 and 8+00. At both locations, trucks, bulldozers, and other construction traffic caused a large subgrade "flow" that in turn raised the insulation. Under

direction of the resident engineer, the insulation was removed, the subgrade was removed to the desired depth, and the geotextile, insulation, and base course were all replaced.

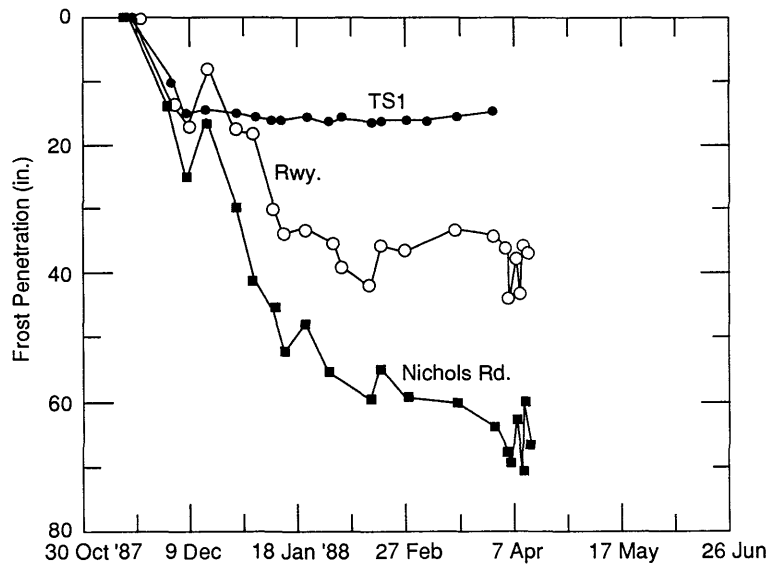
Figure 15. Progression of frost penetration with time, winter 1987–1988.

The progression of frost penetration with time is shown in Figure 15. For the 1987–1988 winter, the insulated pavement at the runway (station 4+50) allowed approximately 2 ft of frost penetration beneath the insulation. Although appreciably less than at noninsulated Nichols Road, the actual frost depth far exceeded all estimates. The unexpected frost penetration beneath the insulation on the runway during winter 1986–1987 constituted the primary reason for installation of the test sections in 1987. In contrast to the limited effectiveness of the insulation at the runway, the insulation at test section 1 prevented frost from penetrating into the subgrade. While Figure 15 is based upon 1987–1988 data, the curves are representative of each year; frost never

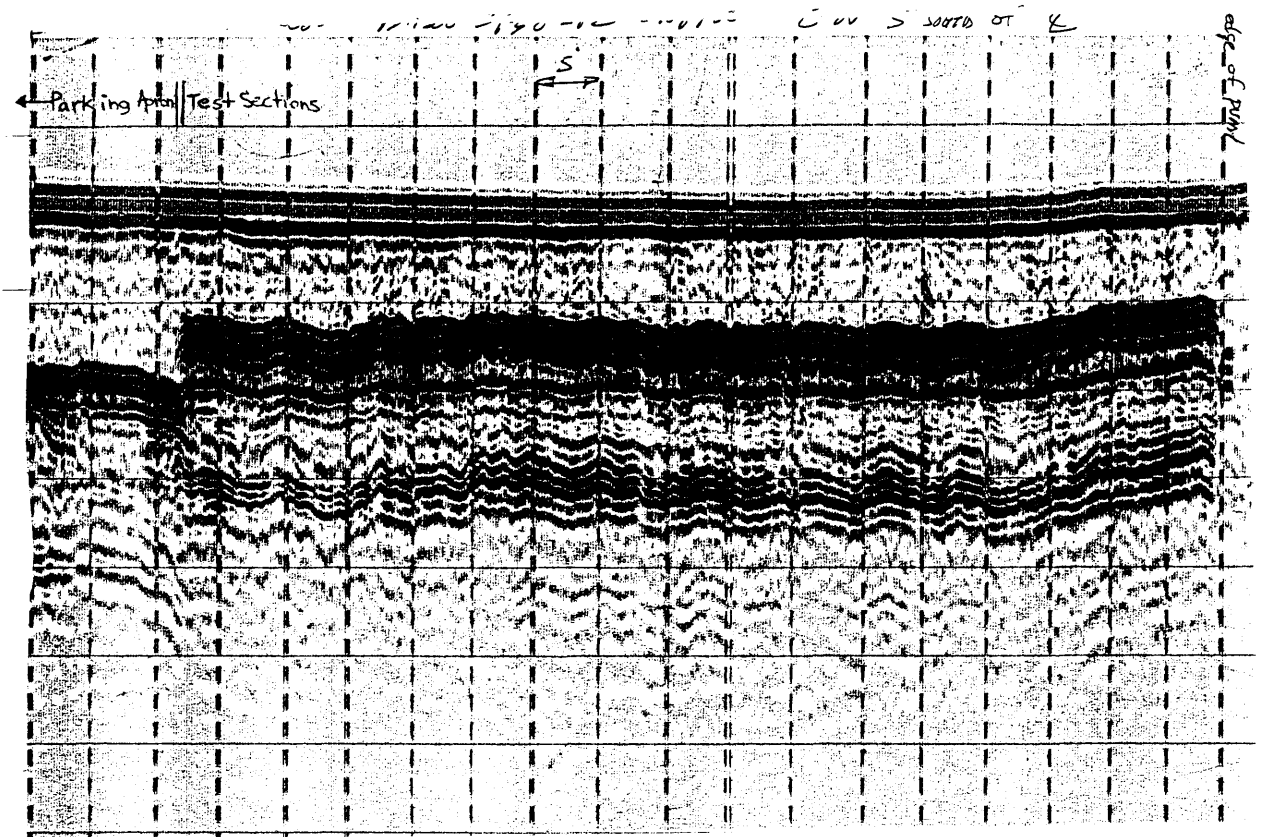
a. Centerline profile at test sections.

The transducer was pulled manually along the centerline of the test sections; the corresponding radar record is shown in Figure 22a. The unequal depths of the insulation at the parking apron and test sections are indicated by the discontinuity in the second set of dark bands.

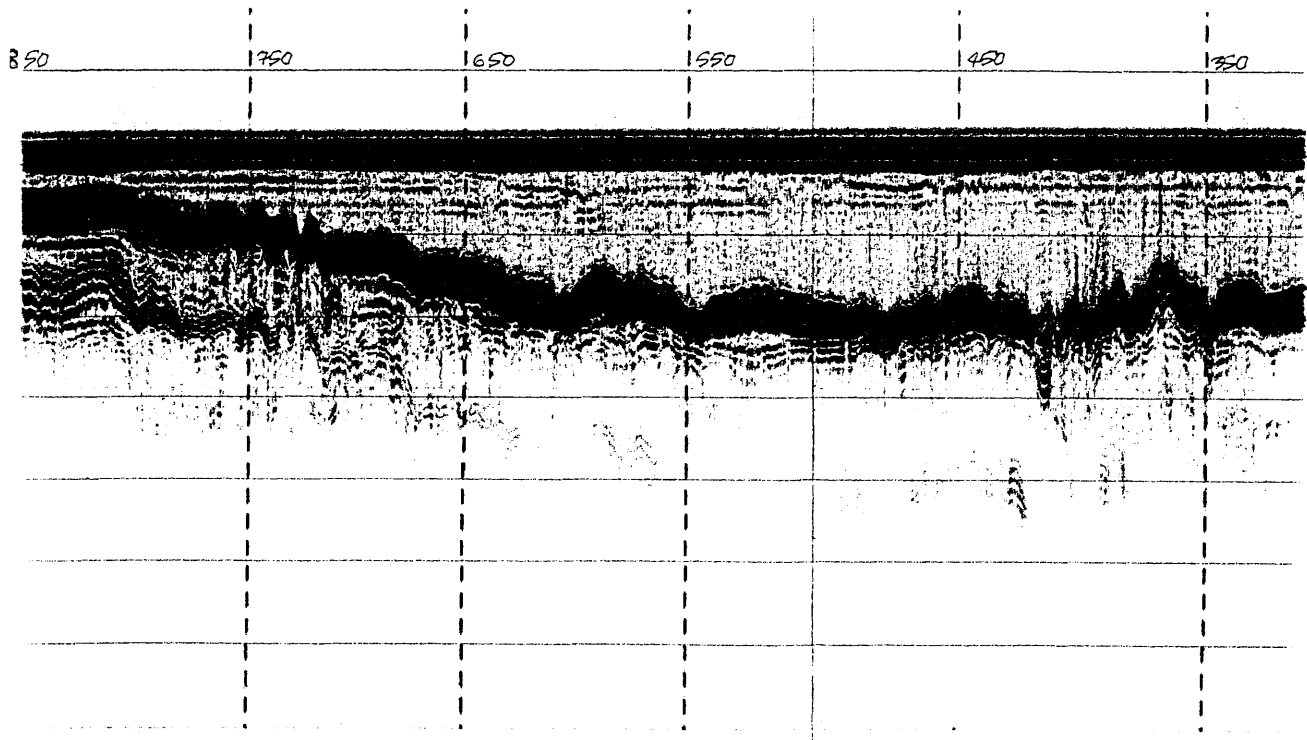
b. Centerline profile at west end of Newton Field, station 3+50 to station 8+50.

In contrast to the relatively uniform depth of the insulation panels at the test sections, Figures 22b and c show the irregular base course thickness and corresponding nonuniform depth of the insulation panels along the centerline at the two ends of the runway. For the insulation panels at shallow depths, the vertical stresses imposed by the design single-wheel load of 30 psi exceed the panels' 40 psi compressive strength. It is possible that this could lead to crushing of the insulation and ultimately lower the efficiency of the insulating layer. In Figure 22d, the individual 2-ft wide panels can be identified and are indicated on the figure.
