REPORT 82-11

*Shoreline conditions and bank recession
along the U.S. shorelines of the St. Marys,
St. Clair, Detroit and St. Lawrence rivers*

May 1982

Lawrence W. Gatto

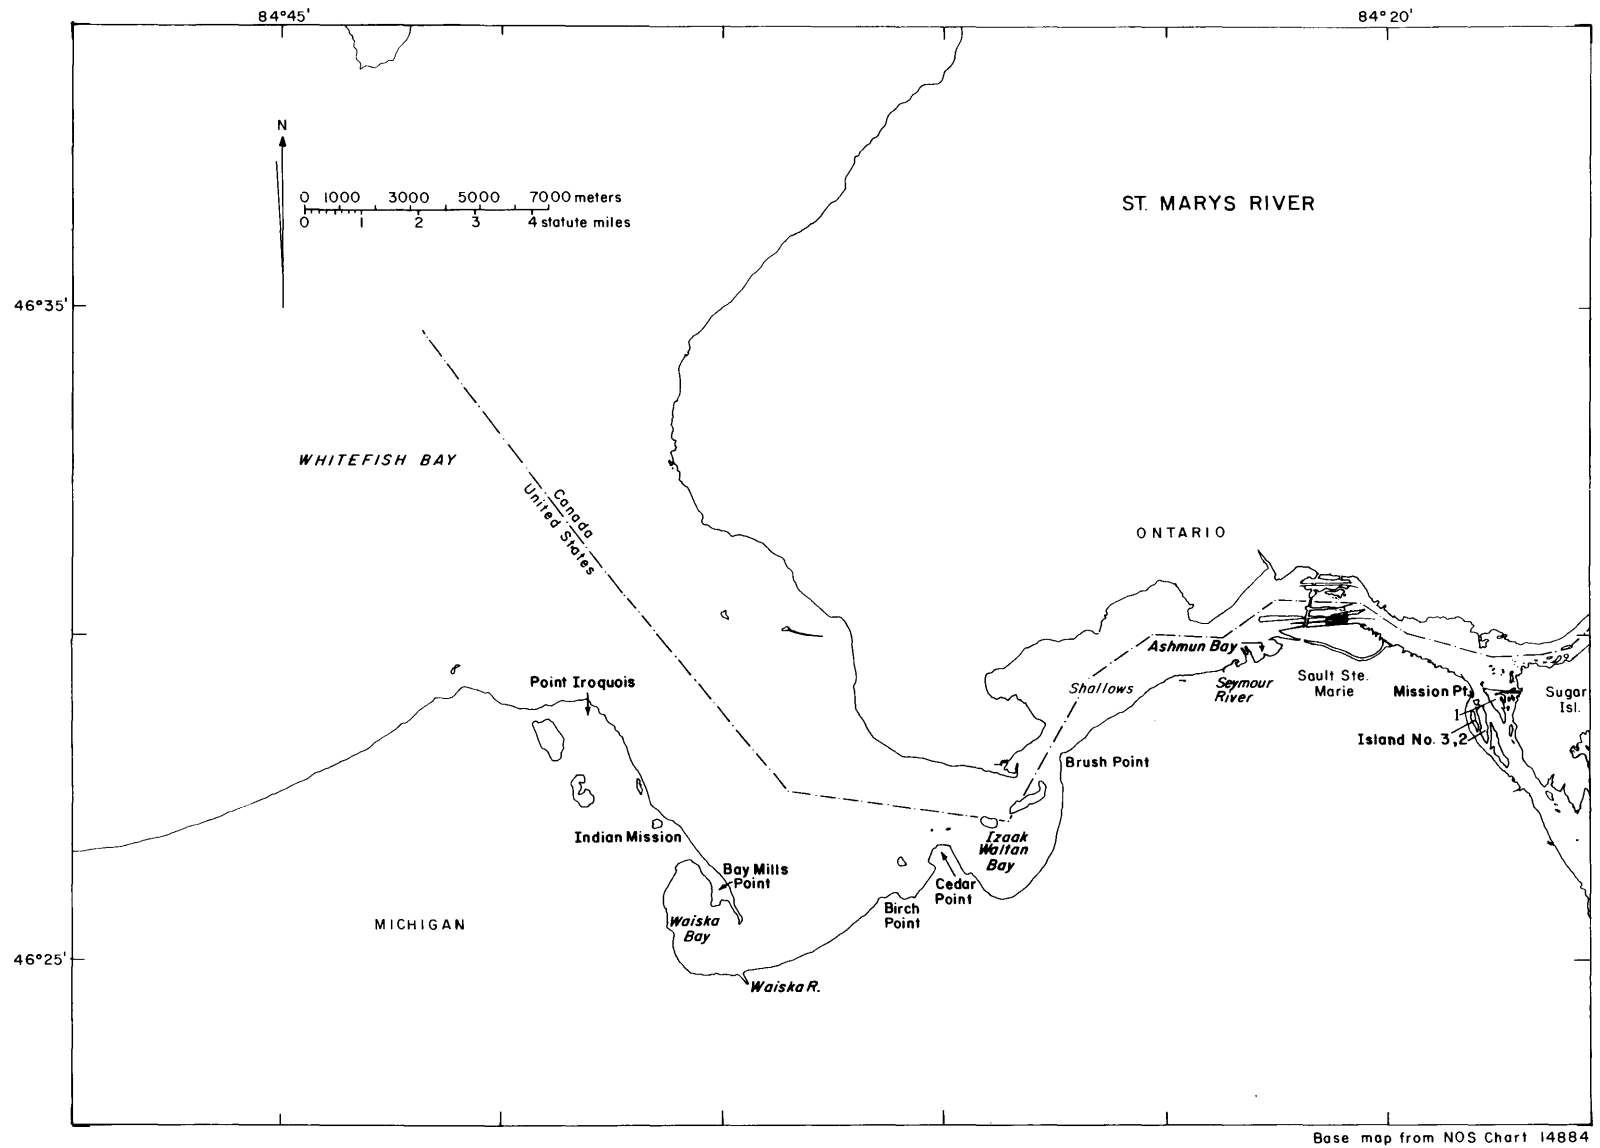
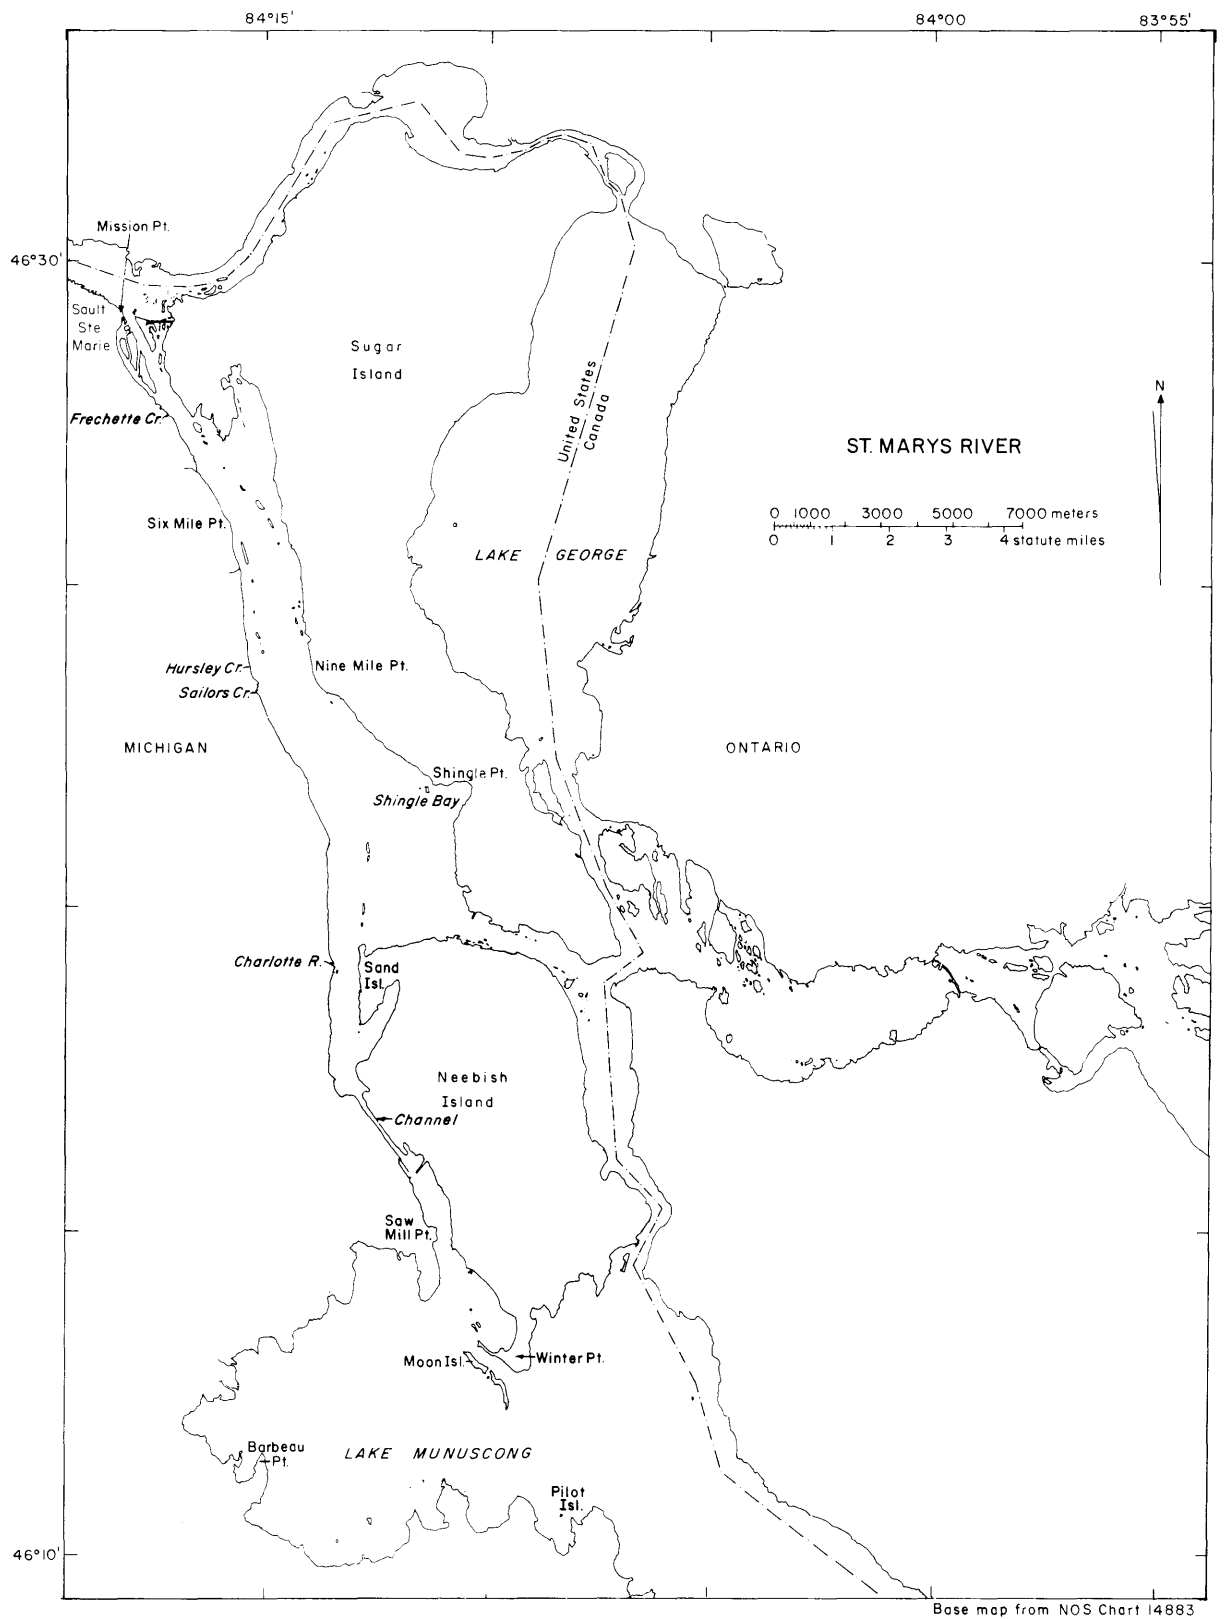
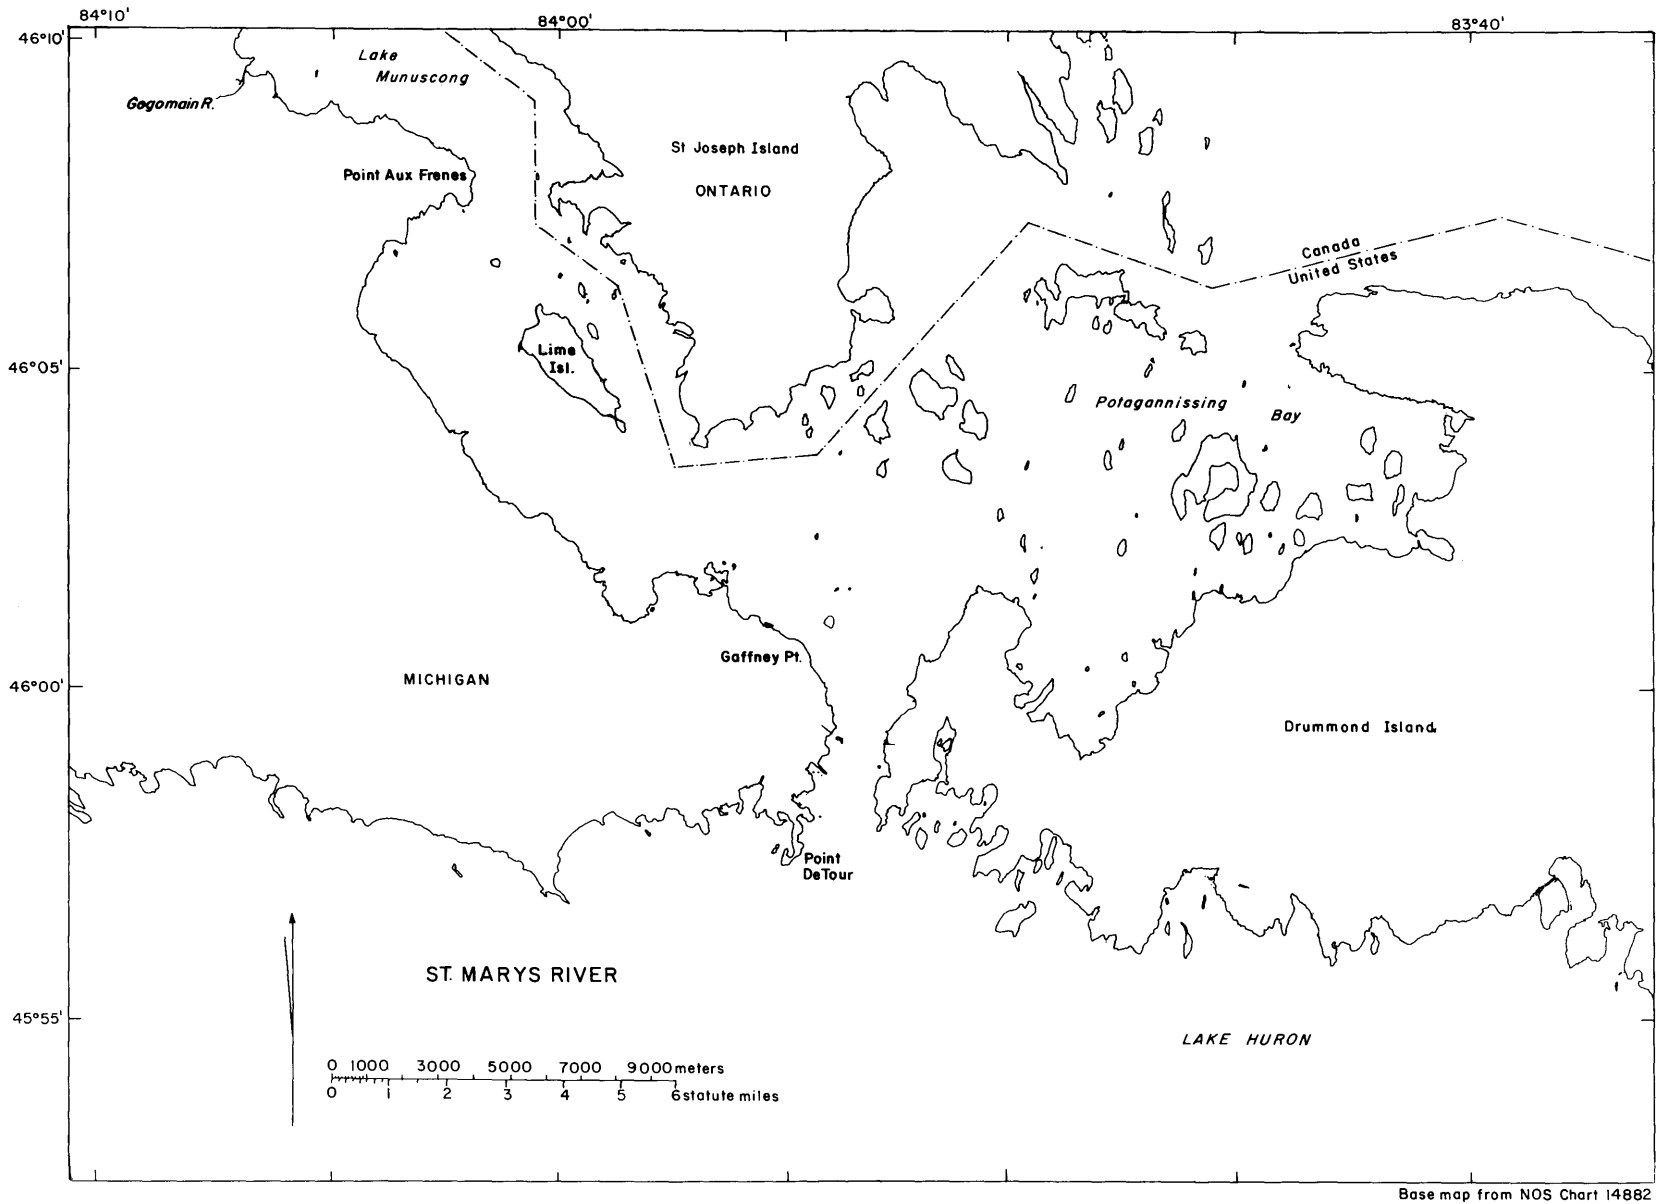
Figure 6. Map of St. Marys River.

Bank profile data taken after the 1979–80 limited winter navigation season show no bank recession north of Six Mile Point, bank recession similar to previous annual amounts along Sugar Island, and local measurable recession at Nine Mile Point (Fig. 6) (Wuebben, in press). However, some of this recession could have occurred as a result of the high water levels during the summer of 1979. Riparian landowners reported noticeable bank recession during this limited winter navigation season at sites that remained stable during winter navigation seasons from 1977 to 1980. Wuebben concluded that there is no clear evidence that winter navigation causes more bank erosion than occurs naturally.

The initial boat survey of the St. Marys River (Fig. 6) was made on 25 and 26 May 1977. The shoreline characteristics and conditions observed are shown in Figures A1-A6. Twenty-eight sites, with 66 partially vegetated or bare banks covering a total of 10.7 miles (Table A1, Fig. A1), were delineated during this survey. The banks at 29 of these reaches (5.2 miles) showed evidence of erosion from May 1977 to May 1980. This is 4.3% of the 122 miles of shoreline surveyed. The banks at 37 reaches (5.5 miles) showed no apparent changes.

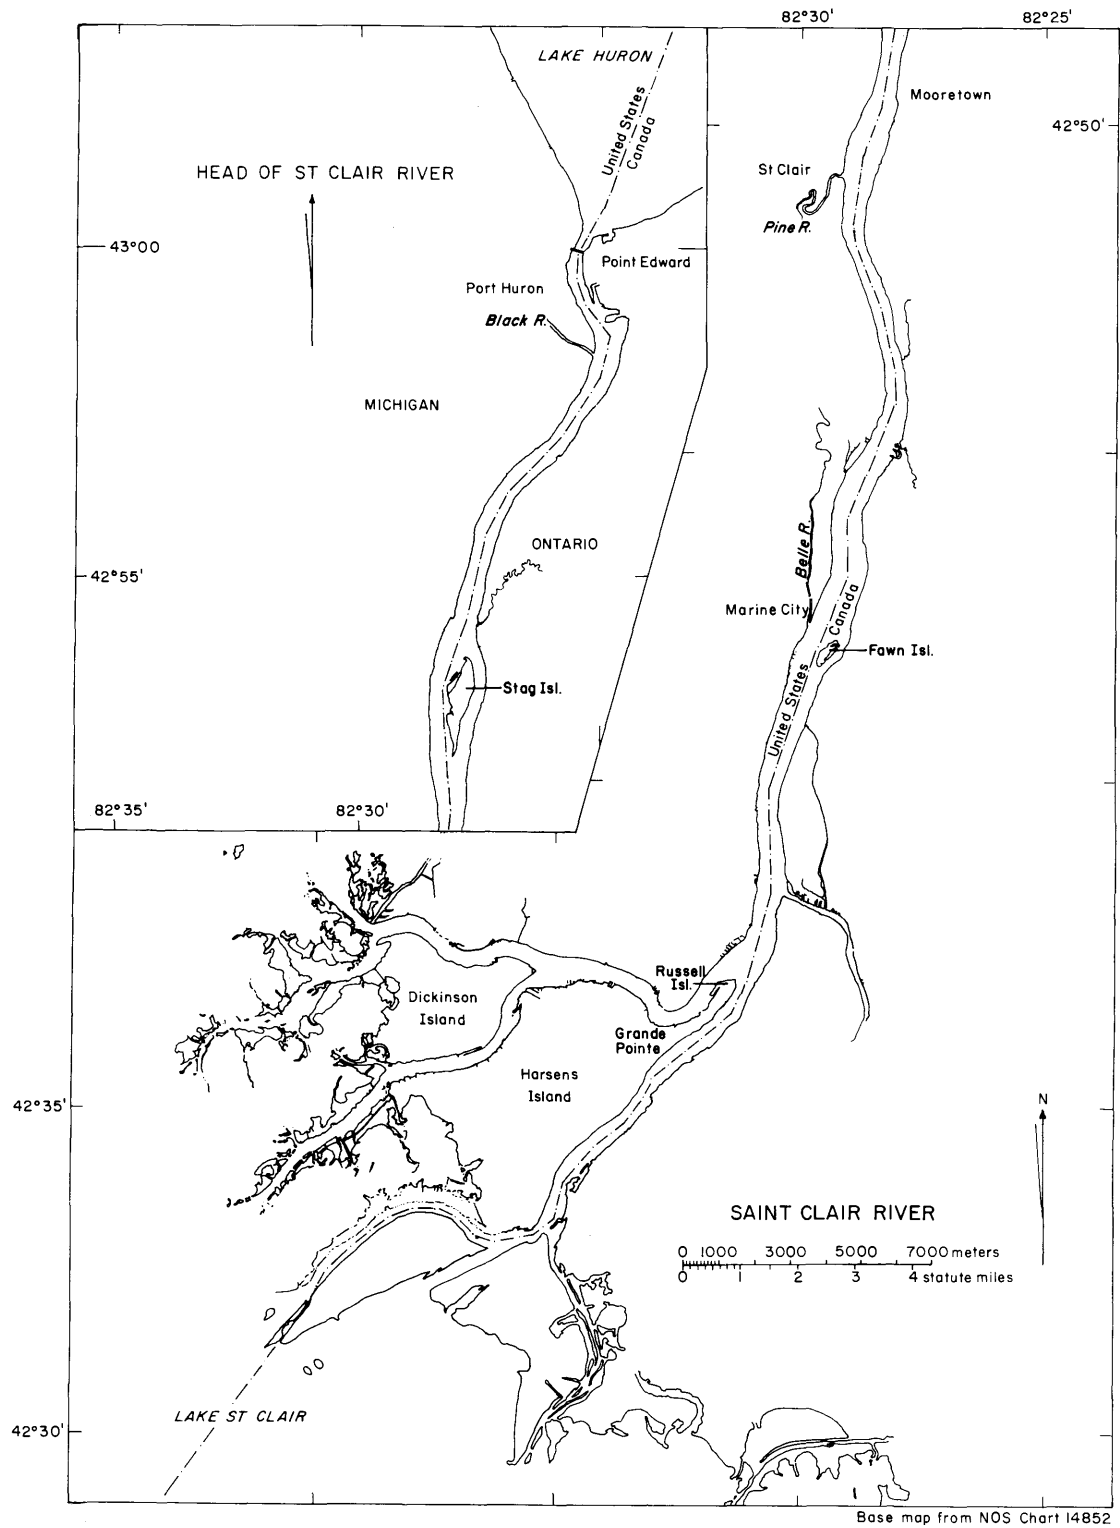
Figure 9. Map of St. Clair River.

The initial boat survey of the St. Clair River (Fig. 9) was done on 23 May 1977. The shoreline conditions and bank characteristics are shown in Figures B1–B3. Partially vegetated or bare banks were delineated along 56 reaches at 25 sites (Fig. B1), covering a total of 3.2 miles. The approximate lengths of the banks at the 24 eroding reaches are given in Table B1. The estimated total length of eroding bankline is 2.1 miles. From May 1977 to May 1980 approximately 5.3% of the banks along the 40 miles of surveyed shoreline were eroding.

The types of bank failure along most of the banks were soil slides and falls along the face of the bank. These were caused by undercutting at the water line, loss of support for overlying sediment, and subsequent collapse. Rotational slumping occurred at reach 11b only (Fig. 10).

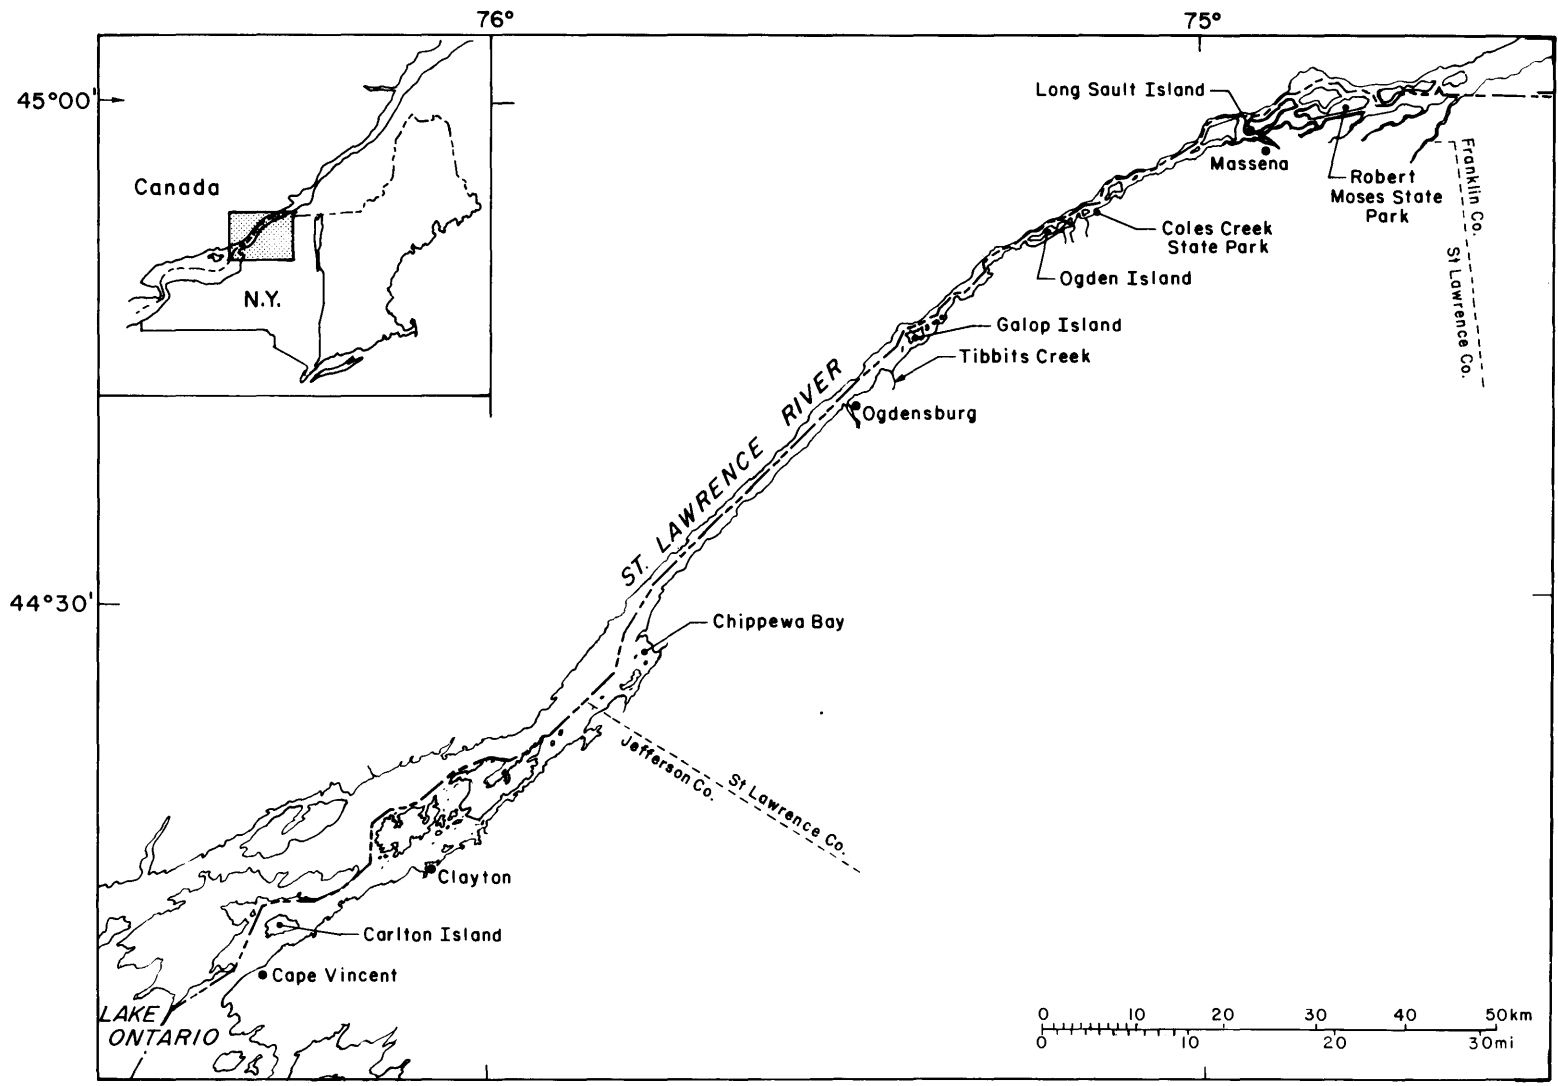
Figure 15. Map of St. Lawrence River.

The St. Lawrence Seaway Development Corporation (1977) surveyed the U.S. shoreline and delineated three areas of potential erosion due to winter navigation—Galop Island, Ogden Island and Long Sault Island (Fig 15). The St. Lawrence–Eastern Ontario Commission (1977b) subsequently did a detailed evaluation of the susceptibility of the bank to erosion. The evaluation was done to determine the nature and extent of bank erosion that occurs in the absence of winter navigation. Six sites were monitored, and 19.23 miles of bank were considered to be actively eroding. Additional sites of erosion were reported along Coles Creek State Park in Waddington, N.Y., and Robert Moses State Park near Massena, N.Y. (Fig. 15).*

The initial boat survey of the St. Lawrence River from Lake Ontario to the U.S.–Canadian border near Massena, New York (Fig. 15), was made on 16 and 17 November 1977. I delineated partially vegetated or bare banks at 114 reaches (covering 10.9 miles) at 48 sites (Table D1, Fig. D1). During this project, erosion occurred along 8.6 miles of the riverbank at 59 reaches. This is 6.6% of the 130 miles of surveyed shoreline. Fifty-five reaches, about 2.3 miles of bank, appeared to be stable from 1977 to 1979. Erosion along some of these banks would probably begin if water levels were raised for an extended period.
