TECHNICAL REPORT SL-84-13

BLAST DOOR AND ENTRYWAY DESIGN AND EVALUATION

July 1984
Final Report

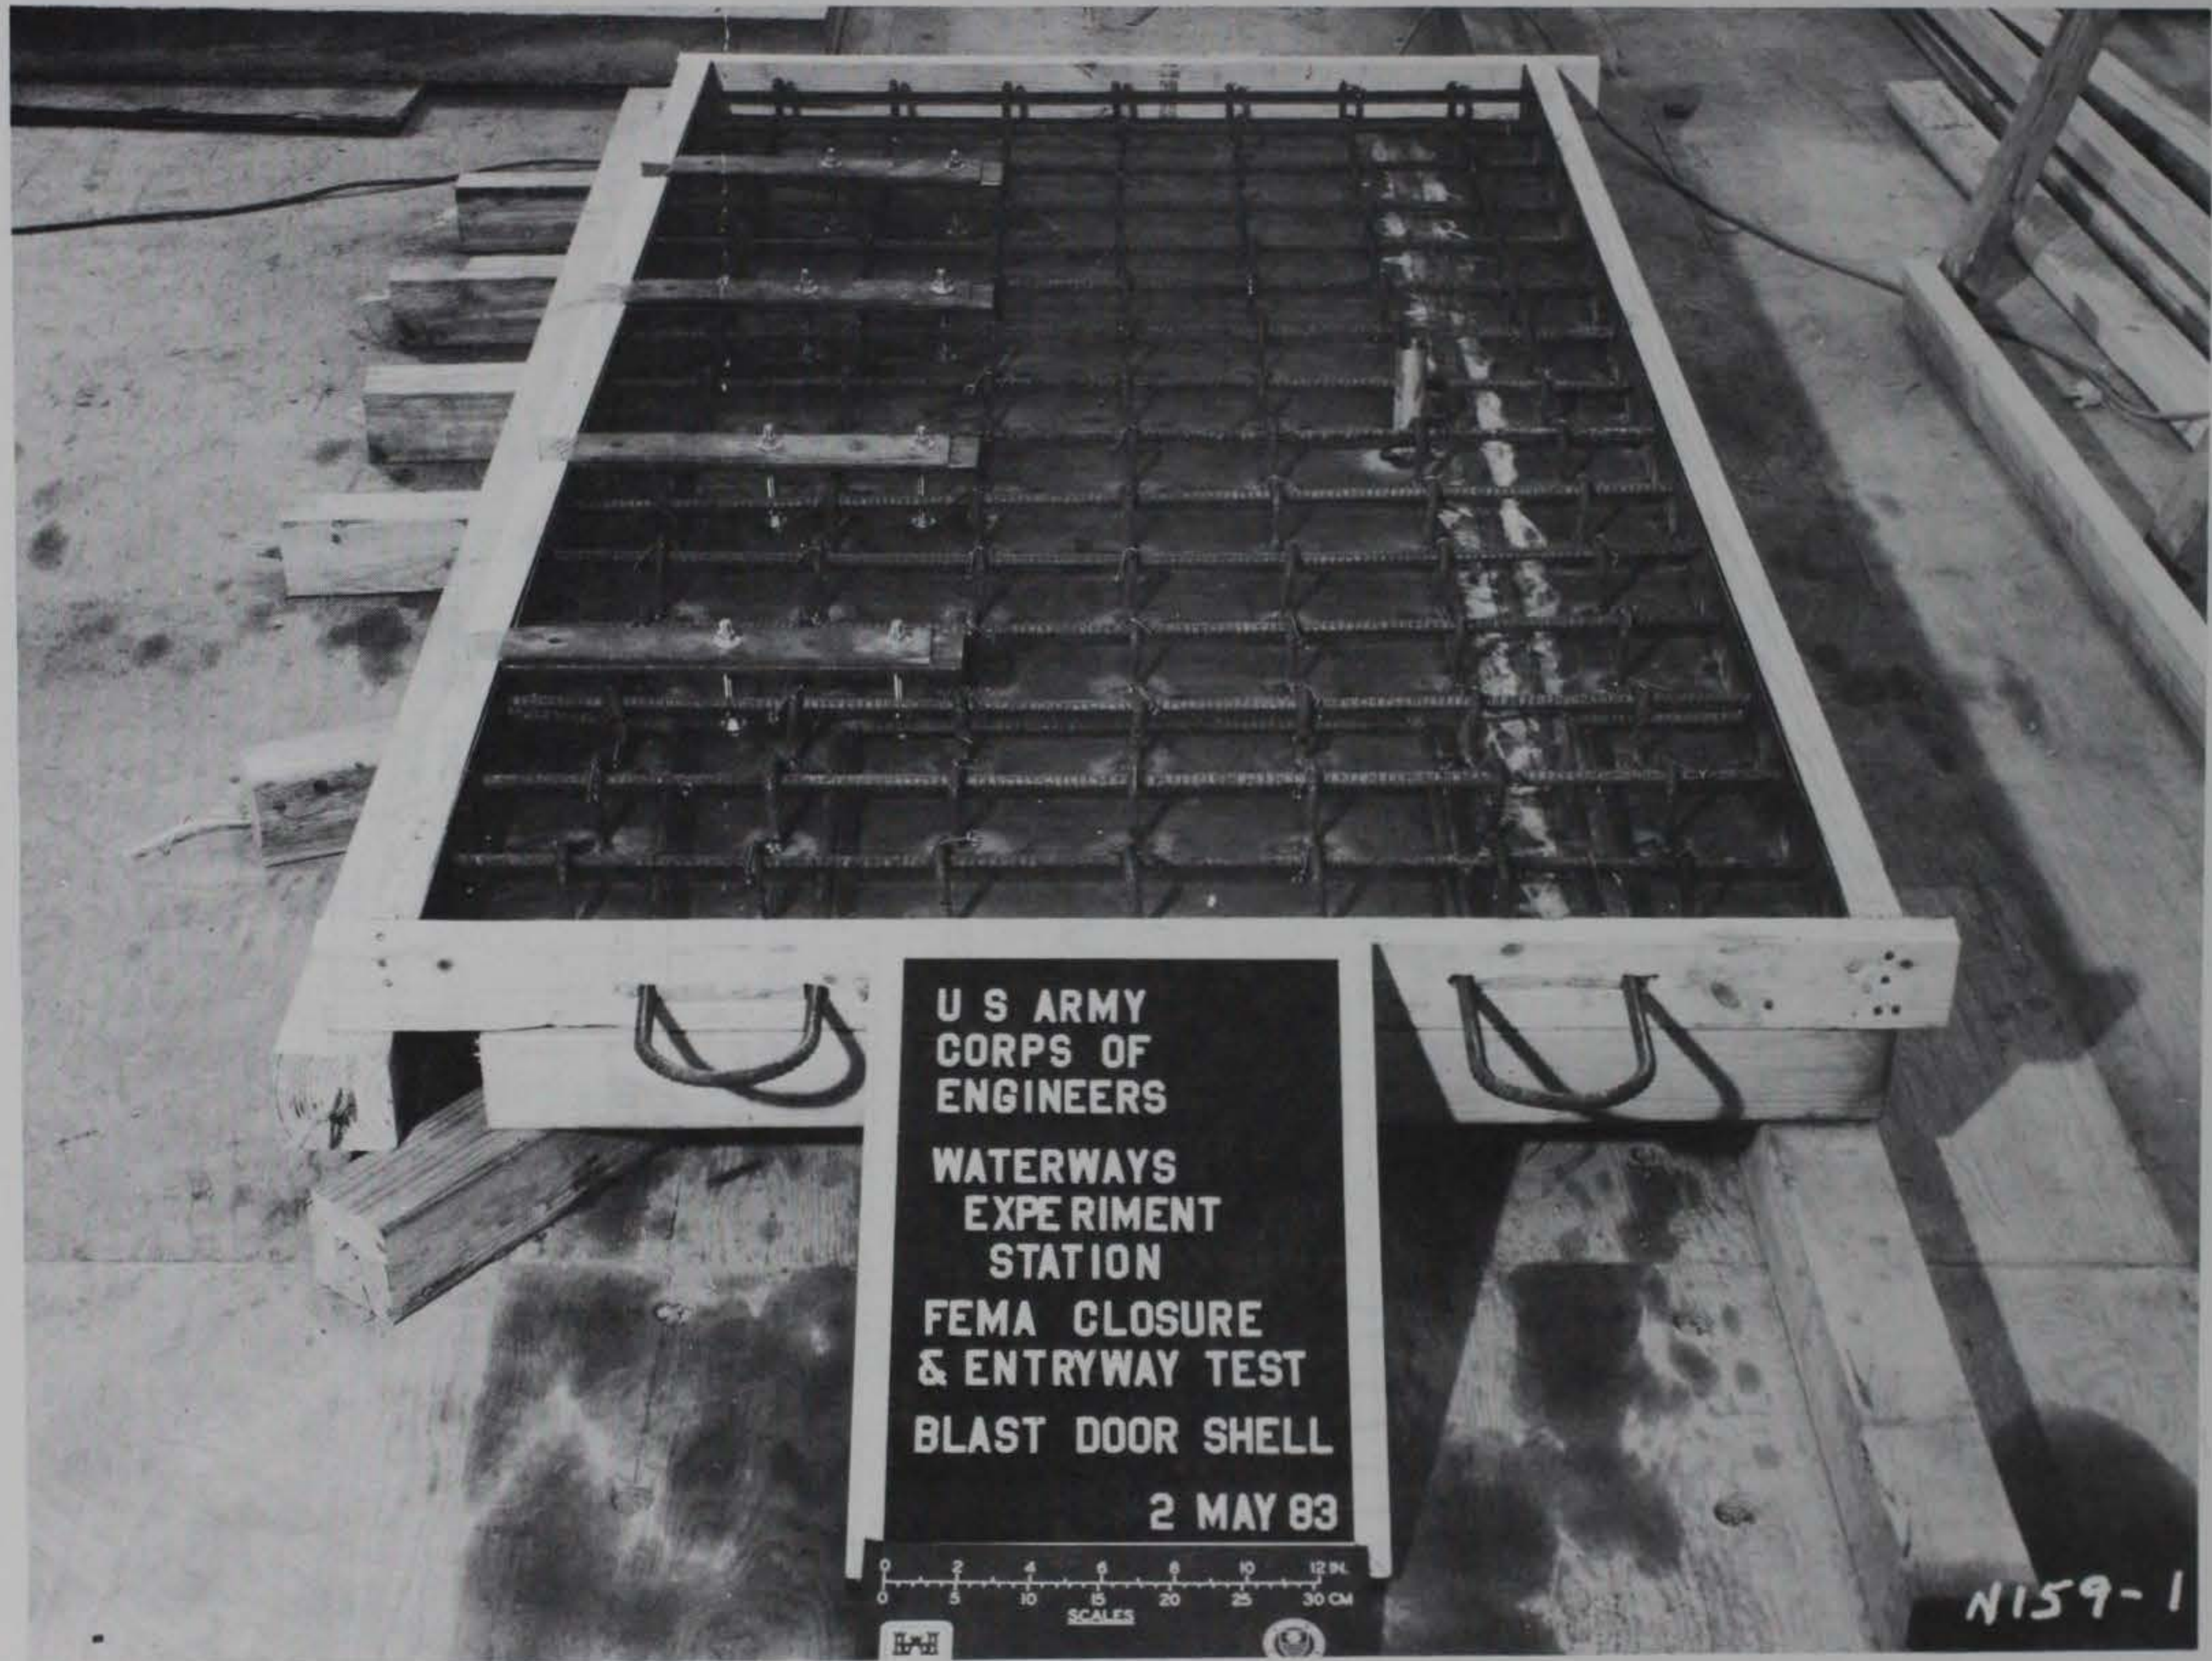
Figure 2.12. Blast door strap hinge details.

Assuming a ductility of 10, the ratio of rebound force to primary load is approximately 0.15, which yields 21 psi on the door in rebound. It was assumed that the hinges would carry about one-half of the rebound load, the other half being carried by the latch mechanism. The hinges used were typical heavy-duty strap hinges with 1/2-inch-diameter pins and 18-inch-long, 1/4-inch-thick straps. The four hinges used satisfied the rebound requirements of the door and gave a high factor of safety for the weight of the door alone. The hinge straps were bent by the manufacturer to accommodate the 3-1/8-inch offset of the door. The hinges were fastened to the door with 3-3/8-inch-diameter bolts and anchored to the door frame and supports with 3/8-inch-diameter bolts (Figure 2.12).

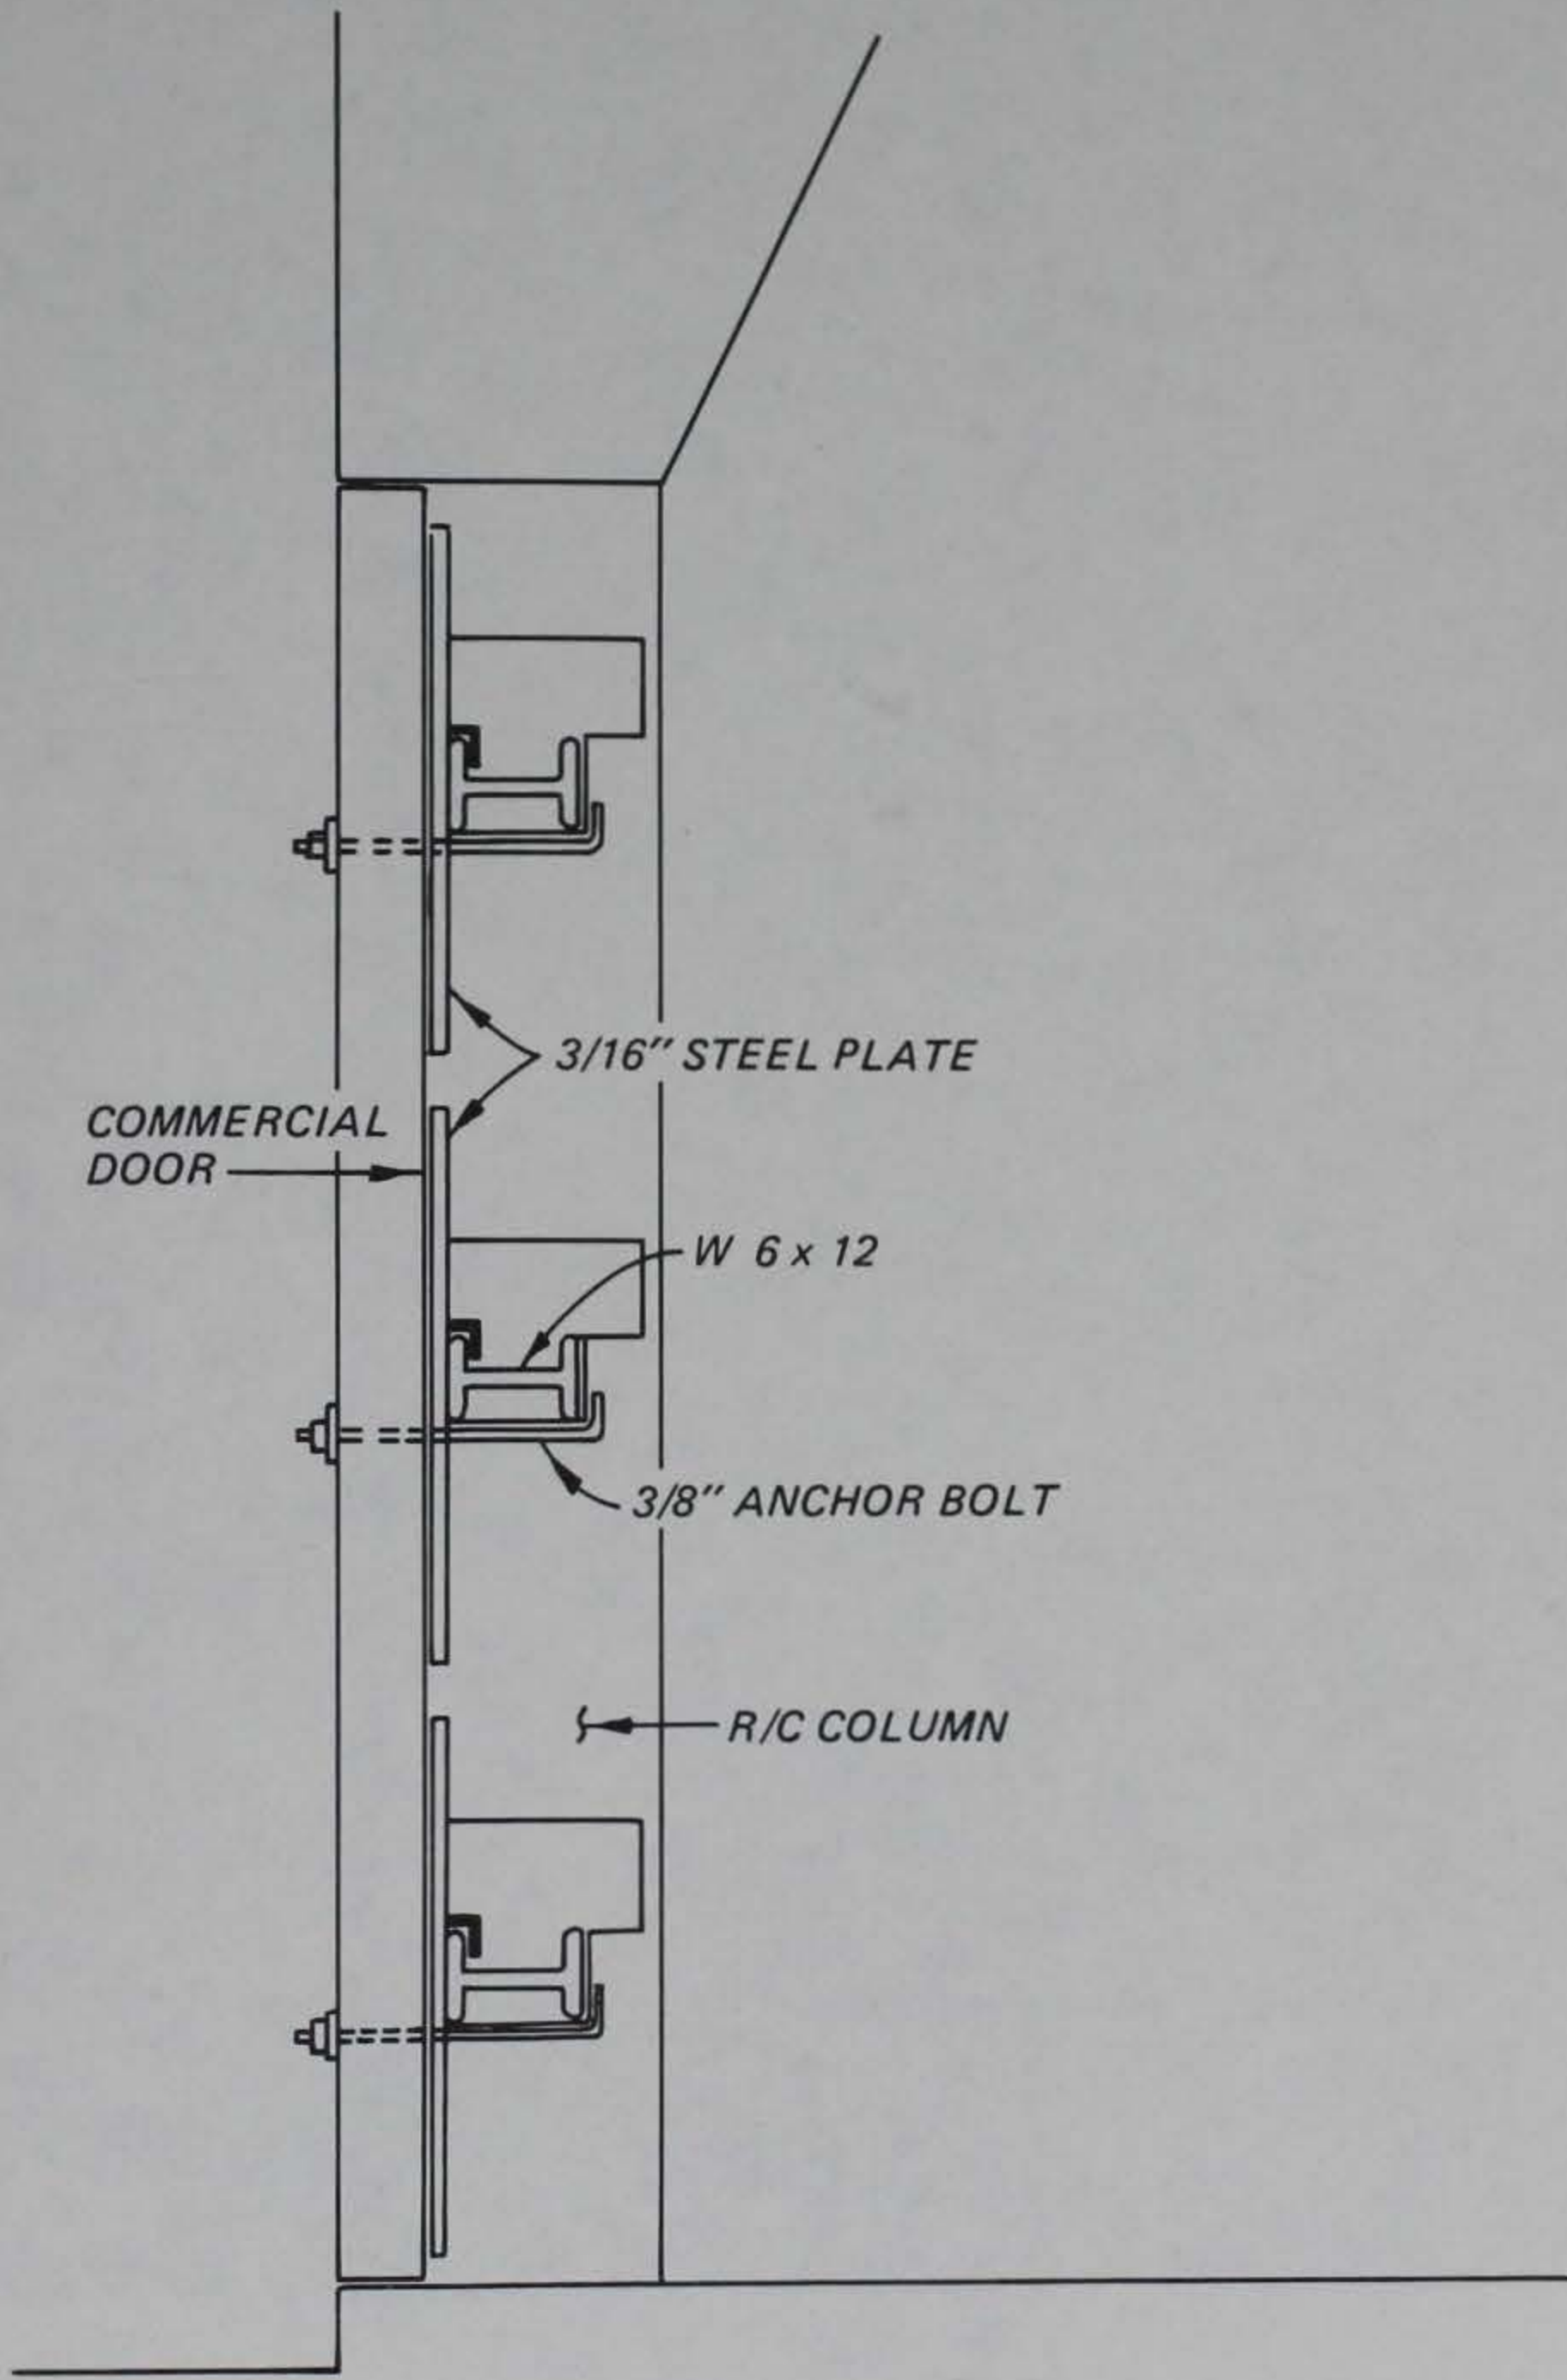
Figure 2.15. Cross section of commercial door and supports.

The three wide-flange beams shown in Figure 2.15 were designed to carry the total load placed on the door. The beams rest in steel boxes constructed of 1/4-inch plate and cast into the concrete door supports. In practice, the

The commercial door was completely destroyed during the test. The door and each of the steel plates supporting it were bent around the wide-flange beams, so that large gaps were left between door and frame at either end of the door. As shown in Figure 4.5, the door was obviously inoperable. One of the steel support plates is shown in Figure 4.6. The pressure records for gages P5 and P6 should have been nearly identical, had the commercial door survived. However, comparison of the pressure records for these gages seems to indicate that the commercial door failed very early (about 10 ms after initial loading).

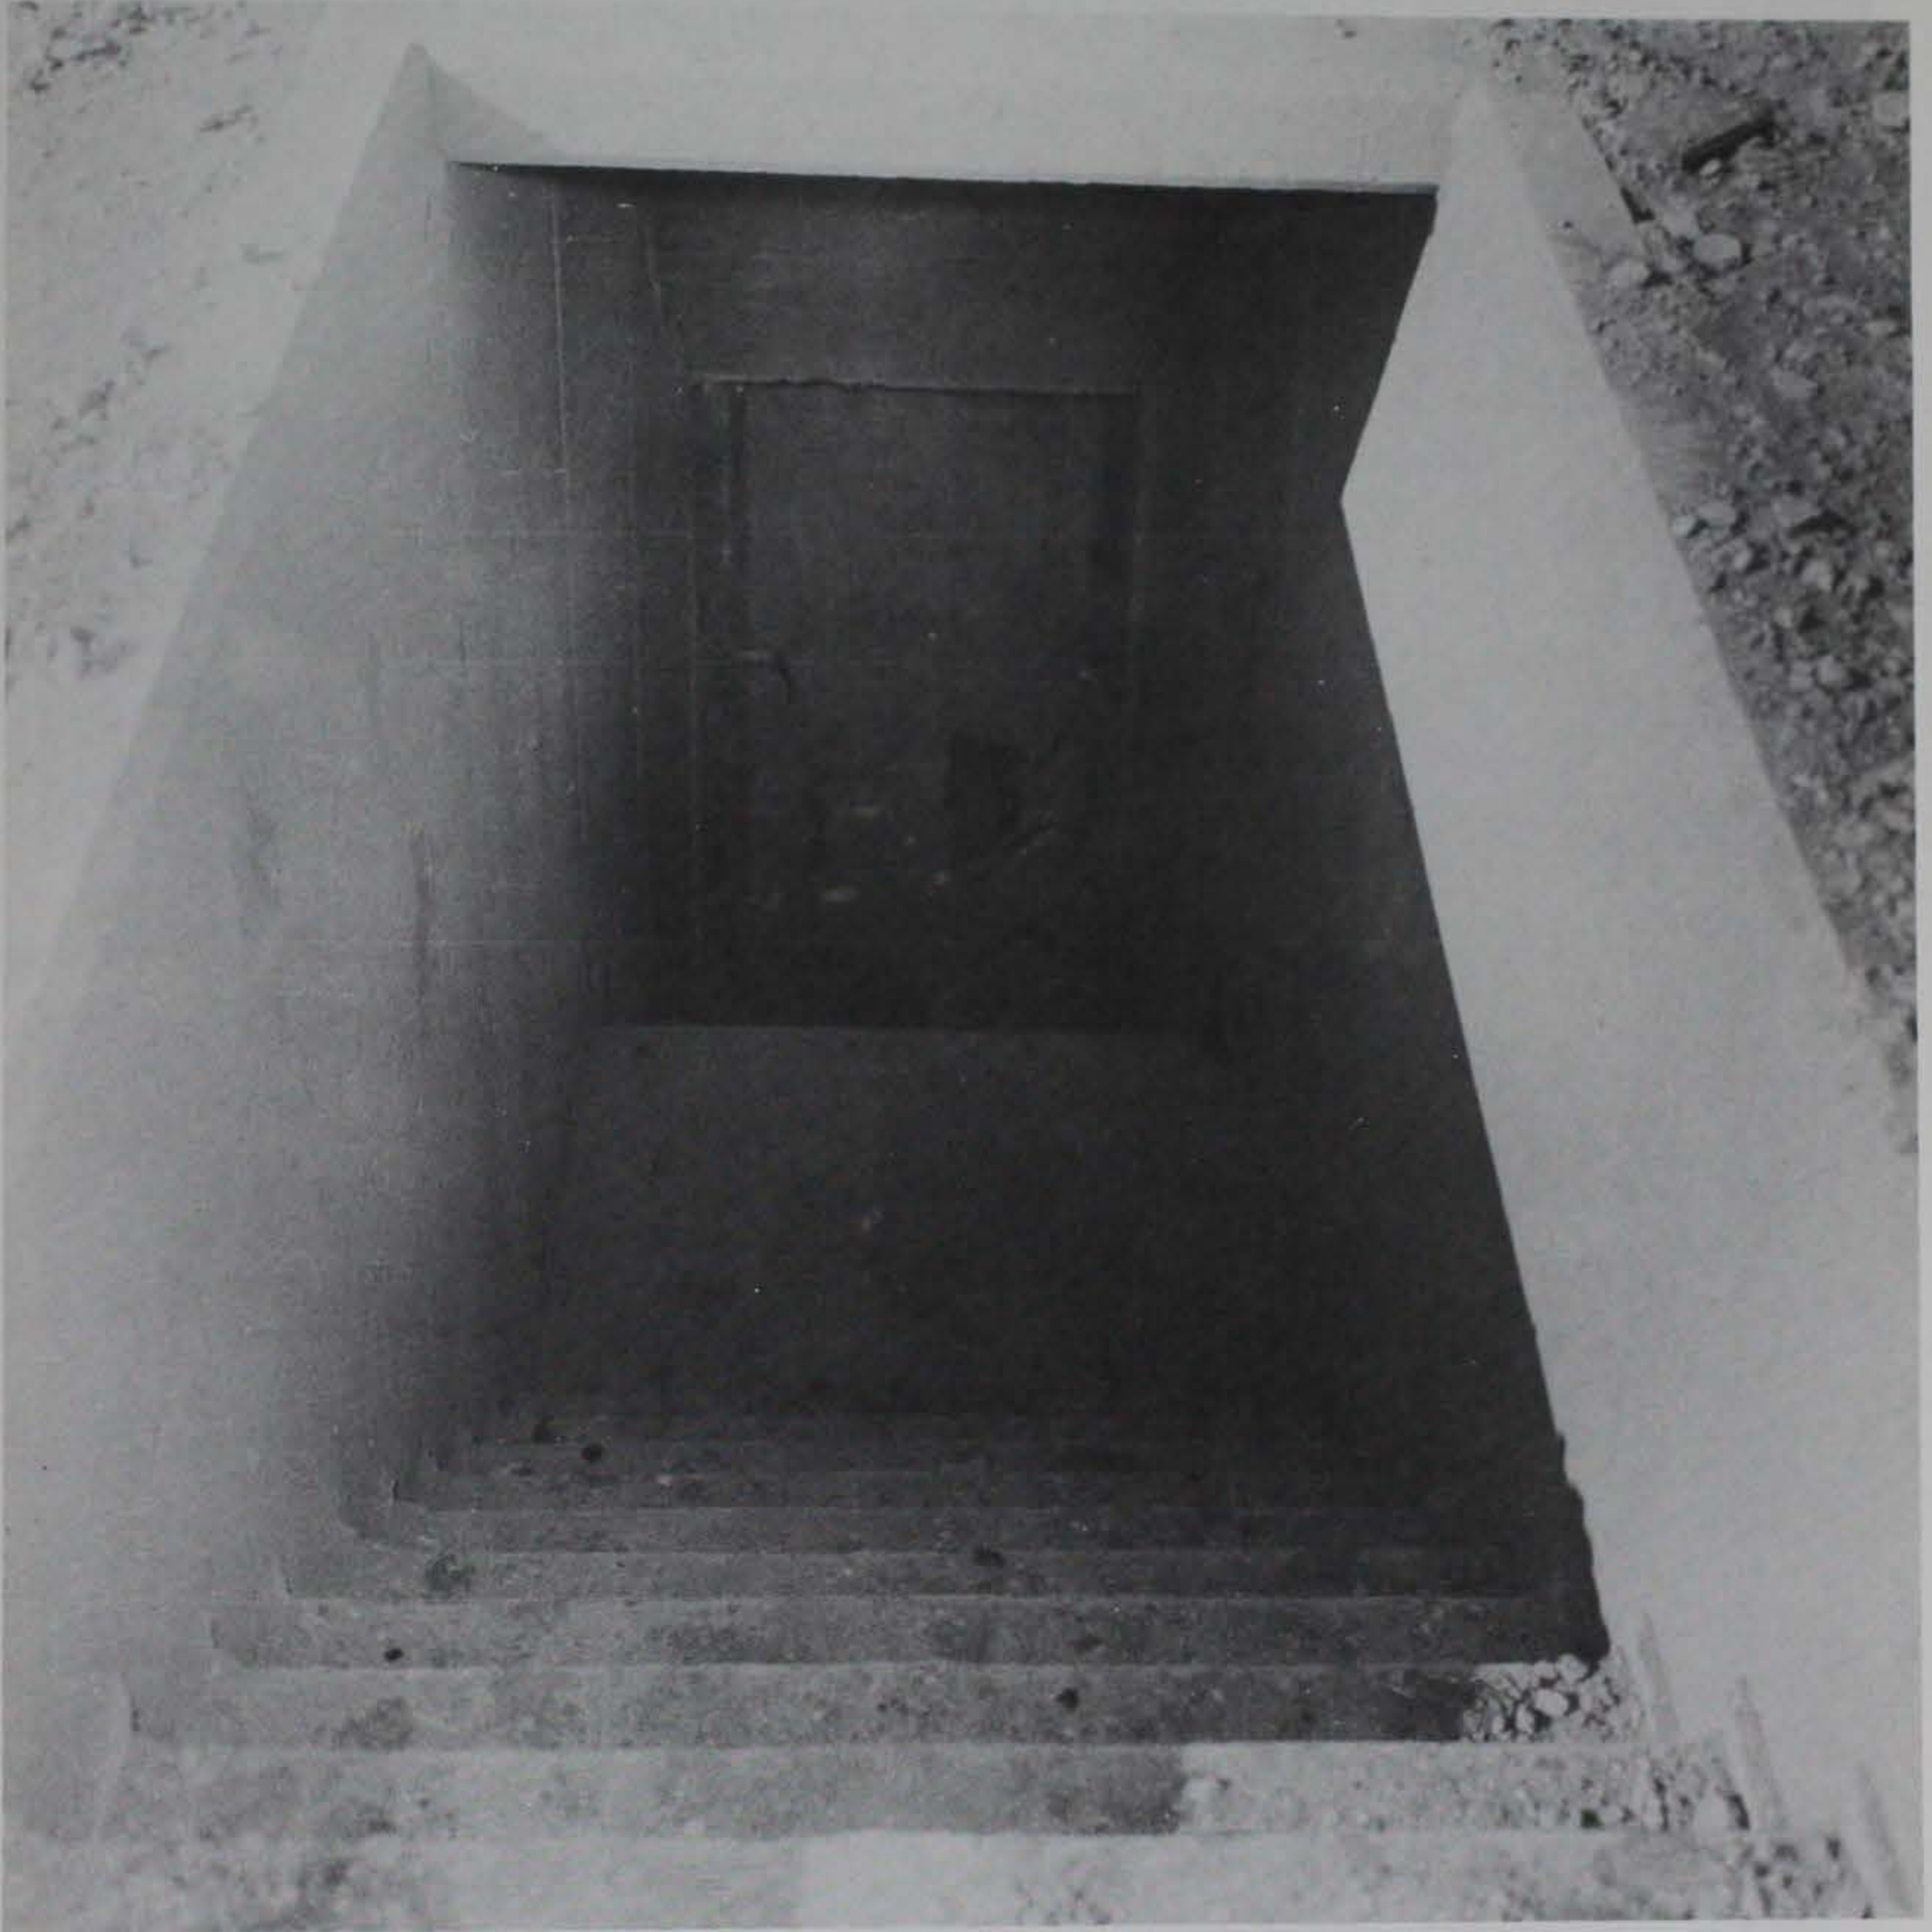
Although the roof and walls of the entryway suffered cracking and some
permanent deflections, there was no structural failure. The stairwell walls
had large cracks along the roof and floor joints, and smaller vertical cracks
along their height. The end wall, which received the most severe loading,
suffered the most damage. Large cracks formed from the floor to the roof
along each wall/door support joint. The end wall was displaced a maximum of
about 2 inches on the east edge and 1-1/2 inches on the west edge. The roof
exhibited minor cracking along its entire length but was largely undamaged. A
posttest surface view of the entryway is shown in Figure 4.1. Wall and roof
damage are shown in Figures 4.2 and 4.3.

Figure 4.1. Posttest surface view of entryway.

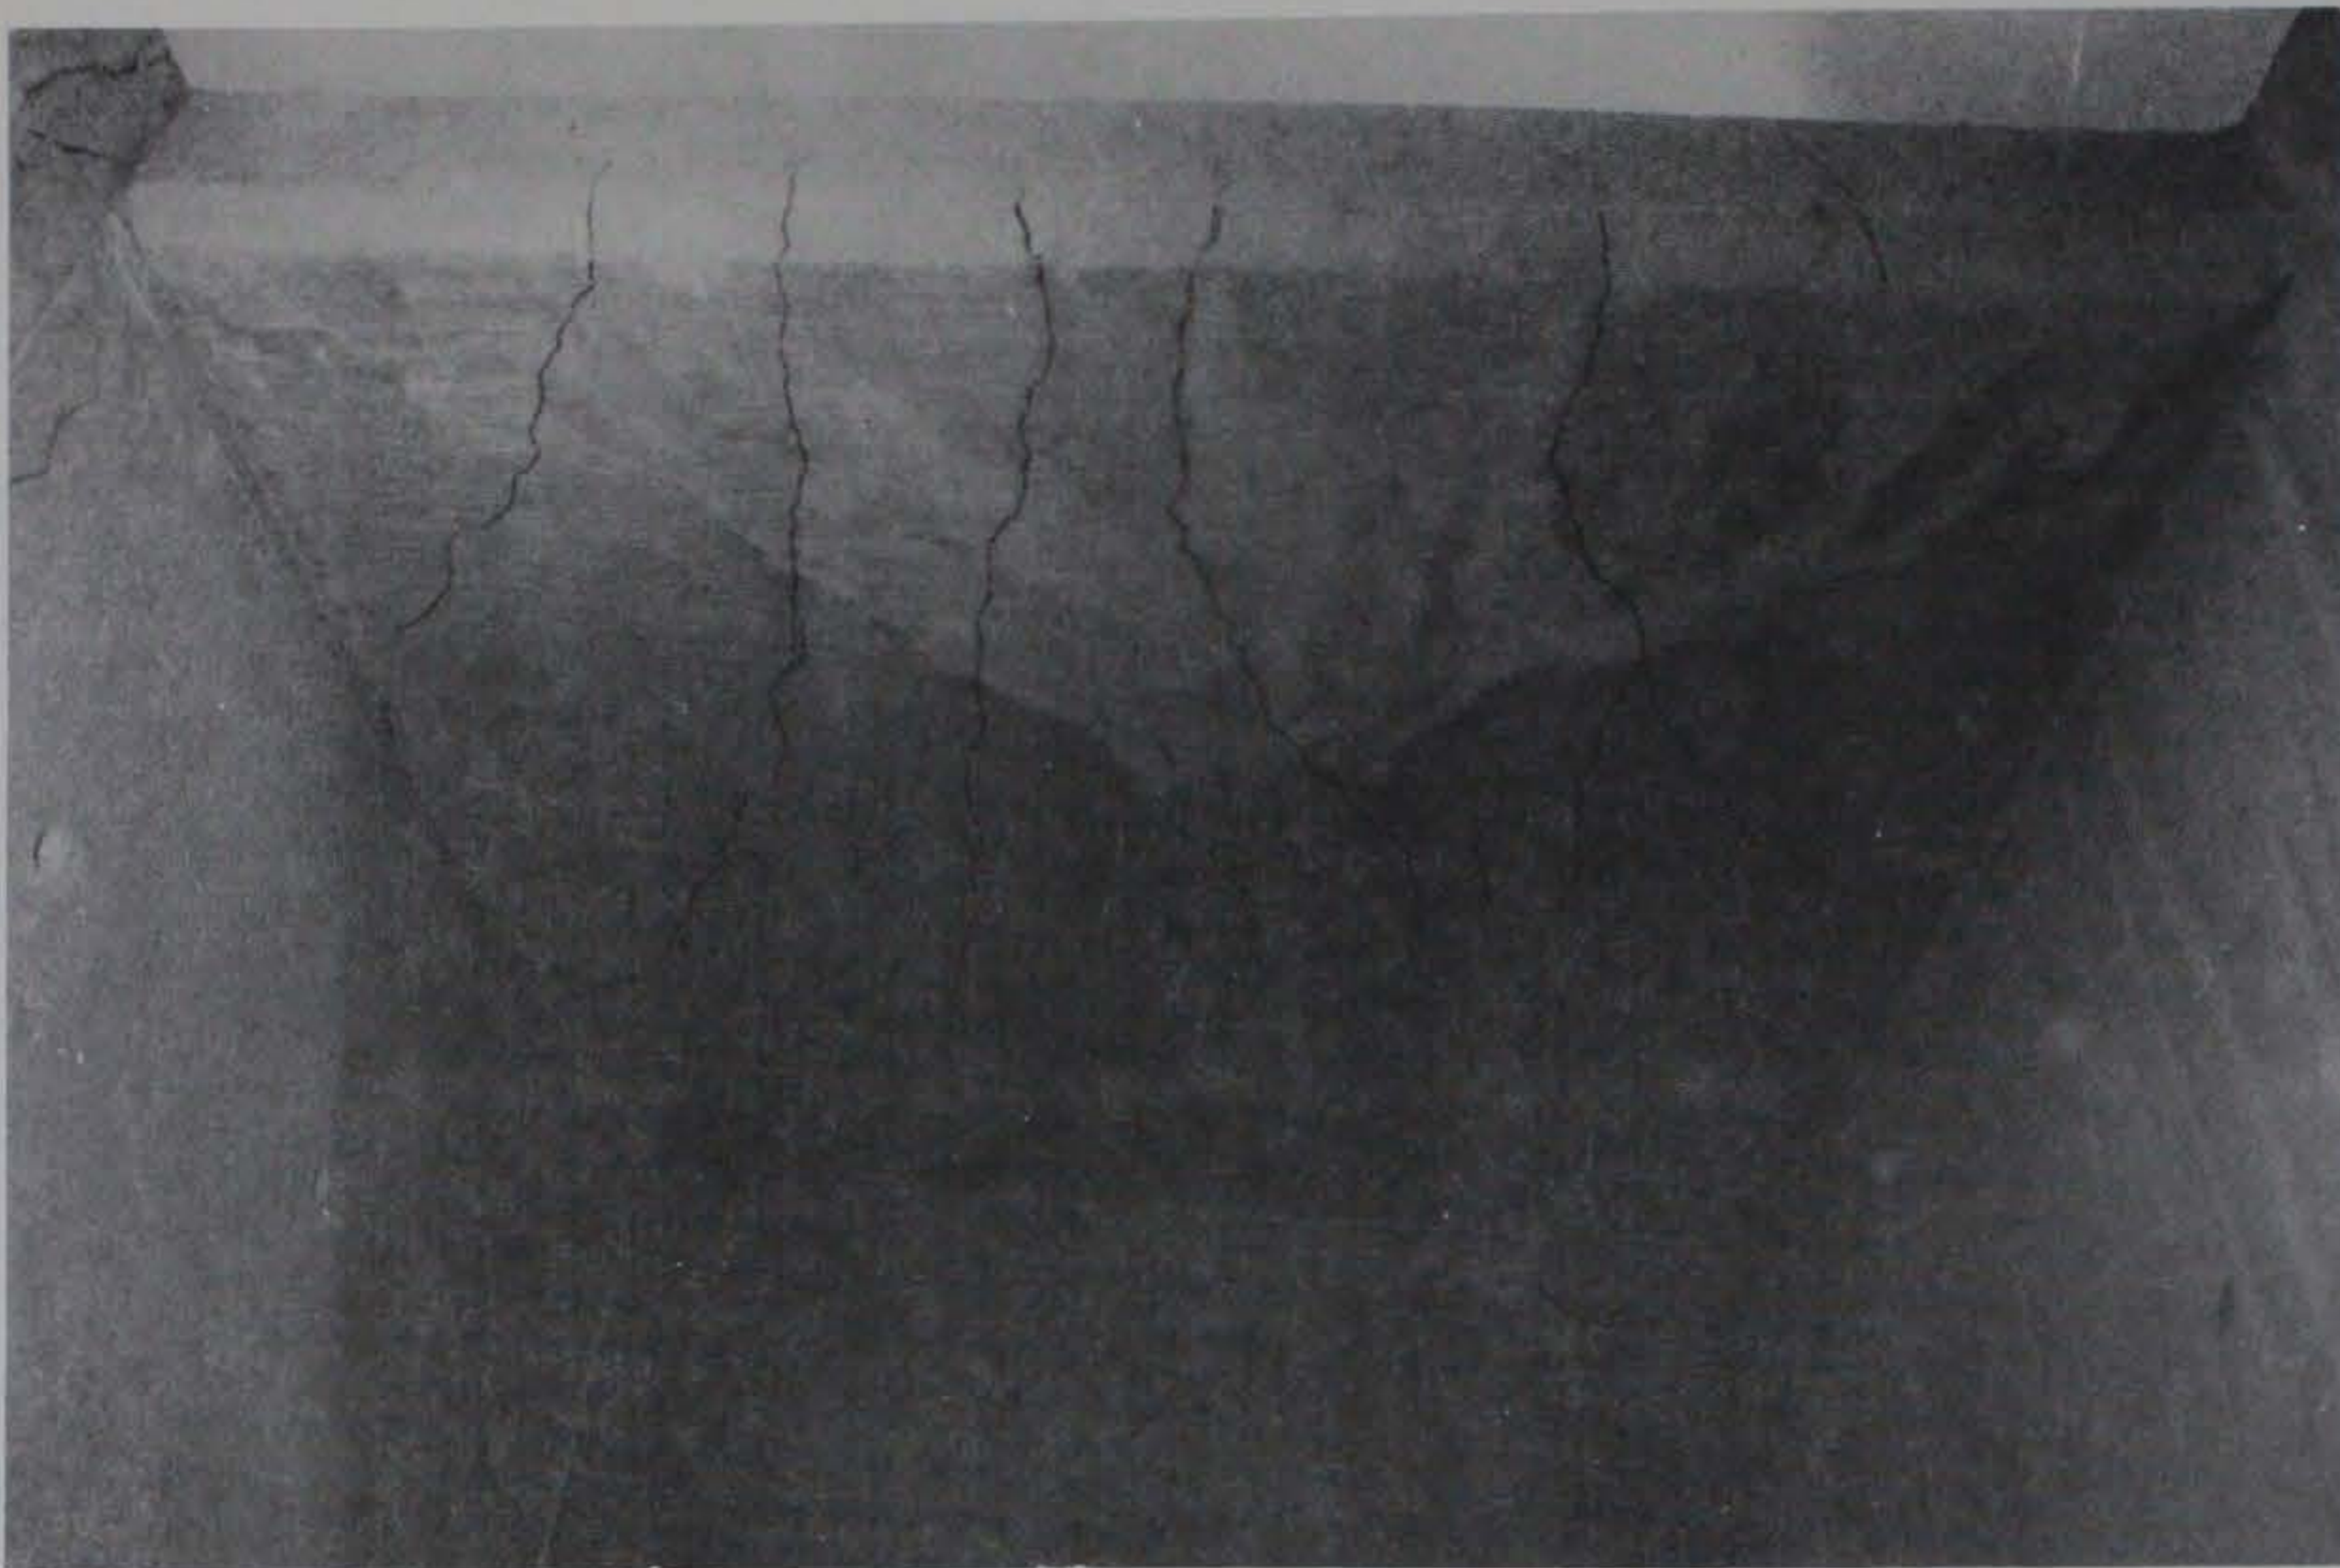
Figure 4.2. Damage to stairwell roof immediately above landing.

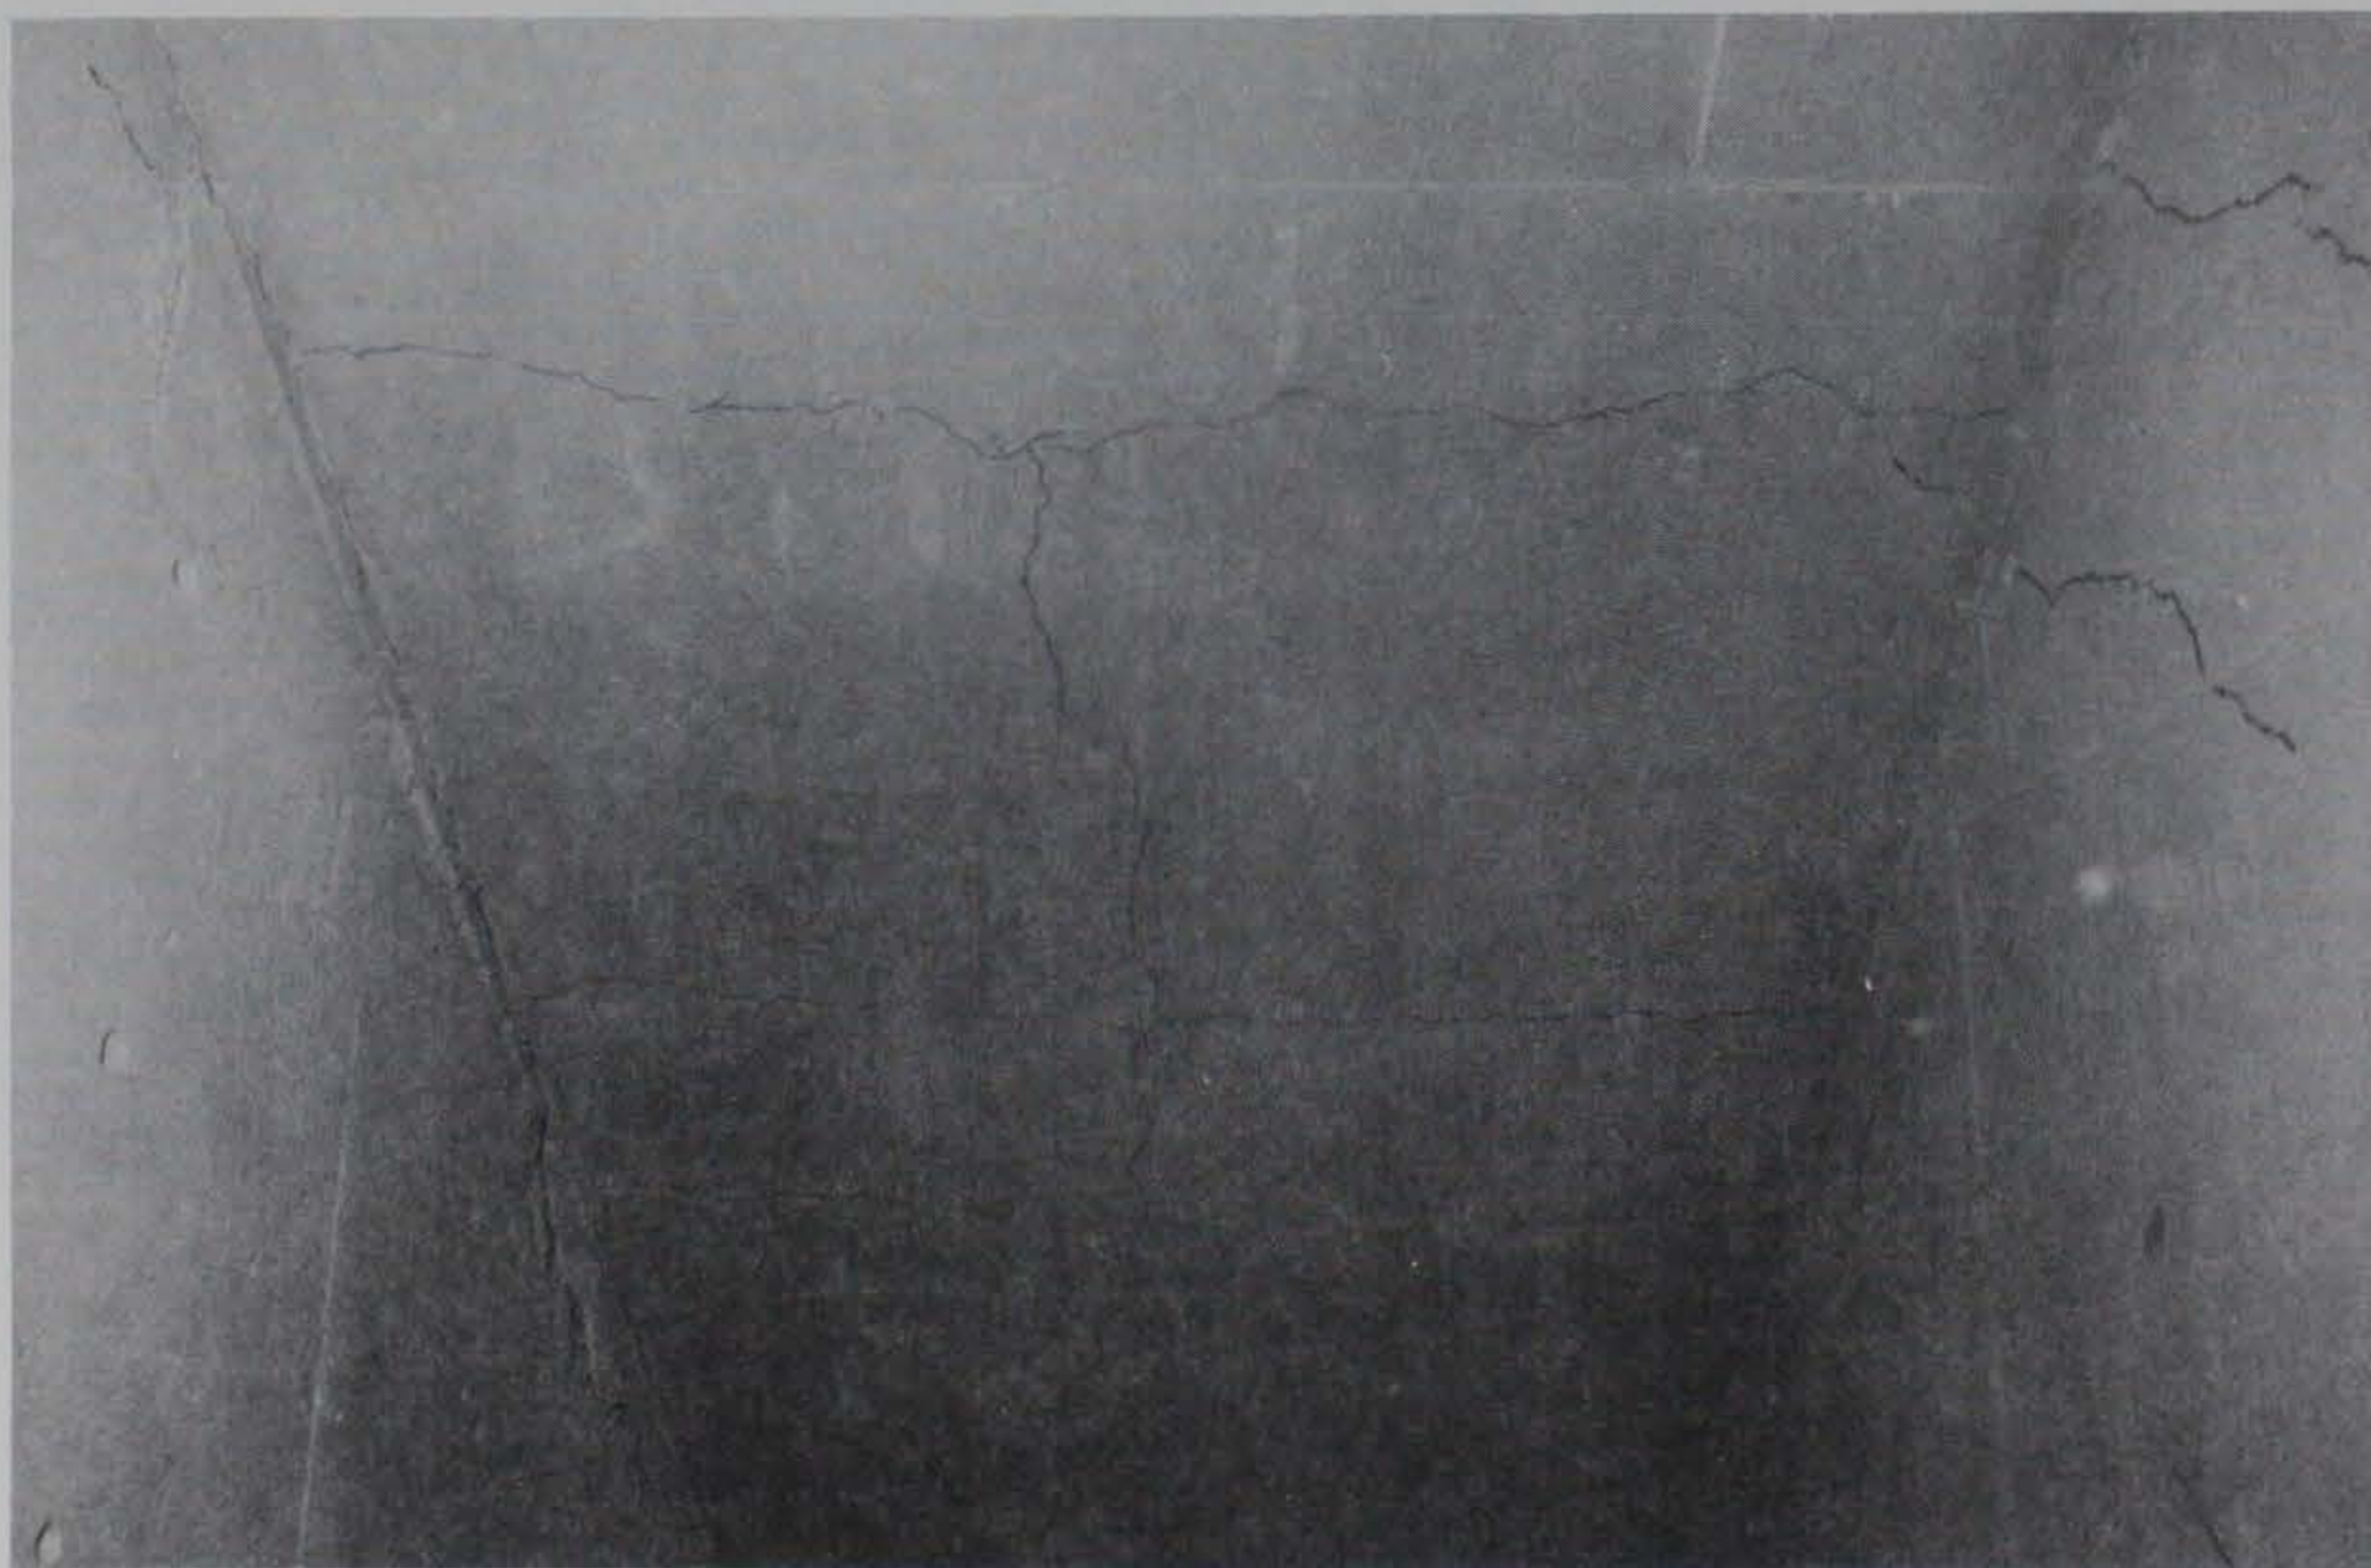
Figure 4.3. Damage to stairwell roof.

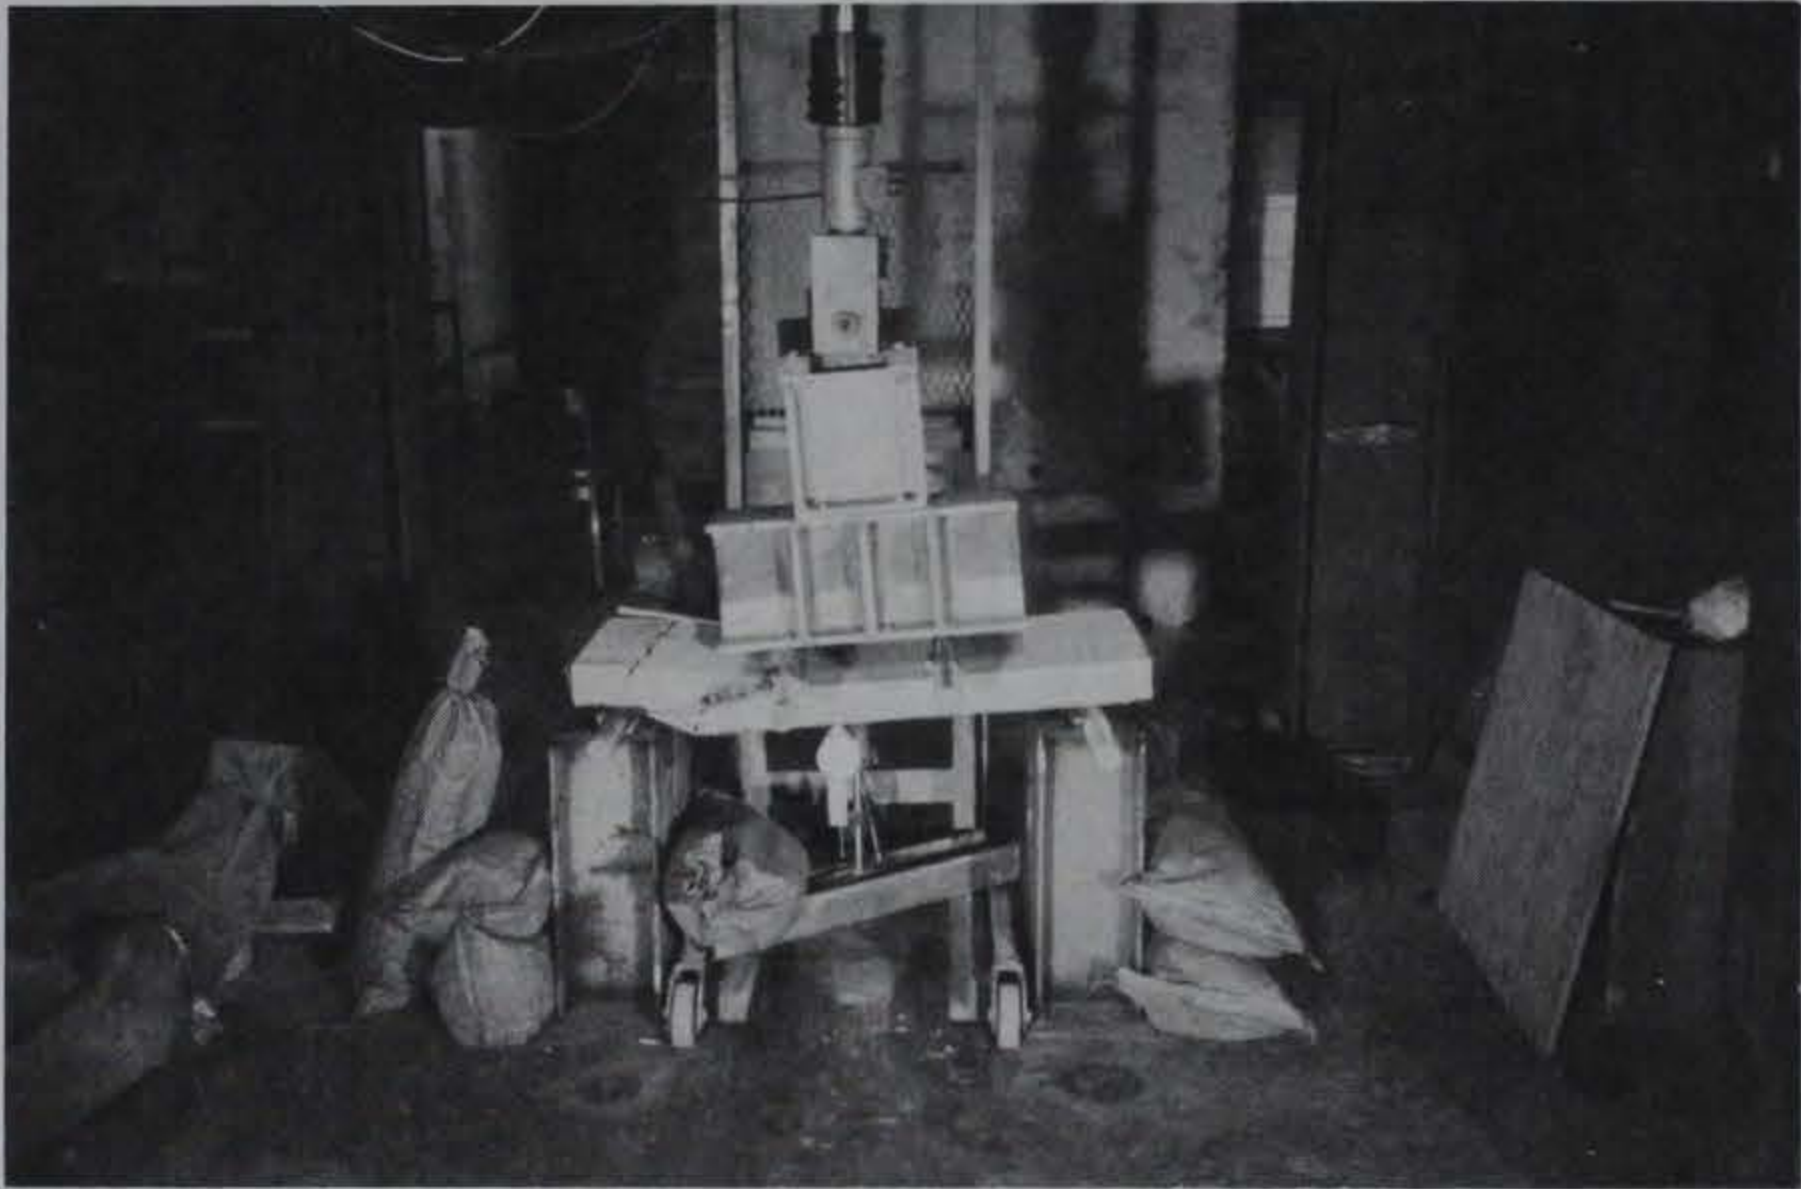
Figure 4.6. Damage to commercial door support plate.
