TECHNICAL REPORT GL-85-11

# DUSTPROOFING UNSURFACED AREAS; FACILITIES TECHNOLOGY APPLICATION TEST DEMONSTRATIONS, FY 84

Clarence R. Styron III, Robert A. Hass, Karen Kelley

Geotechnical Laboratory

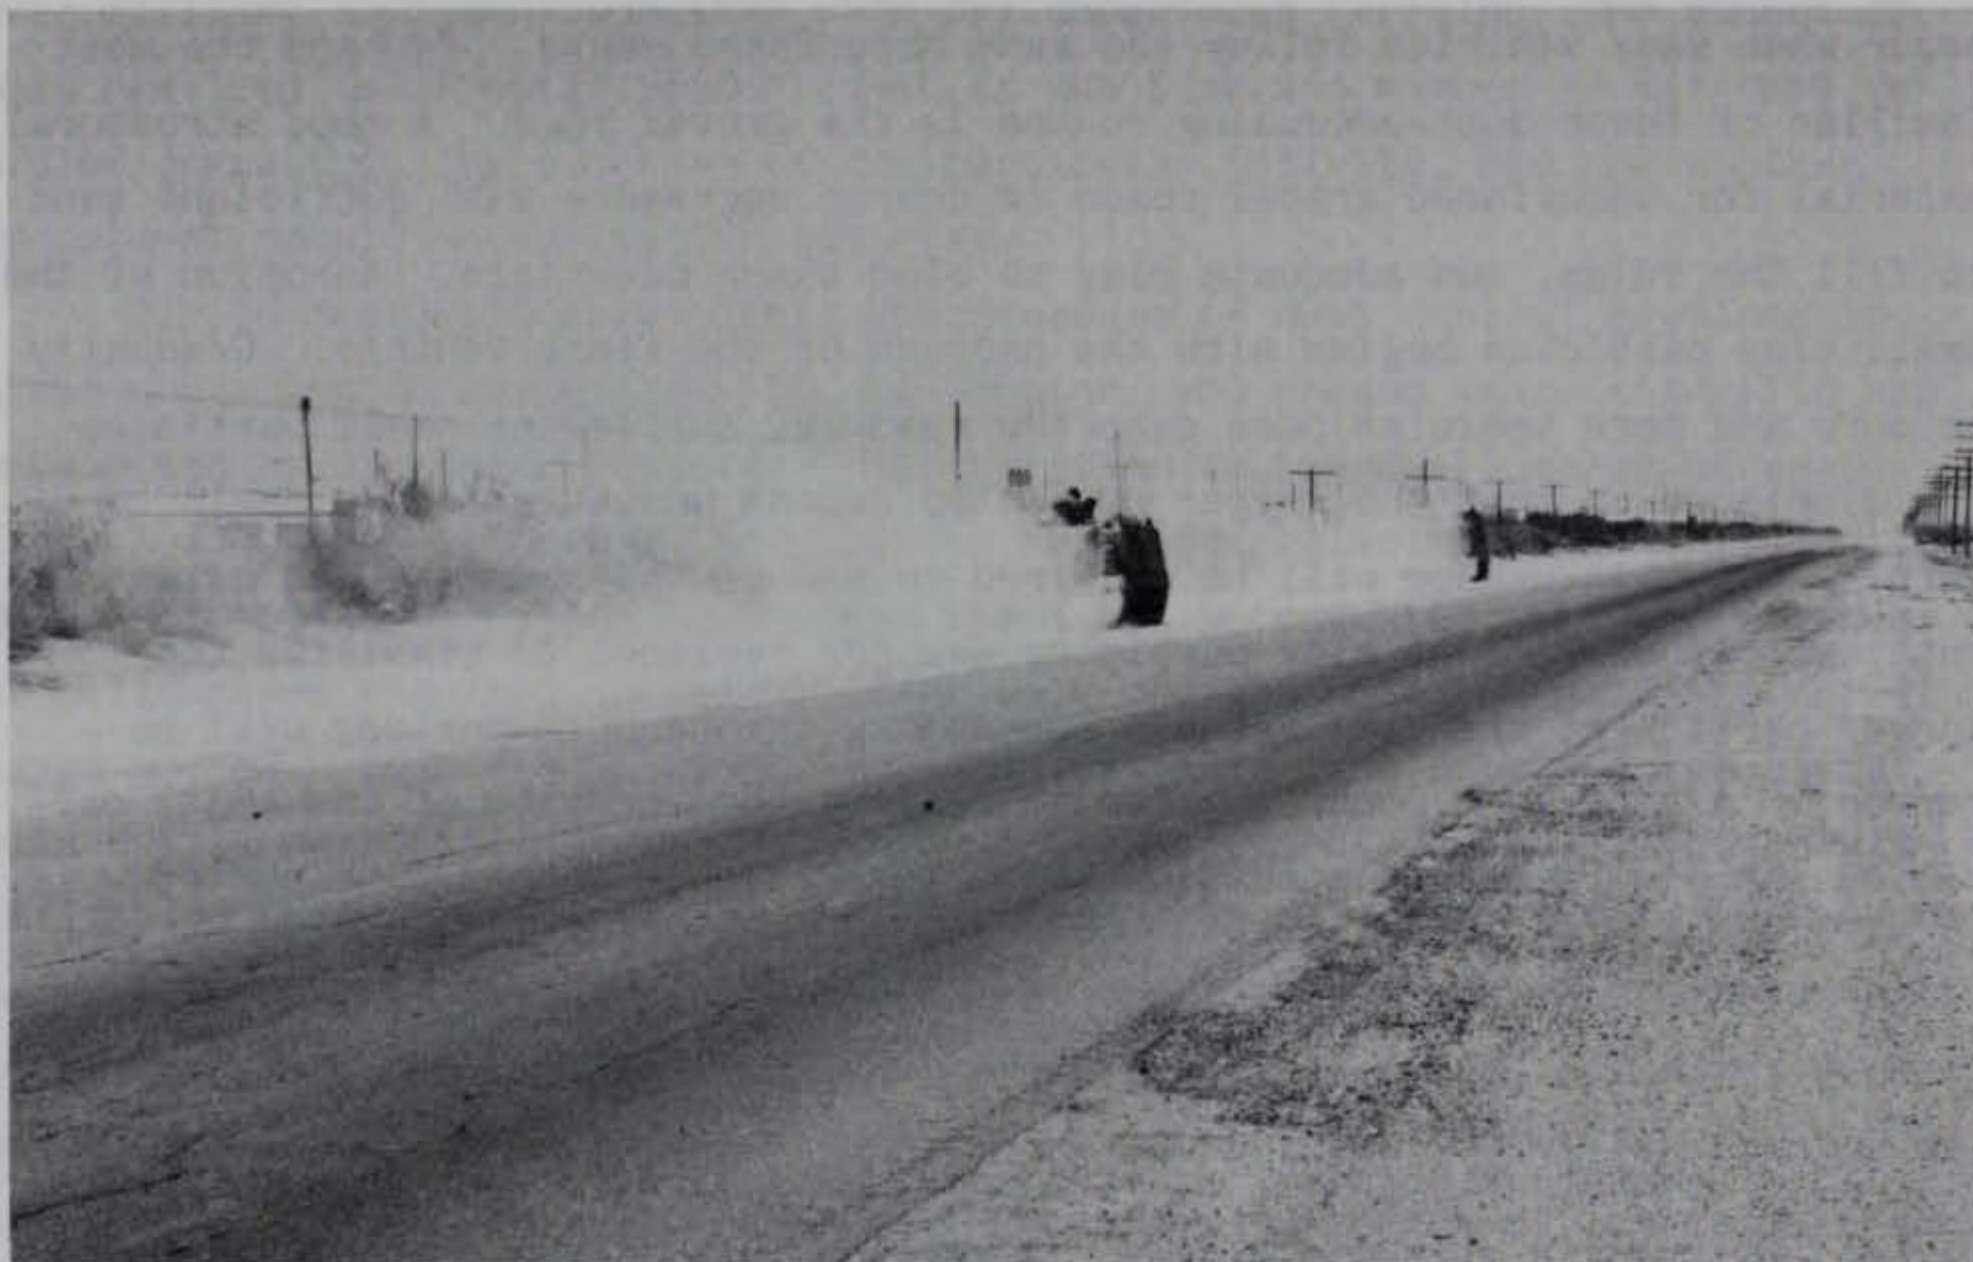
Figure 1. Dust at Fort Bliss, Tex., prior to treatment

8. Fort Stewart, Ga., and Fort Bliss, Tex., were selected for the fiscal year 1984 demonstration sites. Both locations had an immediate need for dust control. Wheeled and tracked vehicles were producing dust on the silty sand roads, and this dust was blowing into the family housing area (Fort Stewart) and nearby adjacent commercial enterprises (Fort Bliss, Figure 1).

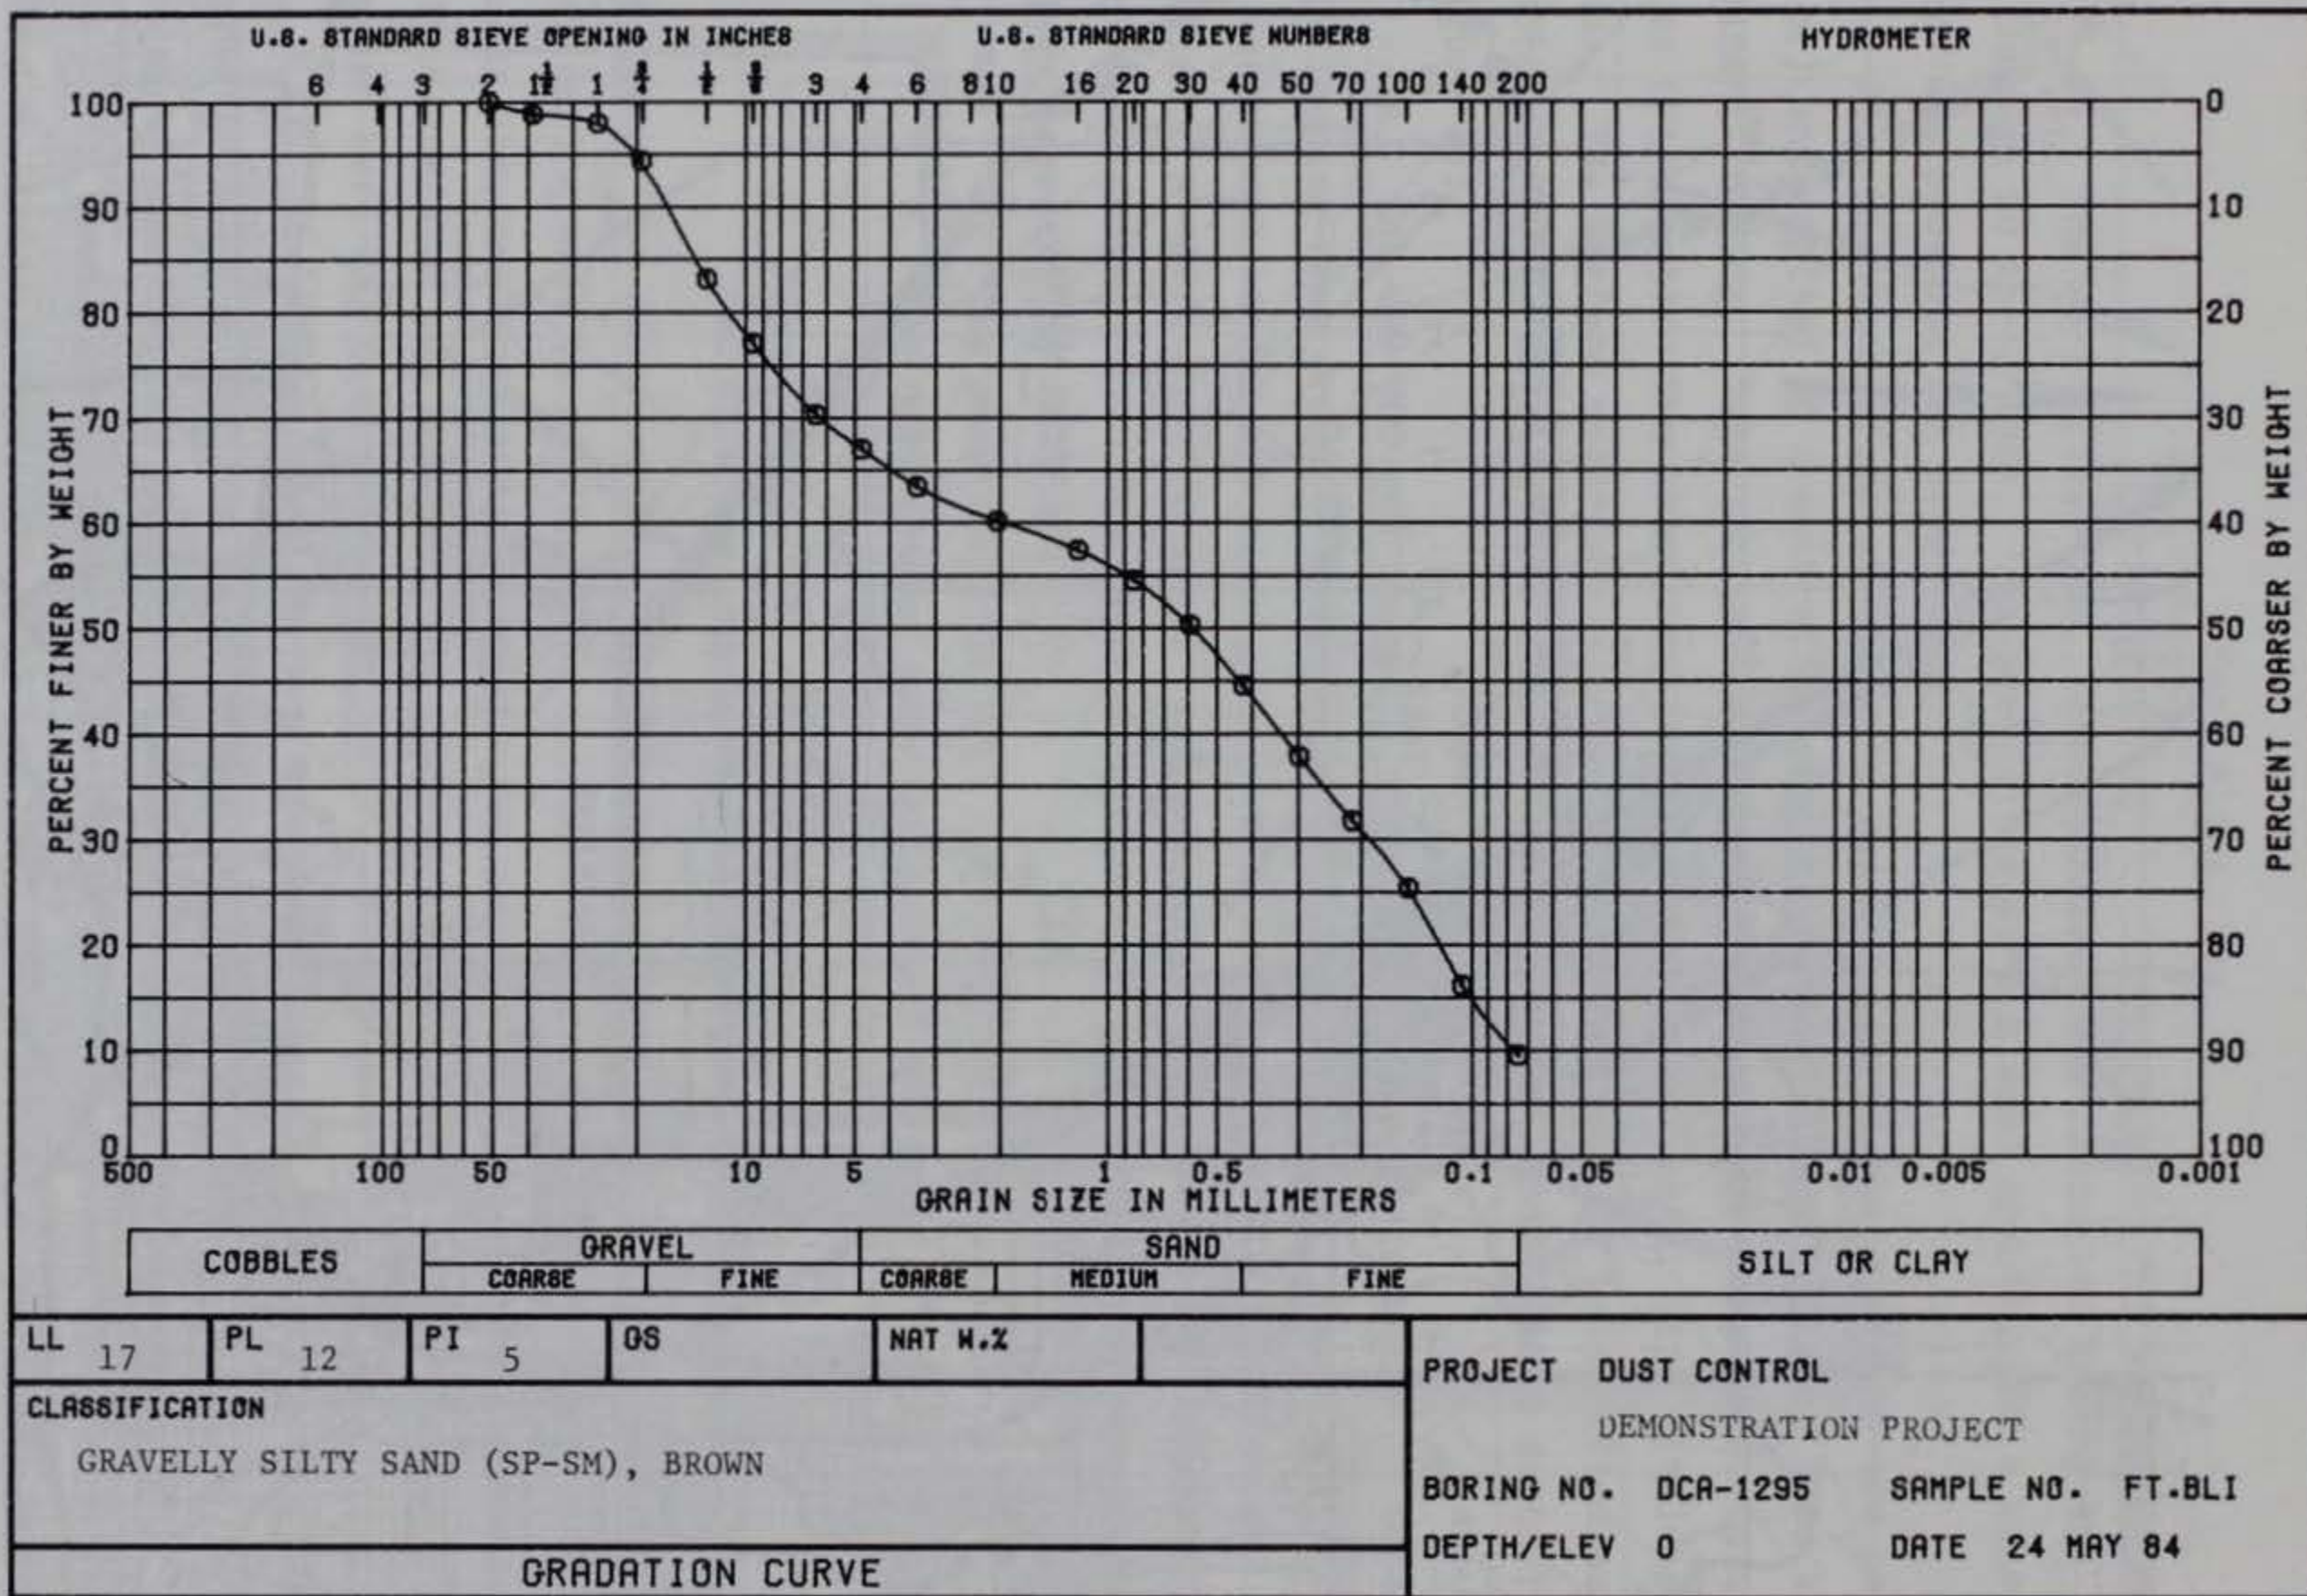
Figure 4. PVA site soil classification, Fort Bliss, Tex.

25. Eighteen drums of PVA were diluted (three parts PVA to one part water) and applied to a nontraffic area measuring 110 by 180 ft. This area is adjacent to Bldg. 11246 located on Sixth Street at Biggs Army Airfield at Fort Bliss (Figure 3). The test area is essentially horizontal with little or no grade. The surface material is brown gravelly silty sand (classified as SP-SM according to the Unified Soil Classification System (USCS)) that dusts readily (Figure 4).

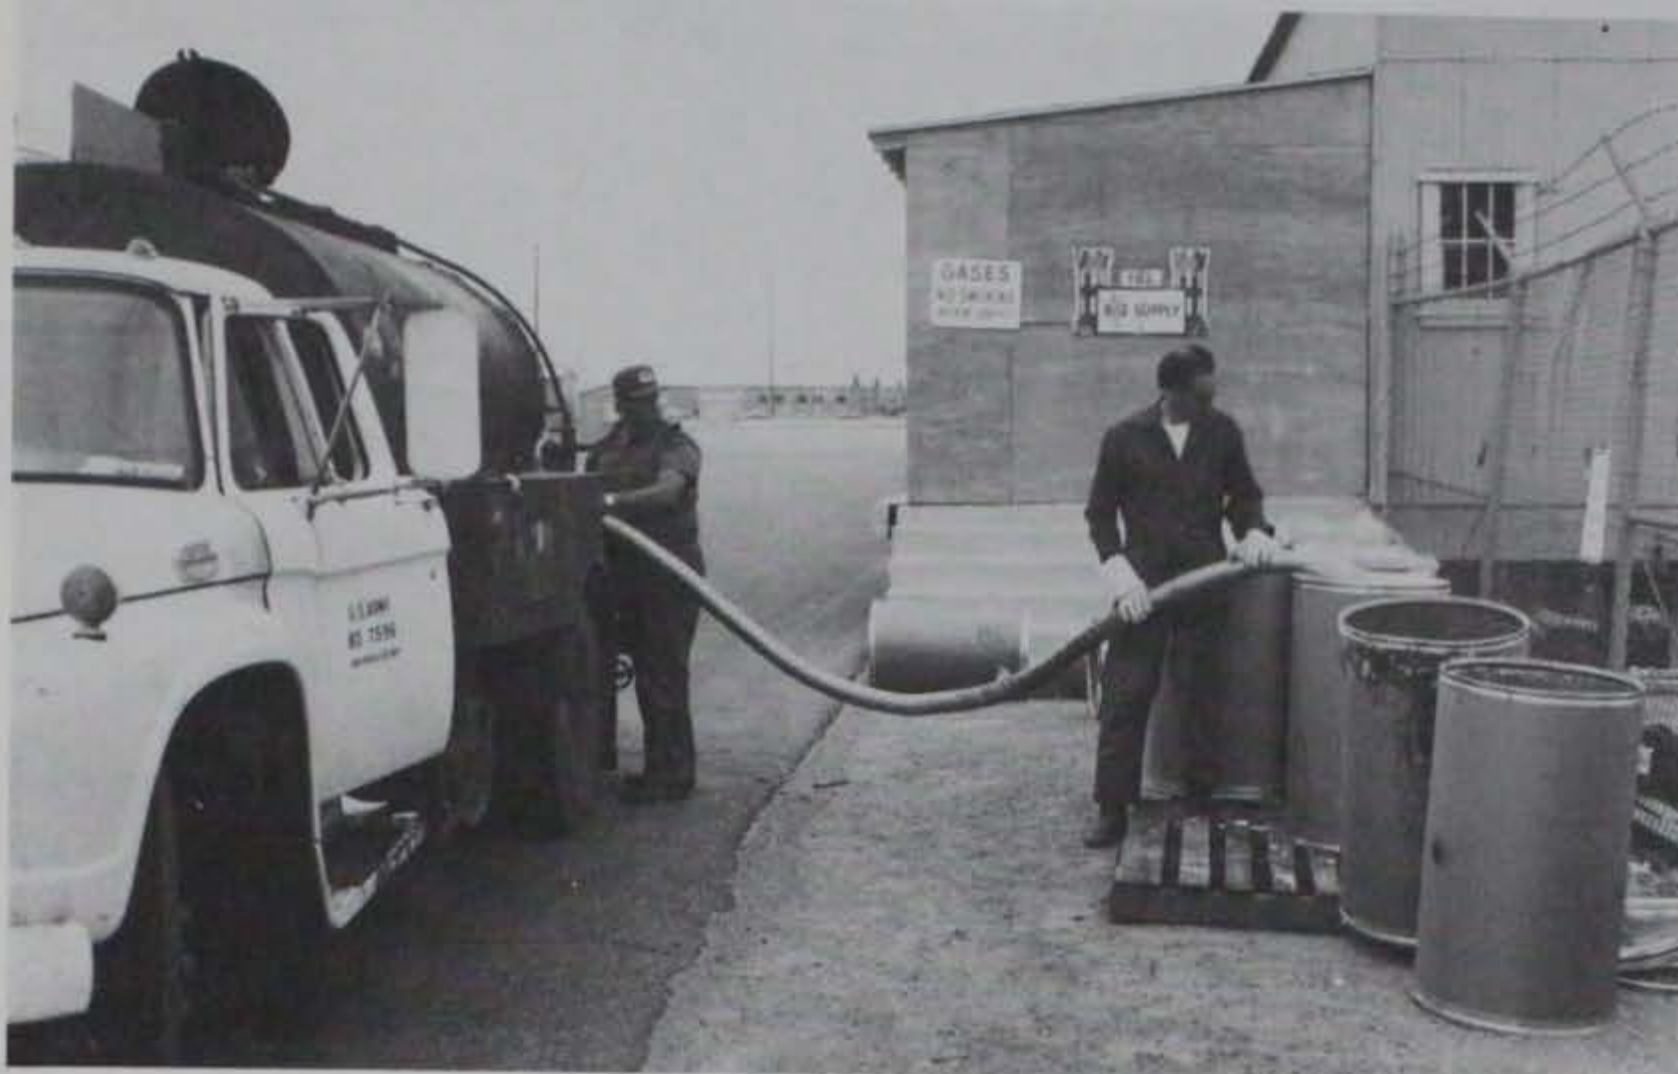
Figure 5. Loading PVA at Fort Bliss, Tex.

26. The WES 900-gal capacity modified asphalt distributor is capable of self-loading from drums (Figure 5). Thus, nine drums of PVA and three drums of water were loaded and mixed, and approximately one-half the area was treated. A 12-ft-wide spray bar was used to apply a strip the same width with each pass (Figure 6). The desired application rate was set by the distributor driver/operator as follows:

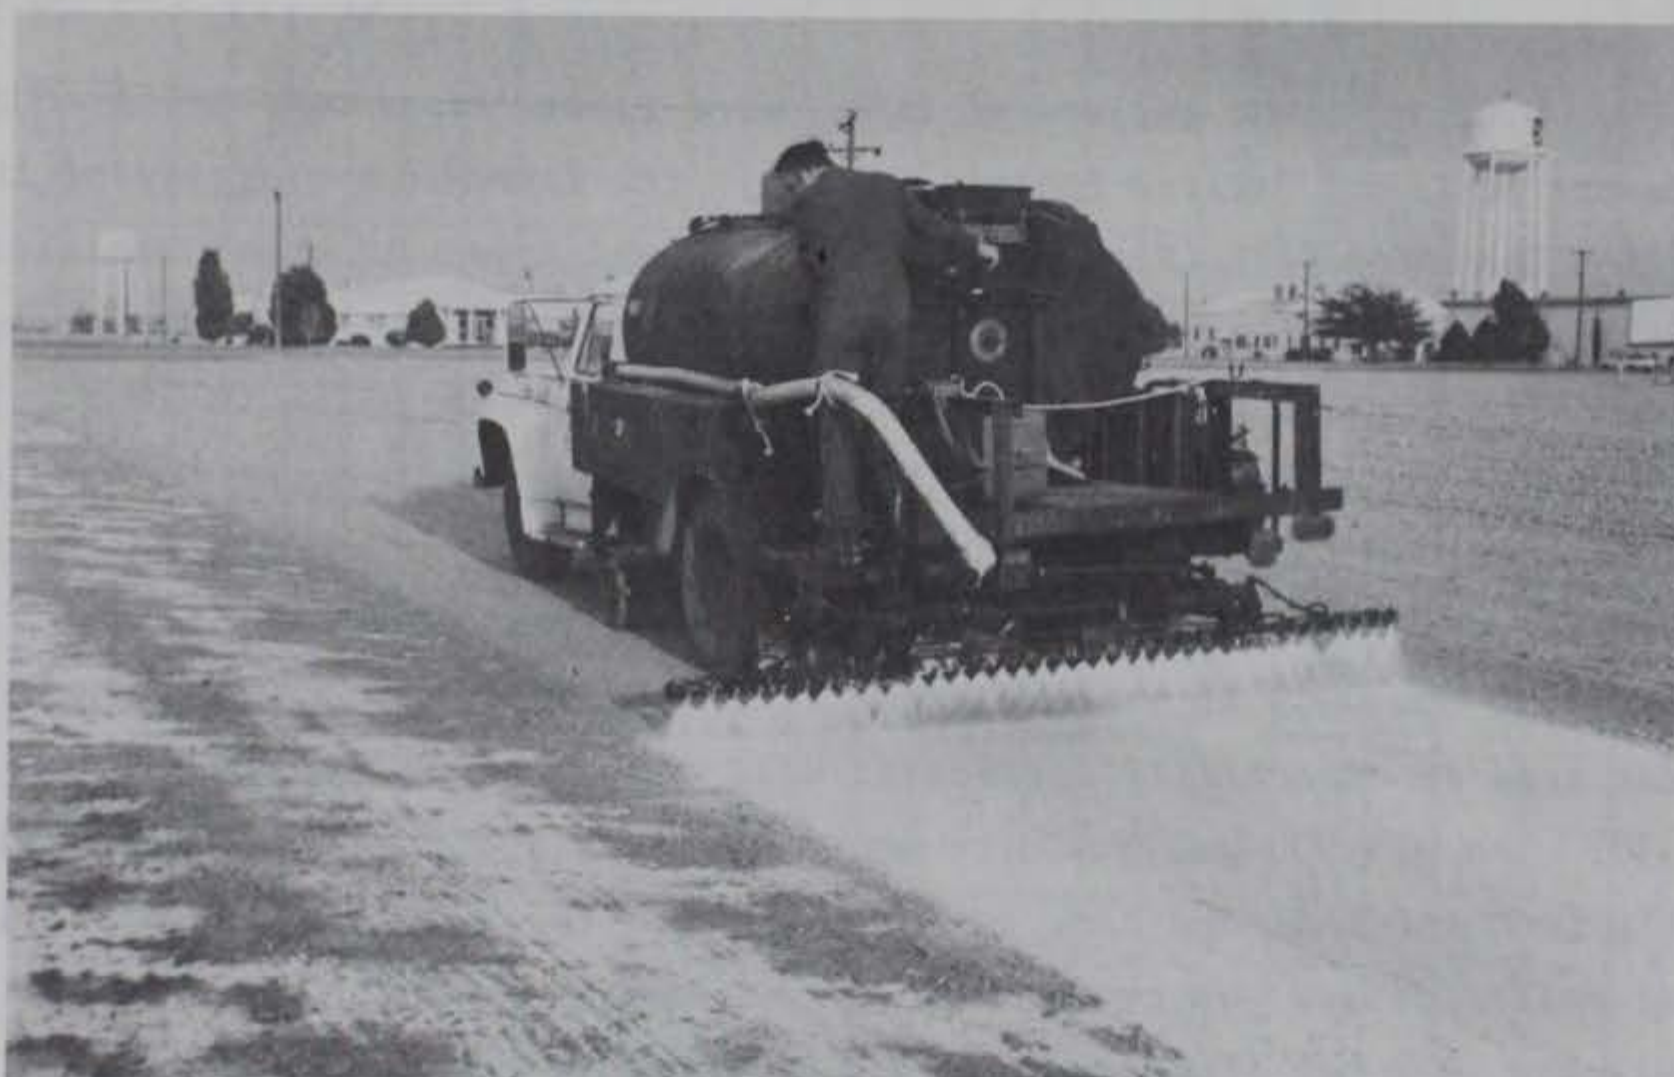
Figure 6. Applying PVA at Fort Bliss, Tex.

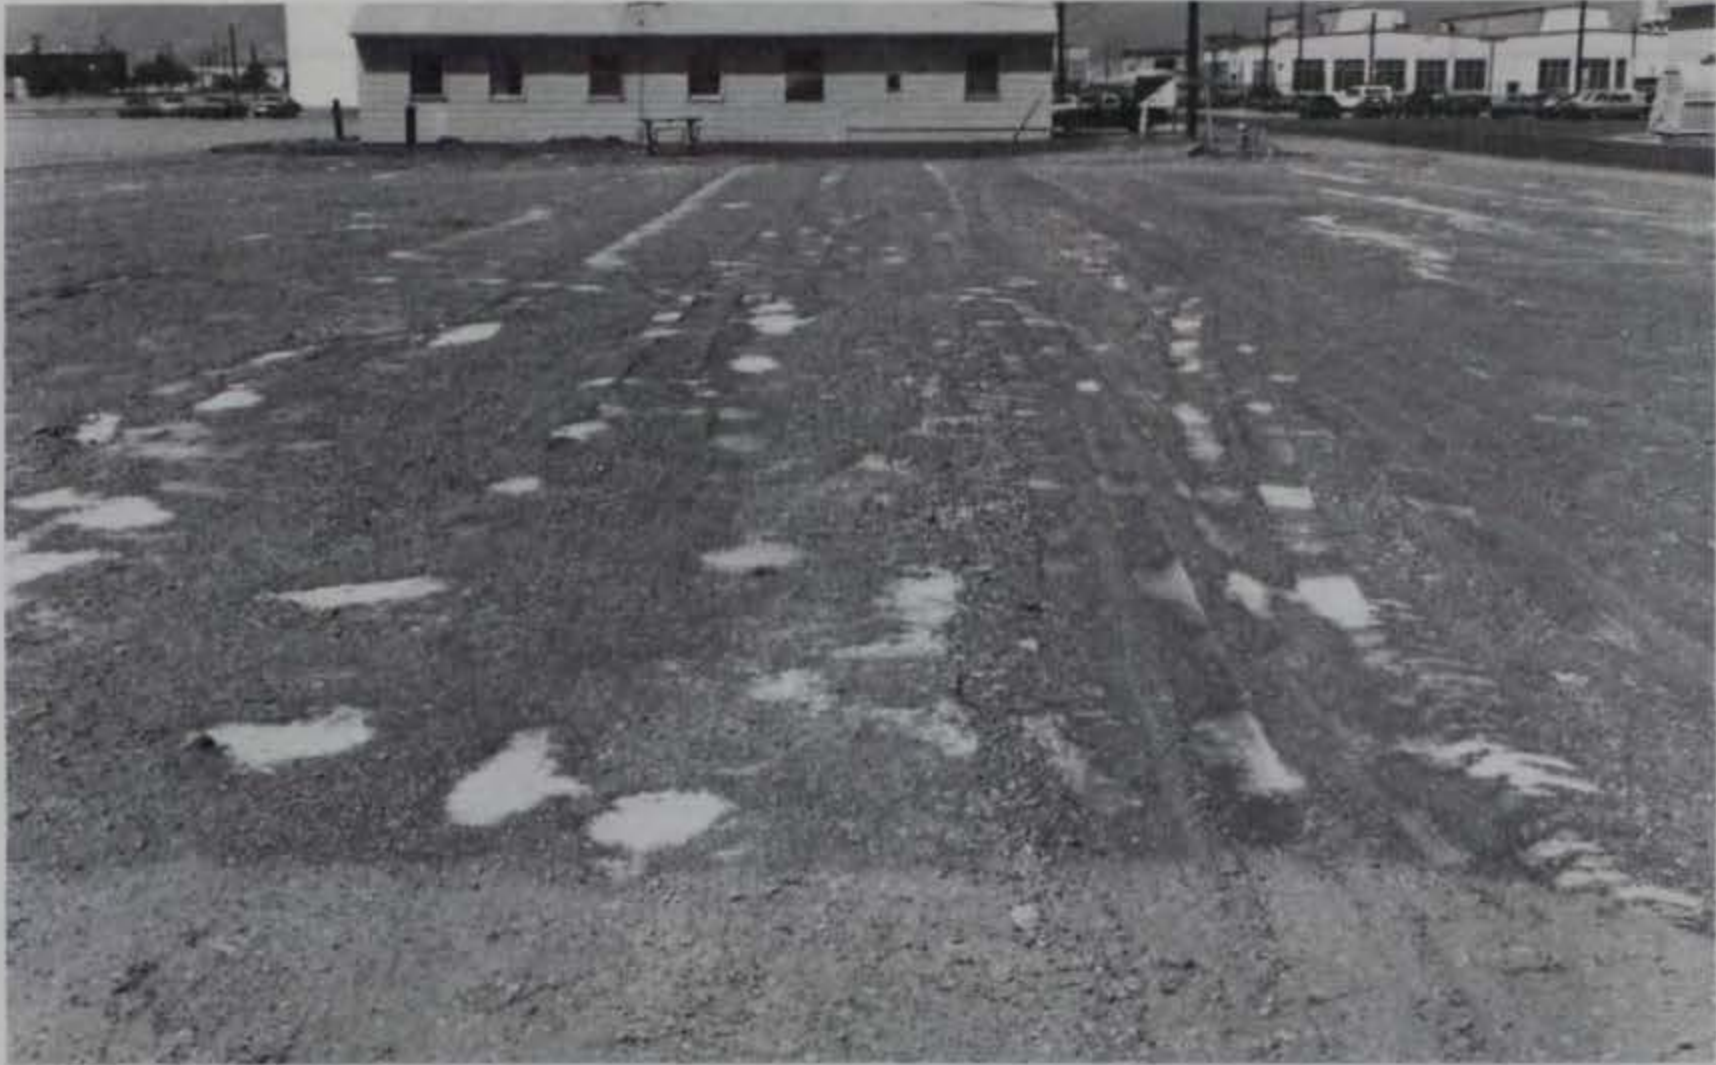
Figure 7. The PVA treated surface, Fort Bliss, Tex.

28. Small depressions and ruts (the treated surface caused by the distributor tires) were filled with PVA, and these ponded areas cured much more slowly than the nonrutted areas (Figure 7). The ponded material cures from

the surface down; if left undisturbed, it may take months to cure completely. This does not impair the dust control integrity of the treated area in any way.

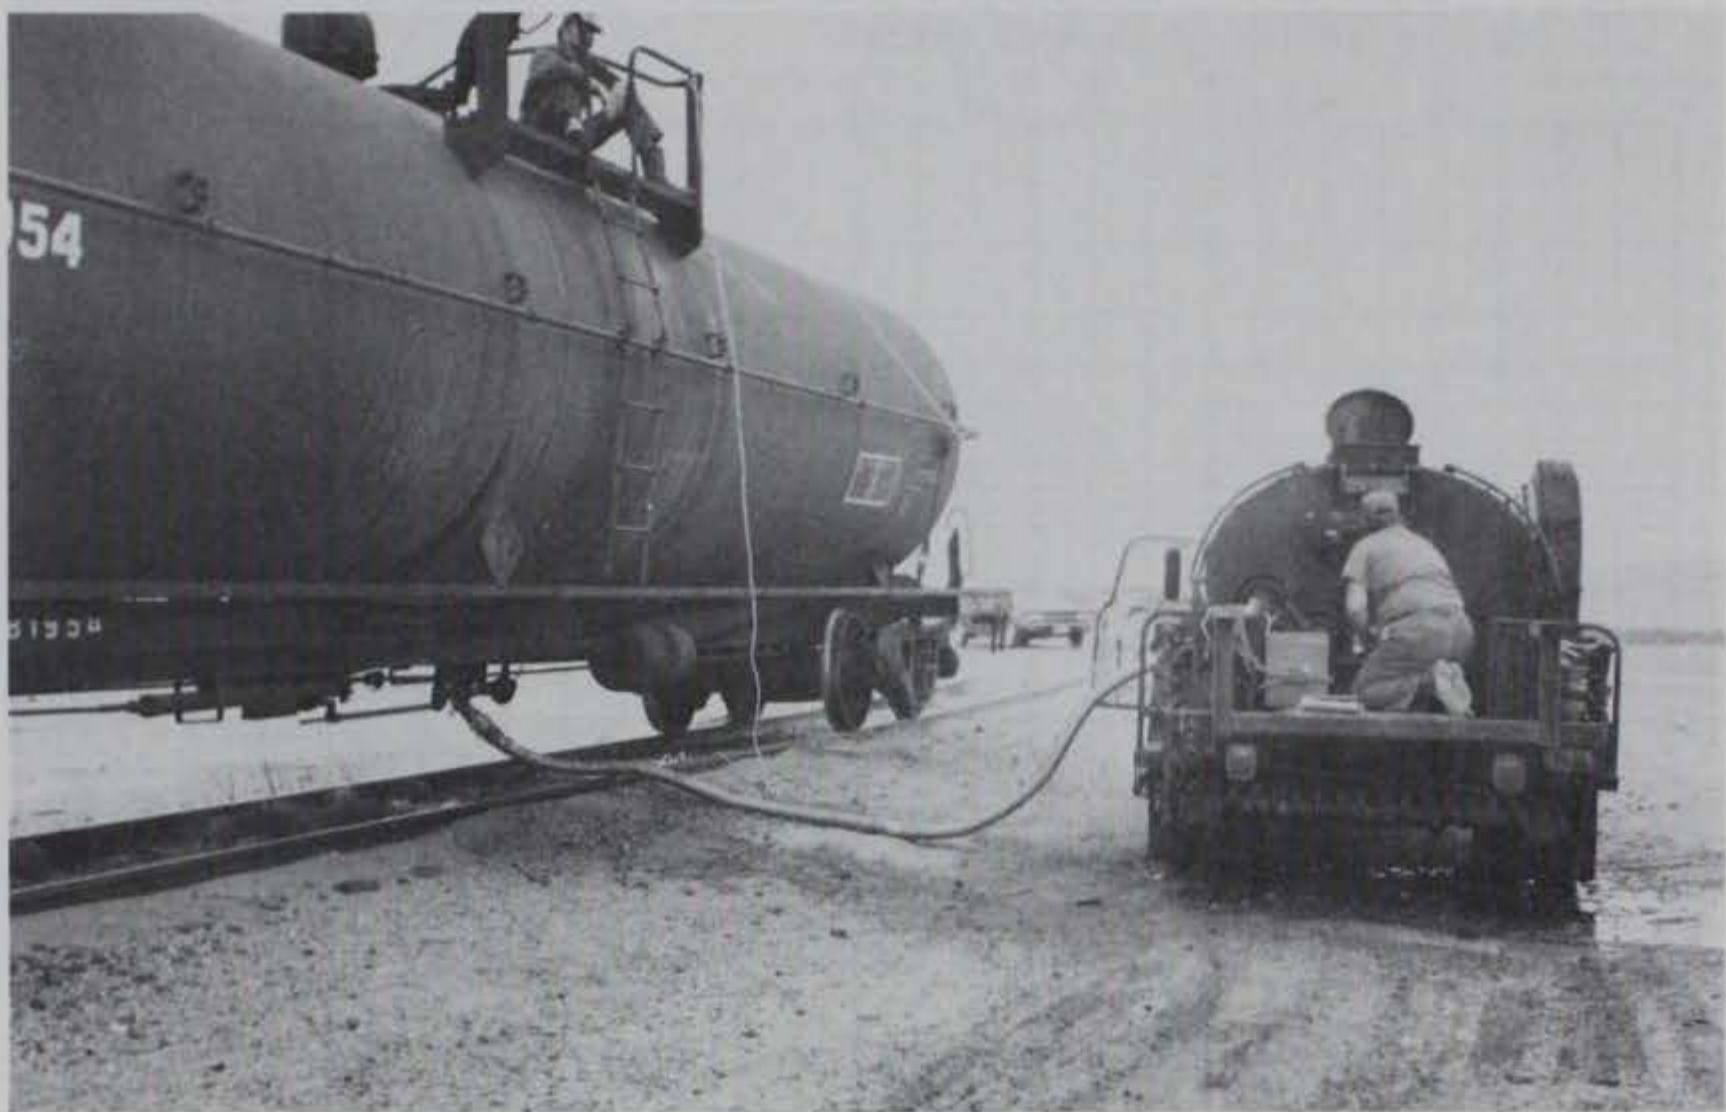
Figure 9. Loading product  $MgCl_2$  from railroad tank car

30. The WES 900-gal capacity modified asphalt distributor was loaded directly from the railroad tank car used to ship the  $MgCl_2$  (Figure 9). A special collar device was required to attach the distributor supply hose to the railroad tank car (Figure 10). The collar must fit a threaded pipe approximately 4-1/4 in. in diameter, turn 45 deg (preferably 90 deg), and the opposite end fit the 3-1/2-in. supply hose.

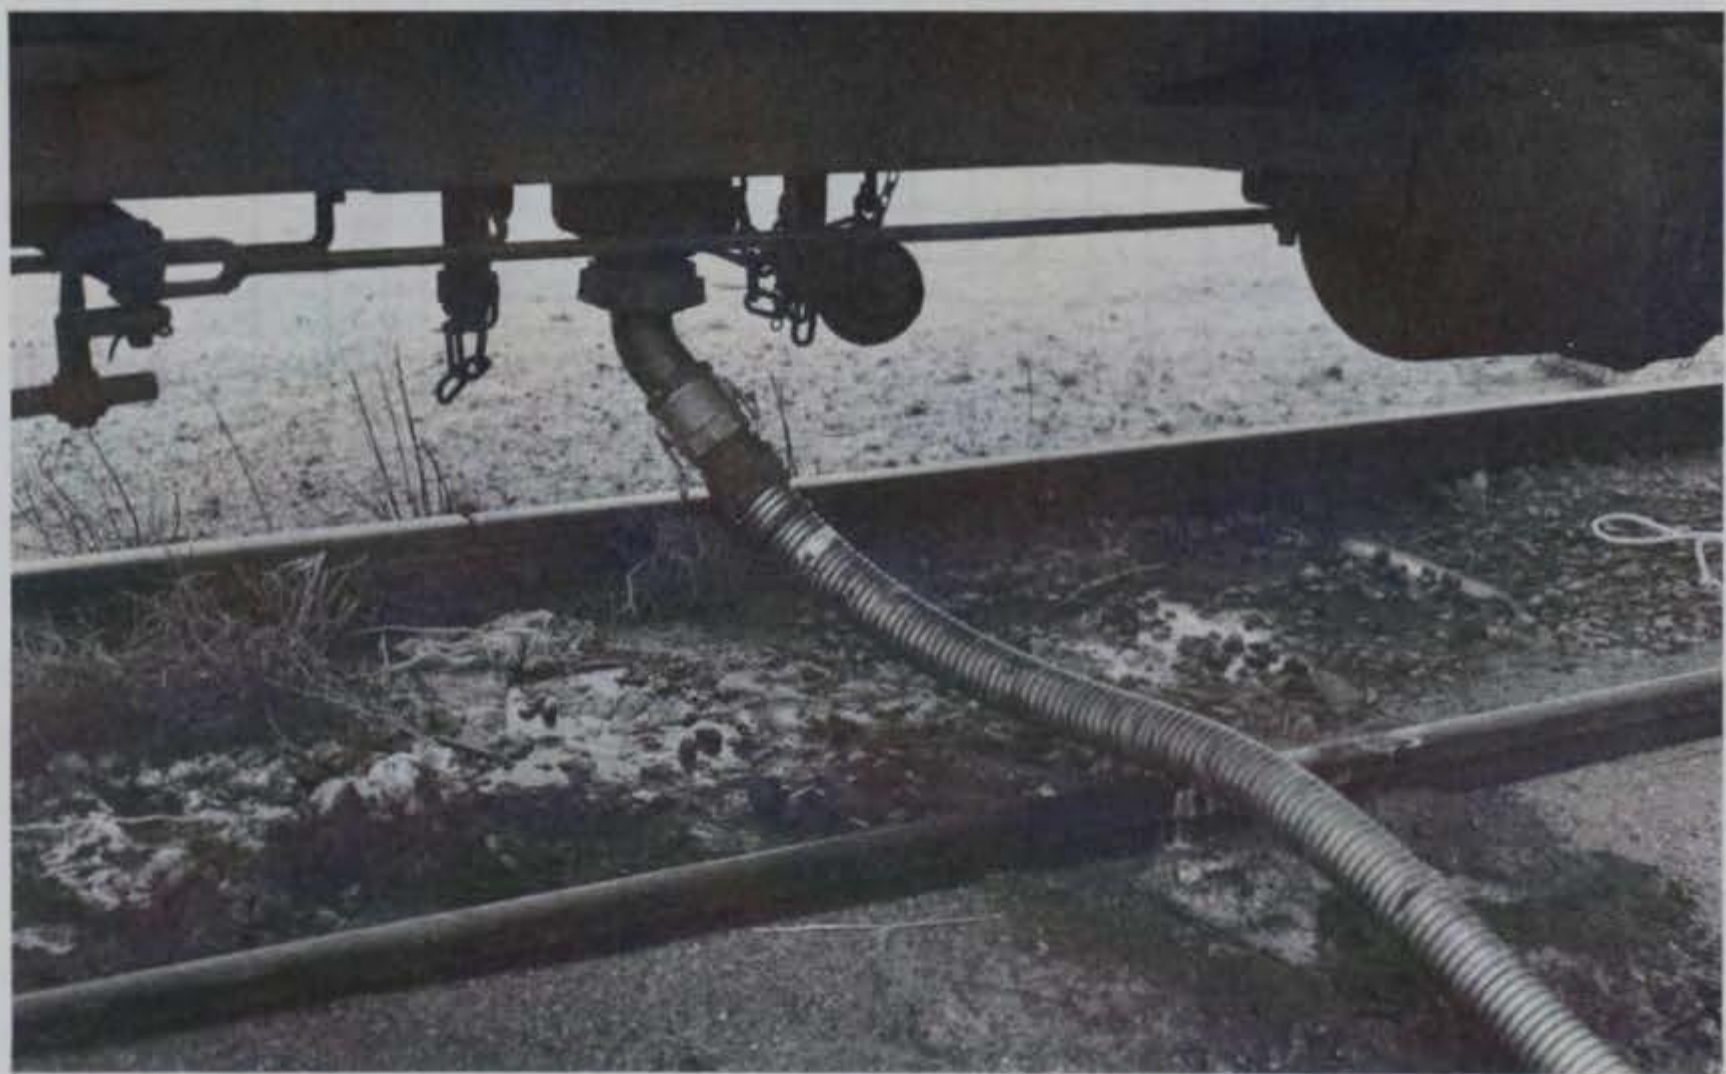
Figure 10. Collar device required for tank access

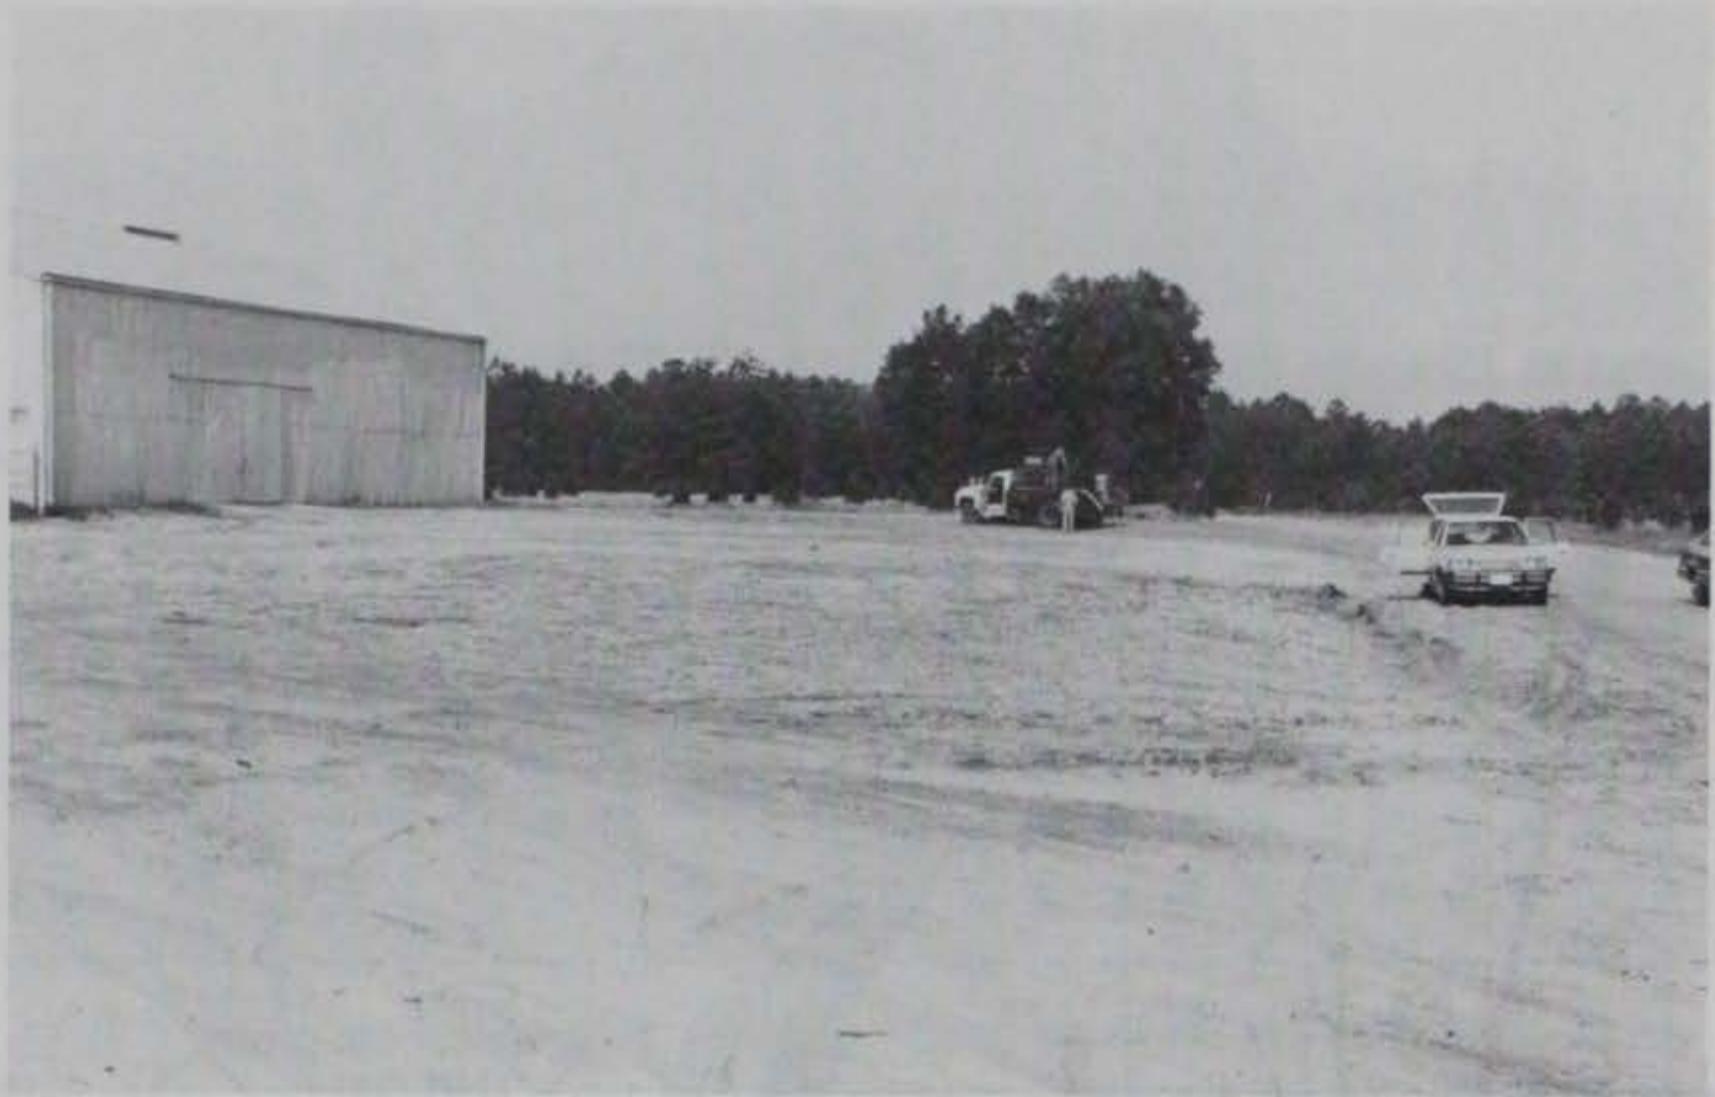
a. PVA test site, Fort Stewart, Ga.

Figure 13. Test site and application of PVA

33. The PVA test site is in an area that is used to load and unload a warehouse located near Zoucks Cemetery (Figures 12 and 13a). Eighteen drums of PVA were diluted three parts PVA to one part water and applied to an area 200 by 90 ft for an actual application rate of 0.49 gal/sq yd (Figure 13b).

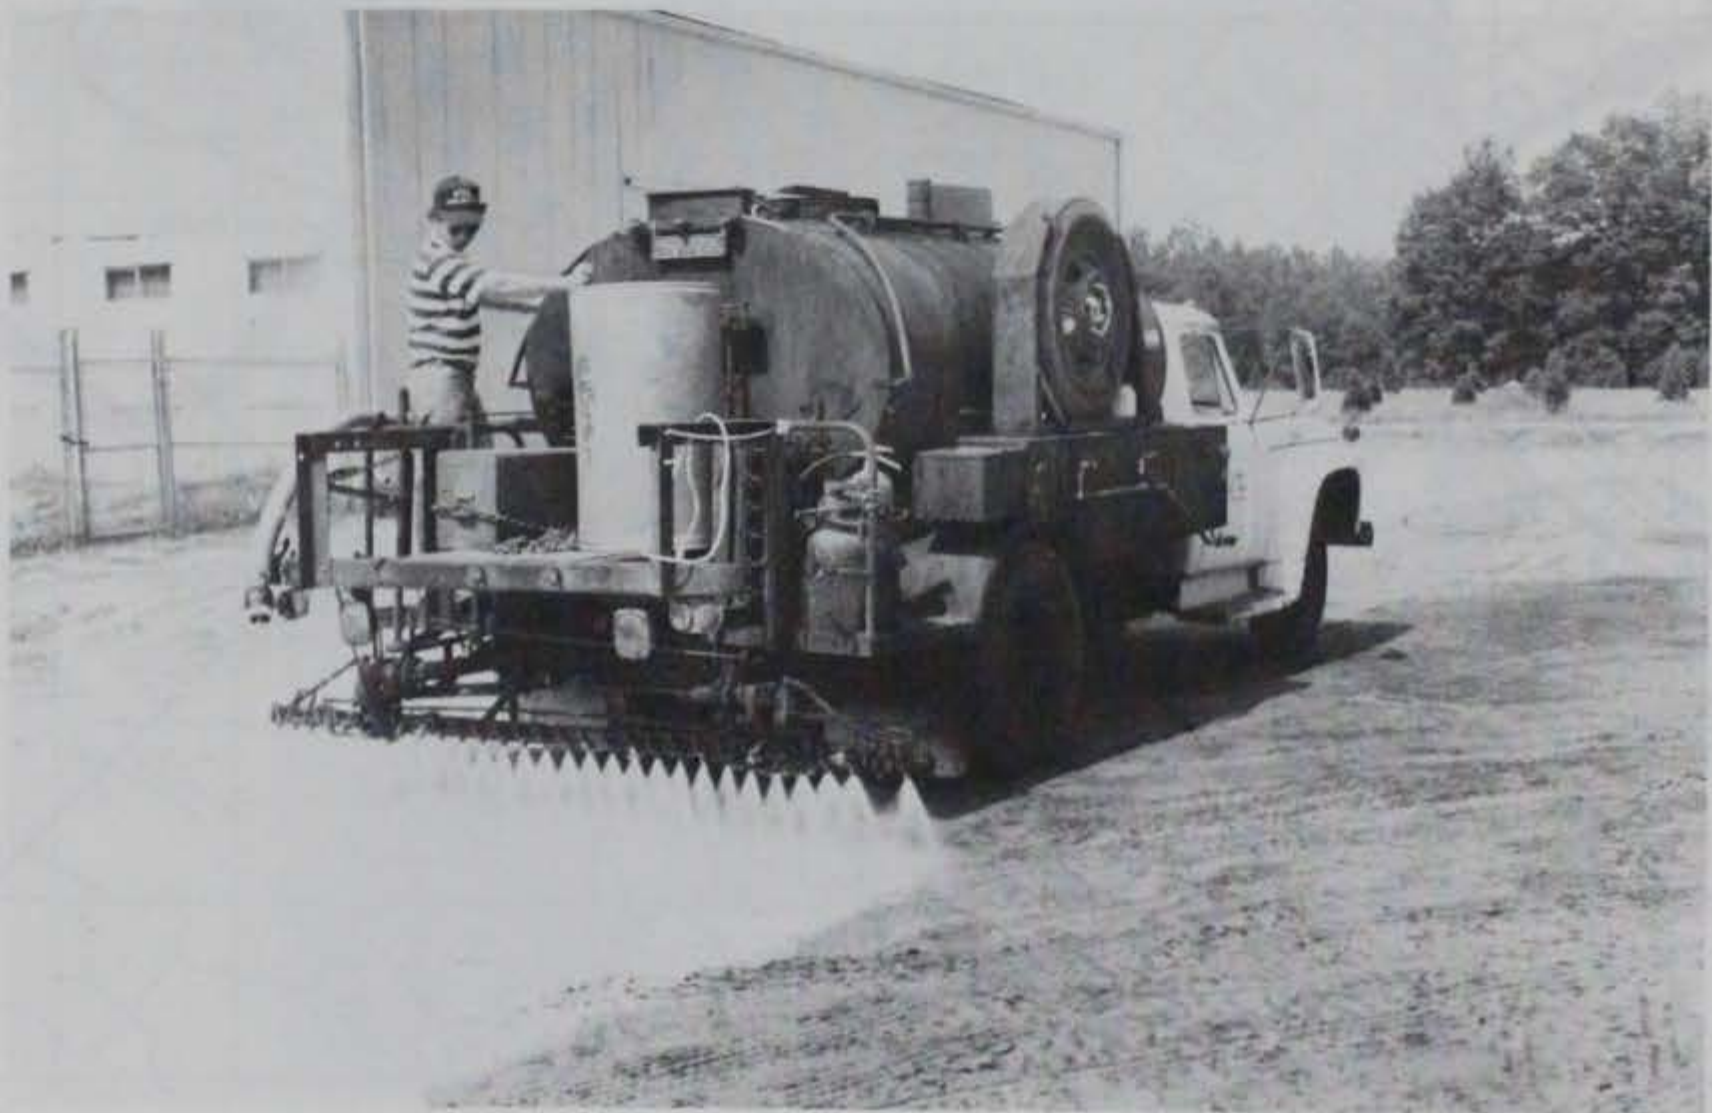
b. Applying PVA, Fort Stewart, Ga.
