TECHNICAL REPORT SL-84-13

BLAST DOOR AND ENTRYWAY DESIGN AND EVALUATION

July 1984
Final Report

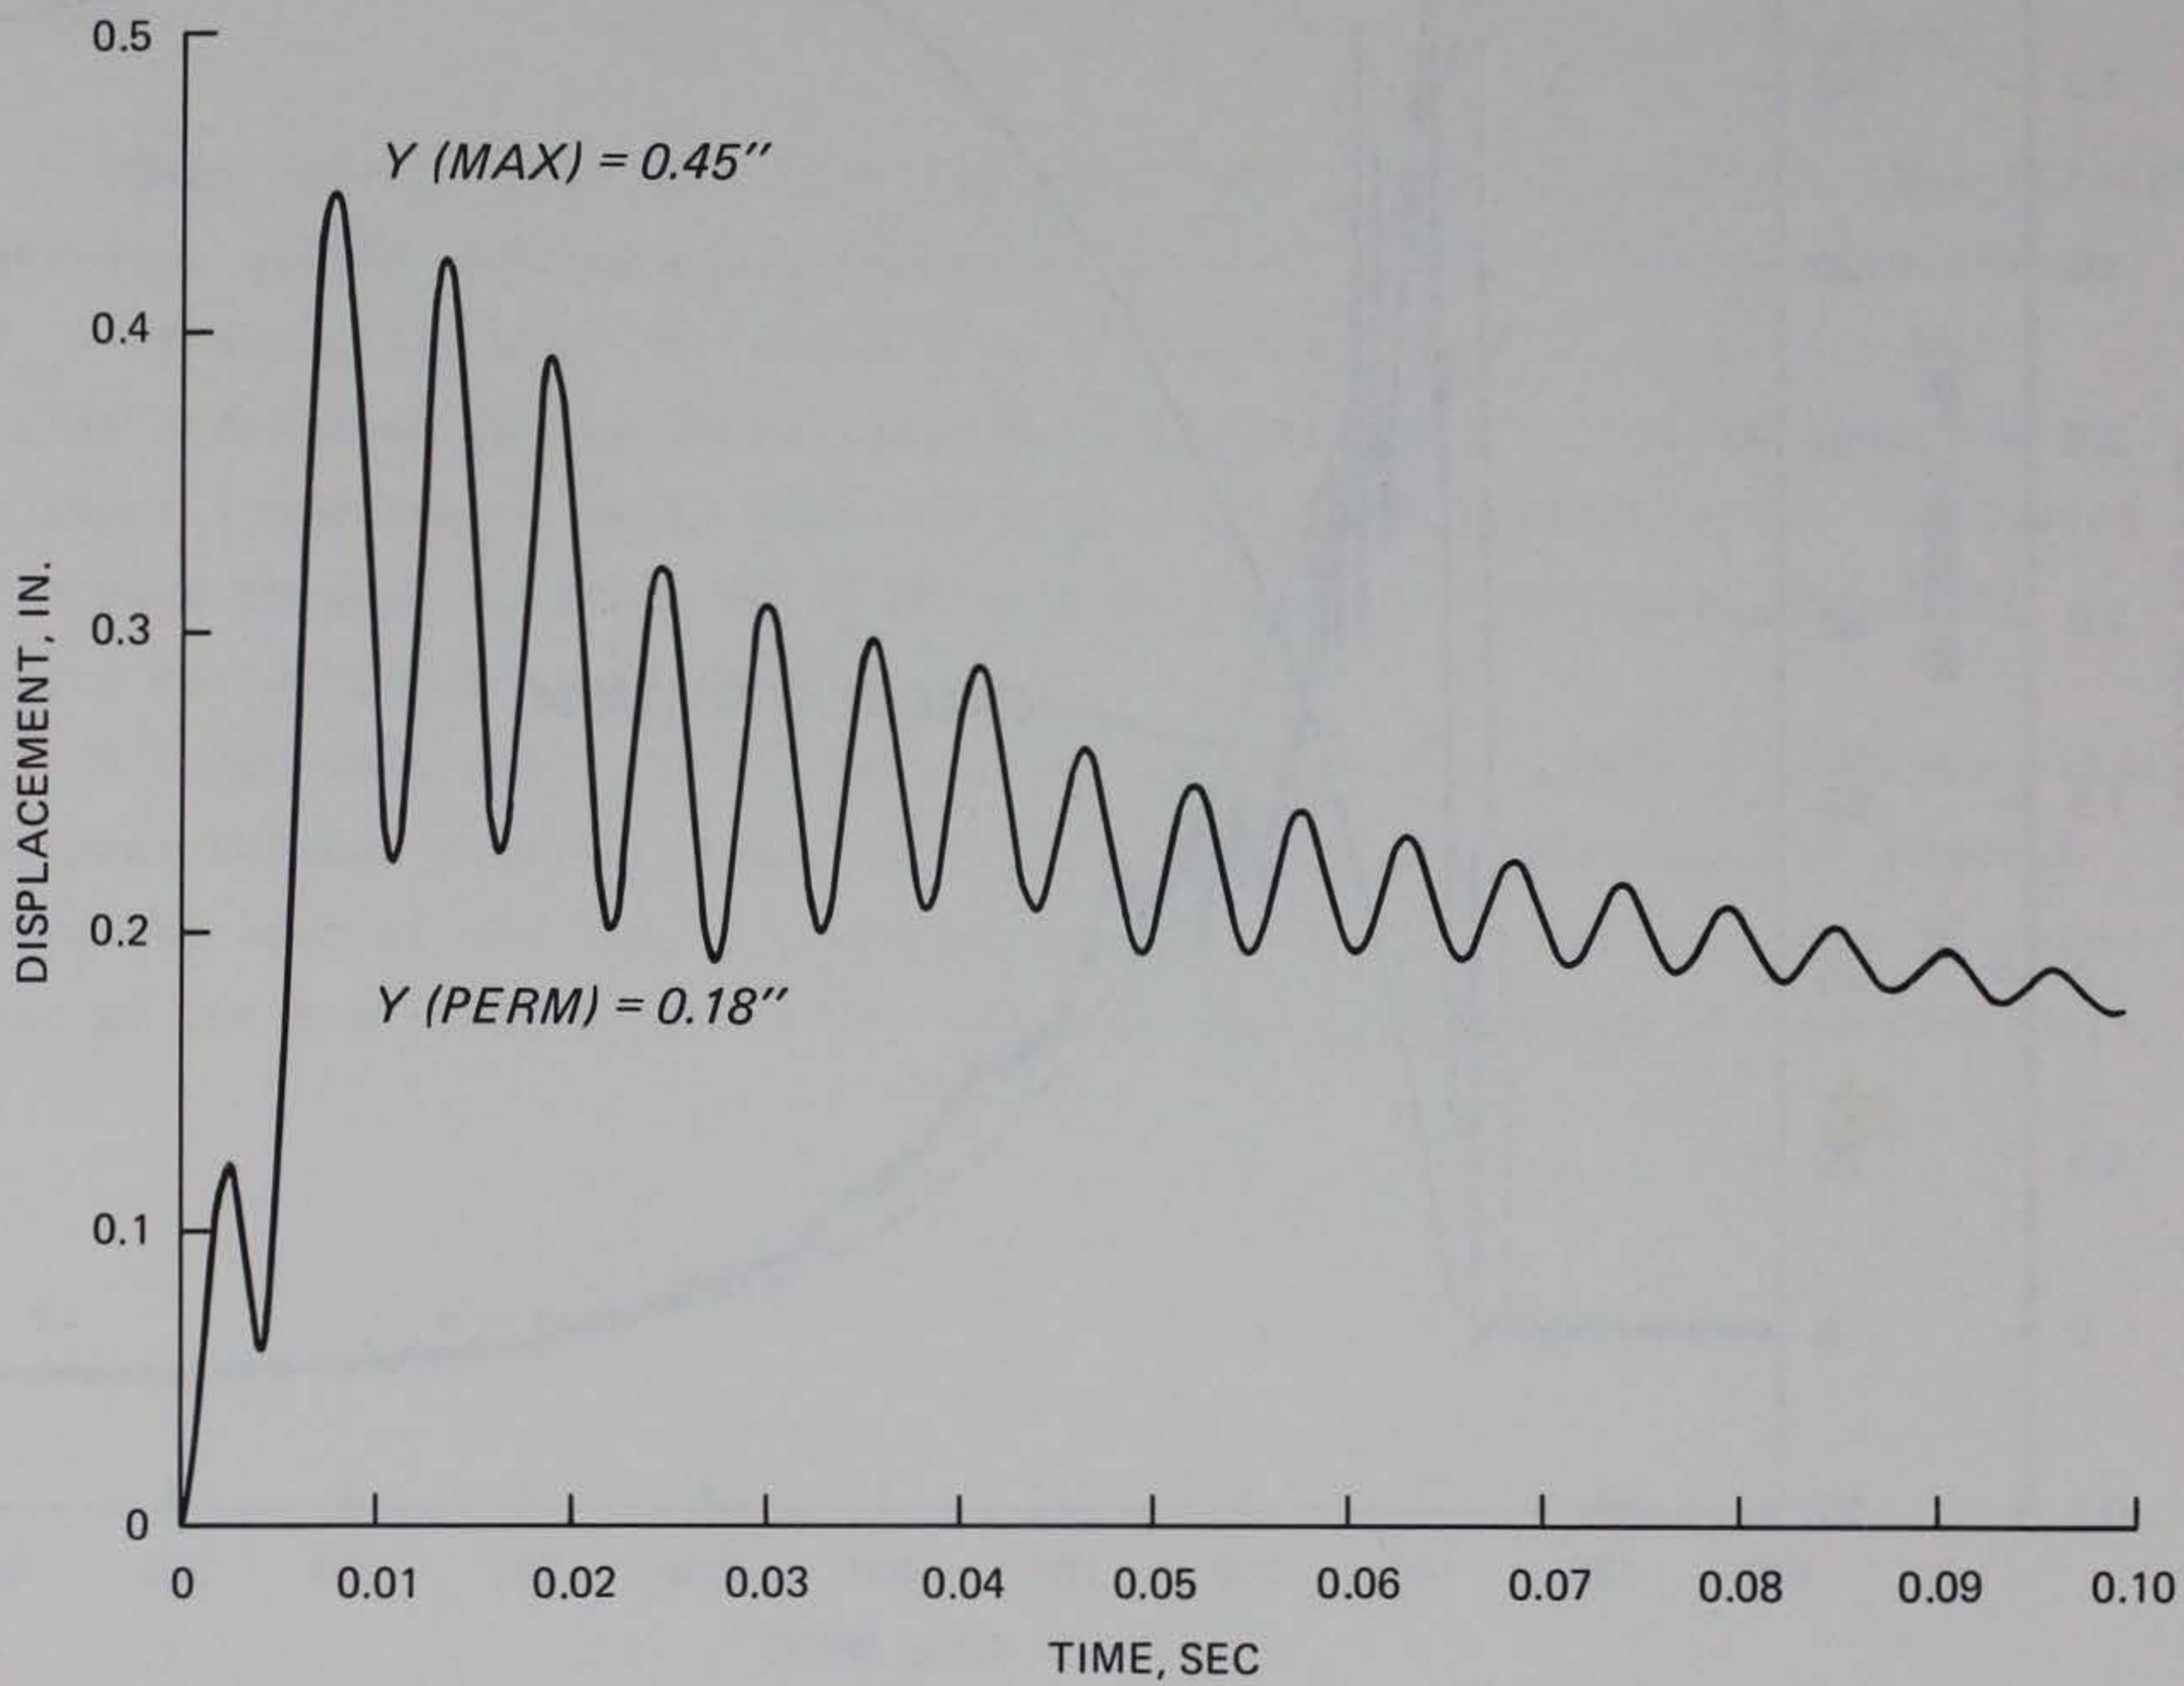
analysis[15] was again performed for the blast door with the airblast record from the center of the door input as the loading function. For this analysis, the door was considered lightly damped (3 percent of critical damping). Results of this analysis are shown in Figure 5.2. The calculated maximum response of the door was 0.45 inch at 8 ms after the door was initially loaded, resulting in a ductility of about 1.7 and a permanent deflection of about 0.18 inch. Recall that the measured permanent deflection in the door was also about 0.18 inch.

Figure 5.2. Calculated response of blast door to DIRECT COURSE loading.
