TECHNICAL REPORT GL-85-11

# DUSTPROOFING UNSURFACED AREAS; FACILITIES TECHNOLOGY APPLICATION TEST DEMONSTRATIONS, FY 84

Clarence R. Styron III, Robert A. Hass, Karen Kelley

Geotechnical Laboratory

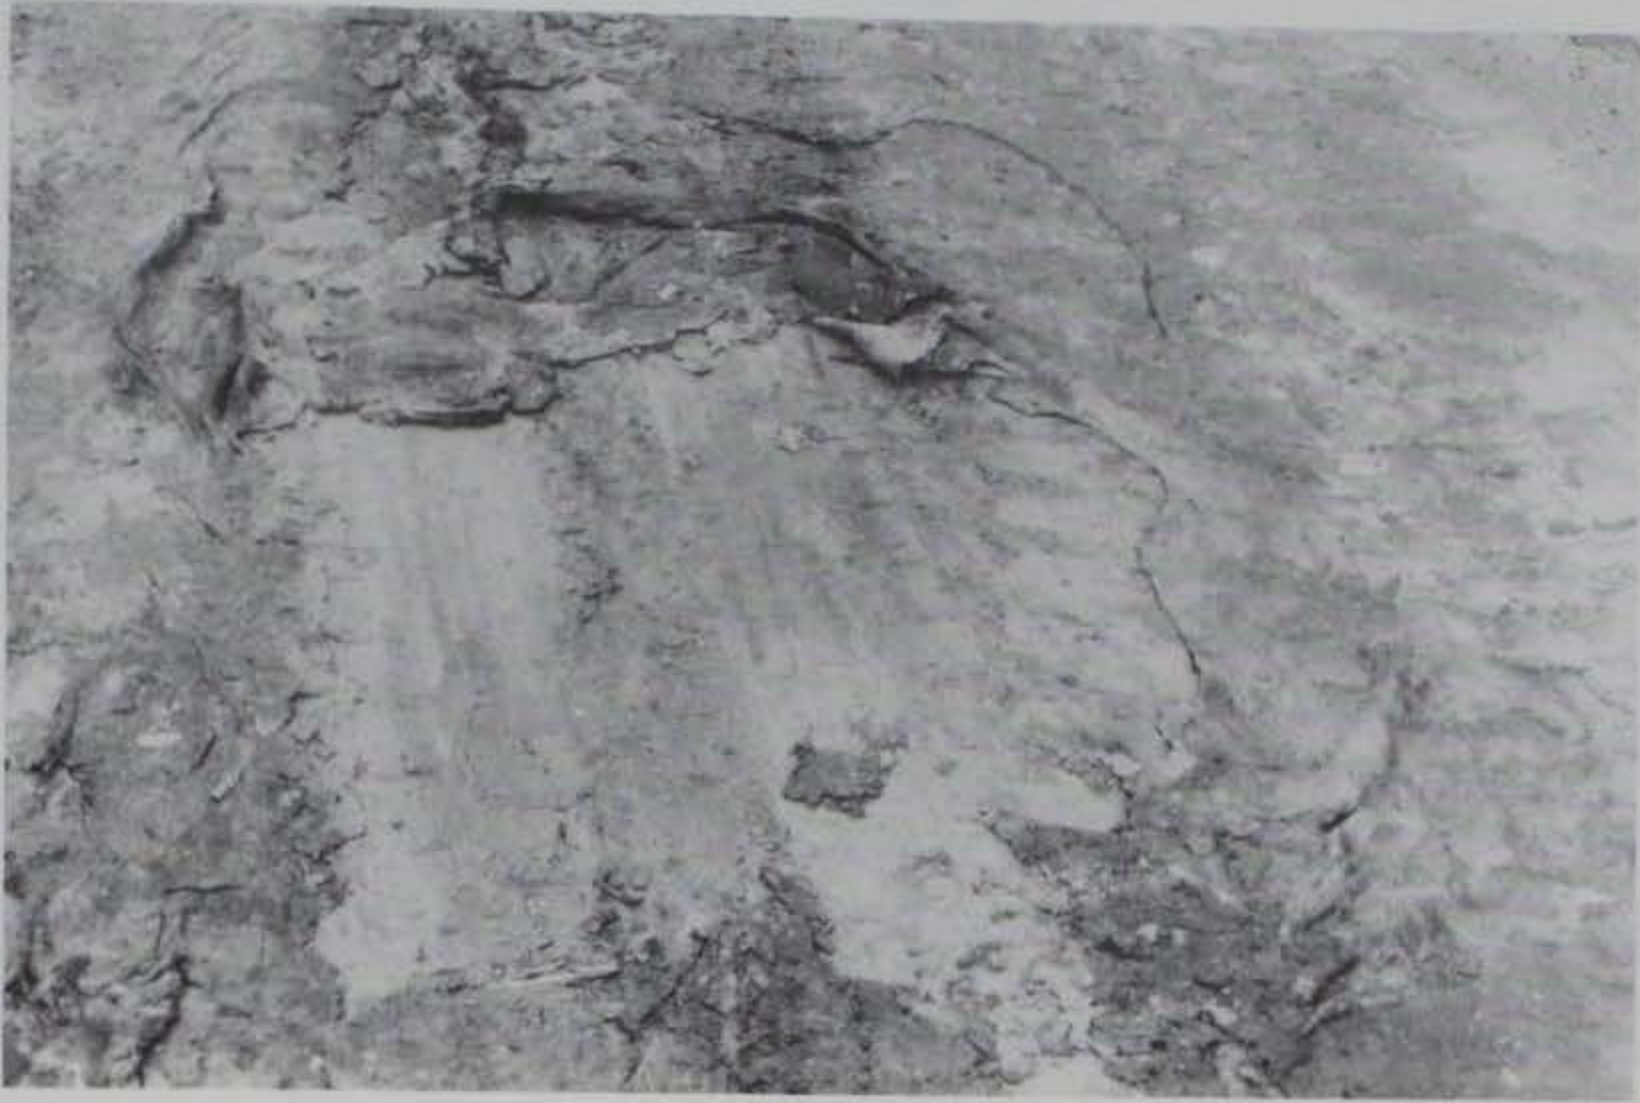
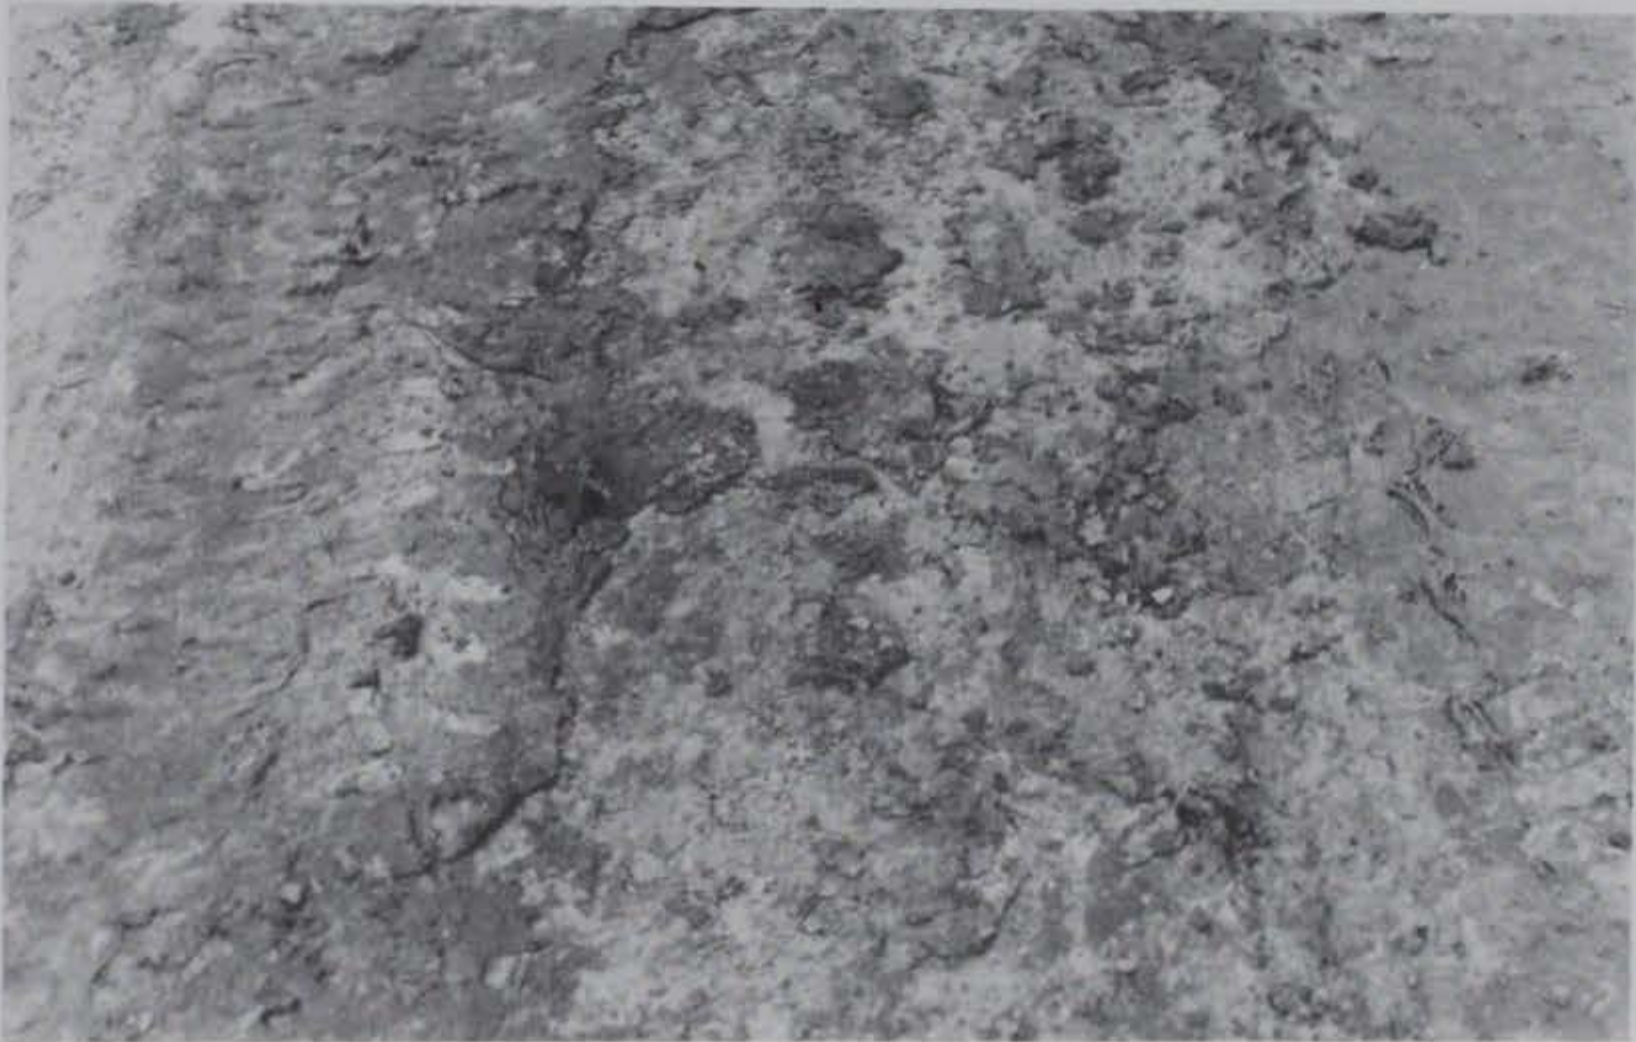
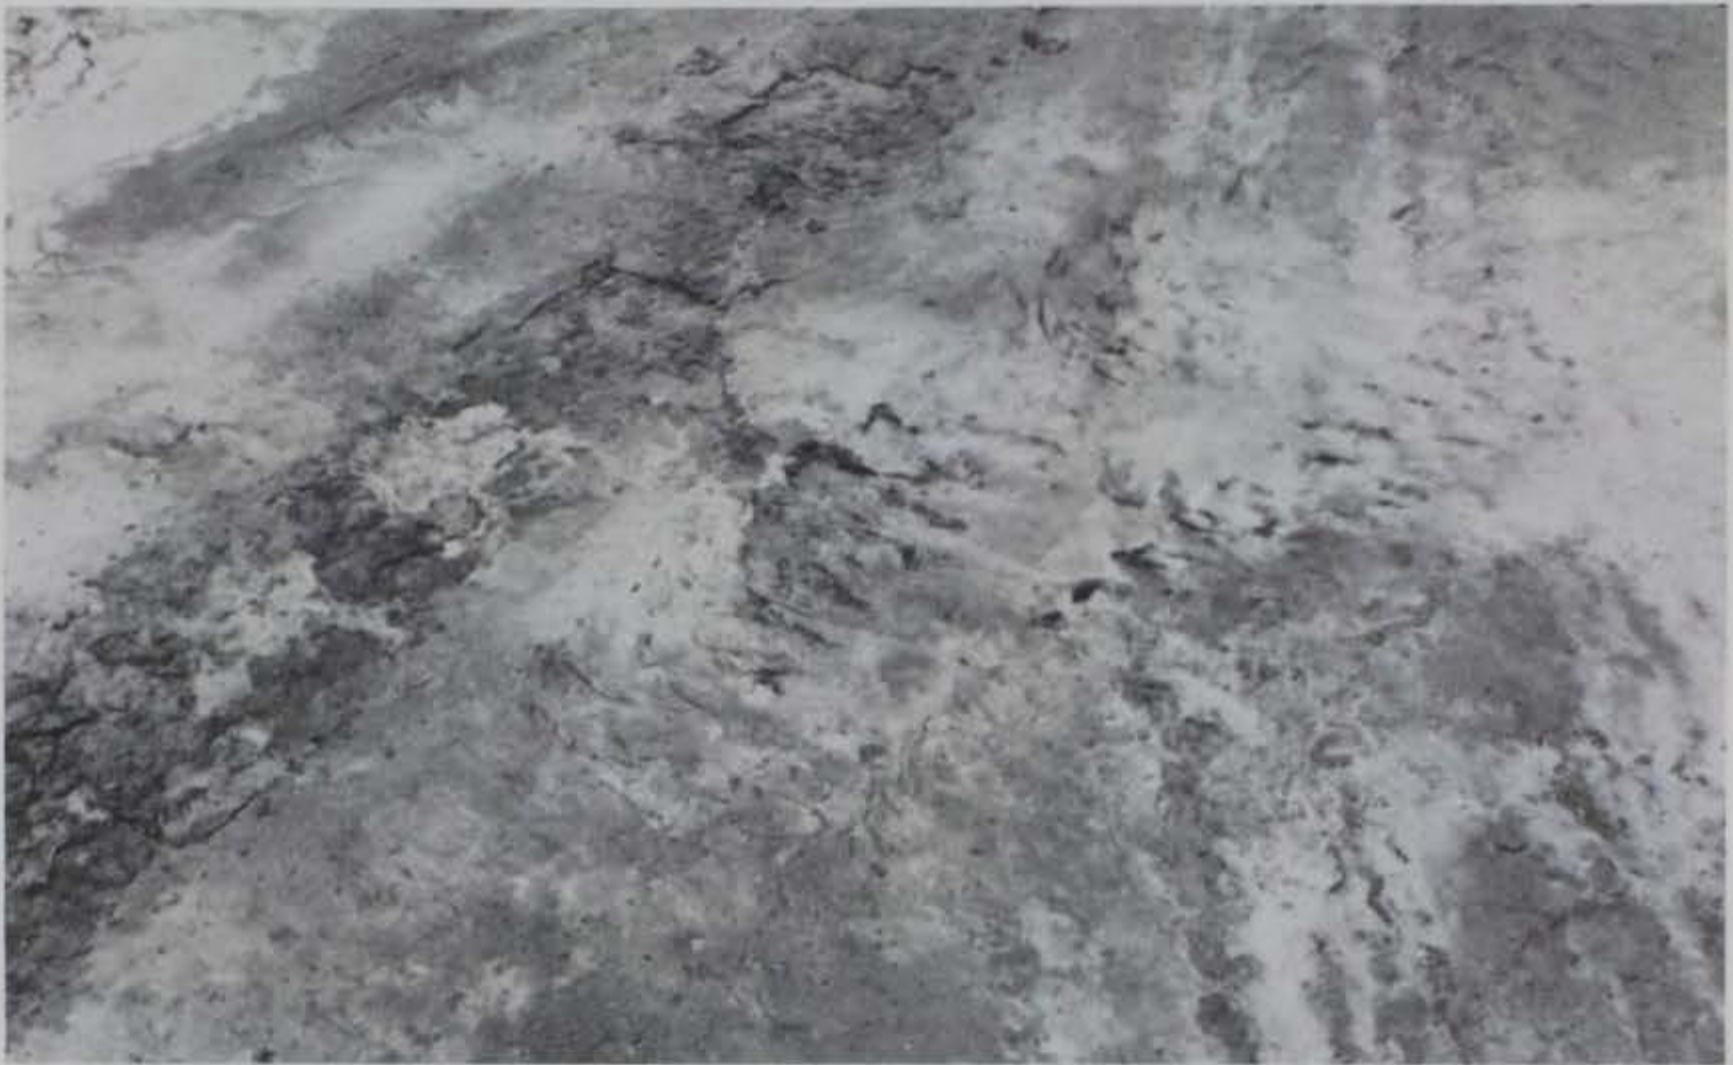
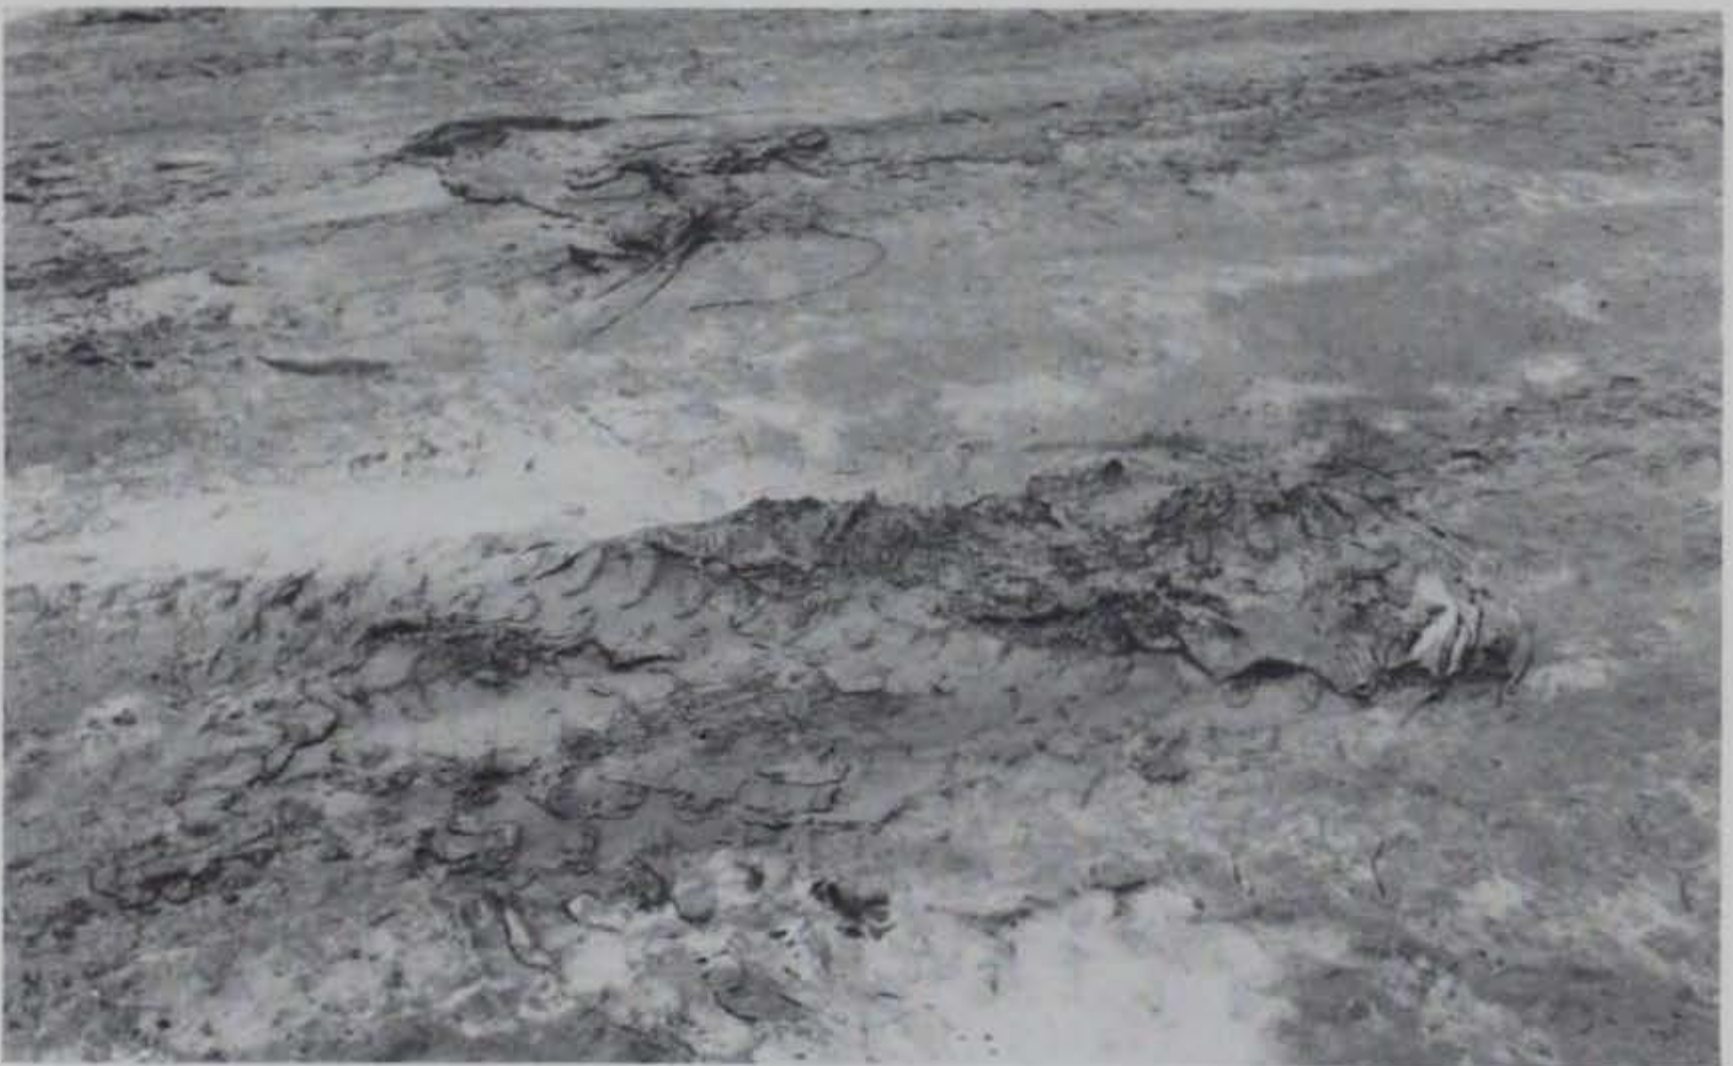
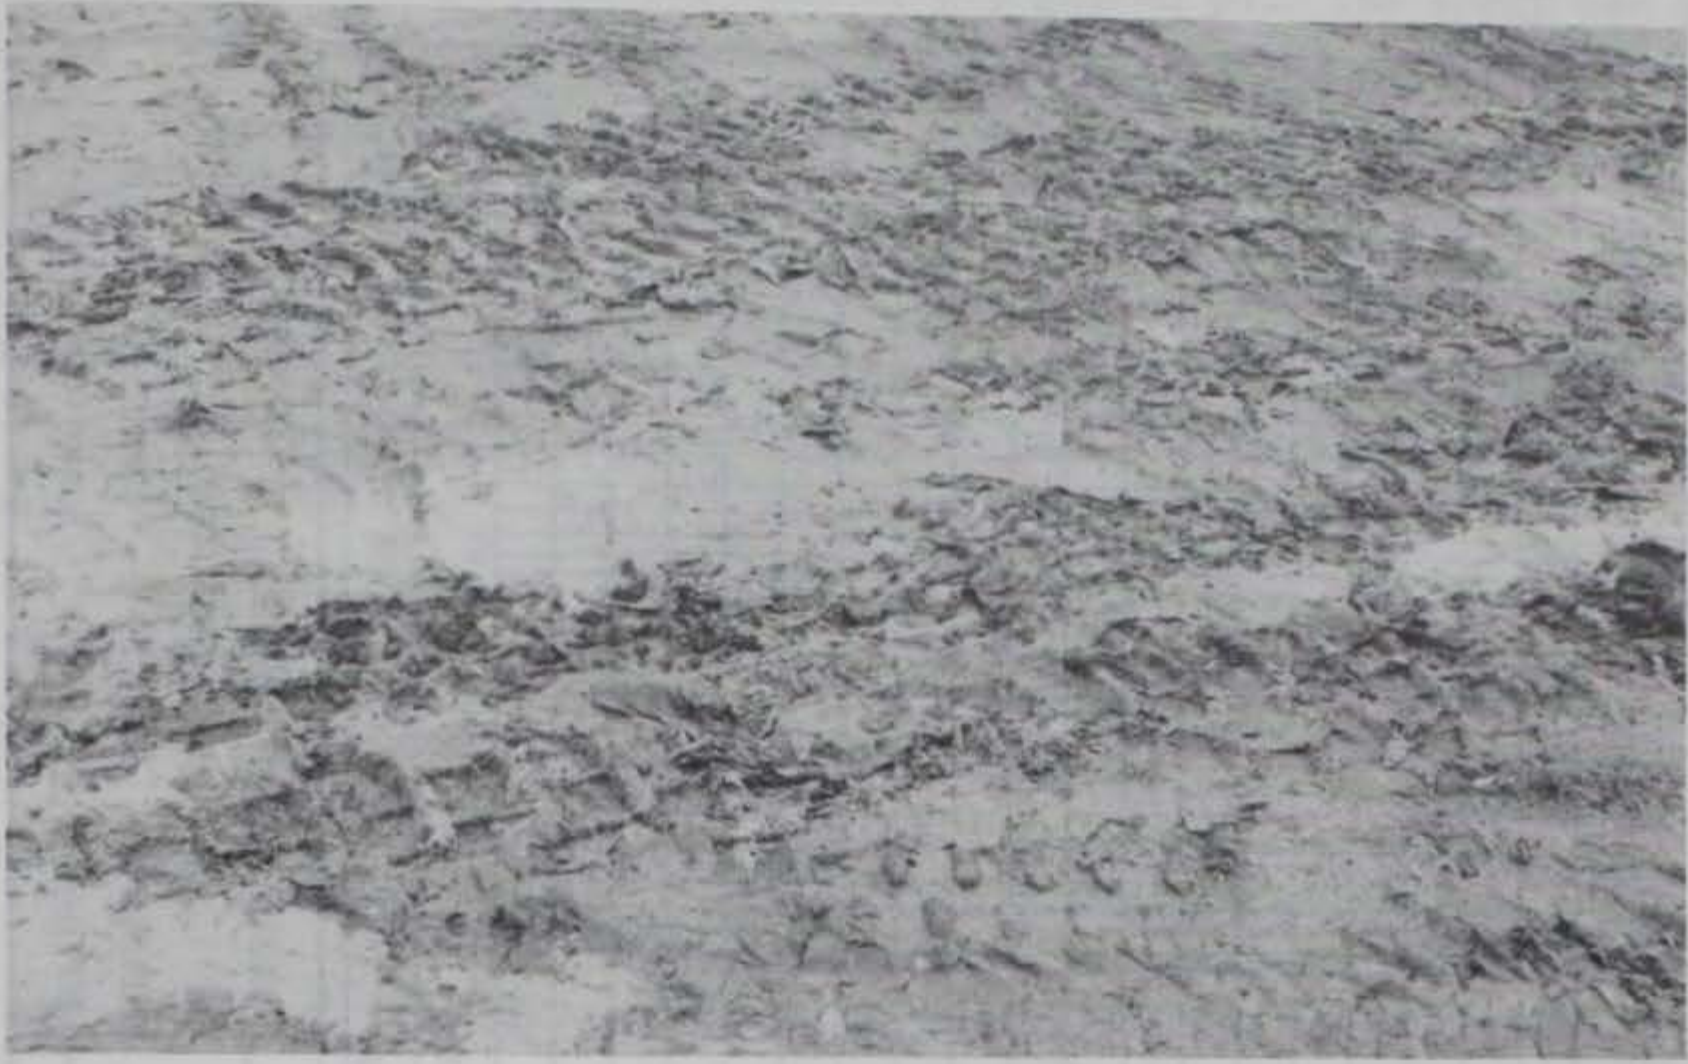
Figure 14. PVA wheel damage prior to cure, Fort Stewart, Ga.  
(Sheet 1 of 3)

34. The PVA section was completed around noon of the second work day. Midmorning of the third work day, ruts and tears caused by numerous passes of at least two large vehicles were observed on the test section. Judging from the way the material stretched and pulled apart, the traffic occurred before the material had completely cured. Vehicles stopping with locked wheels and making fast circular turns had effectively rendered this dust control section an estimated 50 percent effective at this time (midmorning of the third work day) since a large amount of bare untreated material was exposed. Continued traffic of this type will completely destroy this test section. The test section is considered to be of no further practical interest to Facilities Technology Application Test (FTAT) or Research and Development. The two remaining drums of DCA 1295, which would have been used for hand-held spray bar touch-up (if needed) were not used. They would have been insufficient to repair all the damage sustained (Figure 14).
