TECHNICAL REPORT H-74-2

SOUTH ELLENVILLE FLOOD CONTROL PROJECT, RONDOUT CREEK BASIN NEW YORK

Hydraulic Model Investigation

US ARMY ENGINEER WATERWAYS EXPERIMENT STATION VICKSBURG, MISSISSIPPI

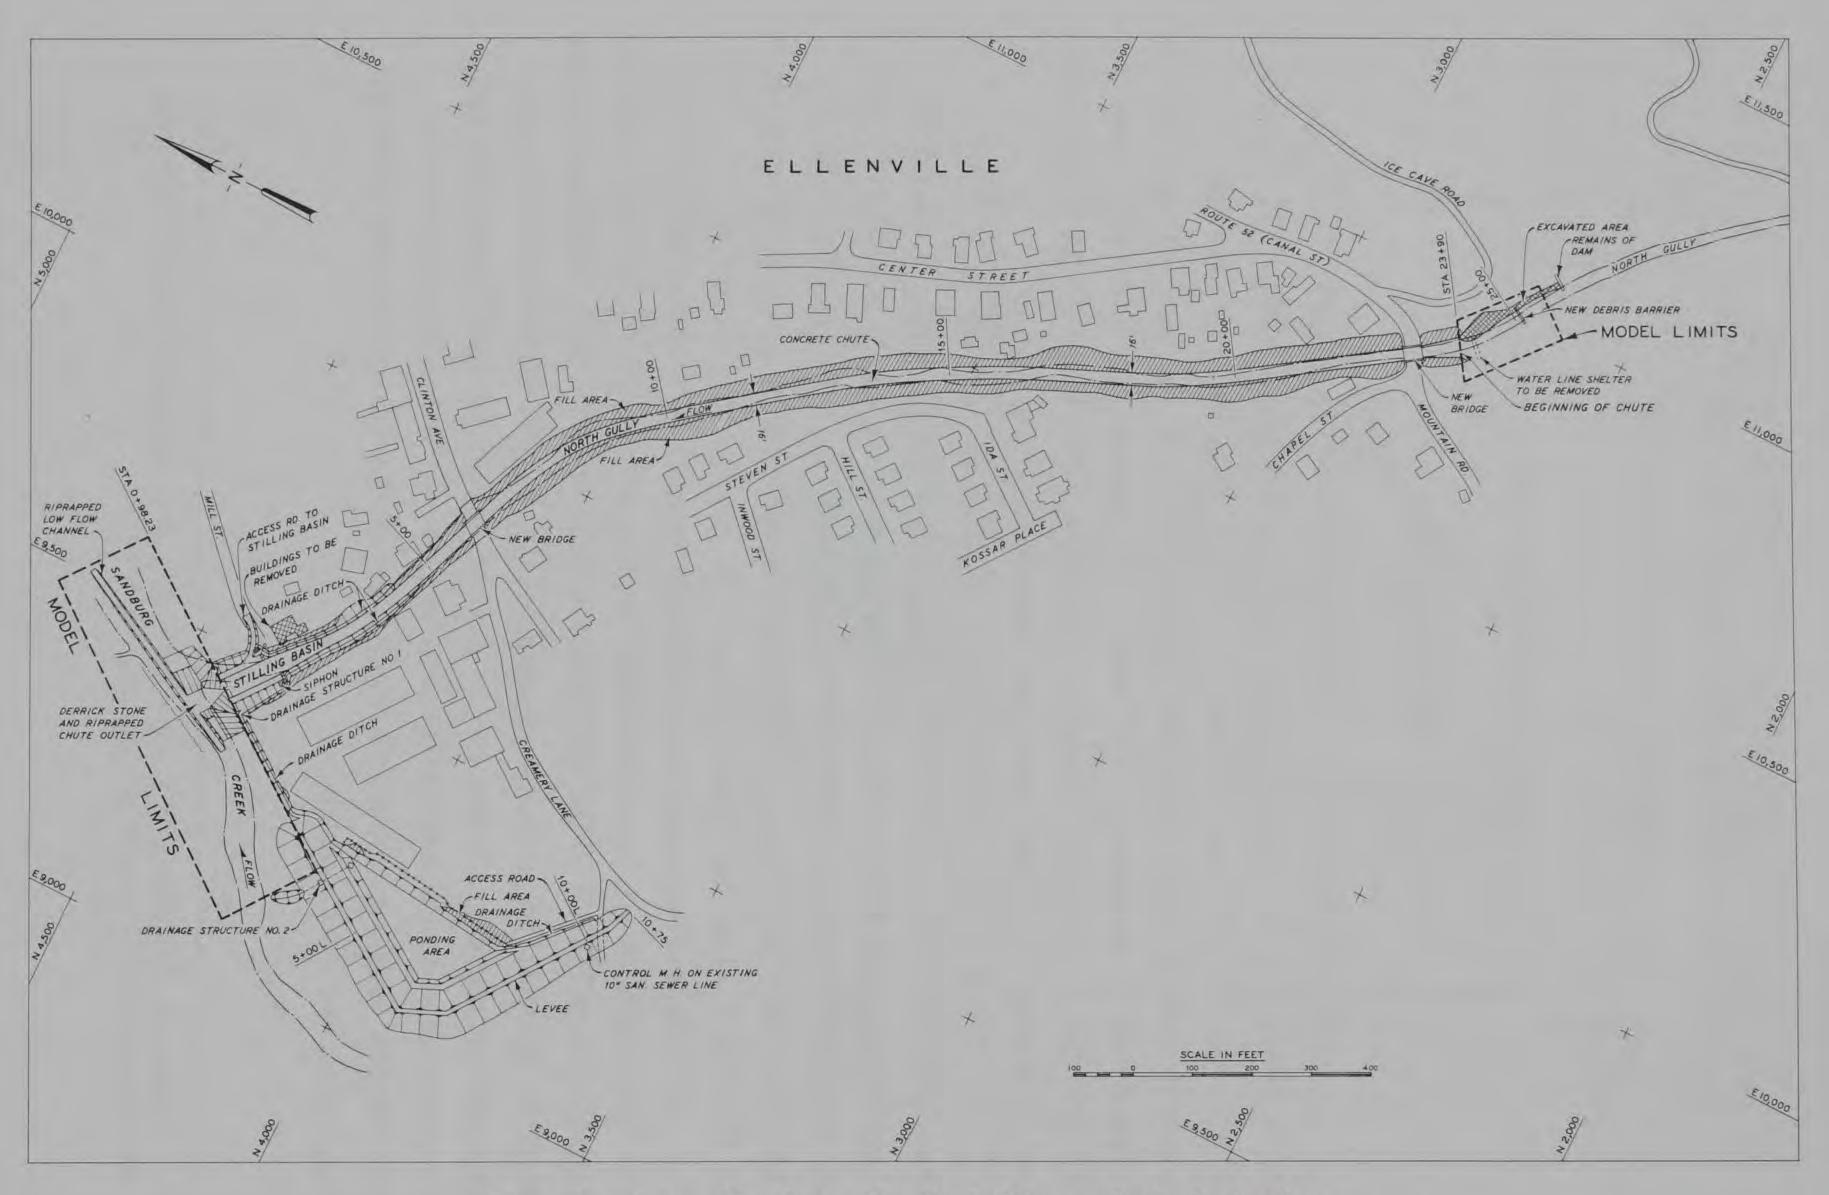
Fig. 2. General plan, North Gully, original design

2. North Gully, known locally as Mountain Brook, is a short flashy stream about 2.4 miles* long with a drainage area of about 2.1 square miles. At Ellenville, the stream flows through developed residential and industrial areas before discharging into Sandburg Creek (fig. 2). The headwaters of North Gully serve as a source of water supply for the village of Ellenville.

4. The plan of improvement to provide protection from the design flood will involve the construction of an upstream debris barrier, 2033 ft of concrete chute, a terminal stilling basin, 325 ft of transition and floodwalls, 782 ft of levee, a ponding area of 1.4 acre-foot capacity, and interior drainage structures along North Gully and the right bank of Sandburg Creek in South Ellenville, N. Y. (fig. 2).

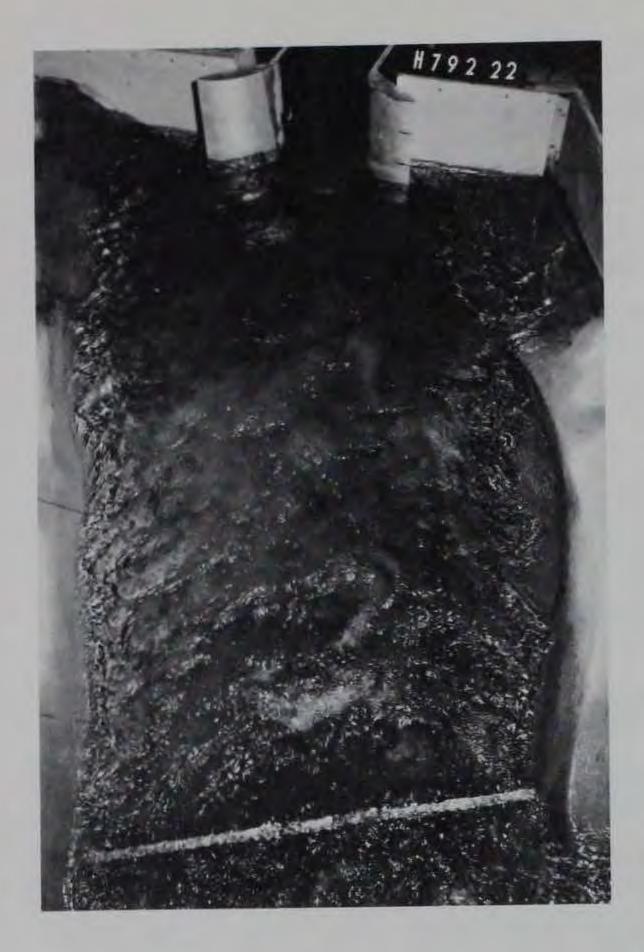
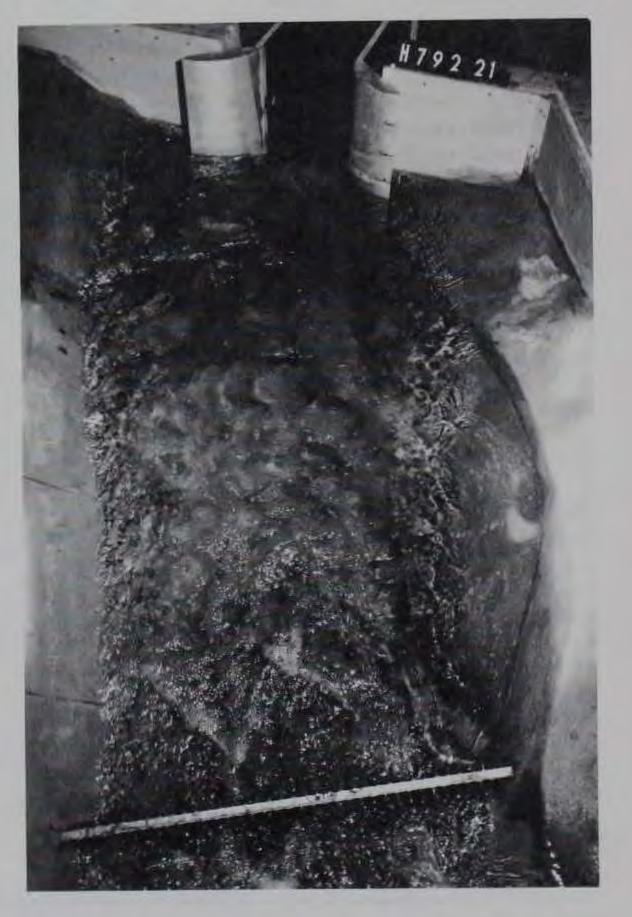
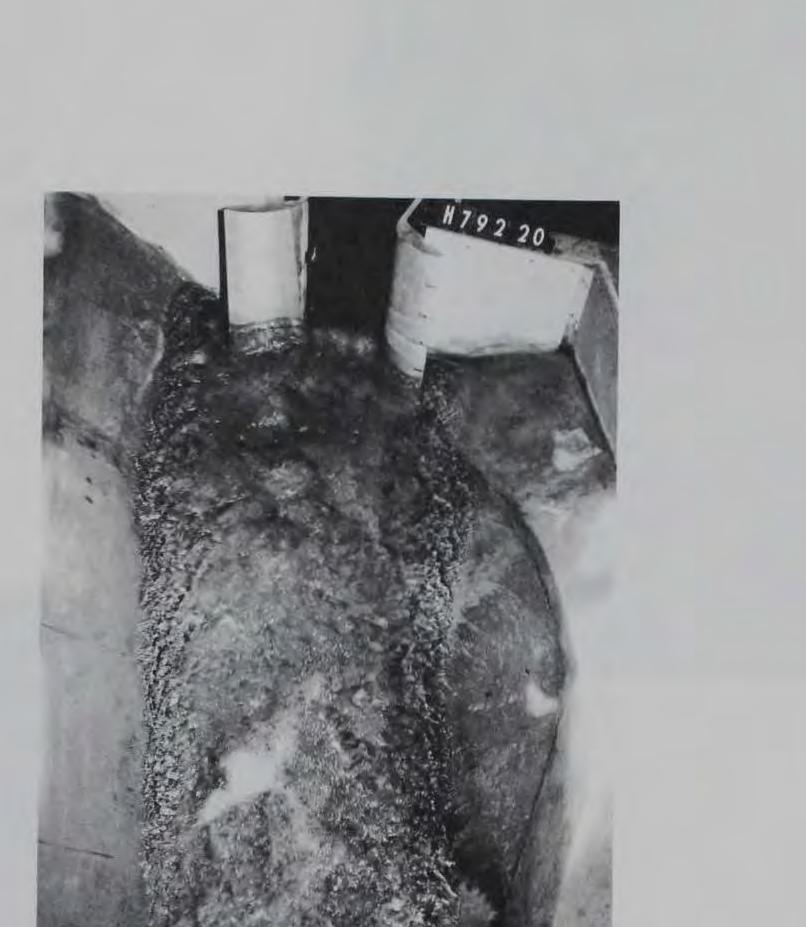
a. Discharge 3750 cfs (design)

b. Discharge 2500 cfs

Photo 1. Flow conditions in approach to North Gully chute, type 2 entrance (sheet 1 of 2)

c. Discharge 1500 cfs Photo 1. (sheet 2 of 2)

Satisfactory subcritical flow conditions were obtained in the 16. approach to the chute for the full range of flows by providing a simple weir (5 ft high) with quadrant wing walls (type 2 design, plate 1) as shown in photos la, b, and c. This design permitted flows as large as 5000 cfs to enter the chute without overtopping the 10-ft-high chute walls. Even for conditions in which the debris barrier was fully choked and debris was level with the top of the weir downstream of the barrier (photos 2a, b, c, and d), flow conditions in the entrance to the chute were satisfactory. Although the type 2 design entrance was satisfactory, the proximity of the weir to the proposed new bridge on Route 52 resulted in moving the entrance to the chute 23.7 ft upstream into North Gully (type 3 design, plate 1). Flow conditions were satisfactory for all discharges, and even the presence of large rocks and boulders choking the debris barrier and chute entrance had little effect on flow conditions at the entrance to the chute (photos 3a, b, c, and d). Type 4 design

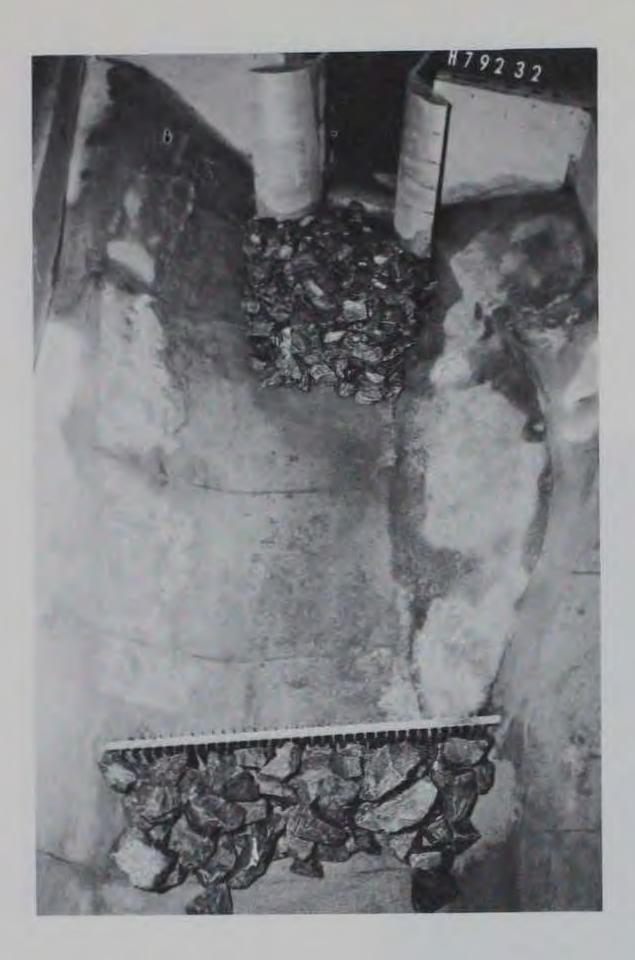
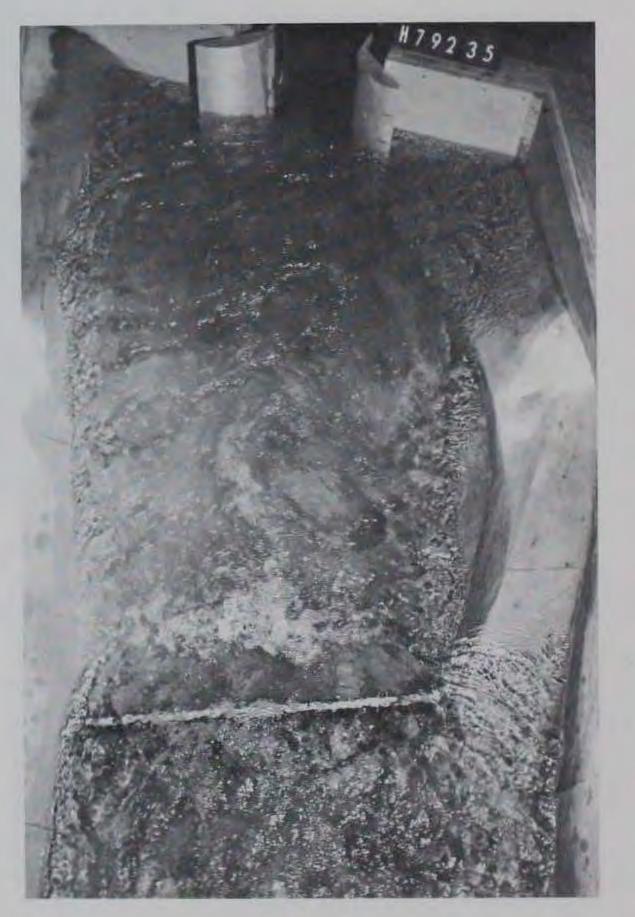
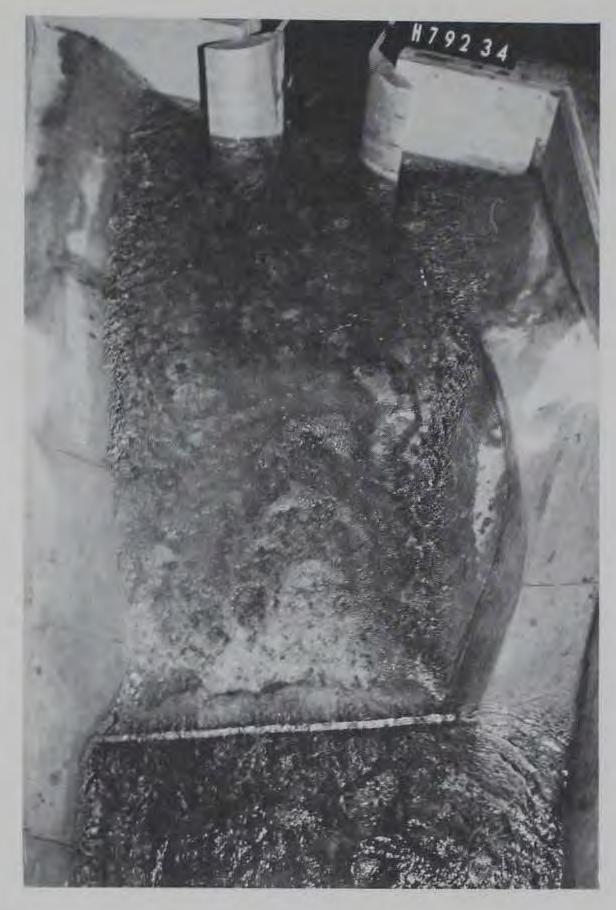
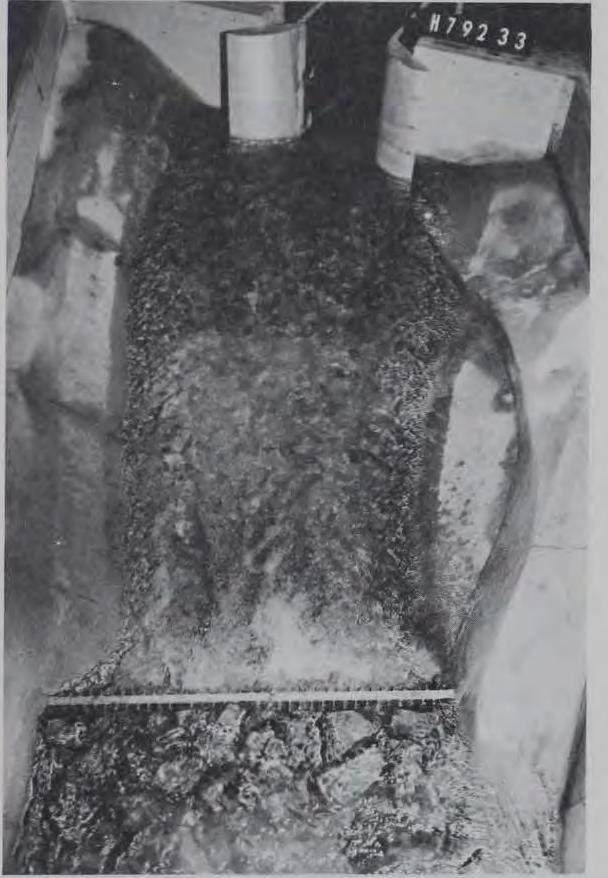
a. Dry bed

b. Discharge 3750 cfs

Photo 2. Type 2 entrance, debris accumulated upstream of barrier and weir (sheet 1 of 2)

c. Discharge 2500 cfs

d. Discharge 1500 cfs

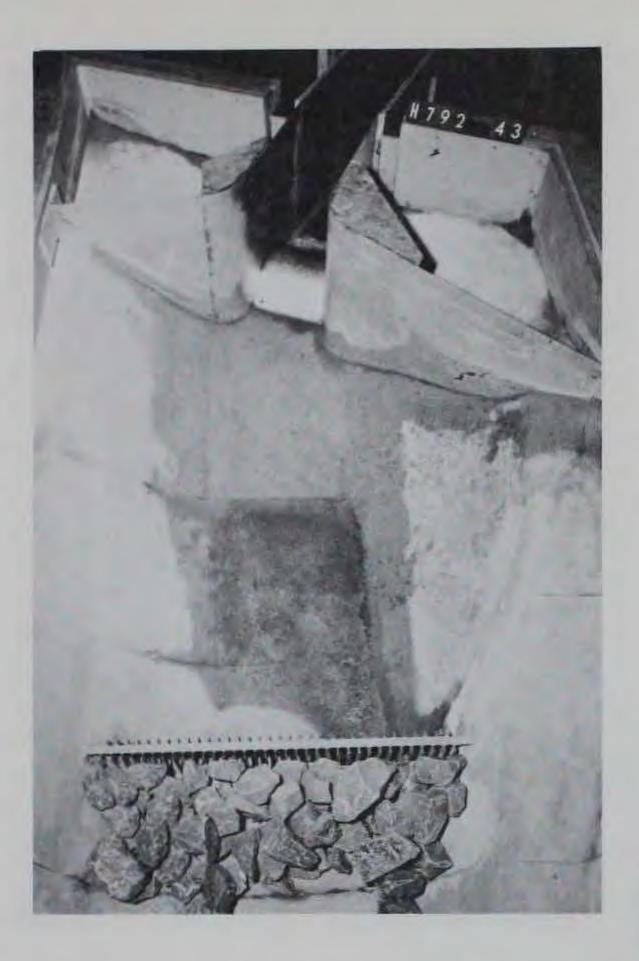
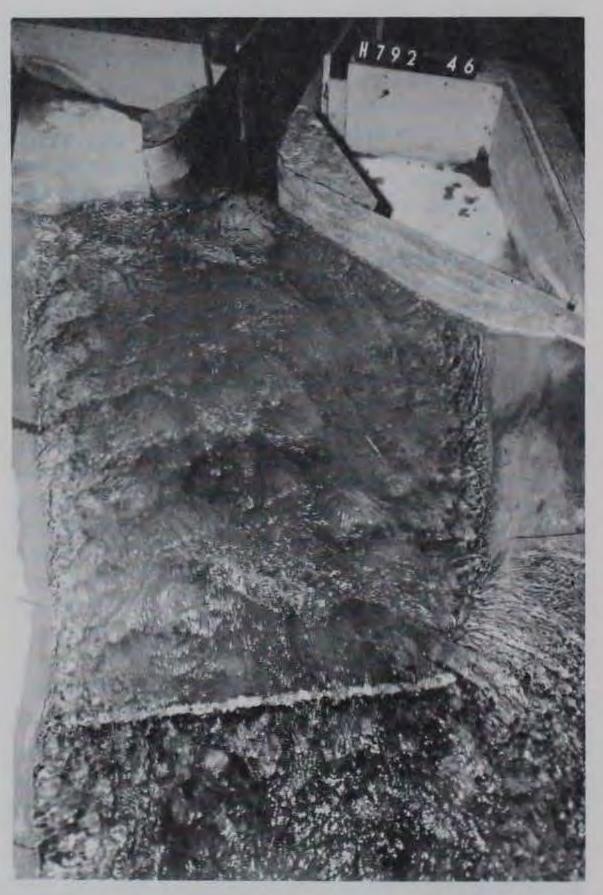
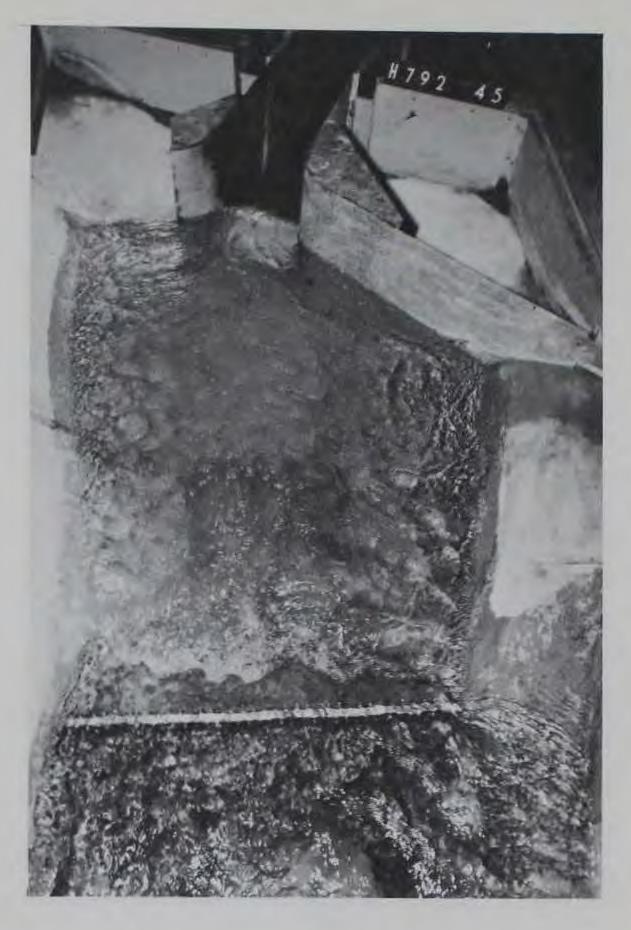
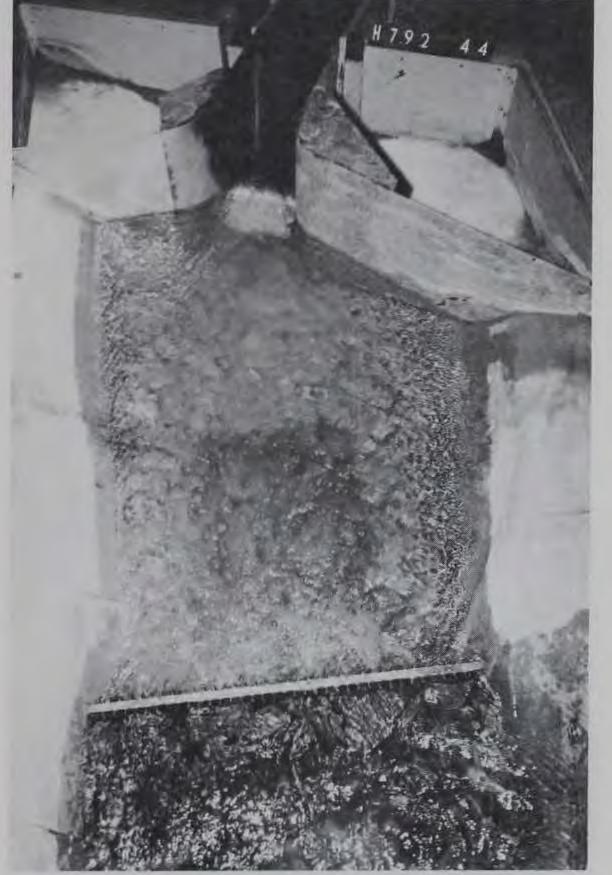
a. Dry bed

Photo 3. Type 3 entrance, debris upstream of barrier (sheet 1 of 2)

b. Discharge 3750 cfs

c. Discharge 2500 cfs

d. Discharge 1500 cfs

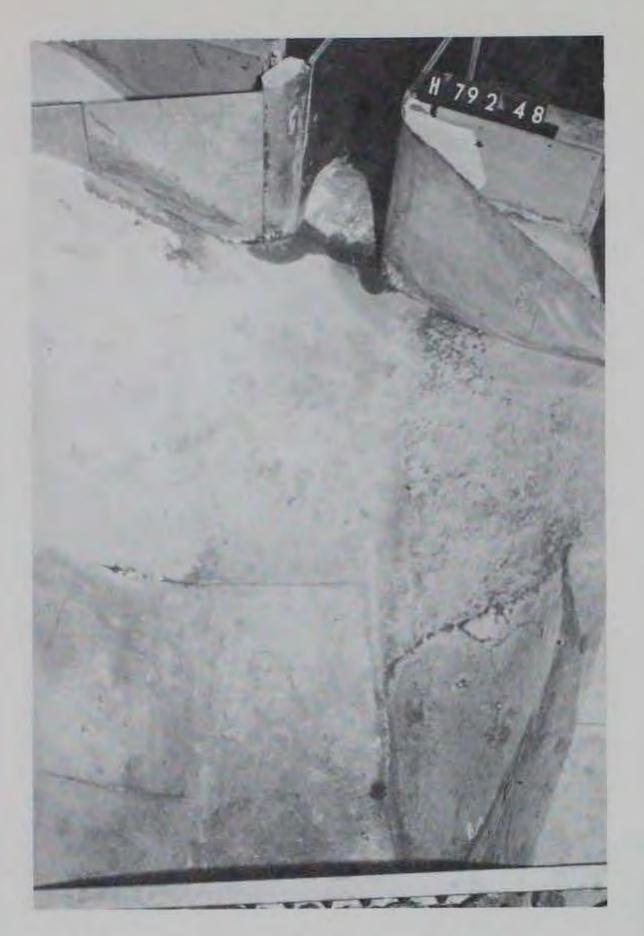
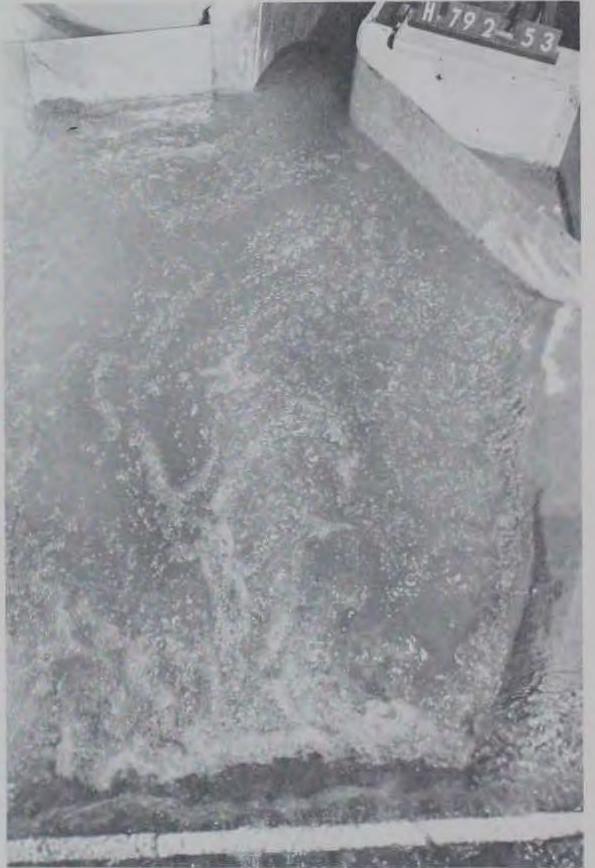
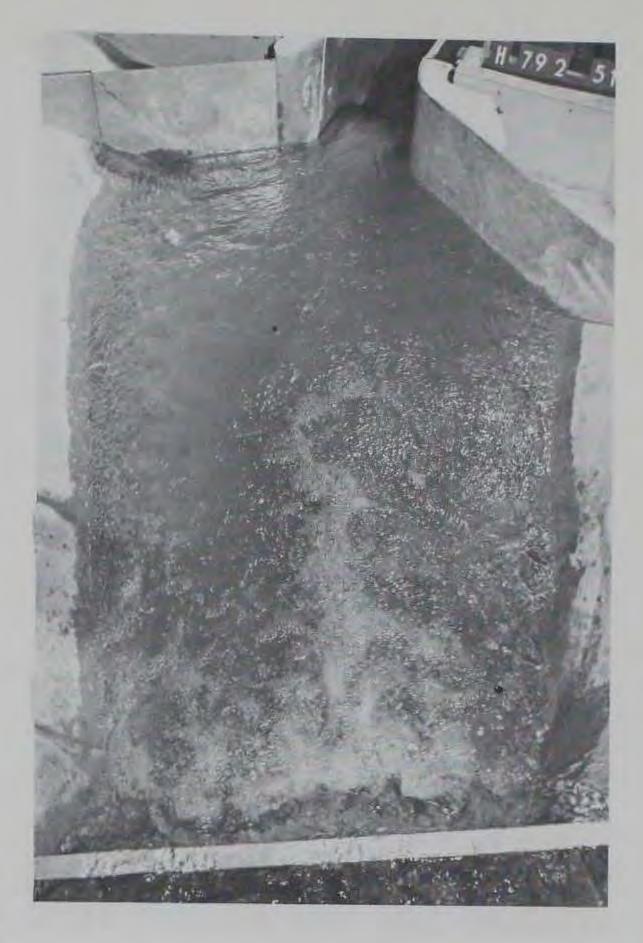
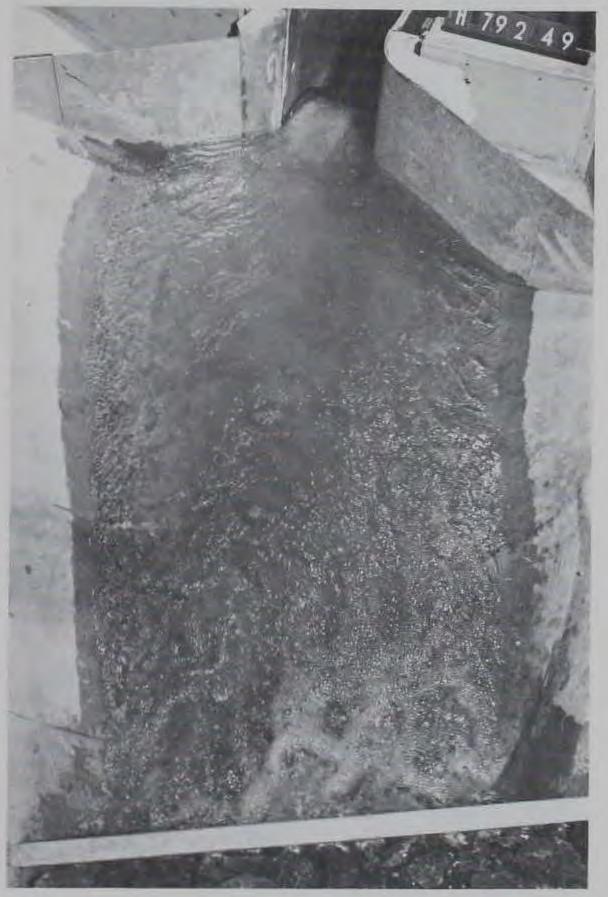
a. Dry bed

b. Discharge 3750 cfs

Photo 4. Type 4 entrance, debris upstream of barrier; sta 25+05, el 458.0. (sheet 1 of 2)

c. Discharge 2500 cfs

d. Discharge 1500 cfs

18. Shown in plate 2 are the locations and elevations of the various debris barriers investigated in conjunction with the type 4 design entrance. Photos 4a, b, c, and d show a dry-bed view and flow conditions with the type 4 design entrance installed in the model. The following are general conclusions as to the effect of location and height of the debris barriers in North Gully on entrance conditions to the highvelocity chute:

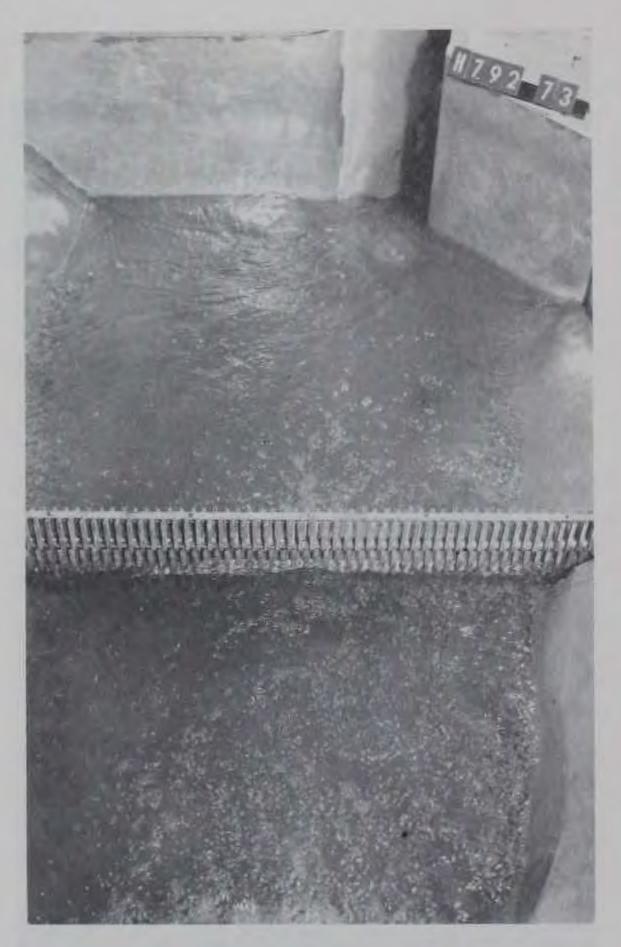
a. Dry bed

b. Discharge 3750 cfs; flow is distributed across approach channel

> Photo 5. Type 5 entrance, unchoked debris barrier; sta 24+55, el 468.0. (sheet 1 of 2)

c. Discharge 2500 cfs; majority of flow along left bank of approach channel

d. Discharge 1500 cfs; majority of flow along left bank of approach channel

maintain this criterion and to obtain additional debris storage, the debris barrier (el 468.0) and the chute entrance were moved downstream to sta 24+55 and 23+65, respectively (type 5 design, plate 1, photo 5a). In order to improve flow conditions, the height of the weir was raised from 5 ft to 7.25 ft.

20. This arrangement resulted in the center line of the chute being offset an additional 8 to 9 ft to the right of the center line of the approach channel, and caused the lower flows (1500 and 2500 cfs) to be concentrated along the left bank of the approach (photos 5c and d). This resulted in considerable runup and splash-over along the 10-fthigh left chute wall in the vicinity of the Route 52 bridge. With the design discharge (3750 cfs), flow was more evenly distributed across the approach channel at the entrance to the chute (photo 5b); and no overtopping of the chute walls occurred downstream of the weir. Tests with the debris barrier choked with rock revealed better flow conditions at the chute entrance than those observed with the unchoked barrier (photos 6a, b, c, and d).

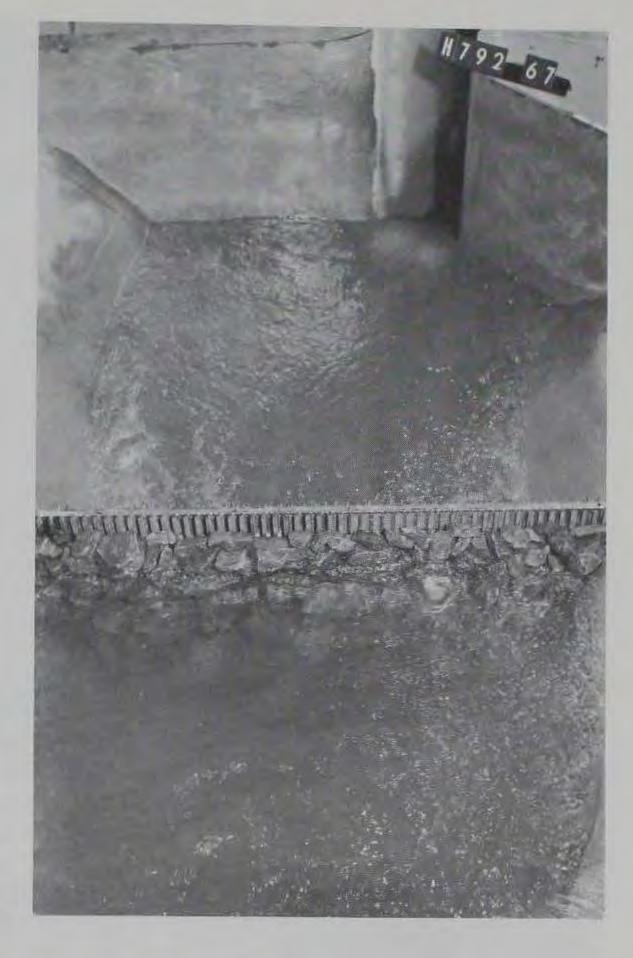
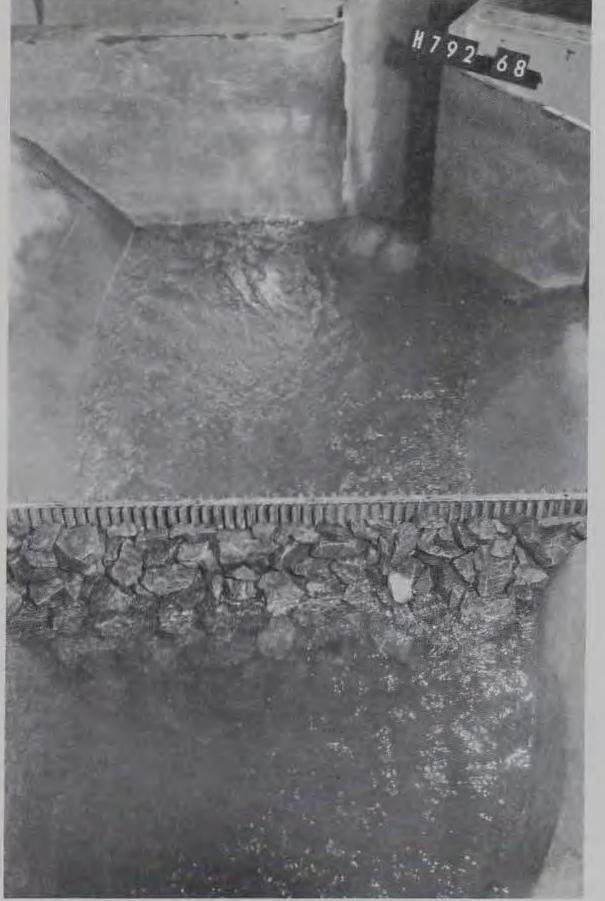
b. Discharge 3750 cfs

Photo 6. Type 5 entrance, fully choked debris barrier; sta 24+55, el 468.0. (sheet 1 of 2)

c. Discharge 2500 cfs

d. Discharge 1500 cfs

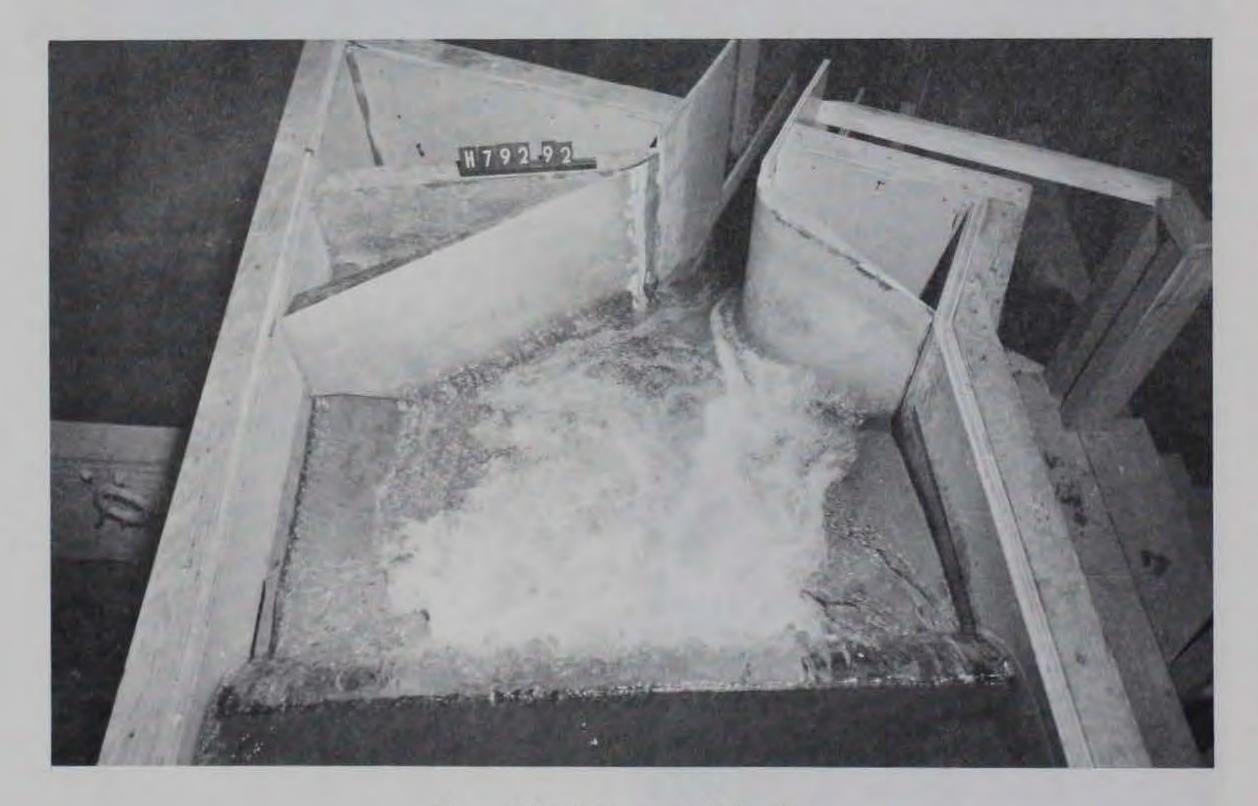
a. Dry bed

b. Discharge 3750 cfs

Photo 7. Type 5 entrance, choked debris barrier; sta 24+55, el 478.5. (sheet 1 of 3)

c. Discharge 2500 cfs

d. Discharge 1500 cfs

e. Discharge 1000 cfs

f. Discharge 730 cfs

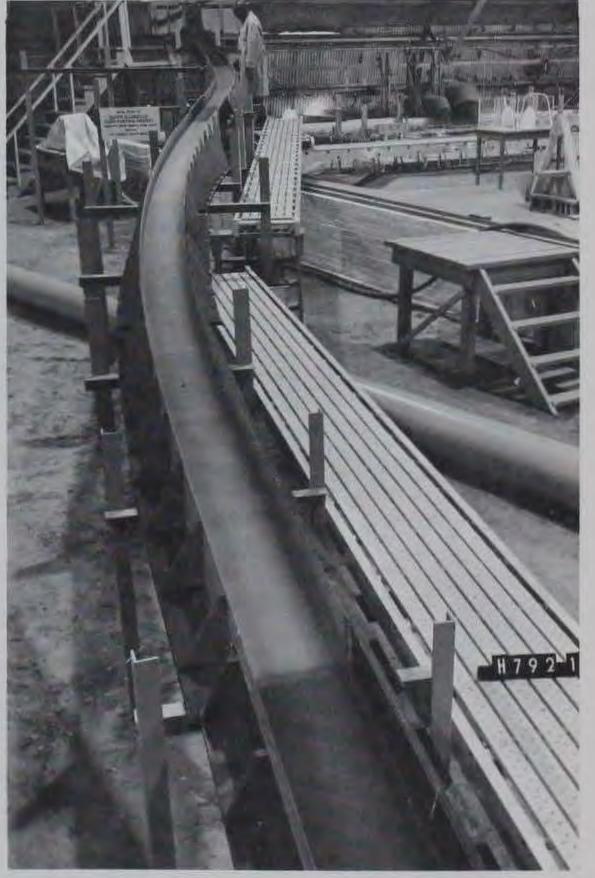
a. Discharge 3750 cfs

b. Discharge 2500 cfs

Photo 9. Flow conditions in original chute looking upstream from sta 11+59.46 (sheet 1 of 2)

c. Discharge 1500 cfs Photo 9. (sheet 2 of 2)

27. In tests of the original design, flow conditions were generally satisfactory throughout the reach for the full range of discharge (photos 9 and 10). However, a cross-wave pattern originating at S.C. sta 4+55.36 and continuing to T.S. sta 4+05.86 was observed at a flow of 1500 cfs (see photo 11). This wave pattern resulted in uneven flow distribution in the stilling basin at the lower discharges (300 to 1500 cfs).

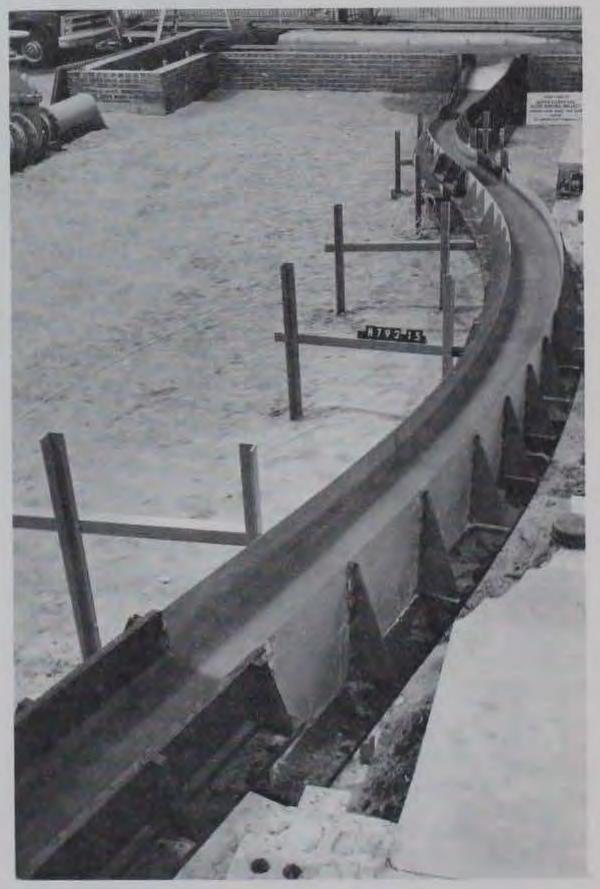
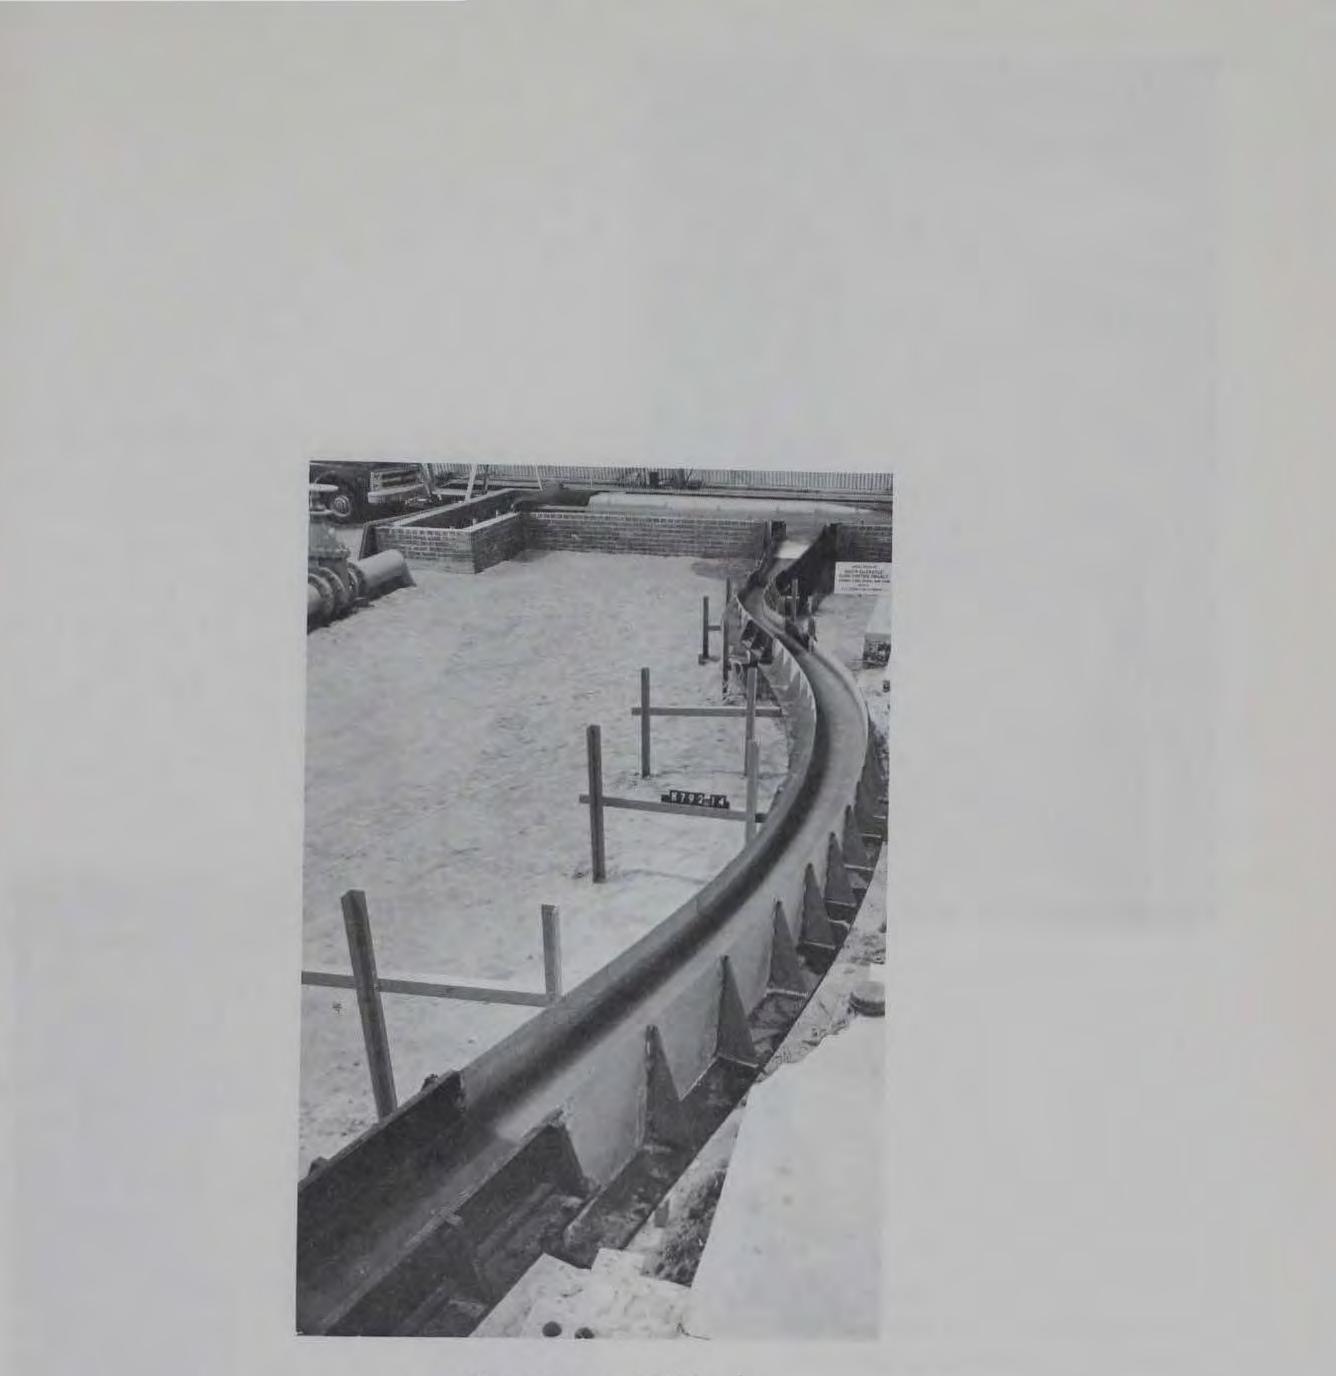
a. Discharge 3750 cfs

b. Discharge 2500 cfs

Photo 10. Flow conditions in original chute looking downstream from sta 10+11.49 (sheet 1 of 2)

c. Discharge 1500 cfs Photo 10. (sheet 2 of 2)

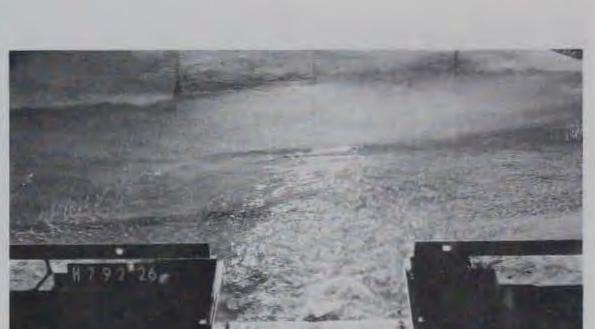
b. Discharge: North Gully 2500 cfs Sandburg Creek 0 cfs

Photo 12. Flow conditions in the original design stilling basin, end-sill control (sheet 1 of 2)

c. Discharge: North Gully 1500 cfs Sandburg Creek 0 cfs

d. Discharge: North Gully 600 cfs Sandburg Creek 0 cfs

32. With the end sill as the control, flow conditions in the original design stilling basin were satisfactory at the intermediate and design flows (2500 and 3750 cfs), although the toe of the jump extended downstream into the stilling basin some 25 to 30 ft at the design discharge of 3750 cfs (photos 12a and b). However, at the smaller discharges (600 to 1500 cfs), end-sill control tended to submerge the jump with resulting eddy action in the basin (photos 12c and d). In several

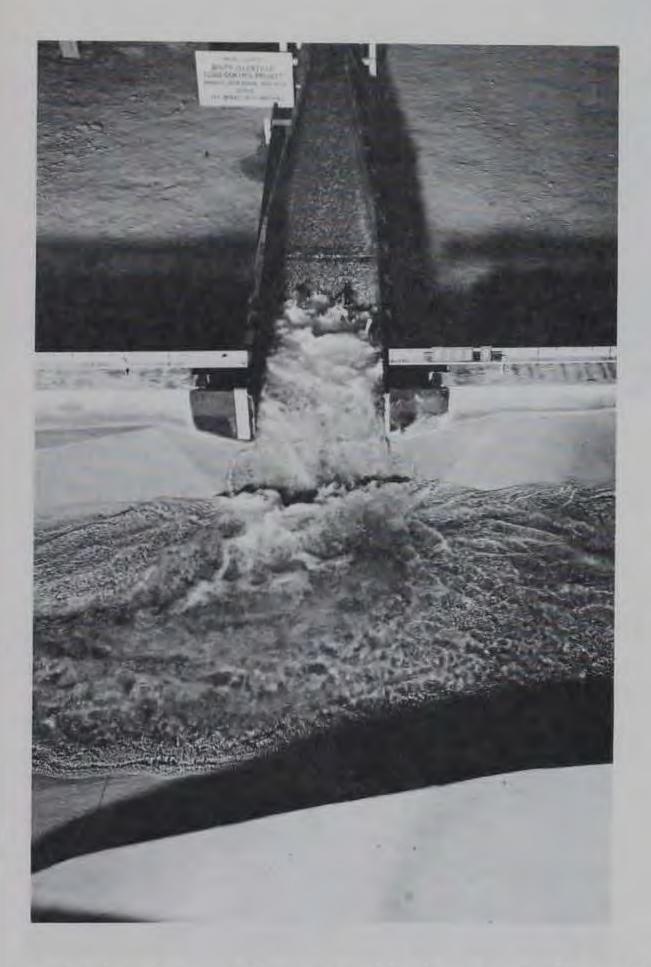
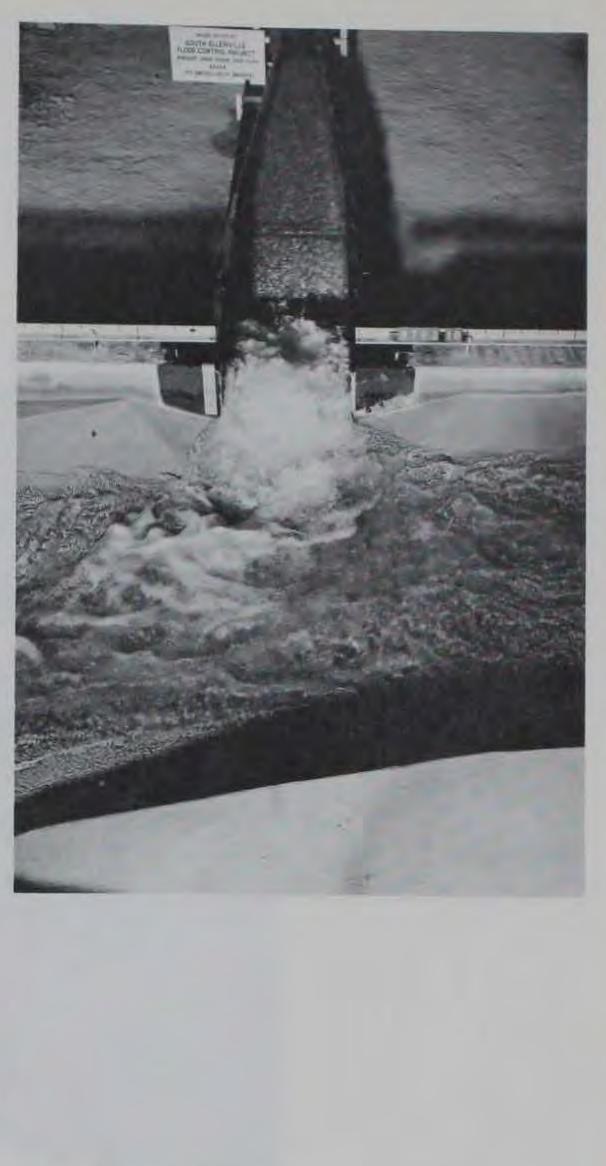
Discharge:	
North Gully	2500 cfs
Sandburg Creek	0 cfs

Photo 15. Flow conditions at the junction of North Gully and Sandburg Creek in original design stilling basin. Discharges 1500, 2500, and 3750 cfs in North Gully and 0 cfs in Sandburg Creek (sheet 1 of 2)

c. Discharge: North Gully 1500 cfs Sandburg Creek 0 cfs

cases when the end sill was removed and tailwater levels were reduced, the eddy action continued, influenced by unbalanced flow entering the basin at the low discharges. This eddy action also was apparent when high flows in Sandburg Creek submerged jump action in the North Gully basin (photos 13a and b). With rocks or gravel in the basin, these eddies could cause considerable abrasion to the stilling basin. Flow conditions at the junction of North Gully and Sandburg Creek appeared satisfactory when the latter was flowing full (photos 14a and b); however, when flow through North Gully was considerable with little or no flow in Sandburg Creek, flow from North Gully tended to attack the bottom and sides of Sandburg Creek at the junction of the two streams (photos 15a, b, and c).

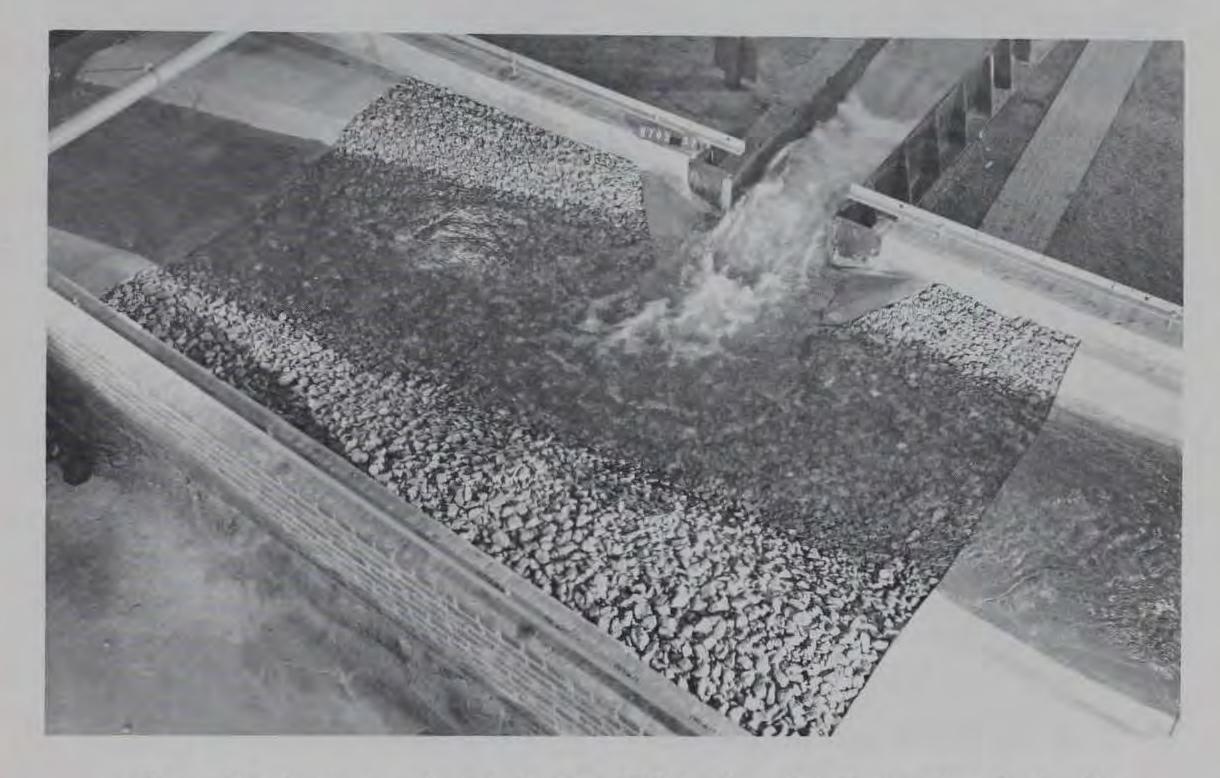
a. Discharge: North Gully 3750 cfs, Sandburg Creek 0 cfs

b. Discharge: North Gully 2500 cfs, Sandburg Creek 0 cfs

Photo 18. Flow conditions at the junction of North Gully and Sandburg Creek in type 2 stilling basin. Discharges 1500, 2500, and 3750 cfs in North Gully and 0 cfs in Sandburg Creek (sheet 1 of 2)

c. Discharge: North Gully 1500 cfs, Sandburg Creek 0 cfs Photo 18. (sheet 2 of 2)

33. In an effort to reduce or eliminate the eddy action at low flows in the original basin, the type 2 basin was installed (plate 18). This design, which flattened the transition upstream of the basin and modified the entrance drop to a more vertical drop, improved basin action for all discharges and greatly reduced the tendency for eddy action at the lower flows (compare photos 16a, b, c, and d with photos 12a, b, c, and d). Although some slight circulation occurred along the right side of the basin at the lower flows, materials introduced into the basin were deposited along the end sill and did not circulate to cause abrasive damage. With a discharge of 2500 cfs in North Gully, a tailwater of 324.5 (4.2 ft above normal) was required in Sandburg Creek to cause eddy action in the basin. The tailwater could not be raised sufficiently to cause the design flow of 3750 cfs to eddy, and debris from the chute was either deposited against the end sill or washed into Sandburg Creek. The original basin wall height (el 327.41) was adequate for all expected flows. Flow conditions at the junction of North Gully and Sandburg Creek were satisfactory when there was flow in both streams (photos 17a, b, and c); however, when all flow was confined to North Gully with little or no flow in Sandburg Creek, the flow from North Gully tended to attack the bottom and sides of Sandburg Creek at the junction of the two streams (photos 18a, b, and c).

36. Flow conditions at the junction of North Gully and Sandburg Creek (below the type 2 basin) appeared satisfactory when the latter was flowing full (photos 17a, b, and c); however, when flow through North Gully was considerable with little or no flow in Sandburg Creek, the discharge tended to attack the bottom and sides of Sandburg Creek (see paragraph 33). This condition was corrected by providing the splash pad shown in photo 20. Flow patterns and bottom velocities in Sandburg Creek for various combinations of flows are shown in plates 20 and 21. With the exception of the paved splash pad area, velocities were not considered excessive and no displacement of the riprap occurred in Sandburg Creek.

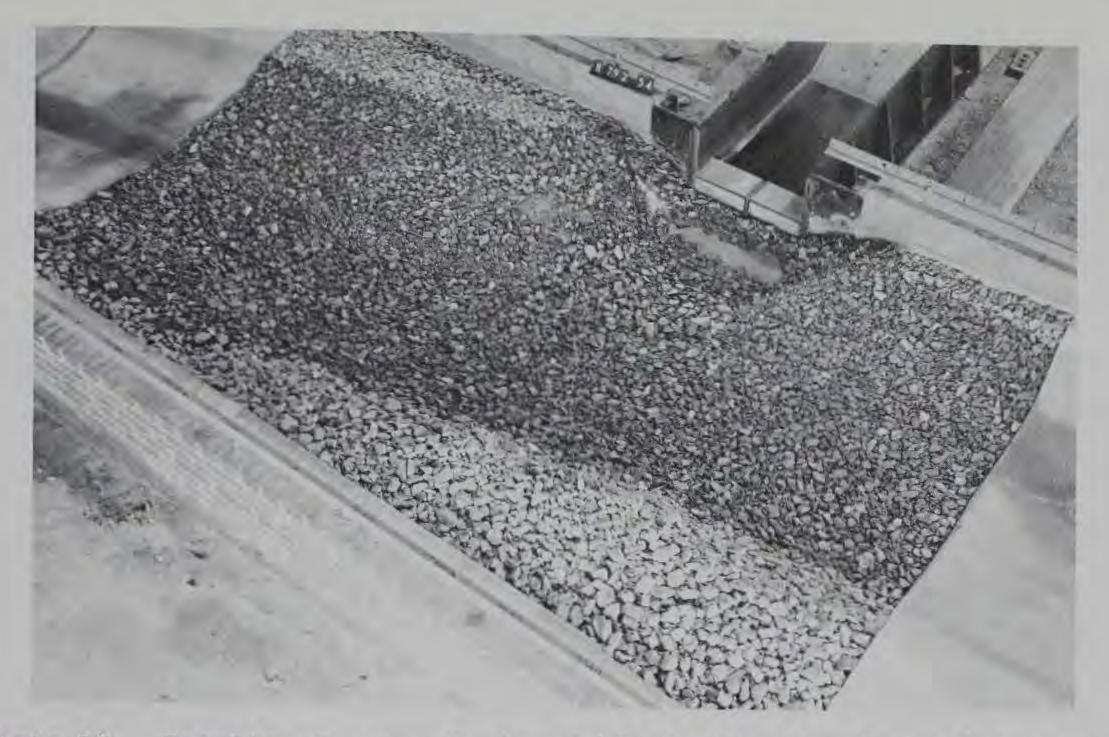
Photo 19. Results of scour tests of 45-min duration (model) with the type 2 stilling basin and riprap simulating prototype stone with an average weight of 360 lb (48-in.-thick layer). Discharge varied from 1500 to 3750 cfs in North Gully; no flow in Sandburg Creek

34. Initial scour tests within an area of Sandburg Creek (100 ft upstream and 160 ft downstream of the North Gully stilling basin) covered with riprap simulating prototype stone with an average weight of 360 lb and a thickness of 48 in. revealed no failure with any combined flow in North Gully and Sandburg Creek. However, with flow through North Gully only, discharges of 1500 to 3750 cfs displaced riprap as shown in photo 19. Photo 20 shows the results of scour of 2-hr duration (model) with a paved splash pad (40 ft long and 52 ft wide) below the type 2 basin. No failure of the riprap occurred although the area was exposed to flows from North Gully only of 1500 to 3750 cfs and combined flows in North Gully and Sandburg Creek up to 15,000 cfs (5,000 cfs North Gully, 10,000 cfs Sandburg Creek).
