TECHNICAL REPORT HL-89-17

KINZUA DAM, ALLEGHENY RIVER PENNSYLVANIA AND NEW YORK

Hydraulic Model Investigation

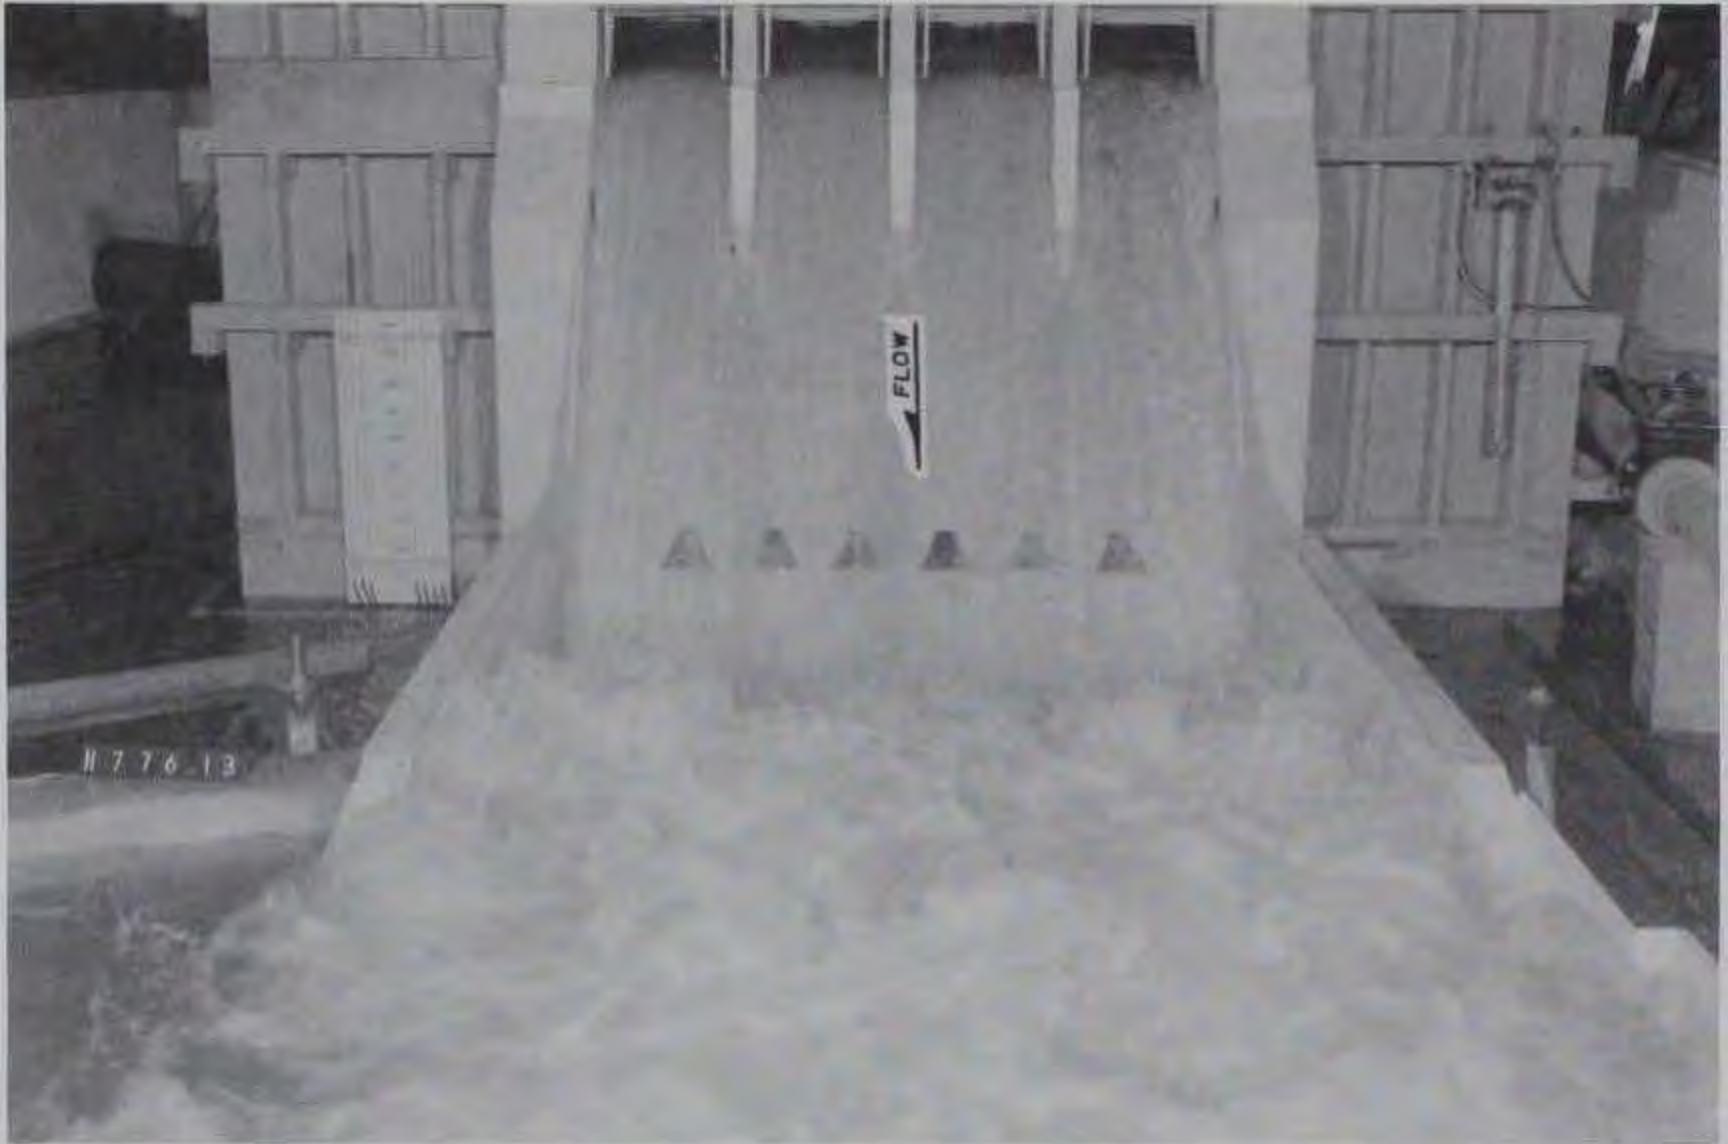
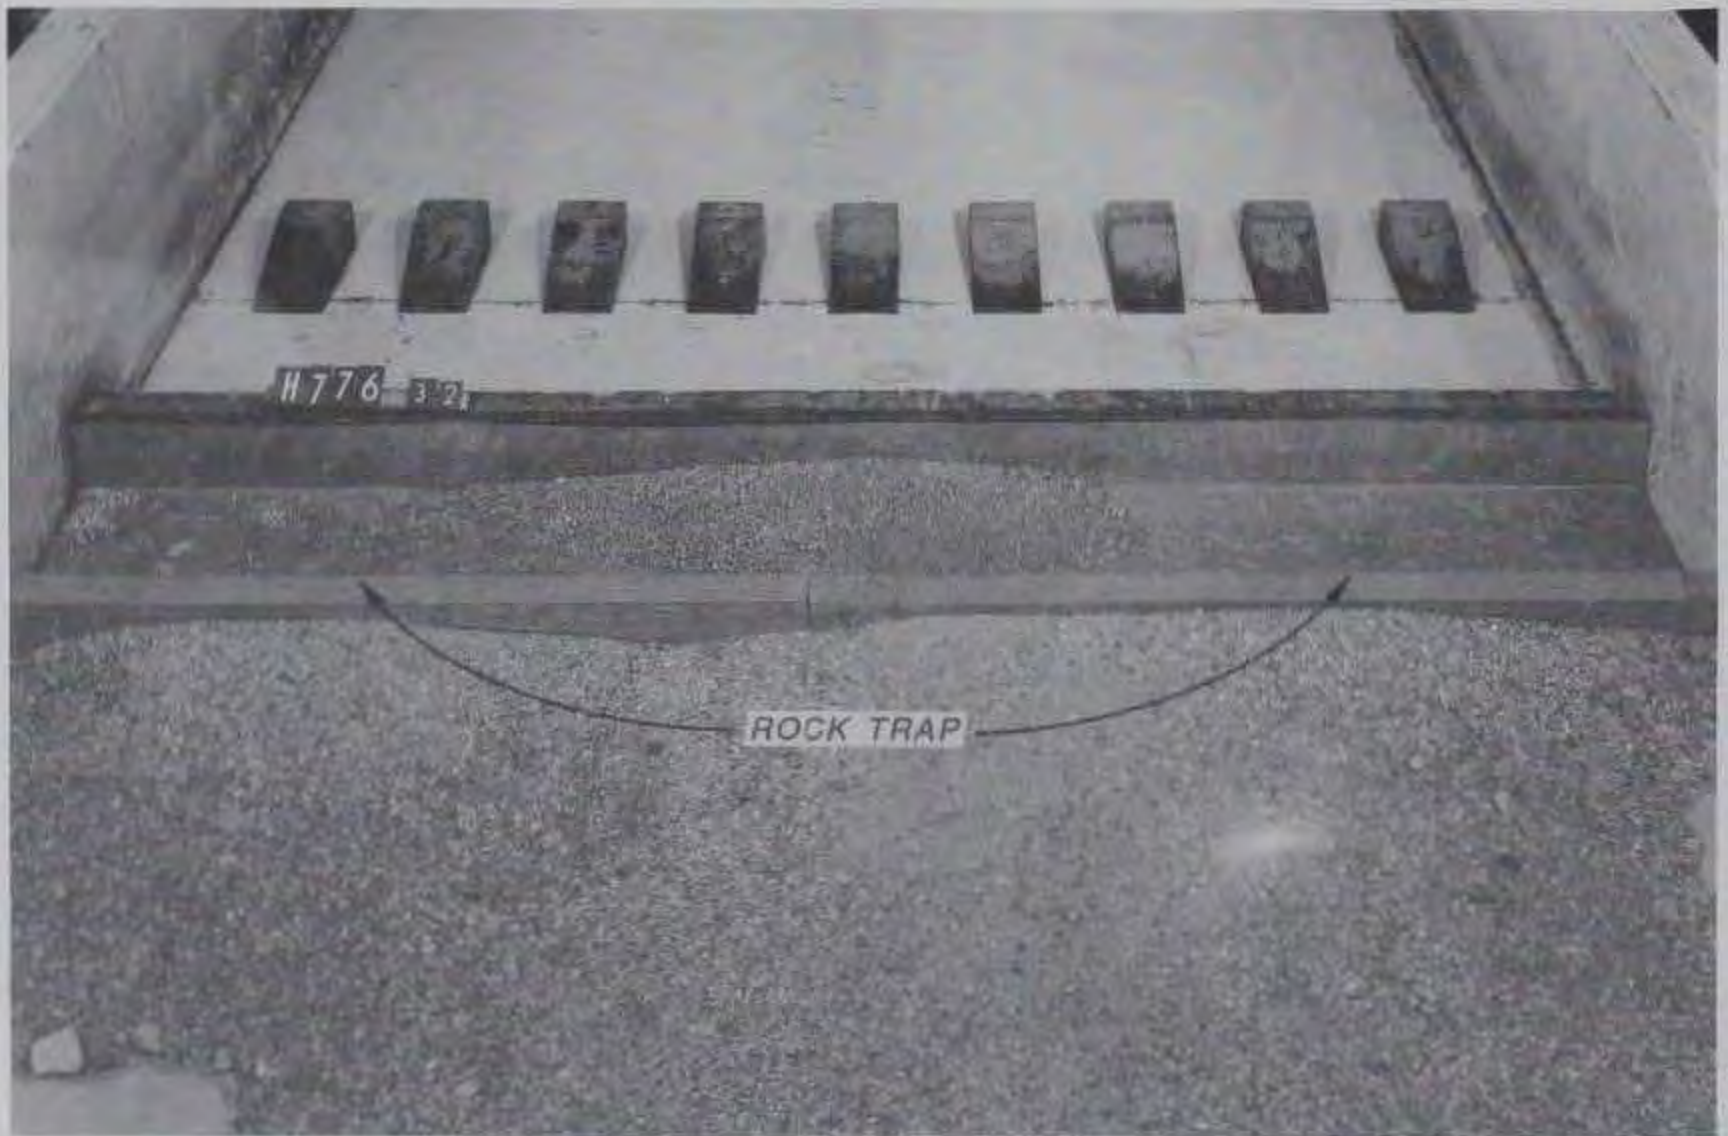
a. Discharge 114,000 cfs, tailwater el 1,266

b. Dry bed view of rock trap

Photo 4. Type 2 rock trap

16. Test results of five rock trap configurations are shown in Table 3. The type 1 design trap was intended to simulate capping the cofferdam (built to effect basin repairs) at el 1,194 and using it as the downstream trap wall. The type 2 design trap contained a wall immediately upstream of the cofferdam at el 1,190 (same as end sill). Types 3, 4, and 5 design traps were provided by the Pittsburgh District. Based on the data shown, the type 2 design trap was the most effective in trapping the loose rock being transported by the flow from the exit channel toward the stilling basin. Due to top of rock contours downstream of the end sill, the final design of the rock trap was as shown in Plate 4. This trap will function similar to the type 2 trap except that it will have less volume available to trap material. Spillway operation at a discharge of 114,000 cfs was found to be satisfactory with the trap installed (Photo 4a). The flow was contained within the stilling basin and any stone present in the basin was swept out. Photo 4b shows a dry bed view of the rock trap. The cut section near the center of the trap wall was used in wall load tests as described later.

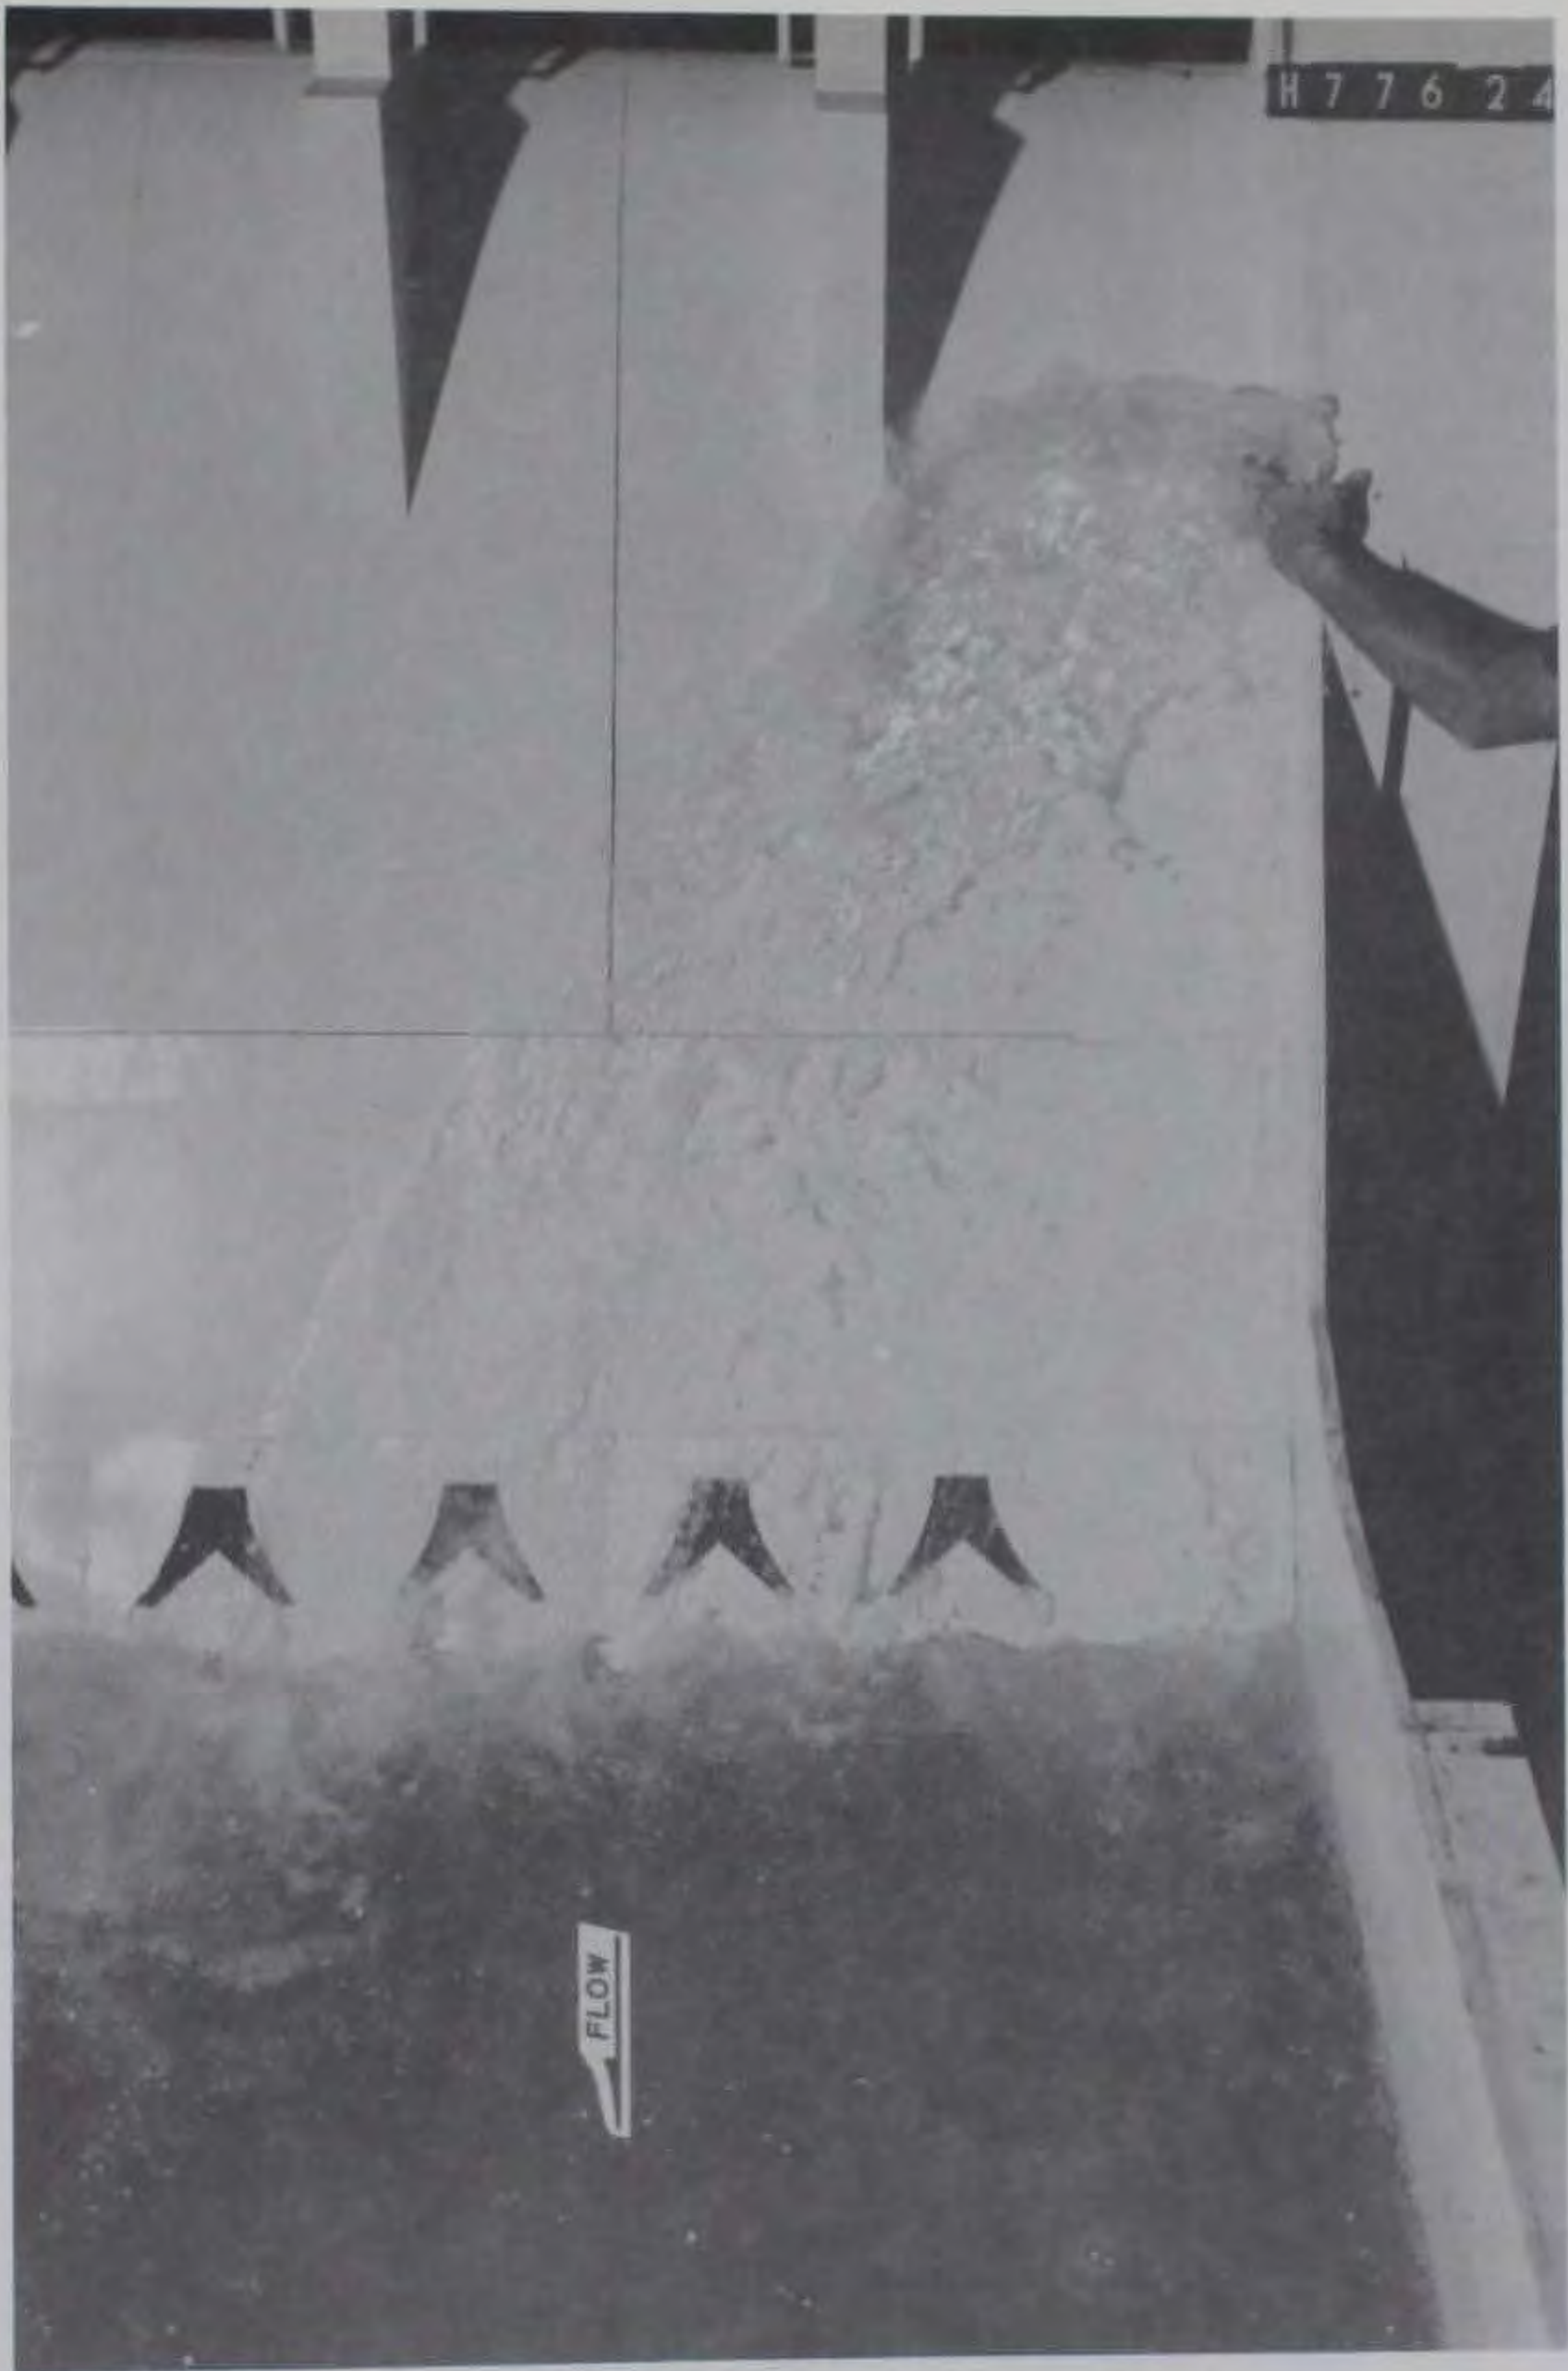
Photo 9. Sluice gate in modification 1 fully open

Photo 10. Sluice gate in modification 1 at 45-deg angle

Photo 11. Sluice gate in modification 1 at 90-deg angle

Photo 12. Sluice gate in modification 1 at 105-deg angle from downstream wall

Photo 13. Sluice gate in modification 1 at 130-deg angle from downstream wall

20. Additional upper sluice modification tests were conducted by attaching a door to the upper sluice opening. The door was hinged on the downstream edge of the opening. Photos 9 through 13 show the sluice in modification 1 operating with the door in various positions. It can be seen from these photos that with the door closed 90 deg or more from the downstream training wall, the flow was distributed fairly uniformly on the spillway slope. Because very little flow was noted near the wall, the door was modified in an attempt to get more even distribution. The door was cut in half diagonally and the lower upstream half was removed for one test. This same cut line was curved for two other tests, resulting in a concave and a convex upstream door edge. All three performed very well when closed at least 90 deg. In addition to these tests, several screen or grid covers over the sluice opening were evaluated, but none provided significant flow distribution improvement. It is recognized that a door on the sluice opening closed 90 deg or more would restrict flow somewhat; but since these sluices seldom operate at full capacity, discharge adjustments could be made.
