TECHNICAL REPORT HL-92-1

BRUSH CREEK, KANSAS CITY, MISSOURI

Hydraulic Model Investigation

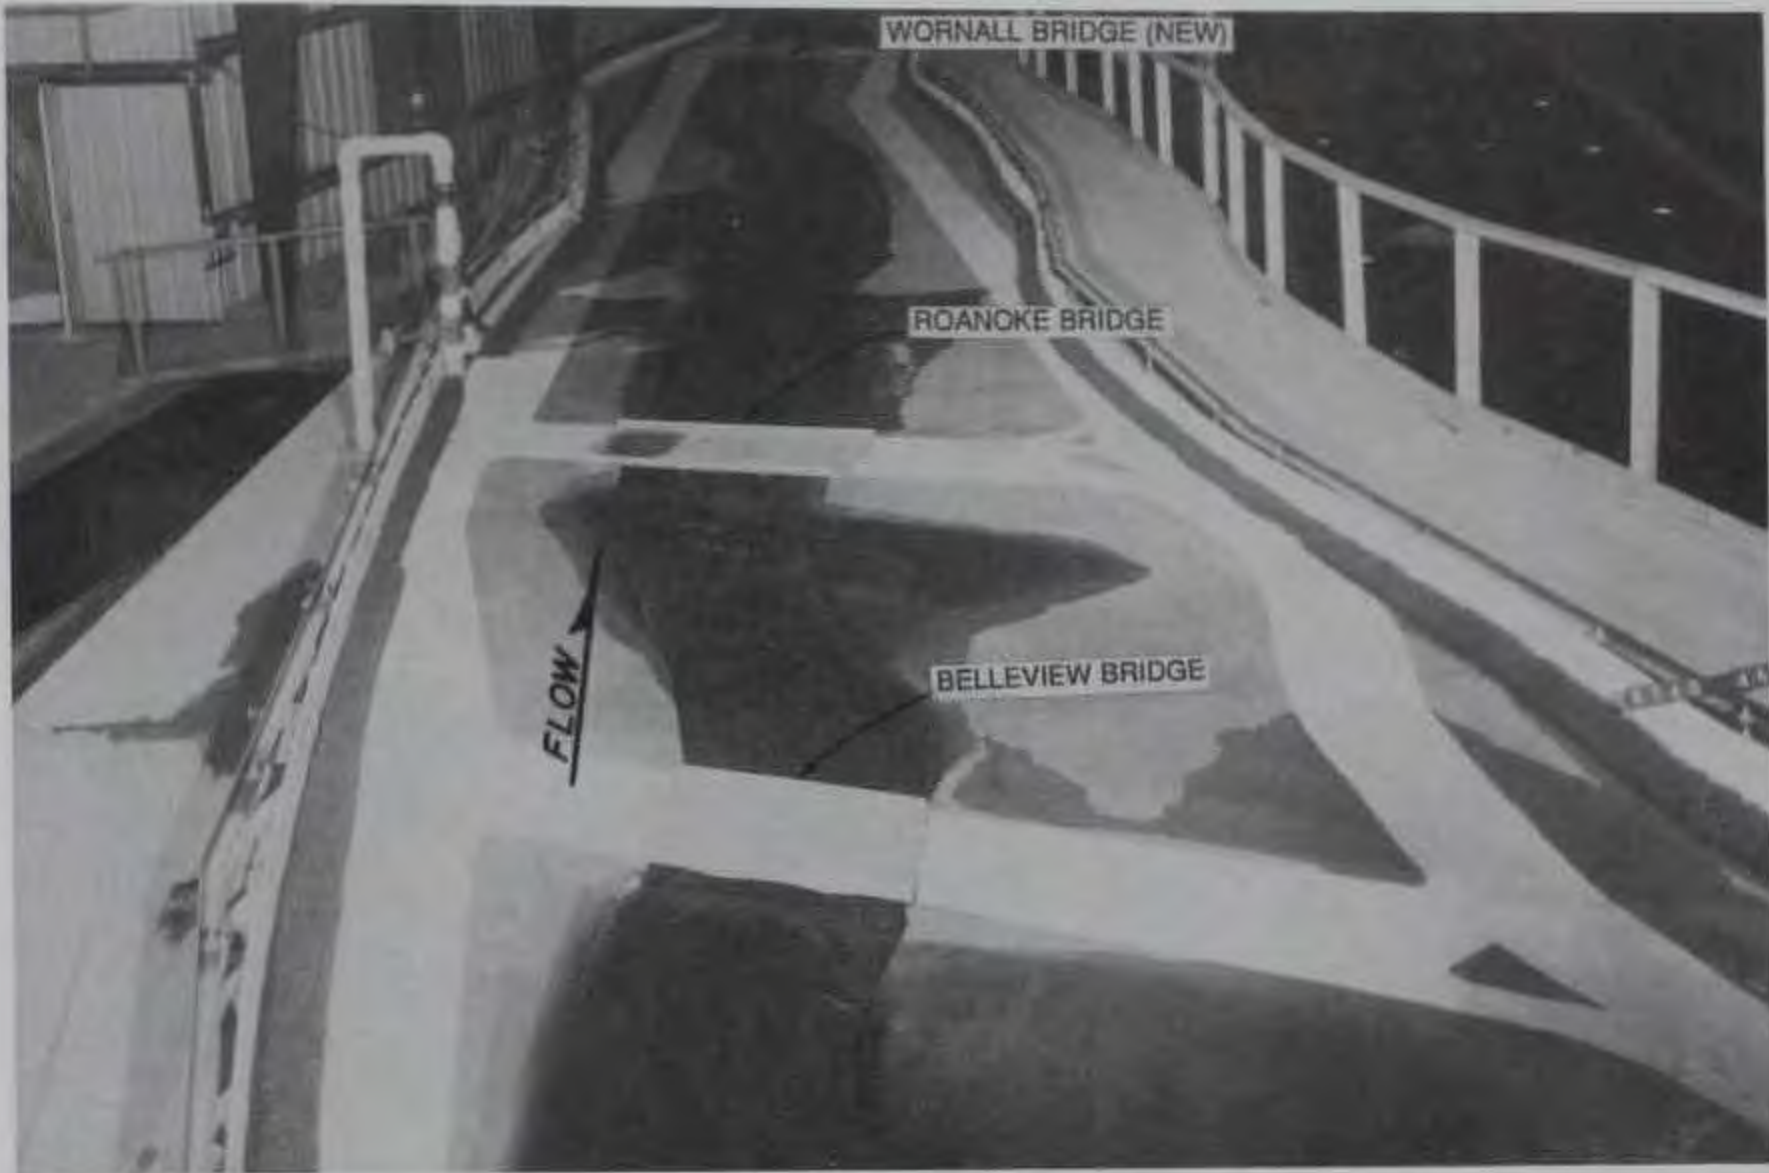
Photo 5. (Sheet 4 of 4)

c. Sta 35+00 to sta 61+00

d. Sta 61+00 to sta 81+00

e. Sta 81+00 to sta 112+00

f. Sta 112+00 to sta 147+00

g. Sta 135+00 to sta 147+00

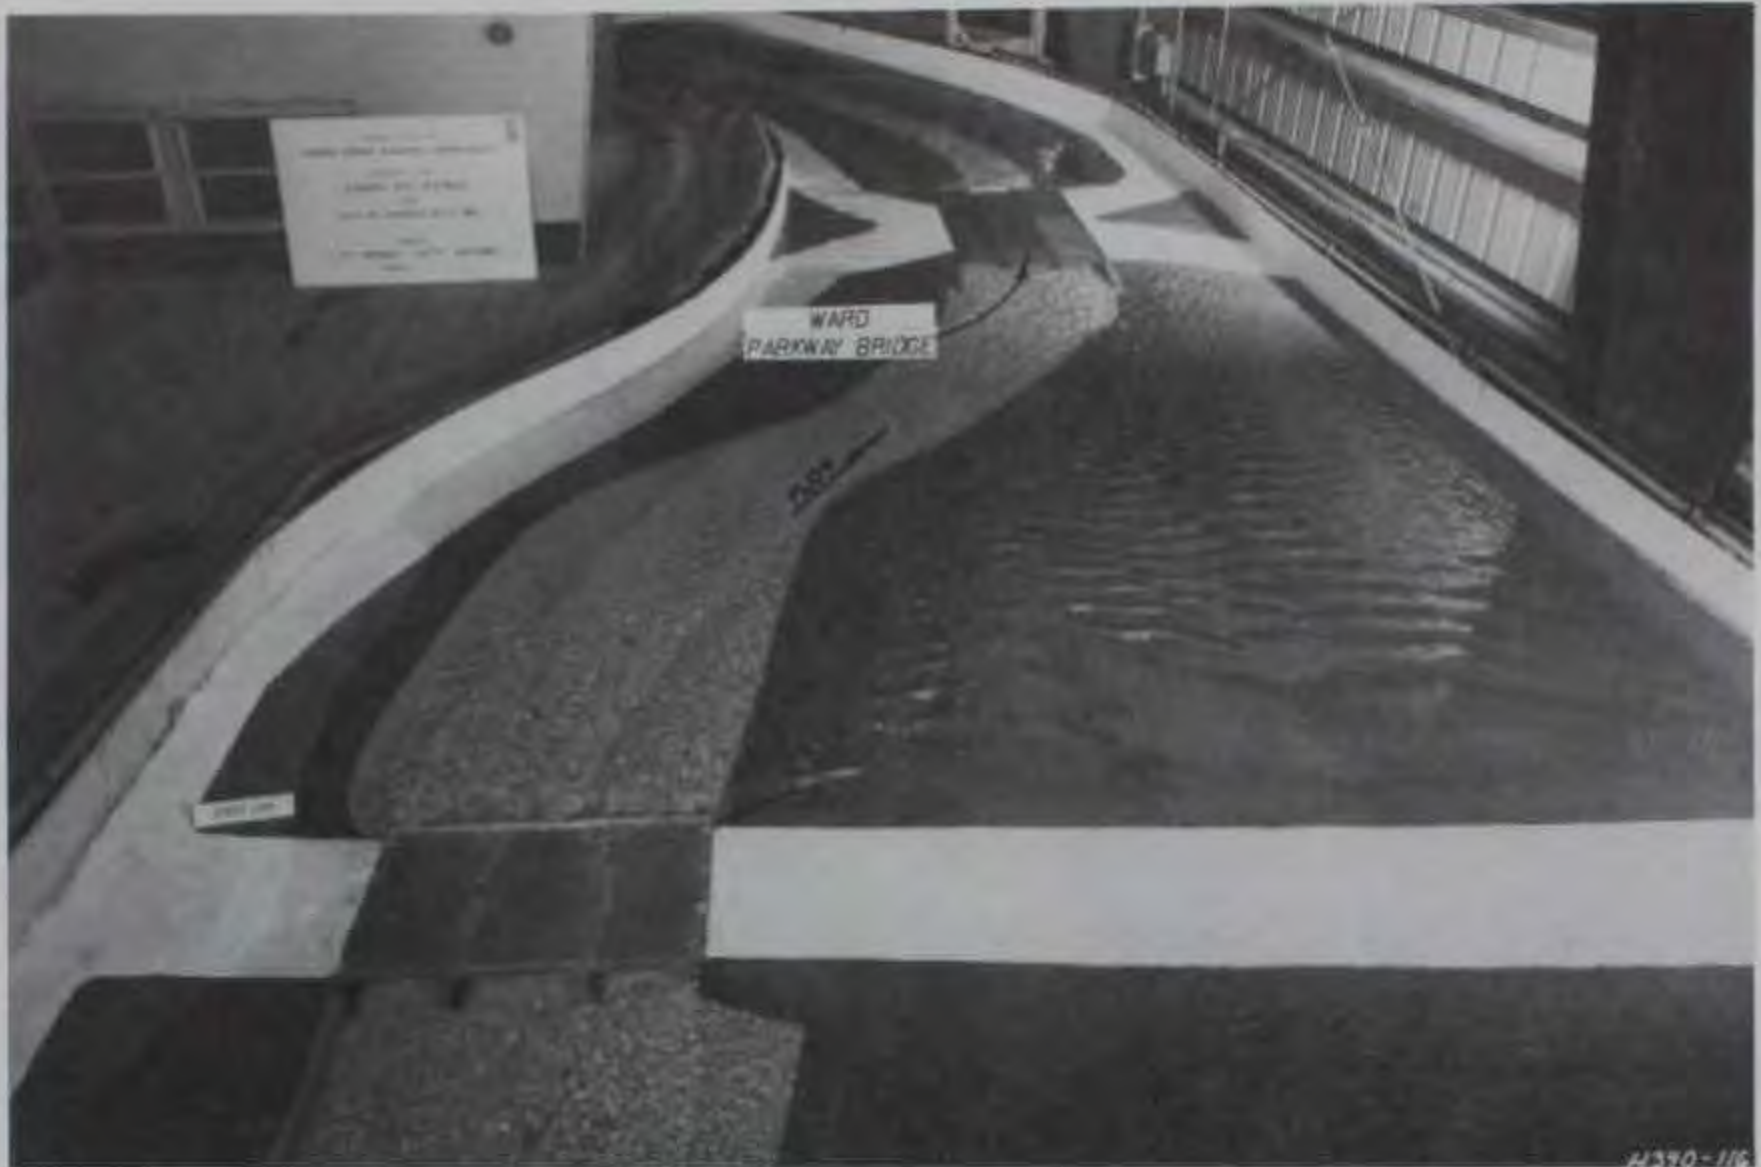
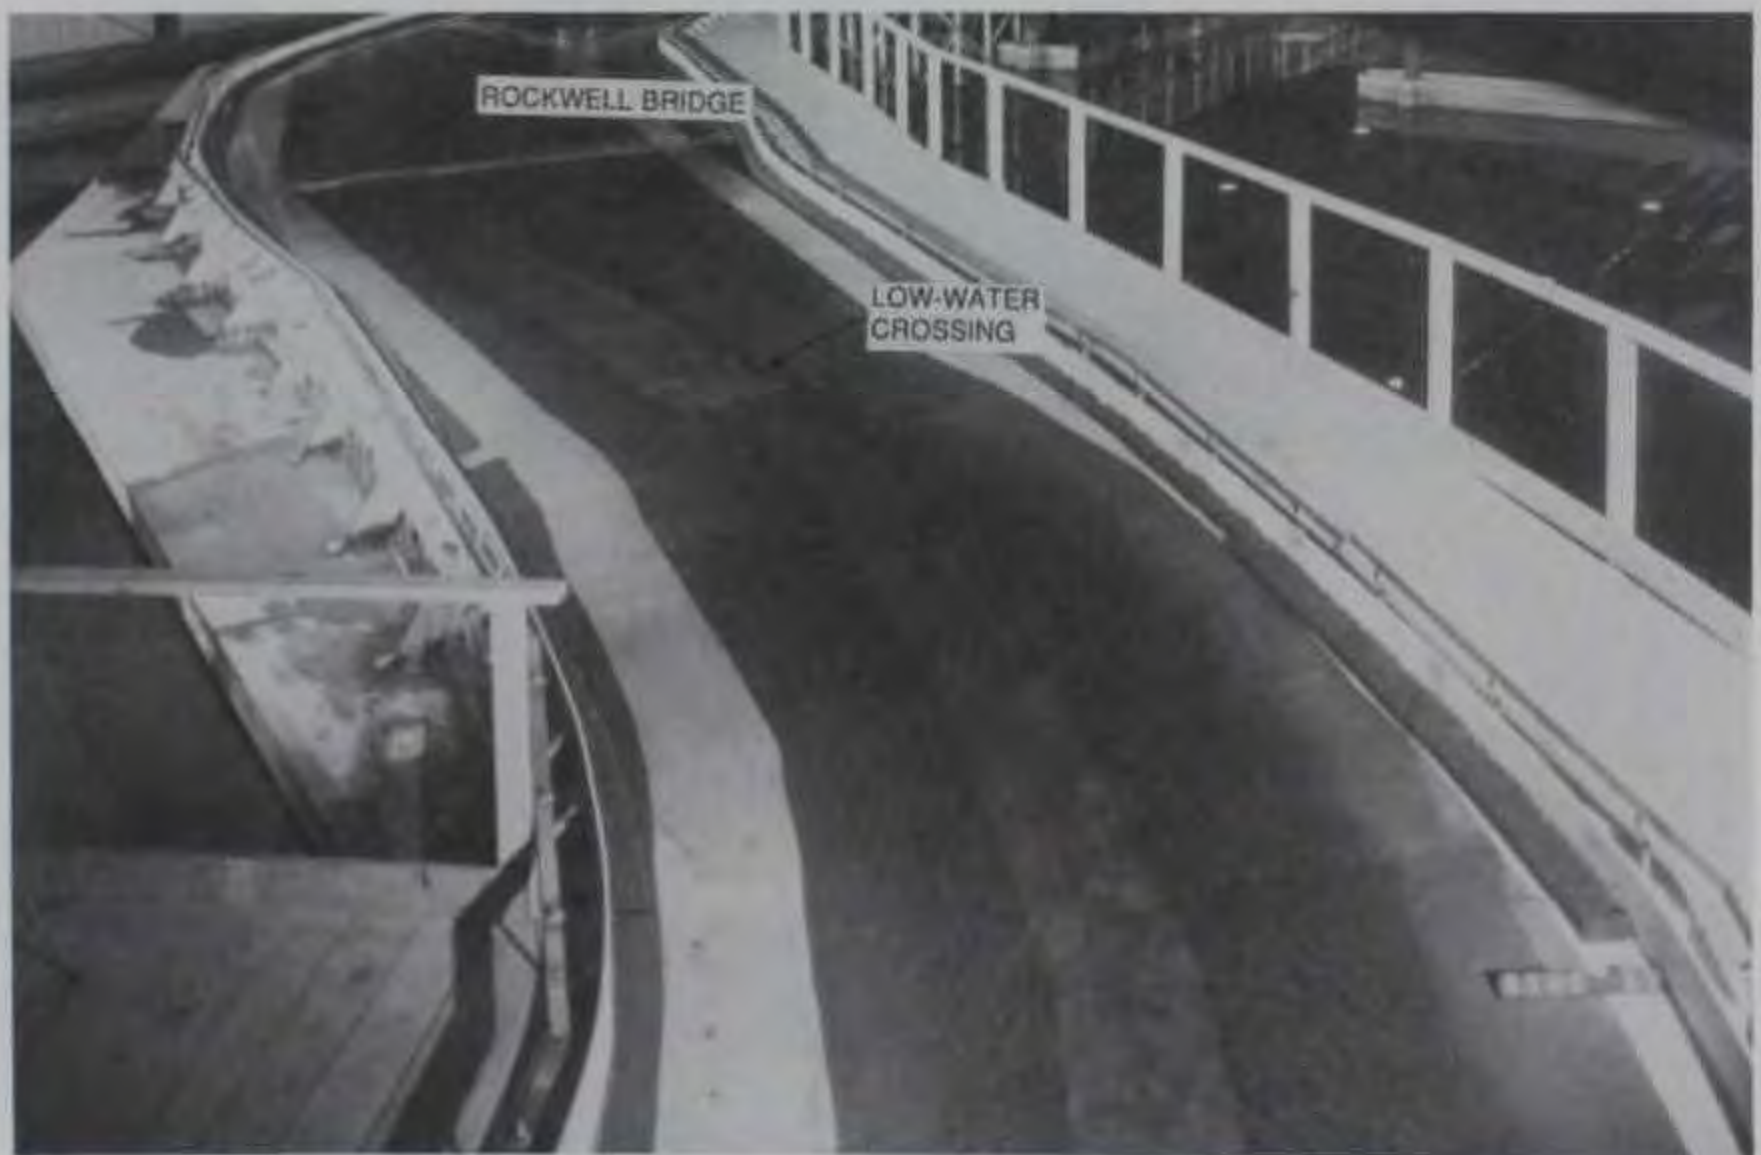
Photo 6. Existing conditions, 100-year flood (Sheet 1 of 4)

a. Sta 0+00 to sta 15+00

b. Sta 14+00 to sta 37+00

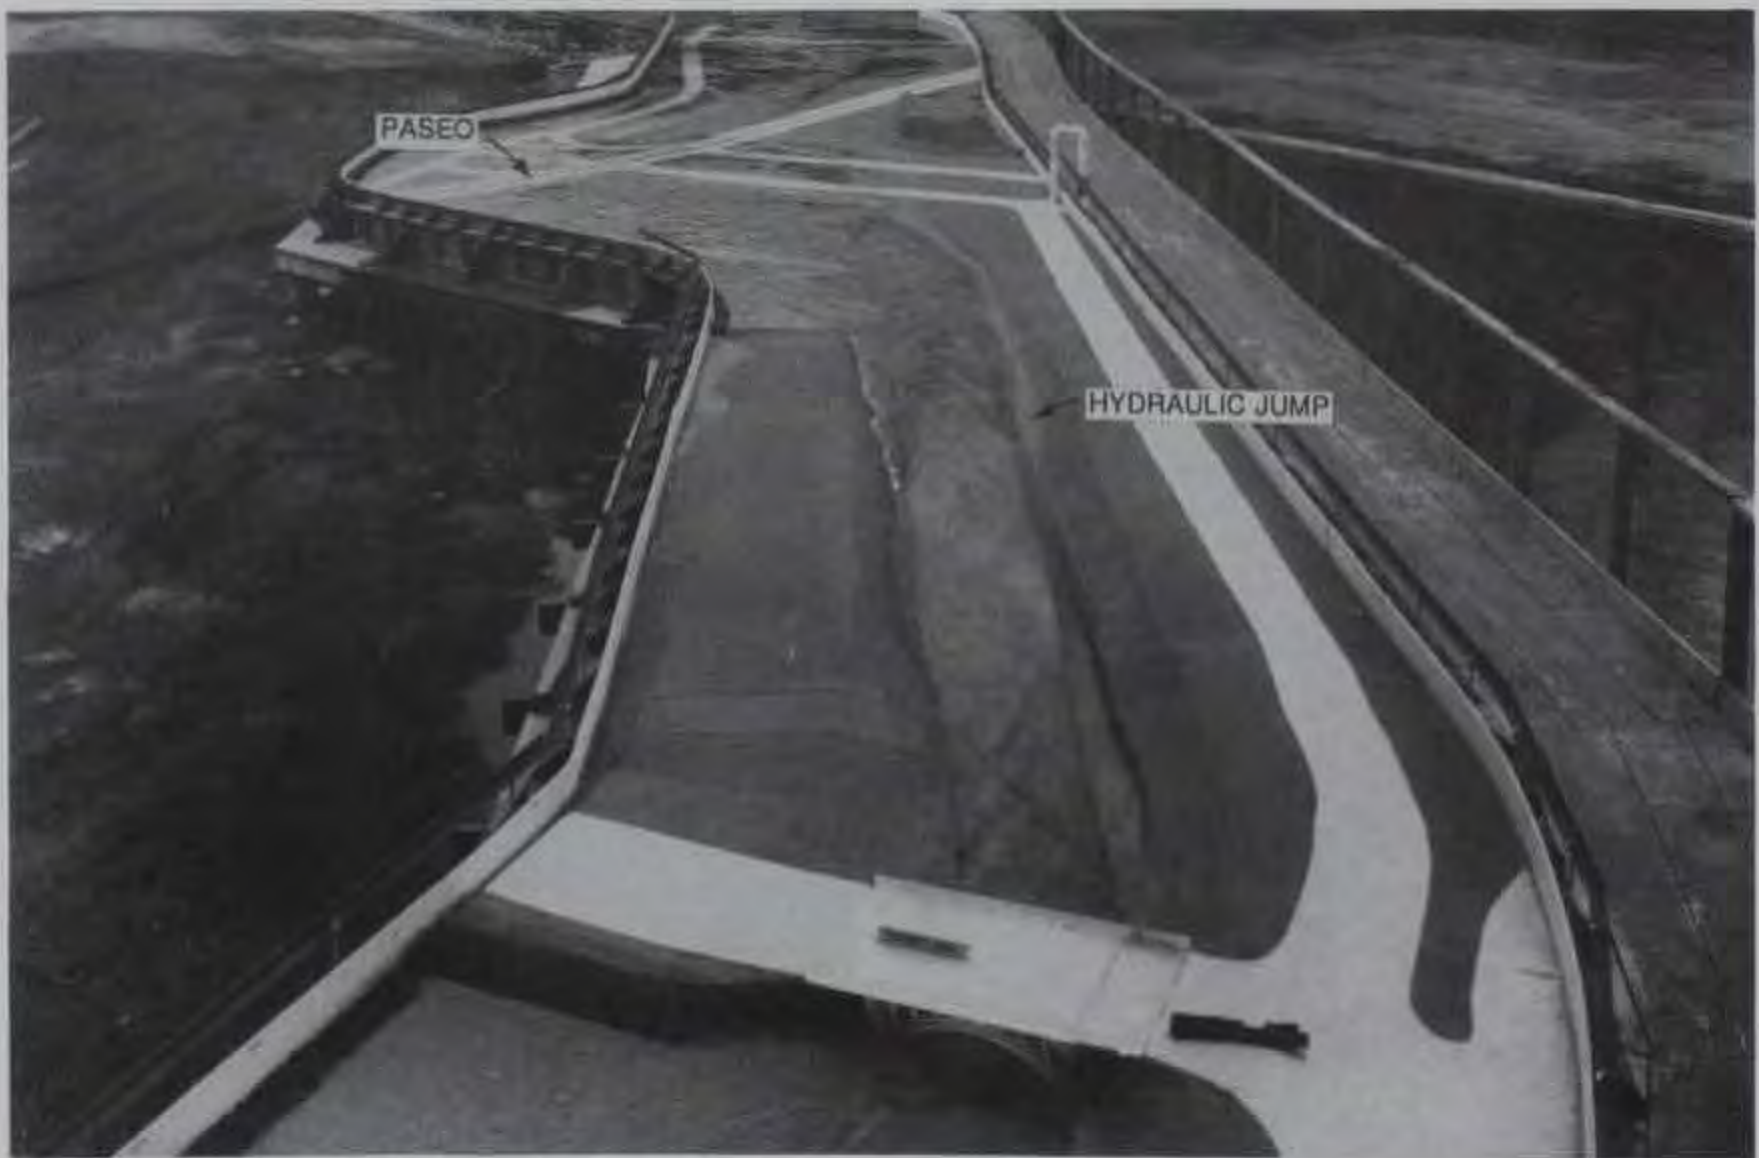
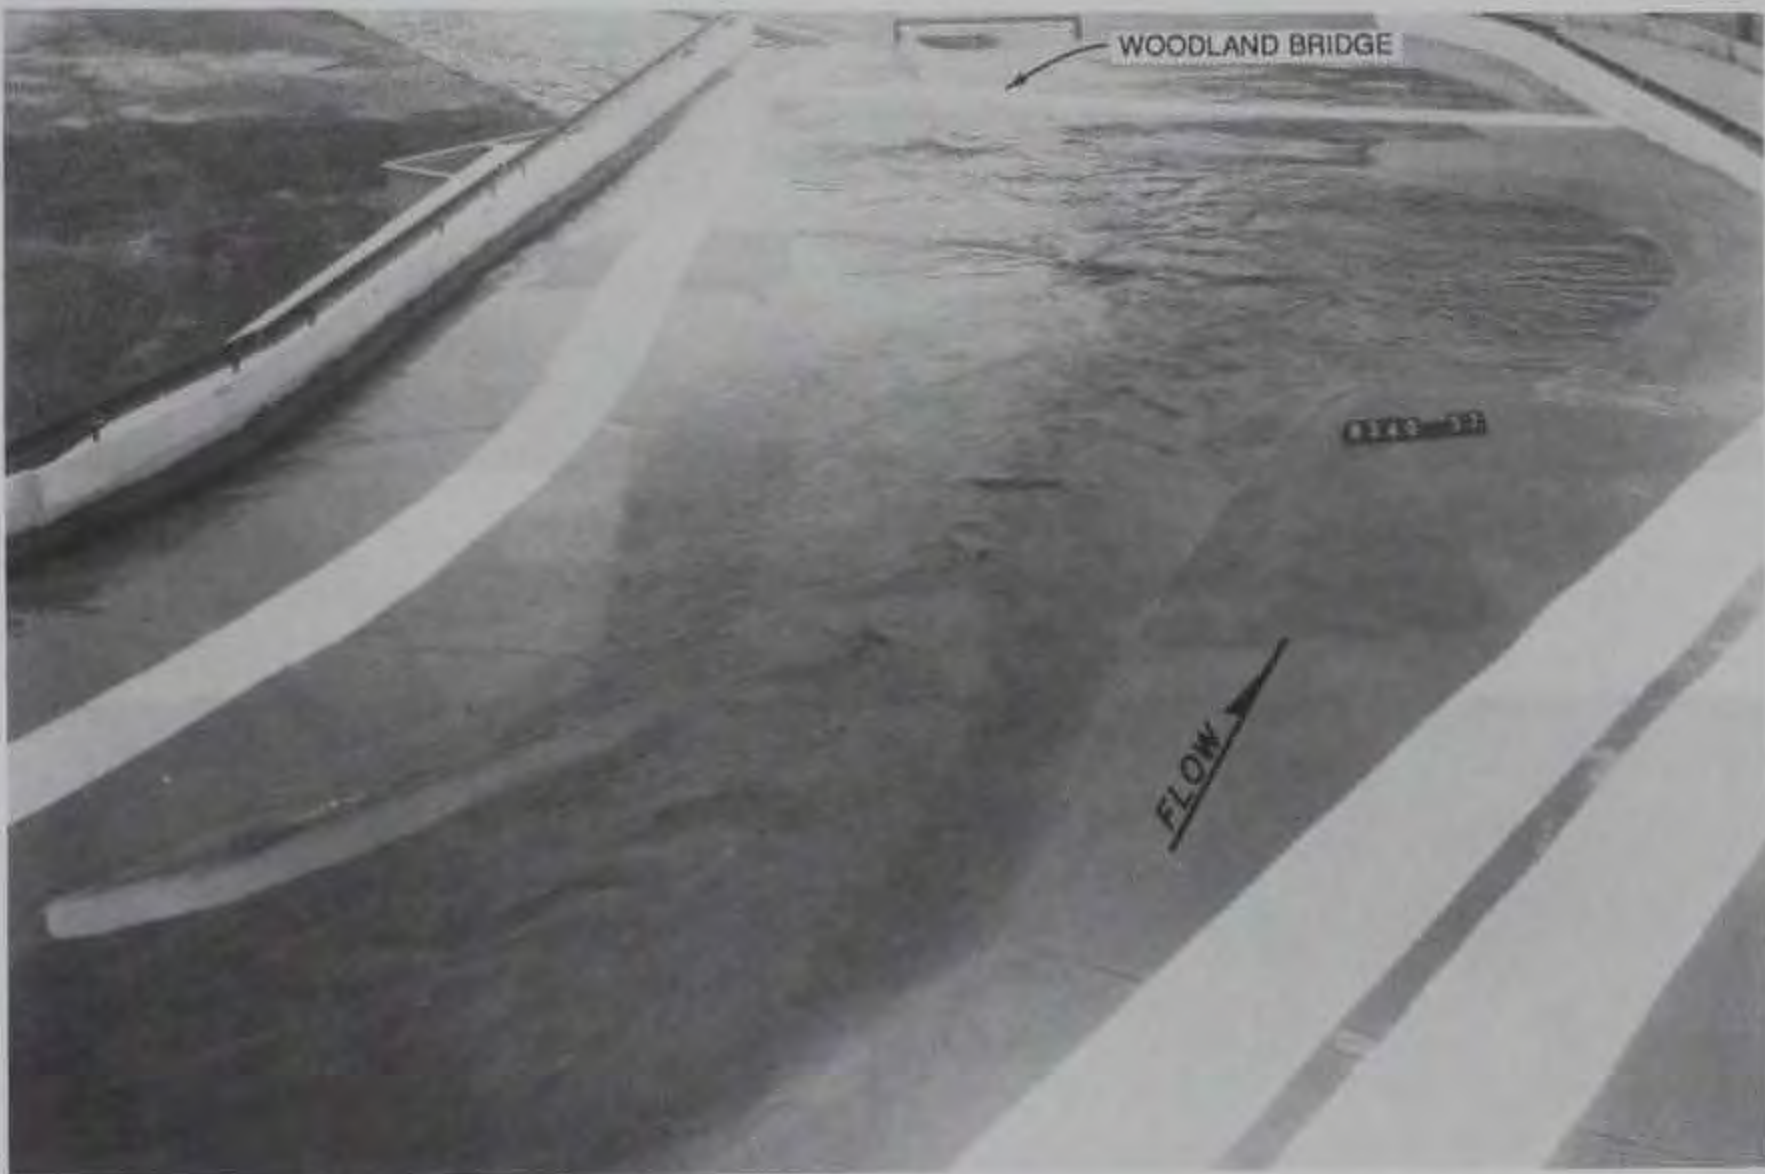
Photo 6. (Sheet 4 of 4)

c. Sta 35+00 to sta 61+00

d. Sta 61+00 to sta 81+00

e. Sta 81+00 to sta 112+00

f. Sta 112+00 to sta 147+00

g. Sta 135+00 to sta 147+00

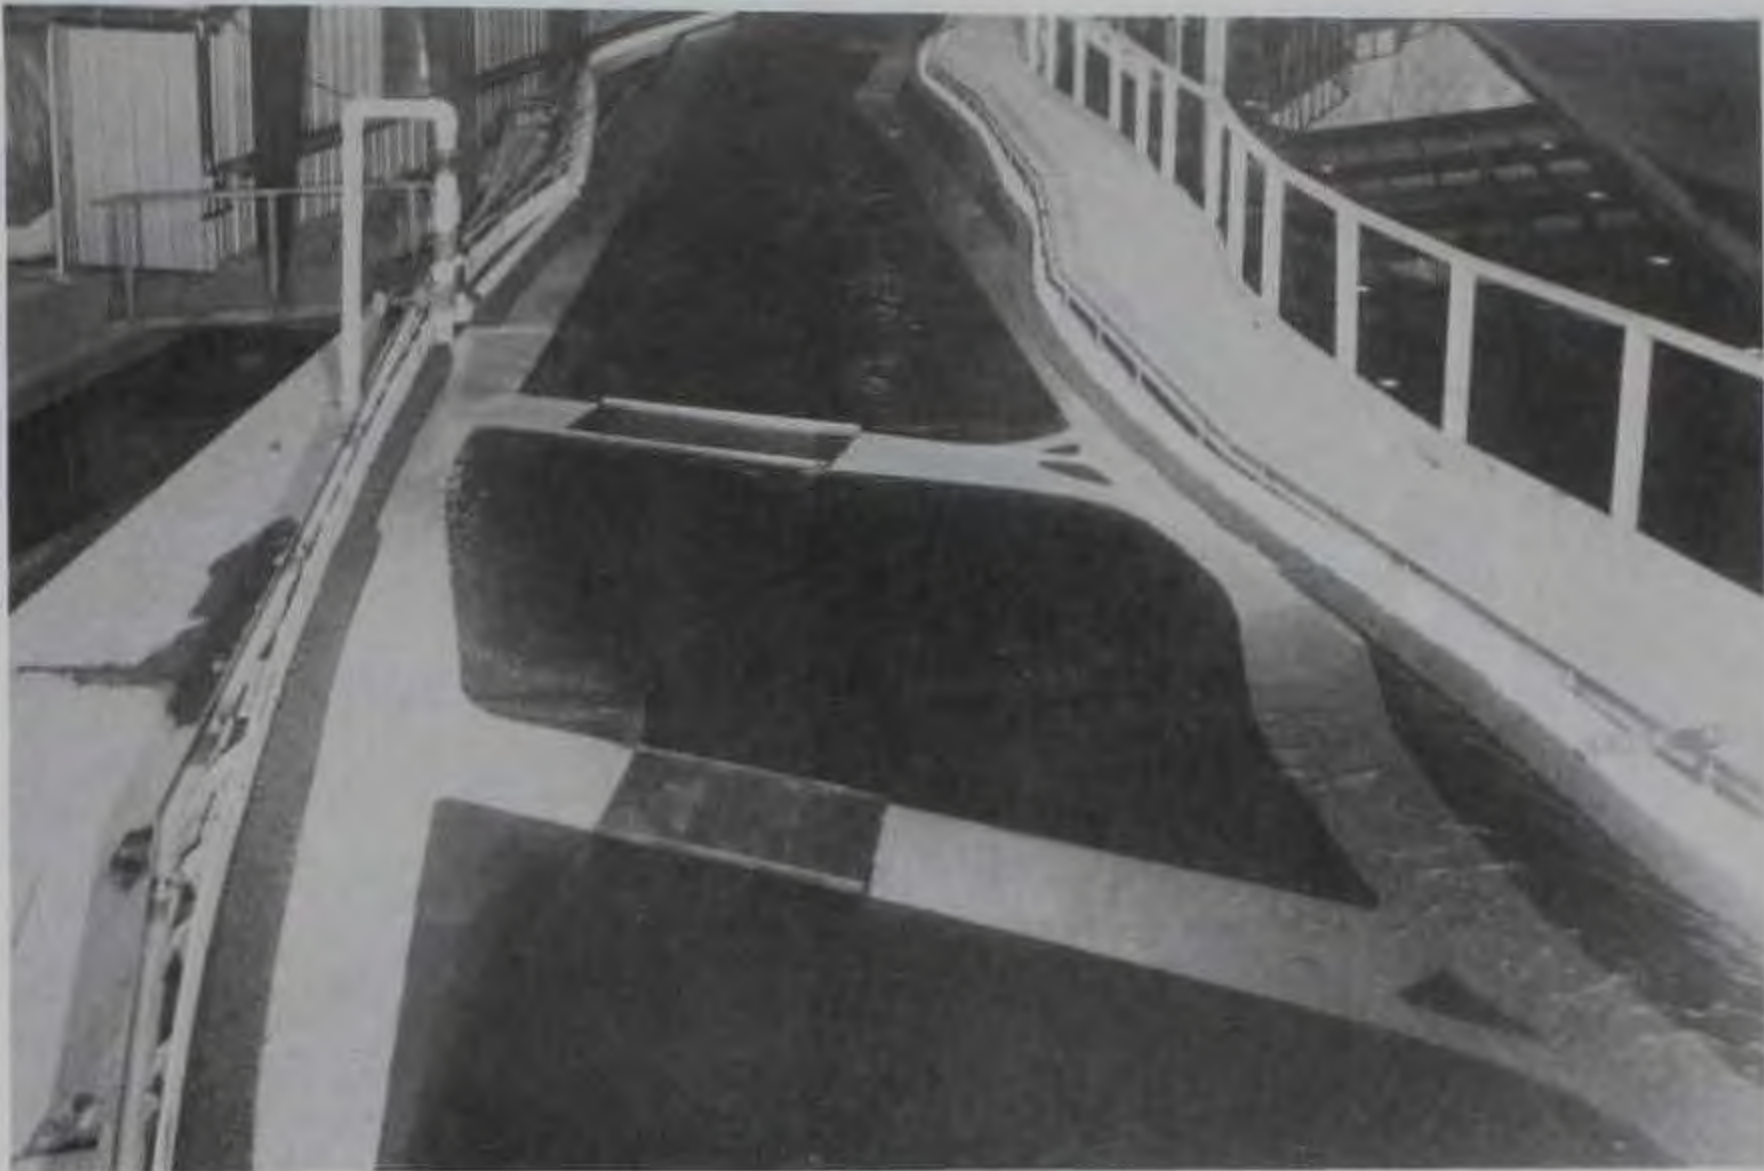
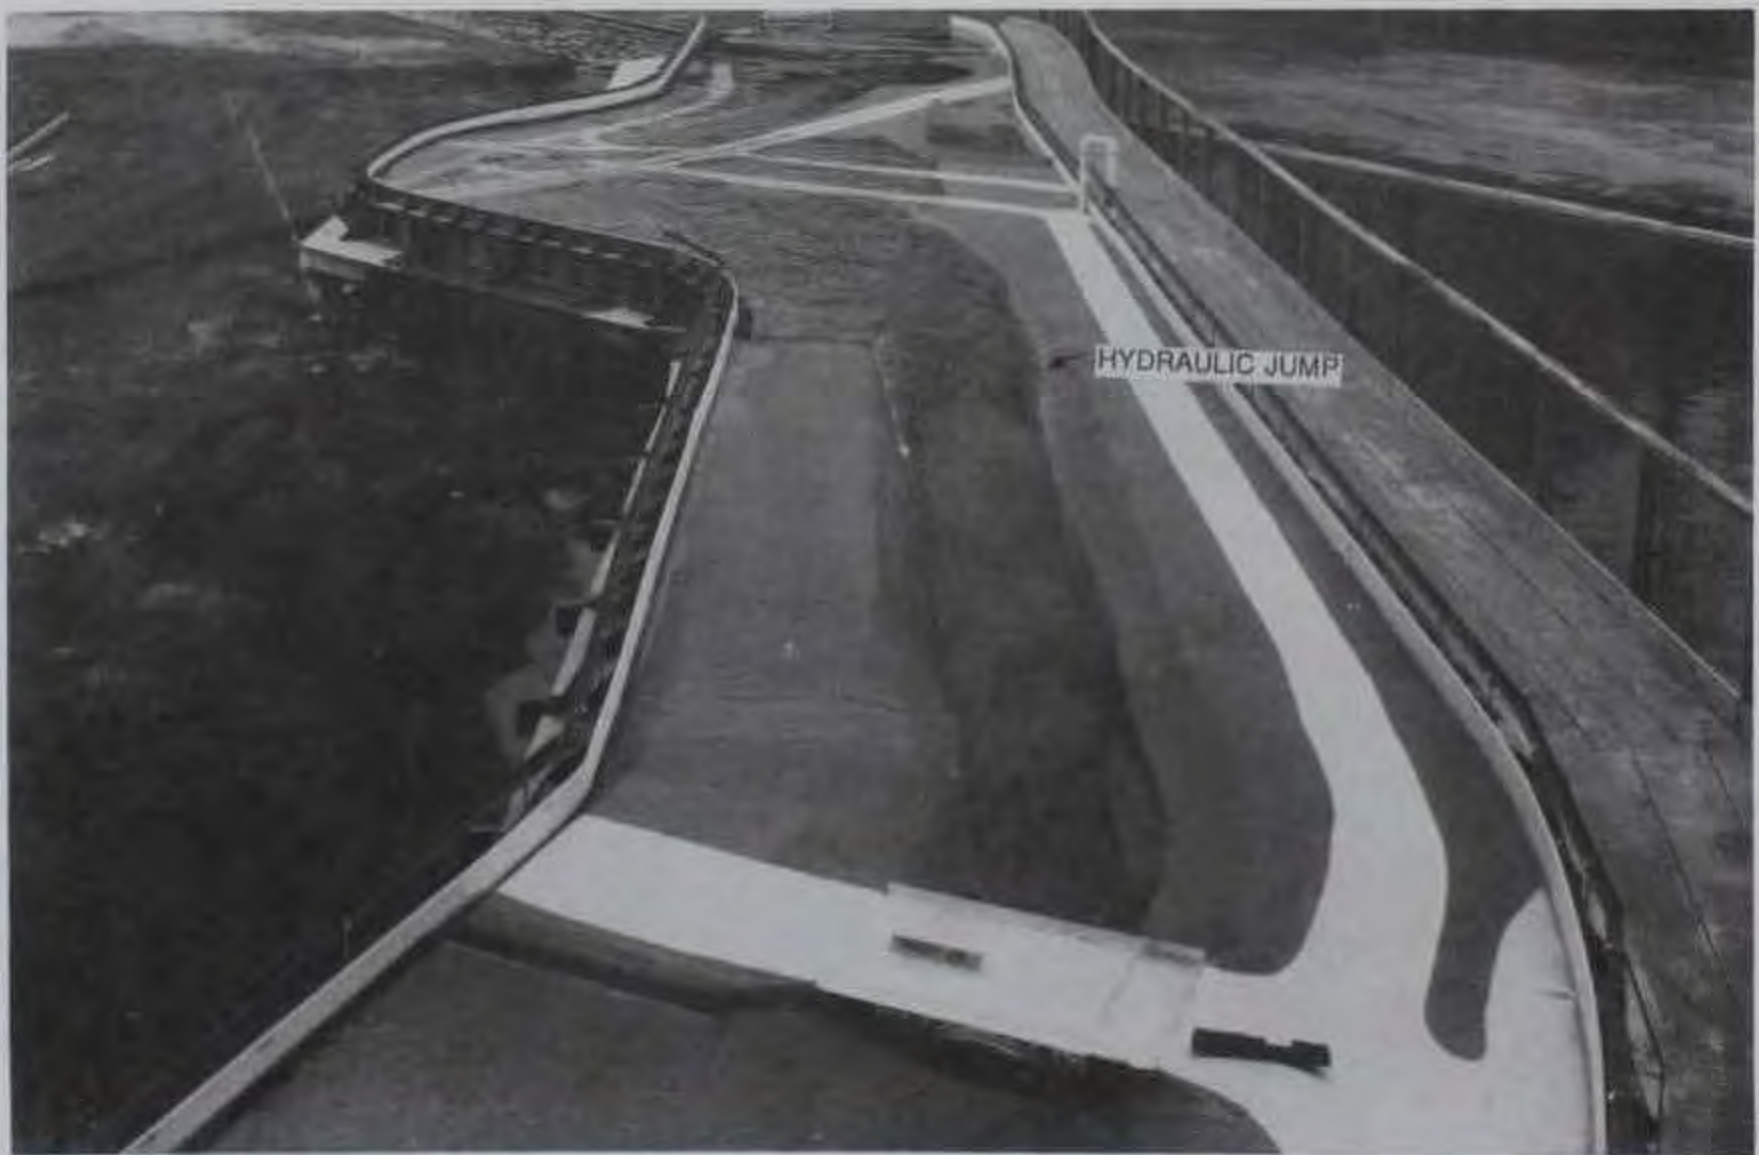
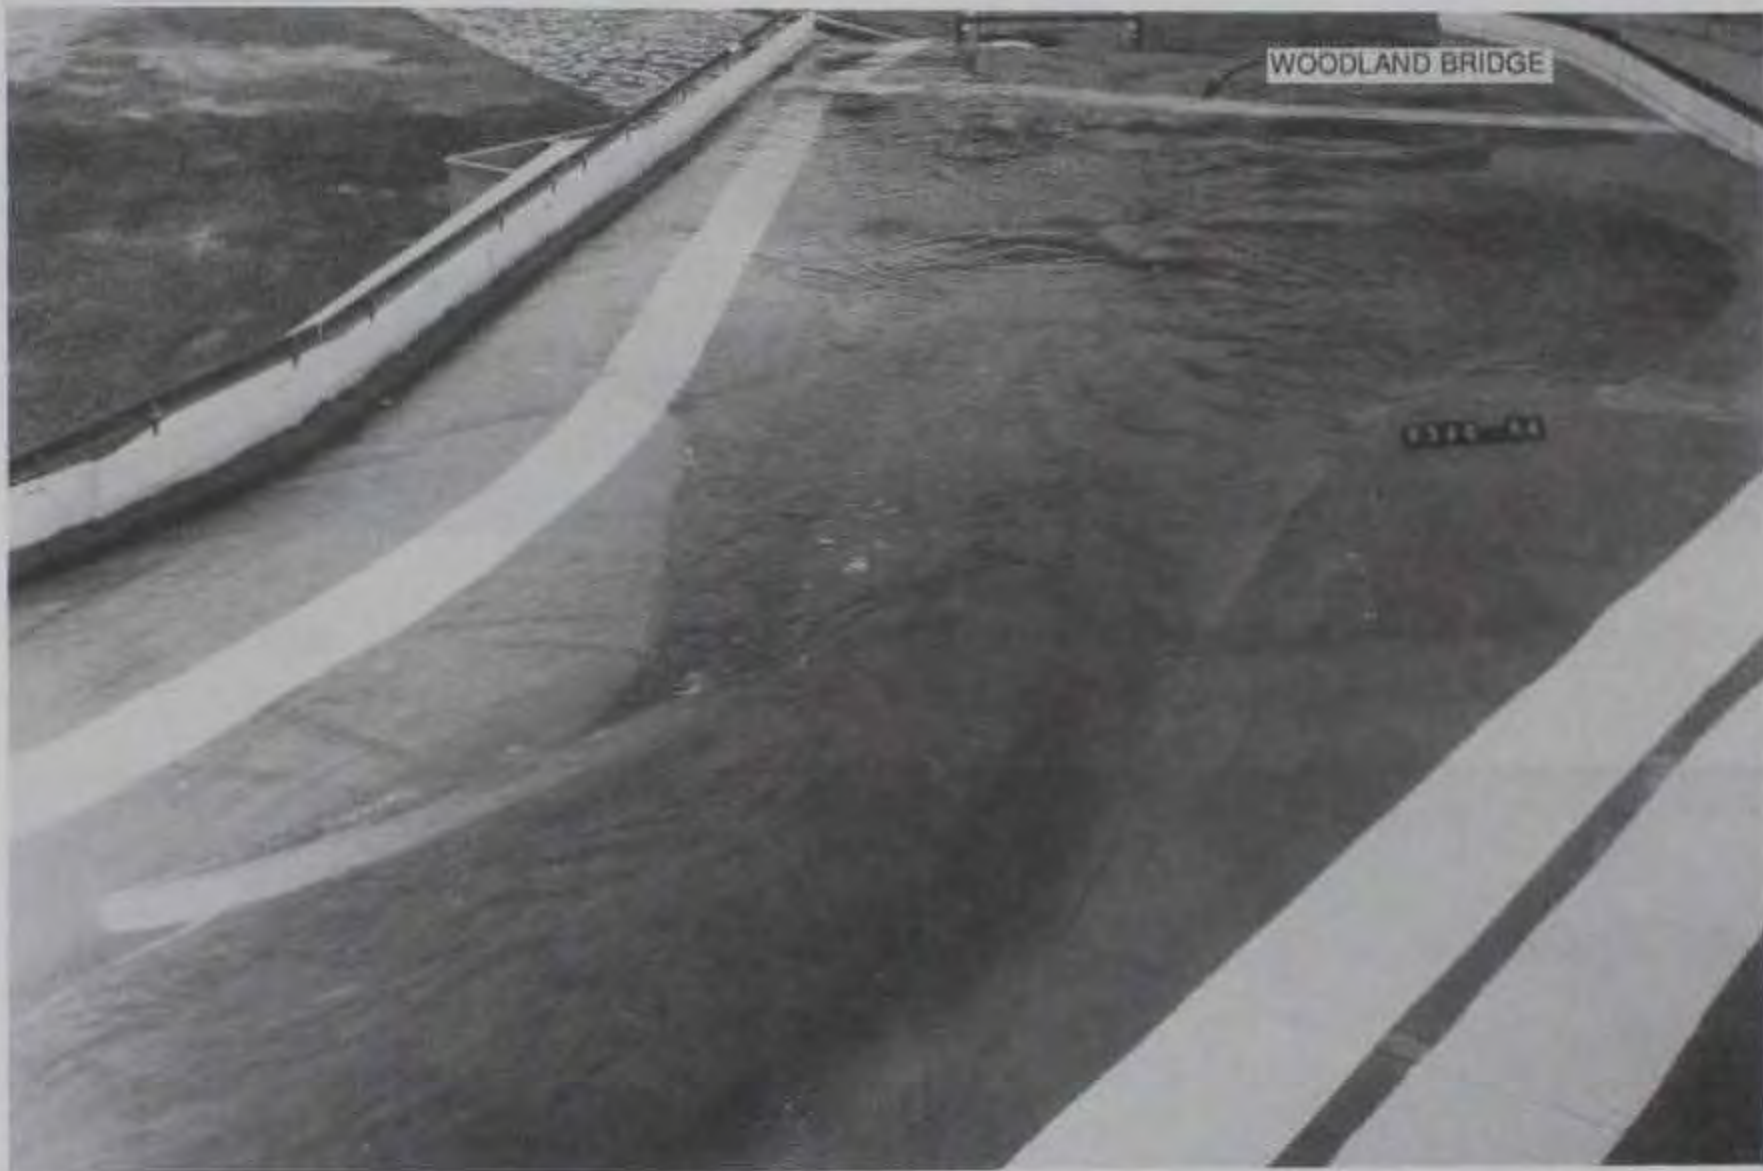
Photo 7. (Sheet 4 of 4)

c. Sta 35+00 to sta 61+00

d. Sta 61+00 to sta 81+00

e. Sta 81+00 to sta 112+00

f. Sta 112+00 to sta 147+00

g. Sta 135+00 to sta 147+00

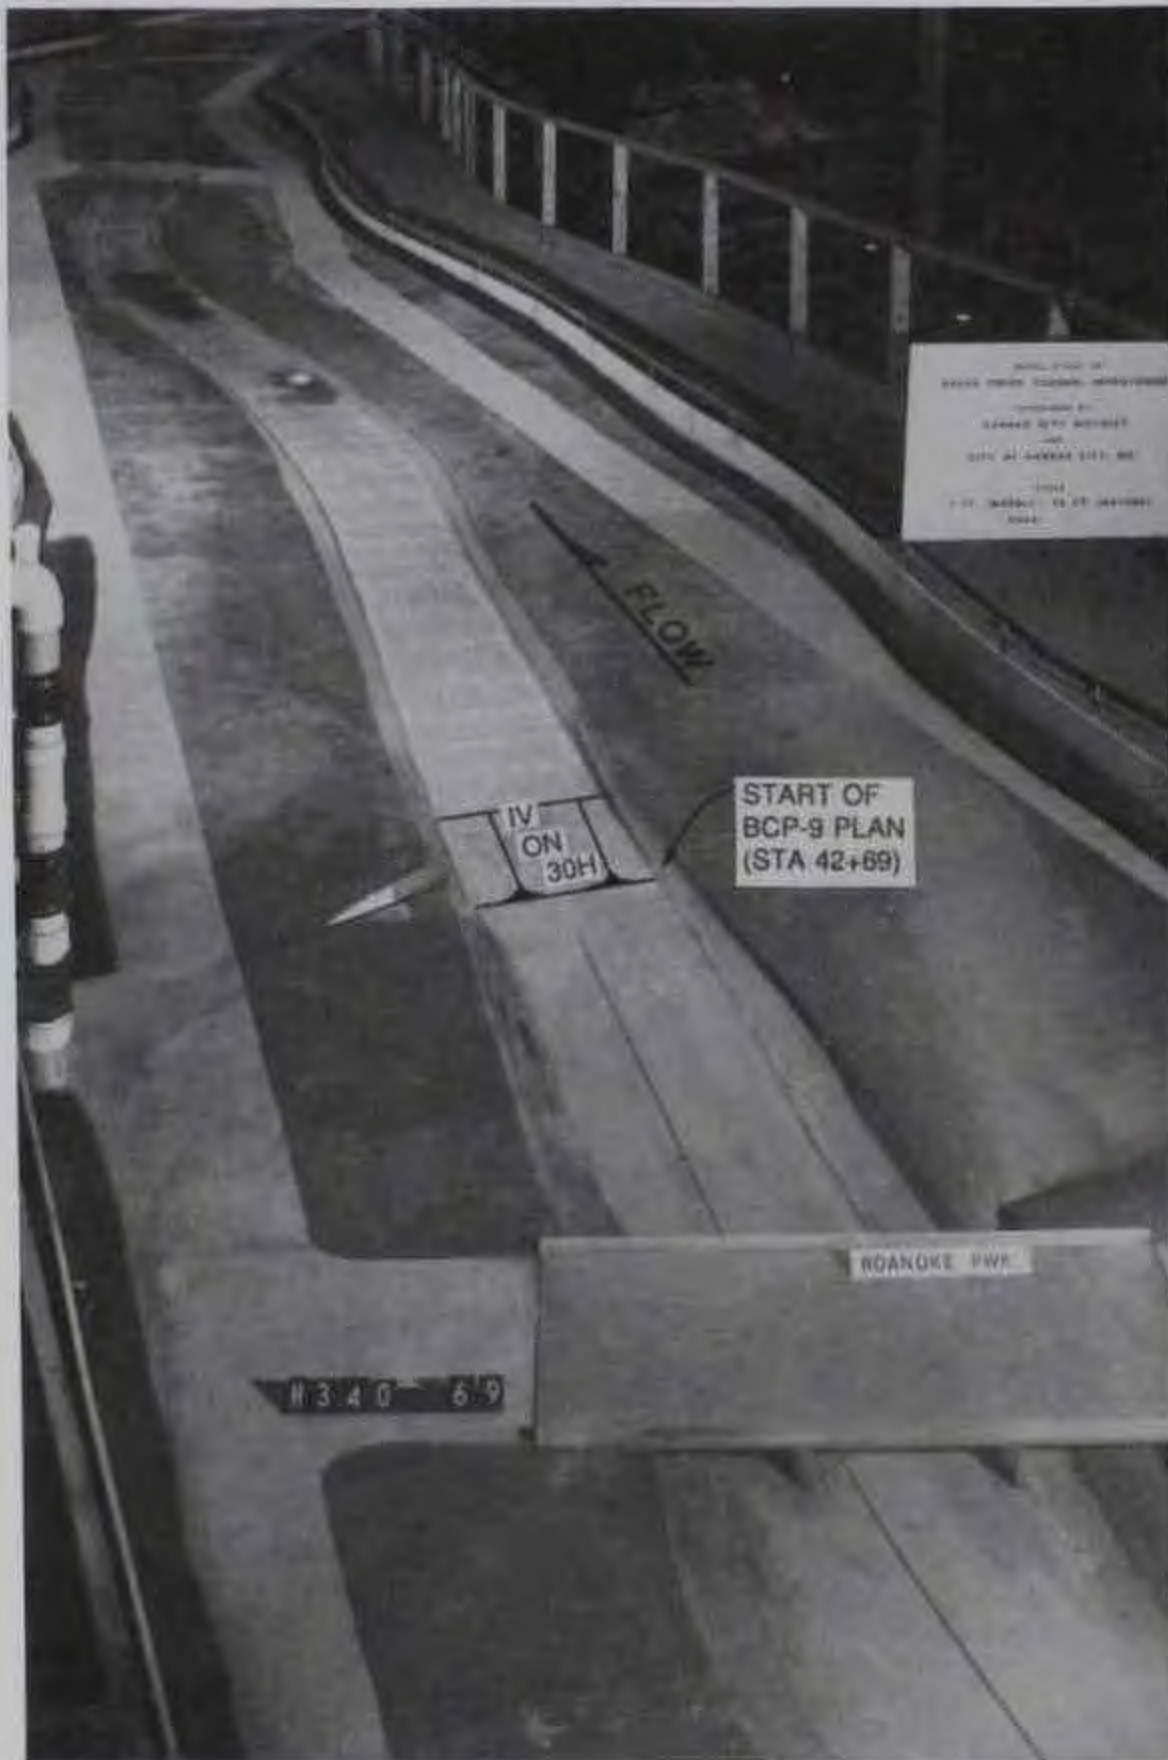
Photo 22. Corps BCP-9 Plan (Continued)

a. Sta 39+00 to sta 70+00

b. Sta 70+00 to sta 94+00

c. Sta 94+00 to sta 114+00

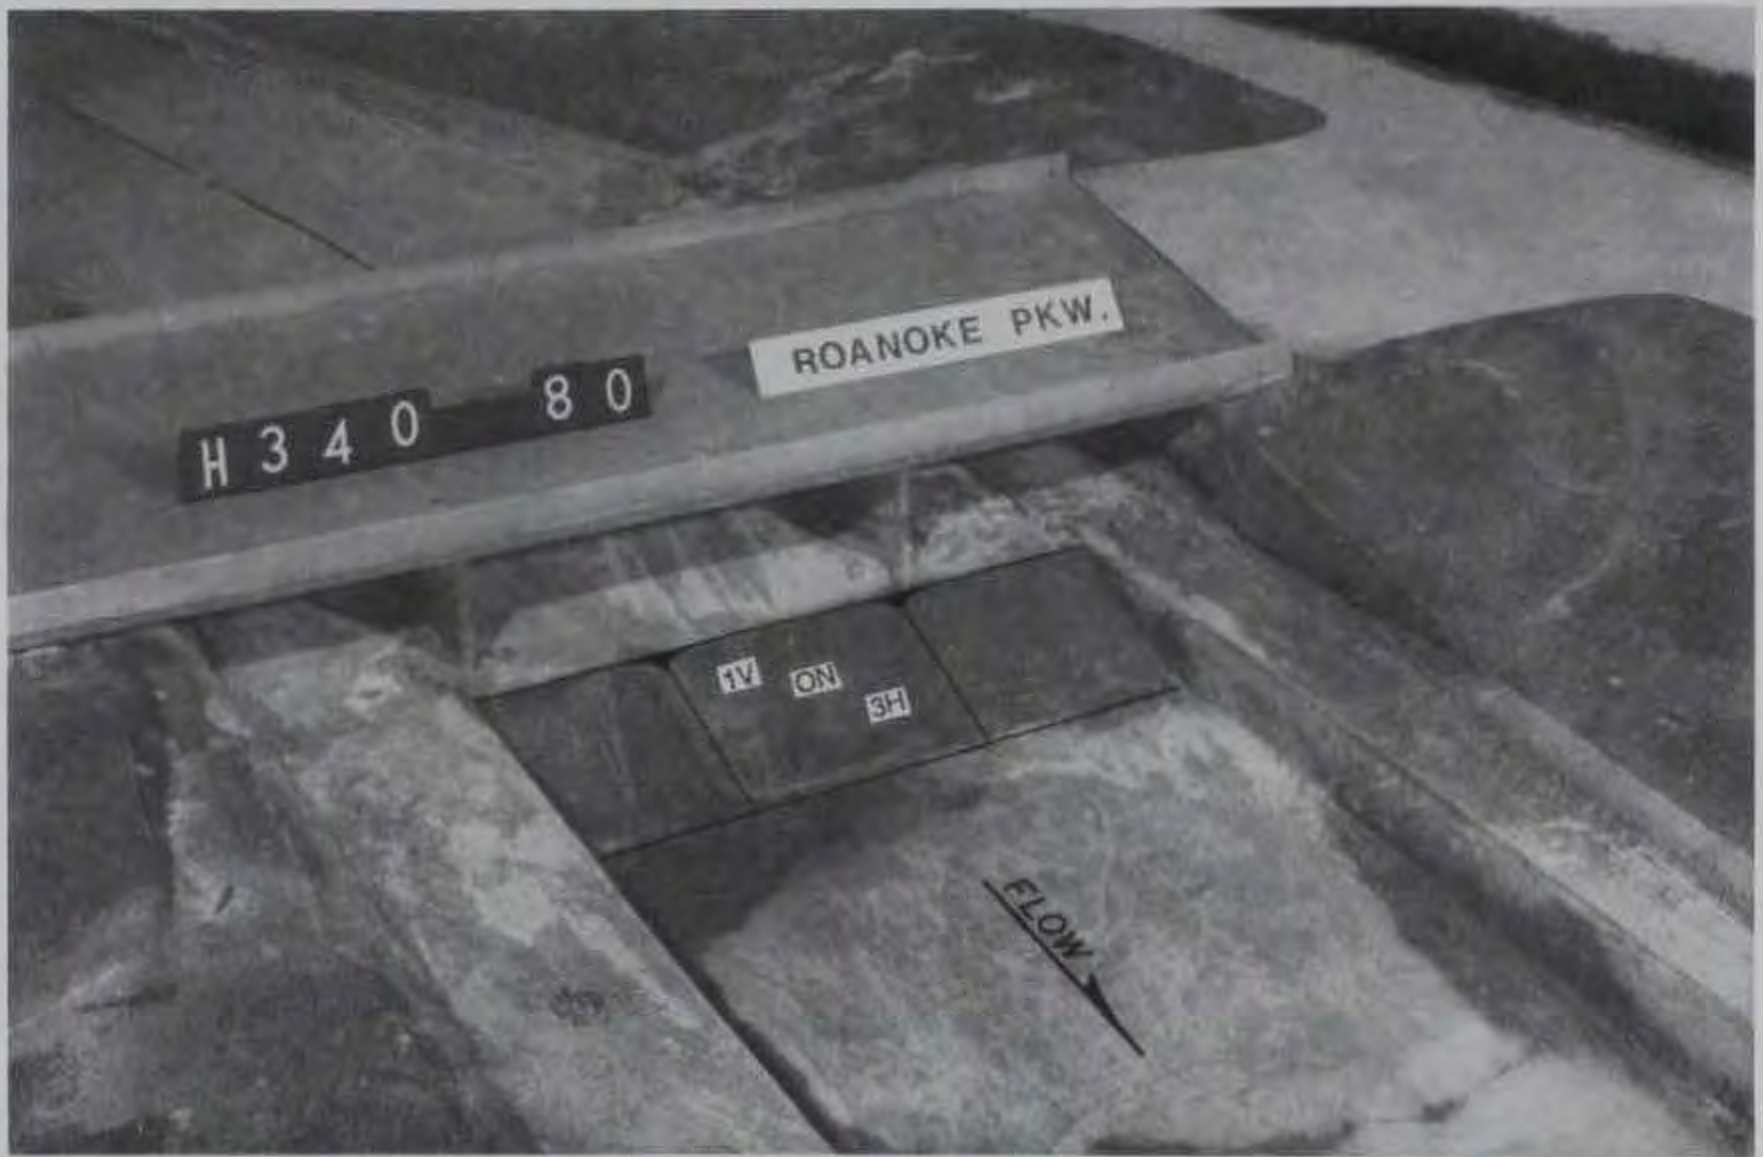
Photo 27. Transition into BCP-9 Plan (1V on 3H slope)

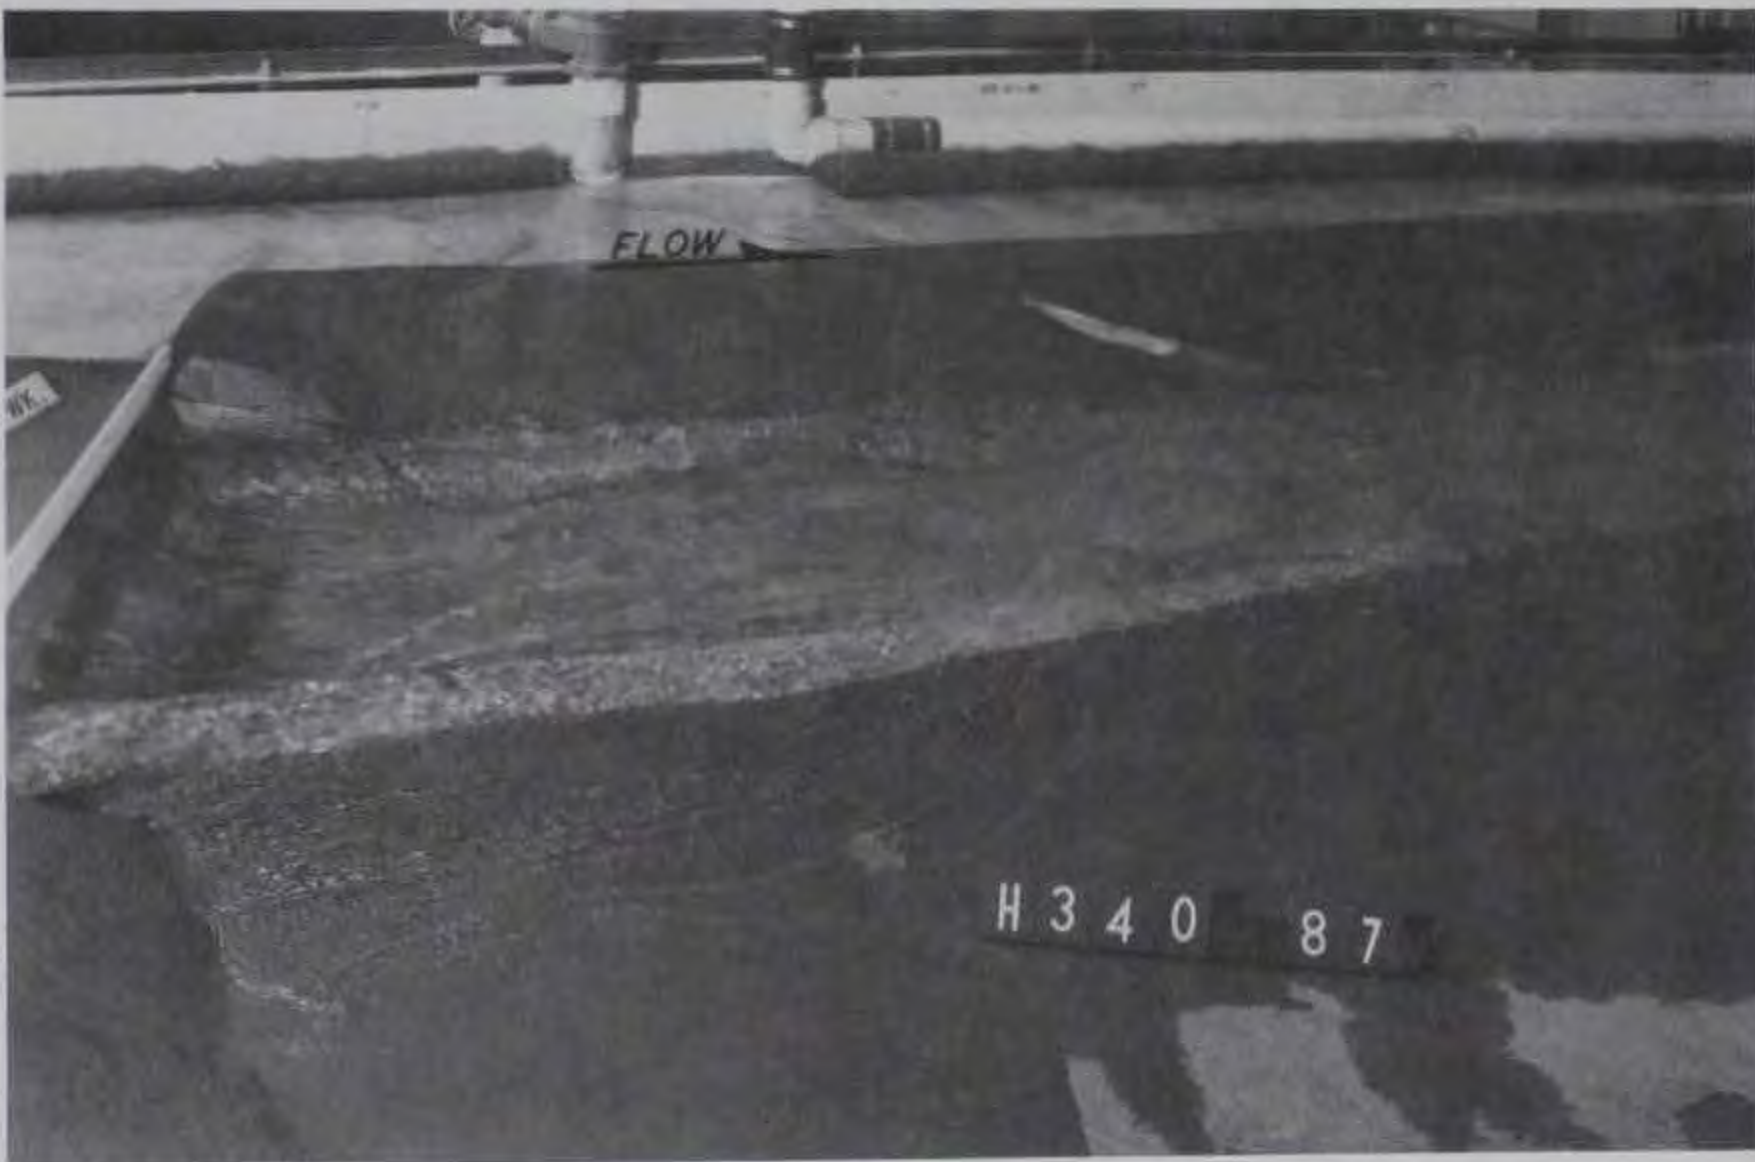
a. 10-year flood

b. 500-year flood

Photo 28. Flow conditions at transition into BCP-9 Plan (1V on 3H slope)
