TECHNICAL REPORT HL-92-1

BRUSH CREEK, KANSAS CITY, MISSOURI

Hydraulic Model Investigation

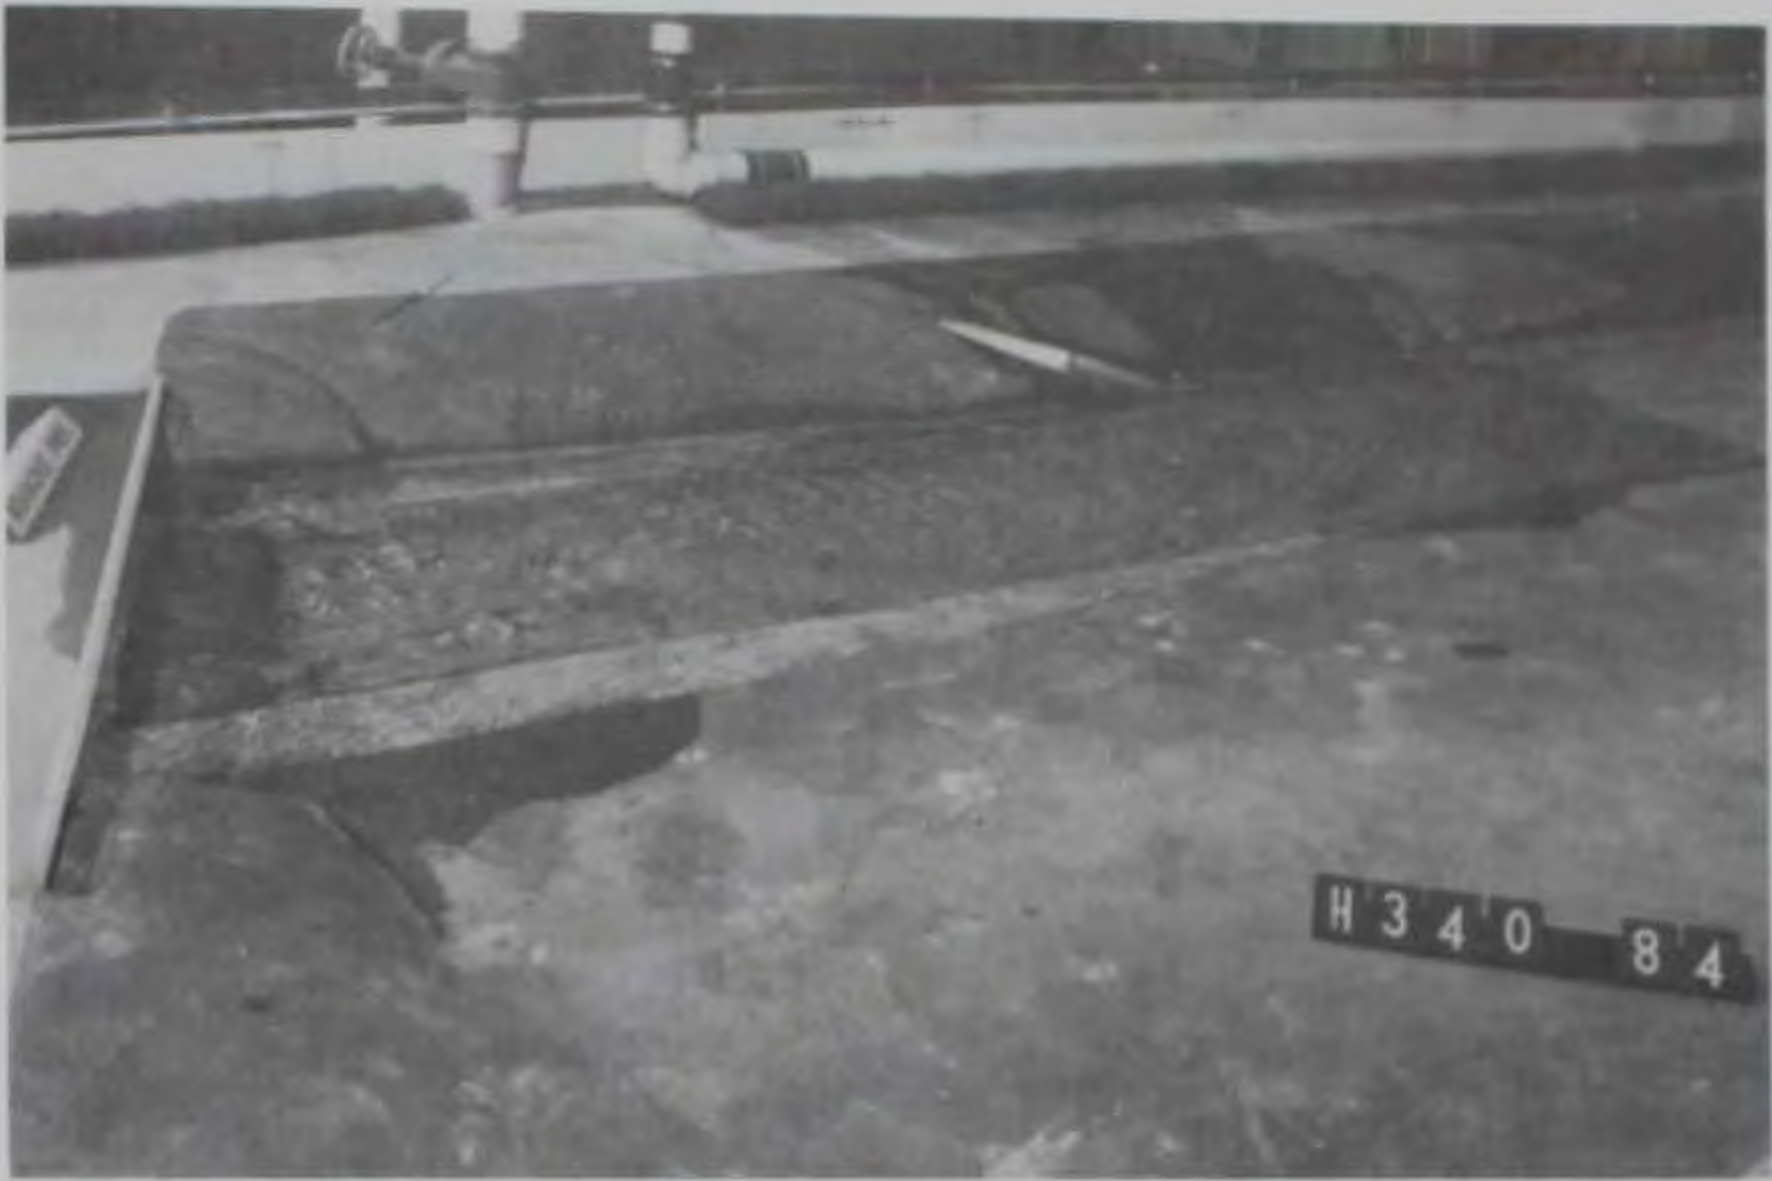
a. 10-year flood

b. 500-year flood

Photo 30. Flow conditions at vertical drop transition
into BCP-9 Plan

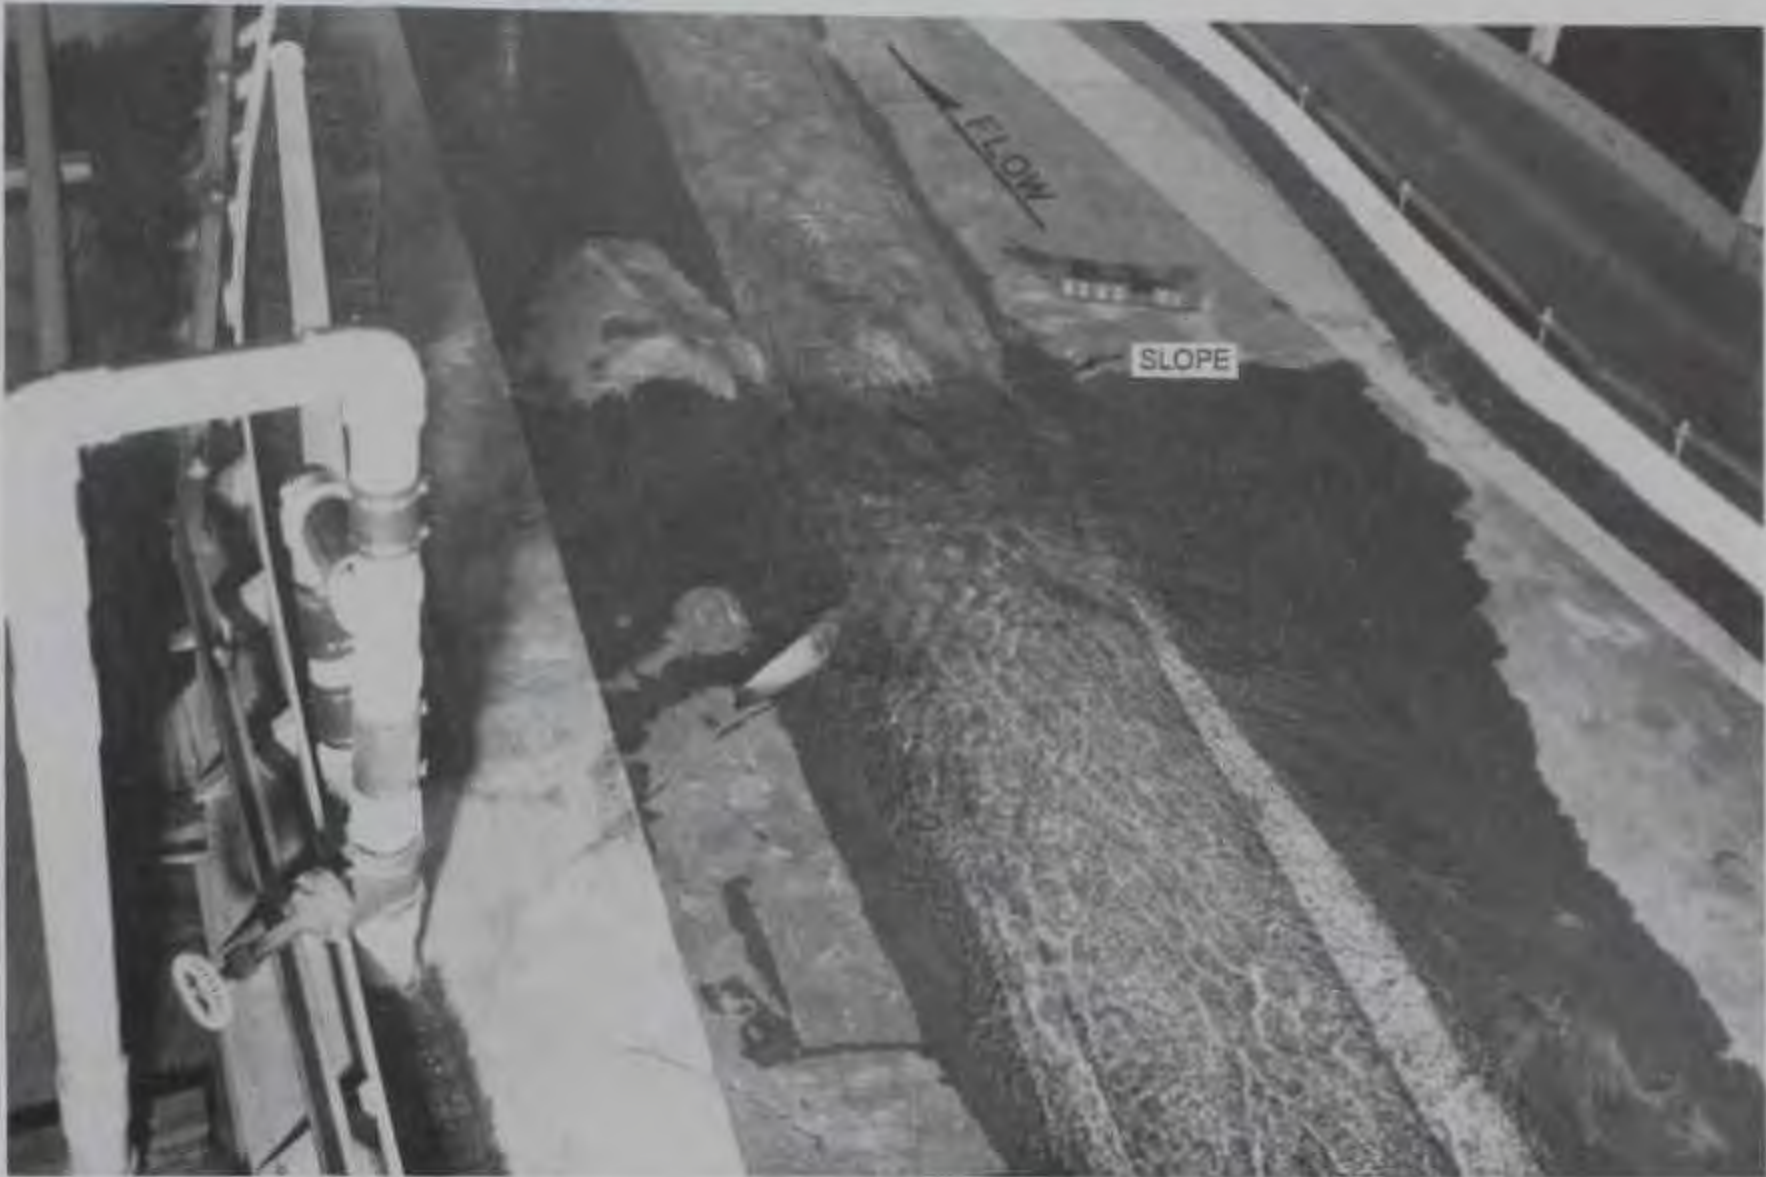
a. 10-year flood

b. 500-year flood

Photo 32. Flow conditions at 50-ft-long slope transition

modification. Flow conditions, shown in Photo 32, for the 10-year and 500-year floods revealed overbank lateral flow into the deepened channel. The existing topography of the left overbank assisted in redirecting the flow back into the modified channel.

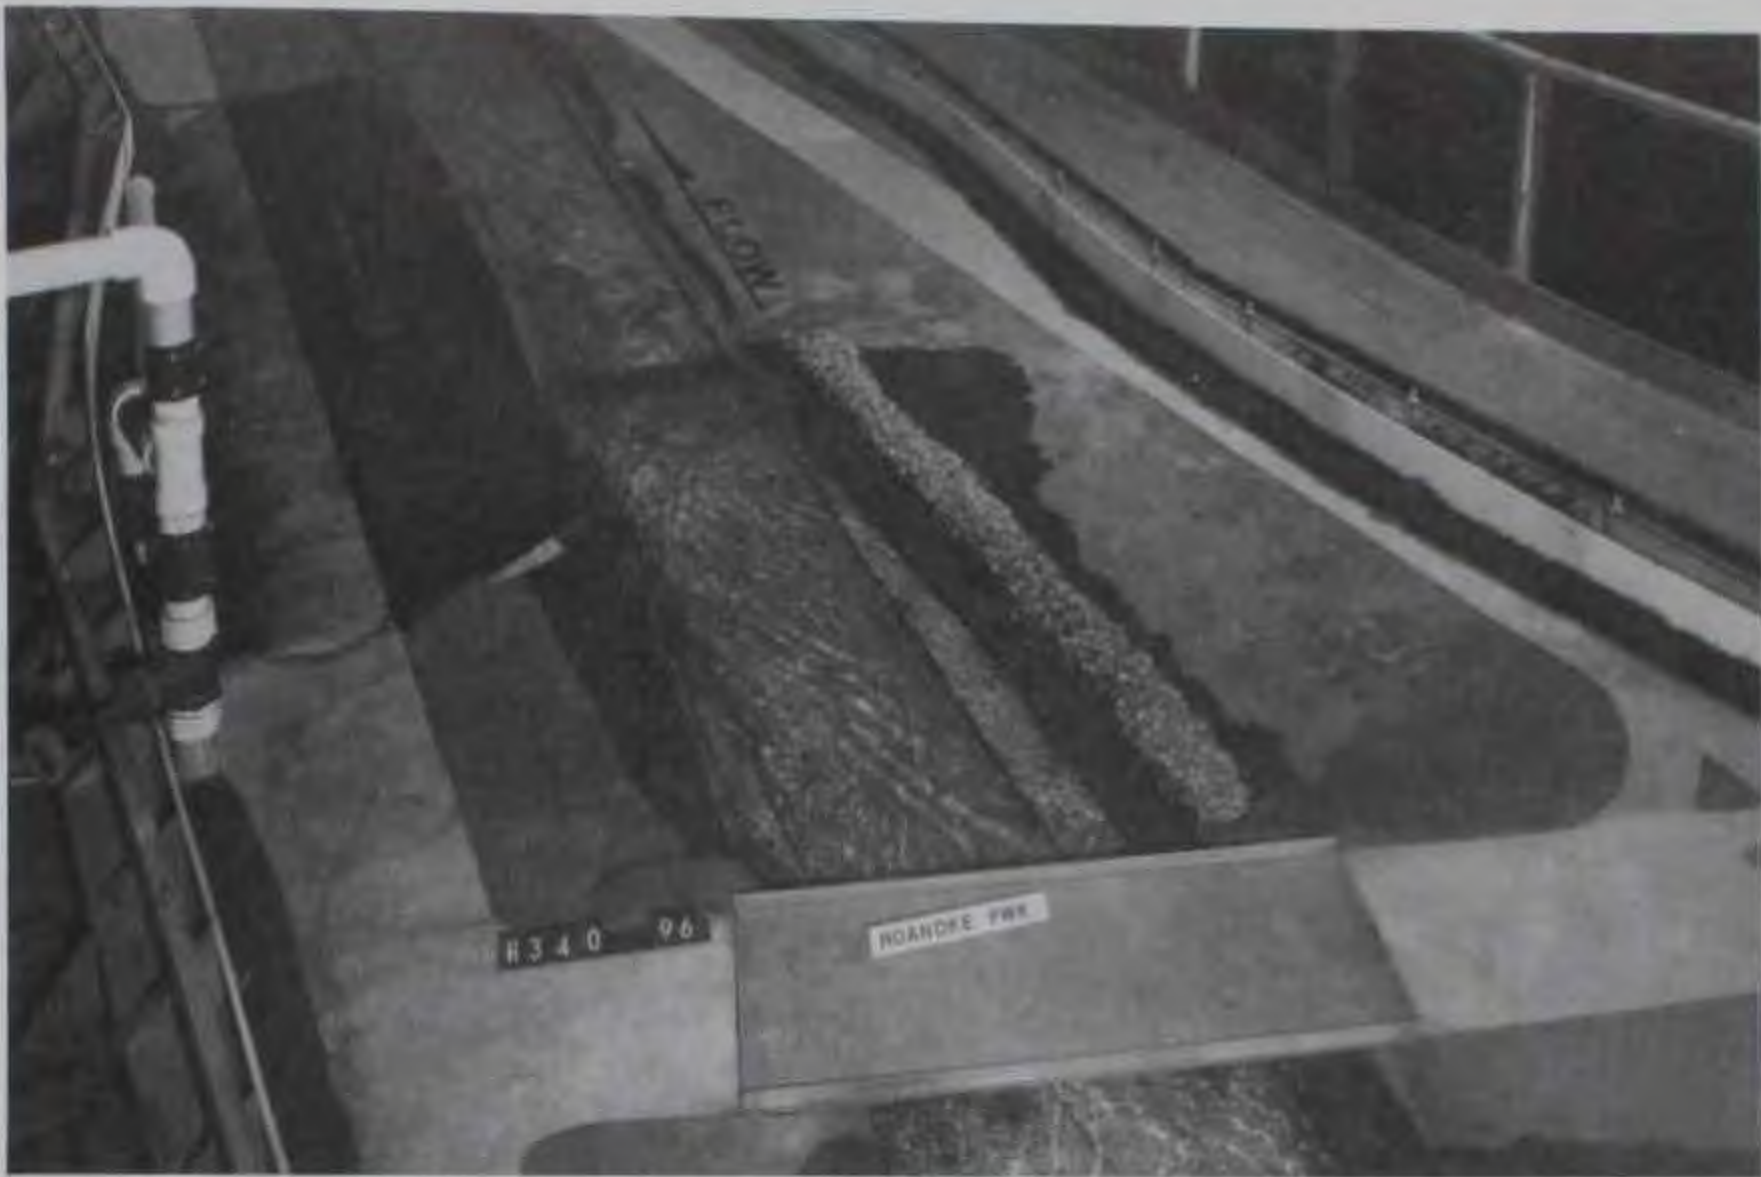
a. 10-year flood

b. 500-year flood

Photo 34. Flow conditions at 50-ft-long slope transition with rock berm

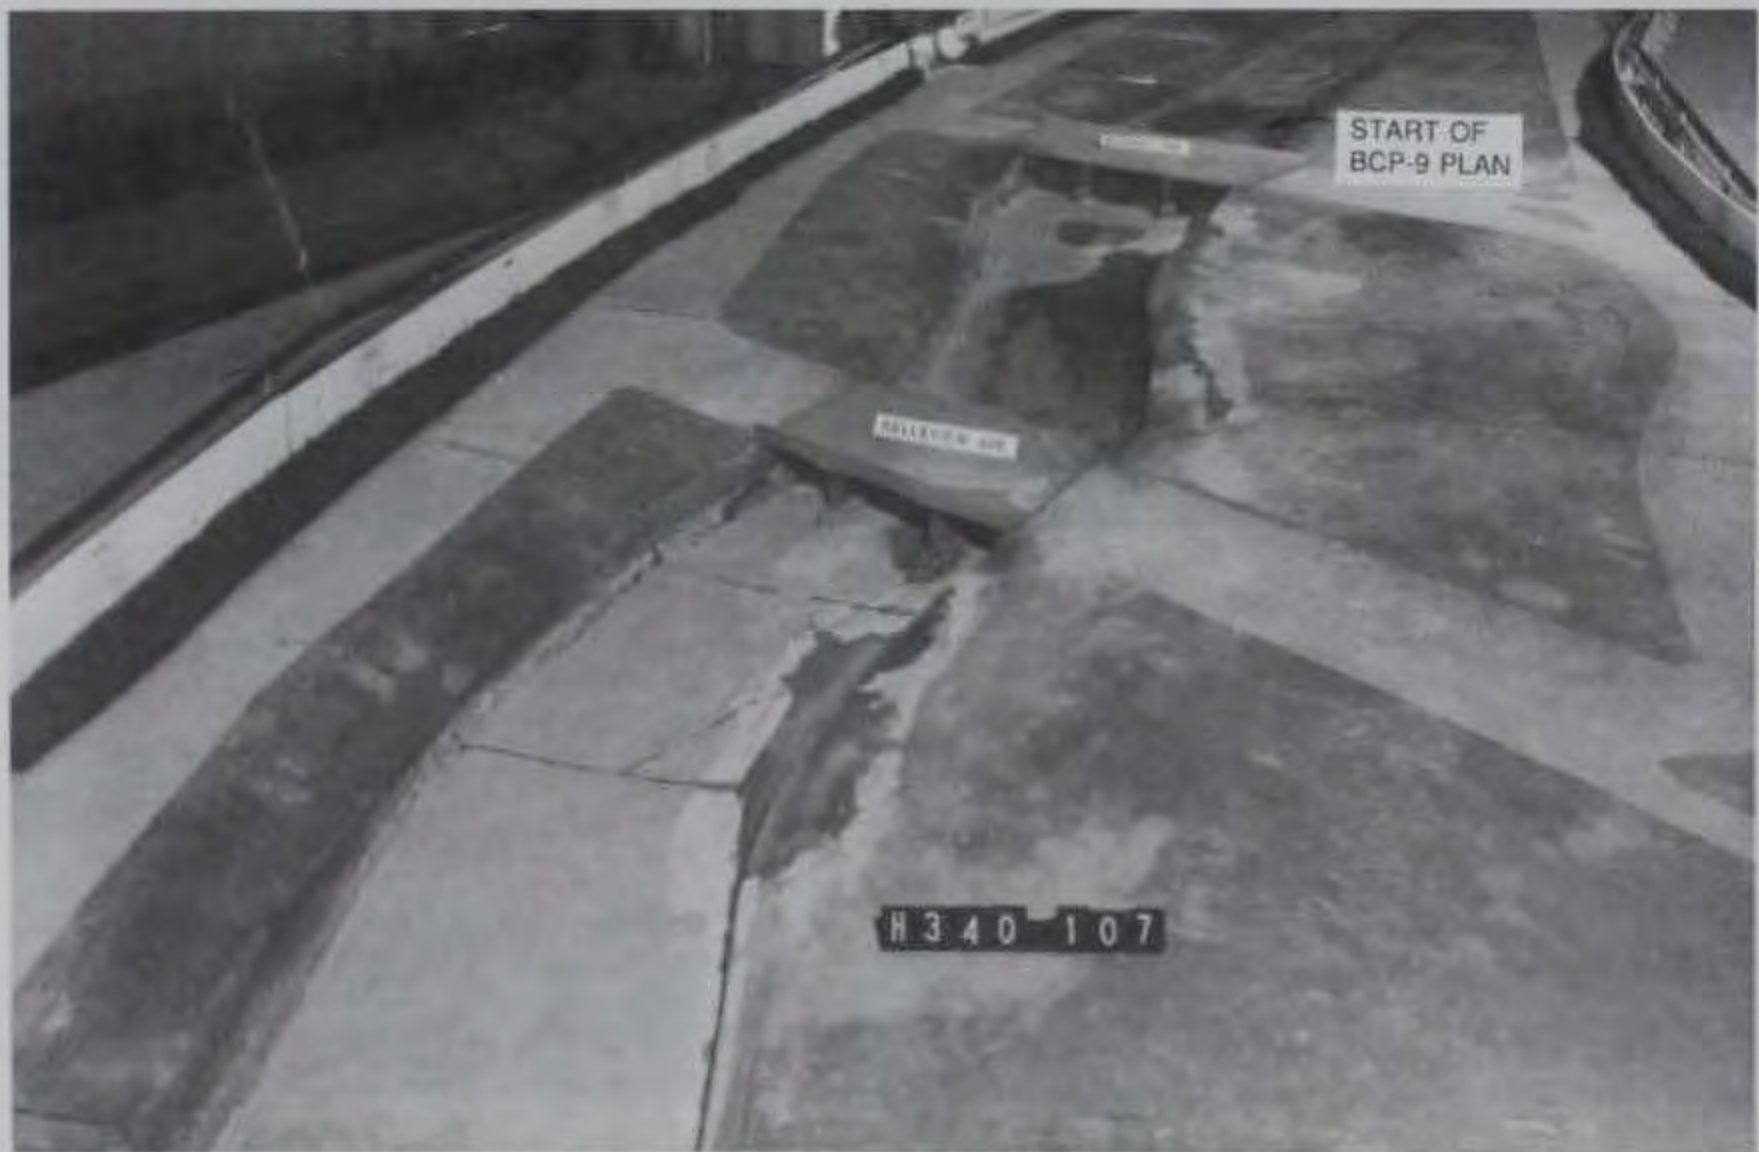
a. Sta 20+00 to sta 31+00

b. Sta 34+00 to sta 40+00

Photo 35. City upstream plan

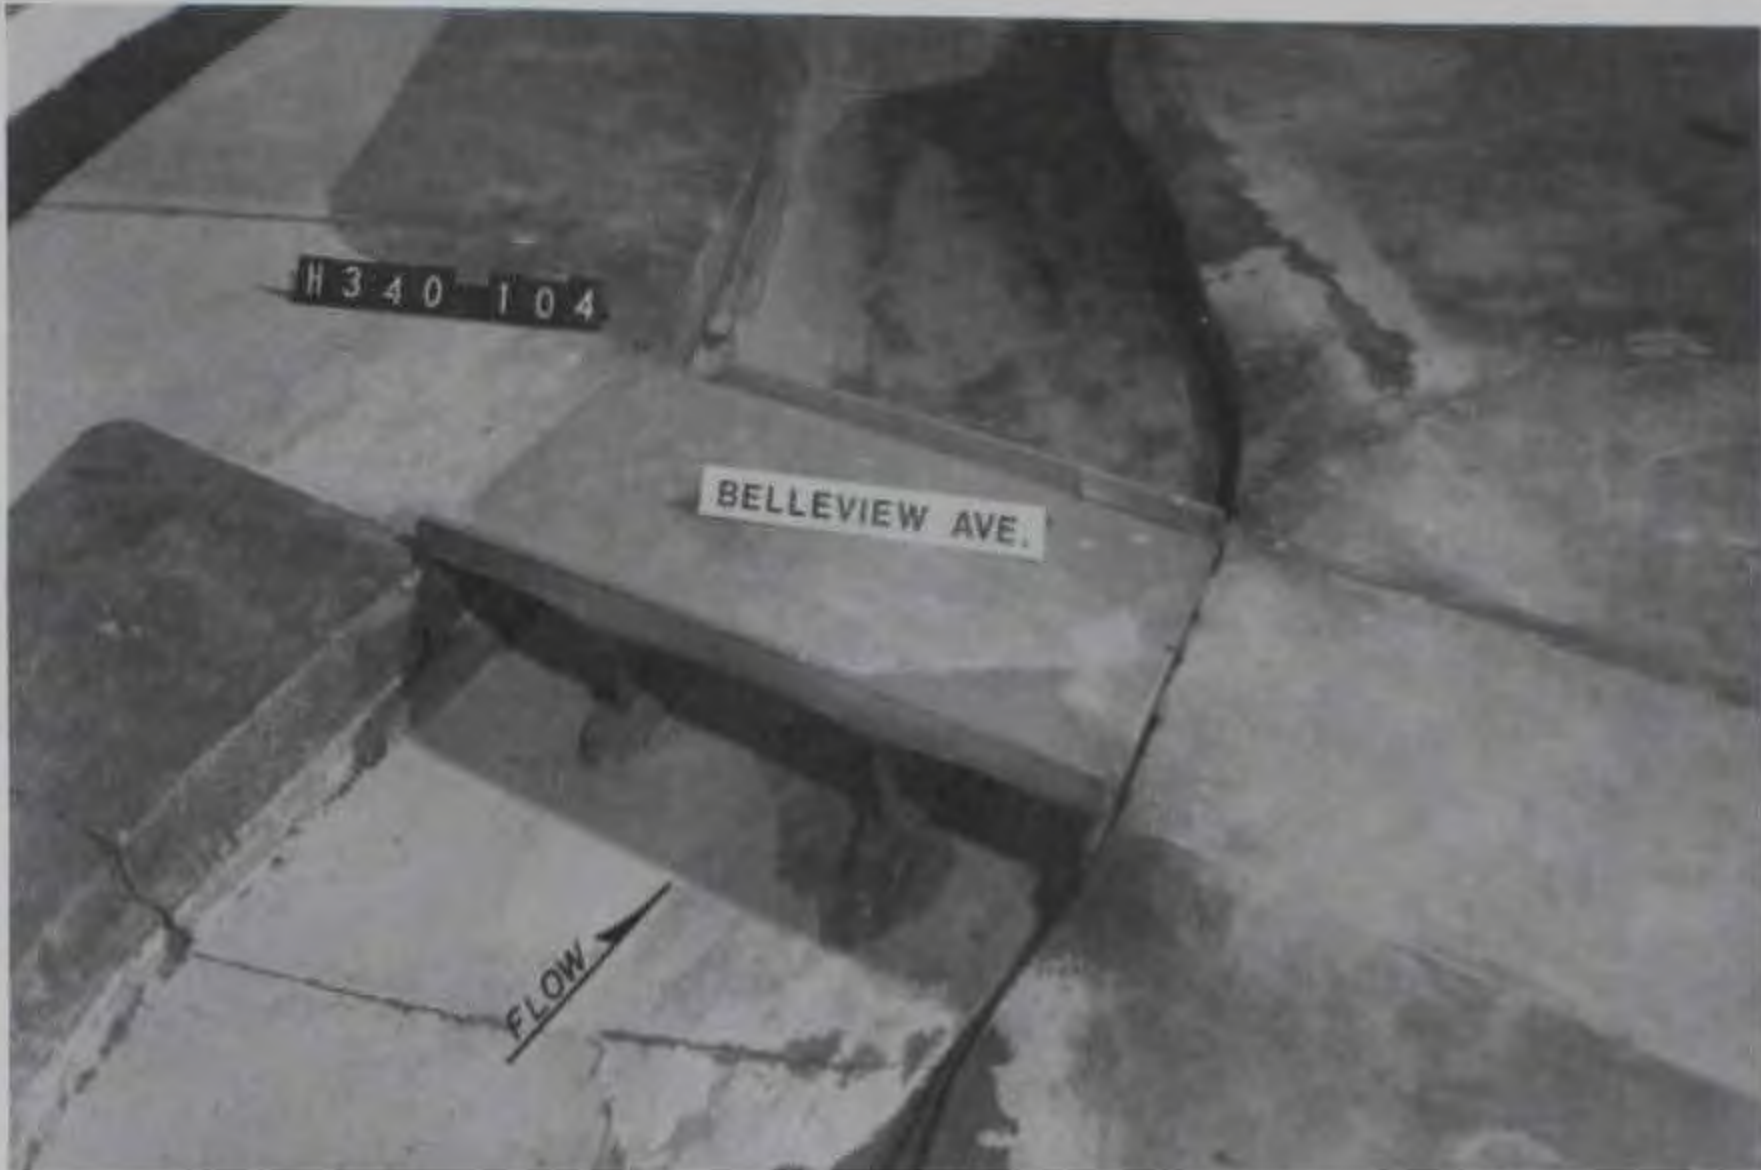
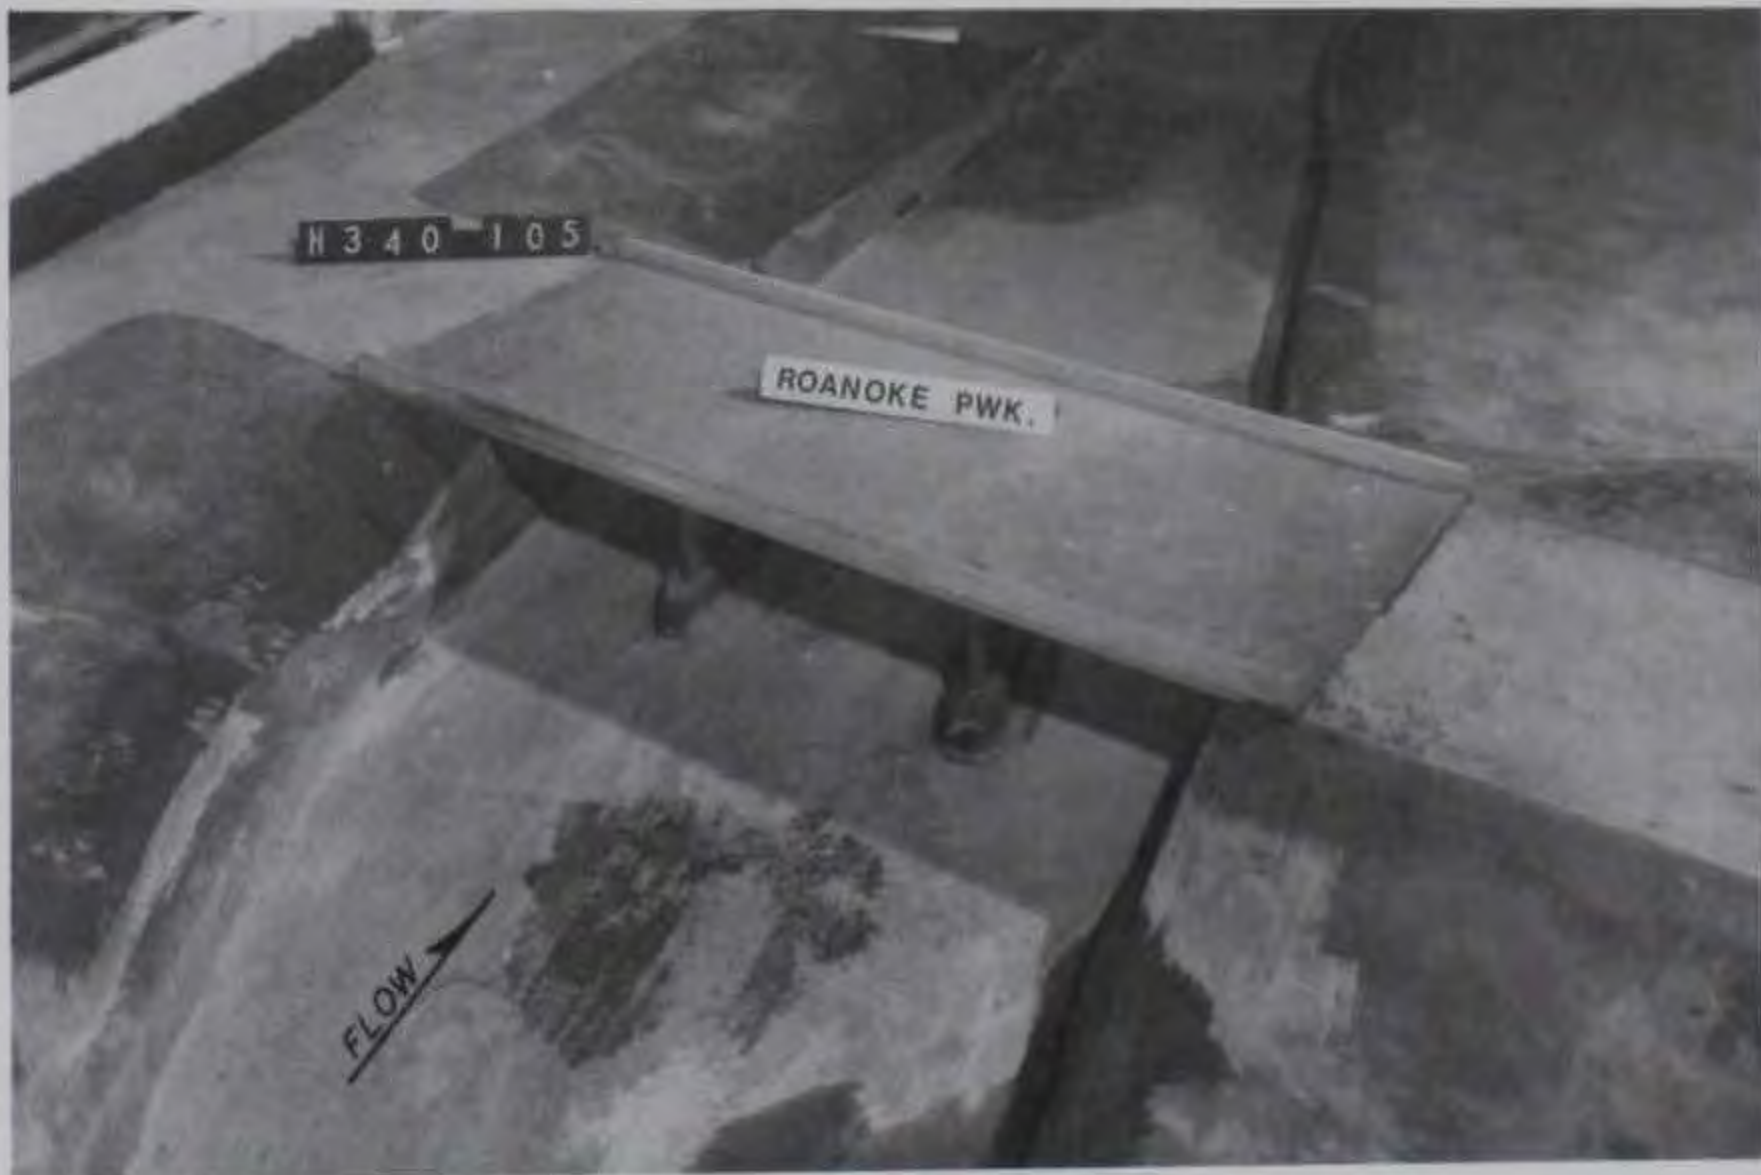
a. Belleview Avenue Bridge

b. Roanoke Parkway Bridge

Photo 36. City upstream deepening modification

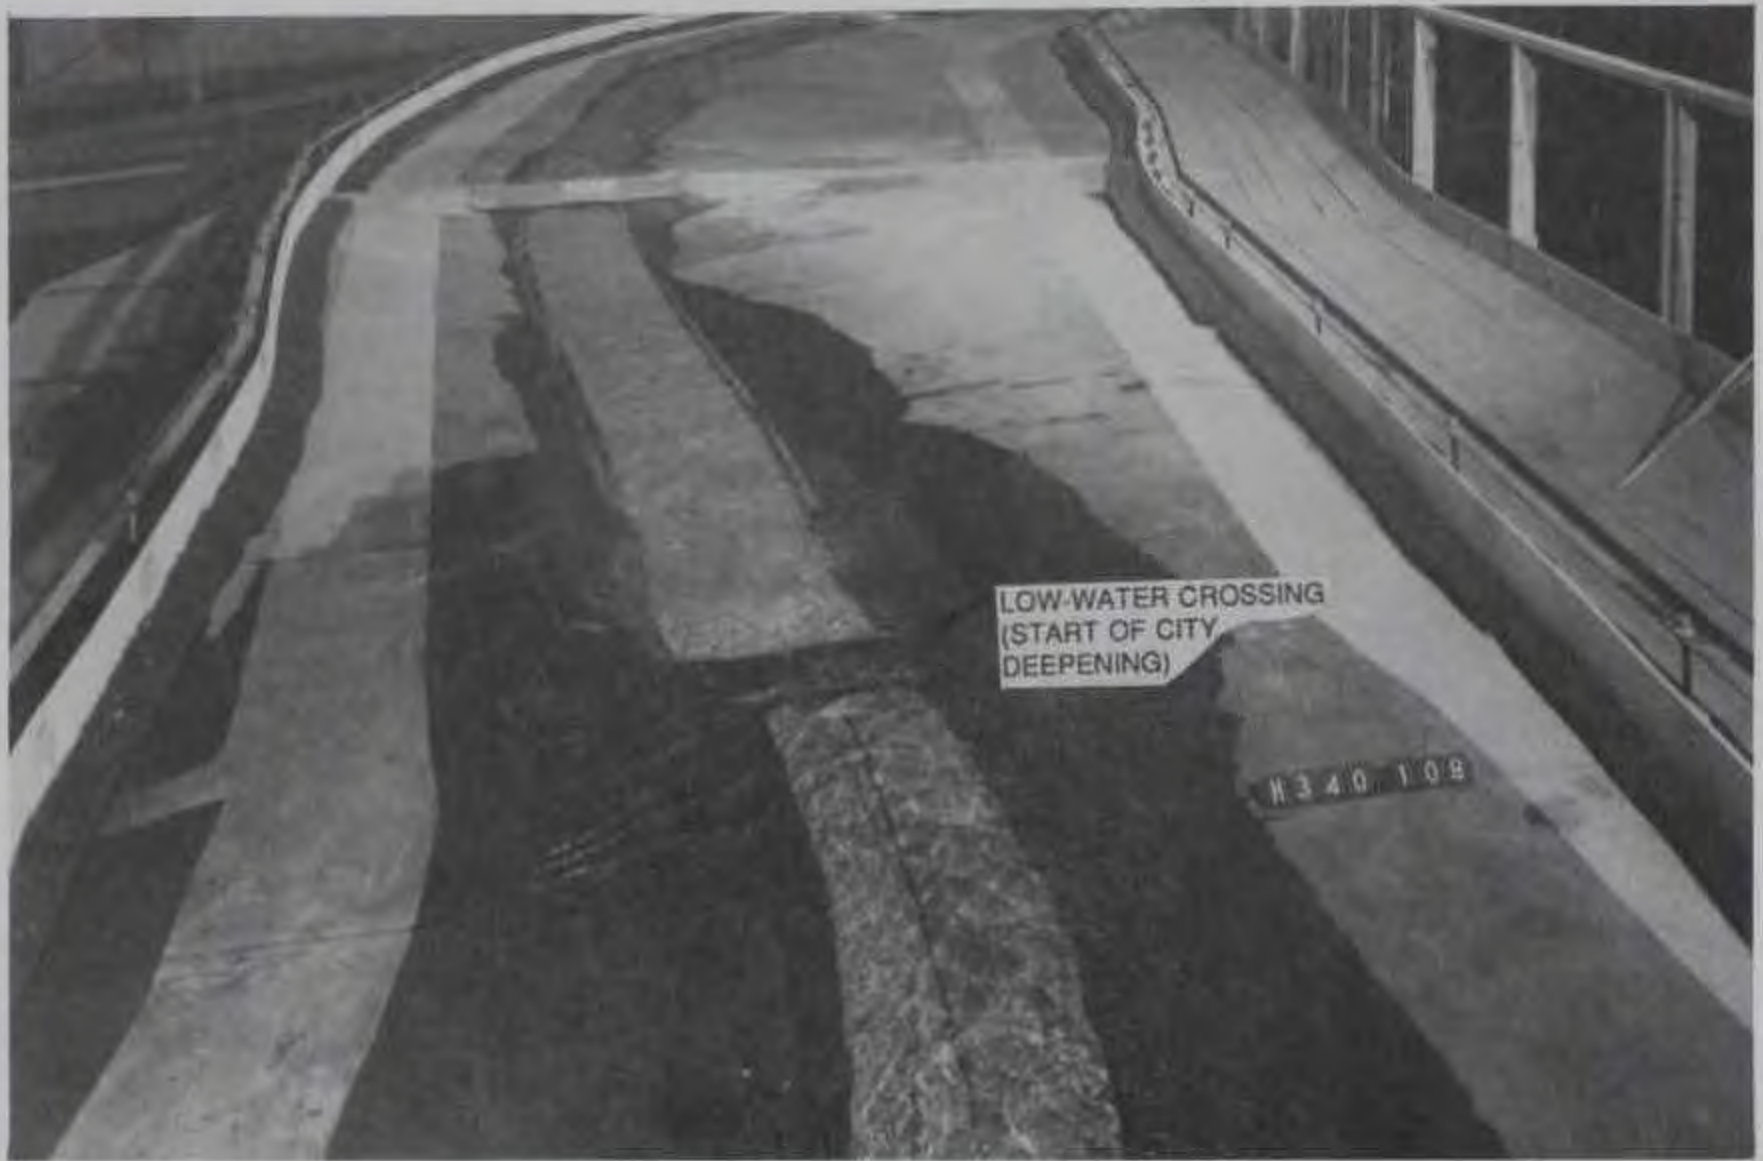
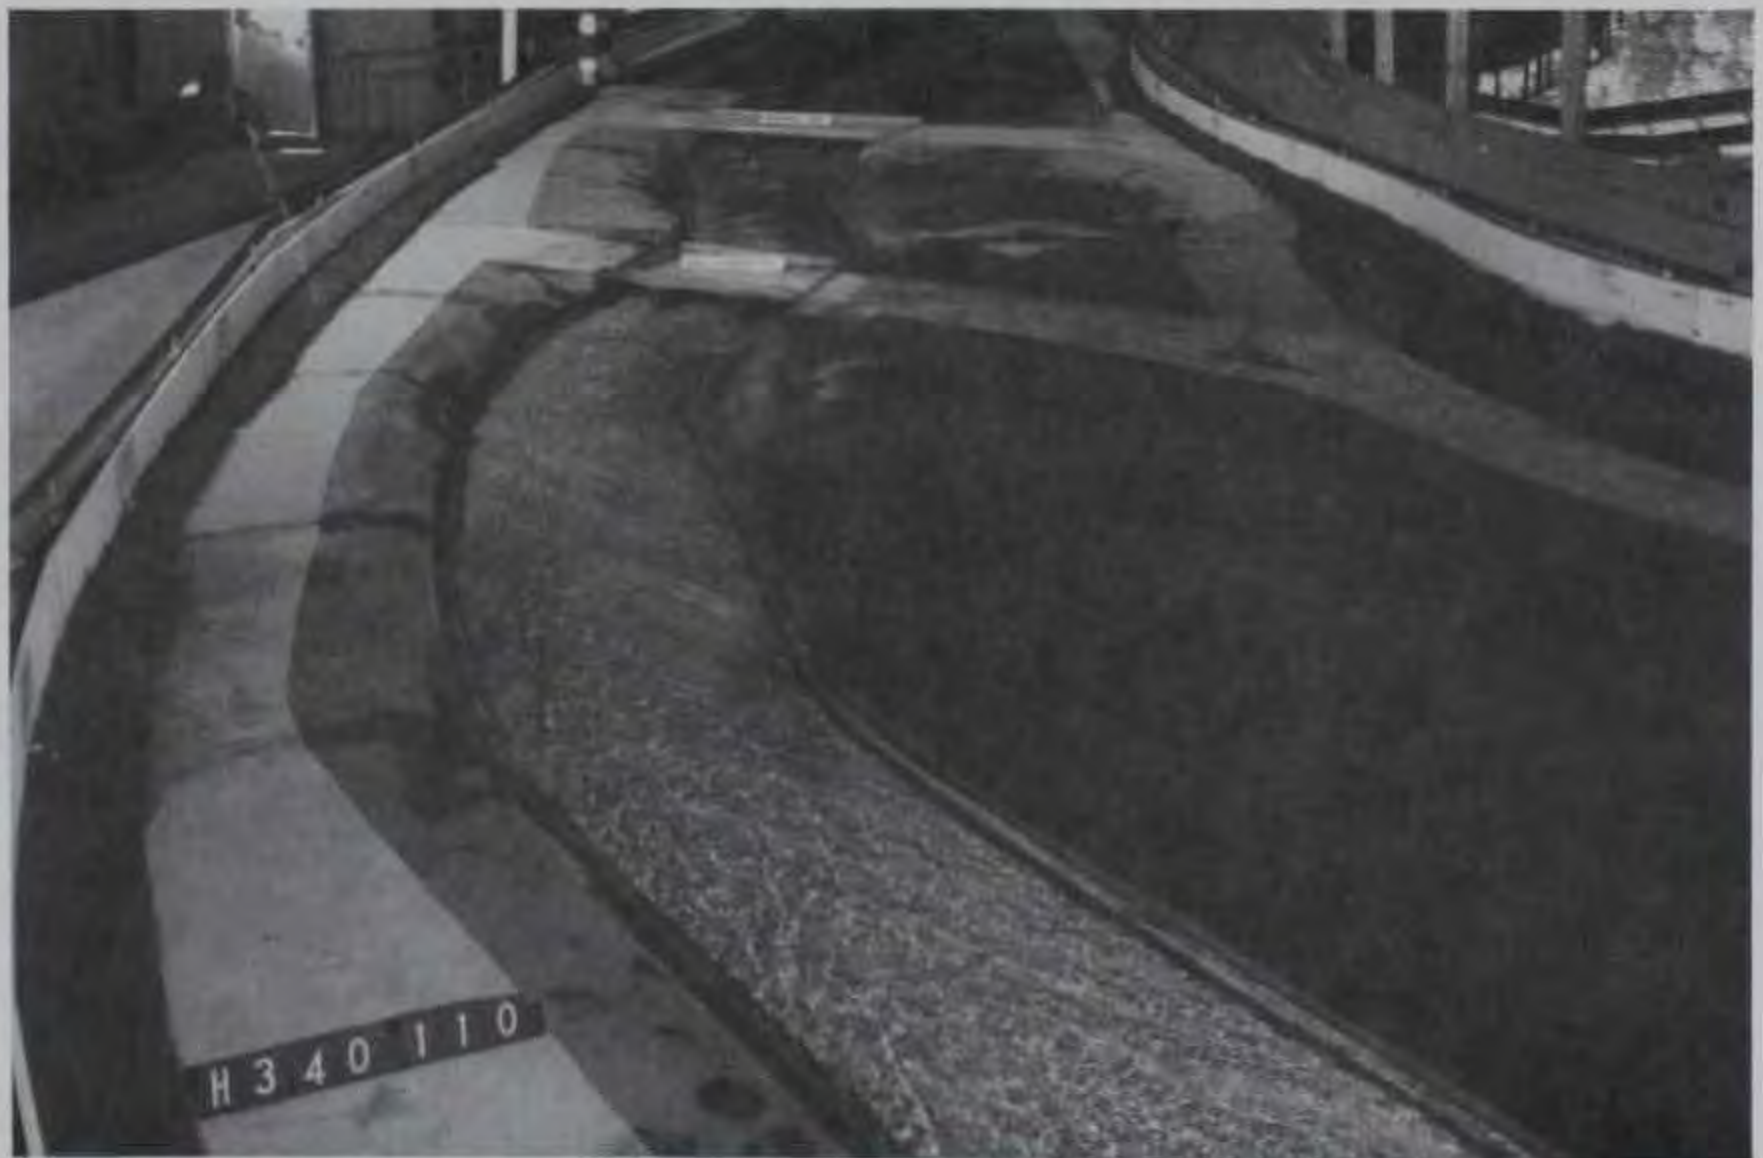
a. Sta 18+00 to sta 36+00

b. Sta 31+00 to sta 40+00

Photo 37. City upstream deepening plan, 10-year flood

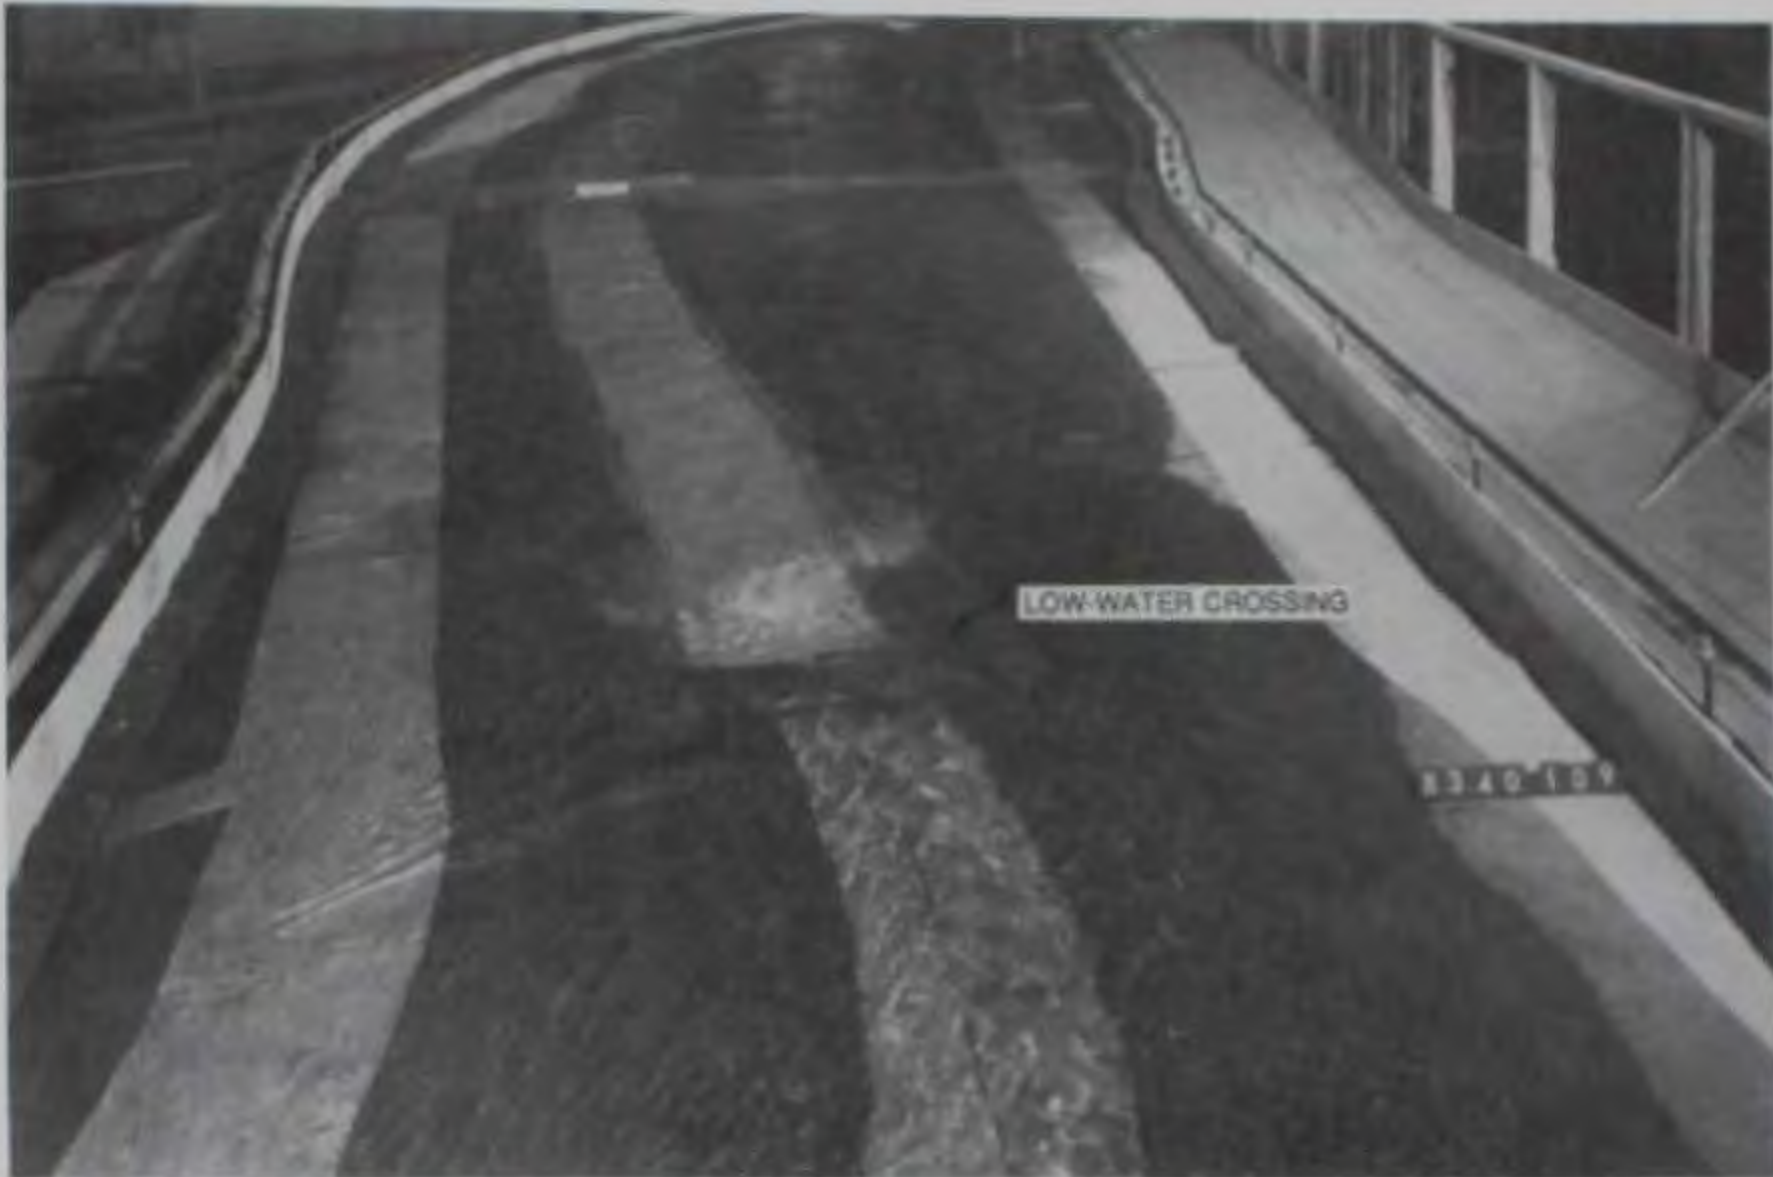
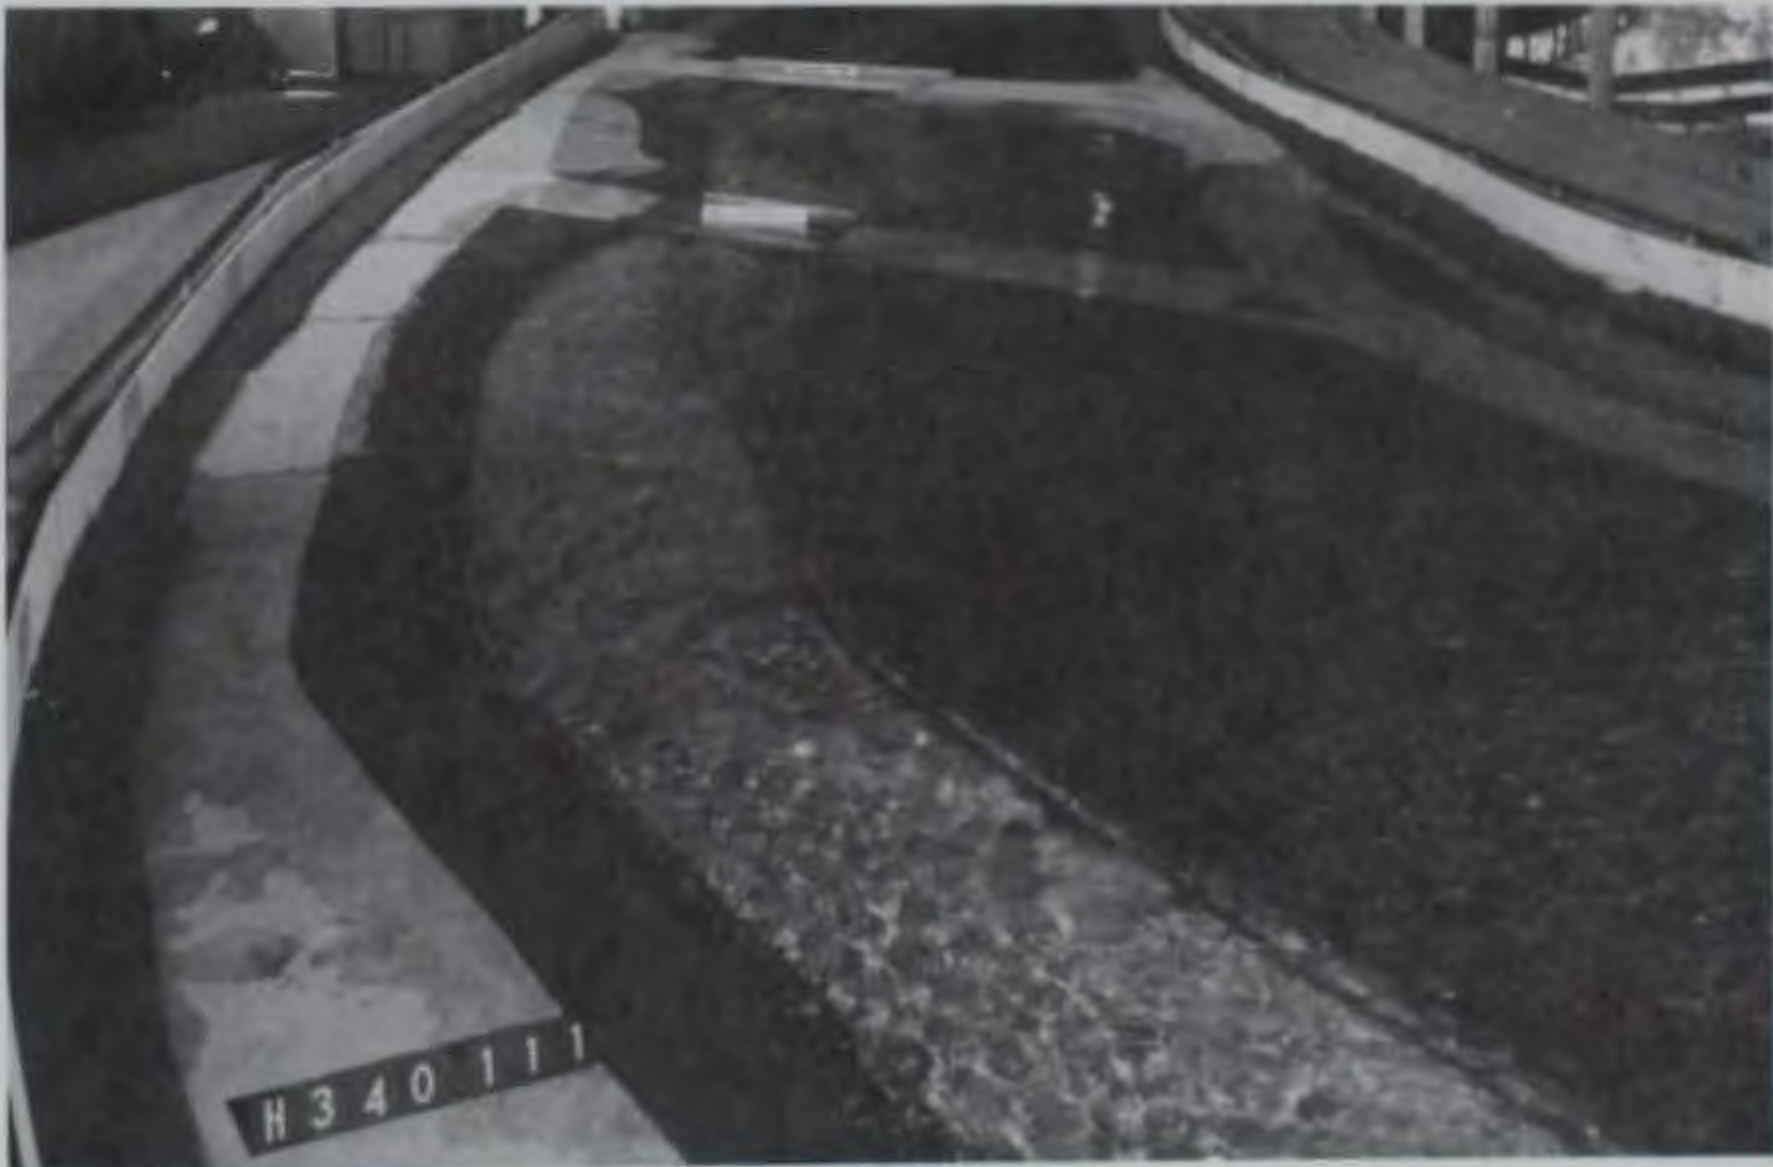
a. Sta 18+00 to sta 36+00

b. Sta 31+00 to sta 40+00

Photo 38. City upstream deepening plan, 500-year flood

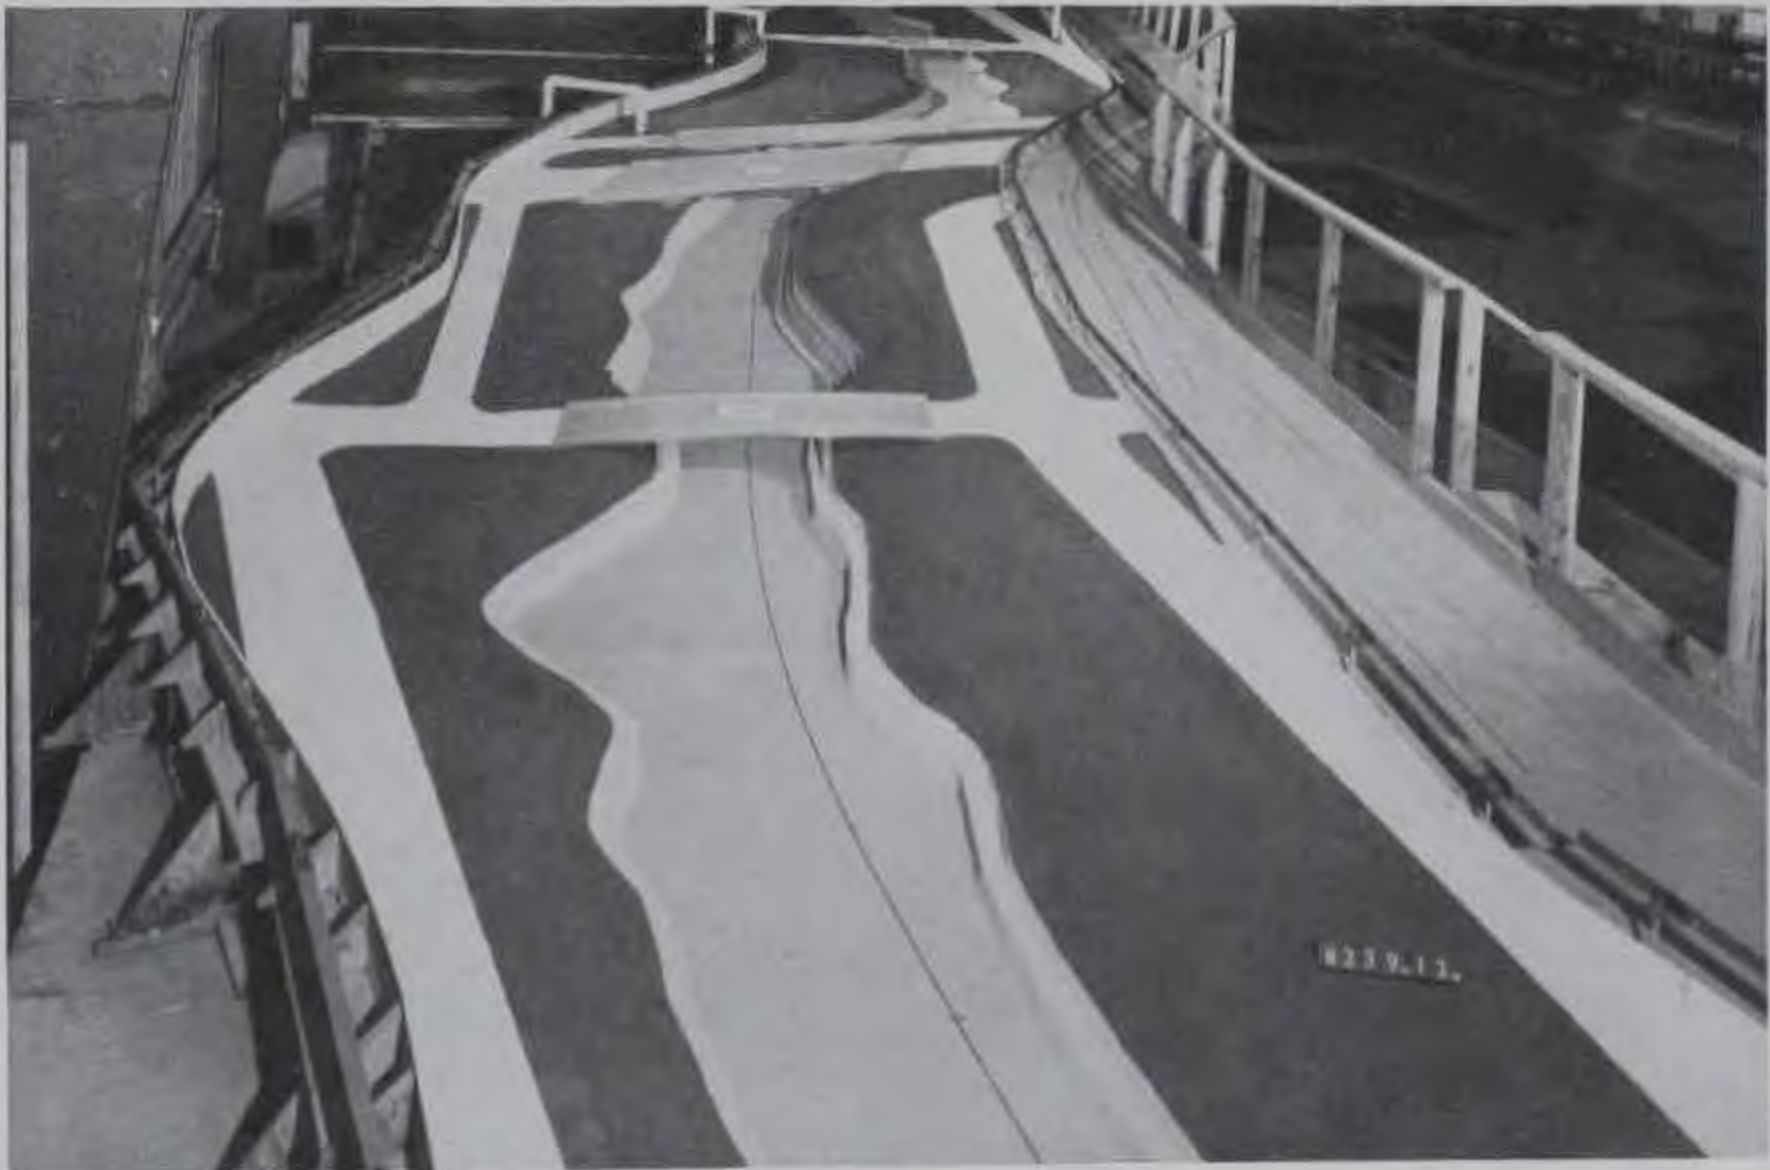
b. Sta 60+00 to sta 84+00
