TECHNICAL REPORT HL-92-1

BRUSH CREEK, KANSAS CITY, MISSOURI

Hydraulic Model Investigation

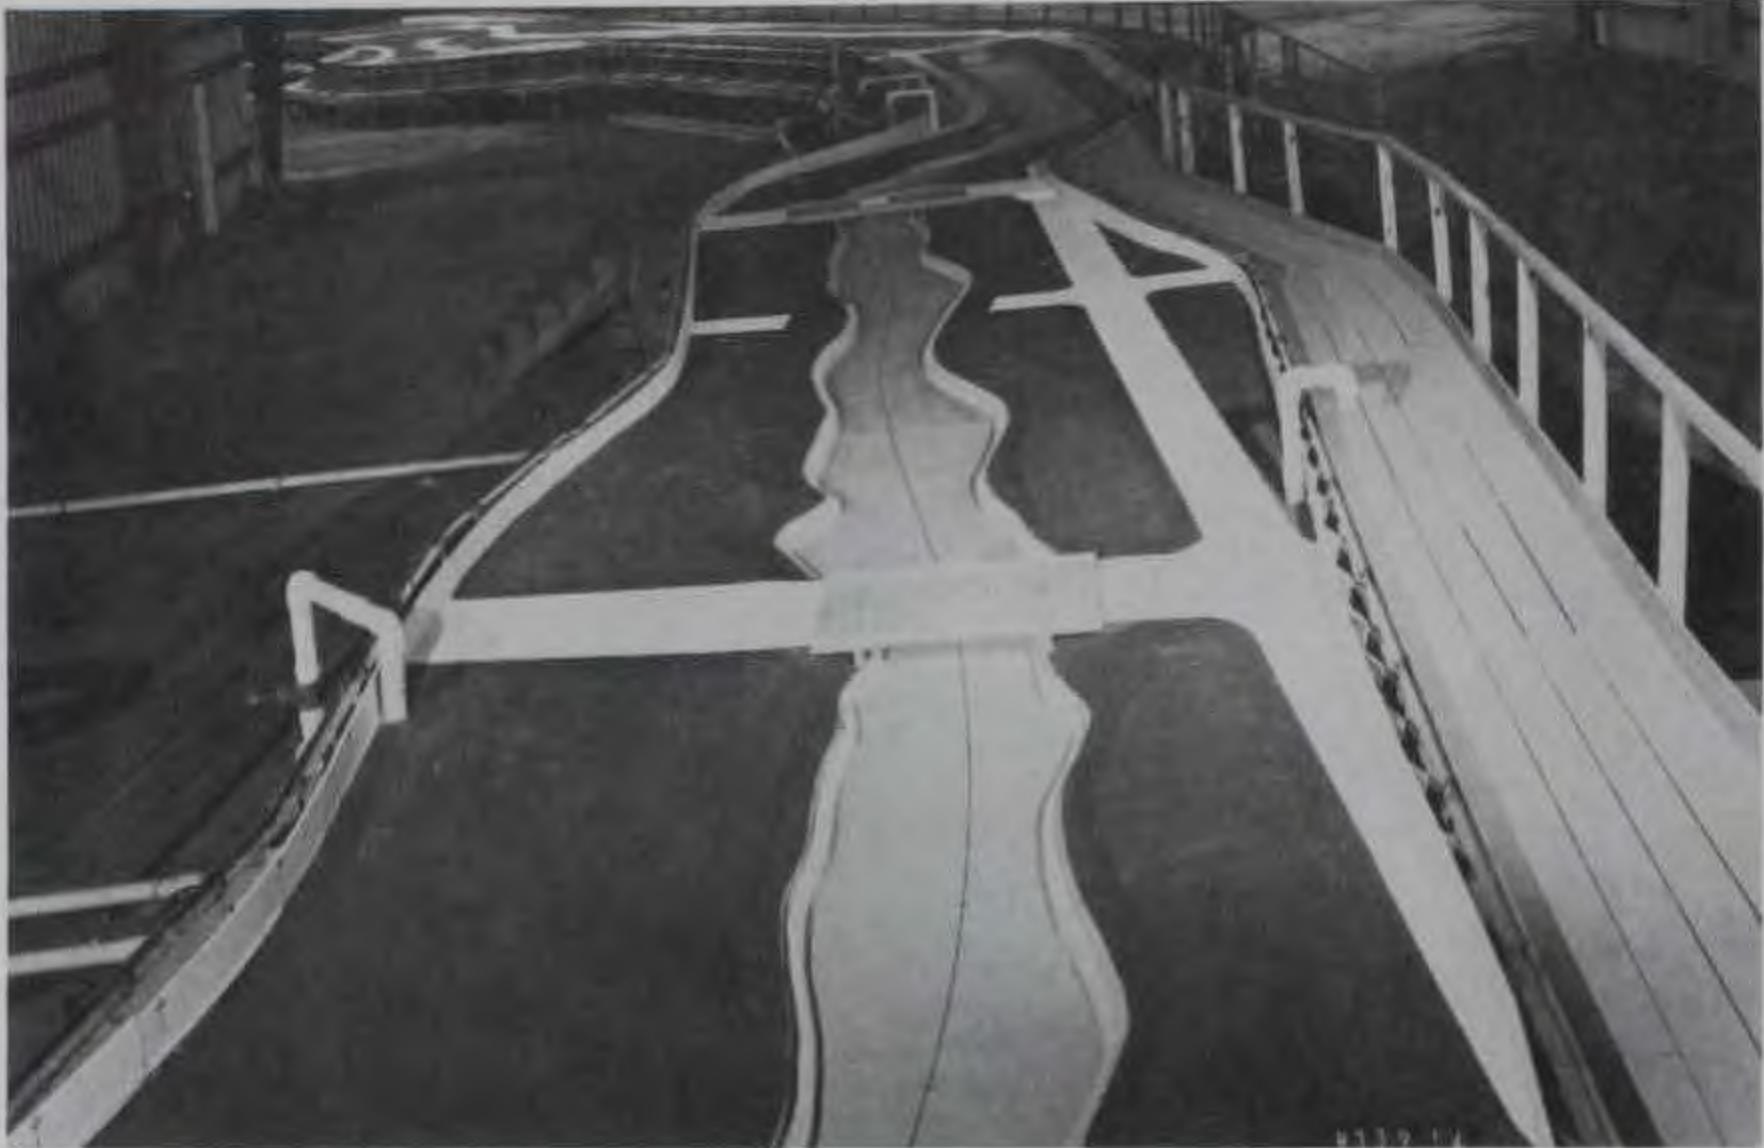
c. Sta 81+00 to sta 112+00

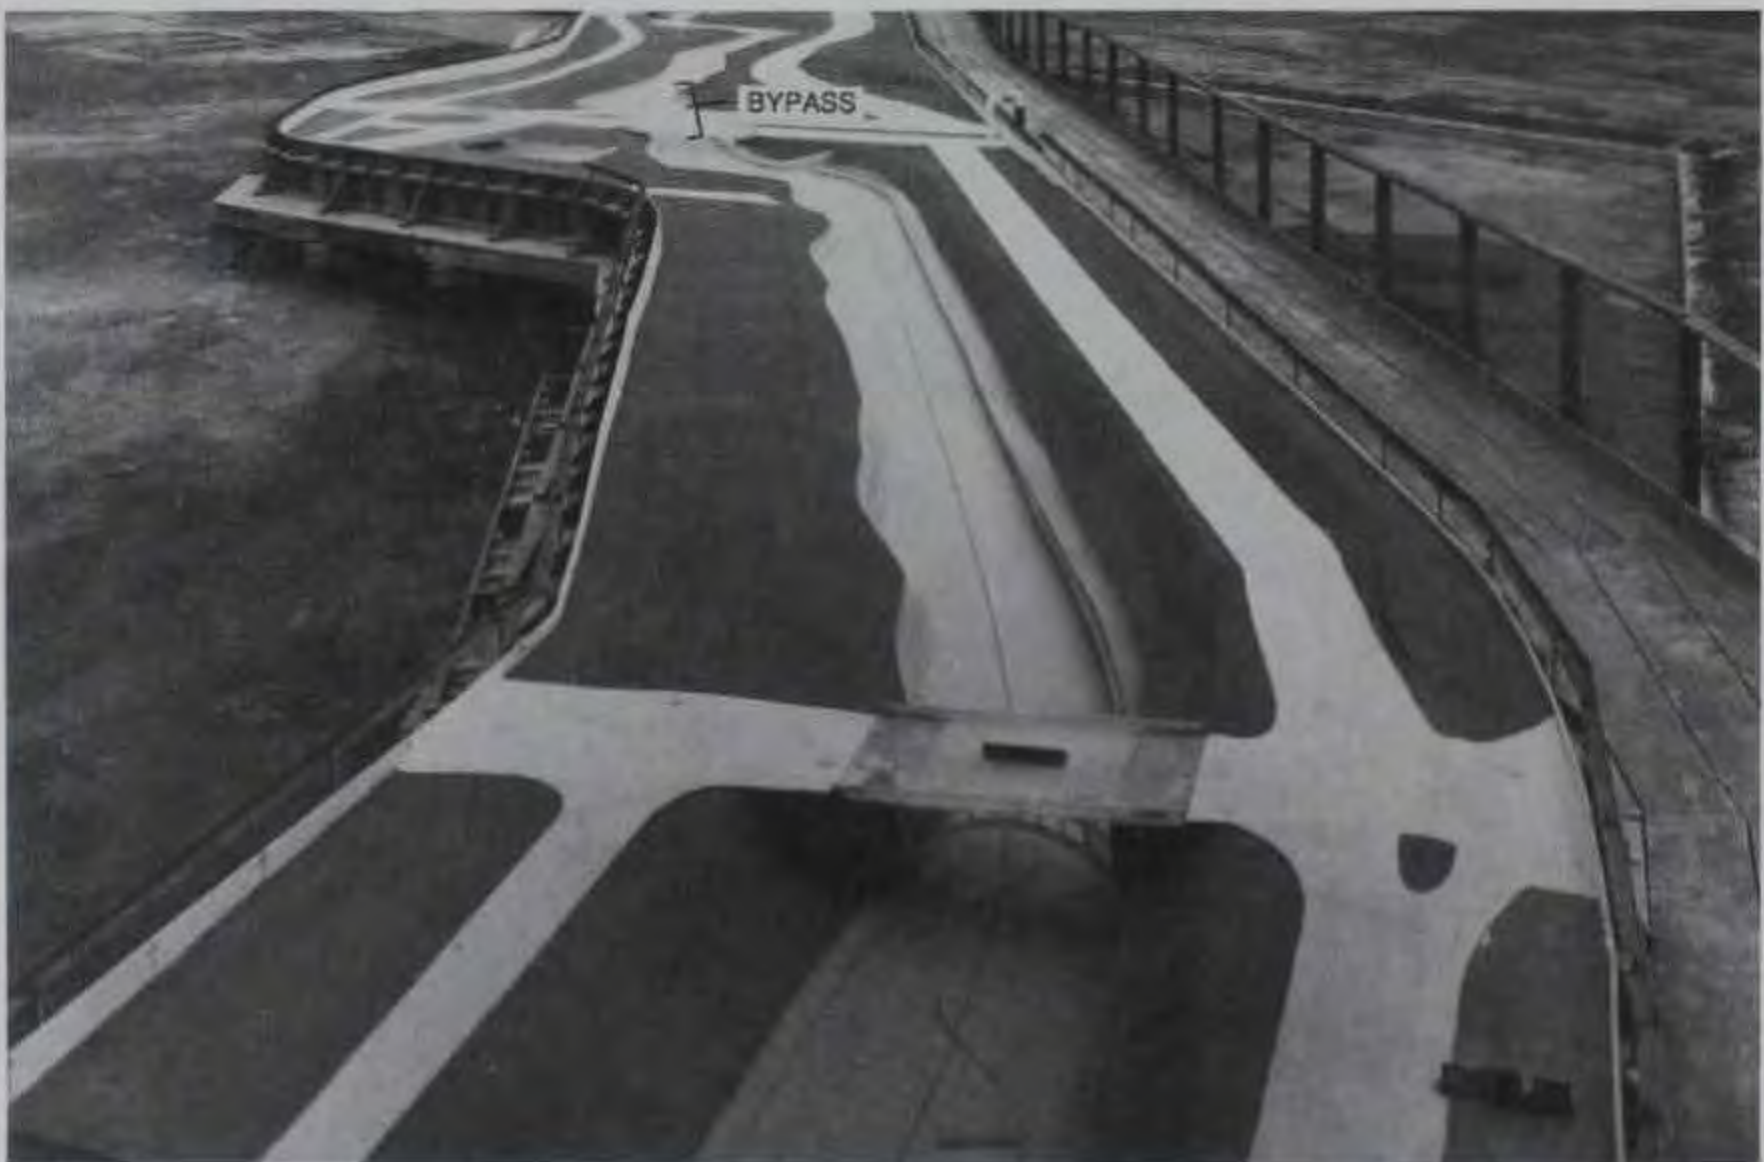
d. Sta 112+00 to sta 147+00

Photo 40. (Concluded)

turned the flow some 90 deg, and flooding frequently occurred (Photos 5f, 6f, and 7f). The Park Plan calls for bypassing the existing tunnel with a straightened open channel (Photo 40d). Two new bridges will span the channel on Paseo Boulevard (Photo 58). Dam 4 initially was to be located under the downstream bridge.

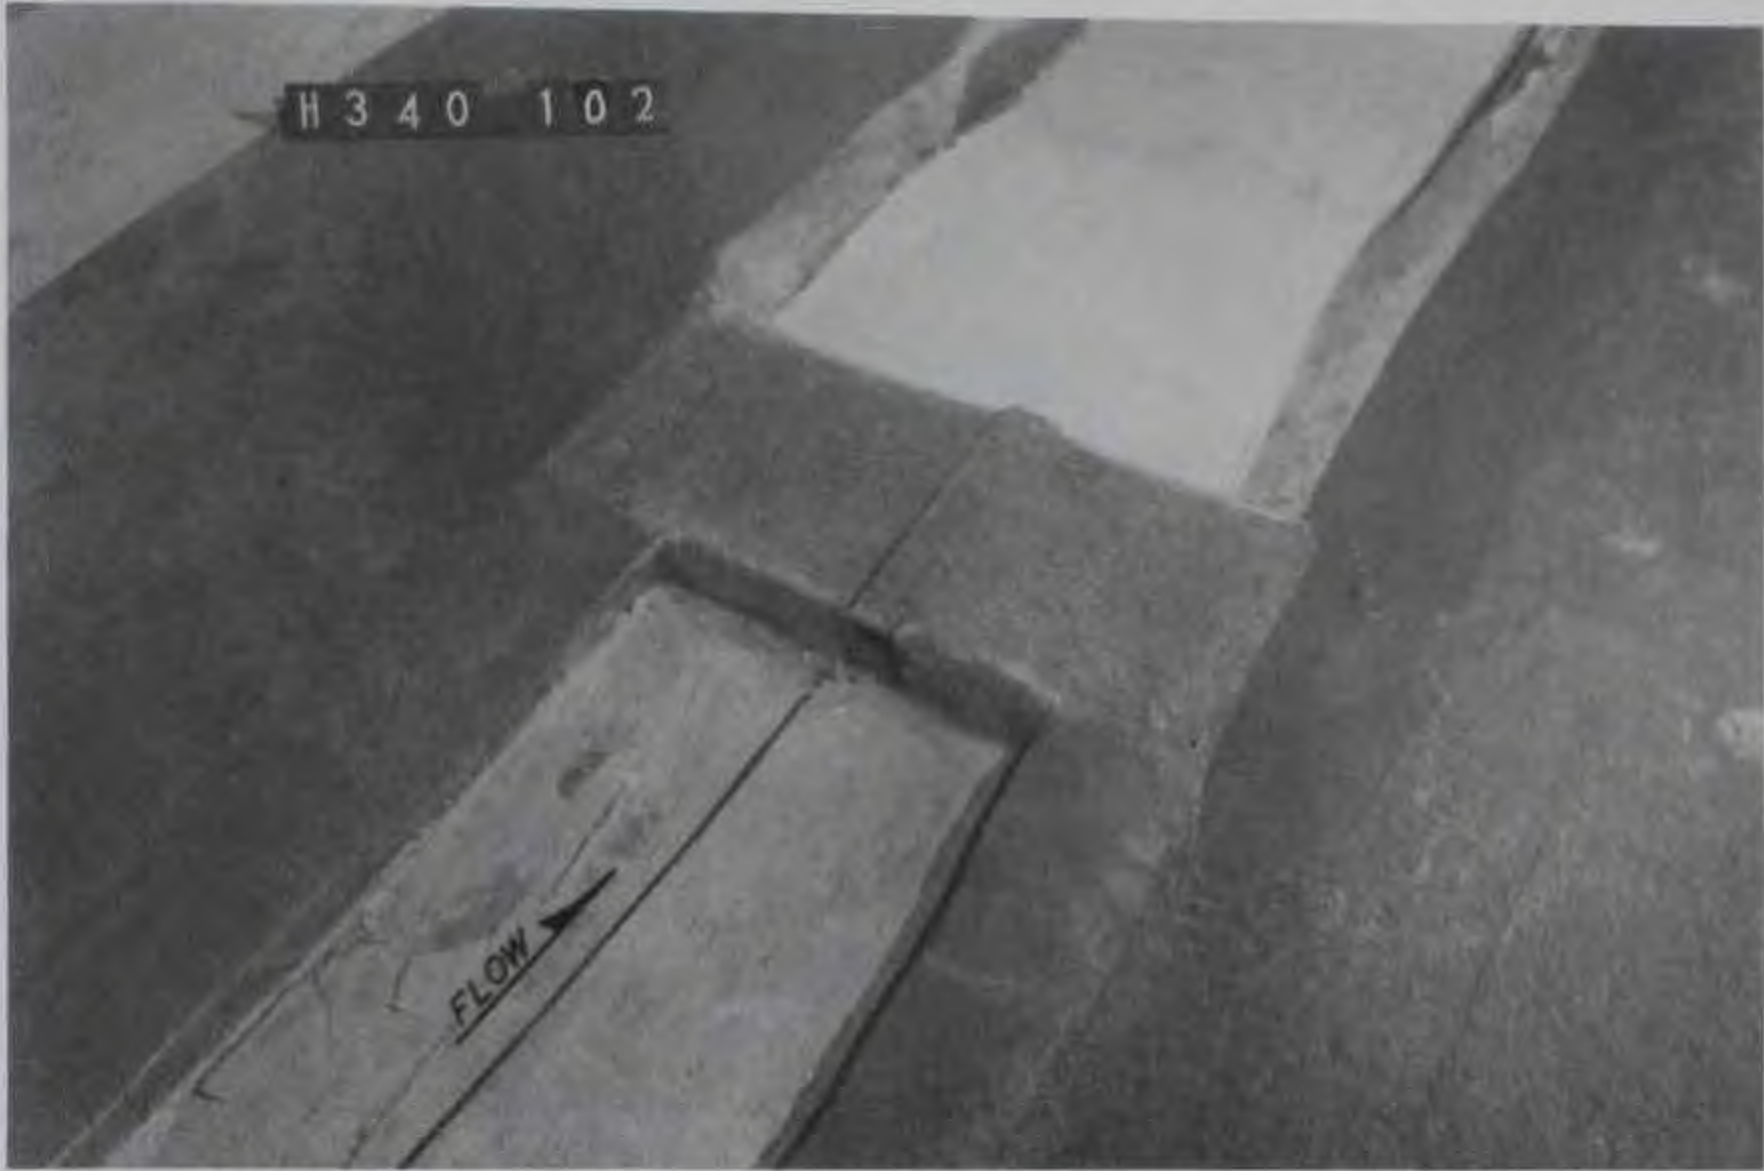
Photo 41. Modification at low-water crossing (51st Street)

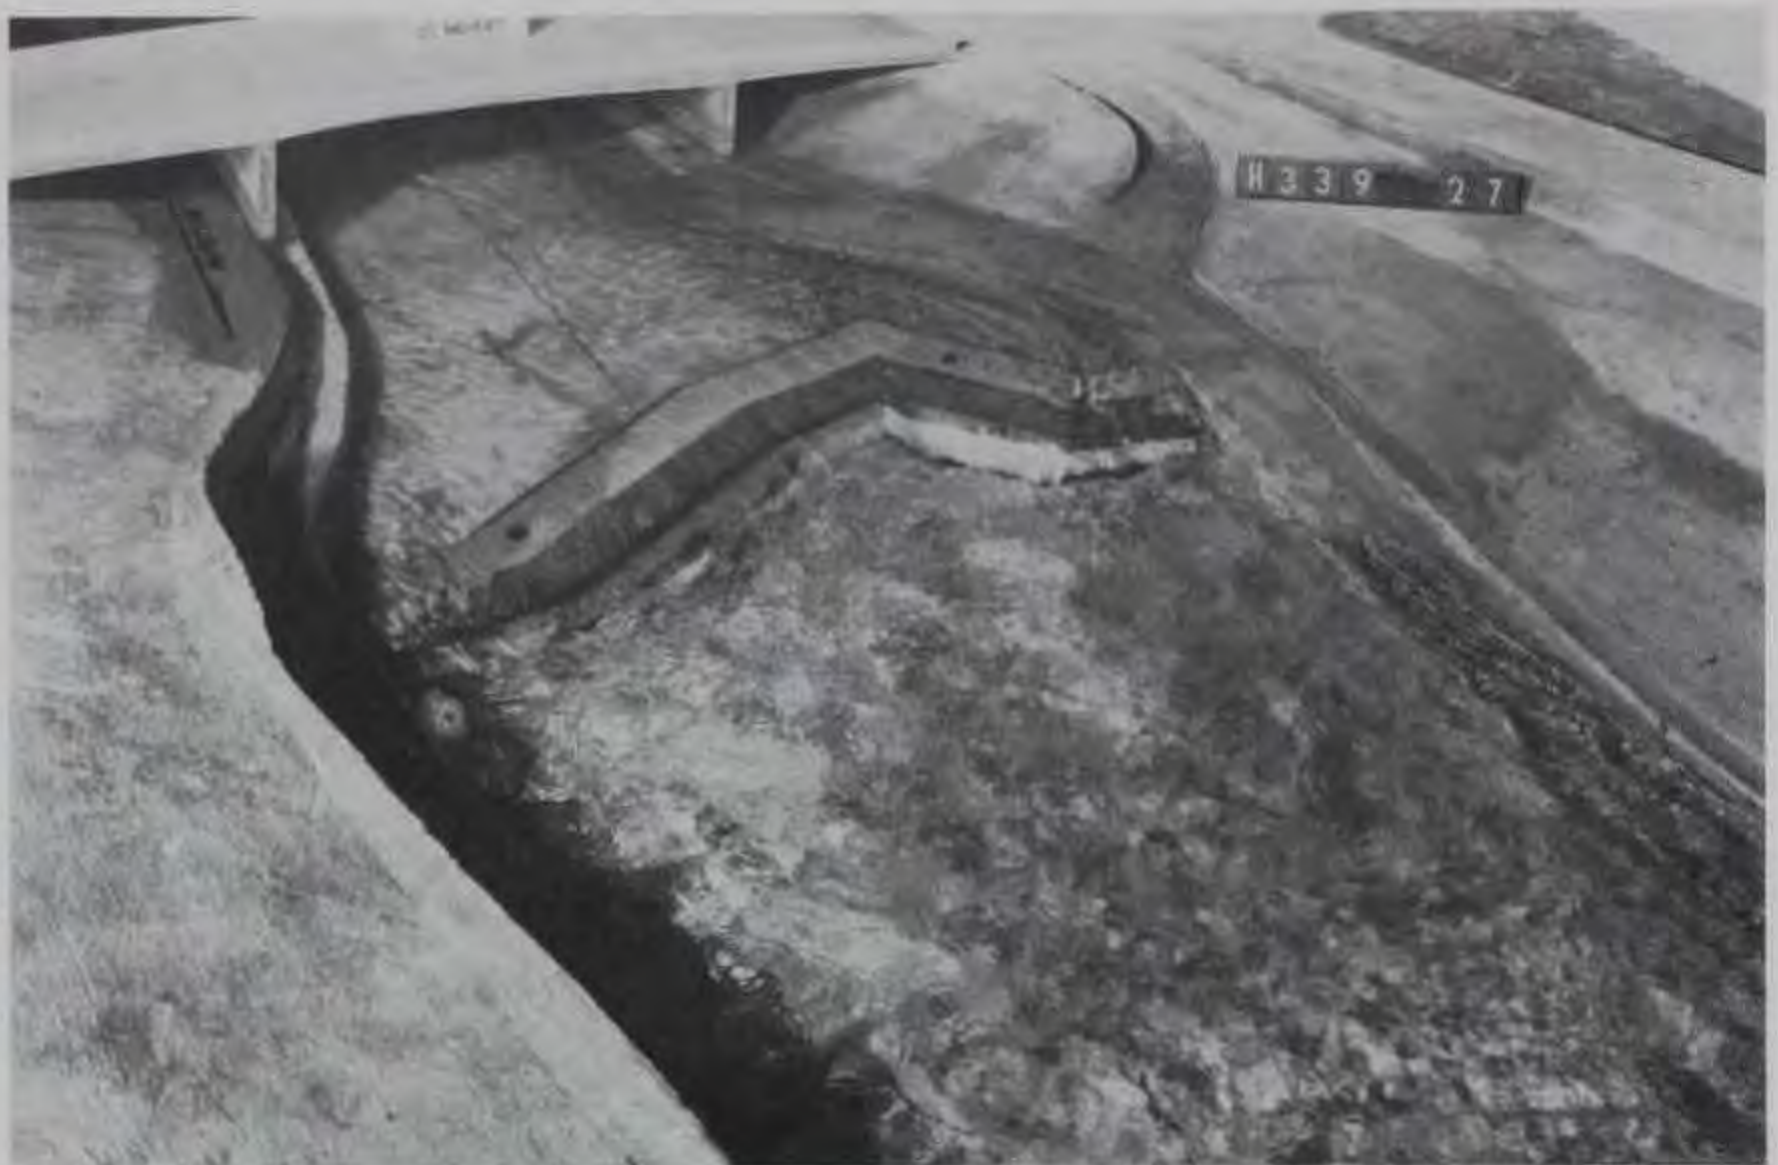
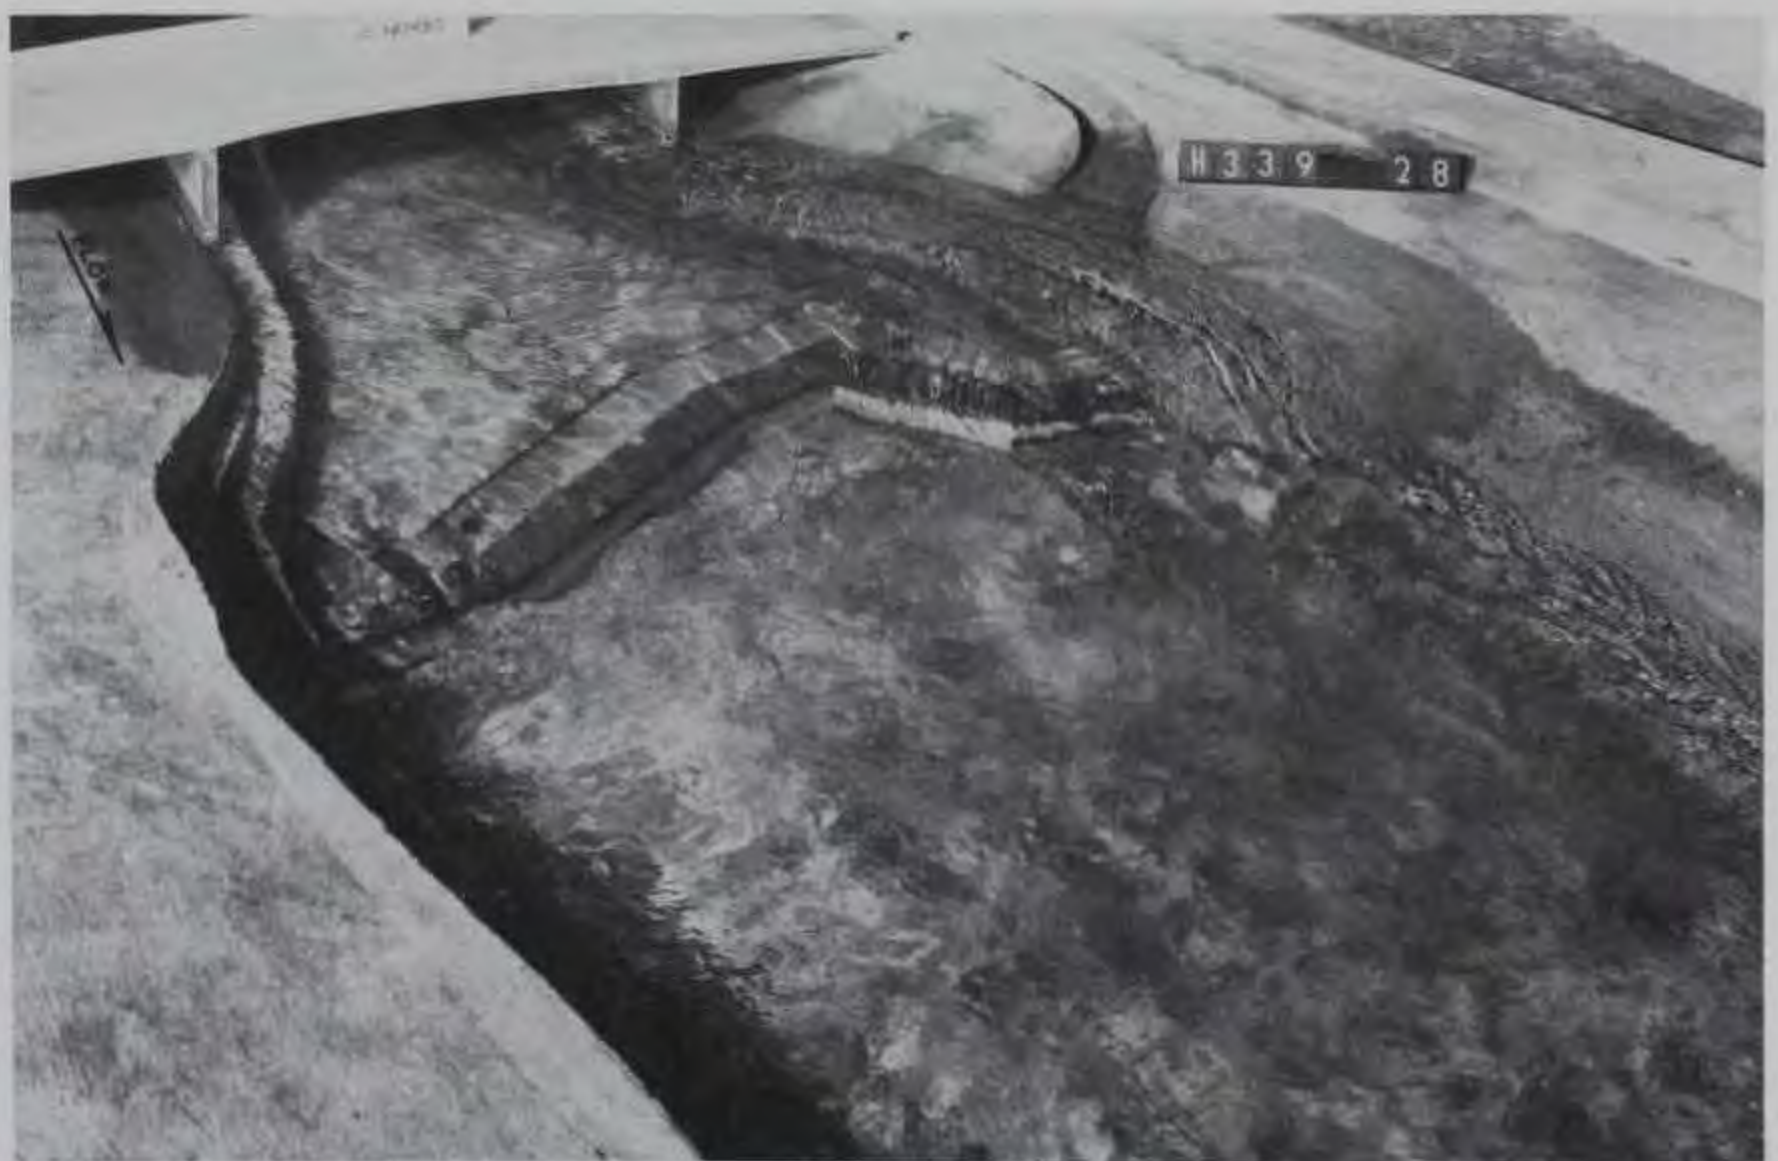
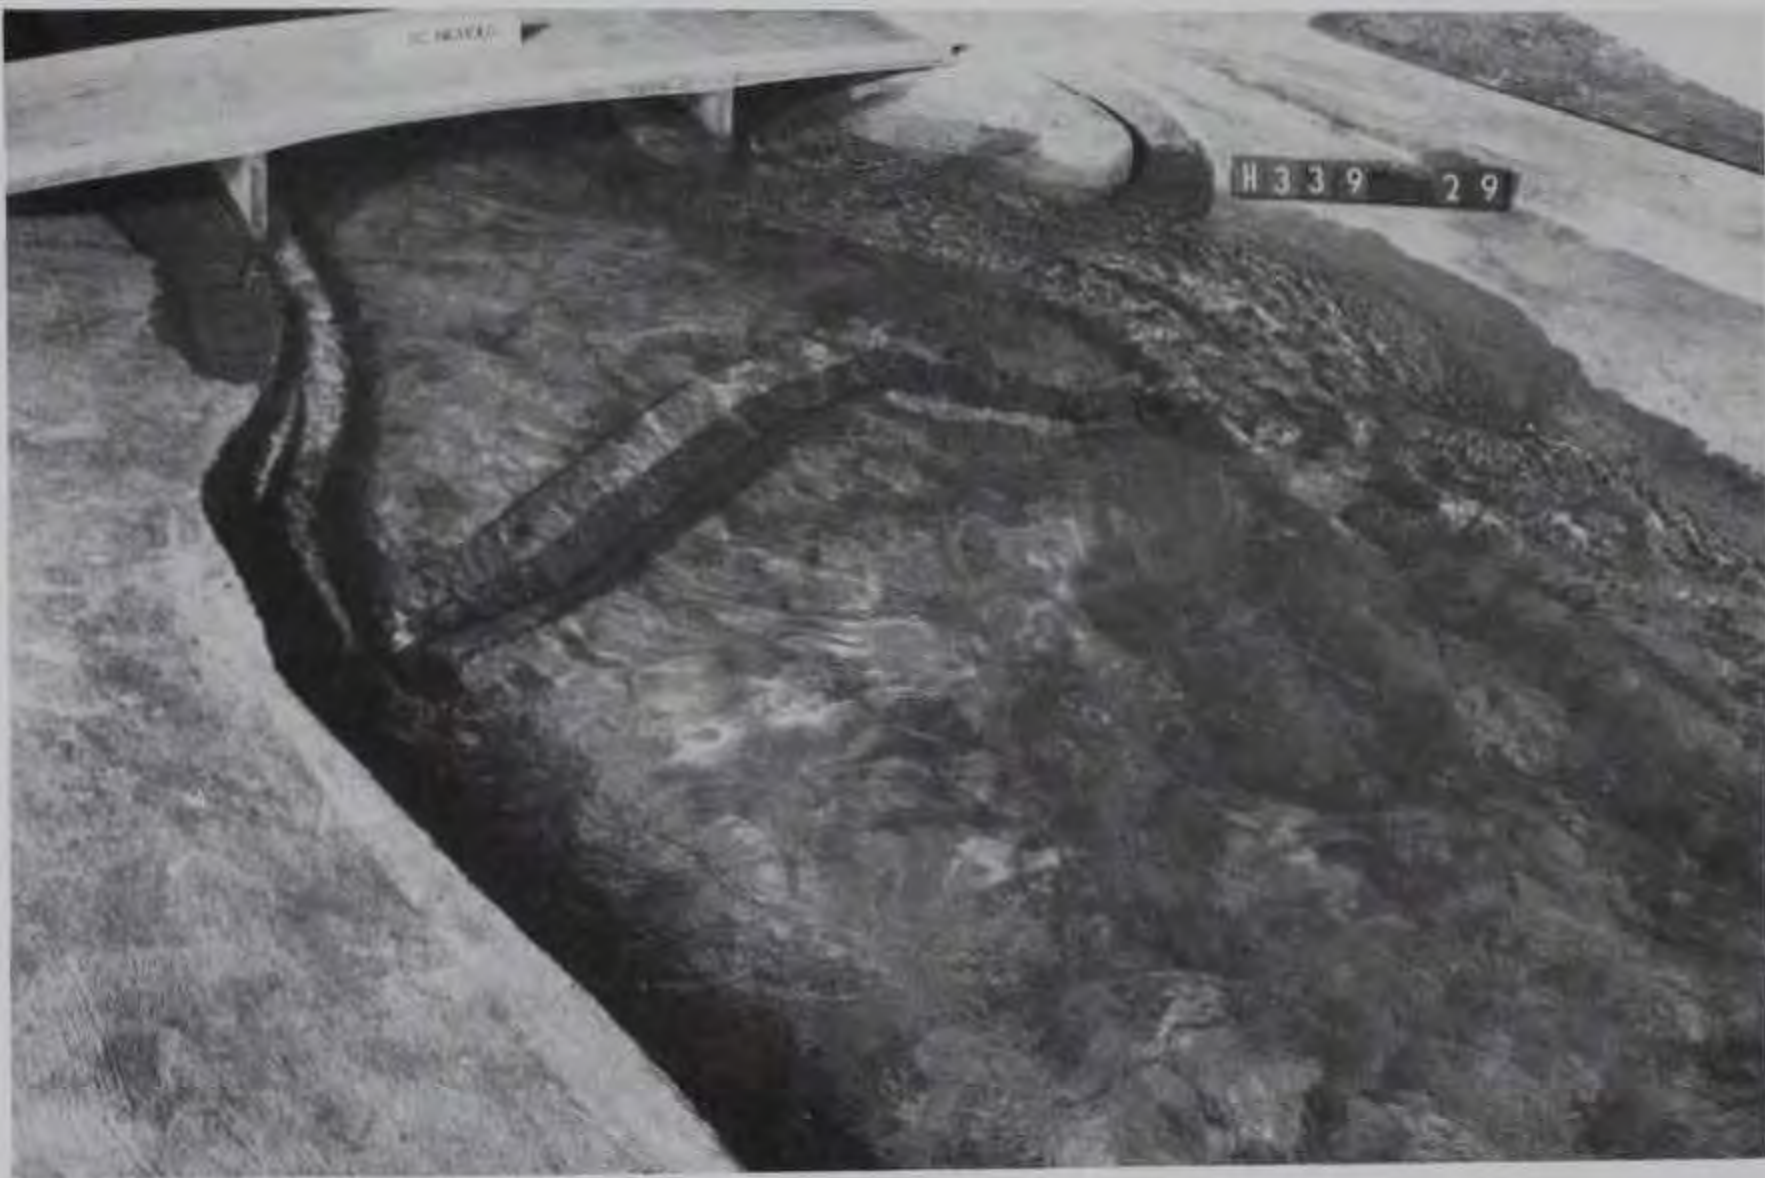
a. 10-year flood

b. 100-year flood

Photo 43. Flow conditions at irregular dam 1 (sta 68+65) (Continued)

c. 500-year flood

Photo 43. (Concluded)

66. Some concern was expressed as to what effect the irregular shape of the dam would have on flow conditions. Flow conditions for the 10-, 100-, and 500-year flows, shown in Photo 43, indicated that no adverse effects would be caused by the irregular shape. Therefore, the irregular dam concept can be used throughout the Park Plan.

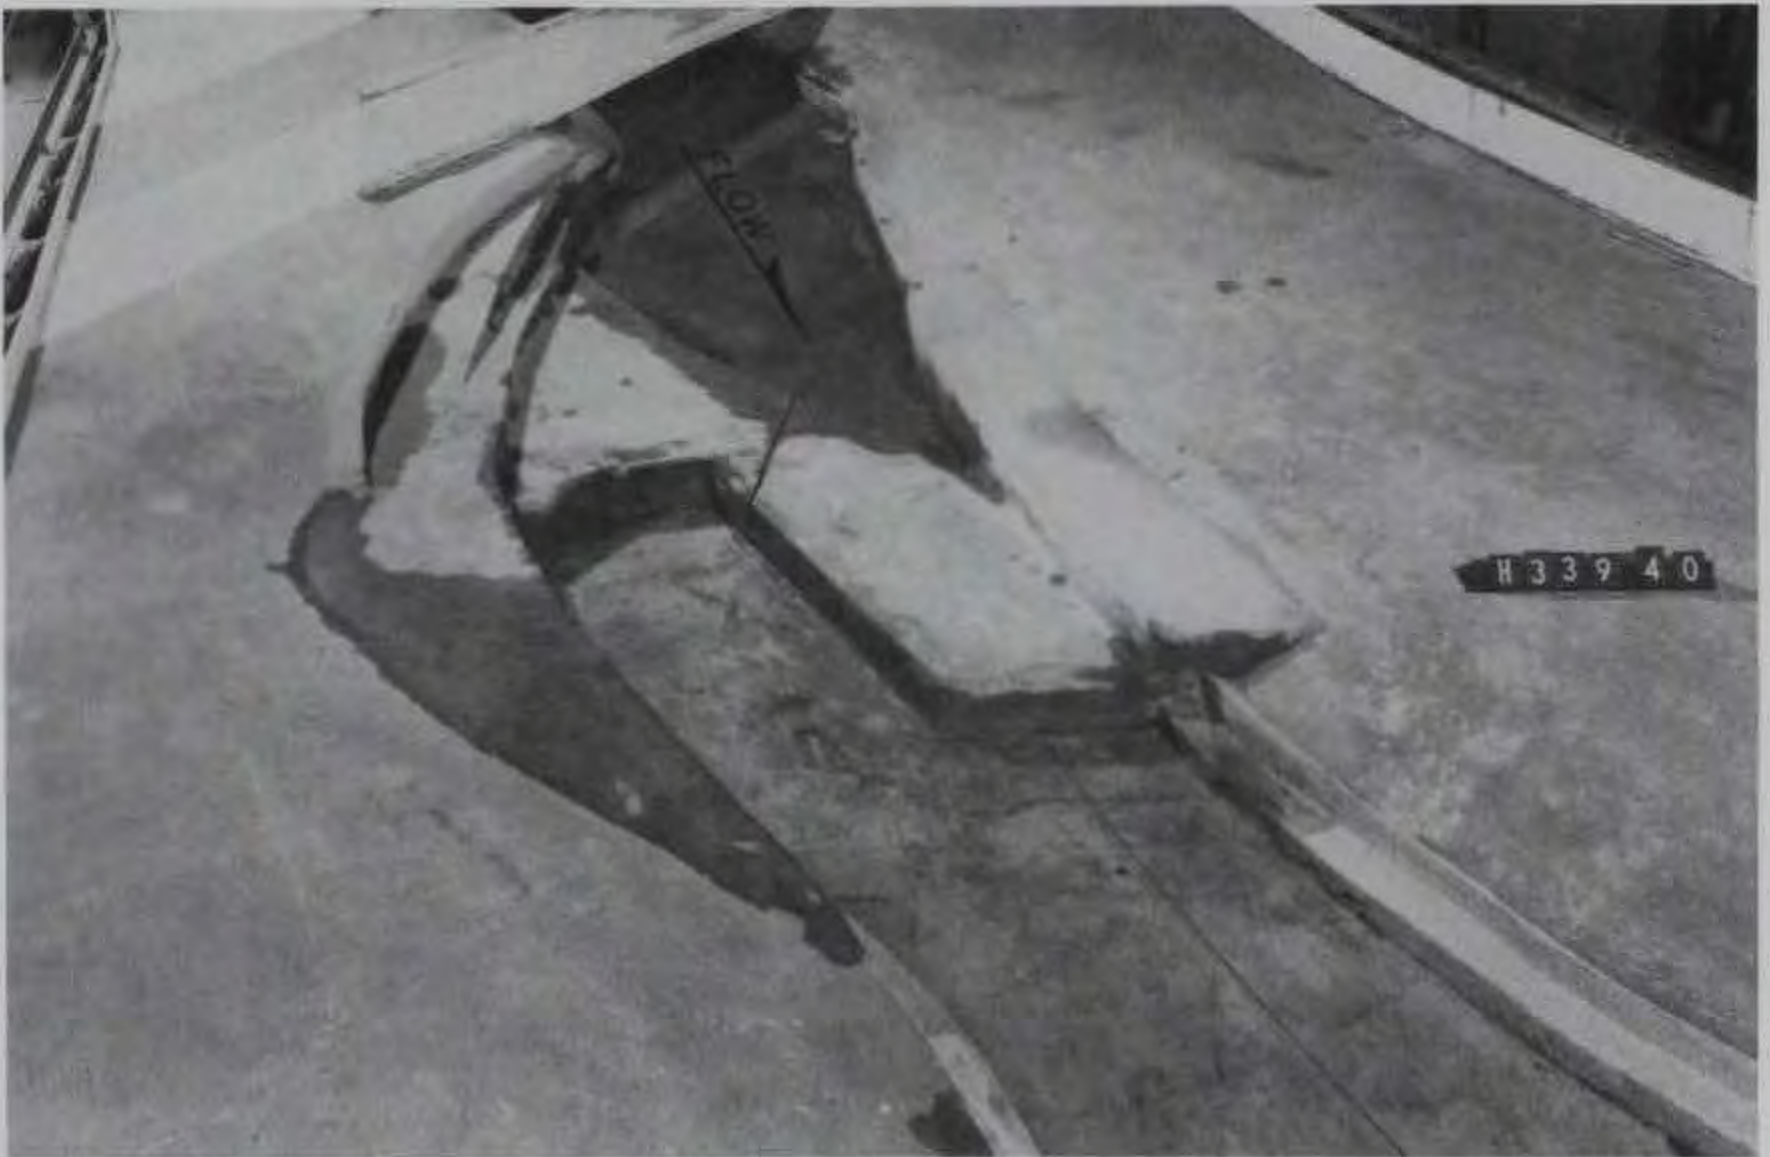
Photo 44. Irregular dam 1, sta 79+00

67. Dam 1 was subsequently relocated downstream to sta 79+00 (Photo 44)

to prevent the relocation of a large sanitary trunk sewer. The crest remained at el 814.0. The bed profile upstream to sta 60+32 was changed to el 807.0 to reduce excavation. Water-surface elevations in the vicinity of the Plaza were acceptable when the channel bottom was smooth. However, when the channel bottom roughness was increased, the water-surface elevations in the Plaza area were unacceptable. The crest of the dam was lowered to el 813. This change provided acceptable water-surface elevations in the Plaza area with rough bottom conditions. Flow conditions for the 10-, 100-, and 500-year flows shown in Photo 45 indicate that no adverse effects are caused by the irregular shape or modifications required for the storm drain. However, because of the concentrated flow present immediately downstream of this dam, measures should be taken to provide adequate protection, such as paving the channel in this area.

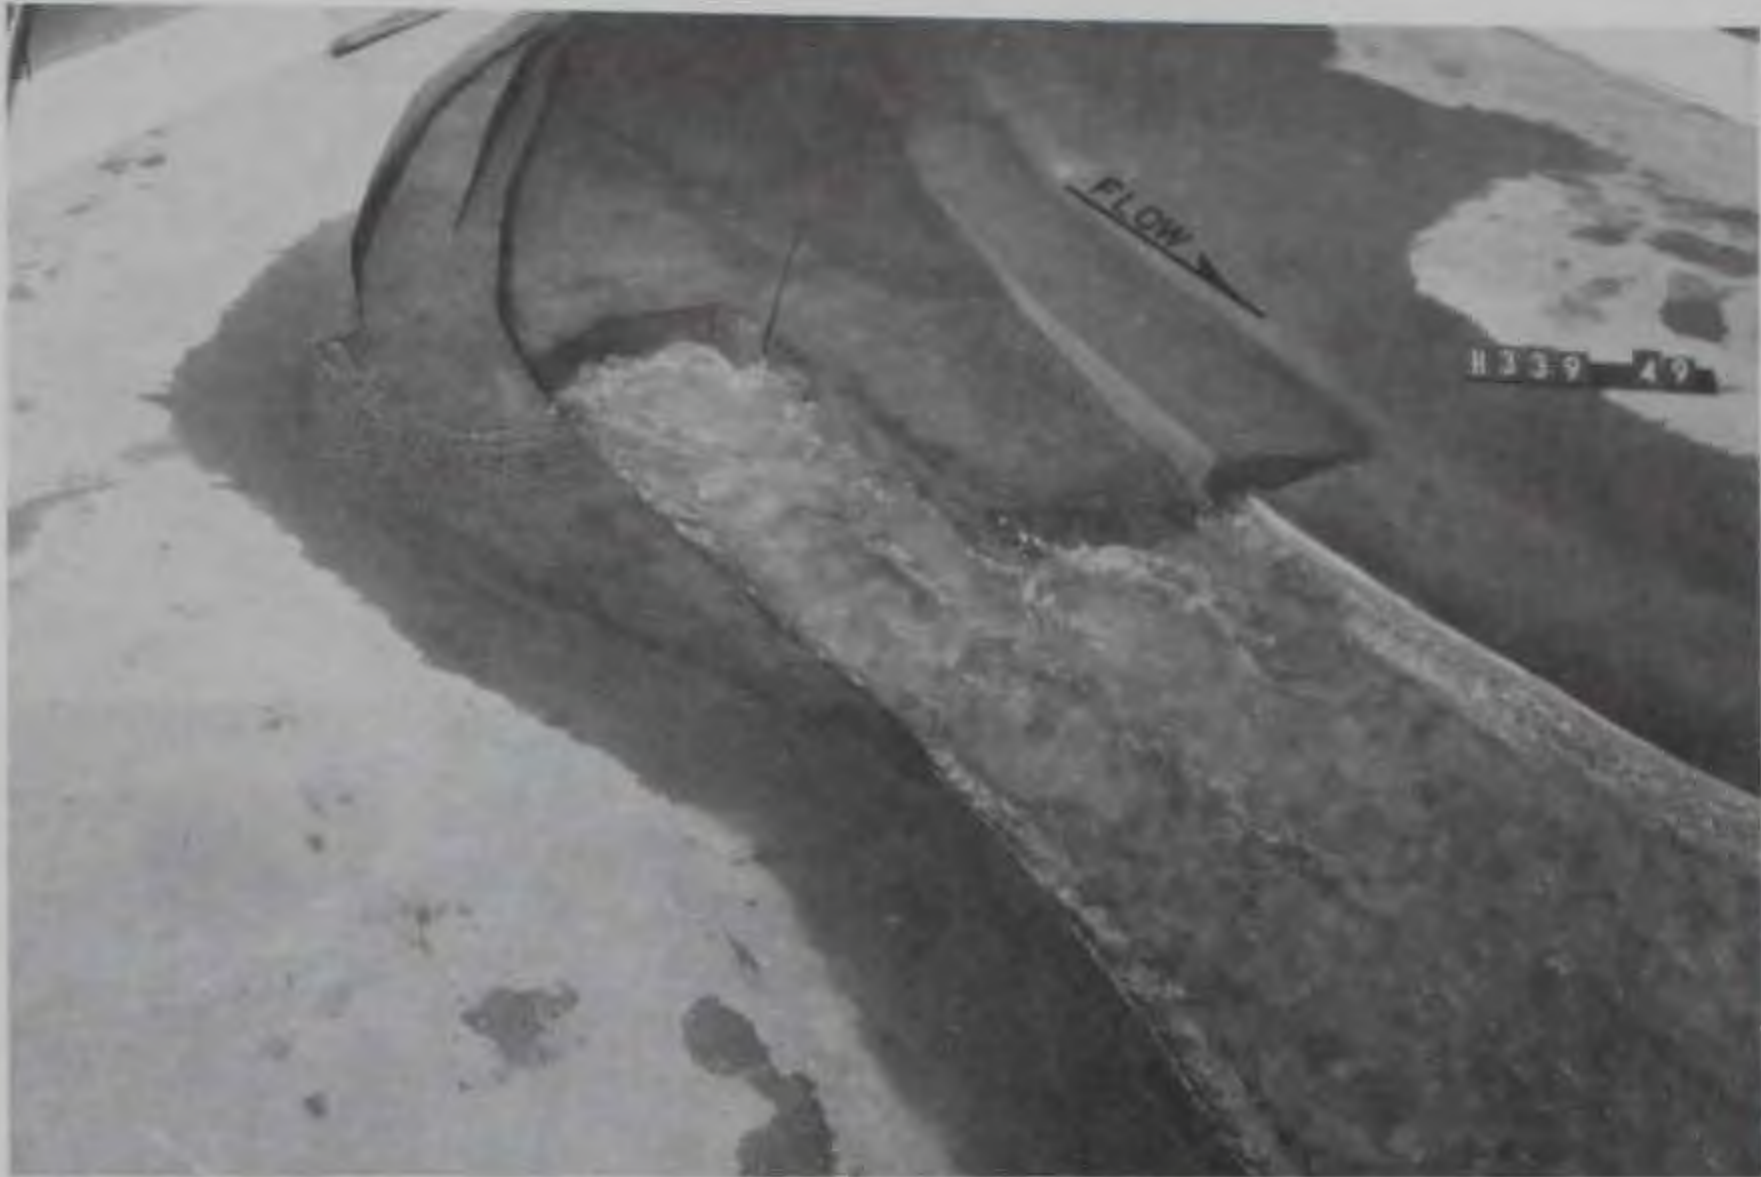
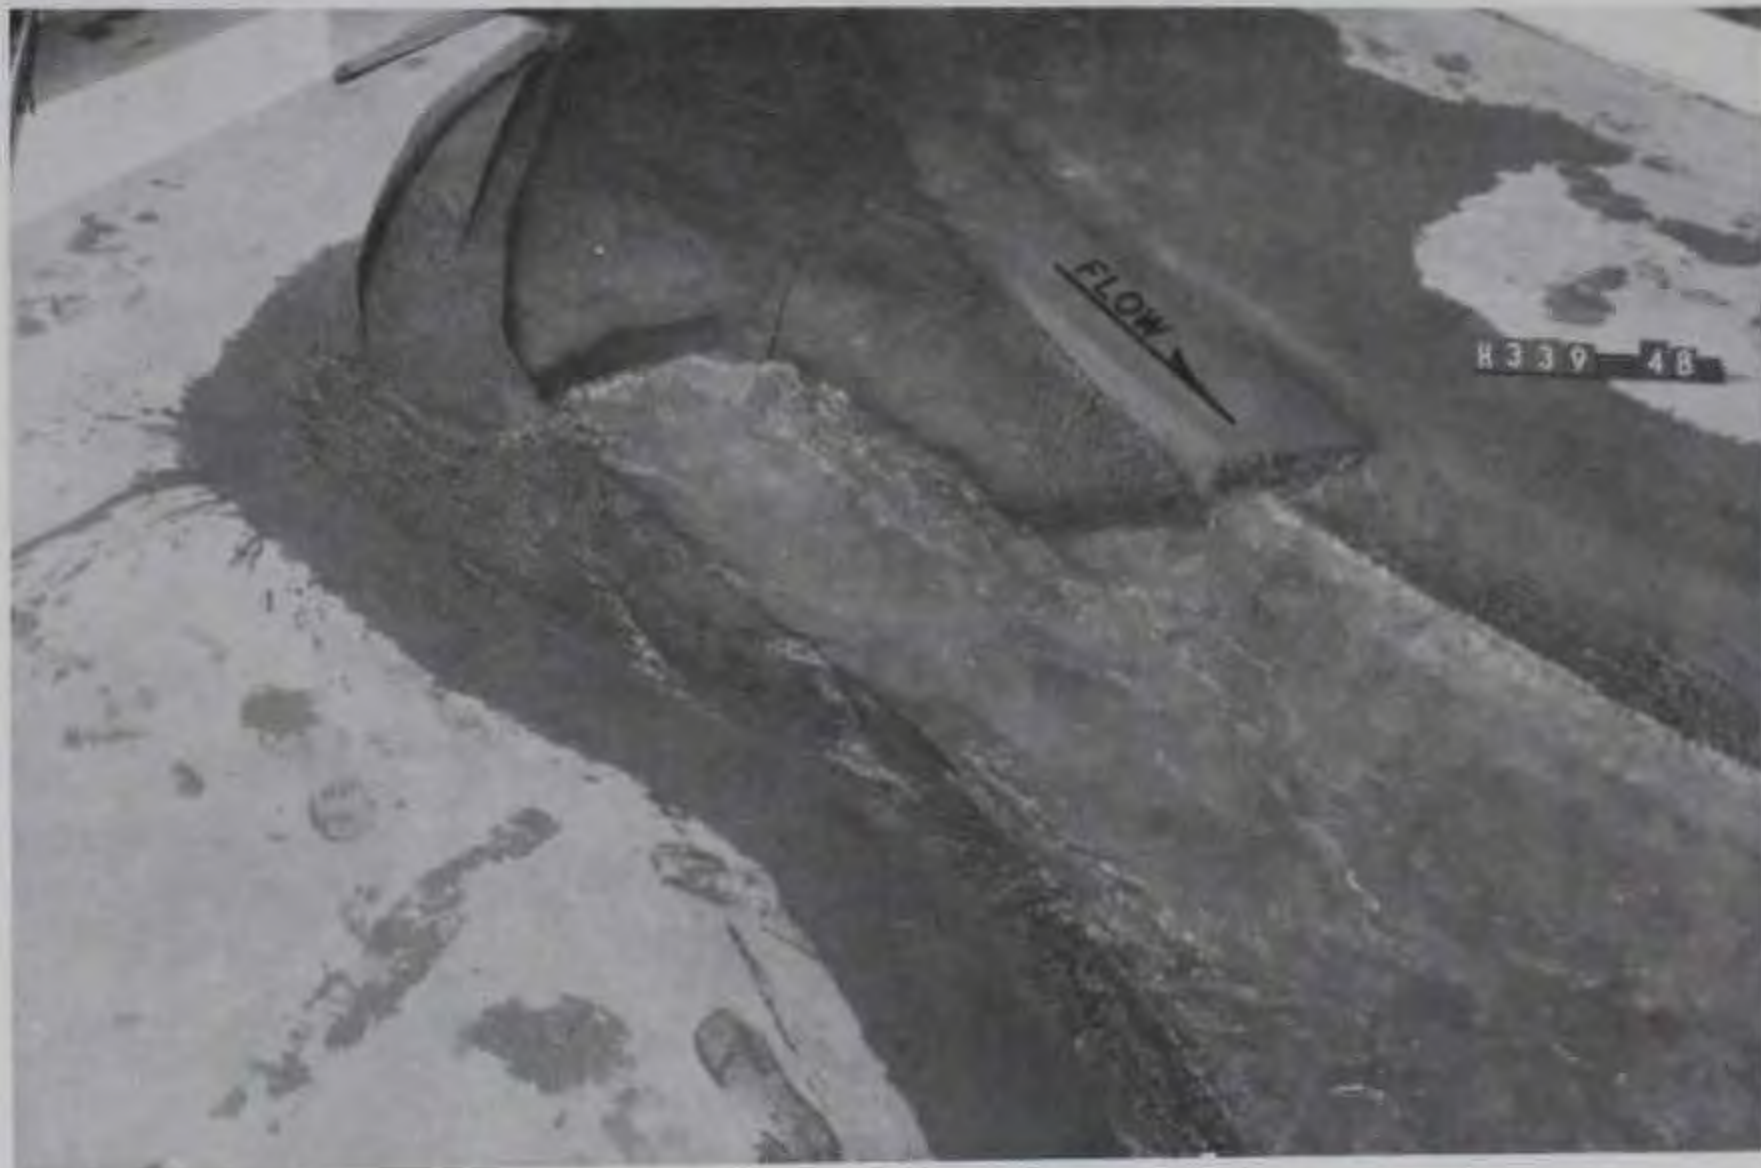
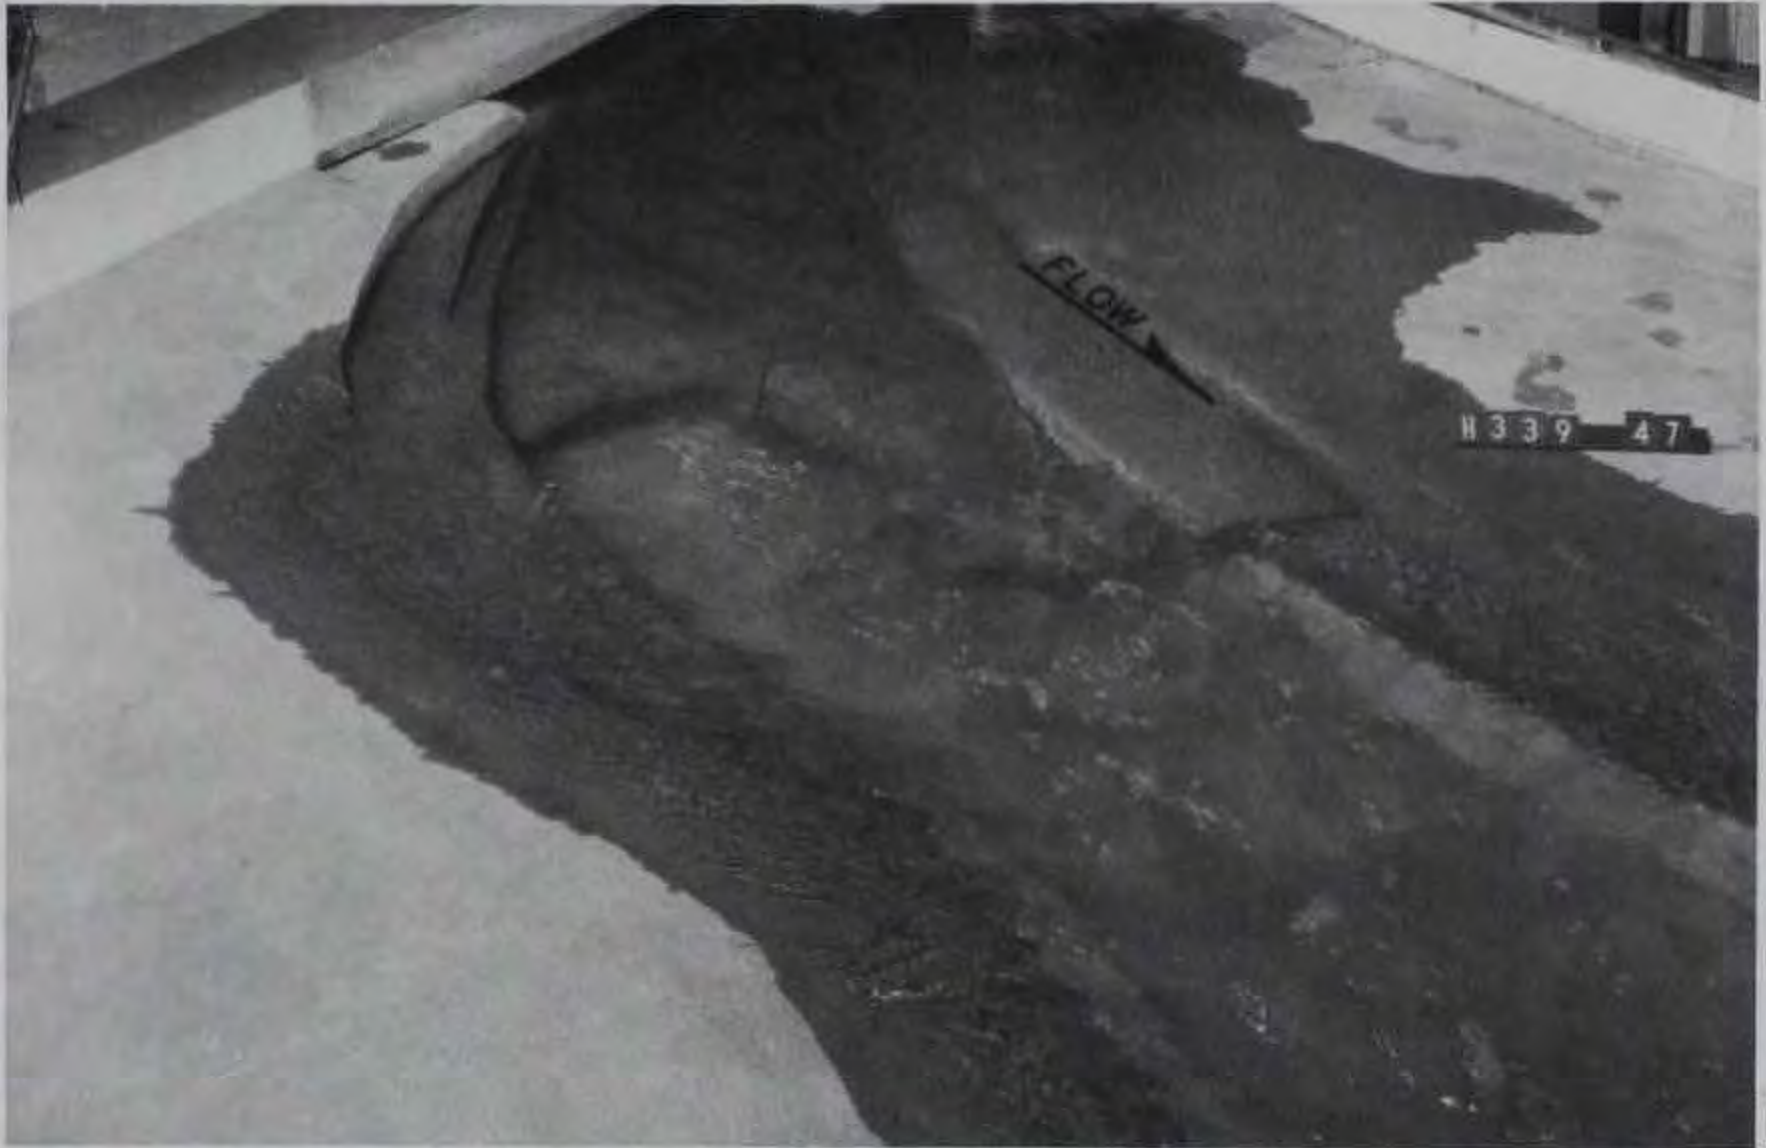
a. 10-year flood

b. 100-year flood

Photo 45. Flow conditions at irregular dam 1 (sta 79+00) (Continued)

c. 500-year flood

Photo 45. (Concluded)
