TECHNICAL REPORT HL-92-1

BRUSH CREEK, KANSAS CITY, MISSOURI

Hydraulic Model Investigation

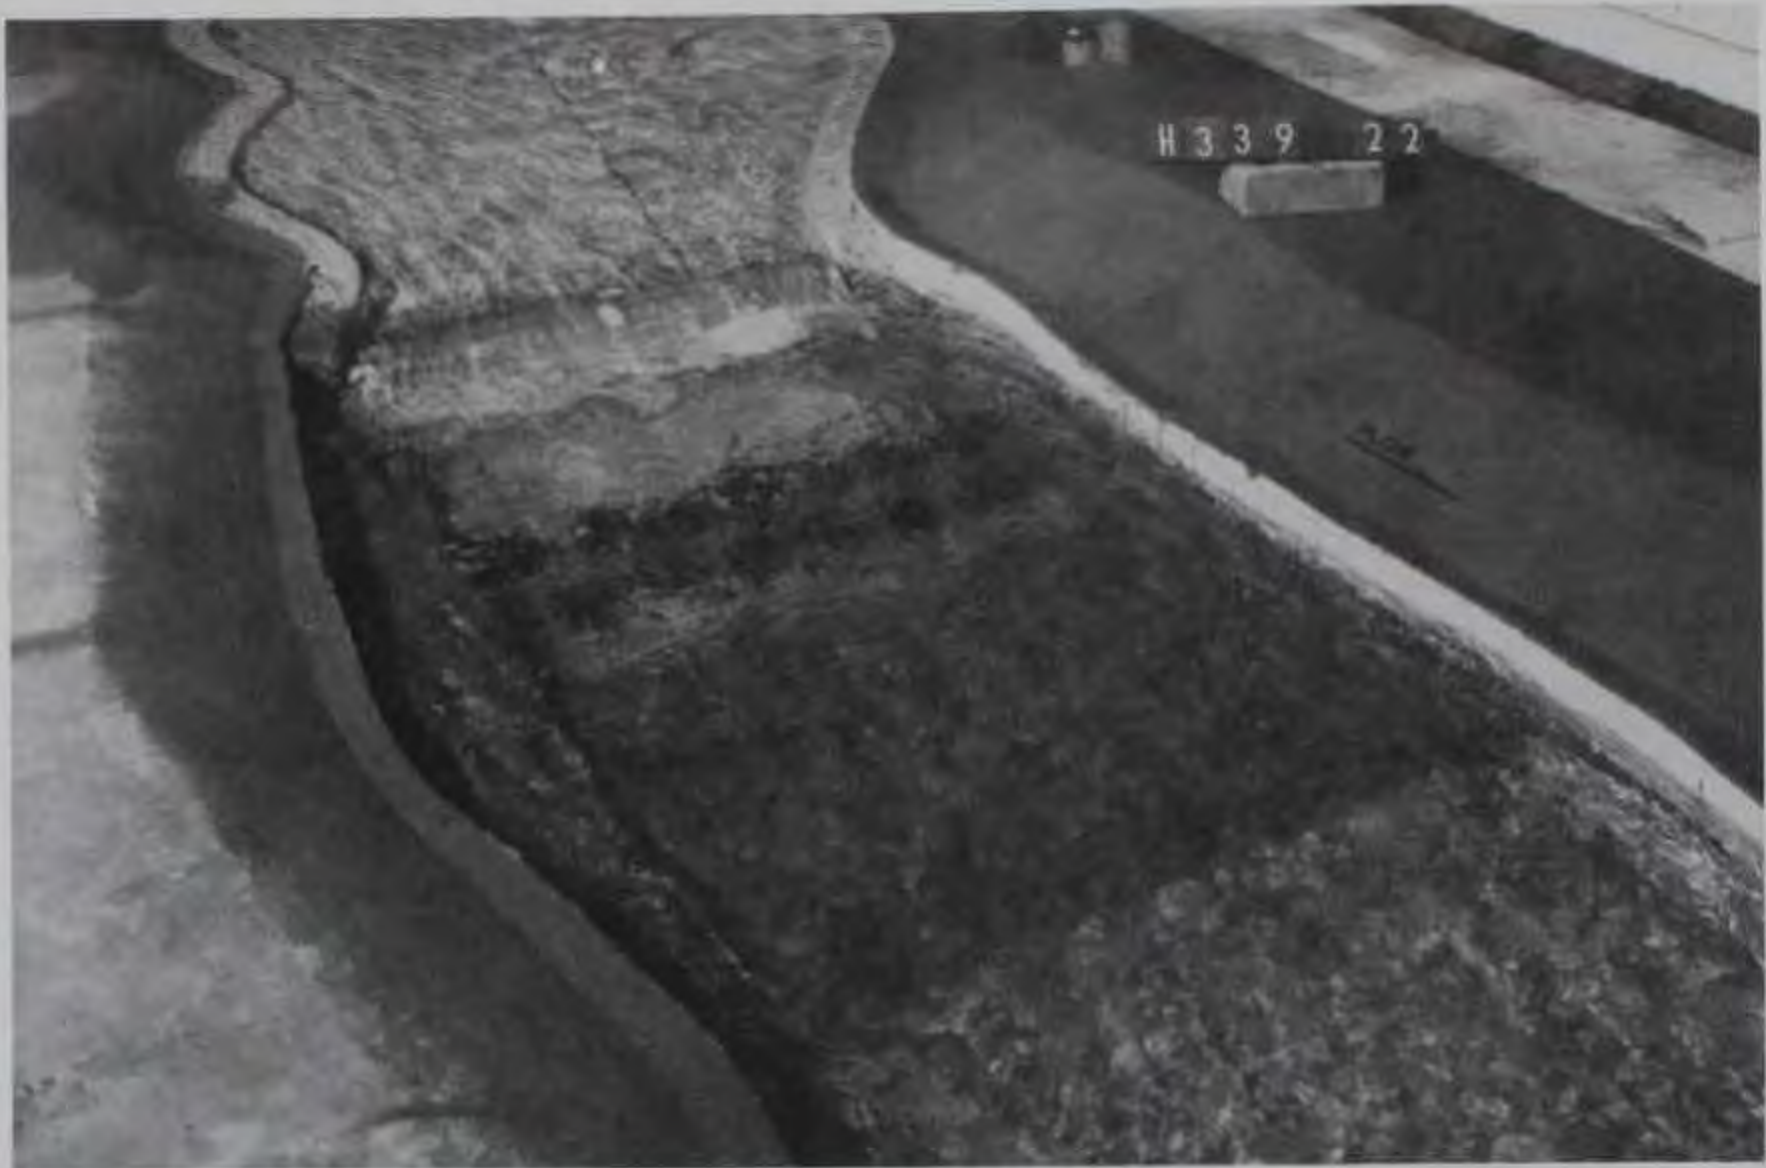
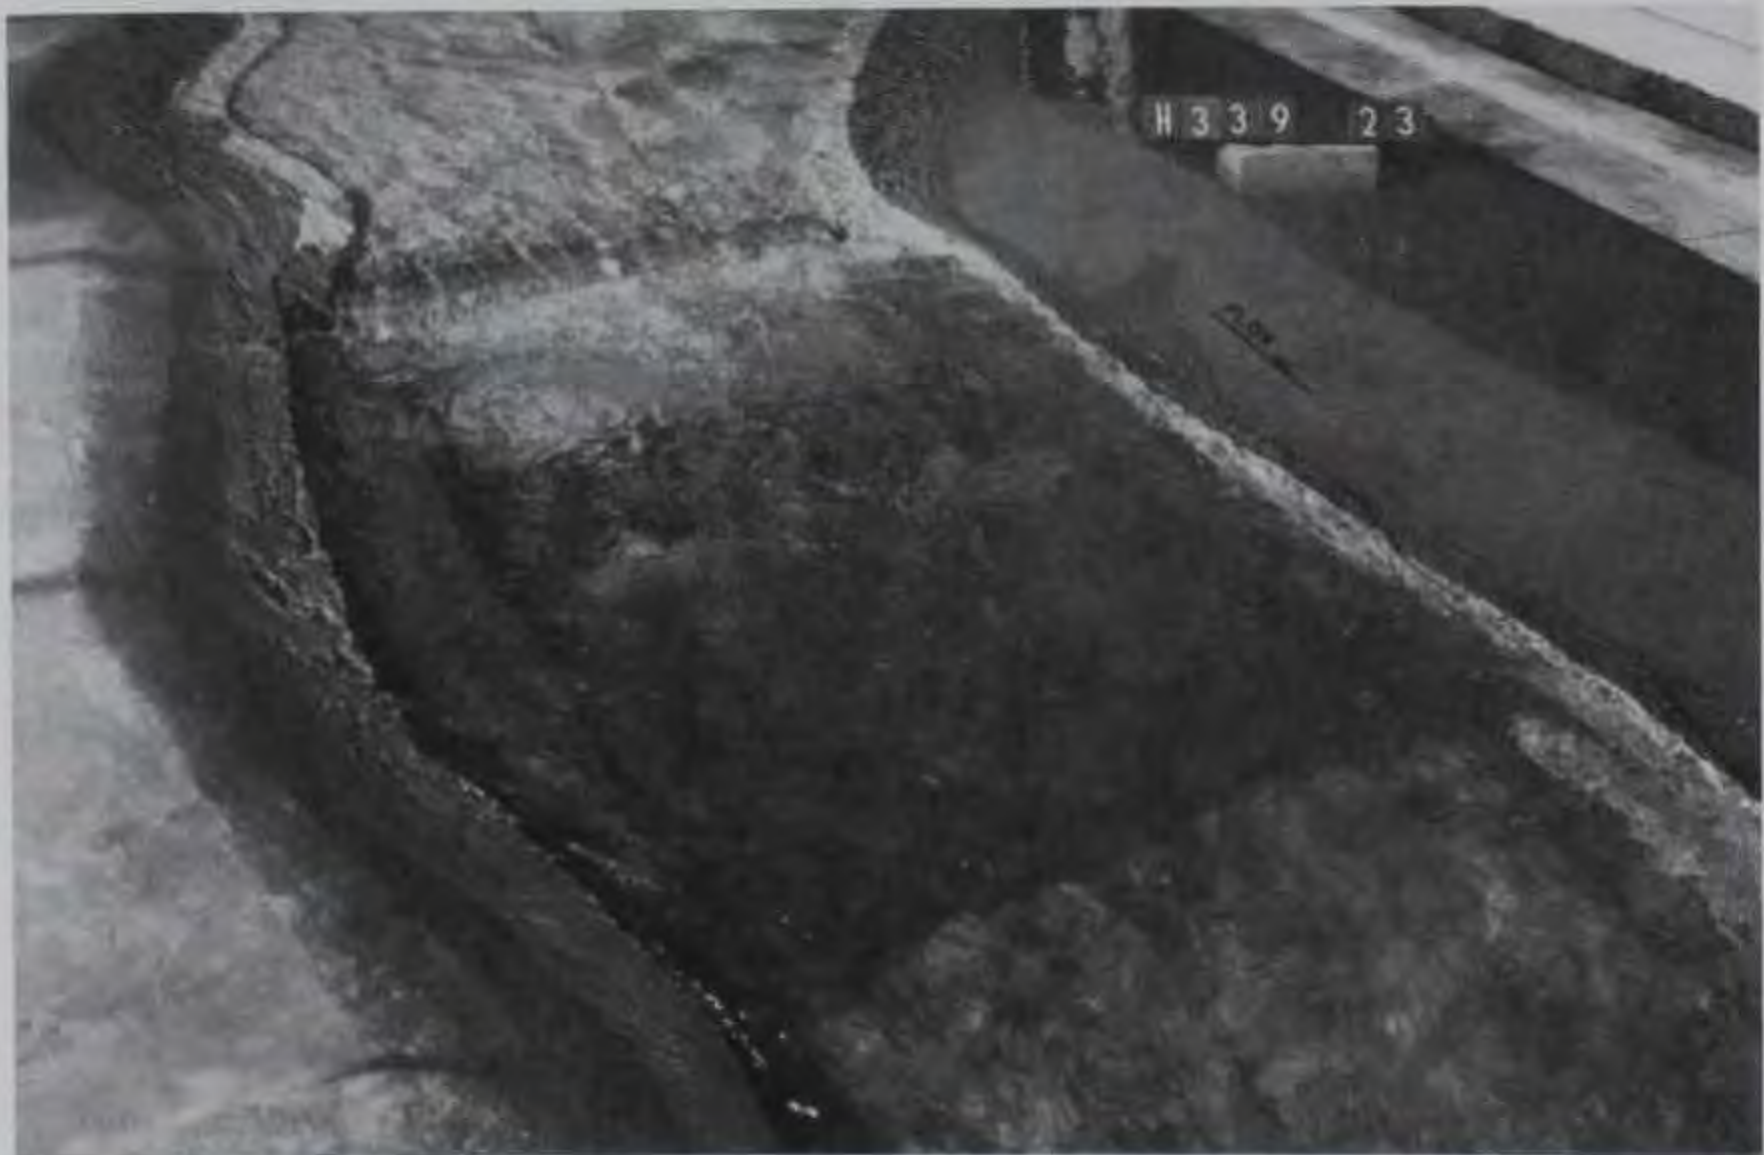
a. 10-year flood

b. 100-year flood

Photo 47. Flow conditions at drop 1, type 1 design stilling basin

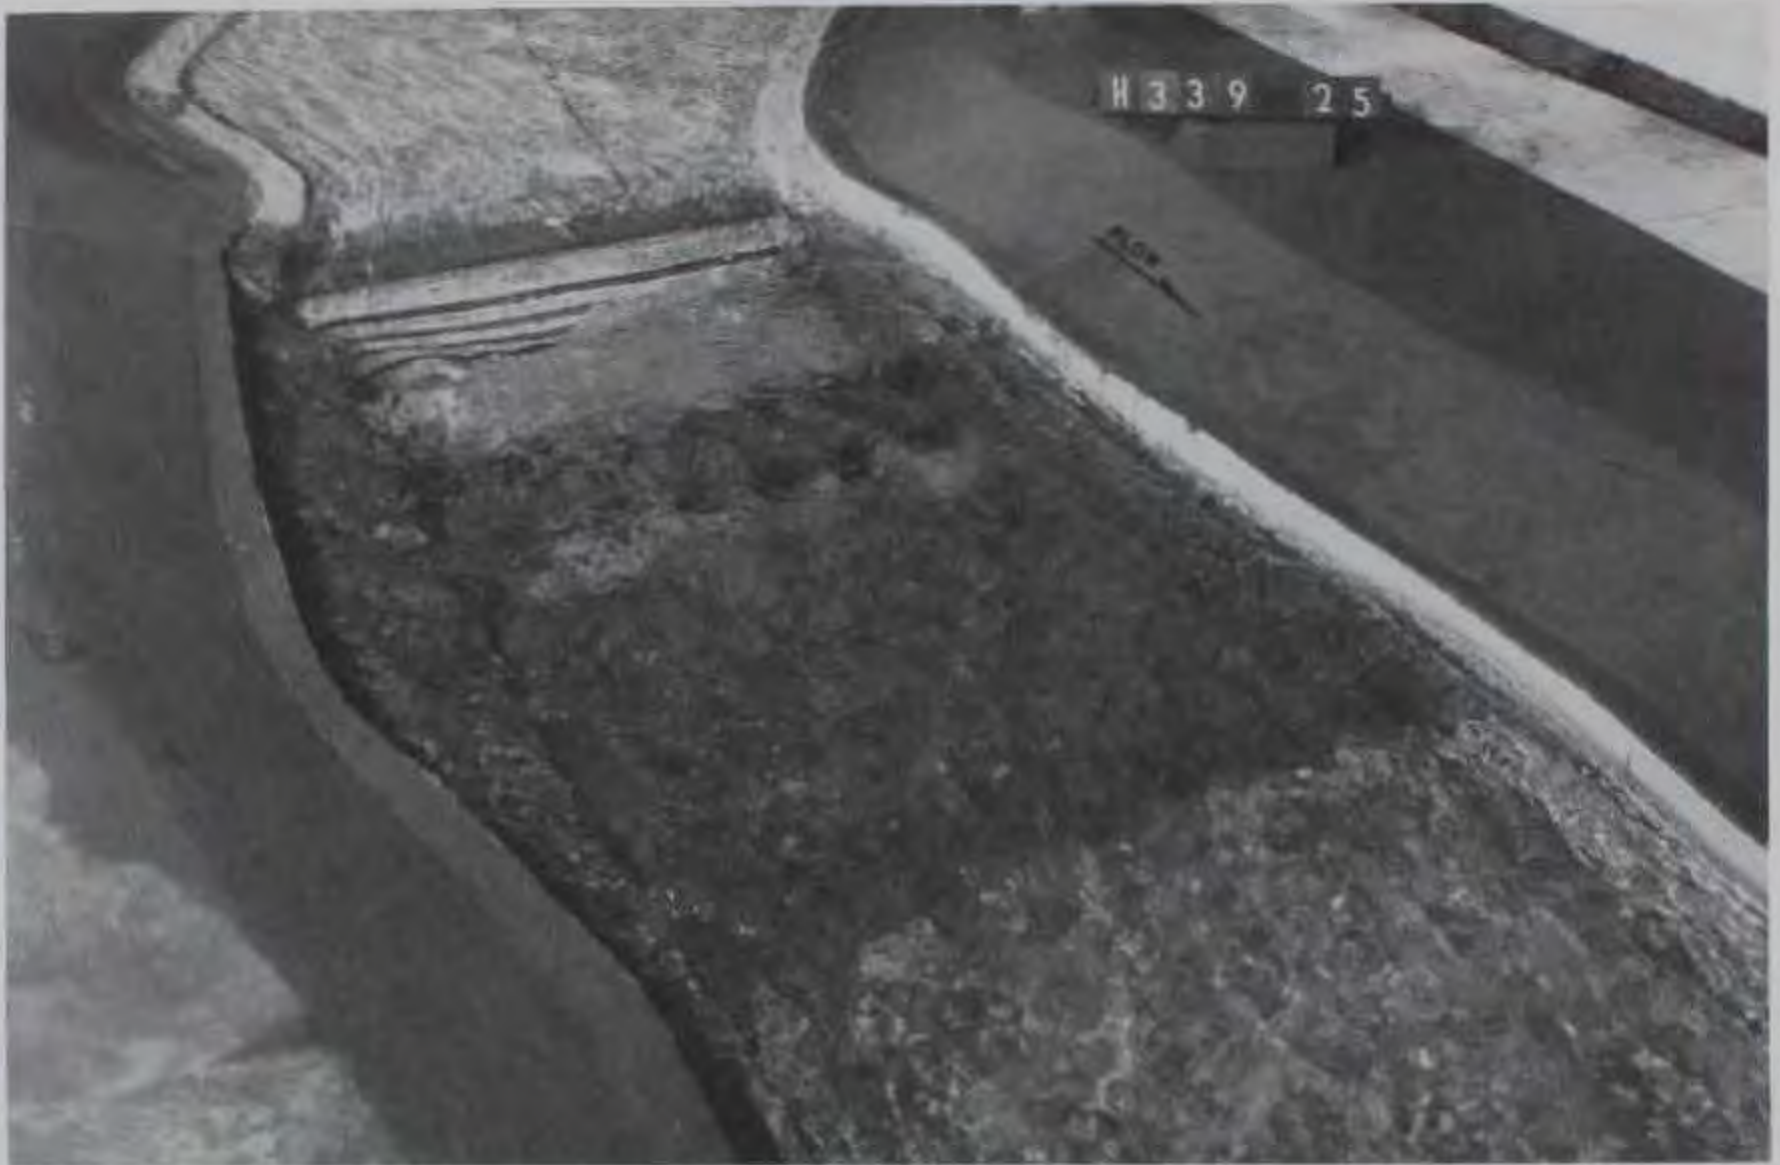
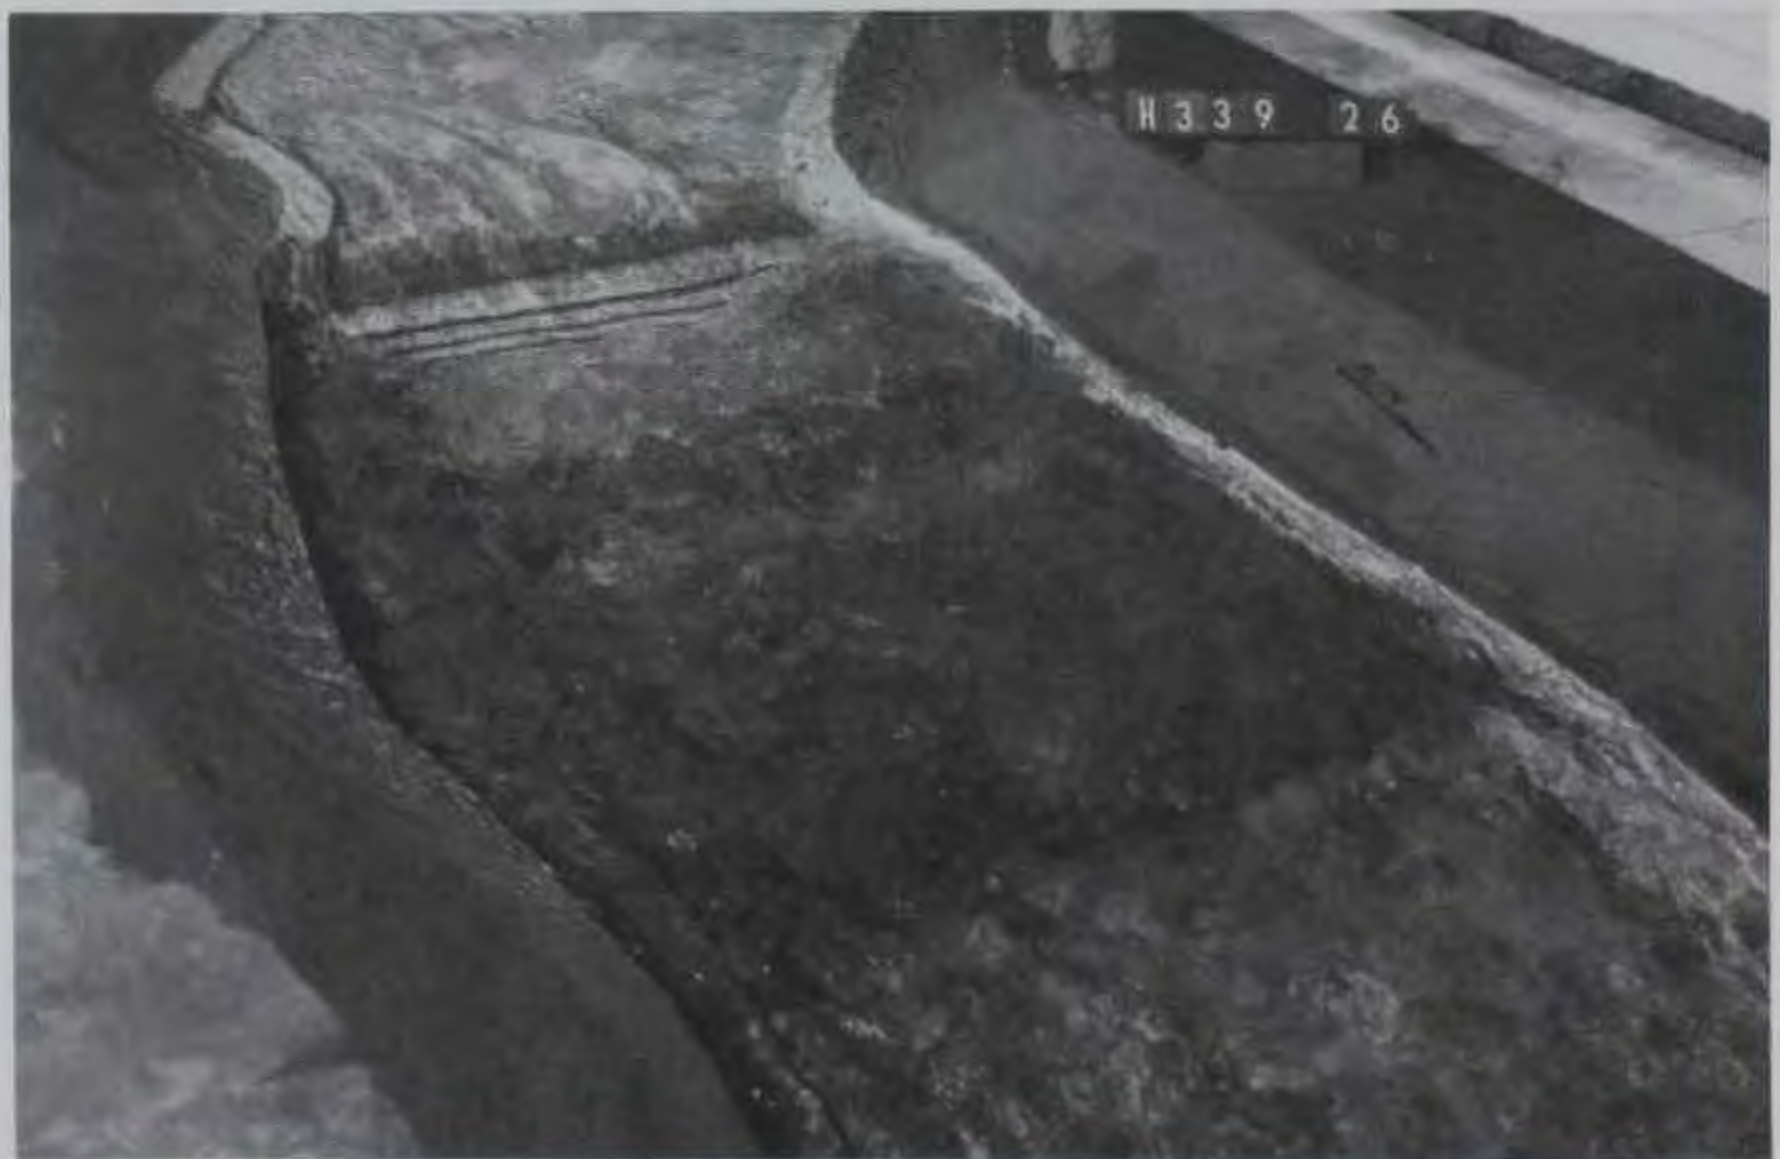
a. 10-year flood

b. 100-year flood

Photo 49. Flow conditions at drop 1, type 2 design stilling basin

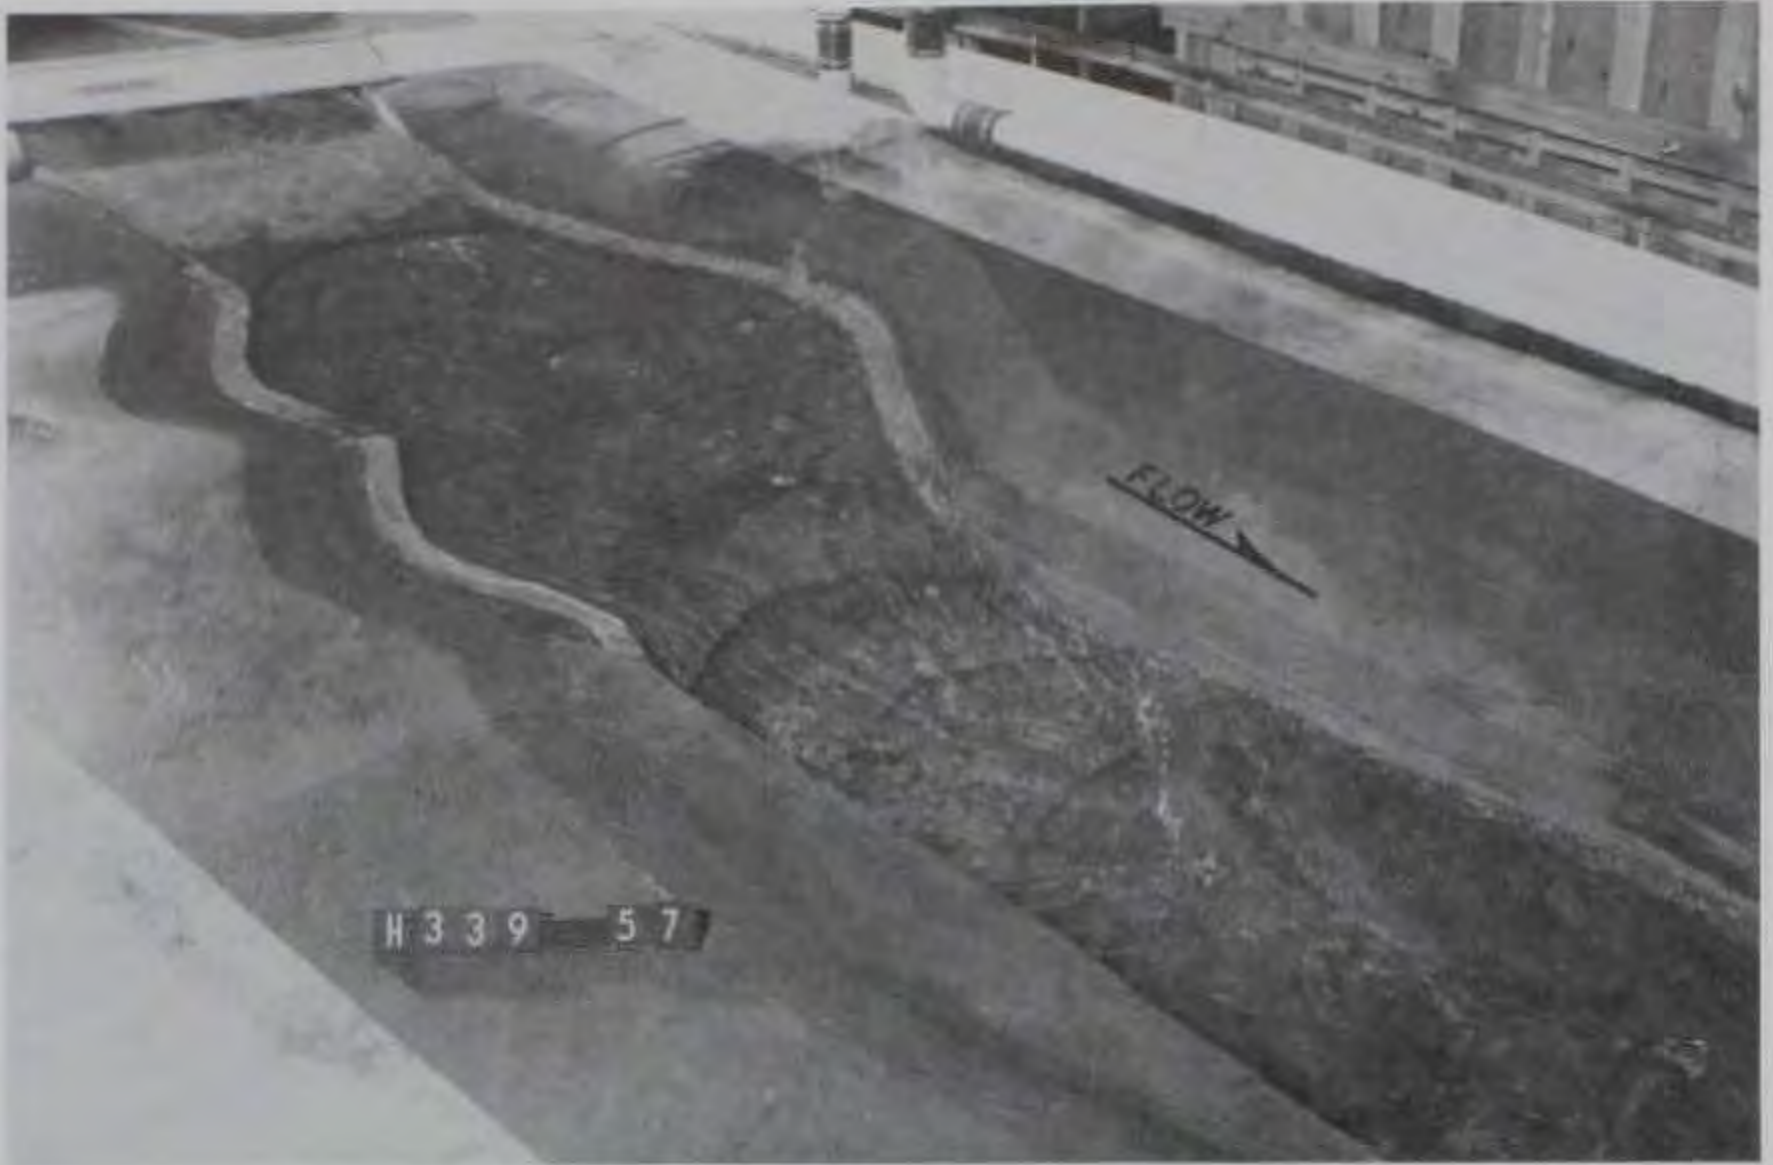
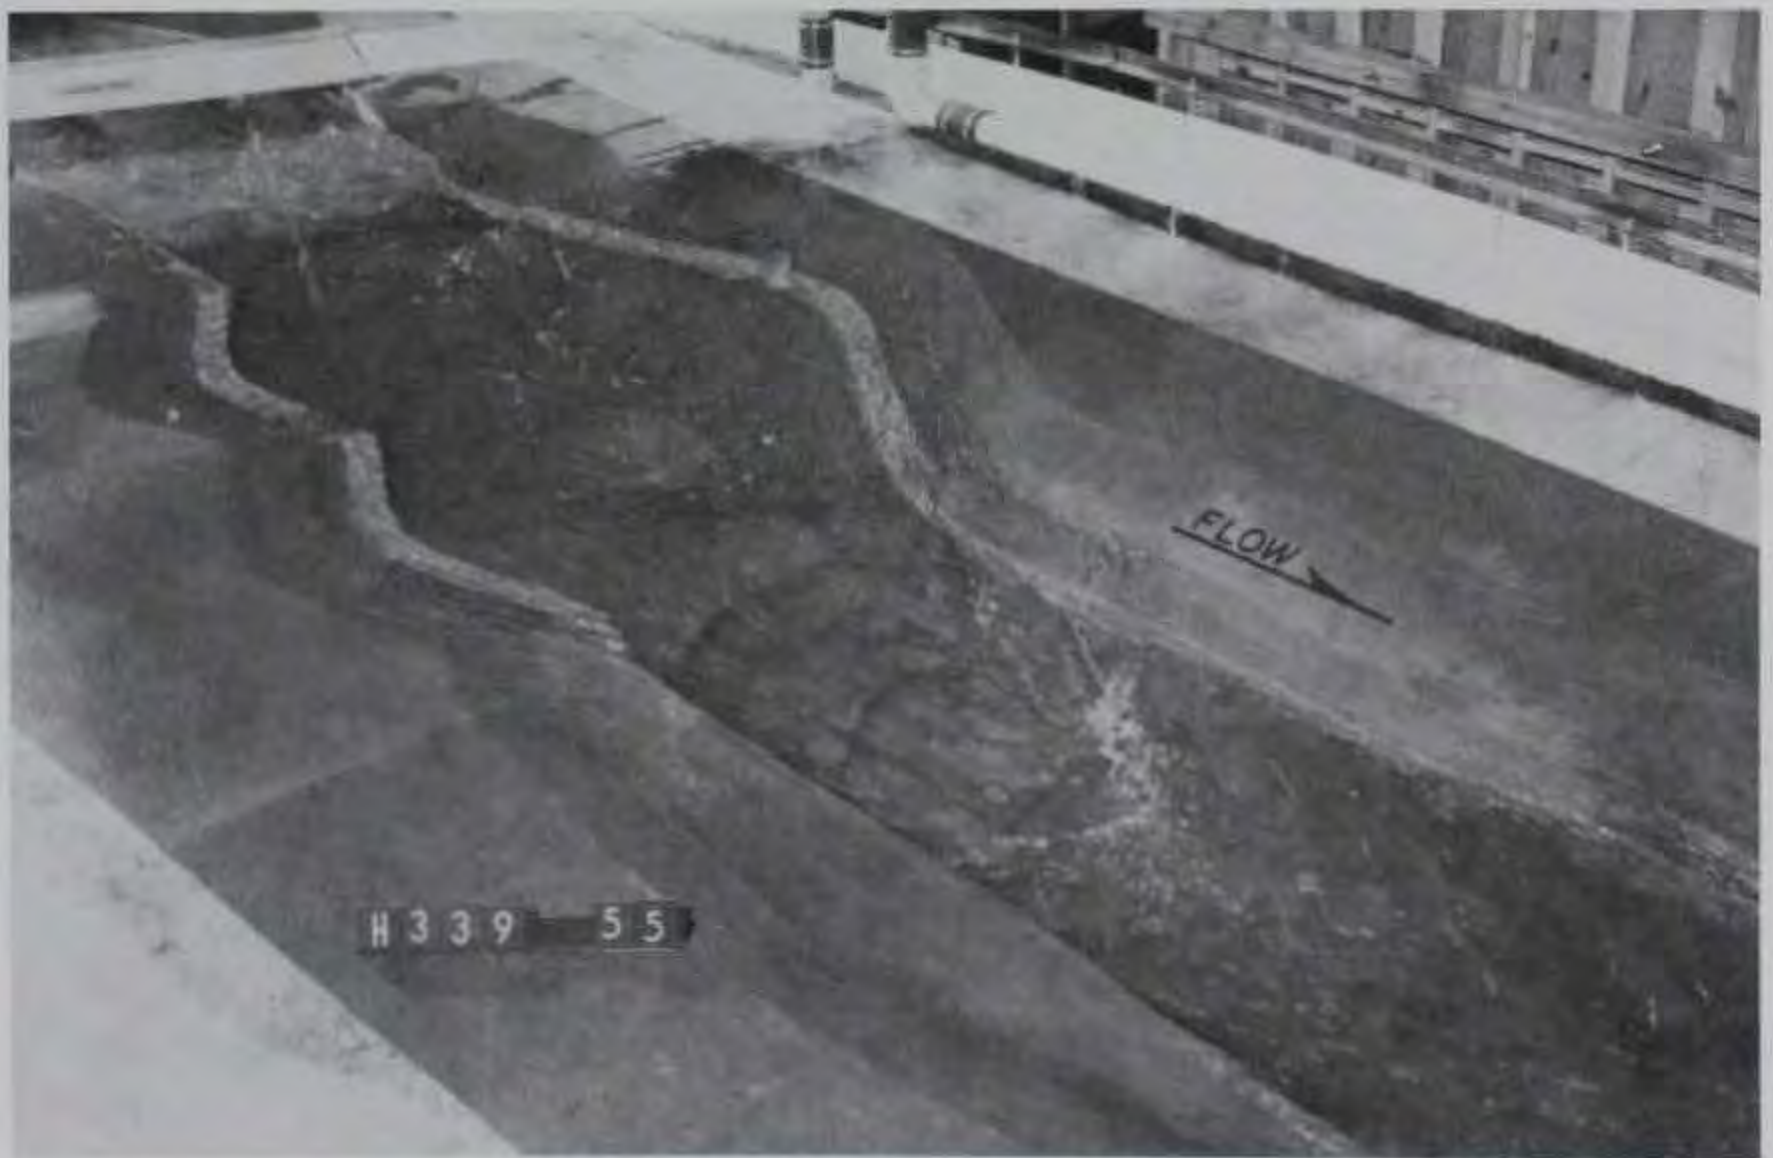
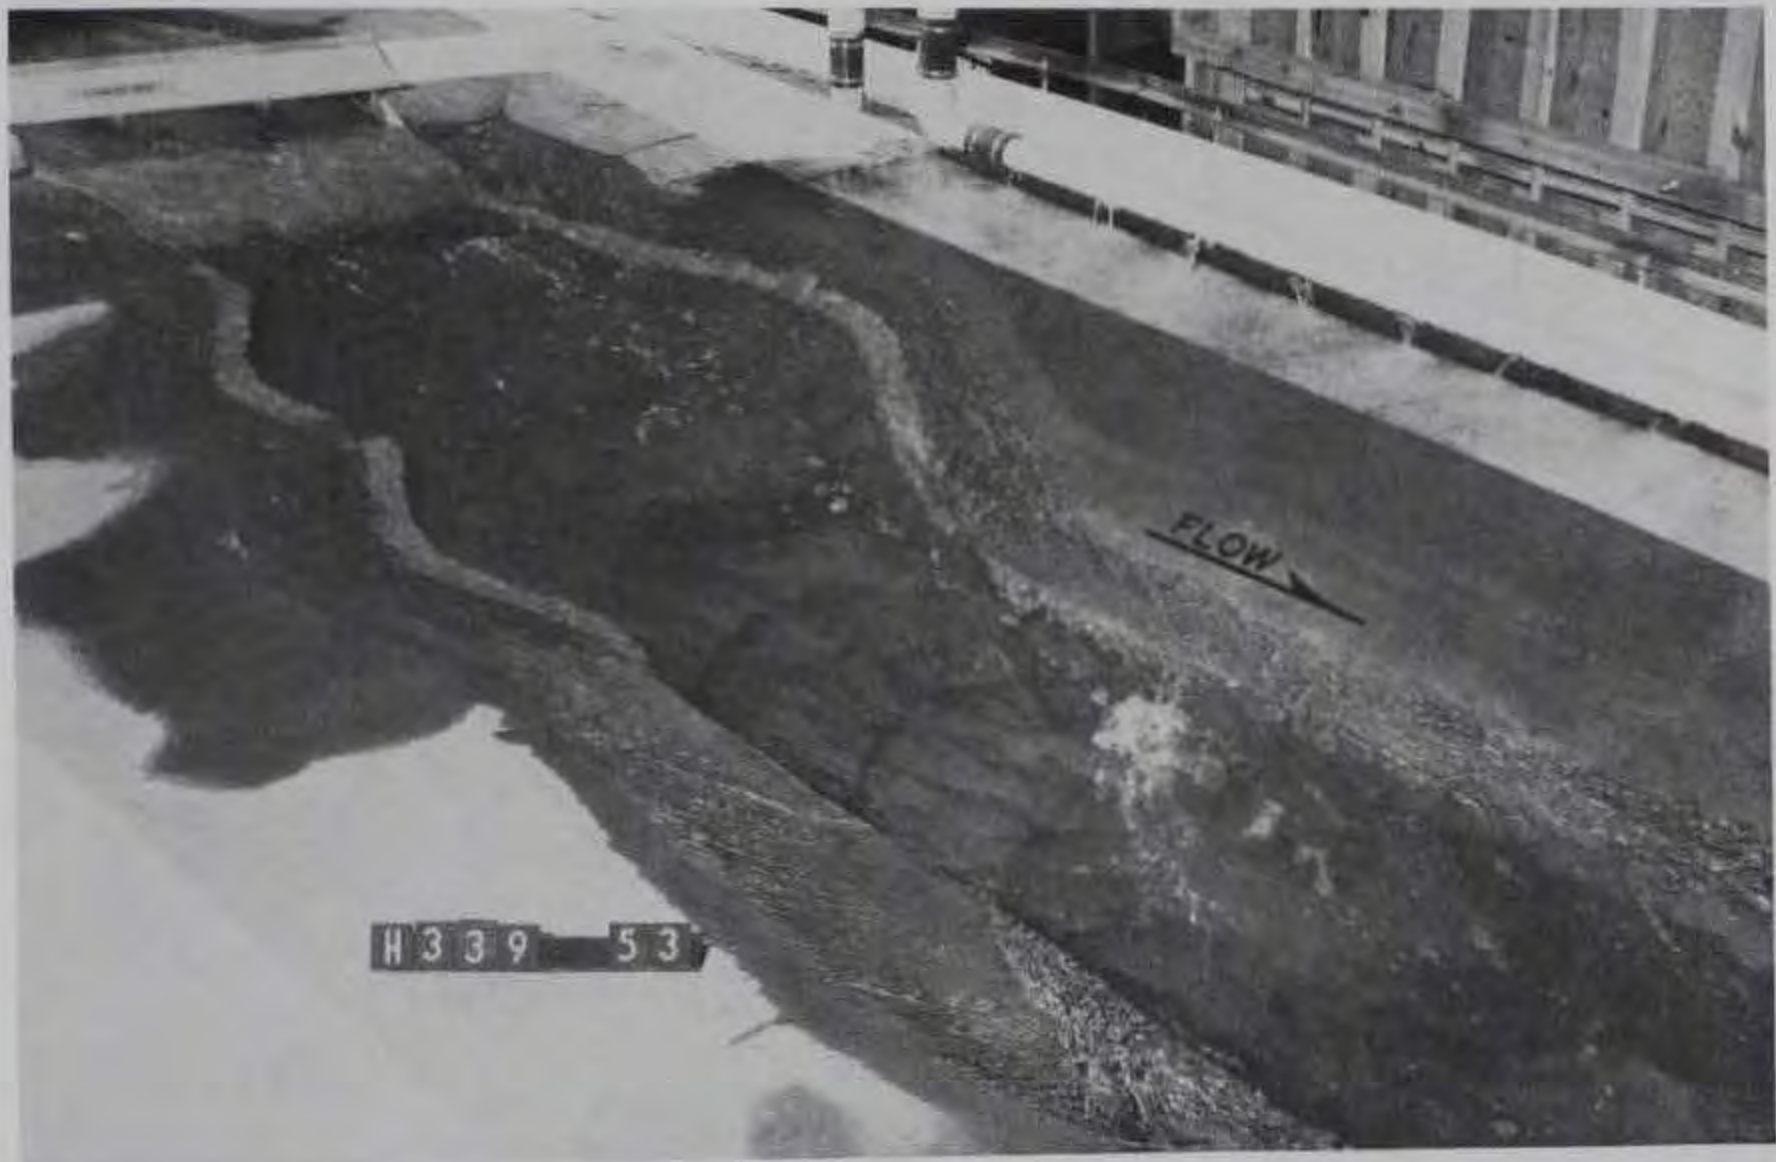
a. 10-year flood

b. 100-year flood

c. 500-year flood

Photo 51. (Concluded)

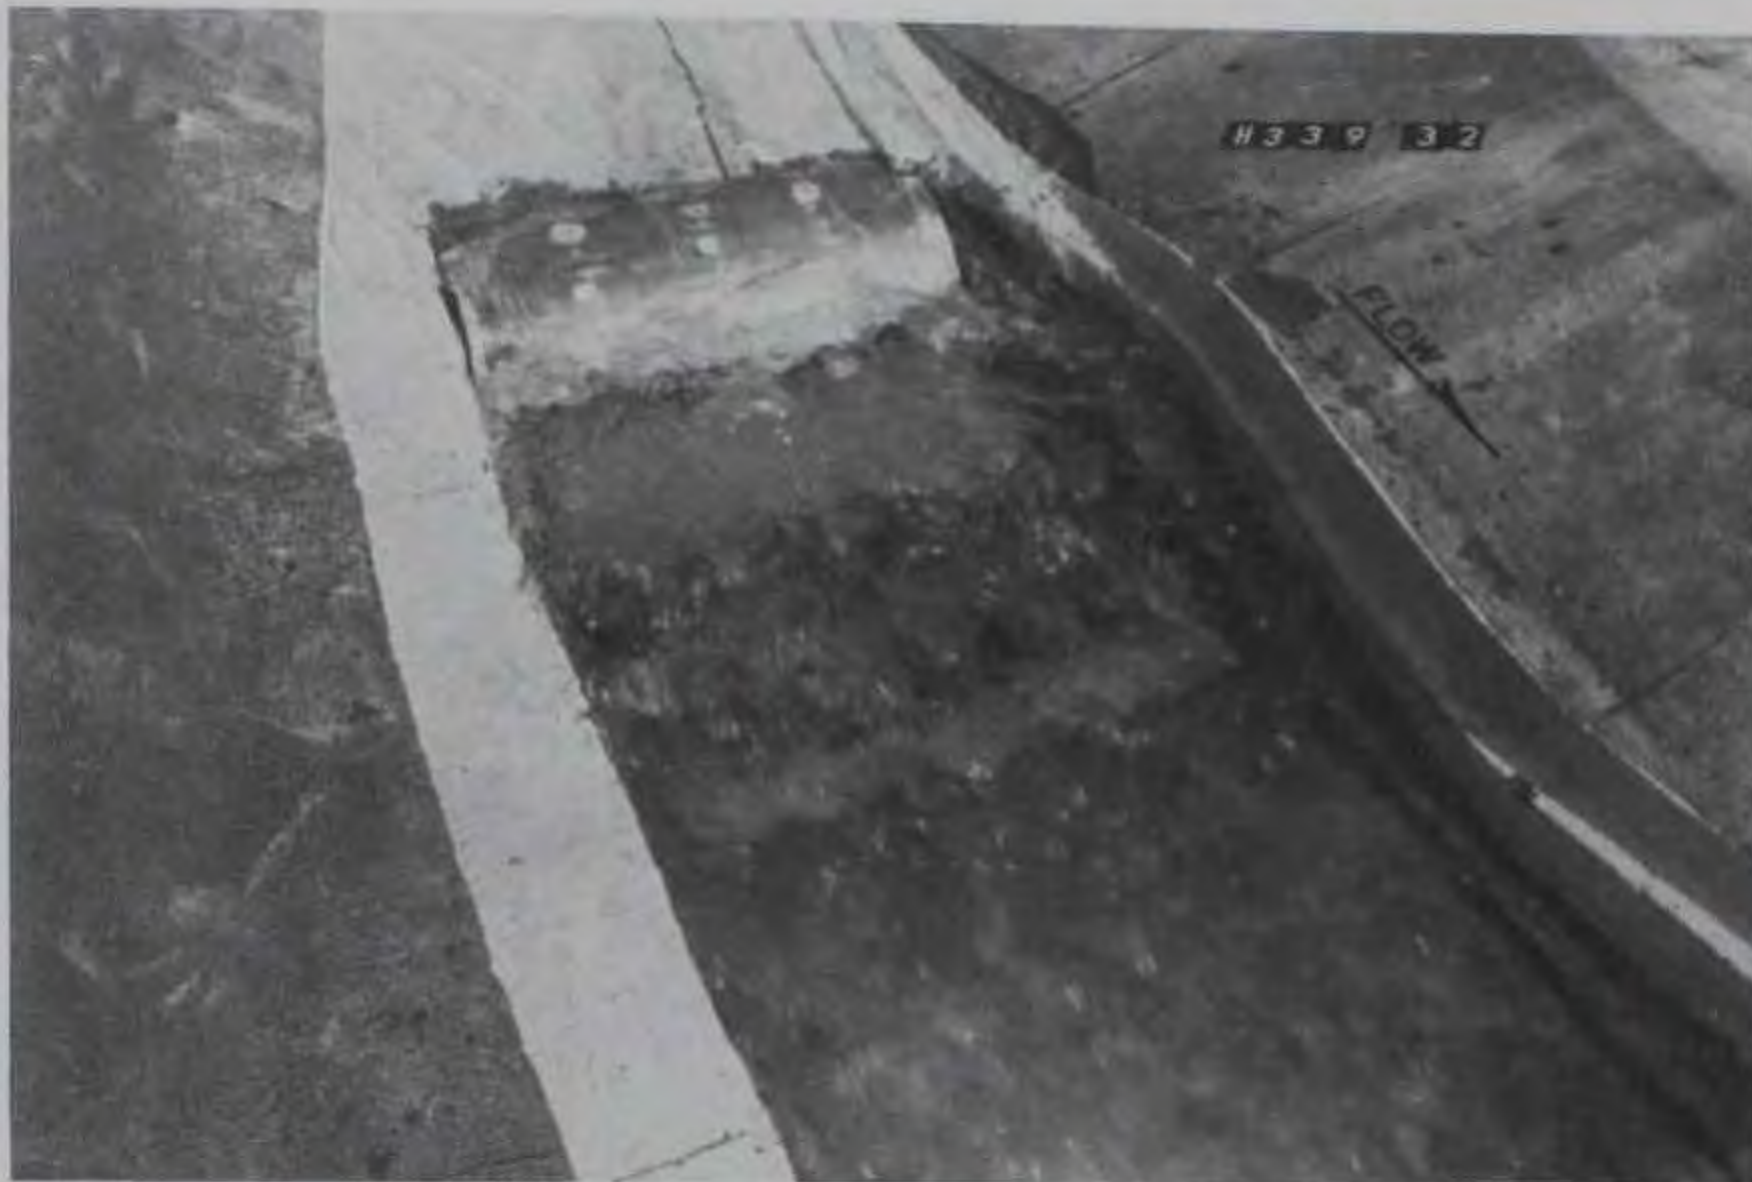
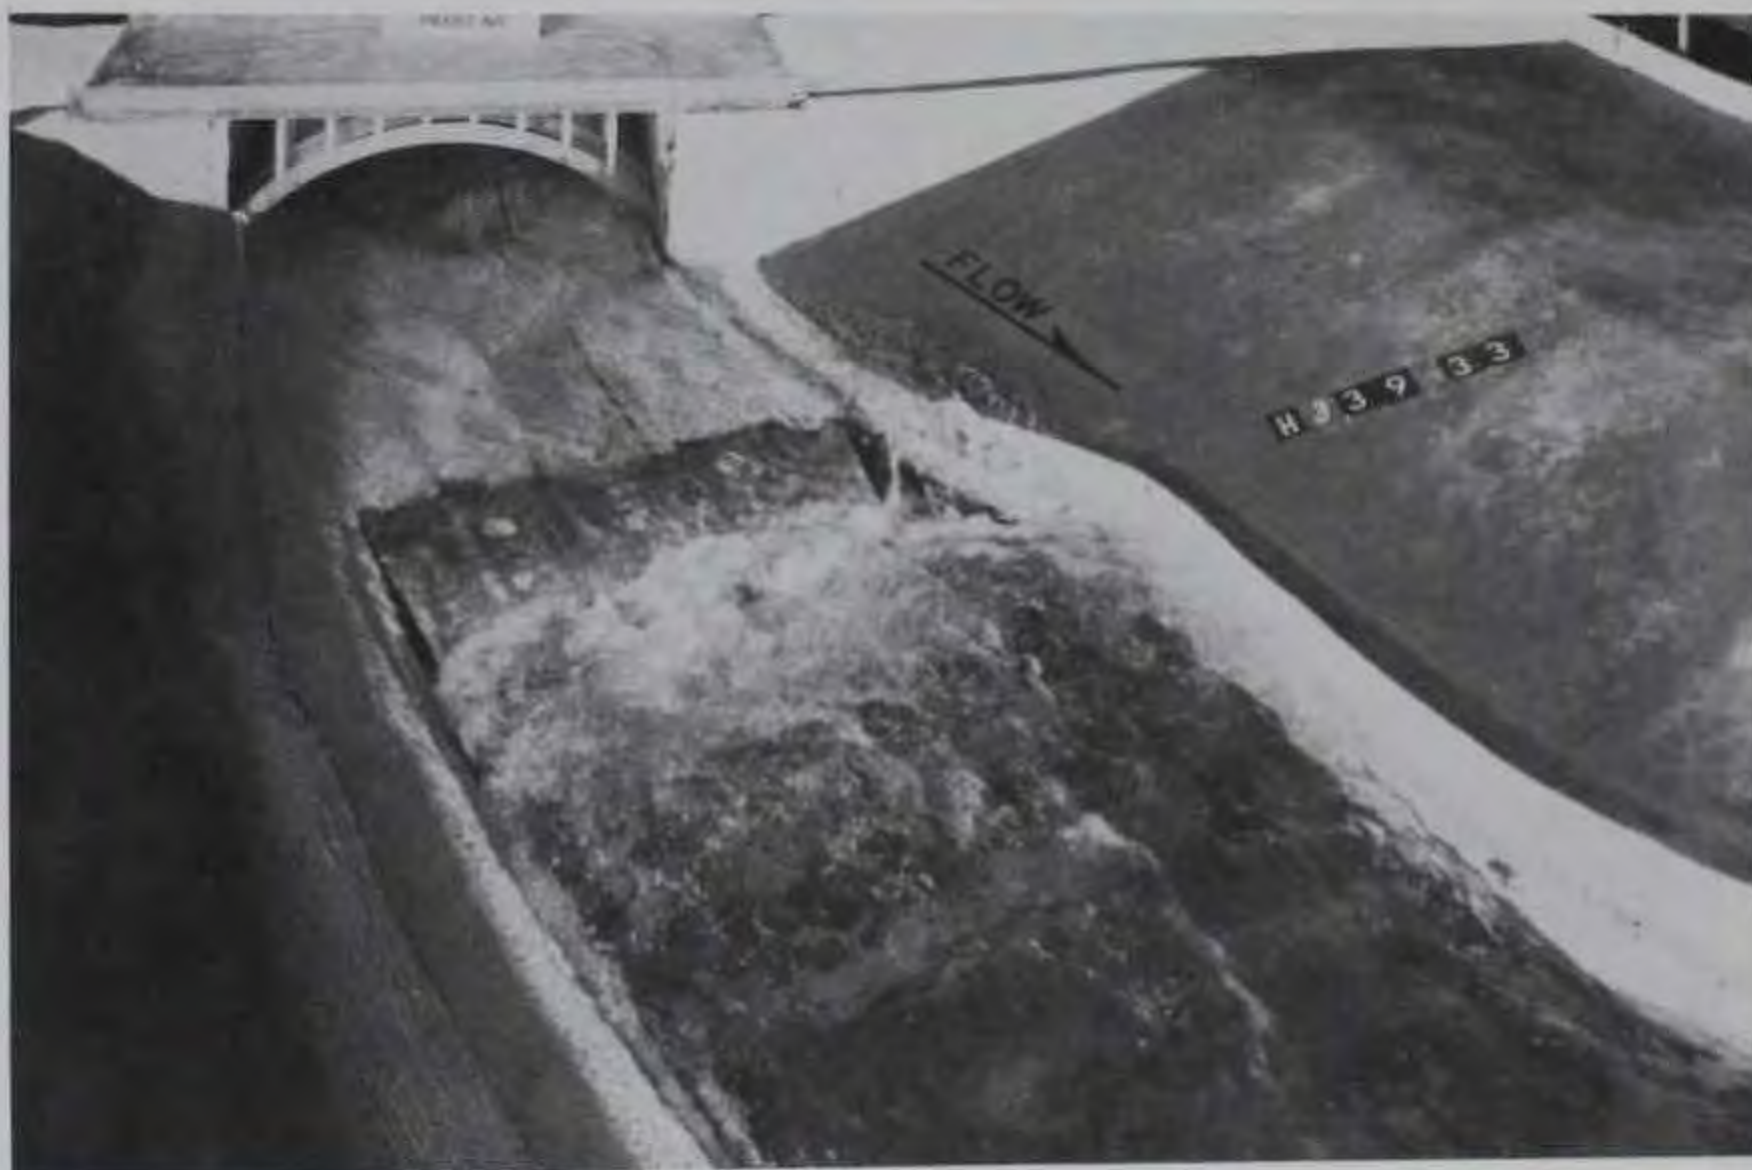
a. 10-year flood

b. 100-year flood

Photo 53. Flow conditions at drop 2, type 1 design stilling basin

73. Type 1 design. It was observed from the various tests conducted that a hydraulic jump will develop just downstream of Troost Avenue. Because of this, a drop structure was required in this vicinity to prevent excessive erosion from occurring. Due to the higher unit discharge in this reach and because of the narrow channel width (70 ft), a drop structure identical to the Roanoke drop structure would not perform satisfactorily. The type 1 design drop structure (Photo 52) was designed for a width of 70 ft and a unit discharge of 287 cfs/ft (100-year flood). Based upon experience gained on the Roanoke drop structure, the Troost drop structure was designed with the longer $X^2 = 4HY$ parabolic trajectory. Details of the type 1 design are shown in Plate 20. Flow conditions with the type 1 design are shown in Photo 53.

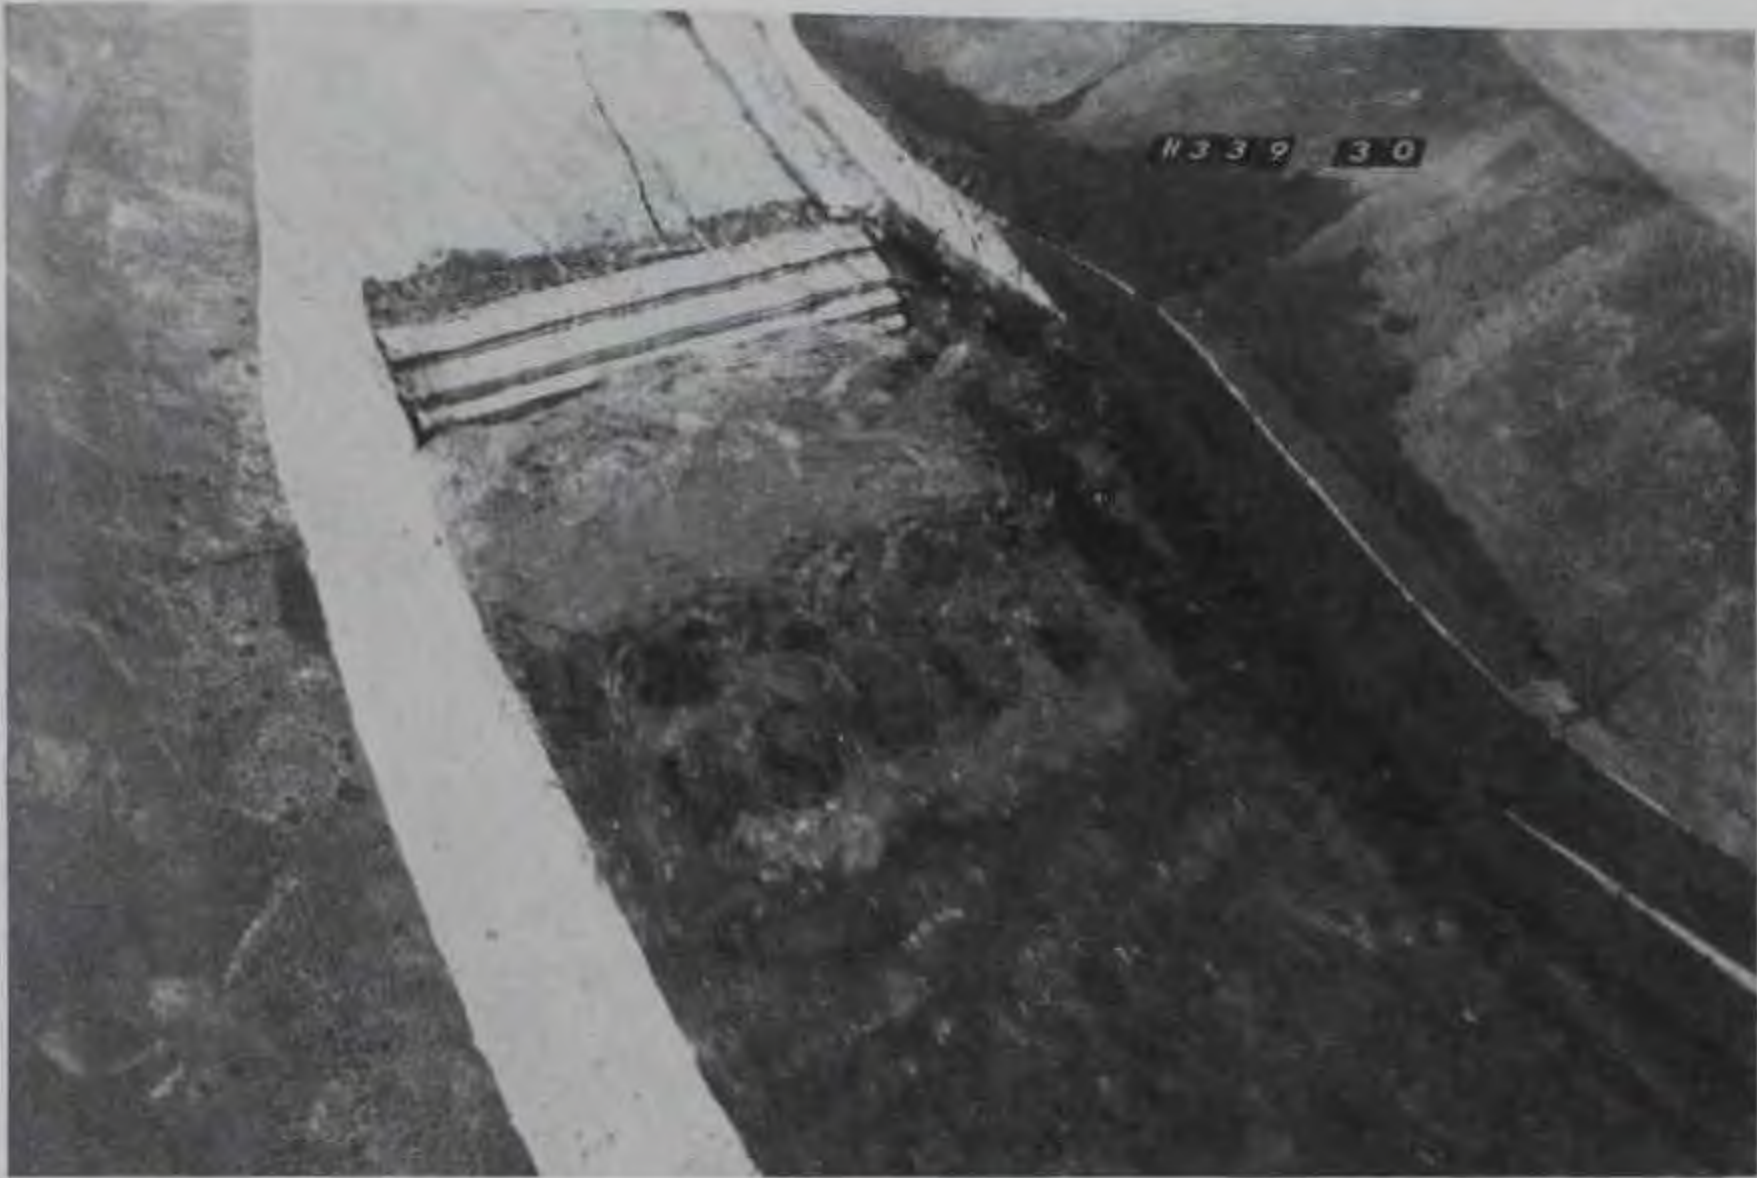
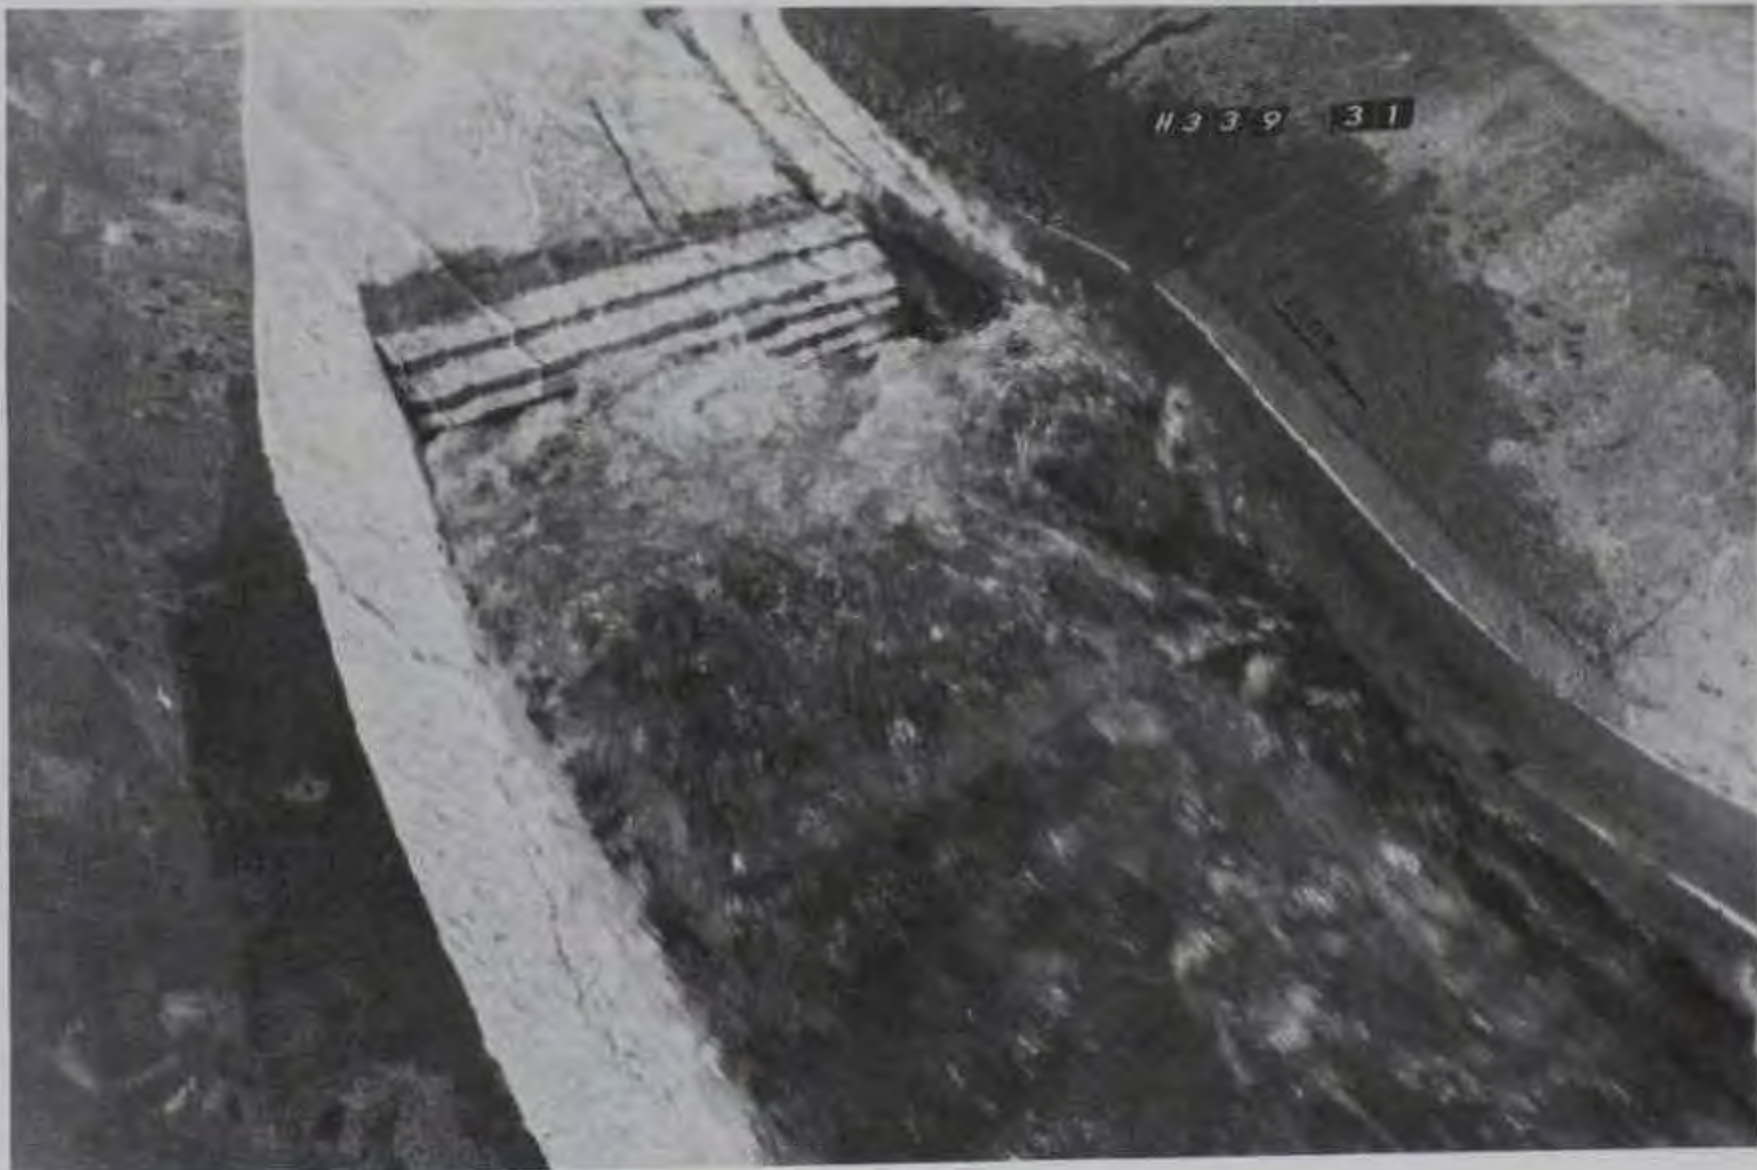
a. 10-year flood

b. 100-year flood

Photo 55. Flow conditions at drop 2, type 2 design stilling basin

74. Type 2 design. The type 2 design (Photo 54) used a stepped trajectory instead of the parabolic trajectory for reasons stated in paragraph 70. Details of the type 2 design are also presented in Plate 20. Flow conditions shown in Photo 55 indicate satisfactory performance and effective energy dissipation. Therefore, the stepped trajectory can be safely used.
